EARTHQUAKE IN ROMANIA MARCH 4, 1977

An Engineering Report

National Research Council
and
Earthquake Engineering Research Institute

Glen V. Berg, University of Michigan, Ann Arbor
Bruce A. Bolt, University of California, Berkeley
Meté A. Sozen, University of Illinois, Urbana
Christopher Rojahn, U.S. Geological Survey, Menlo Park

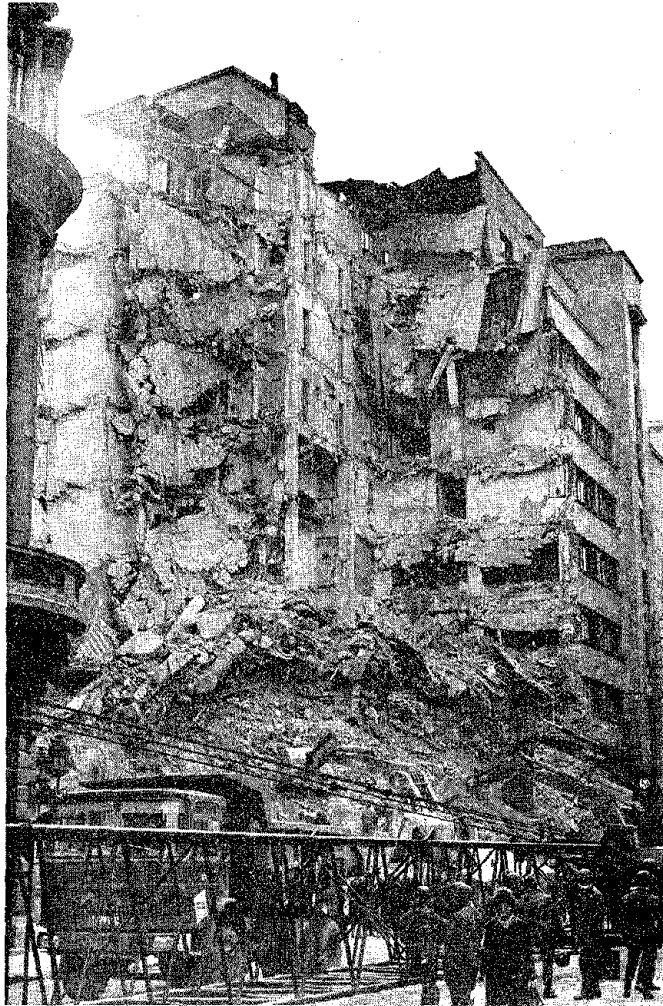
Figure 16 Collapsed building constructed prior to the 1940 Romanian earthquake.

Most of the earthquake damage was concentrated in the city of Bucharest. Thirty-five buildings collapsed, most of them near the heart of the city. Figure 16 shows one collapsed structure, and the street map of Figure 6 locates many of them. All but three of the

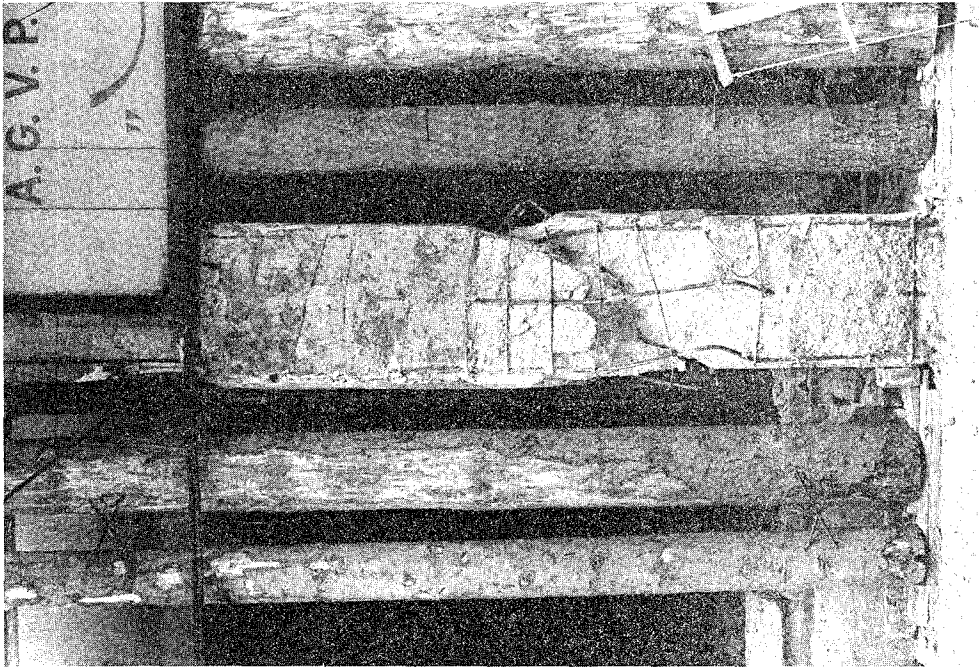
Figure 18 Column in open ground story of tall building designed and constructed before the 1940 Romanian earthquake.

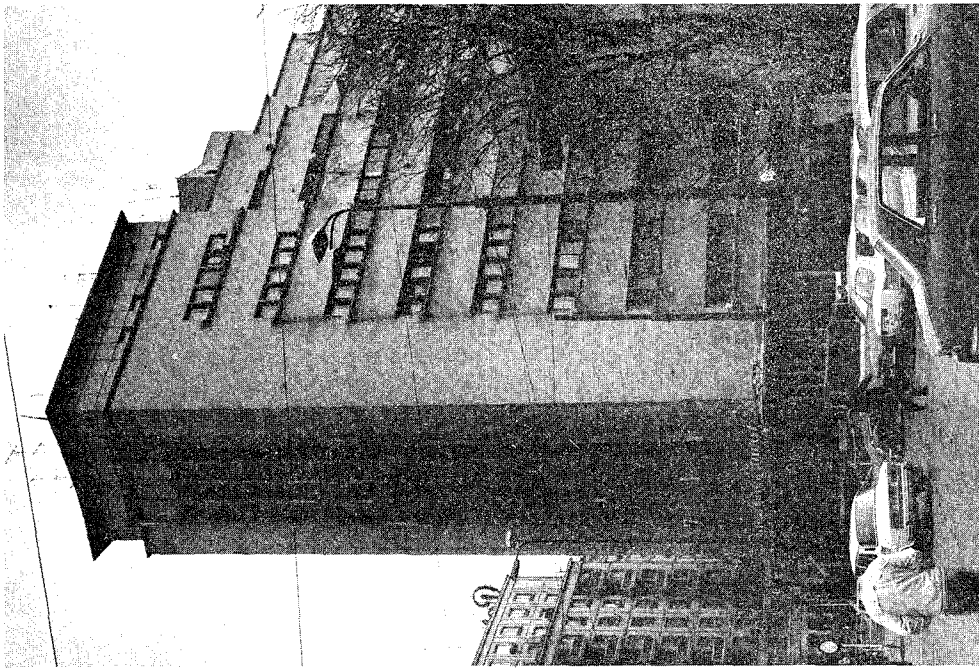
Figure 17 Apartment building with soft ground story designed and constructed prior to the 1940 Romanian earthquake.

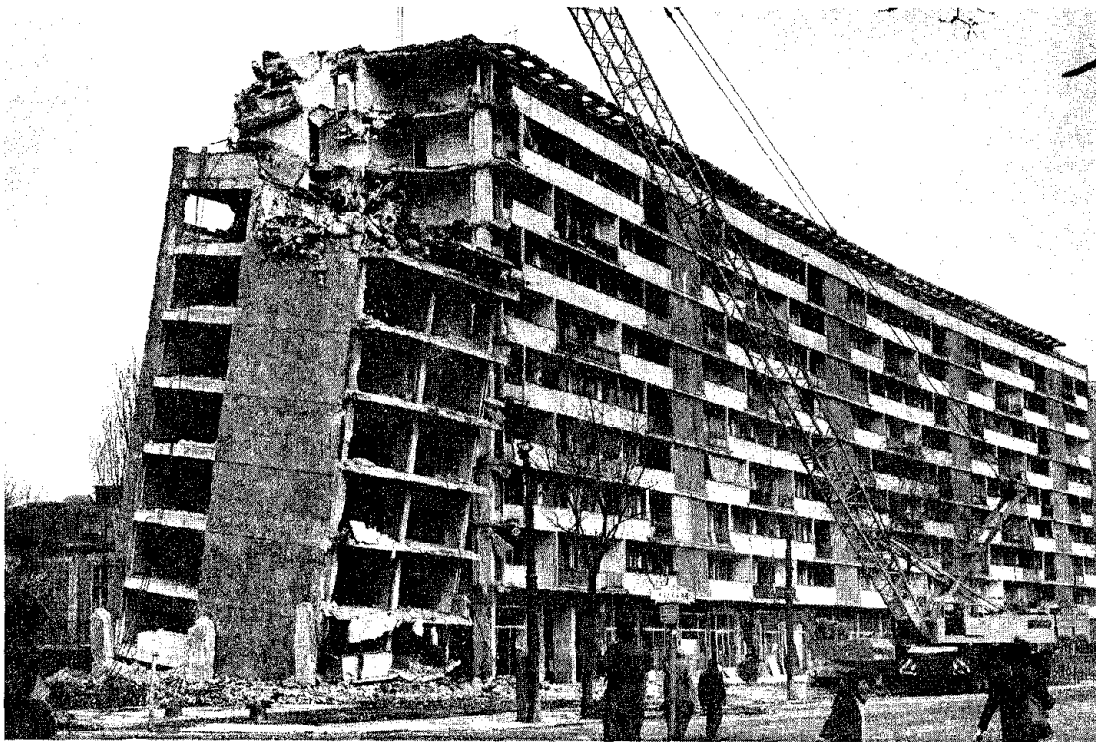
The three exceptions to good behavior of modern buildings were the collapsed computing center, a three-story flat slab building discussed in more detail later, and two apartment buildings away from the center of the city. One of the apartment buildings collapsed completely and had been removed within a few days after the earthquake. Another new apartment building (Fig. 19) collapsed at one end, where trouble had been encountered with the foundation and some underpinning work had been done. The foundation problems and the partial collapse were probably related.

Figure 19 Partial collapse of new apartment building.

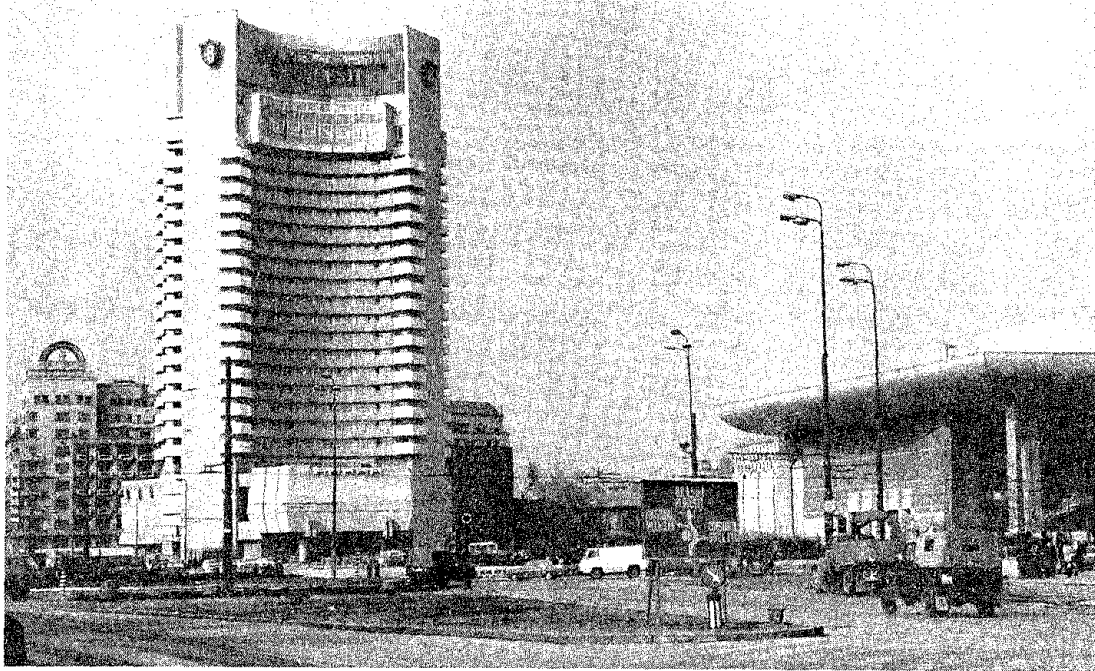
Figure 20 Inter-Continental Hotel.

The Inter-Continental Hotel (Fig. 20) is probably the best known modern building in Bucharest, at least to Americans. It is a reinforced-concrete frame and shear-wall structure, shaped in plan like an equilateral triangle with blunt vertices and concave sides. It was apparently designed as a symmetric building, without regard to torsion coupling, whereas in fact that three vertical planes of symmetry are 120 degrees apart and torsional response is strongly coupled with translational response other than in a plane of symmetry. Damage to the building was insignificant, consisting mainly of partition cracks and plaster damage.

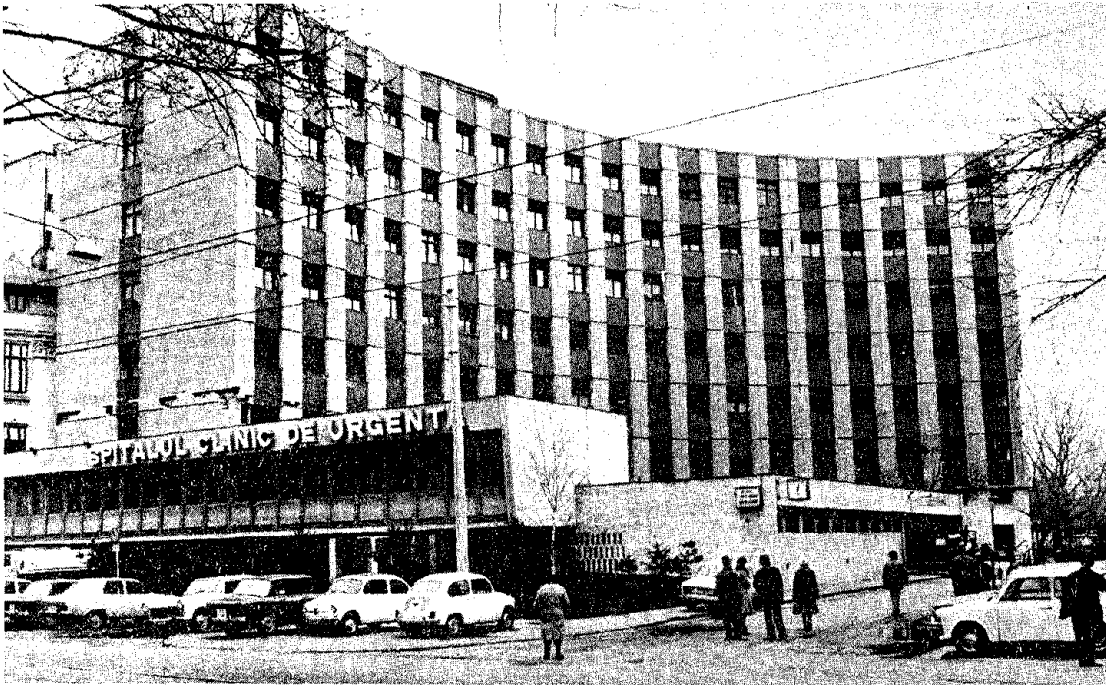
Figure 21 Emergency Hospital.

The Emergency Hospital had 635 occupied beds before the earthquake, and 600 additional patients were admitted immediately after the earthquake. At 4:00 a.m. on March 5, 1977, the hospital was ordered to be evacuated. Evacuation took over 3 hours. The building was constructed in 1970 with a relatively flexible reinforced-concrete frame. The tower (Fig. 21) is in the shape of a C. The end bents and columns of one end of the tower portion were severely damaged during the earthquake. A nonbearing masonry end wall fell out at the second and third stories (Fig. 22). Many medical supplies were lost, including water. The power was interrupted, but the hospital's emergency generator picked up the electrical load for the building. Elevators were not used after the earthquake struck. Moderate architectural damage occurred in the functional areas of the hospital.

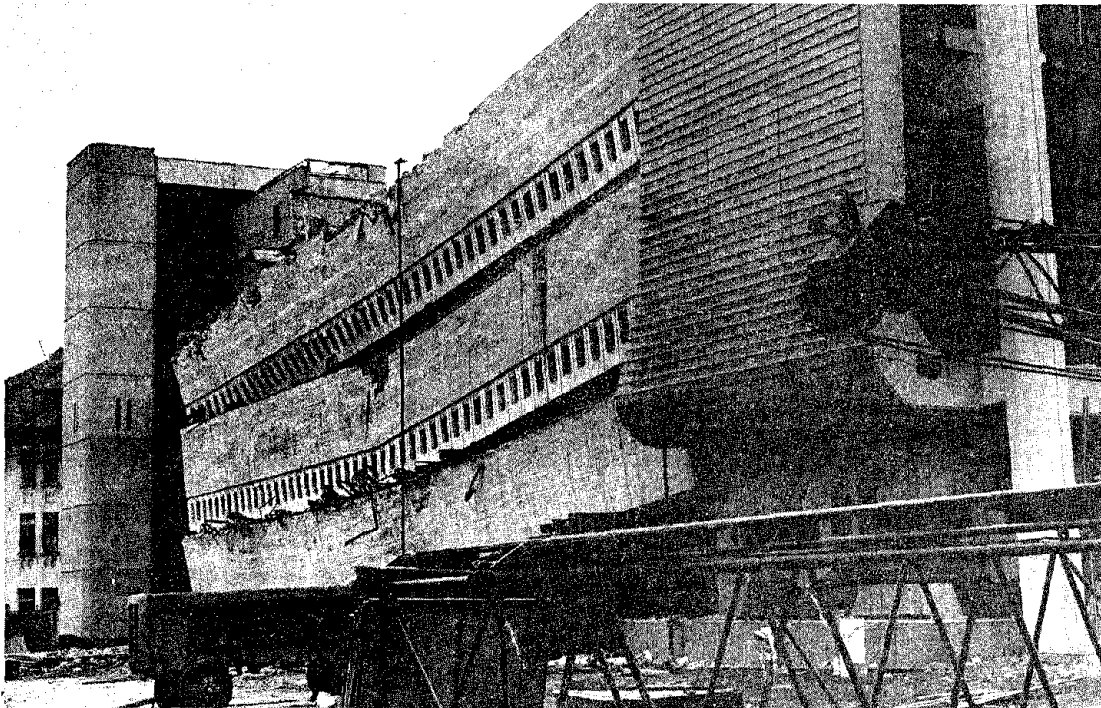
Figure 24 Collapsed computing center.

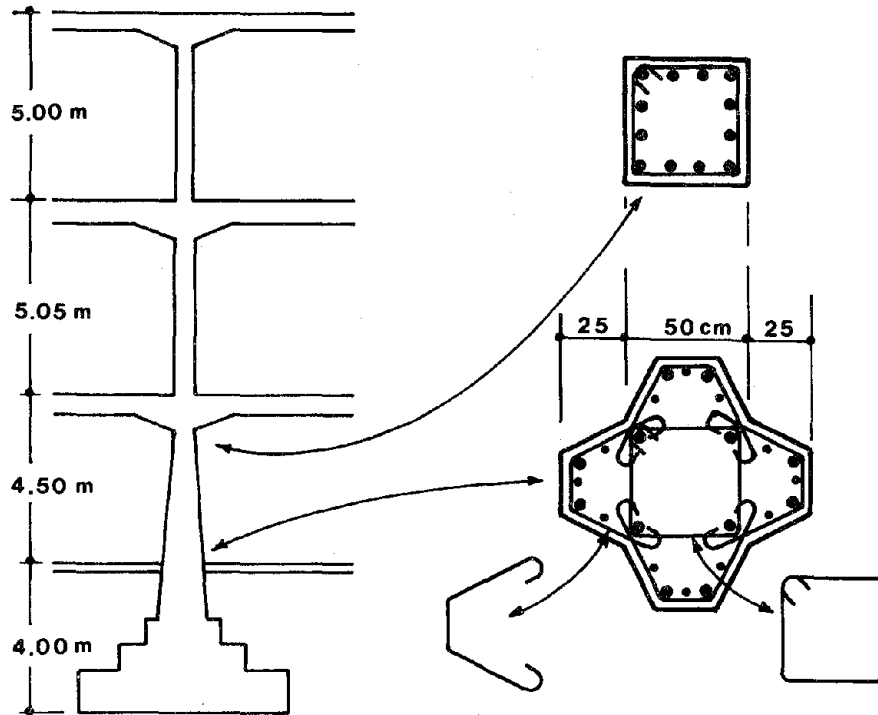
Figure 26 Computing center, typical column and slabs.

Figure 26 is a schematic diagram showing a typical column and floor and roof slabs. The roof slab was 45 cm thick and the floor slabs 55 cm. They were of cellular construction, with 6-cm cover

slabs top and bottom and 20-cm-wide ribs spaced 1.2 m center to center in both directions. The floor and roof slabs were designed as T-beams in both directions. Column capitals dropped 40 cm below the overhead floor or roof slab at each column.

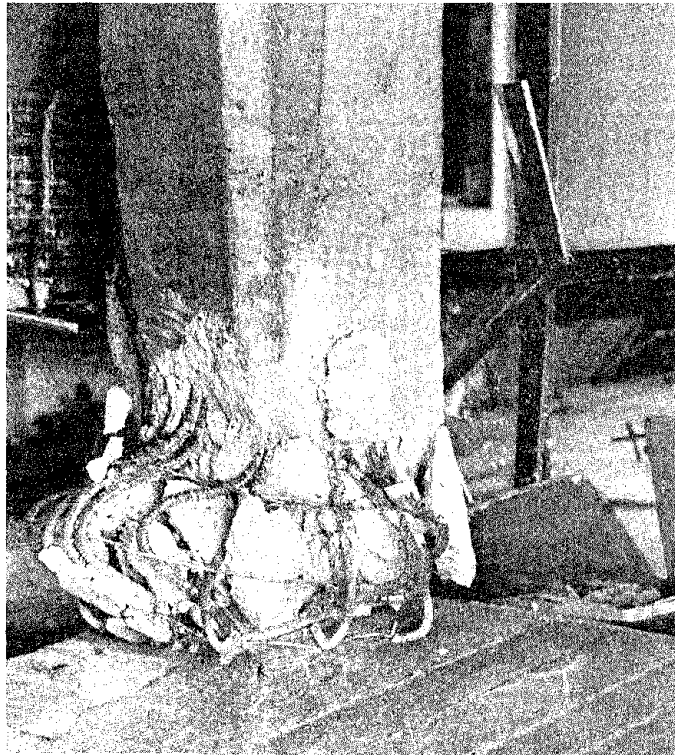
Figure 27 shows the failure of one of the ground-story columns. Some of the buckled vertical bars can be seen outside the visible

Figure 27 Computing center, column failure in ground story.

ties. Every one of the ground-story columns failed; the one shown in Figure 27 is the least damaged of the lot. All except the central column failed at the top in the manner of the column shown in Figure 27, but worse. The central column may have failed elsewhere; it was squashed nearly flat and could not be examined.

Columns in the upper stories were square and prismatic. They too had failed, nearly all of them at the top. It seems likely that the ground-story columns failed first and the upper-level columns failed when the building fell.

The main building was structurally separated from the service towers, and nearly all of the lateral stiffness of the main building derived from the columns. If only column stiffness is considered, the column bases are treated as fixed, and the floors are taken to be rigid, then the three modes of vibration and their periods are as shown in Figure 28. Thus the fundamental mode period for this idealization is in the range of very strong spectral acceleration for both horizontal components of the ground motion recorded in Bucharest. Any flexibility of the floor system or column footings, or any structural damage, would lengthen the period and put it in the range of even greater spectral acceleration. The exterior walls were of virtually no benefit because they were isolated from the ground-story columns and contained a band of steel window sash in each story, which separated them structurally from the story above.
