DESTRUCTIVE EARTHQUAKES IN BURDUR AND BINGÖL, TURKEY - MAY 1971

report and recommendations

W. O. Keightley
Montana State University

1975

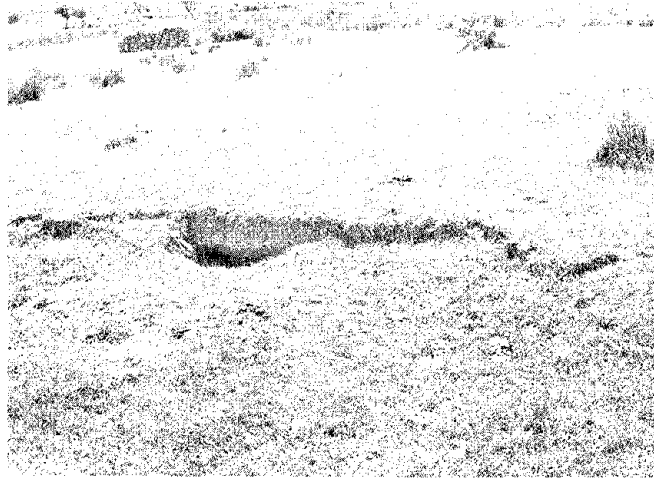
FIGURE 10 Close view of ground breakage on the Burdur Lake plain about 14 km southwest of Burdur. Some earth has been removed from one side. The lake side of the crack is downthrown, supporting the idea that the lake results from graben action.

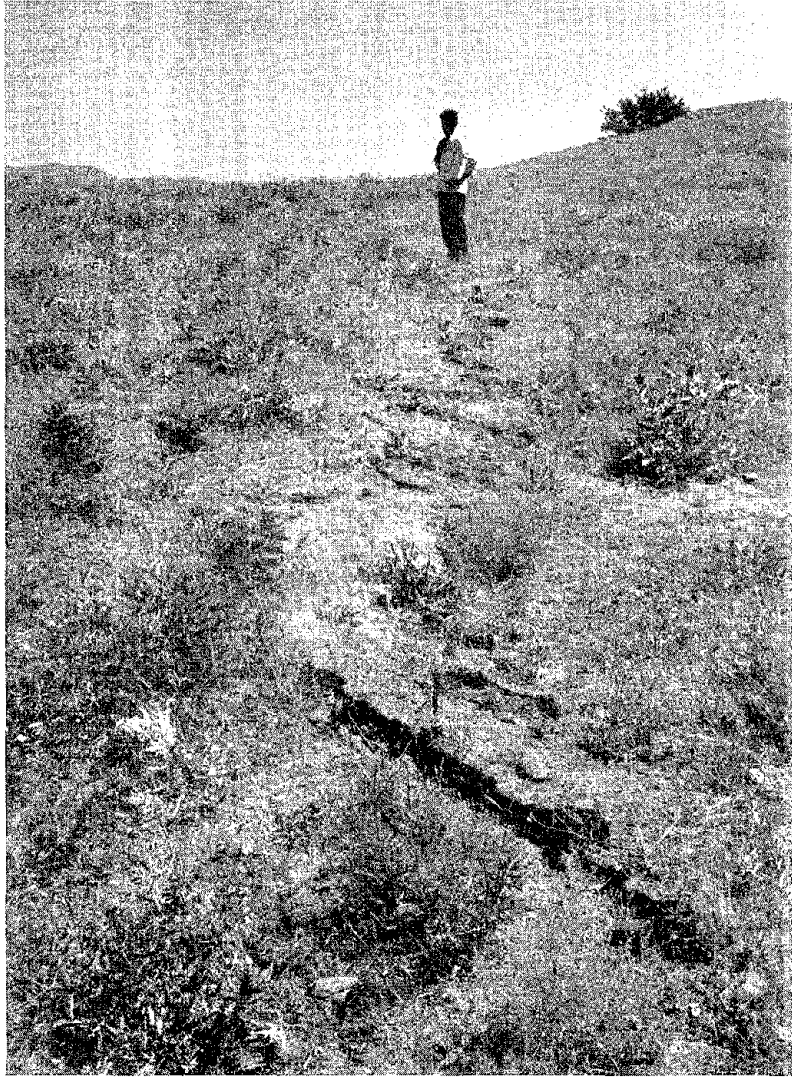
In general the broken ground was within a zone from six to twenty feet wide, trending $N10^{\circ}$ to $20^{\circ}E$, with sometimes one side downthrown by a few centimeters, sometimes the other. Cracks at 20° or so to the direction of the trace consistently indicated left lateral strike, although no markers could be found from which to definitely measure slippage, estimates of which varied from zero to 30 cm at different places. Near the village of Çeltiksuyu the crack crossed some low hills, where it sometimes temporarily disappeared, then reappeared shifted laterally by several meters. At one place the two main cracks bounding the cracked zone came together, and appeared to cross each other, forming an X-shaped crack. Figure 12 shows a part of the ground breakage.

FIGURE 12 Ground breakage near Çeltiksuyu village, where the crack left the Göynük River bottom and traversed some low hills.

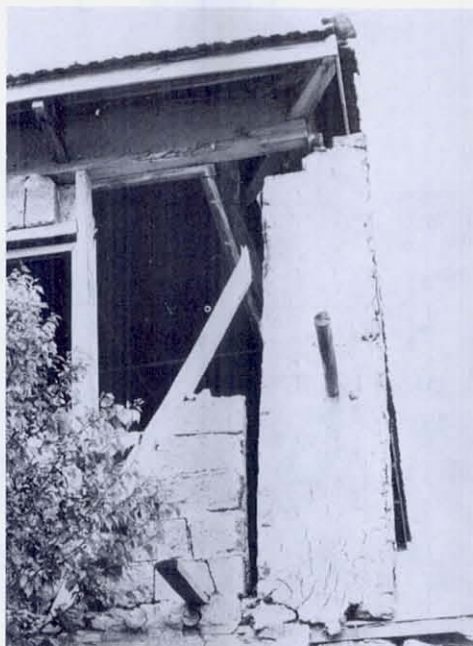
FIGURE 16 A common mode of failure of adobe houses in the Burdur region was the separation of exterior wall corner joints, permitting walls to tip outward. Often a wall was braced perpendicular to its plane by embedding a piece of wood at eye level in the adobe, then installing a diagonal brace from this to the floor. Usually only one or two nails were used, loaded in tension when the joint tried to open. It was always observed that the nails pulled out or broke through the diagonal; in no case was the embedded wood pulled loose.

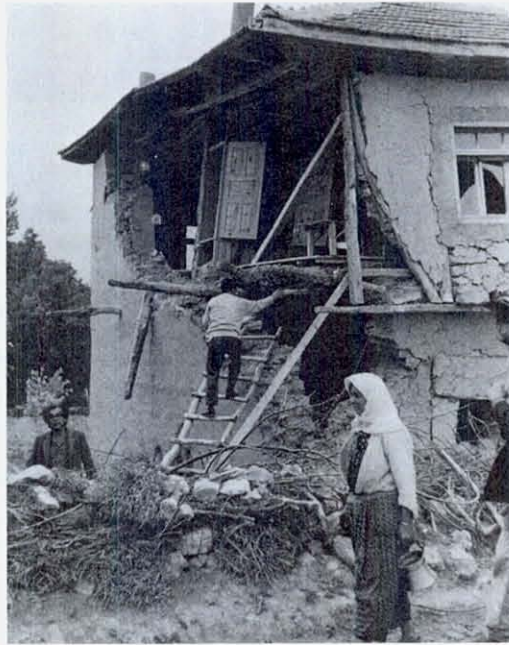
FIGURE 17 Temporary wood braces have been installed to prevent further collapse of this adobe house in Yaziköy, Burdur. In the second story the side wall and the front wall appear to have had no connection. First story walls are probably tied to each other only with interlaced adobe bricks. Is there a relationship between failure of the lower corner and failure of the second story side wall? (Photograph courtesy of Prof. Asim Yeginobali)

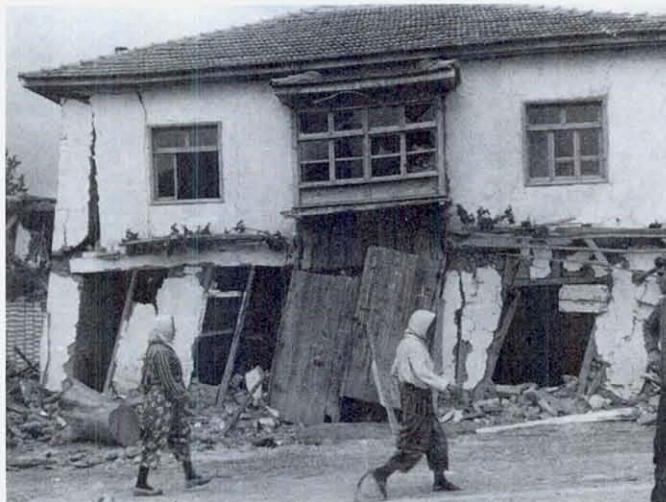
FIGURE 18 This two-story adobe house, on the verge of collapse, contains lateral bracing in the first story. The 60-cm thick walls with wood posts around the windows appeared very strong to the builder, but proved quite inadequate under lateral loading. The front wall in the second story, probably braced like the house in Figure 17, remained rigid, but could not save the building. (Photograph courtesy of Prof. Asim Yeginobali)

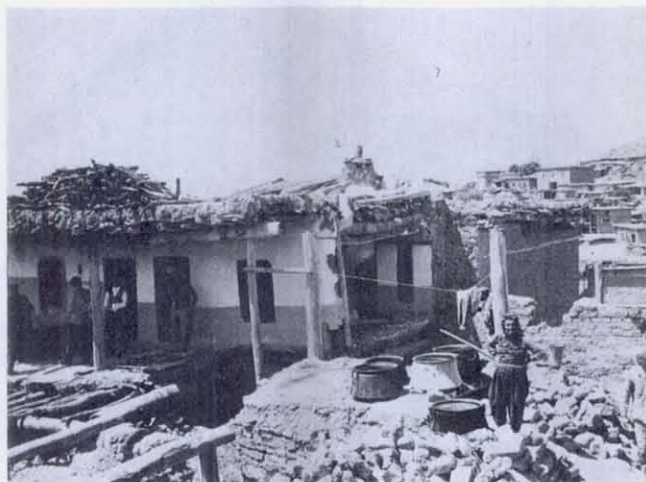
FIGURE 19 This type of construction, in Askeriye, near Burdur, is common in villages on sloping ground. One- and two-story houses are intermingled, the roofs of the one-story houses serving as working platforms. One can easily imagine that when an owner needs more living space, he simply lays up more adobe walls on top of the first story. The tremendous weight and fragility of such structures is frightening.

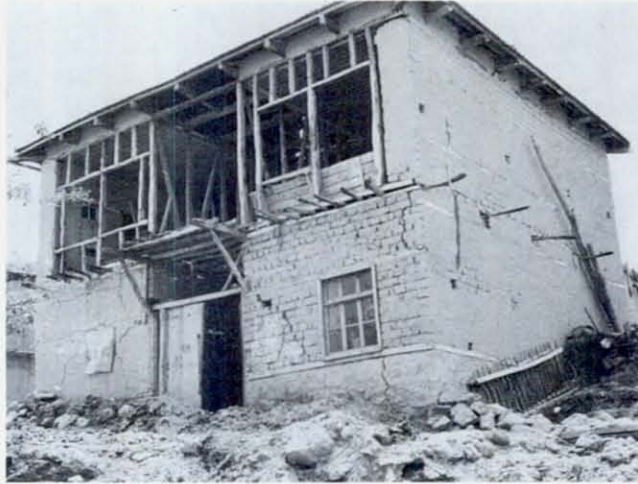
FIGURE 22 This house under construction in Yaziköy, Burdur, has diagonal bracing in upper interior walls, but none in the front wall. Perhaps the hip roof, a rather rigid construction, held the second story walls together. First story adobe walls, without diagonal bracing, are heavily cracked. Mud plaster covers the adobe on the left side.

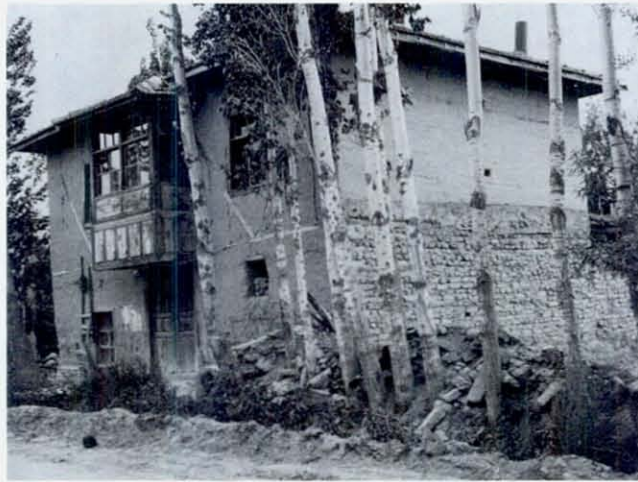
FIGURE 23 This two-story adobe house in Yaziköy, 20 km SW of Burdur, survived, although 193 out of 250 houses in the village collapsed or were heavily damaged. Poplar trees, as seen here, are commonly planted in the villages for fuel and lumber. Increased plantings of poplars and proper instruction for their use in building braced frames in houses would reduce earthquake fatalities.

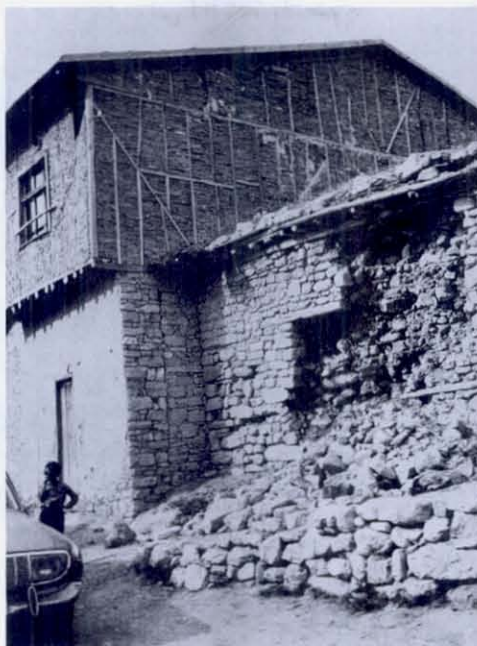
FIGURE 24 In the village of Kisla, near Burdur, a region of light shaking, the face of a stone wall laid in mud mortar has fallen due to lack of long stones to tie the faces together. This mode of failure is not uncommon in thick stone walls. Next door the lightly braced second story of poorly laid brick appears to have lost one triangular panel of brick. As flimsy as it is, the wood framing probably supports the roof, but the brick walls contribute the greatest amount to earthquake load.

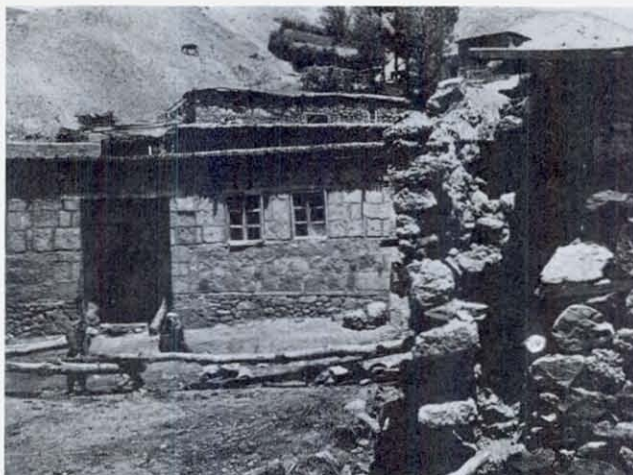
FIGURE 26 Most of the houses in Hacilar are one-story, of uncemented stone, with wood bond members built into the walls. In the foreground the bond members failed to hold the corner together. In the background the building with squared stones appears to be laid in cement mortar, but the mortar is on the surface of the joints only, and no mortar was observed inside the joints. The earthquake displaced some stones perpendicular to the wall and opened cracks between others. The villagers said the squared stones came from "ancient constructions."

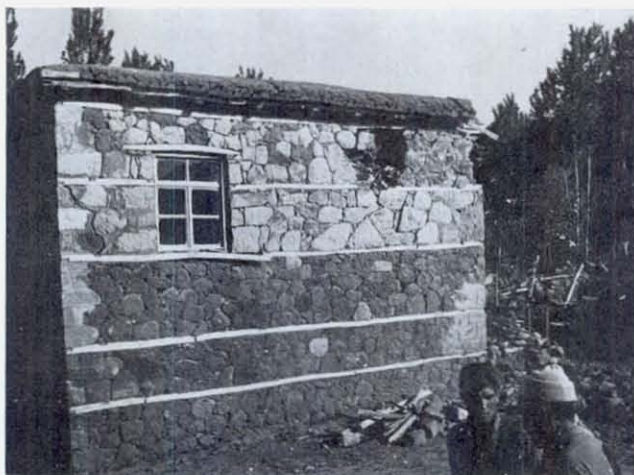
FIGURE 27 The beginning of disintegration of a stone, mud-mortar house in Ekinyolu. Note the corner cracks, perhaps inhibited by the wood bond members, and the falling out of the outside face of the wall near the roof. Under continued shaking the upper part of the wall would likely disintegrate, allowing the roof to fall in.

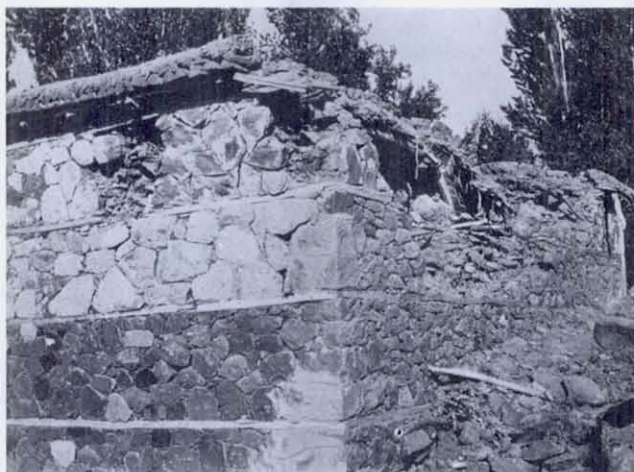
FIGURE 28 Another example of the early stages of failure of a stone, mud-mortar wall - falling out of the outer surface and collapse of the upper portion of the wall which is not tied by the roof beams. There is also some corner cracking.

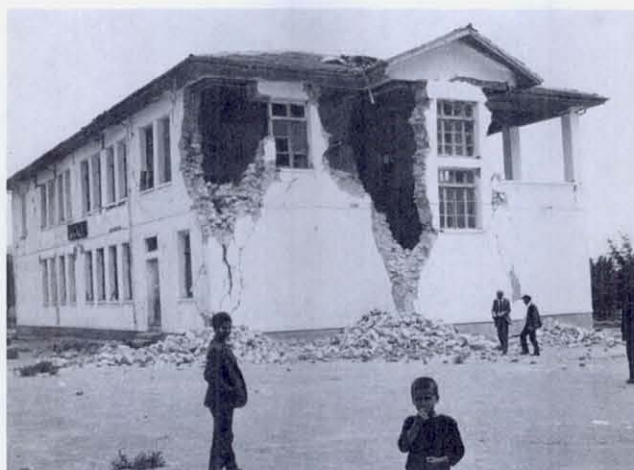
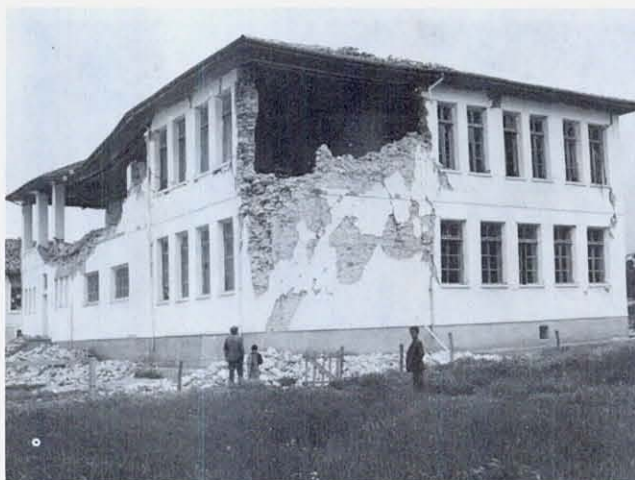
FIGURE 29 This 30-year old primary school in Hacilar, 22 km SW of Burdur, partly brick, partly coarse masonry, was laid in mortar which easily could be powdered in the fingers. Perhaps the nonsymmetry of the second story was responsible for the damage there being greater than in the first story.

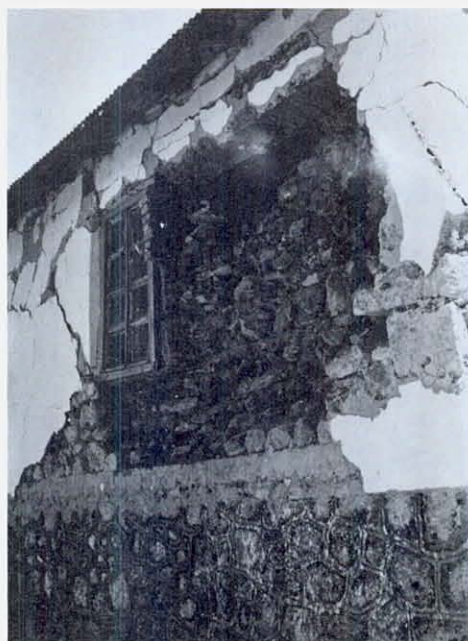
FIGURE 31 The foundation of the $1\frac{1}{2}$ -story school in Hacilar, in the Bingöl district, was laid in hard cement mortar, but upper walls were of rubble laid in weak mortar. Above the windows were a reinforced concrete collar beam and a roof of corrugated steel. No foundation damage was evident, but the rubble walls simply fell apart in places. The weakness of walls made of small stones which do not extend completely through the walls, laid in poor mortar, is obvious.

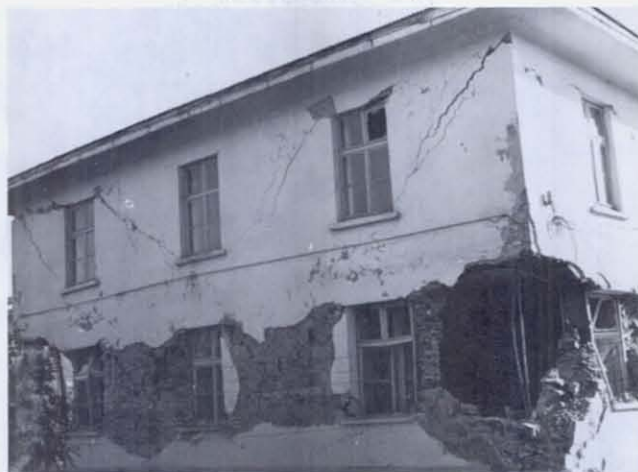
FIGURE 32 End view of a damaged wing of the government building in Bingöl. Cracking in second stories was unusual in Bingöl. Note the cracks seem to start (are widest) at the corners of the building, at the top, where dead load compression is least. Cracks of x-shape occurred in the first story, but cracks were only in one direction in the second story. Perhaps under continued shaking, x-cracking would have occurred in the upper story, resulting in the upper corner dropping out.

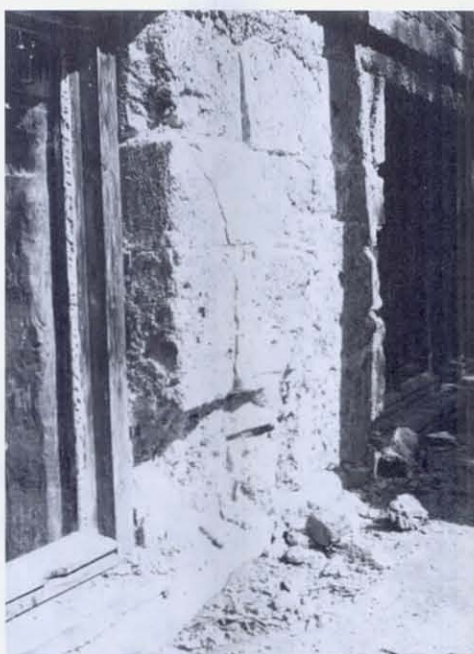
FIGURE 33 The foundation walls of most of Burdur's apartment buildings are made of a porous travertine, consisting of rather hard shelled tubules, randomly spaced, with softer material, almost like rotten bone, between the tubules. The Turkish name for the stone, mined a short distance SE of Burdur, is "Kurna." Here the author has easily thrust his pocketknife, not into a joint or a crack, but into the solid stone itself.

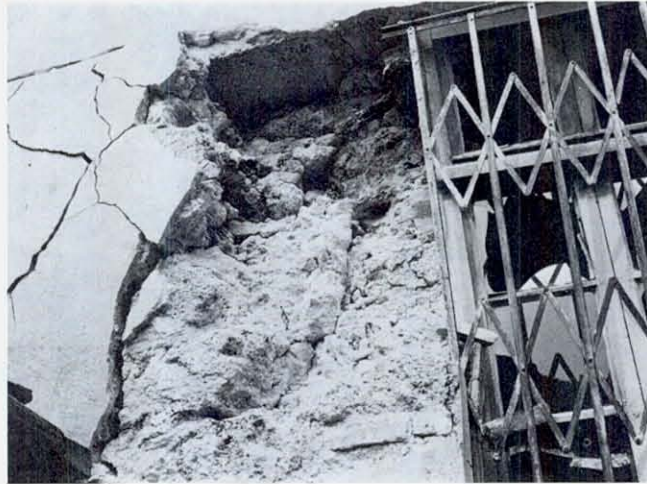
FIGURE 34 A close-up of a shattered travertine foundation wall in Burdur. The stones vary in quality, but usually they contain bands of fibrous or porous material, easily penetrated with a knife. Mortar is probably weakened by the absorption of moisture into the porous stone.

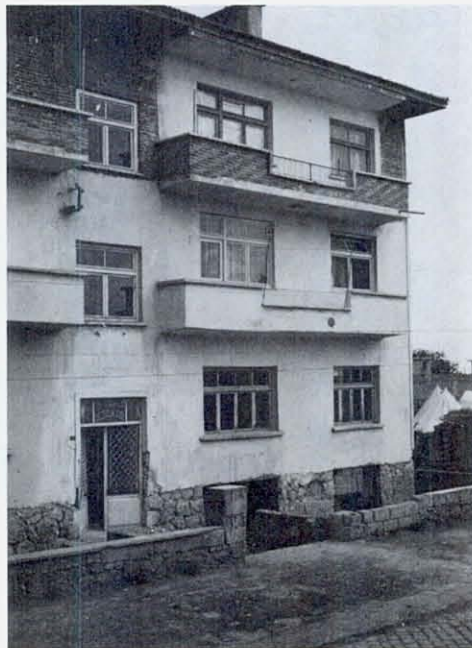
FIGURE 35 This building has been evacuated because the travertine foundation walls are shattered. The next figure shows the building adjacent to this one.

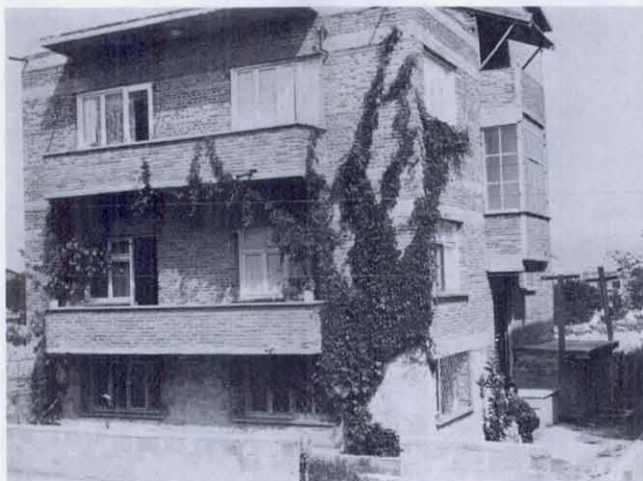
FIGURE 36 Next door to the building with shattered foundations in the previous figure stands this structure which had only minor cracks between foundation stones. The two buildings differ in that this is one story less, and its foundation is made of hard stone. Did the stone or the extra story make the difference in damage?

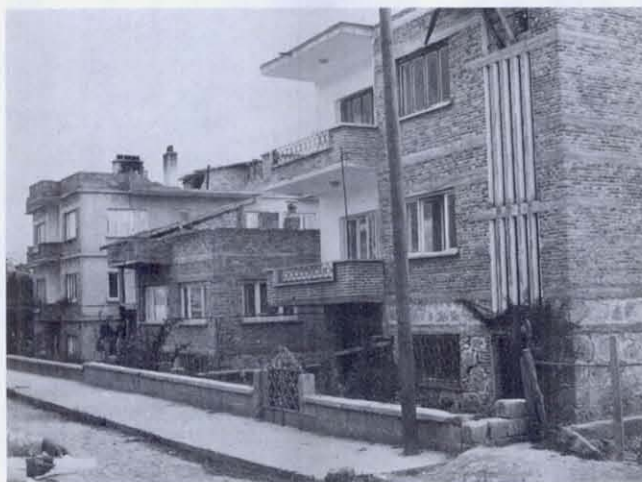
FIGURE 37 The situation pictured here is similar to that illustrated in the two previous figures. The buildings on the ends have travertine foundations, and are badly cracked (see the following figure), but the building in the center, one story shorter, has a foundation of hard stone - limestone or a very fine-grained sandstone - and it suffered no cracks at all. In this neighborhood of Burdur there was great variation in damage, even among buildings with travertine foundations.

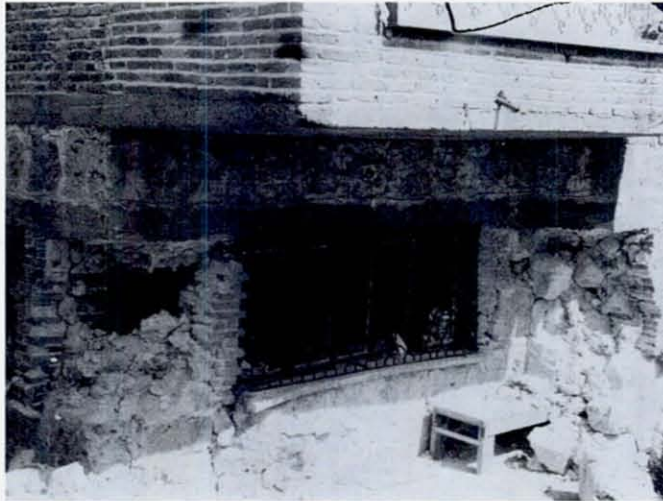
FIGURE 38 A close-up of the nearest building in the previous figure. The walls are very close to complete disintegration. (Photograph courtesy of Prof. Asim Yeginobali)

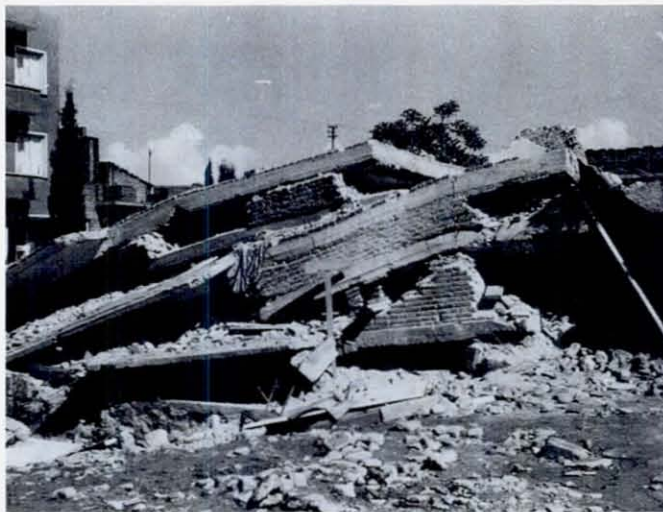
FIGURE 39 Seven persons were killed in the collapse of this $3\frac{1}{2}$ -story masonry apartment building in Burdur. Mortar was made from lime and sand, and travertine was used in the exterior wall, in the lower story. Possibly the walls of the lower story disintegrated unevenly, causing the building to tilt, thereby increasing the shear force on the walls of the upper stories to the point of failure. This building, on a corner lot, was the only collapsed structure for several city blocks. Others in the immediate vicinity suffered cracked lower story walls, but not to the point of disintegration. (Photograph courtesy of Prof. Asim Yeginobali)

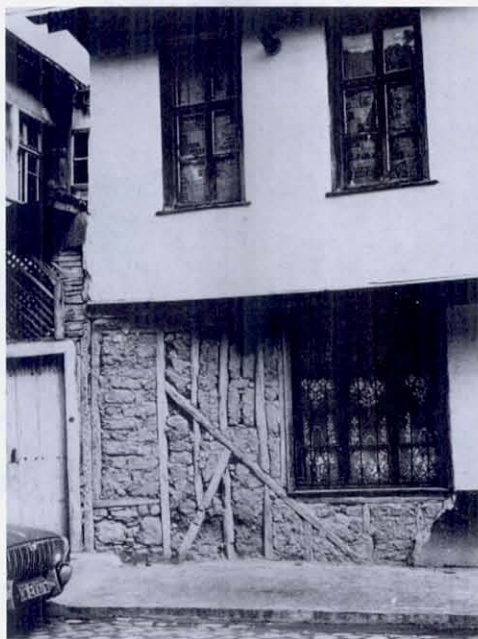
FIGURE 40 An older structure in Burdur, from which the plaster cracked. The bracing is not ideal, and the lack of continuity of the columns shows ignorance of structural principles, yet the construction is much better than plain adobe. The use of brick or adobe infill in braced wood frames as insulation and plaster base is common in older structures. This type of construction would have much merit if proper framing was used with hollow inexpensive bricks.

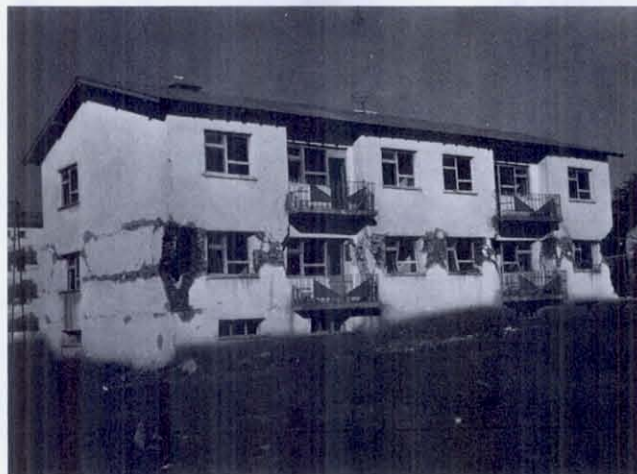
FIGURE 41 This figure and the six following figures show successive views, moving counterclockwise, of a badly shattered apartment house in Bingöl. This view shows principally the north face, as well as the east end wall. A floor plan of the building, made from measurements, is shown later. Note that damage is confined almost exclusively to the first story - perhaps due to the brittle nature of the masonry. Cracking of the first story possibly resulted in reduced lateral force in the second story.

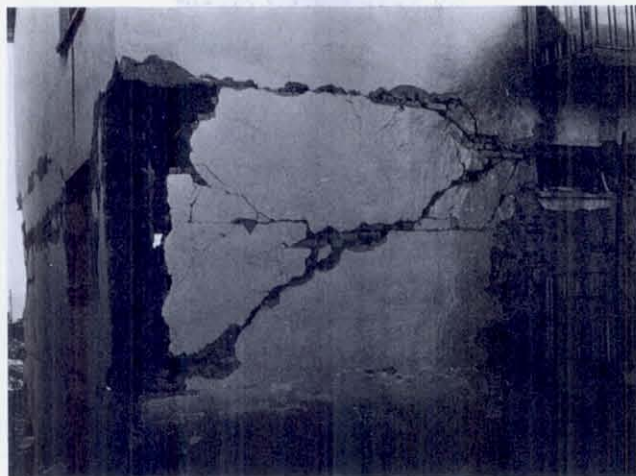
FIGURE 44 A view of the southwest corner, south wall in the foreground. Once the corner has fallen, a single diagonal crack meeting a horizontal crack on the bottom of the collar beam is enough for a large segment of wall to be lost. The collapse of the corner, the large diagonal crack, and the distortion of the frames of the small windows indicate that the second story shifted left relative to the first.

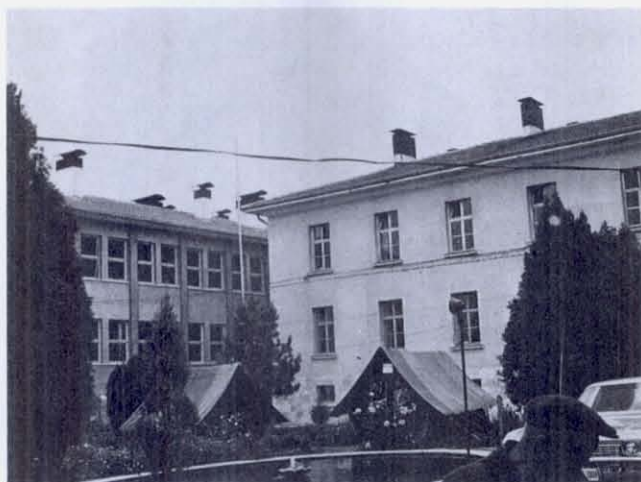
FIGURE 51 The government building in Burdur, made of hard stone set in lime mortar, had some plaster cracking inside and perhaps some mortar joint cracking, but not extensive. The building continued in use after the earthquake. The chimneys on this building, some of which had guy wires, and those on the building next door did not fall or appear to be damaged. Tents in the garden were used by officials for handling relief work.

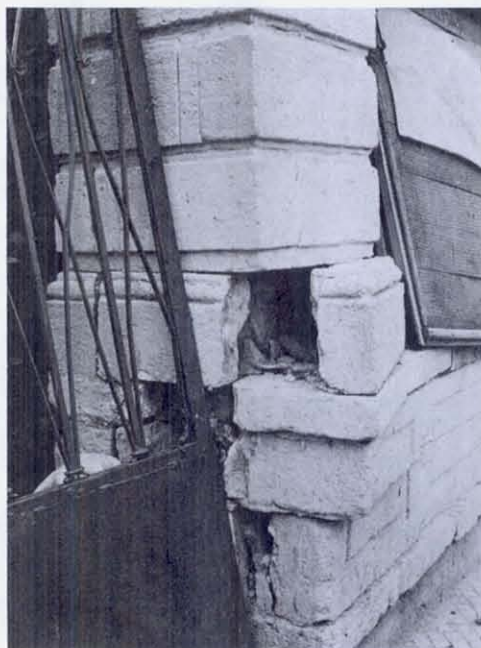
FIGURE 52 A close-up of the gatepost damage at the park entrance in Burdur. Although the exterior was made of well-fitted stones, the interior was filled with rubble laid in weak mortar, a common practice in ancient times as well, as evidenced in the many Roman ruins in Turkey.

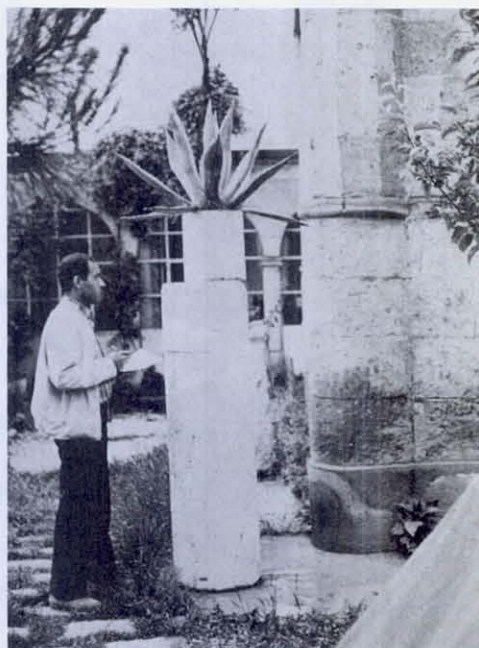
FIGURE 53 This section of an ancient stone column on display in Burdur's museum, 40 cm diameter by 154 cm tall, can be easily rocked by hand, yet it did not topple during the earthquake. The flower pot on top was displaced about 10 cm, but did not fall off.

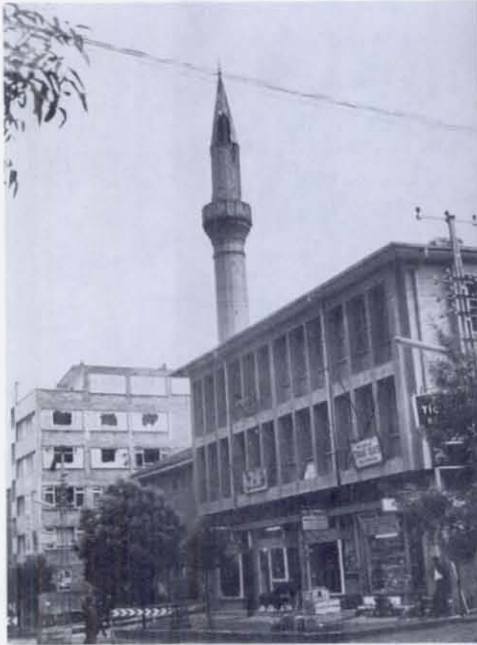
FIGURE 56 Most of the unreinforced masonry minarets in Burdur suffered displaced stones near the top. Lower portions did not show damage. On the other hand, in Yazıköy, 20 km SW, this minaret was broken off at the base. The sheet metal cap covering a wood frame on top of the Tabac Mosque has been torn open by workmen in preparation for dismantling the top portion. Possibly the discontinuance above the balcony of the interior stone steps, built between a central stone column and the outside wall, was responsible for the damage being localized in the top section. The reinforced concrete building with broken windows in the background (shown later) had heavy partition damage as well as structural damage.

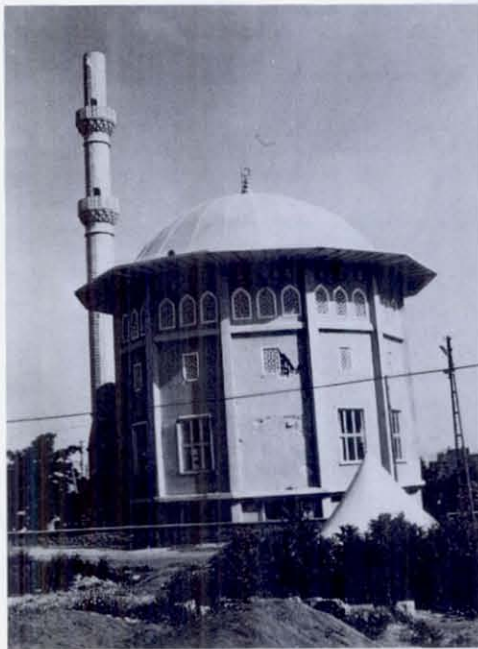
FIGURE 57 Yeni Mosque, just east of the fairgrounds in Burdur, suffered badly cracked cinder block walls between concrete columns, but no damage to major columns. So little cement had been used in the cinder blocks that they could almost be broken in the hand. The undamaged minaret, not yet completed with a cap, should be a model for future minaret construction. Reinforcing steel, just visible at the top, was placed in hollow blocks, which were then filled with mortar. Mortar and bricks observed near the base of the minaret were of good quality.

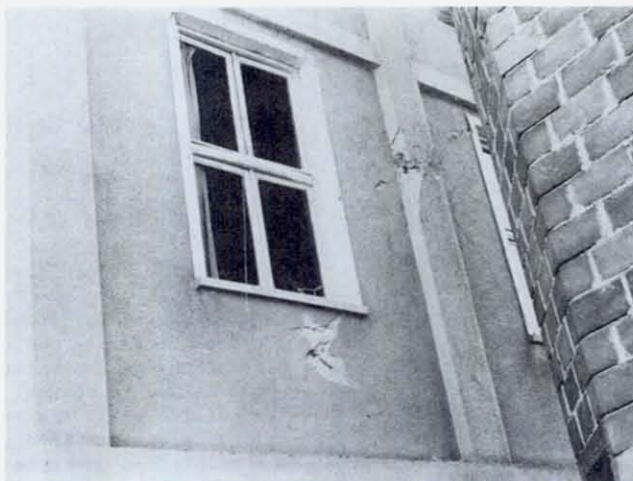
FIGURE 58 When the masonry panel in the entrance structure of Yeni Mosque cracked diagonally, this light reinforced concrete column cracked with it, its stiffness and strength having no noticeable influence on the behavior of the wall. This is in contrast with the performance of the heavy columns supporting the roof, shown in the previous figure.

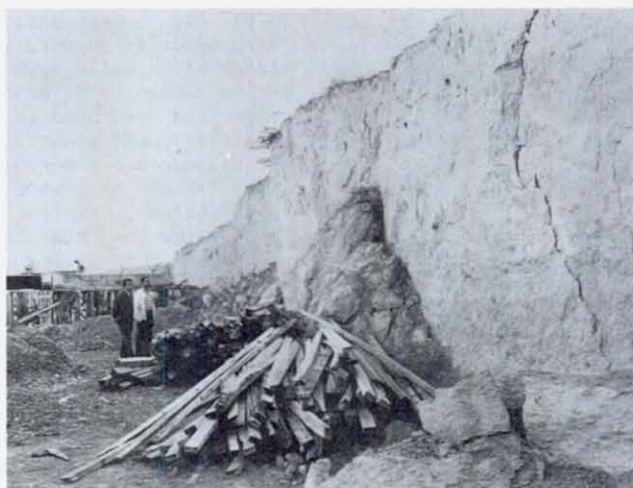
FIGURE 59 This 20-foot high bank of lacustrine clay with thin gravel lenses at a construction site on the west side of Burdur, undercut in some places, has stood for nine months with only small falls of earth. Soil everywhere observed in the Burdur region was firm, and no damage was attributed to soil failure.

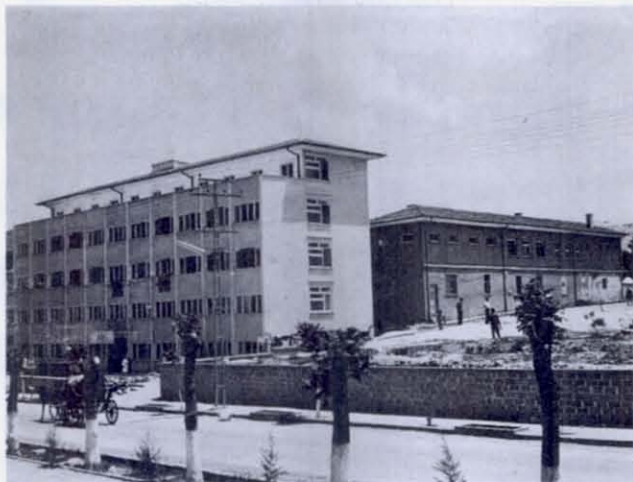
FIGURE 60 Burdur's new 5-story reinforced concrete hospital had every column in the first story broken in flexure, leaving the building slightly displaced in the longitudinal direction. The two-story reinforced concrete framed laundry building, on the right, had only minor masonry cracking on one end wall. No damage was observed on the concrete block wall in the foreground.

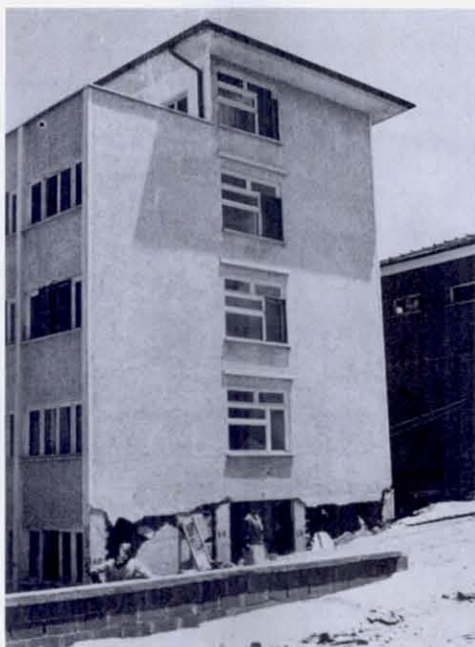
FIGURE 61 A closer view of the south end wall of the hospital showing the columns to be relatively weaker in the longitudinal direction of the building. The furthest corner is completely fractured, and has begun to fall away from the structure.

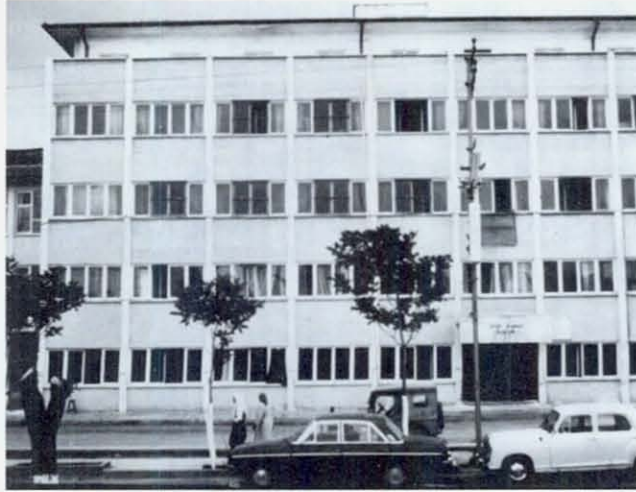
FIGURE 62 A front view of Burdur's hospital, showing permanent displacement to the right in the lowest story. The structure on the left is a second and third floor passageway to an older masonry building, which was severely cracked.

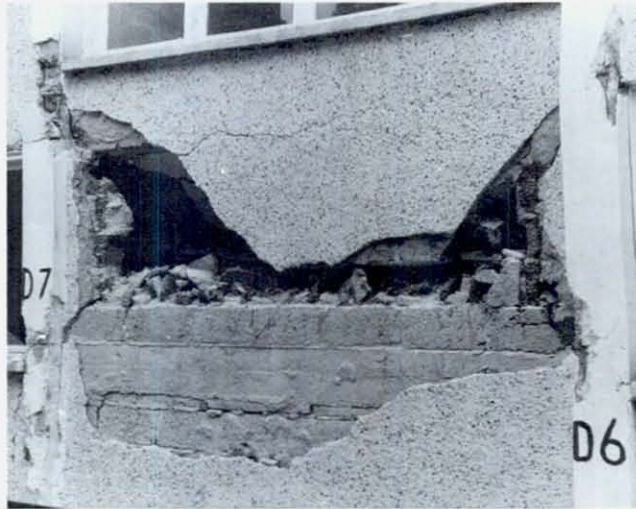
FIGURE 63 Column damage in the rear of the hospital. Most columns fractured at the top and bottom of window openings, being relatively fixed by concrete spandrels and cinder block walls above and below these openings.

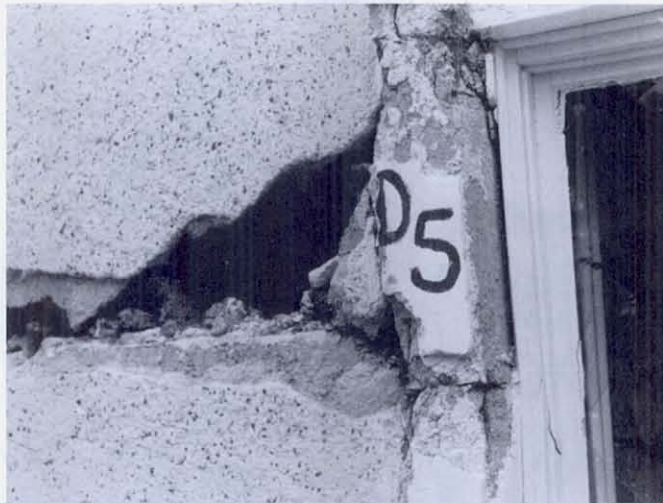
FIGURE 64 A close-up of column damage at the rear of the hospital. Concrete was rather soft to a knife point, but no honeycomb was evident. The small column dimensions in the longitudinal direction of the building raise the suspicion that earthquake forces in the longitudinal direction were not considered in the design.

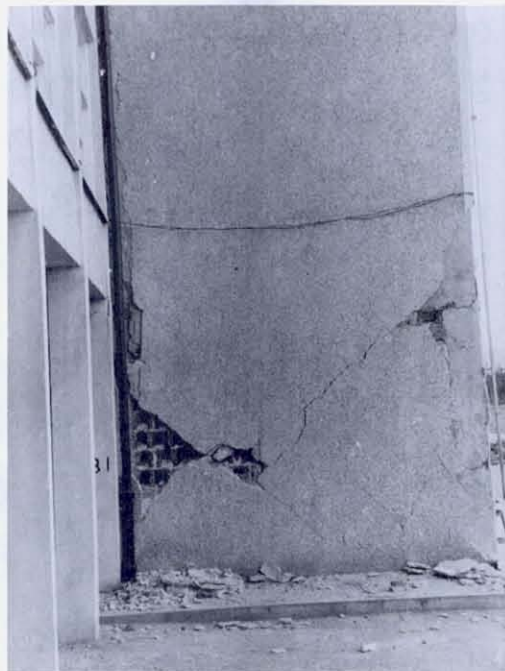
FIGURE 65 The north end wall of the hospital, front wall to the right, with a front column exposed. Note that the diagonal crack in the cinder block wall continues through the column. The outside faces of the cinder blocks have broken off and fallen with the exterior plaster. The white columns on the left support a passageway to an older masonry building.

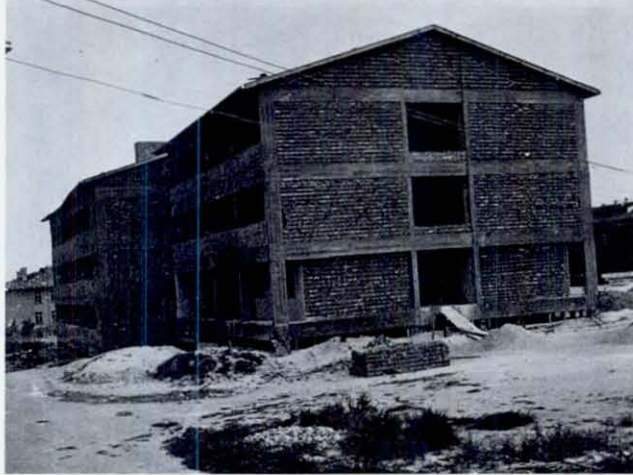
FIGURE 66 Under construction, across the street from Burdur's hospital, is this 3-story school, of rather common design in Turkey. Every exterior column, between the top of the foundation wall and the bottom of the first floor, was shattered, causing the building to settle slightly. There was also minor damage to brickwork at roof level and in the first story. Note the chimneys standing in the background.

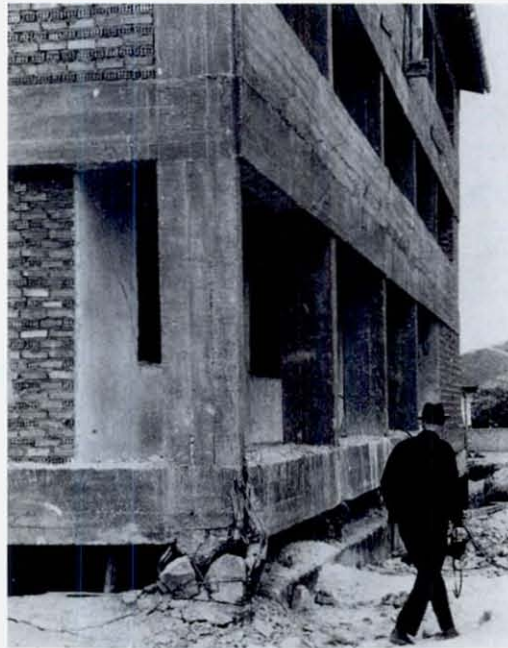
FIGURE 67 A close-up showing shattered columns, and some cracking of brickwork. Interior columns in the basement were free to deflect over their entire height, whereas the exterior columns were greatly restrained by the heavy basement walls. This great difference in stiffness resulted in all the lateral load being resisted by the exterior columns, and consequently suffering all the damage. Note that the columns are weaker in the longitudinal direction of the building, but column damage appears to be caused chiefly by motions in the transverse direction. Plans and additional photographs of this building are shown in Reference 12. (Photograph courtesy of Prof. Asim Yeginobali)

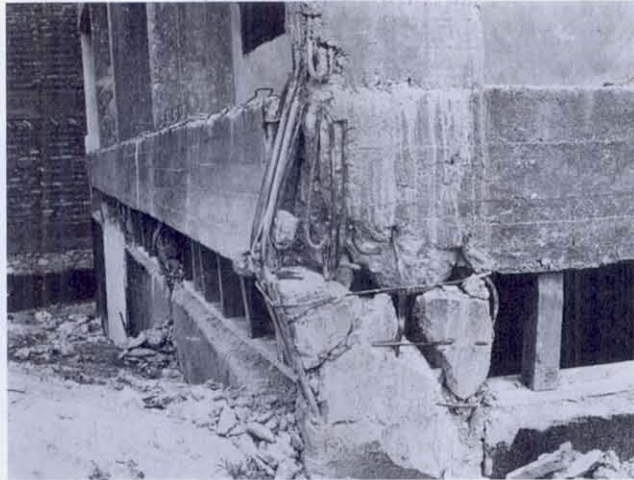
FIGURE 68 A close-up of the nearest corner column appearing in Figure 66. Additional column ties, more strongly anchored - perhaps by welding, would have been required to prevent this failure.

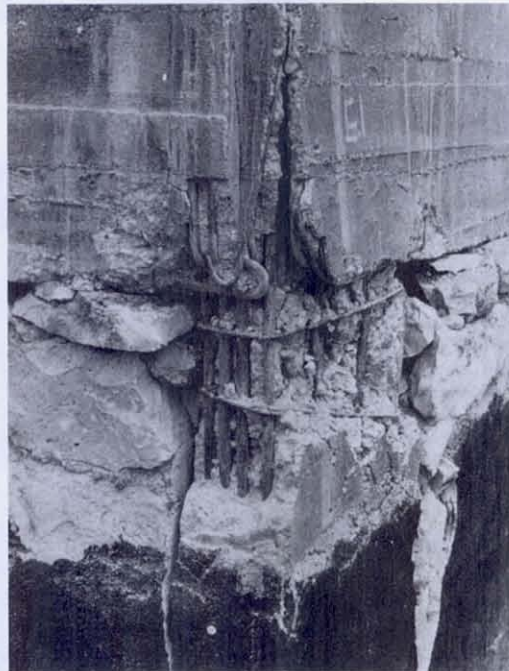
FIGURE 69 Another corner column at the top of the foundation wall in the new Burdur school: heavy beams not tied together, permitting concrete to be lost; a laterally weak column insufficiently tied; and poorly compacted concrete. A designer might have assumed that the foundation walls would brace the column and prevent failure, but the walls are of no help against forces directed toward the outside. In hindsight, a better design would be to rest the first floor slab directly on the foundation walls, providing a large area for the transfer of horizontal forces. (Photograph courtesy of Prof. Asim Yeginobali)
