ENGINEERING REPORT
ON THE
MURADIYE-ÇALDIRAN, TURKEY, EARTHQUAKE
OF
24 NOVEMBER 1976

P. Gülkan, A. Gürpınar, and M. Celebi
Middle East Technical University, Ankara, Turkey

Committee on Natural Disasters
Commission on Sociotechnical Systems
NATIONAL RESEARCH COUNCIL

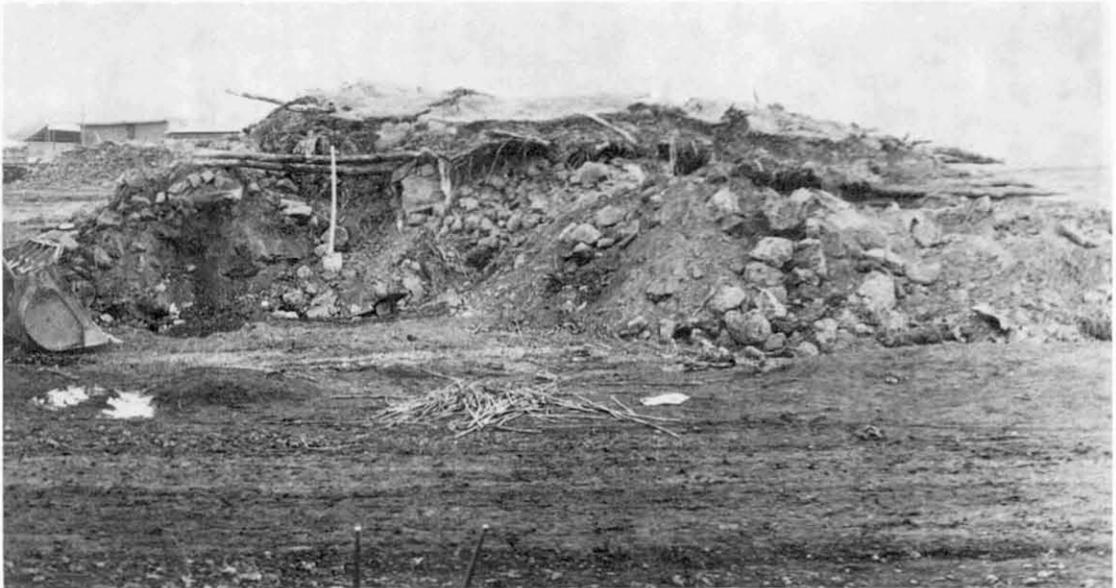
Çaldıran was totally obliterated by the earthquake (Figure 4). Located about 25 km north-northeast of Muradiye on the edge of a plain bearing the same name, Çaldıran was directly on the path of the fault rupture formed during the earthquake. The town had a population of 3,300 and of the 532 dwellings it contained, 505 either collapsed or were damaged beyond repair. One out of every six persons was killed. There was one building with three stories (officers' housing) and several others for government services with two. The remaining units were typical for eastern Turkey, which is relatively poorer and less developed than the rest of the country. Although a few dwellings were constructed partially of hollow concrete blocks, almost all the remaining were of adobe or rubblestone held together by mud, with little vertical reinforcement by timber and the typical heavy mud roof underlain by unfinished poplar trunks (Figure 5).

5. Typical Rural House in Çaldıran after the Earthquake

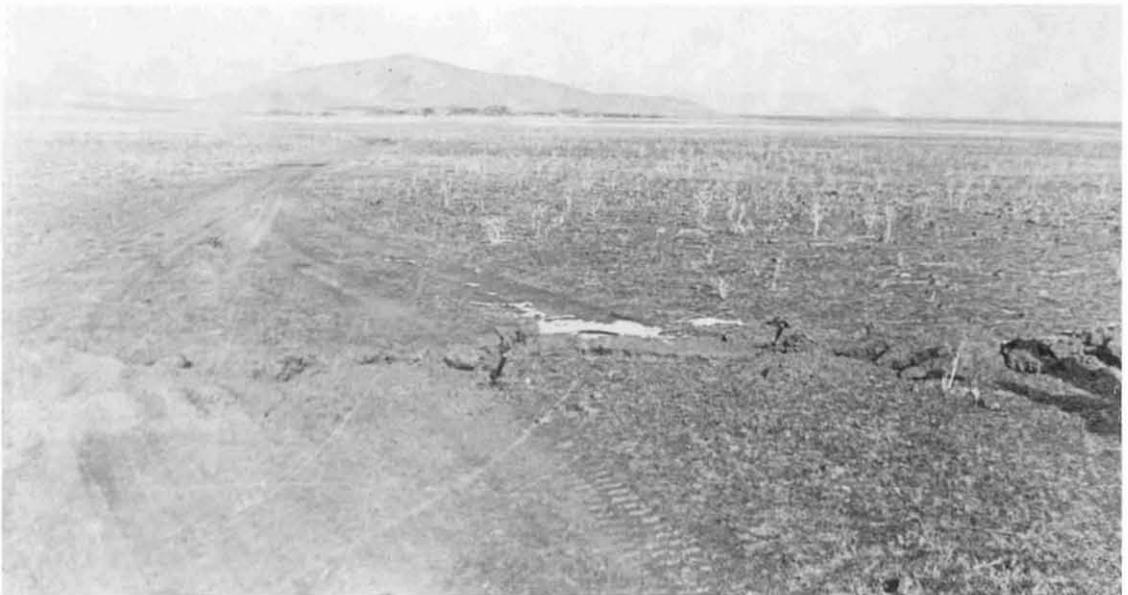
Sense of Displacement: - The sense of the displacement which took place along the fault trace is definitely right-lateral. This rightward motion is clearly manifest along intersected roadways (Figure 15), stream beds (Figure 16), water conduits (Figure 17), and vehicle tracks (Figure 18). As opposed to this consistent lateral throw, it was not possible to identify significant vertical movement. On relatively steep slopes cut by the scarp, it was observed that the side on the lower elevation had moved downward relative to the portion above. An inference on the direction of the vertical movement cannot be built upon this observation since it is related to the stability of the slope material. Where the trace has cut through flat topography, there was no definite consistency in the sense of the vertical displacement since both the north and the south blocks were observed to have shifted up at different places. Nevertheless, weakly consistent observations have indicated a slight upward displacement of the northern block [Arpat et al. (1977)].

15. Roadway Displaced 238 cm, 2 km West of Çaldıran

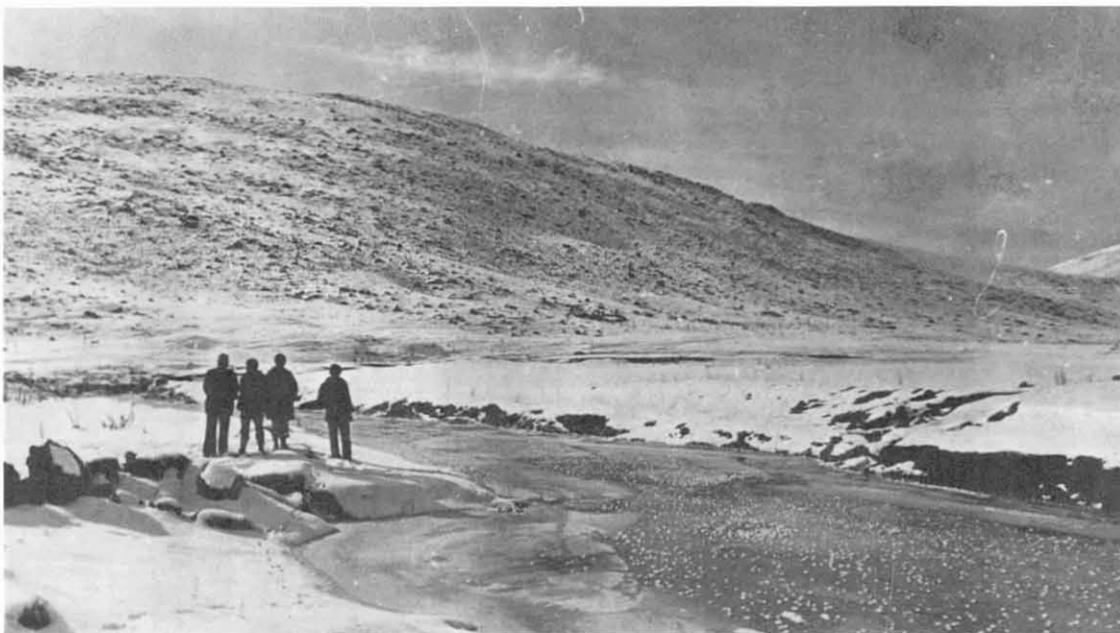
16. Stream Bed Displaced 230 cm, 1.5 km East of Alaçayır

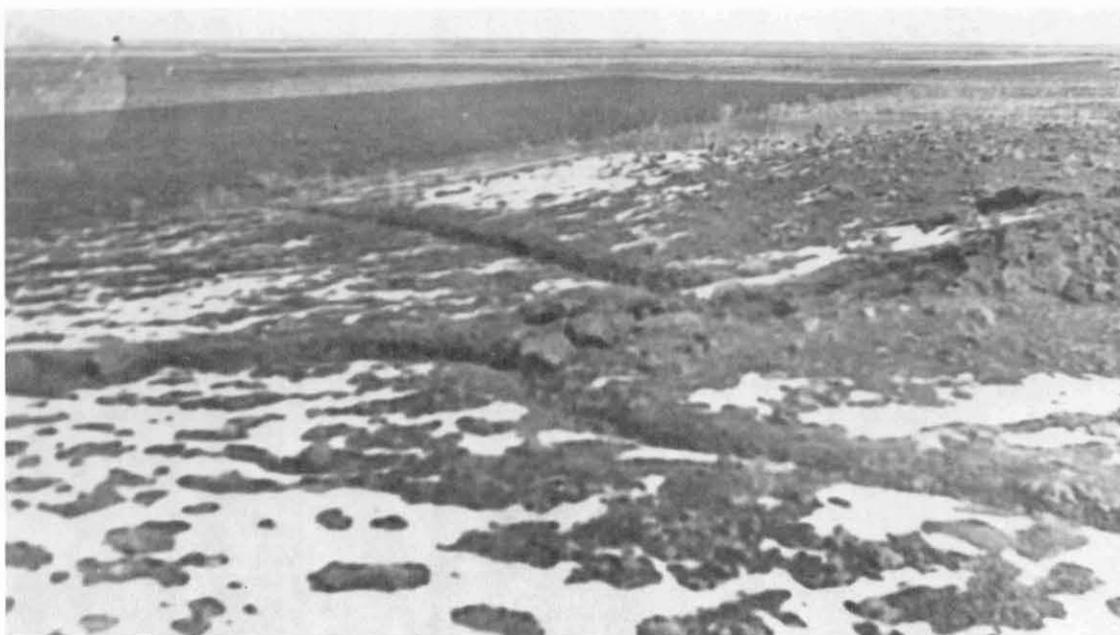
Magnitude of the Lateral Slip: - It was possible to gather data from various locations for the evaluation of the magnitude of the lateral slip which took place during the earthquake. In Sarıkök, a village near the western tip of the fault (Figure 7), a 225 cm right-lateral slip was noted on the roadway sitting on basaltic rock. At a distance of 1.5 km to the east of Alaçayır in the same general area, lateral displacements of 330 and 370 cm were measured on a meandering stream bed intersected at several points by the fault (Figure 16). Since the stream was frozen at the time of the earthquake, the shifted banks were not eroded, thus permitting accurate measurements to be made. Two kilometers west of Çaldıran where the scarp cuts through flat alluvial deposits, a set of intact vehicle tracks had moved 238 cm sideways (Figure 15). Also, an oxcart track had shifted 210 cm laterally to the right (Figure 18), and a water canal evidenced 206 cm lateral movement in the same direction.

17. Water Trench Displaced 206 cm, 1.5 km West of Çaldıran

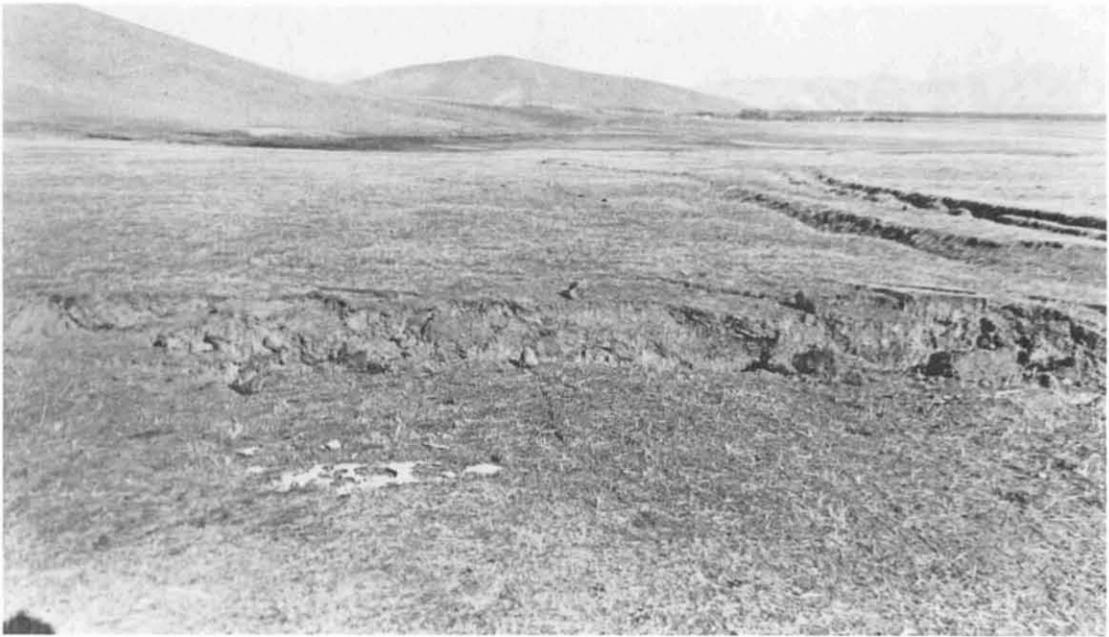
18. Oxcart Tracks Displaced 210 cm, 2 km West of Çaldıran

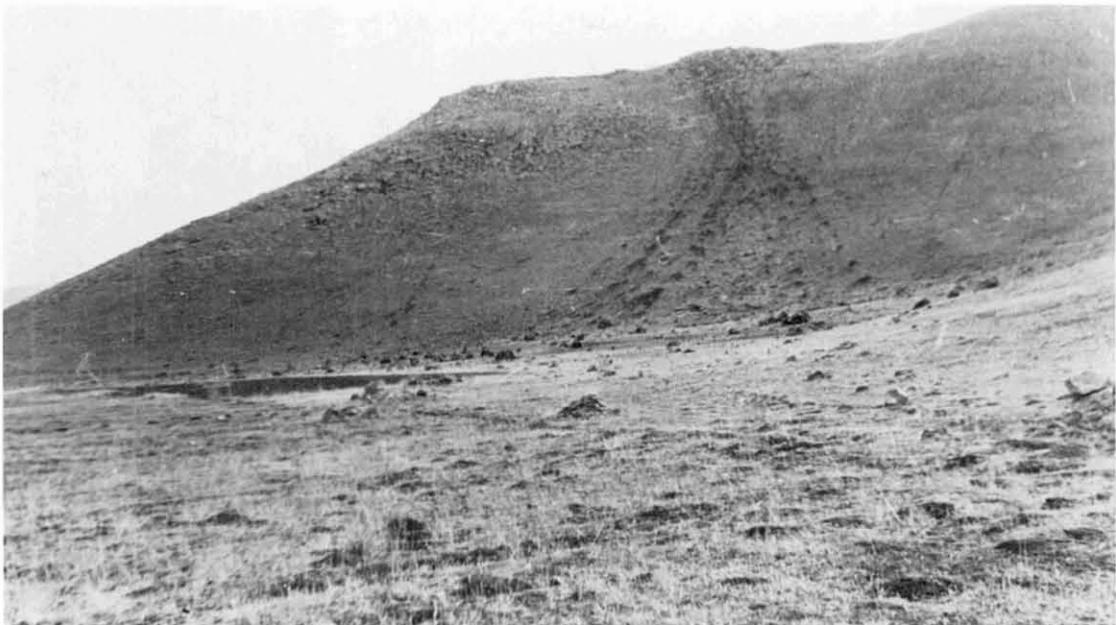
Rockfalls: - Some cases of rockfalls were observed along the steep slopes of the valley through which the Muradiye-Çaldıran road passes (Figure 31). In view of the likely sites along this valley, however, the number of actual rockfalls was below the expected figure. This can perhaps be explained in terms of significant local variations in the maximum acceleration experienced at different sites.

31. Rockfalls Visible from the Muradiye-Çaldıran Road

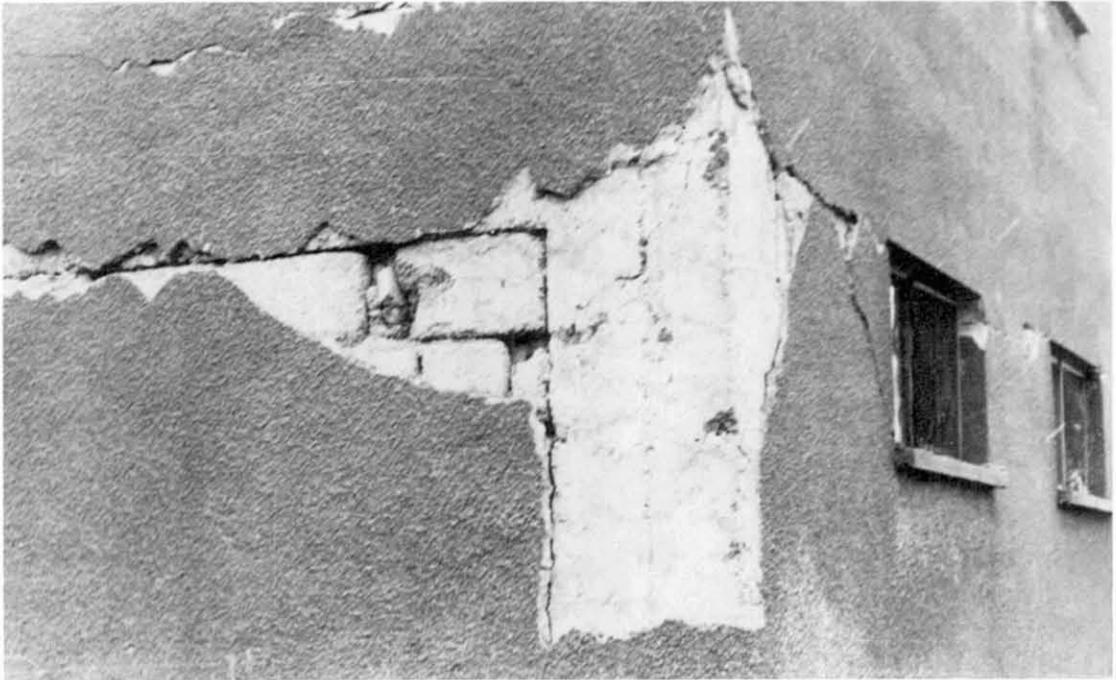
The Mobile Gendarmerie Platoon Building, Çaldıran: - This two-storey structure served as the base of the military unit in Çaldıran and was located on loose topsoil approximately 100 m from the fault rupture traversing the town. The T-shaped building contained the sleeping and general services quarters in the rear portion; official business was conducted in the front half (Figure 35). If reinforced concrete design philosophy is geared against total collapse and no deaths in case of "very strong" earthquakes, this building fulfilled those functions. The filler walls were unreinforced, hollow concrete block, ordinarily very weak and brittle when subjected to in-plane loads. The inside of the building was a shambles, but sign of structural distress were limited to the upper ends of some columns in both stories. The stiffness effect of the filler walls apparently created a condition in which no single column was overly stressed. In zones of obvious force concentration, such as beam-column joints with filler panel walls, there were cases of shear failure (Figures 36, 37, and 38), but as a whole, the building was essentially intact. Circles in Figure 35 indicate the directions in which the following three photographs were taken. In spite of its unfortunate proximity to a capable fault, this building was judged to be repairable after the earthquake.

36. Column Damage in the Military Building

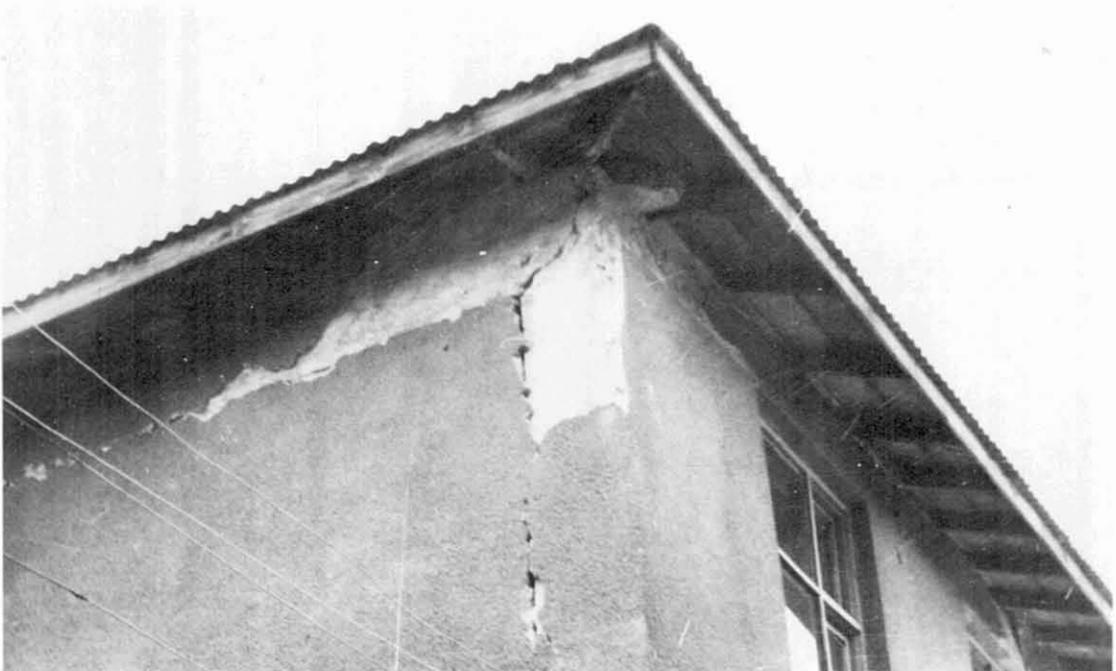
37. Column Damage in the Military Building

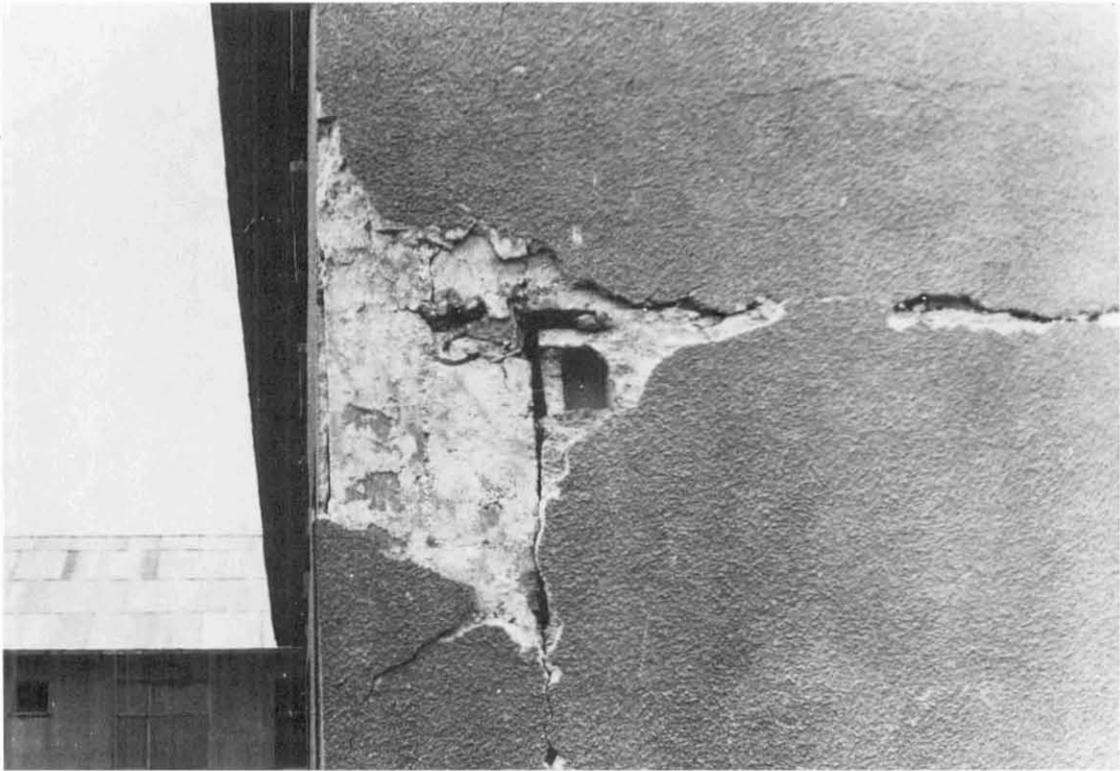
38. Column Damage in the Military Building

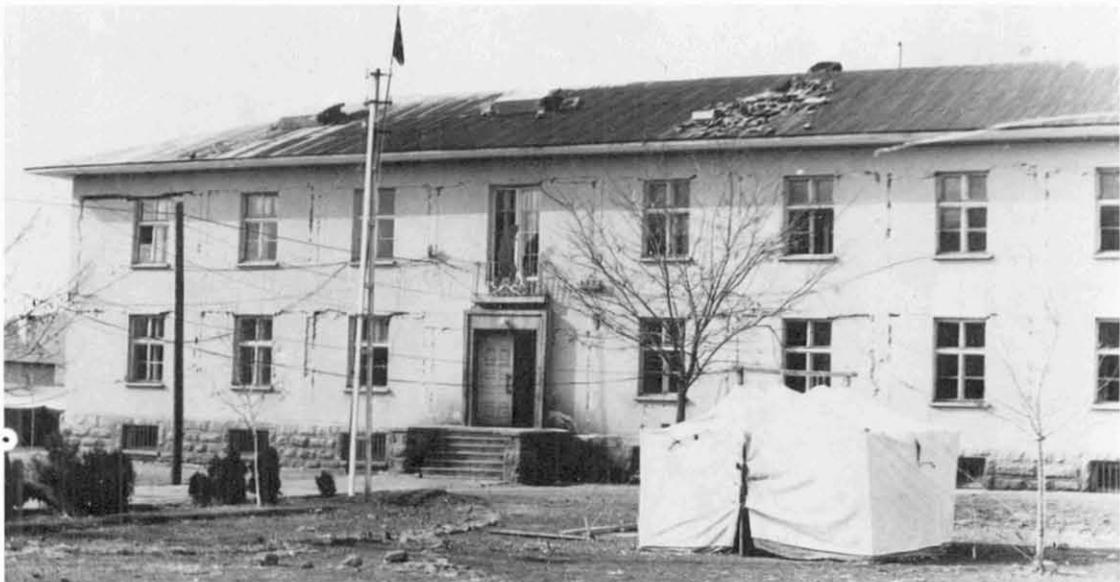
Local Government Services Building, Muradiye: - A general view of the basement-plus-two-storey structure is provided in Figure 39. Filler walls were again concrete block tiles which appeared to have worked loose from the main structural system during vibration (Figure 40), allowing the reinforced concrete frame to be easily identified. There was no damage to the component stone masonry walls of the basement level. Walls parallel to the long axis of the building in the other floor levels were surprisingly free of diagonal cracking related to in-plane forces. This probably related more to the nominal bond between the structural framing and the walls than to the direction in which vibrations took place. The plan of the building was simple: there were twelve column lines in the long (north-south) direction, with a window opening between each as shown in Figure 40, and four in the short direction.

39. Government Services Building, Muradiye

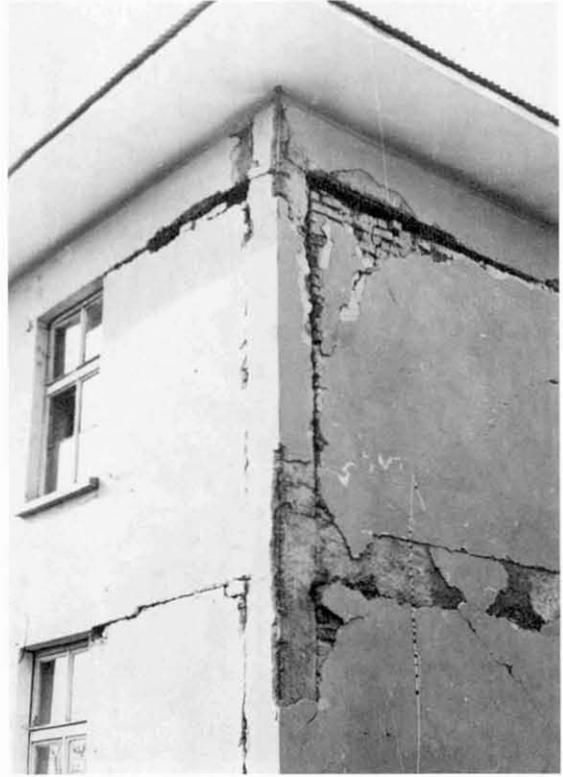
The overall quality of materials and workmanship in this building appeared to be poorer than the military building in Çaldıran. Hinging had been initiated at the ends of columns in the second storey facing north (Figure 41), and a panel wall had toppled outward (Figure 42). An interior column which had failed in shear on the next column line adjacent to a chimney conduit appeared to have no transvers reinforcement (Figure 43).

41. Second-Storey Column, Government
Building, Southwest Corner

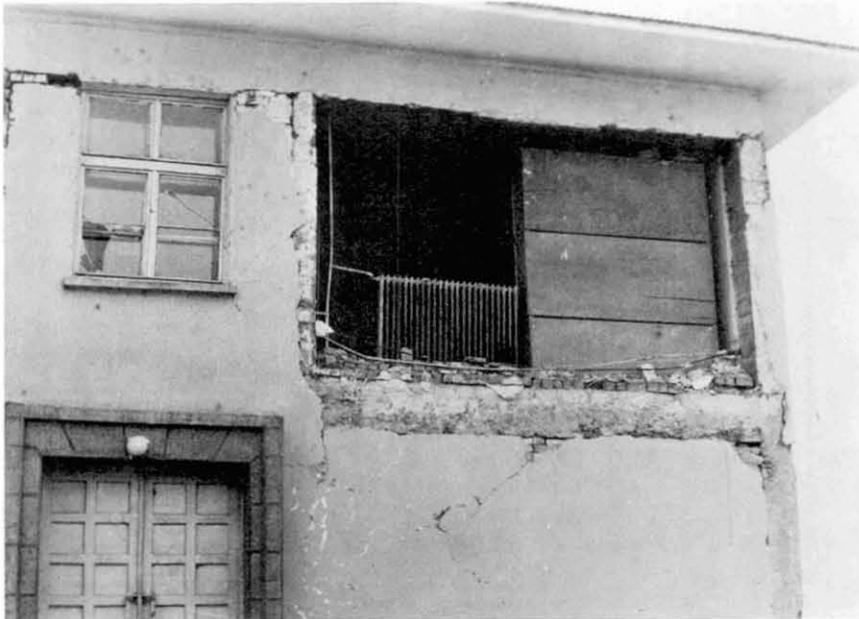
42. Second-Floor Wall, Government Building, North Face

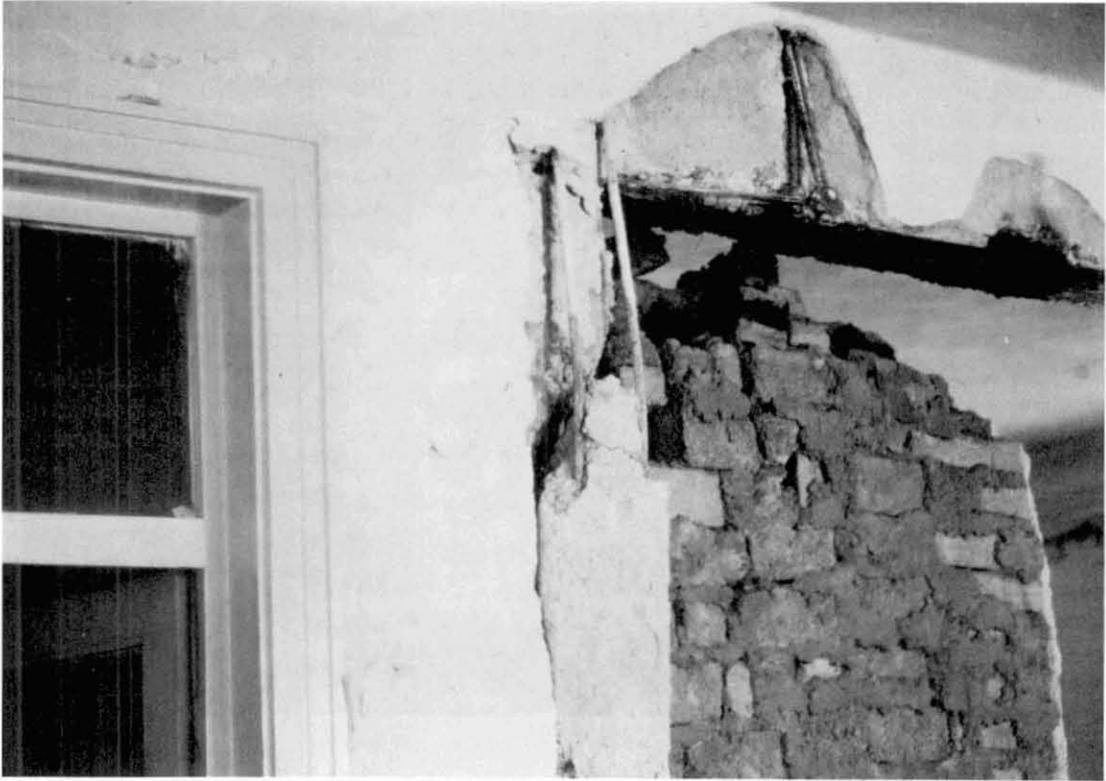
43. Interior Column, Government Building

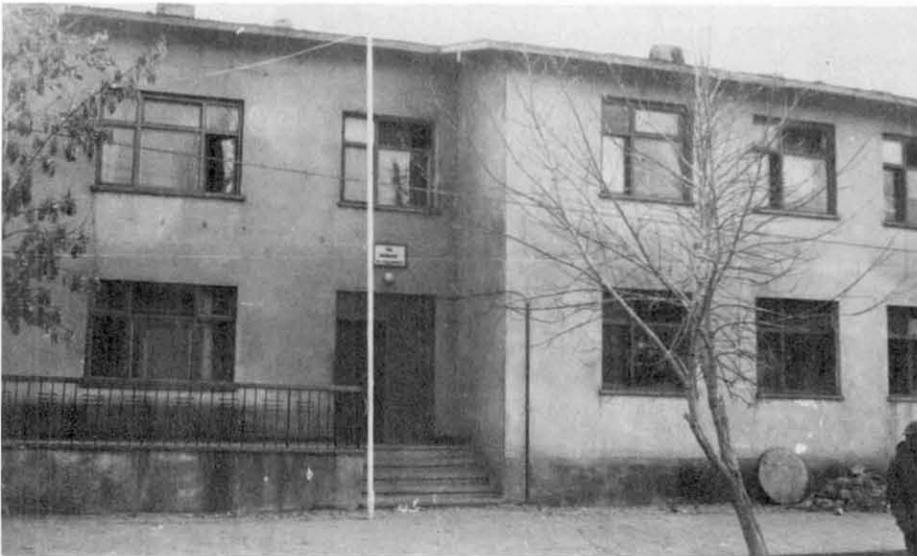
Other Buildings in Muradiye: - Several other reinforced concrete structures in Muradiye generally faired well and there was no major failure in any of them. The district gendarmerie building, a two-storey structure shown in Figure 44 lost its chimneys, but there was no evidence of significant structural distress. A brick masonry version of the same

44. Gendarmerie Building, Muradiye

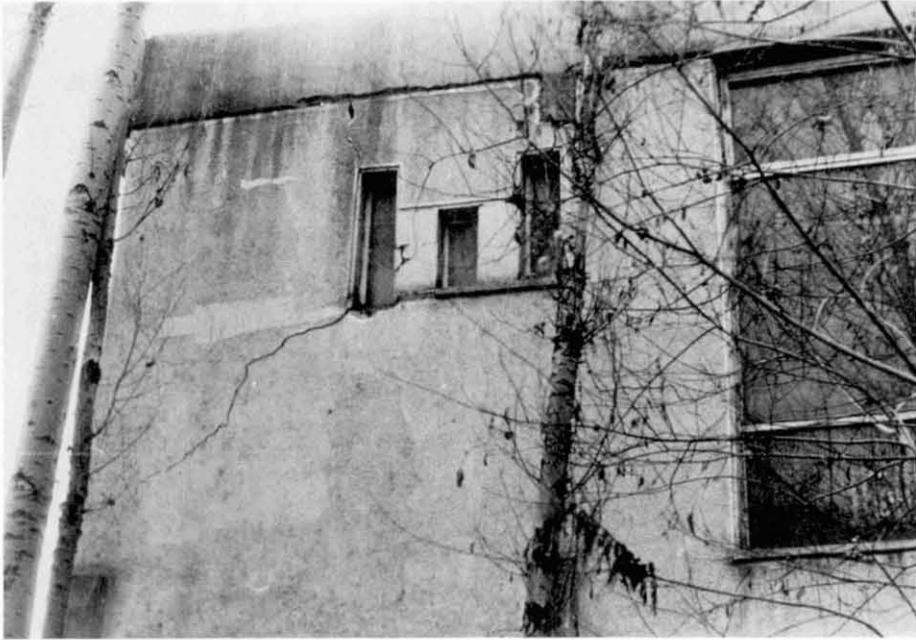
The two-storey, brick walled, Agriculture Bank building (Figure 46) located opposite the government building also performed quite well, although a cantilevered portion on the northern face showed signs of excessive sagging (Figure 47). A four storey bank employees' housing building next to the bank (Figure 48) also remained intact and serviceable immediately after the earthquake. It is to be noted that a traditional structure adjacent to this building suffered total collapse (right of Figure 48). The post office building shown in Figure 49 is on the same side of the main road; it showed no evidence of having been subjected to severe ground motion. The meteorological observations building shown in Figure 50 had a penthouse-like appendage, stiffened by brick walls, on top of the ground storey. Although concrete quality was visibly poor and contained large pieces of aggregate, the structural framing system had enough strength to withstand the dynamic forces created during the earthquake.

47. Agriculture Bank, Crack in North Face Cantilever

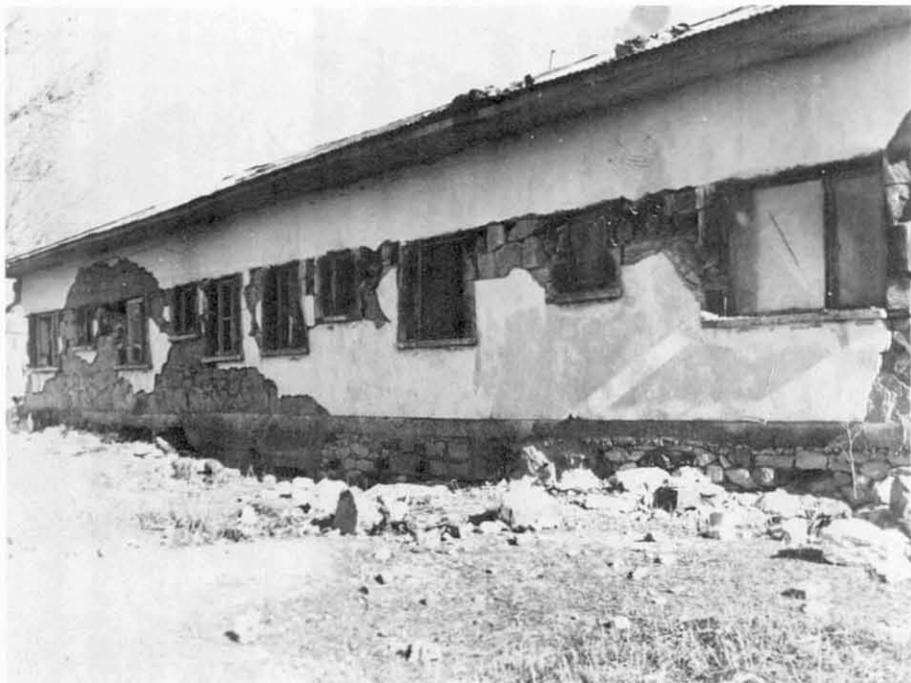
Post Office Building, Çaldıran: - Located partially on an artificial embankment held in check by stone walls around the garden perimeter, the two-storey brick masonry building suffered heavy damage (see Figures 54 and 55). There were large settlements of the loose material and the eastern face of the building had tilted because of these settlements. Corners of the building subjected to force concentrations had fallen away leaving conical openings. The state of the structure four days after the main event suggested that collapse could become imminent during a fairly strong aftershock.

54. Post Office, Çaldıran

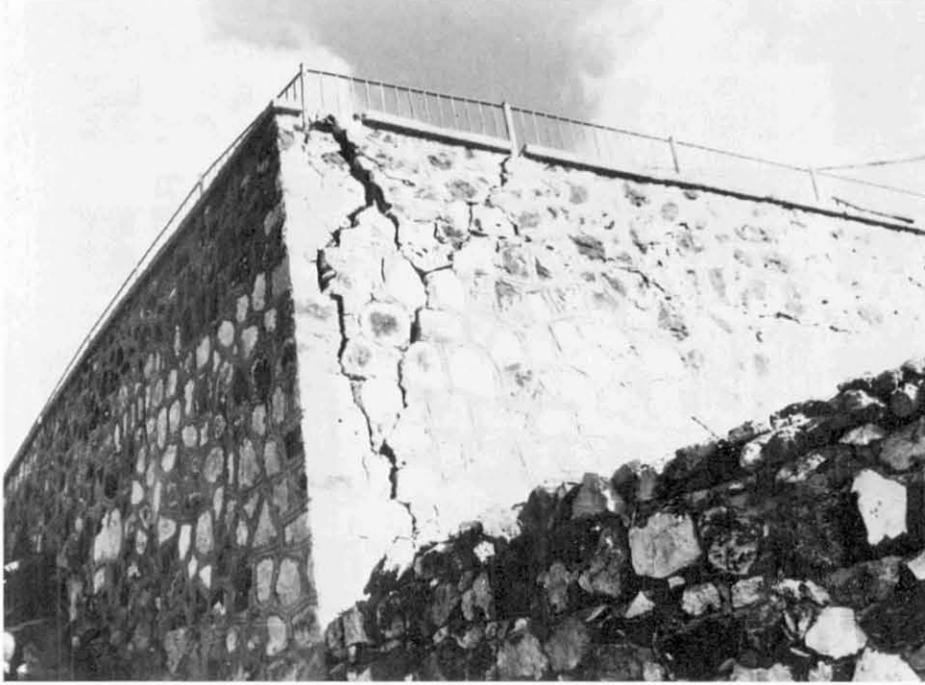
55. Wall in Front of Post Office, Çaldıran

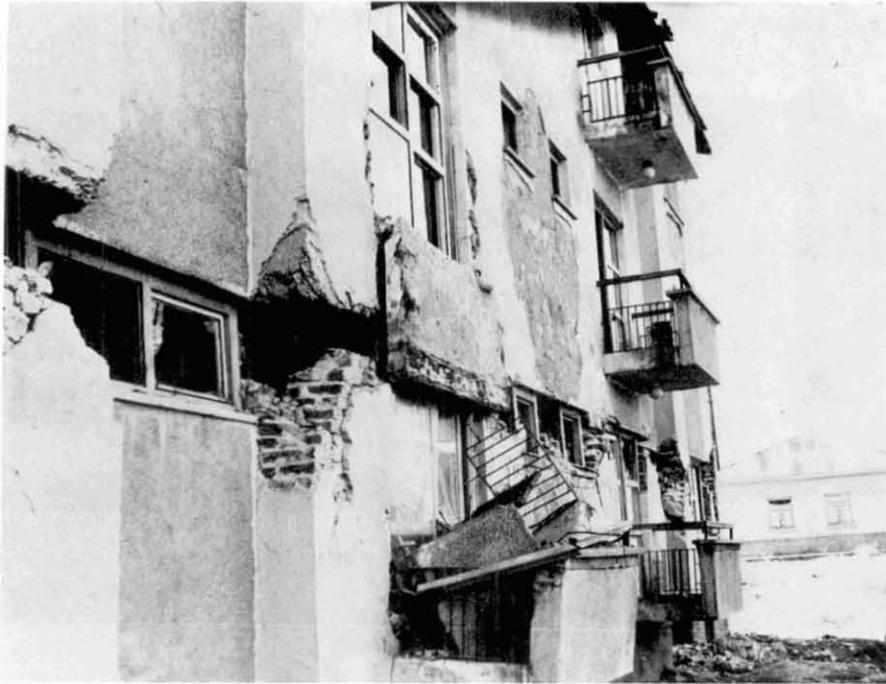
59. Failed Balcony, Employees' Lodging, Muradiye

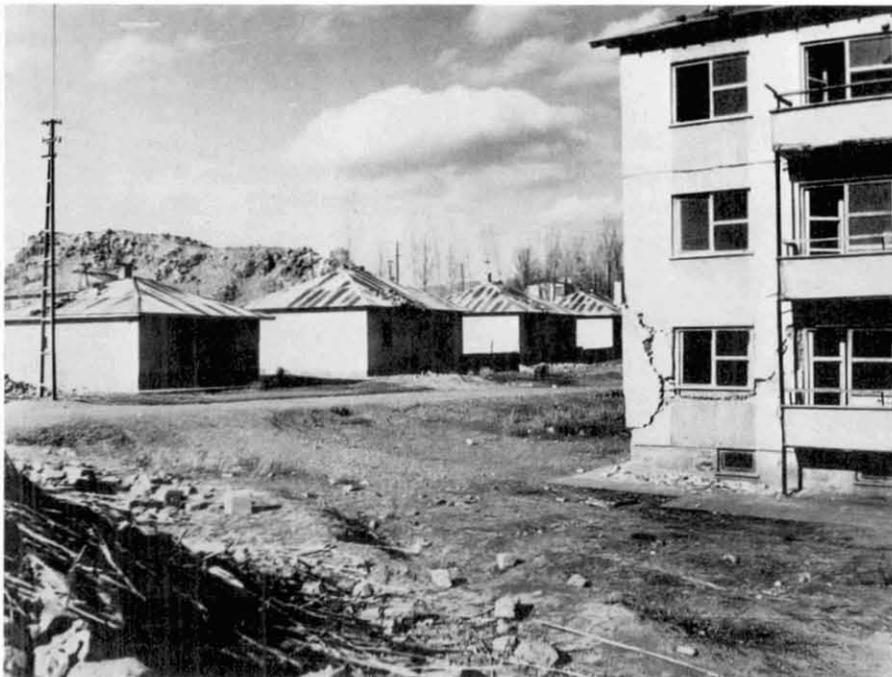
Government Employees' Housing Muradiye: - This three-storey brick masonry building, very similar to the officers' lodging building in Çaldıran shown in Figure 51, suffered far greater damage in spite of the fact that the intensity rating for Muradiye was judged to be two units less. Figure 57 shows a general view of the building. Shear failure in the upper ends of the brick wall panels of the ground floor destroyed structural continuity, as shown in Figure 58. A second floor balcony turned downward a full right angle and its parapet wall fell on the balcony below (Figure 59). The poor behavior of this building can be partially explained in terms of the excessive openings for windows (see Figure 58). Single-storey units nearby, built reportedly in 1946 for government employees, came through without damage (Figure 60).

60. Single-Storey Employees' Buildings, Muradiye

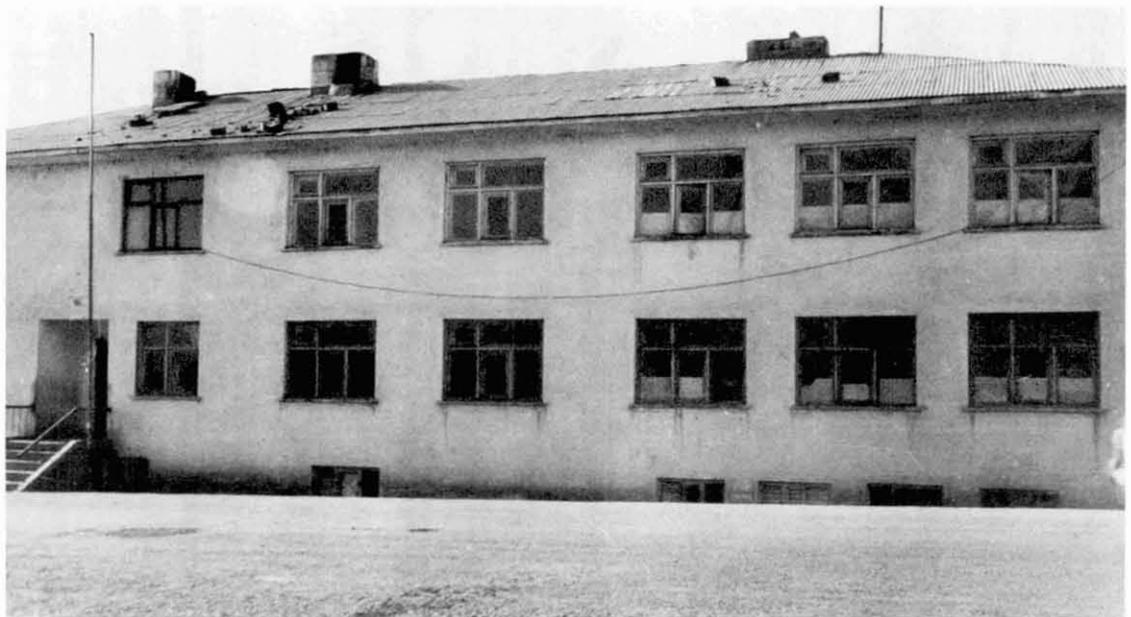
High School and Junior High School, Muradiye: - Both of these schools were built as two-storey brick masonry units. Some two-directional diagonal cracking developed between the window openings in the high school building (Figure 61); its roof was observed to have shifted slightly toward the east. Although inclined cracks joined at the corners, no gaping holes were formed. The junior high school building immediately on the back showed similar behavior and was judged to be in no danger of collapse.

61. High School, Muradiye

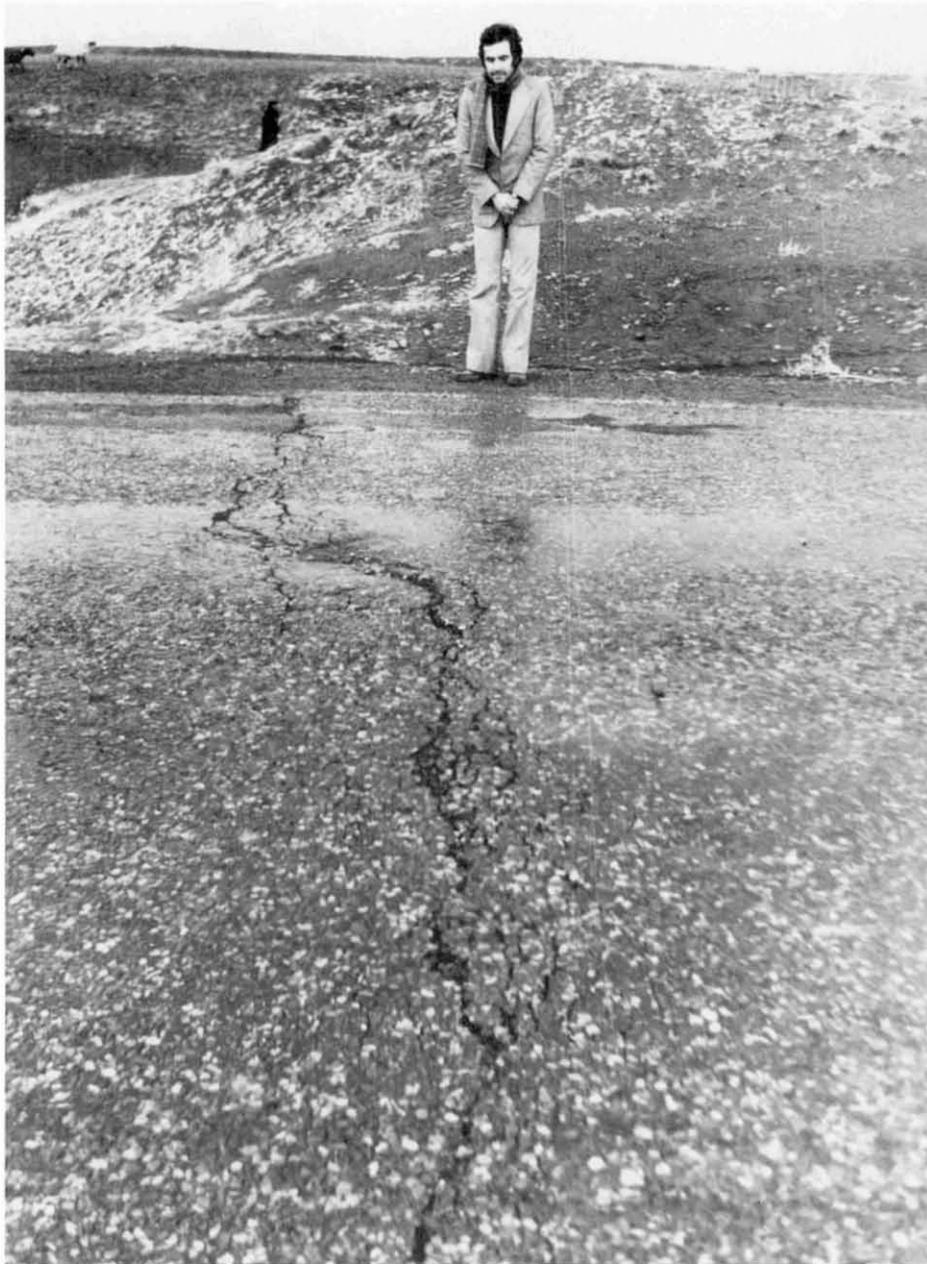
Settlements: - Settlements were observed, especially in youthful alluvial formations in stream beds. Fills behind bridge abutments were often subject to small amounts of settlement. There were no examples of dramatic settlements and no structural failure could be related to soil instability.

63. Settled Bridge Embankment
