THE CENTRAL GREECE EARTHQUAKES OF FEBRUARY-MARCH 1981

A Reconnaissance and Engineering Report

James O. Jirsa (Team Leader), Professor of Civil Engineering, University
of Texas at Austin

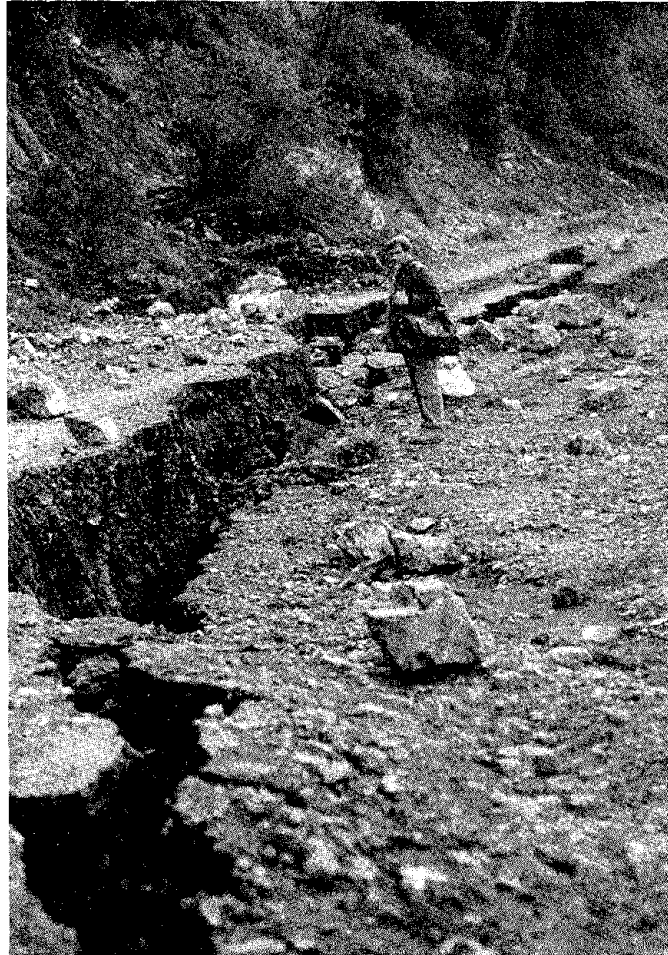
FIGURE 2.5 Ground rupture along the Shinos trace.

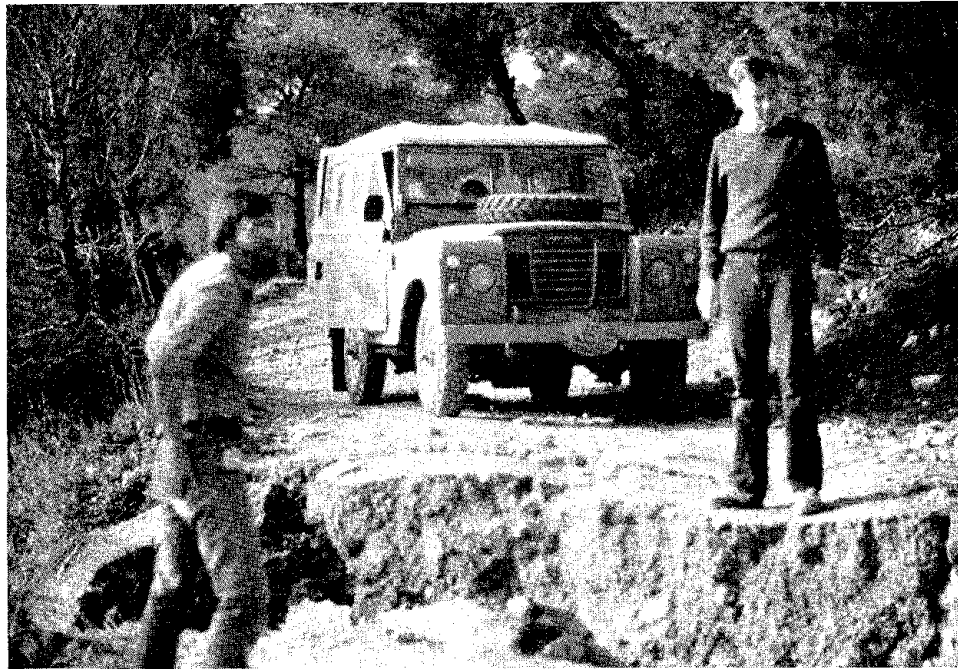
FIGURE 2.8 Vertical offset of road in the central part of the Kalamaki rupture trace.

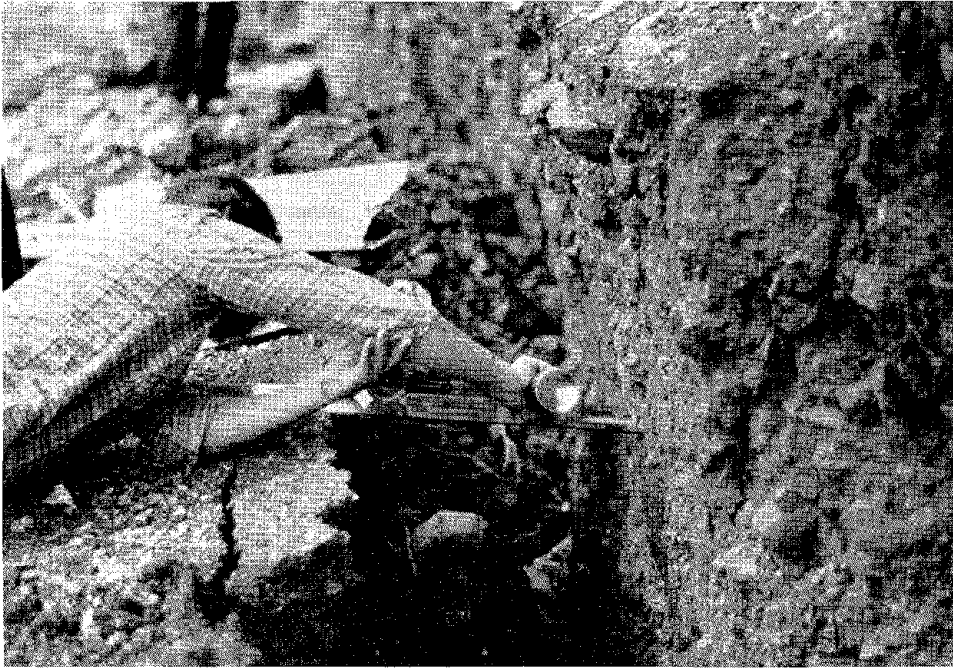
FIGURE 2.12 Typical ground rupture along the Kalamaki and Kapareli traces. At this location there were 60 cm of dip-slip displacement and 50 cm of rotational "opening" displacement.

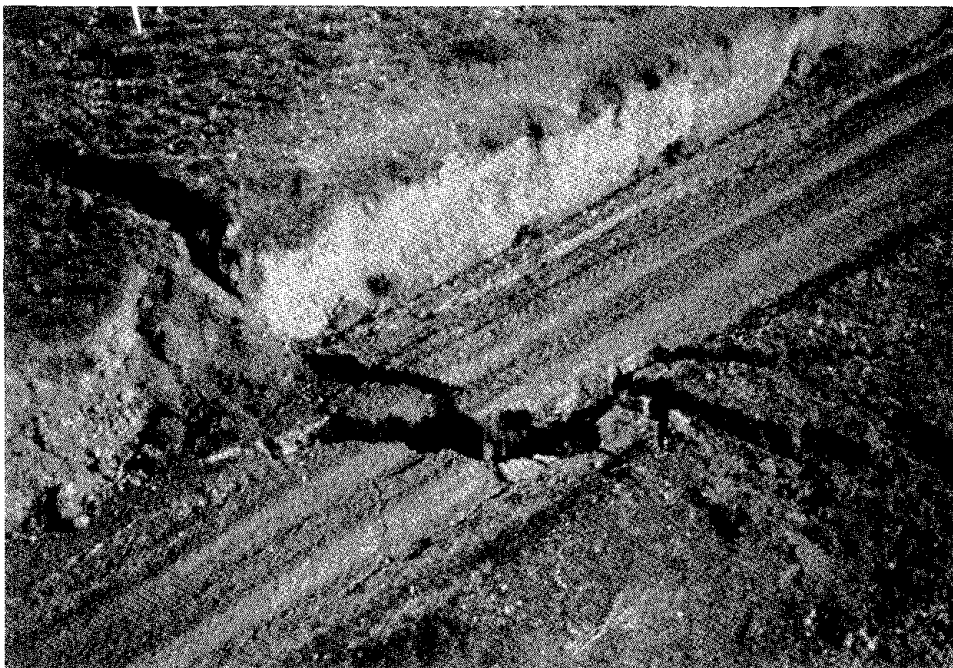
FIGURE 2.13 Part of the Kapareli surface rupture, showing combination of dip-slip and rotational "opening" displacement. In this case the opening displacement exceeded the dip-slip component.

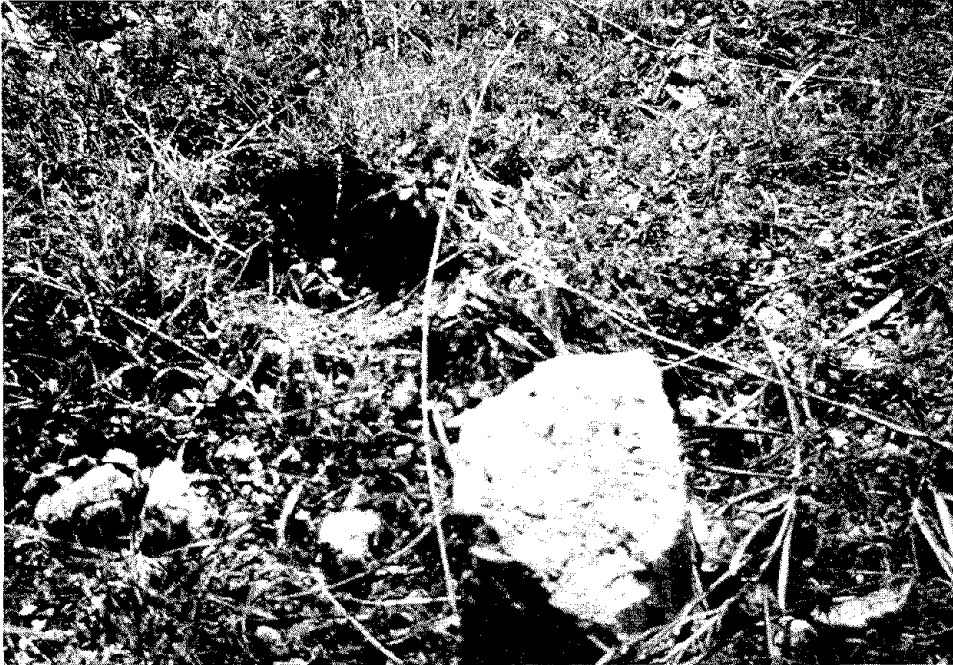
FIGURE 2.15 Typical "flipped" rock around the Kapareli and Kalamaki rupture traces. This phenomenon indicates near-field vertical acceleration of over 1.0 g during the March 4 earthquake (magnitude 6.2).

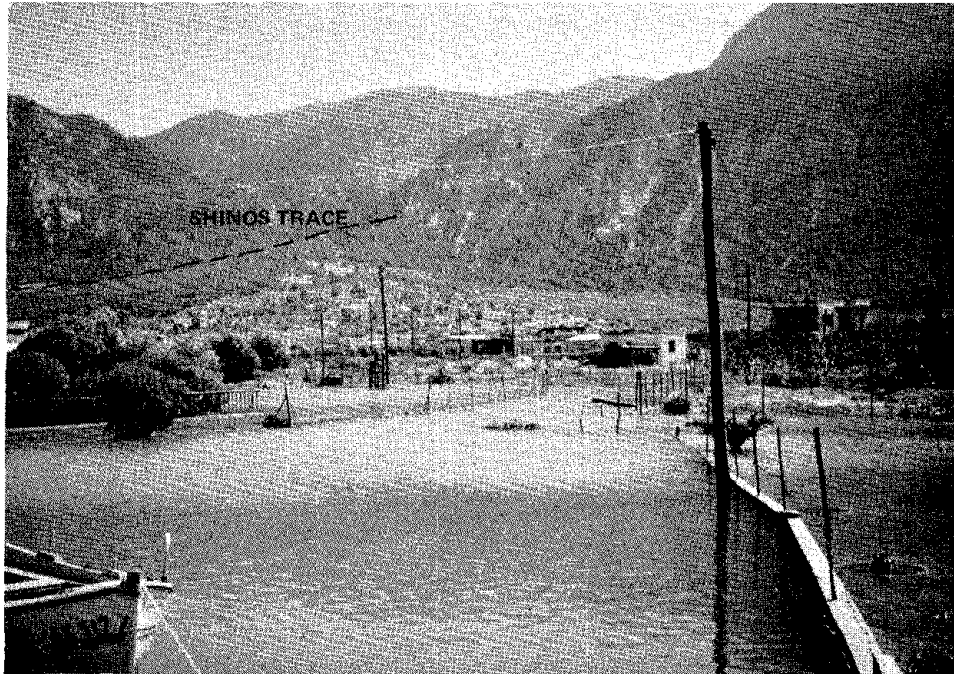
FIGURE 2.16 Subsidence of the ground surface north of the Shinos trace (looking south). A segment of the Shinos trace is shown where it crosses a large alluvial fan.

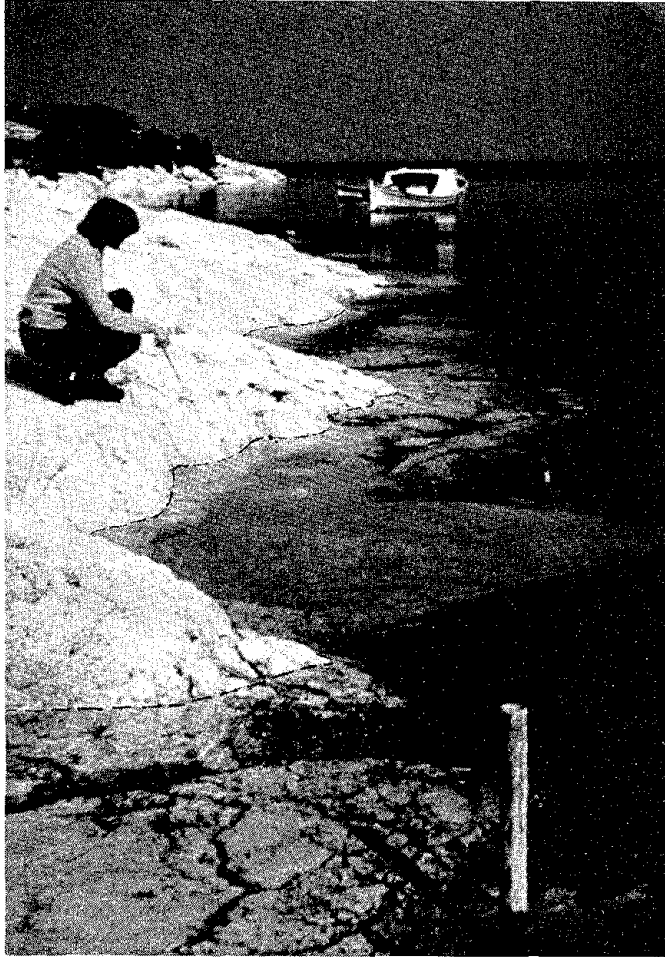
FIGURE 2.17 Submerged concrete docks north of Shinos. The dotted line indicates the present water level. At this site over 1.0 m of subsidence was documented associated with the earthquakes of February 24 and 25, 1981.

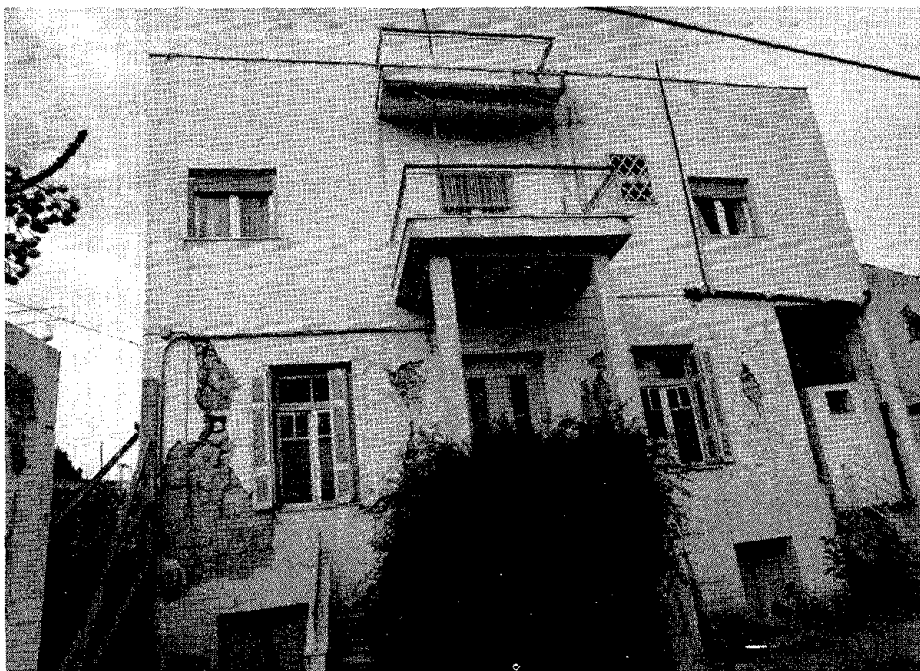
FIGURE 4.4 Additions are very vulnerable, as in this case in Megara. Usually the old building (the lower one) suffers most of the damage.

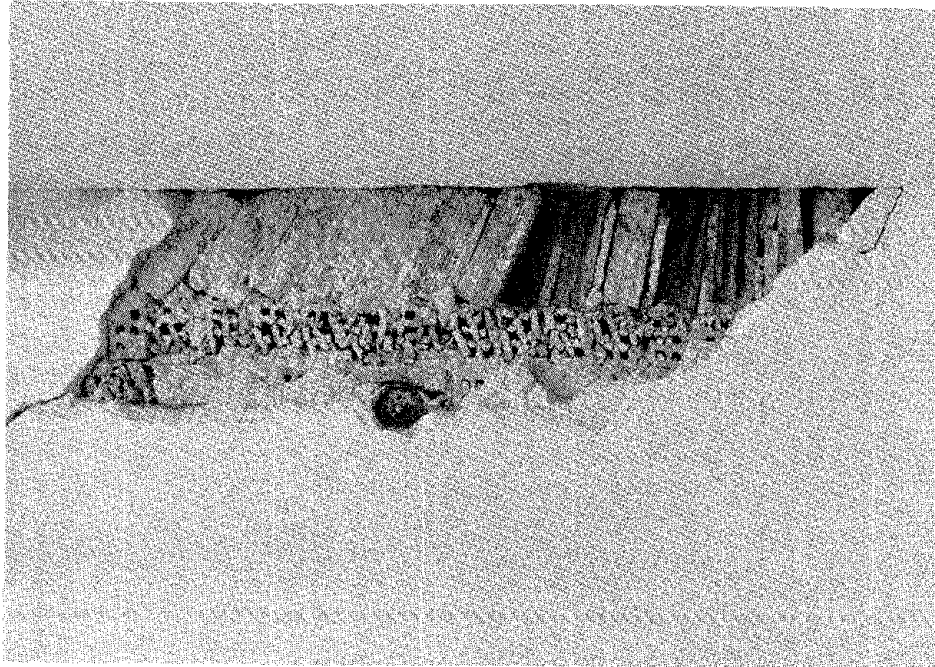
FIGURE 4.12 Detail of failure shown in Figure 4.11. Typical practice calls for the inclined bricks to be wedged under the ceiling beam. The underlying row of bricks are crushed.

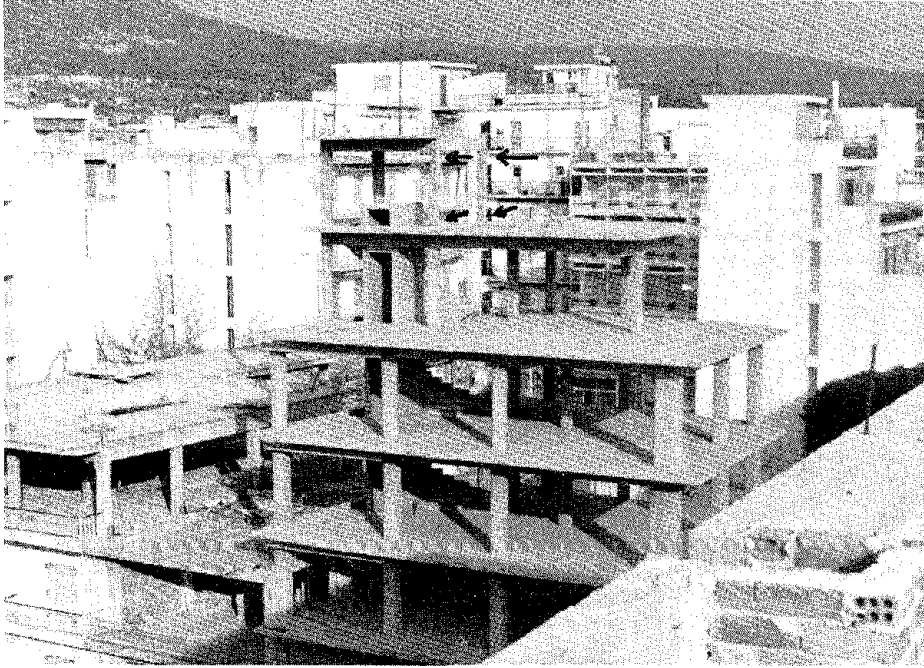
FIGURE 4.15 Eccentrically located walls in reinforced concrete frame under construction. This is a typical example of a drastic change in the plan area in a penthouse. Collapses of such penthouses were reported.

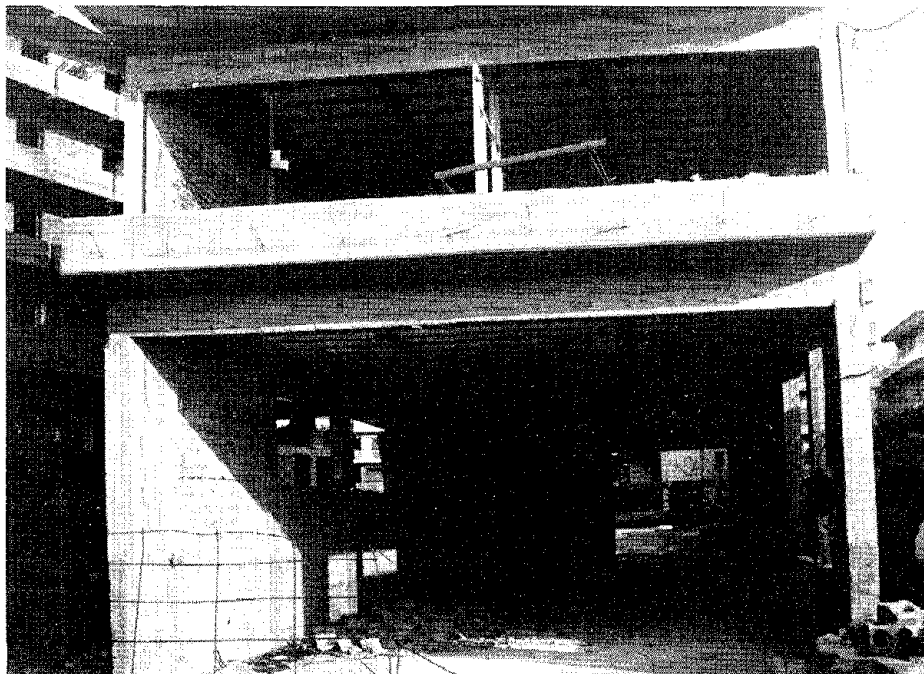
FIGURE 4.16 Difference in stiffness of framing and walls in orthogonal directions. The first story is flexible in one direction.

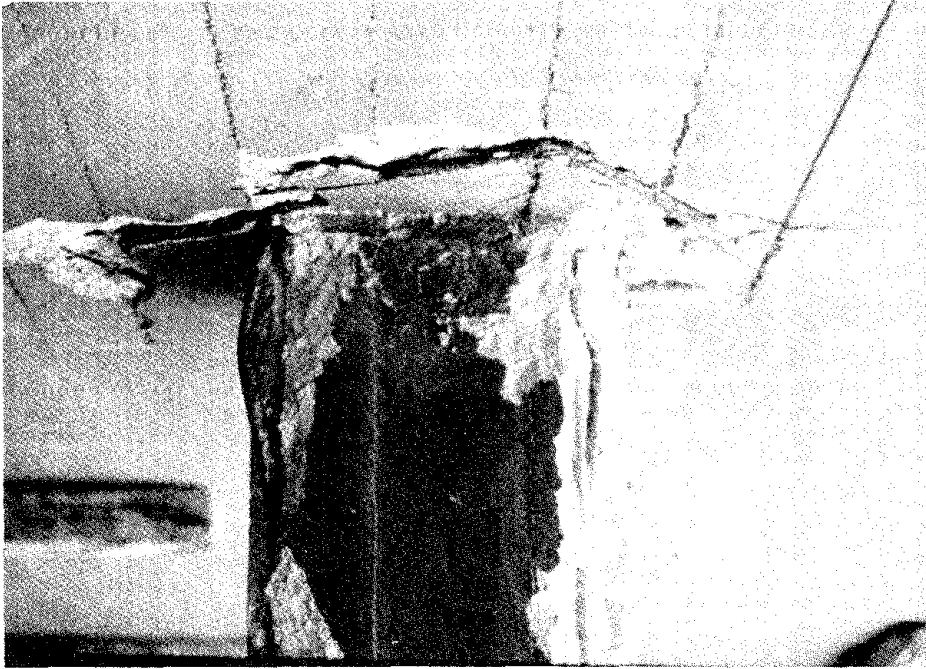
FIGURE 4.19 Typical damage of column-to-slab connections. A steel plate has been fixed at the top of the column to add support.

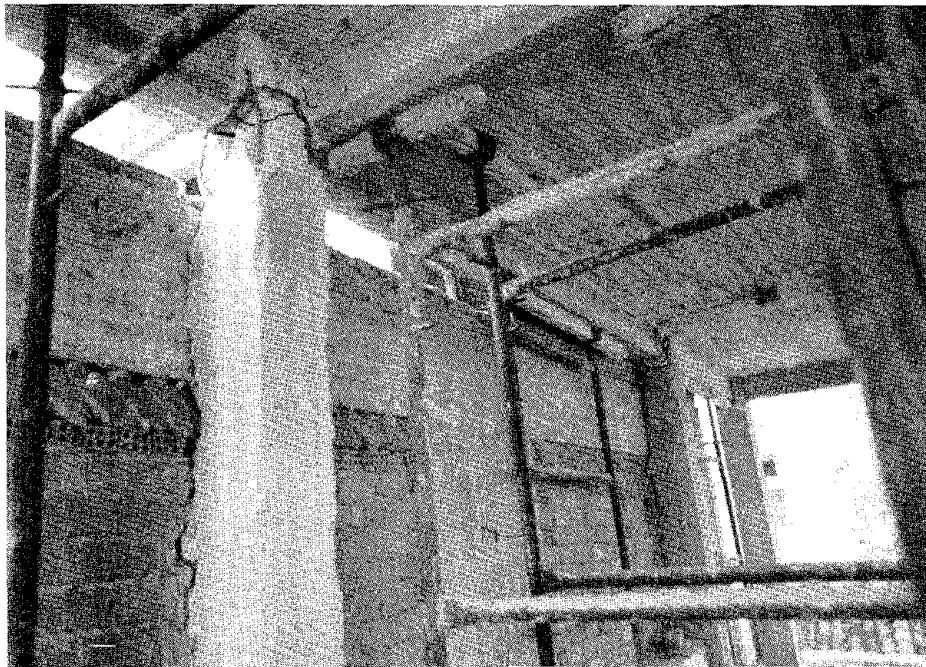
FIGURE 4.20 Hammer effect between two adjacent buildings not separated in Megara.

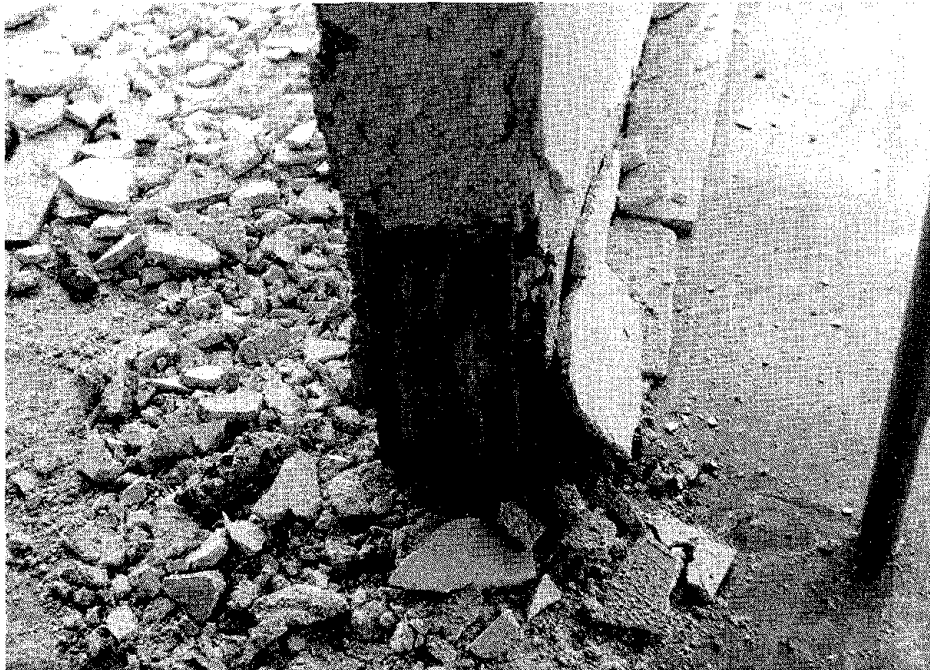
FIGURE 4.24 Poor detailing--too many steel bars appear in the lower part of the column. Most of the bars are from the lower story. The hooks opened and initiated the damage.

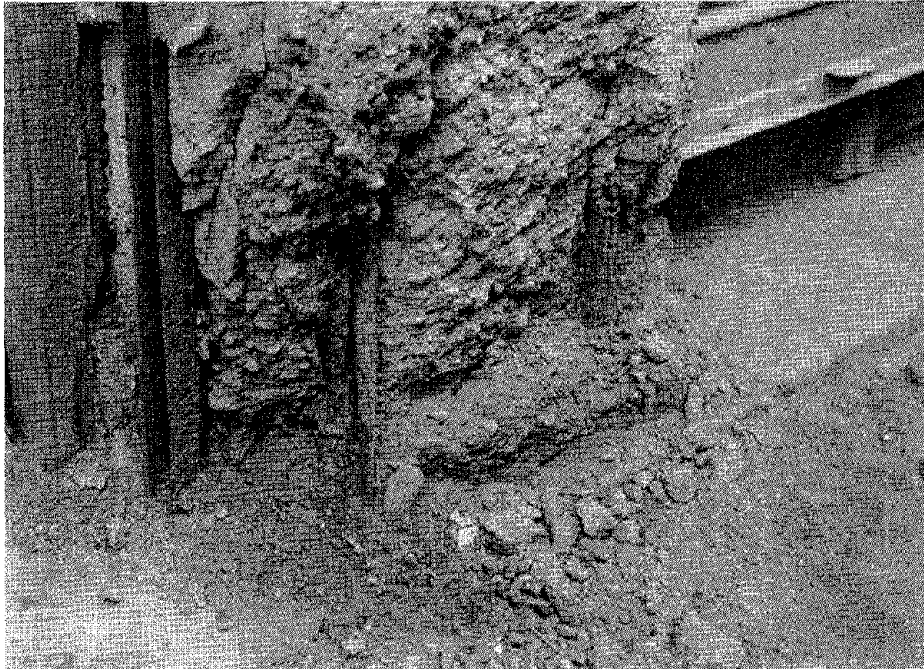
FIGURE 4.25 Nearly complete rusting of reinforcing steel bars at the bottom of a column, due to poor concrete quality.

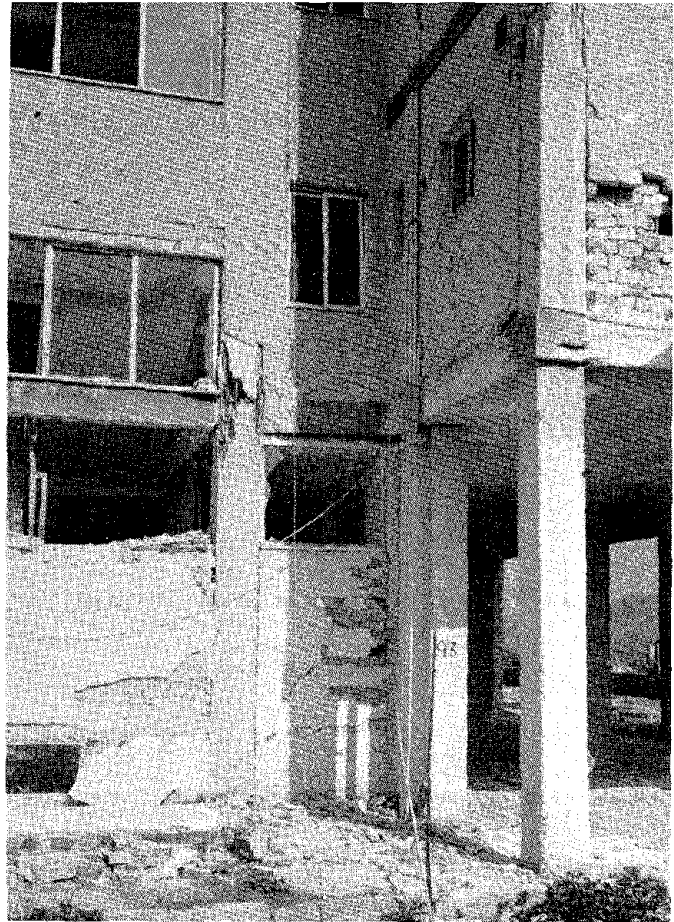
FIGURE 4.28 Conduits for electric cables pass through the column just inside the reinforcing bars and along the brick walls through channels chipped into the column and walls.

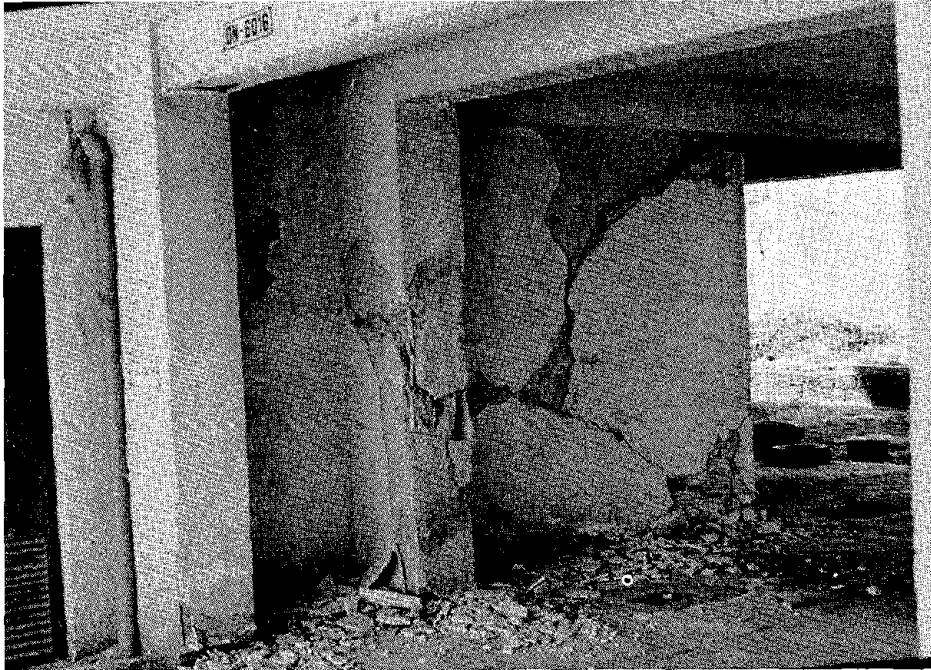
FIGURE 4.30 Typical shear failure of reinforced concrete column confined by a brick wall. The rupture of the masonry extends through the column.

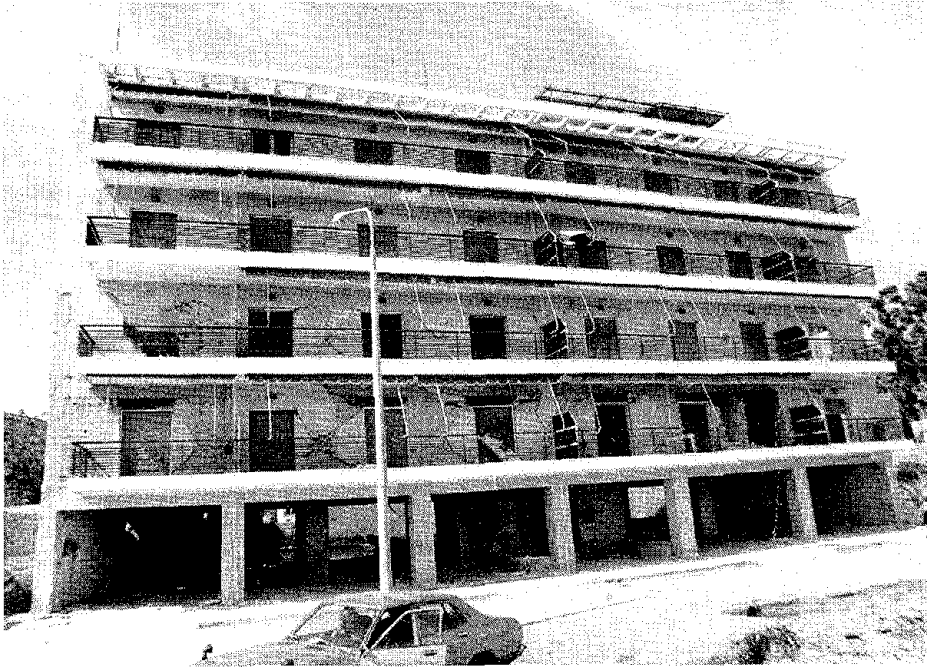
FIGURE 4.32 Typical apartment house with an open first story and no shear walls. The floor beams are flexible and the story heights are low.

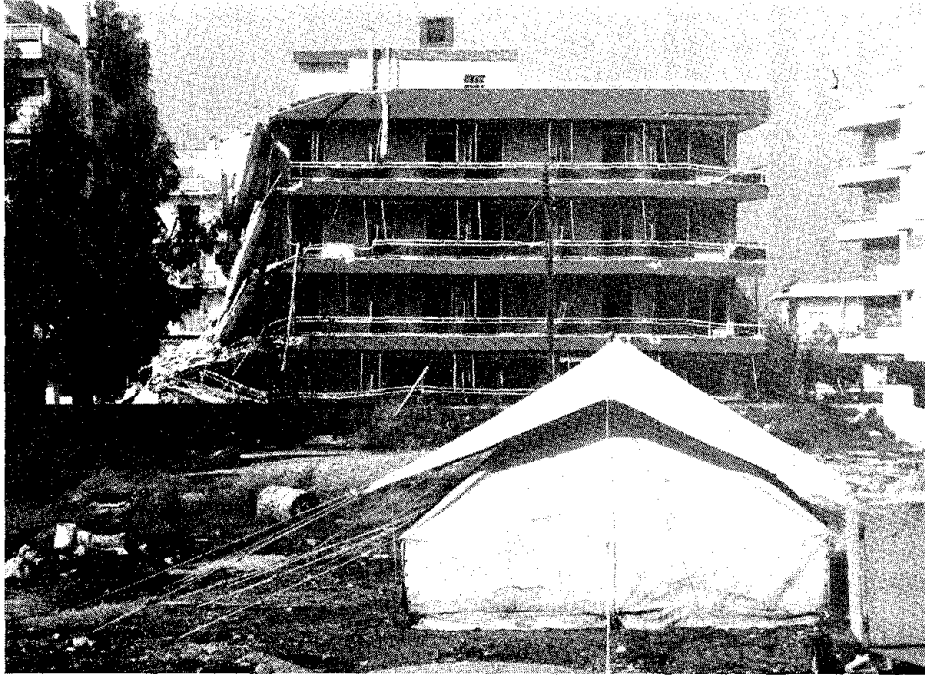
FIGURE 5.2 Partially collapsed five-story block of flats "Segas" in Loutraki. (Note temporary tent shelters in foreground.)

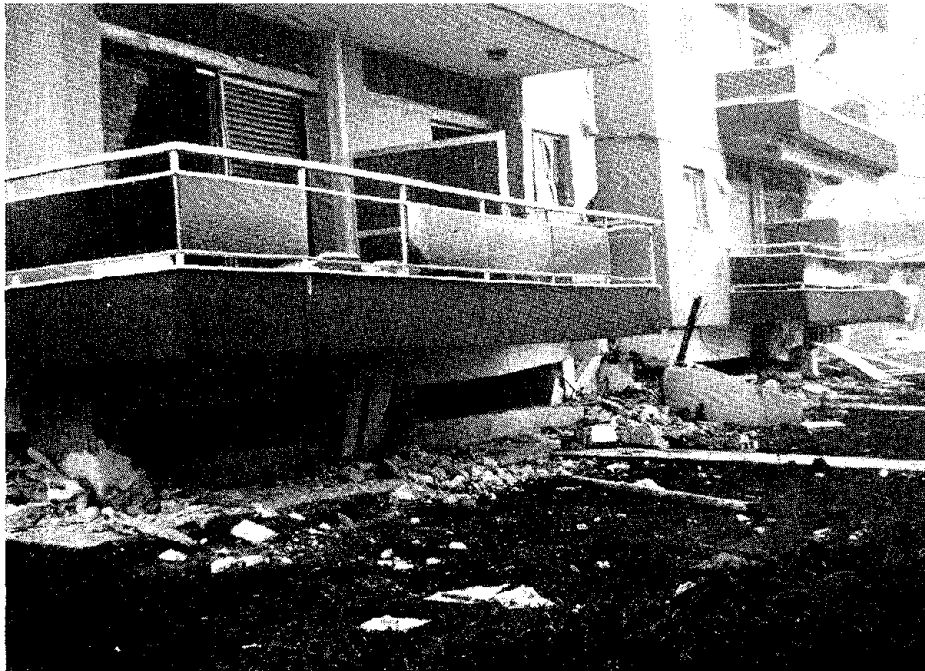
FIGURE 5.3 Failure of first-story columns.

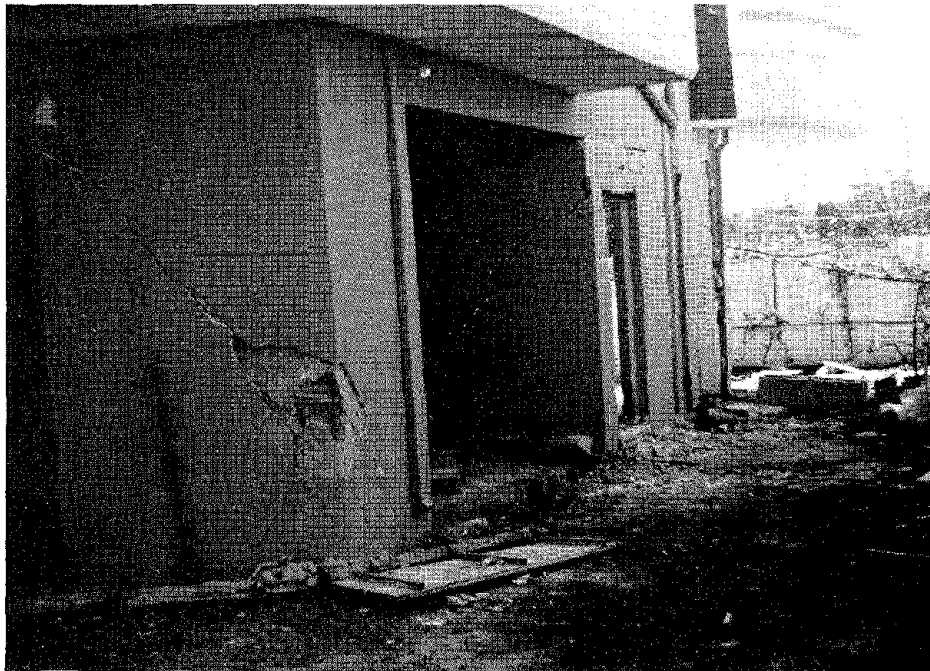
FIGURE 5.5 Failed wide column.

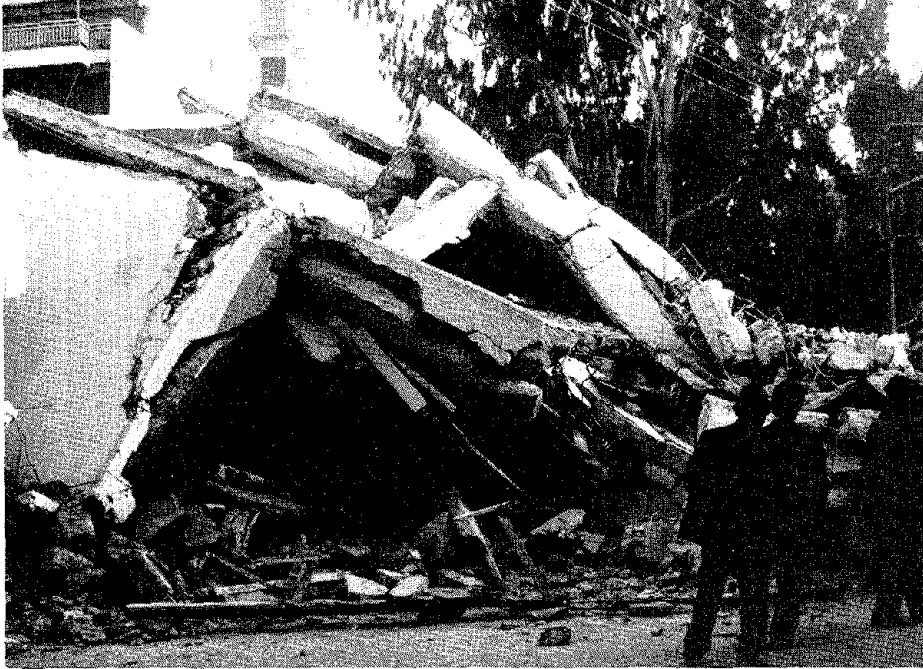
FIGURE 5.6 Collapse of Contis Hotel in Loutraki.

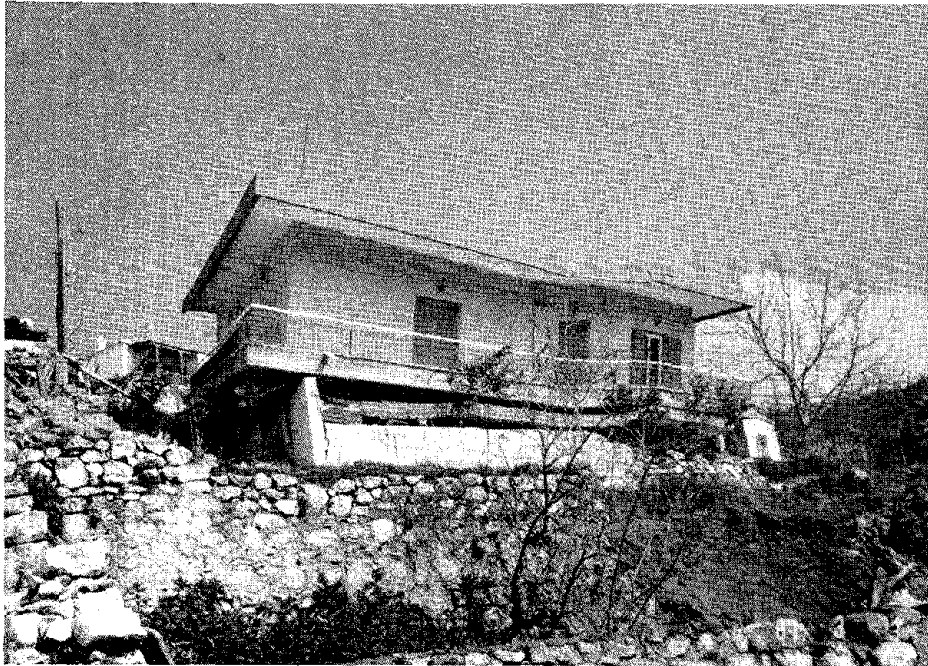
FIGURE 5.10 Damage to a three-story house built on sloping ground in Perahora. The retaining wall at the back of the house, which acts as a footing, functioned as the axis of rotation.

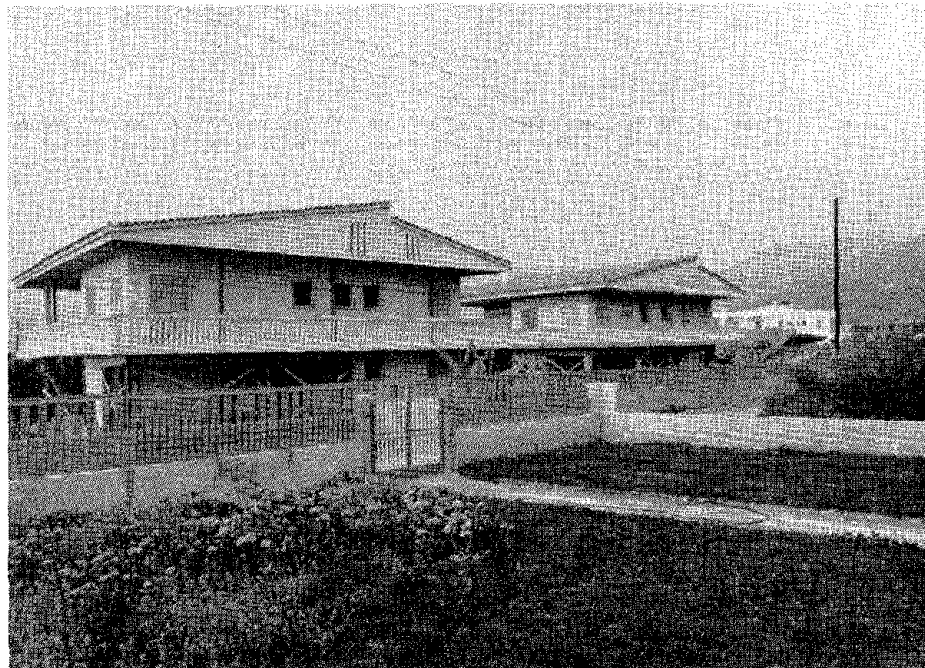
FIGURE 5.12 Three identical two-story buildings in Alepohori showed quite different behavior. The degree of damage increases from left to right. The left building is closer to the sea--no more than 60 m away--and suffered little damage to its first story. The third building collapsed totally (see Figure 5.13).

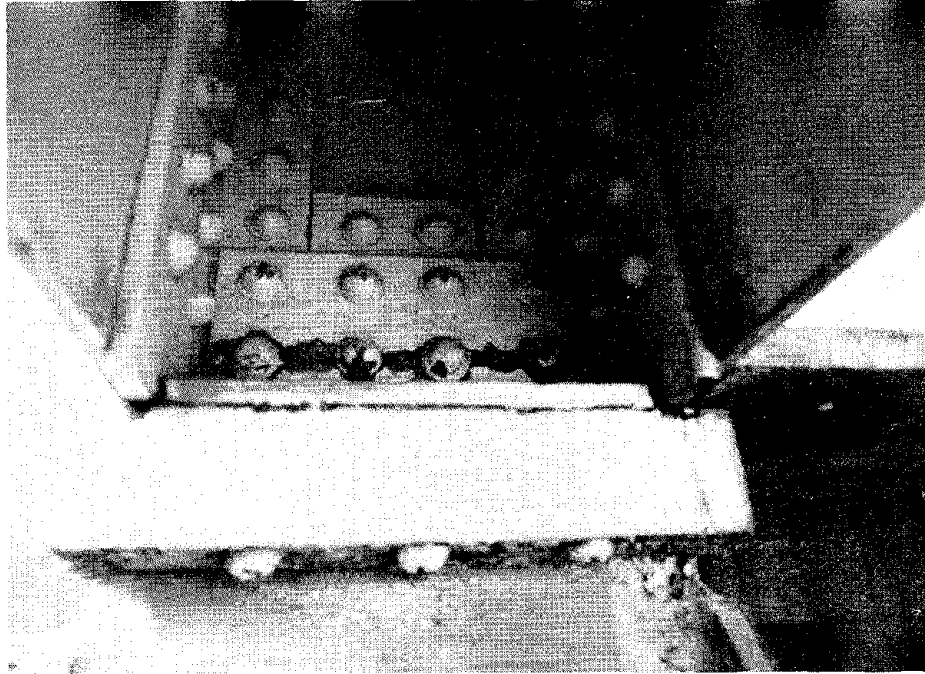
FIGURE 5.18 At the hinged support of the old road bridge over the Corinth Canal, two or three rivets that were connecting the support with the main girder broke in shear. Some tension was also observed in the L-shaped stiffening members.

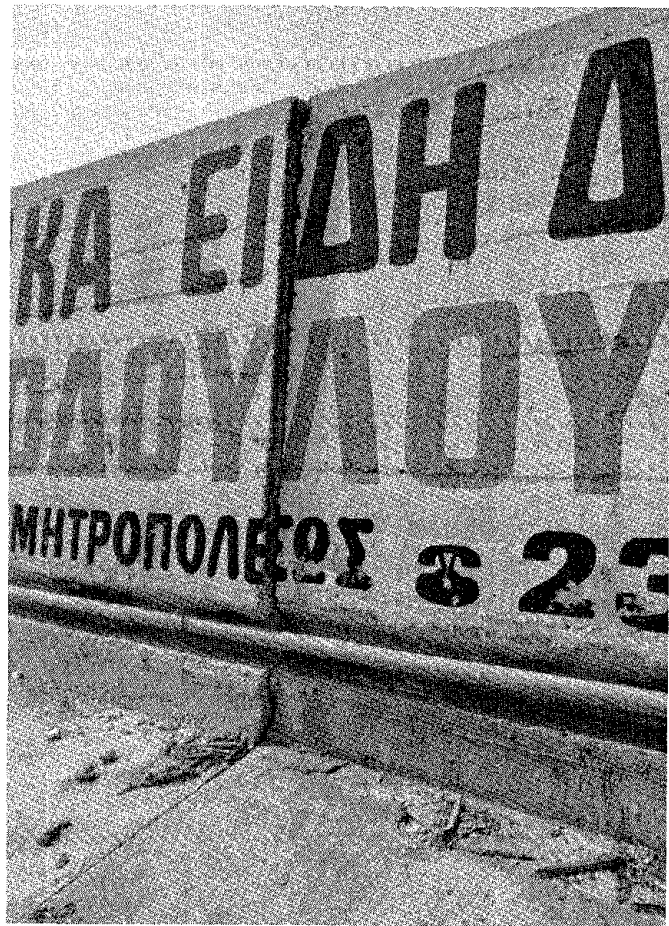
FIGURE 5.24 Jetty in Kiato. Differential settlements and rotations of the concrete blocks were observed.

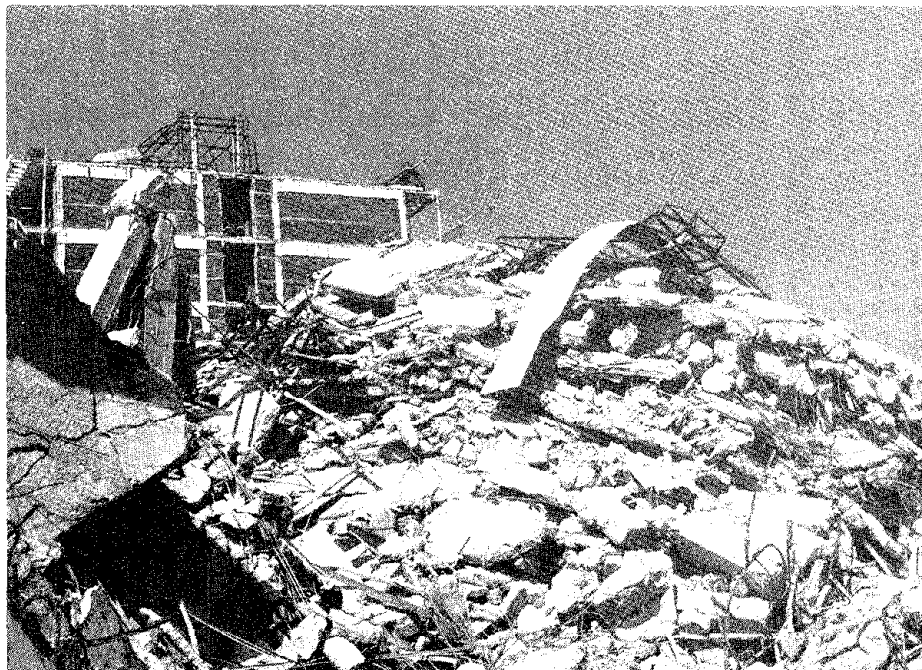
FIGURE 5.26 Collapse of nearly completed hotel in Vrahati.

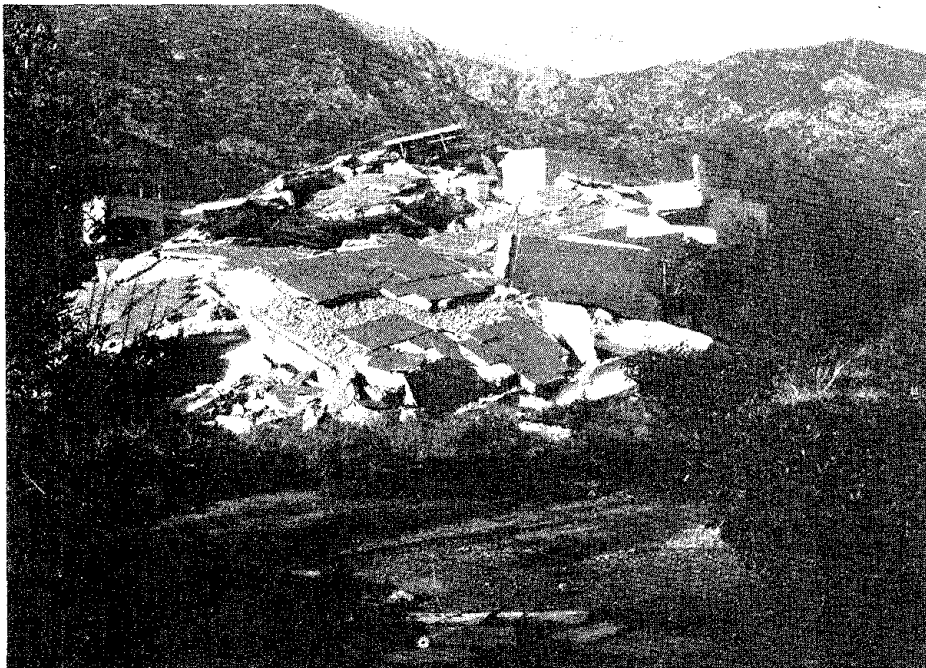
FIGURE 5.30 Collapse of Kineta bungalows.

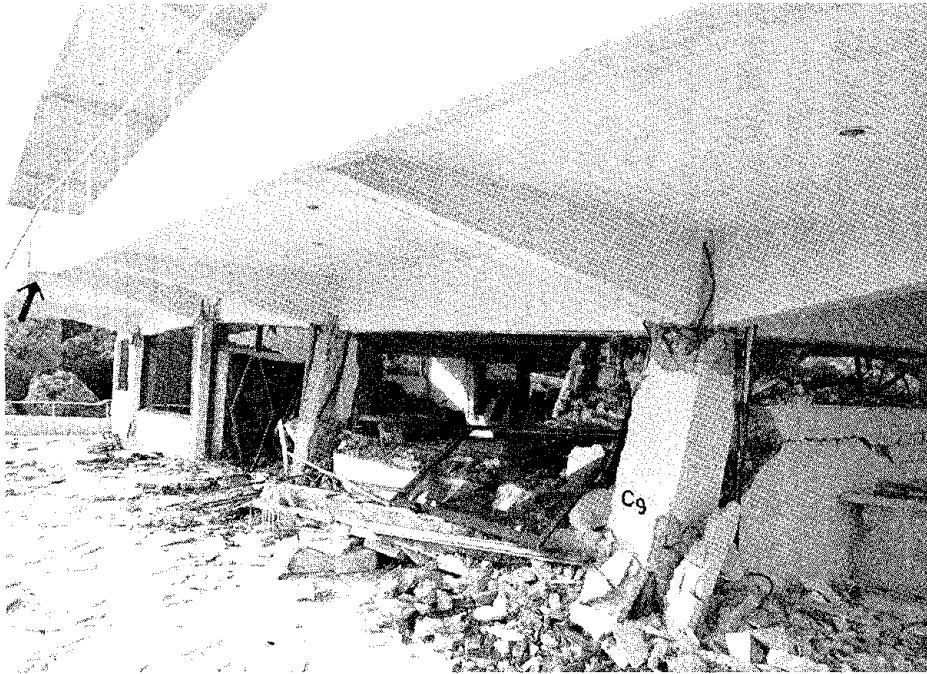
FIGURE 6.4 Vip's Hostel in Perahora. This view from the south shows part of the damaged columns in the second story. The arrow shows the large deformation of the ceiling. There are no ties in the column-to-beam connection (c_9).

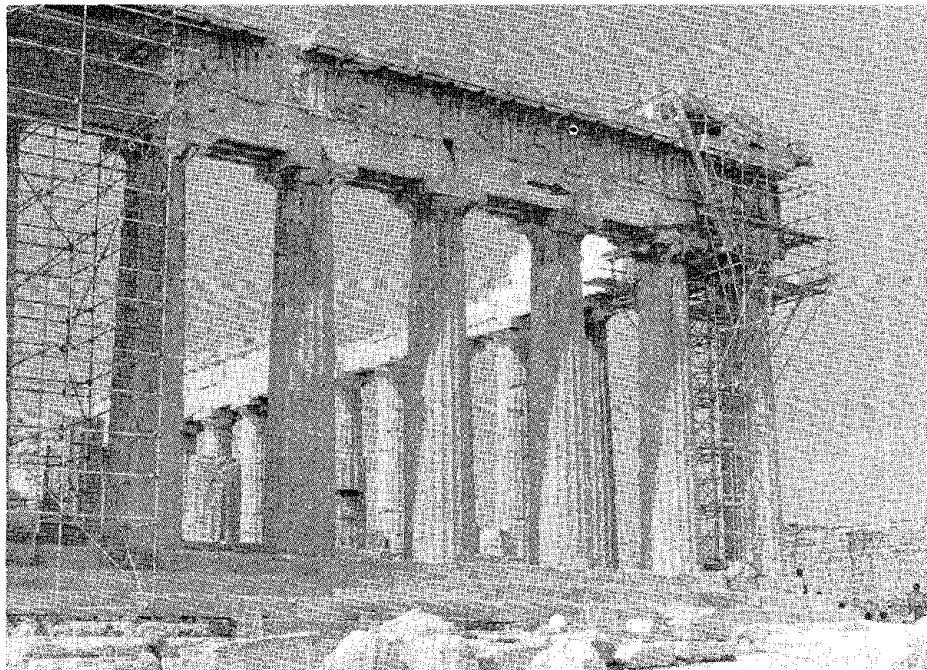
FIGURE 6.44 East view of the Parthenon. The arrow indicates a large crack in the head beam over the third pillar. There are also large cracks in the head beam between the first and second pillars.

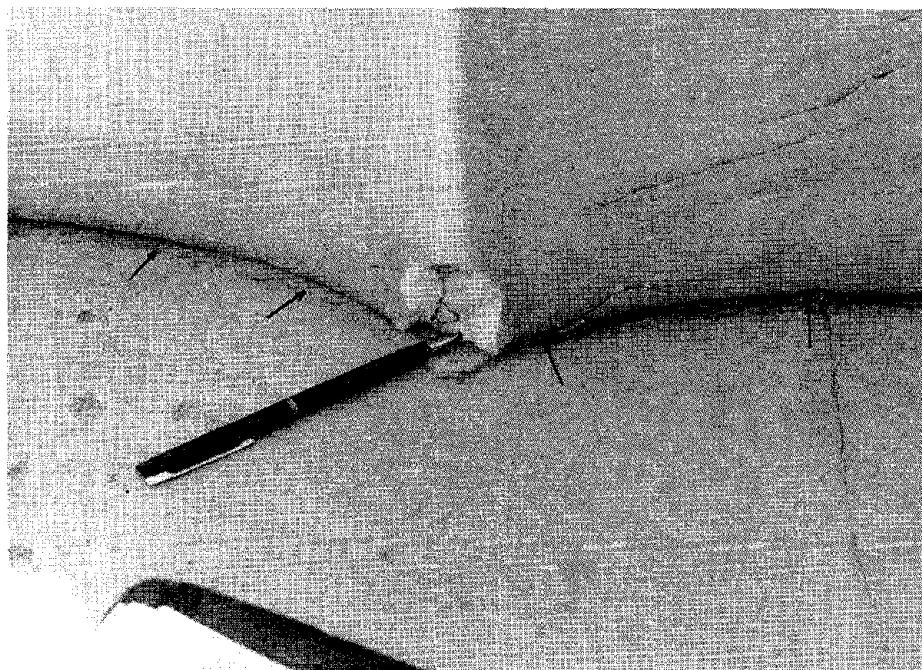
FIGURE 6.49 Lowest part of the pillar at the northeast corner of the Parthenon. This shows typical breaking of the edge of the pillar. An anticlockwise rotation and displacement of about 1-2 cm to the west was observed. Source: Dontas (1981).

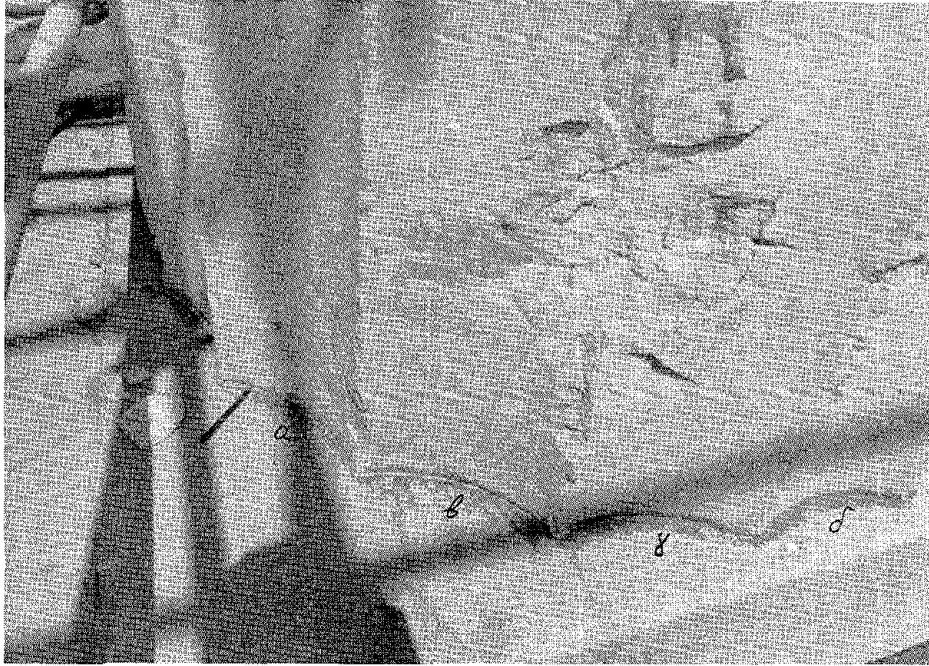
FIGURE 6.51 Lower part of the pillar at the southeast corner of the Parthenon. A clockwise rotation and displacement of the pillar to the east of about 1-2 cm was observed. Some fallen marble chips may be seen. Source: Dontas (1981).
