Earthquake Resistance of High-Rise Systems

DIGESTS OF CASE STUDIES

OF TALL BUILDINGS DAMAGED IN EARTHQUAKES

Fritz Engineering Laboratory Report No. 474.6

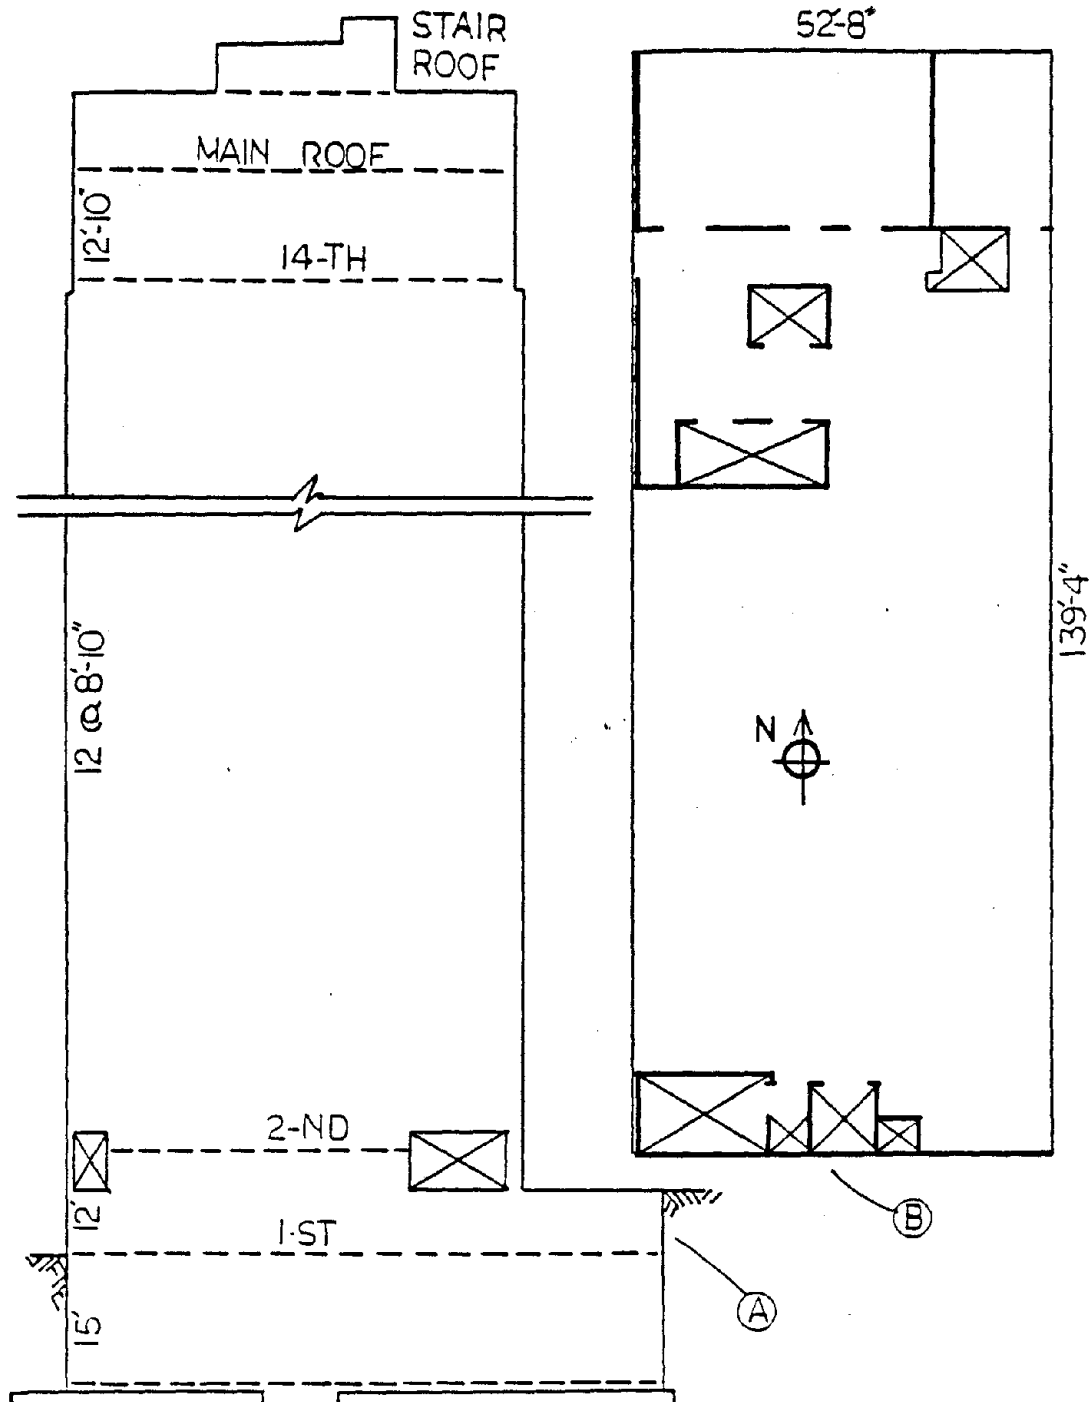
Figure 2-1: Anchorage Westward Hotel:  
(A) Elevation of exterior S-wall.  
(B) Typical plan.

Substantial damage occurred in the exterior W-wall at the top of the 8th story. There was also significant damage in the interior E-W shear wall at the 2nd floor level. Its E-end concrete column fractured and the steel section buckled. There were no shear connectors between the steel section and the concrete, so that the contact surface was of zero shear strength in the reinforced concrete. The W-end failures were even more severe: the steel bars also buckled

and the ties broke. The reinforcing bars were spliced at this level. Above this location, at the 8th story, the connection plate fractured; an examination of the walls near the S-end of the building found slight movement along several joints. In several instances laitance had not been removed from the joint. Additional damage occurred to an outside column in the 1st story, similar to the other failures and at a location where the bars were spliced. Failures occurred in the lintels above all door openings in every story in the interior E-W wall. Stirrups were used in the lintels in the lower 8 stories but not in the upper 6 stories, which experienced the worst damage.

Pounding damage occurred between the 14-story building and the ballroom building. Additional pounding damage occurred between the 6- and 14- story buildings, although they were separated by a 4" structural gap.

The facades and glazing survived the earthquake with only minor damage. A curtain wall mullion came apart from the slip joint next to the structural failure at the 8th story, but it did not fall. Typical hammering damage occurred where the tower adjoins the 3-story ballroom. The facade on the top of the tower, being subjected to heavy racking, cracked the concrete slab around the supporting inserts. The metal lath and plaster partitions were damaged, and plaster covering a damaged concrete shear wall was broken loose.

Since damage was more pronounced in the 9th story, which was the roof of the original building at this point, it seems reasonable to attribute this damage, in part, to construction problems at the juncture between the addition and the original building. Failures were also concentrated at points of bar splicing. The damage to the lintels over doorways was due to vertical shear caused by seismic overturning forces. Overturning stress in the shear wall, when viewed as a vertical cantilever, must be transferred from the tensional component at one end to the compressional component at the other end of the wall by means of shear through the lintels above doors. The high shearing stresses in the lintels resulted in damage vertically aligned between floors.
