EL-ASNAM, ALGERIA EARTHQUAKE OF OCTOBER 10, 1980

A Reconnaissance and Engineering Report

**National Research Council
Committee on Natural Disasters**

Earthquake Engineering Research Institute

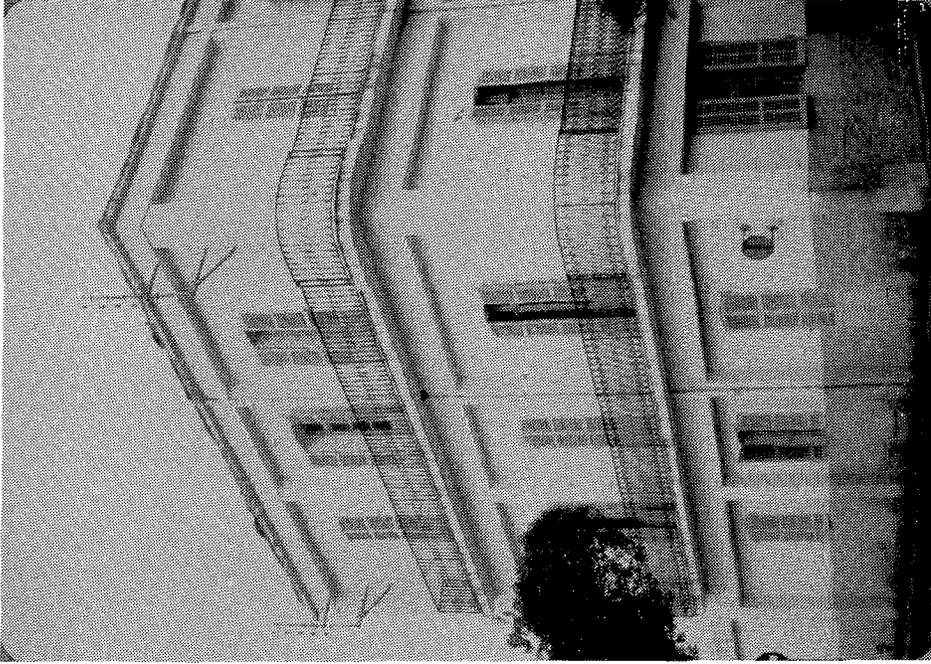
Fig. 1.14 Structure in El-Asnam Strengthened with RC Frame After 1954 Earthquake. It sustained only minor damage in October 10, 1980 earthquake.

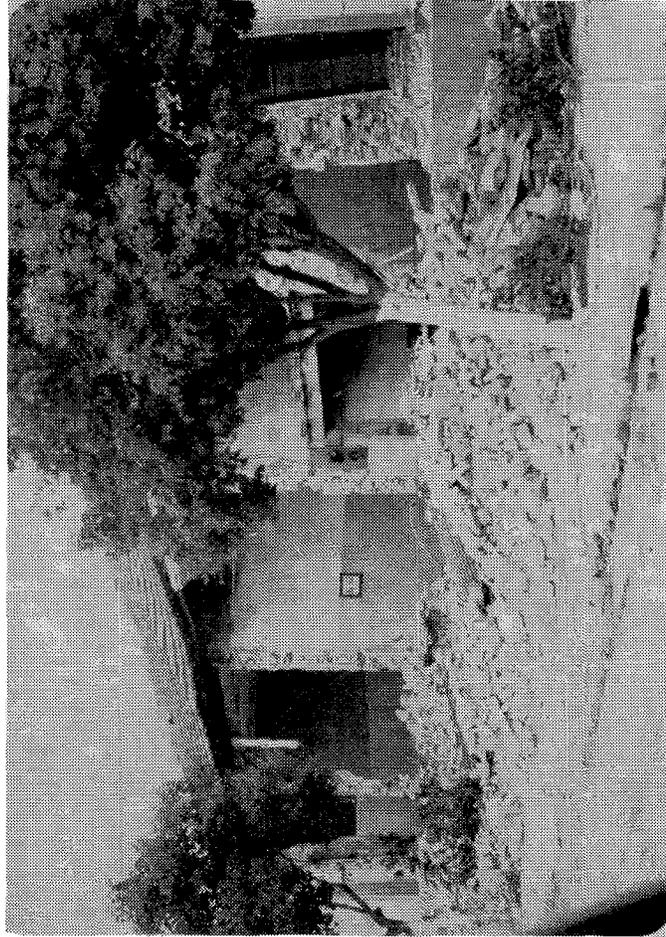
Fig. 1.13 Collapsed One-Story Masonry Structures in El-Asnam

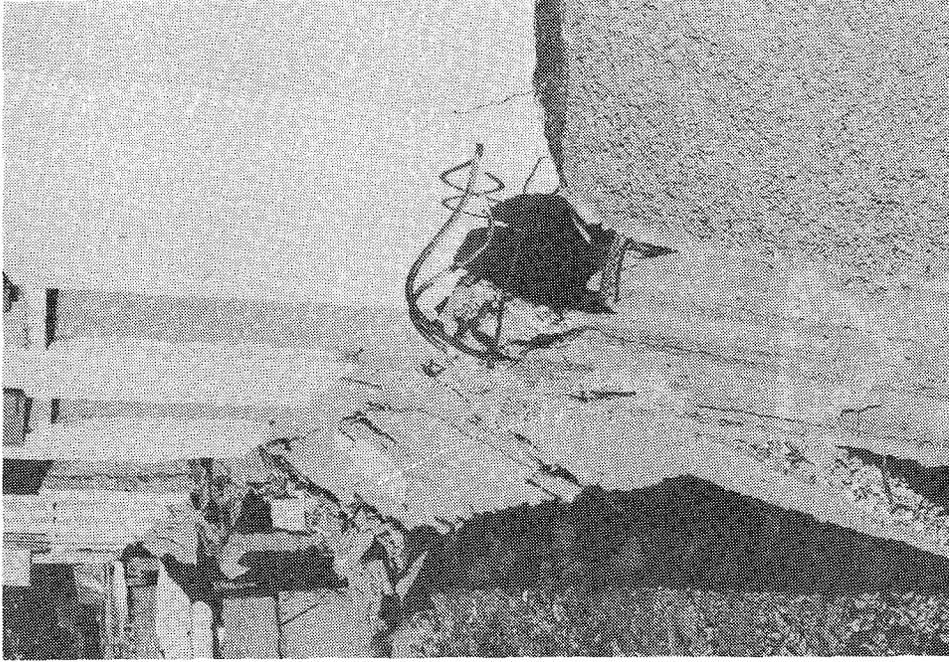
(b) Failure of *Vide Sanitaire*

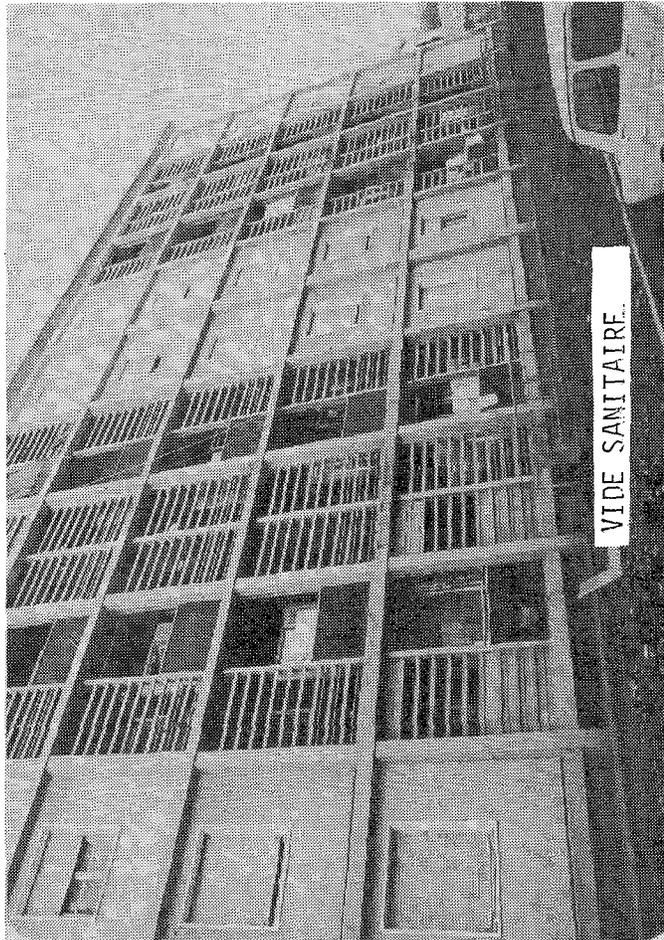
(a) Building in Algiers. Most buildings of this type in El-Asnam lost their 1 meter high columns.

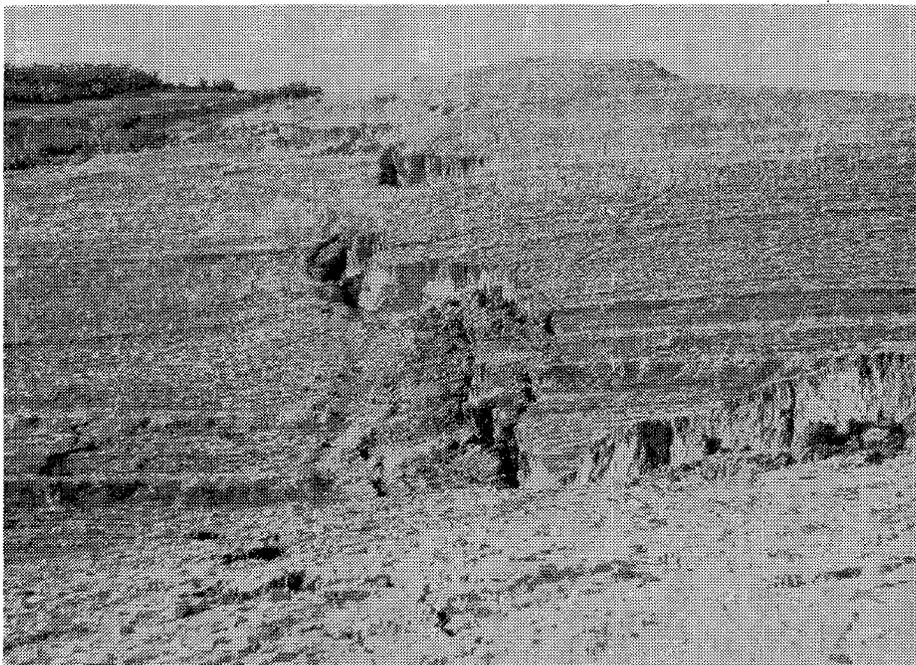
Fig. 2.9 Break Along Beni Rached Fault

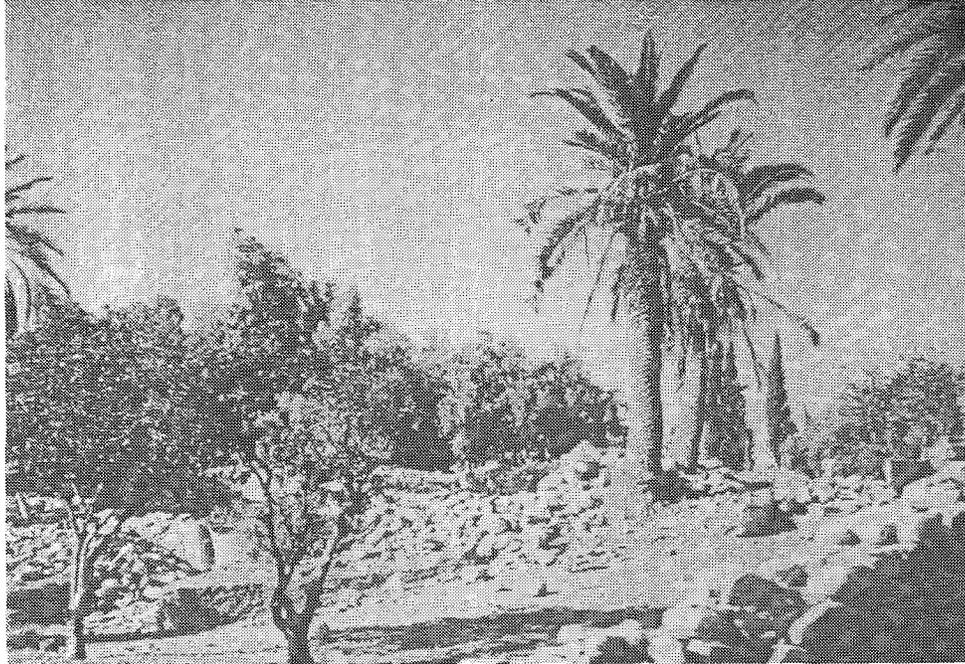
Fig. 3.1 Debris from Collapsed Houses, El-Abadia

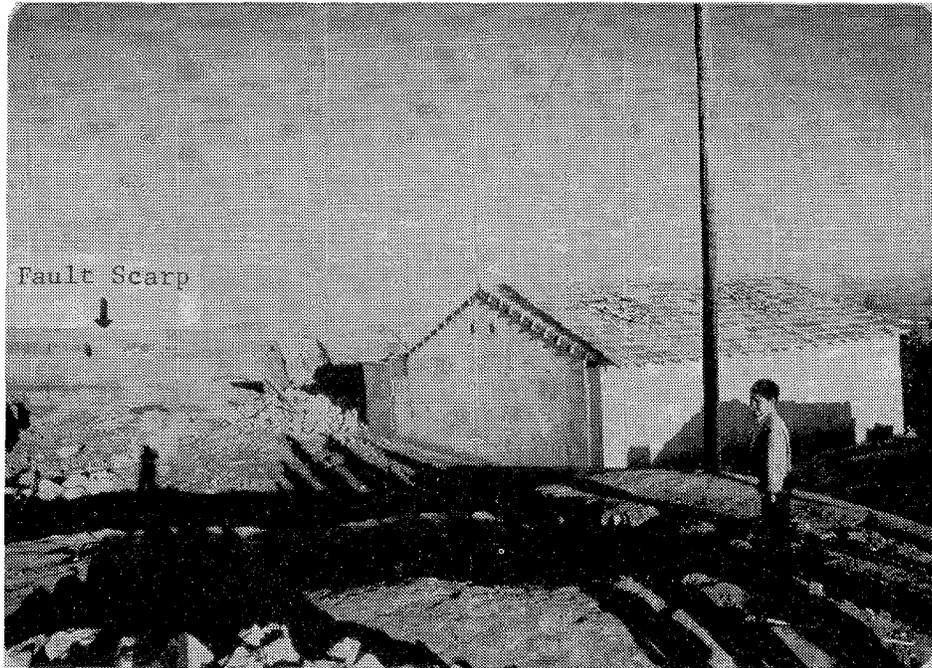
Fig. 3.3 Unreinforced Masonry House with Loose Tiles That Did Not Suffer Major Damage. Note fault rupture in background.

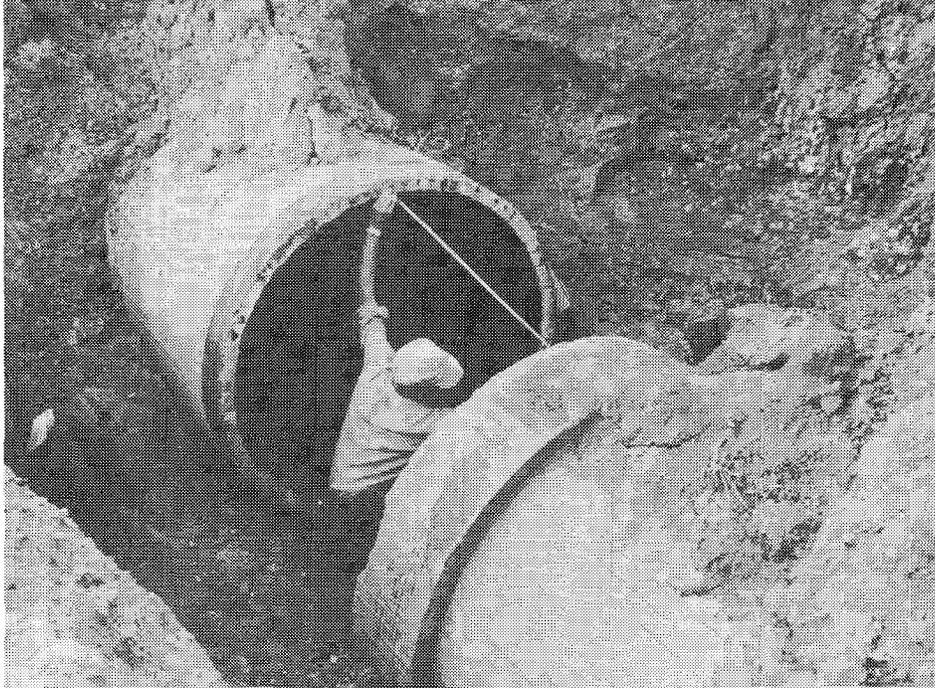
Fig. 3.4 Irrigation Water Main Ruptured by Secondary (Normal) Trace of Oued Fodda Fault

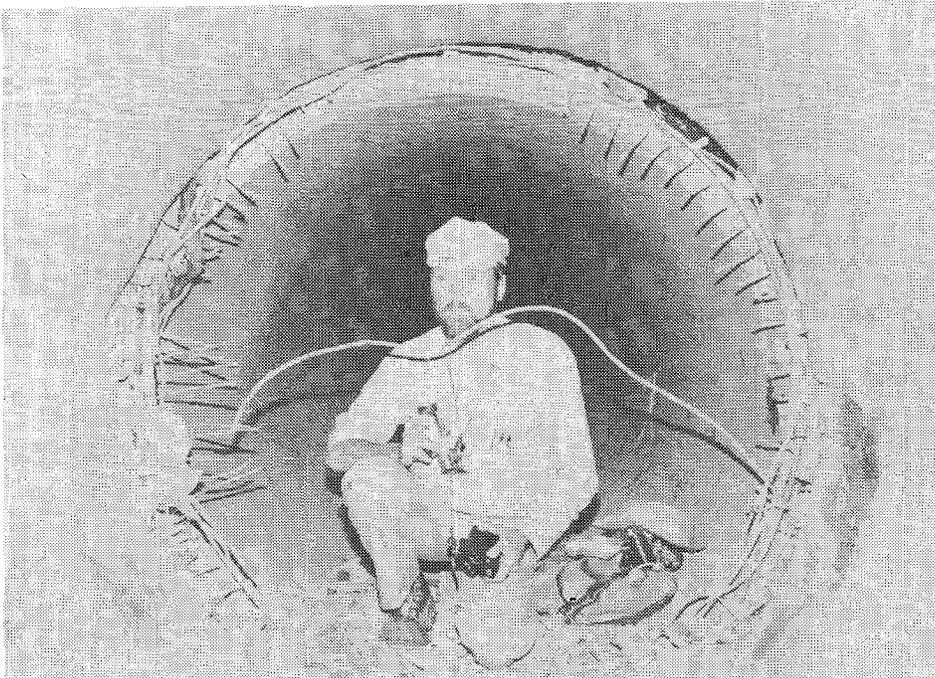
Fig. 3.5 Inside of Irrigation Water Main Where It Crosses Main Trace (Thrust) of Oued Fodda Fault. Compression has shortened steel RC pipe about 0.5 meter where two pipe segments join.

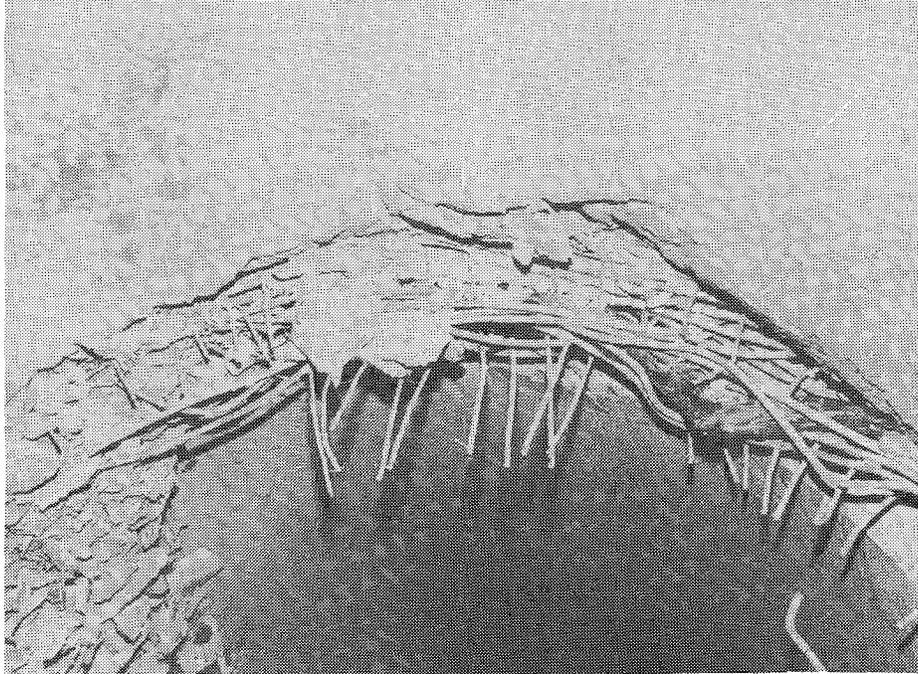
Fig. 3.6 Closeup of Damaged Irrigation Main Shown in Fig. 3.5

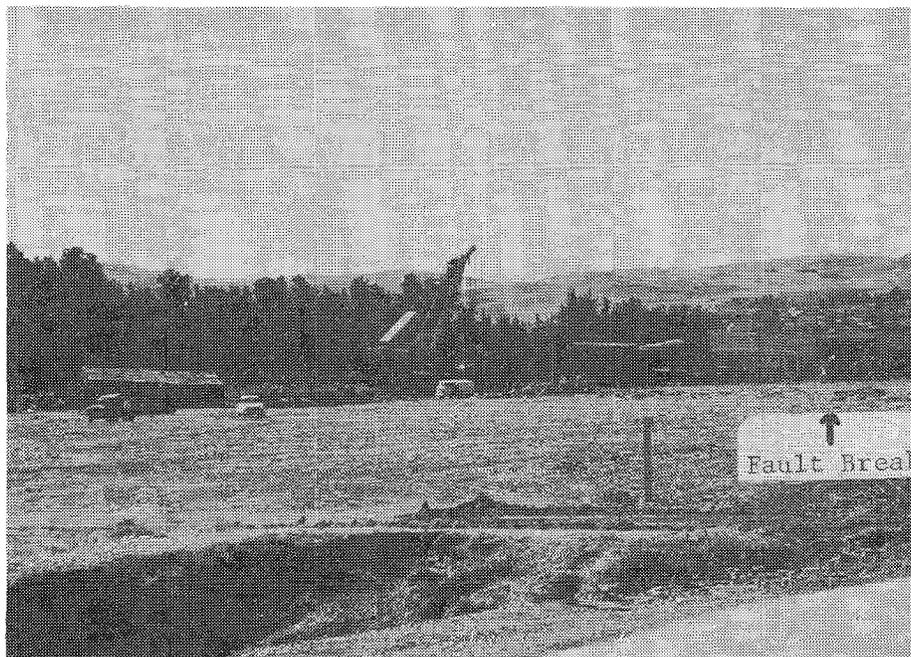
Fig. 3.10 Overturned Train. Note fault break.

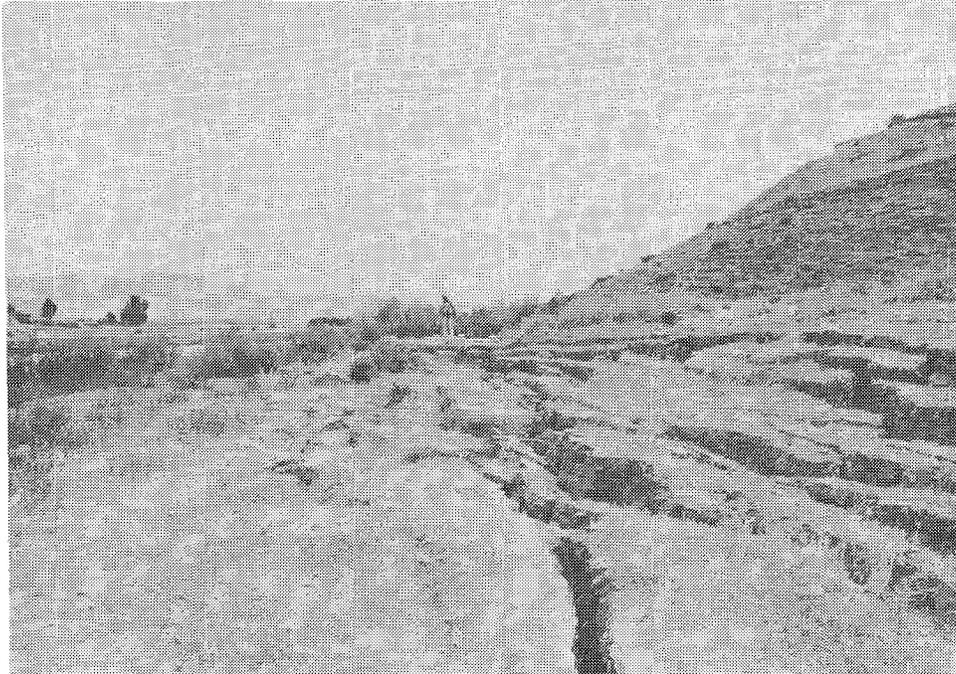
Fig. 3.15 Fissures and Fault-like Scarps Produced by Lateral Spreading of Alluvium Toward Oued Cheliff Channel

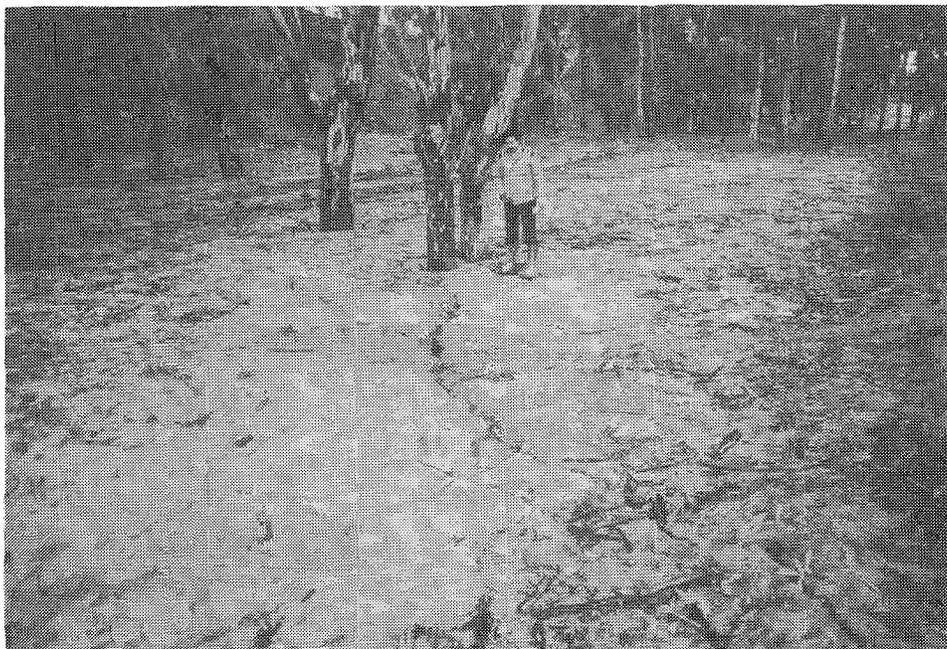
Fig. 3.16 Sand Boil Along Ground Crack at Site 2 Terminating at Tree Trunk. Note depressions around trees.

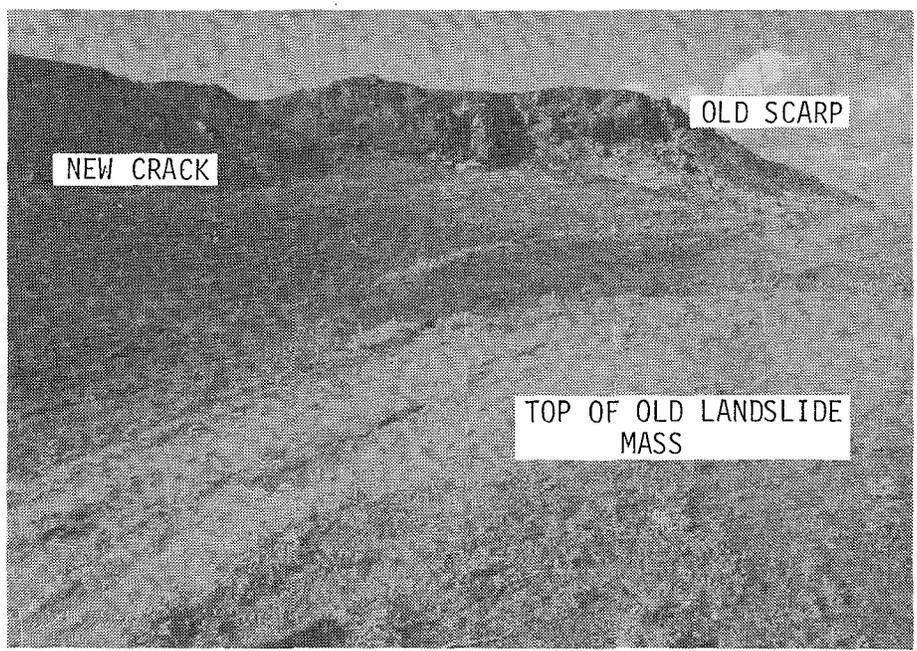
Fig. 3.19 Old Landslide Scarp, New Subsidence Crack, and Top of Old Landslide Mass at Site 8

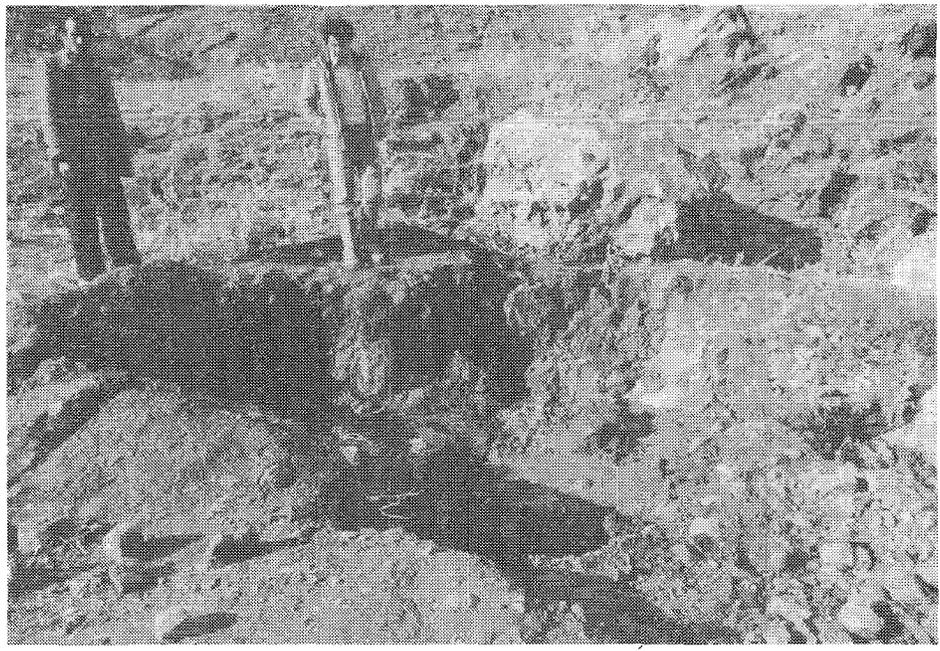
Fig. 3.21 Geyser Crater at Crest of Old Landslide Mass at Site 8

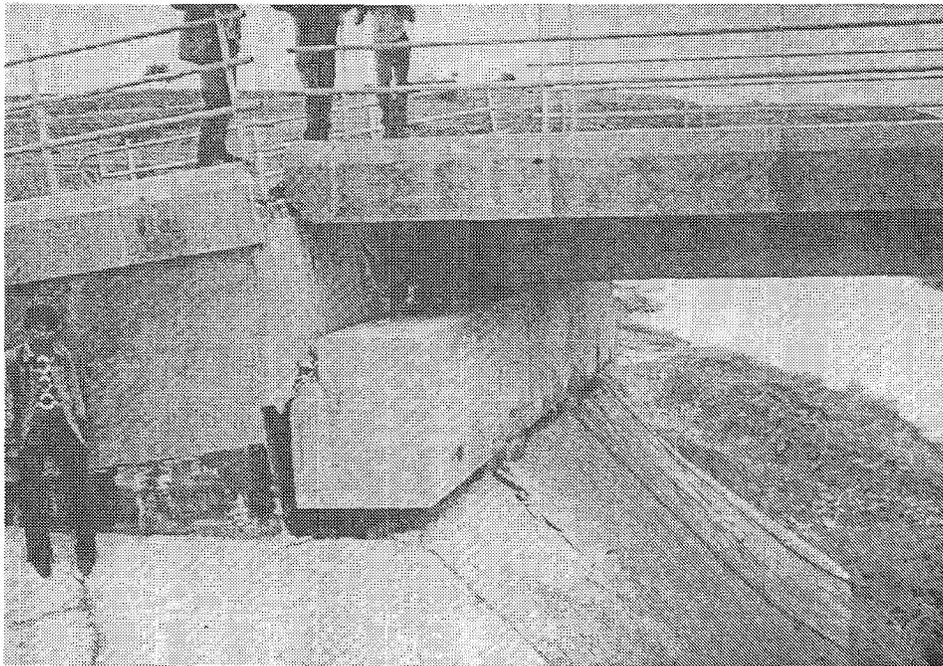
(d) Damage at End Support

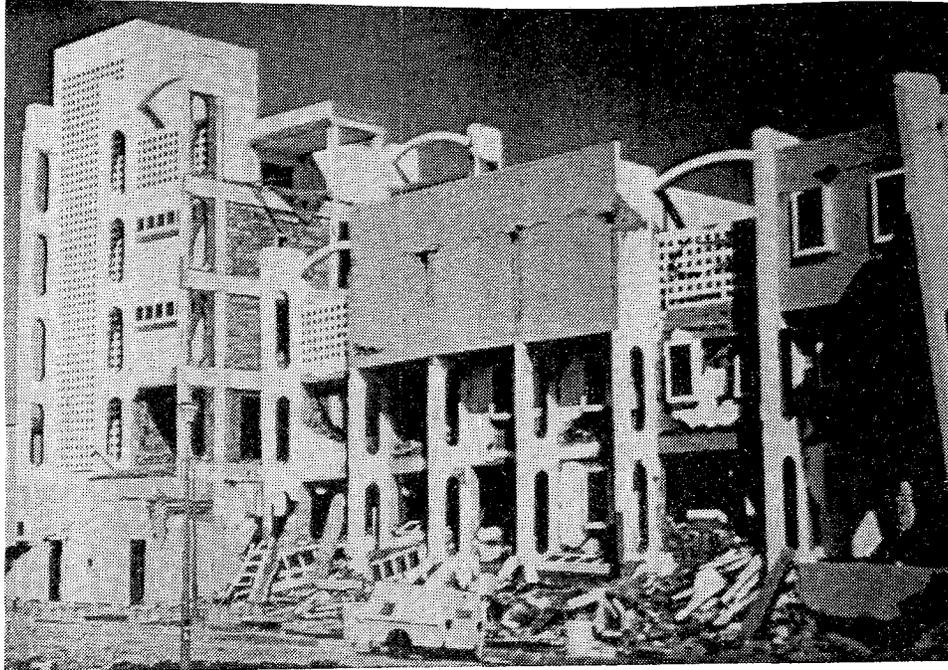
Fig. 3.26 Collapsed Clinic Which Was Nearing Completion.
Soft first story failed.

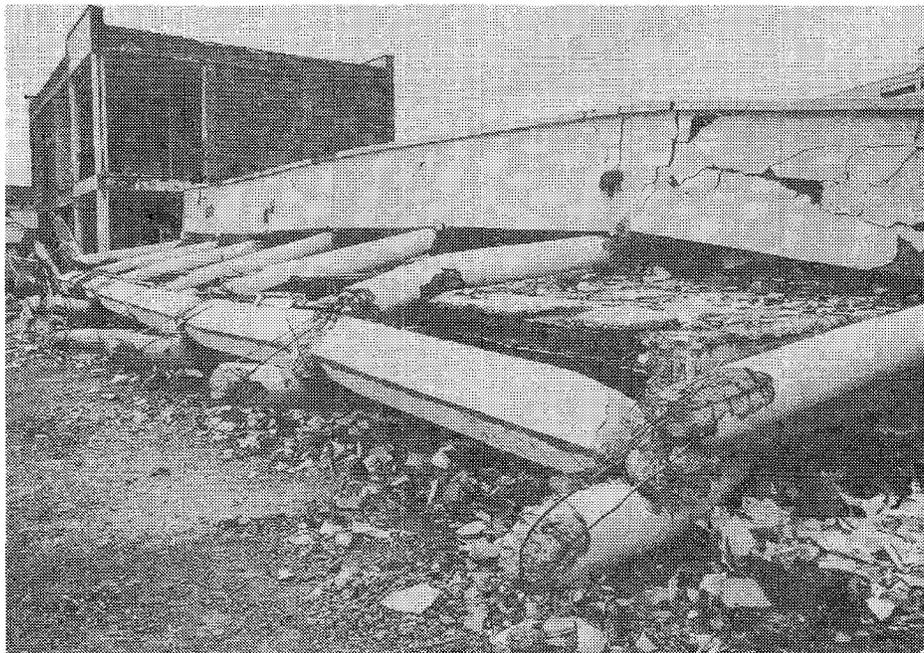
Fig. 3.27 Collapsed High School. Note lack of ties
in beam-column connections.

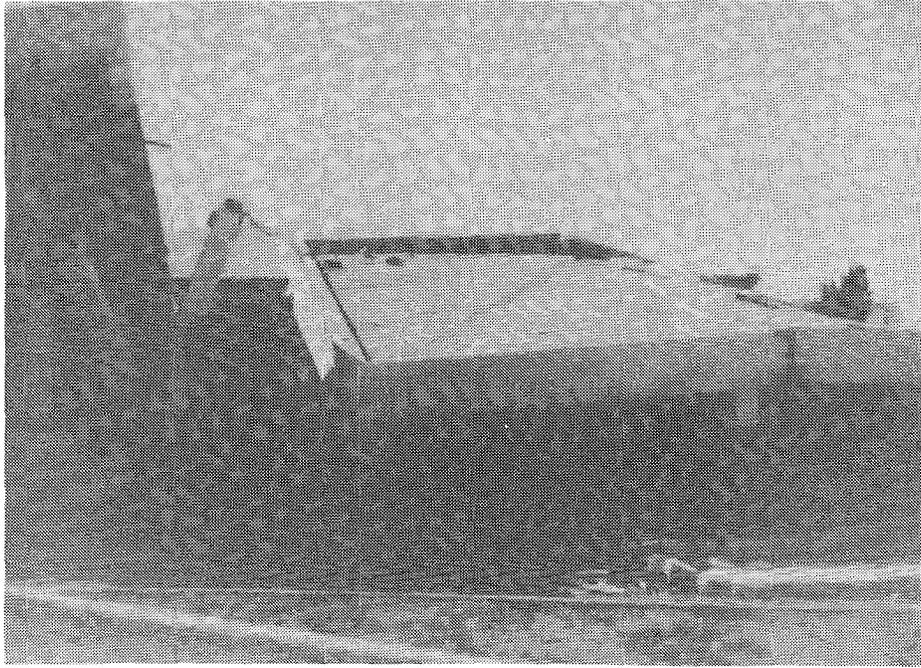
Fig. 3.39 Collapsed RC Industrial Plant Office Building

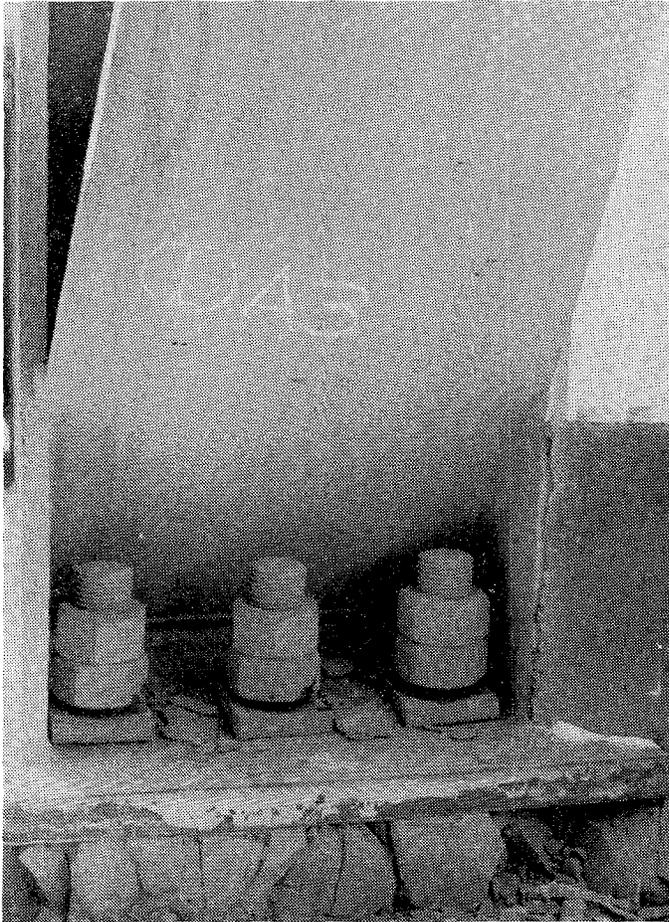
Fig. 3.41 Damage at Supports of Steel Frame of Tower Shown in Fig. 3.40

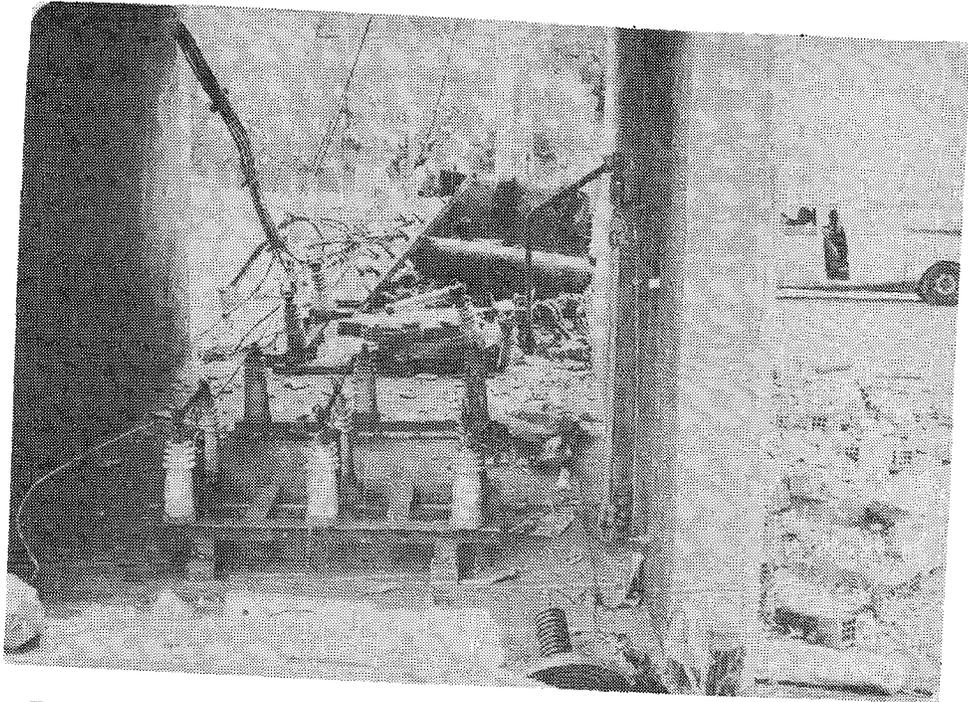
Fig. 3.44 Overturned Transformer and Other Electrical Equipment

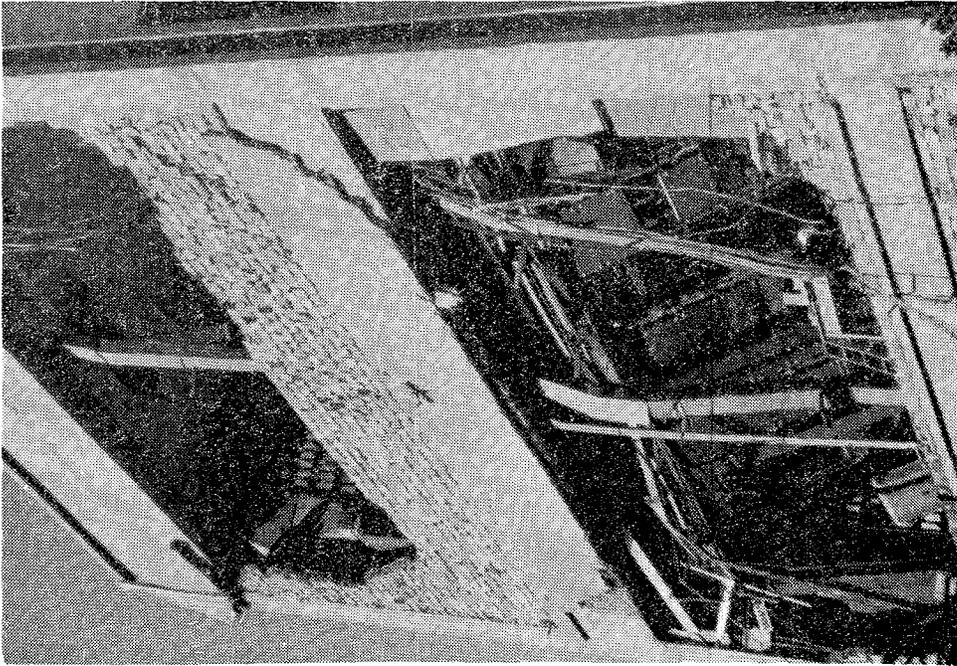
(c) Damaged Masonry and Equipment

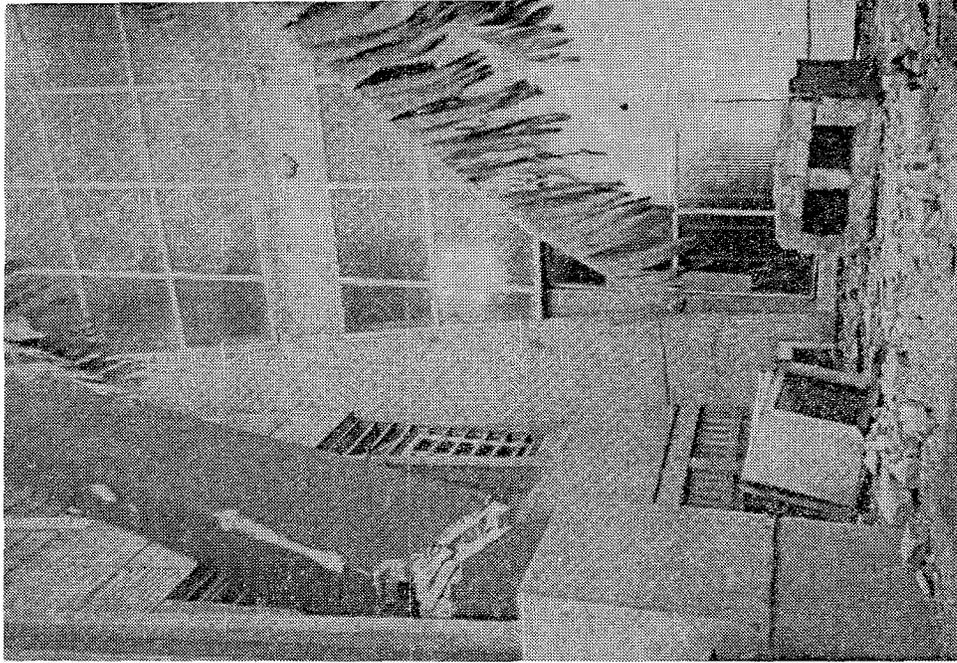
(d) Failed Chimney Attached to Building

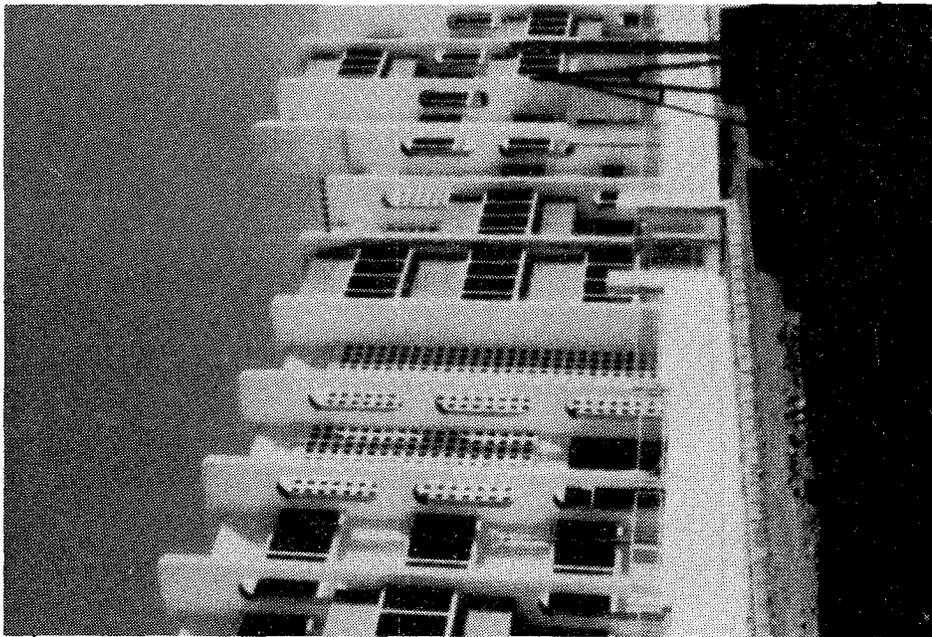
Fig. 4.6 Clinic Building Similar to That Shown in Fig. 4.5, Which Suffered Slight Damage. Note heavy ornamentation.

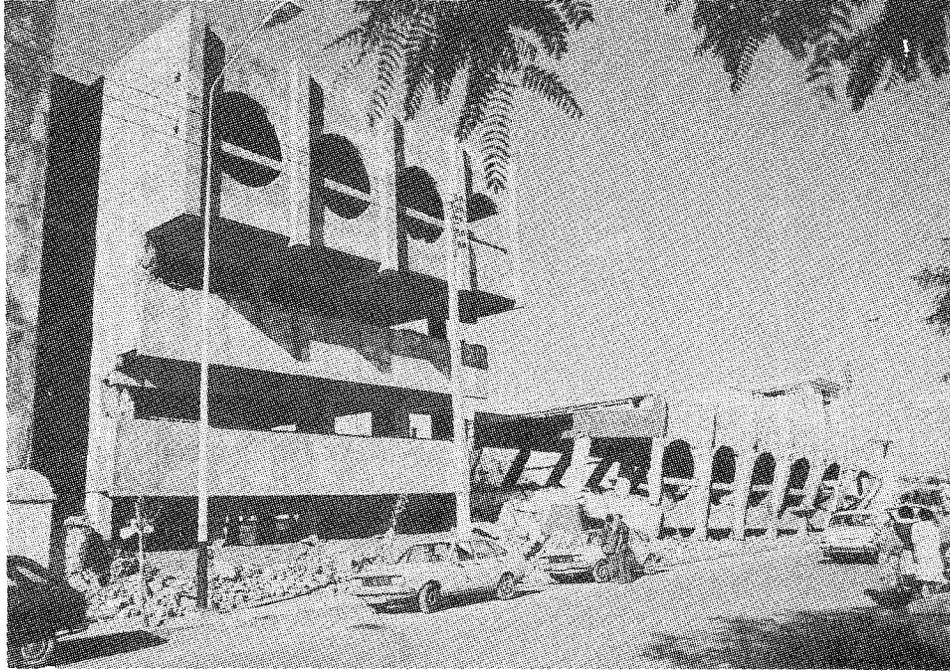
(a) Two Cultural Center Buildings. One collapsed completely; the other remained standing with moderate damage.

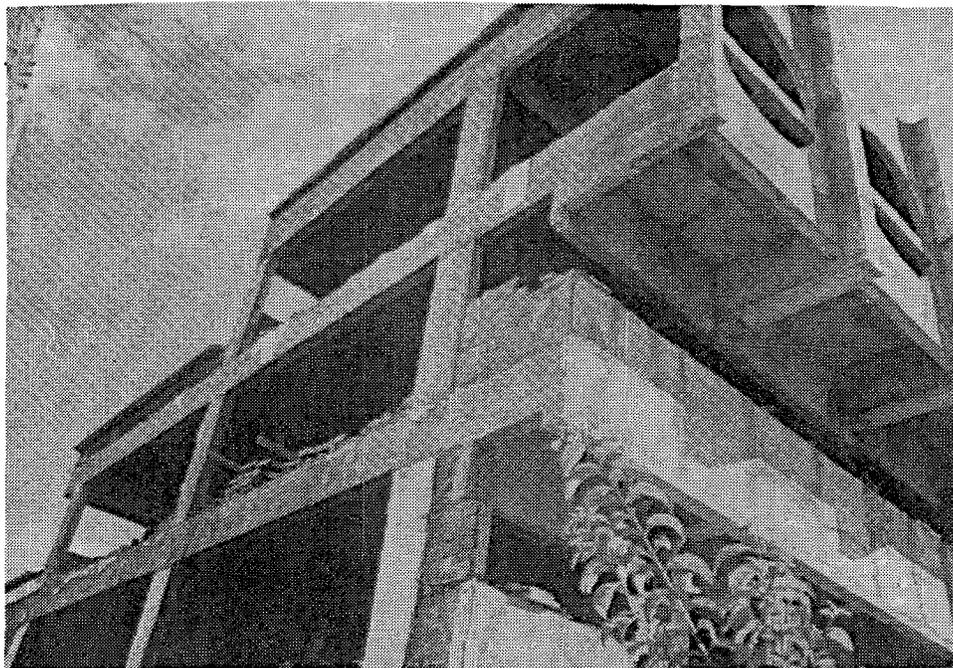
(d) Architectural Form Which May Have Aggravated Structural Weaknesses During Earthquake

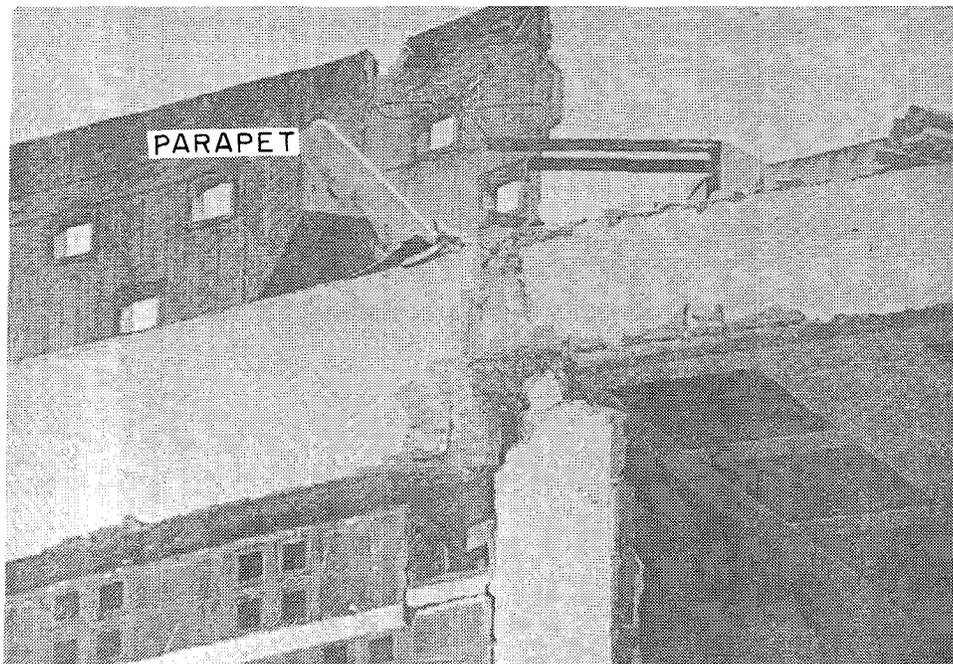
Fig. 4.10 Parapets on Roof of Cité An Nasr

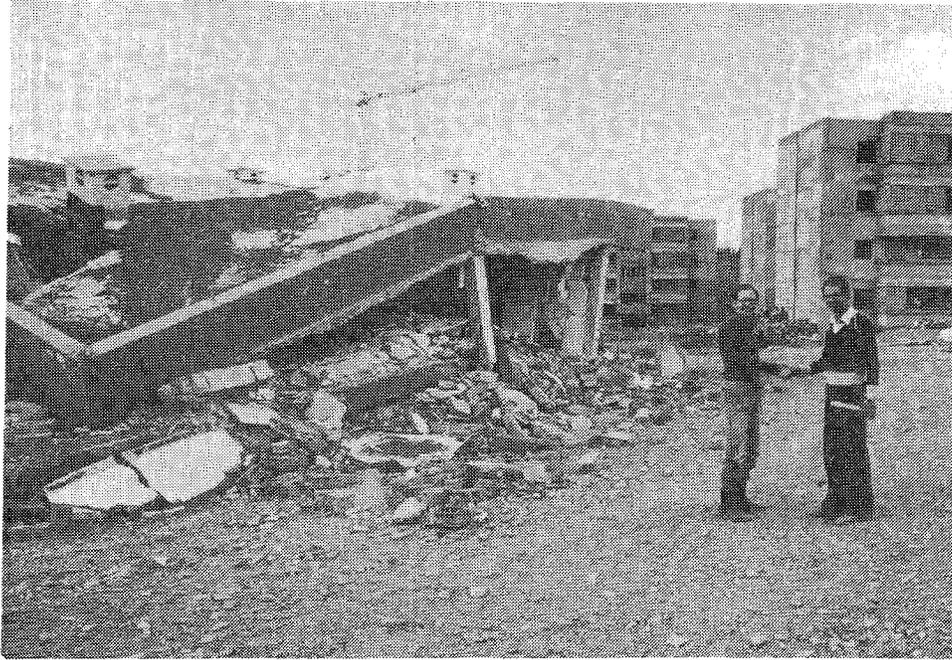
(a) Collapsed Apartment House. Buildings in background had shear walls and performed well.

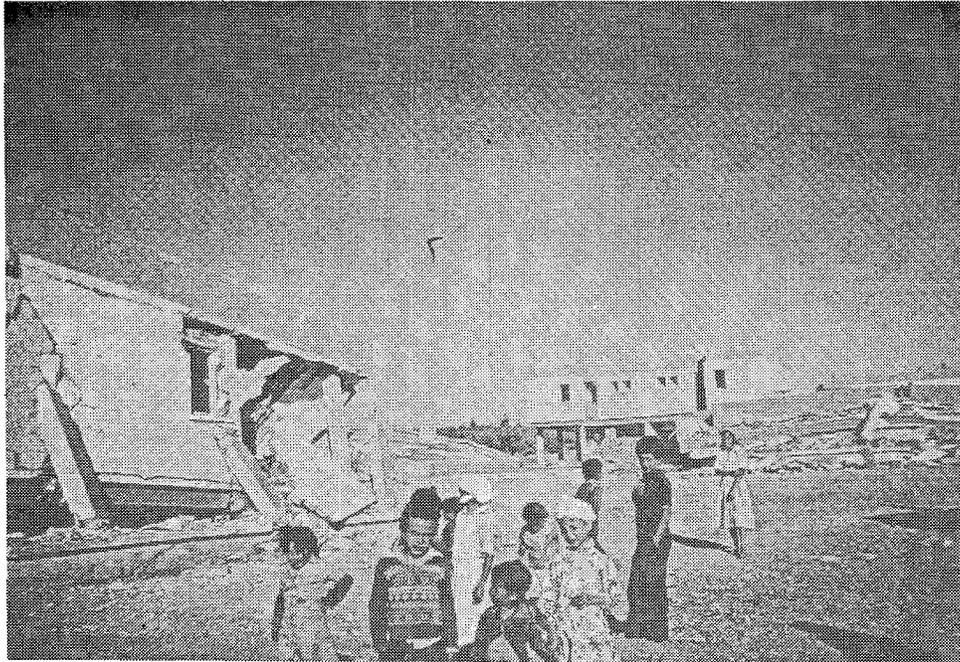
Fig. 4.13 Collapsed Two-Story House Under Construction, Boucaa Sahnoun

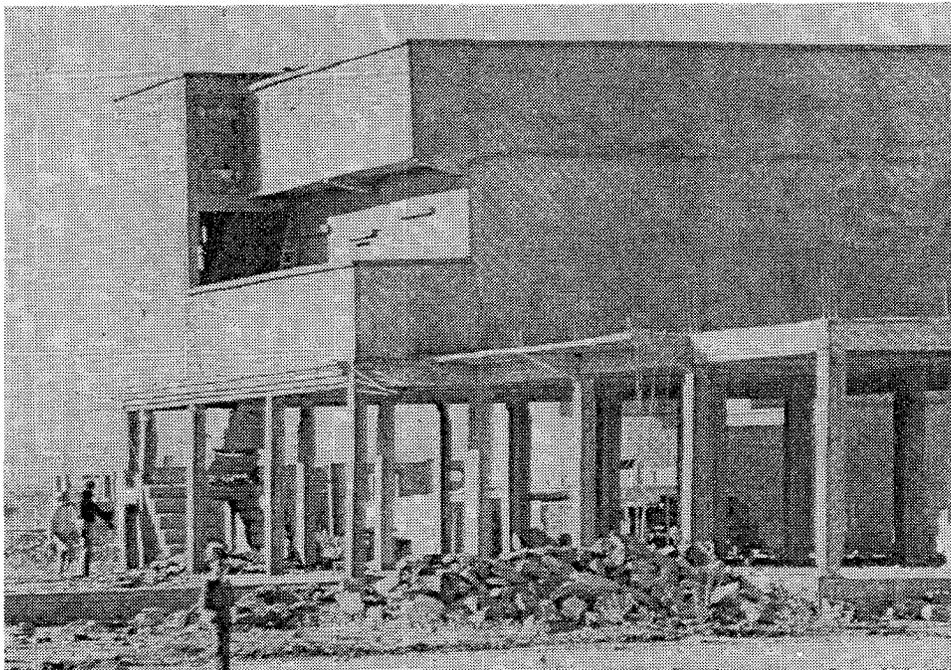
Fig. 4.14 Damaged Three-Story House Under Construction, El-Attaf

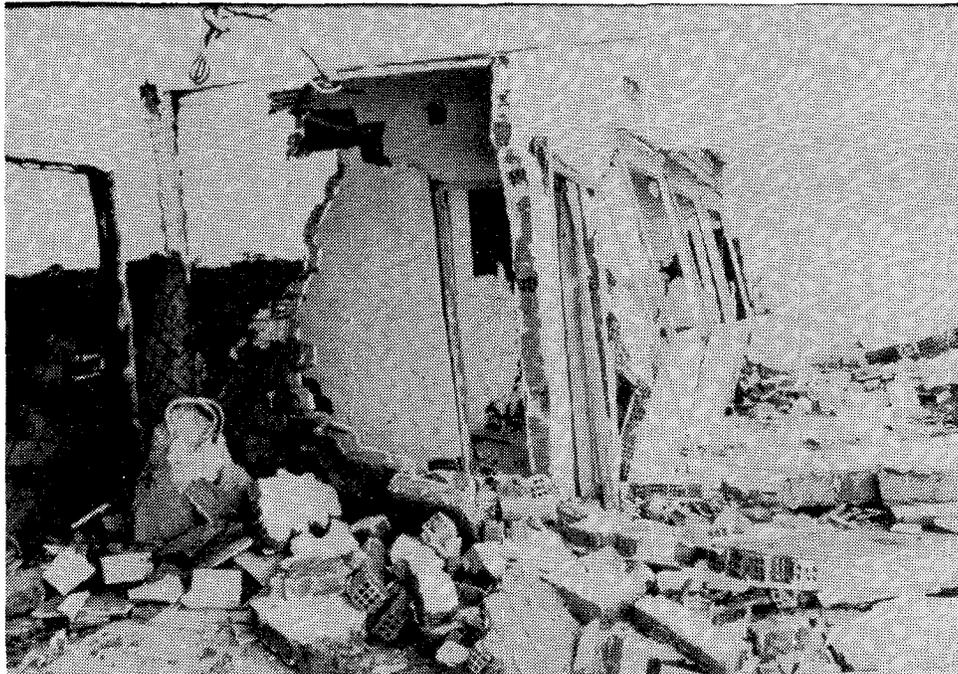
Fig. 4.20 Heavy Damage to Interior Partitions of Buildings That Remained Standing

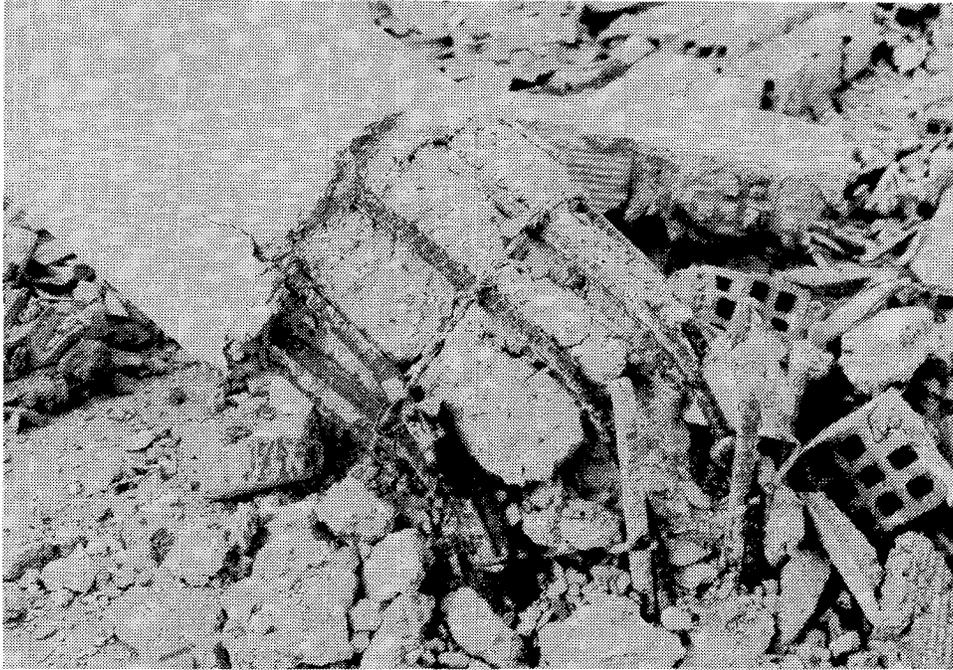
Fig. 4.23 Inadequate Lap Splicing of Main Reinforcement at Bottom of Column

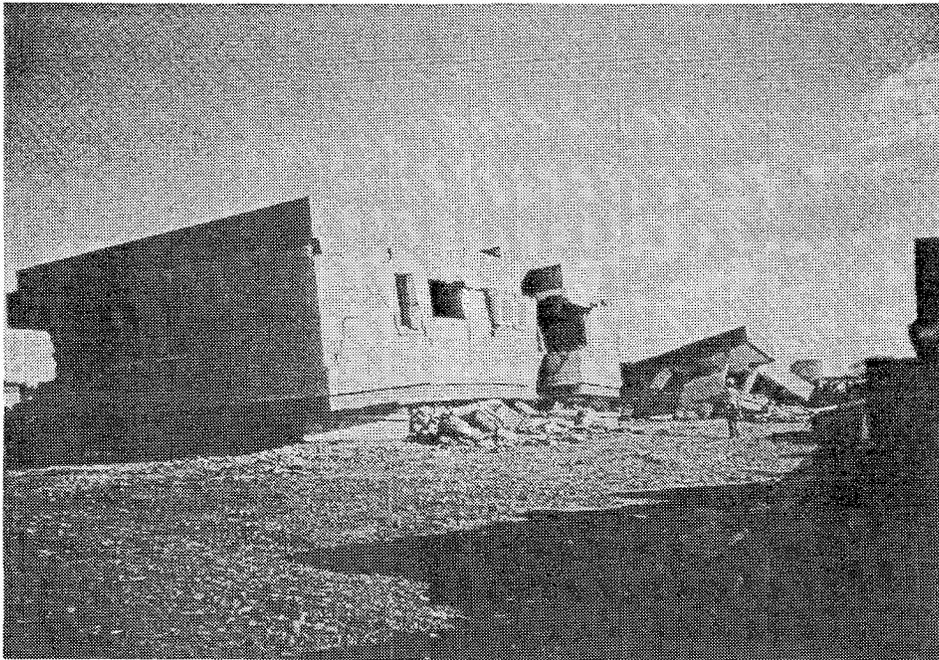
Fig. 4.24 Collapsed Two-Story Houses Under Construction in Boucaa Sahnoun That Had Soft First Story

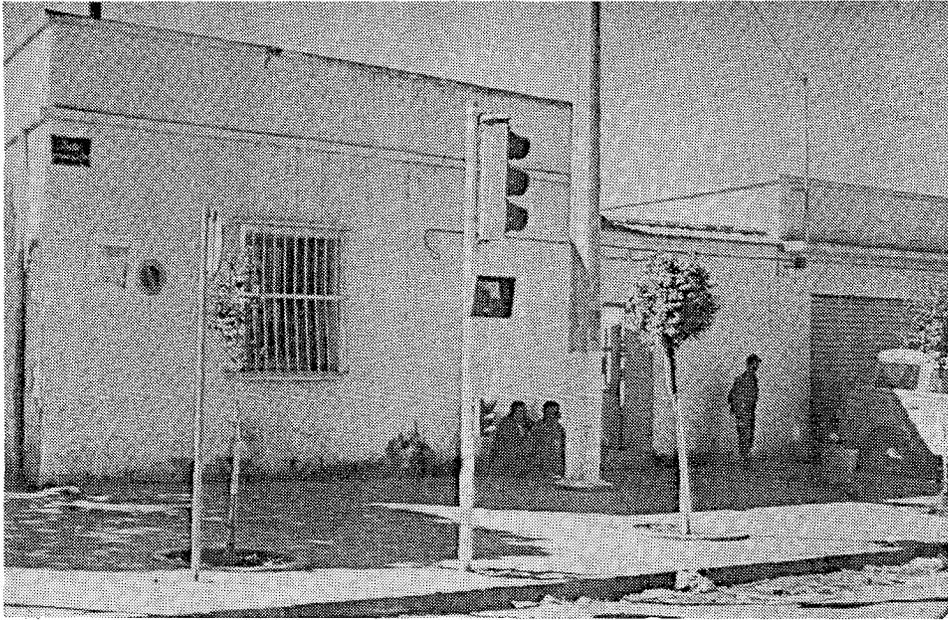
Fig. 4.25 House Occupied by CTC That Performed Very Well

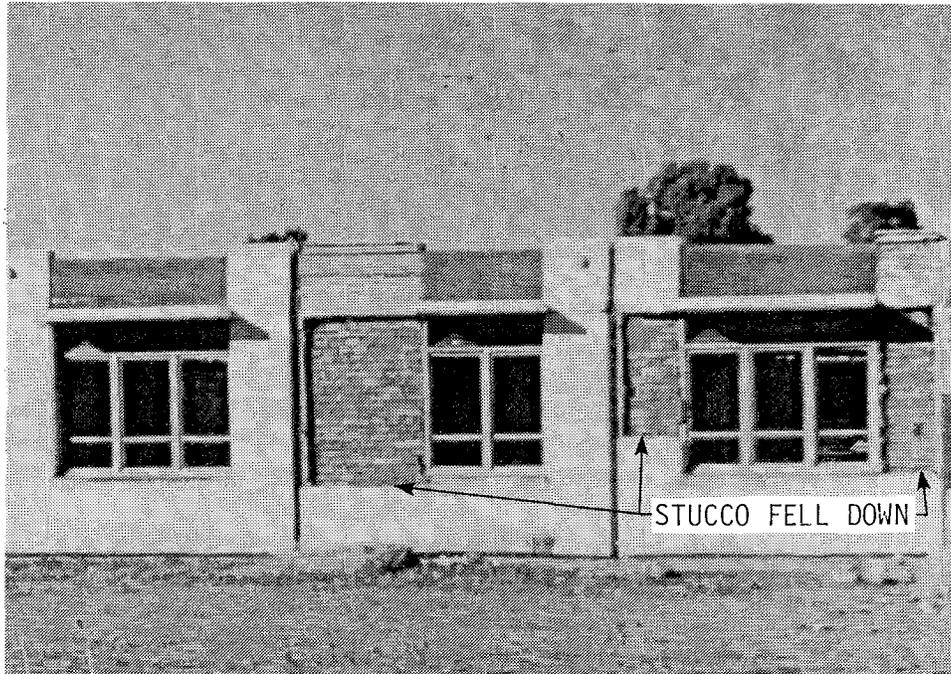
(a) Classroom Buildings with Only Minor Nonstructural Damage

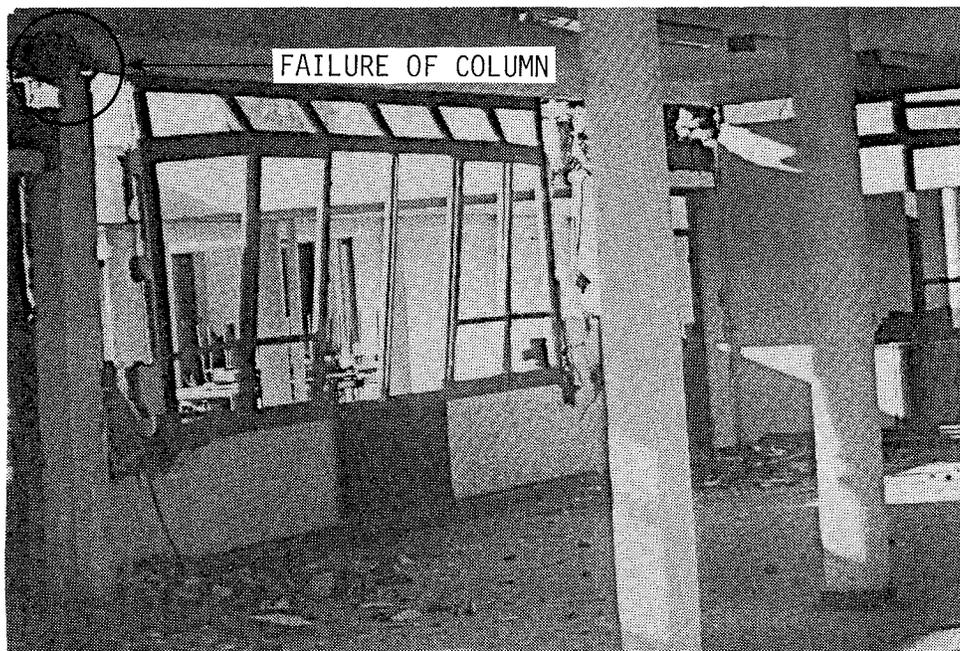
(b) Main Hall, Showing Broken Windows and Structural Damage
