EL-ASNAM, ALGERIA EARTHQUAKE OF OCTOBER 10, 1980

A Reconnaissance and Engineering Report

**National Research Council
Committee on Natural Disasters**

Earthquake Engineering Research Institute

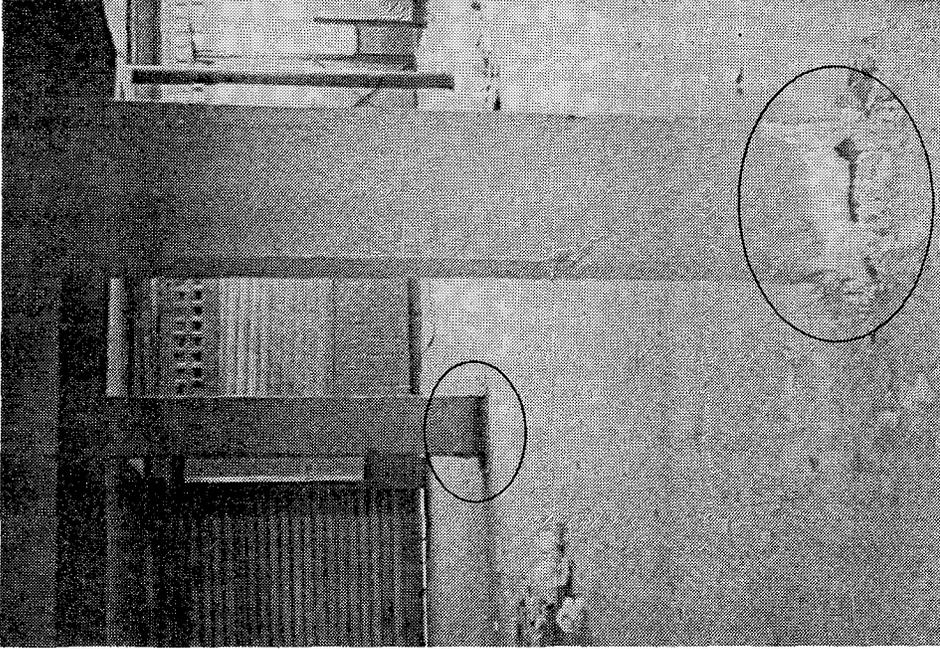
(b) Damaged Columns

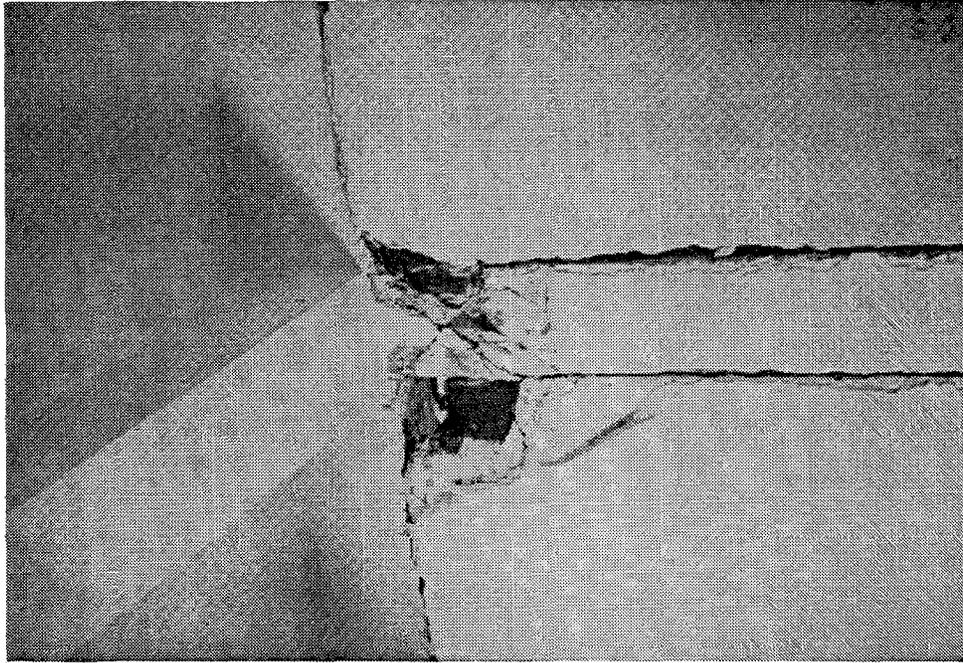
(a) Shearing of Second-Story Column

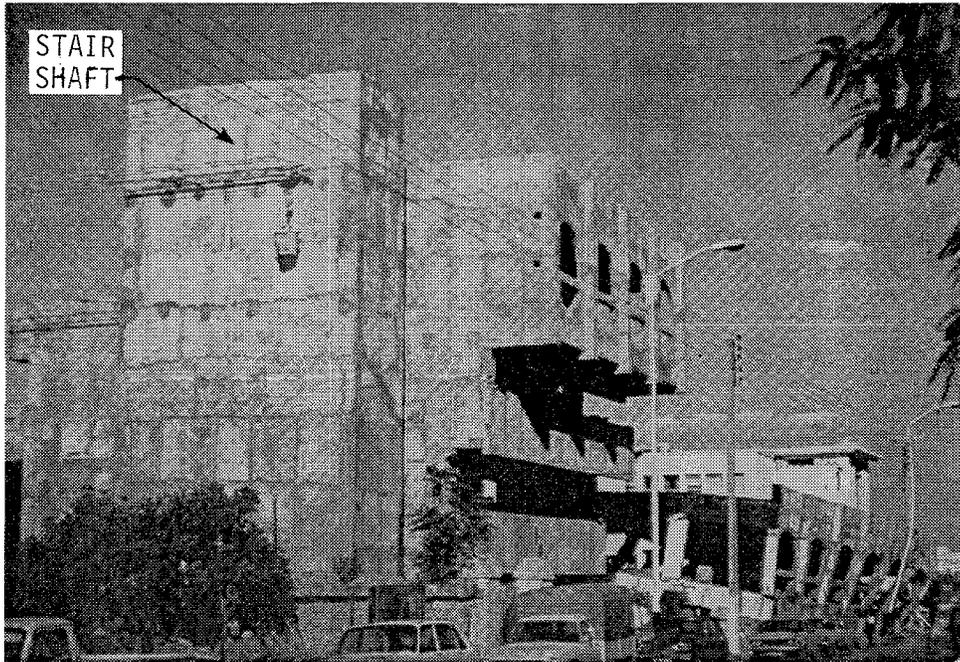
Fig. 4.33 Cultural Center. The stair shaft performed well; the middle building had serious damage; the building in background collapsed.

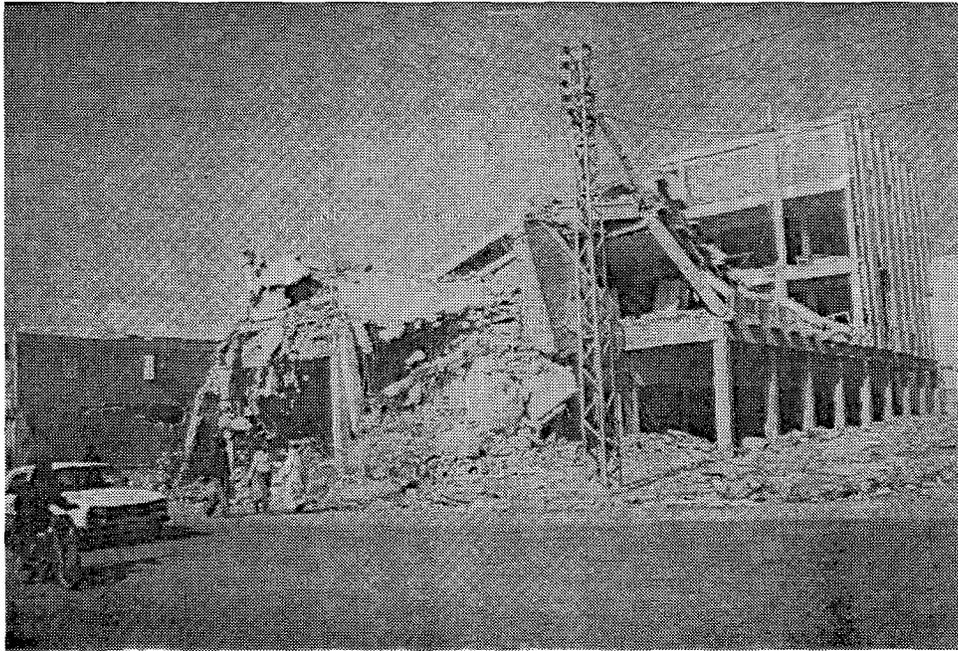
Fig. 4.34 Four-Story RC Galerie Algérienne. Unit that collapsed is in foreground, unit that remained standing in background.

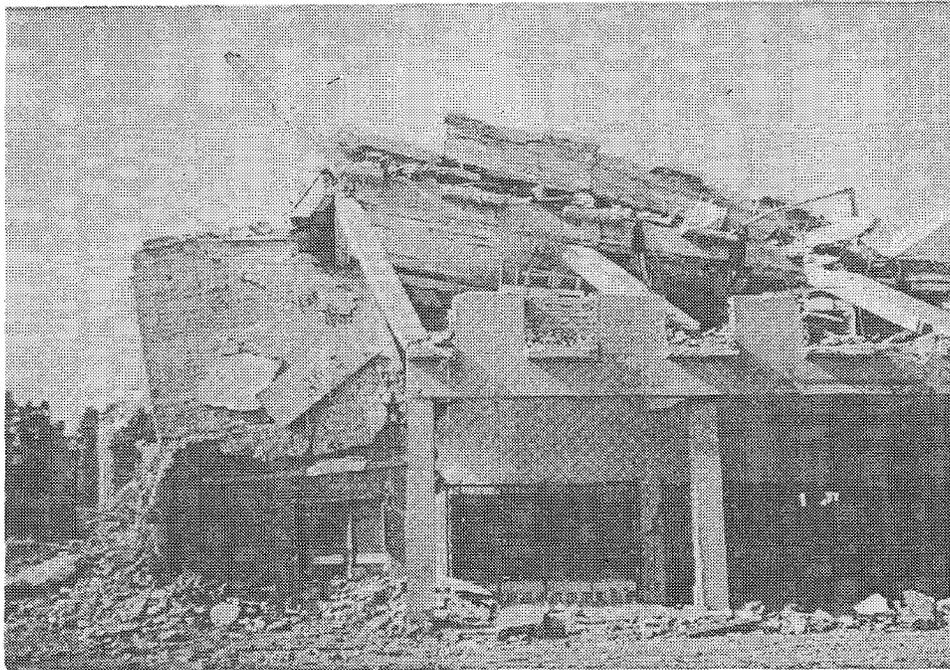
Fig. 4.37 Closeup of Galerie Algérienne Unit That Failed, Showing
Hinging and Shearing of Second-Story Columns

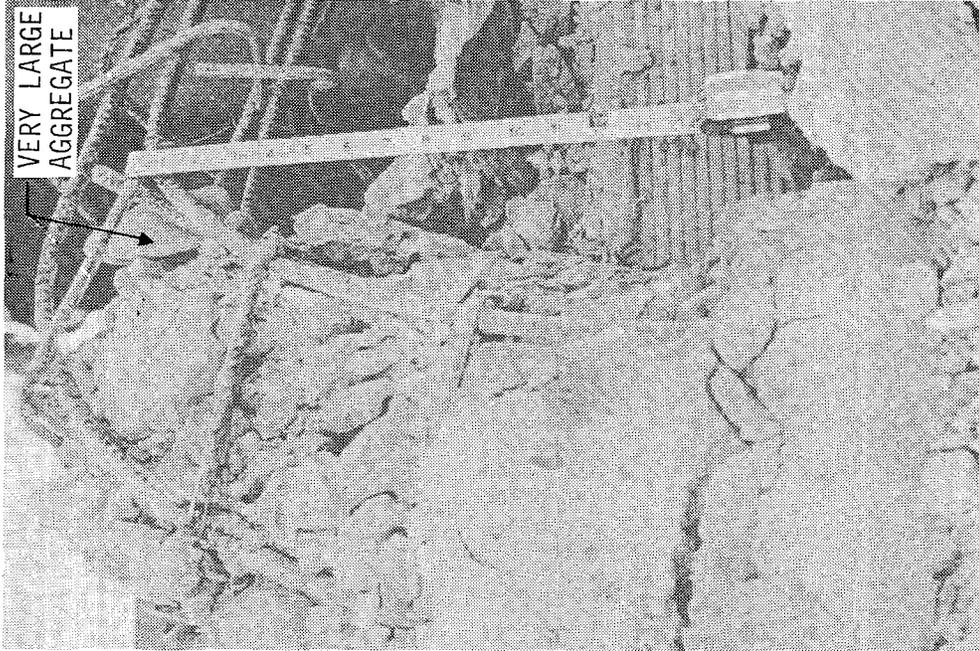
Fig. 4.41 Failed Boucaa Sahnoun Villa RC Column. Note lack of adequate transverse reinforcement and poor quality of concrete, particularly large size coarse aggregate.

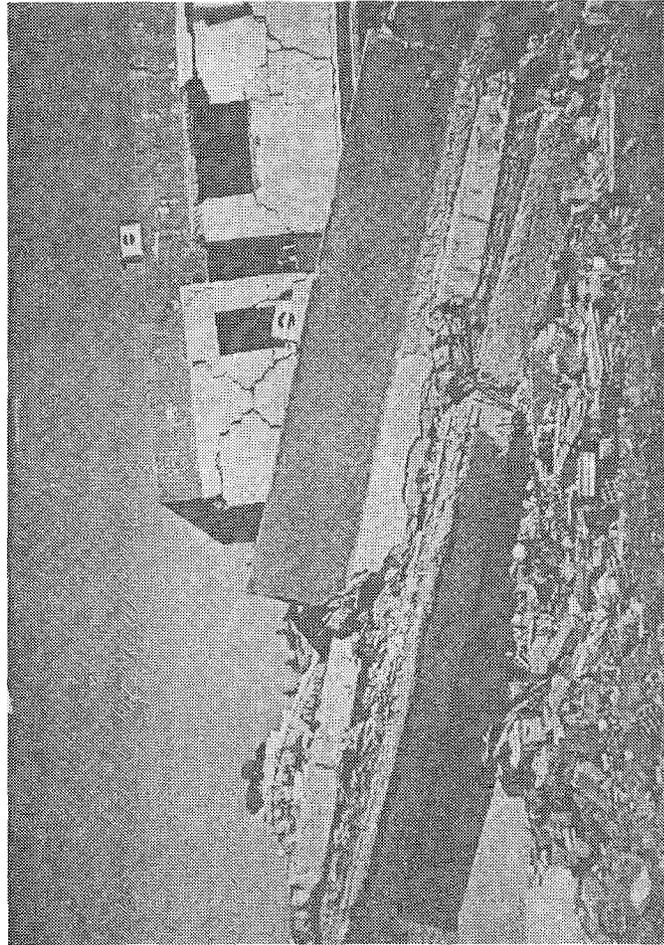
Fig. 4.40 Boucaa Sahnoun Villas. Shearing of first and second-story columns led to complete pancaking of several houses.

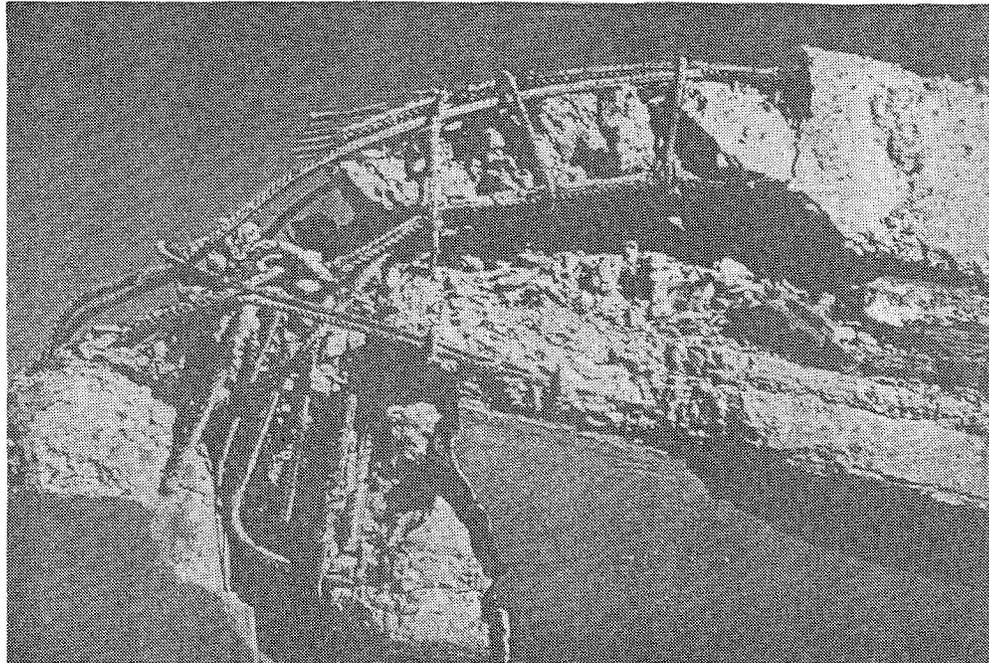
Fig. 4.42 Failed Boucaa Sahnoun Villa Column-Beam Joint.
Note absence of reinforcement.
