**Seismic Hazards In Unreinforced
Masonry Buildings
In The Pacific Northwest**

FINDINGS ON THE STRUCTURAL CONDITIONS
OF UNREINFORCED MASONRY BUILDINGS
IN SEVEN STUDY TOWNS

SEISMIC HAZARDS IN UNREINFORCED
MASONRY BUILDINGS IN SMALL TOWNS
IN THE PACIFIC NORTHWEST

April 15, 1985

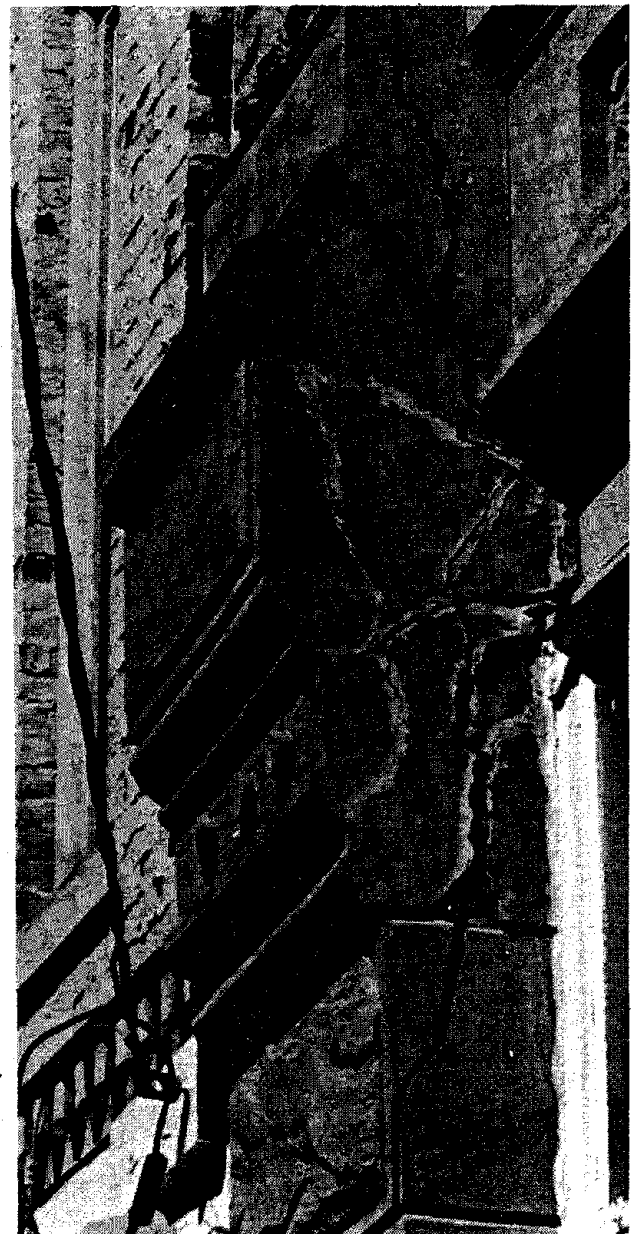
Fractured Facade Element

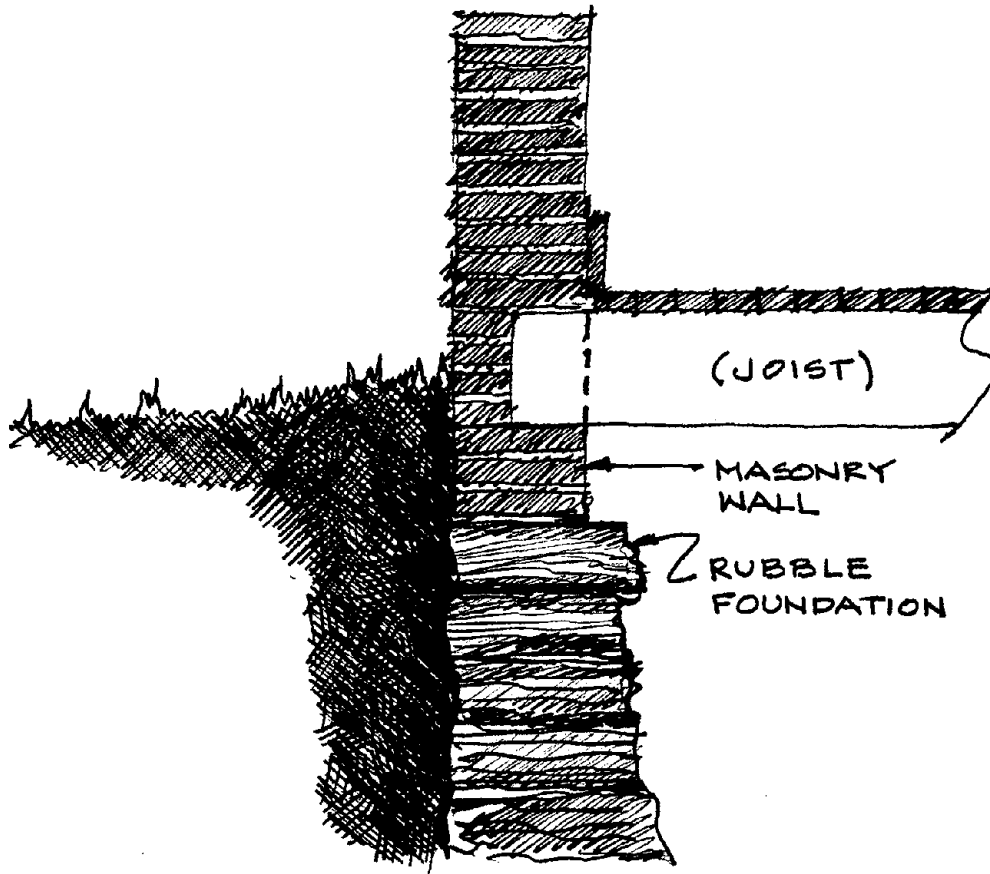
Figure 11. Diagram depicting what was a common condition found in many of the survey buildings. Rotten joist ends, water damaged masonry, poor wall/foundation connection

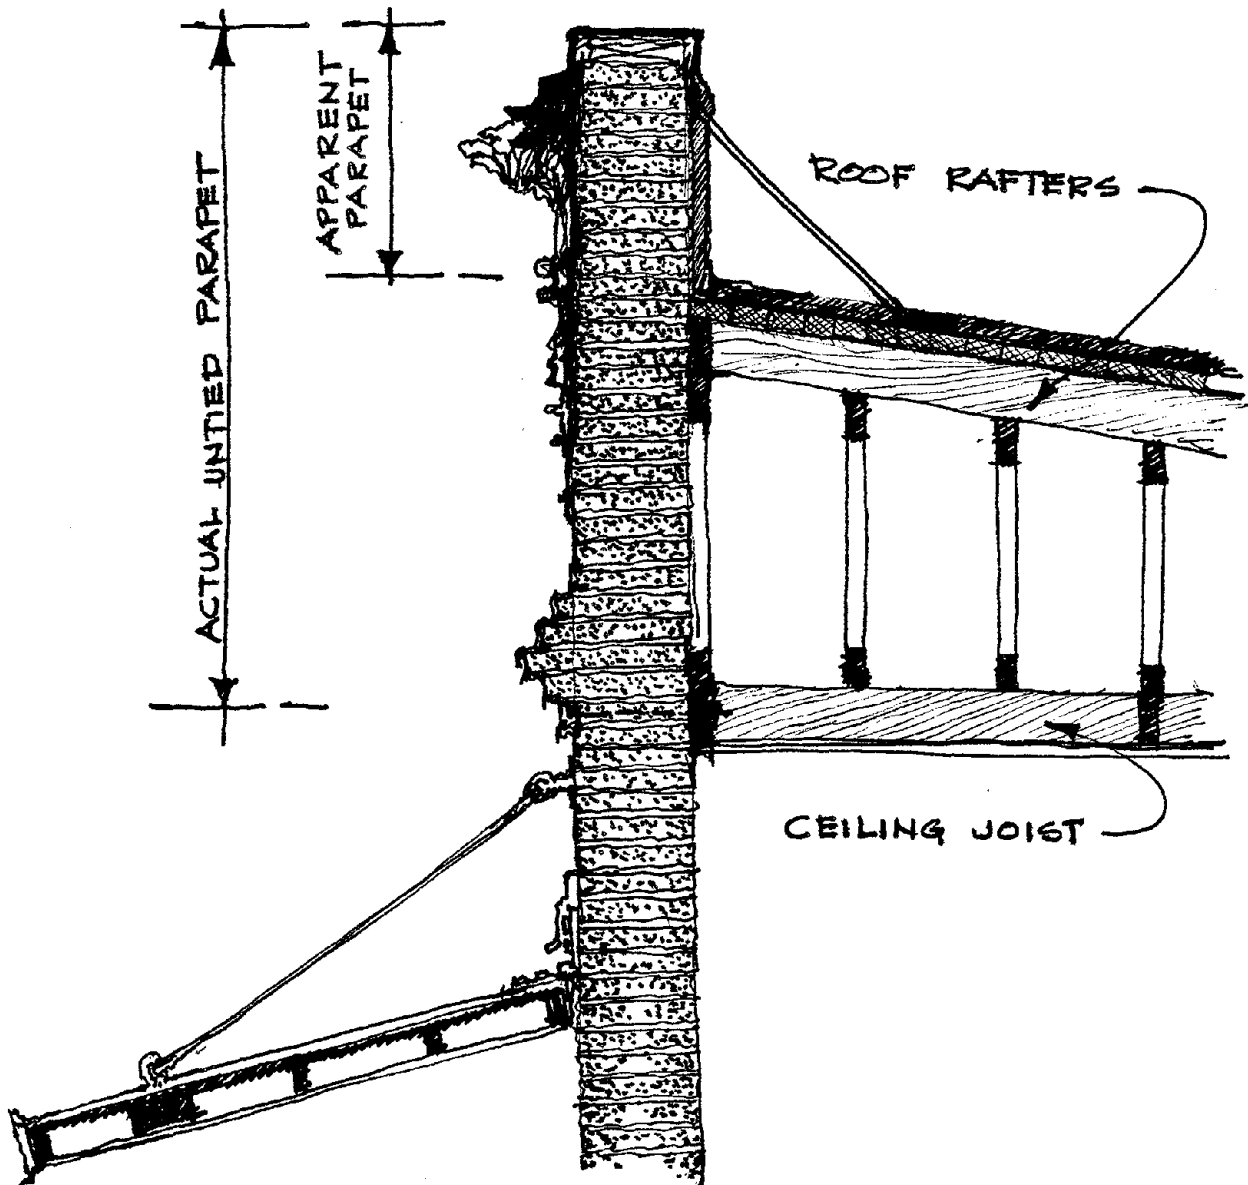
Figure 12. Section of typical parapet extending untied from the upper floor. The apparent parapet height is only to the rafters but in fact it extends in many cases 6 feet to the ceiling joists. In many cases the joists simply pocket into the brick and there is no tying of parapet to flooring

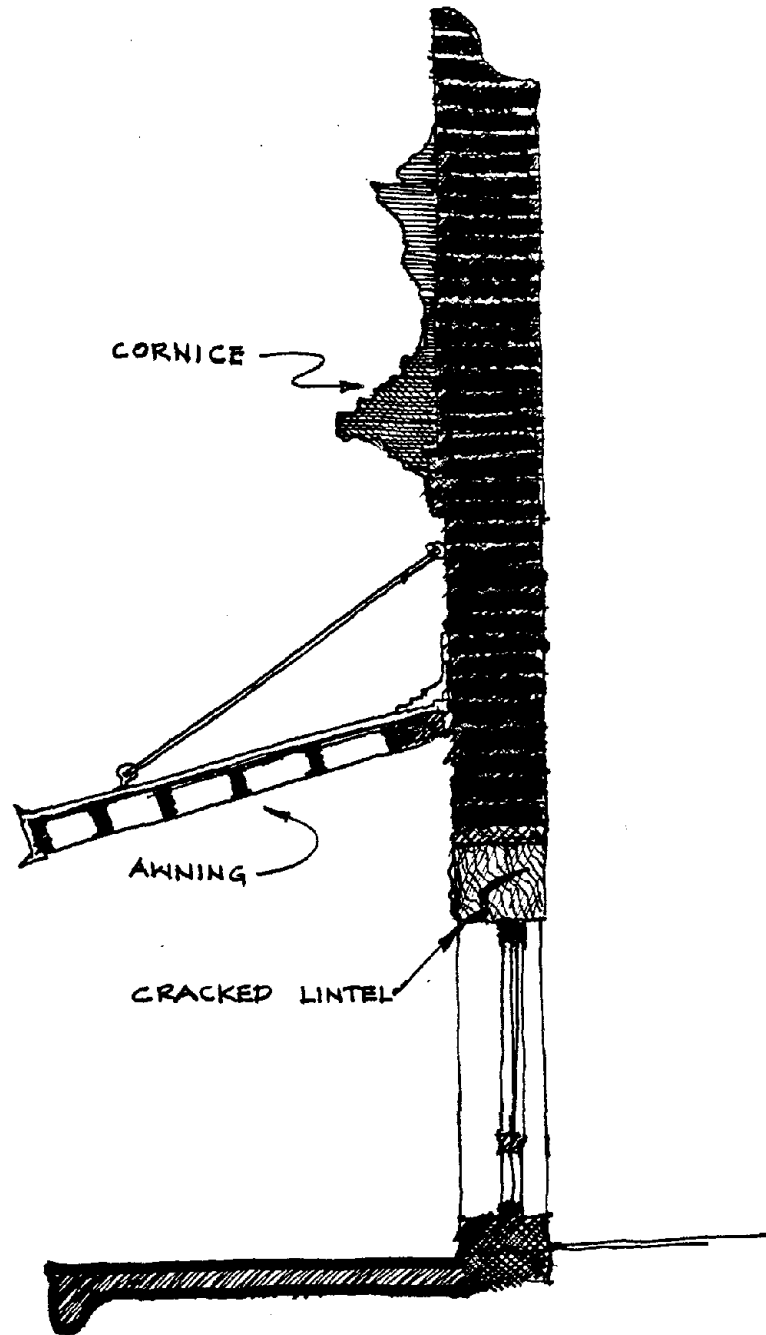
Figure 13. Section of unsecured appendages that appear on many unreinforced masonry buildings. These appendages in the case study buildings in some instances were deteriorated and in some cases overhung the public sidewalk or street.

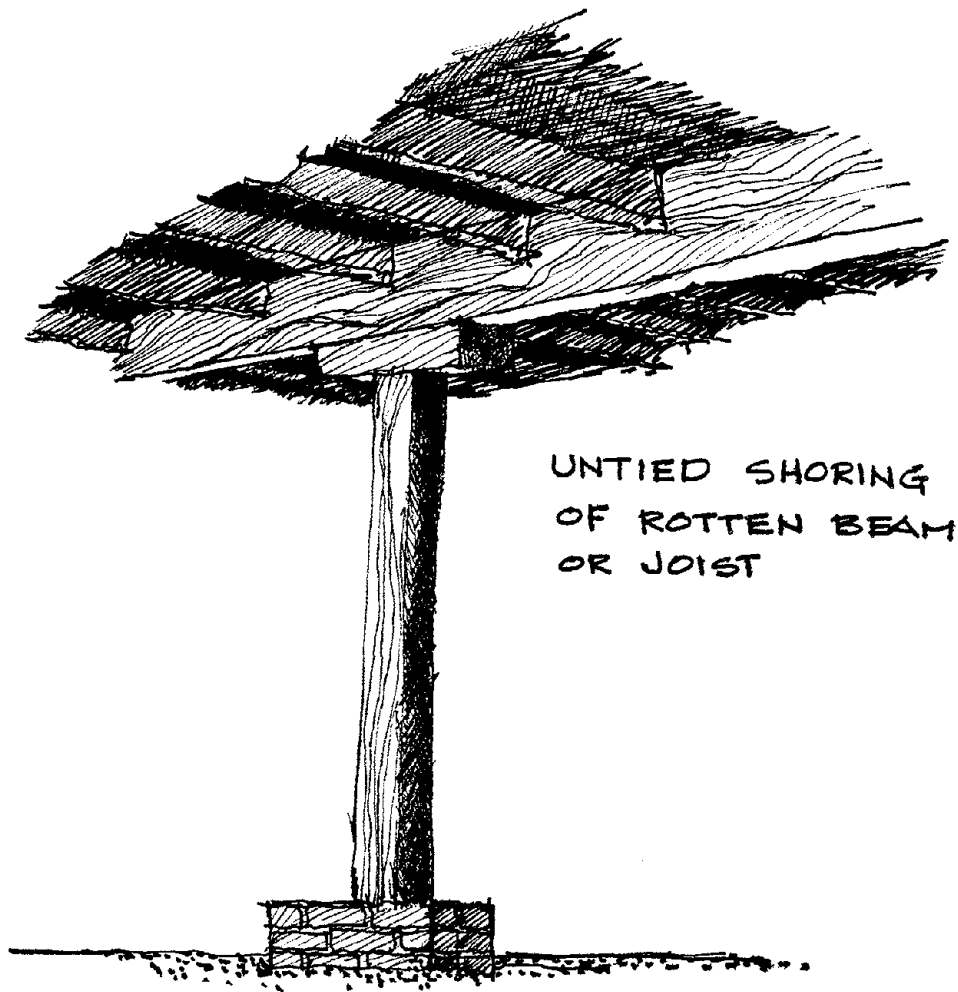
Figure 14. Diagram of shoring of joist or beam that had become rotten because of the presence of water and the lack of ventilation in basement foundations. This condition of shoring was found in many of the case study buildings. The shoring was typically untied and may not withstand the strong lateral forces that could occur with an earthquake.

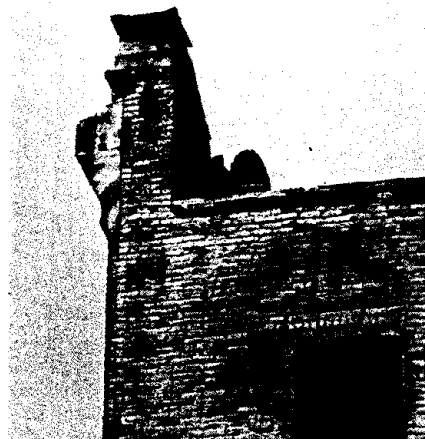
Fig. 16

- Spalling and cracking of brick in URM wall is revealed

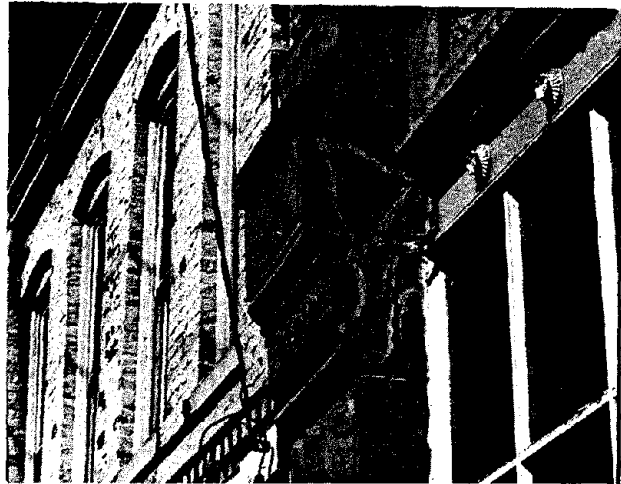
--Shown is a fractured
member of a URM
structure overhanging
the public sidewalk

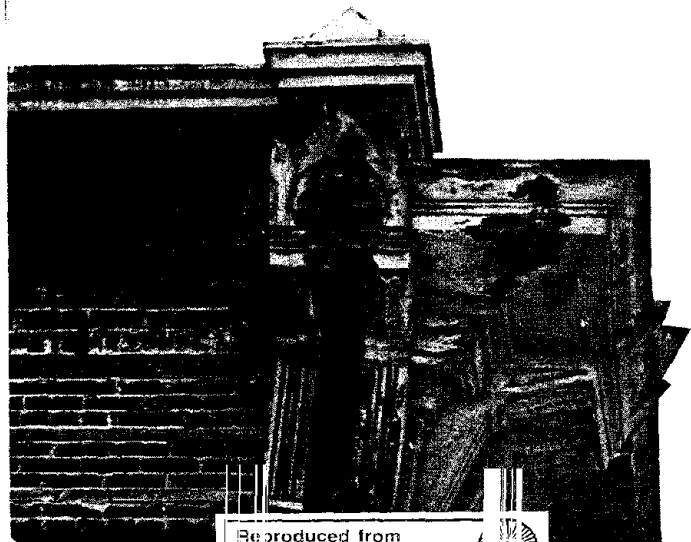
Fig.18

Failing
Cornice

--In this example
a deteriorated
cornice is shown.
It is separating from
the parapet wall

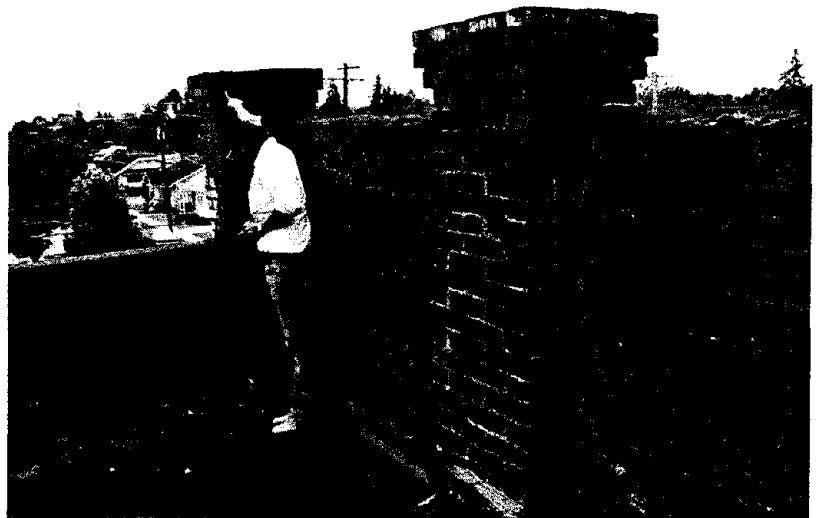
--Deteriorated mortar
in parapet wall. Six ft.
high above roof and
extending four feet
below to ceiling
joists

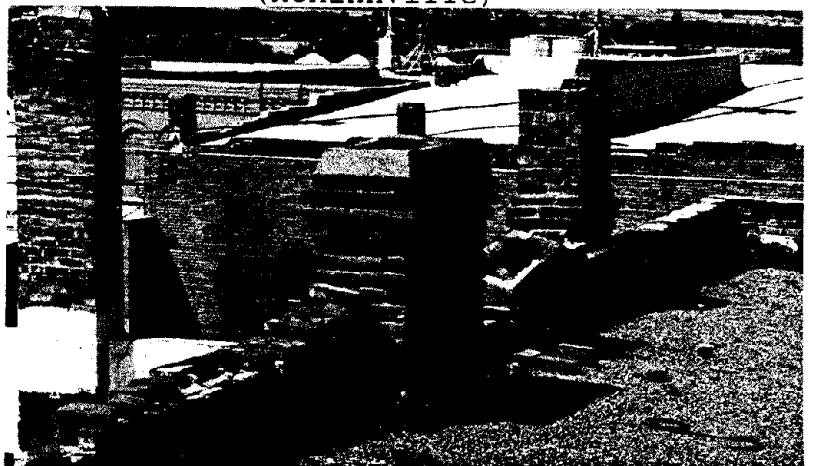
Crumbling
Parapets

--Parapets and chimneys
with loose and dis-
lodged bricks

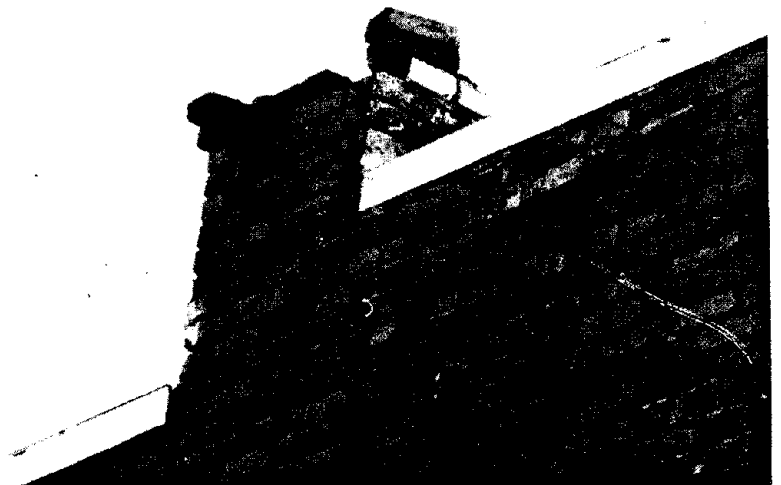
Loose
Brick

--Extensive erosion of
mortar joints with
loose and missing
brick

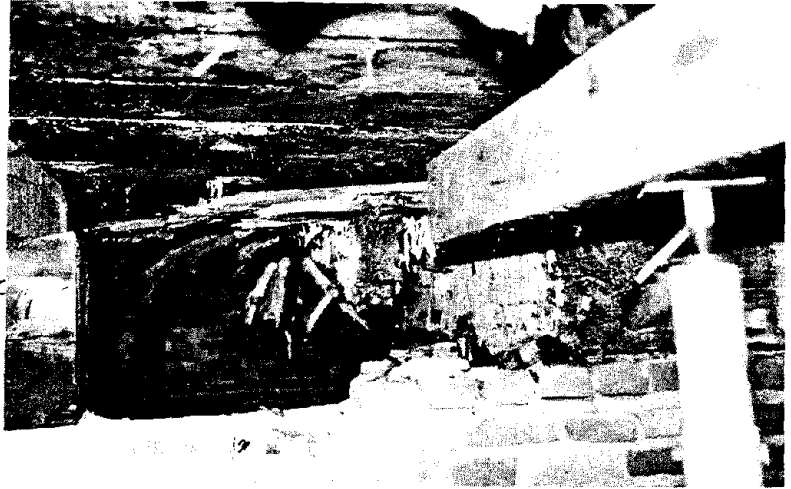
--An example of rot of structural timber due to the presence of water and the lack of ventilation. House jacks support rotted joists and beams

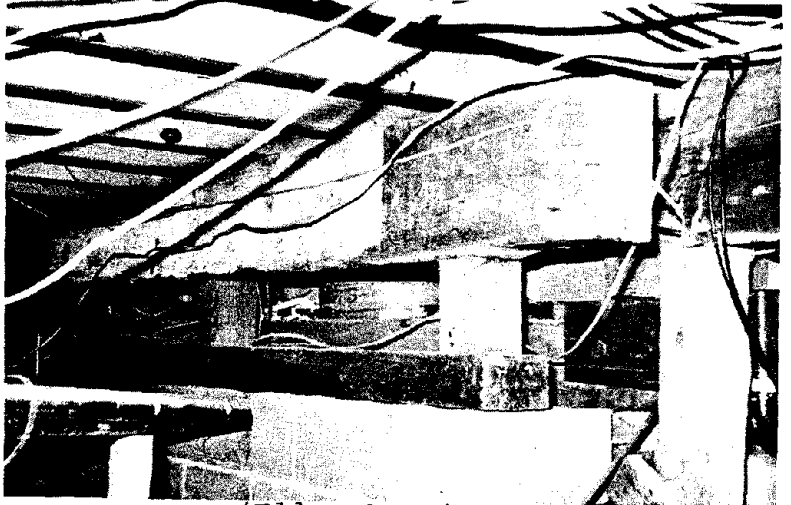
Discontinuity

--Discontinuity of beams in new construction. No lateral reinforcement

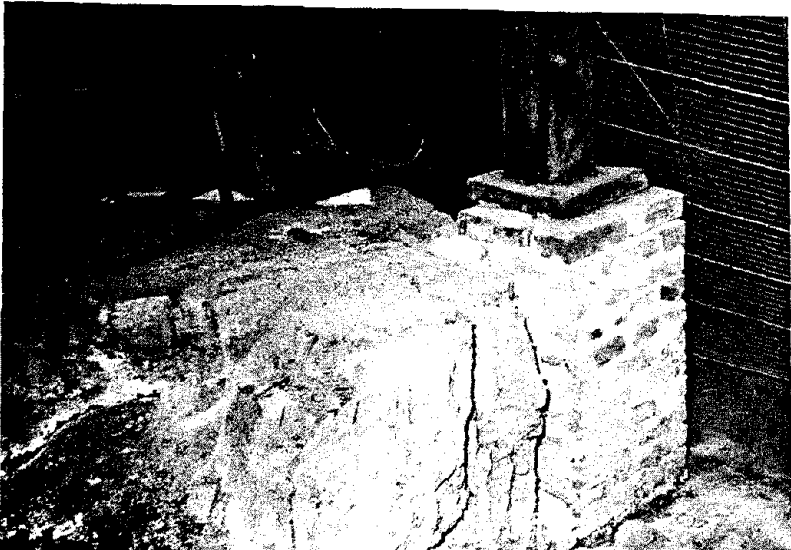
URM
Pilaster

--Shown is an unreinforced masonry pilaster supporting load bearing column

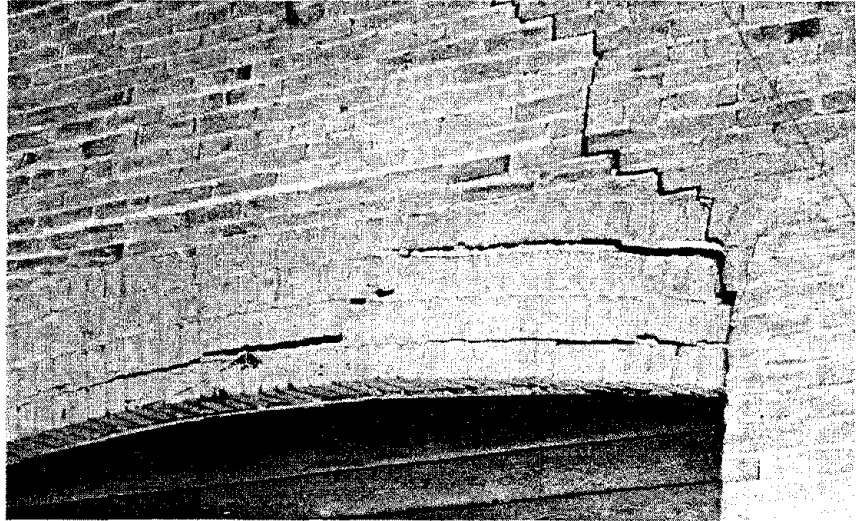
--Fracturing shown due to settlement of an URM wall

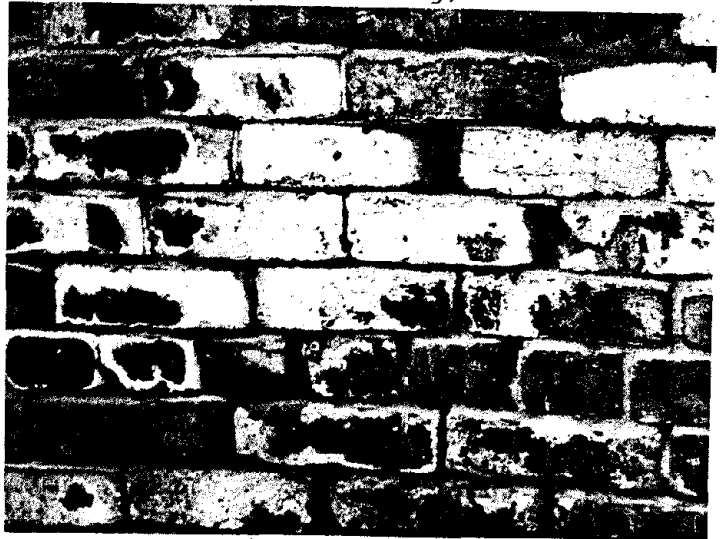
Erosion of Mortar

--Shown is a typical case of erosion of mortar joints in an URM wall. In some cases mortar could be scraped away with a fingernail

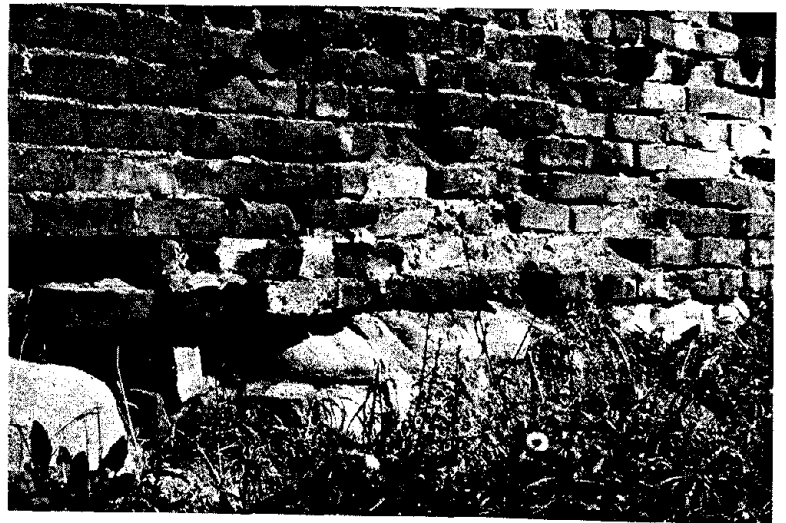
Spalling of Brick

--Advanced deterioration showing spalling brick, missing brick, and mortar erosion in a URM wall. In this example brick could be removed by hand
