**Seismic Hazards In Unreinforced
Masonry Buildings
In The Pacific Northwest**

**FINDINGS ON THE STRUCTURAL CONDITIONS
OF UNREINFORCED MASONRY BUILDINGS
IN SEVEN STUDY TOWNS**

Prepared for
National Science Foundation
Earthquake Hazards Mitigation Program

Appendix--Volume 2

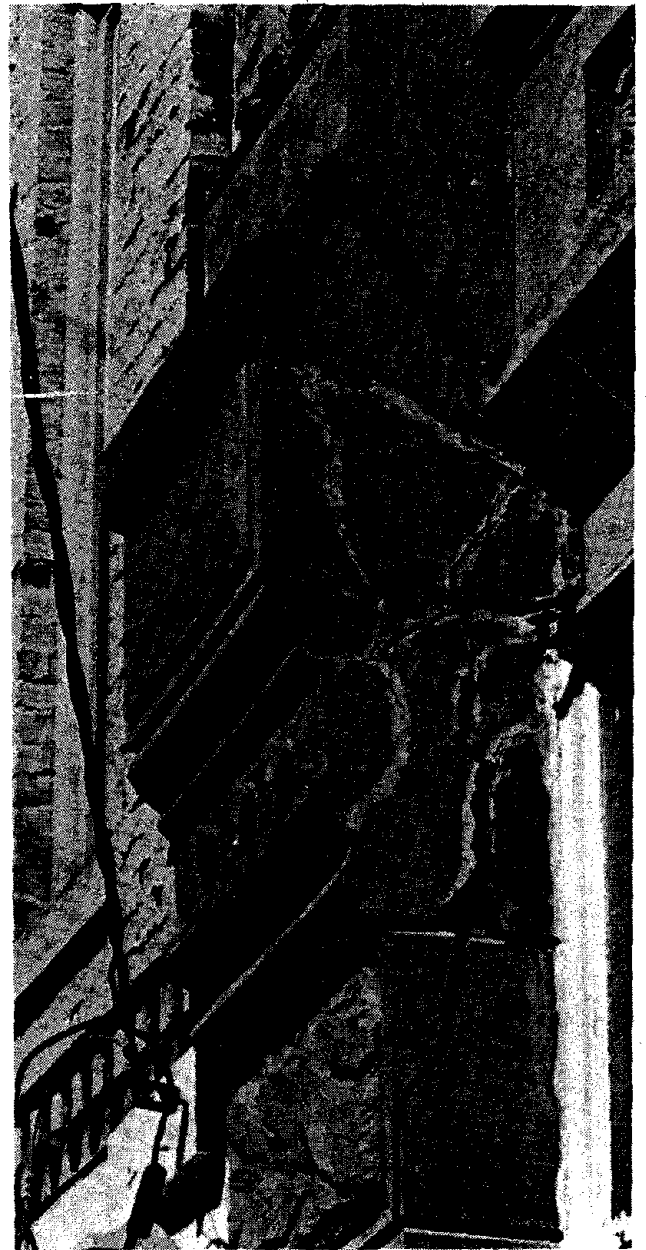
Fractured Facade Element
