SEISMIC DAMAGE BEHAVIOR OF BURIED
LIFELINE SYSTEMS DURING RECENT
SEVERE EARTHQUAKES IN U.S., CHINA
AND OTHER COUNTRIES

Leon Ru-Liang Wang

Technical Report No. ODU LEE-02
In Lifeline Earthquake Engineering Research Series

December 1985

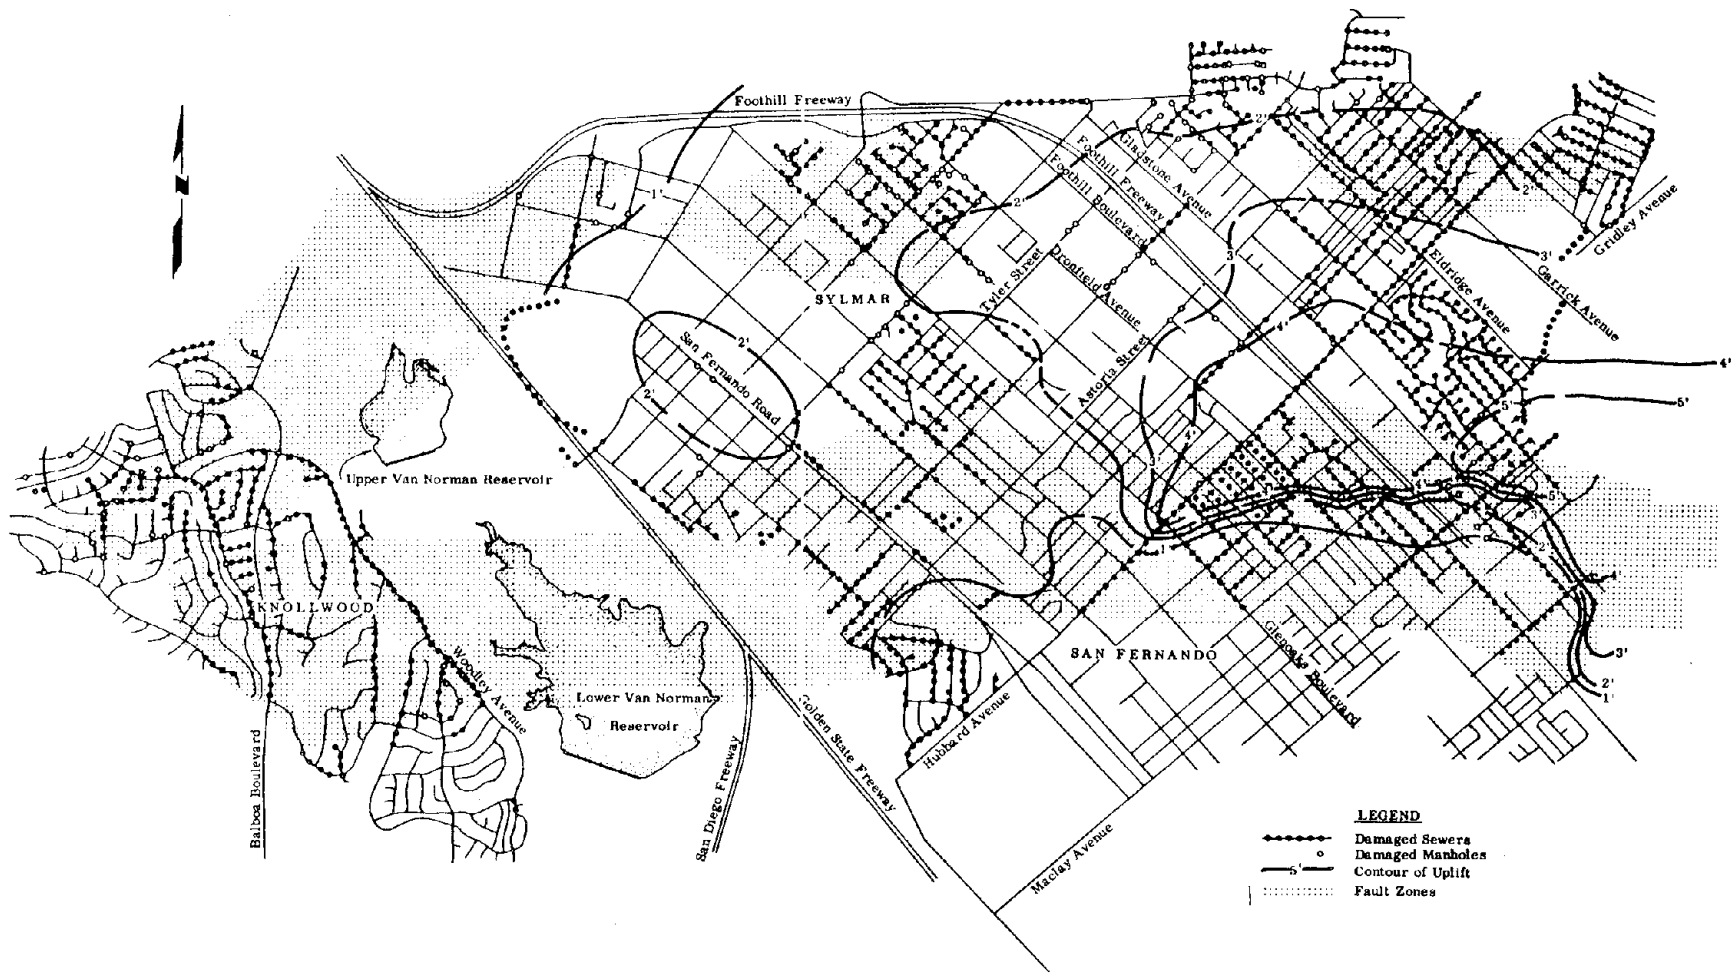
Los Angeles had over 6,000 miles of sanitary sewers. An assessment of the damage, as shown by the video tapes, indicated that 126,000 linear feet of mainline needed to be reconstructed. Data on the extent of sewer pipe damage is given in Table 2.2.

Figure 2.4 - Map showing major sewer damage in San Fernando Area

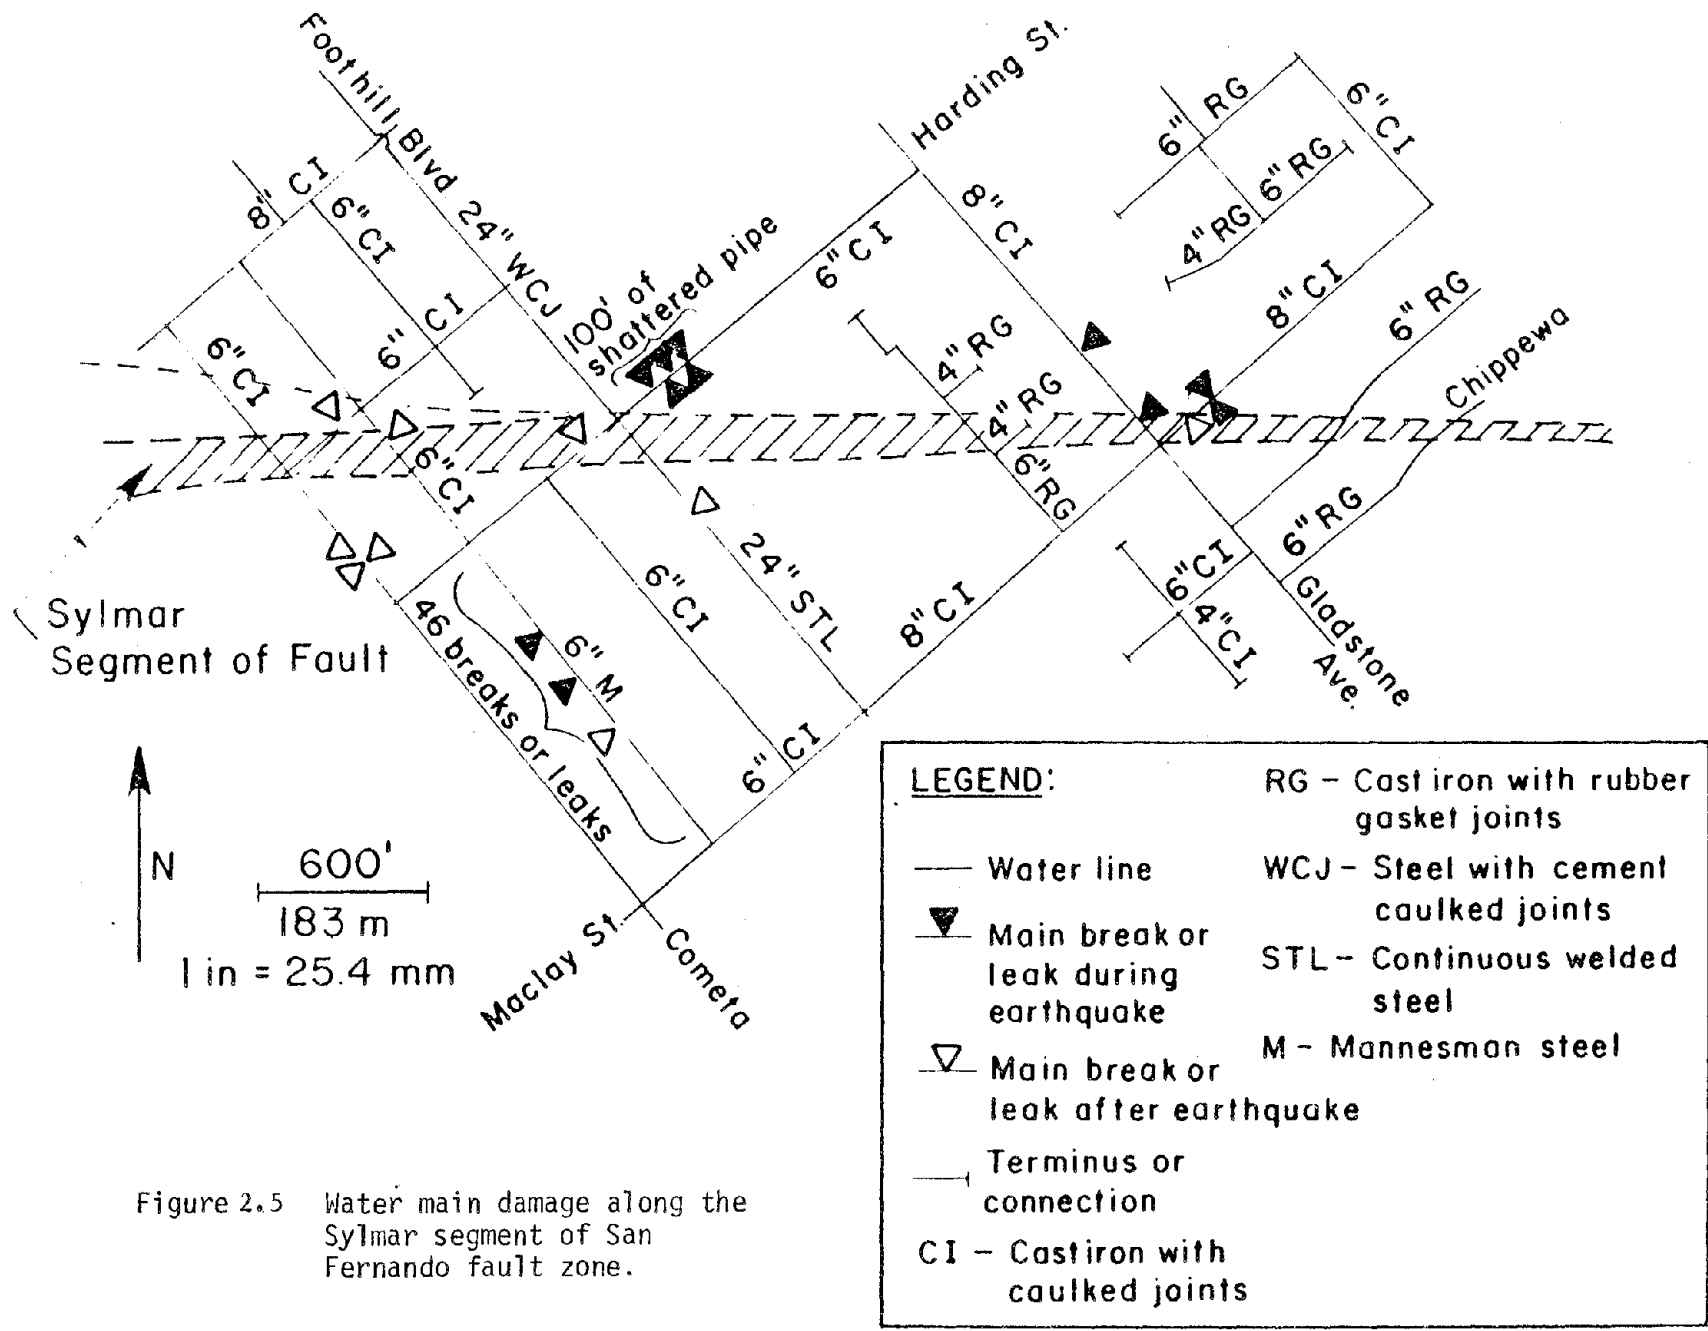
All the cast iron water mains with cement-caulked joints that crossed the fault in the area under consideration were damaged. Most of the mains were composed of 18 ft (5.5 m) lengths of gray, cast iron pipe joined at cement-caulked, bell-and-spigot couplings. Both northwest and northeast trending lines ruptures, but damage was most prominent along northeast trending lines where compressive ground deformations were largest. The most

striking damage occurred along the northeast-trending line at Harding Street where 100 ft (30 m) of cast iron line were shattered.

Figure 2.5 Water main damage along the Sylmar segment of San Fernando fault zone.

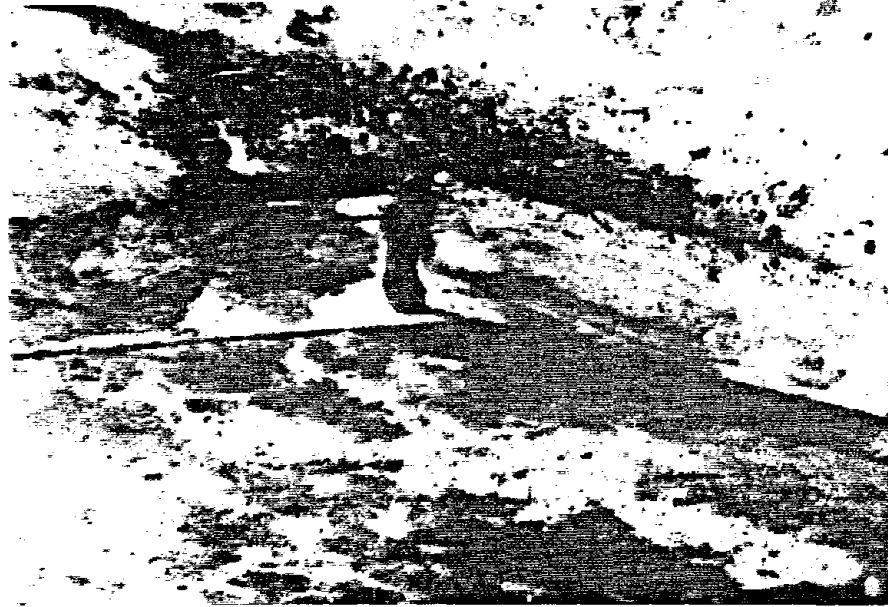
Figure 3.2 A Pipe Broken in Yingkou City From Haicheng Earthquake

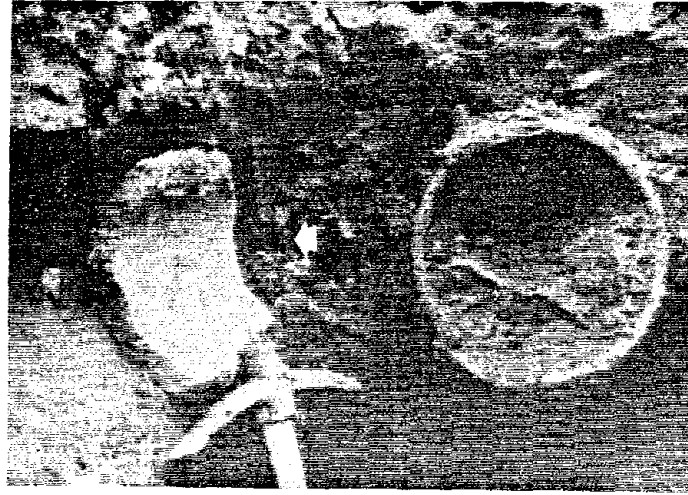
Figure 4.3 Concrete Pipe Damage in Jixang Road

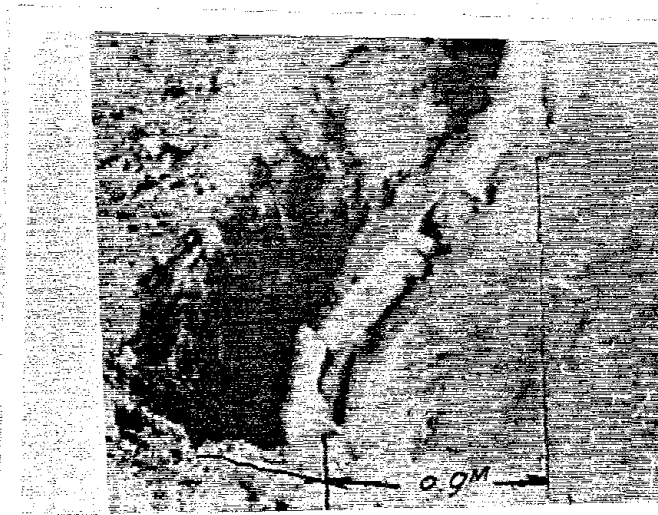
Figure 4.4 Damage of a Pipe Due to Ground Failure

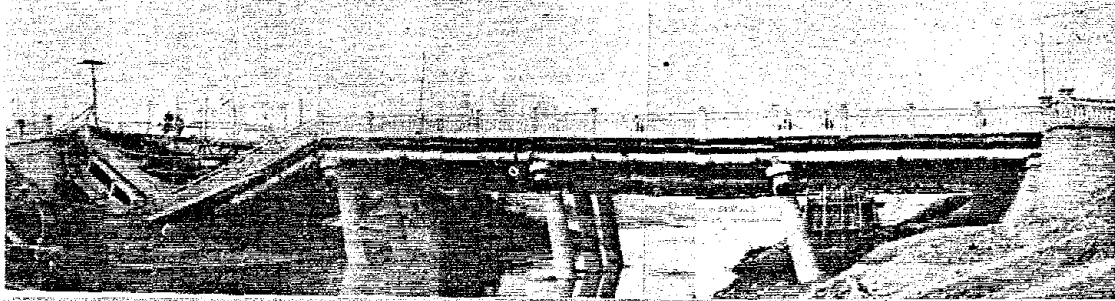
Figure 4.5 Failure of Shengli Bridge and Pipeline

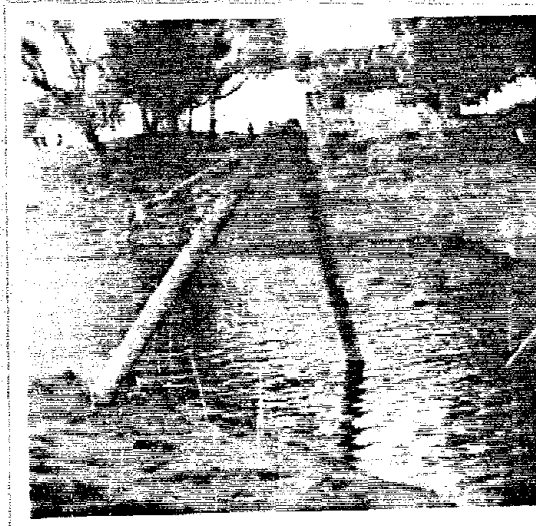
Figure 4.6 Breakage of a River Spanning Pipe

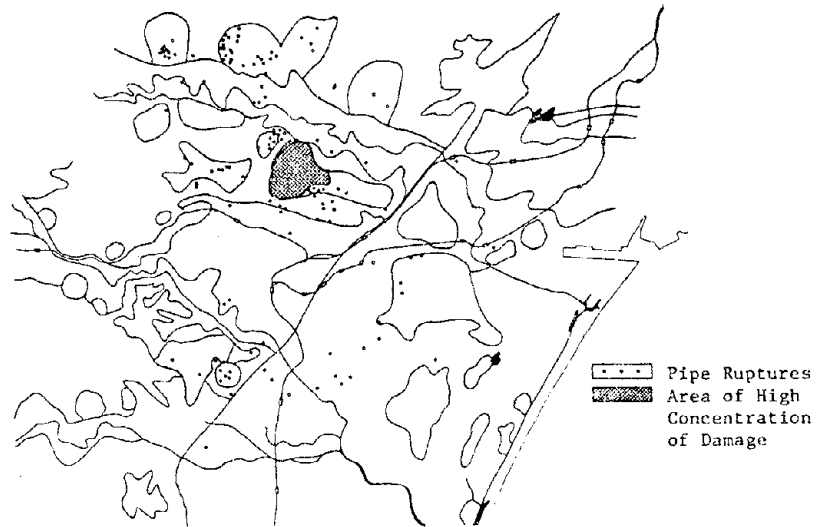
5.3 Location of Ruptures in Water Distribution Mains (Ref. 2)

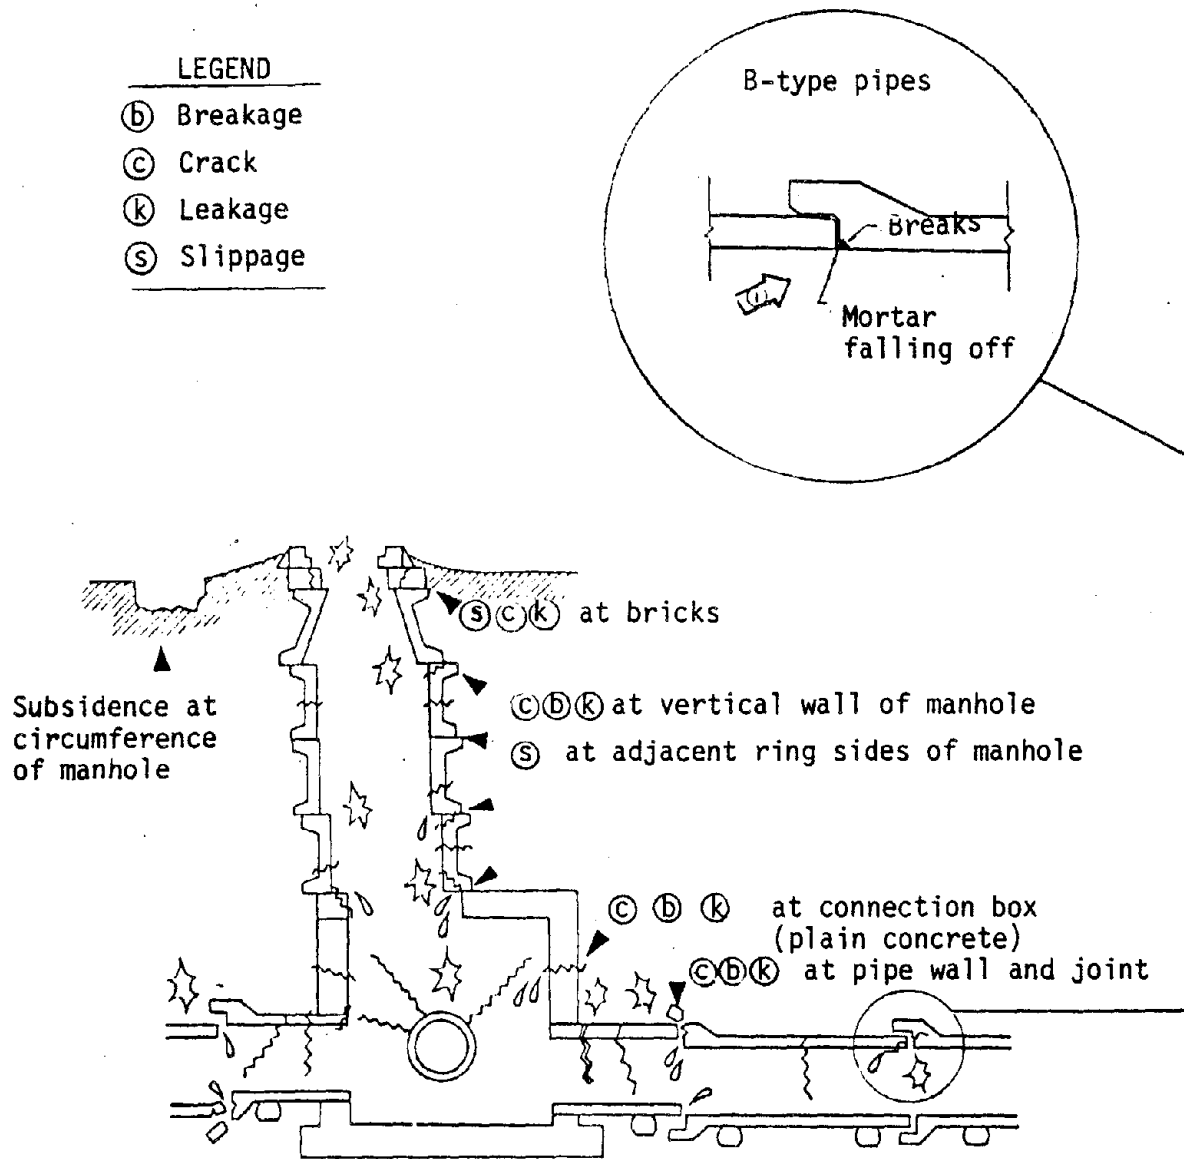
Fig.5.4 Damages to buried pipes and manholes
