**PMFSEL REPORT NO. 86-4  
MAY 1986**

**SEISMIC STRENGTHENING OF A  
REINFORCED CONCRETE FRAME  
USING REINFORCED CONCRETE PIERS**

**Report on a Research Project  
Sponsored by  
National Science Foundation  
Grant No. CEE-8201205**

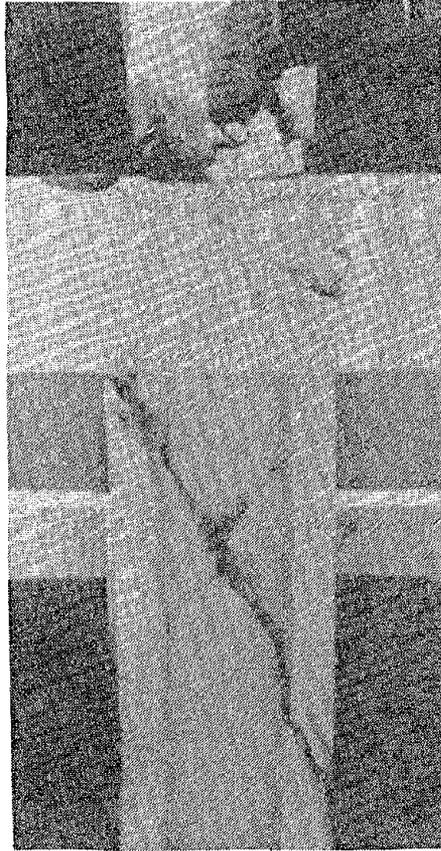
Fig. 1.2 Typical short column shear failure  
Olive View Hospital, San Fernando  
1971

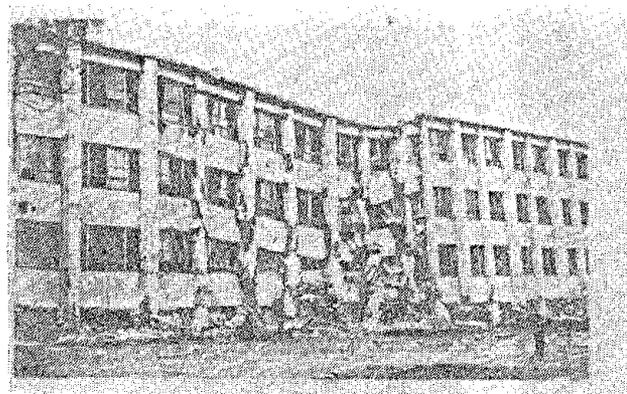
Fig. 1.3 Severe damage due to short column  
shear failure. Hokodate Coleege,  
Tokachi-oki 1968 [10]

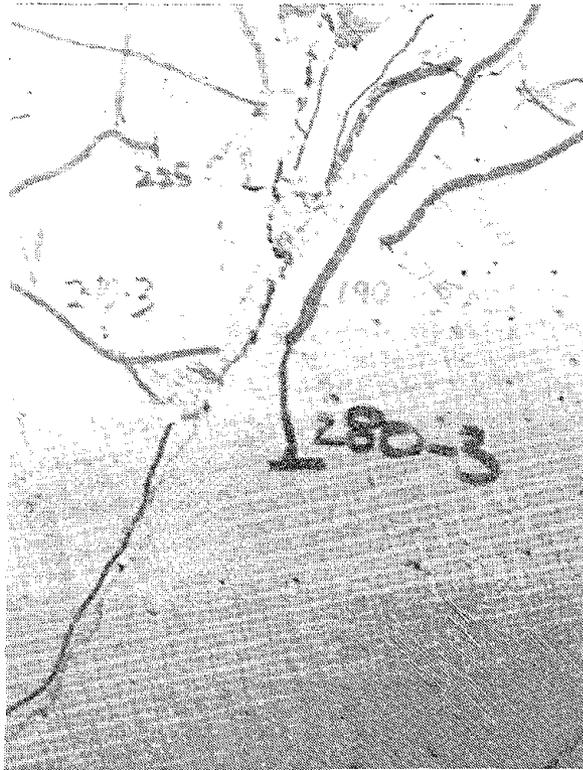
Fig. 3.12 Large flexural crack with some concrete spalling at 0.5% drift. Interior of first level beam, north of south pier

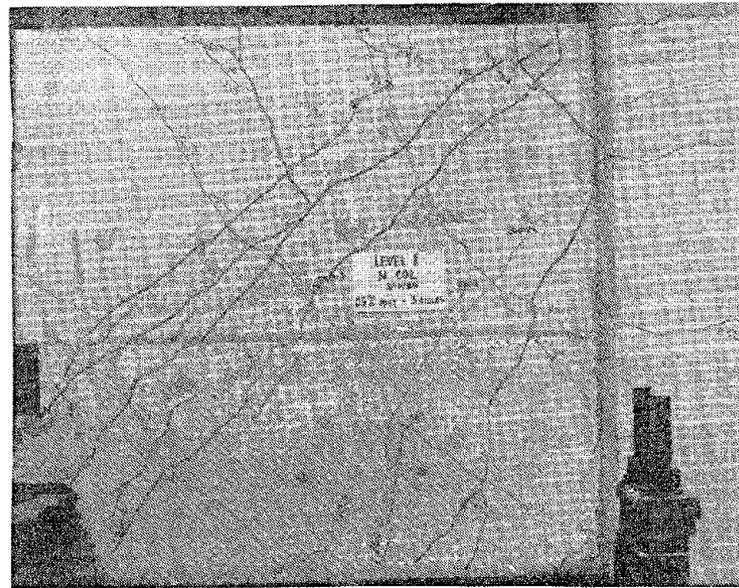
Fig. 3.13 Crack pattern on exterior face of north end, first level beam, 0.5% drift

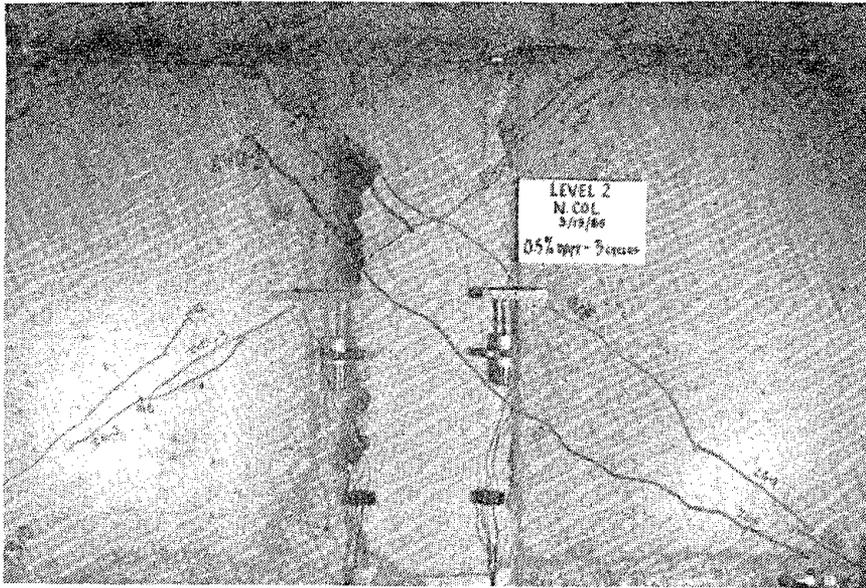
Fig. 3.14 Marked shear cracks on interior of north pier, second level, 0.5% drift

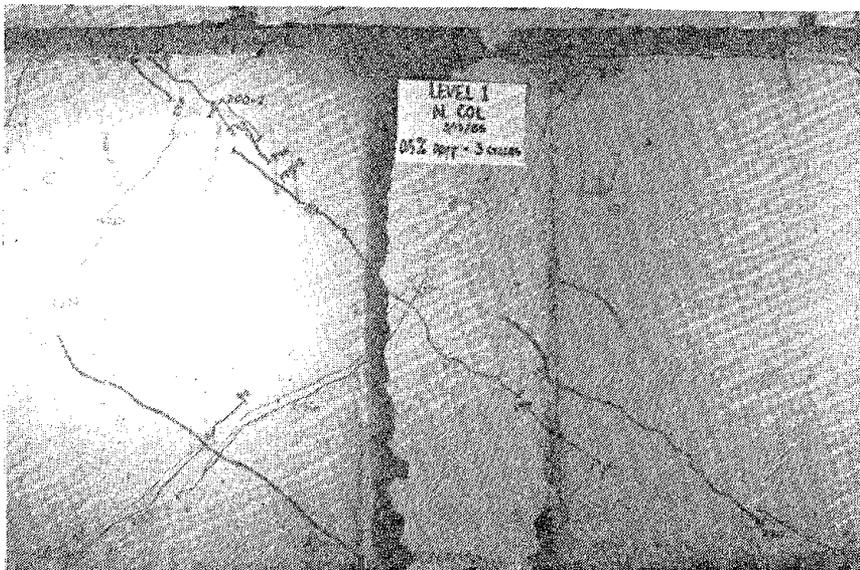
Fig. 3.15 Marked shear cracks on interior of north pier, first level, 0.5% drift

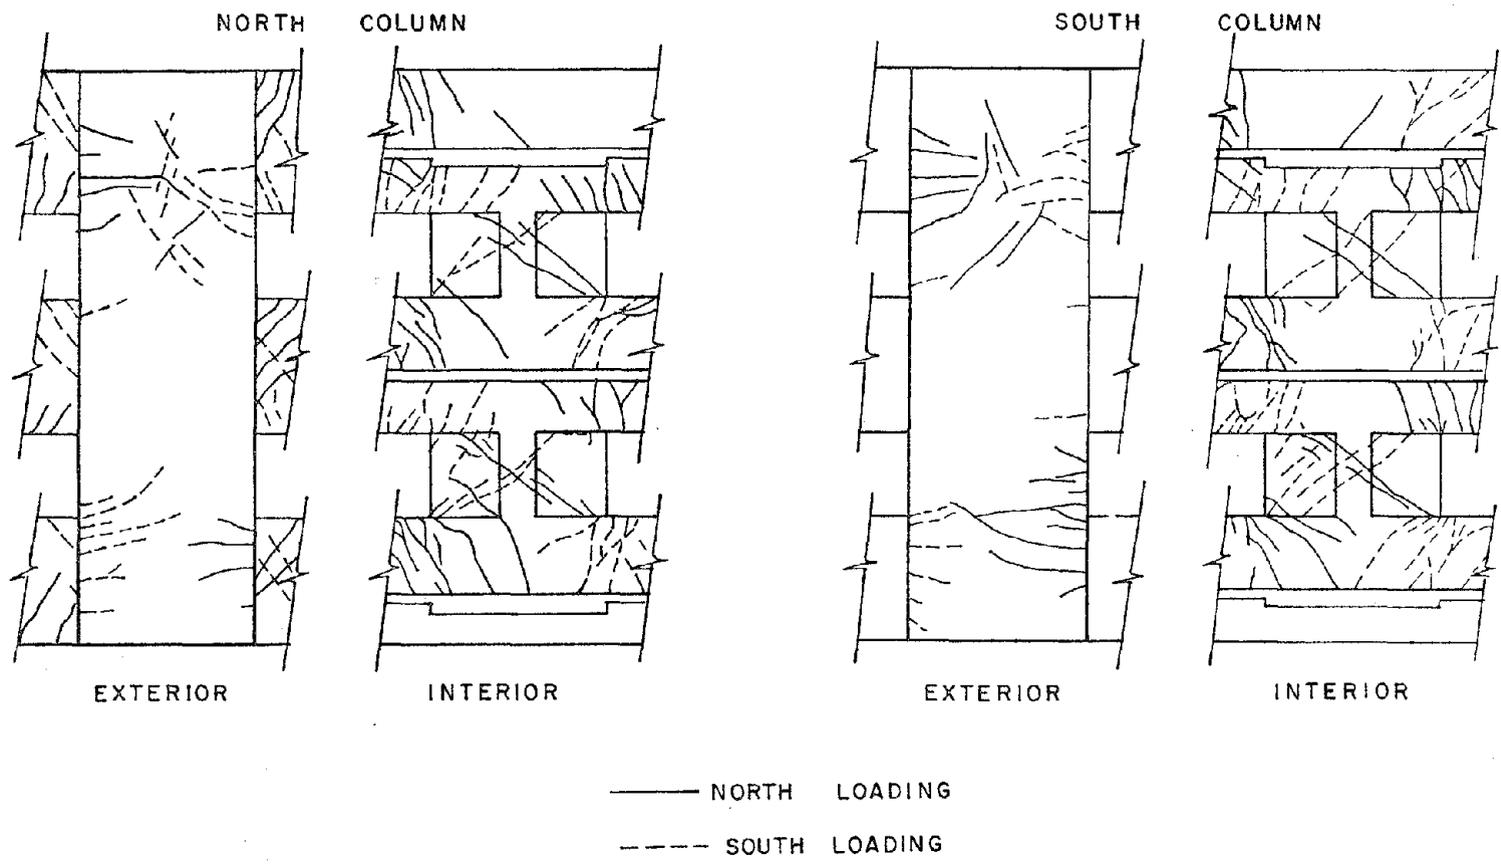
The majority of the shear cracking in the piers occurred on the interior face. These shear cracks initiated in the weak plane of the new/existing concrete interface as flexural

Fig. 4.2 Crack patterns of piers after three cycles to 0.5% drift

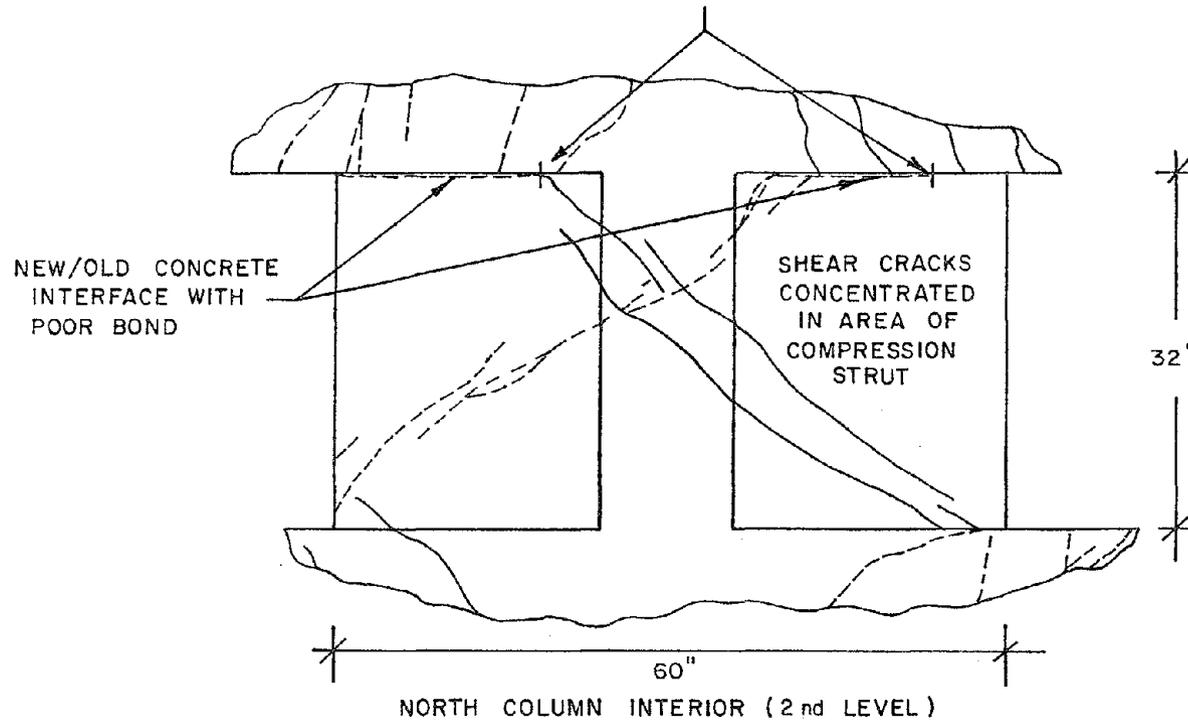
TRANSITION FROM FLEXURAL CRACK TO SHEAR  
CRACK UNDER LOADING IN THE OPPOSITE DIRECTION

Fig. 4.3 Crack pattern, interior window segment, north pier, second level, three cycles to 0.5% drift
