REPORT NO.
UCB/EERC-87/11
SEPTEMBER 1987

RESIDUAL STRENGTH OF SAND FROM DAM FAILURES IN THE CHILEAN EARTHQUAKE OF MARCH 3, 1985

PEDRO DE ALBA
H. BOLTON SEED
EUGENIO RETAMAL
RAYMOND B. SEED

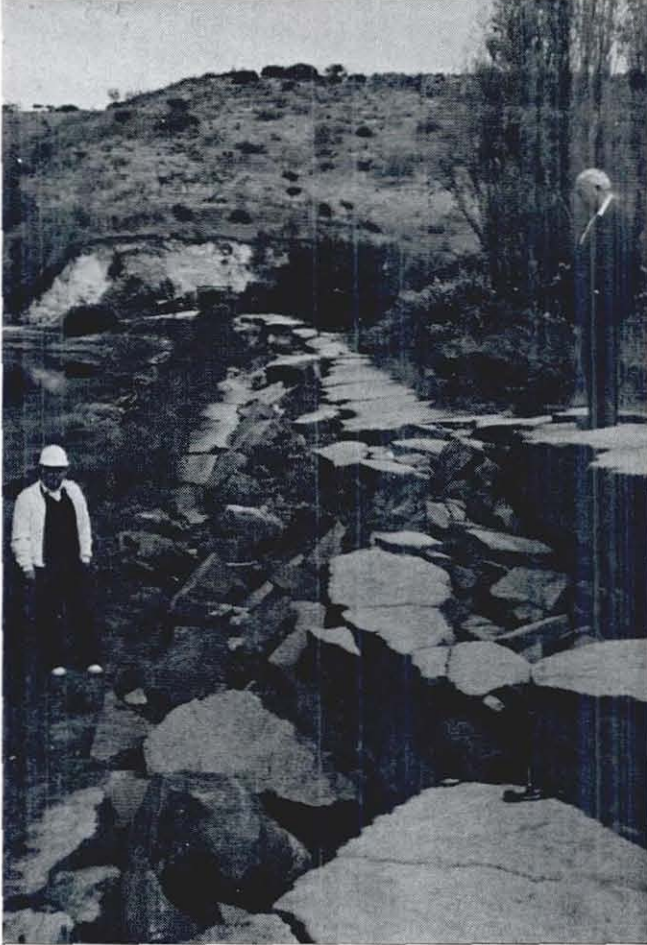
During the 1985 earthquake, the dam experienced major sliding of both the upstream and downstream slopes, with the largest displacements occurring in the upstream slope. The resulting loss of freeboard was about 2 m (6.6 ft.) in the middle one-third of the embankment, thus dropping the crest of the dam to the same elevation as the spillway crest. An emergency breach was opened near the right abutment and the reservoir was emptied within a few days of the earthquake. Subsequent surface inspection showed an extensive pattern of longitudinal cracks, especially in the upstream slope, with crack widths of up to 0.8 m (2.6 ft.) and depths of up to 2 m (6.6 ft.). Fig. 2 shows cracking in the upstream slope. Horizontal displacements in the zone of greatest damage reached about 11 m (36 ft.) at the toe of the upstream slope and 6.5 m (21 ft.) at the toe of the downstream slope.

Fig. 2 CRACKING AND SLUMPING IN UPSTREAM
SLOPE OF LA MARQUESA DAM

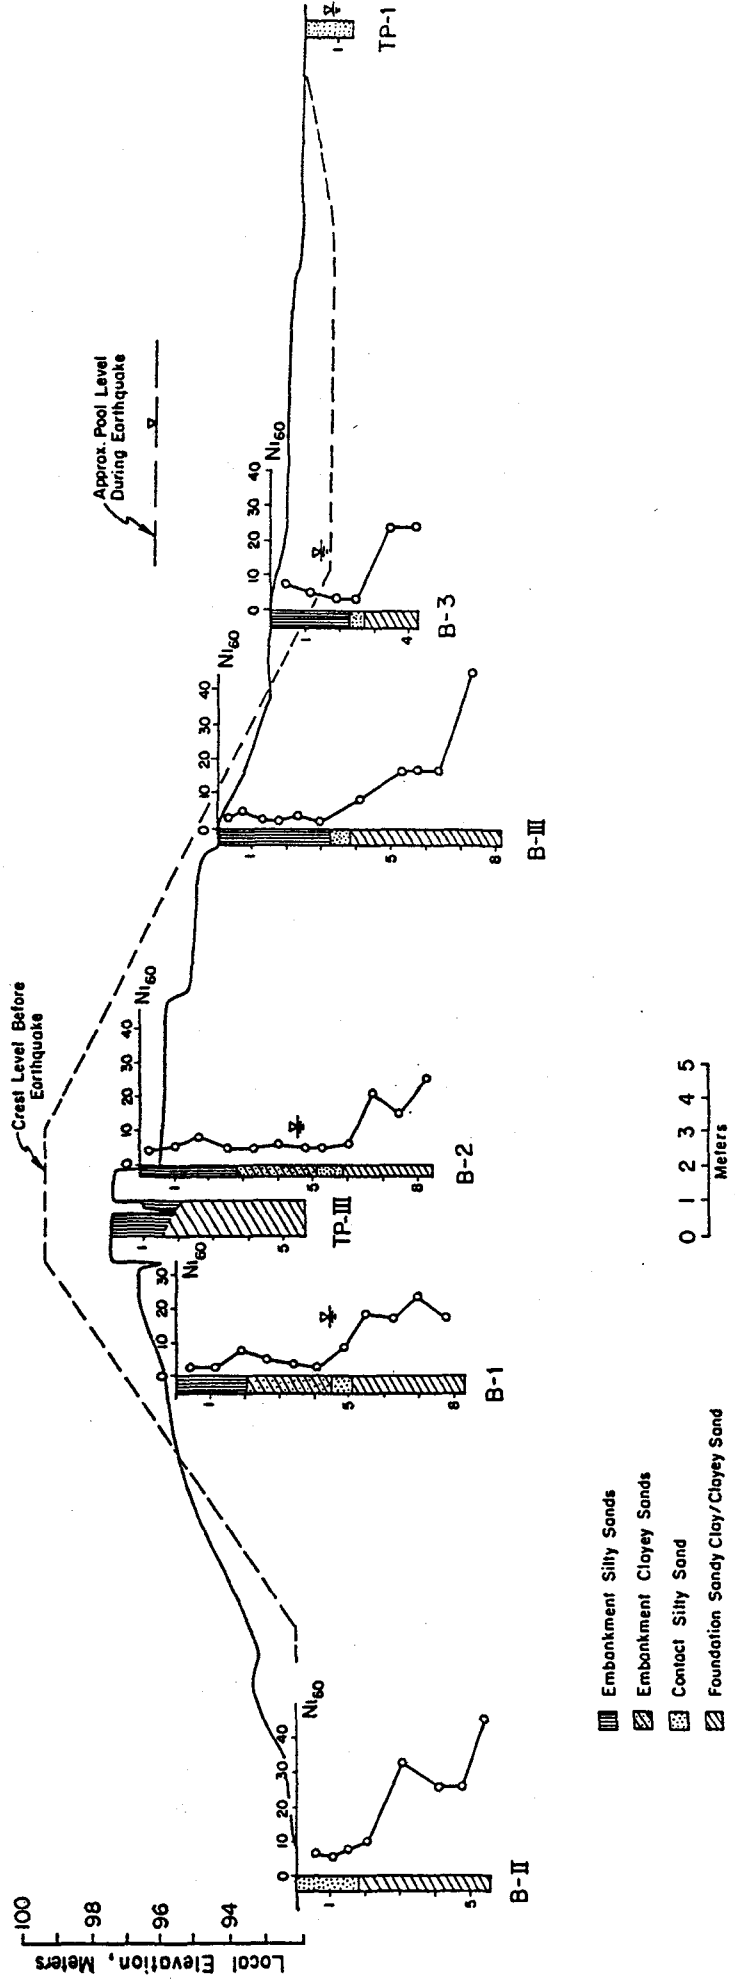
Figure 4 summarizes the results of the two exploration programs. SPT N-values have been normalized, as suggested by Seed et al., for the effects

Fig. 4 CROSS-SECTION THROUGH FAILURE ZONE OF LA MARQUESA EMBANKMENT

The most easily defined layer in the foundation is the clayey sand/sandy clay which appears at about local elev. 90.5 meters (referred to subsequently as the base sandy clay). Blowcounts, fines content and plasticity all increase simultaneously in this layer. This clay is a residual material, and it is exposed in the abutments and in the main channel upstream of the dam. Immediately above the base sandy clay, a layer of silty sand was identified in all the borings of section A-A; this will be referred to subsequently as the contact silty sand.

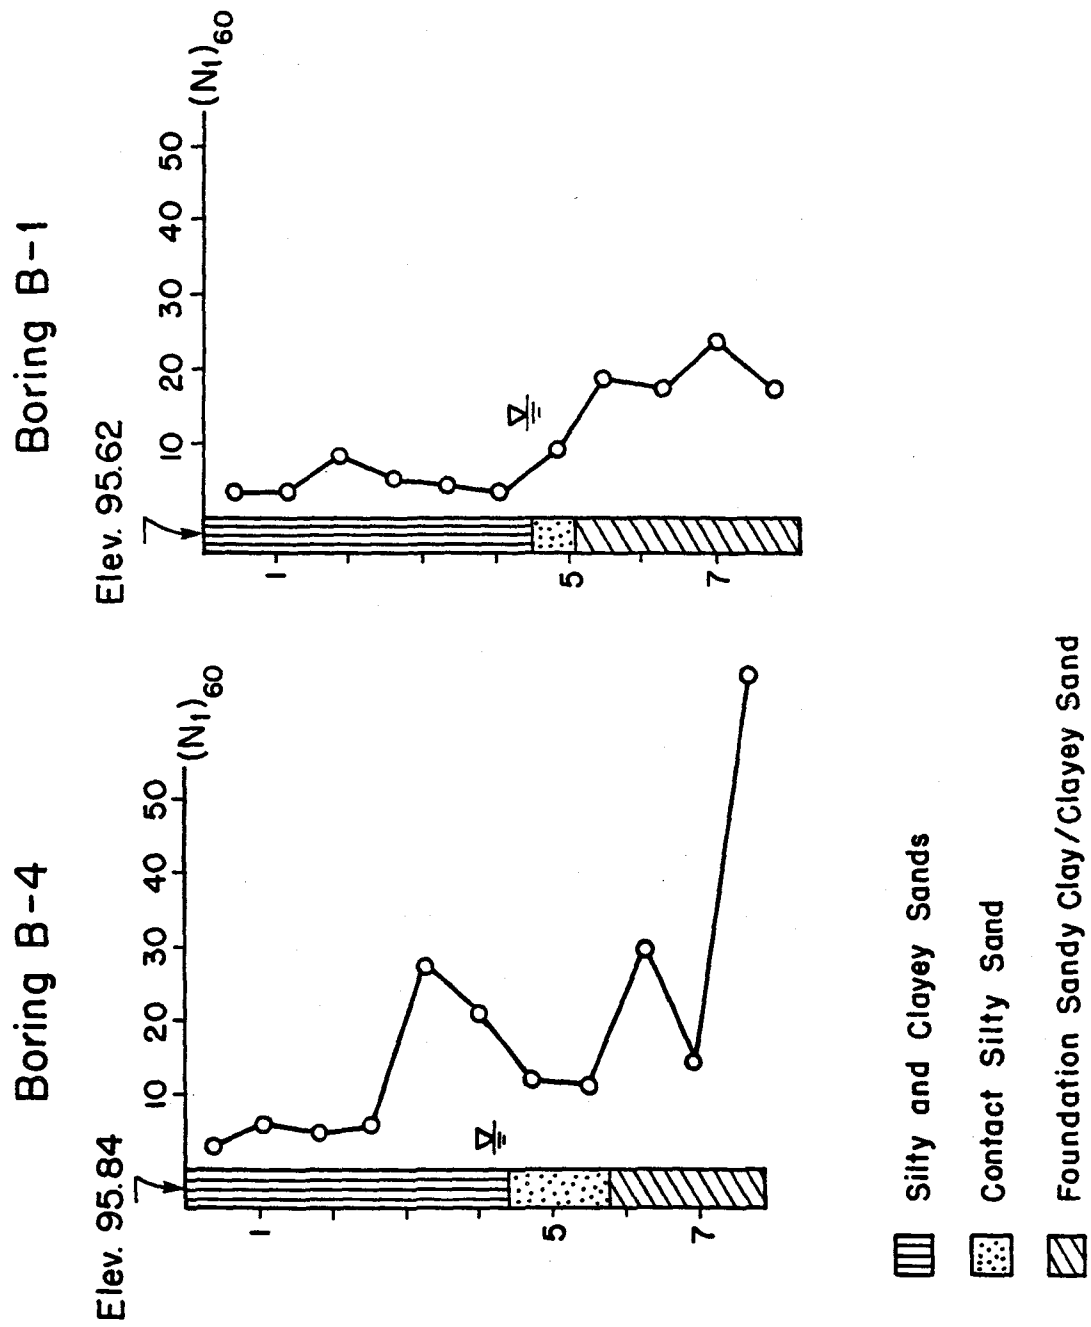
Figure 5 compares downstream boring B-1 of section A-A with boring B-4, also located on the downstream slope, but away from the major damage zone, at about 28 meters (92 ft.) from B-1. A boring on the upstream slope would have been more desirable, but it was not possible to locate an undamaged portion of the upstream slope that was not practically at the abutment. The downstream slope at B-4 showed only minor cracking, with no significant movement. It is interesting to observe that what is evidently the same contact silty sand appears above the base sandy clay in Boring B-4, although the thickness of this layer at this location is about 1.4 m (4.6 ft), compared to 0.75 m (2.46 ft) in boring B-1.

Fig. 5 COMPARISON OF BORINGS B-1 AND B-4 AT LA MARQUESA DAM

It is of interest to compare the values of $(N_1)_{60}$ measured in the silty sand layer in Borings B-1, in the major damage zone, and B-4 where damage was minor, (see Fig. 5). The $(N_1)_{60}$ value measured in Boring B-4 was 11 bpf and that in Boring B-1 was 9 bpf, a difference of only 2 bpf. The fines content was similar at both locations. From this comparison, it would appear that pre-earthquake blowcounts under the embankment may not have been substantially different from the values measured after failure, and that as a first approximation these latter values can be considered indicative of the pre-earthquake values. It is also important to note that the data from boring B-II of the 1985 study is not considered representative of conditions under the embankment. The surface disruption pattern beyond the downstream toe suggests that liquefaction did not extend as far as this boring. While blowcounts at this

location are comparable to those under the embankment it should be noted that the fines content (37%) and, more importantly, the plasticity of the fines (PI = 11%) are significantly greater in this area than in the contact silty sand at other locations under the embankment, and the clayey nature of this soil may well have prevented liquefaction from occurring at this location.

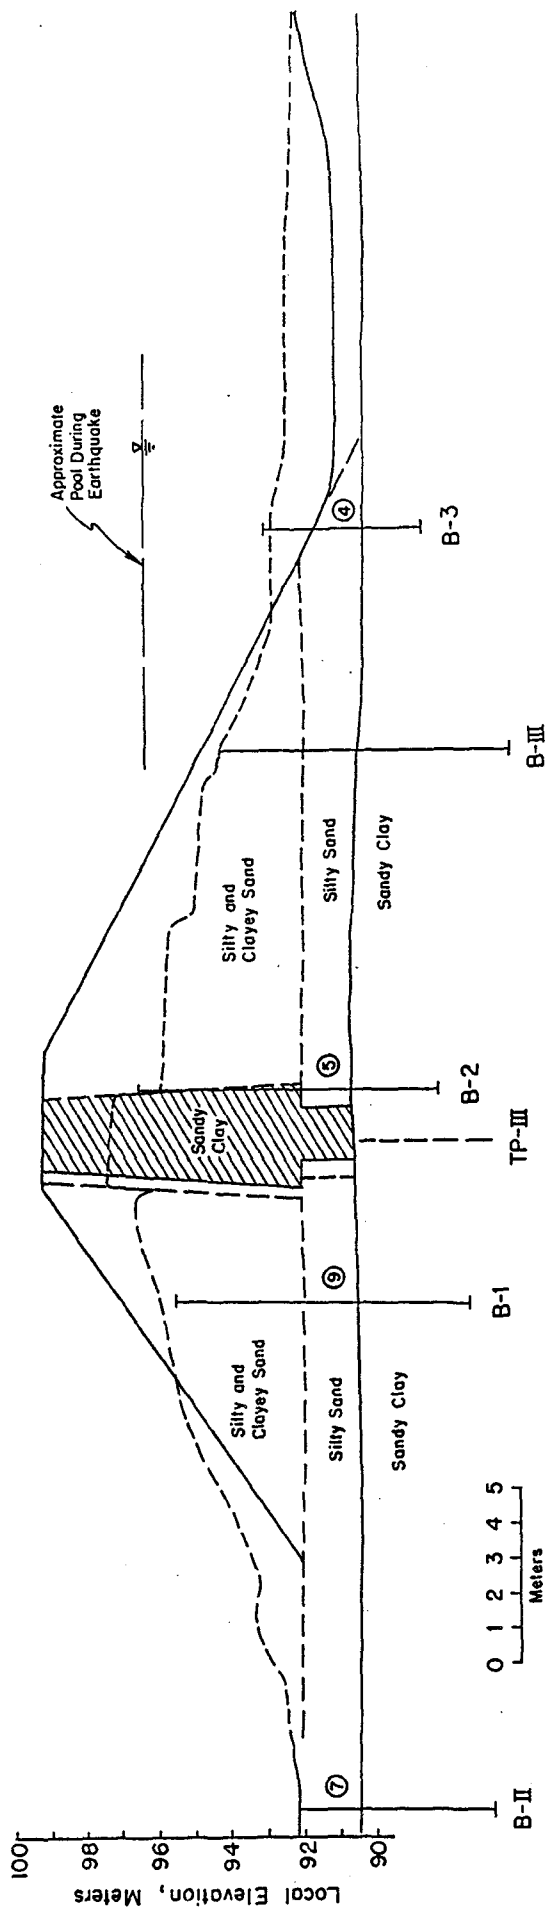
Figure 6 shows a reconstruction of section A-A based on the exploration results. The existence of a relatively narrow core zone of more plastic material at the center of the dam was confirmed by borings B-2 and TP-III, as well as by the damage pattern observed at the crest of the dam. This core location is also consistent with the zoning specified in the 1943 reconstruction plans.

The core is surrounded by silty and clayey sand shells; these shell zones were built directly on the contact silty sand, whereas this sand was removed under the core. This removal was called for in the specifications for the 1943 reconstruction, and is confirmed by the fact that the dam operated for many years without significant seepage at the downstream toe.

The reconstructed section in Fig. 6 shows a somewhat larger thickness of the contact silty sand than that reported in the borings, where a maximum value of 0.8 m (2.6 ft) was encountered under the embankment. Study of the damage pattern suggests that the large horizontal and vertical upstream deformations were probably due to liquefaction of the contact silty sand as will be discussed subsequently. The assumption of a larger pre-earthquake thickness for the contact silty sand under the major damage section is supported by the 1.4 m (4.6 ft) thickness of this material in boring B-4 outside the major

Fig. 6 RECONSTRUCTED CROSS-SECTION THROUGH FAILED PORTION OF LA MARQUESA EMBANKMENT

This belief is consistent with the large deformations of the upstream slope, and it accounts for the large volume which is now missing from the upper part of the pre-earthquake section, (see Fig. 6), while remaining consistent with the observed surface disruption beyond the toe of the slope.

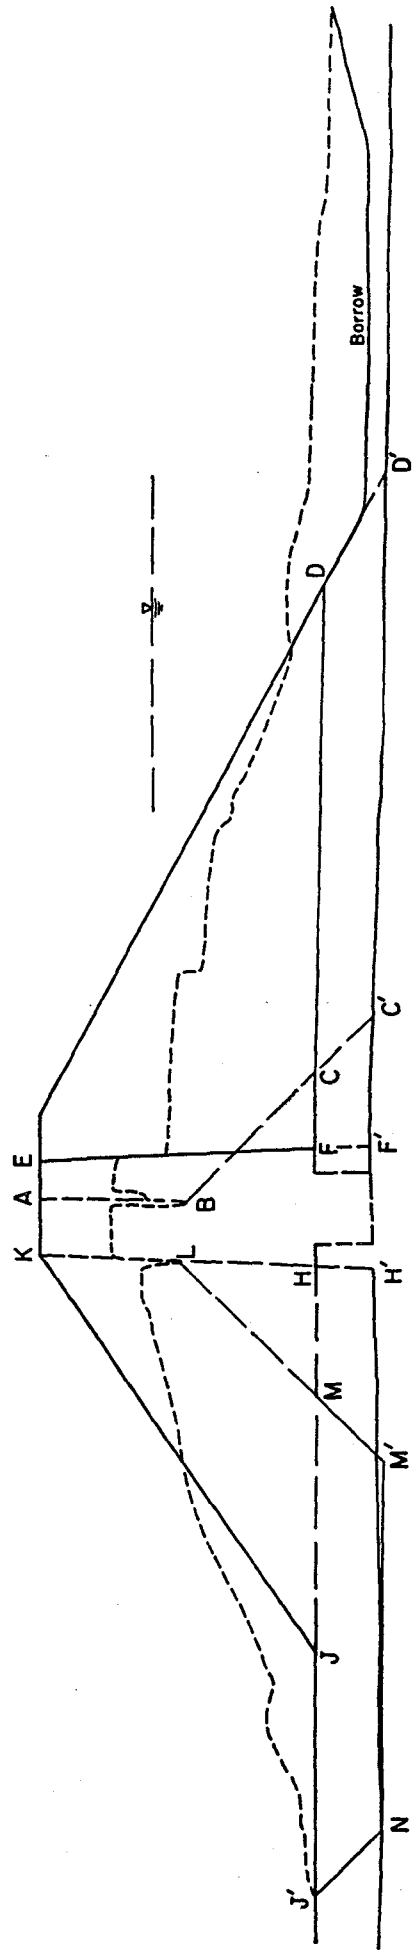
Figure 7 summarizes the different potential failure surfaces considered in the case (a) analyses for the upstream and downstream slopes. As

Fig. 7 POTENTIAL SLIDING SURFACES THROUGH ORIGINAL SECTION OF LA MARQUESA EMBANKMENT

A second series of type (a) analyses was carried out assuming failure along surfaces ABCD and ABC'D' in Fig. 7, suggested by the damage pattern of the upstream slope, as shown. These were simple sliding wedge analyses, carried out considering a uniform residual strength along BCD or BC'D' and the same yield acceleration previously calculated. Residual strength values on the order of 290 to 340 psf were obtained by these analyses. These values represent an upper bound to the residual strengths that might be calculated for these surfaces, since if a higher undrained strength is assumed for the part of the failure surface that passes through the more plastic embankment materials along BC, then the residual strength required for equilibrium along CD or C'D' will be lower.

The same type of analysis was carried out for the downstream slope, considering the surfaces indicated in Fig. 7. In this case, for a horizontal deformation at the toe of about 6.5 m (21 ft), a yield acceleration of 0.03g was determined and used to quantify the residual strength of the liquefied silty sand. The results of these analyses for the downstream slope led to a computed upper limit for residual strength of 580 psf.

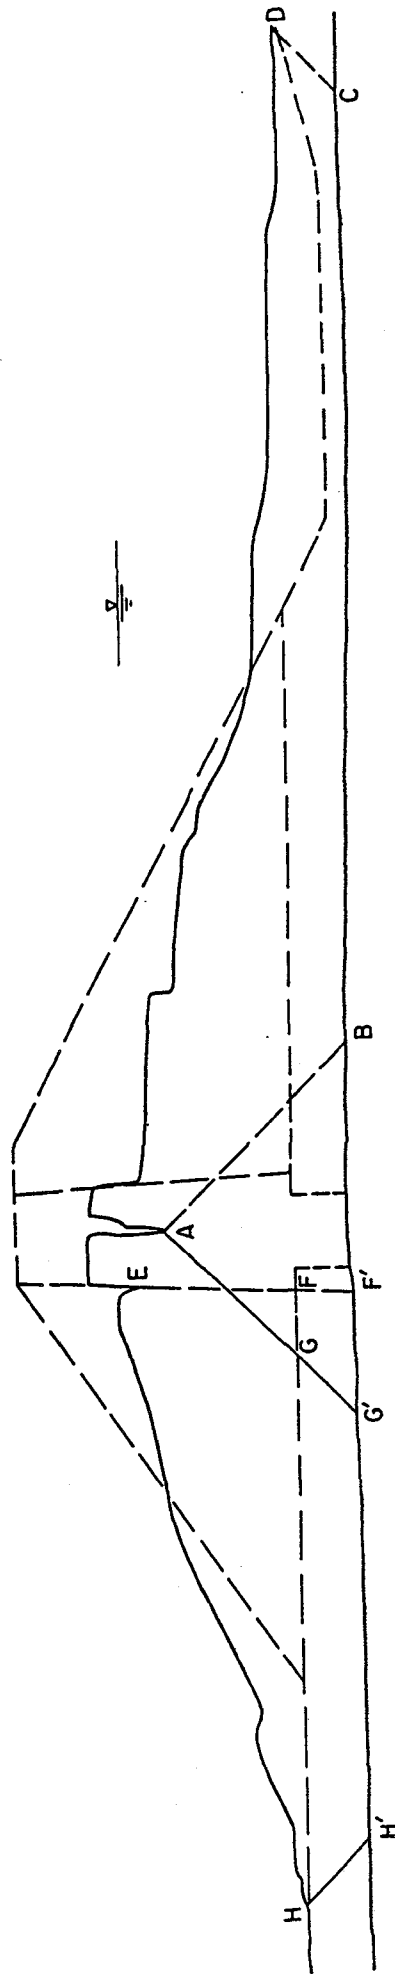
Type (b) analyses, to determine the residual strength required for a factor of safety of unity once earthquake shaking had stopped, were carried out for the surfaces shown in Fig. 8 and the results are summarized in Table I. Again, a uniform strength was assumed along the sliding surfaces considered. In this case, it is clear that very low strengths could be obtained, depending on the sliding surface considered; however, the values of interest are those consistent with the failure mechanisms proposed. For

Fig. 8 POTENTIAL SLIDING SURFACES FOR POST-EARTHQUAKE STABILITY ANALYSIS OF LA MARQUESA EMBANKMENT

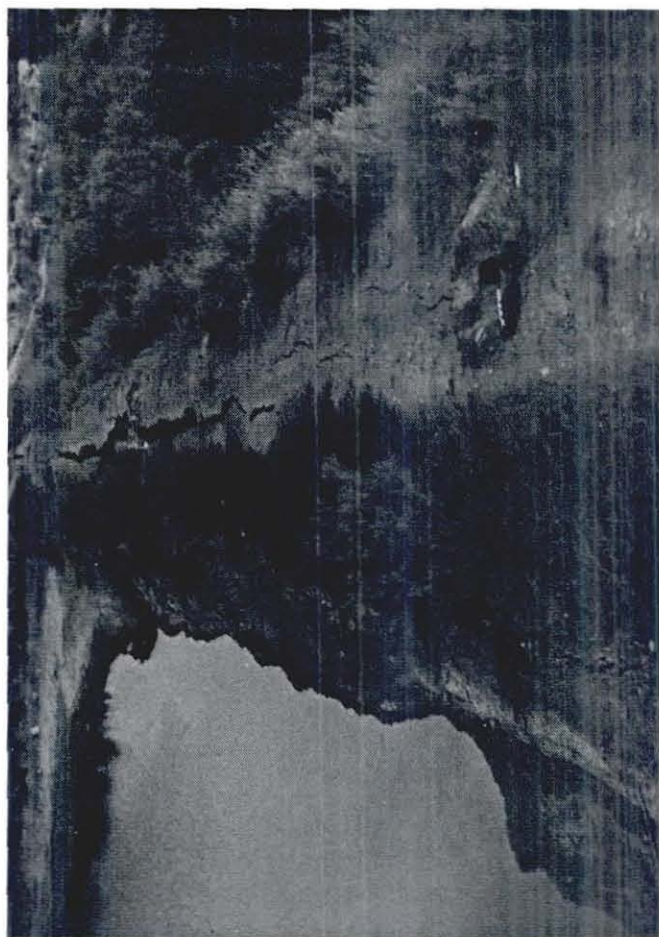
The damage pattern observed upstream is somewhat similar to that at La Marquesa Dam; the middle third of the embankment suffered major displacements, with the upstream toe moving out about 5 m (16 ft) and the failed embankment zone breaking up into blocks between longitudinal cracks. A major crack 80 m (260 ft) long with a maximum width of 1.2 m (4 ft) developed along the crest; in the area of greatest damage the upstream side of the crack settled more than 2.6 ft (80 cm) relative to the downstream side as shown in Fig. 10. A second major 60-m (197 ft)-long crack developed about 2 m (6.6 ft) below the crest in the upstream slope, with a surface width of about 80 cm (2.6 ft) and a drop of 1.5 m (4.9 ft) between the downstream and the upstream sides. Although the water level in the dam was relatively low at the time of the

Fig. 9 OVERALL VIEW OF LA PALMA DAM SHORTLY AFTER EARTHQUAKE

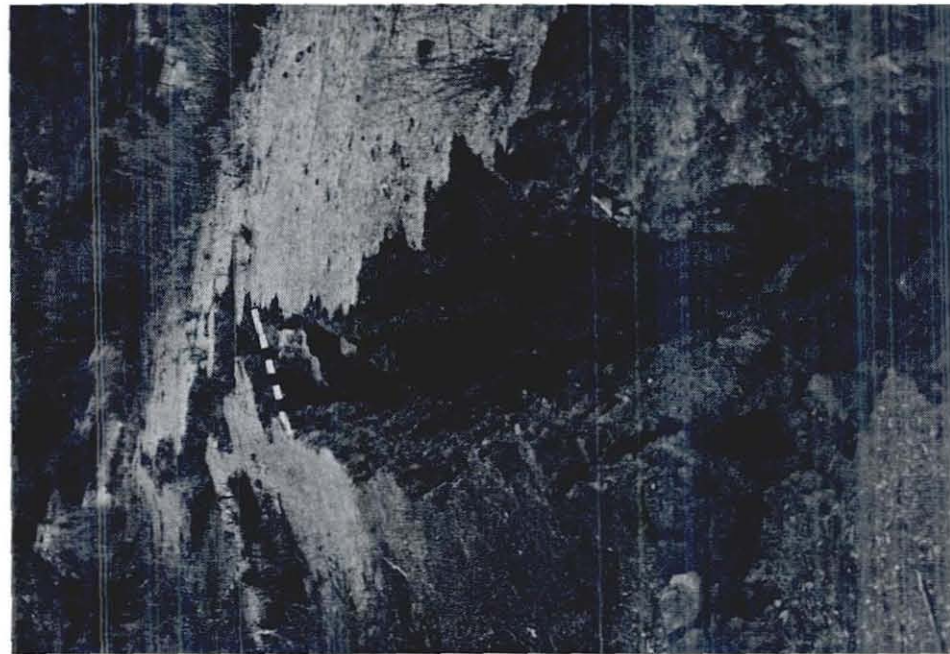
(a) Cracking in Slope of Dam

Fig. 10 CRACKING AND SLUMPING IN UPSTREAM SLOPE OF LA PALMA DAM

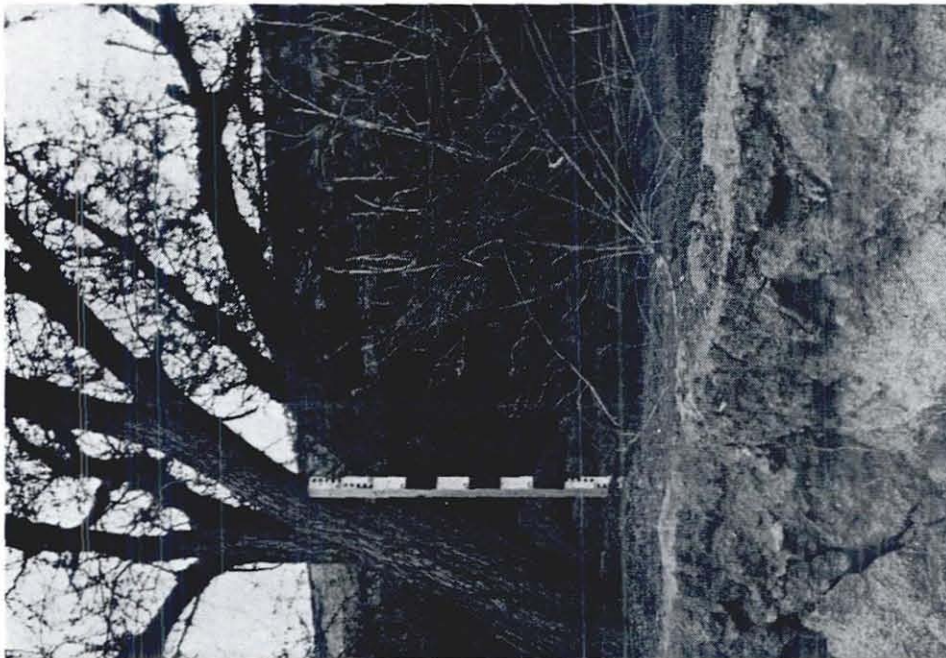
(b) Slumping of Crest of Dam--tree was formerly on crest of embankment

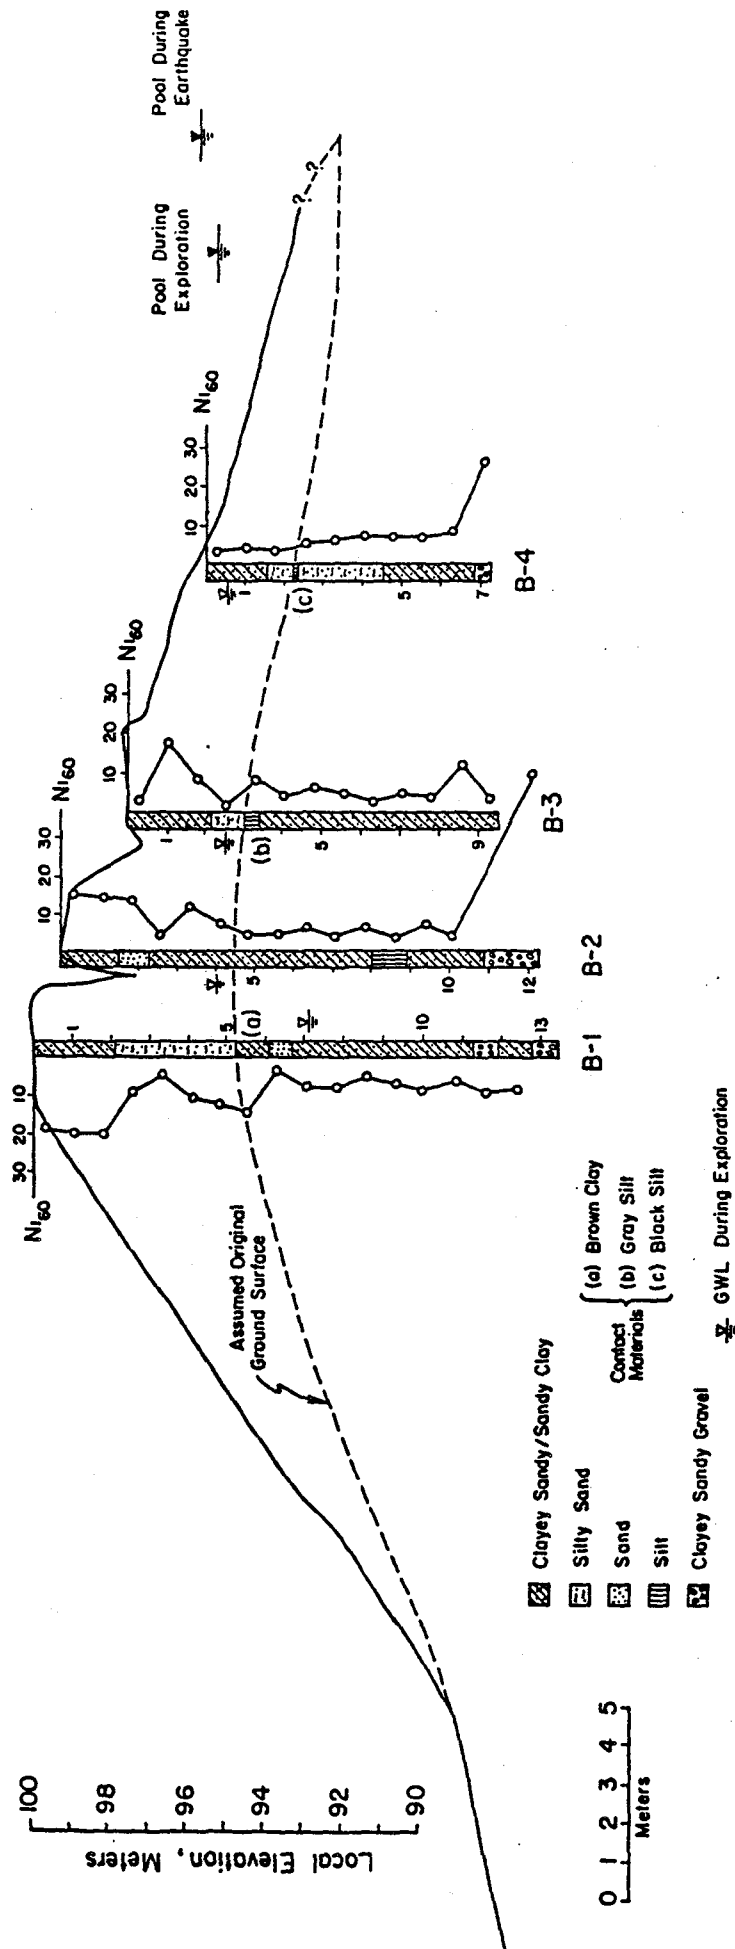
The soil profile and the results of SPT tests for Borings B-1, B-2, B-3 and B-4 along section BB are summarized in Fig. 12. Measured N-values were normalized as for La Marquesa Dam and the results are presented in terms of $(N_1)_{60}$. Plasticity index and fines content were determined for each split-spoon sample.

From these results, it was concluded that the contact between the embankment and the original ground surface was defined by the black and grey silts in Borings B-3 and B-4, and by the brown sandy clay in Boring B-1. No clearly defined contact could be found in Boring B-2; this was taken to indicate stripping to an impervious base for the core in this area. This belief is supported by the water levels observed in the borings during exploration, which are indicated in Fig. 12. The water levels in Borings B-2 to B-4 are approximately the same as the pool level, while in boring B-1 the water is

Fig. 12 CROSS-SECTION THROUGH FAILURE ZONE OF LA PALMA EMBANKMENT

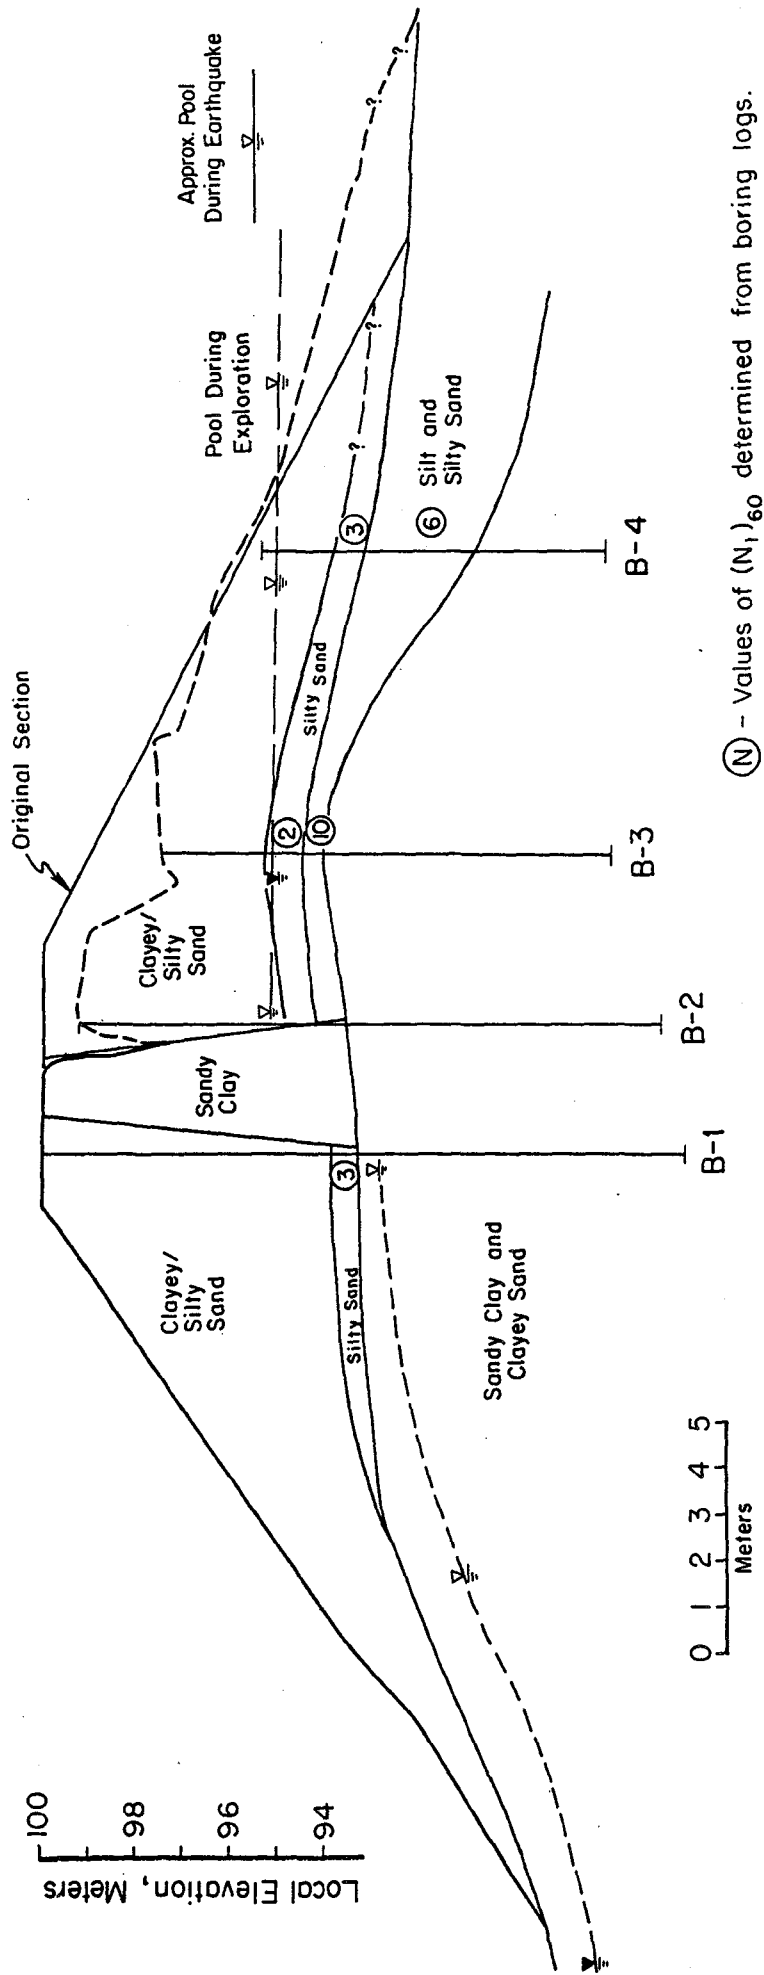
Figure 14 shows a reconstructed section of the embankment based on the results of the exploration program. Basically, the dam is rather similar in section to La Marquesa, with a sandy clay core supported by clayey and silty sand shells. The upstream shell and part of the downstream shell are underlain by a layer of loose silty sand. This layer is significantly looser than the underlying silts and silty sands, and it is highly probable that this is

Fig. 14 RECONSTRUCTED CROSS-SECTION THROUGH FAILED PORTION OF LA PALMA EMBANKMENT

the layer that liquefied during the earthquake, resulting in the failure of the upstream slope. Liquefaction probably did not occur under the downstream shell because the loose silty sand was above the water table in this area.

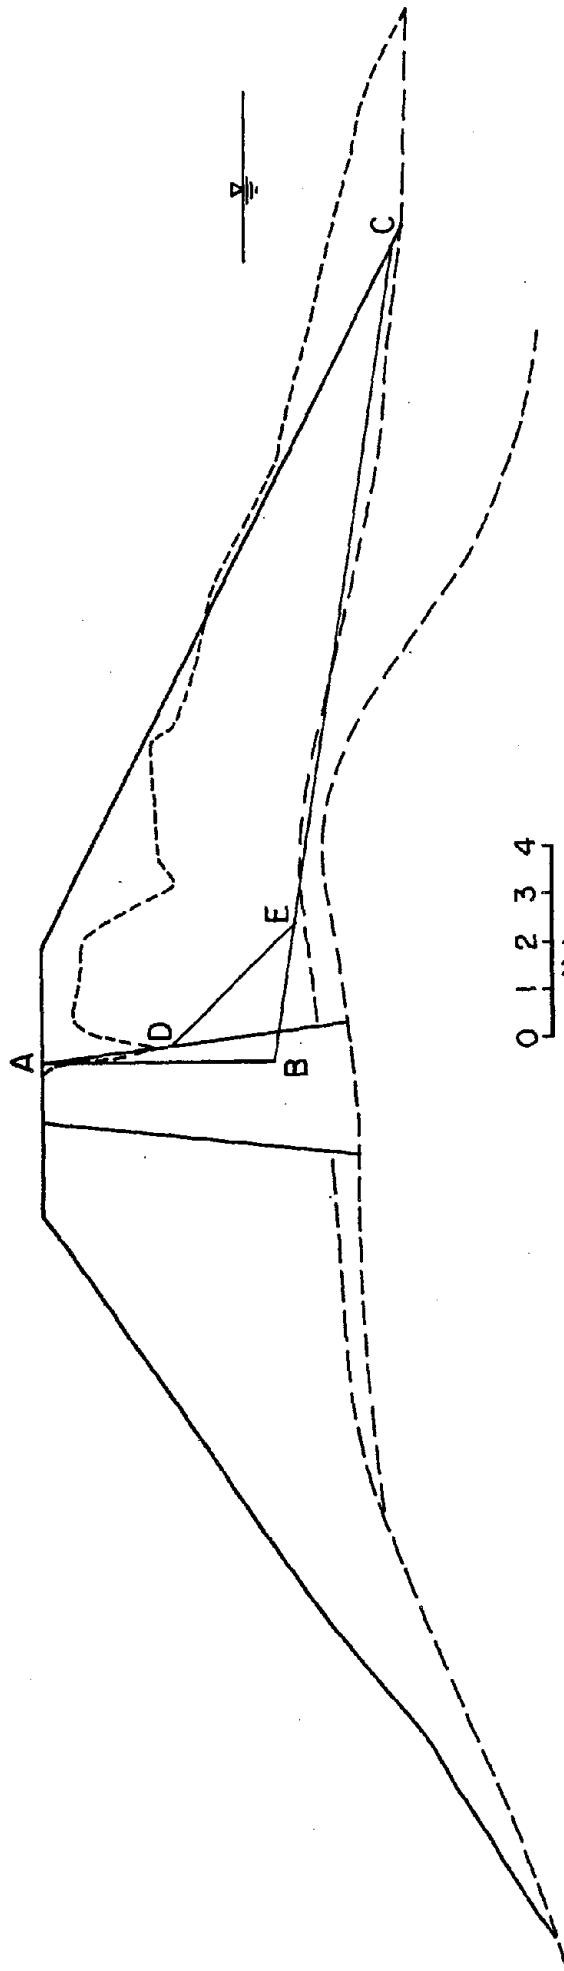
Fig. 15 shows the potential failure surfaces chosen for the case (a) analyses; as at La Marquesa Dam, wedge ABC was considered to have full effective at-rest earth pressure acting along AB with resistance provided by the residual strength of the liquefied sand acting along BC. For a horizontal toe displacement of 5 m and a free-field acceleration of 0.46 g a yield acceleration $k_y = 0.027$ g, was determined from the Makdisi-Seed deformation charts and a residual strength value of 295 psf was calculated for this case. An alternate surface suggested by the surface damage pattern, ADEC, was also studied using a sliding-wedge analysis procedure and assuming a uniform strength along the surface. A similar residual strength value, of 300 psf, was obtained in this case. Again, this would be an upper bound for the section ADEC since, if a higher value of undrained strength is assumed along DE in the embankment material, the residual strength along EC will be significantly lower than the computed value.

Fig. 15 POTENTIAL SLIDING SURFACES IN UPSTREAM SHELL OF LA PALMA DAM BASED ON ORIGINAL CROSS-SECTION

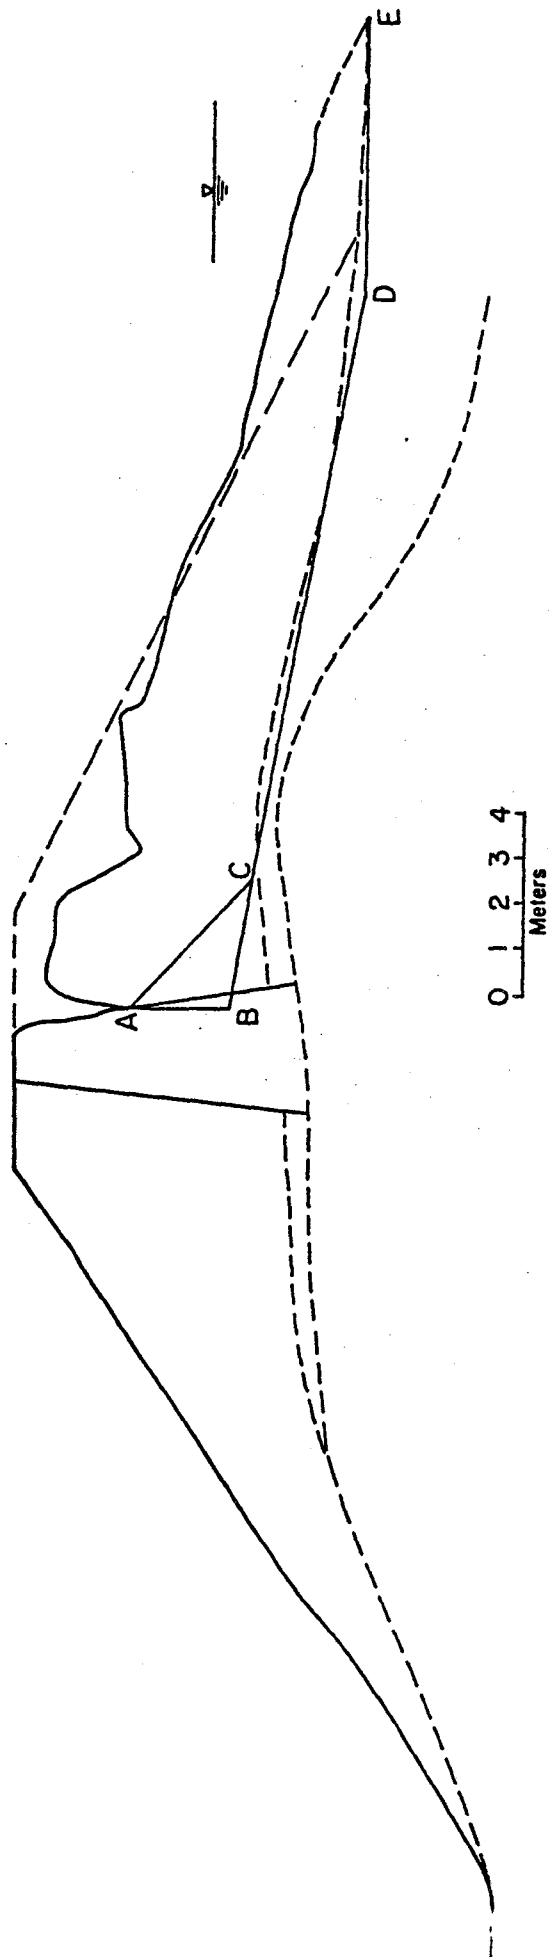
Case (b) analyses for the upstream slope at La Palma are summarized in Fig. 16 and Table II; lower bound values of residual strengths on the order of 120 psf were obtained, as shown.

Fig. 16 POTENTIAL SLIDING SURFACES FOR POST-EARTHQUAKE STABILITY ANALYSIS OF UPSTREAM SHELL OF LA PALMA DAM
