**REPORT
on the
WHITTIER-NARROWS, CALIFORNIA
EARTHQUAKE OF OCTOBER 1, 1987**

J. Pantelic¹ and A. Reinhorn²

Technical Report NCEER-87-0026

NATIONAL CENTER FOR EARTHQUAKE ENGINEERING RESEARCH
State University of New York at Buffalo
Red Jacket Quadrangle, Buffalo, NY 14261

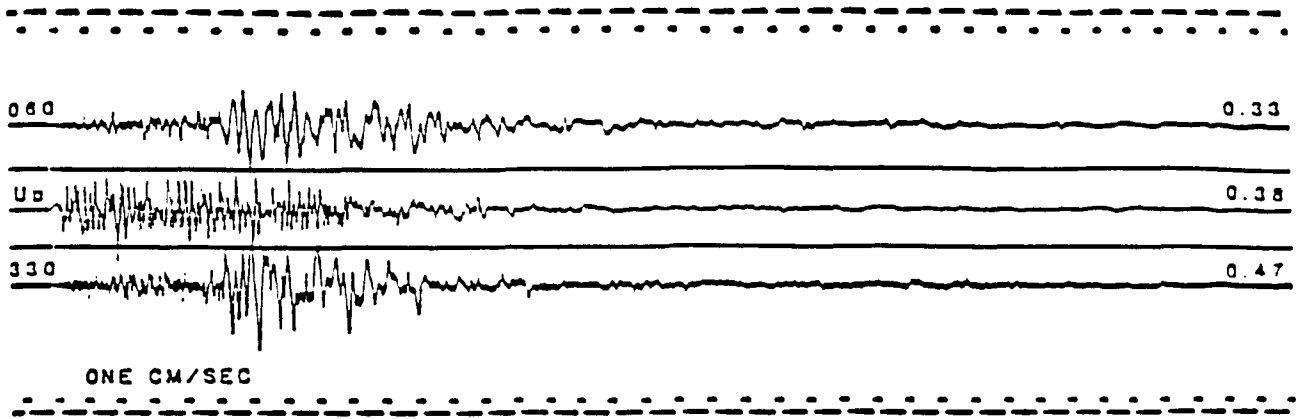
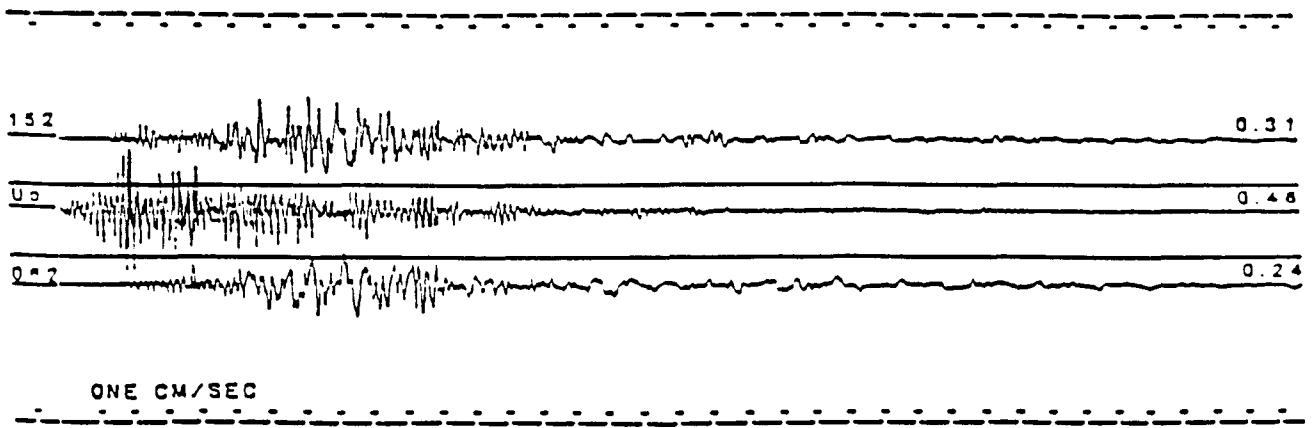
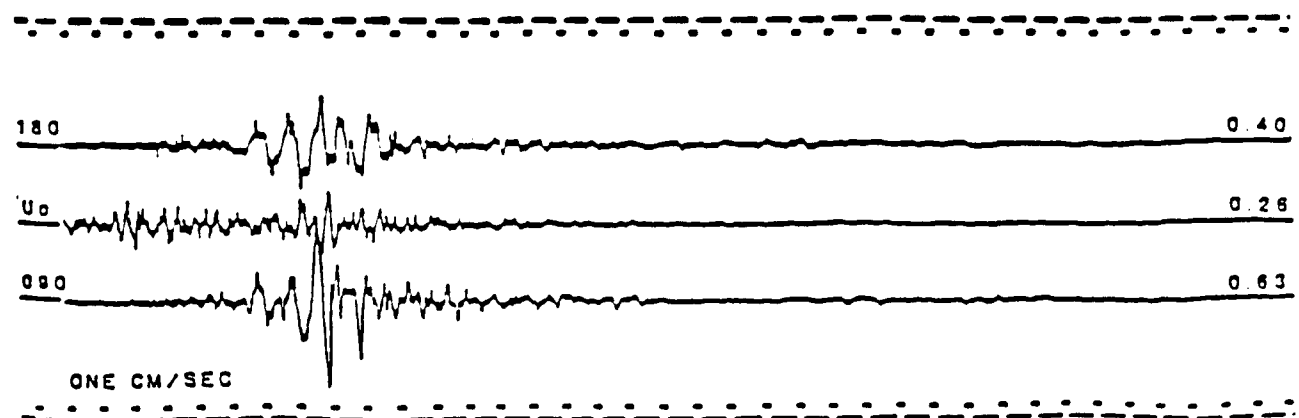
Figure 1-2 Accelerograms of Ground Motion in Whittier Area [2].

- (a) Garvey Reservoir (3 Km from epicenter): .47g horizontal .38g vertical
- (b) Whittier Narrows Dam (4 Km from epicenter): .31g horizontal .46g vertical
- (c) Whittier-7215 Bright Ave. Bldg. (10 Km from epicenter): .63g horizontal .20g vertical.

Figure 1-2 shows characteristic accelerograms for the above ground motions. Peaks (exceeding .10g) continued for approximately 5 seconds while the whole event lasted 15 seconds. The earthquake generated unusually high peak accelerations, however, they lasted only a short period of time.

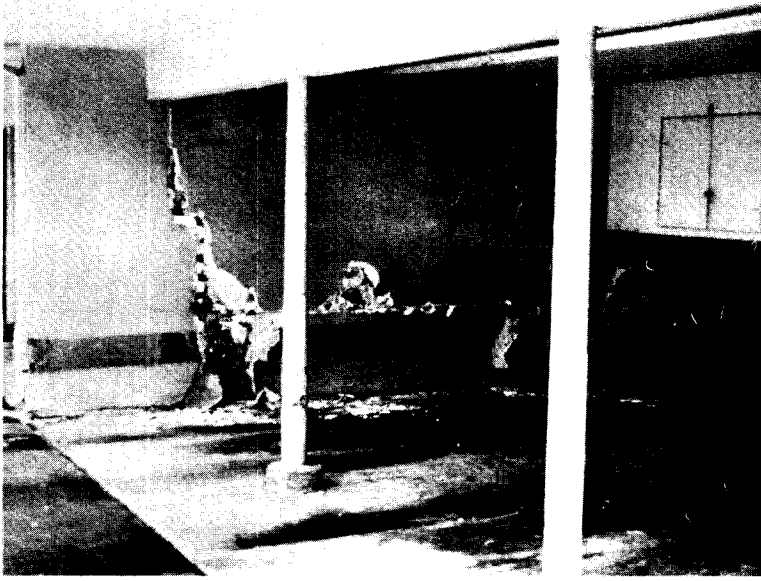
Load bearing unreinforced masonry walls constructed of hollow or solid blocks had a large number of failures and caused collapse of entire walls and roofs. The extent of damage varied from minor cracks to complete collapse of walls. Several commercial buildings in Whittier suffered damage. Some collapsed over vehicles parked next to them. Older, unreinforced masonry walls failed due to in-plane cyclic shear cracking (see Figure 1-3), out-of-plane instability and impact with adjacent buildings (pounding). Several streets with commercial buildings had to be closed in Alhambra, Whittier Center and South Pasadena. Several buildings in San Gabriel Mission (constructed in 1791) were severely damaged. In particular, the bell tower failed and brought about the collapse of part of the adjacent 1500-seat Civic Auditorium. (This tower survived a large number of previous earthquakes.) In areas of Whittier, piers of unreinforced masonry that were acting as shear walls showed flexural failures between windows combined with some diagonal shear cracking.

*Figure 1-3
Masonry walls
cracked severely
in-plane due to high
shear and compression
at the first story
(Photo from the Bay
Area Regional
Earthquake
Preparedness Program
(BAREPP)
collection).*

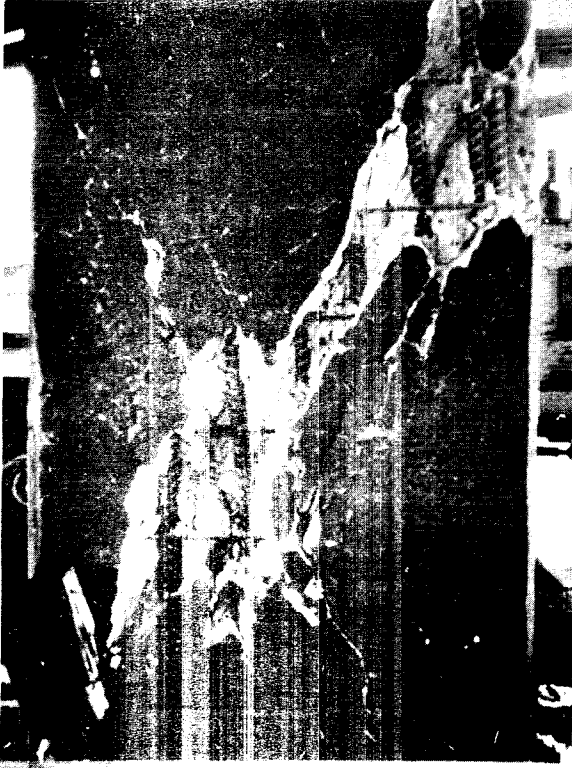
Major damage was caused to the supporting columns of a large highway overpass at the junction of I-5 and I-605. The columns suffered several load reversals and developed sizable diagonal cracks (see Figure 1-4). The columns have large diameter bars (#18) tied with small diameter hoops (#3) with large spacing (12"). Shear failure was expected in this type of structure (communicated by Mr. Ray Zelinski, Caltrans). Presently, investigations are being carried out by researchers at UCLA and Caltrans to clarify the details of these failures.

*Figure 1-4
Cyclic shear produced x shear cracks in center columns of the I5 - I605 highway overpass (Photo courtesy of State of California, Department of Transportation).*

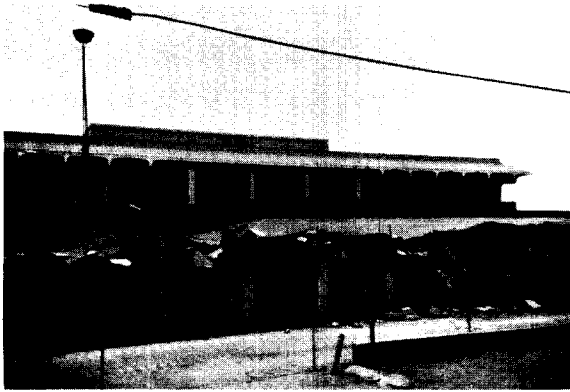
A two-story parking structure adjacent to a department store (May Co.) at Whittier Quad suffered severe damage and partial collapse due to the shear failure of columns (see Figure 1-5). Large girders had much stronger sections than the supporting columns, creating conditions for a catastrophic collapse (strong beams vs. weak columns) (see Figure 1-6). The damaged and the collapsed columns (interior columns) were braced by deep spandrel beams and developed shear failure that is characteristic of short columns [1]. The outside columns were widely tied by #2 and #3 bars without confinement of the beam column connections.

Figure 1-5 (above)
Shear failure of columns and joints led to the complete collapse of the roof of the parking garage at the Whittier Quad.

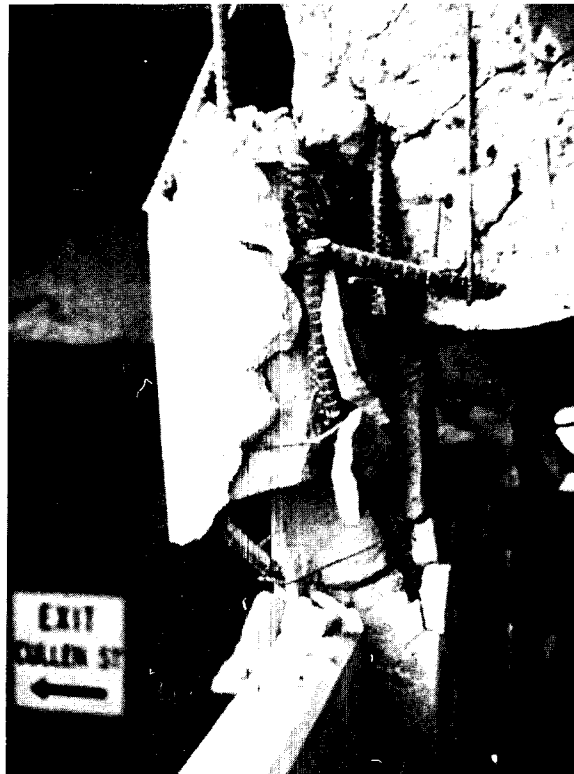
Figure 1-6 (right)
Typical strong beam-weak column connection and "short" column failure due to the lack of stirrups and properly anchored bars (Photo from the BAREPP collection).

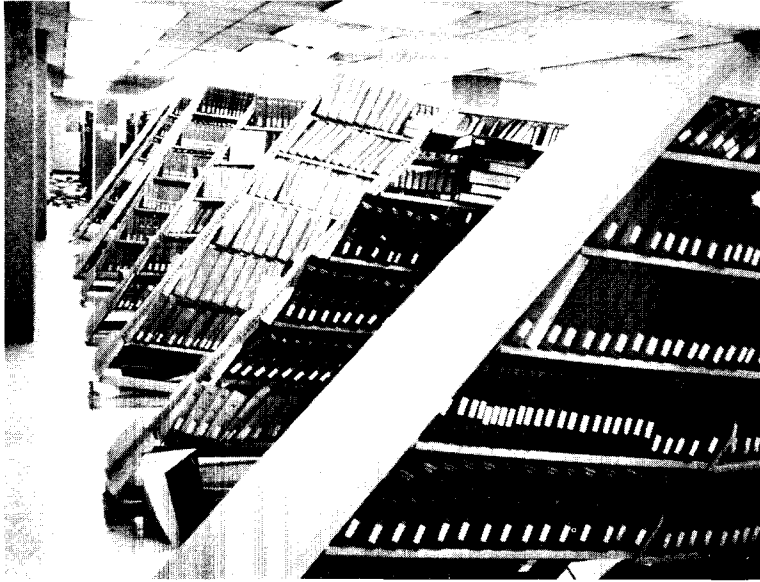
Building contents including storage racks, books, laboratory chemicals, etc., suffered extensive damage in buildings which did not have structural damage (see Figure 1-8). Moreover, flying objects caused extensive damage to walls, claddings and other building contents. In one case, at California State University, chemicals spilled and reacted with each other creating toxic materials. Buildings had to be closed and clean-up operations took several days. The replacement of nonstructural components and building contents was estimated at approximately 50% of the retrofit costs at California State University. According to reports of structural engineers and architects these costs may be exceeded in some tall buildings.

*Figure 1-8
Damaged shelves at
California State
University at Los
Angeles library are
supported by the
confined books.*

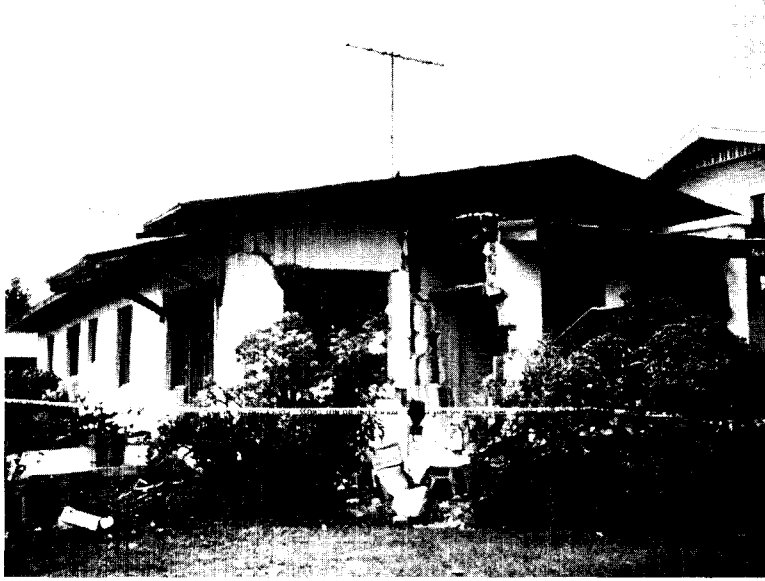
*Figure 2-3
Many single family residences such as this hollow-tile home on Painter Avenue in Whittier were damaged in the earthquake. They were cordoned off as unsafe for occupancy, while the residents sought shelter elsewhere.*
