JOINT U.S.-ROMANIAN SEMINAR ON EARTHQUAKES AND ENERGY

VOLUME 2: EARTHQUAKES

**EDITORS:
SAMUEL ARONI
ROMULUS CONSTANTINESCU**

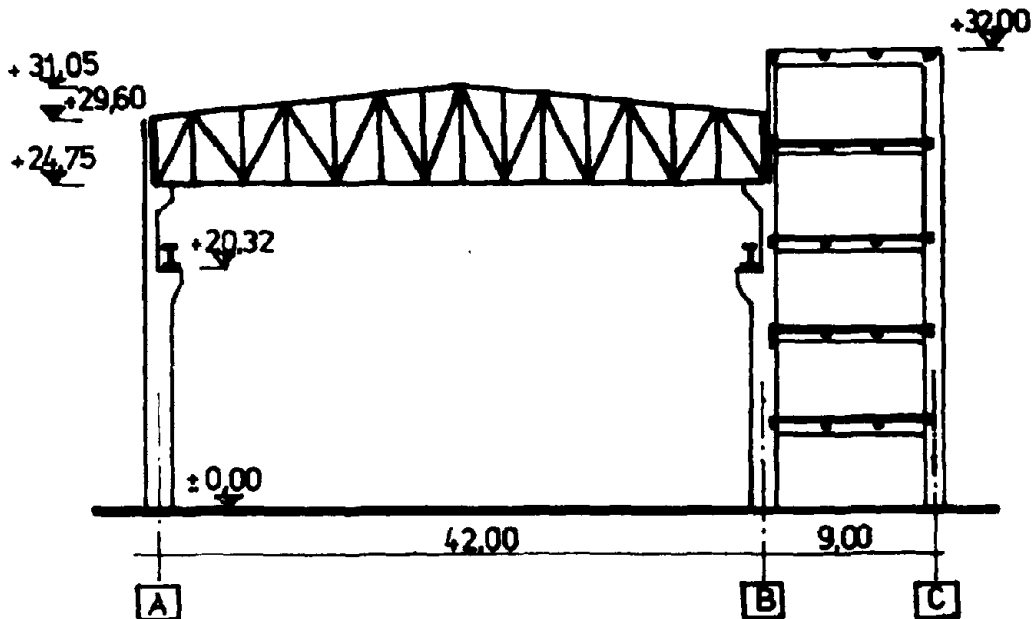
Fig.1

- The engine room of a thermoelectric-power station in Bucharest (fig.1) with a span of 42 m, a 9 m bay and a clear height of 31 m was provided with a reinforced concrete panel roof, supported by steel trusses. The columns, supporting the mounting heavy cranes, were made of reinforced concrete. The columns on one of the sides are common with those of a multistored cast-in-place concrete building. During the earthquake the reinforced concrete columns failed and the anchorage zones of the trusses were damaged. That led to the collapse of the roof framing. Under the conditions of an excessive seismic action the main causes of the collapse may be considered as follows: a heavy roof located at a high level, an important difference between the lateral stiffness of the columns and the multistory building and a poor quality of the cast concrete.

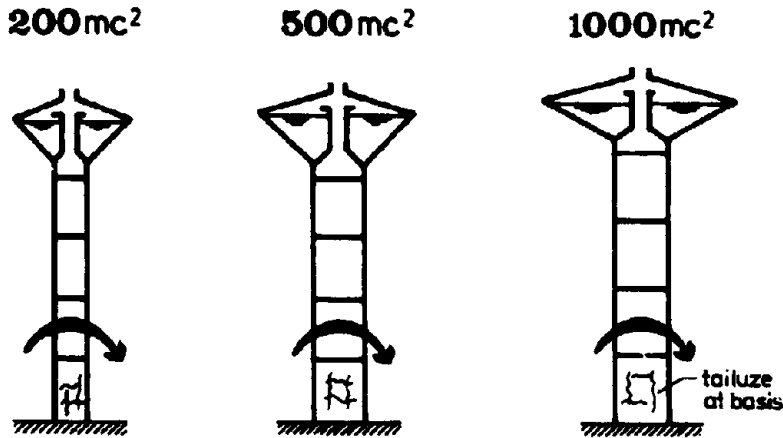
FIG.3

Failures happened at many water towers not to their container shells, but to the support cylinders, due to shear forces greater than the section capacity or due to some foundation deficiencies.

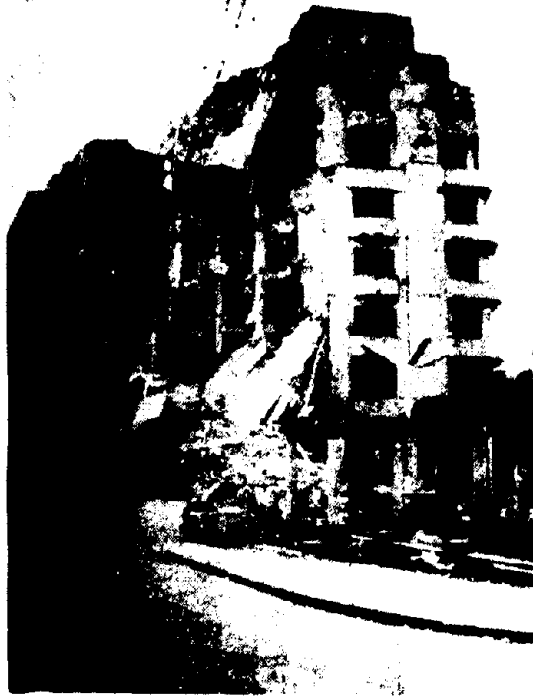
Photo 4-"Lido"building damaged

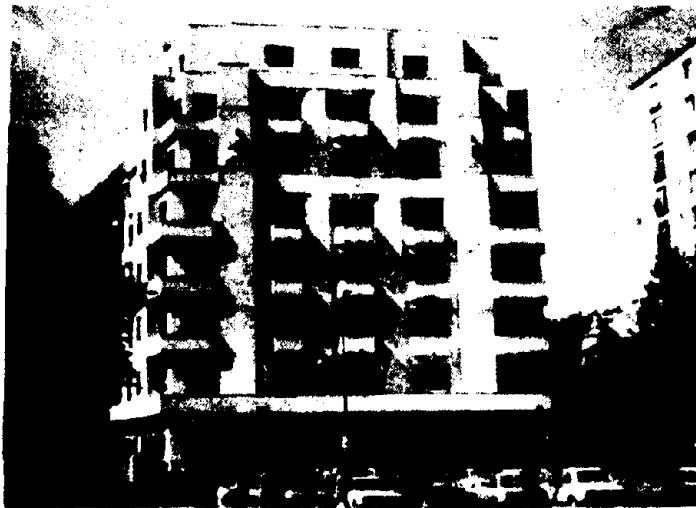
Photo 5-"Lido"building strengthened.

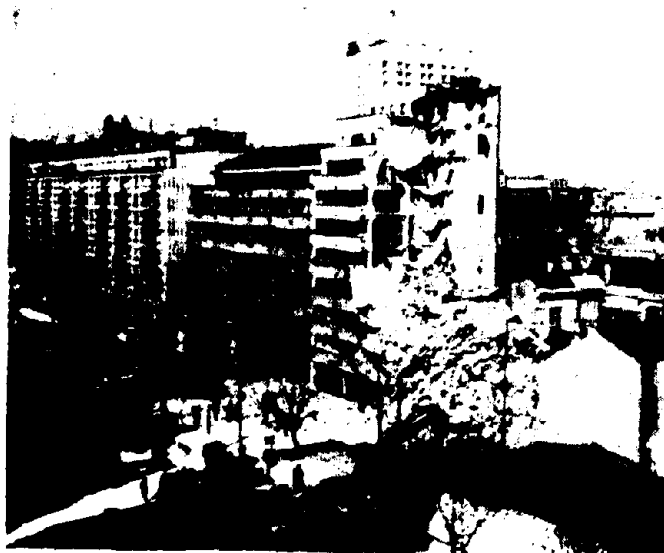
Fig.2 "Casata" building (noted "A" in fig.1) after collapse at the March, 4th 1977 Vrancea Earthquake.

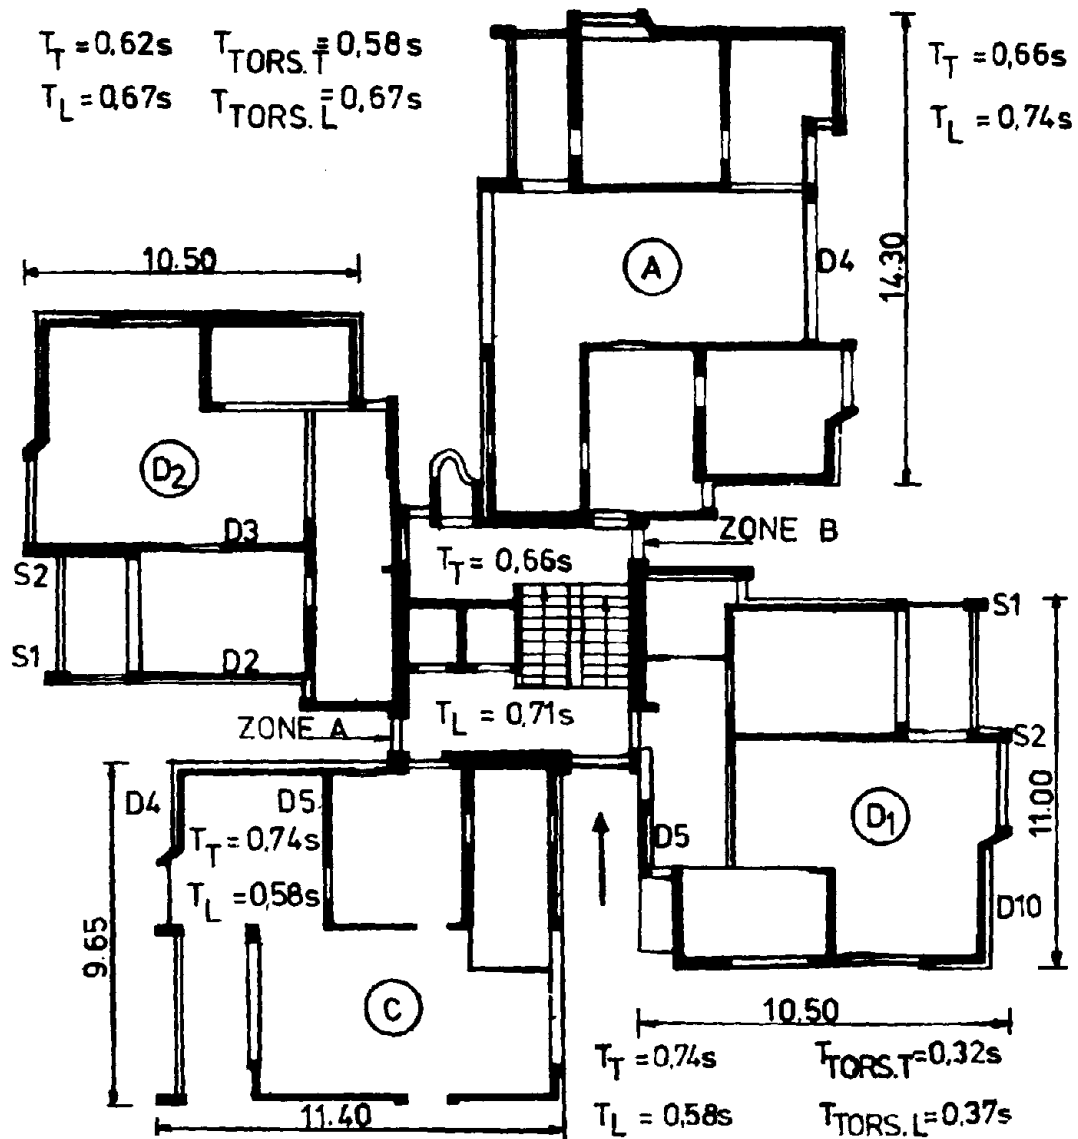
BUILDING WITH SEPARATED UNITS
 DAMAGED AT 4.03.1977 IN BUCHAREST

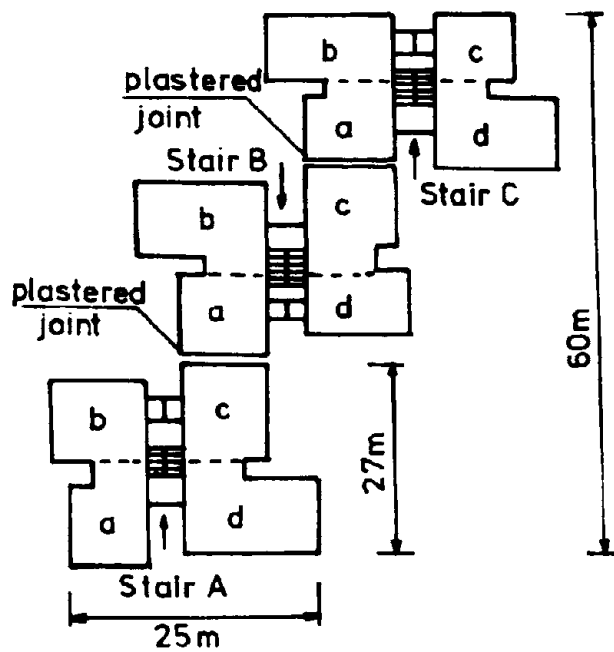
Buildings consisting of units coupled 2 by 2 in Bucharest
 Moderate damage at 4.03.1977
