# ARCHITECTURAL AND URBAN DESIGN LESSONS FROM THE 1985 MEXICO CITY EARTHQUAKE

June, 1988

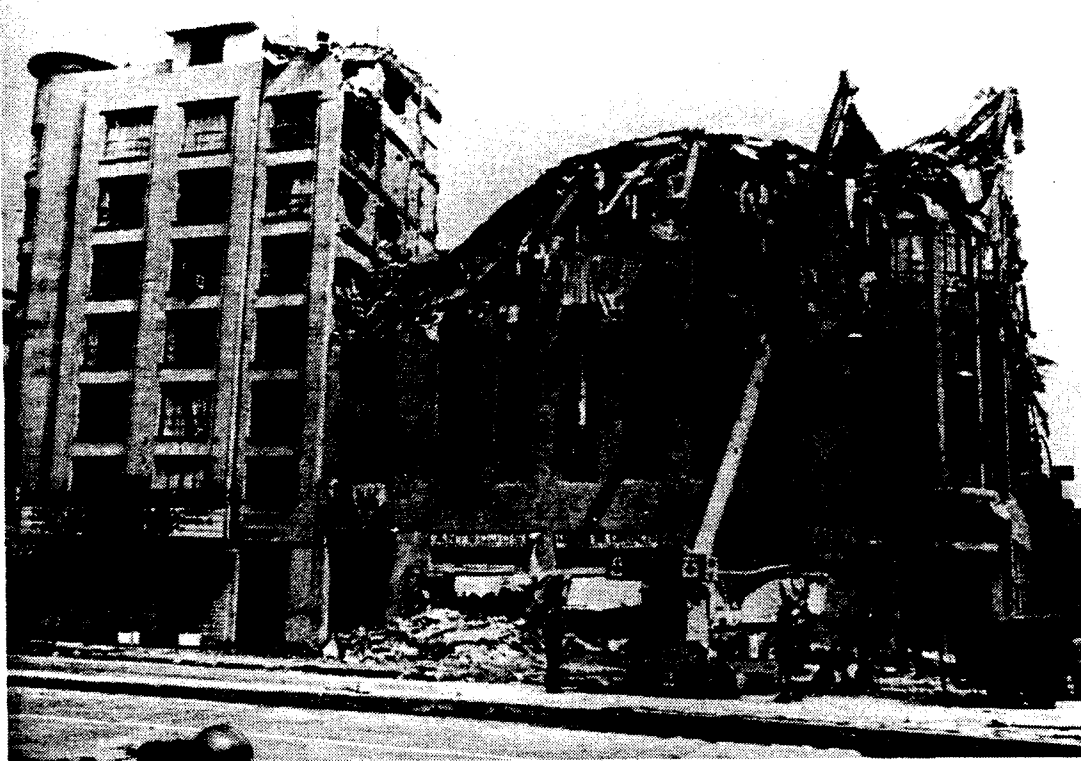
Of the seriously damaged buildings, engineering investigators from Mexico City University found that 38% suffered an upper story failure (Figure 6). This can be attributed to 'whipping' action as the earthquake motion amplified in the upper stories of the building. In some cases, architectural or structural irregularities contributed to the failure: a change of column size, or the introduction of irregular framing or unusually flexible columns in some locations. Modern U.S. seismic codes distribute a larger percentage of the seismic forces to the upper stories of a tall building in the effort to recognize this problem, but this does not deal with the problem of architectural irregularities.

Figure 6. Upper story failure.

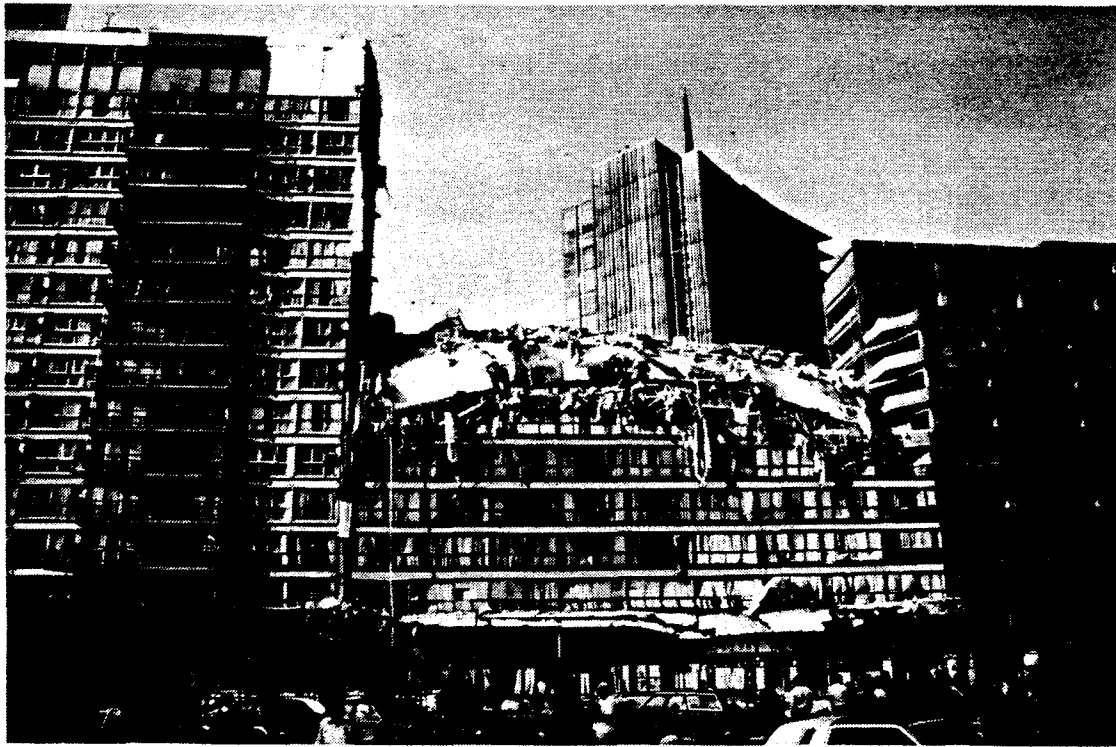
The Mexican engineers found that 40% of the seriously damaged buildings suffered a mid-story failure (Figure 7). In some cases failure could be attributed to a construction change, but most frequently the failure was caused by 'pounding' from an adjoining building, vibrating out of phase, so that the buildings impacted one another. While pounding has long been recognized as a problem, the extent of pounding failures in Mexico City confirmed this as a major issue. Current codes impose 'drift' limits - the extent to which lateral deflections are permitted. In theory this should protect against pounding, but in practice the code drift limits do not represent possible actual motion. To separate buildings to the extent necessary to protect against pounding the space between buildings needs to be very great (of the order of 5 feet for a 12-story building) and this presents real estate and urban problems.

Figure 7. Mid-story failure.

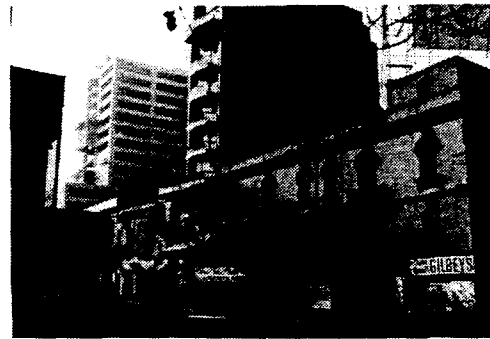
An interesting specific instance of the support phenomenon is shown in Figure 8. In this instance (towards the center of the intense damage zone in the city) the slender eight story building has a tall first floor and clear span between its outside walls: shear walls or bracing along the plane parallel to the street appear non-existent. Yet this building, that would be very suspect as a free-standing building, suffered little damage and clearly was braced by the lower buildings alongside, whose response to the ground motion would be minimal. This building group, then, responded as a large short period structure with a setback tower, rather than as a set of individual masonry buildings and an eight story tower.

Figure 8.  
Tall building supported  
by low masonry buildings  
on either side.

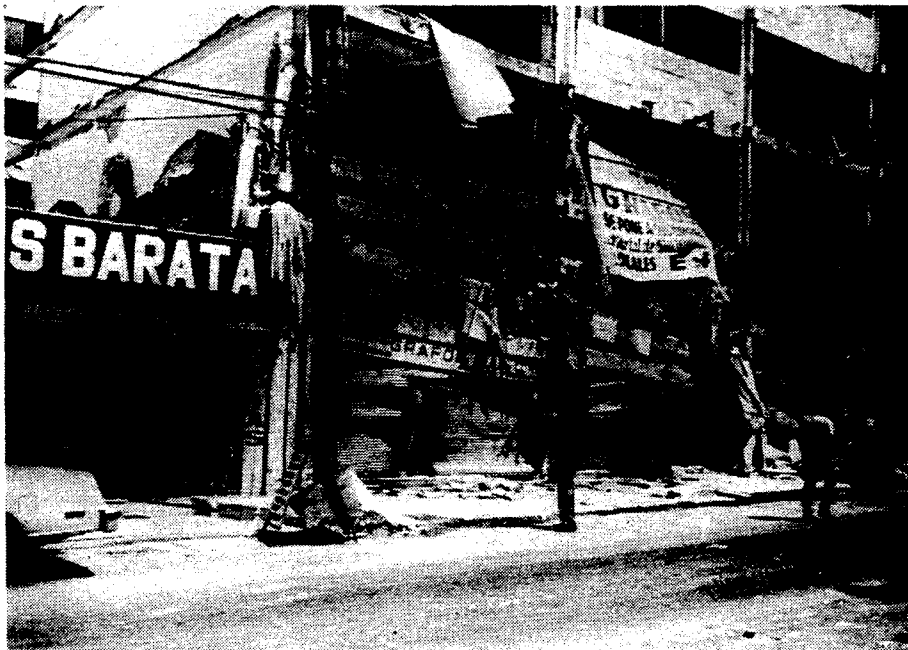
Weak first stories accounted for 8% of building failures. The percentage is probably much greater because many of the total collapses were also precipitated by this characteristic. But in buildings with weak first floors and stiff upper floors - created generally by open planning in the first floor to accommodate stores or lobbys - often the upper floors retained enough integrity to survive (Figure 9). The Mexico City experience reinforced the risks of this configuration, particularly for heavy frame structures lacking in resisting walls.

Figure 9. Weak first floor failure

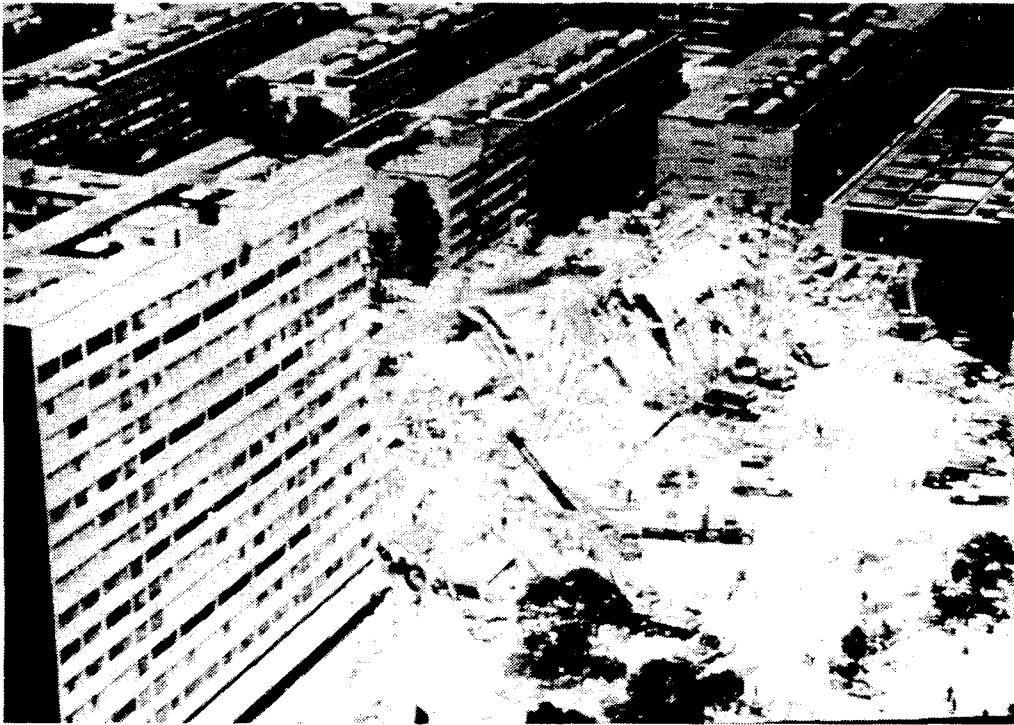
It is harder to diagnose the failures of those buildings that totally collapse (Figure 10). Often, however, no single cause predominates. Irregularities in plan or loading may combine with a weak first floor, with inadequate connections, or with construction deficiencies, to produce collapse. When the total collapse occurs to an occupied building heavy loss of life is inevitable, and the niceties of structural or nonstructural damage cease to be of concern.

Figure 10. Total collapse.

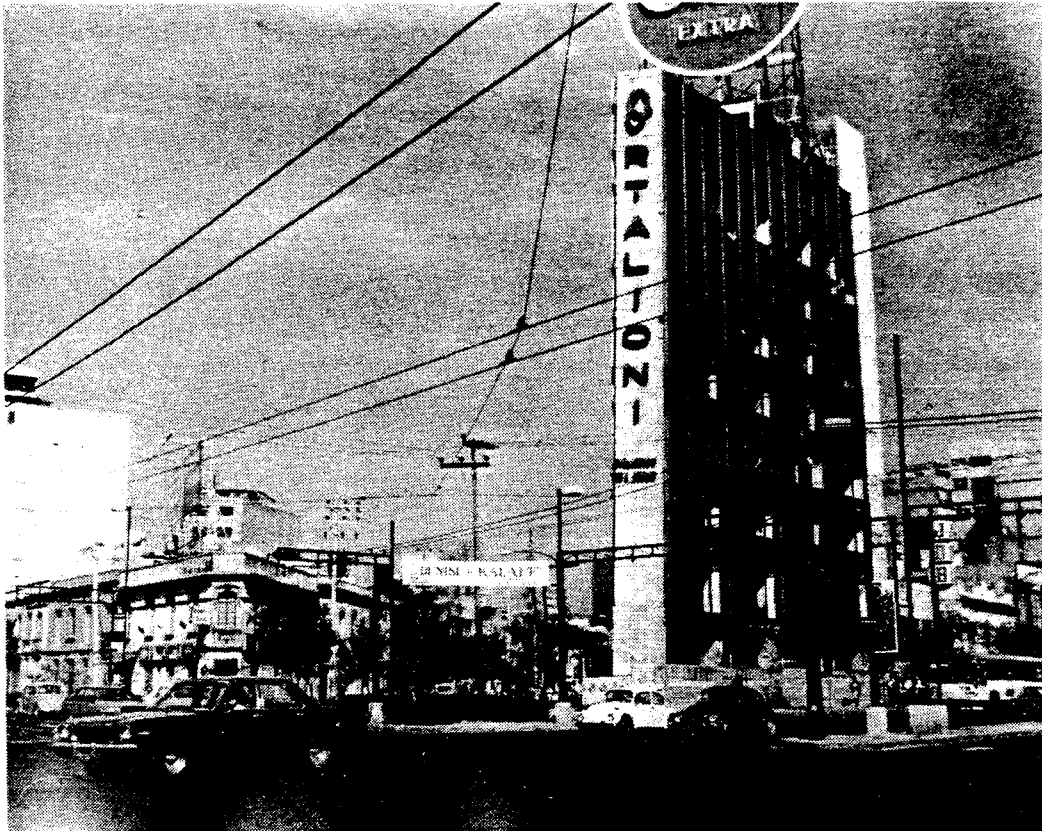
be the result of designing buildings on tight urban sites created by streets intersecting at an acute angle. This form is typical for U.S. cities, where our rectangular grids are intersected by diagonal streets. The wedge shape building often has a solid party wall and two open sides, which is a prescription for torsion (Figure 11).

Figure 11. Distortion of a wedge shape building at a corner. This building was later demolished.

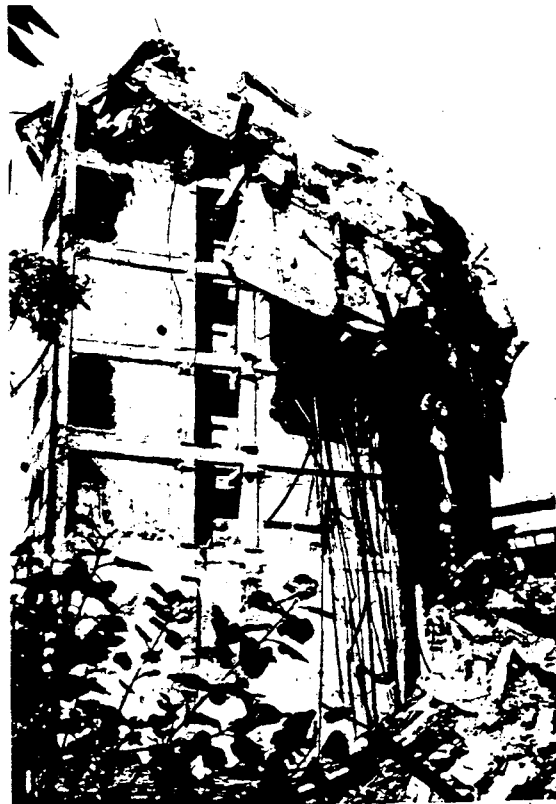
FIGURE 3 Collapsed Upper Floors, Reinforced Concrete High-Rise Building

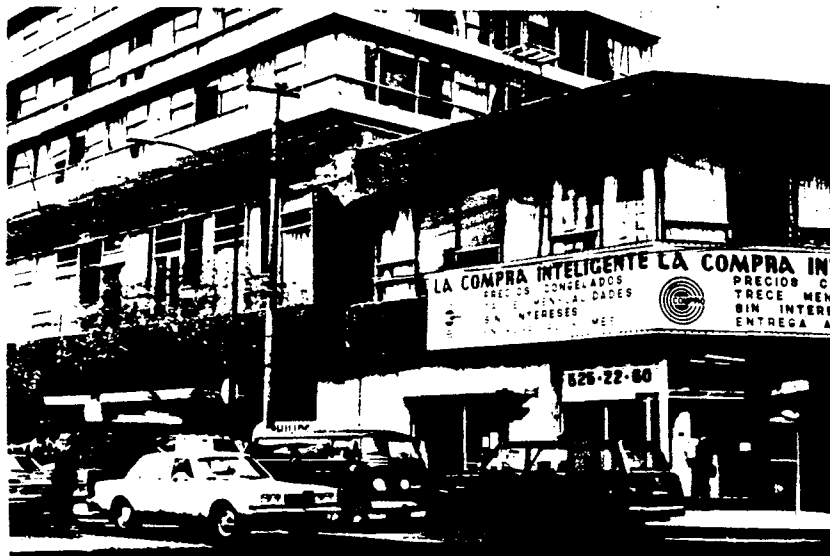
Example of Pounding Damage Between Adjoining Buildings

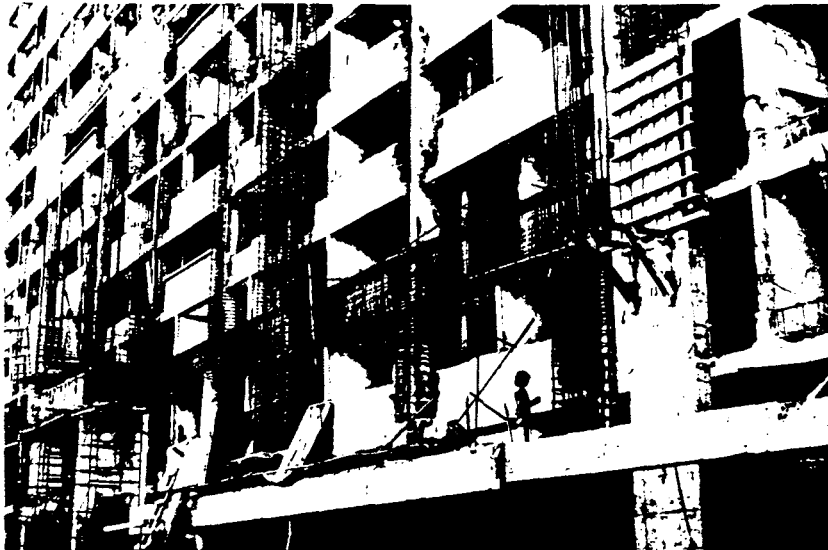
FIGURE 5 Post-Earthquake Repair of Damaged Building

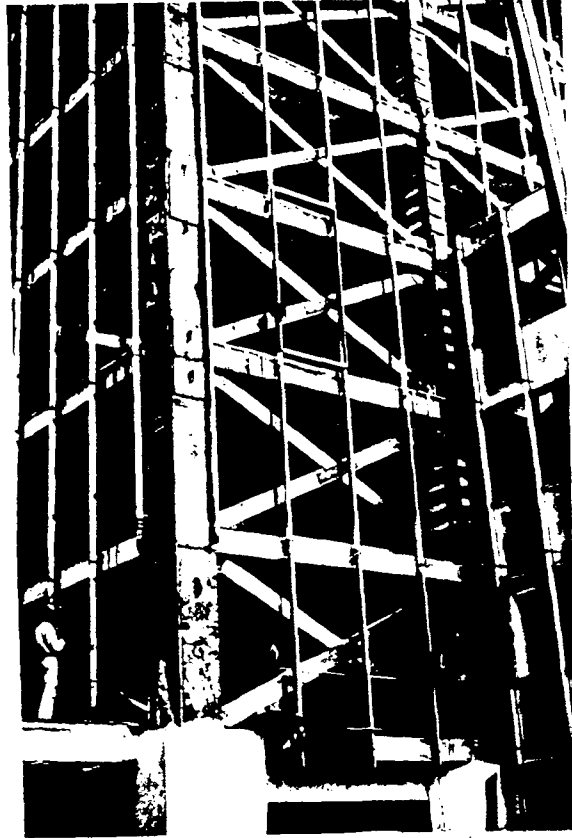
FIGURE 6 Post-Earthquake Repair of Damaged Building

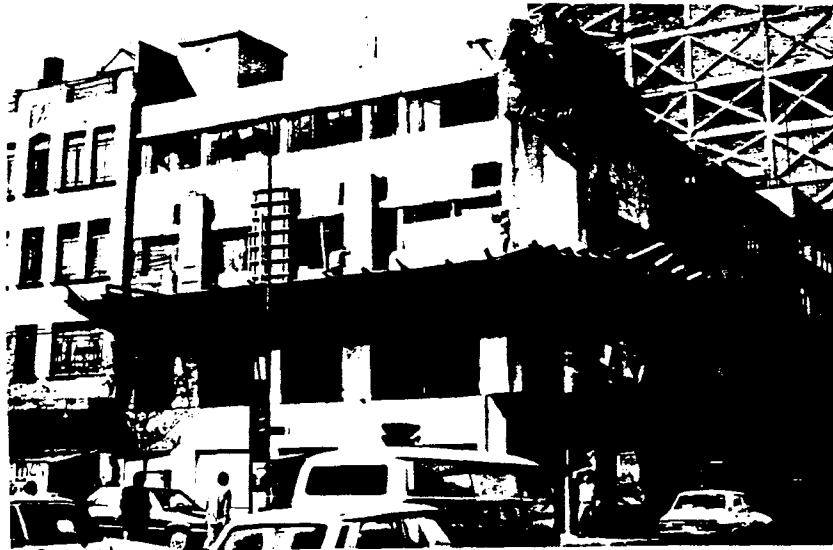
FIGURE 7 Post-Earthquake Repair of Damaged Building

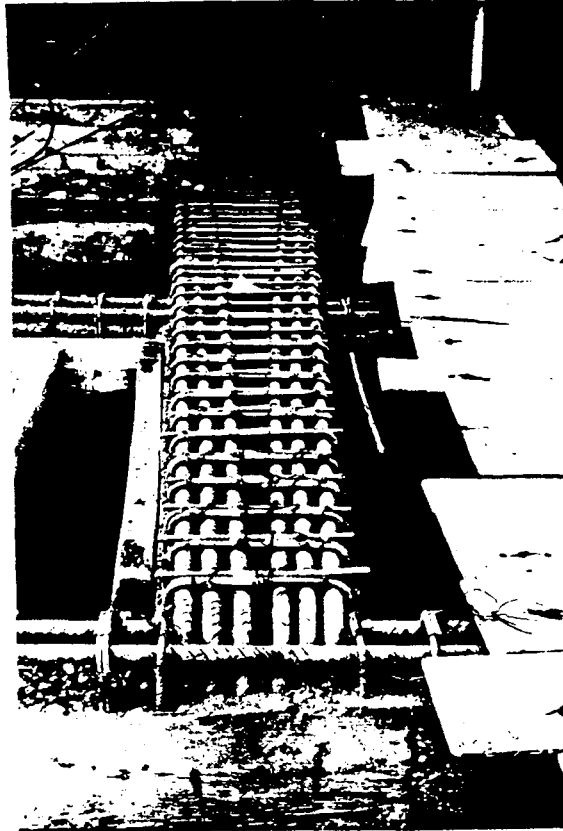
Repair and Strengthening of Existing Foundation System on High-Rise Building at Tlateloco

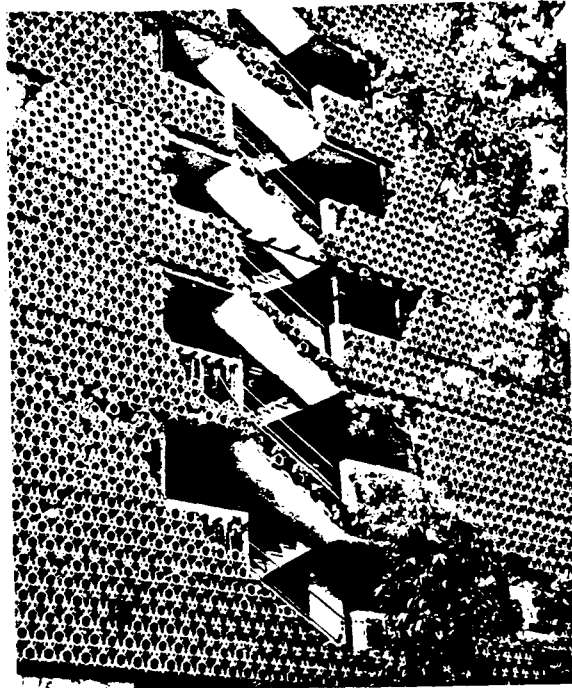
Damage of Nonstructural Masonry Screen at Stairway

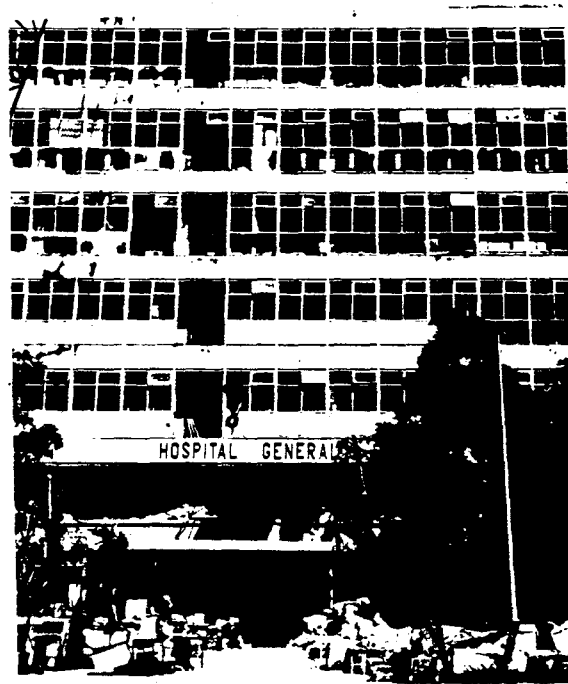
FIGURE 9 Damaged Window Wall Assembly
