EFFECTS OF THE 1985  
MICHOACAN EARTHQUAKE  
ON WATER SYSTEMS AND OTHER BURIED  
LIFELINES IN MEXICO

A. Gustavo Ayala and Michael J. O'Rourke

Technical Report NCEER-89-0009

March 8, 1989

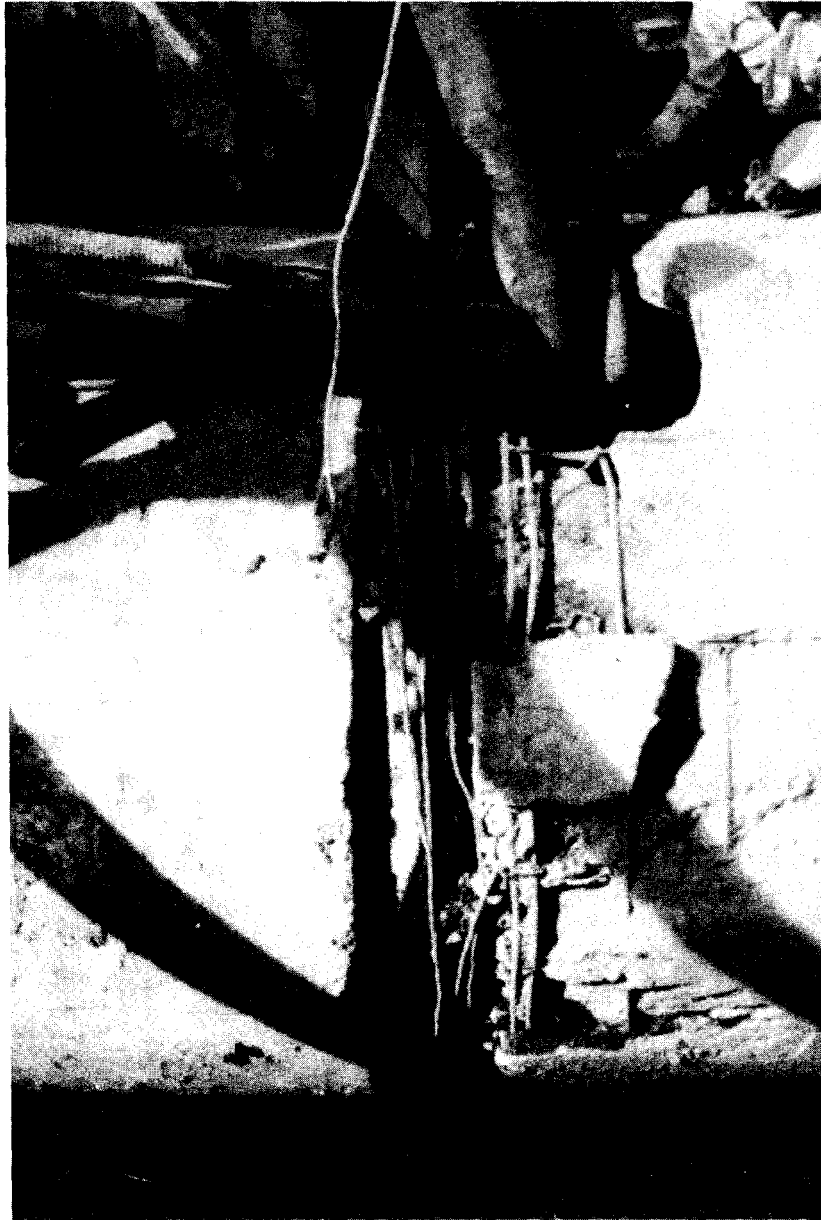
The 1979 Guerrero earthquake damaged a 72"φ buried reinforced concrete aqueduct at 10 locations along its 6 kilometer length in southeast Mexico City. Figures 2-2 and 2-3 show typical damage. Pipeline failures were mainly the result of tension and/or compression at joints. In order of incidence, the failures were due to compressional crushing at the bells, pull out accompanied in some instances by rotation at the joints. An evaluation of the damage indicates that the failures were due to a lack of flexibility in the system as opposed to a lack of strength, [1] and [2]. The repair method used consisted of either replacing the broken pipes or repairing the joints with a bolted steel collar. Unfortunately neither of these procedures improve the deformation characteristic (ie, flexibility) of the pipeline joints. Replacing the broken pipes theoretically returns the system to its pre-earthquake

FIGURE 2-2 Aqueduct Damage During 1979 Guerrero Earthquake

condition, hence leaving it vulnerable to future seismic damage. Repairing with a bolted steel collar has the effect of marginally reducing the overall flexibility of the system as a whole, and does not prevent damage at adjacent joints during future earthquakes.

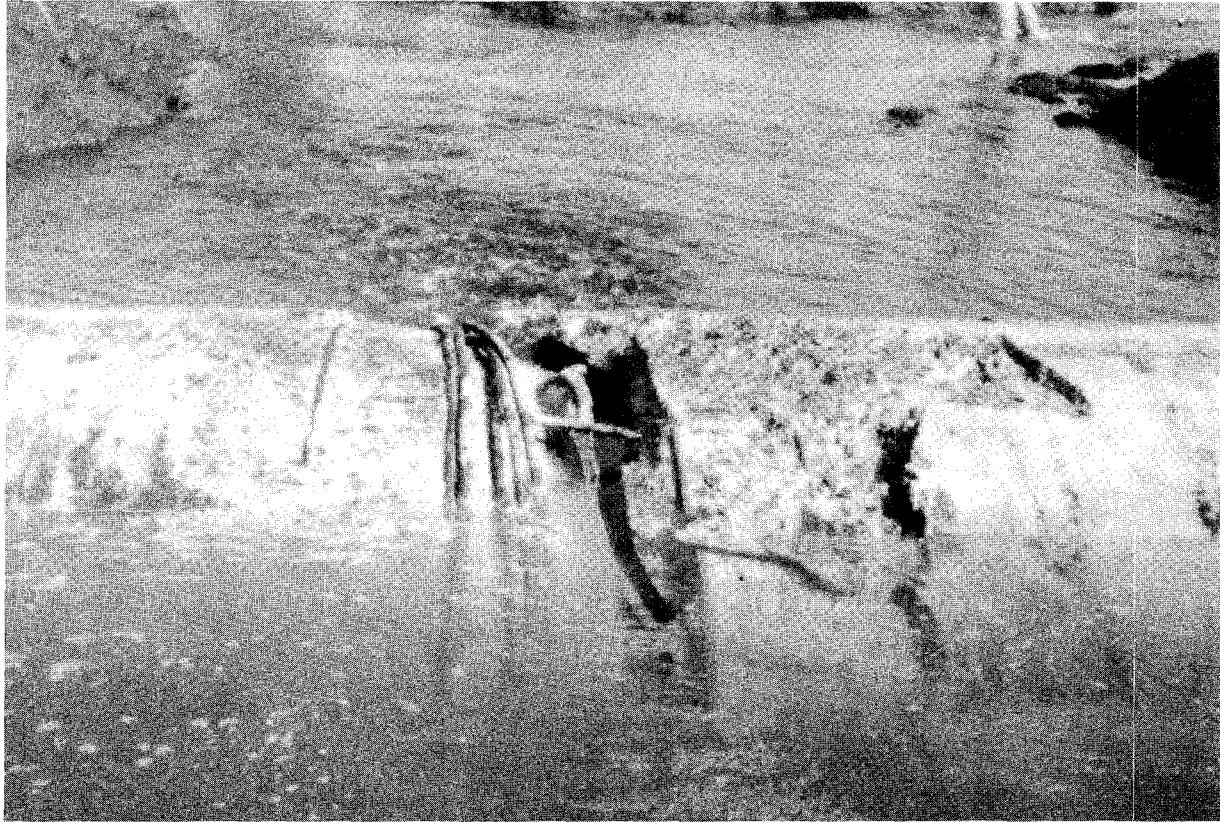
FIGURE 2-3 Aqueduct Damage During 1979 Guerrero Earthquake

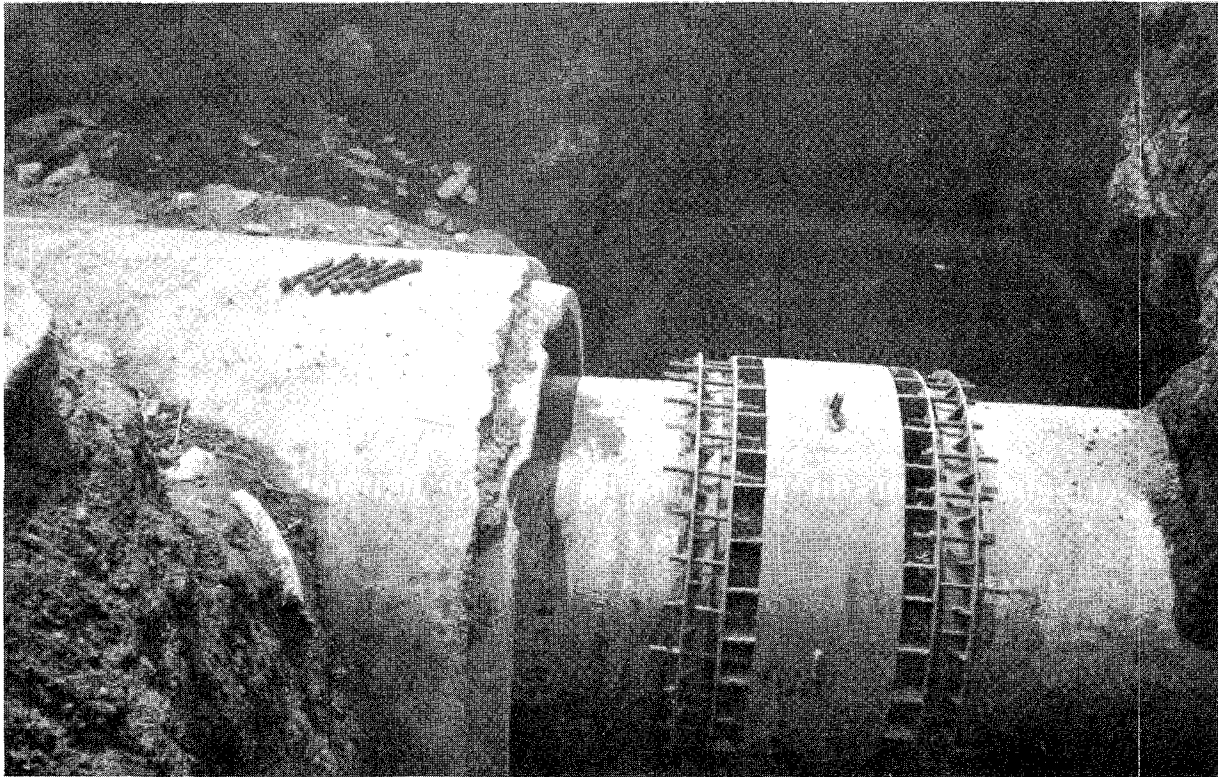
FIGURE 4-4 Steel Saddle On Damaged Pipe

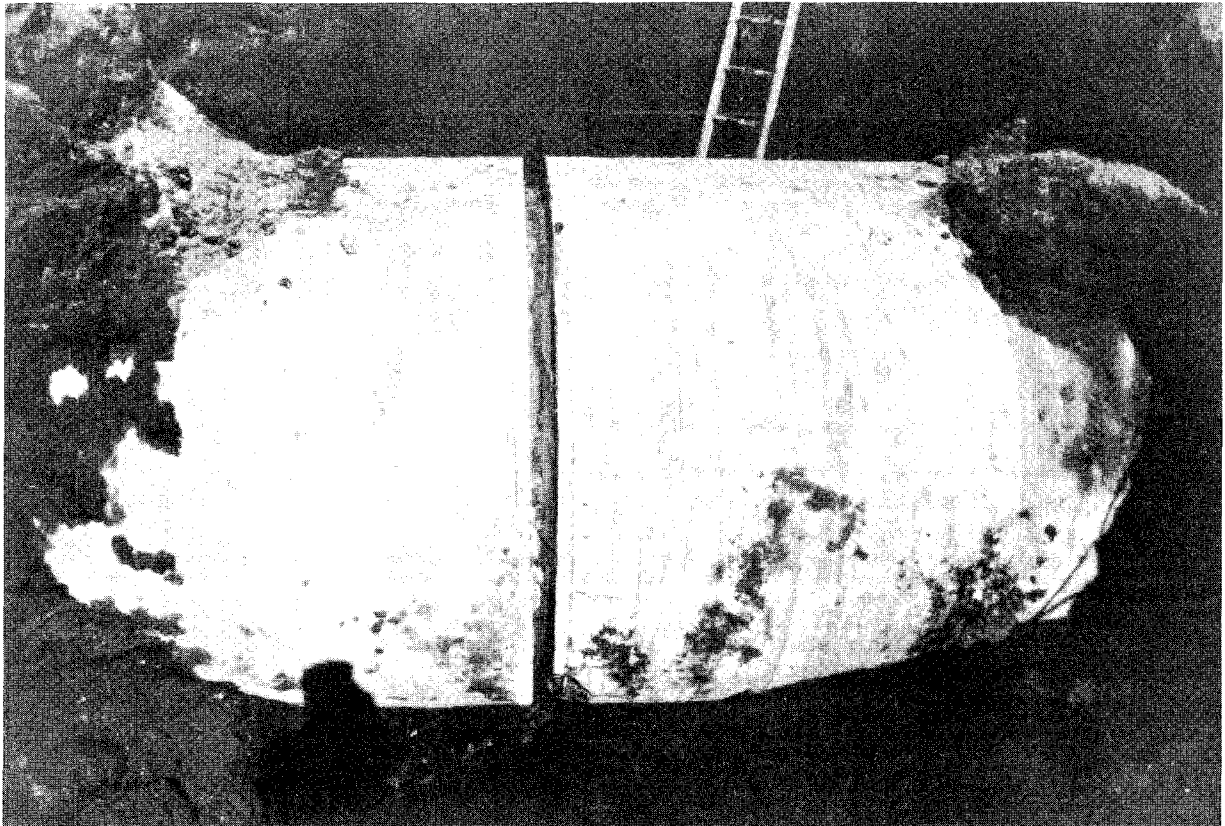
FIGURE 6-3 Joint Separation In A 72"φ 'Lock Joint' Pipe,  
1985 Michoacan Earthquake

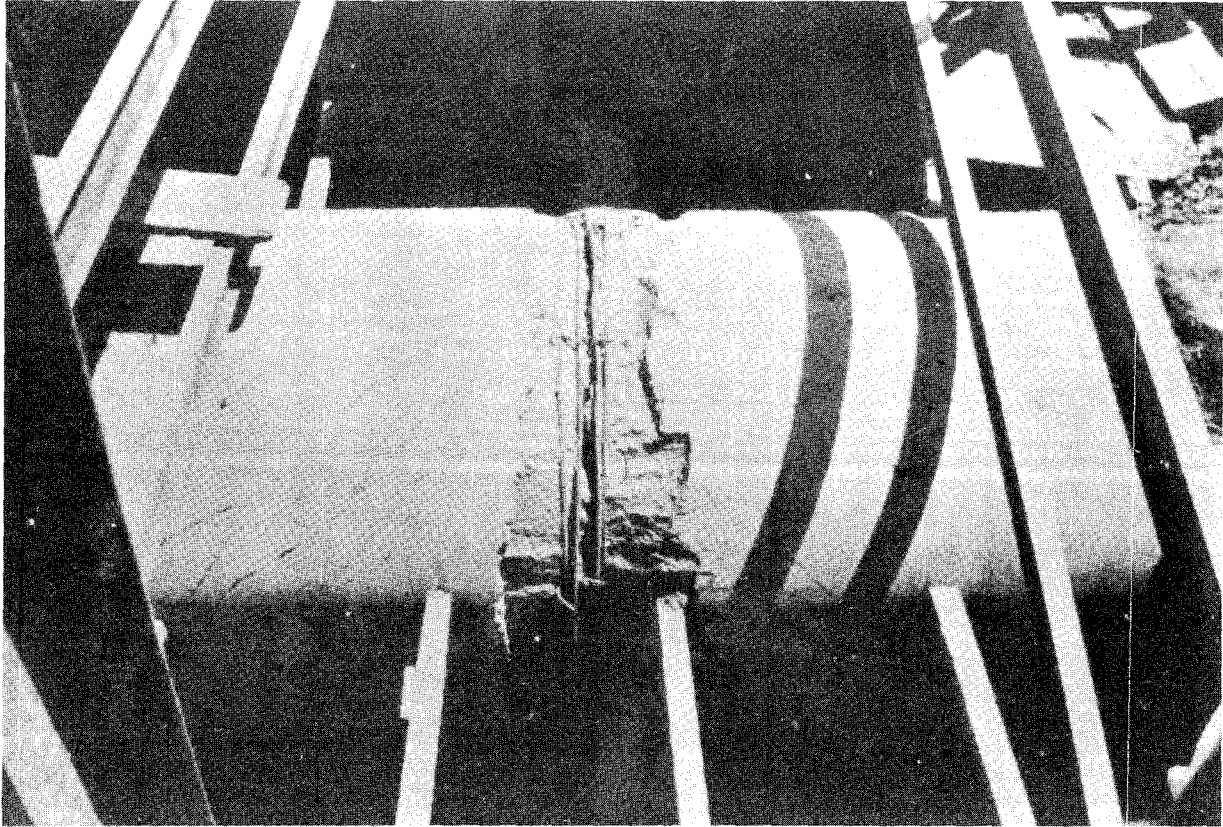
FIGURE 6-4 Crushing Failure In A 72"φ 'Lock Joint' Pipe,  
1985 Michoacan Earthquake

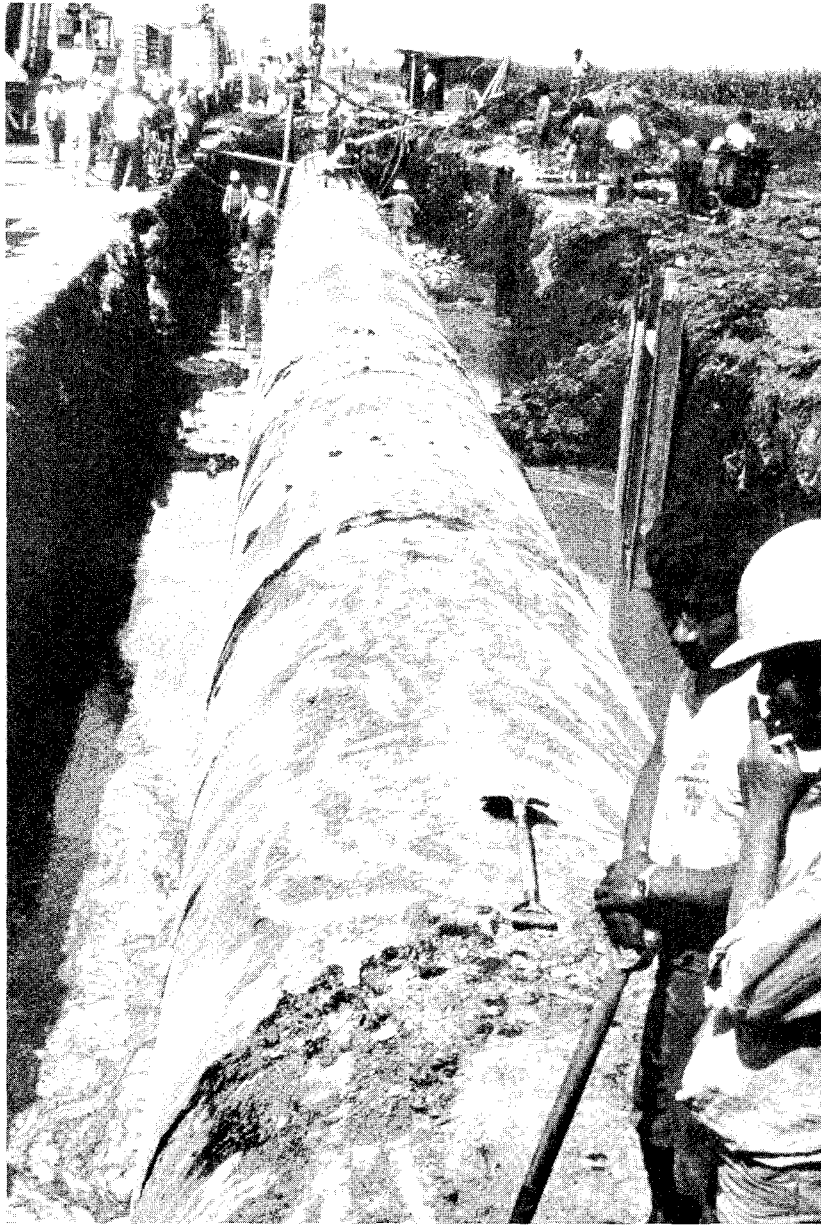
FIGURE 6-5 Joint Separation At 11 Points Close To A "T" Junction,  
1985 Michoacan Earthquake

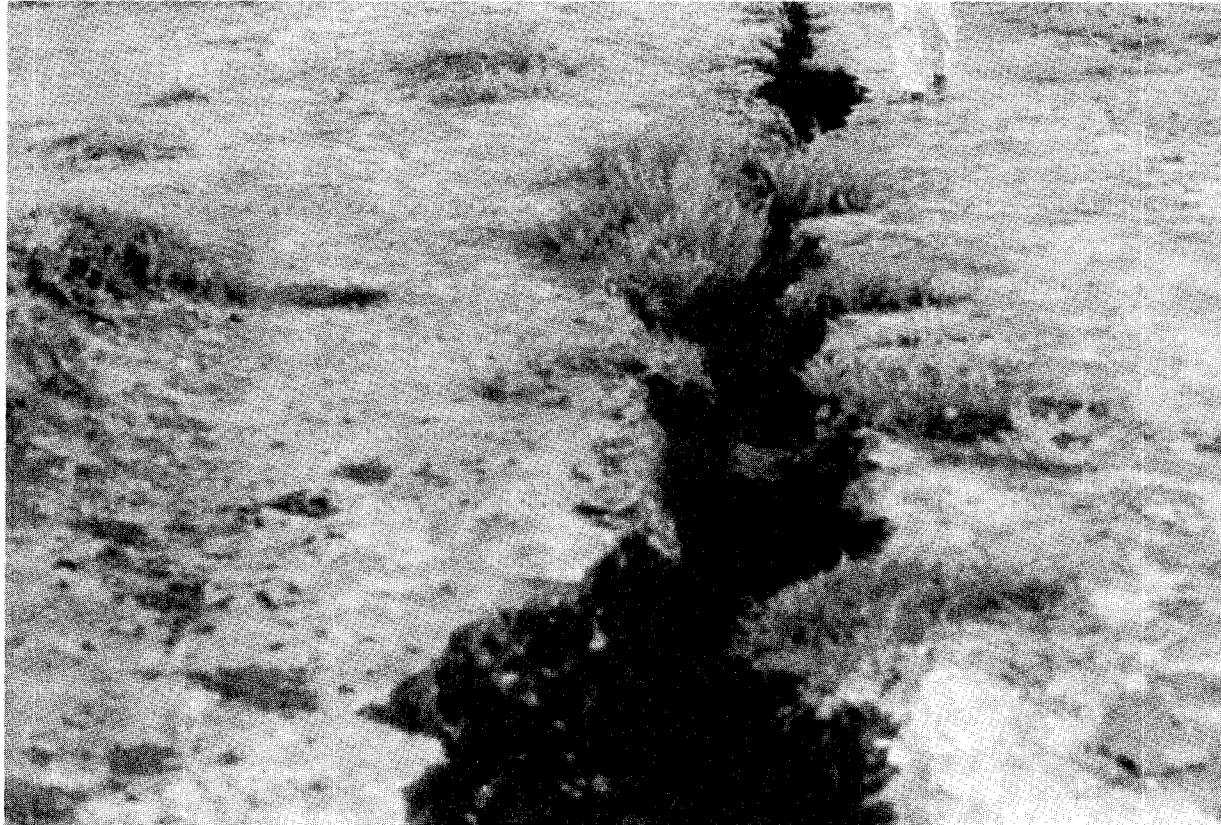
FIGURE 6-6 Severe Ground Cracking In The Vicinity Of The Aqueducts,  
1985 Michoacan Earthquake

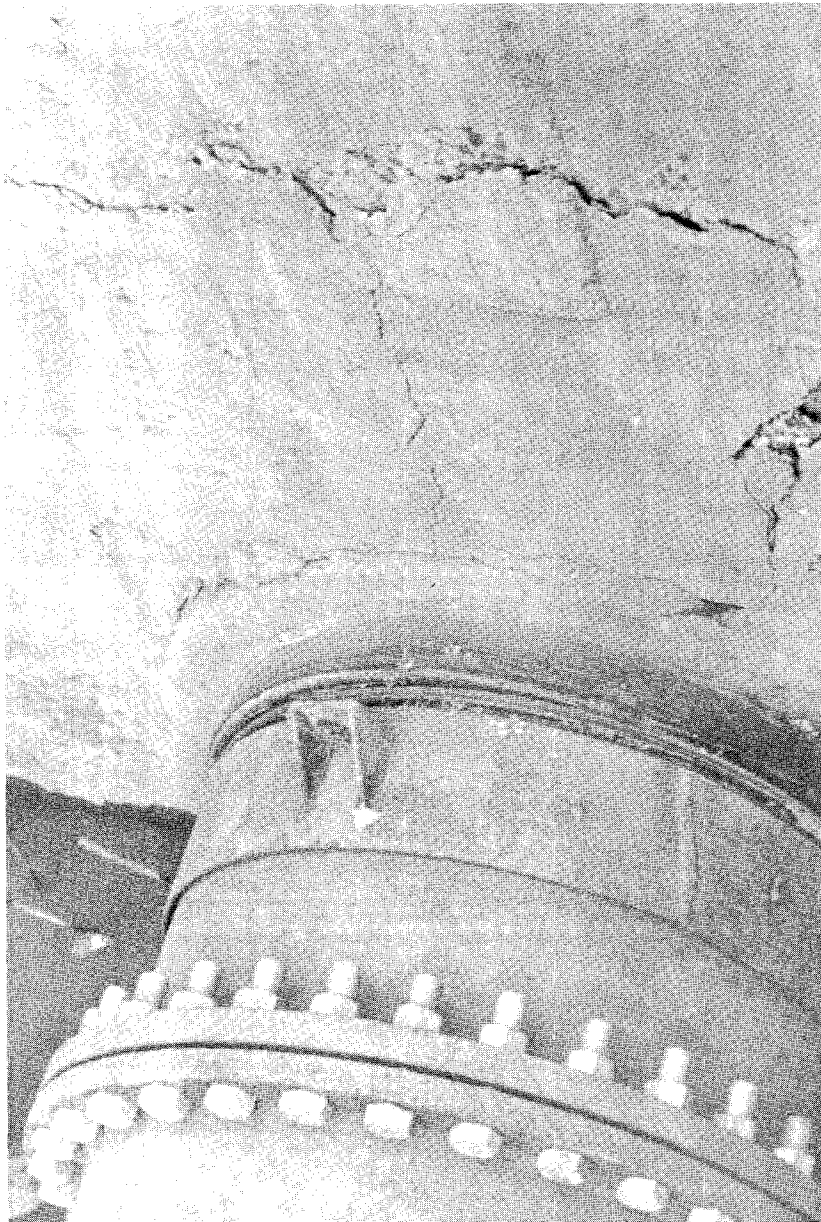
FIGURE 6-7 Cracking At A Valve Box Wall

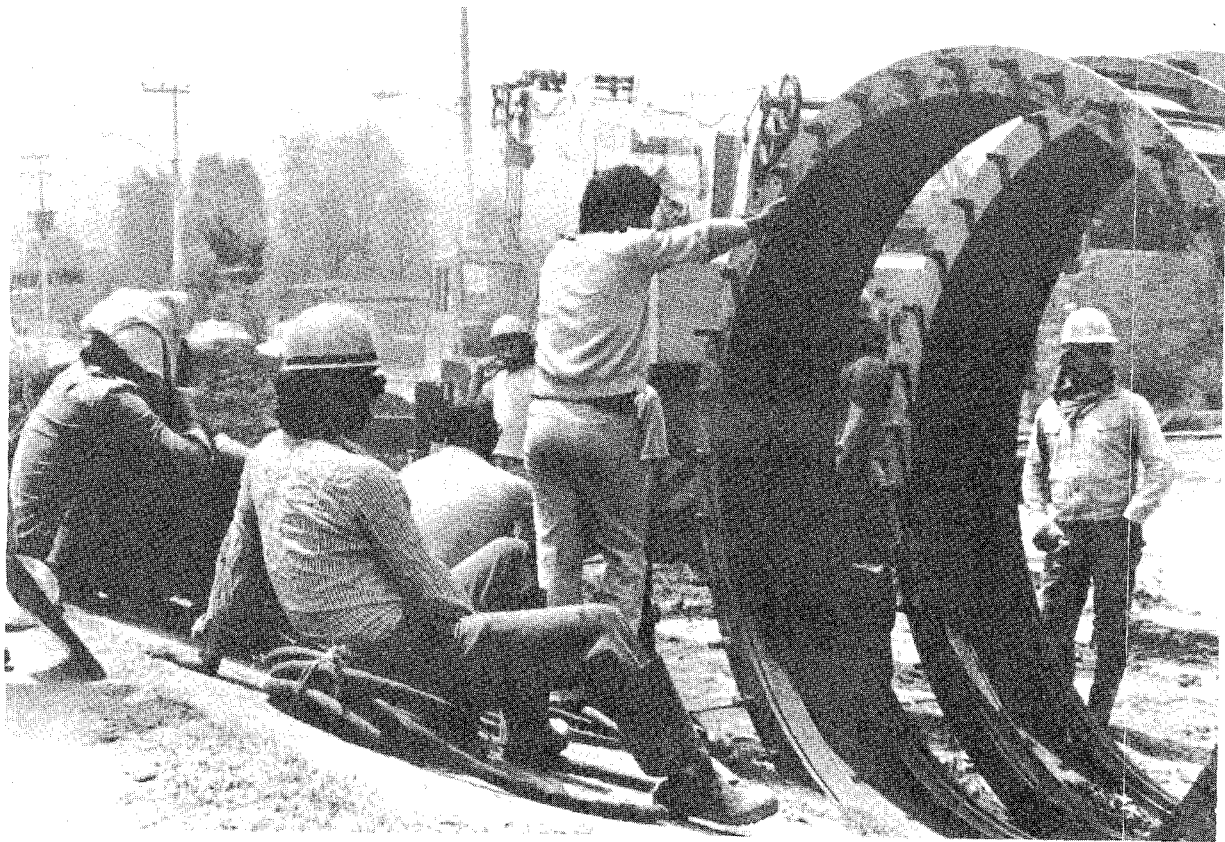
FIGURE 6-12 View Of A Steel Repair Saddle

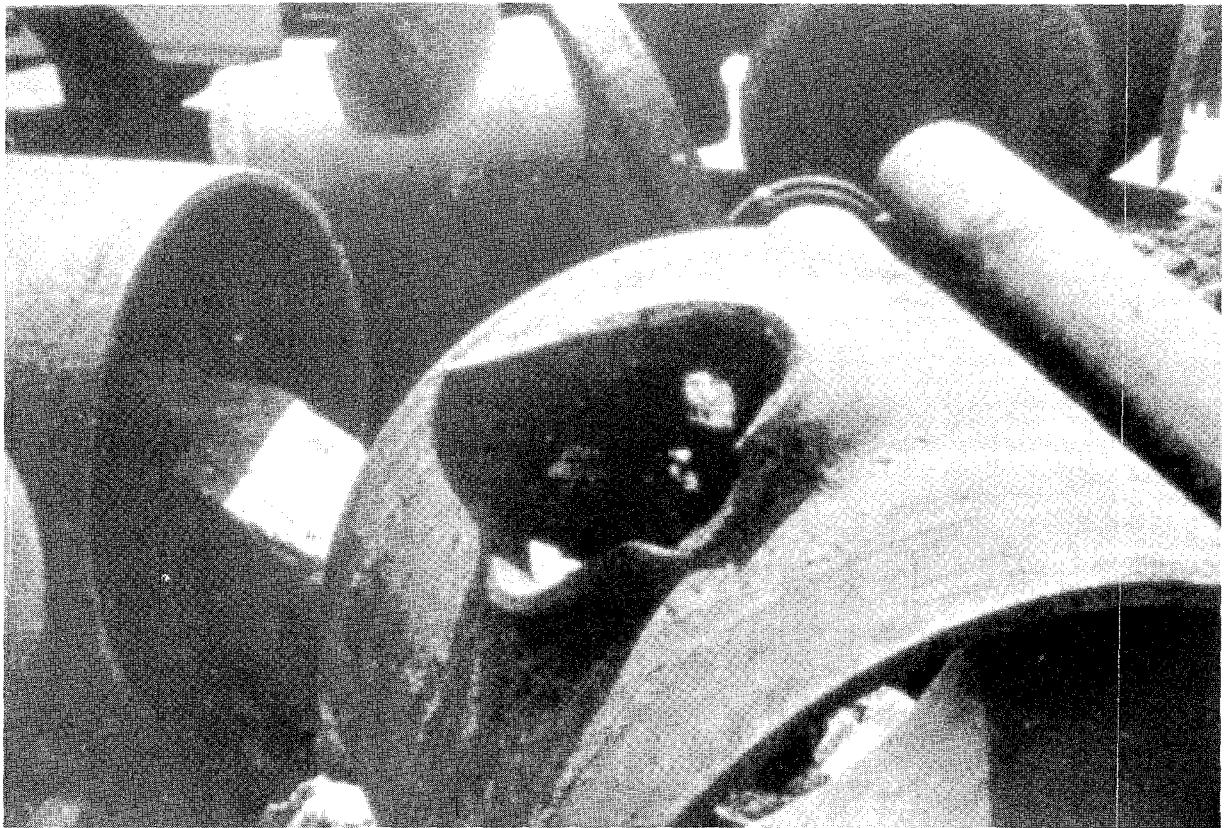
FIGURE 6-13 Fractured Cast Iron "T", 1985 Michoacan Earthquake

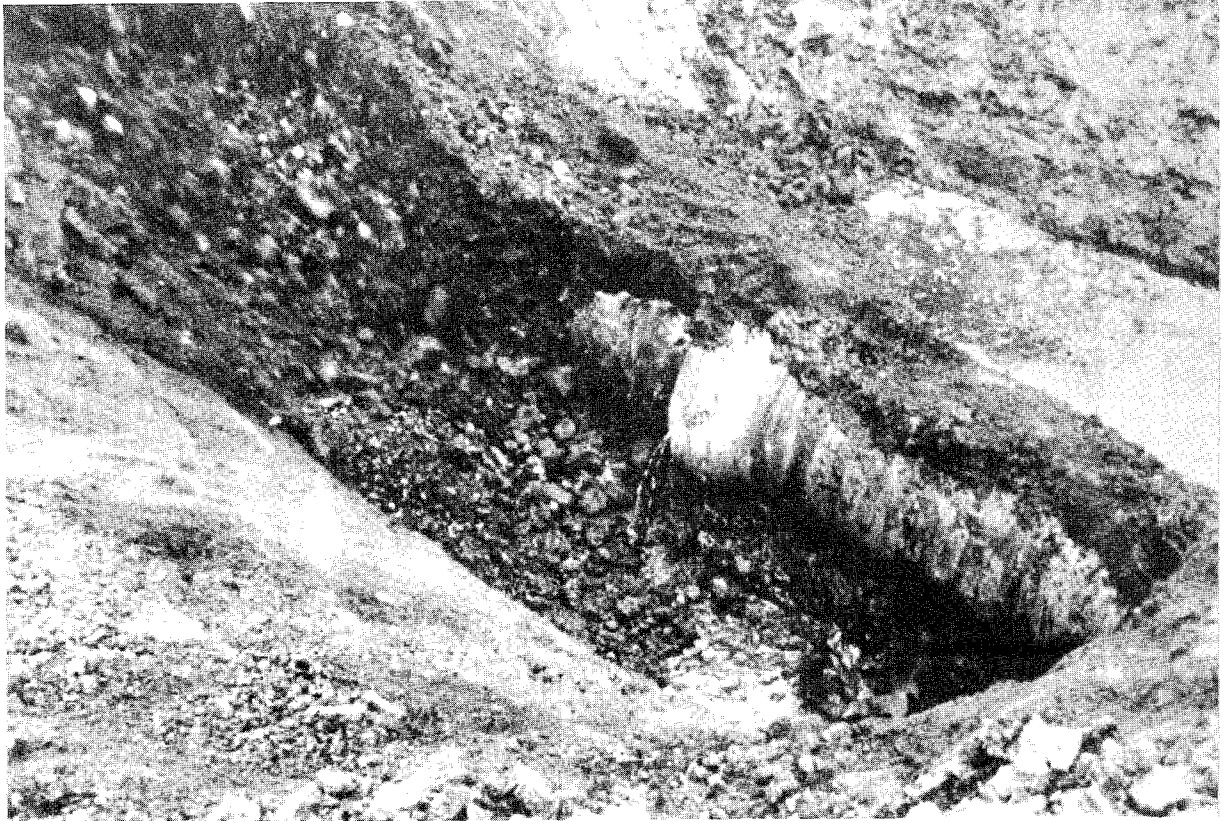
FIGURE 6-16 Leak At The Bell Of An Asbestos Cement Pipe, 1985 Michoacan Earthquake

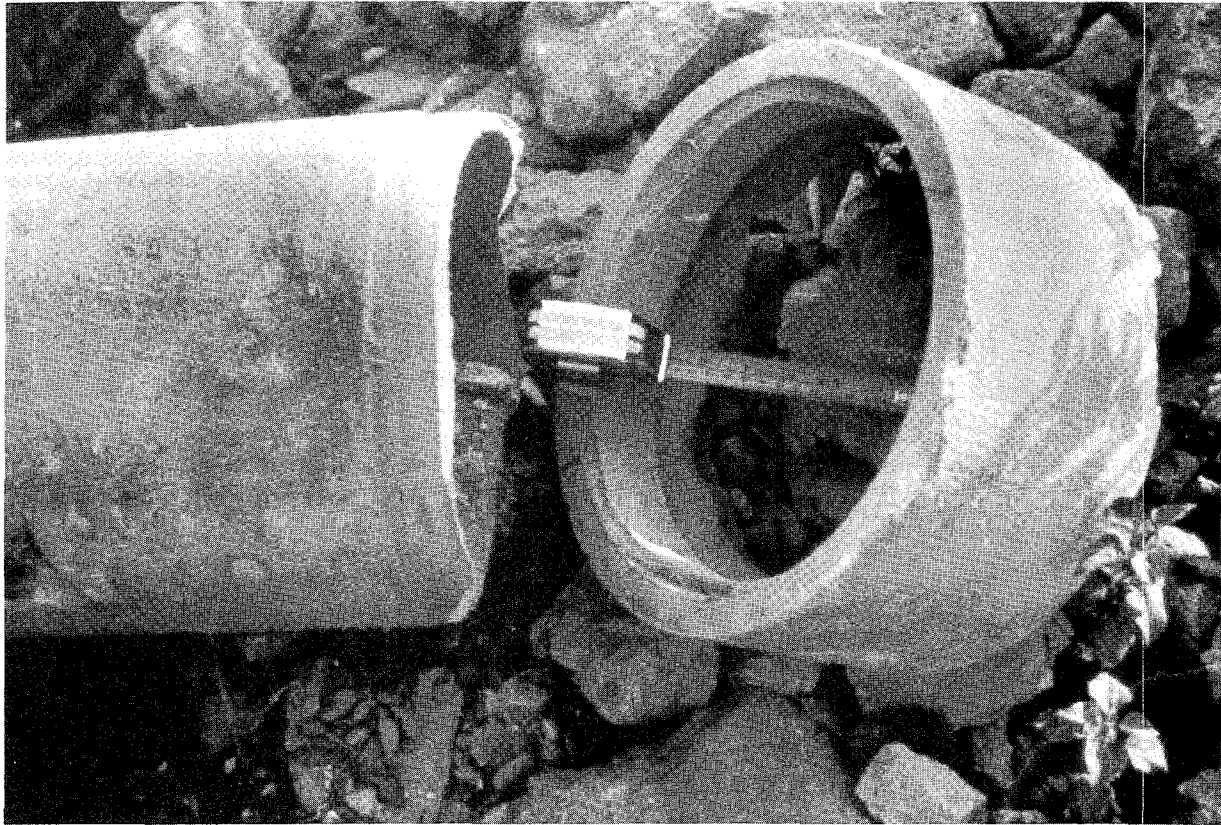
FIGURE 6-17 Break Near Joint Of An Asbestos Cement Pipe, 1985 Michoacan Earthquake

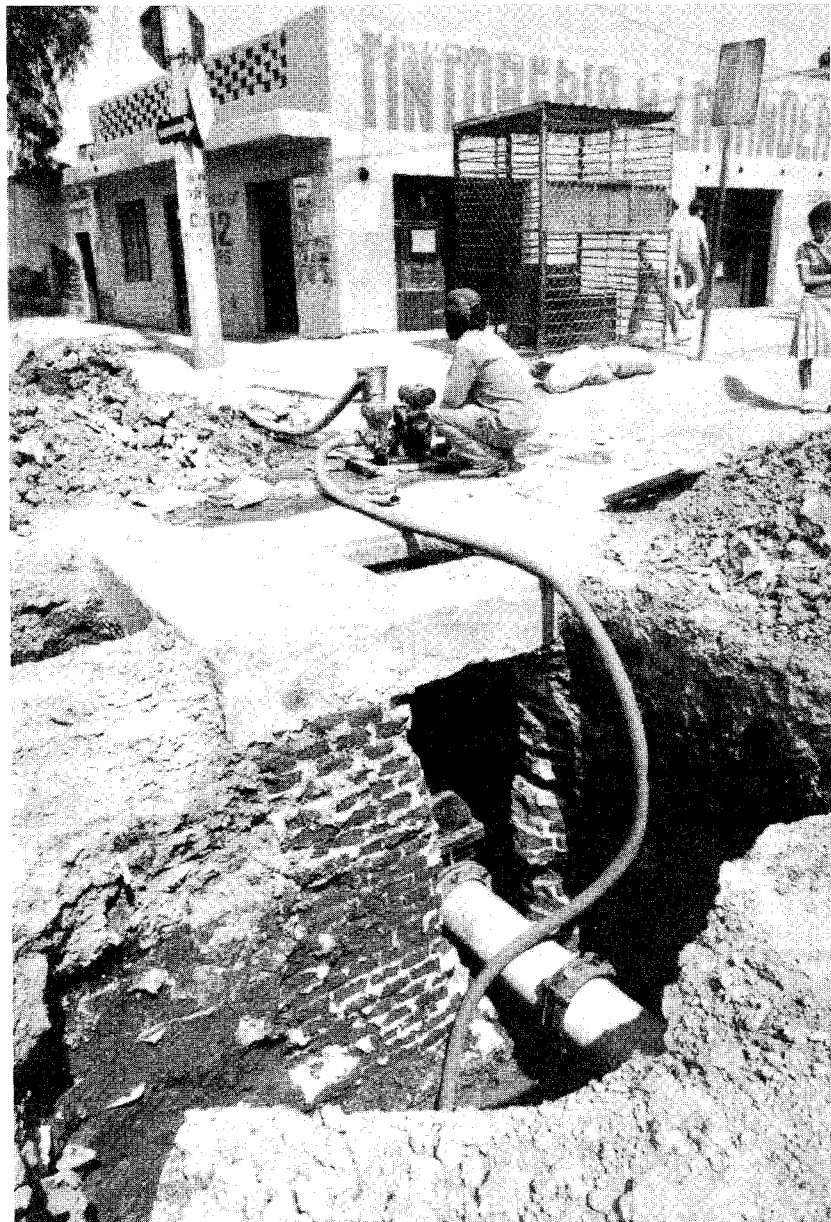
FIGURE 6-18 Repaired Leak At A Valve Box

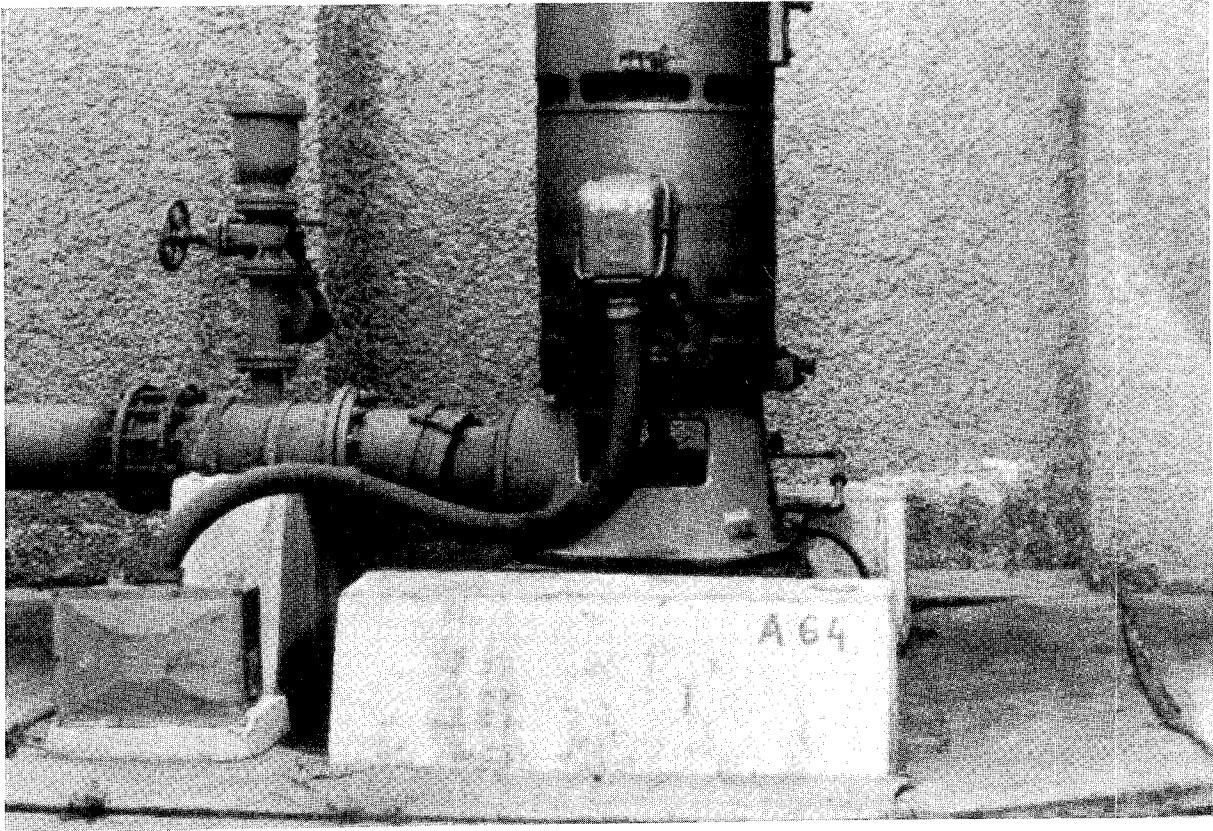
FIGURE 6-19 Well Damage At 'La Caldera' Tank, 1985 Michoacan Earthquake

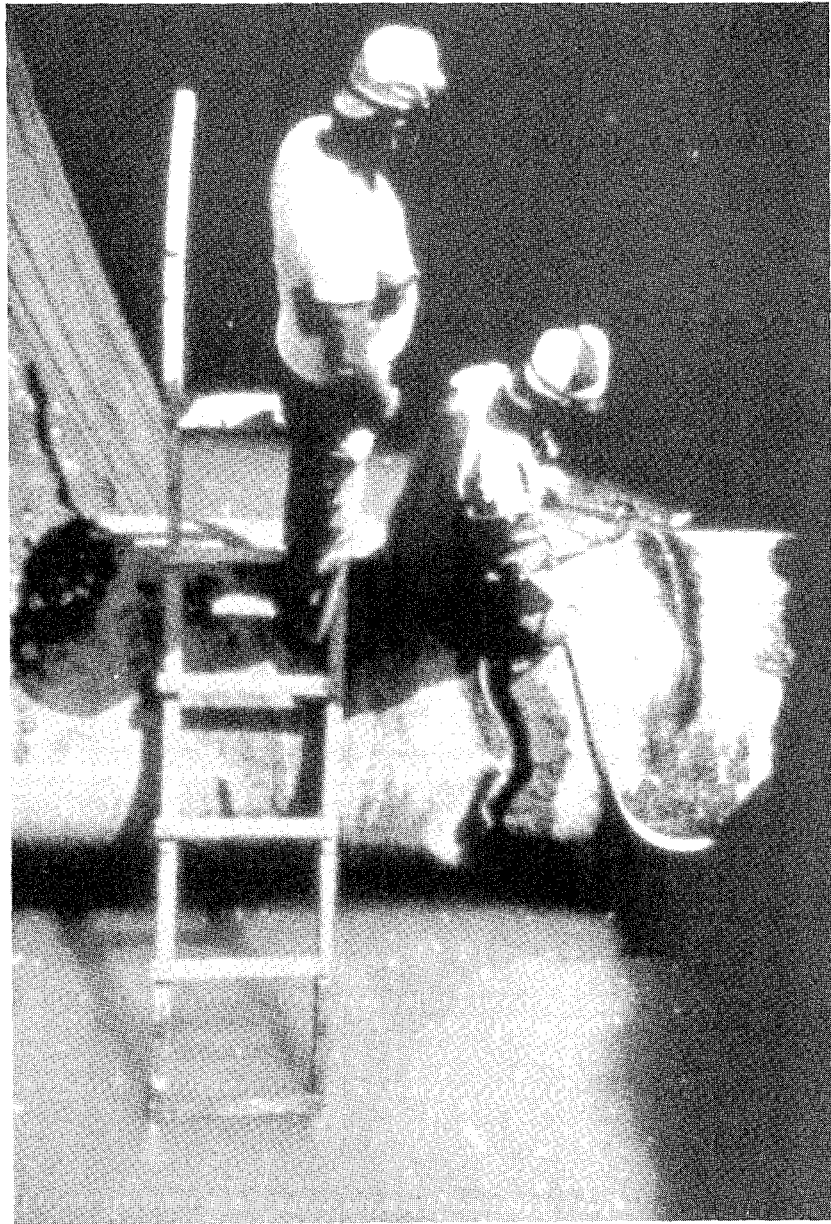
FIGURE 7-2 Local Buckling Failure Of Ciudad Nezahualcoyotl Pipeline - 1985  
Michoacan Earthquake

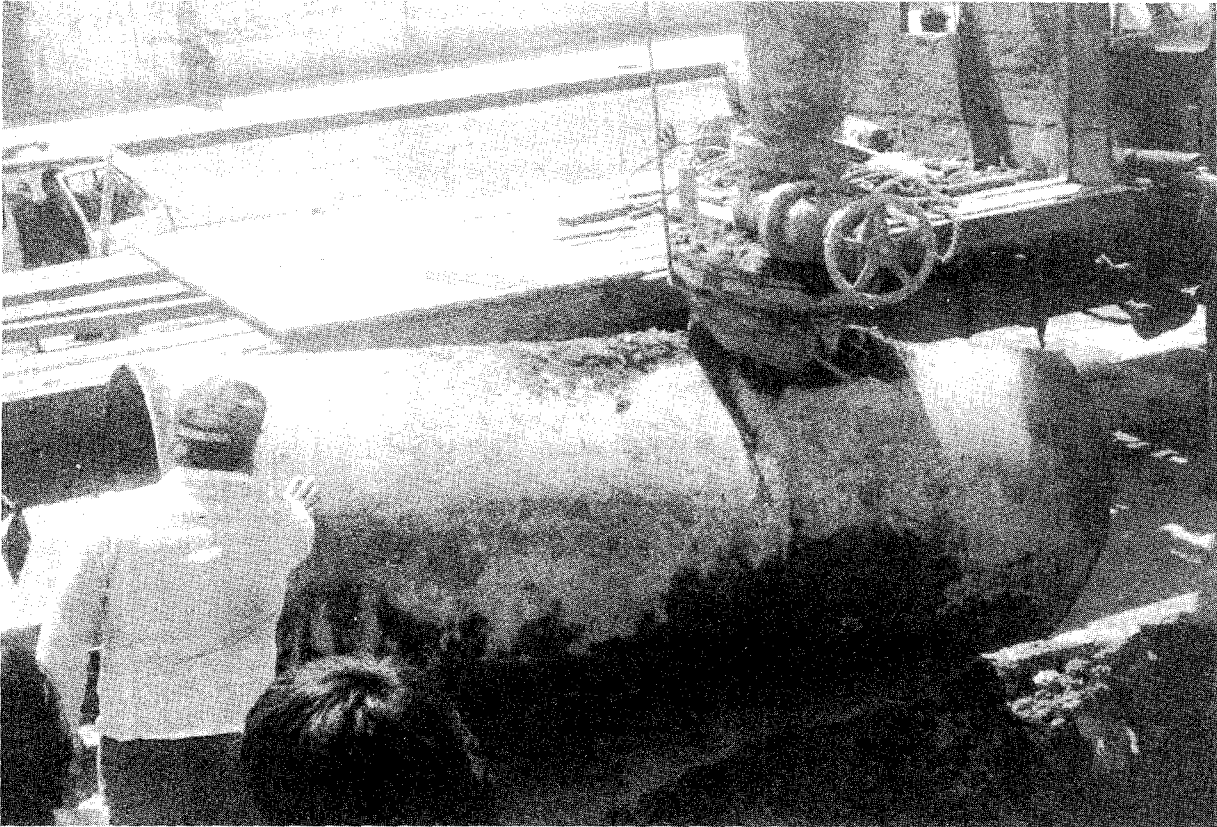
FIGURE 7-3 Wrinkling Deformation Close To A Valve Location, Ciudad Nezahualcoyotl Pipeline, 1985 Michoacan Earthquake

As mentioned previously, the observed locations of compressional wrinkling were at 300 to 500 meter spacings. Note that at any particular instant in time, the procedure described above suggests that areas of high compressive stress would occur at a spacing of about 520m. That is high compression regions are a wavelength apart, or 520m for the critical quarter wavelength of 130m.

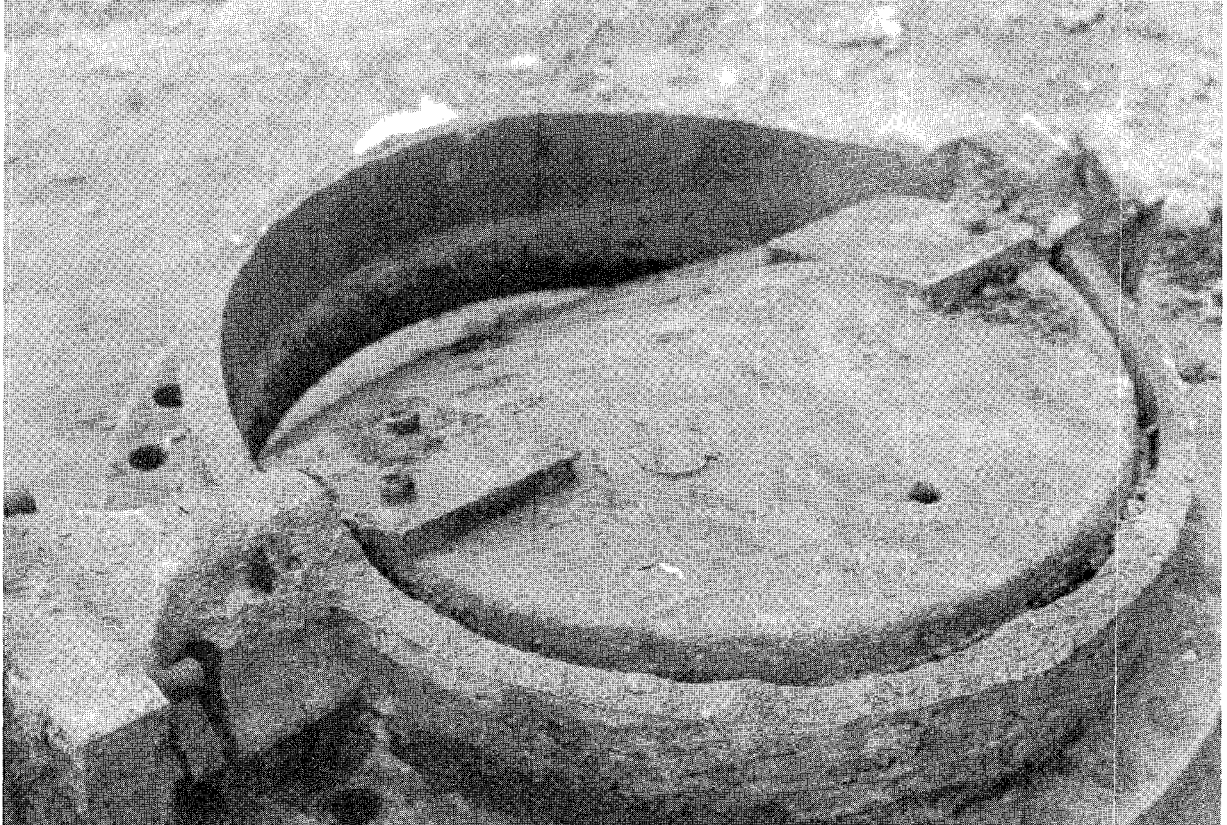
FIGURE 7-4 Broken Butterfly Valve

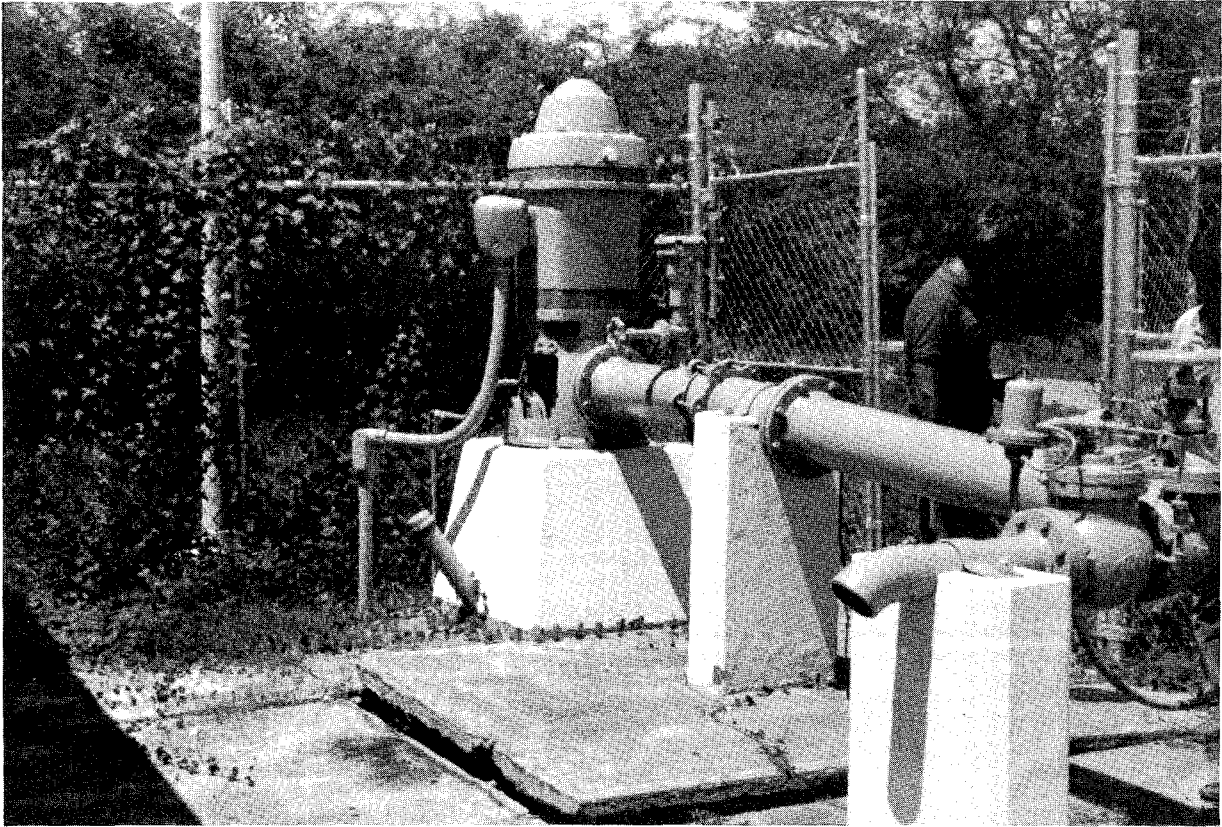
FIGURE 9-2 Damage To A Well, Epicentral Region - 1985 Michoacan Earthquake

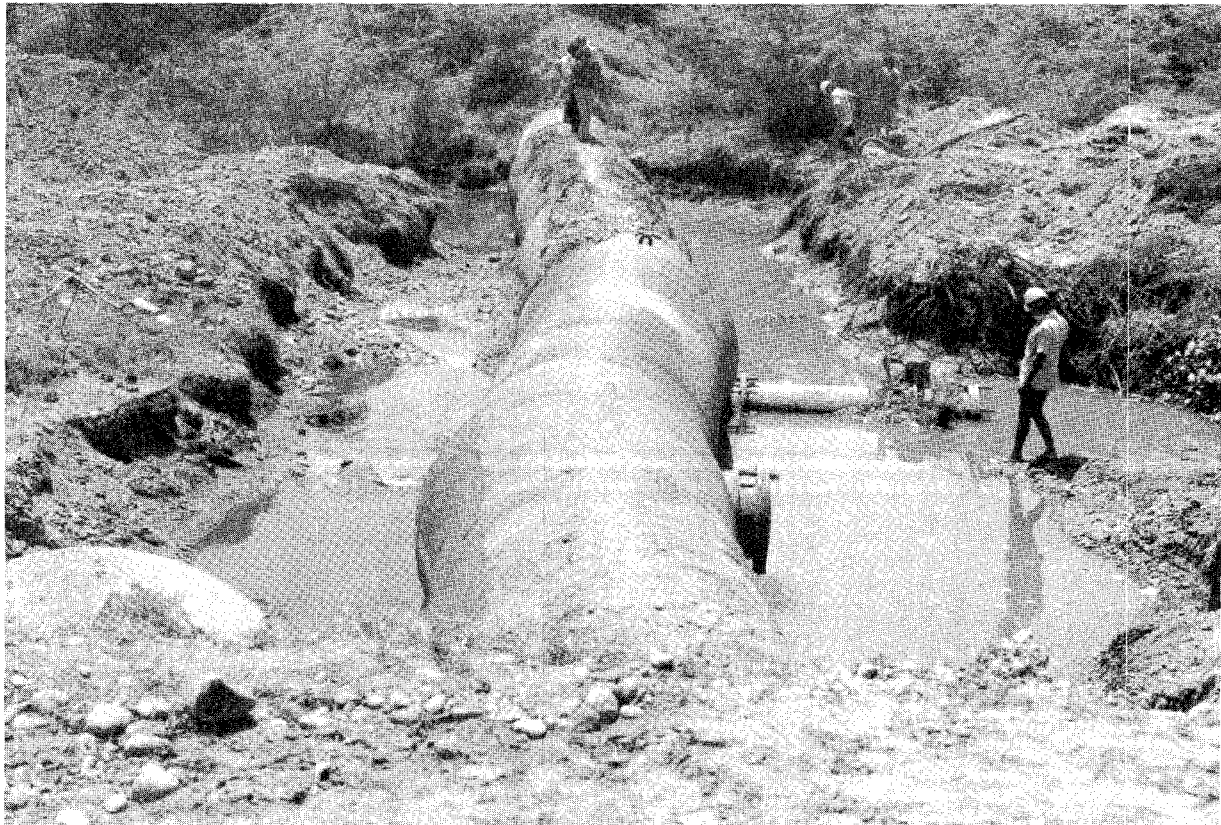
FIGURE 9-3 Damage To A 72"φ Above Ground Pipeline, Epicentral Region, 1985  
Michoacan Earthquake
