**LIQUEFACTION HAZARDS AND
THEIR EFFECTS ON BURIED PIPELINES**

T. D. O'Rourke and P. A. Lane

Technical Report NCEER-89-0007

February 1, 1989

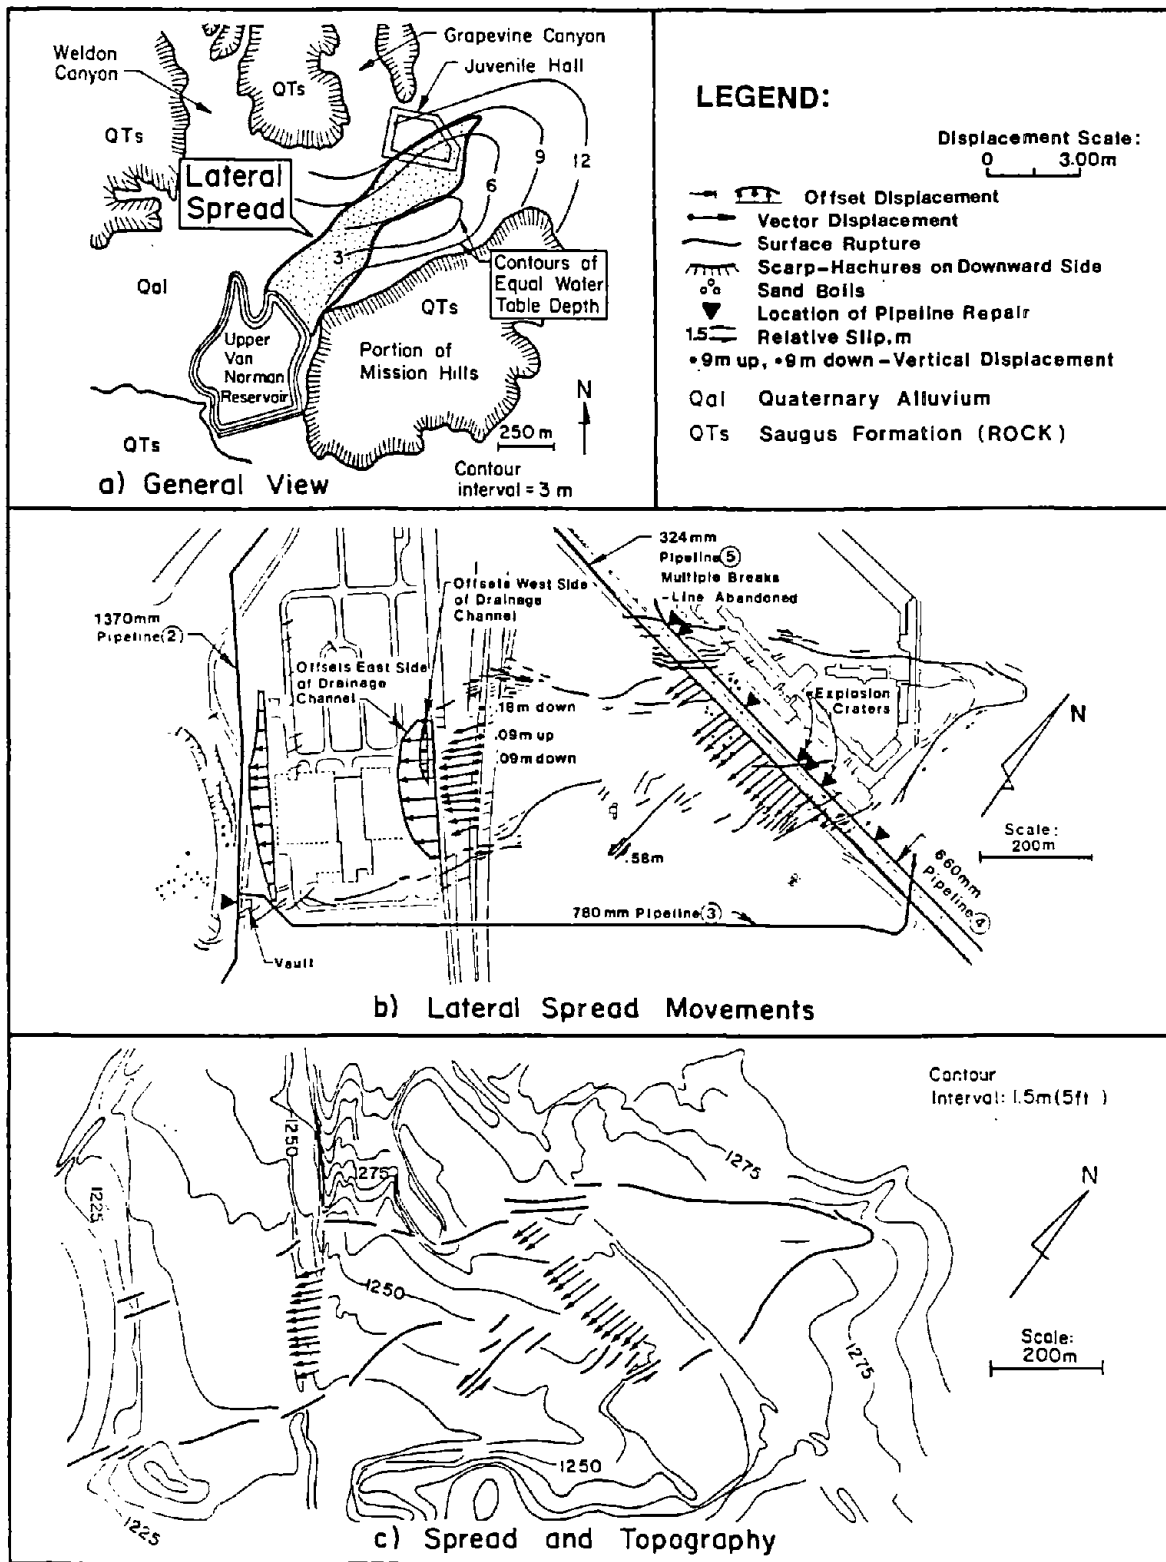
FIGURE 2-9. Plan Views of Lateral Spread on the East Side of Upper Van Norman Reservoir [after O'Rourke, 1986]

In Figure 2-9b, the displacement vectors along San Fernando Road show the pattern of the ground deformation imposed on the pipes. In Pipeline No. 5,

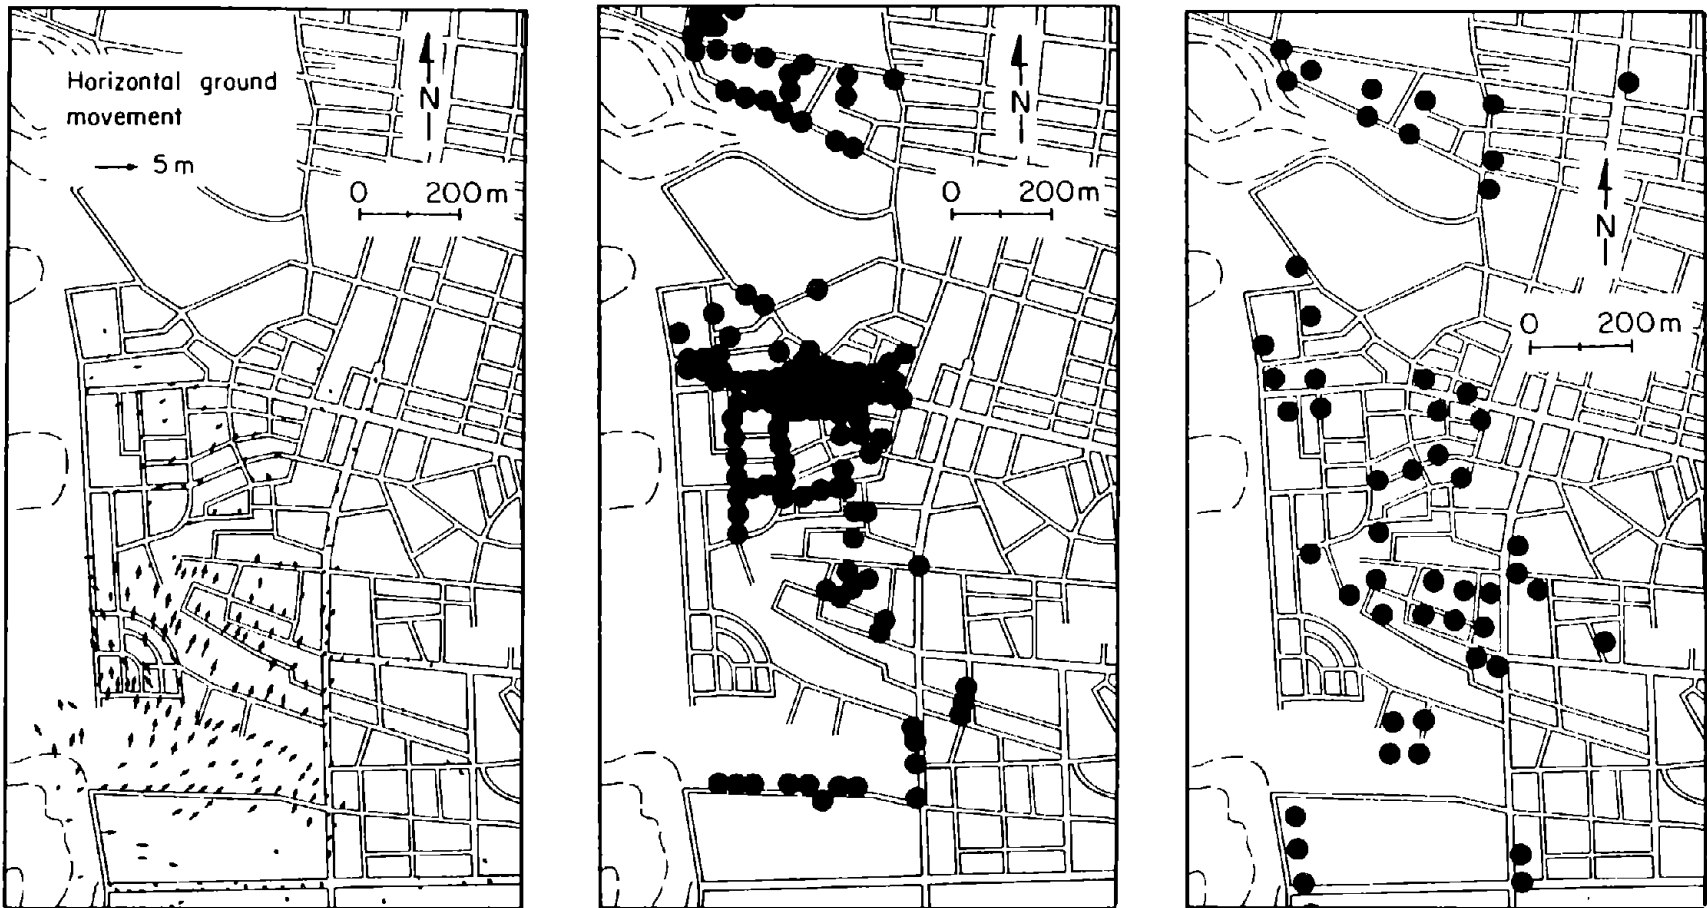
FIGURE 2-11. Relationship Between Ground Displacements and Damage to Pipelines in Zone A, Noshiro City [after Hamada, et al., 1985] (© ASCE. Used by Permission.)

Another study [Kawashima, et al., 1985] was conducted on the damage to sewage pipelines in Noshiro City from the 1983 earthquake. In the precast reinforced concrete sewage network, 8,757 m of the 60,000 m of pipeline were

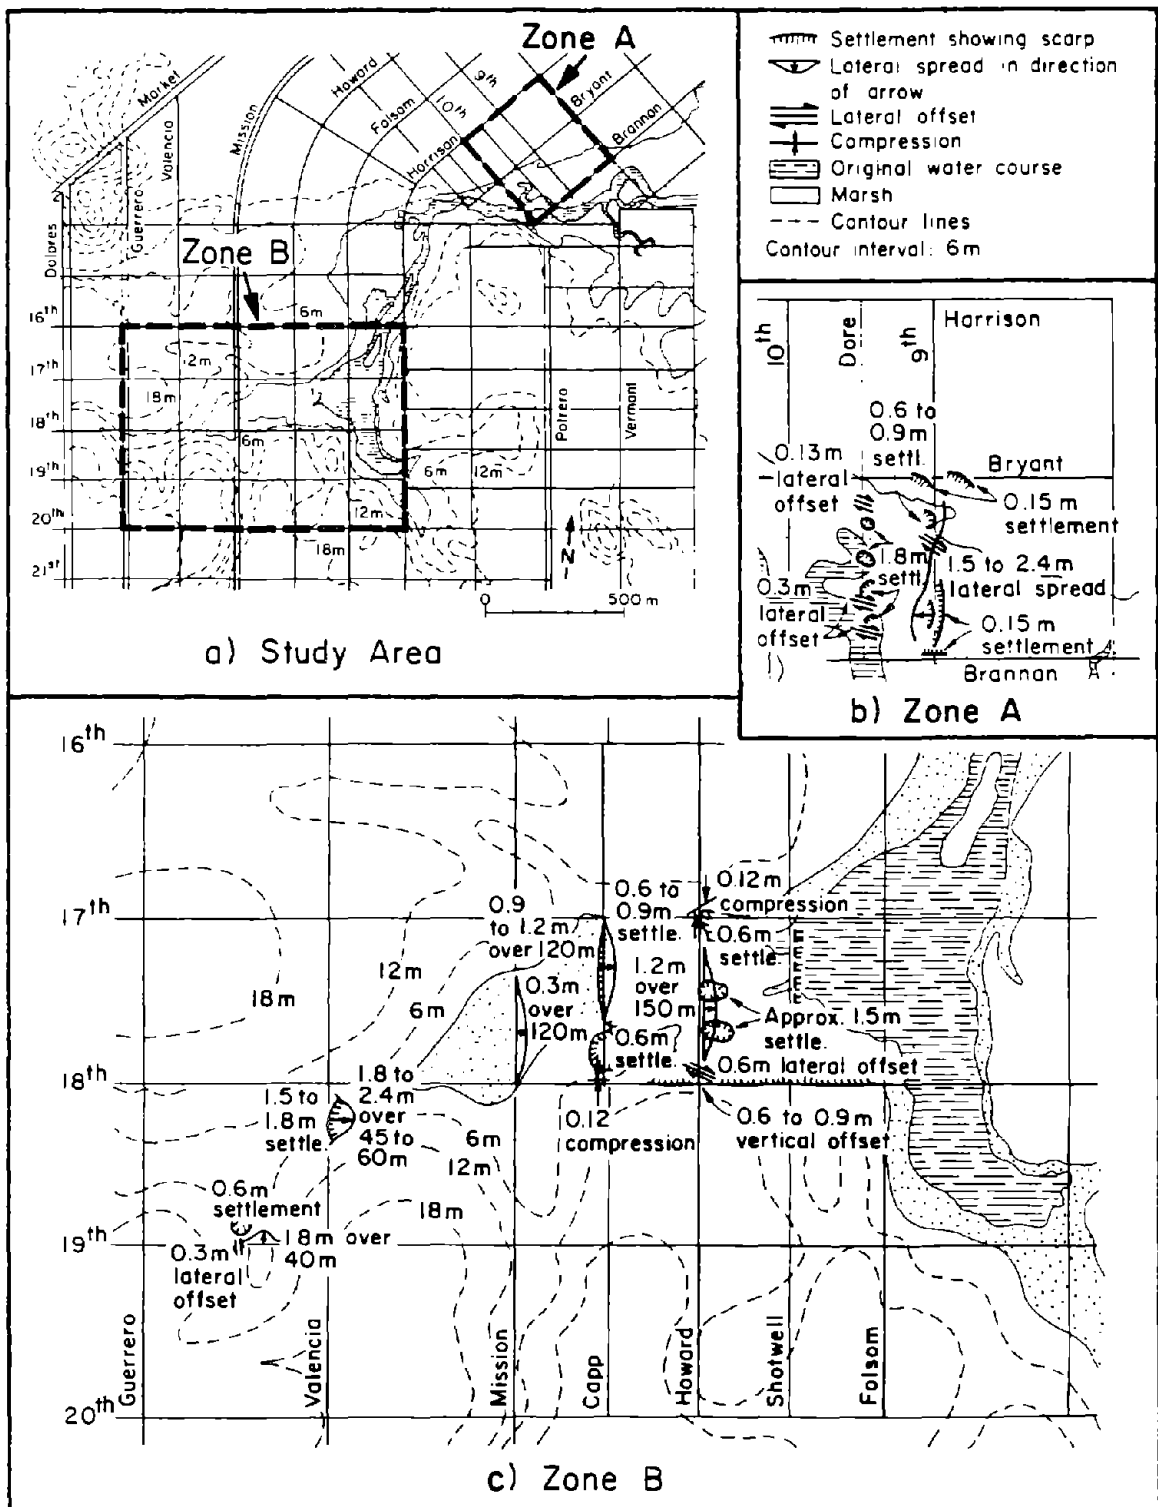
FIGURE 3-6. Earthquake-Induced Ground Movements in Mission Creek Zone

The most severe distortions occurred in areas where the former ravines narrowed, thereby restricting movements to a limited zone. In the region formerly known as "The Willows" [Hall, 1906], along Valencia Street between 18th and 19th Streets, some of the most extreme disturbances occurred. The

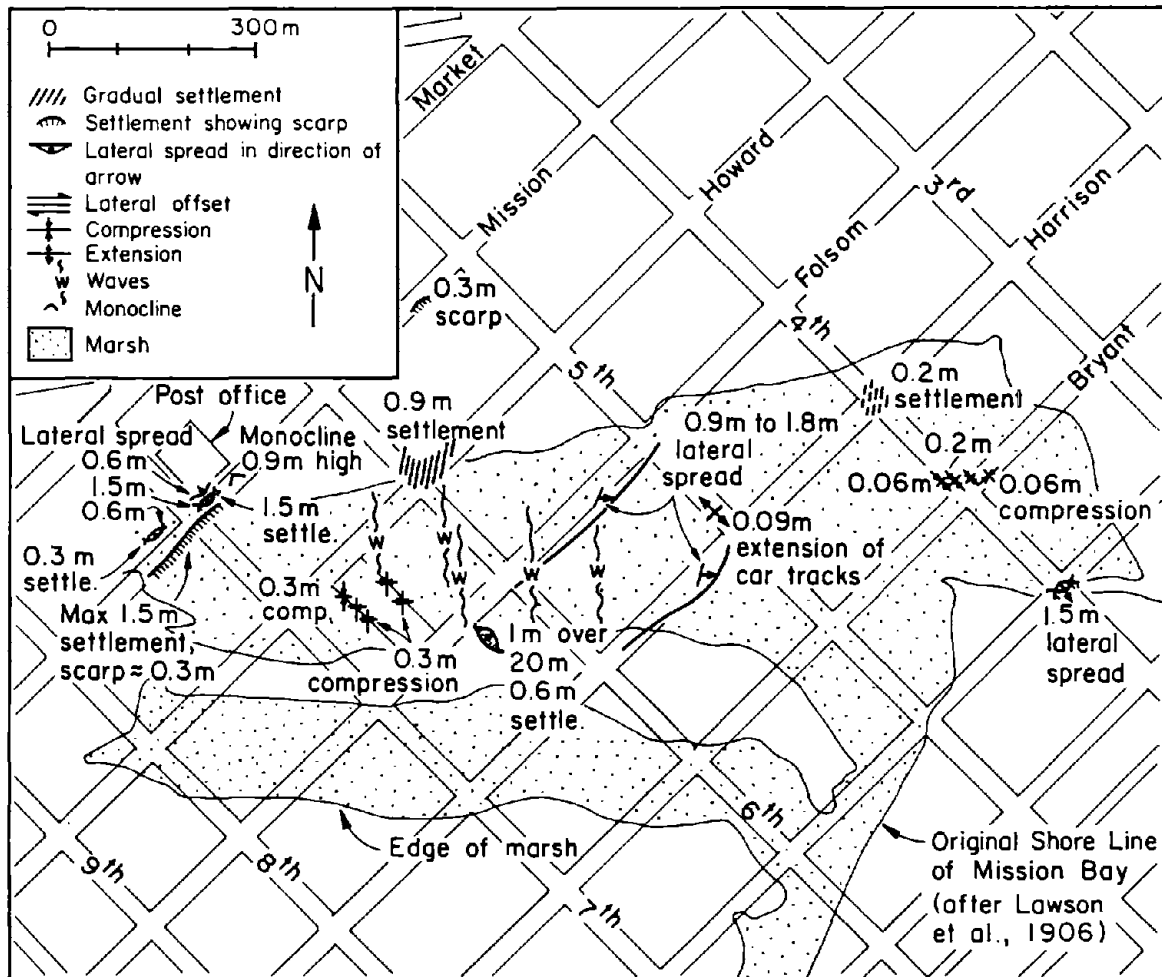
FIGURE 3-9. Earthquake-Induced Ground Movements in South of Market Zone

Figure 3-9 shows the ground movements relative to the shore line of the former marsh in the South of Market Zone. The general direction of flow in this zone was west to east, with maximum horizontal displacements of 0.9 to 1.8 m near the center of the channel. Wave forms, with their crests parallel to the direction of flow, were common. The amplitude and length of the

The northern limit of ground movements in this zone was Mission Street at

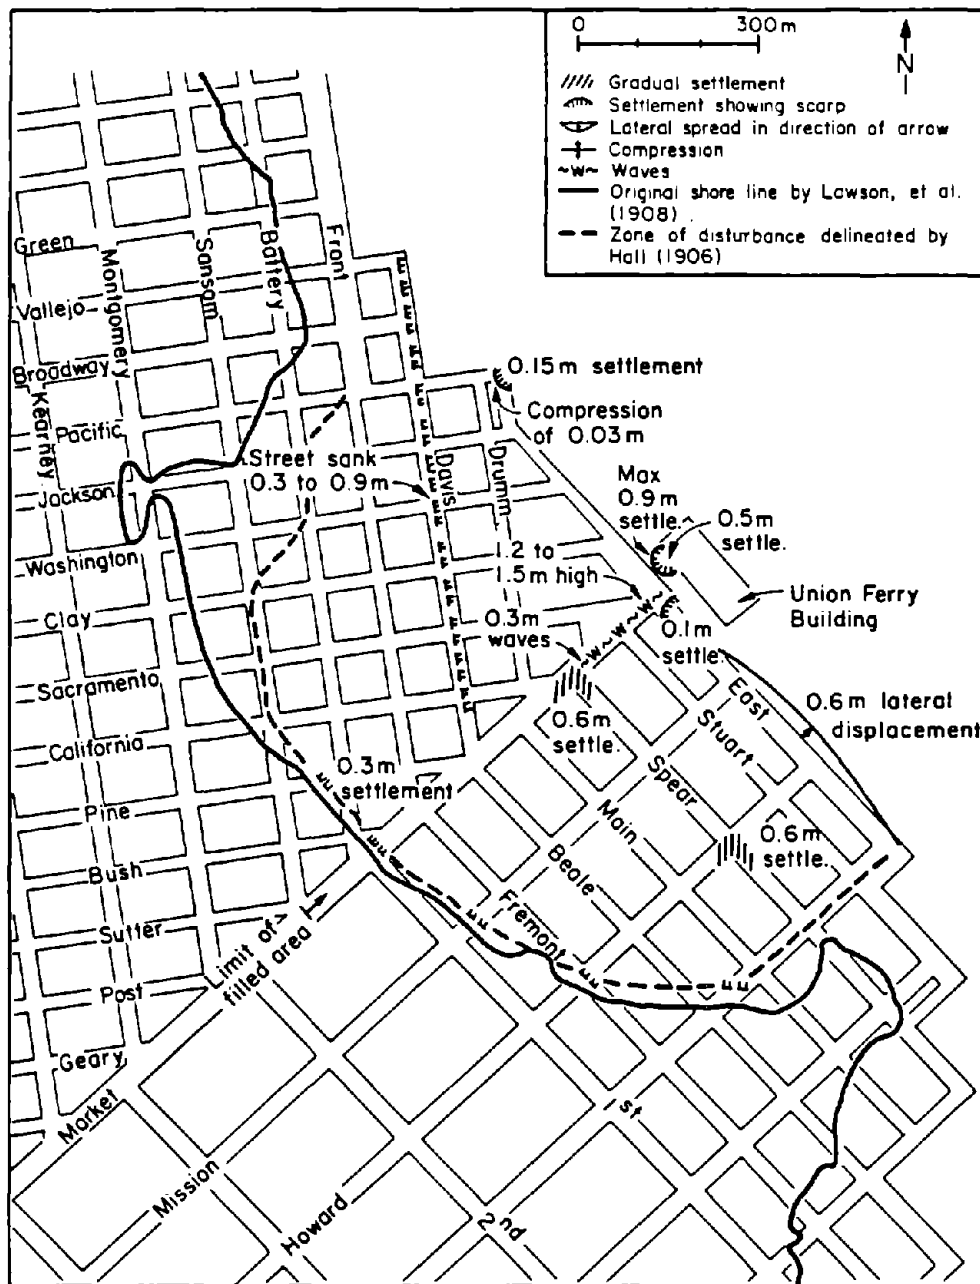
FIGURE 3-12. Earthquake-Induced Ground Movements in Foot of Market Zone

Wave forms were again prevalent on most of the streets eastward of this boundary, with the crest of the waves perpendicular to the general direction

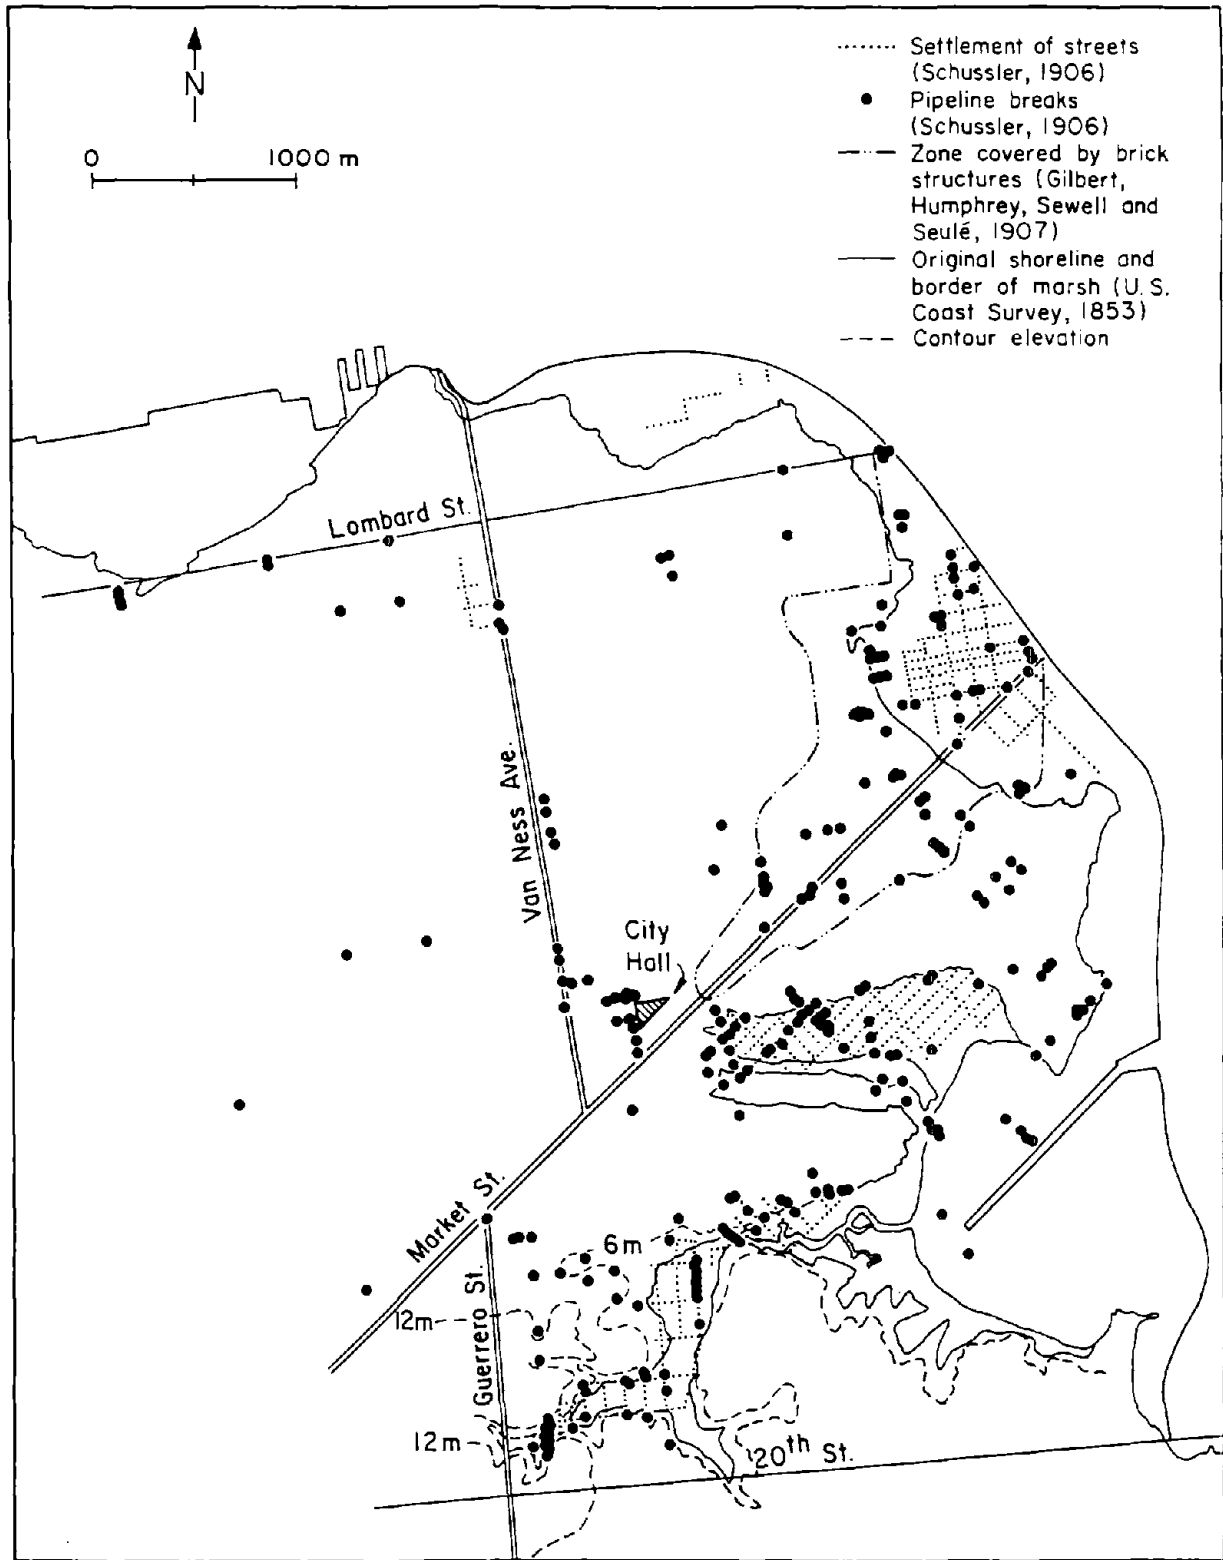
FIGURE 3-15. Pipeline Breaks and Street Settlements in San Francisco After 1906 Earthquake [after Schussler, 1906; Manson, 1906]

Several trends are apparent in studying pipeline breaks in the three major zones of ground displacements. In the Mission Creek Zone, pipeline breaks are concentrated where elevation contours converge or loop outward, signifying buried ravines and narrow stream channels. A large proportion of the breaks lie along the boundary between solid and "made" ground, particularly along the border of the former marshes in Mission Creek and South of Market Zones, and along the shore line of the former Yerba Buena Cove in the Foot of Market Zone. The differential movements are most severe along the margins of the in-filled areas, and therefore pipelines are particularly vulnerable in this zone. As Schussler [1906] describes (p. 14):
