INVESTIGATION ON THE CAUSE OF NUMEROUS UPPER FLOOR FAILURES DURING  
THE 1985 MEXICO CITY EARTHQUAKE

Roberto Villaverde

Department of Civil Engineering  
University of California, Irvine

November, 1989

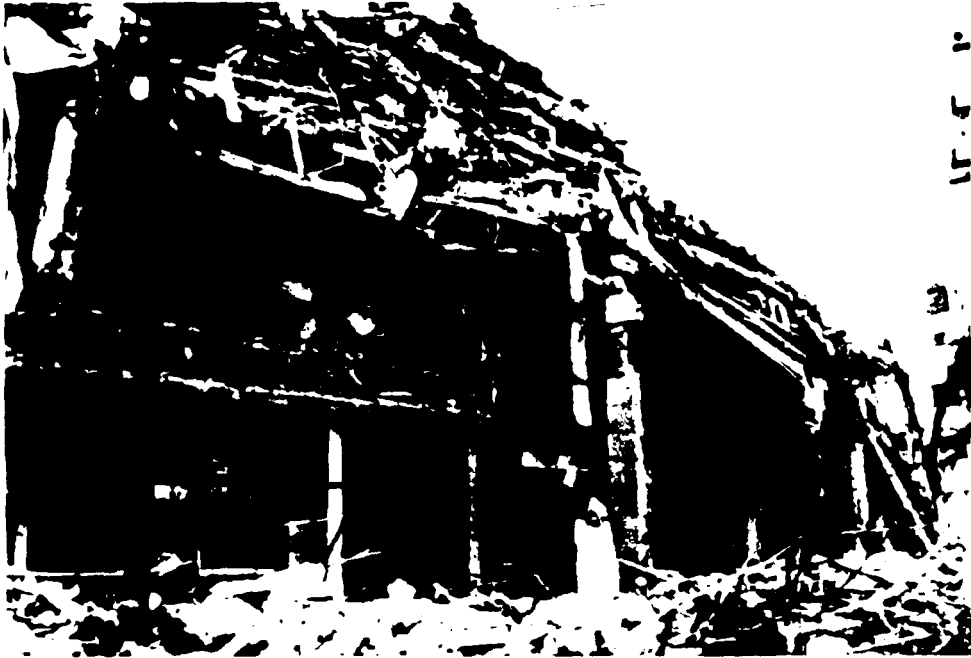
Figure 2.1. Building on Ave. Cuauhtenoc and Puebla

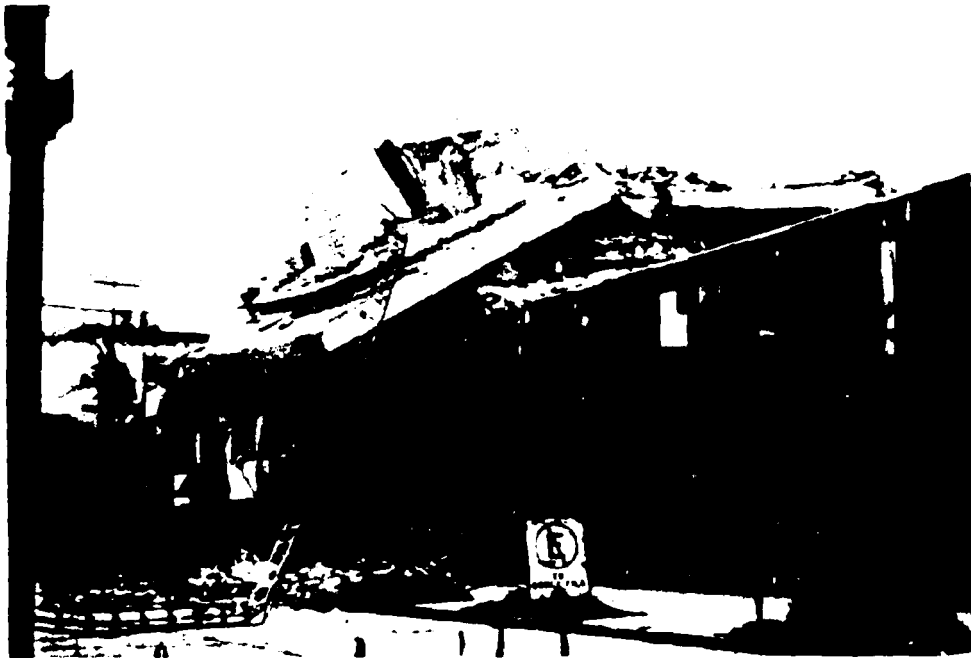
Figure 2.2. Building on Medellin and Ave. A. Obregón

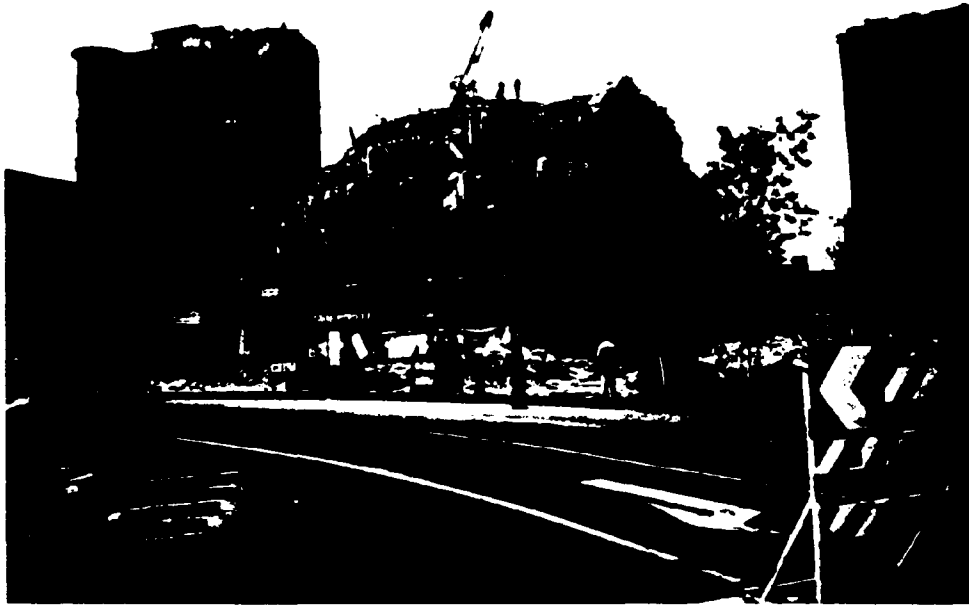
Figure 2.4. Building on Juárez No. 117

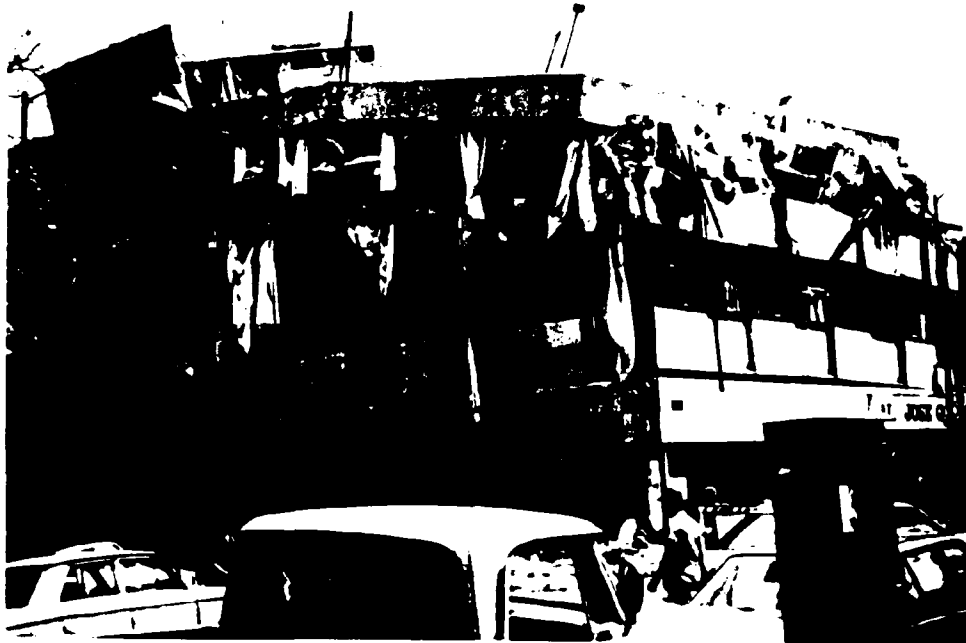
Figure 2.5. Building on Hamburgo and Dinamarca

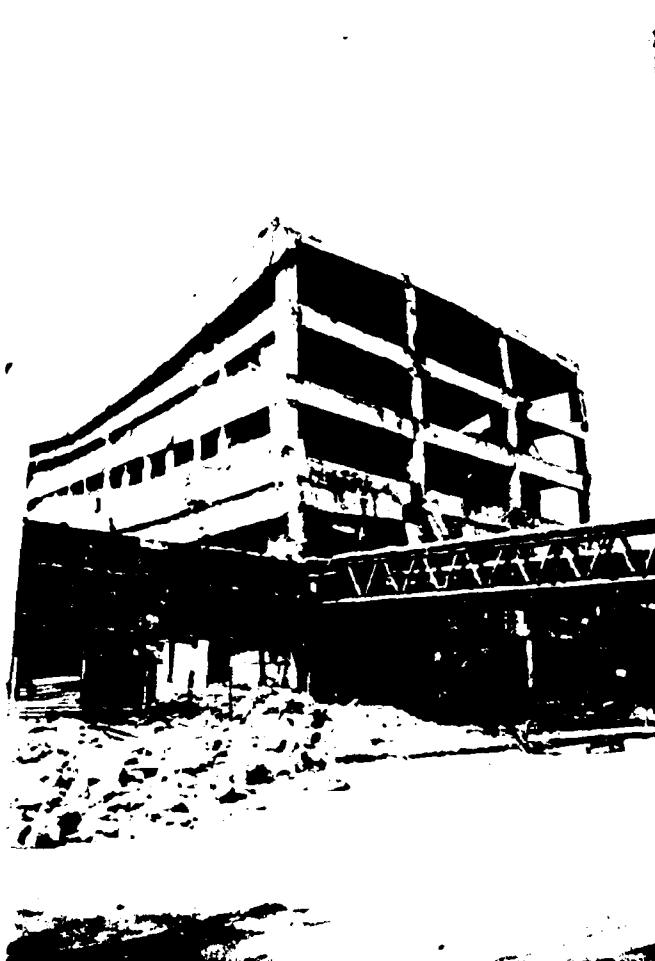
Figure 2.6. Building under construction on Ave. Hidalgo and Paseo de la Reforma (Banco de México)

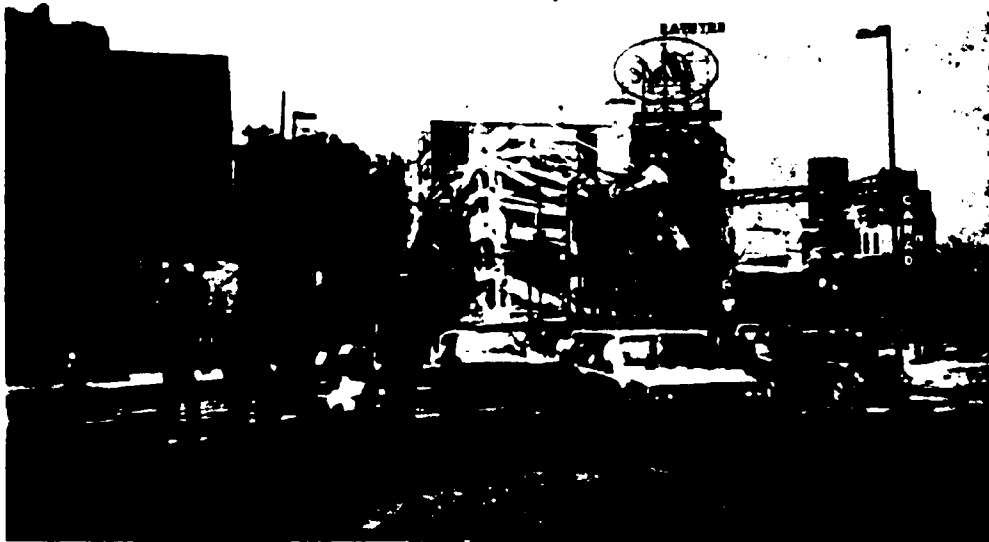
Figure 2.10. Building on Ave. de los Insurgentes and Monterrey

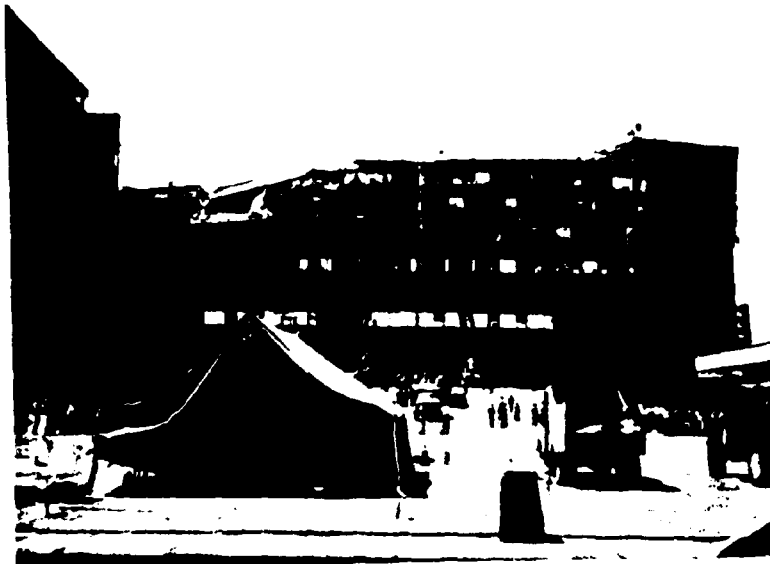
Figure 2.14. Building on Ave. Universidad and Xola (Secretaria de Comunicaciones y Transportes; photograph after International Masonry Institute, 1986)

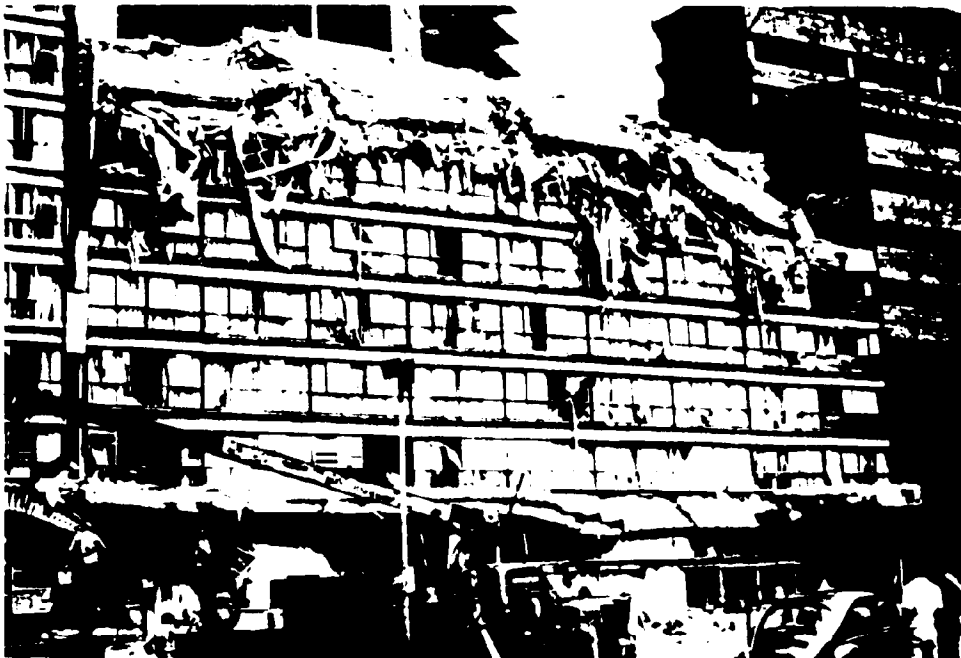
Figure 2.16. Building on Calle Roma (Hotel Continental)

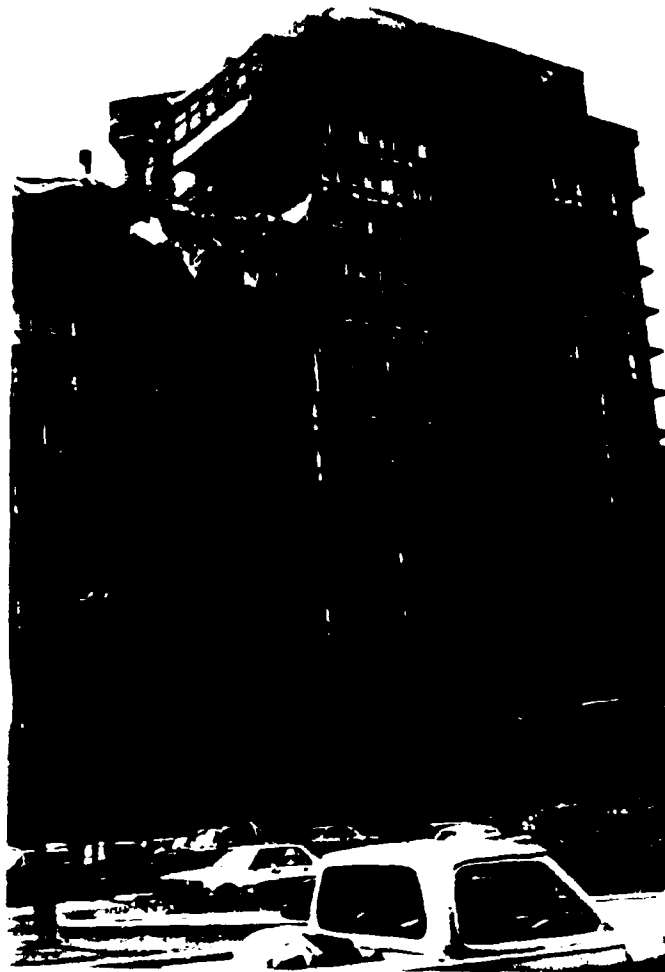
Figure 2.12. Building on Paseo de la Feferra Hotel Continental

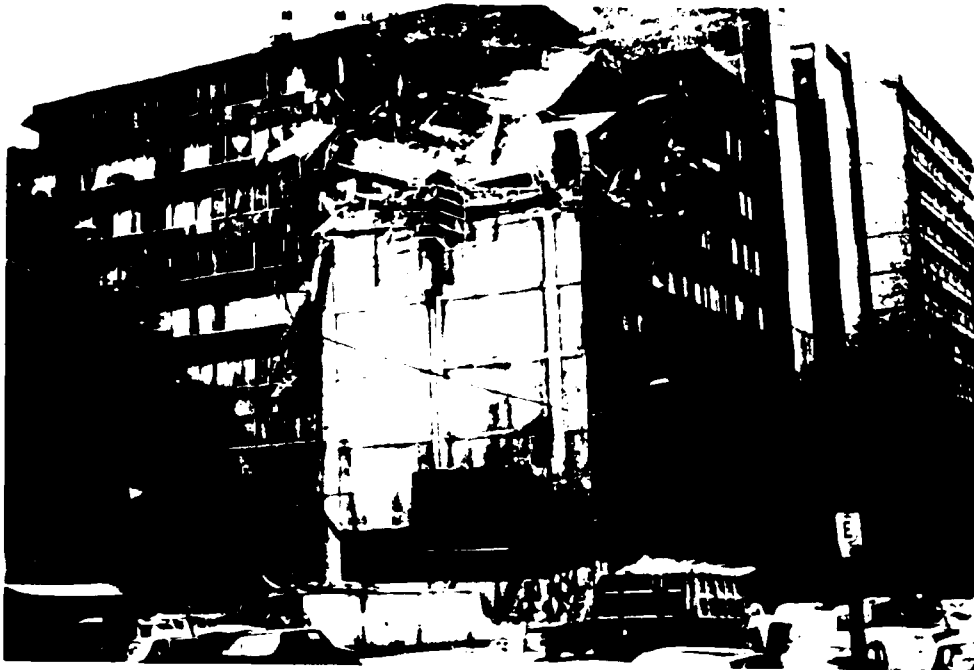
Figure 2.20. Building on Ave. Morelos No. 98

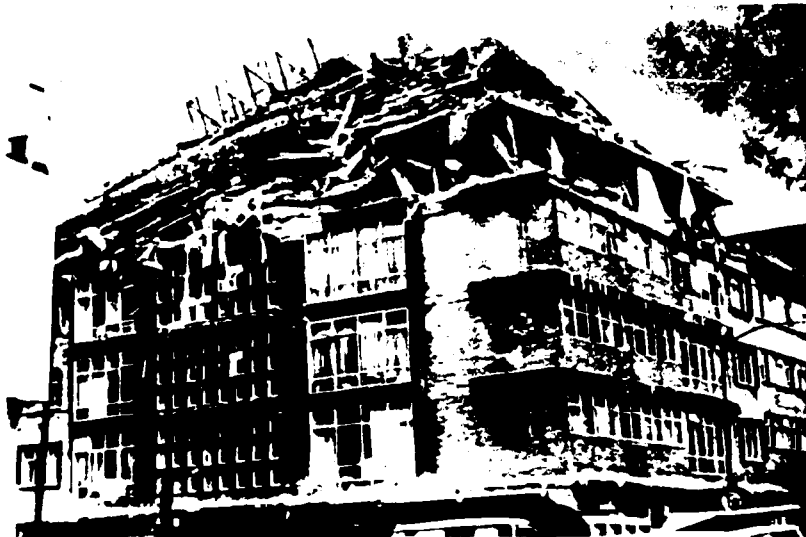
Figures 2.21 and 2.22) despite the fact that the implicit intention of building codes is to avoid the formation of plastic hinges in columns whenever the forces for which buildings are designed are exceeded. Thus, although undoubtedly the listed factors might have contributed to the upper floor failures in some cases, those without an apparent cause of failure and the large number of buildings that experienced this type of collapse seem to indicate that the criteria used in the design of these buildings somehow failed to insure the integrity of their columns and, hence, seem to suggest the existence of a possible weakness in such design criteria.

variations in their plan area along their height. Finally, in regard to the apparent cause of failure, it was observed that in some cases there was a clear evidence of pounding between adjacent buildings; important torsional effects, particularly in the case of corner buildings; overloaded floors, as in the case of some garment factories and government buildings; and a lack of seismic design, as it was true for those constructed in the 1940s. Notwithstanding, it was found that many of the buildings with upper floor collapses did not show an evidence of the cause that might have contributed to the collapse of their upper floors, except, of course, the failure of their columns (see Figures 2.21 and 2.22, for example).

Figure 2.21. Building on Liverpool and Berlin

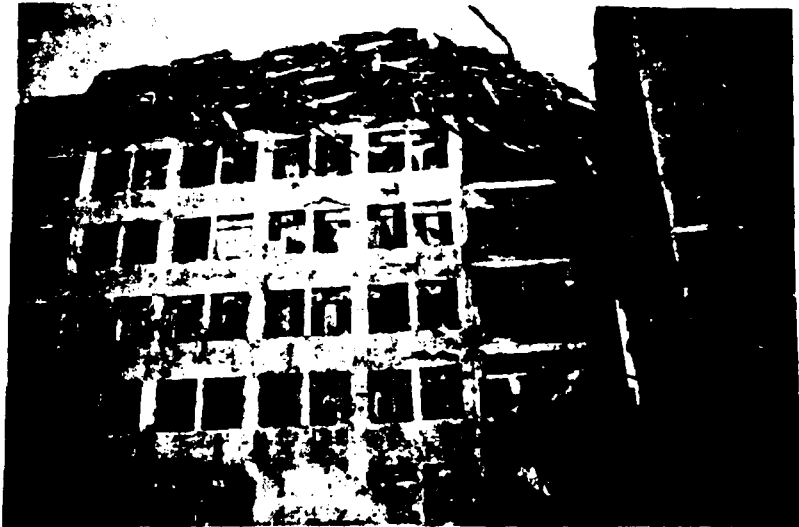
Figure 2.25 Building on Lázaro Cardenas No. 21 (photograph after R. Hanson, 1986)

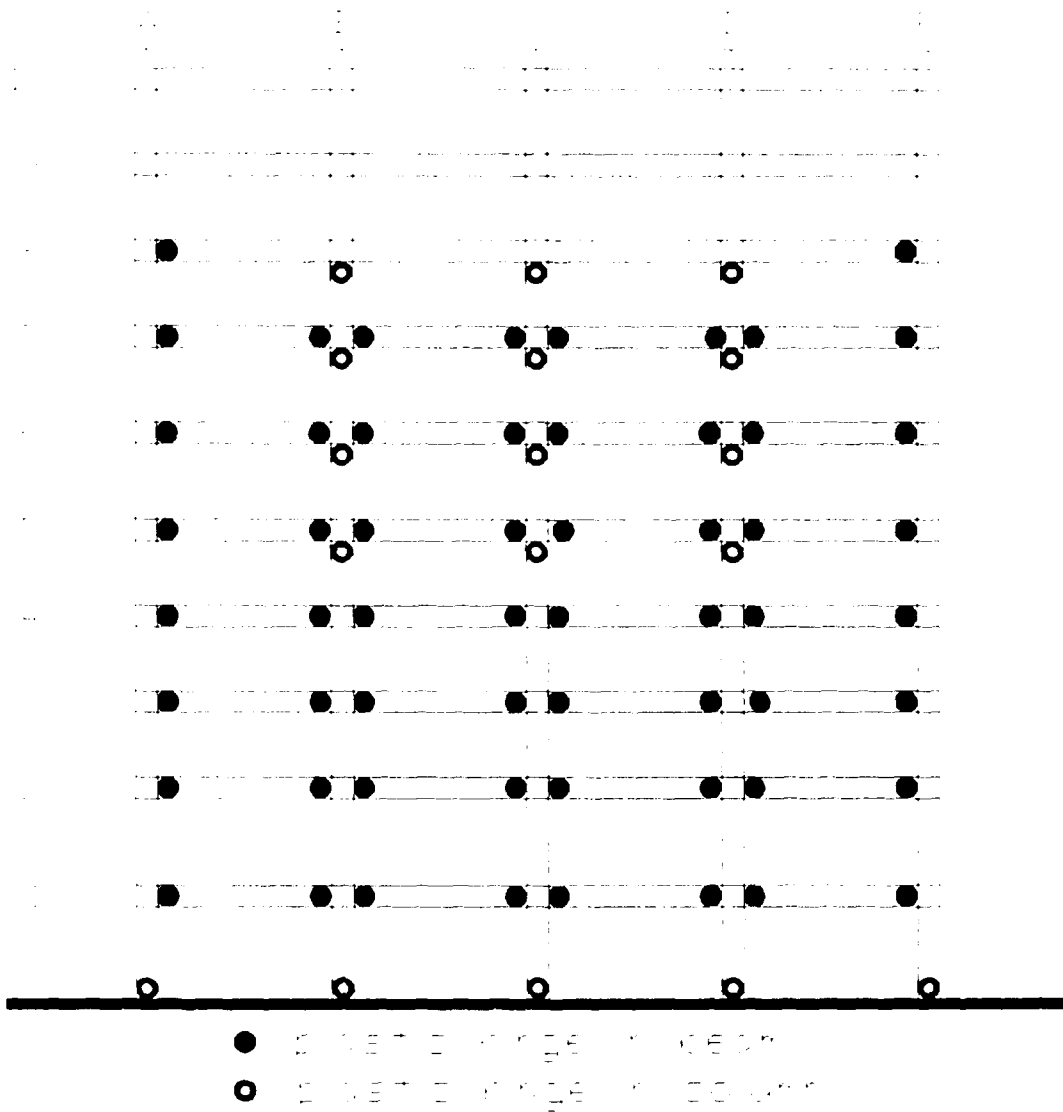
Figure 3.8 shows the plastic hinges which according to the computer analysis would have formed in the structure if it had been subjected to a ground motion identical to the SCT record. This distribution of plastic hinges may be thus contrasted with the actual damage the structure suffered during the 1985 earthquake, damage that is shown schematically in Figure 3.9. Note that except for the plastic hinges at the lower ends of the columns of the first floor, which do not appear in the description of the actual damage, the pattern of damage seems to be adequately predicted by the computer model. Furthermore, one notices that such plastic hinges do show in one of the exterior rectangular frames of the building (see Figure 3.10), a fact that suggests that perhaps the plastic hinges at the bottom of the interior frame were there but somehow were overlooked during the damage survey.

Figure 3.8. Plastic hinges in interior longitudinal frame of original STC building after 70 sec. of the SCT, S60E, ground motion

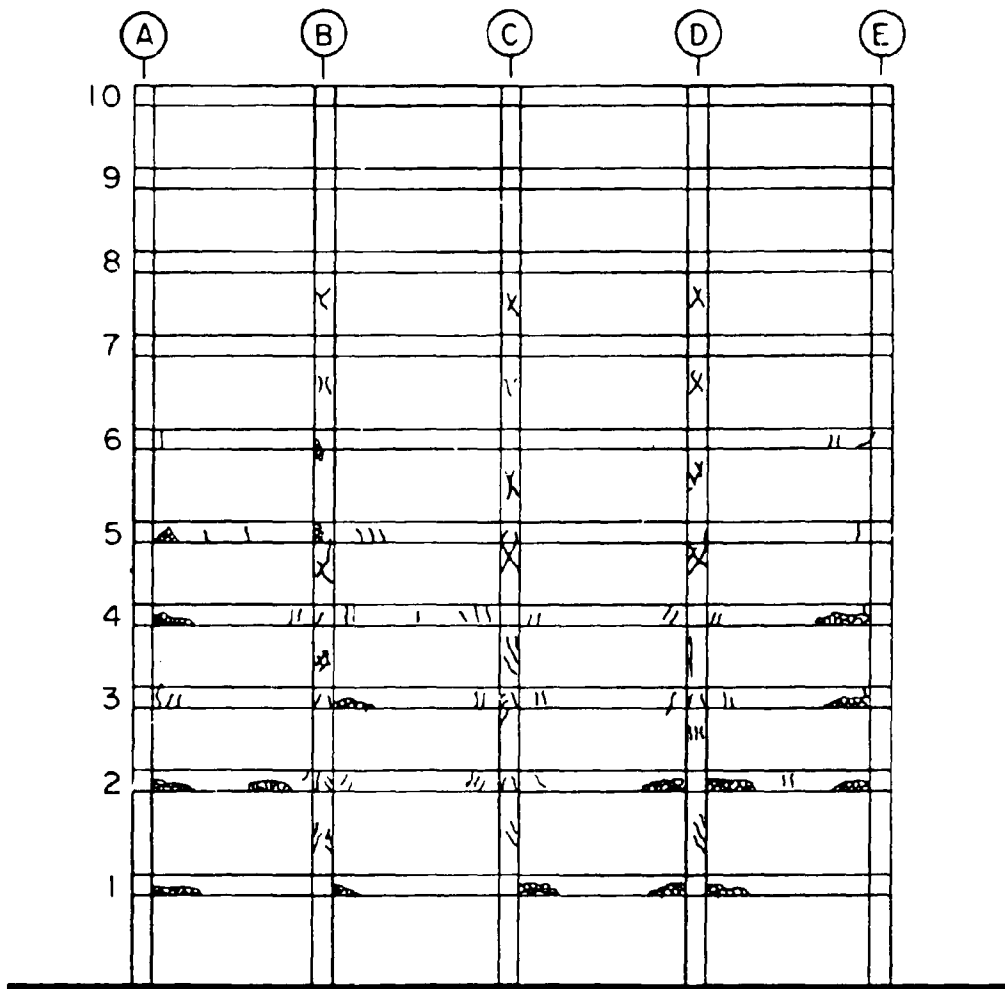
Figure 3.9. Damage sustained by interior longitudinal frame of STC building during the earthquake of September 19, 1985 (after Meli and López, 1986)

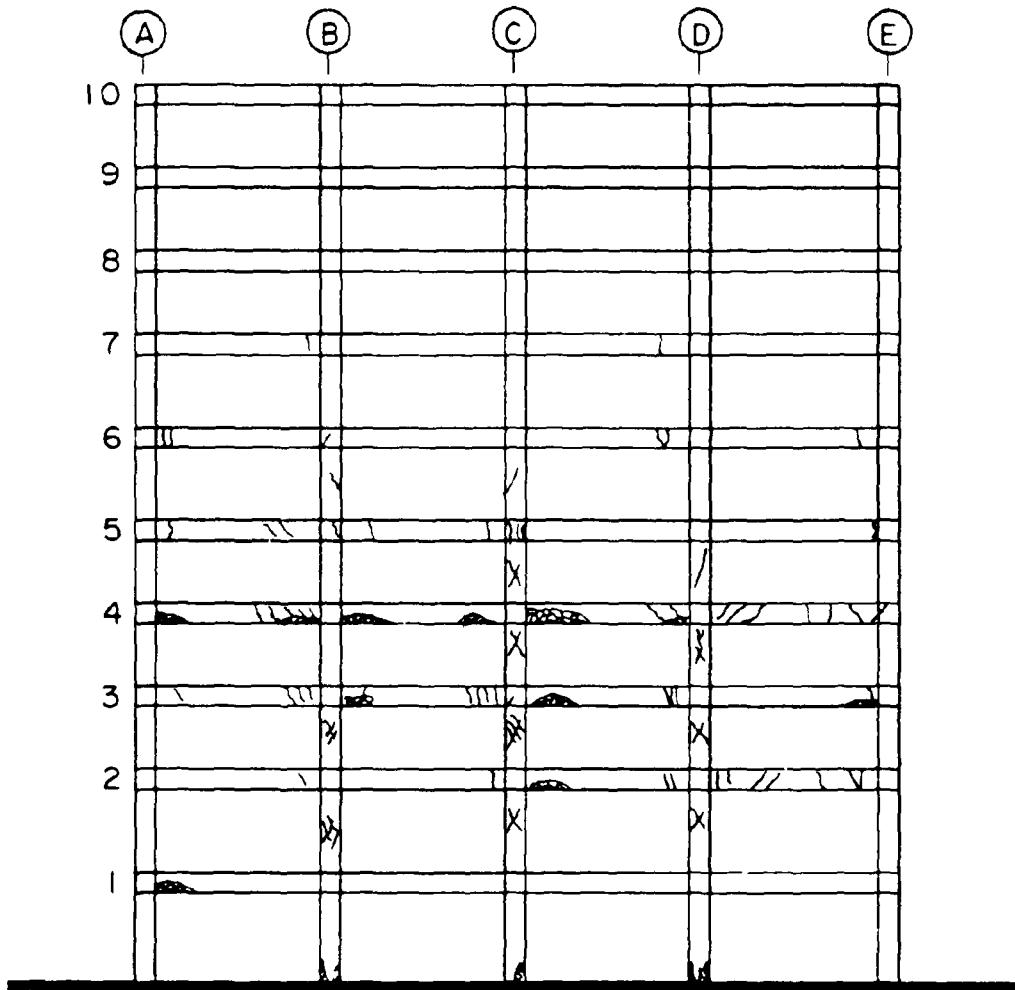
Figure 3.10. Damage sustained by exterior longitudinal frame of STC building during the earthquake of September 19, 1985 (after Meli and López, 1986)

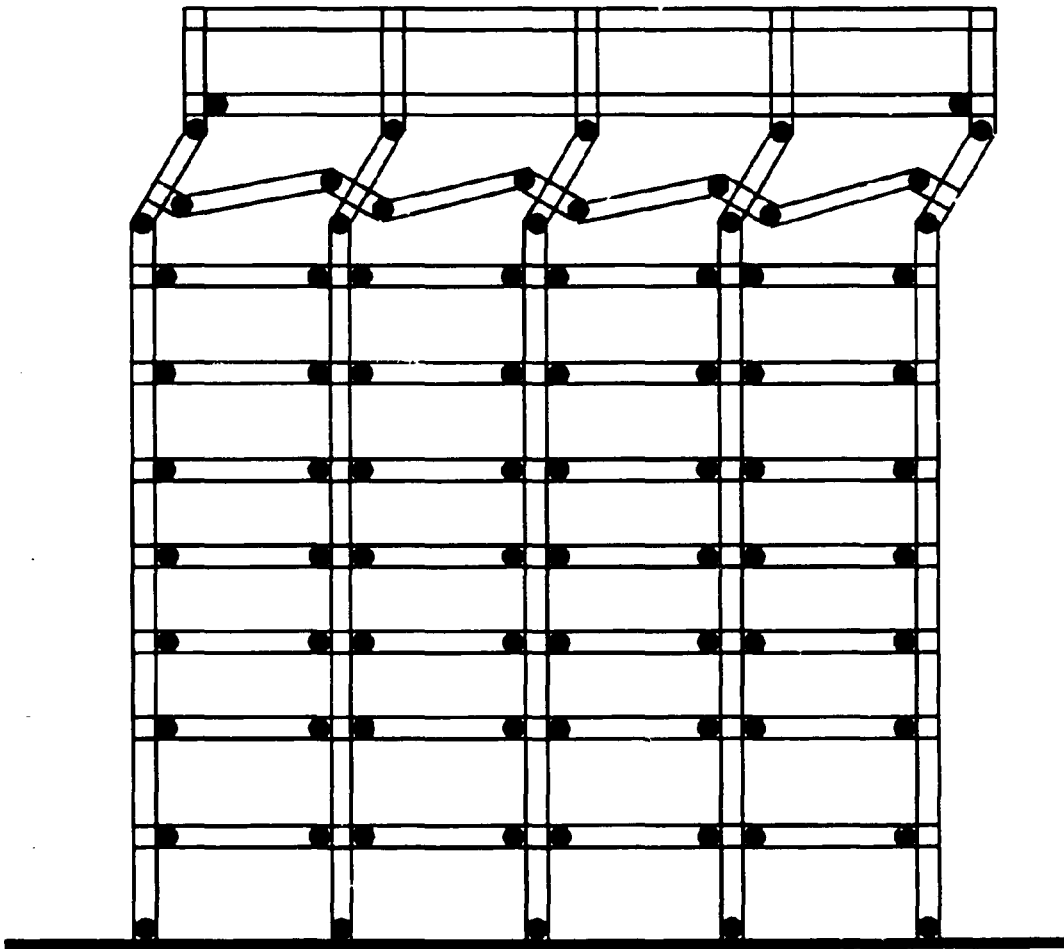
action of the beams if the design forces are exceeded. But because of the development of plastic hinges and the deterioration of the beams, the natural periods of the structure were elongated in such a way that the structure was forced to vibrate in its mode with the natural period that was the closest to the predominant period of the ground motion: its third mode. This, together with the large ground accelerations which the structure was still subjected to after it entered into its inelastic range and the fact that its columns were designed for a first-mode distribution of shear forces, induced the formation of plastic hinges in the columns of some of its upper stories and the consequent lateral instability of these stories.

Figure 3.21. Upper floor failure mechanism in interior longitudinal frame of designed 10-story building
