RECONNAISSANCE REPORT ON THE NORTHERN IRAN EARTHQUAKE OF JUNE 21, 1990

M. Mehrain

Technical Report NCEER-90-0017

October 4, 1990

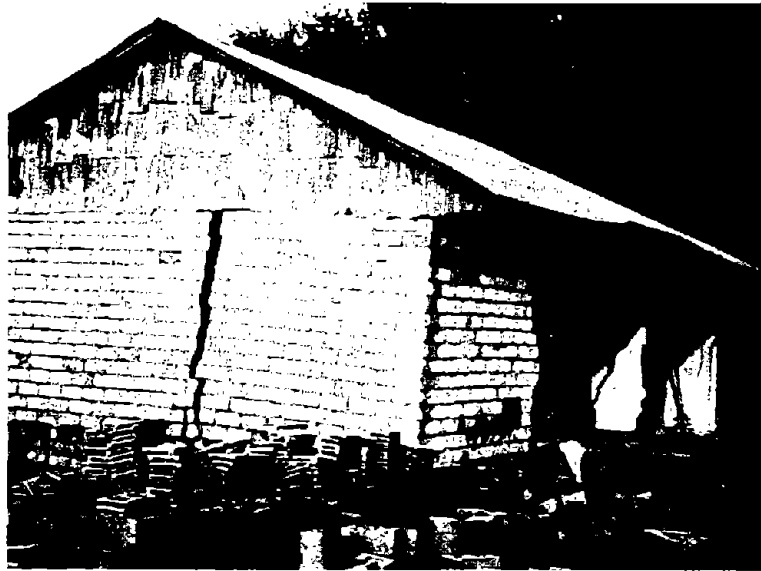
Figure 2-4 Wall crack caused by liquefaction settlement.

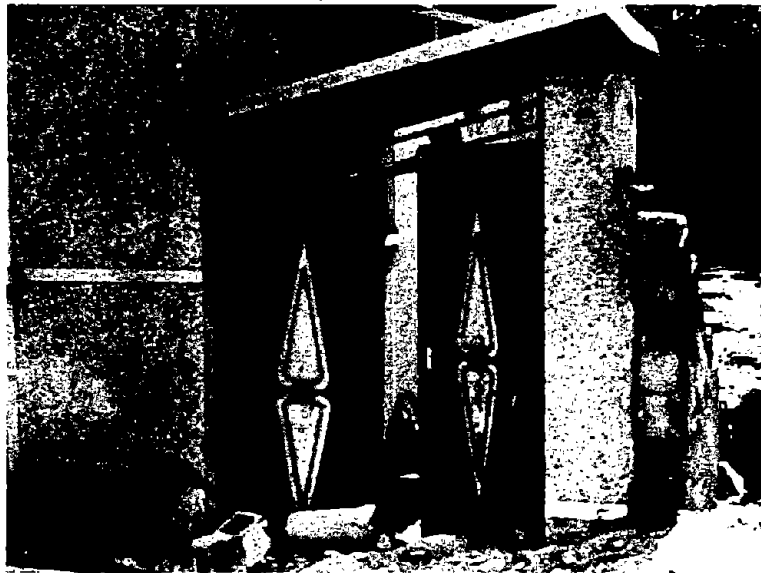
Figure 2-5 Large differential settlement due to liquefaction

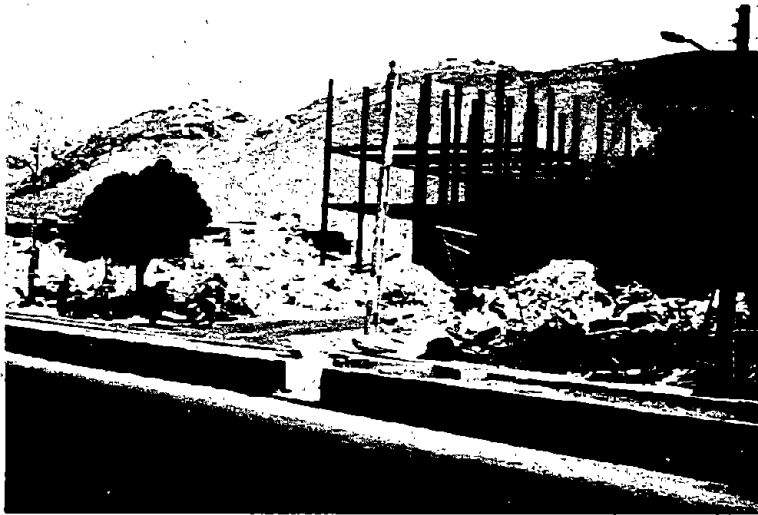
Figure 3-1 Destruction of buildings in the epicentral region

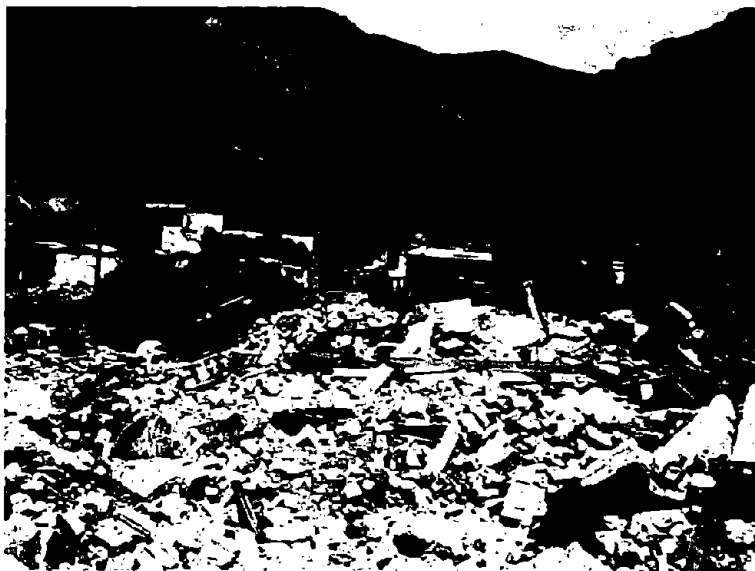
Figure 3-2 Widespread collapse of unreinforced masonry buildings.

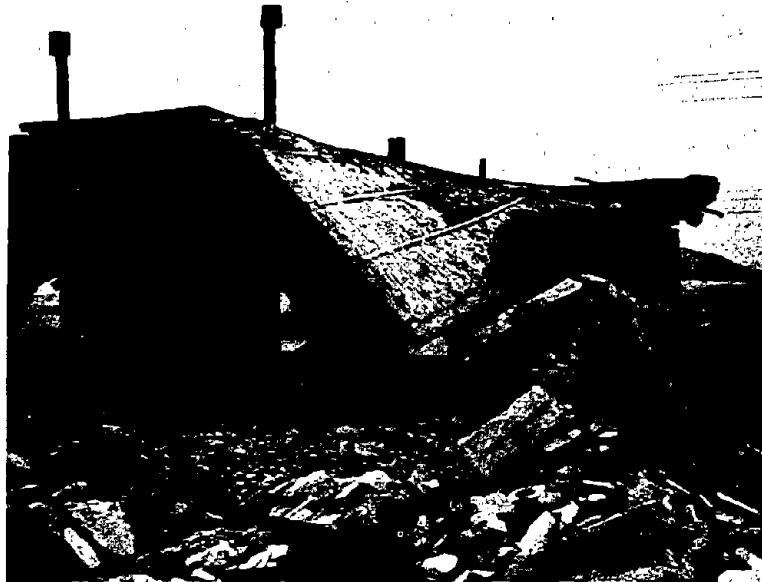
Figure 3-3 Roof collapse in an unreinforced masonry bearing wall structure. The roof is brick infilled steel beam (jack arch) system which is very common in Iran.

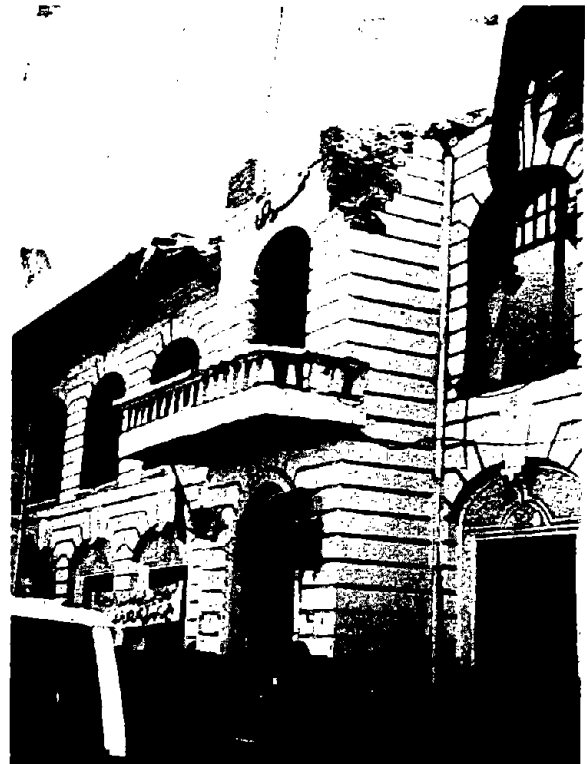
Figure 3-4 Parapet and partial roof collapse of Rasht City Hall.

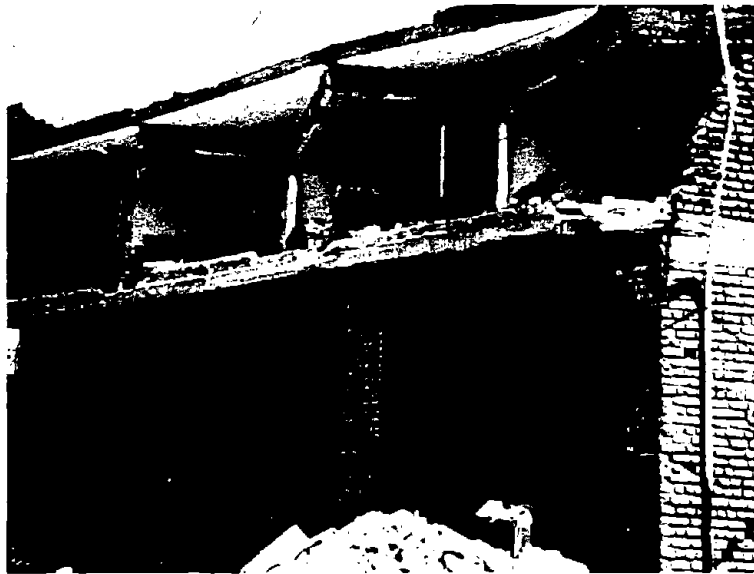
Many unreinforced masonry bearing wall structures used reinforced concrete bond beams (concrete beams poured on top of walls). Potential for total collapse of these buildings appears to have reduced (Fig. 3-6).

Figure 3-6 Building of Figure 3-5. Presence of reinforced concrete bond beam prevented roof collapse

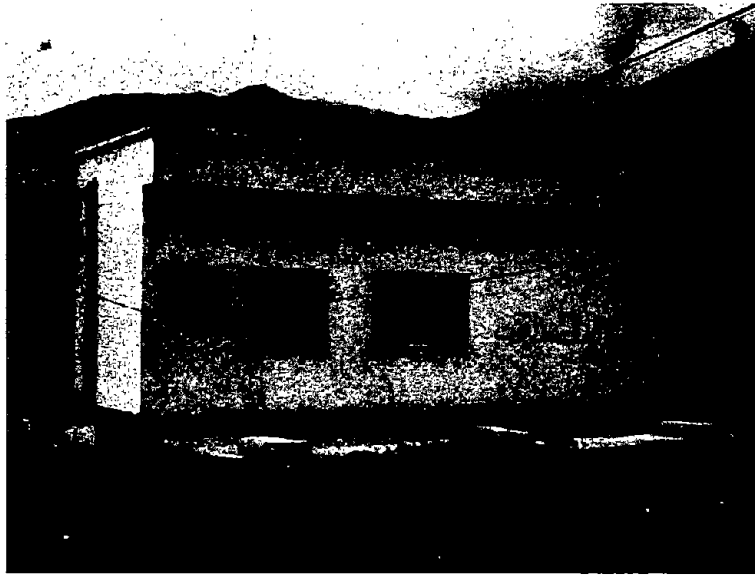
A exception to the damage pattern is the Rostamabad post office (Fig. 3-7) which appears to be unreinforced masonry, but remained undamaged. Further review of this building should reveal the reasons for its good performance.

Figure 3-7 Post office building in the area of high ground motion appears to be undamaged

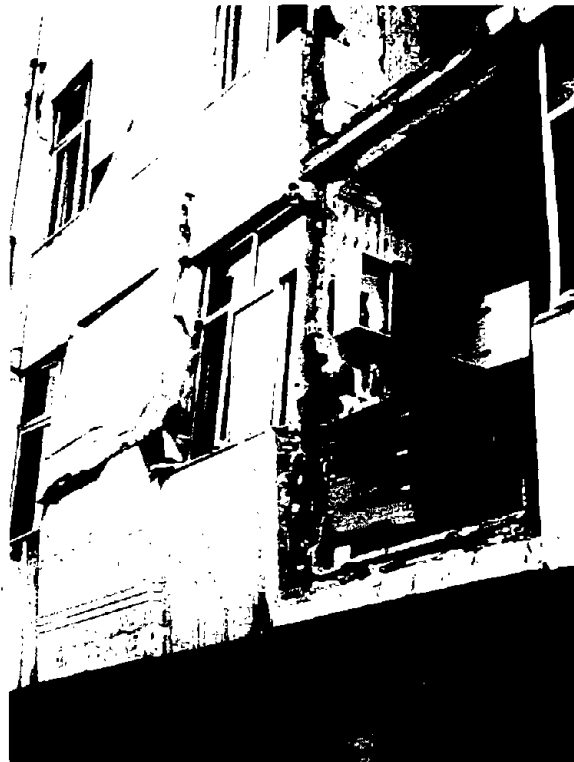
Thin unreinforced hollow or solid brick masonry infill is used almost exclusively in buildings in Iran. These thin walls have repeatedly proved to have poor performance in severe earthquakes. Their performance during this earthquake proved not to be an exception. Widespread damage to buildings with thin unreinforced masonry infill occurred in Rasht, located some 60 km from the epicenter. Numerous relatively modern buildings with expensive architectural finishes were evacuated by their residents due to extensive cracking or collapse of these "non-structural" elements (Fig. 3-8).

Figure 3-8 Typical damage to hollow clay unreinforced masonry infill walls

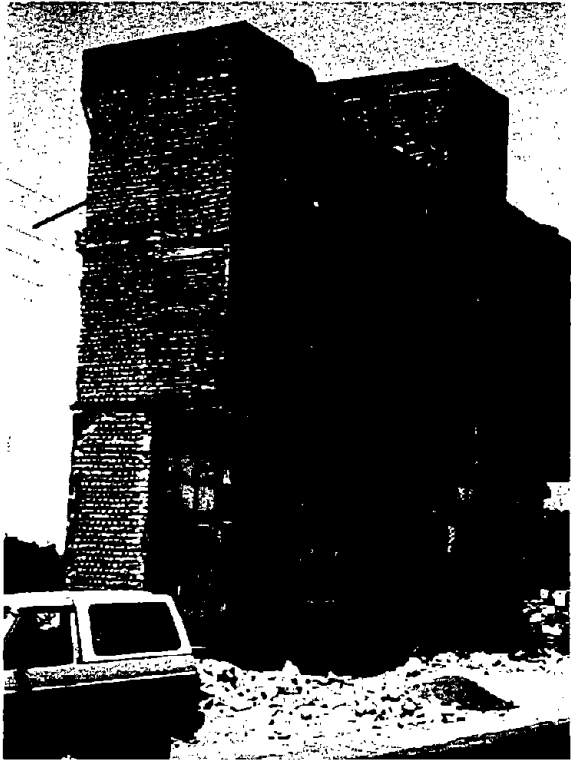
The thin unreinforced masonry infill in a three-story steel structure in Manjil (Fig. 3-9) appears to have performed better due to the presence of light steel sections which had been installed in plane of the wall. This resulted in reduction of wall span for out-of-plane bending.

Figure 3-9 Masonry infill constructed with light steel reinforcement

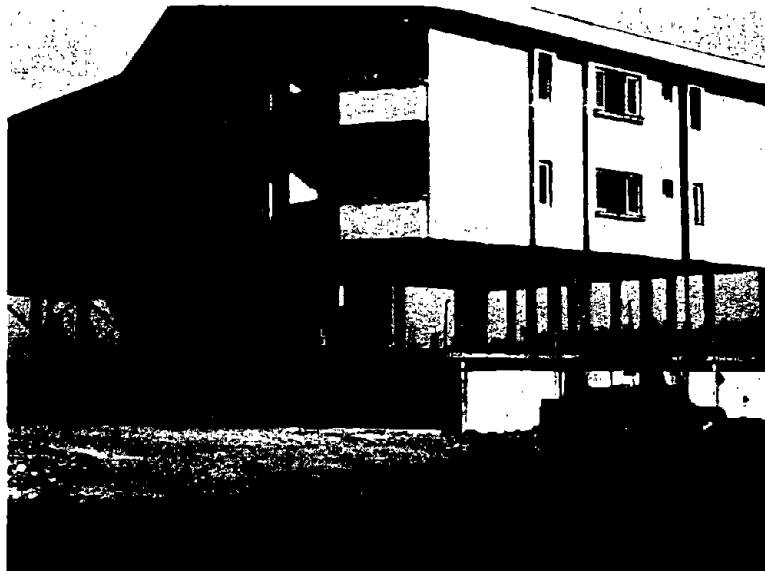
Extensive damage was experienced in many of these steel buildings which have 4 to 8 stories. Several cases of total collapse occurred in the City of Rasht, where a majority of these structures were constructed. The degree of damage to mid-rise steel buildings in Rasht could also be related to the hypothesized long period of the ground motion in this city. The damage to all steel structures surveyed by the author may be traced to major deficiencies in the design and construction of the structures. Fig. 3-10 shows a 4-story damaged steel structure which lacks bracing on one side. The bracing, where provided, is shown in Fig. 3-11. These braces failed at the connections and, according to the building technician, have been repaired to their original configuration. This points to very poor design of brace as well as welding at connections. Poor welding was also observed in the gravity load system of this building.

Figure 3-10 Damaged steel structure with inadequate bracing

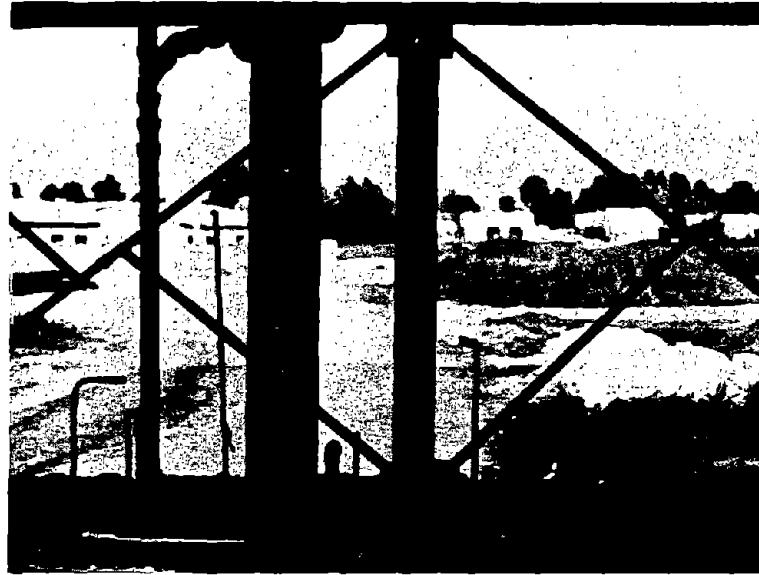
Figure 3-11 Steel bracing of building in figure 3-10.

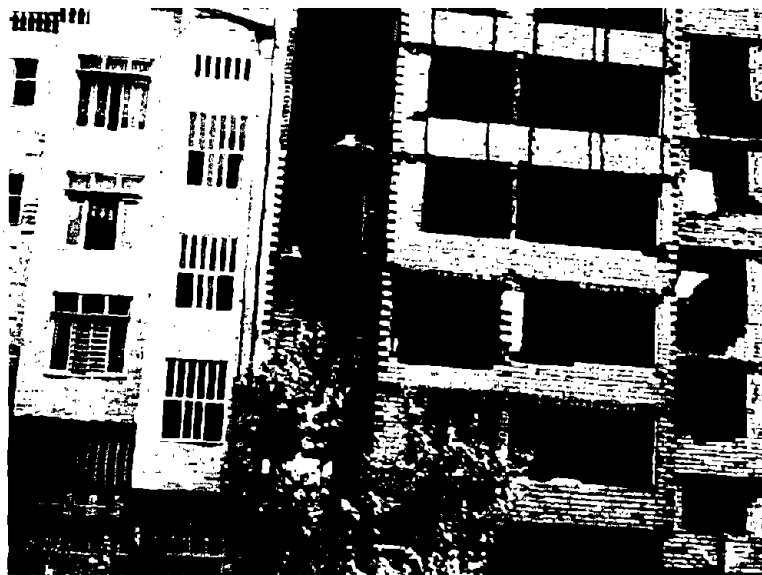
Fig. 3-12 shows permanent sway of an 8-story steel structure which was under construction at the time of earthquake. Fig. 3-13 shows the second floor framing of the same building, indicating a lack of moment frames in the direction in which permanent sway occurred.

Figure 3-12 Permanent sway of an 8-story steel structure under construction

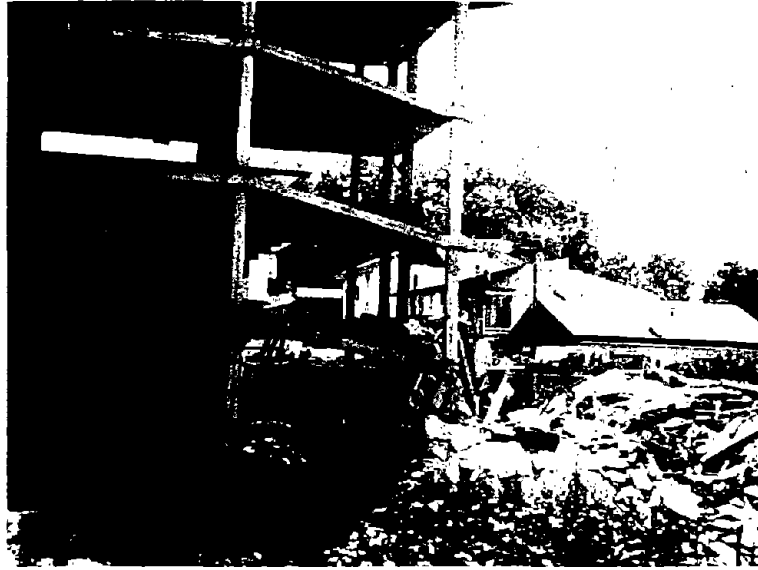
Fig. 3-15 shows two adjacent 5-story concrete frame buildings that were under construction at the time of the earthquake. The structure on the right collapsed completely, impacting and buckling the corner column of the structure to the left.

Figure 3-15 Collapse of a mid-rise concrete building and damage to the adjacent building.

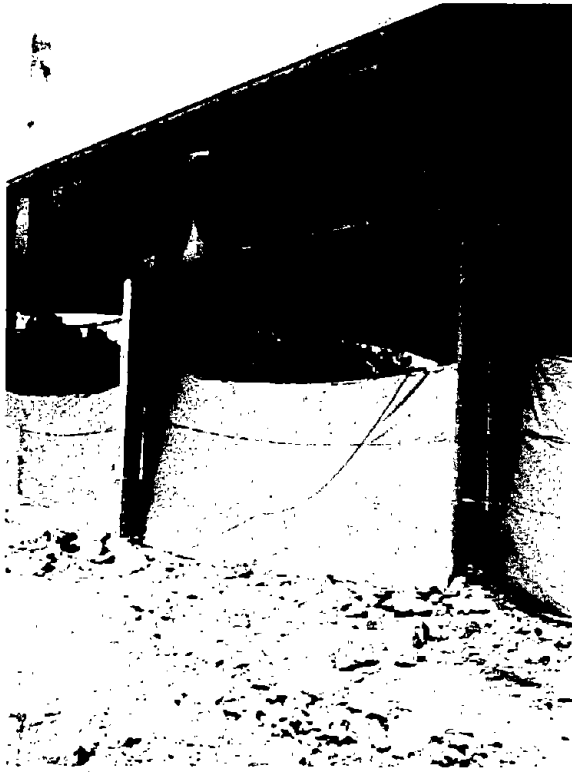
A great majority of industrial buildings in the earthquake stricken area are of light steel construction (Soule or Butler type). Although extensive damage and collapse of infill was experienced, the structure itself performed well. Even when the steel rod-bracing was ruptured, the structure often remained undamaged. Fig. 3-17 shows such a structure in Ganjeh, some 30 km from the epicenter.

Figure 3-17 Light steel industrial building without structural damage after rupture of rod bracing.

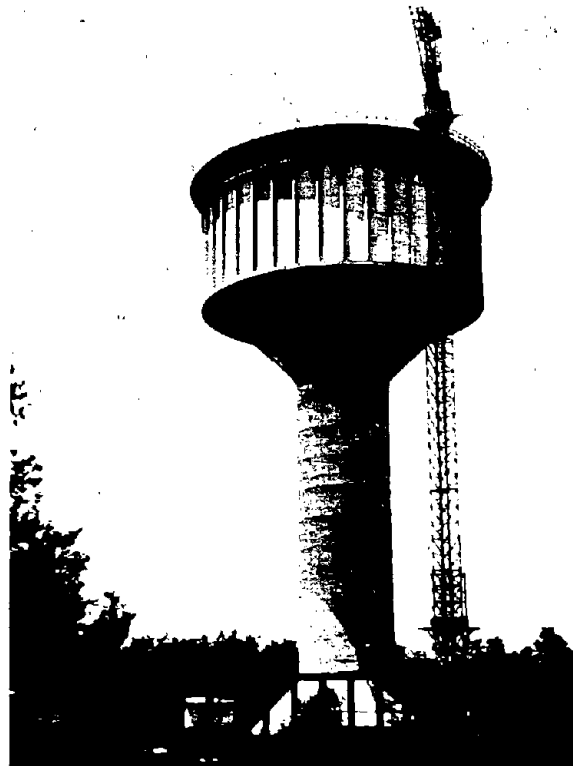
Two similar elevated tanks (Fig. 3-18) in the same area, which were under construction and were thus empty, experienced horizontal cracks at the shaft near the base.

Figure 3-18 Concrete elevated water tank without water exhibited tension cracks at the base of its shaft.

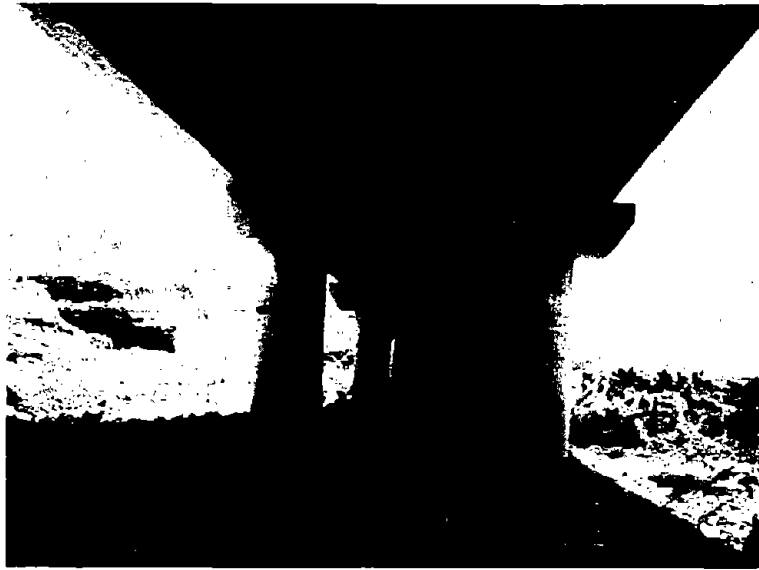
Bridges: There are many steel and concrete bridges in the area. No major damage to bridges was reported. One major bridge (Fig. 3-21) within 20 km of the epicenter showed lateral displacement at the ground level of approximately 10 inches (Fig. 3-22). There was no readily observable damage to the columns or girders of this bridge.

Figure 3-21 Concrete bridge with large lateral pier displacement appears to be undamaged
