Case Studies of Liquefaction and Lifeline Performance During Past Earthquakes

Volume 1
Japanese Case Studies

Edited by
M. Hamada and T. D. O'Rourke

Technical Report NCEER-92-0001

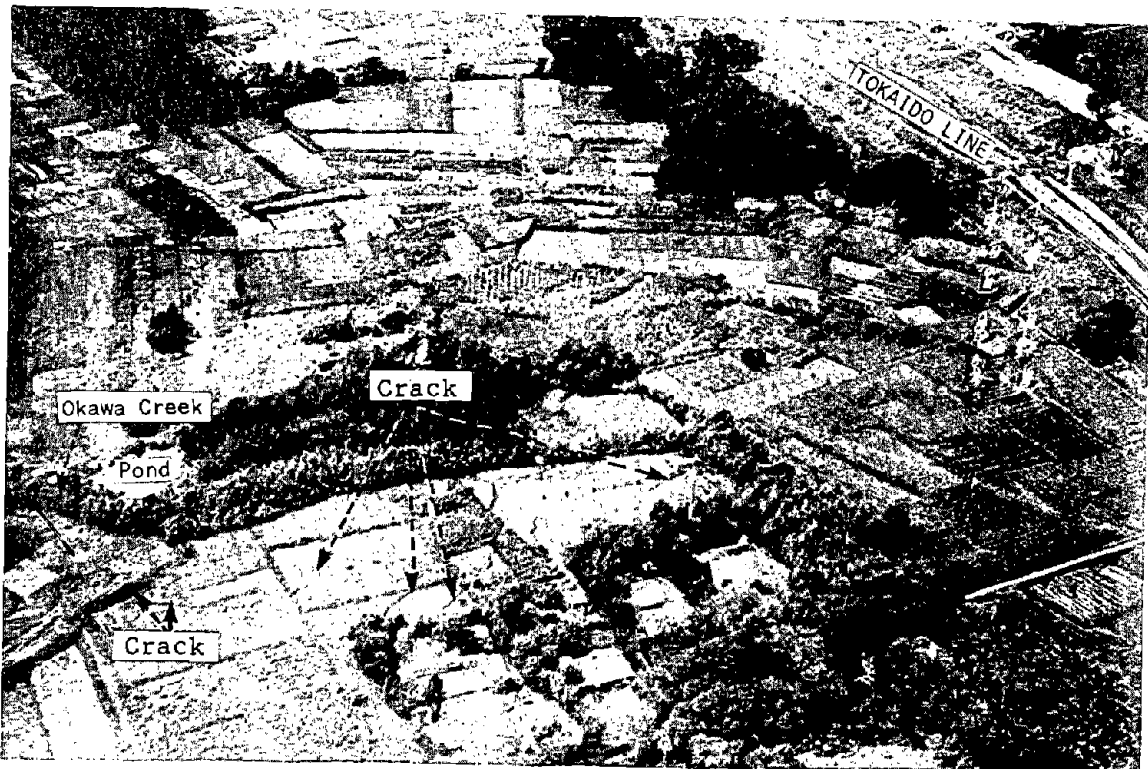
Figure 7 Aerial Photograph of Nakajima Area Showing Ground Cracks Caused by the Kanto Earthquake (Looking Southeast) (Association for the Development of National Education, 1926)¹⁵⁾

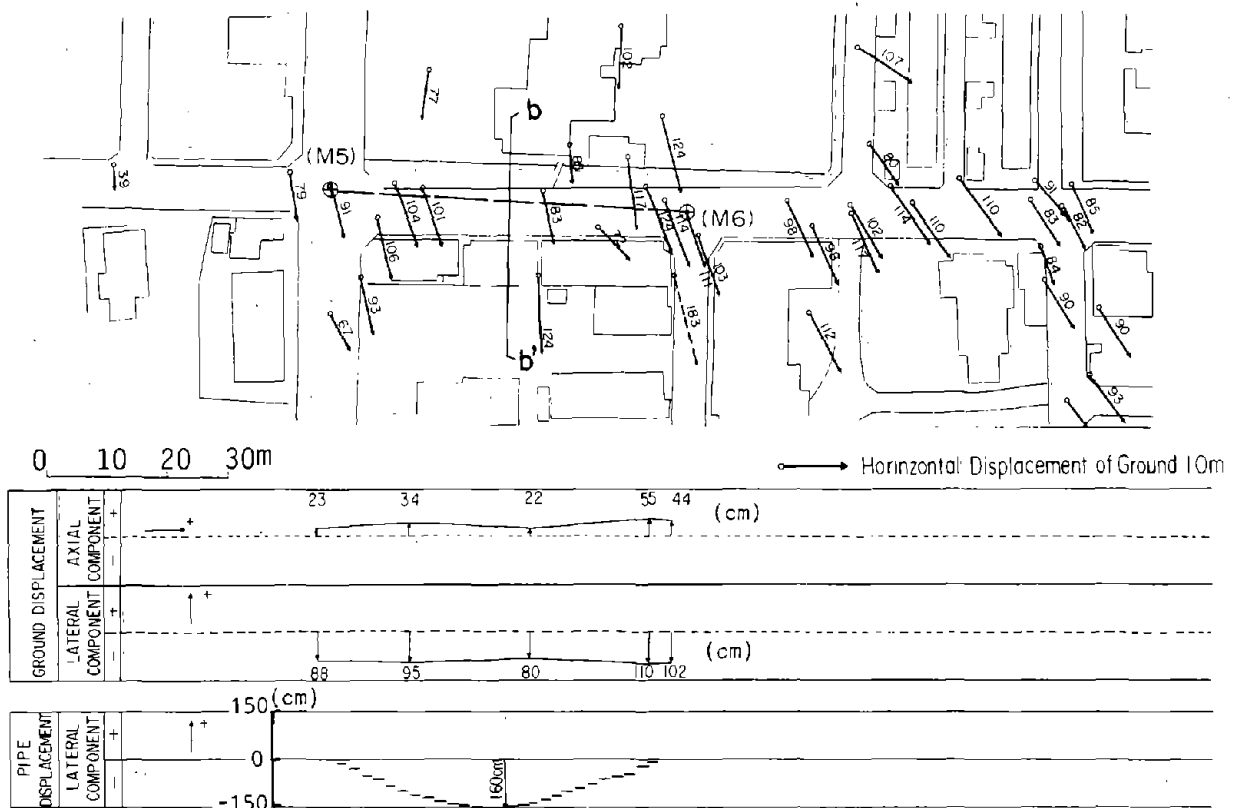
Figure 29. Movement of Wastewater Pipe and Ground Displacements (Haginodai Route)

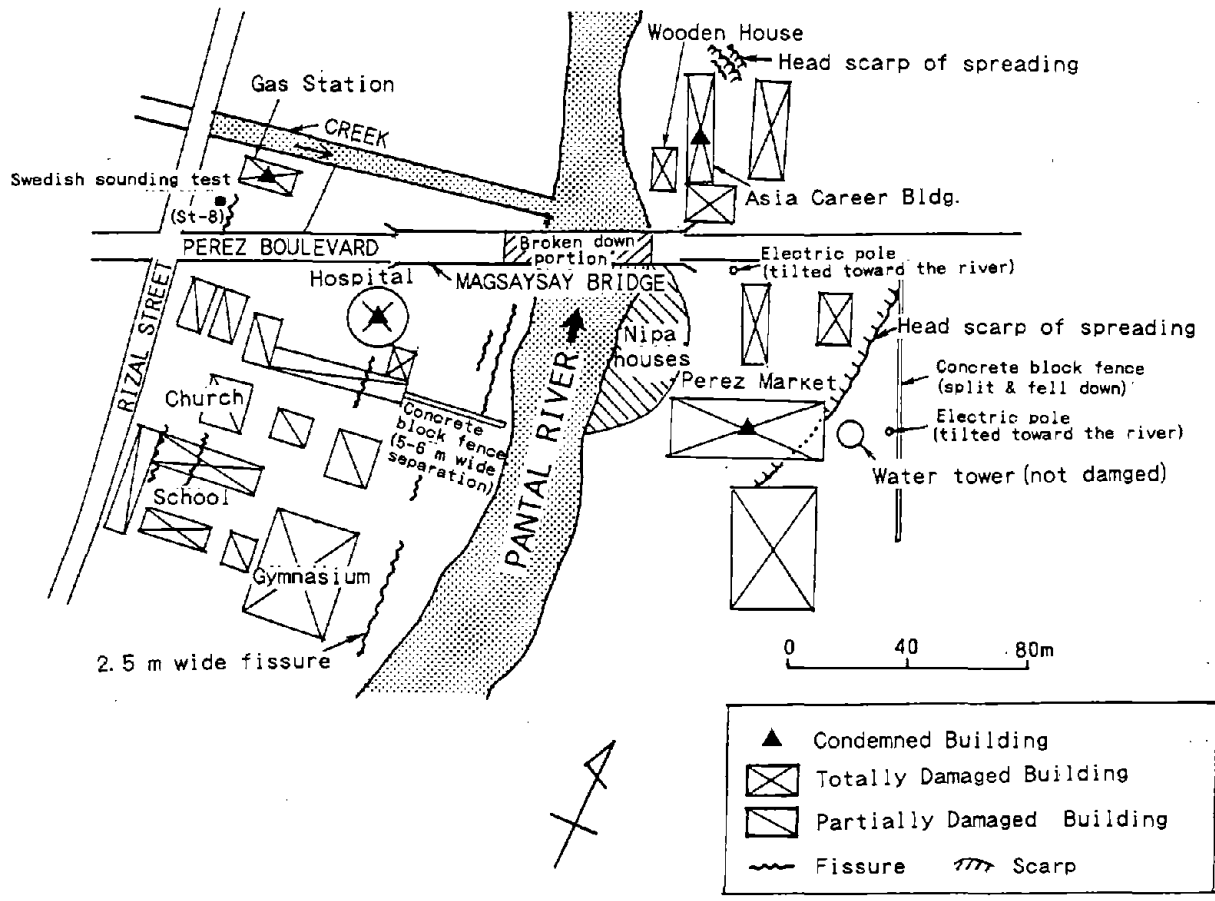
Figure 6. Damage in the Vicinity of Magsaysay Bridge

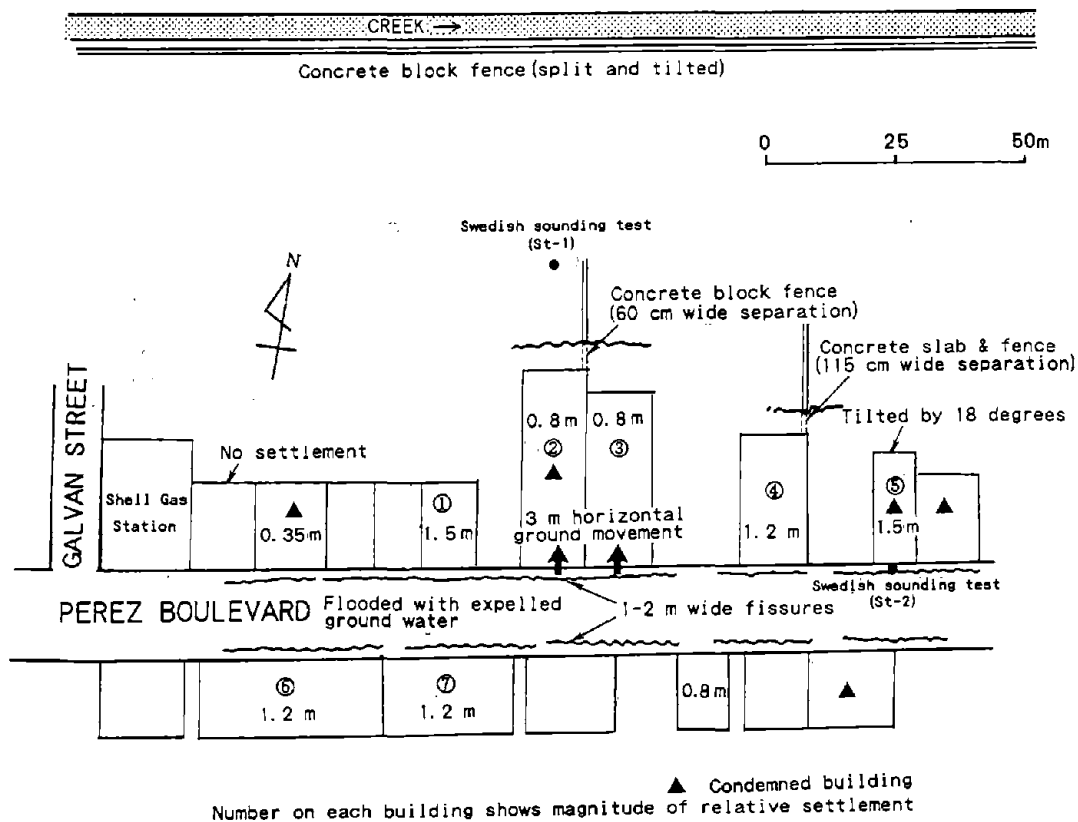
Figure 8. Damage in the Central Section of Perez Boulevard

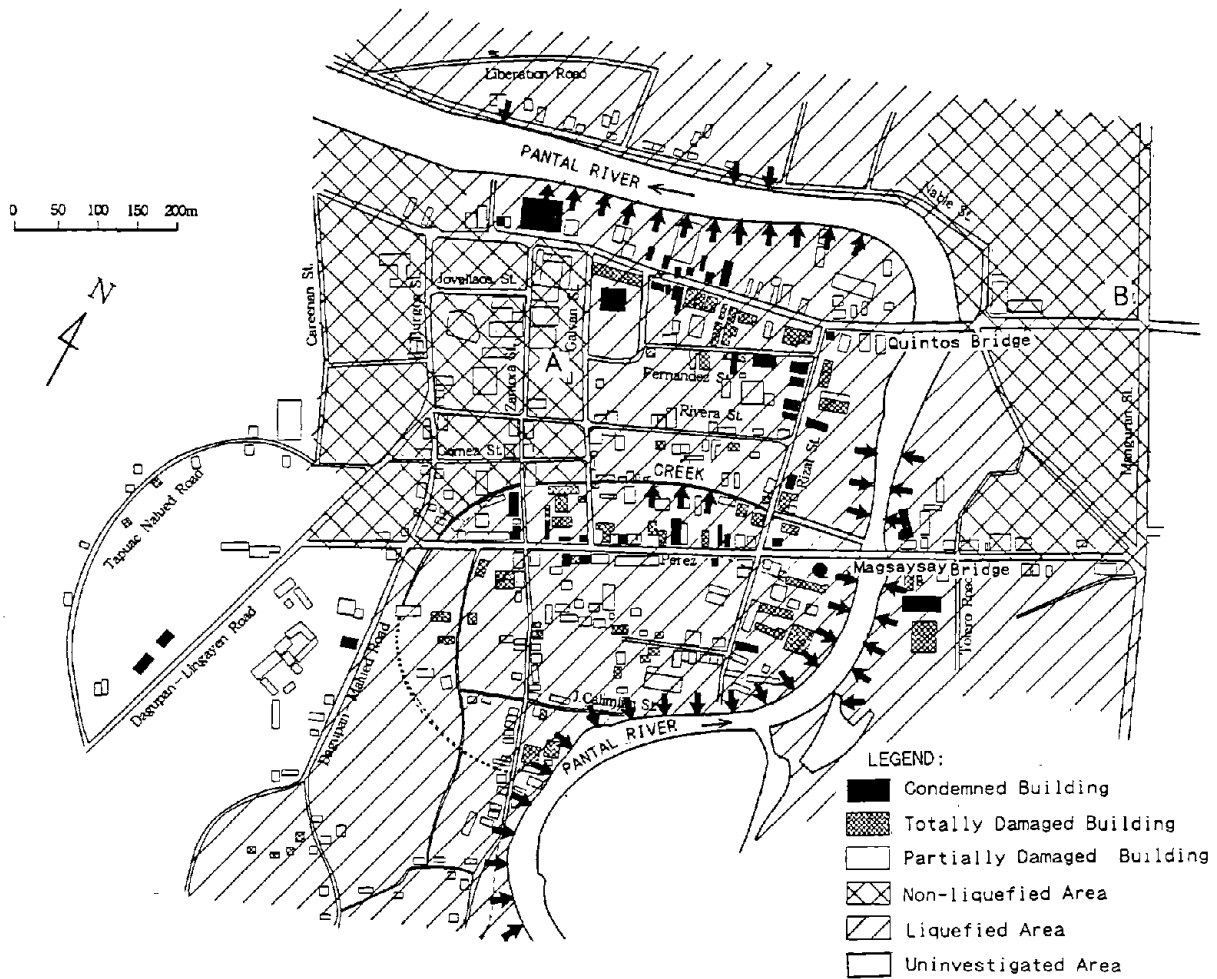
Figure 11. Damage to Buildings and Liquefied Area in Central Dagupan
