Case Studies of
Liquefaction and Lifeline
Performance During Past Earthquakes

Volume 2
United States Case Studies

Edited by
T. D. O'Rourke and M. Hamada

Technical Report NCEER-92-0002

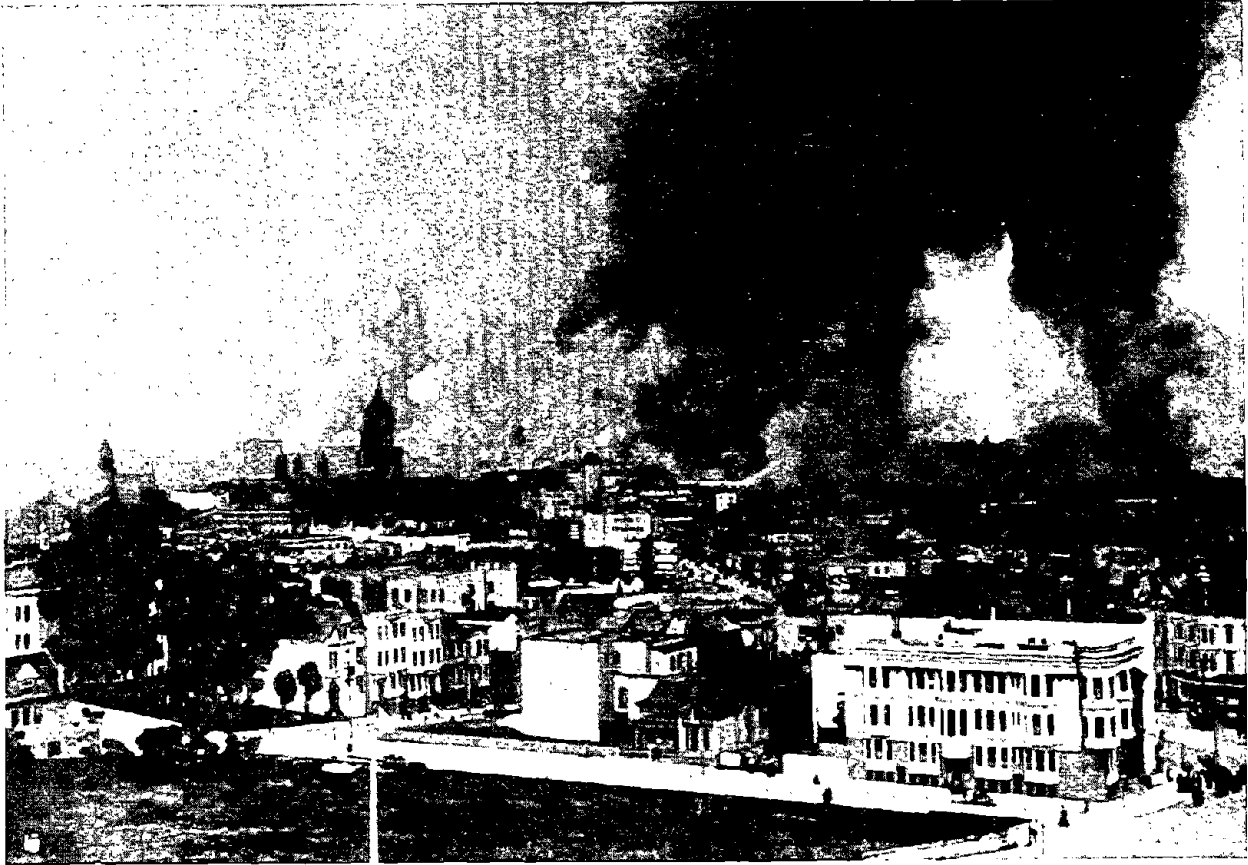
Fire following the 1906 San Francisco earthquake as seen by looking northeast from Duboce Park. The fire burned 10.6 km², destroying 490 city blocks and causing partial destruction of 32 additional blocks. Fire fighting was severely hampered by ruptured water mains at locations of soil liquefaction. This conflagration was the largest single fire loss in U.S. history. (photo courtesy of San Francisco Public Library)

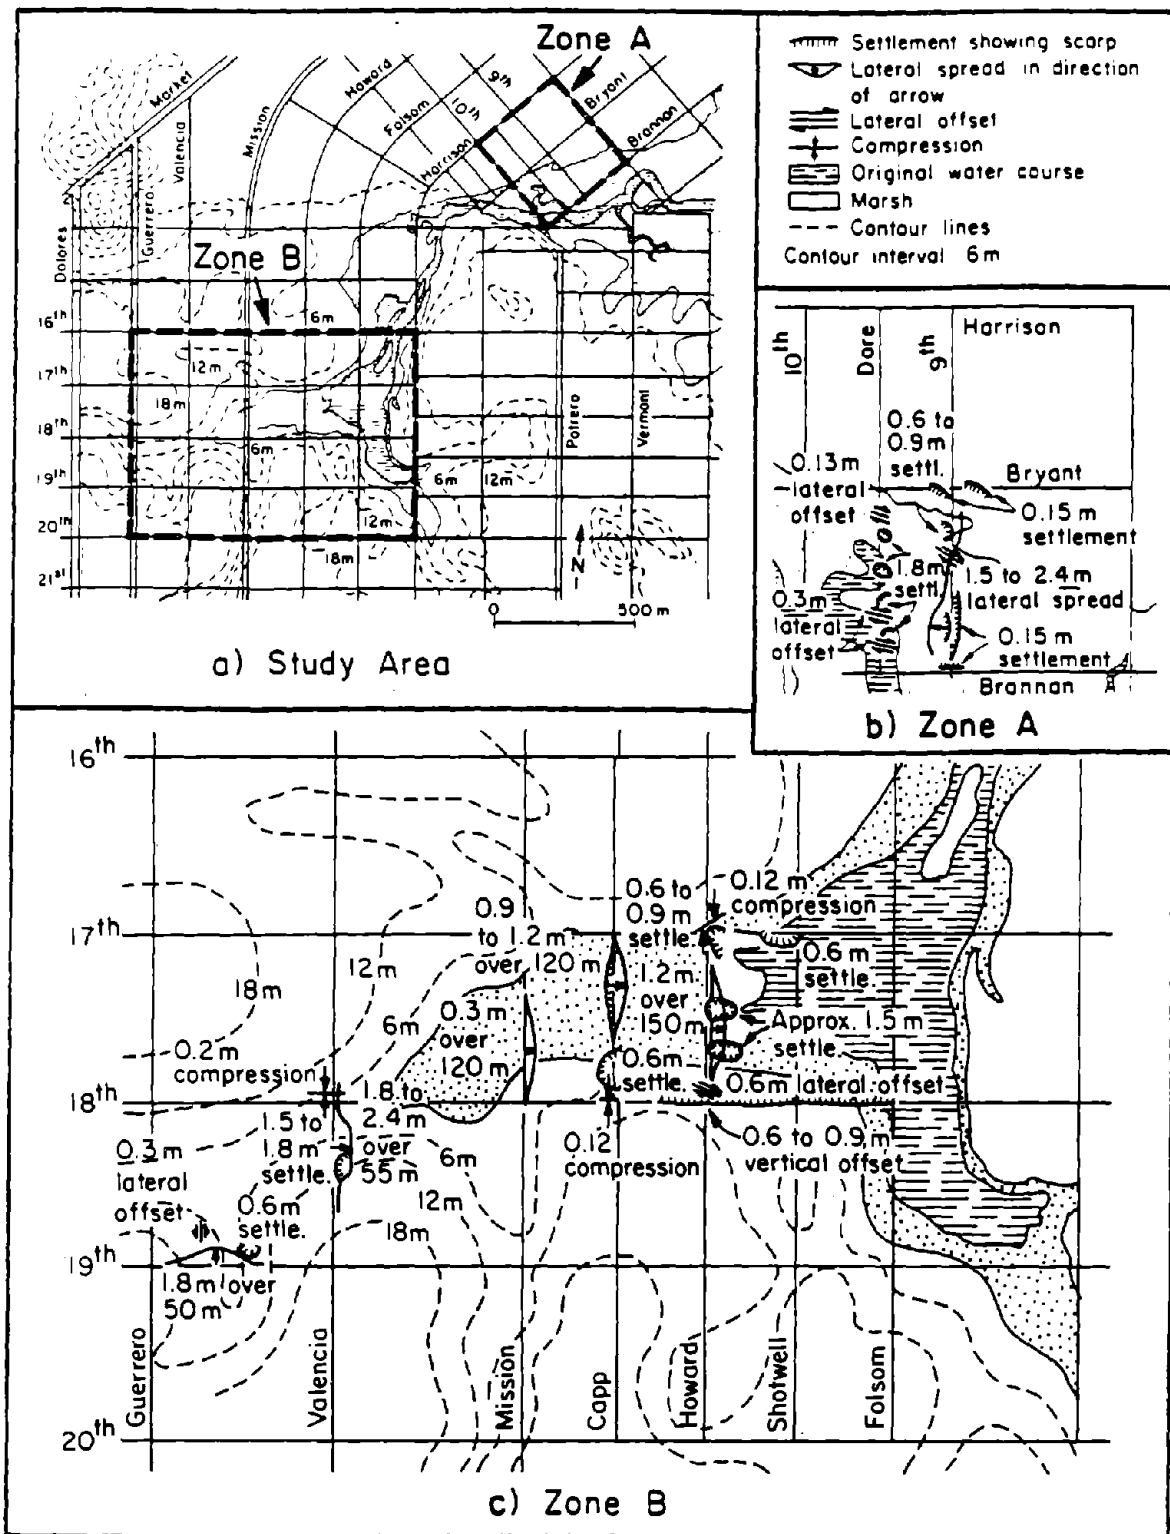
Figure 9. Earthquake-Induced Ground Movements in Mission Creek Zone

On Howard St., toward the center of the block, examples of bearing capacity ground failure can be seen in photographs of wood frame houses which were left tilting severely off vertical. The street and the adjacent land in front of the houses settled considerably, up to as much as 1.5 m in areas. Immediately after the earthquake, only about one-third of all the buildings within a four-block area, between 17th and 18th Sts. from Folsom to Valencia Sts., were left

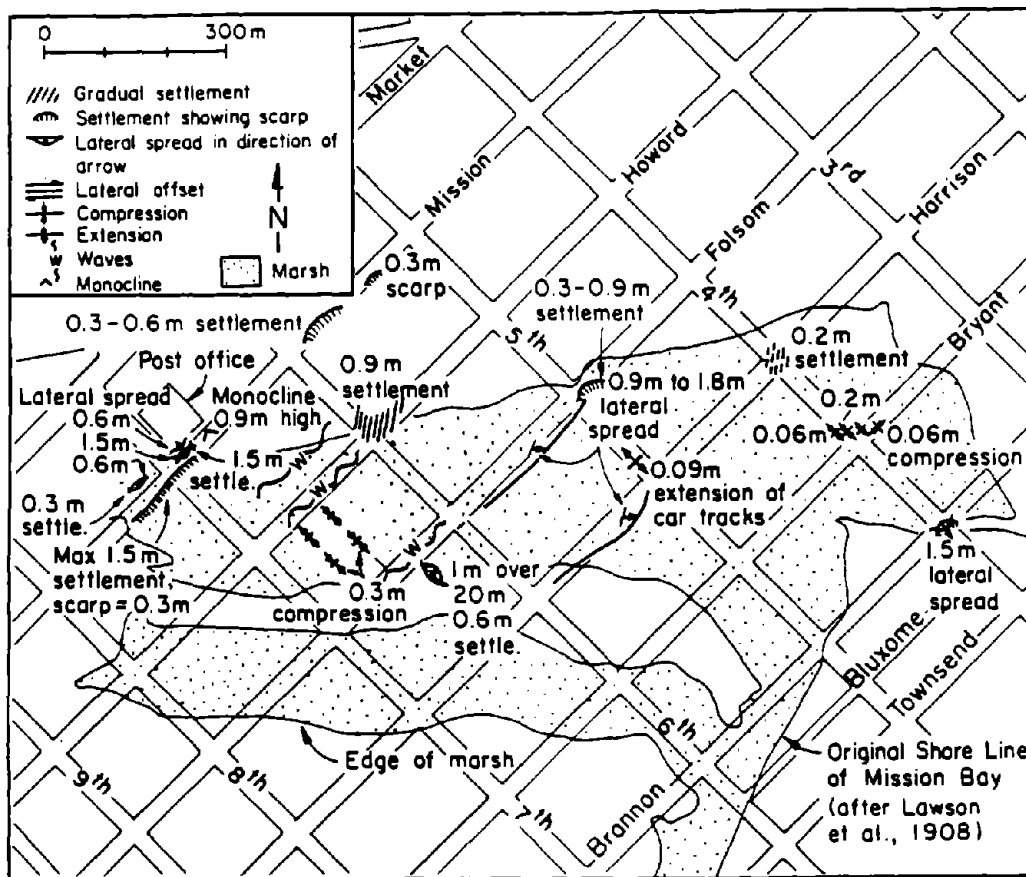
Figure 13. Earthquake-Induced Ground Deformations in South of Market Area

The northern limit of ground movements in this zone was Mission St. at 7th St. near the head of the former marsh. The post office, the southern corner of which was founded on filled ground, settled 0.6 m at the building line and 1.5 m at the curb. The ground displaced laterally 1.5 to 2.1 m southwest of the building. A 0.9-m-high monocline near the southwest corner of the building bent cable car tracks and pavement blocks into an arch.

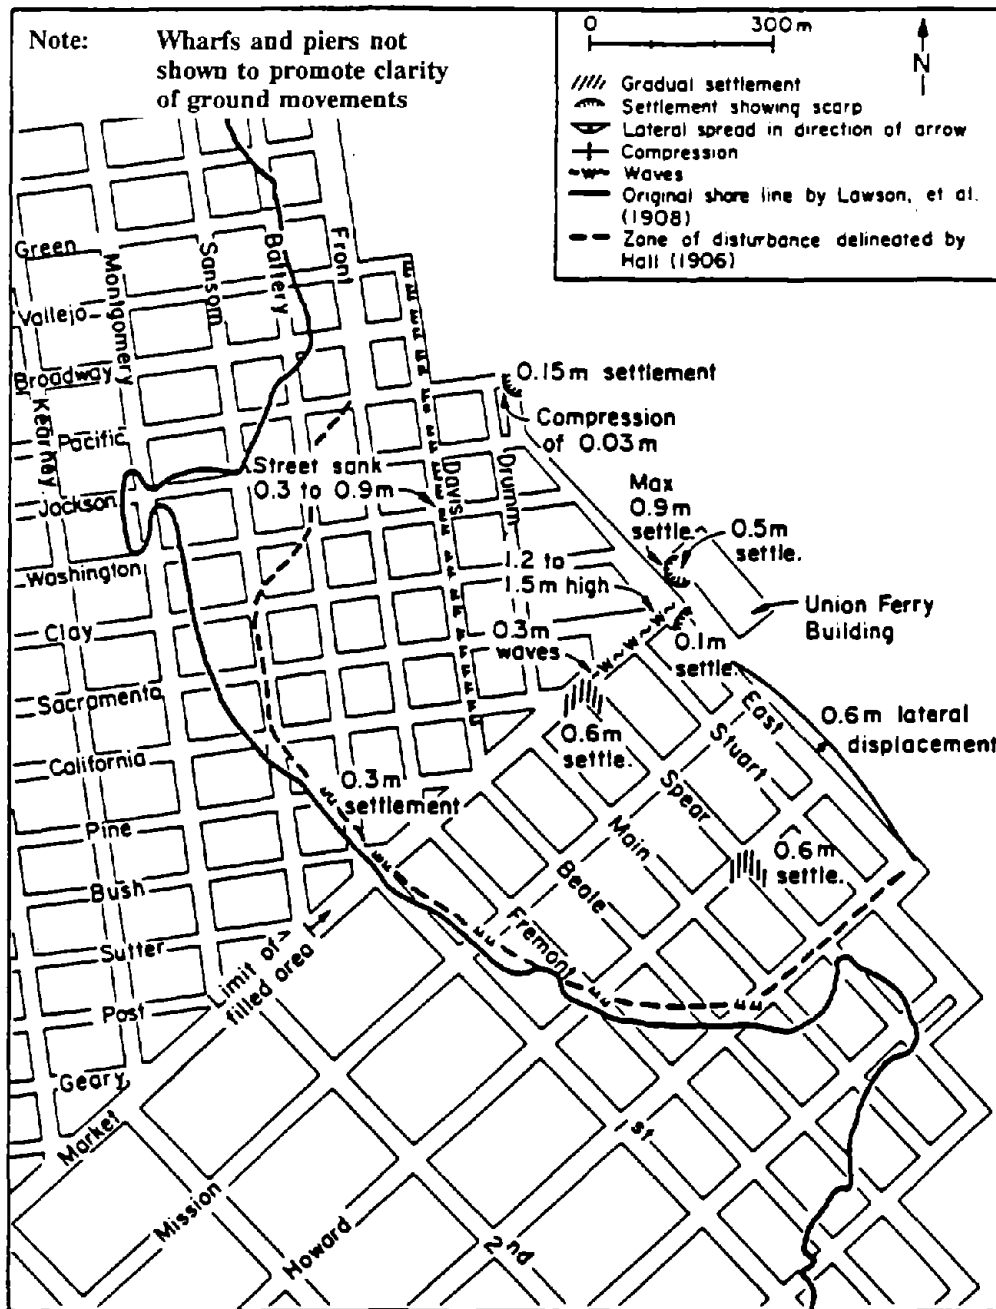
Figure 19. Earthquake-Induced Ground Movements in Foot of Market Area

Much of the area also experienced settlements. Along Davis St. between Vallejo and California Sts., subsidence of 0.3 to 0.9 m was observed at every street crossing (Hall, 1906). Settlements of 0.6 m also occurred along Spear St. at

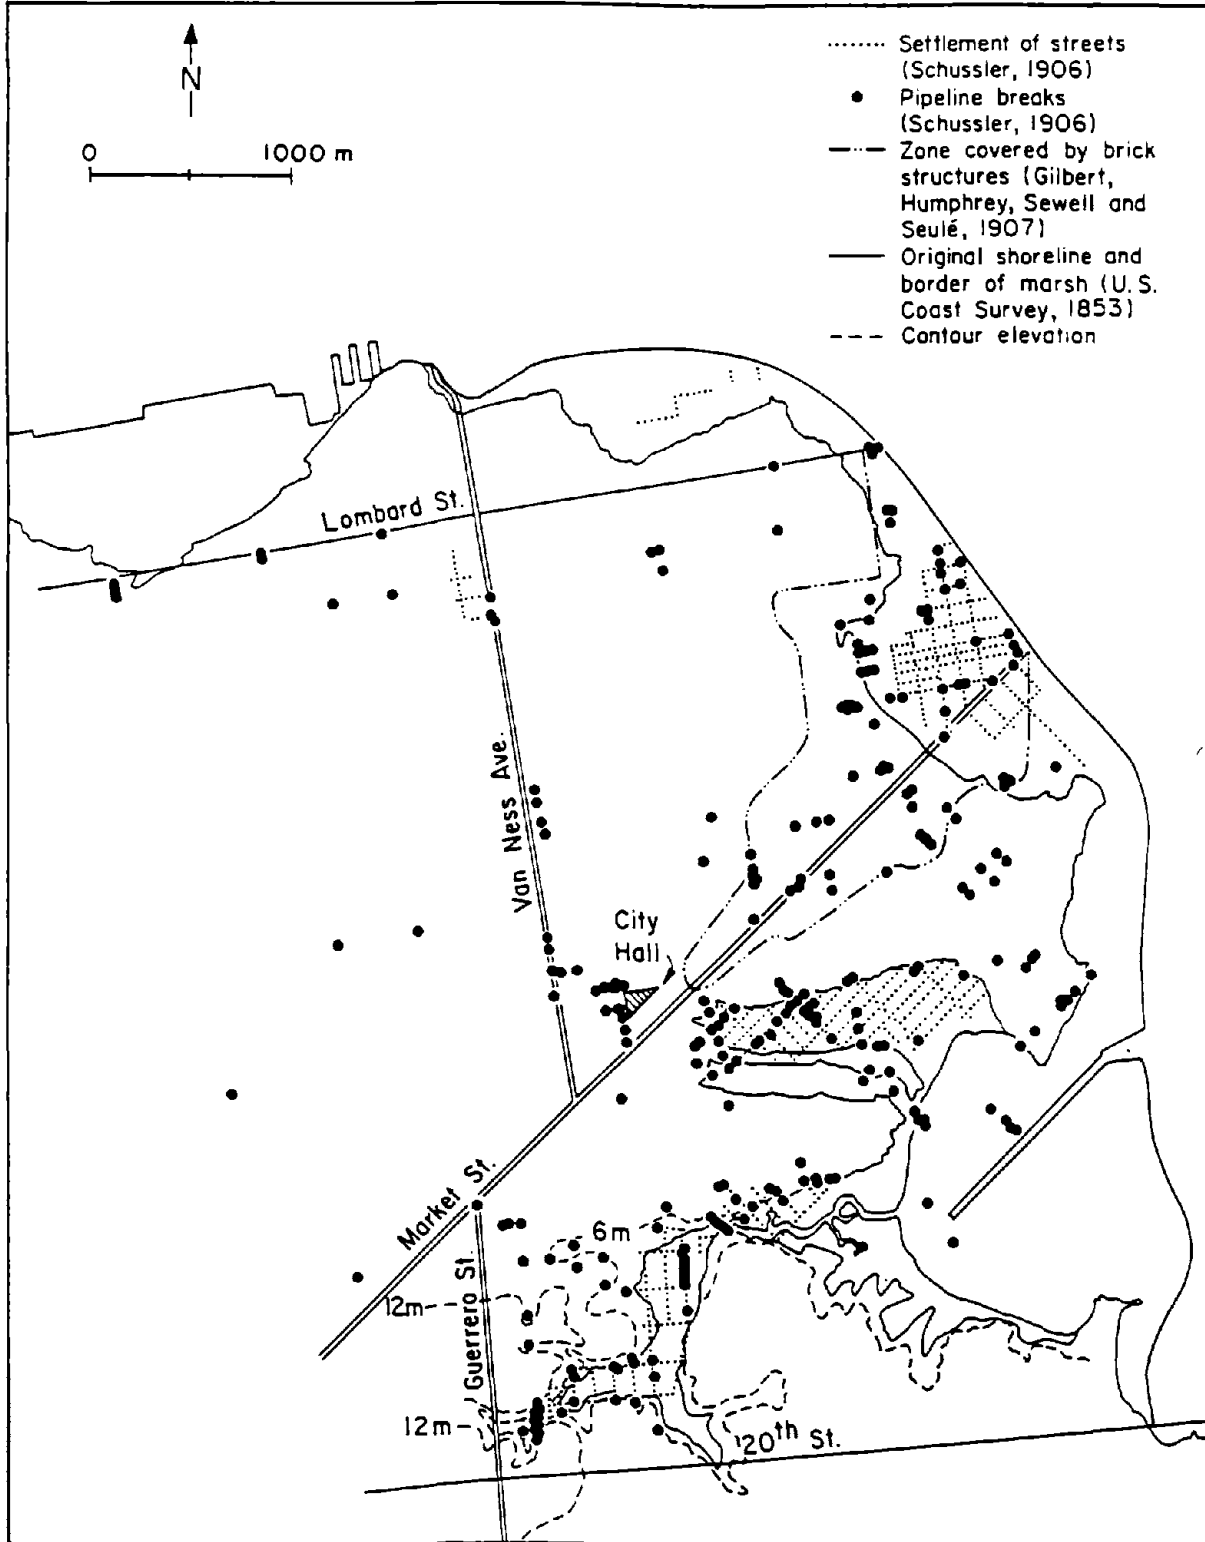
Figure 30. Pipeline Breaks and Street Settlements in San Francisco After 1906 Earthquake (after Schussler, 1906; Manson, 1906)

There is a remarkable correlation between the locations of pipeline breaks and the subsurface topography. Approximately 50% of all pipeline breaks south of Market St. fall on or within the zero contour lines which mark the boundaries of the in-filled marshes and former bay. Approximately 80% of all pipeline breaks south of Market St. fall on or within the 12 m contour lines. As shown in the figure, all of the street settlements occurred in filled areas.

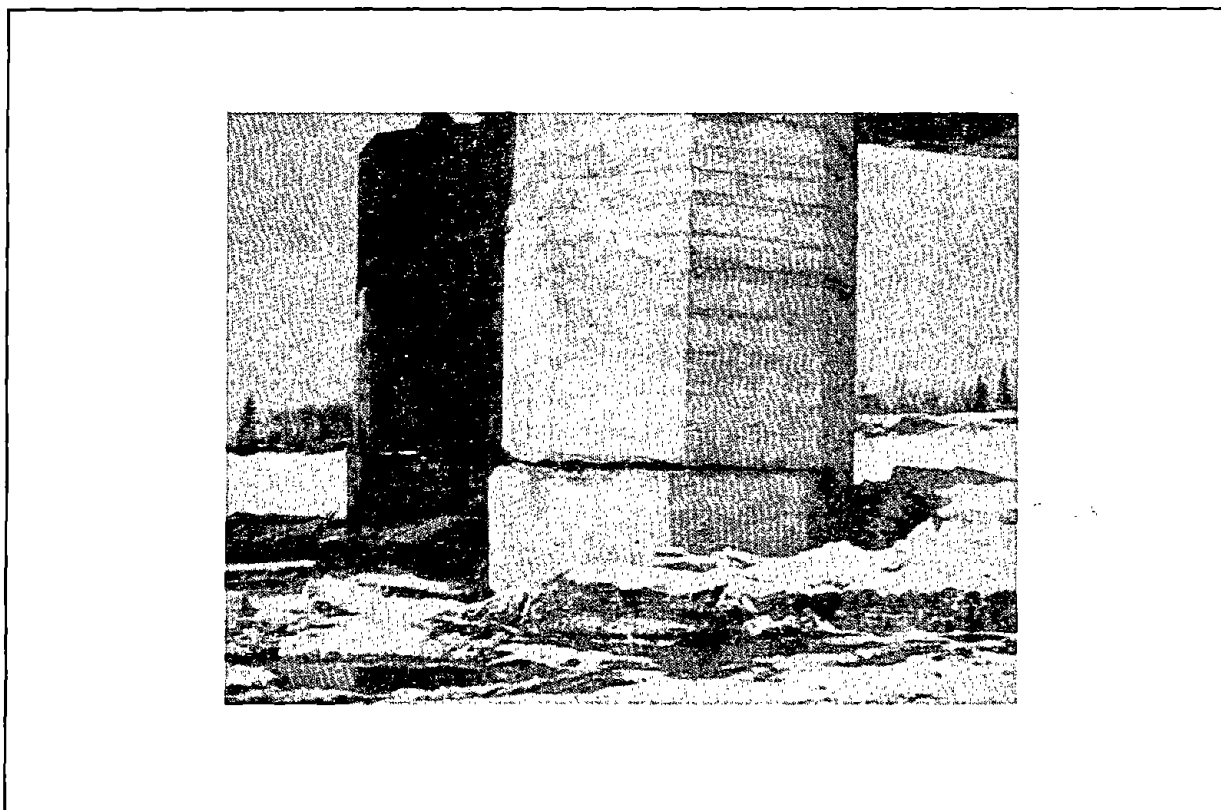
Figure 16 Broken and Displaced Piers at Bridge Milepost 147.1.

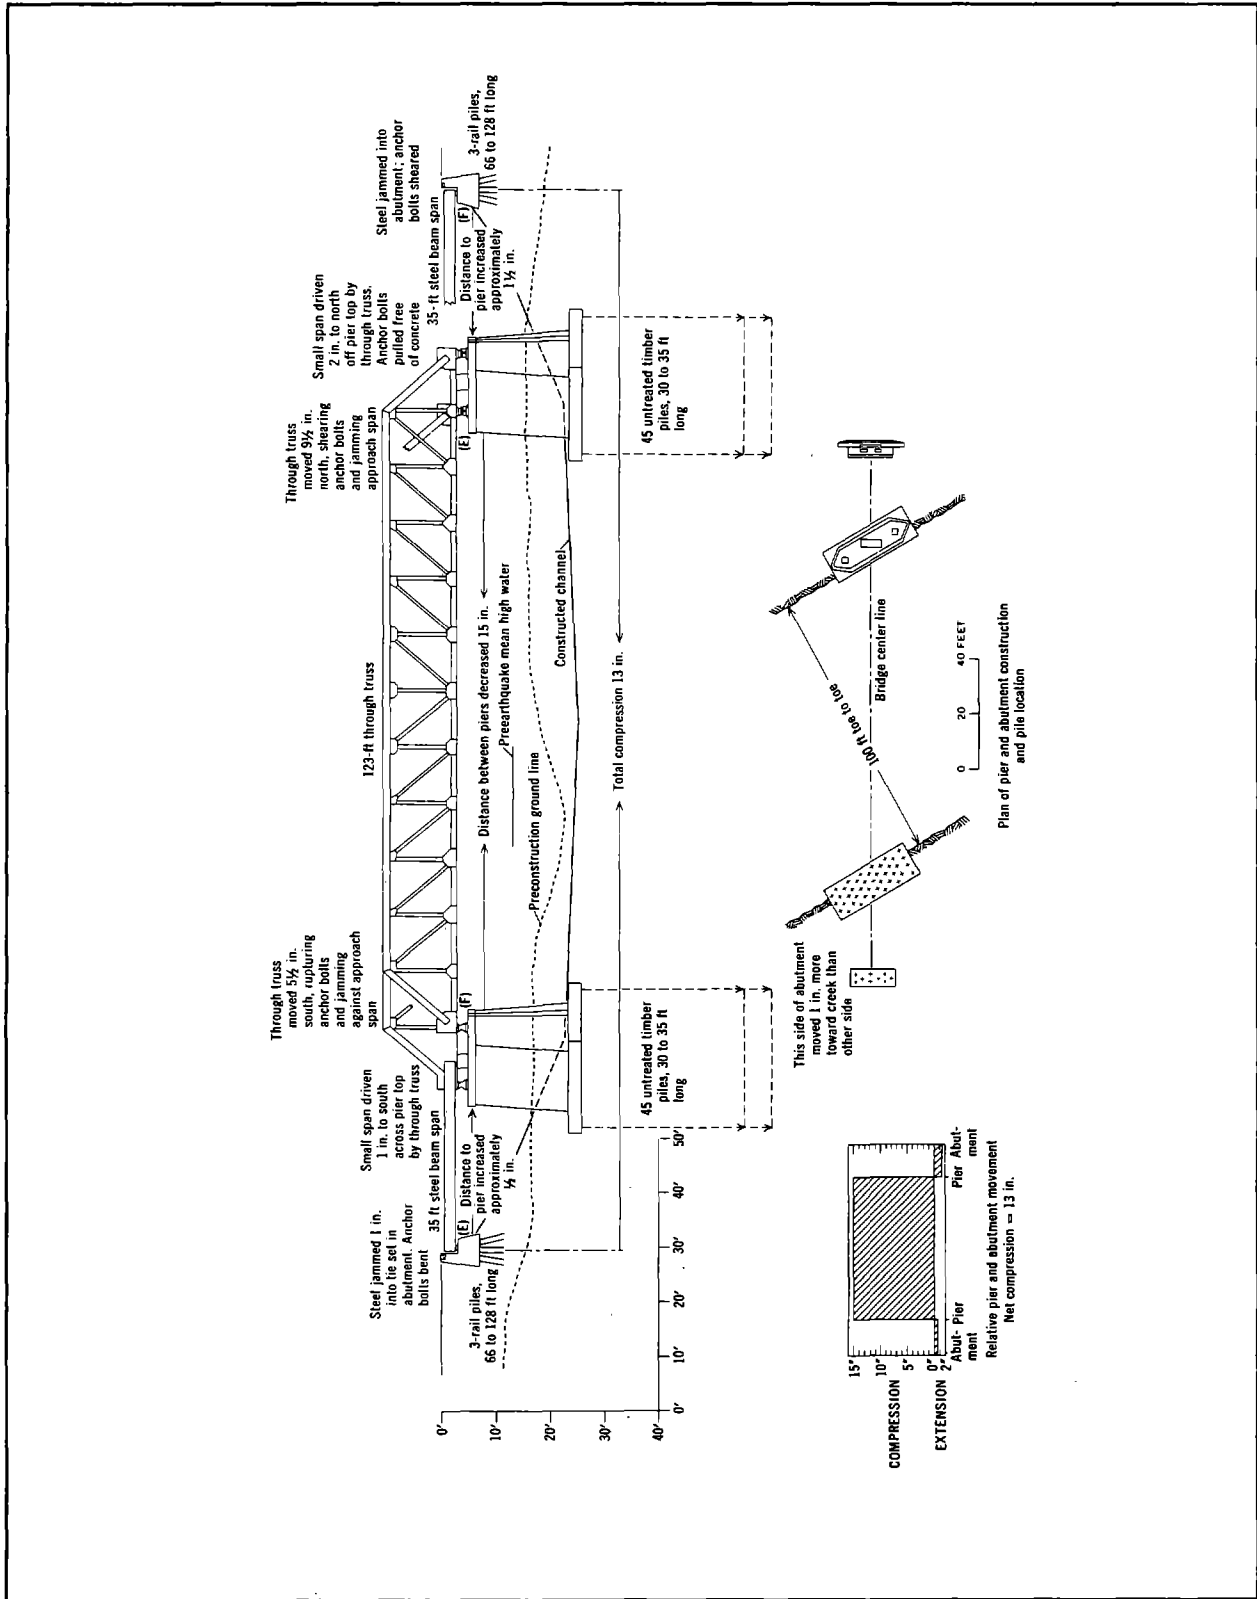
Figure 36 Construction of and Damage to Ship Creek Bridge at Milepost 114.3 (after McCulloch and Bonilla, 1970).

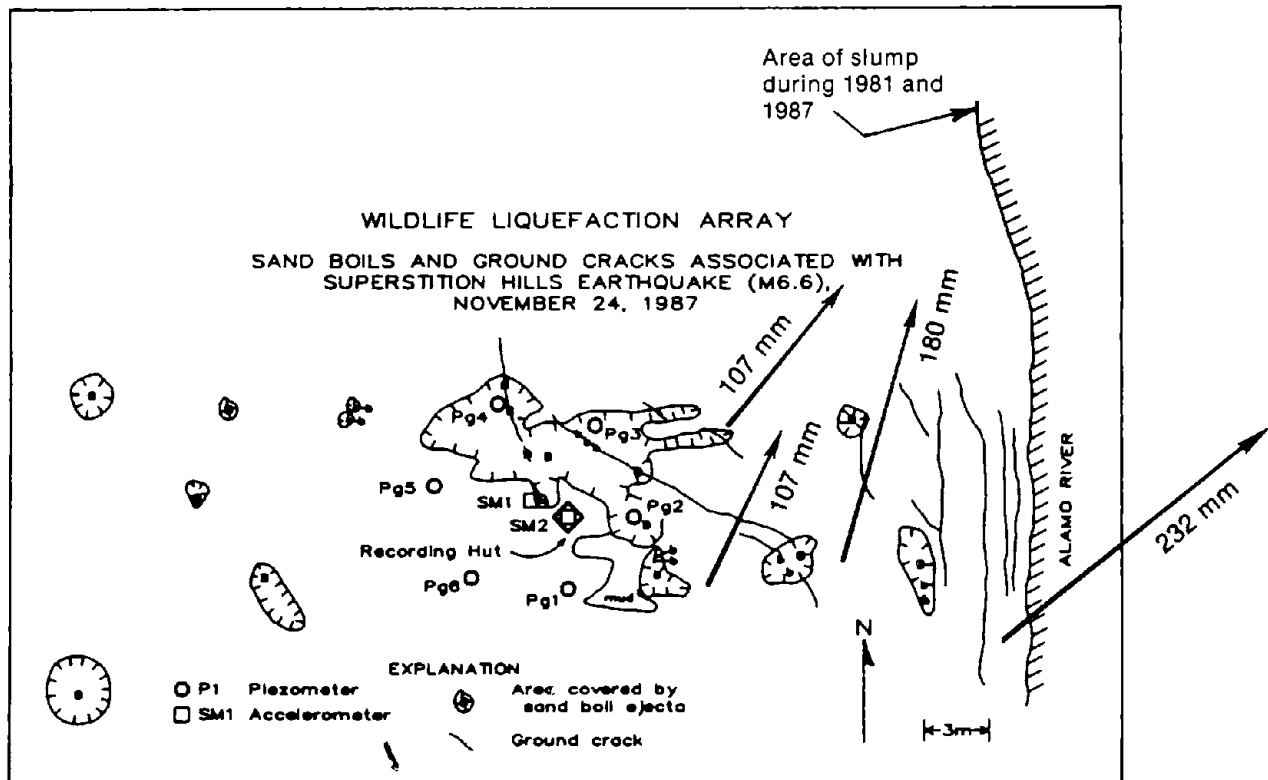
Figure 40. Sand boils, Lateral Spreading, and Cracks at Wildlife Liquefaction Array (Holzer, et al., 1989b; Youd & Bartlett, 1988)
