REPORT NO.
UCB/EERC-90/21
DECEMBER 1990

OBSERVATIONS AND IMPLICATIONS OF TESTS ON THE CYPRESS STREET VIADUCT TEST STRUCTURE

MARTIN E. BOLLO
STEPHEN A. MAHIN
JACK P. MOEHLE
ROY M. STEPHEN
XIAOXUAN QI

Report to the California Department of Transportation

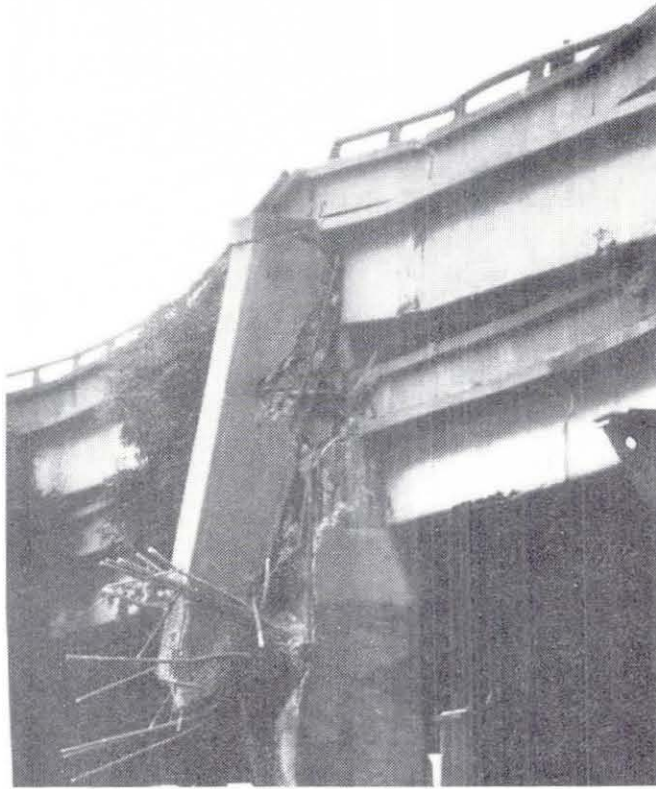
Fig. 1.14 Close-up view of failed column.

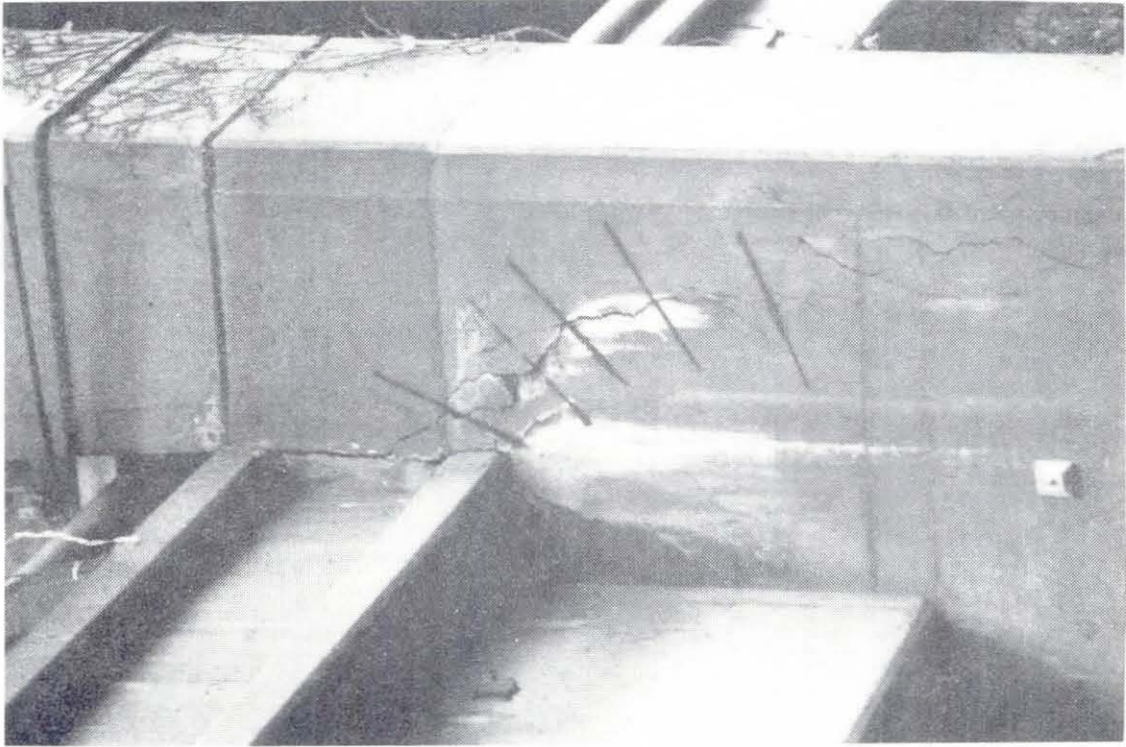
Based on damage observations (e.g., see Figs. 1.16 through 1.19), it appears that the collapse of the typical bent was triggered by failure of the reinforced concrete section that includes the lower beam-column joint and the upper column pedestal just above the joint. Beam-column joints just to the south of the collapsed portion of the viaduct showed cracking damage suggestive of the type of failure observed in the northern portion (Fig. 1.16). The damage shown in Fig. 1.16 occurred in a typical bent of the type illustrated in Fig. 1.4. Other types of frames are likely to have sustained damage and collapse modes different from that shown in Fig. 1.16. However, in all types of frames the collapse appears to have involved failure of the connection between the lower bent cap and the upper column [1.2]. Collapse of the structure is believed to have resulted in several secondary failures such as shear failures in columns, and connection failures in the upper beam-column joints. Demolition photos (Appendix A) demonstrate how local damage to a column could have contributed to a progressive collapse of the structure.

Fig. 1.17 Joint cracking.

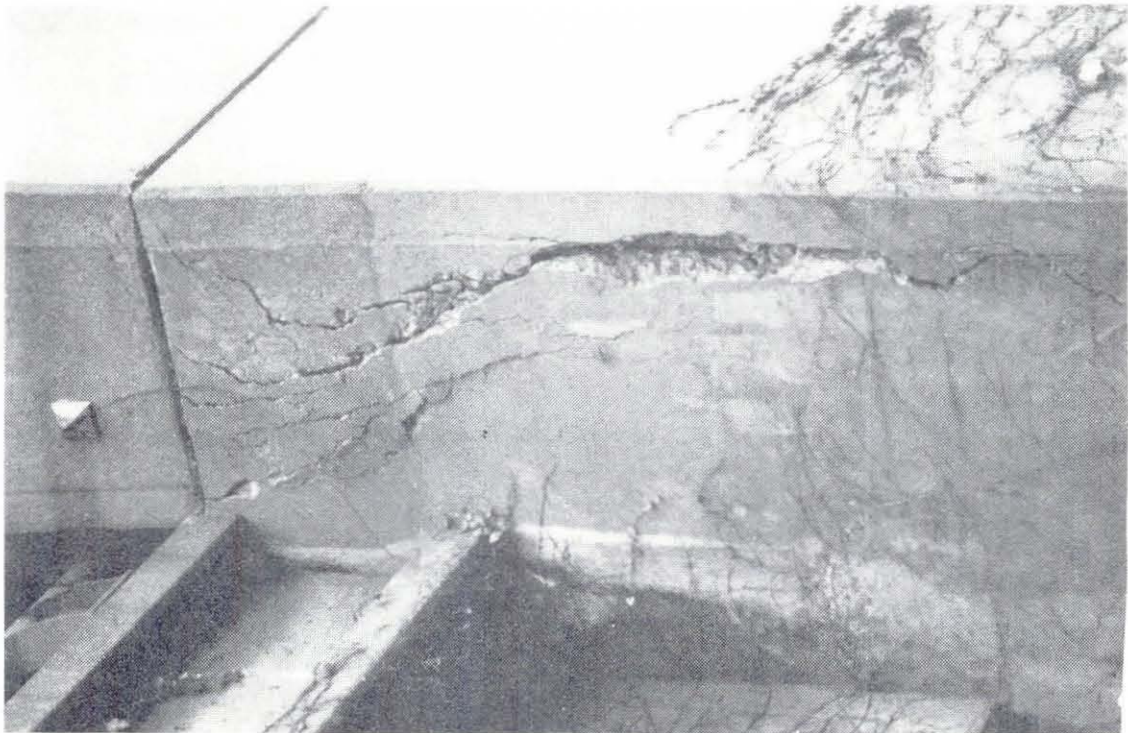
Fig. 1.16 Joint cracking indicative of incipient failure.

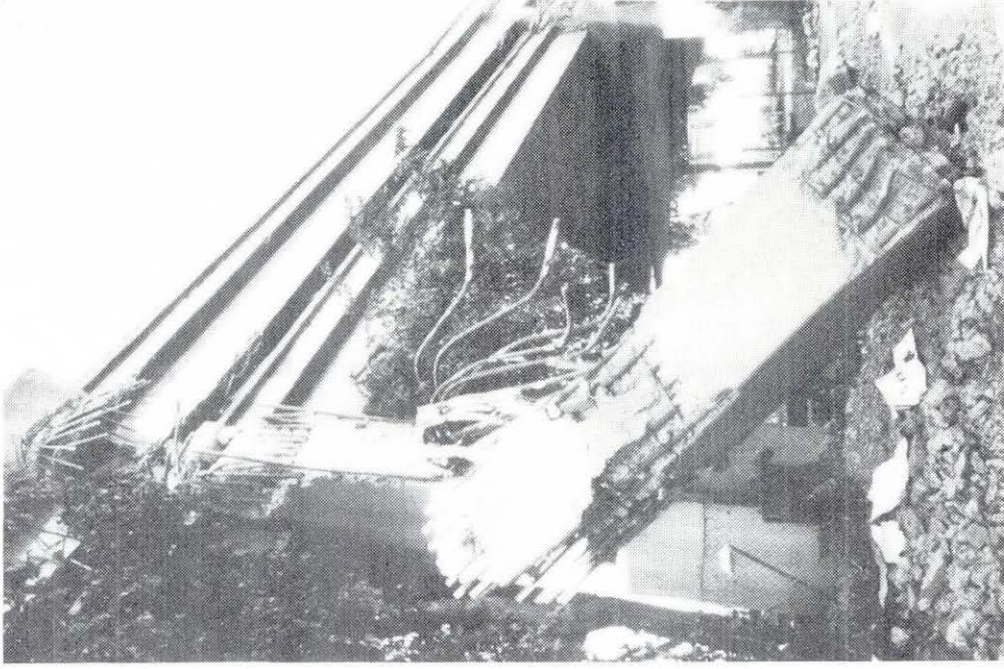
Fig. 1.19 Fallen upper column.

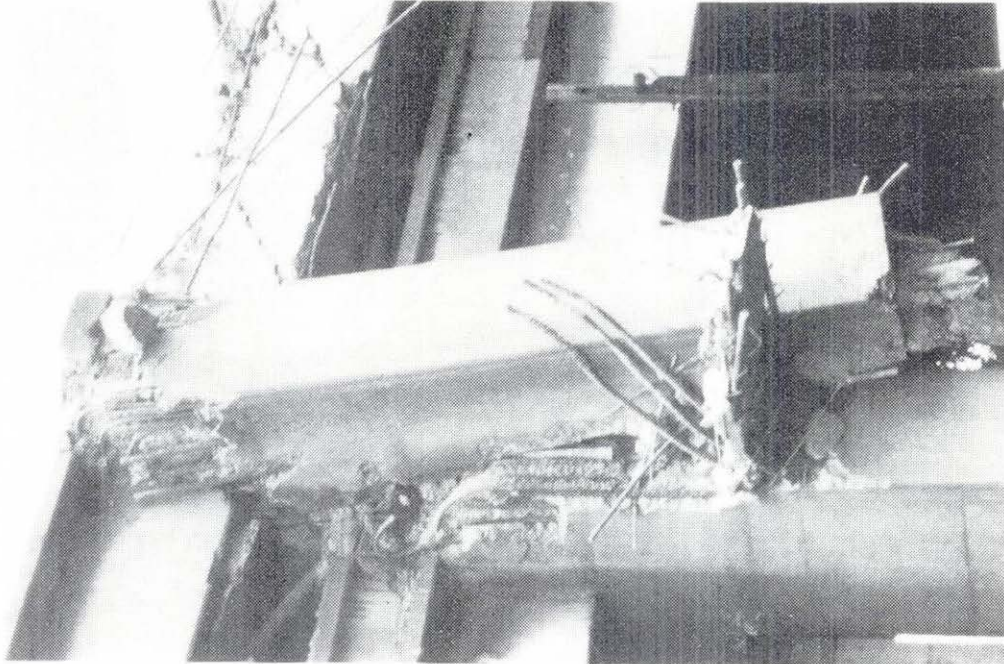
Fig. 1.18 Close-up view of failed upper column, illustrating collapse mechanism.

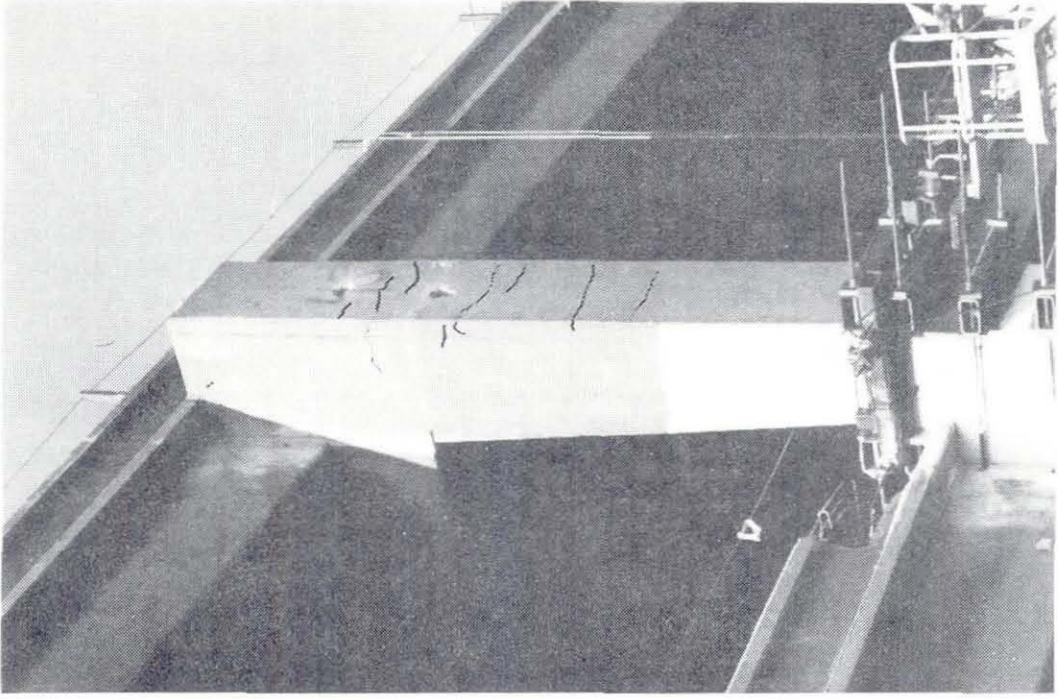
Fig. 2.10(b) Existing hairline cracks on the west face of Bent 46.

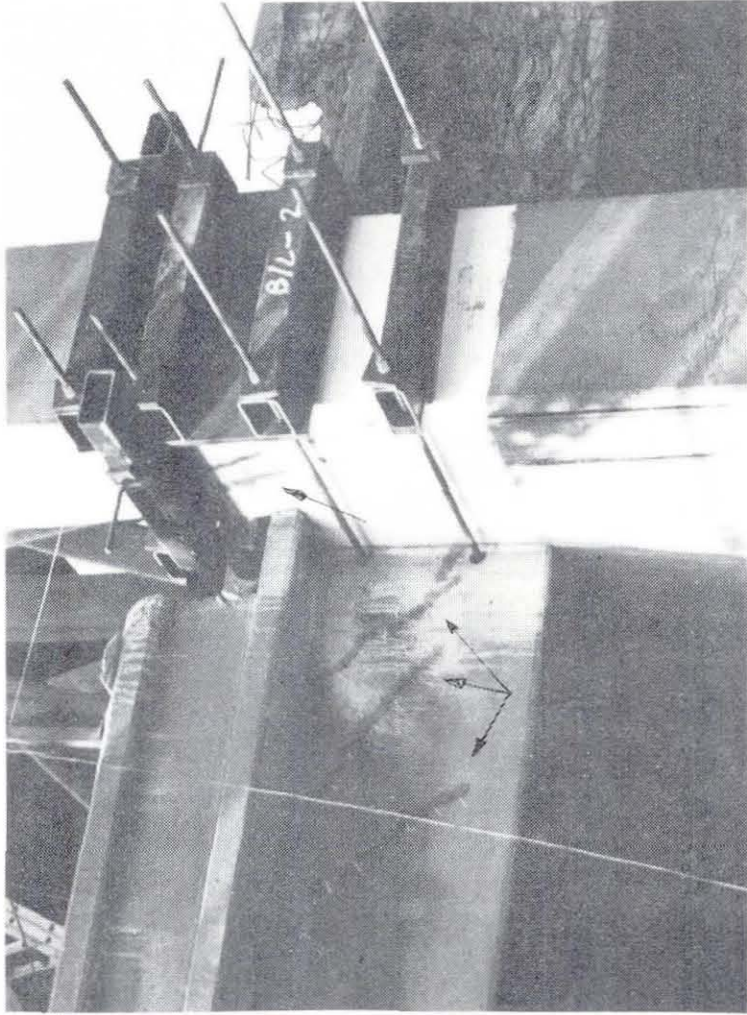
Prior to testing, an attempt was made to repair the cracks present in the lower joints by injecting epoxy. Cores taken from Bent 46 during preparations for the subsequent retrofit test showed that the epoxy had not penetrated across the full width of the joint.

Fig. 2.10(a) Epoxied existing cracks on the east face of Bent 47.

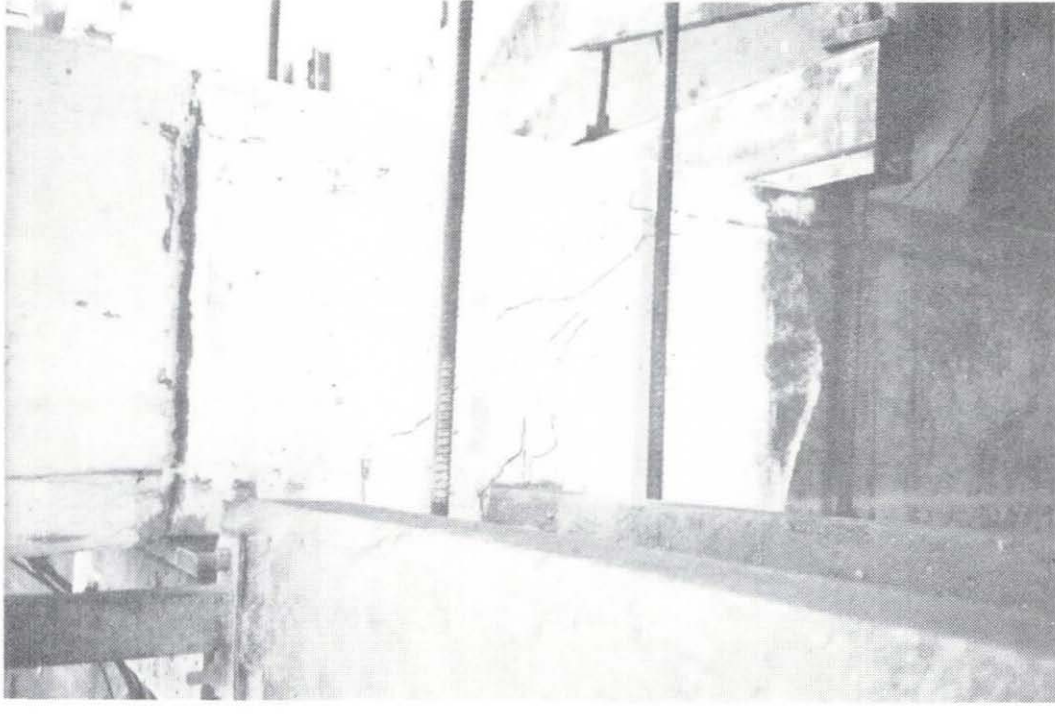
Fig. 3.6 Damage to the west end of Bent 46 after completion of the original structure static load test. The joint retrofit has been removed.

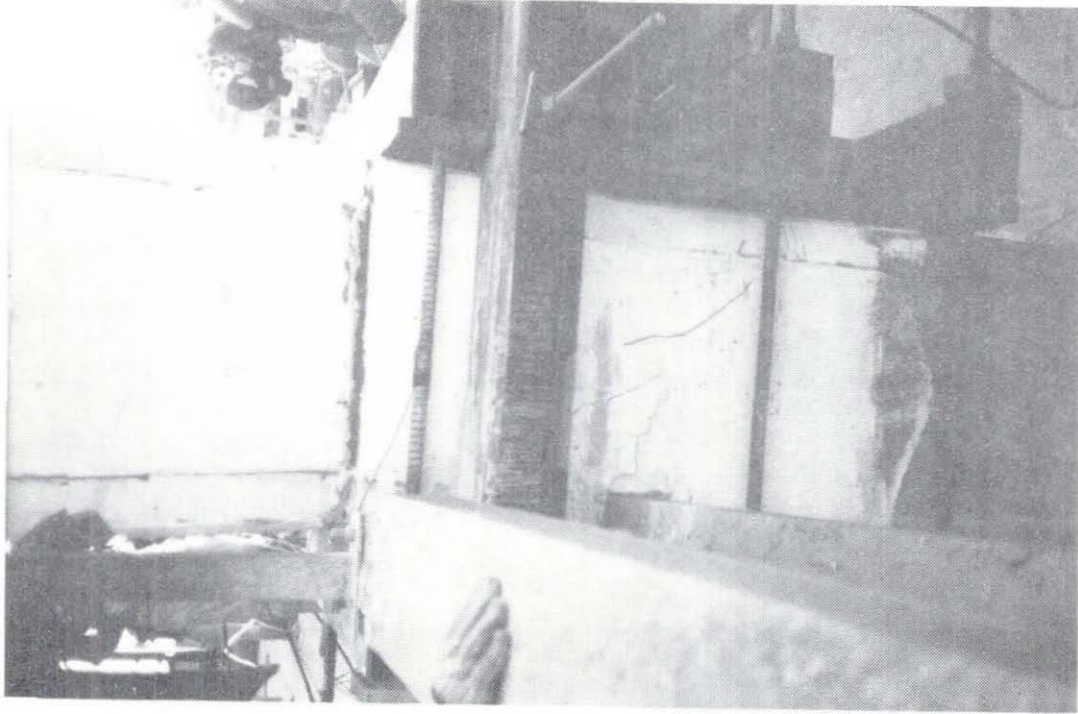
Fig. 3.5 Damage to the lower joint on the west end of Bent 46 during the third load cycle of the static load test on the original structure.

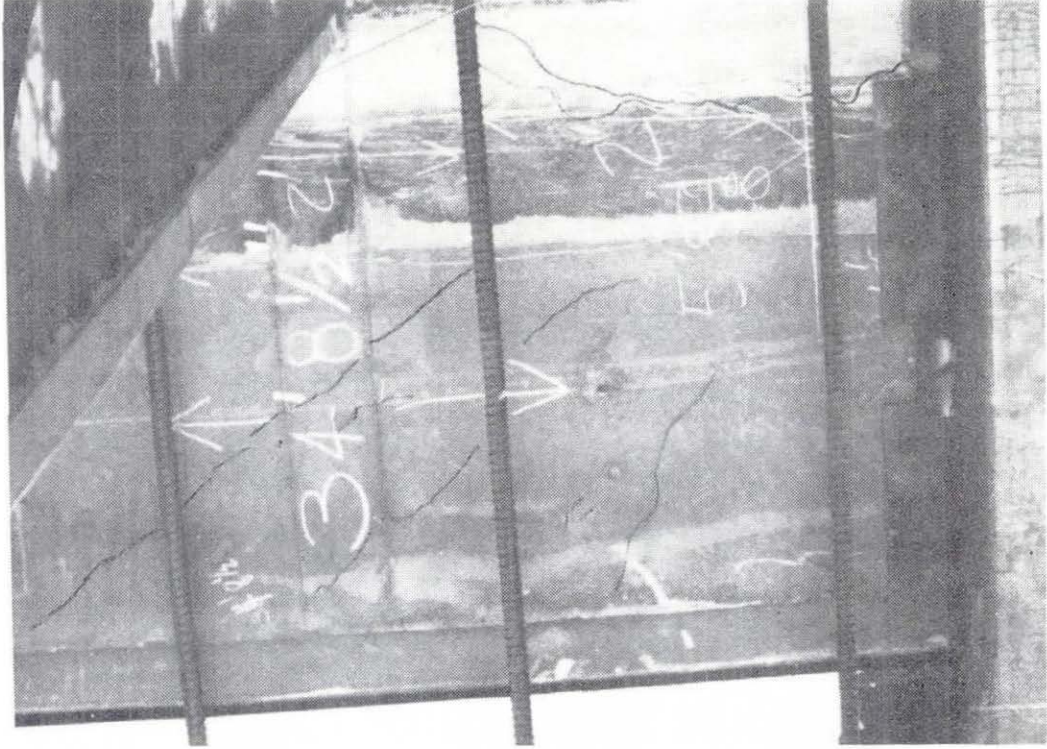
Fig. 3.22 Diagonal crack formation in the top east joint of Bent 45 after Cycle 7.

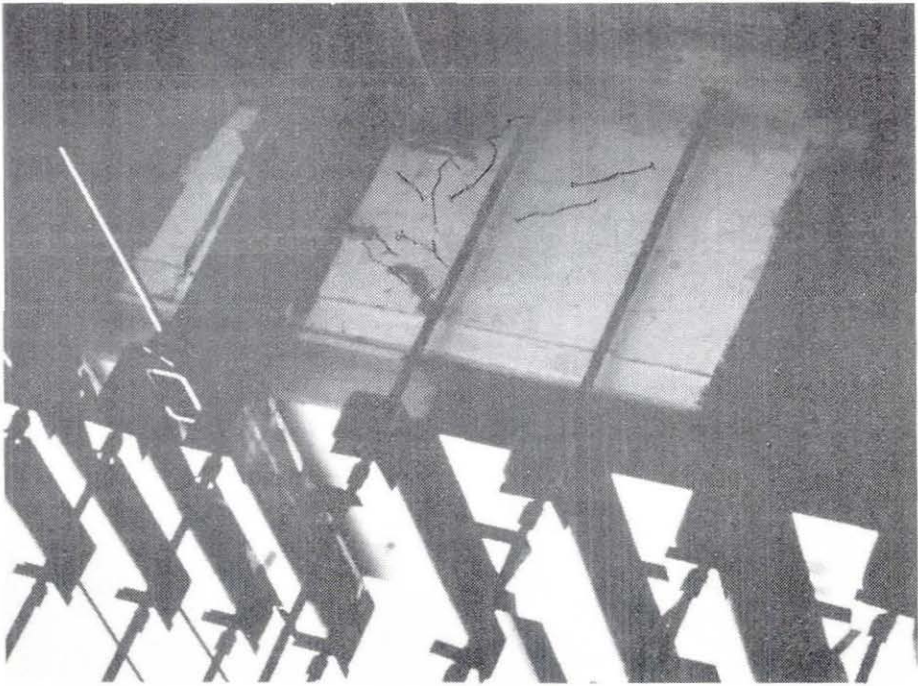
Fig. 3.21 Inclined cracks in the lower joint of the NE face of Bent 45 after Cycle 7.

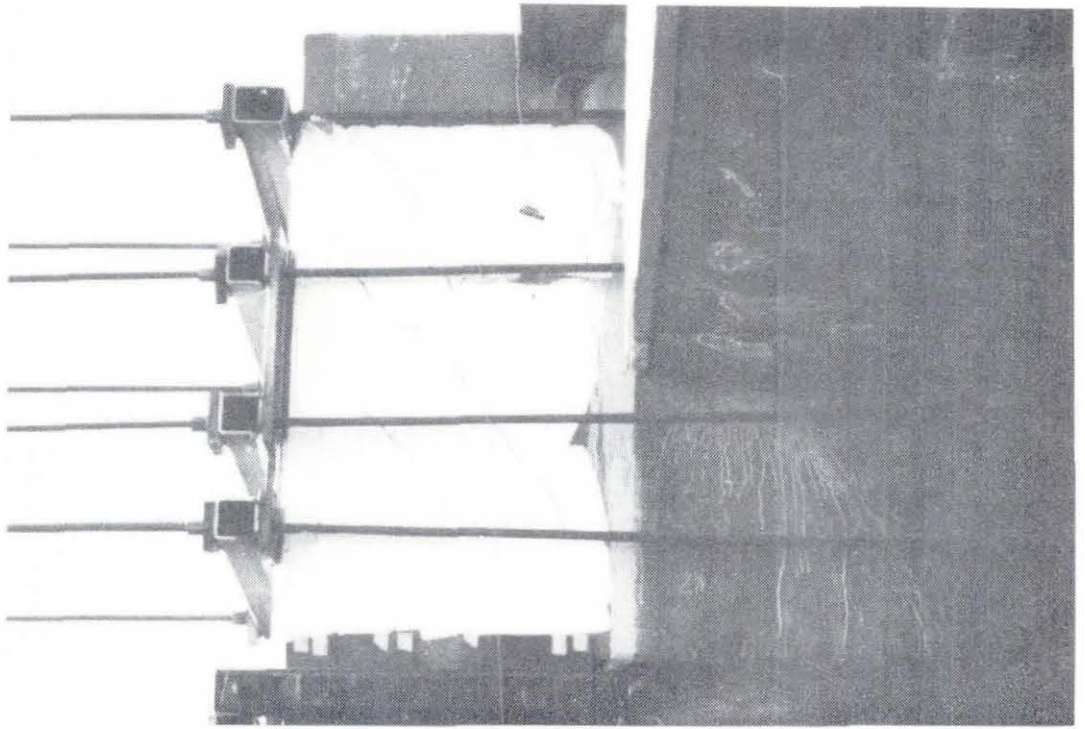
Fig. 3.23 Bent 46 after Cycle 7.

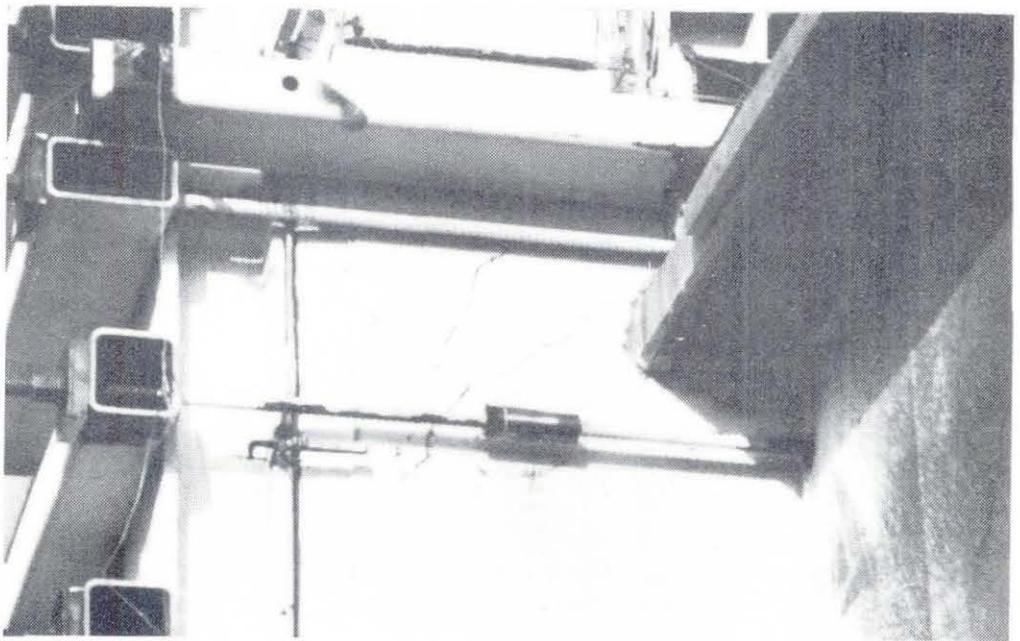
Fig. 3.24 Crack formations in the lower joint of the west end of Bent 45 after Cycle 8.

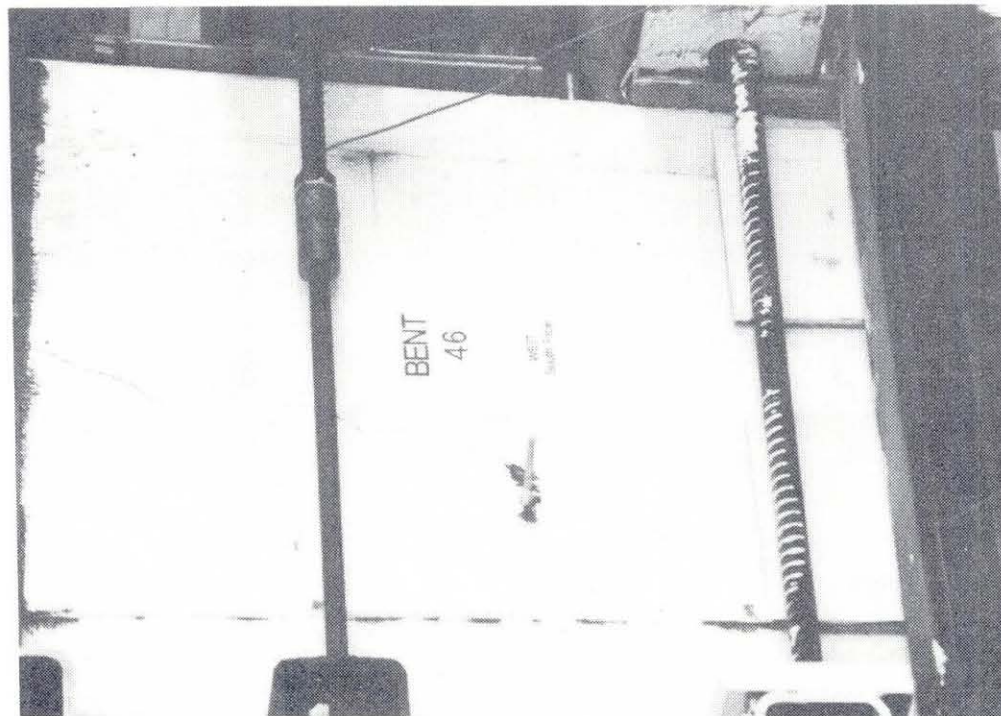
Fig. 3.26 Column shear cracks formed on the west end column of Bent 46 during Cycle 8.

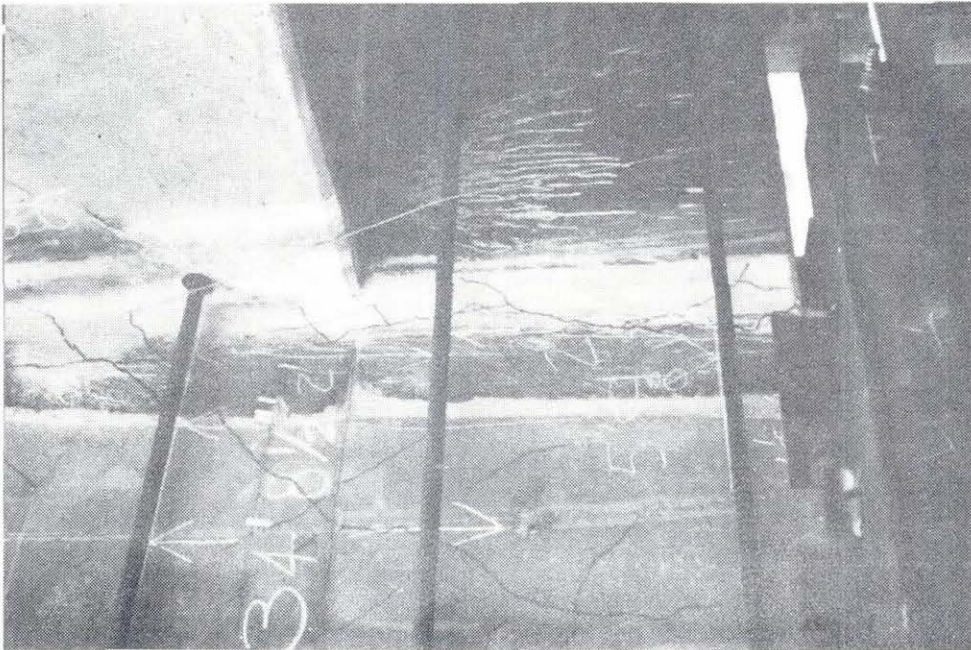
Fig. 3.28 Diagonal crack formation in the top east joint of Bent 45 after Cycle 9.

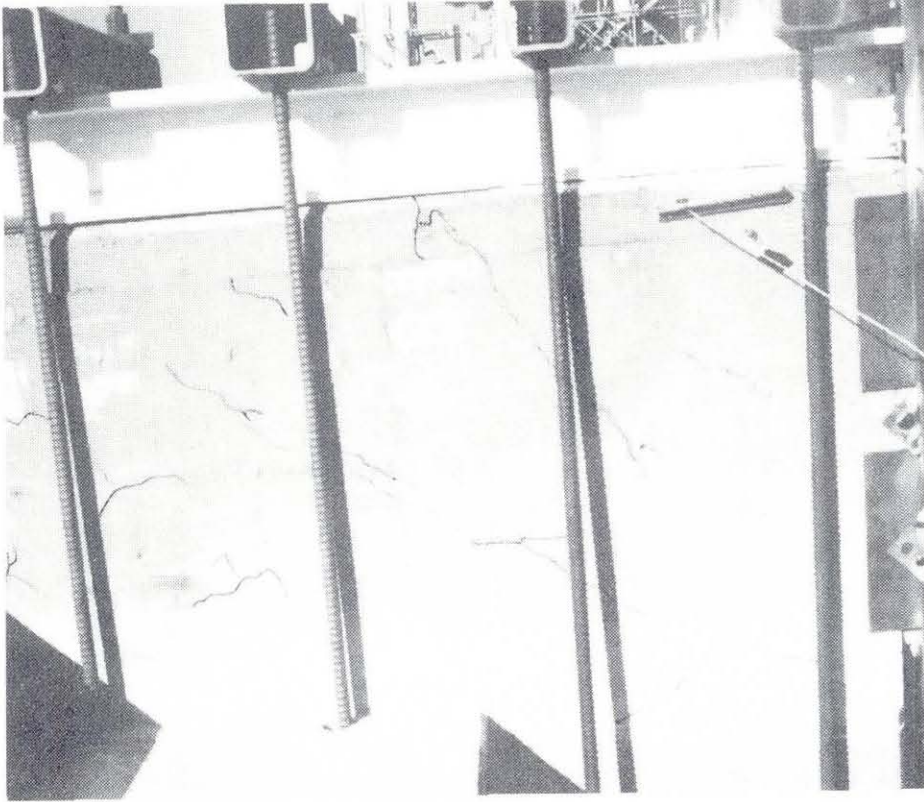
Fig. 3.29 Diagonal crack formation after Cycle 10, upper east joint, Bent 45.

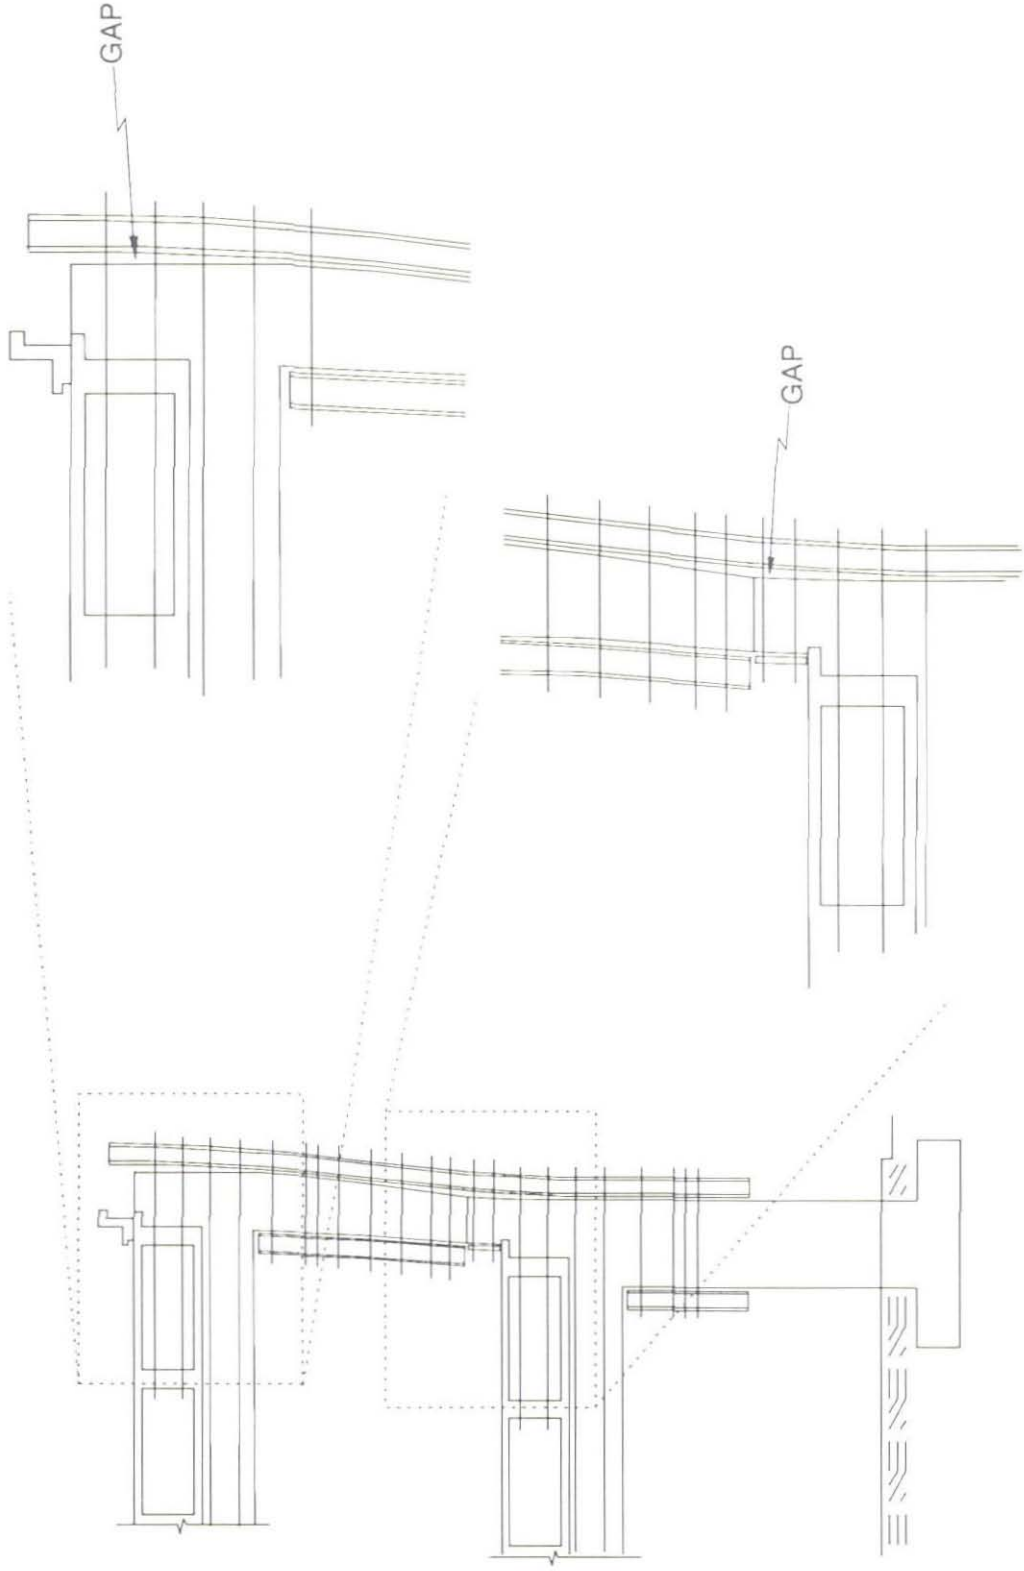
Fig. 3.30 Separation of Wide Flange Retrofits From Columns

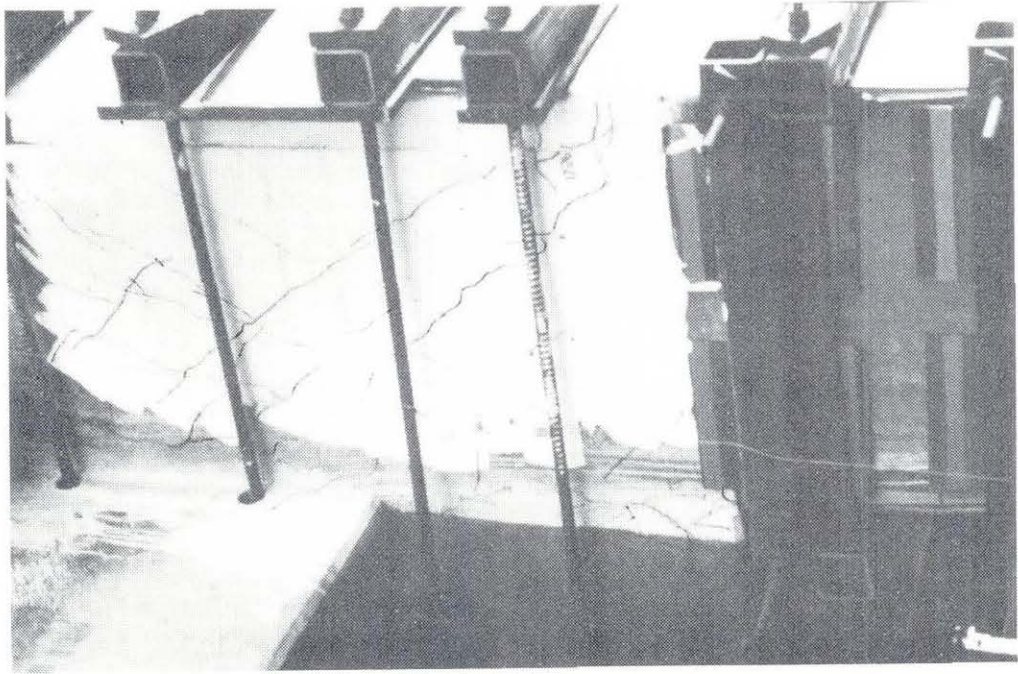
Fig. 3.31 Inclined cracks formed after Cycle 12, upper joint of NW face of Bent 46.

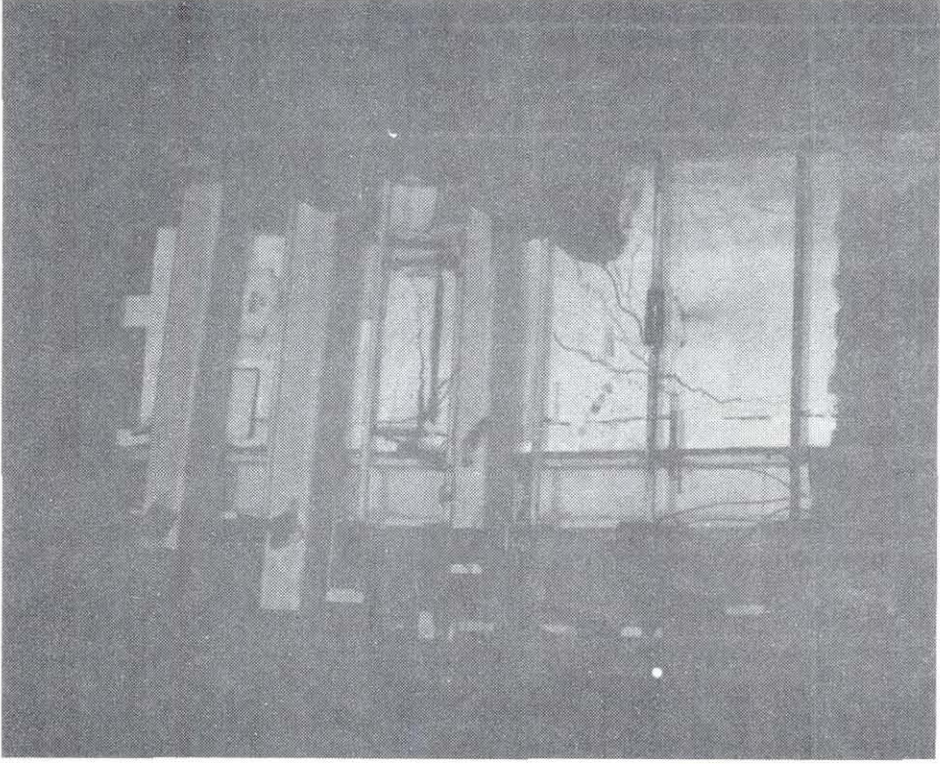
Fig. 3.32 Bent 45, west column. Shear key horizontal crack under last (4000 kip) load cycle.

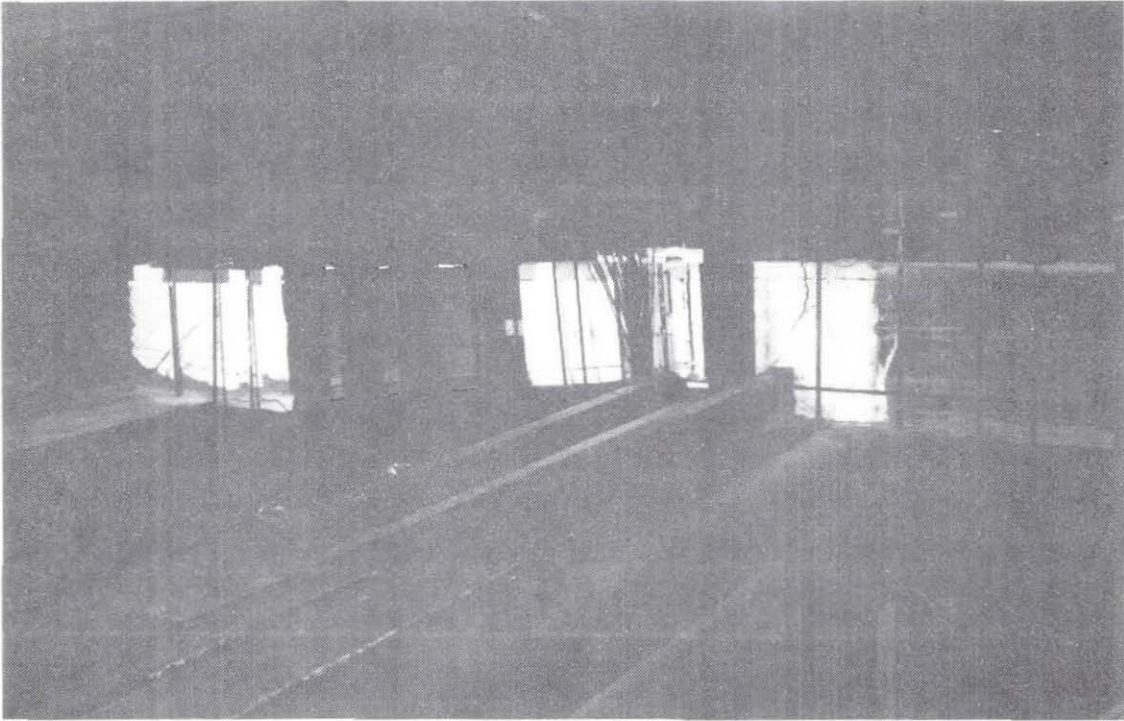
Fig. 3.33 Bent 46, west column deflected shape under 4000 kip load.

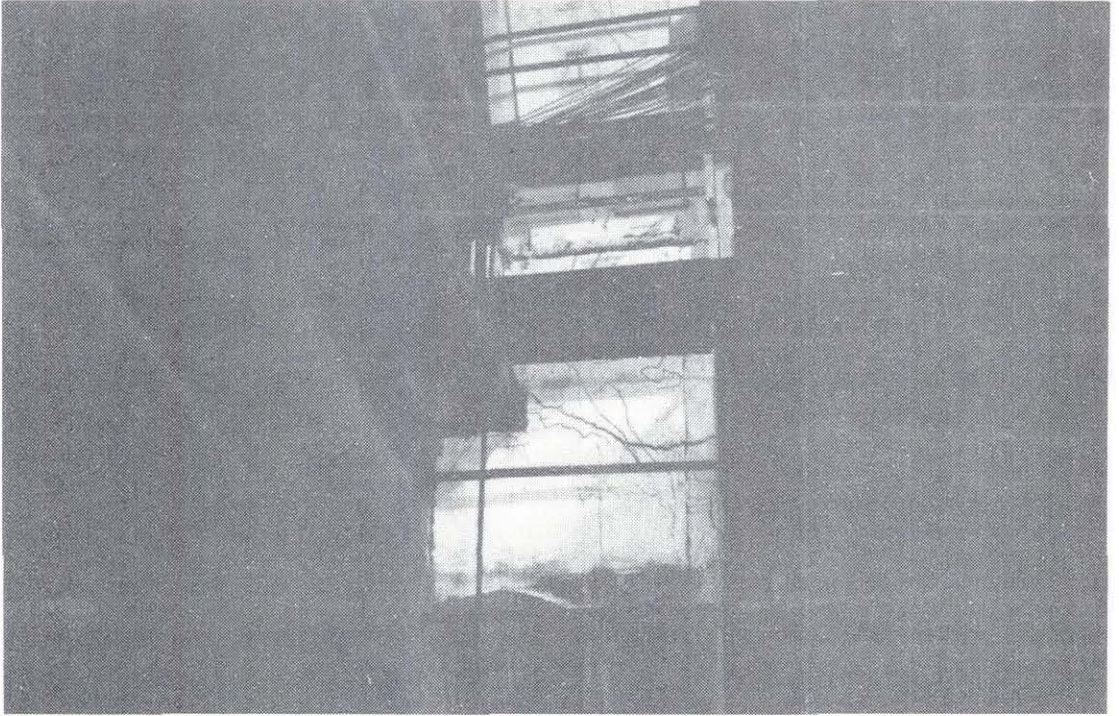
Fig. 3.35 Bent 46, west column shear key opening and horizontal flexural crack at lower deck level (bottom of upper column) under 4000 kip load.

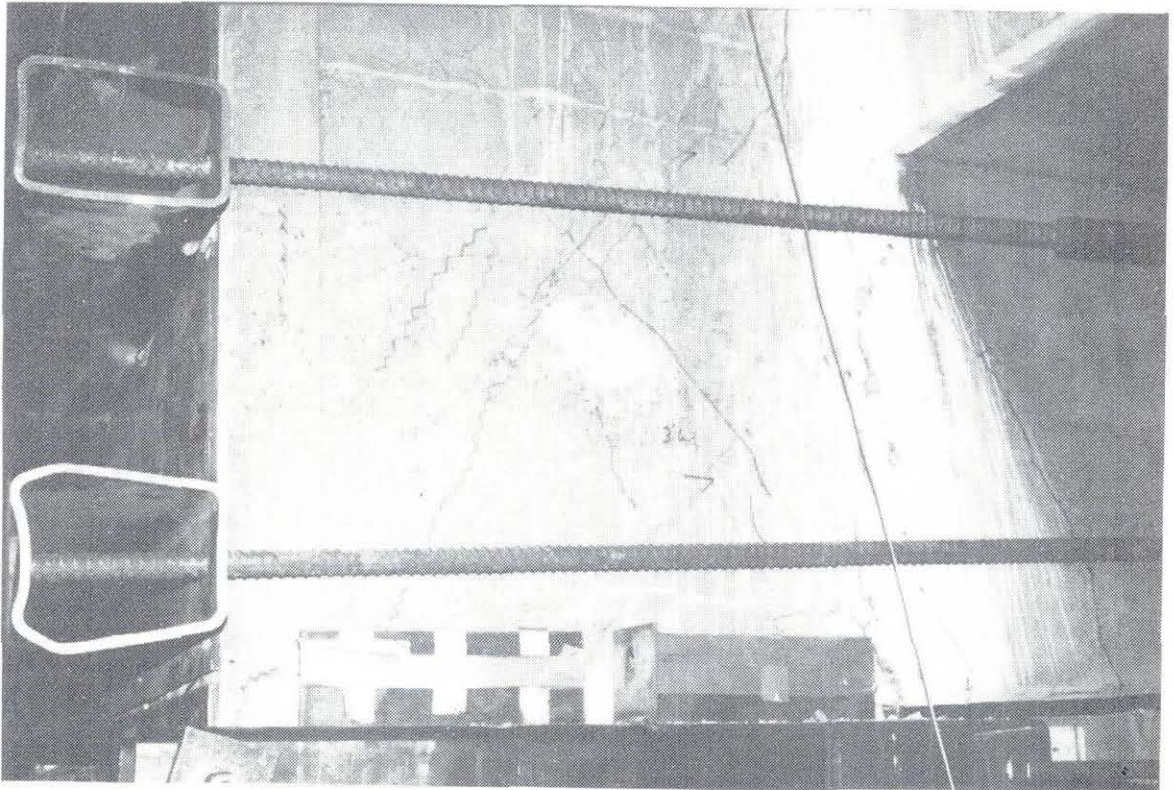
Fig. 3.36 Buckled HSS-section, top west joint of Bent 47.

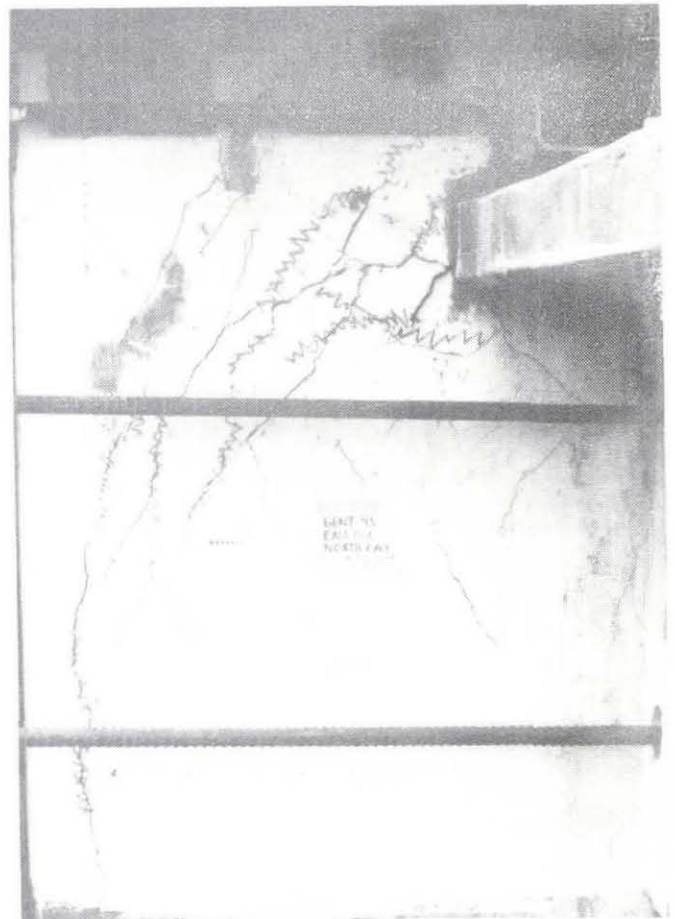
Fig. 3.37 Damage to the east end of Bent 45.

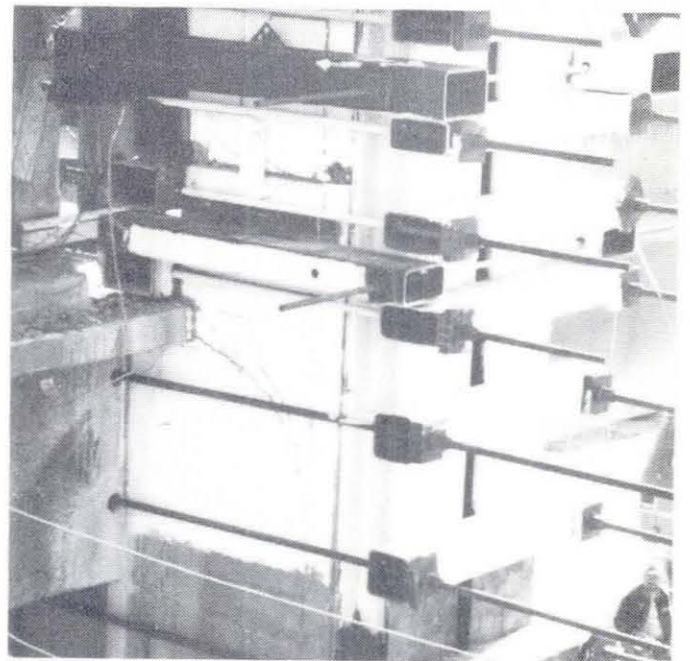
Fig. 3.38 Damage to the west end of Bent 45.

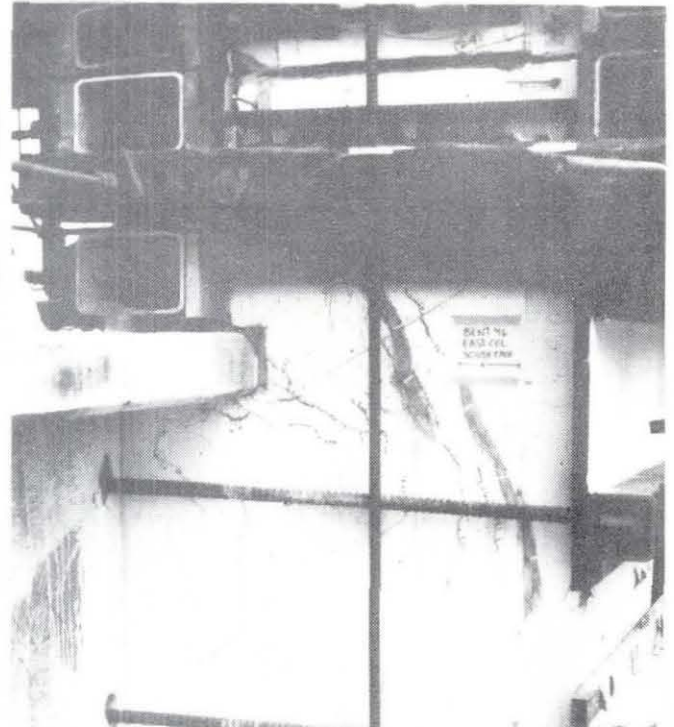
Fig. 3.39 Damage to the east end of Bent 46.

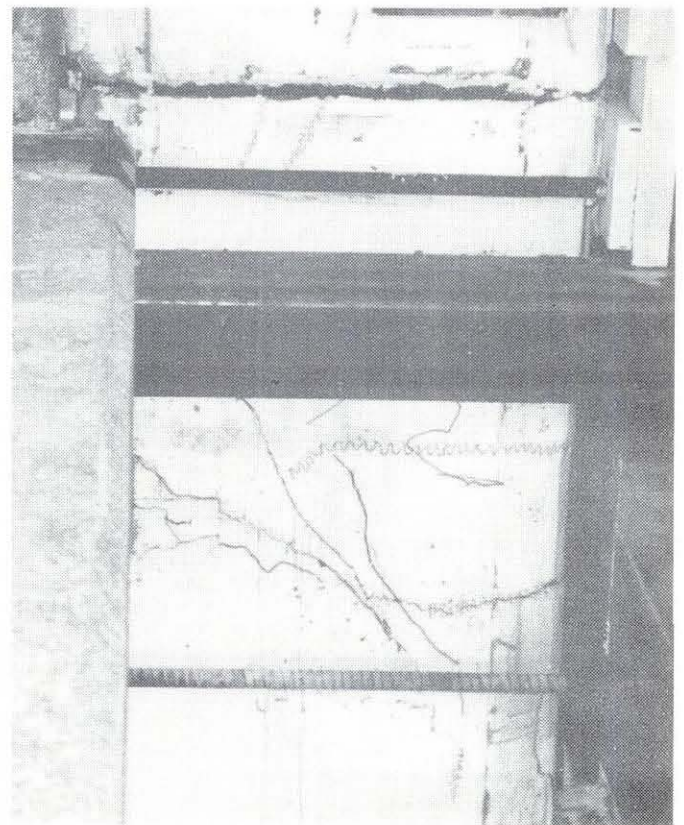
Fig. 3.40 Damage to the west end of Bent 46.

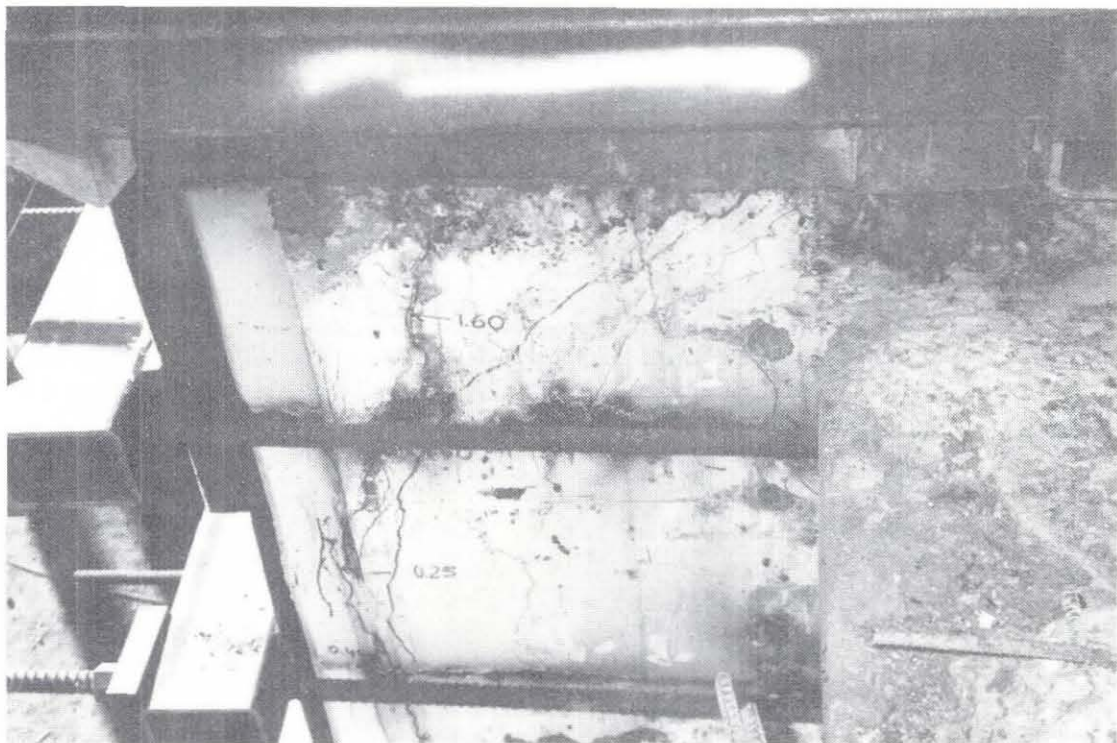
Fig. 3.41 Damage to the east end of Bent 47.

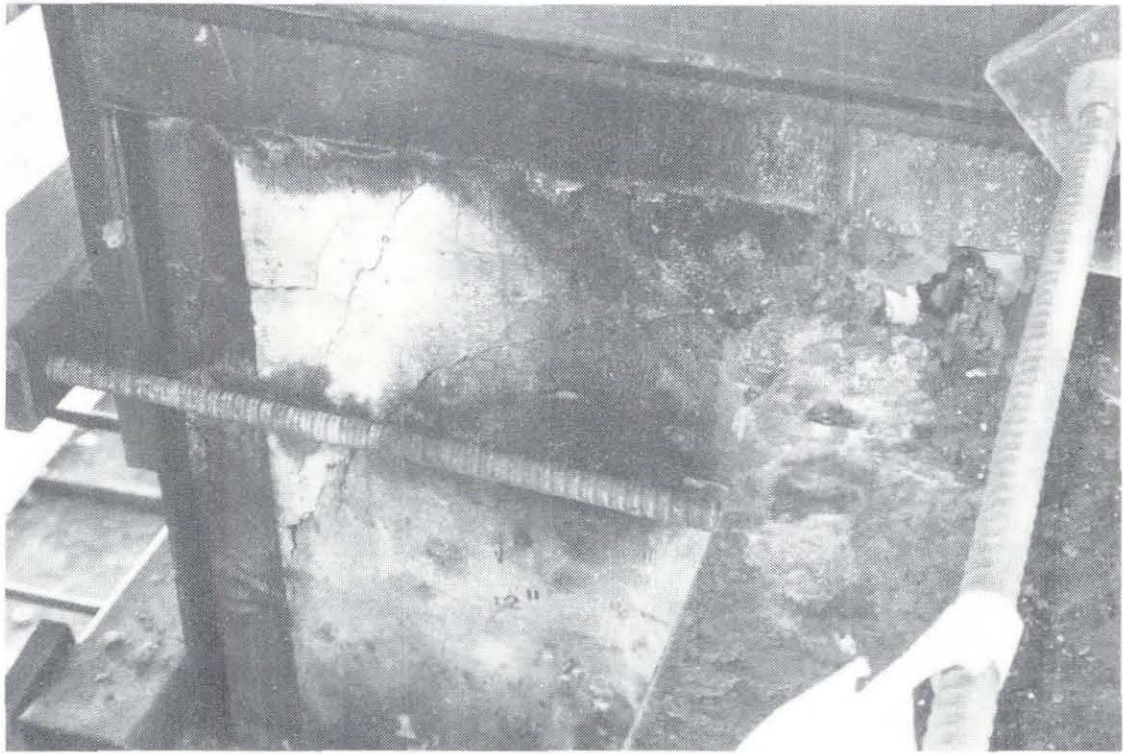
Fig. 3.42(a) Damage to the west end of Bent 47.
