REPORT NO.
UCB/EERC-90/21
DECEMBER 1990

OBSERVATIONS AND IMPLICATIONS OF TESTS ON THE CYPRESS STREET VIADUCT TEST STRUCTURE

MARTIN E. BOLLO
STEPHEN A. MAHIN
JACK P. MOEHLE
ROY M. STEPHEN
XIAOXUAN QI

Report to the California Department of Transportation

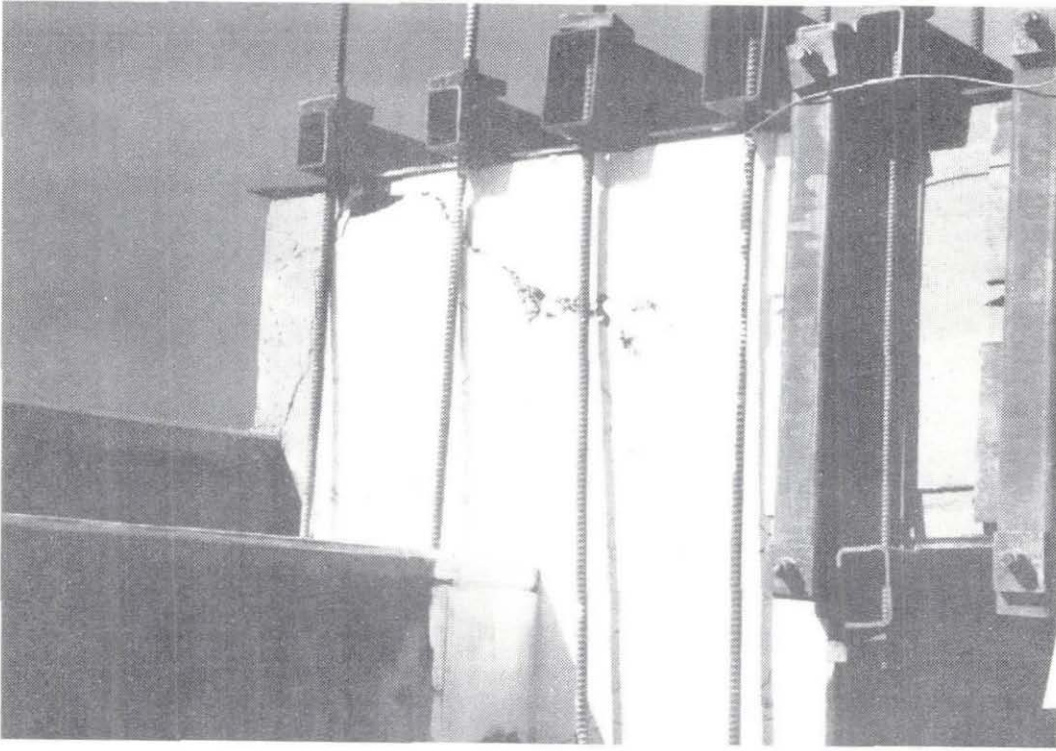
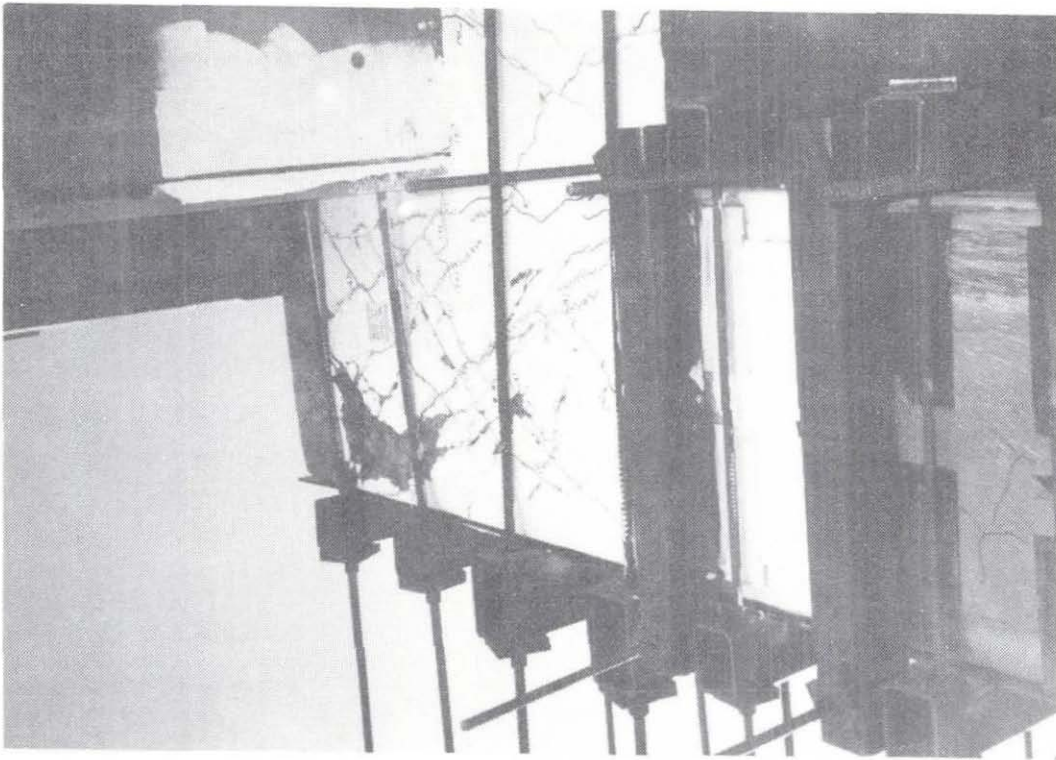
Fig. 3.42(b) Damage to the top joints on the east end of Bent 47.
