**Observations on Water System and
Pipeline Performance in the Limon Area of Costa Rica
Due to the April 22, 1991 Earthquake**

M. J. O'Rourke

D. Ballantyne

Technical Report NCEER-92-0017

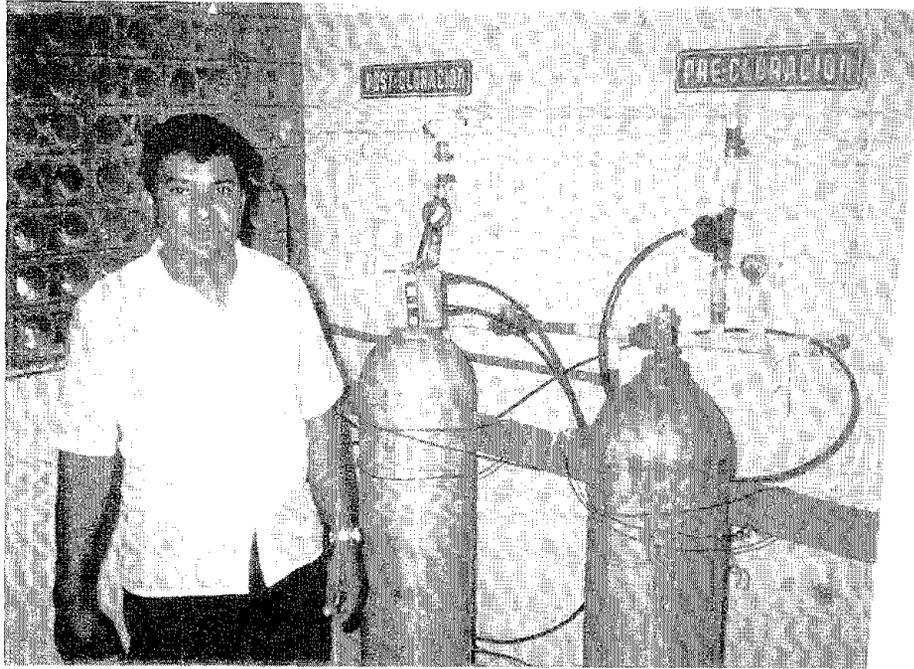
This is the third significant earthquake in the past years where chlorine leaks have resulted from earthquake damage [9, 10]. In both the 1989 Loma Prieta earthquake and the 1990 Philippine earthquake, vertical chlorine cylinders without lateral restraint also toppled, breaking connecting piping.

FIGURE 2-4 Chlorine Cylinder which Topped Breaking Connection Pipe and Releasing Chlorine

The Uniform Building Code [11] now requires that structures housing gaseous chlorine systems be designed to automatically contain and neutralize any chlorine leak. These systems require air scrubbers with emergency generators so they are operable when power supply is lost. As a result of the cost for these facilities, many small chlorination systems are being designed using sodium hypochlorite, chlorine bleach. Although the chemical cost is approximately twice that of gaseous chlorine, the capital cost of the system including life safety components, is much less.

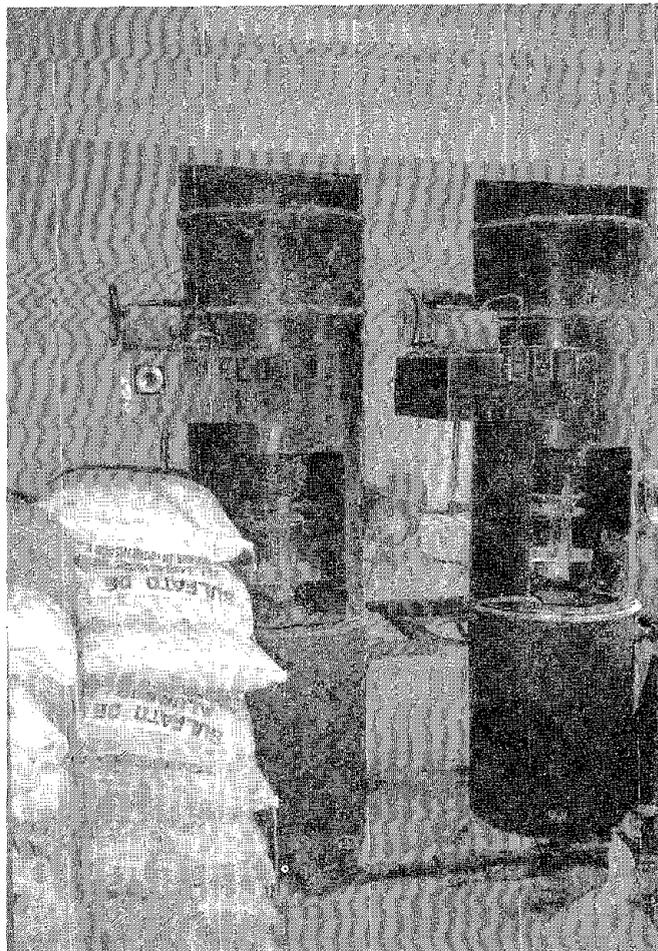
FIGURE 2-5 One of the Two Unanchored Dry Chemical Feeders Fell over and was Reinstalled after Repairs

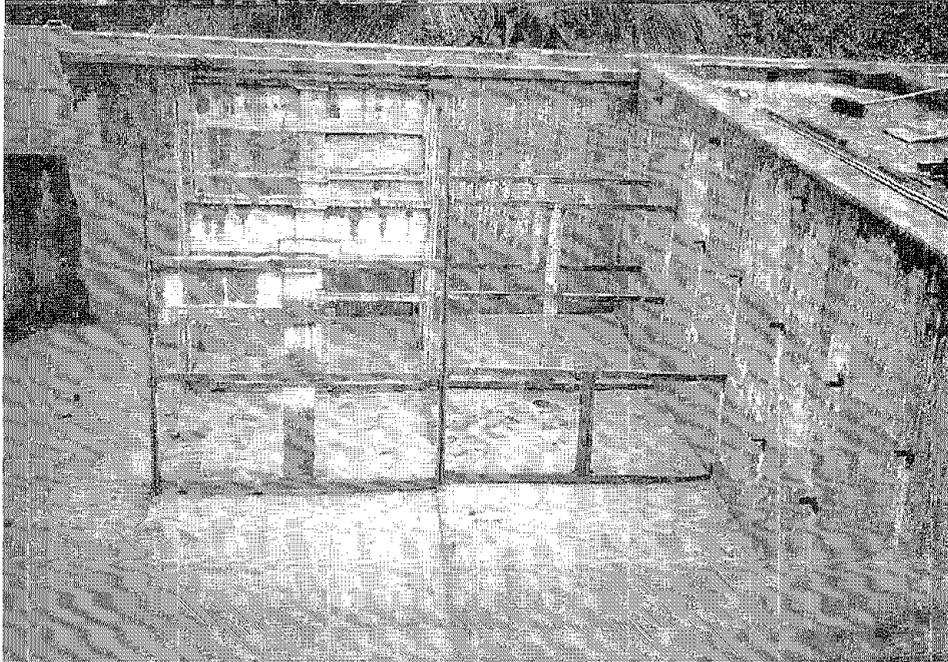
Asbestos cement baffles in the flocculators and asbestos cement clarifier plates were broken as shown in Figure 2-6 through 2-9. One concrete channel cracked. Glassware in the lab and the portable radio, sitting on the shelf, were undamaged. There was no reported damage to the filters.

These extreme loads shattered the non-ductile asbestos cement baffles in the flocculators at the water treatment plant in Bomba. Extensive baffle damage occurred in the Loma Prieta earthquake at water and wastewater treatment plants. Examples include racking of the reactor clarifiers at the Rinconada Water Treatment Plant, breaking up of the wooden baffles in the flocculator at the Montevina Water Treatment Plant, and bending of the baffles structural supports in the chlorine contact tank at the San Mateo Wastewater Treatment Plant [12].

FIGURE 2-7 Flocculator Baffles Being Replaced after Earthquake Induced Hydraulic Load Damage

To minimize earthquake damage, baffles must be designed to either resist these significant hydraulic loads, or to break away with a design for easy repair. Design to resist loads, depending on the configuration, become cumbersome. Break away designs are encouraged. Break away designs should provide a restraint to keep the baffle from falling to the tank bottom.

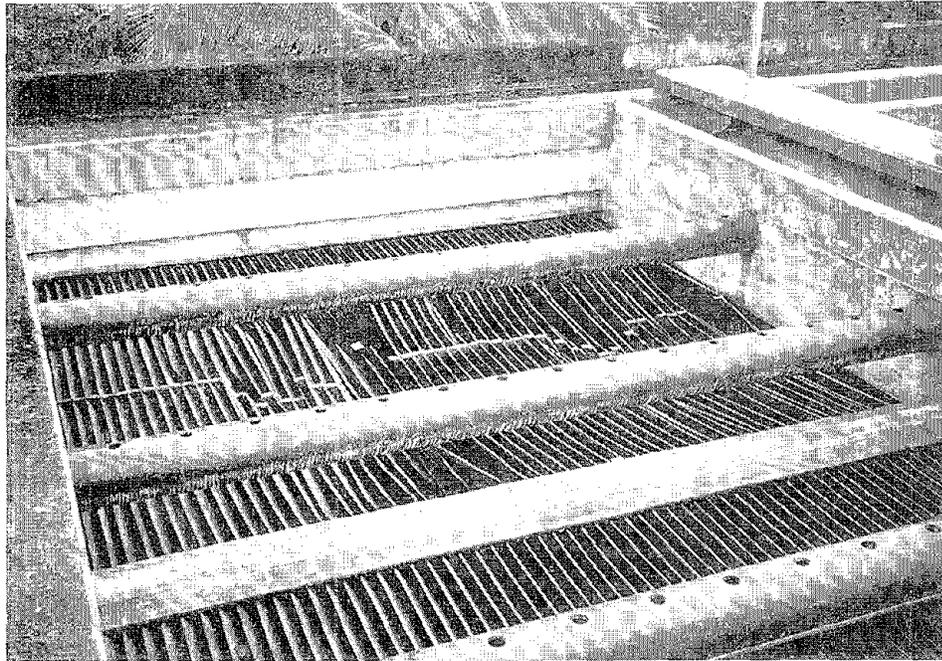
FIGURE 2-8 Broken Asbestos Cement Clarifier Plates, Similar Plates at Siquerres Water Treatment Plant (~ 190 gal) Were Undamaged

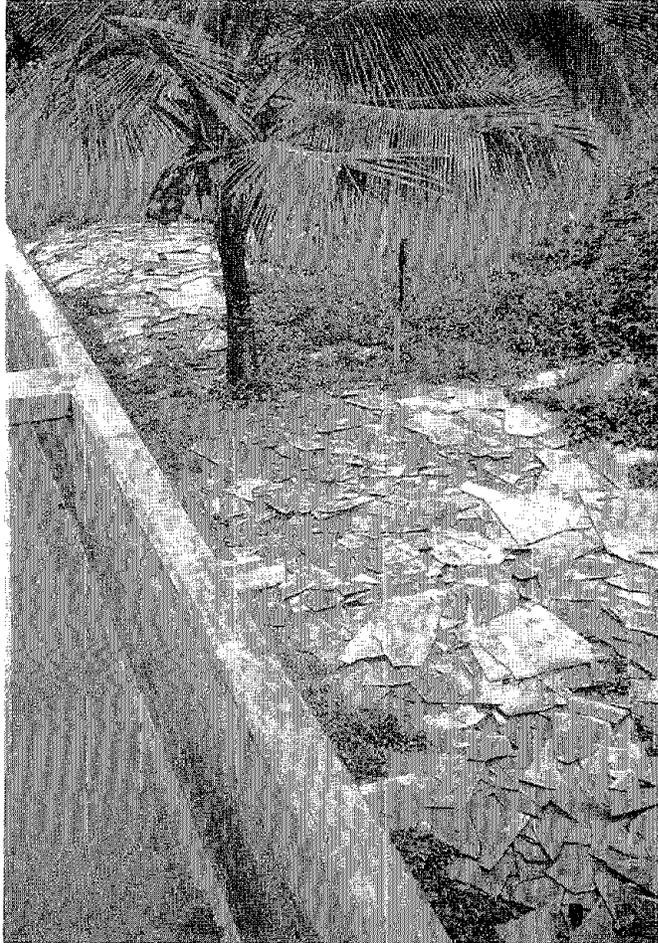
FIGURE 2-9 Piles of Broken and Removed Asbestos Cement Flocculator and Clarifier Plates

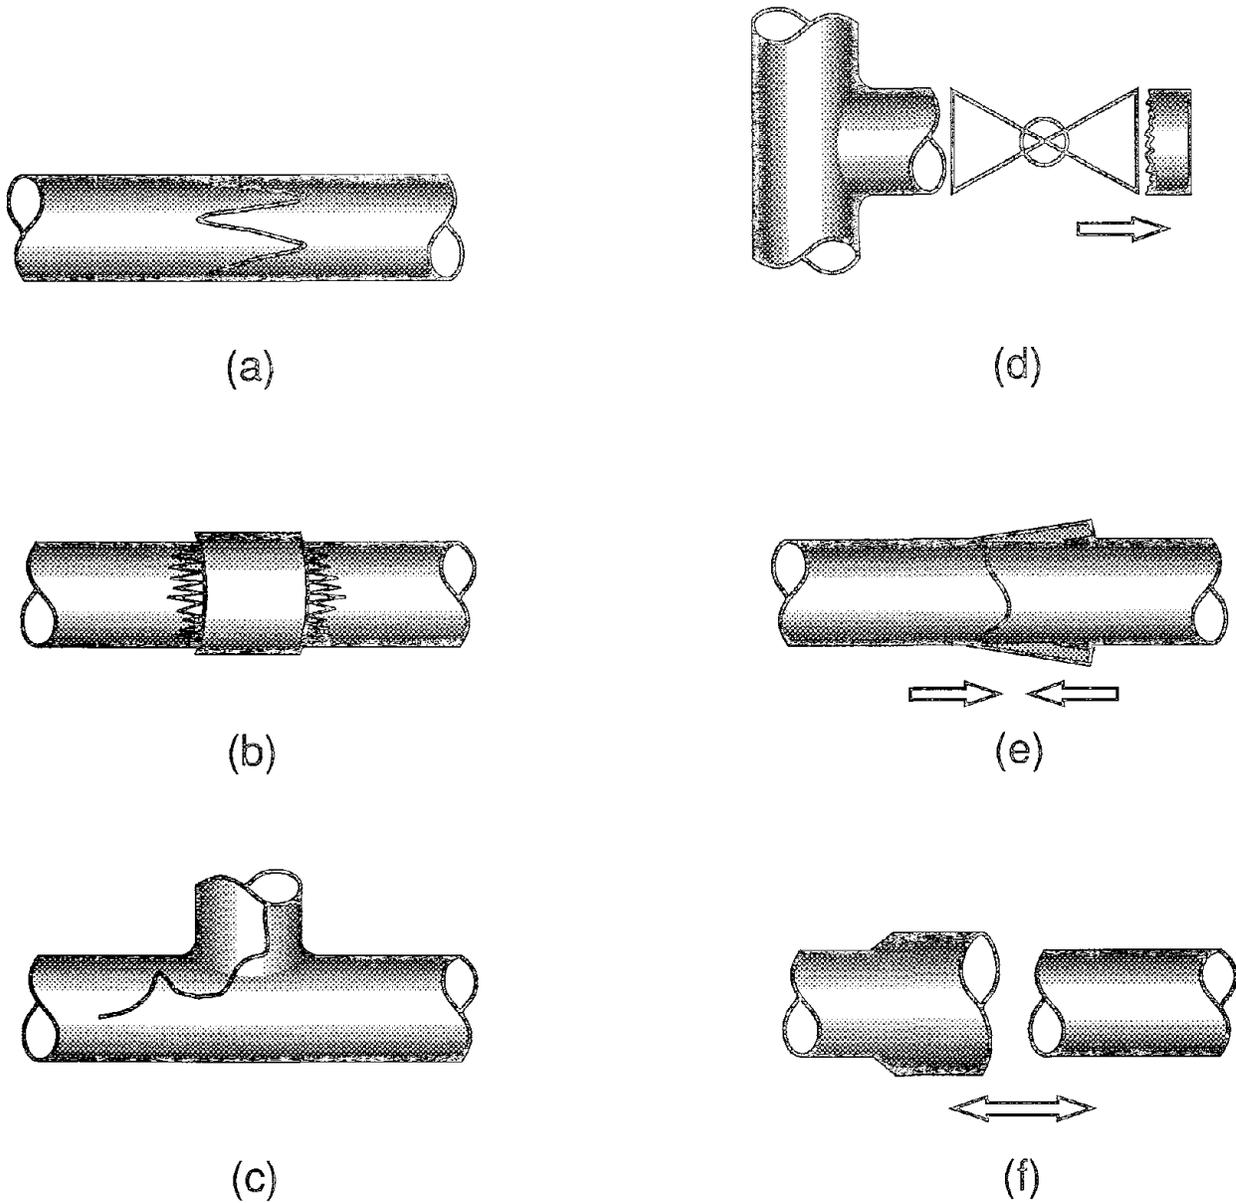
FIGURE 3-3 Damage Mechanisms; (a) pipe segment break, (b) break in union piece, (c) blowout at Tee, (d) disconnection at Tee, (e) compressive telescoping at joint, (f) tensile pull-out at joint

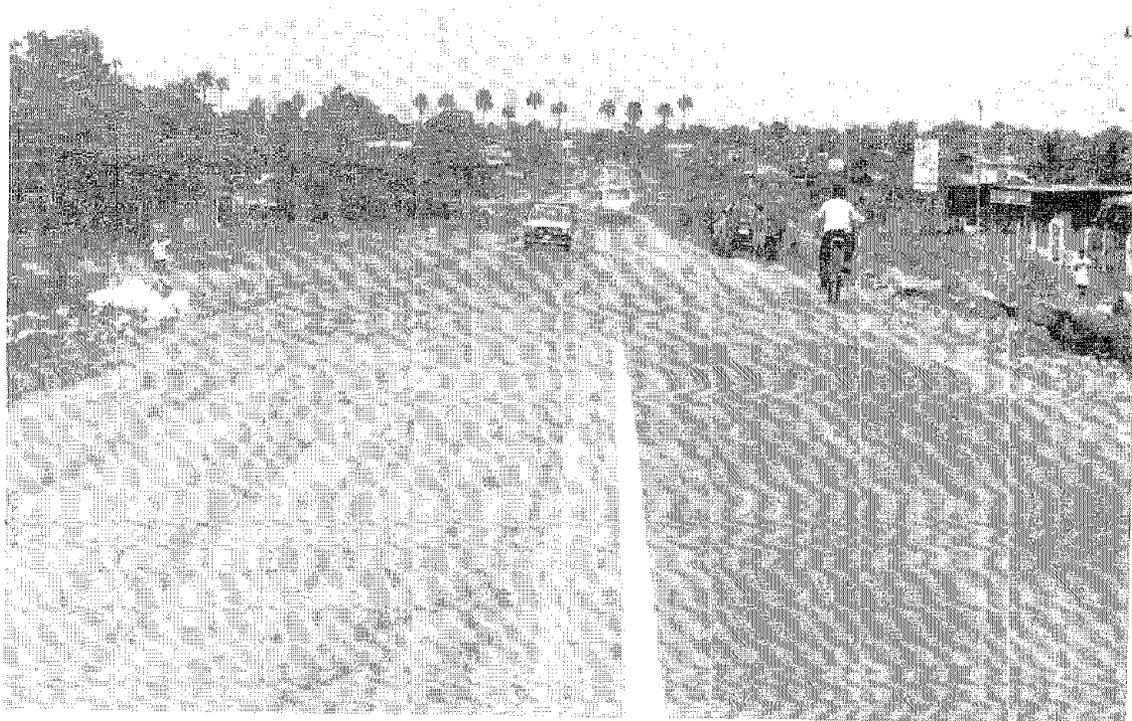
FIGURE 3-6 View Looking East Showing 13 m (42 feet) of Road Damage near Railroad Underpass. RCCP Transmission Line to Right.

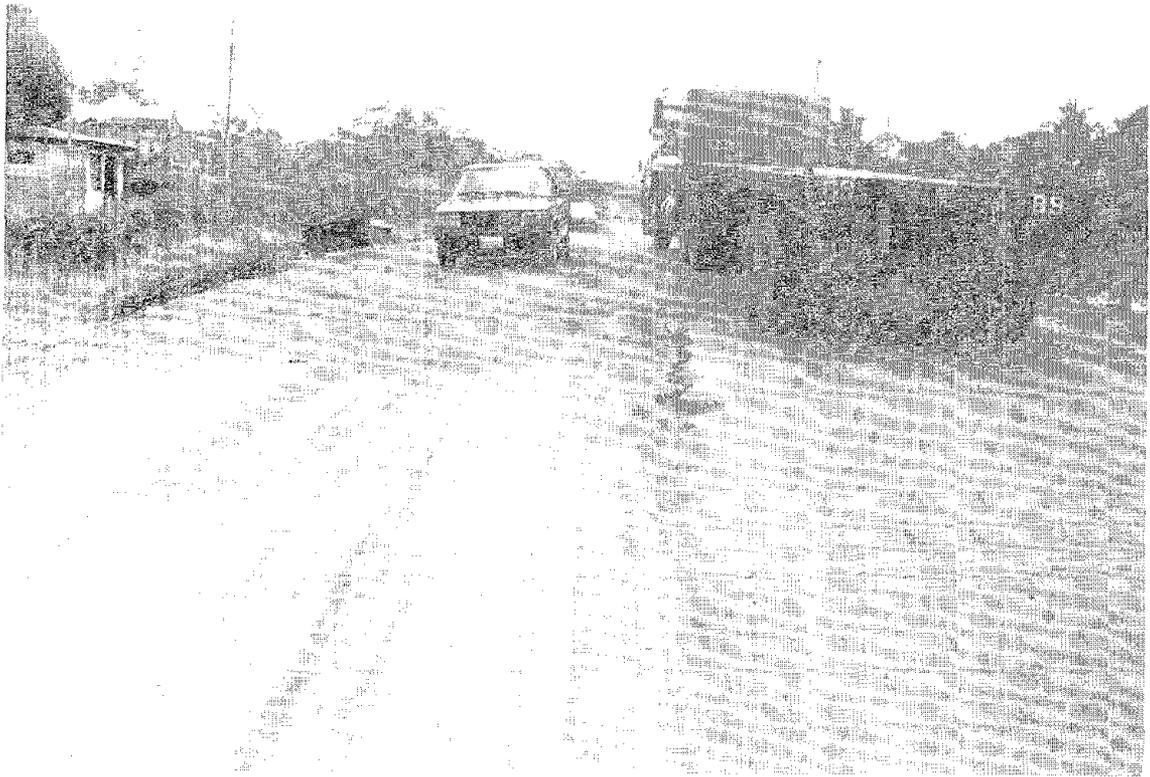
FIGURE 3-7 View Looking West towards Railroad Underpass Showing 40 cm (16 inch) Lateral Offset of Road Centerlines. Cab of Flatbed Truck #89 over Railroad, Width of Road Stripping is 10 cm (4 inch).

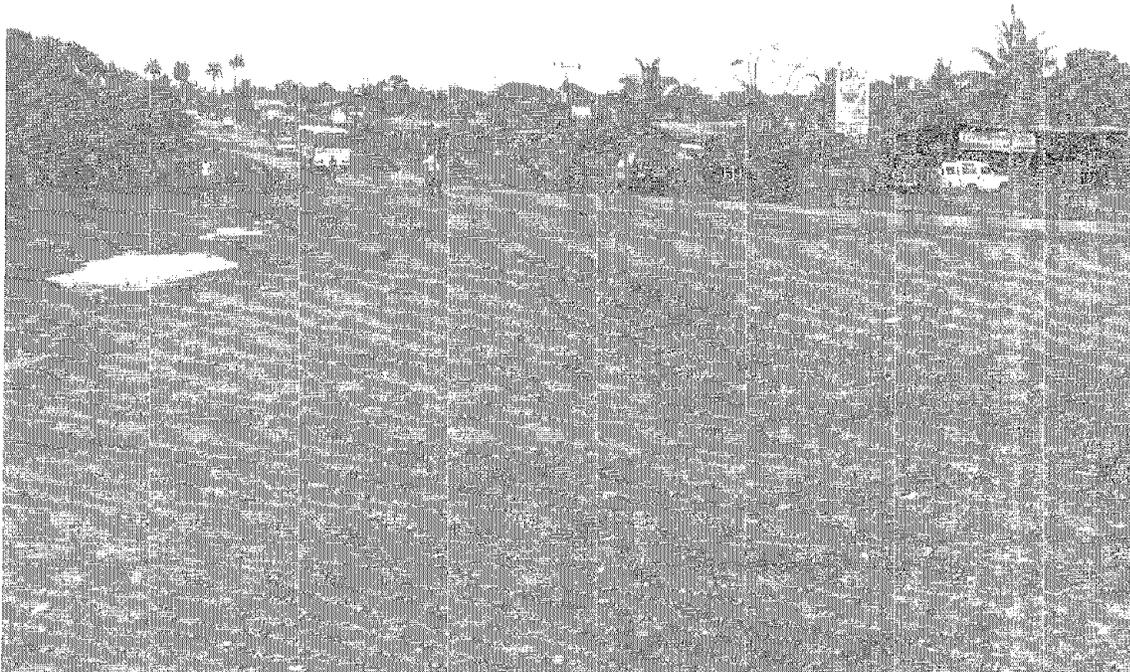
FIGURE 3—10 View Looking East from Railroad Underpass Showing Scarp at Side of Garbens.

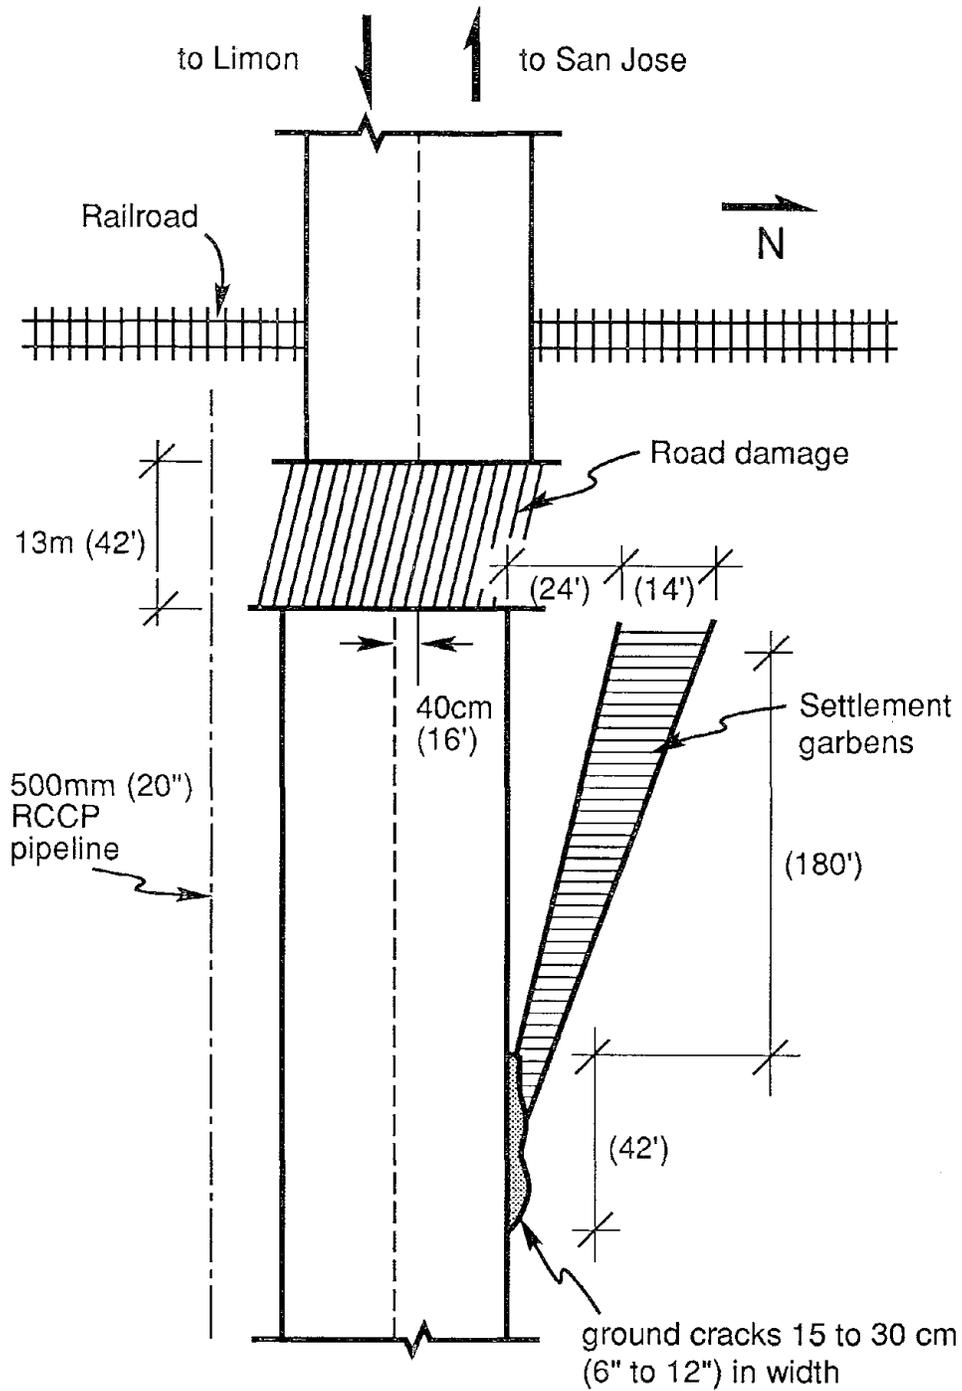
FIGURE 3-11 Plan View of Road Damage, Ground Cracks, Garbens and 500 mm (20 inch) RCCP Transmission Pipe Damage Immediately East of Railroad Underpass.

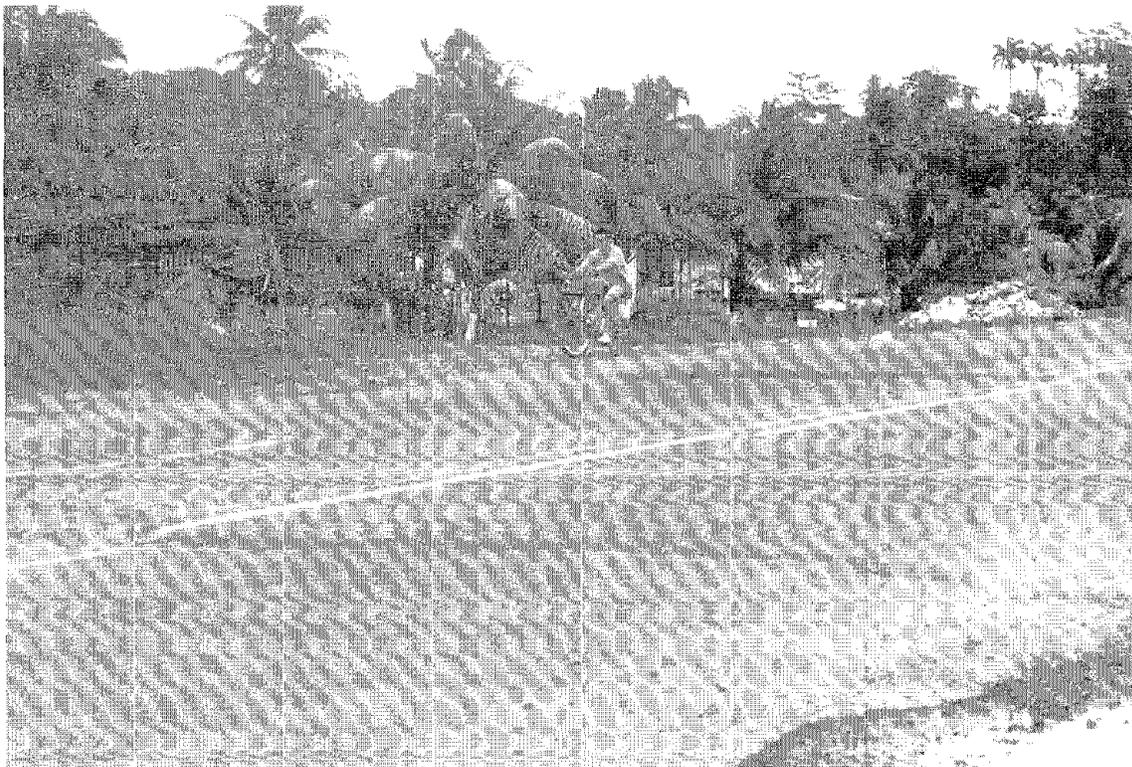
FIGURE 3-12 Vertical Settlement in Road near Pueblo Nuevo Entrance, about 500 m East of Railroad Underpass.

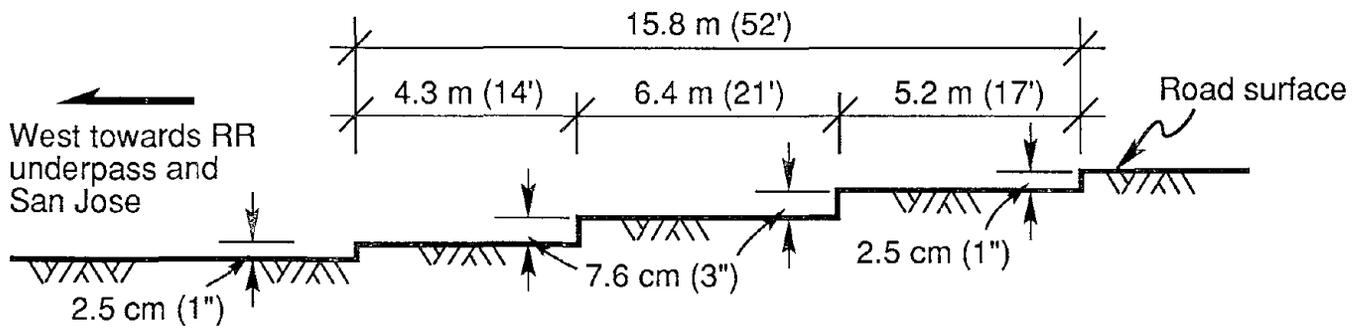
FIGURE 3-13 Elevation View of 20 cm (8 inch) Vertical Settlement over 16 m (52 feet) of Road Surface near Pueblo Nuevo Entrance.

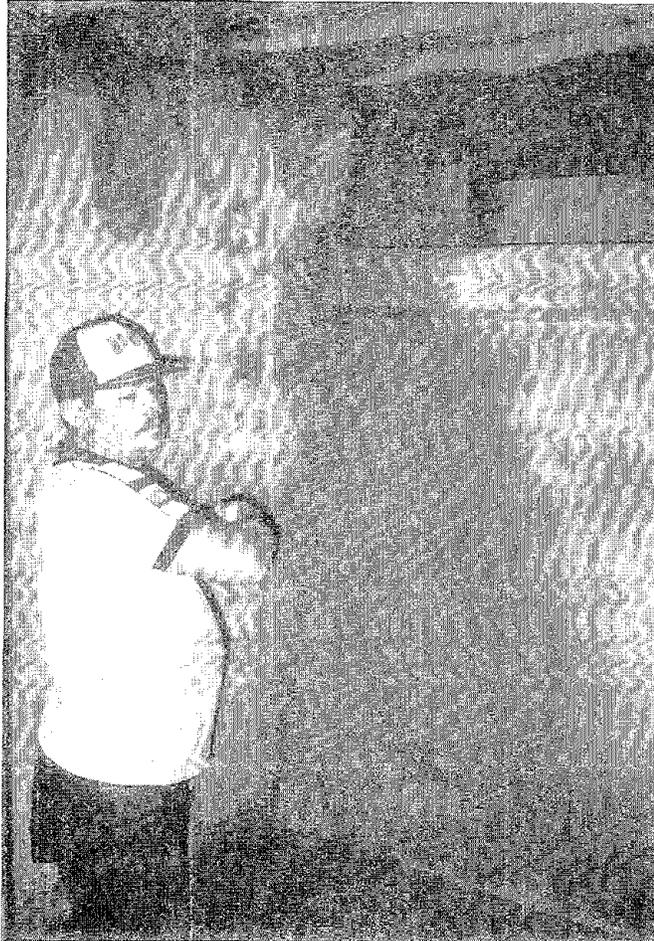
Reinforced concrete tanks have resisted damaged from earthquakes very well. This may be a result of the conservative tank design employed to minimize cracking for water-tightness. The only significant concrete tank or channel cracking reported in the Loma Prieta earthquake was at the Santa Cruz Wastewater Treatment Plant [12]. In that instance, the crack occurred at a construction joint between two segments constructed at different times. A secondary concern associated with undermining by leaking water may be a problem. At the water treatment plant in Bomba, there was inadequate information available to evaluate the likely cause of the cracking.

FIGURE 3-17 Repaired Cracking at Top and Corner of the 4 Million Liter Concrete Reservoir in Limón

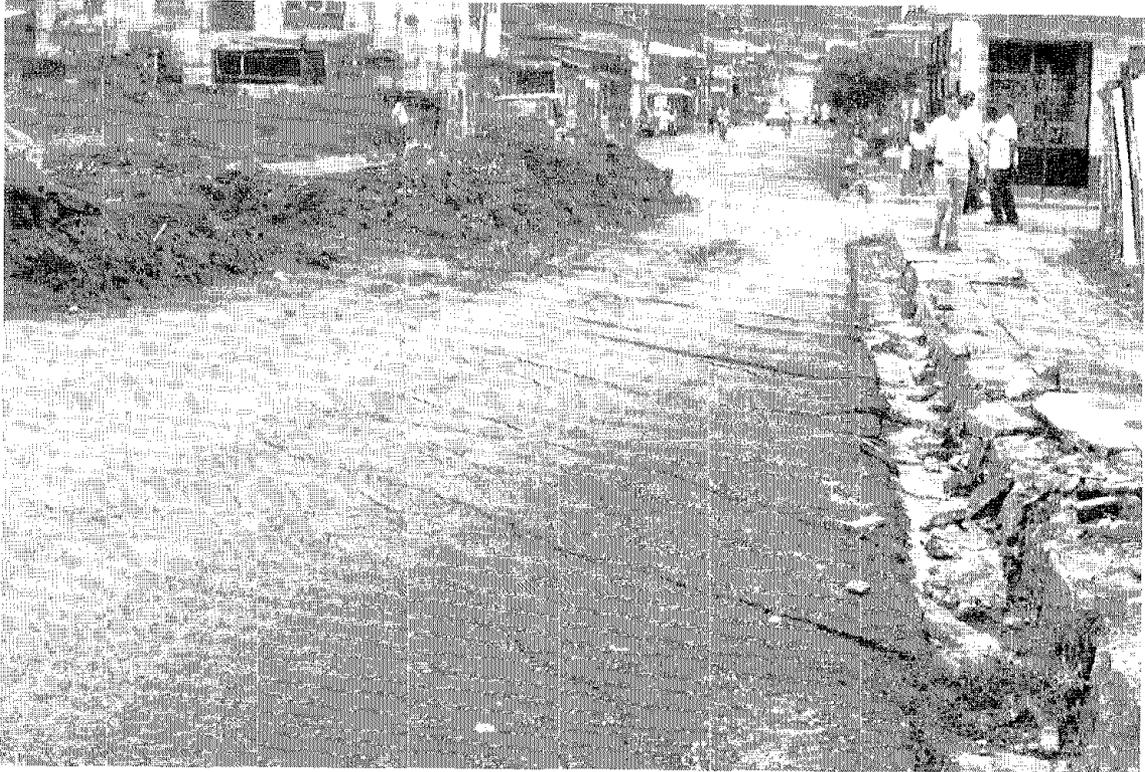
FIGURE 3-20 Road Surface Damage Adjacent to Distribution Pipe Break Shown in Figure 3-19

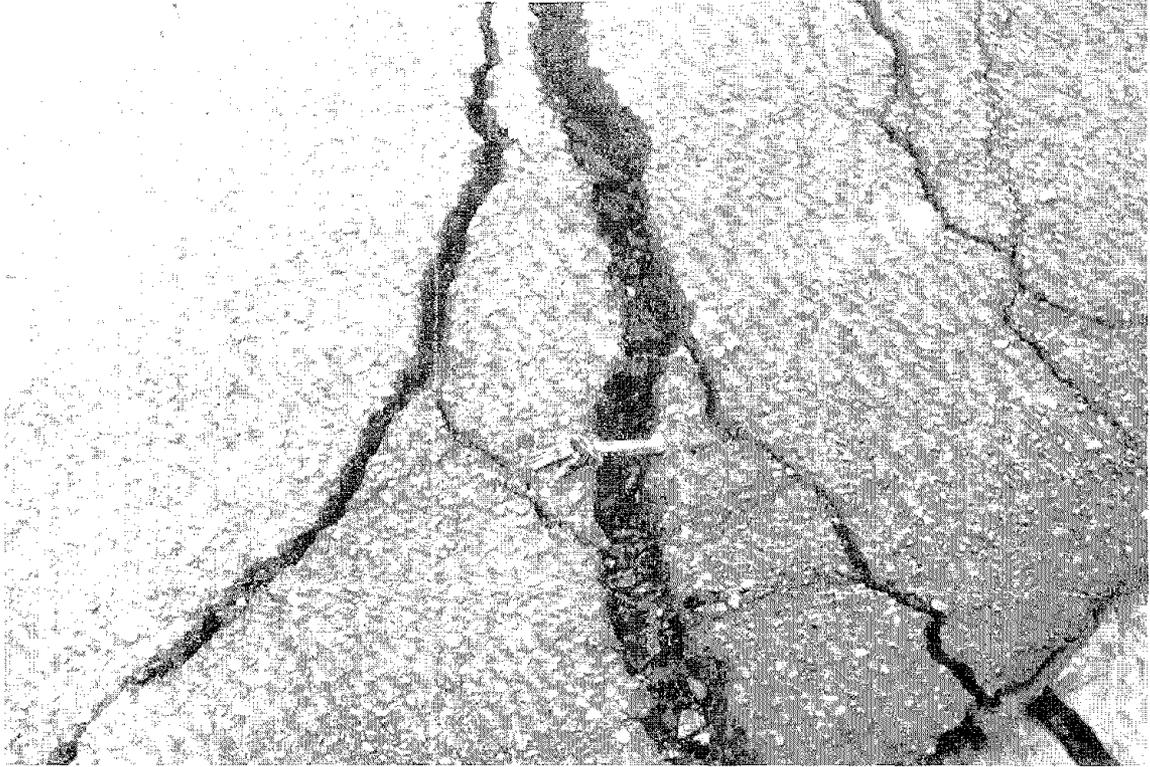
FIGURE 3-21 Close-Up of Superficial Road Cracks Shown in Figure 3-20

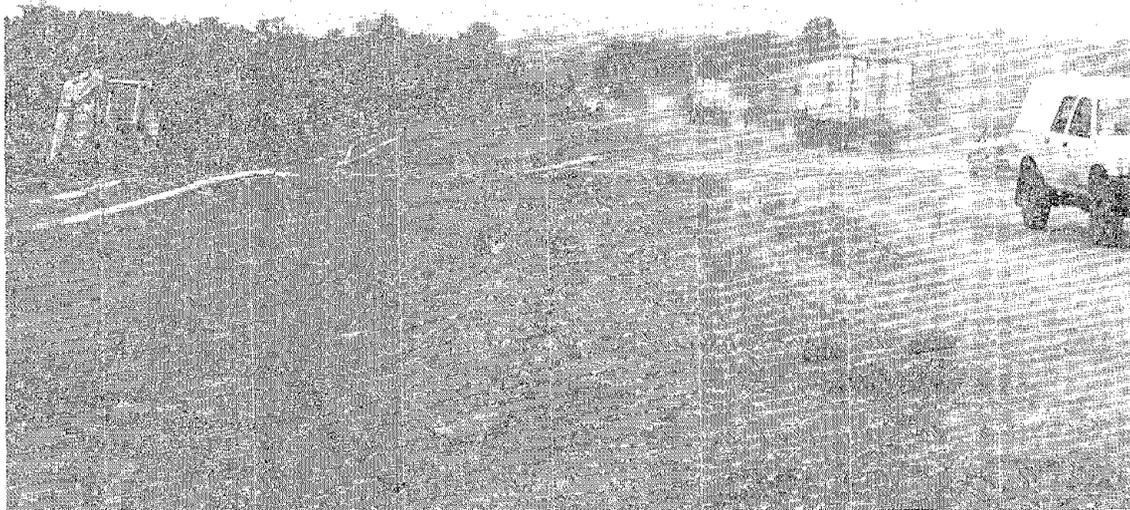
FIGURE 3-22 Heavy Road Damage near Village of Estrada in General Vicinity of RECOPE Pipe Leak, Note That Road Surface at Somewhat Higher Elevation Than Banana Plantation on Left.

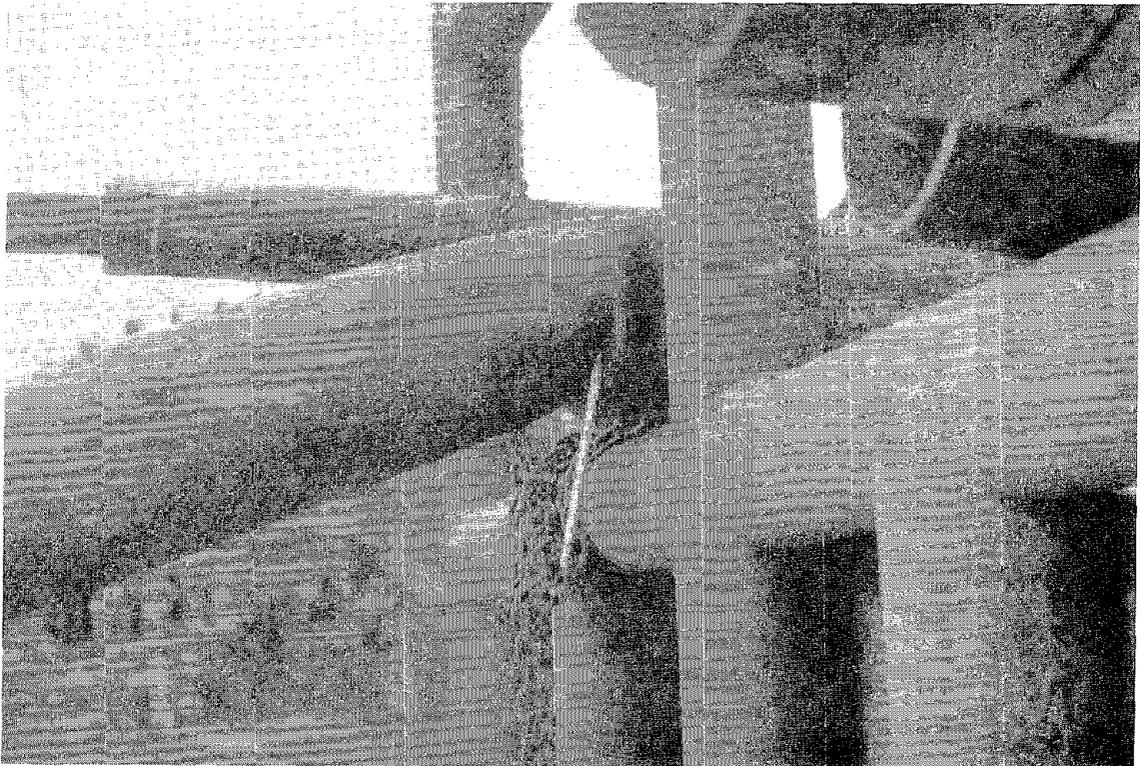
FIGURE 3-24 Damaged Portion of RECOPE Pipeline on Back of Repair Truck, Pencil Stuck in Tensile Crack Generated by Severe Local Buckling (Wrinkling) on Compression Side of This Flexural Failure.

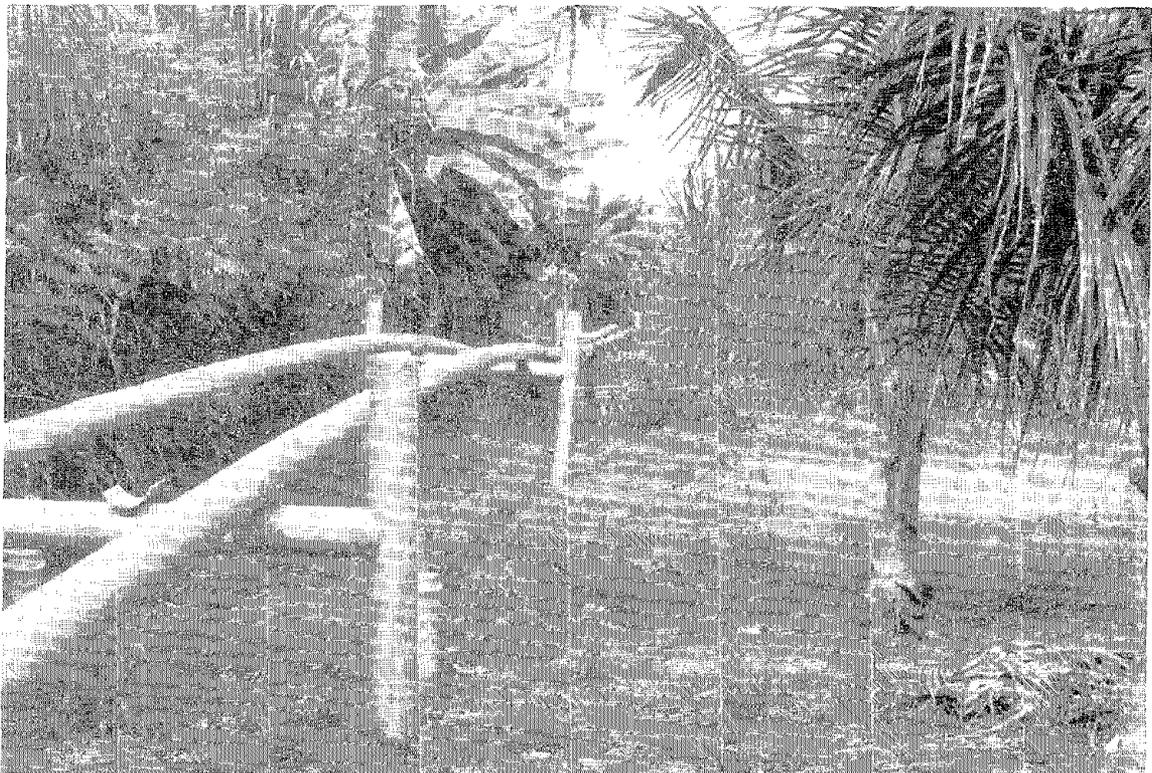
FIGURE 3-28 Ejected Sand at Base and to Right of Tilted Steel Support Frame for Undamaged RECOPE Pipeline.

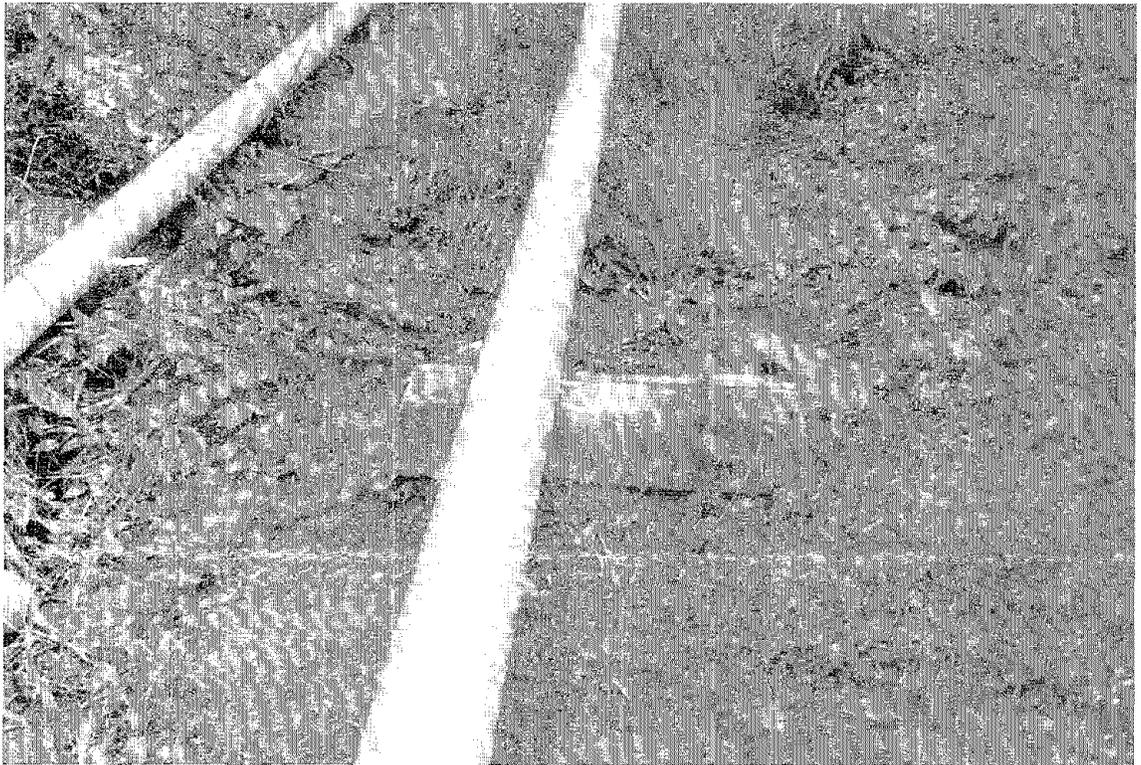
FIGURE 3–29 15 cm (6 in) Relative Movement of Undamaged RECOPE Pipeline Adjacent to 400 m Length of Road Damage to Route 240.

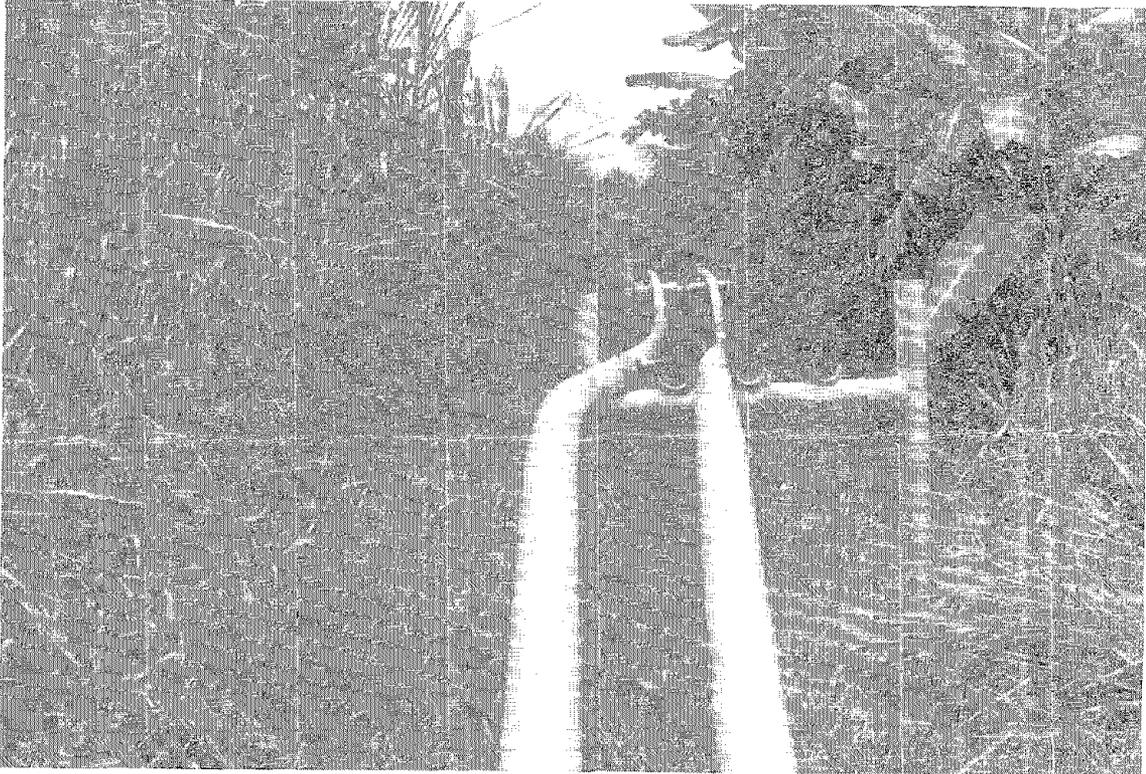
FIGURE 3-30 Severe Distortion of Undamaged RECOPE Pipeline Adjacent to 400 m Length of Road Damage to Route 240. Note Pipelines no Longer in Semicircular Steel Saddles.

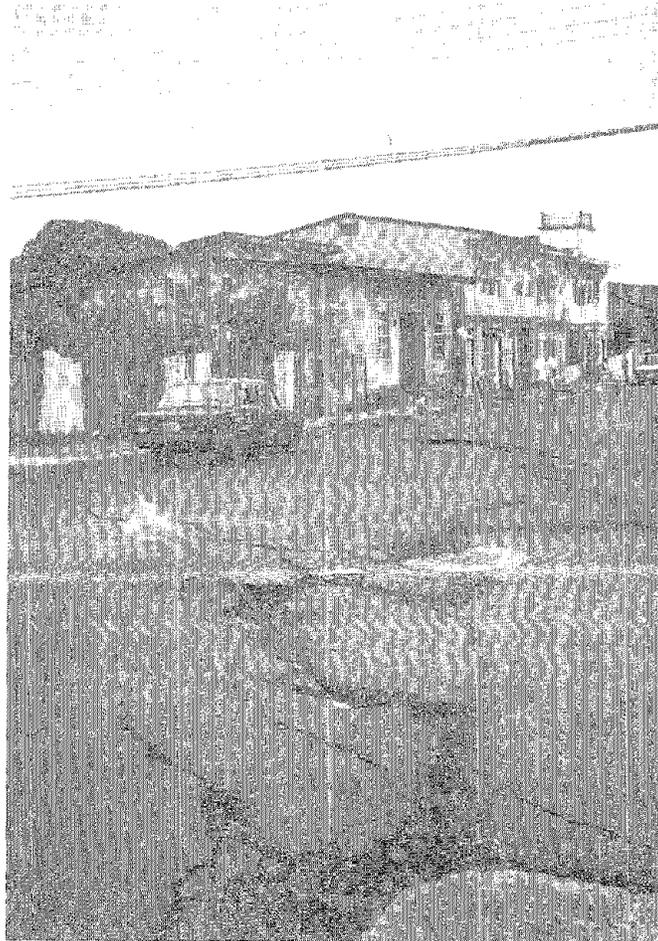
FIGURE 4-3 Ground Cracking Likely due to Lateral Spreading in Limón, which Caused Damage to Buried Pipelines
