Report No. CCEER 93-6

**RESPONSE OF BRIDGE HINGE  
RESTRAINERS DURING EARTHQUAKES--  
FIELD PERFORMANCE, ANALYSIS, AND DESIGN**

M. Saiidi, E. Maragakis  
S. Abdel-Ghaffar, S. Feng, and D. O'Connor

**May 1993**

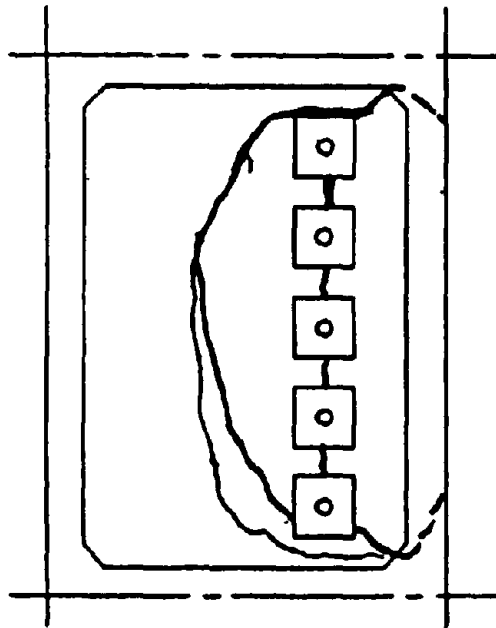
The damage in the soffit of the North Connector Viaduct was similar to the above damage. The hinge with significant concrete spalling was hinge number 33. Four of the nine cells in this part of the structure were retrofitted with high-strength rods. These were the first, fourth, fifth, and the eighth cell from the west edge. Six rods were placed in one row in the first cell. The other cells had each six rods placed in two rows of three rods. The damage occurred only in the first cell. Again, punching shear followed by bending action was the mode of the diaphragm failure.

Fig. 2.2 - Crack Pattern Inside the Cell.

It should be noted that in excess of 100 sets of restrainers are used in the structure and that damage was observed only in two of the diaphragms. It is recommended that all the cells which are retrofitted by one row of rods and which are not retrofitted by a bolster be reevaluated and the diaphragms be strengthened.

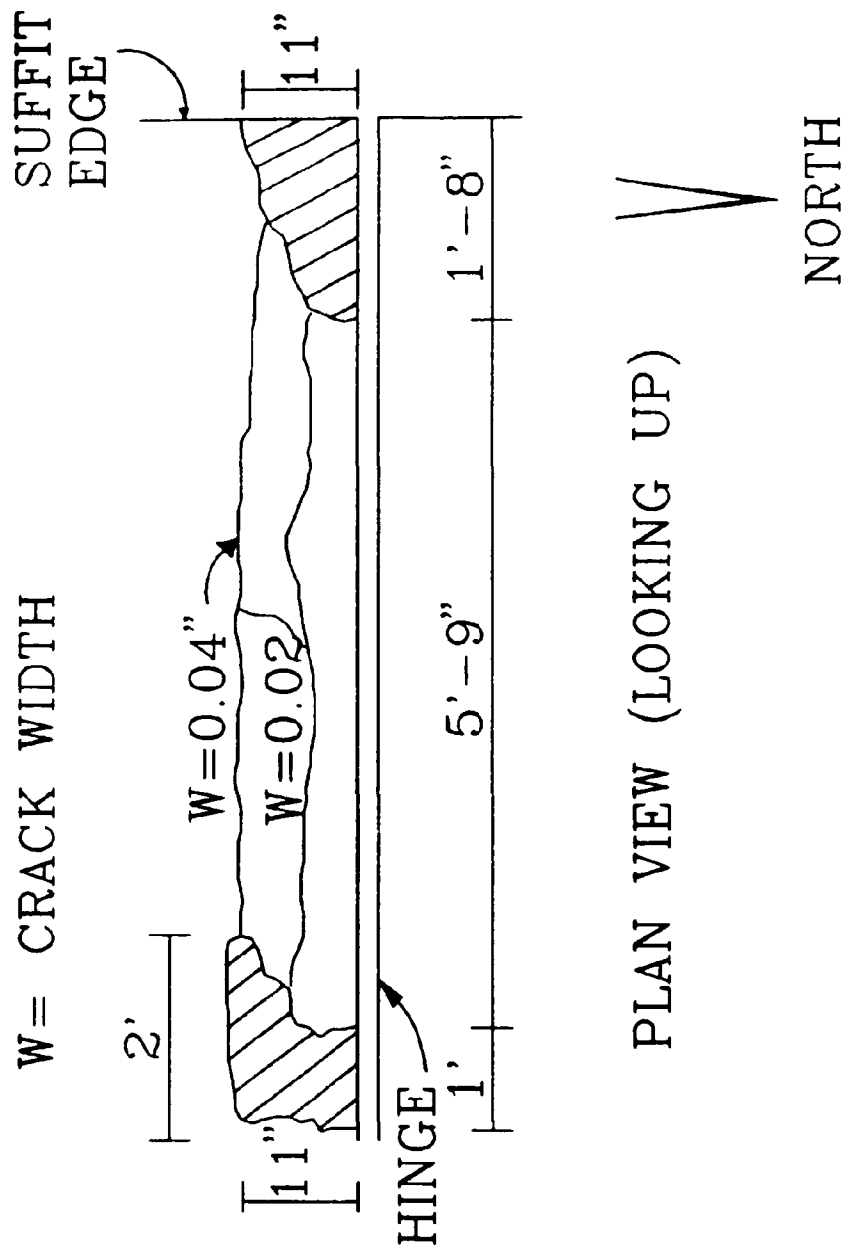
The field investigation took place on June 10, 1991. Some of the details of the field visit may be found in App. A in Ref. 14. The cause of damage is attributed to the inadequate punching shear strength of the damaged diaphragms. The restrainers in the damaged cells were placed in one row. This was true for both Hinge 20 and 33. The associated critical punching shear section for Hinge 20 is shown in Fig. 2.4.a. Note that the failure area is a relatively small and narrow area compared to the critical section for two rows of restrainers (Fig. 2.5.a). Tests on punching shear strength of reinforced concrete slabs have shown that the shear strength drops

Fig. 2.3 - Crack Pattern at the Bottom Soffit Near Hinge 33.

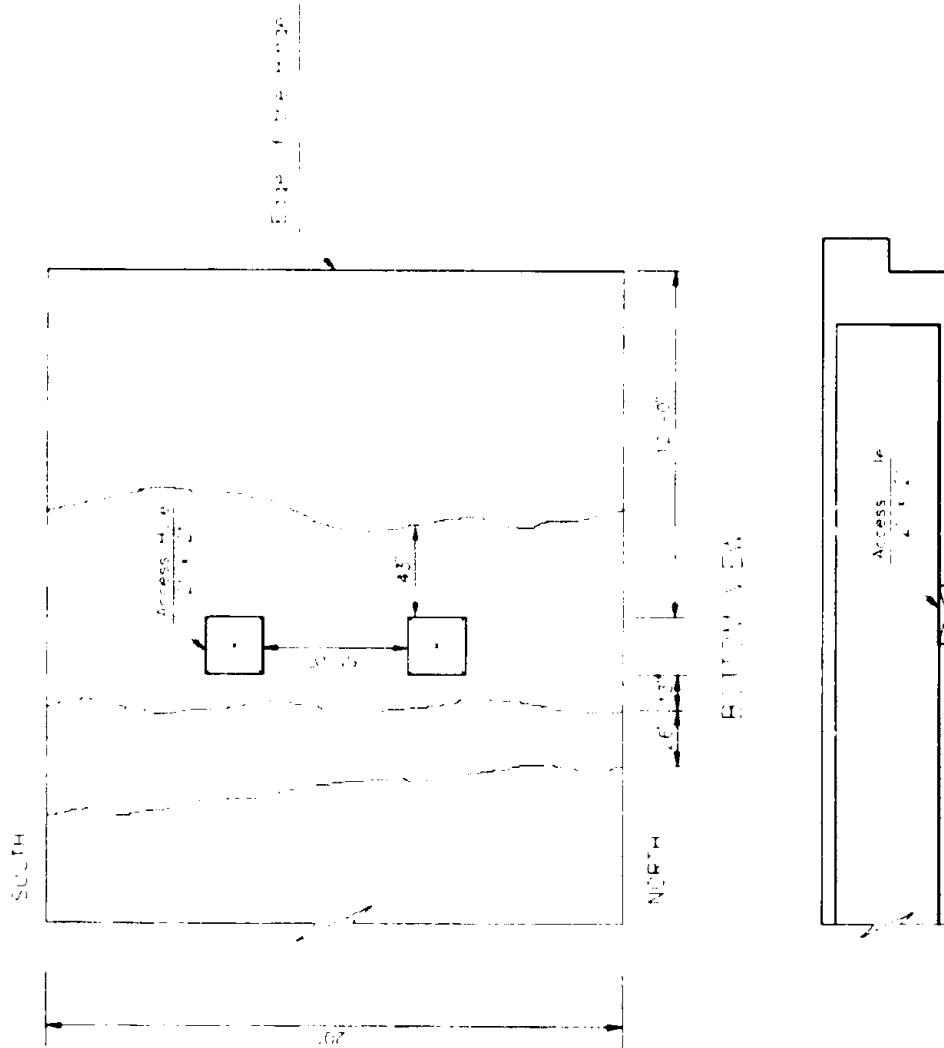
In September 1991, the researchers were notified that several wide cracks have been noted at the bottom soffit near the hinge connecting the on-ramp bridge to I-92, near Bent 32-R. There was also some spalling of concrete at the railing in the hinge area which indicated possible pounding. Because there were no access holes in the box girder cells, the bridge was not visited until November 21, 1991 after access holes were cut into the two inner cells. Figure 2.6 shows the major cracks in the bottom soffit as observed looking up. The two cracks on the left side of the access holes had extended to nearly the full height of the south exterior cell. Figures 2.7 and 2.8 show the girder cracks as observed inside the second cell from the south. The crack widths are also shown. Note that the cracks were nearly parallel with slight inclination. The cracks shown in Fig. 2.6 were observed on the bottom slab inside the cell. Some of these cracks were as wide as 0.05 inch. Because the bottom of the top slab was covered by stay-in-place forms the web cracks could not be traced through the top slab. The grooved top surface of the deck prevented the tracing of the cracks on the top deck. However, the fact that typically the vertical cracks extended over the entire web could indicate that they perhaps propagated to the top slab. The hinge gap on the edge with spalled concrete was 2 in. and on the other edge was 3 in.

shear. Because the location of the cracks was close to the hinge, the moments had to be relatively small and the cracks could not have been caused by flexure alone. The damage to one of the columns and spalling of concrete at the hinge could indicate relatively large movement of the superstructure and utilization of the restrainers. The total yield force for the restrainers was 1564 kips. The direct tensile cracking strength of the superstructure is 2300 kips based on a concrete compressive strength of 4000 psi and assuming a tensile strength of  $6\sqrt{f'_c}$ , in which  $f'_c$  is the concrete compressive strength. The comparison of these figures suggests that it is unlikely that restrainer forces alone have caused the cracks. However, it is possible that the restrainer tensile force in the superstructure reduced the flexural strength and helped open the flexural cracks that were developed by vertical loads.

The sensitivity of the flexural strength and the cracking moment of the superstructure to axial tension was calculated. It was determined that, for a restrainer force of one-half of the yield force (a force level expected during a moderate earthquake) the ultimate positive and negative moment capacities would drop by approximately 30 and 13 percent, respectively. When the restrainers approach the yield level, the ultimate positive and negative moment capacities drop by approximately 65 and 25 percent, respectively. Although not evident in this bridge, the axial tension could also significantly reduce the shear strength of the section [14]. In prestressed concrete members, the tension will reduce the effective prestress force. These effects are not usually considered in design, but they can be critical. It can be observed that placing too many restrainers can have detrimental effects on the superstructure.

**Fig. 2.6 - Crack Pattern at the Bottom Soffit of the 92/101 NE Connector.**

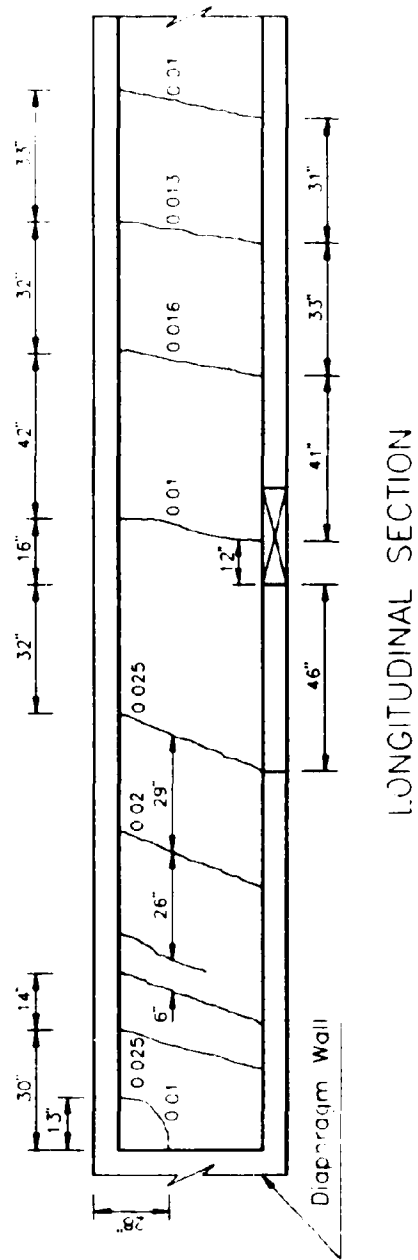
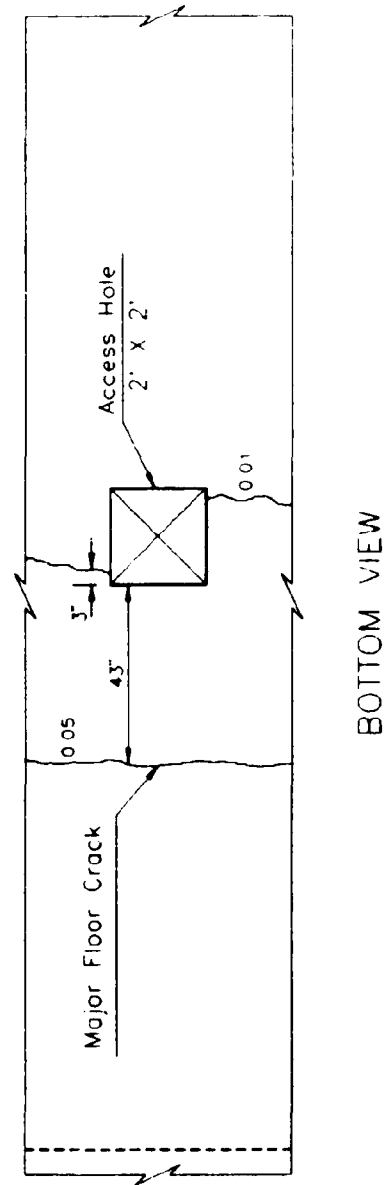
The fact that the cracks were nearly vertical suggested that they were not caused by

**Fig. 2.7 - Girder and Bottom Slab Cracks in the South Girder.**

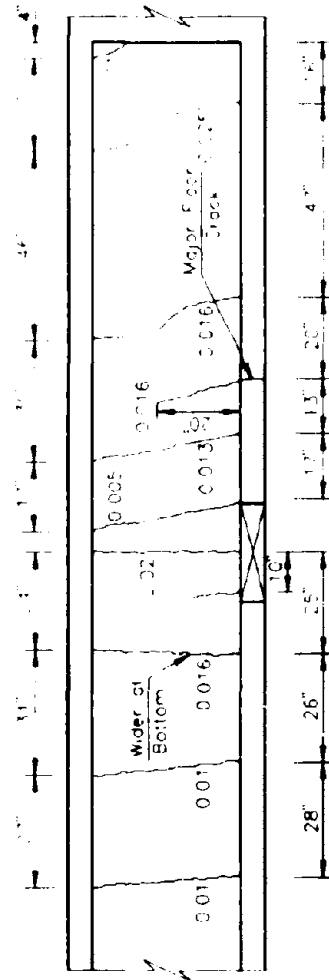
Fig. 2.8 - Girder Cracks in the North Girder.
