**The Island of Guam Earthquake of
August 8, 1993**

S.W. Swan and S.K. Harris
EQE International
44 Montgomery Street, Suite 3200
San Francisco, California 94104

Technical Report NCEER-93-0017

September 30, 1993

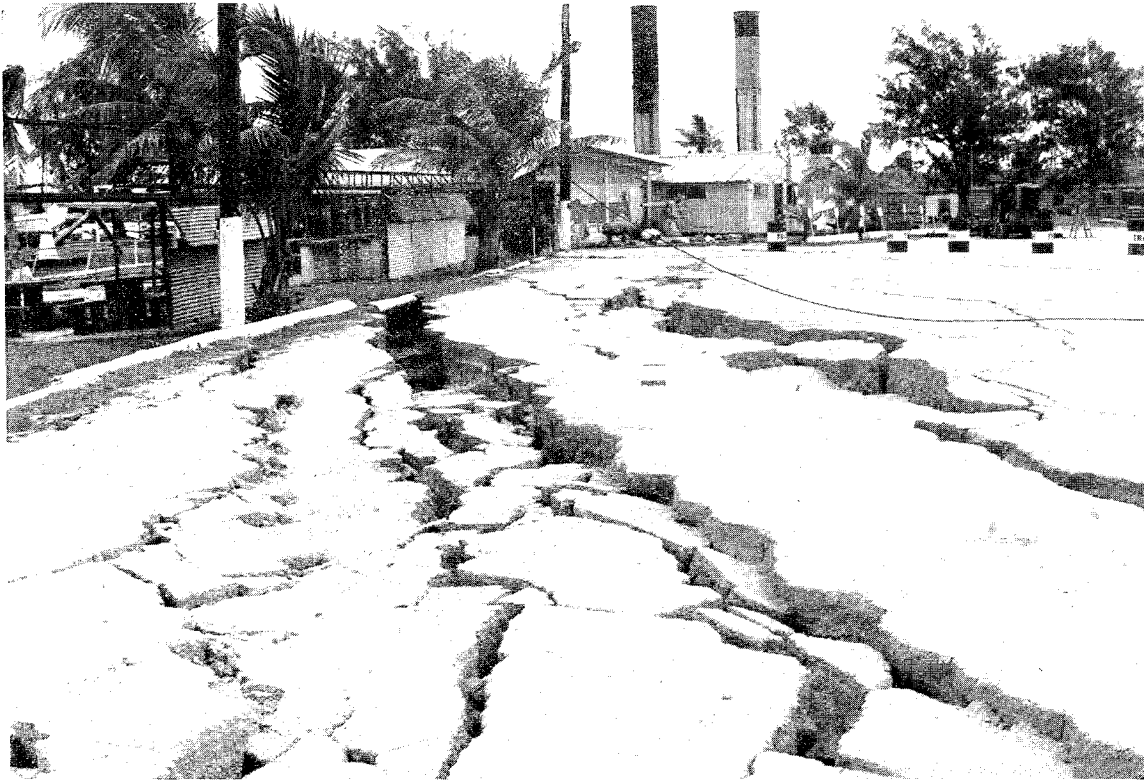
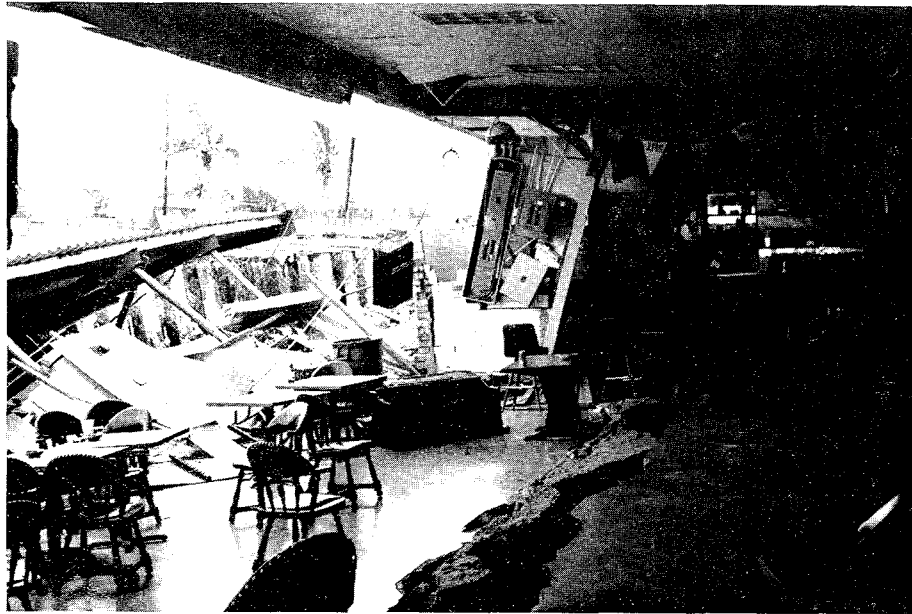
The isolated instances of liquefaction observed in the earthquake occurred in the harbor area. Sand boils were observed at various locations. Settlement and spreading created large fissures running for several hundred meters in sections of the Navy base (Figure 4-2). Buried water lines and electrical conduit were fractured by the soil displacement. Liquefaction-induced spreading split the enlisted personnel's shoreside recreation center on the Navy base, collapsing about half of the wood-frame structure. Although the center was full at the time of the earthquake, people were able to leave before the building began to disintegrate.

Figure 4-2: Liquefaction in the soft alluvium and fill beneath the Navy port area created fissures running several hundred meters (top photo). The enlisted personnel's shoreline club partially collapsed due to liquefaction-induced spreading beneath the structure (bottom photo).

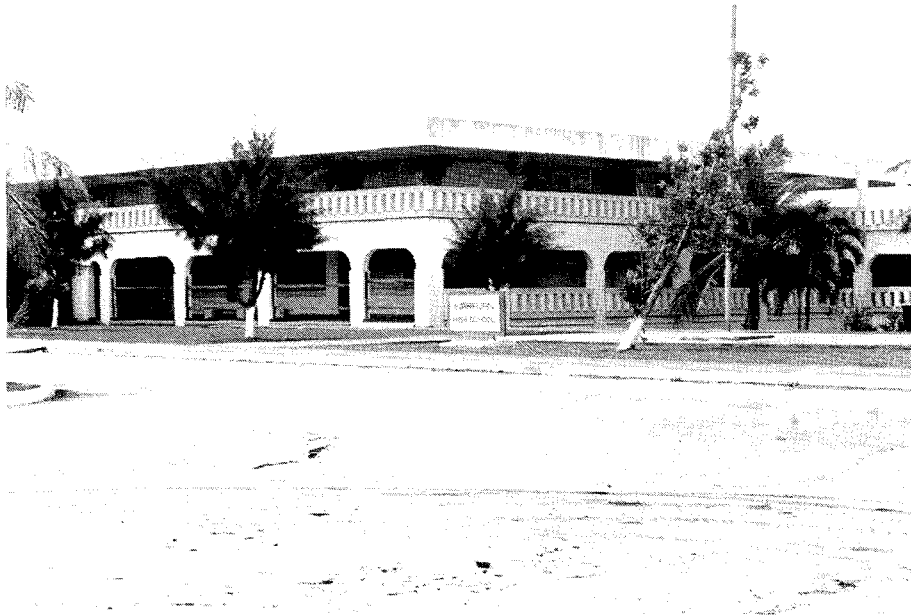
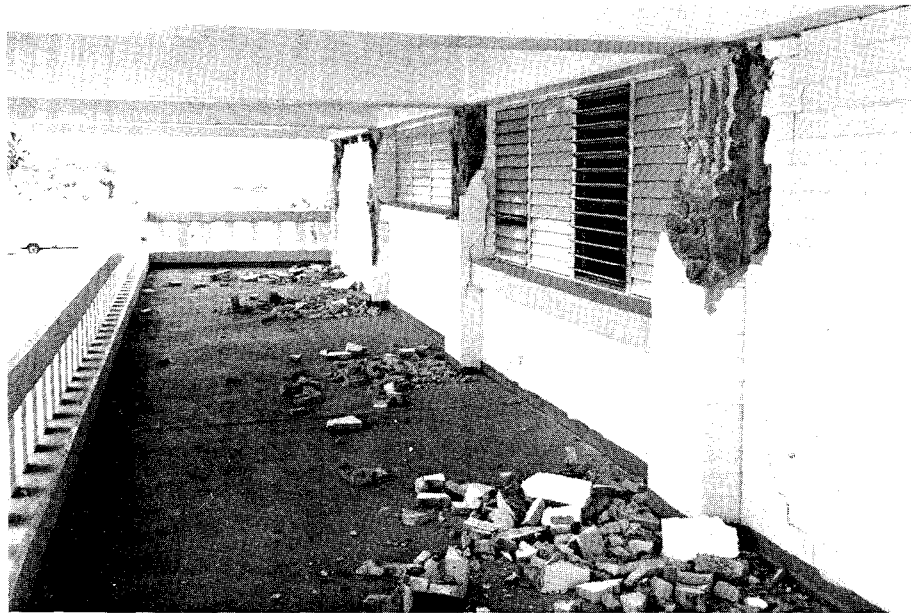
The most severely damaged school was Inarajan High School, at the southern end of the island (Figure 5-1). The school consists of several adjoining two- and three-story concrete-frame buildings with masonry in-fill, and was constructed in 1973. One wing with partial-height in-fill walls suffered severe cracking and spalling of concrete columns. This is an example of the "short column effect", where the presence of the partial-height in-fill walls shortens the effective height of the columns, forcing them to fail in shear. It appeared that at least one wing of Inarajan High School would have to be demolished.

Figure 5-1: One wing of Inarajan High School suffered shattered concrete due to the short column effect, where shear loads from half-height masonry in-fill were transferred into the columns.

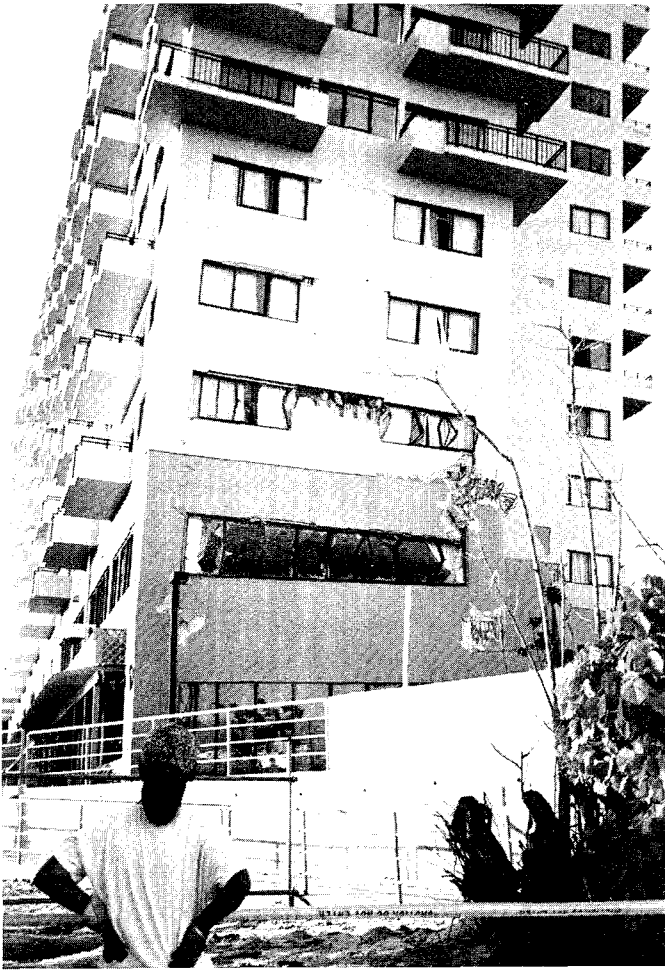
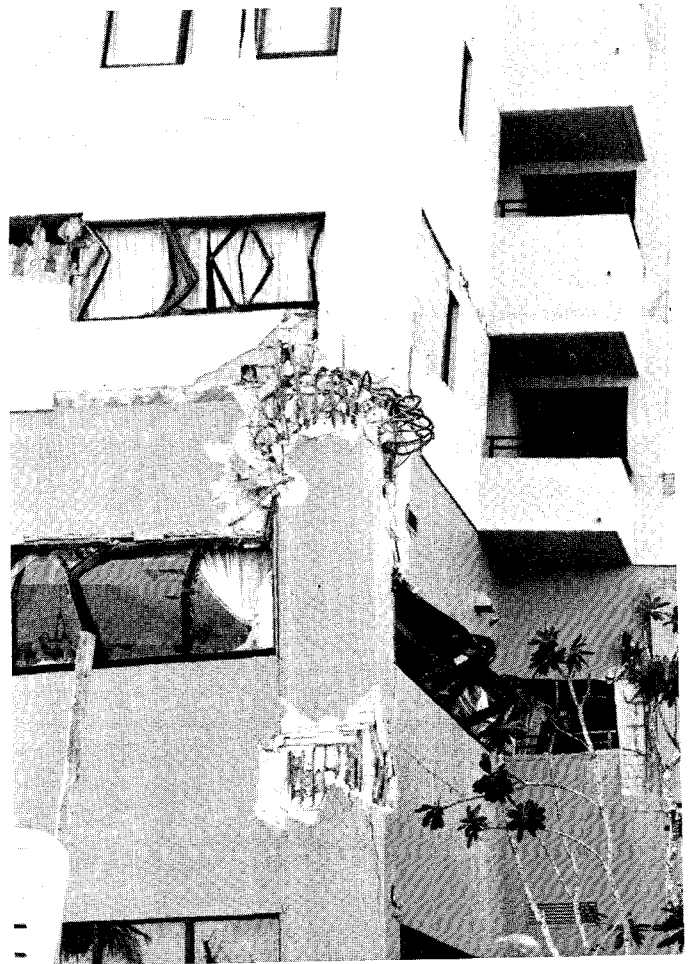
Two of the most serious instances of damage involved concrete-frame structures with concrete-masonry in-fill. In both cases, due to architectural and functional reasons, the in-fill was discontinued in lower stories, leaving the concrete frames to resist the imposed seismic demands alone. This created dynamic irregularities in the buildings, including soft-stories and torsion. Both of these buildings were of fairly recent design, but did not appear to include any special detailing in soft story columns to ensure the required ductility.

Perhaps the most dramatic effects were suffered by the Royal Palm Resort complex, a twelve-story structure that was open only 18 days prior to the earthquake (Figure 5-2). In the rear wing (adjacent to the beach) several columns in the second story collapsed, causing the wing to tilt substantially. The floors above the damaged level contained guest rooms, while the floors below appeared to contain mostly open common areas. Consequently, most of the in-fill shear walls above appear to have been discontinued below the third floor, creating the soft story. Other damage visible from the exterior included moderate shear cracking of in-fill walls and working of joints between in-fill and concrete elements. Following the collapse, guests were temporarily trapped in the damaged wing. Remarkably there were no serious injuries. It appeared that the rear wing of the building could not be repaired and would have to be demolished.

Figure 5-2: A partial collapse occurred in the seaward wing of the Royal Palms Condominiums. A discontinuity in masonry in-fill at the second floor concentrated shear on the corner columns.

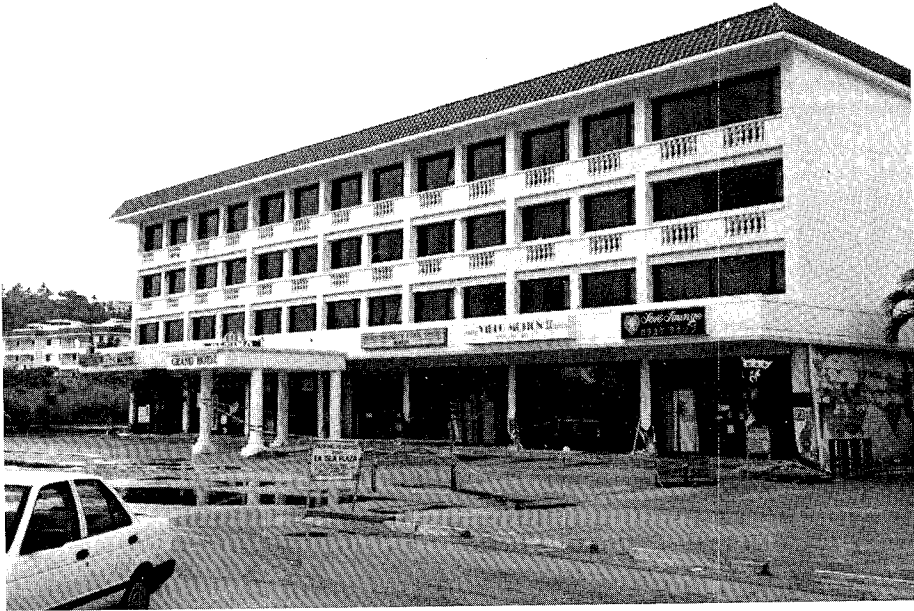
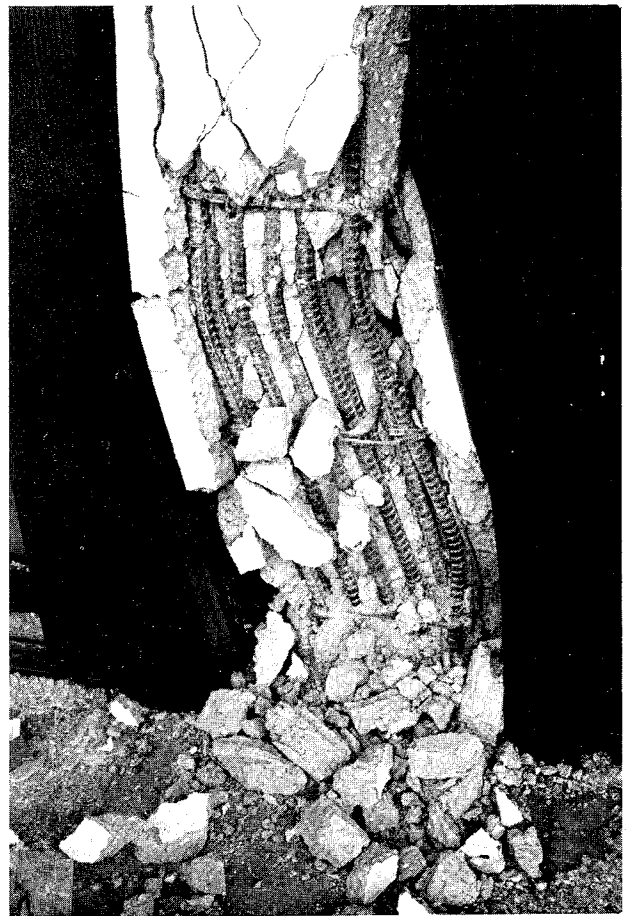
The four-story, five-year-old Grand Hotel was also severely damaged (Figure 5-3). In-fill walls enclosed most of the ground floor along the sides and rear of the building, while the front was mostly open, with large storefront windows between columns. The lack of shear resistance across the front created a soft first story, combined with a tendency for structural torsion. While the upper three stories of the building appeared essentially intact, the second floor shifted nine

Figure 5-3: The Grand Hotel near Tumon Bay suffered the most extensive damage of low-rise structures on the island. A soft first story effect shattered columns at the base of the building and shifted the upper three floors nine inches relative to the ground.

inches relative to the foundation, shattering concrete in the ground floor columns. Some of the columns lost their ability to resist gravity loads, leaving portions of the building supported by the in-fill masonry walls. The building was subsequently slated for demolition.

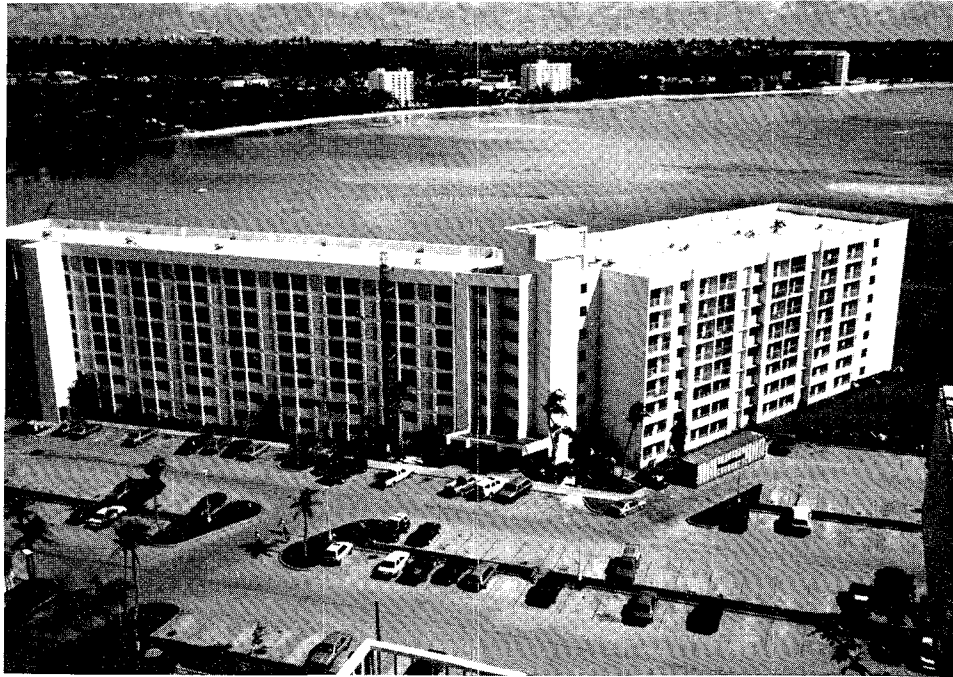
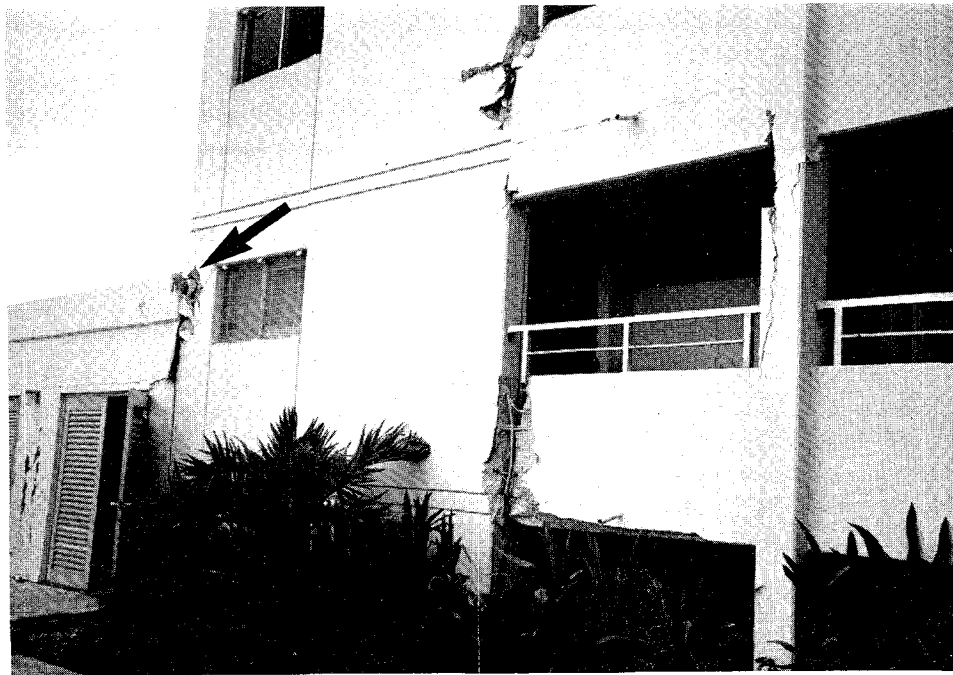
The Alupang Cove condominium complex in Tamuning also suffered serious, although repairable, degree of damage (Figure 5-4). The building consists of two eight-story wings that join at an angle. The most visible damage occurred along a breezeway in the northern wing. In this area, concrete columns and masonry screen walls were severely damaged, leading to a partial loss of vertical support for the breezeway. These elements do not appear to have been intended to resist lateral loads, but were damaged because of the building's flexibility in its longitudinal direction. Shear cracking occurred in concrete spandrels at their interface with a major concrete shear wall at the eastern end of the breezeway. Other damage observed appeared to be due to improper detailing. Major pounding damage to a bearing wall was observed at the ground floor between the main structure and the abutting one-story mechanical building. In the southern wing, concrete spalled from floor slabs at their attachment to a major shear wall,

The Alupang Cove Condominium Complex suffered effects typical of mid-to high-rise buildings in the tourist area.

Figure 5-4: Shattered columns, shear cracking at spandrels, and pounding damage at the interface of the one-story mechanical building (at left) are seen along the front fact of the Alupang Cove.

exposing the slabs' embedded prestressing tendons. Repair of the prestressed slabs presents a problem since the exposed tendons cannot be retensioned.

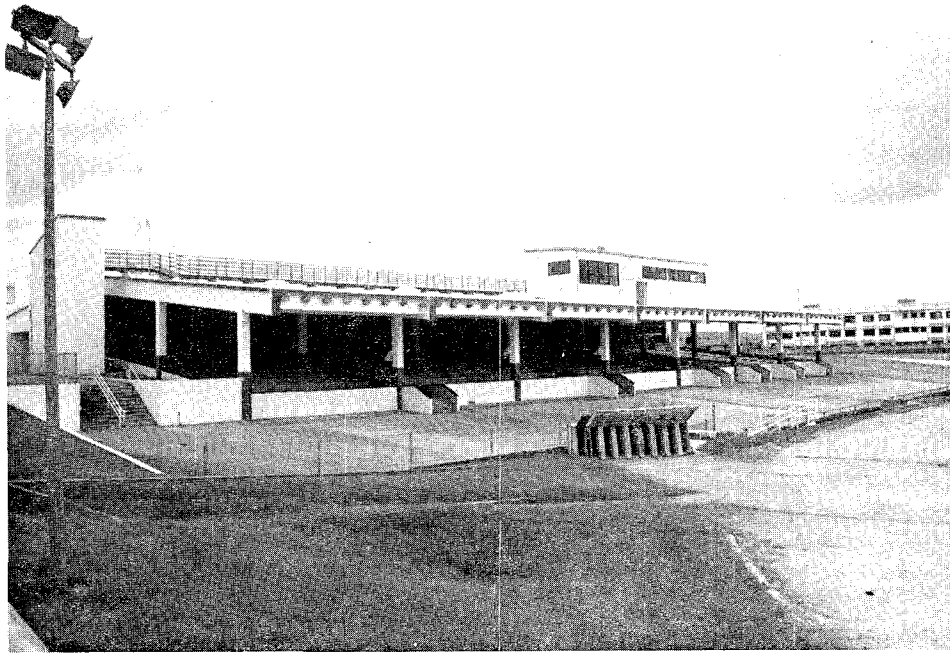
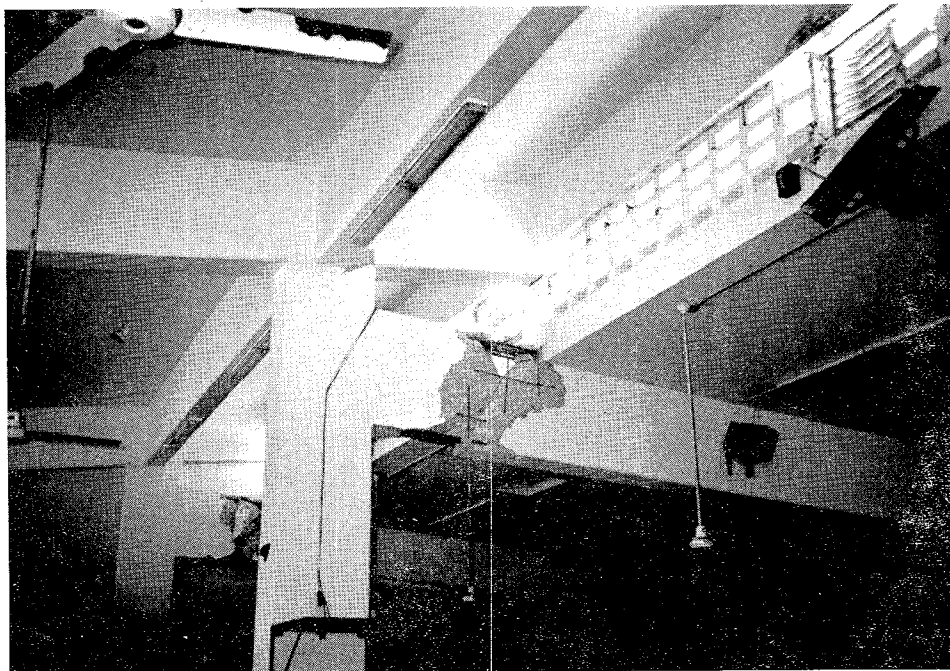
The grandstand roof structure of the Greyhound Racetrack near Tamuning was severely damaged (Figure 5-5). The structure consists of a large main roof, supported only by concrete columns, and a second lower roof, supported on one side by the main-roof columns and on all other sides by concrete shear walls. There is a concrete-block screen wall in the vertical space between the two roofs. The screen wall apparently failed as it attempted to transfer seismic forces from the main roof to the lower roof. At this point the only remaining lateral load path between the two structures was through the large roof beams supporting the lower roof. These beams developed dramatic inclined cracks, apparently due to torsion induced by the shear transfer.

Figure 5-5: The Greyhound Racetrack consists of two concrete canopies offset vertically at the center of the structure. The concrete beams spanning between the two canopies were shattered by the different response motions of the two halves of the structure.

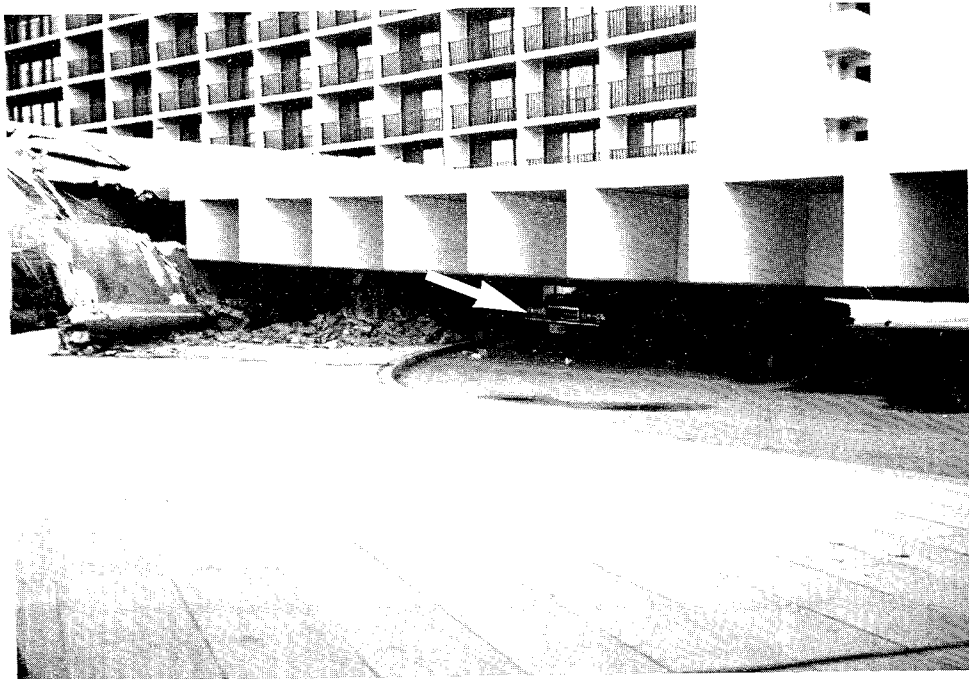
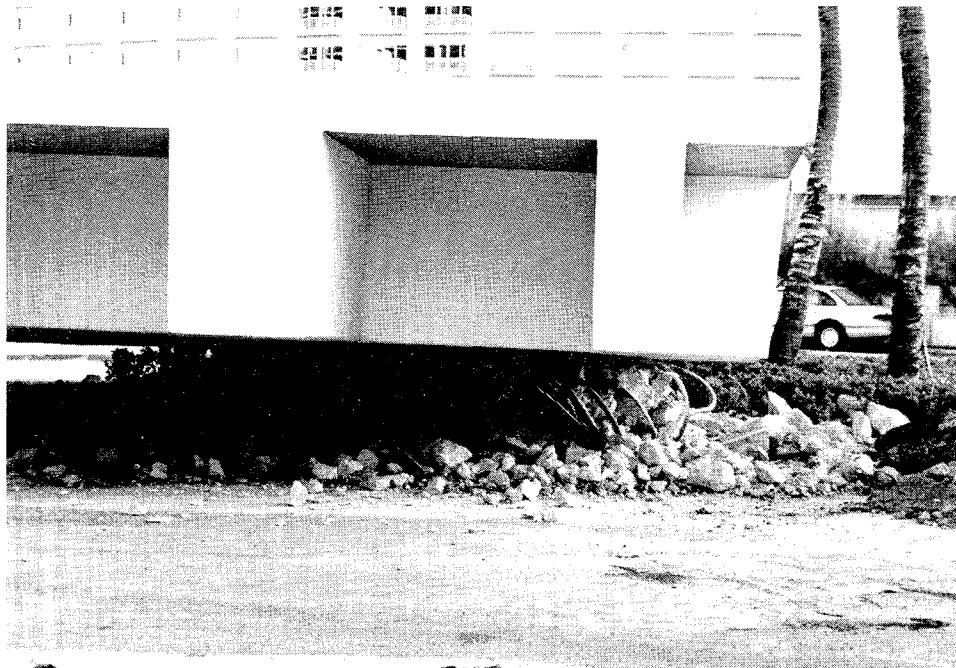
Concrete canopies, consisting of heavy slabs supported by concrete columns, are common on the island. Frequent damage to the supporting columns was observed, apparently due to improper detailing of highly stressed top connections. The most notable instance of such damage was the collapse of the canopy at the entrance to the Reef Hotel on Tumon Bay (Figure 5-6). The canopy's four concrete columns failed catastrophically, dropping the slab onto two parked taxis beneath. Fortunately, the drivers were out of the cars at the time of the earthquake. The concrete columns completely shattered and their longitudinal reinforcing buckled. The minimal horizontal ties appeared to be ineffective in providing confinement. Although there were no other instances of life-threatening collapse of canopies, minor to moderate damage of canopy columns was observed throughout the island.

Figure 5-6: The most severe instance of concrete canopy damage occurred at the Reef Hotel, where crushing of concrete columns dropped a heavy slab onto taxis parked near the entrance.

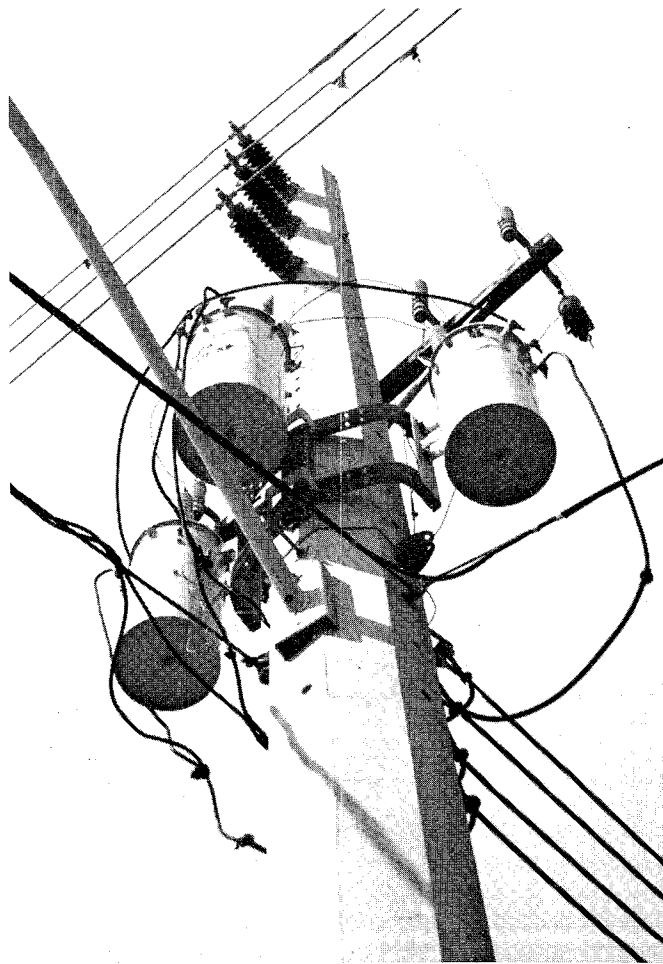
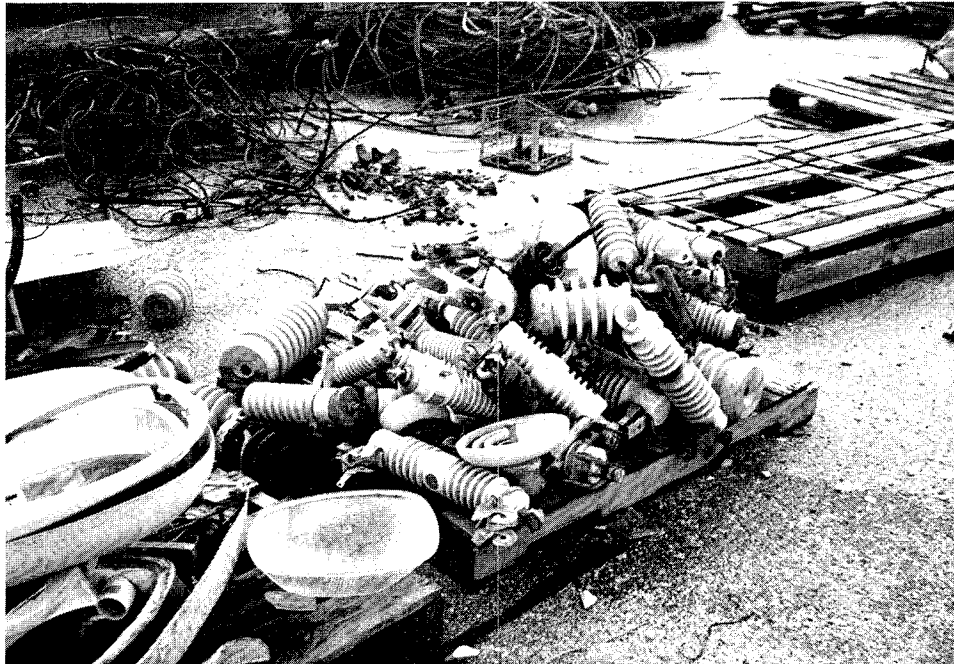
The transmission and distribution system experienced minor damage. Power Authority engineers estimated two or three dozen broken porcelain insulators supporting transmission cable on power poles. There were a few instances where cables detached and fell to the ground in the transmission or distribution system. The 115 and 34.5 kV substations suffered a few

Figure 6-1: Wind loads on Guam result in power and transmission poles of heavy reinforced concrete (top photo). A small portion of poles suffered broken ceramic insulators. Broken insulators are collected on pallets in the Power Authority's service yard (bottom photo).

isolated instances of broken porcelain or detached conductors (Figure 6-1). There was no damage in the major switchyard equipment such as transformers or circuit breakers. Several large substation transformers were noted to have shifted on their base pads, as much as 16 inches at one station. There were no instances of damage to power poles or transmission towers.

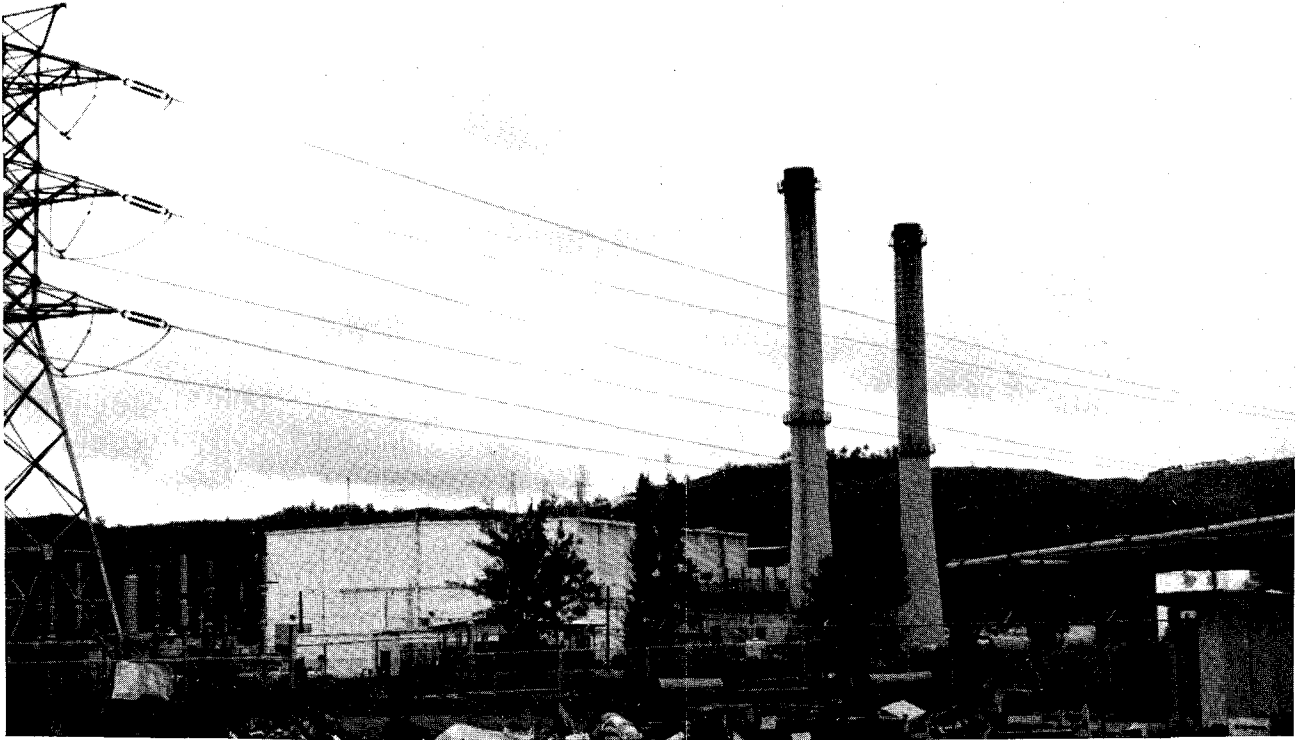
Damage in all generating plants was minor except for the Navy-operated steam plant located in the port area (Figure 6-2). Settlement of soil fill created vertical offsets of up to four feet near the plant's salt water intake channel, fracturing the buried circulating water lines to the condensers. Two of four generating units were operating at the time of the earthquake. The plant's DC power supply was lost when batteries toppled from their racks. Simultaneous loss of DC and AC operating power meant that the spinning turbines coasted down without lube oil pressure, possibly resulting bearing damage. Additional damage in the plant included an overturned station service transformer, an overturned motor control center, and leaks in various piping systems. The turbine buildings were not accessible for a week following the earthquake due to airborne asbestos dislodged from thermal insulation.

Figure 6-2: Overturned power supply equipment, such as batteries, motor control centers, and the station service transformer (at right), cut off both DC and AC power to two operating units at the Navy's Piti Steam Plant. Damage to the plant severely reduces the island's generating capacity.

Repairs were completed to one of the larger units at the Navy steam plant, and it was brought back on line about four weeks after the earthquake. This provided some relief to the island's electrical system. The Navy plant represents about 20% of Guam's generating capacity. With the plant off line, the remaining generating capacity could barely meet demand.

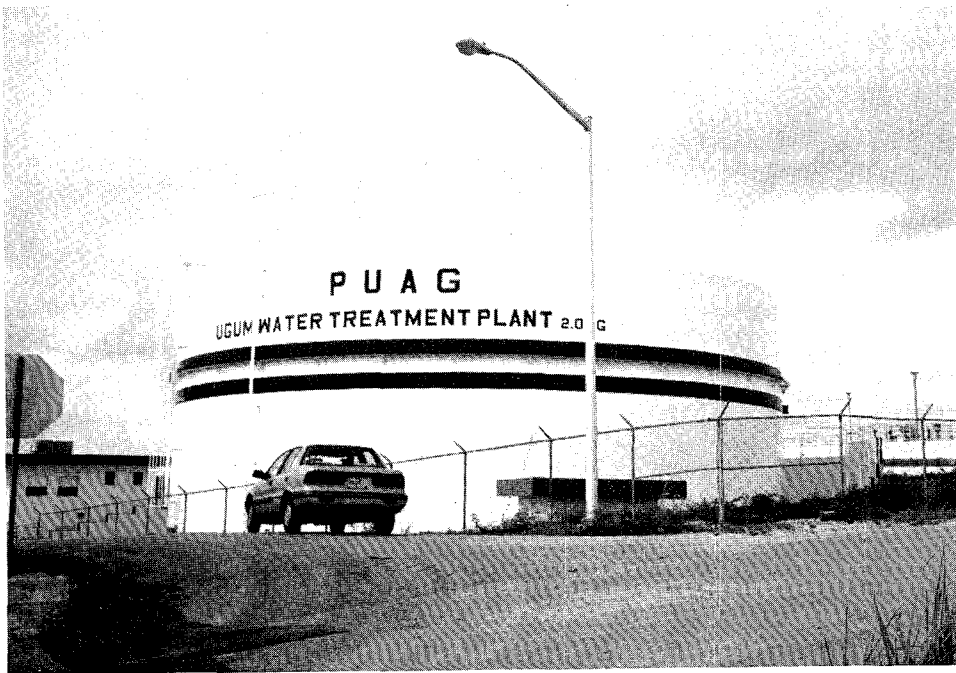
The PUAG water and wastewater system management indicated that all wells, pumps, storage tanks, and treatment plants survived the earthquake without significant damage (Figure 6-3). Restoration of service however was limited by damage in the buried piping systems.

As of Saturday, the sixth day after the earthquake, over 100 breaks had been reported in water mains. Nevertheless, most of system remained pressurized in the heavily populated areas surrounding Agana. Most of the pipe failures appeared to be leaks rather than ruptures. There were, however, instances of total loss of flow in water mains. Within the firm limestone site of Anderson Airbase, for example, a six-inch water line fractured and offset 12 inches.

Figure 6-3: The Public Utility Agency of Guam (PUAG) reported no damage to their welded steel storage reservoirs or the Uguum Water Treatment Plant (above). Over 100 breaks occurred in the island's 500 miles of buried water mains. Repairs are underway to a broken main near Agana at right.
