**Engineering Aspects of the October 12, 1992  
Egyptian Earthquake**

**A.W. Elgamal, M. Amer, K. Adalier and A. Abul-Fadl**

Technical Report NCEER-93-0018

October 7, 1993

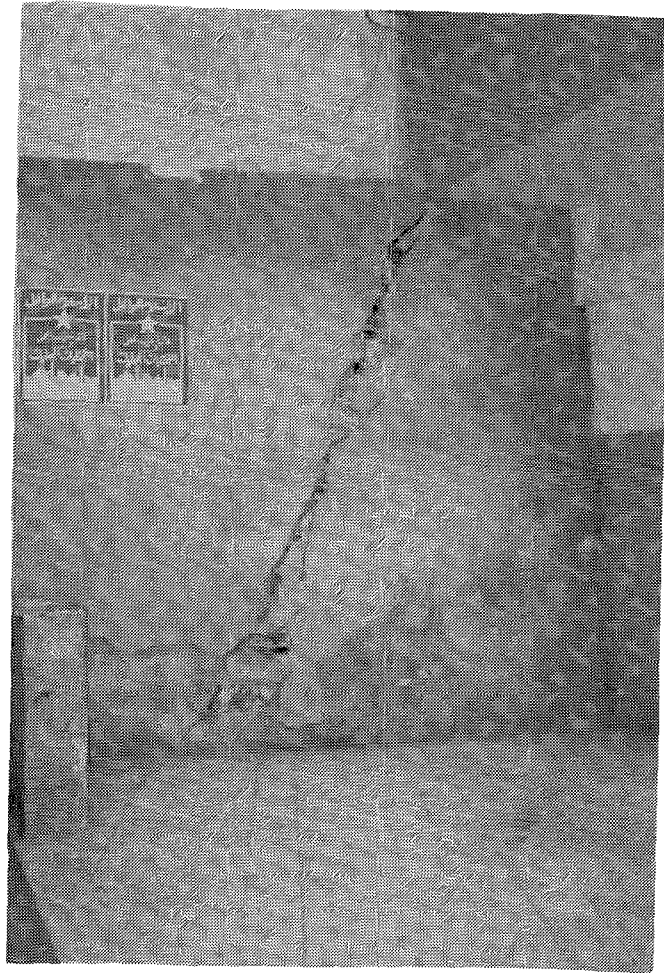
**FIGURE 1-4** Shear crack in masonry wall,  
Misr Elkadima district (Old Egypt).

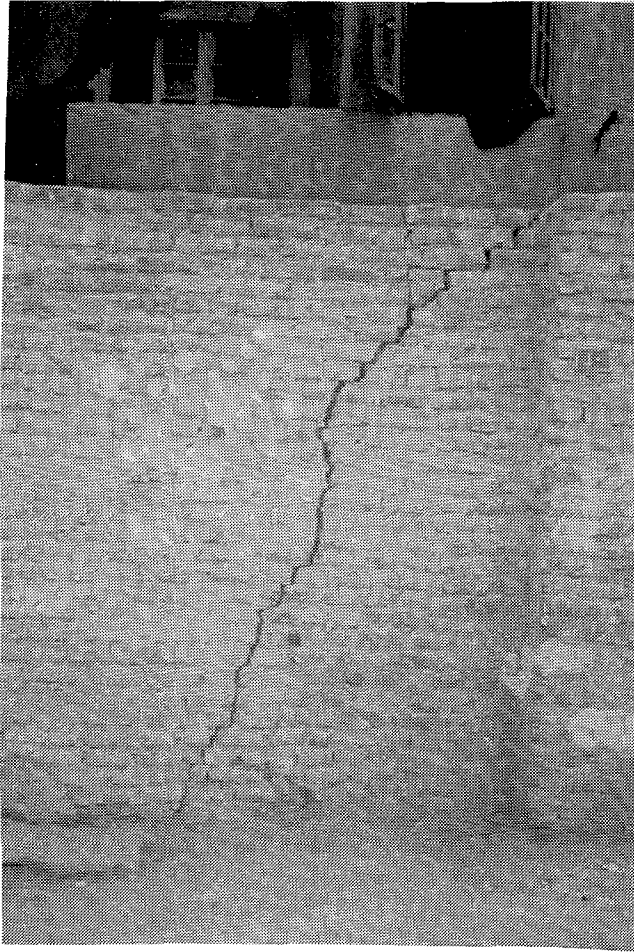
**FIGURE 1-5** Shear crack in red brick wall, Misr Elkadima district (Old Egypt).

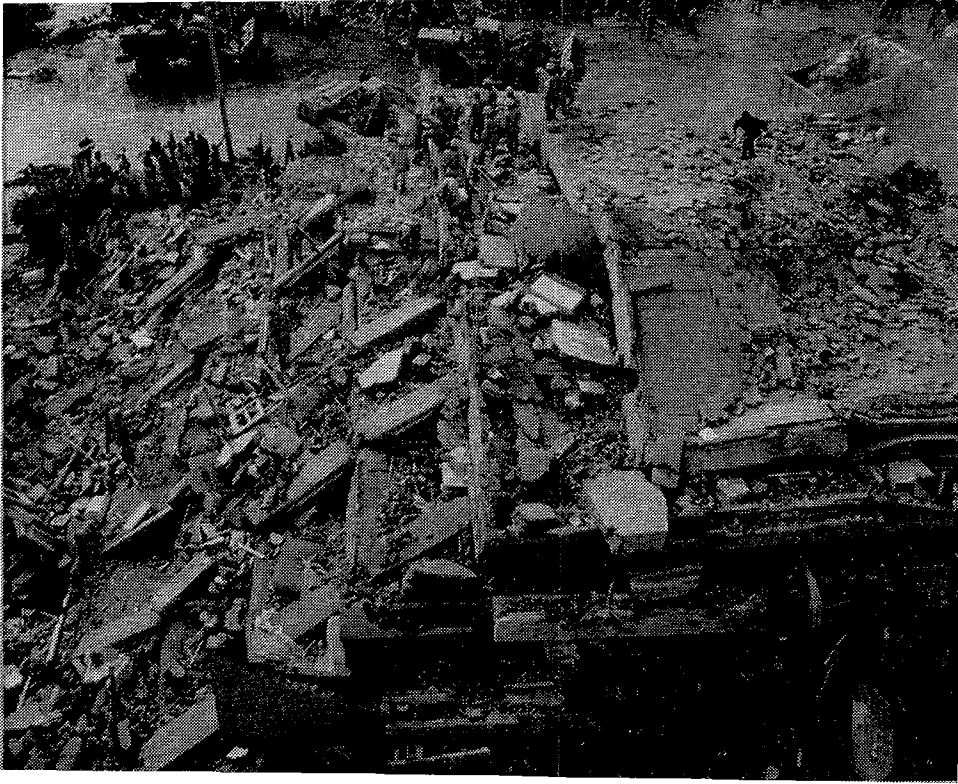
Only one such structure (14 story) was found to have totally collapsed (figure 1-6) due to seismic excitation (Khater, 1992). This particular building was later found to have been erroneously underdesigned and very poorly constructed. Despite the absence of any aseismic design considerations in these structures, no significant damage occurred due to: i) the static factor of safety, ii) the significant lateral resistance provided by the infilled

**FIGURE 1-6** Collapsed 14-story reinforced concrete structure (Heliopolis district).  
[National Geographic, Vol. 183, No. 4, April 1993.]

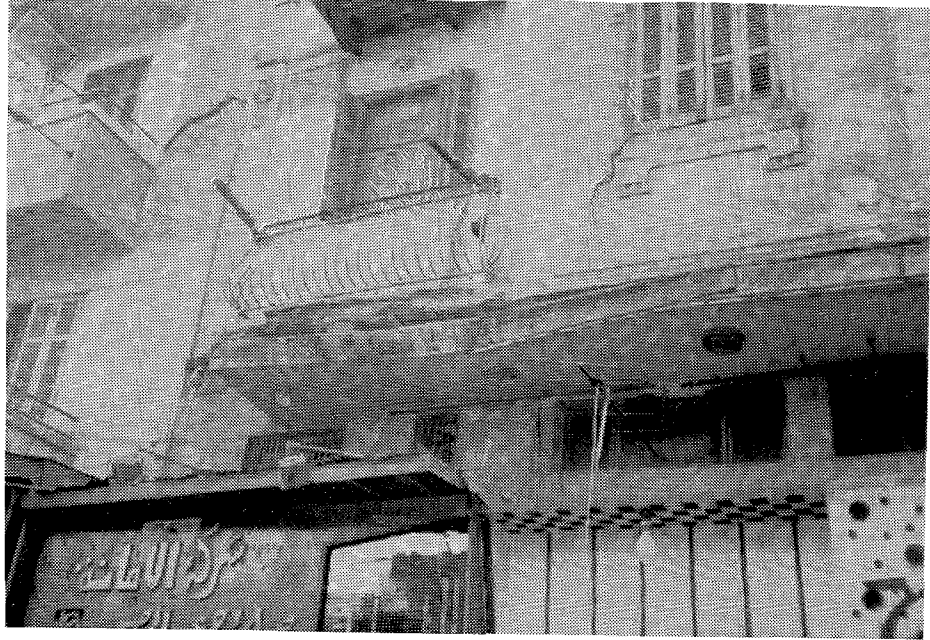
**FIGURE 1-7 Shear crack at window corner  
(Elsayyeda Zenab district).**

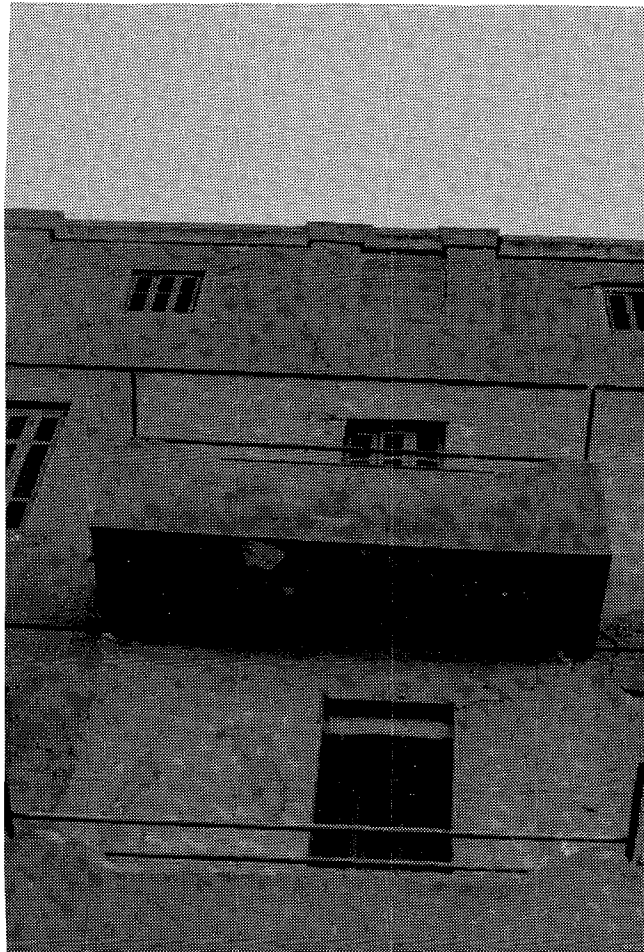
**FIGURE 1-8 Shear cracks in masonry walls.**

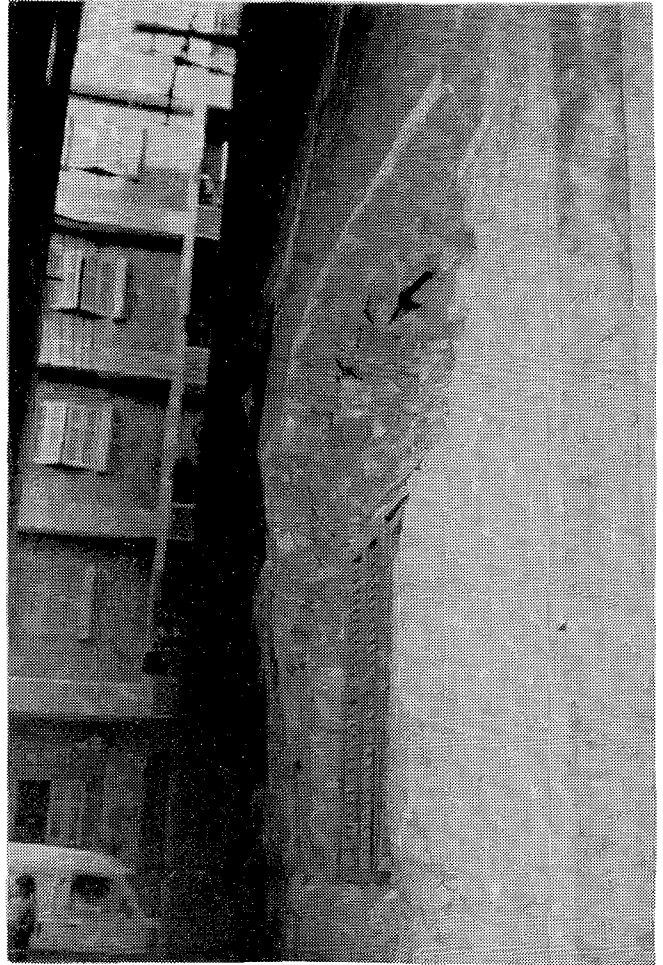
**FIGURE 1-9** Fallen plaster around window in a load bearing wall of a building in Elsayyeda Zenab district.

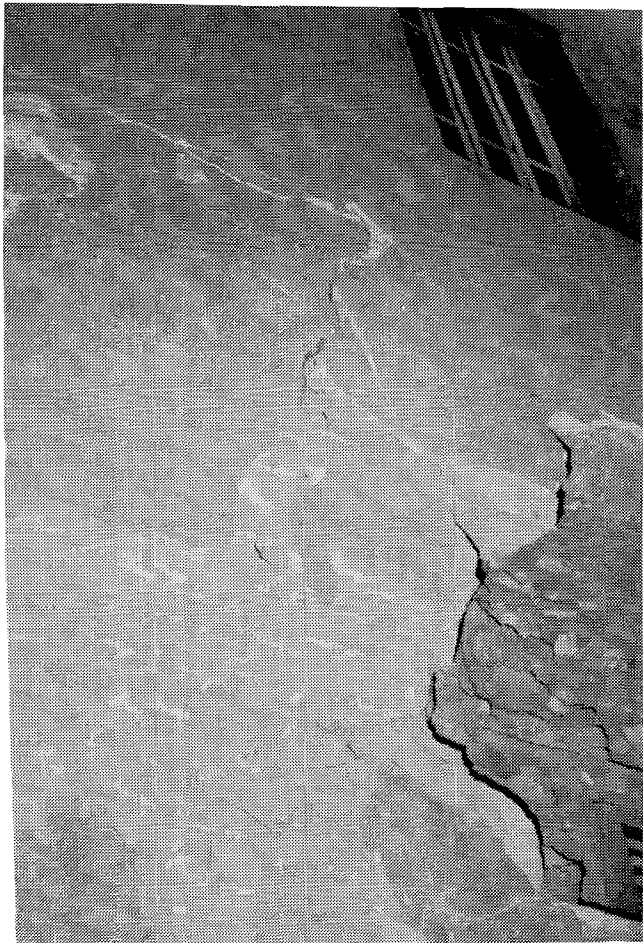
**FIGURE 1-10** Fallen plaster exposed stone/mortar wall.

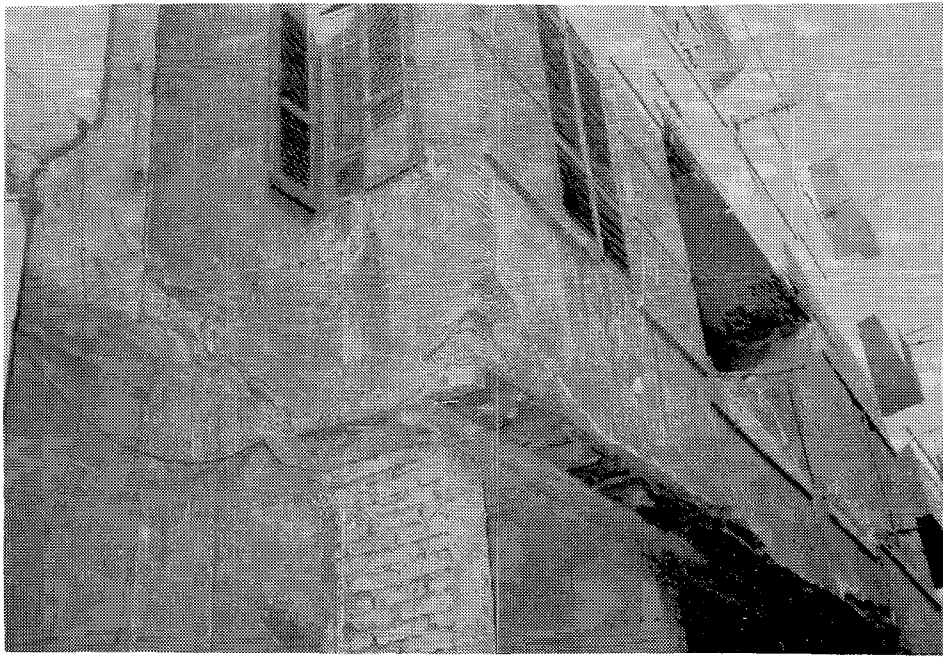
**FIGURE 1-11** Fallen plaster exposed wood beams in ceiling.

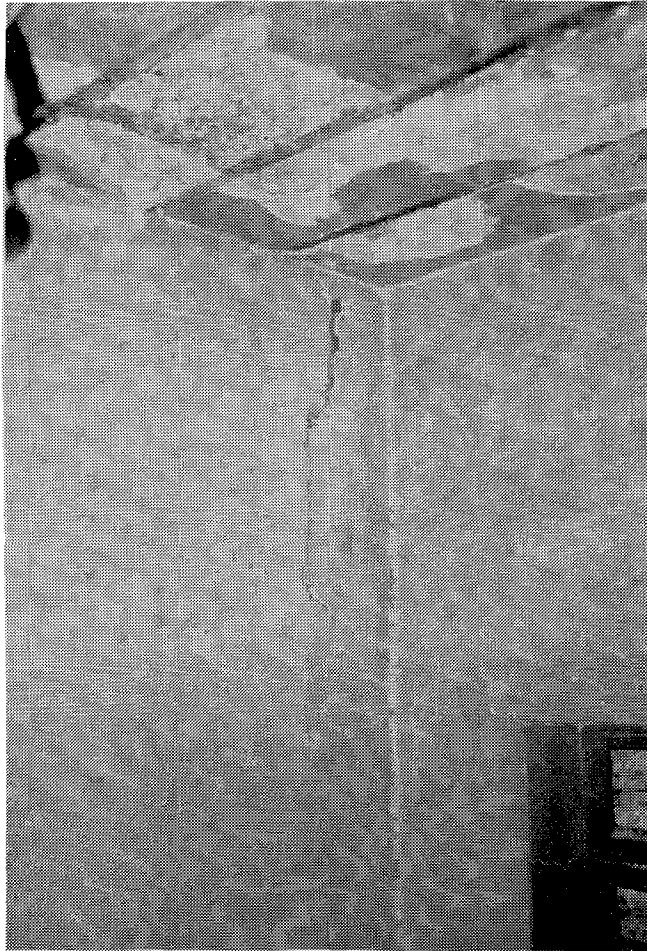
**FIGURE 1-13** Fallen plaster and cracks inside an apartment, Mohamed Ali Street.

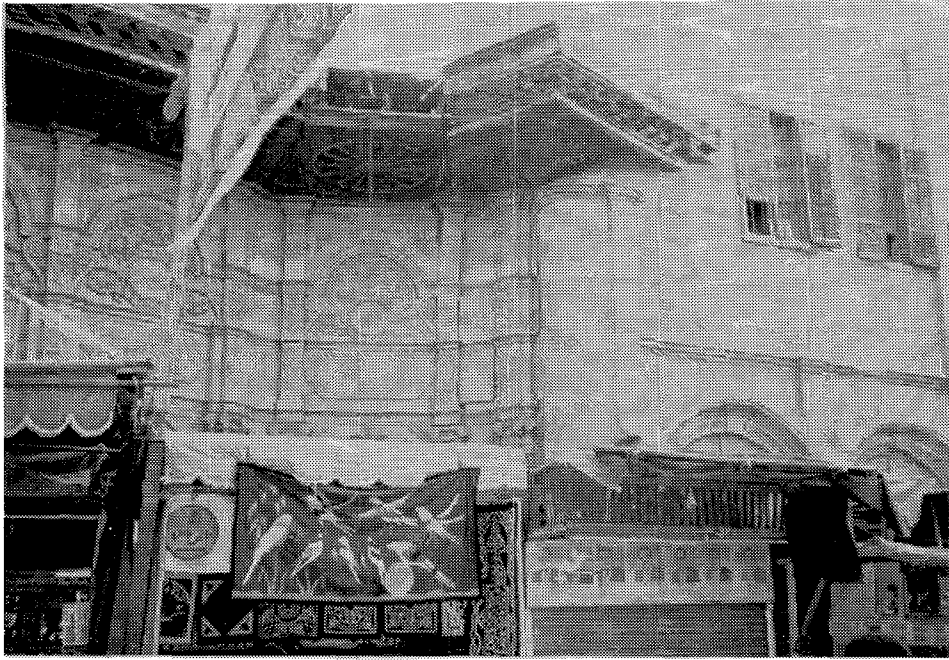
**FIGURE 1-14** Fallen and dislocated heavy stone ornaments in an antique building in Elghouriah district.

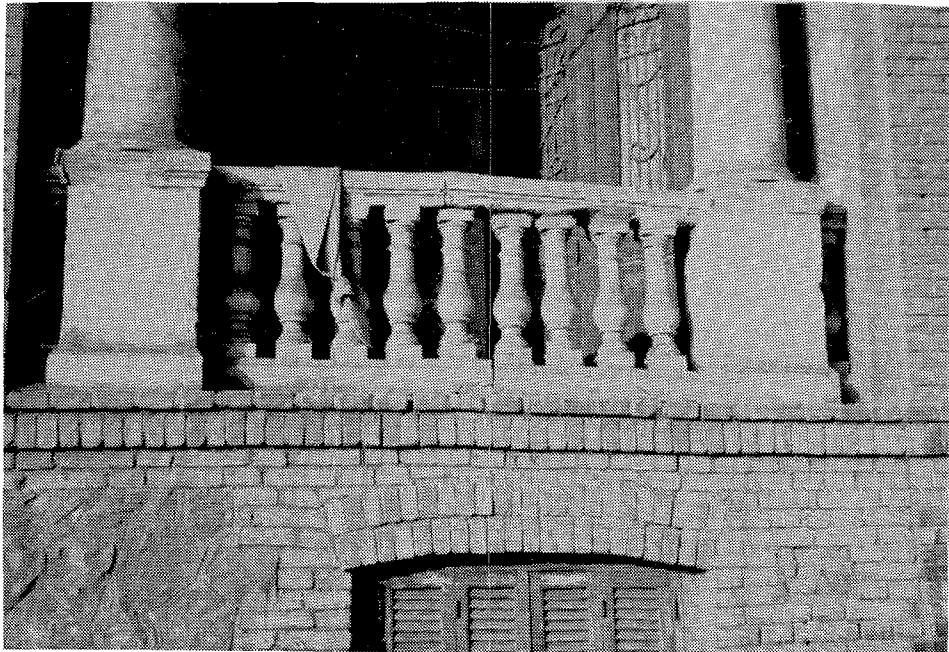
**FIGURE 1-15** Dislocated stone balcony parapet (El-Khalaa district).

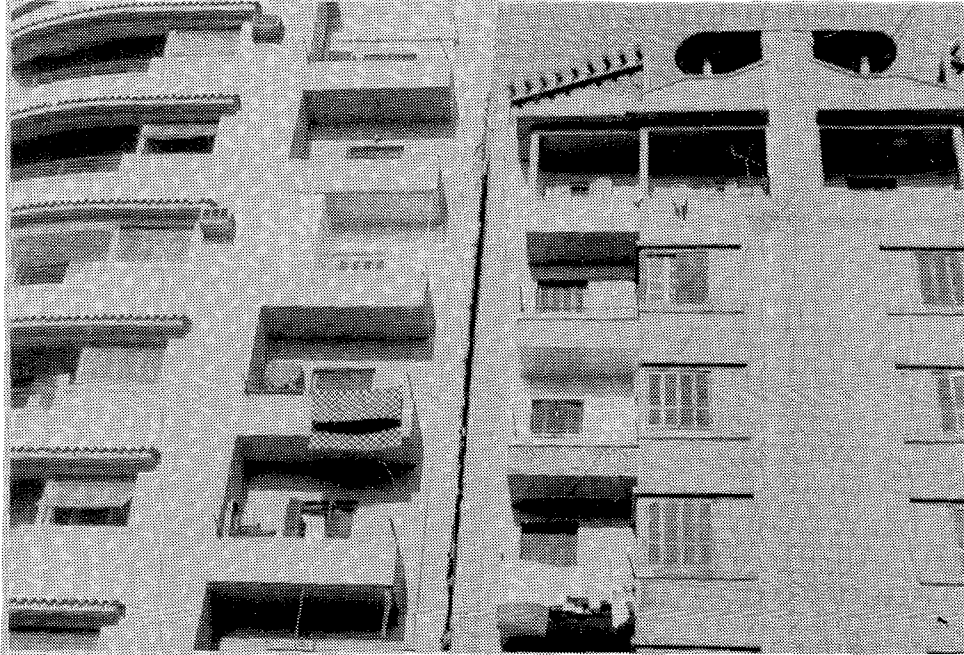
**FIGURE 1-16** Open crack between reinforced concrete building 1 (Kadri St., Elsayyeda Zenab district).

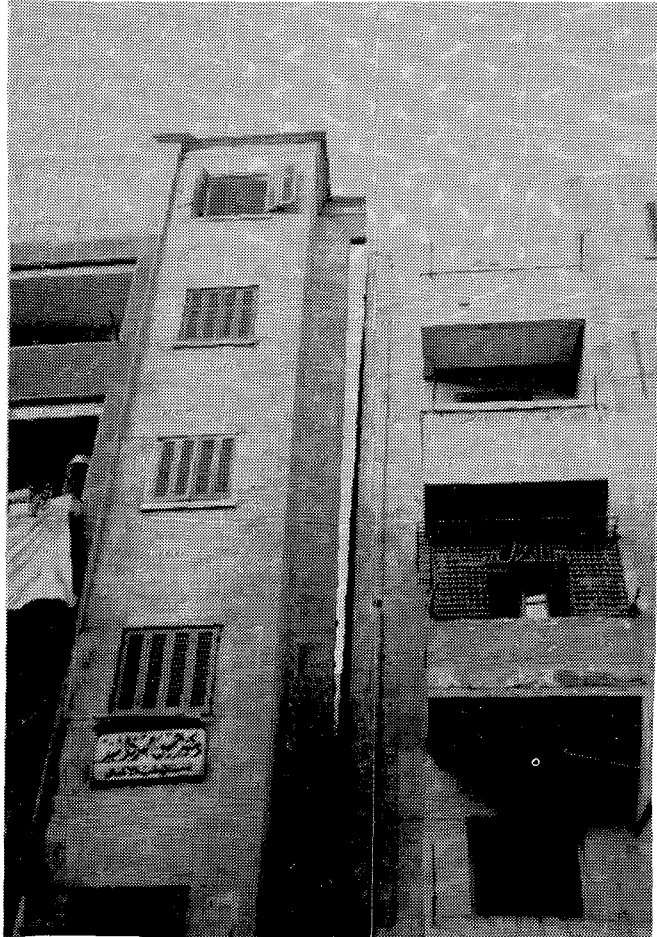
**FIGURE 1-17** Open crack between reinforced concrete building 2 (Magless Elshaab Street, close to Elsayyeda Zenab).

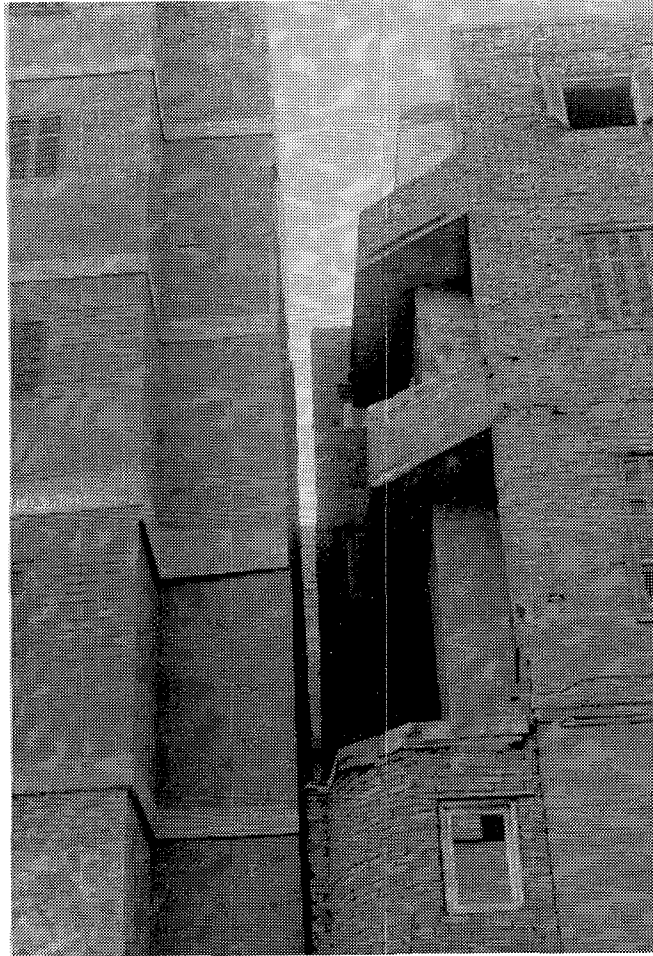
**FIGURE 1-19** Open crack between reinforced concrete building 3 (Kadri Street, Elsayyeda Zenab).

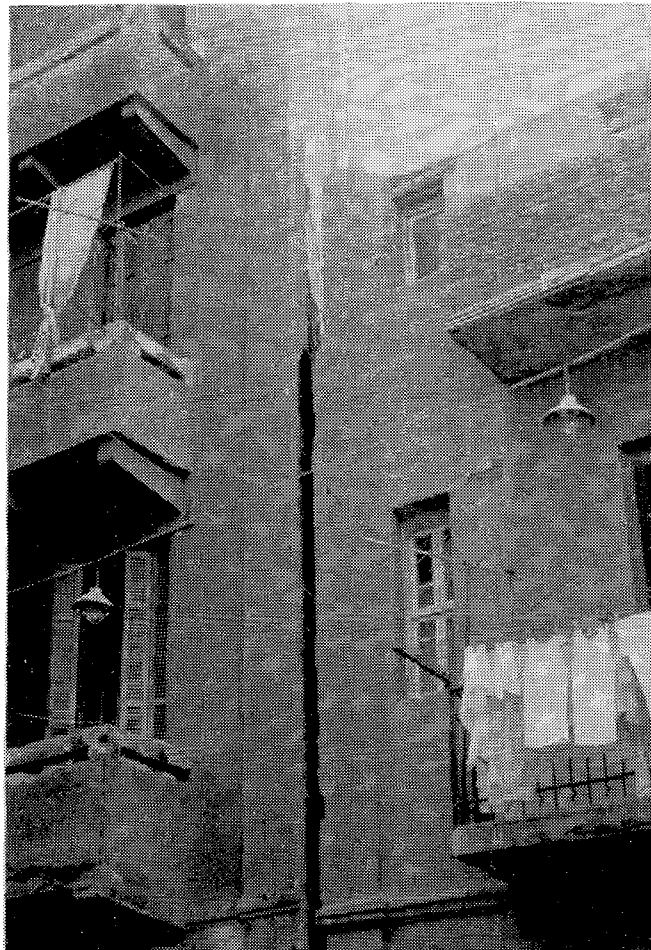
**FIGURE 1-20** Open crack between reinforced concrete building 4 (Kadri Street, Elsayyeda Zenab).

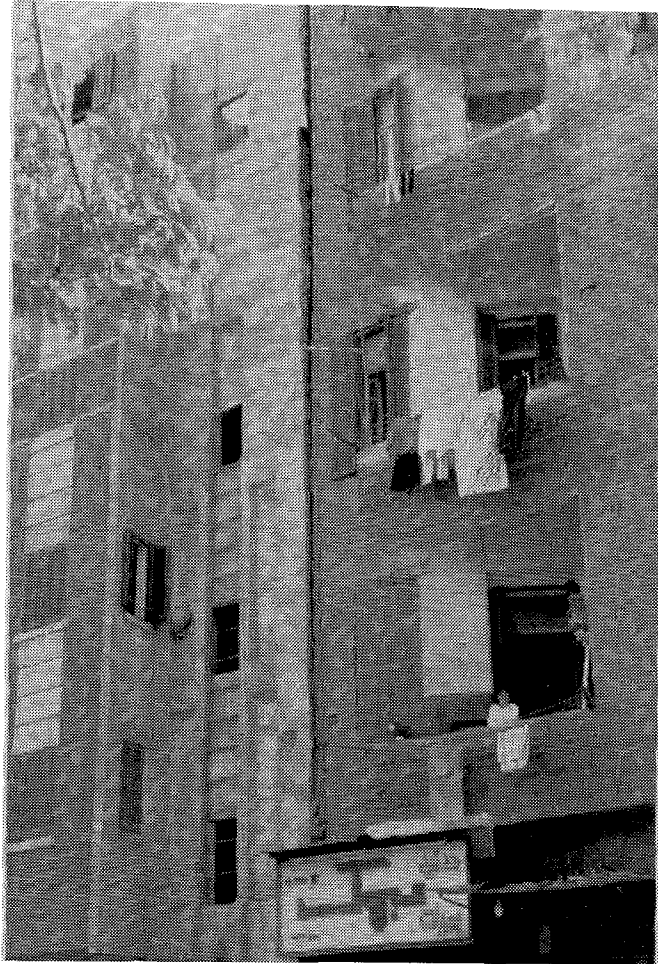
**FIGURE 1-22** Open crack between reinforced concrete building 5 (Magless Elshaab Street, across from building of Figs. 1-17 and 1-18).

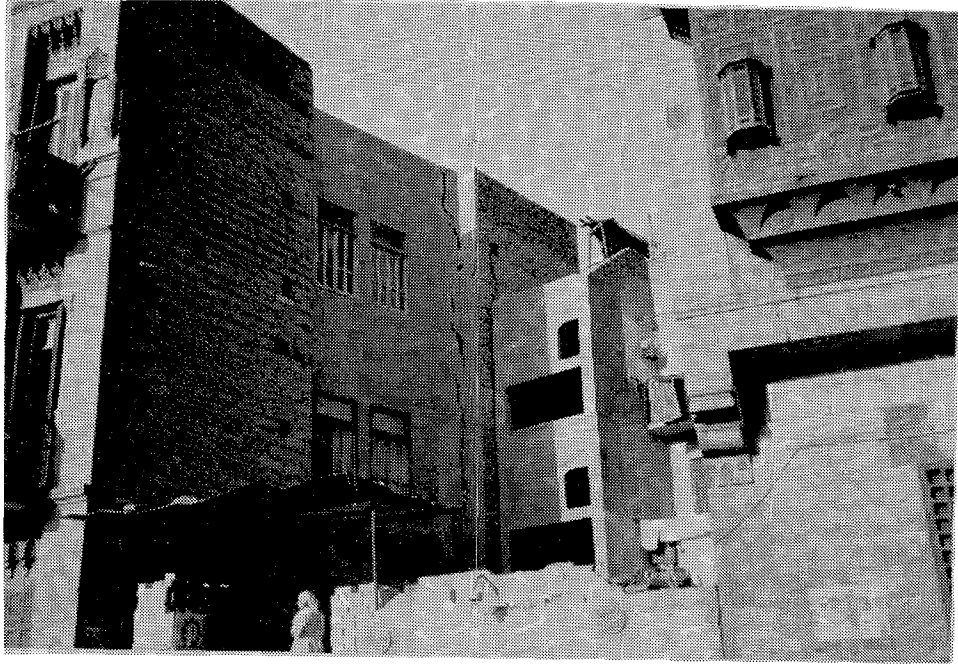
**FIGURE 1-23** Open crack between reinforced concrete building 6 (Elkalaa district).

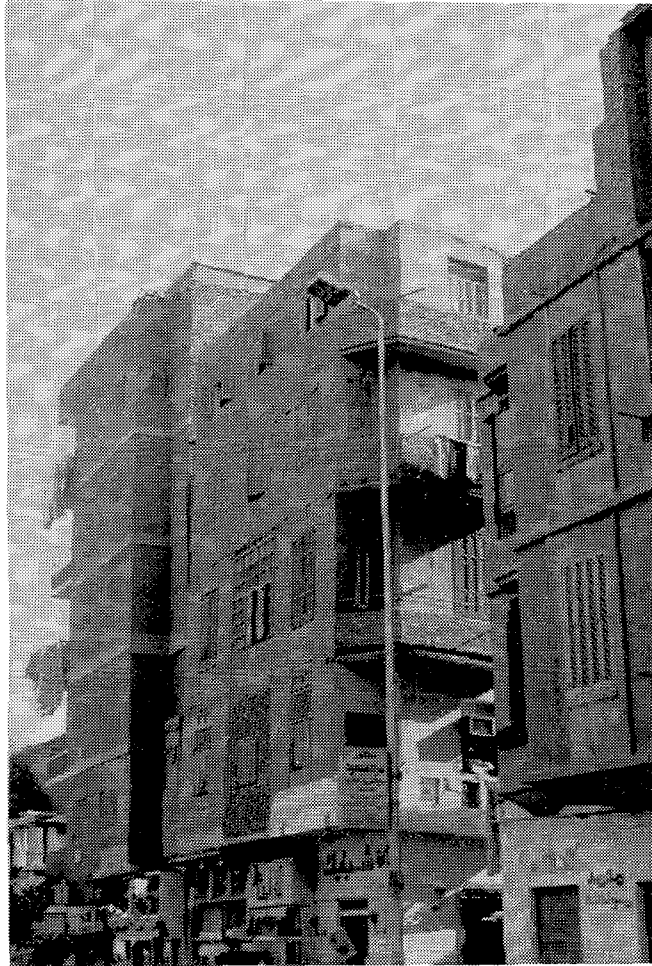
**FIGURE 1-25** Tilting reinforced concrete building.

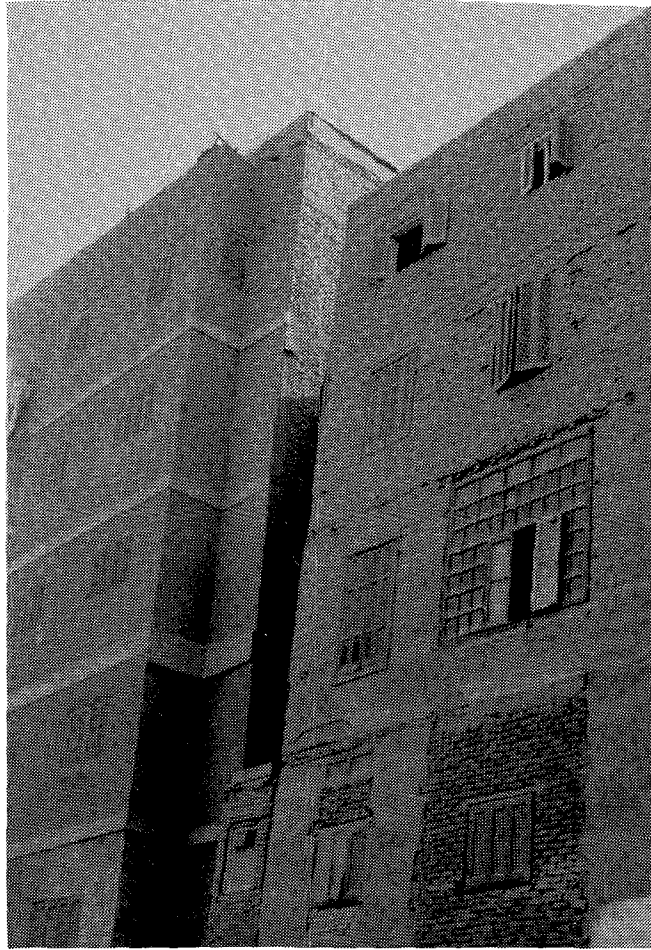
**FIGURE 1-26** Tilting reinforced concrete building.

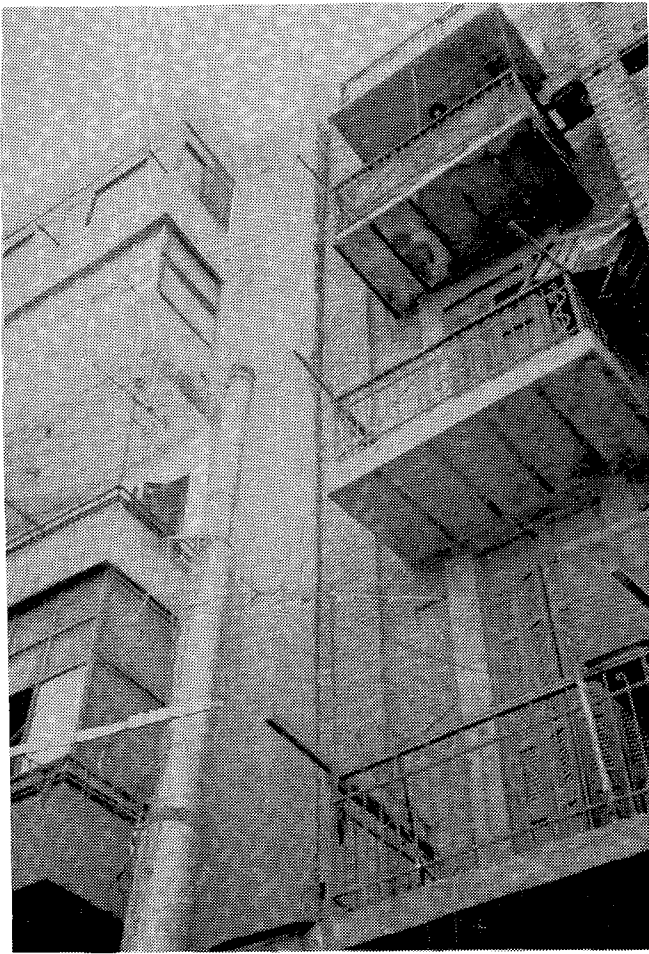
**FIGURE 1-27** Tilting reinforced concrete building.

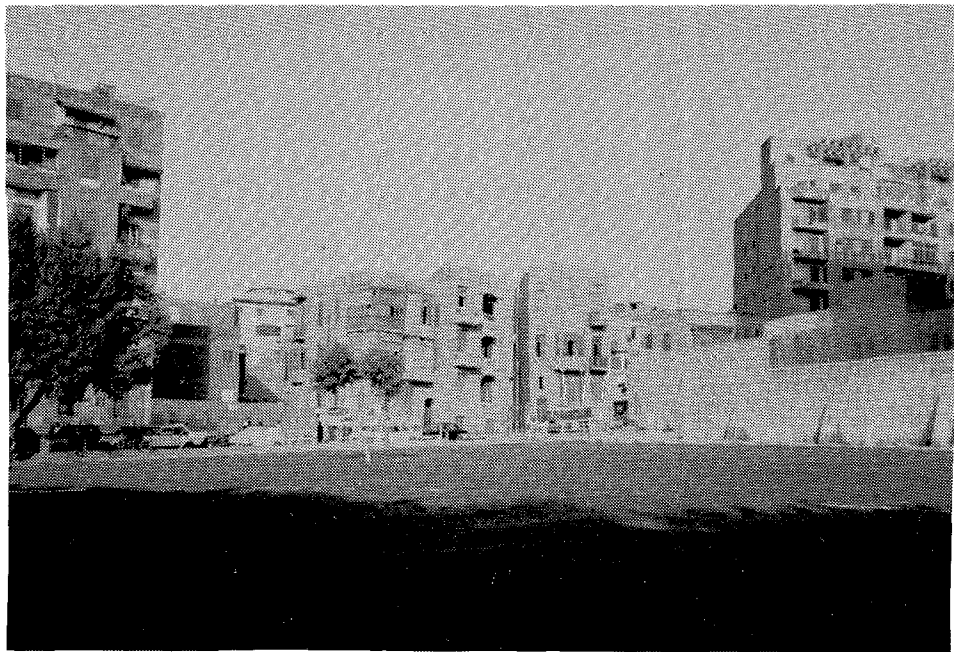
**FIGURE 1-28** Group of tilting buildings; tilt increased after earthquake and buildings were evacuated (Elkalaa district, across from Elsultan Hassan Mosque).

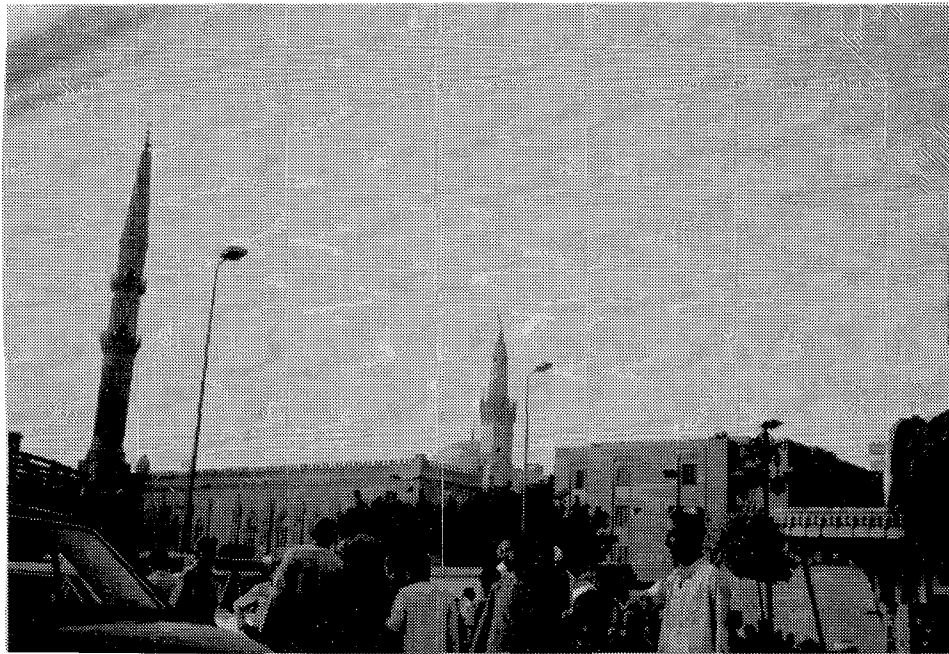
FIGURE 1-30 Dislocated tip of minaret (Elhossein Mosque).

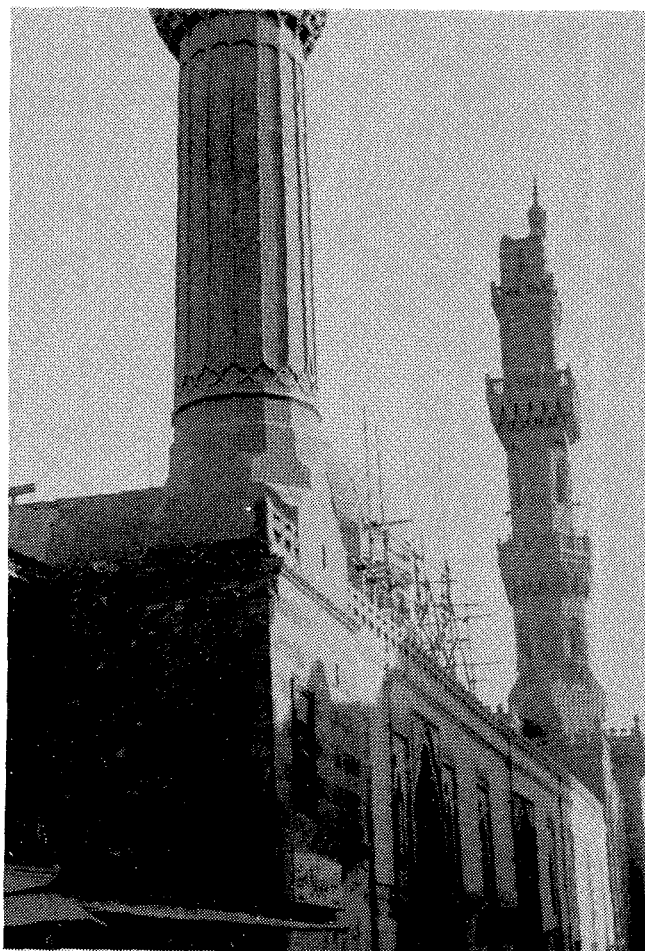
**FIGURE 1-31 Al-Hanafi Mosque: missing minaret top (Elsayyeda Zenab district).**

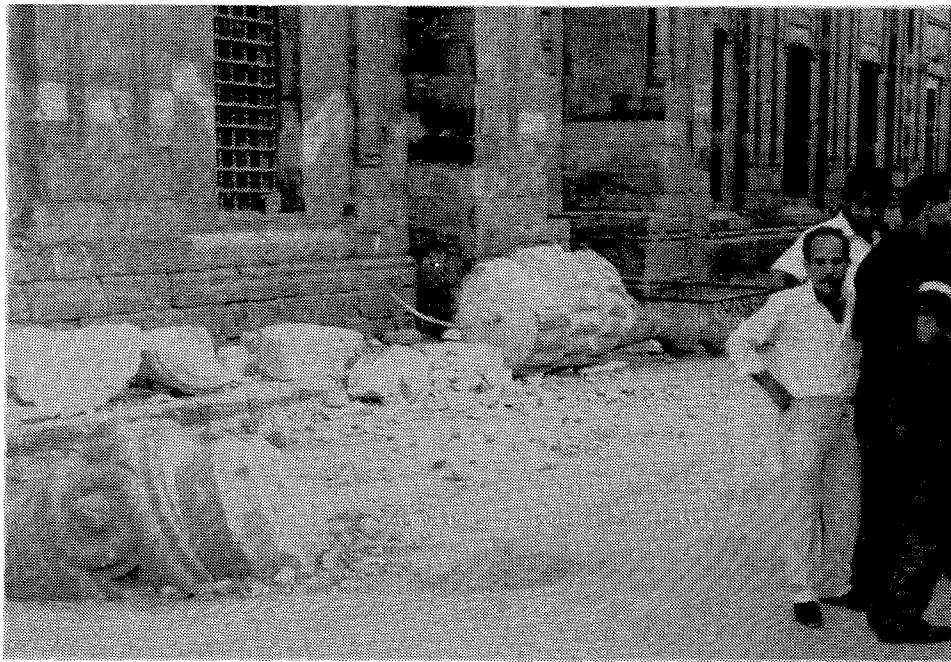
**FIGURE 1-33a** Toppled minaret tops  
(Al-Hanafi Mosque).

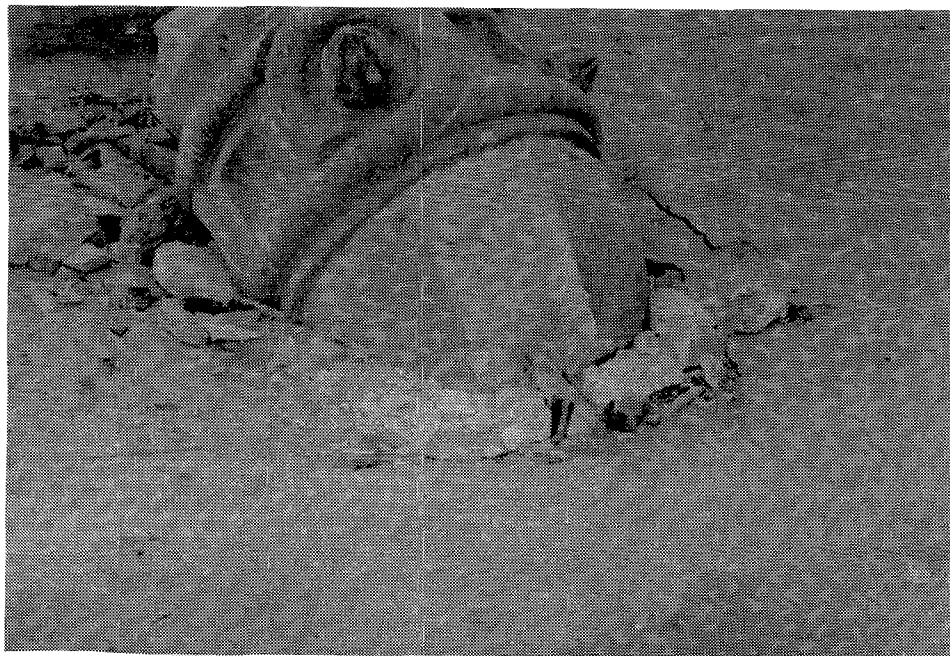
**FIGURE 1-35** Toppled minaret tops  
(Al-Hanafi Mosque).

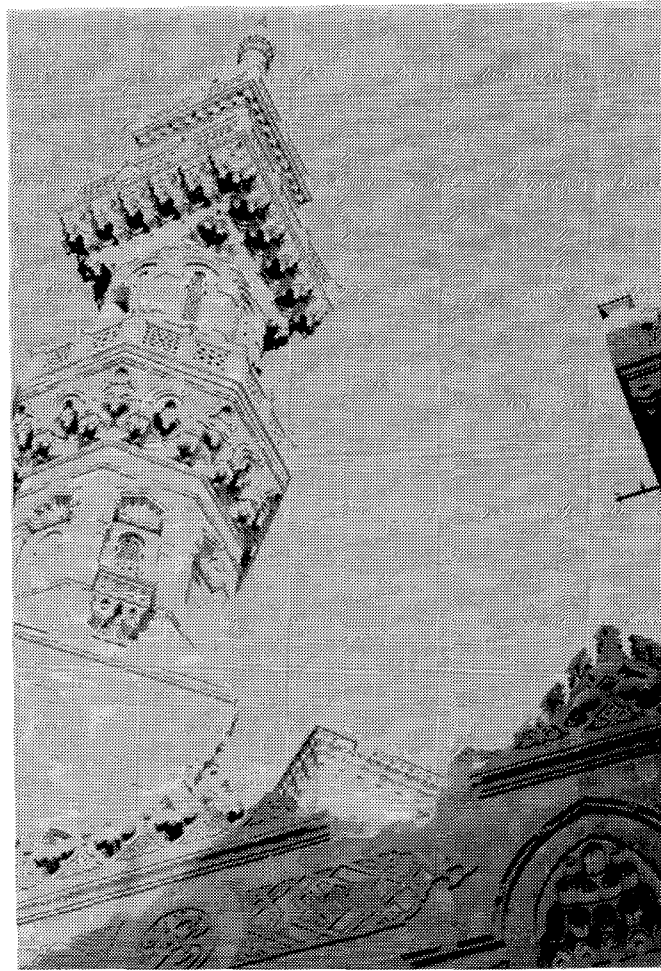
**FIGURE 1-36** Broken ornaments due to toppled minaret top (Al-Hanafi Mosque).

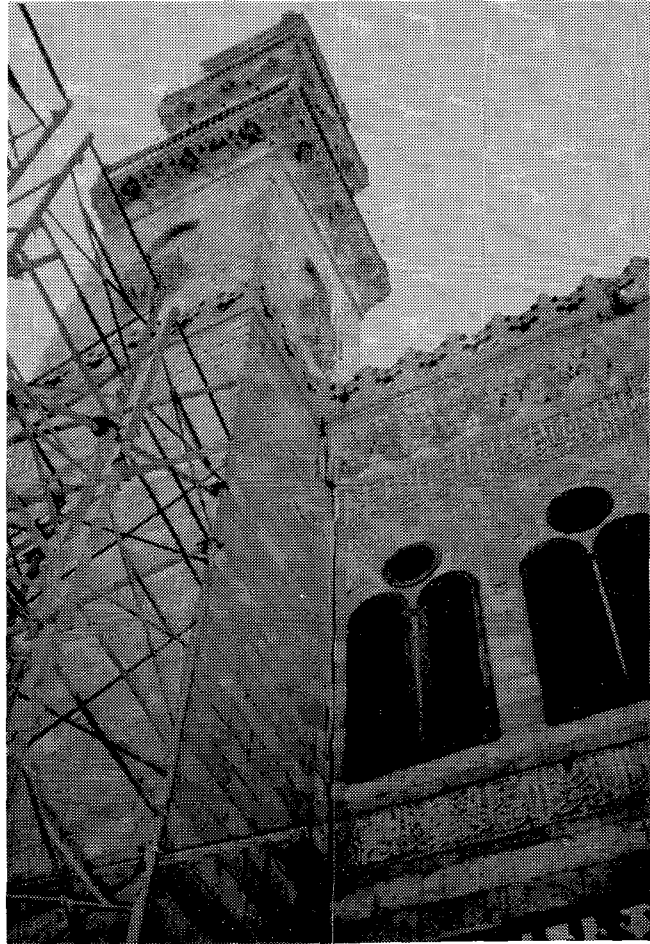
**FIGURE 1-37** Crack between minaret and Mosque (El-Ghuri Mosque); cracks aggravated by earthquake; Schaffelding was placed for routine maintenance before earthquake.

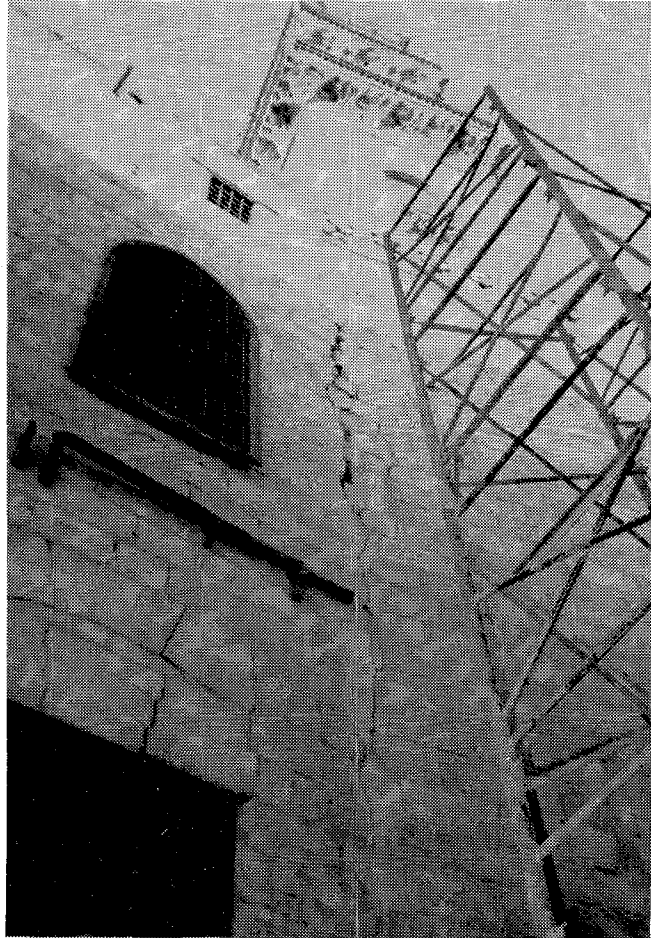
**FIGURE 1-39** Crack between minaret and Mosque (El-Ghuri Mosque); cracks aggravated by earthquake.

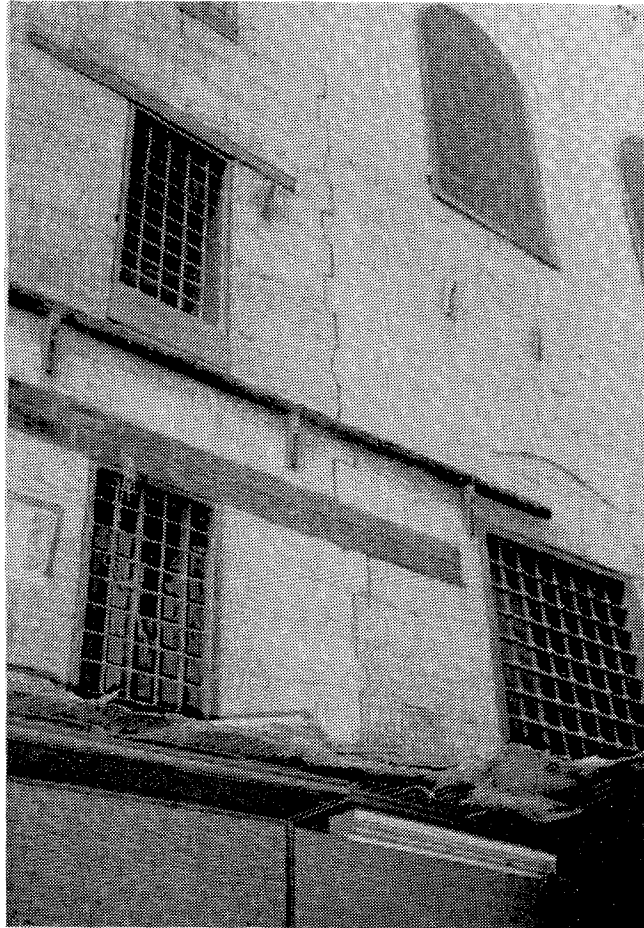
**FIGURE 1-40** Sultan El-Ghuri Mosque:  
Crack in mortar cemented stone wall (cracks  
aggravated by earthquake).

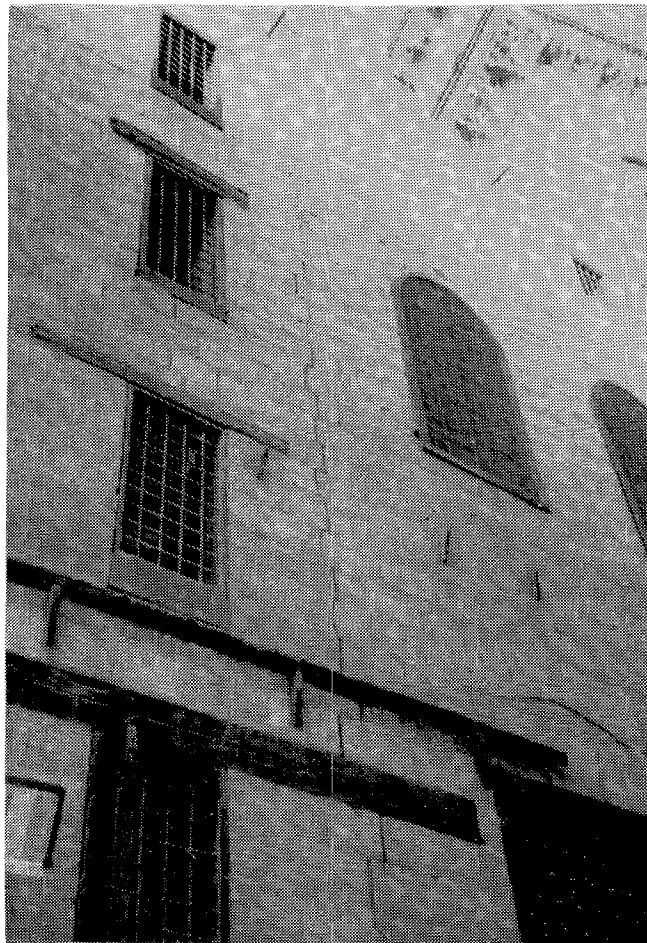
**FIGURE 1-41** Sultan El-Ghuri Mosque:  
Crack in mortar cemented stone wall (cracks  
aggravated by earthquake).

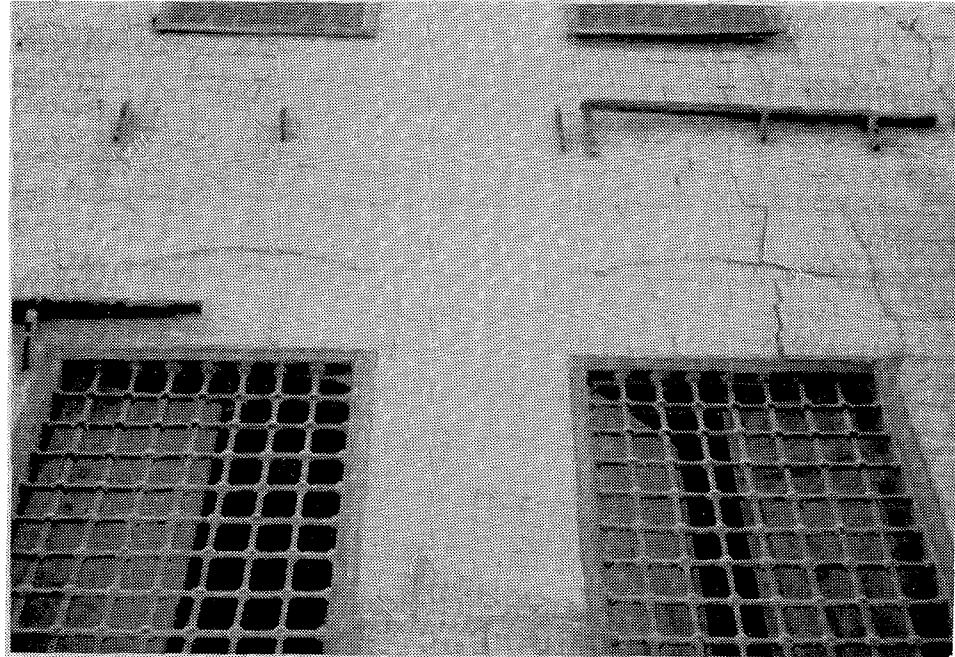
**FIGURE 1-42** Sultan El-Ghuri Mosque:  
Cracks in mortar at keystone above window.

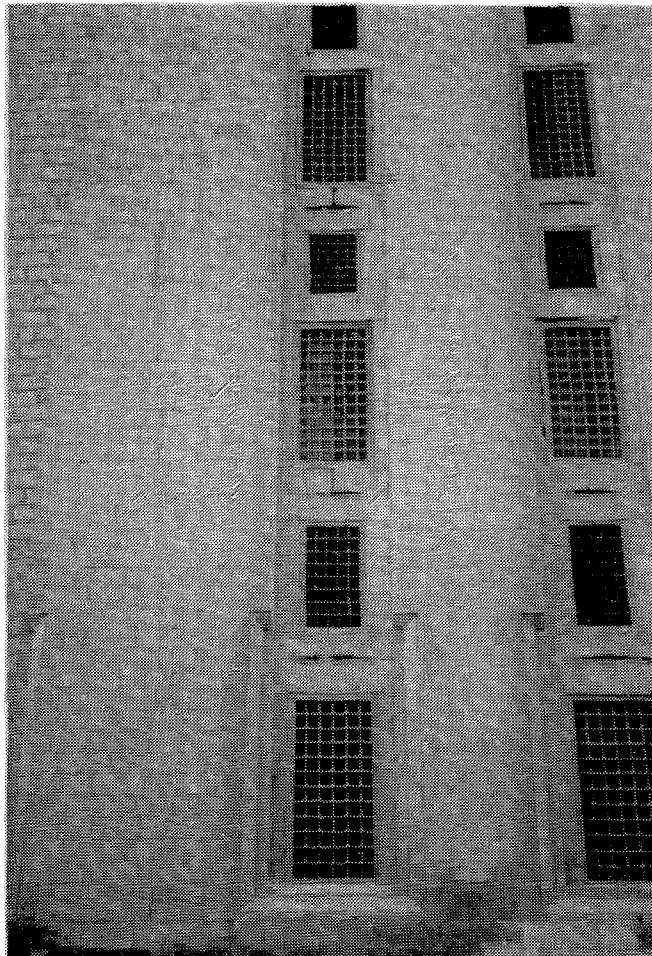
**FIGURE 1-43** Cracks in mortar at keystone  
above windows (with stone dislocations);  
Sultan Hassan Mosque, Alazhar district, close  
to Sultan El-Ghuri Mosque.

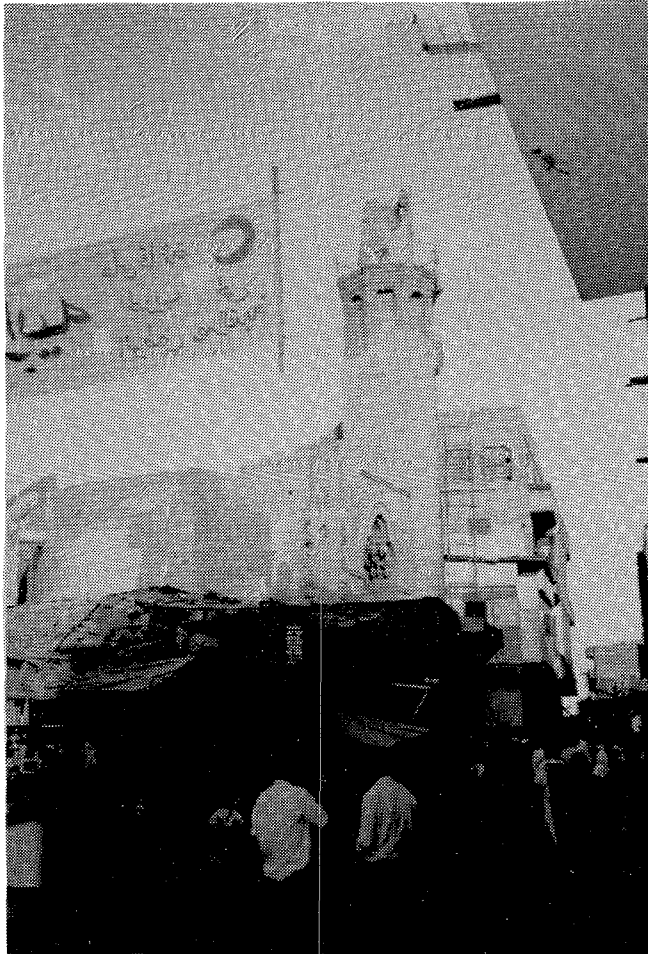
**FIGURE 1-44** Partially collapsed masonry minaret top (Port-Said Street, Sayyeda Zenab district).

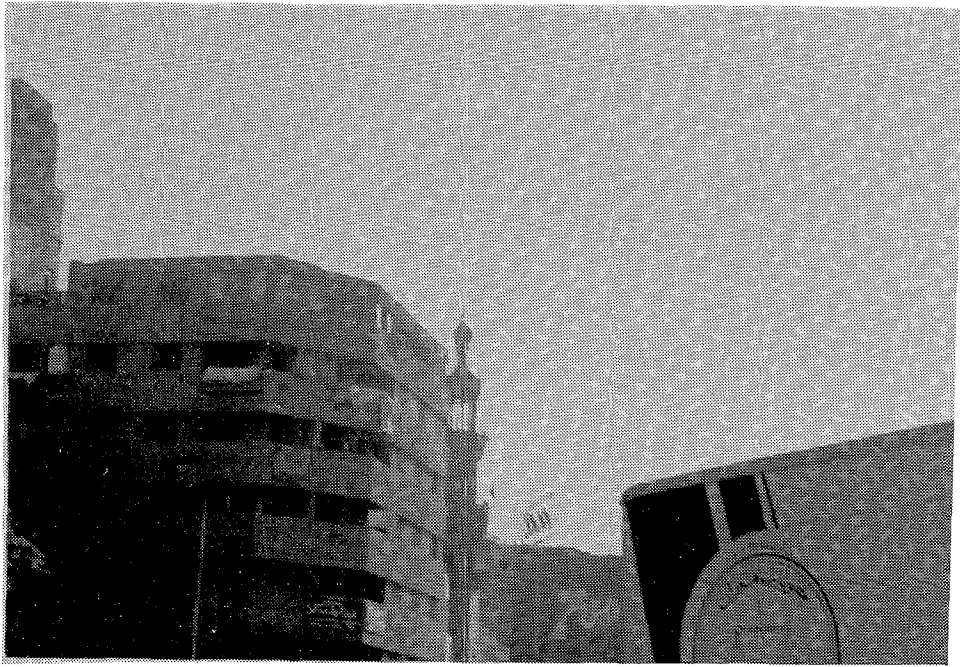
**FIGURE 1-48** Tilted minaret of Figure 1-47 shown relative to adjacent building.

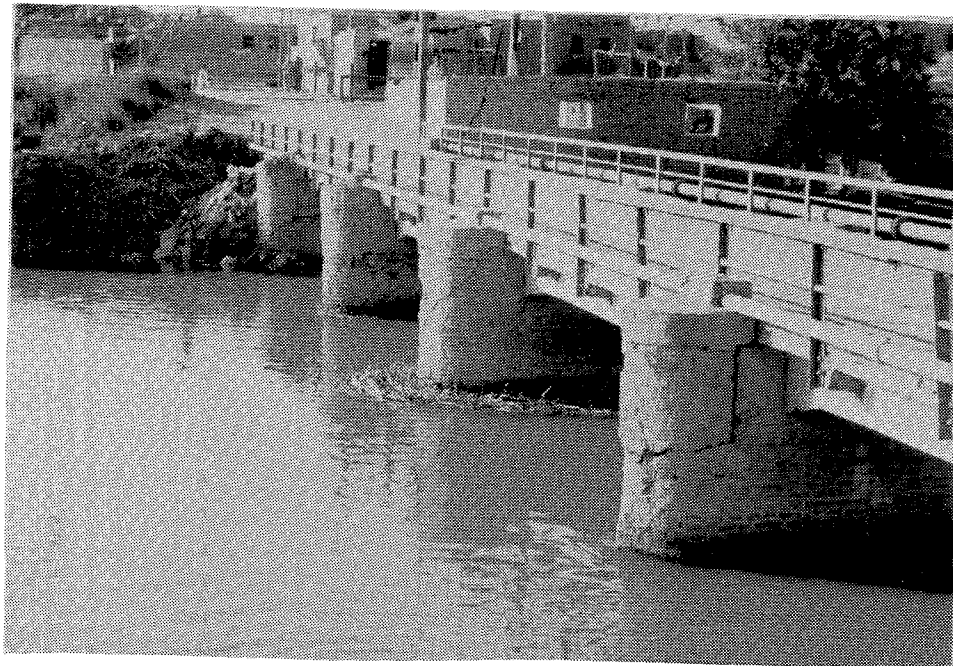
Lateral seismic loads acting on a single span bridge resulted in shear damage to the supporting masonry abutments (figure 1-51). Shear induced cracking also appears in an adobe wall in the background (figures 1-51 and 1-52). Such cracking was intensified around windows (and other open sections), and at interfaces between masonry and concrete (figures 1-53 and 1-54).

**FIGURE 1-51** Cracks in masonry piers of bridge due to lateral seismic loads.
