**Engineering Aspects of the October 12, 1992  
Egyptian Earthquake**

**A.W. Elgamal, M. Amer, K. Adalier and A. Abul-Fadl**

Technical Report NCEER-93-0018

October 7, 1993

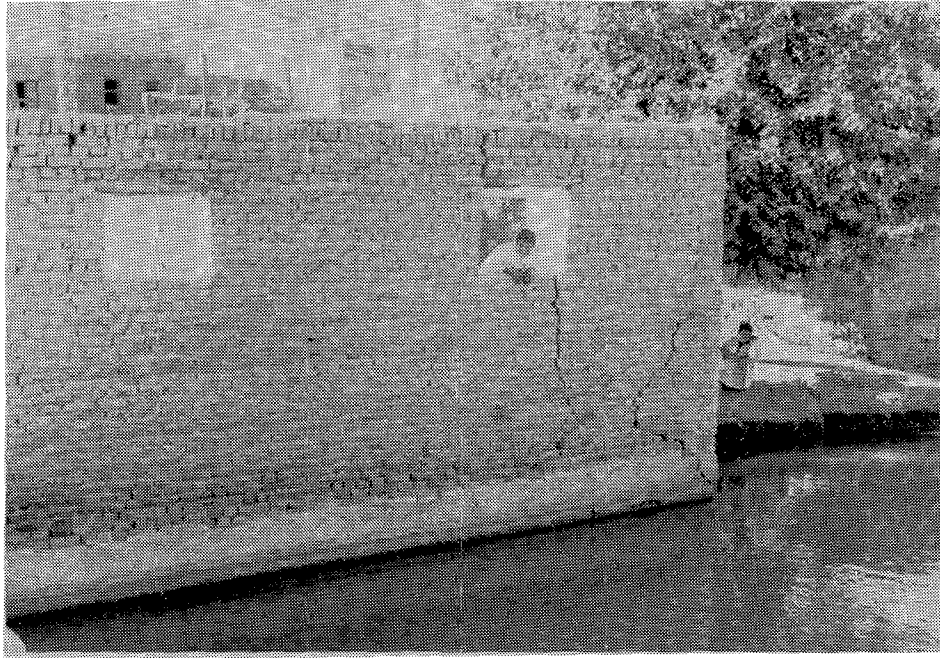
**FIGURE 1-52** Shear cracking in masonry wall.

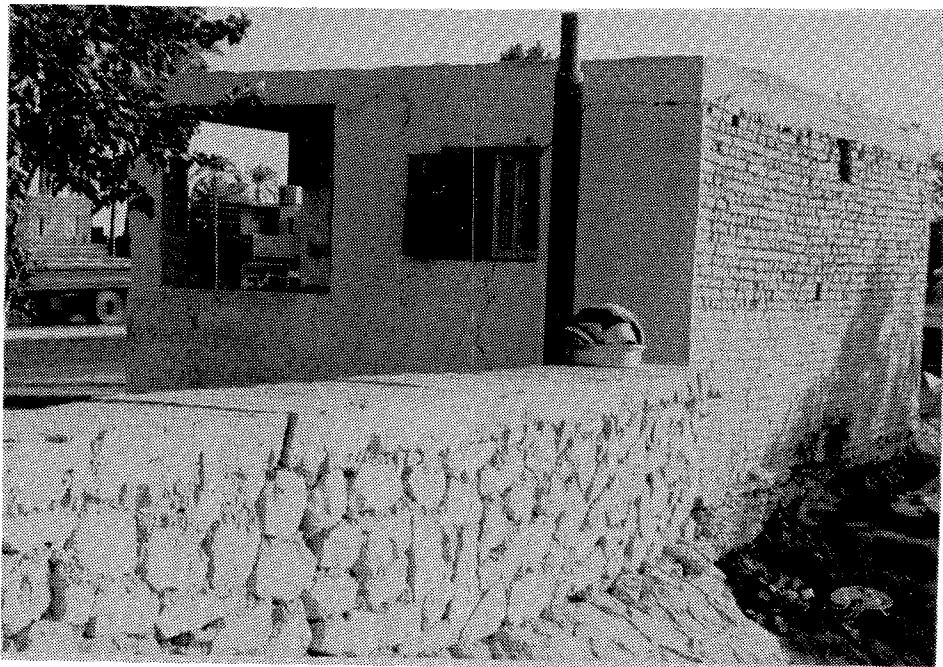
**FIGURE 1-53** Crack around windows and along masonry-concrete interface.

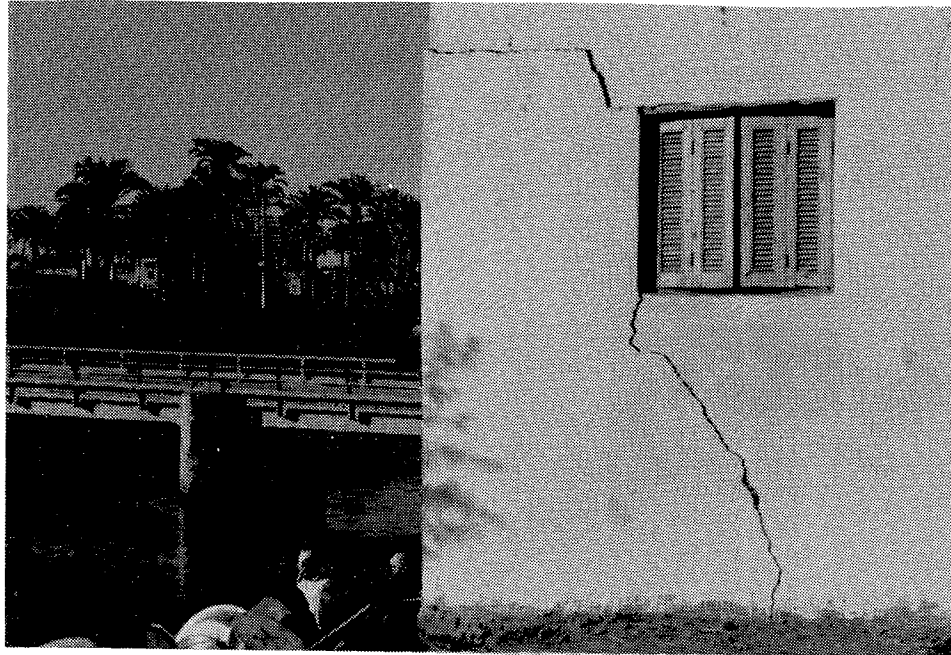
**FIGURE 1-54** Crack around windows and along masonry-concrete interface.

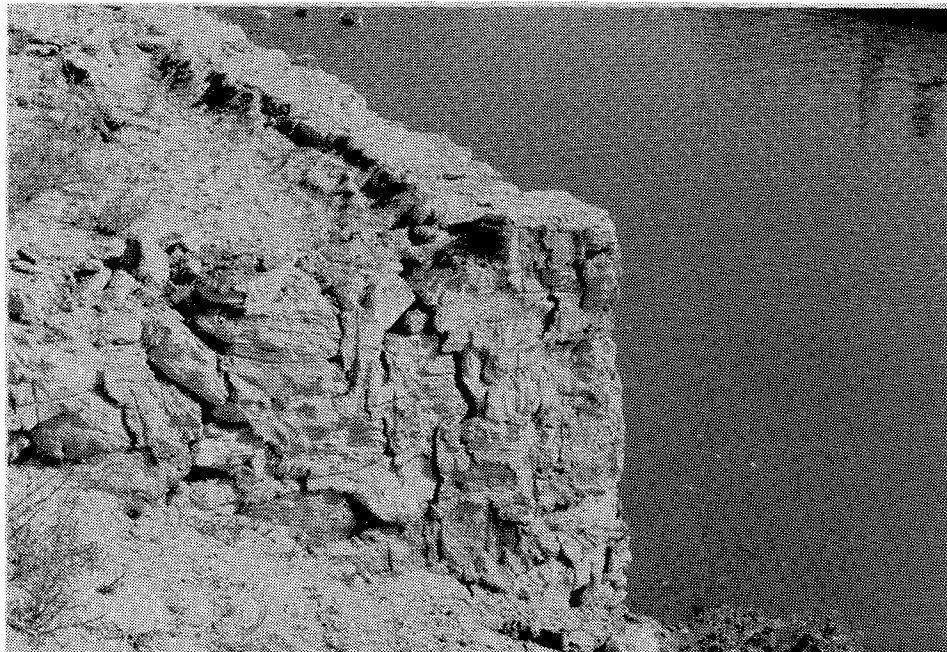
In figure 1-55, cracks along the end of a short 1.5 m high gravity retaining wall were observed. A vertical crack appears along the wall-soil interface, and an inclined crack demarks the deformed soil wedge boundary. Figures 1-56 and 1-57 show the failure of a retaining wall constructed of cemented stone along with a portion of the supported backfill soil. Soil liquefaction associated with the occurrence of large sand boils was observed close to the epicenter. As a consequence, a main road suffered a maximum settlement of about 1.75 m. This liquefaction case history is discussed in the following sections.

**FIGURE 1-55** Cemented stone retaining wall with cracks in backfill and wall-soil interface.

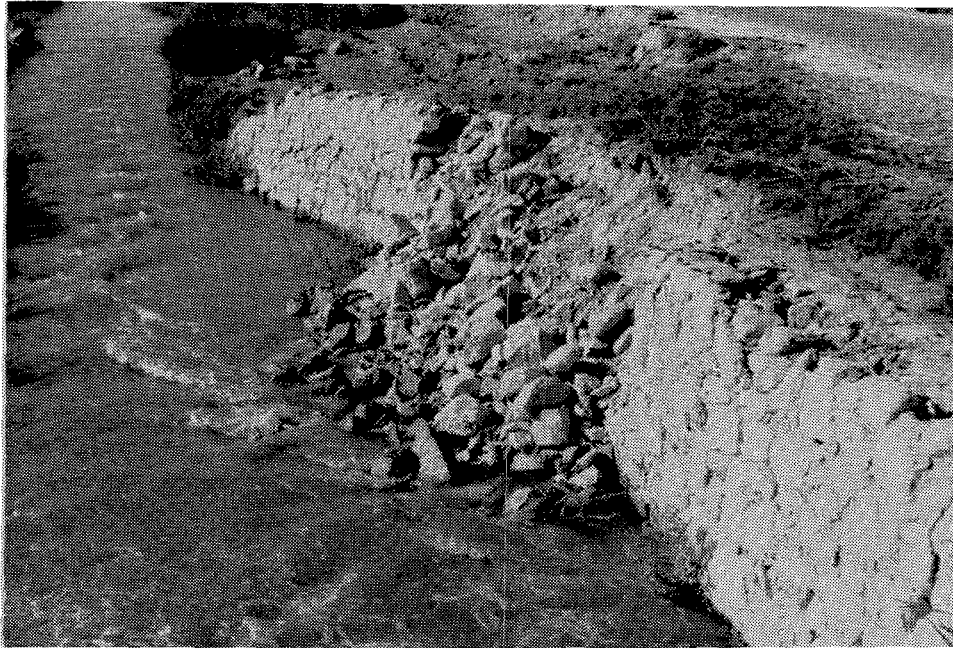
**FIGURE 1-56** Partially collapsed cemented stone wall and backfill.

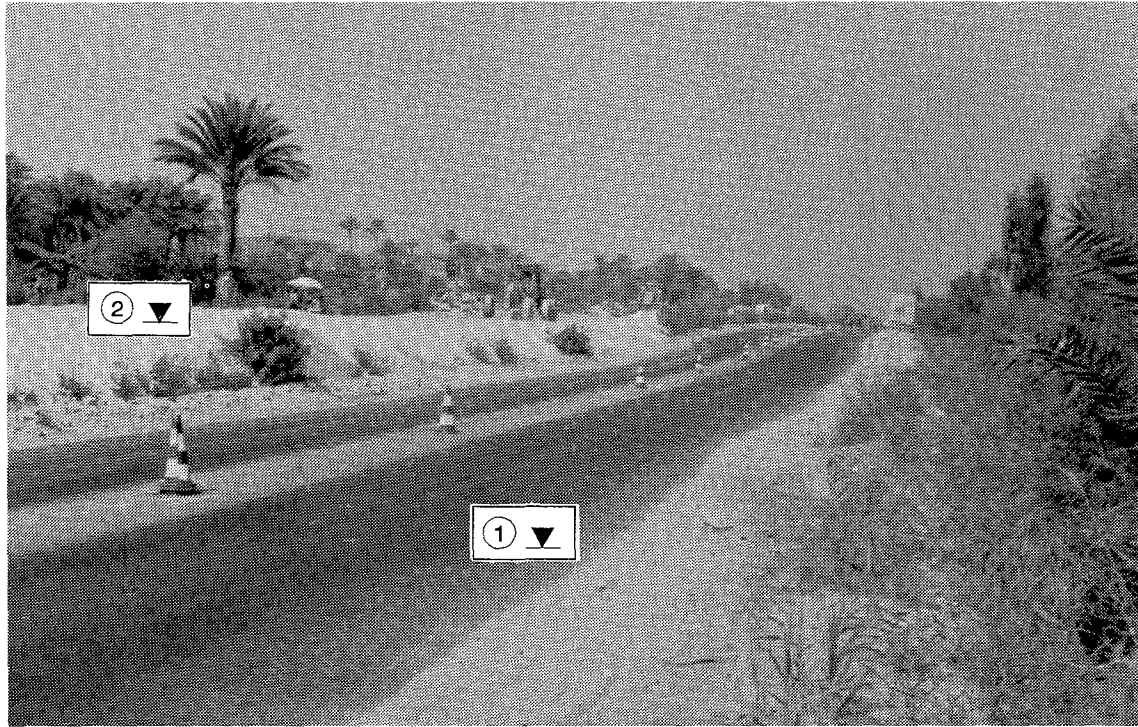
One of the two main roads that connect Cairo and Giza to the South of Egypt (Upper Egypt) was found to have settled (at El-Atff, near the Village of El-Beleda) by as much as 1.75 m shortly after the earthquake (figure 2-1). The road is composed of 2 traffic lanes in each direction with an intermediate median and is about 25 m in width (figure 2-2). At the location of observed settlement (about 1.0 km away from the Nile), the road is bordered on one side by an irrigation canal; and on the other by a drain and agricultural land (figure 2-2). After the earthquake, the road was promptly repaired by: i) building a new sub-base of crushed stone to bring the road to its original elevation, ii) restoring the shoulders and slopes on both sides of the road, and iii) placing a new asphalt pavement (figure 2-1).

It is believed that soil liquefaction below the road was the primary reason behind the observed 1.75 m settlement. This settlement was gradual over a distance of about 200 m, and essentially uniform along the entire 25 m road width. Liquefaction effects were evident in the agricultural field adjacent to the road (figure 2-2). In this field, water laden with sediment erupted through fissures and spread along the ridged (due to prior plowing) agricultural ground surface (figures 2-3 and 2-4). The fissures appeared at a distance of about 20 m away from the road, adjacent to the zone of settlement (figure 2-2).

**FIGURE 2-1 Liquefaction induced settlement at Upper Egypt Road West of the Nile: 1) road elevation after earthquake (2 right lanes); 2) original road elevation being restored during repair (2 left lanes).**

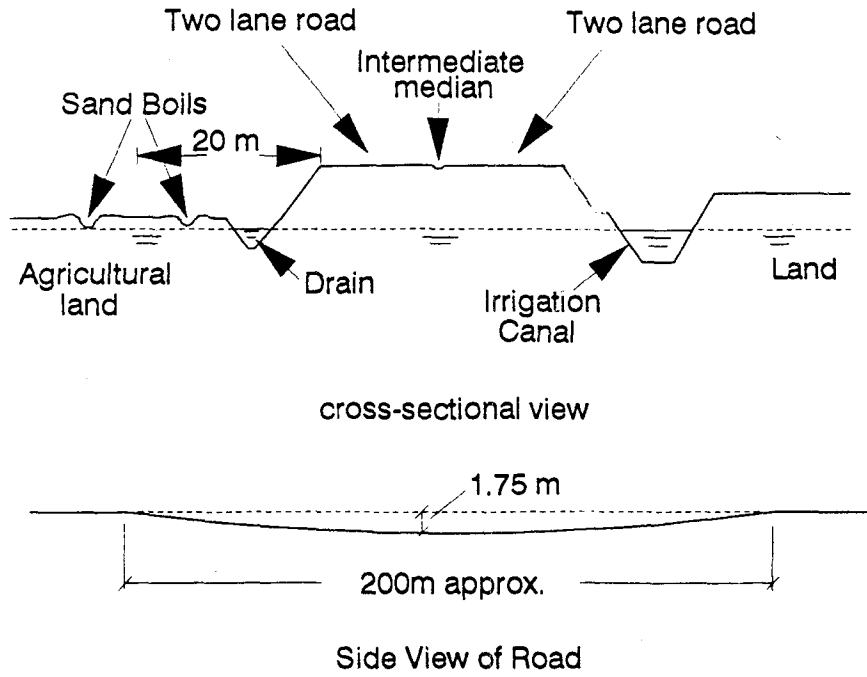
No clear signs of lateral spreading were observed, however. Settlement was essentially vertical and was probably driven by the relatively higher elevation of the road with respect to the surrounding terrain (figure 2-2); thus constituting a localized overburden vertical stress. No sediments were observed to have flowed into the adjacent canal or drain (some sediment migration might have occurred below the water level).

**FIGURE 2-2 Cross-sectional view of Upper Egypt Road site; and side-view after earthquake.**

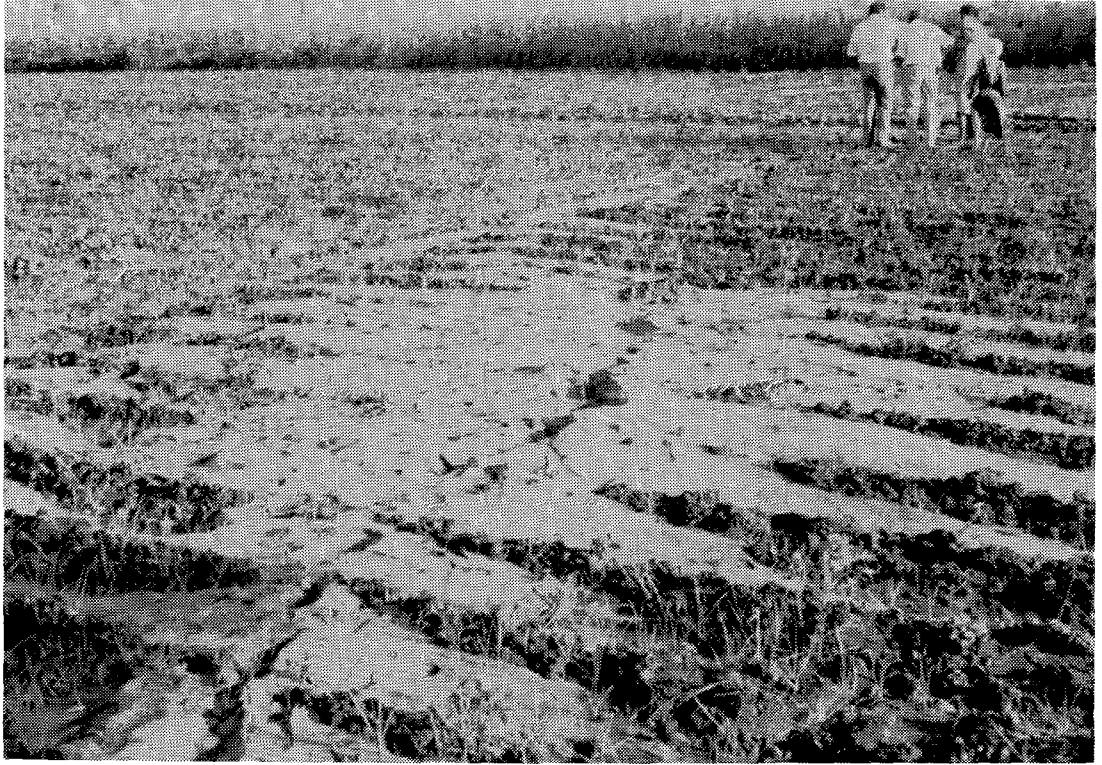
**FIGURE 2-3** Ground fissure and sediment eruption.

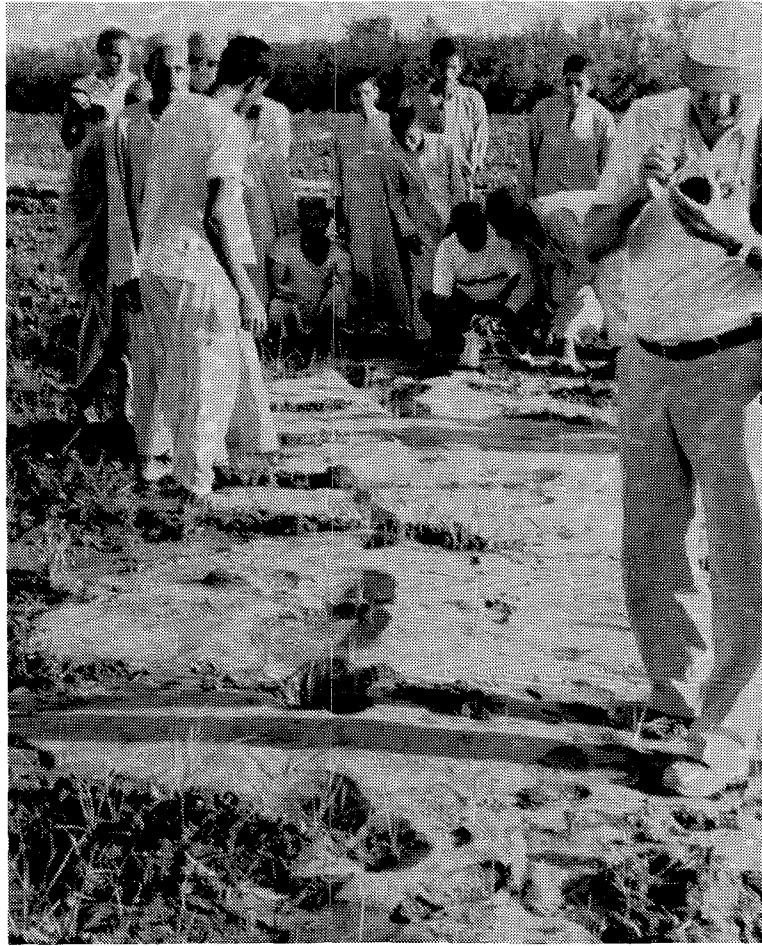
**FIGURE 2-4** Close-up of sediment eruption shown in Figure 2-3.

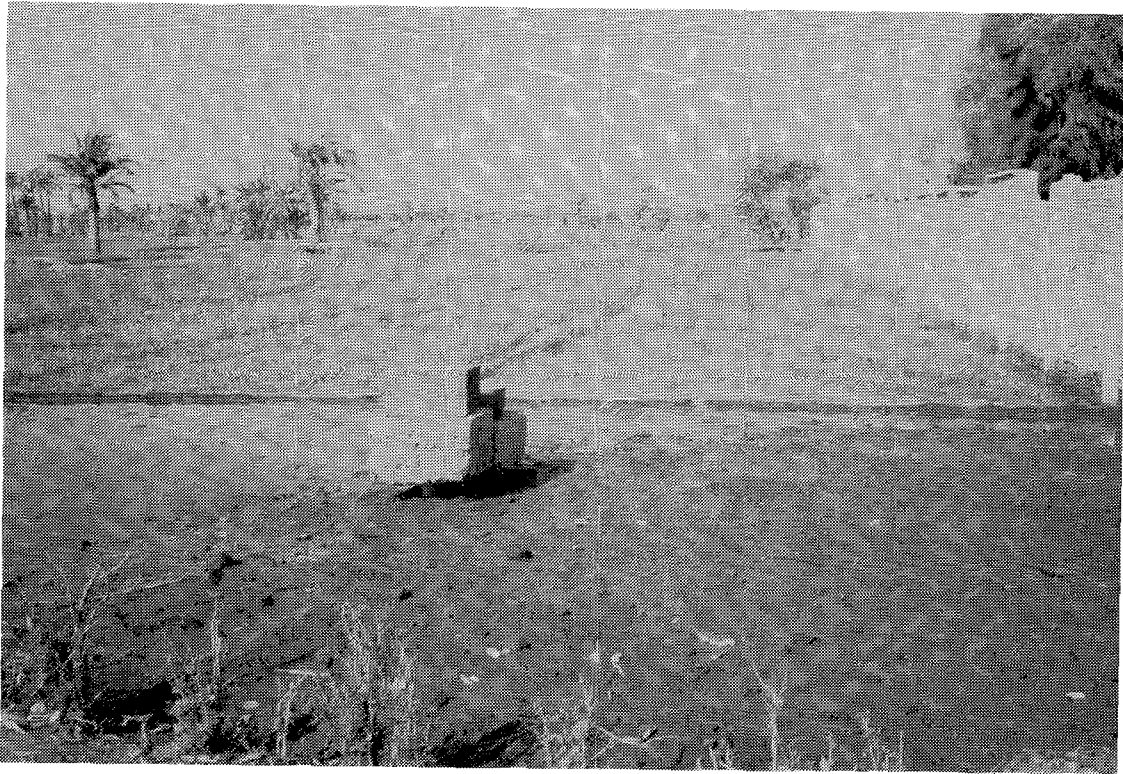
FIGURE 2-7a An abandoned steel pipe covered with a concrete block moved upwards relative to the surrounding soil.

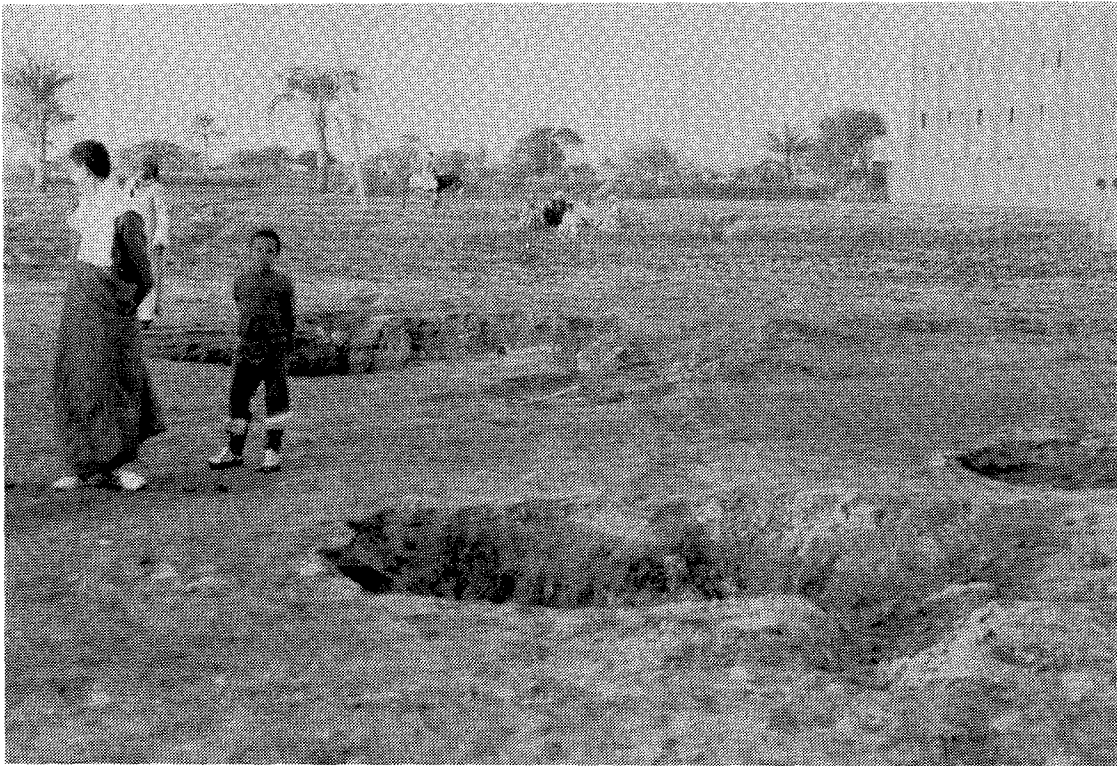
**FIGURE 2-8** Craters Nos. 2, 3, and 4 of Figure 2-6.

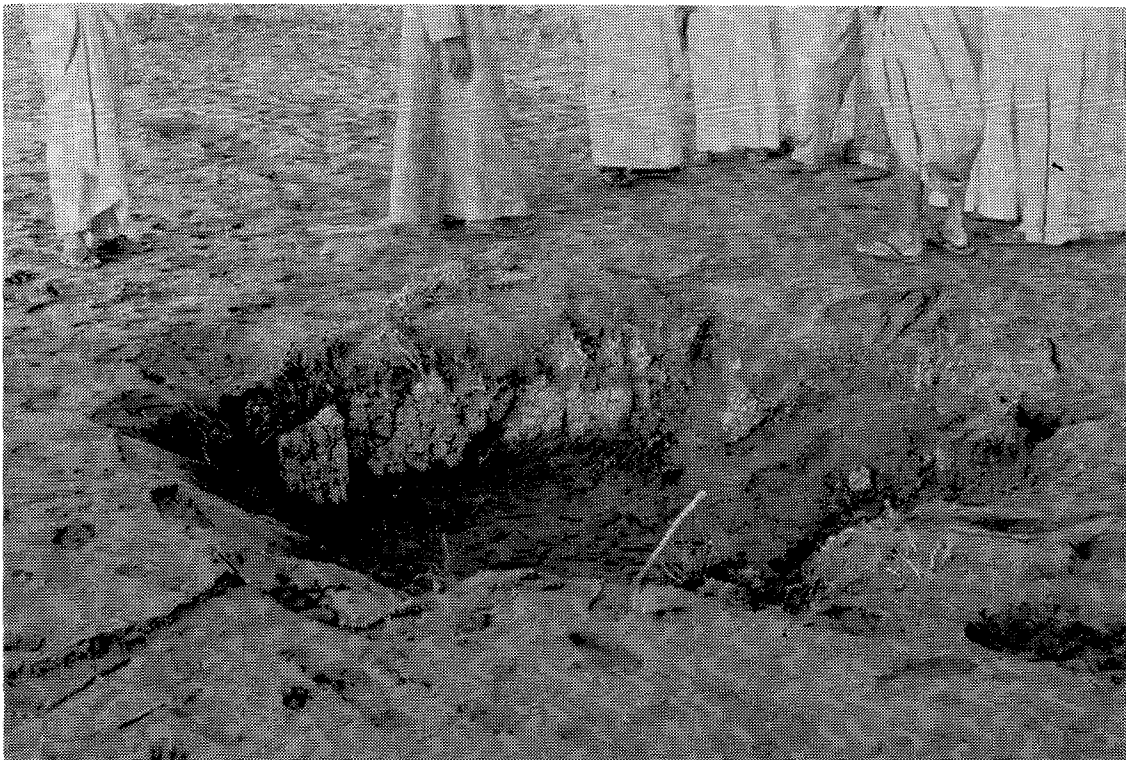
**FIGURE 2-9** Crater No. 5 of Figure 2-6.

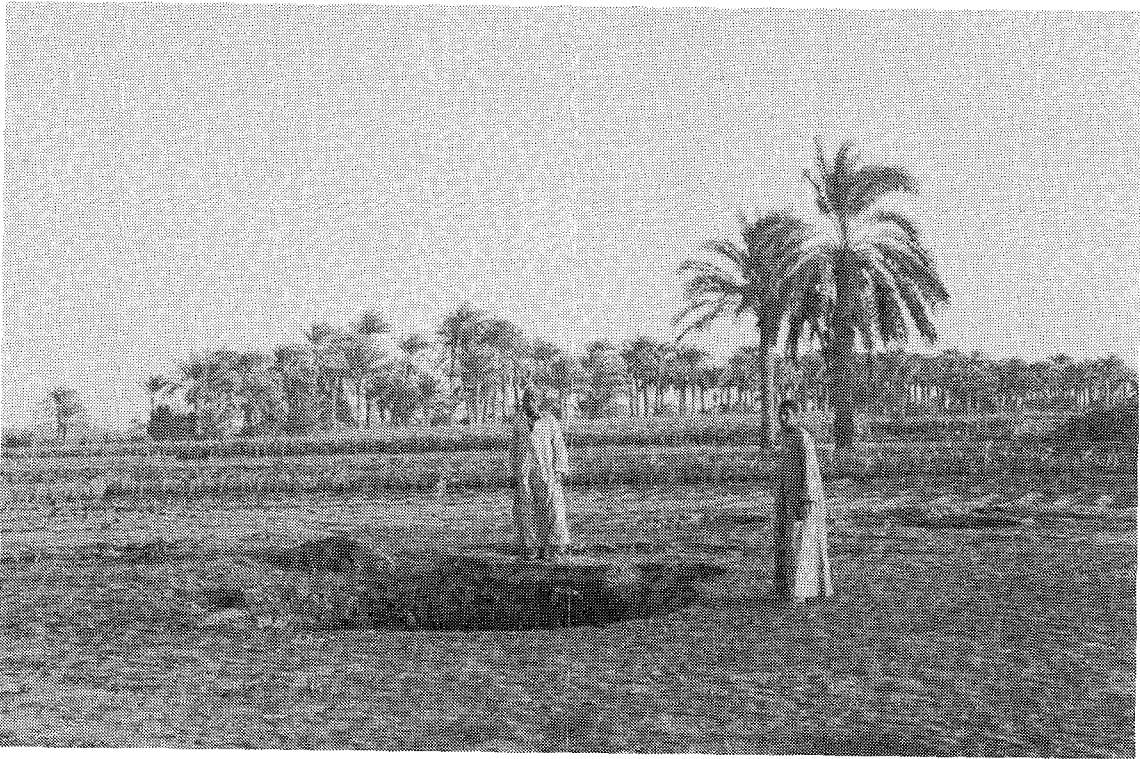
**FIGURE 2-10** Craters Nos. 6, 7, 8, 9, and 10 of Figure 2-6.

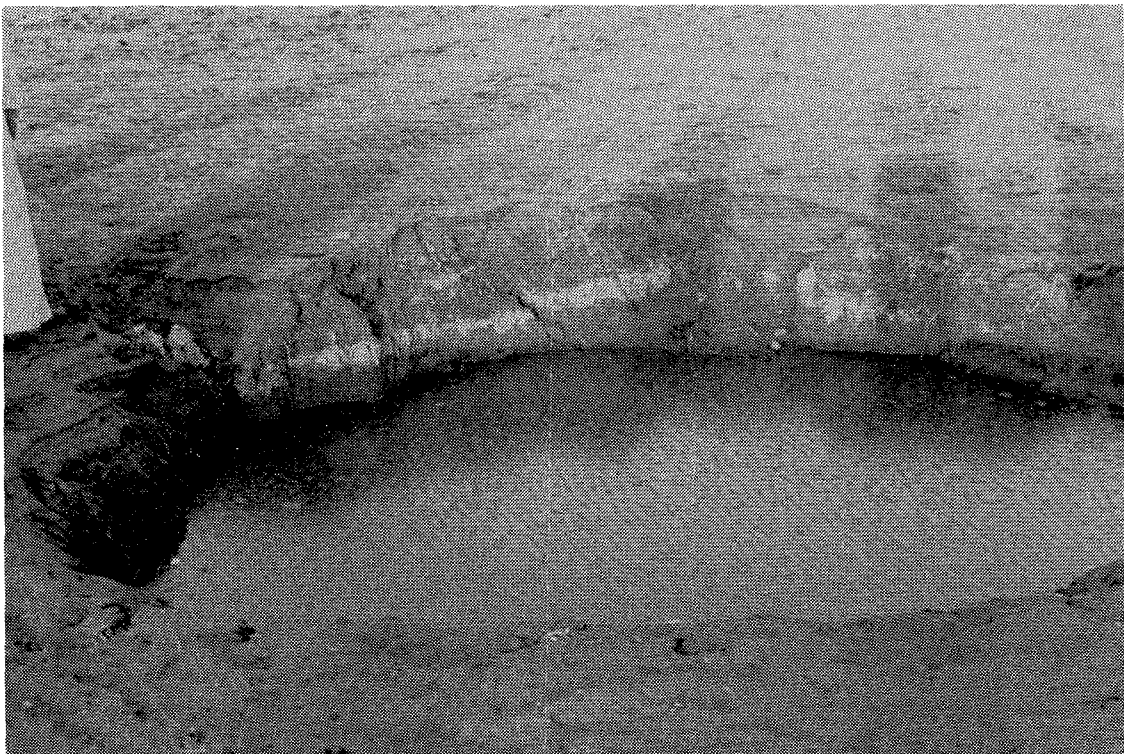
**FIGURE 2-11** Close-up of Crater No. 7 of Figure 2-6.

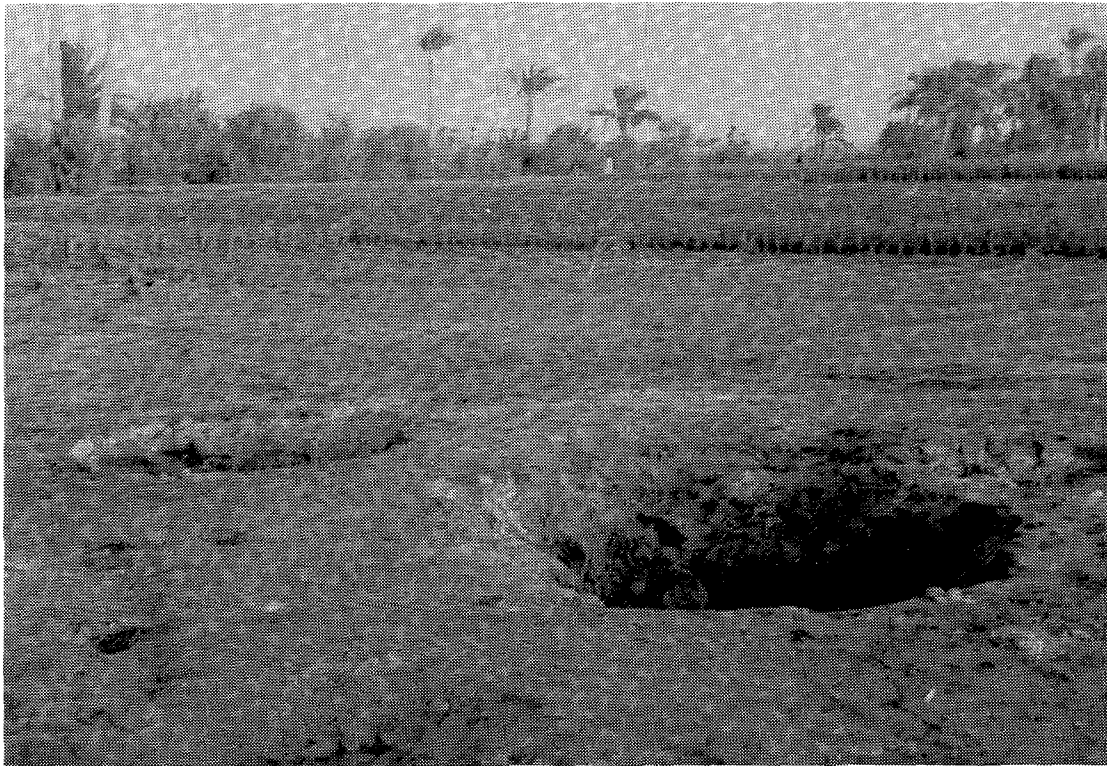
**FIGURE 2-12** Close-up of Crater Nos. 8 and 9 of Figure 2-6.
