**Reconnaissance Report of Damage
to Historic Monuments in Cairo, Egypt
Following the October 12, 1992 Dahshur Earthquake**

Technical Report NCEER-93-0016

August 19, 1993

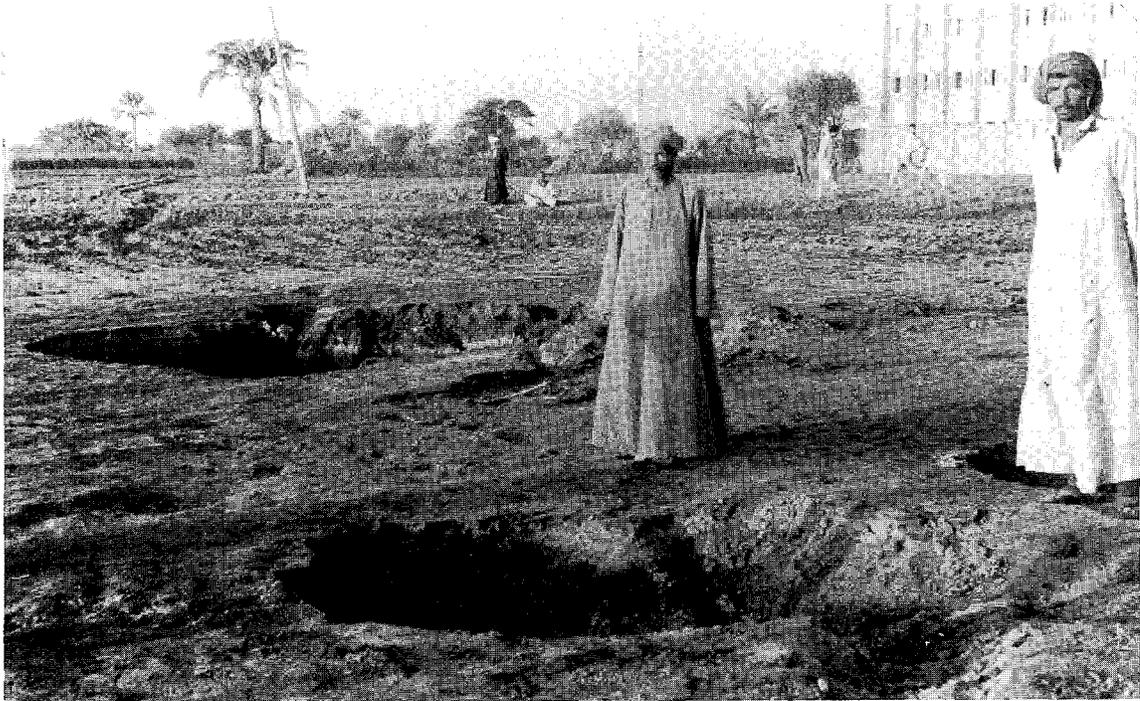
FIGURE 2-10 Remnant craters from sand boils 20 km south of Cairo (courtesy of Ahmed Elgamal, Rensselaer Polytechnic Institute)

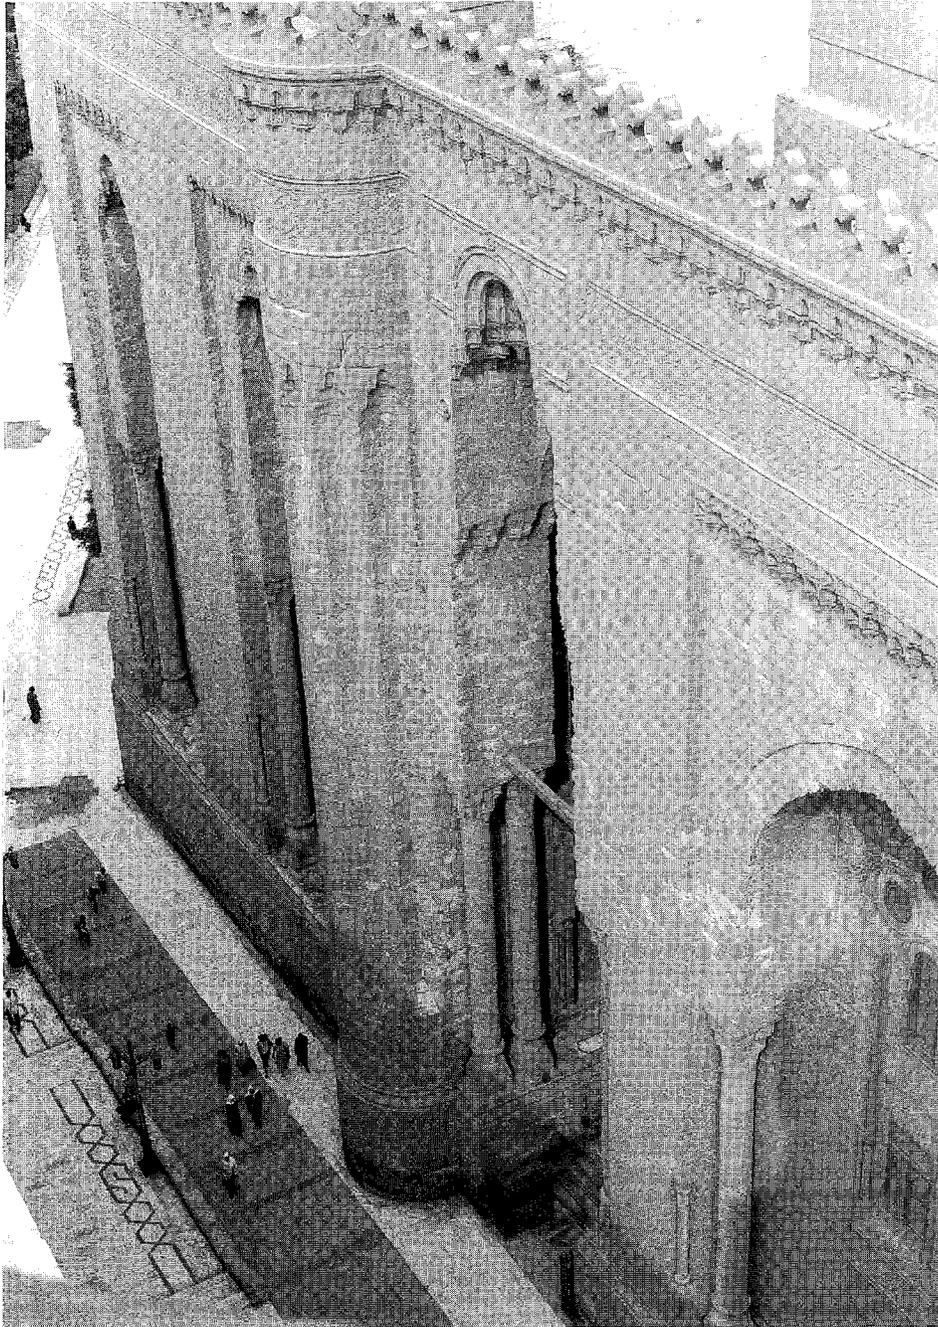
FIGURE 4-1 Main portal of century-old al-Rifai Mosque looking down from the eastern minaret of the Sultān Hasan Mosque showing deterioration of masonry near arches

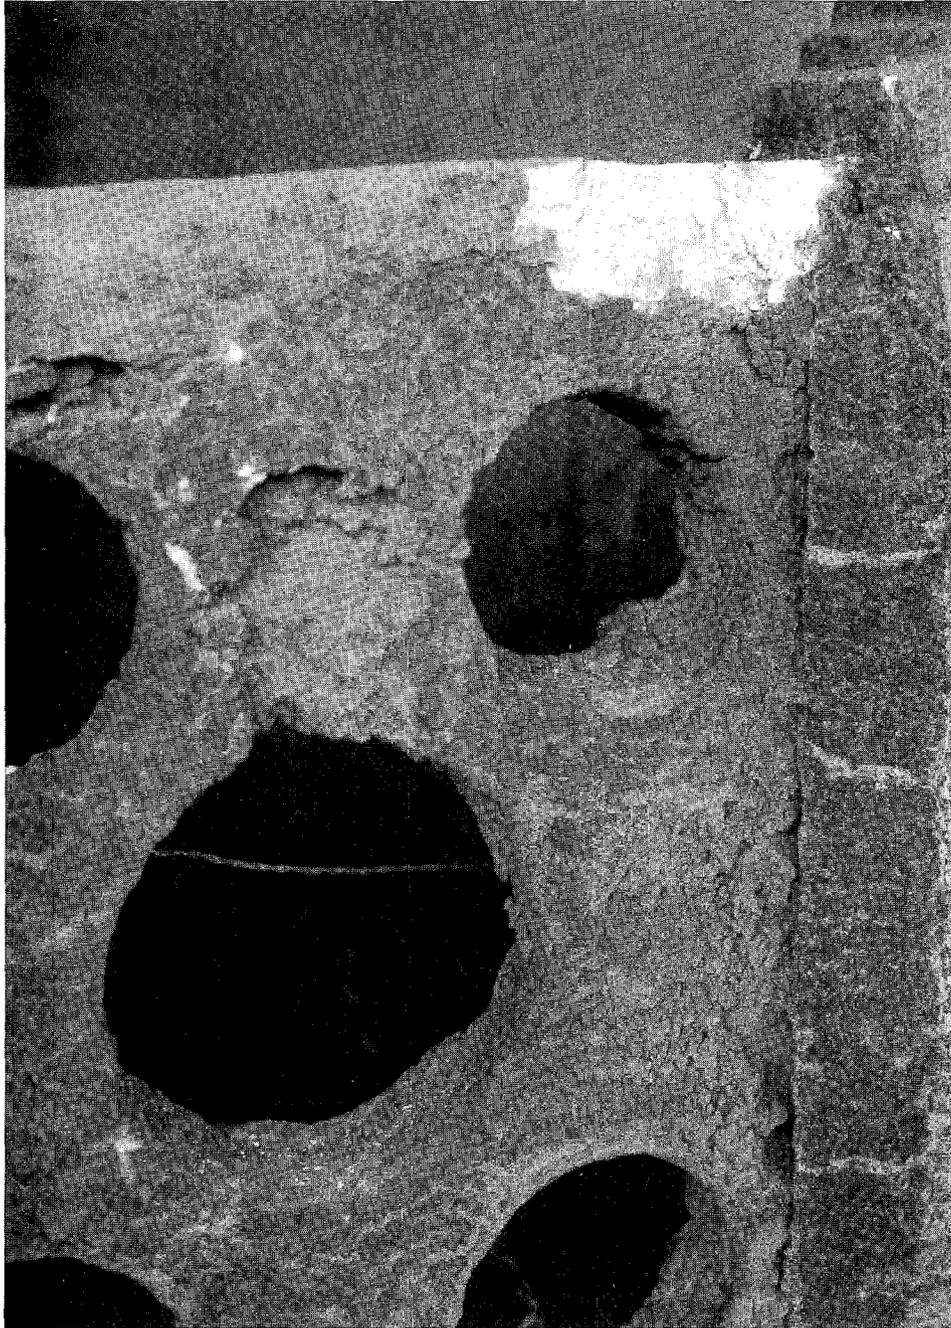
FIGURE 4-2 Balcony wall masonry of Hasan Pasha Tāhir Mosque showing deterioration of stone and spalling resulting from earthquake

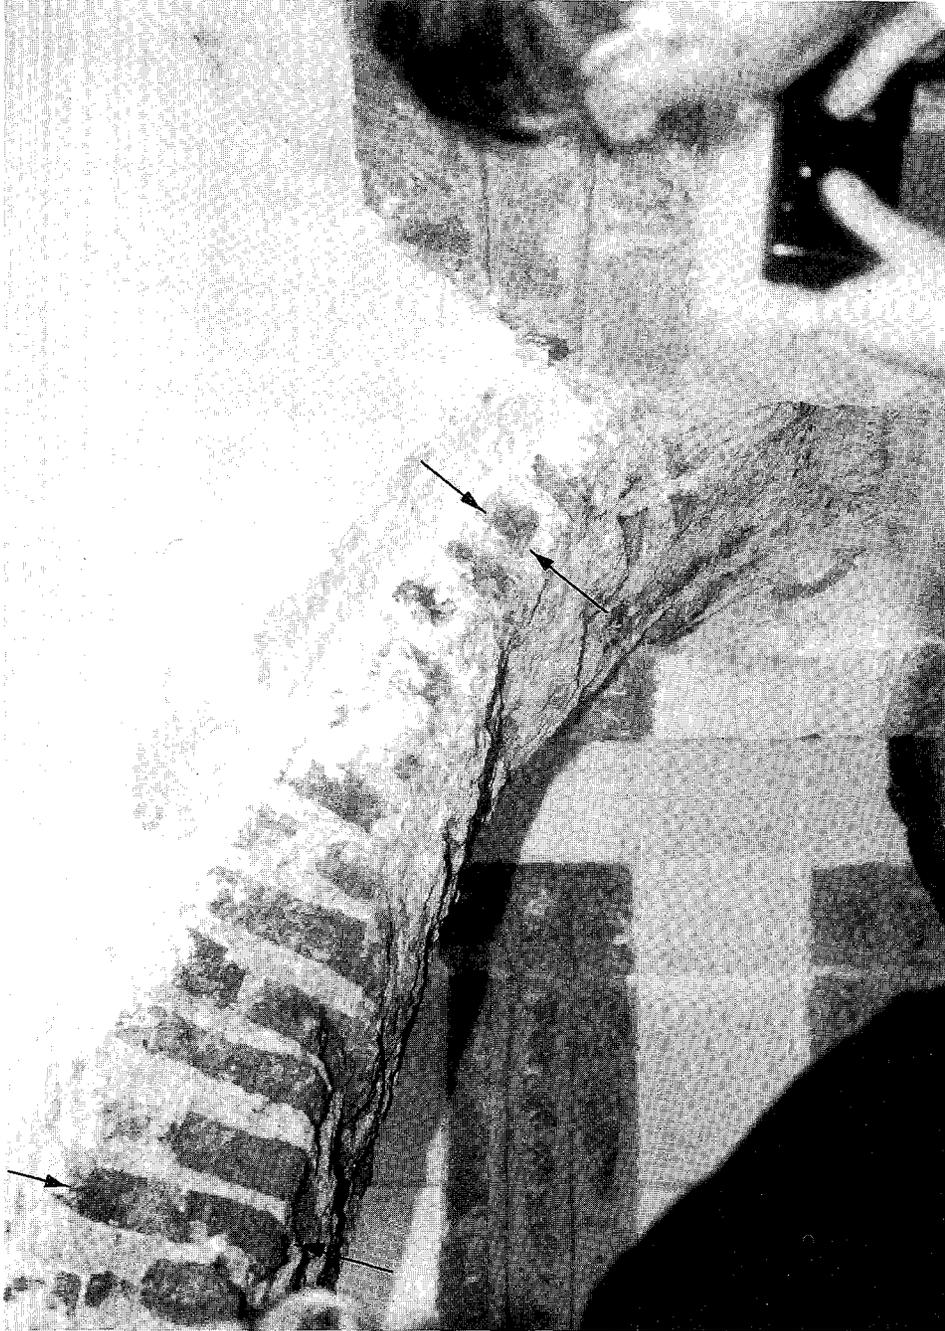
FIGURE 4-3 Brick arch in crypt of Abu Sufein Church showing the loss of a considerable amount of material

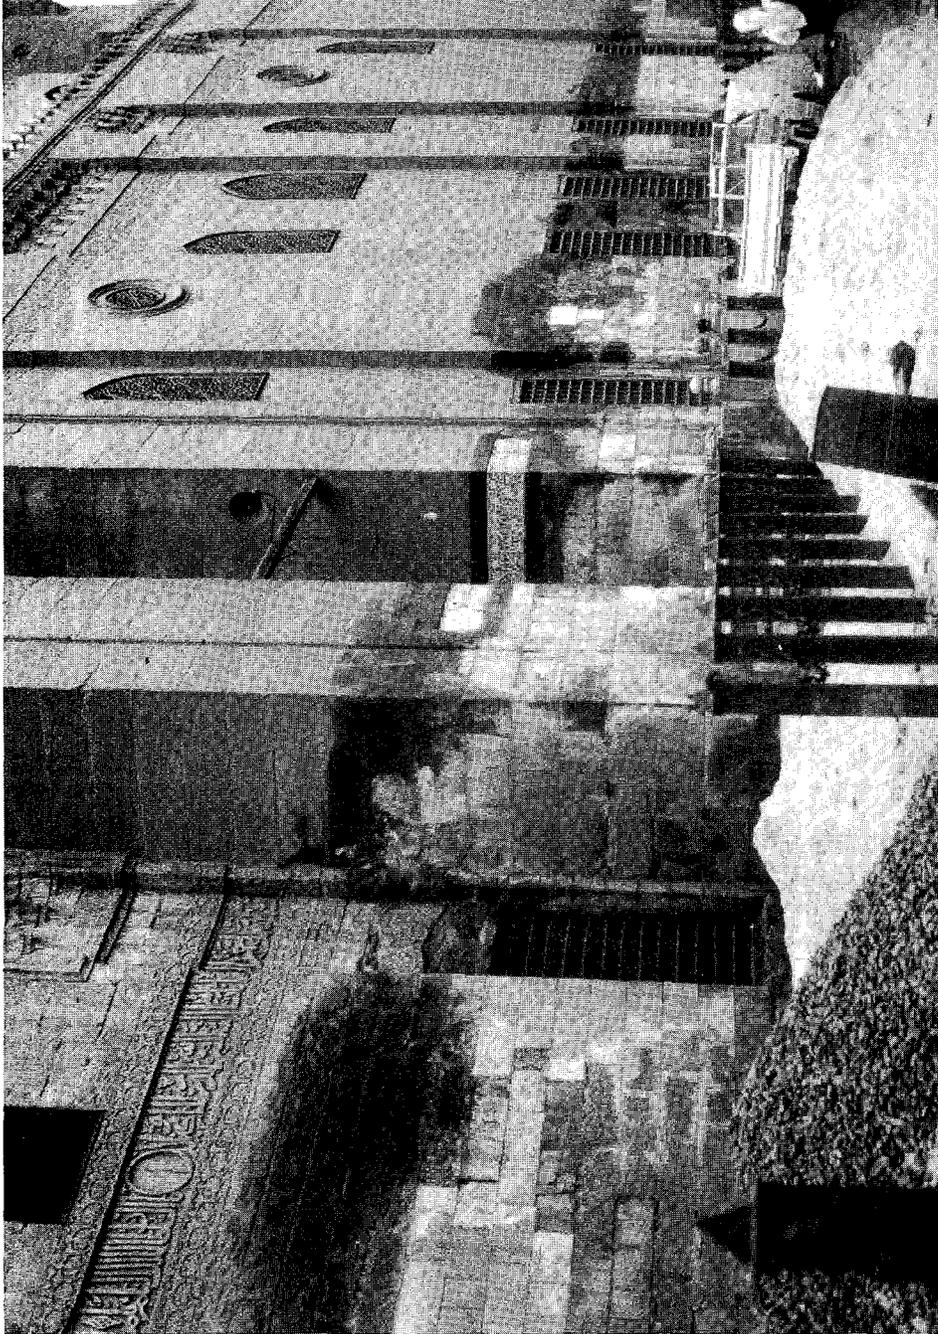
FIGURE 4-4 Southwest exterior wall of Mosque of Sultan Barqūq looking north showing dampness in masonry and progressive deterioration with height

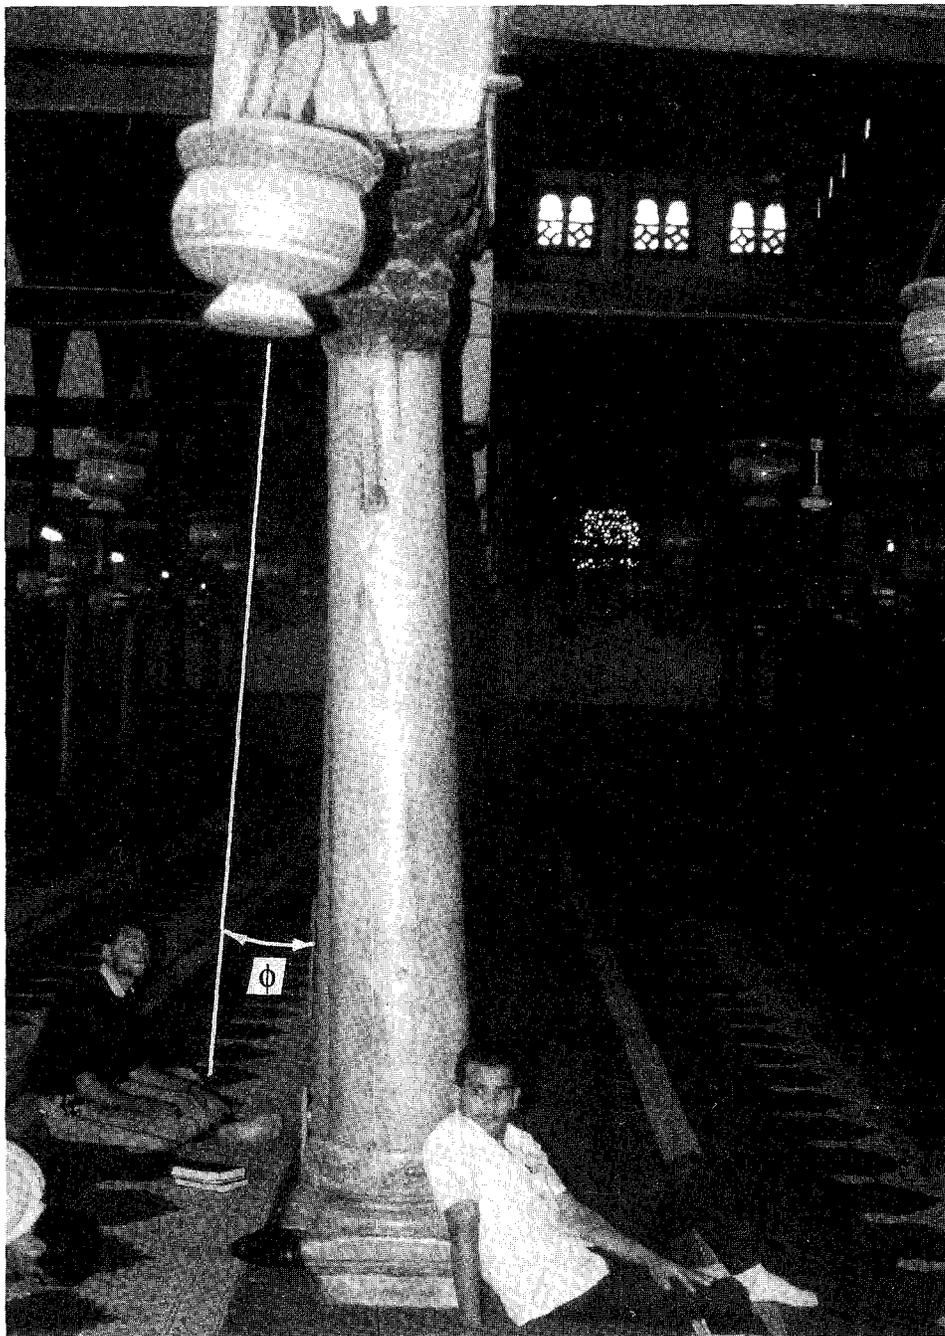
FIGURE 4-6 Column of arcade at al-Azhar Mosque showing tilting effect from previous earthquake

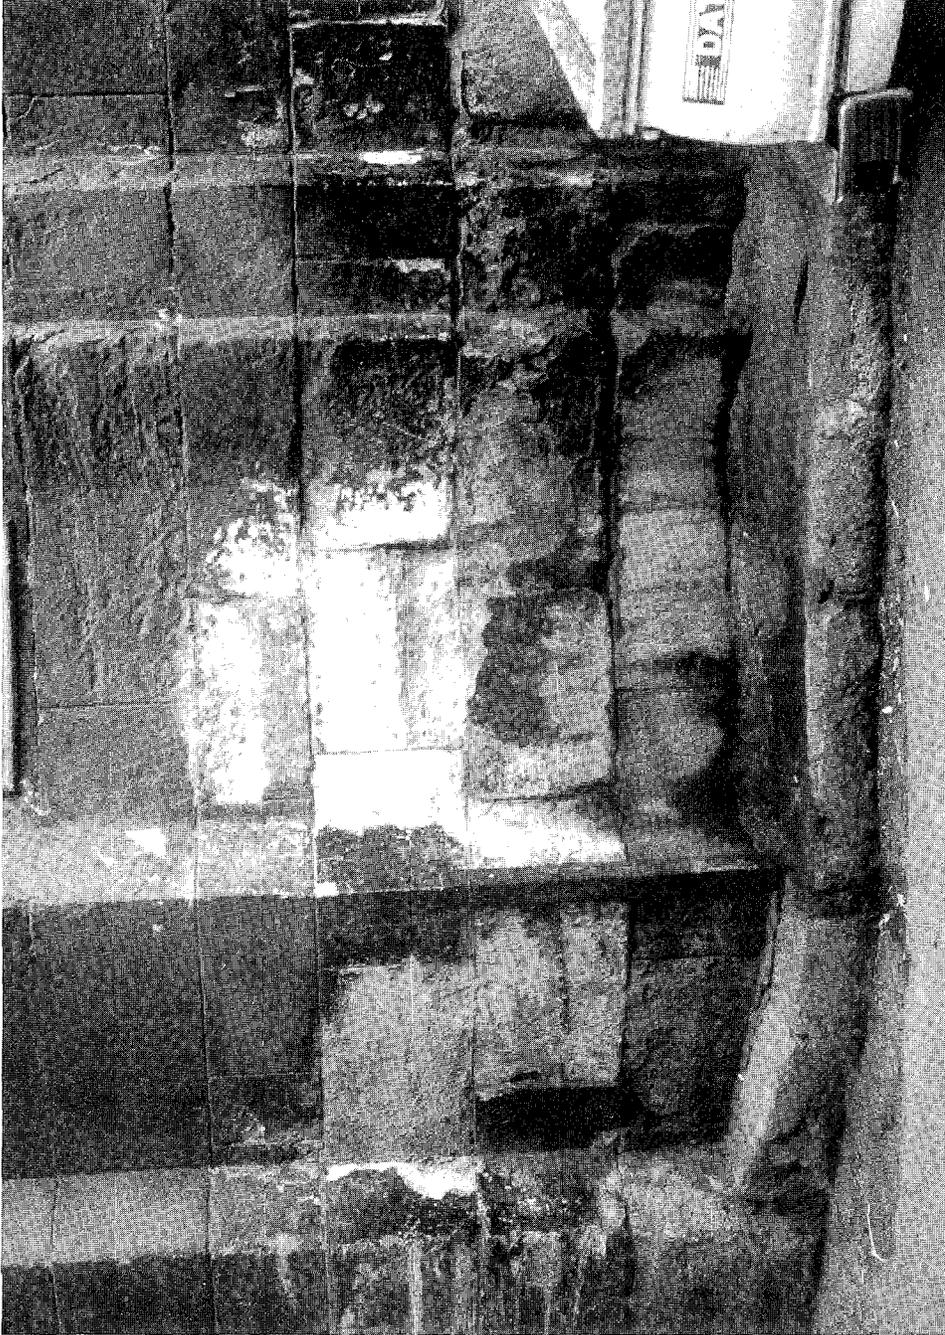
FIGURE 4-7 Inside wall of Bāb al-Futūh showing deterioration from moisture and scraping

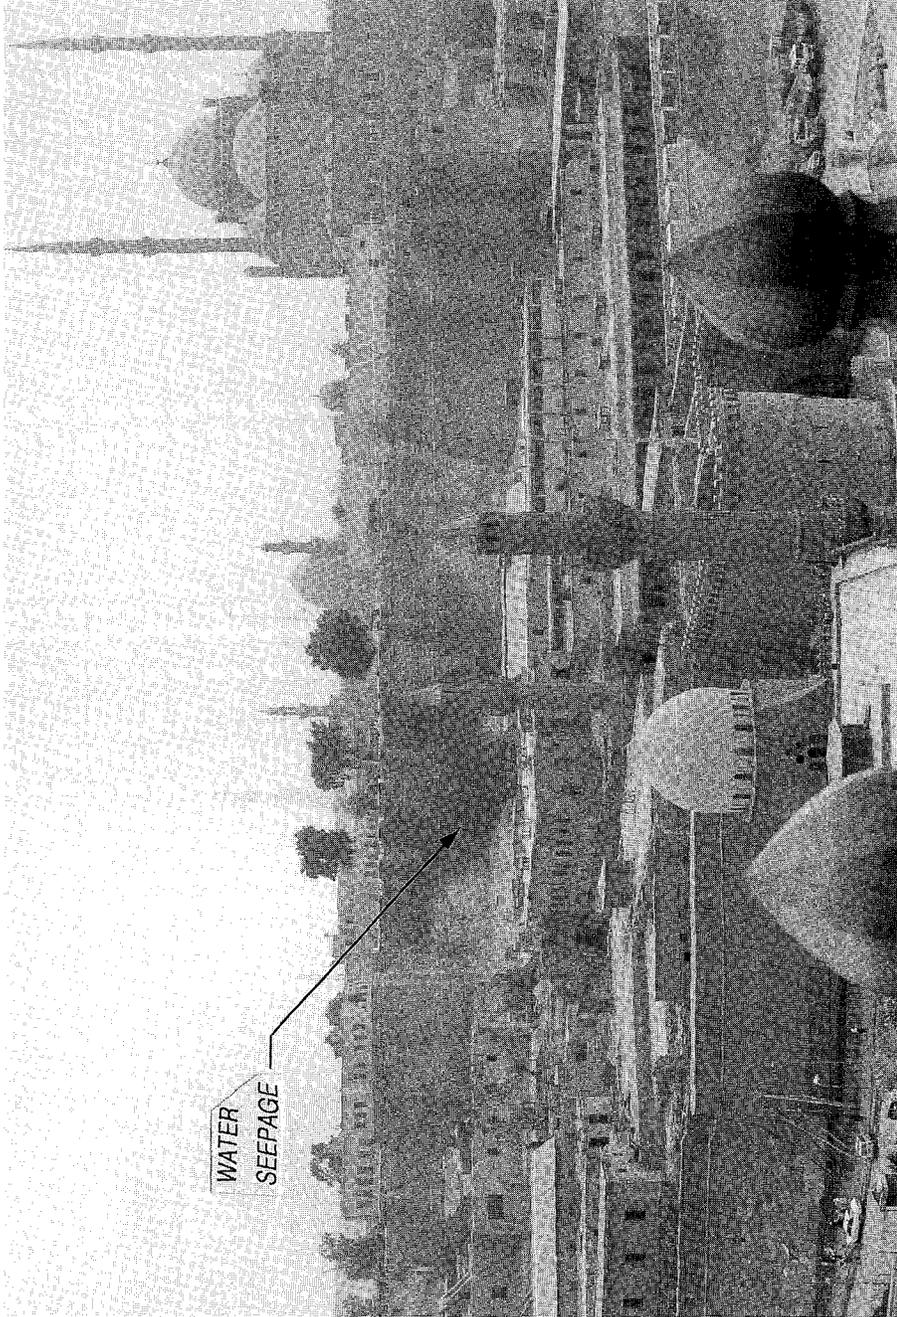
FIGURE 4-9 Citadel looking east from Mosque of Sultān Hasan showing significant moisture seepage through upper wall

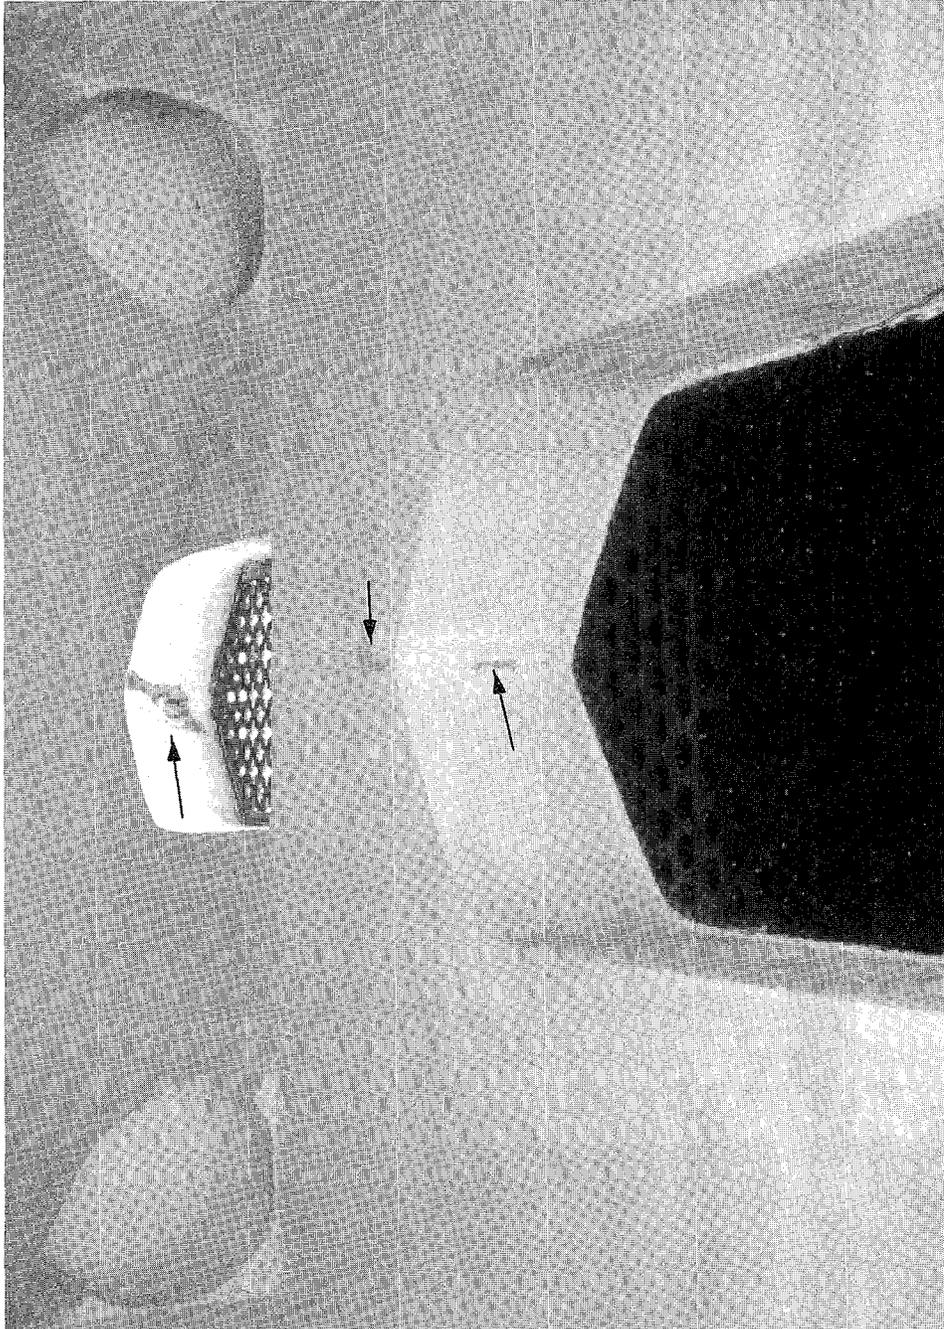
FIGURE 4-10 Wall and small dome at Abu Sufein Church showing cracks and spalling at top of arches

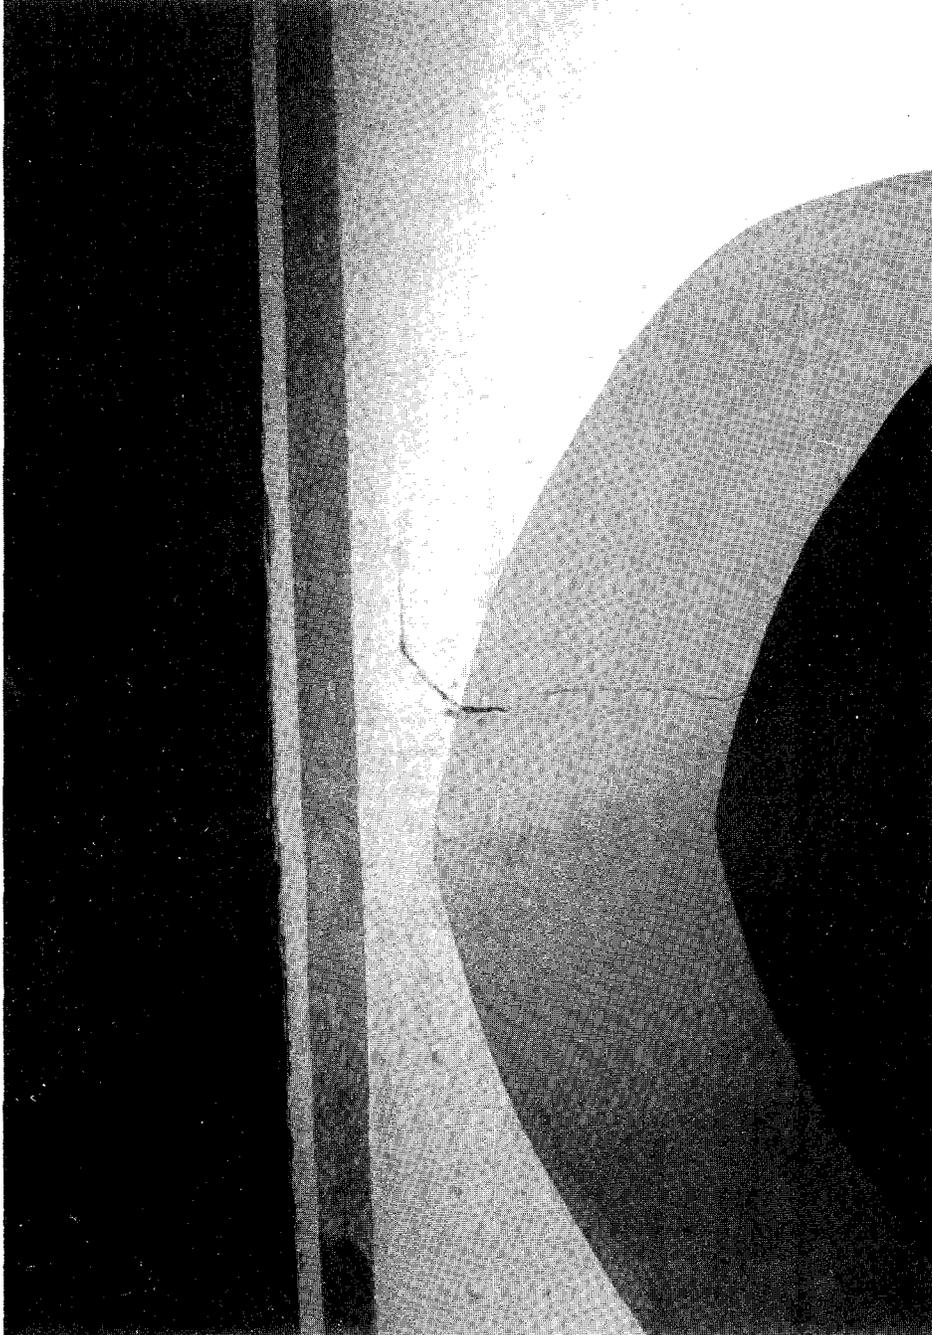
FIGURE 4-11 Arch in arcade of al-Hākīm Bi-Amrillāh Mosque showing minor crack

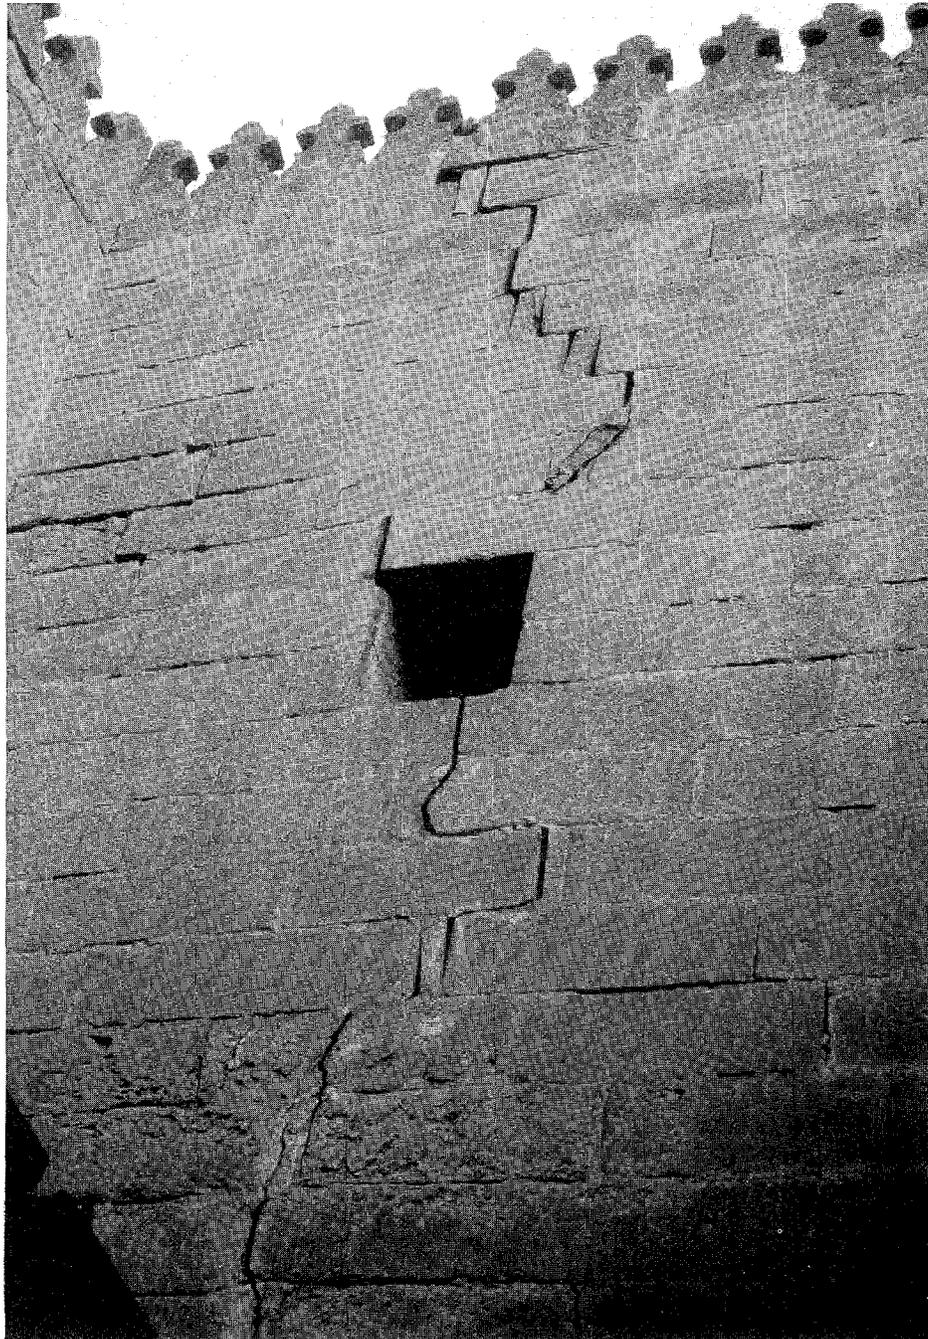
FIGURE 4-12 Wall near back of Mosque of Sultān Barqūq
showing extensive crack in southwestern wall

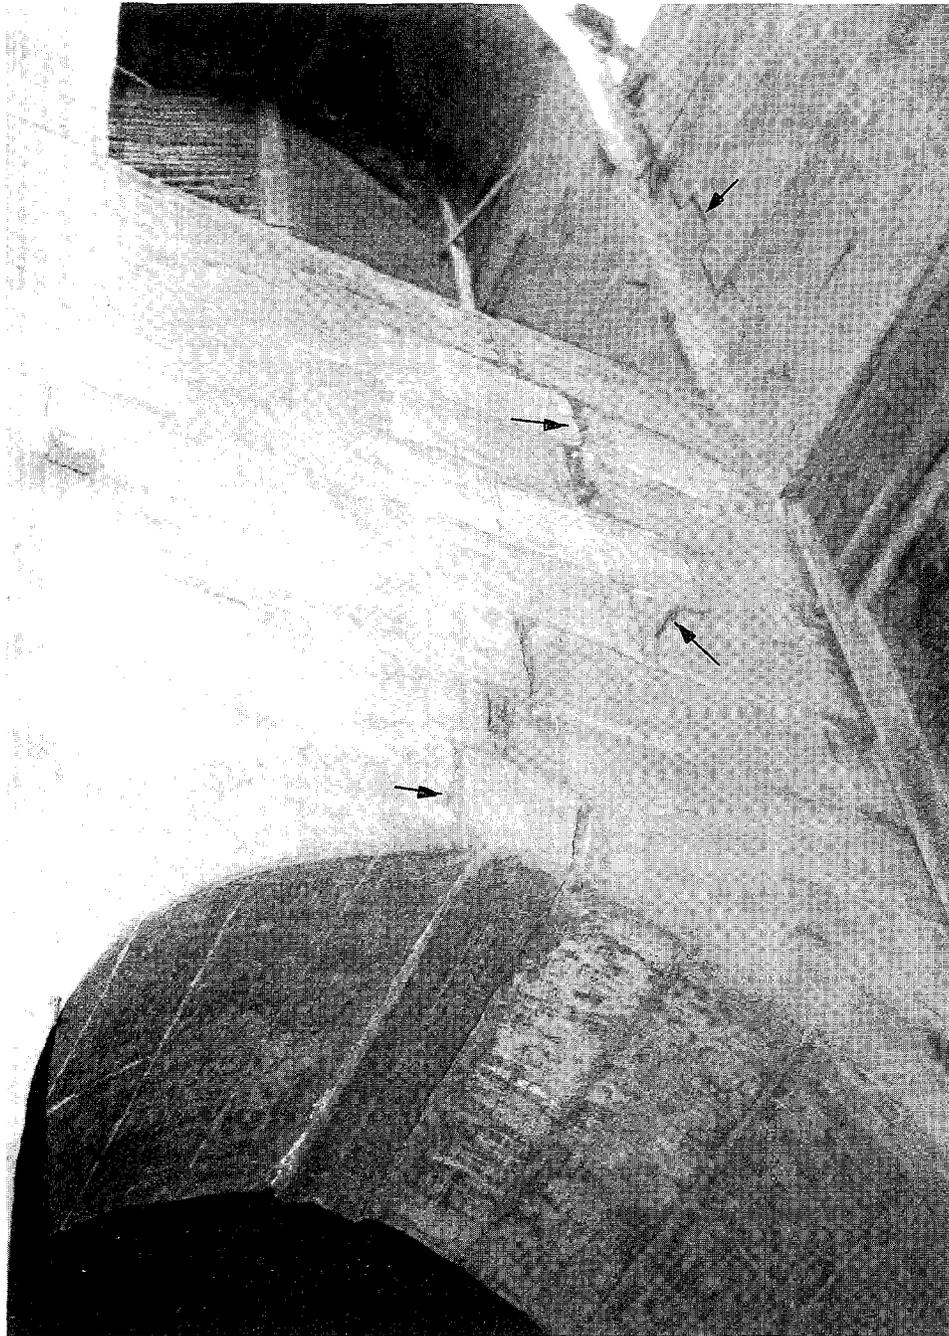
FIGURE 4-13 Wall at southern corner of inner court of Mosque of Sultān Barqūq showing crack in southwestern wall extending down to arch

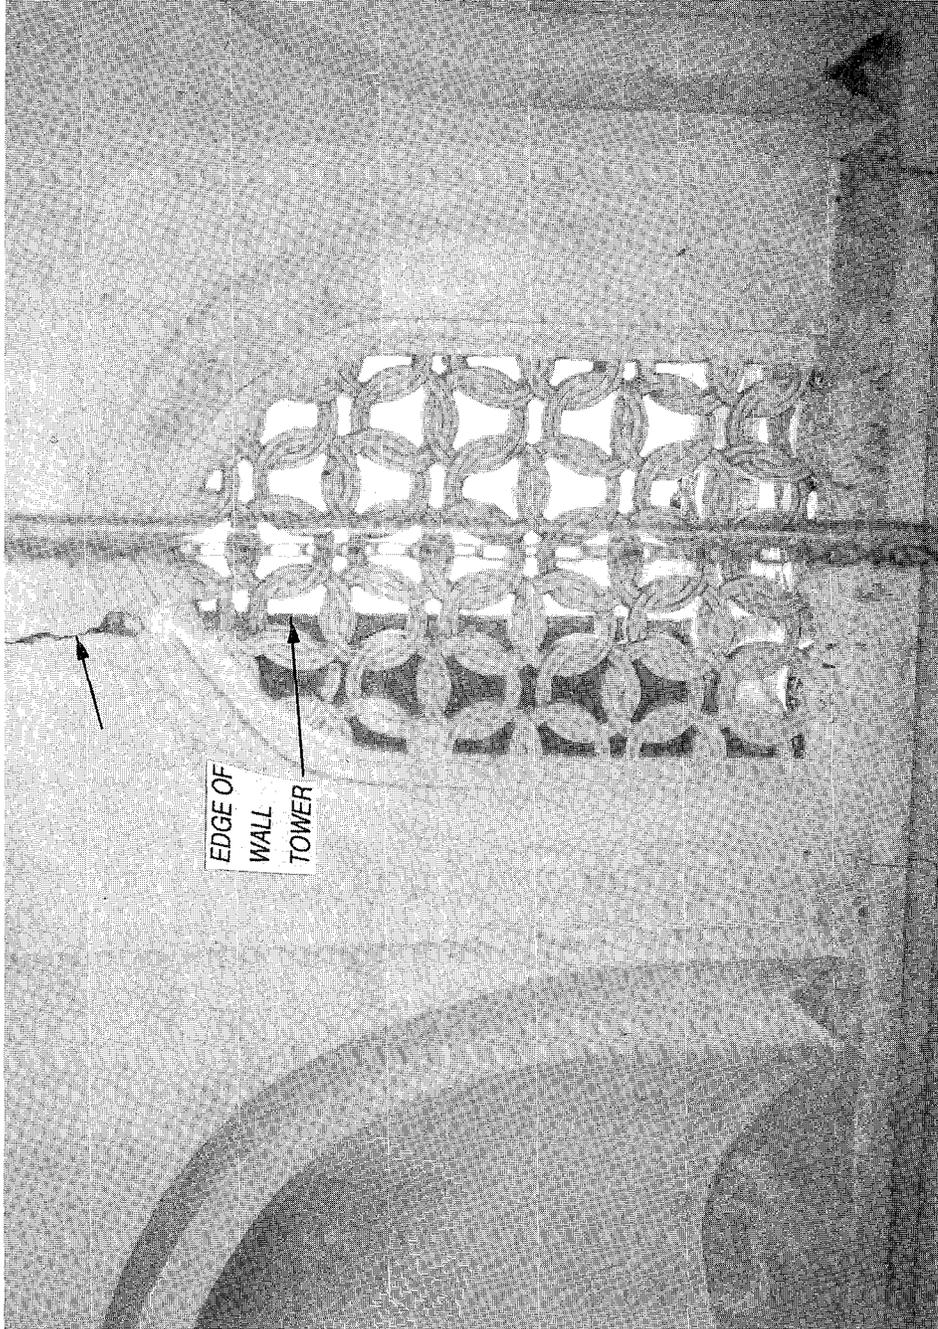
FIGURE 4-14 Base of dome at eastern corner of al-Hākīm Bi-Amrillāh Mosque showing crack extending up from window corresponding to wall tower

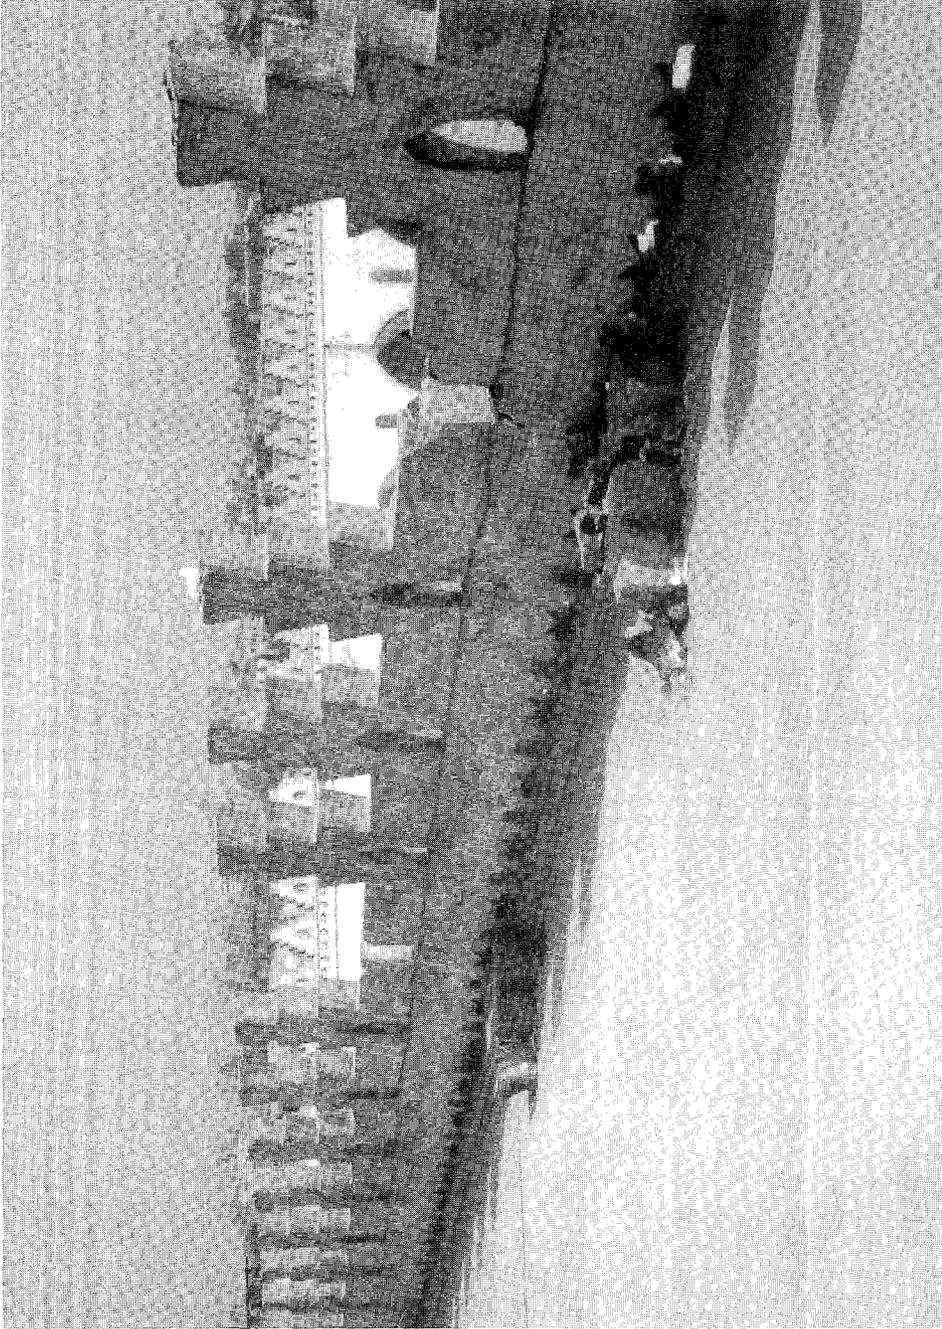
FIGURE 4-15 Walkway above arcade at al-Hākim Bi-Amrillāh Mosque showing fallen parapets

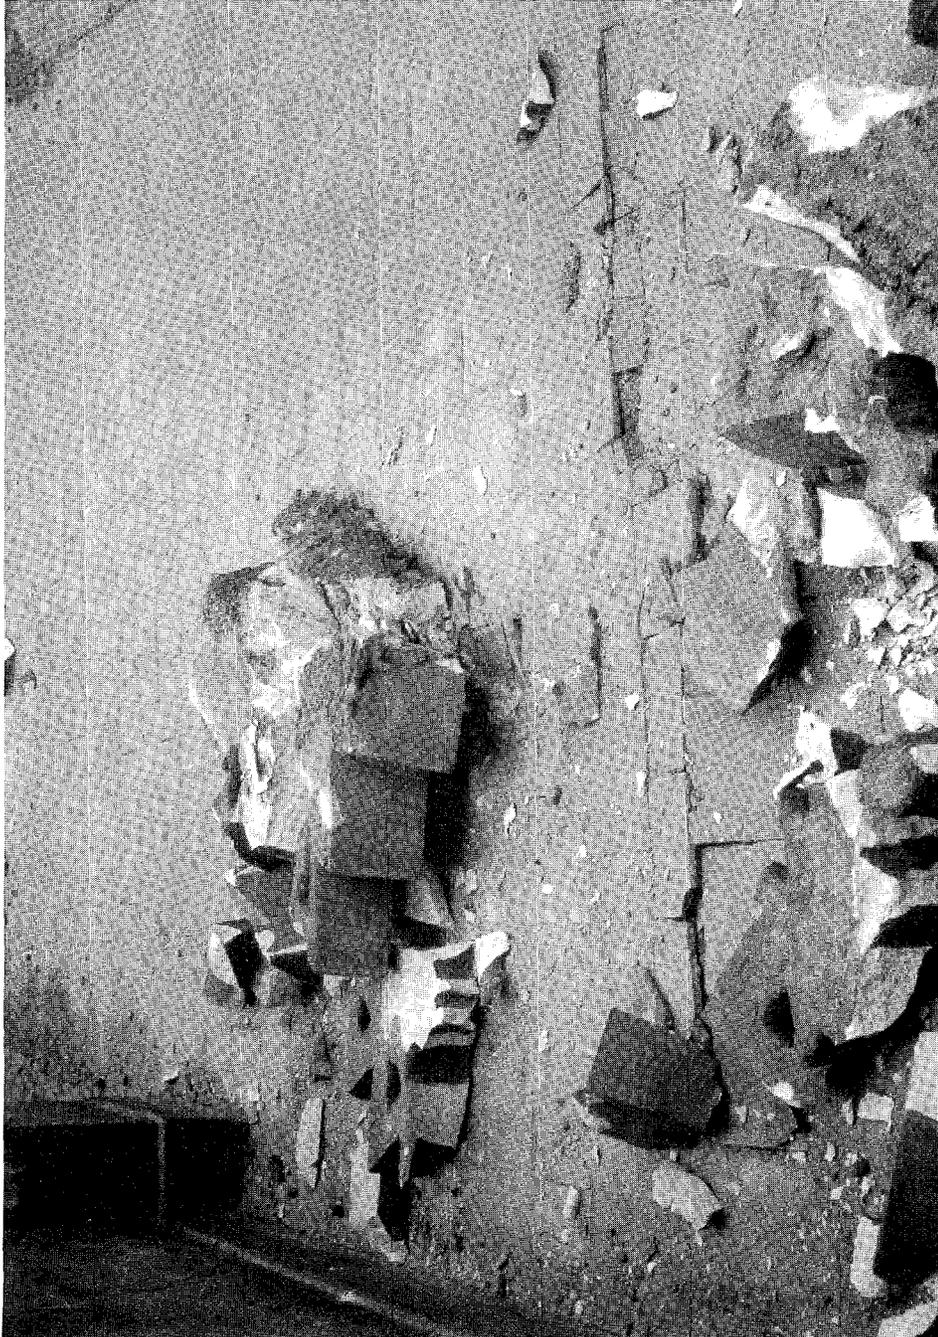
FIGURE 4-16 Walkway above arcade at al-Azhar Mosque showing fallen parapets

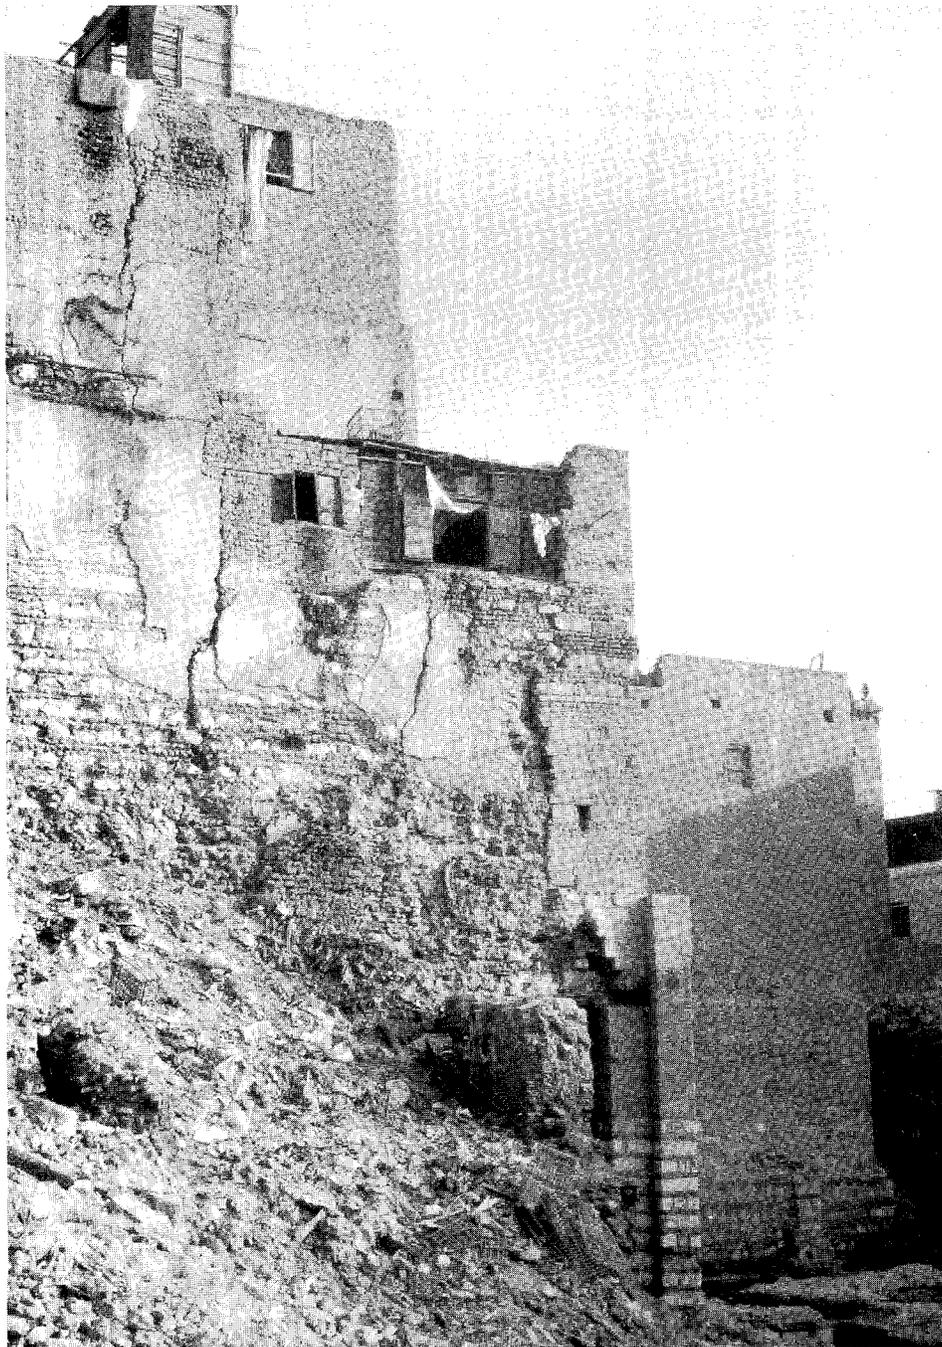
FIGURE 4-18 Residential housing unit behind remains of Madrasa of as-Salih Negm ad-Din Ayyub showing significant cracks

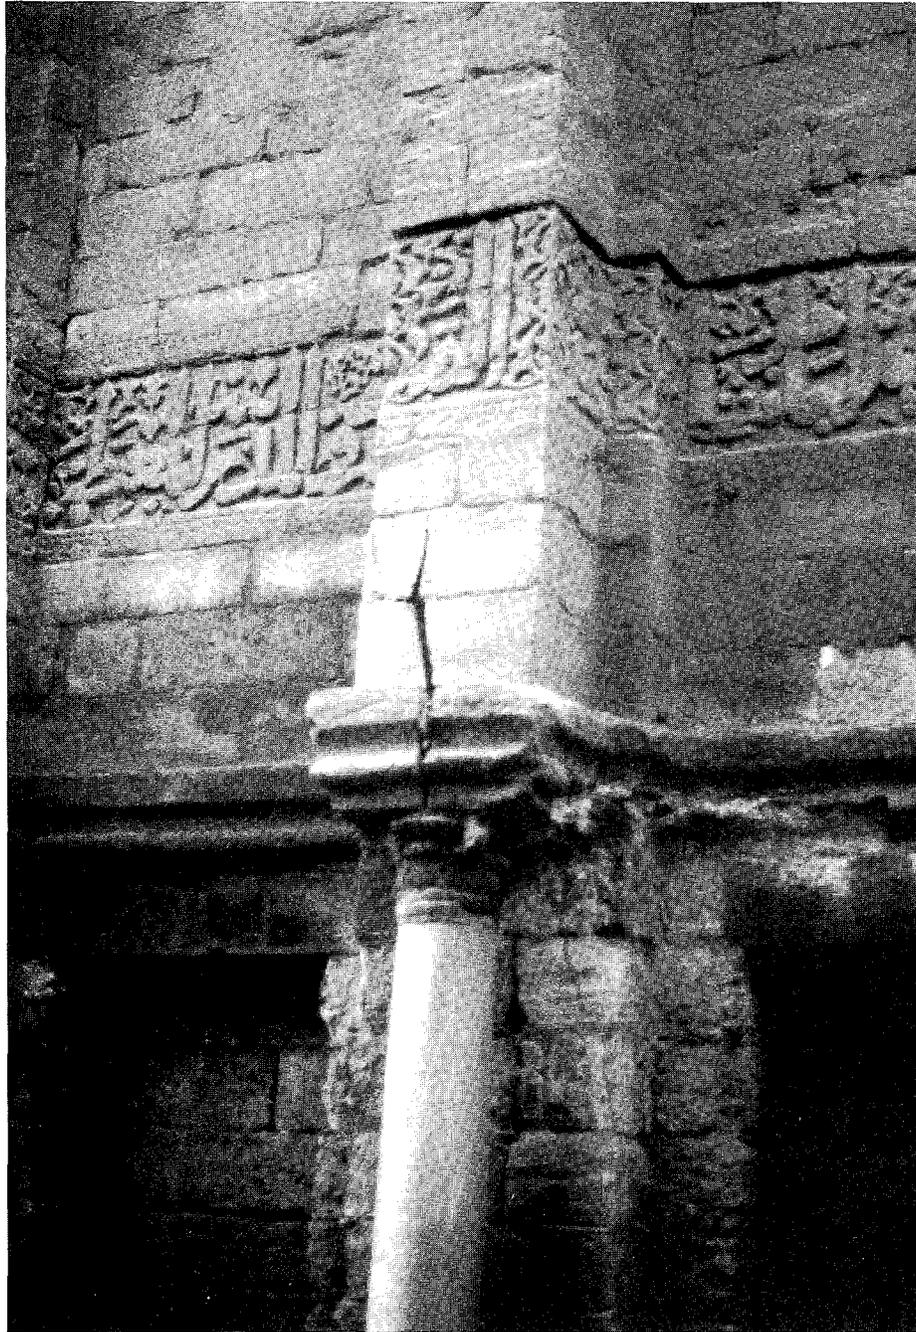
FIGURE 4-20 Marble column at base of recessed panel at Mausoleum of al-Mansur Qala'un showing large crack

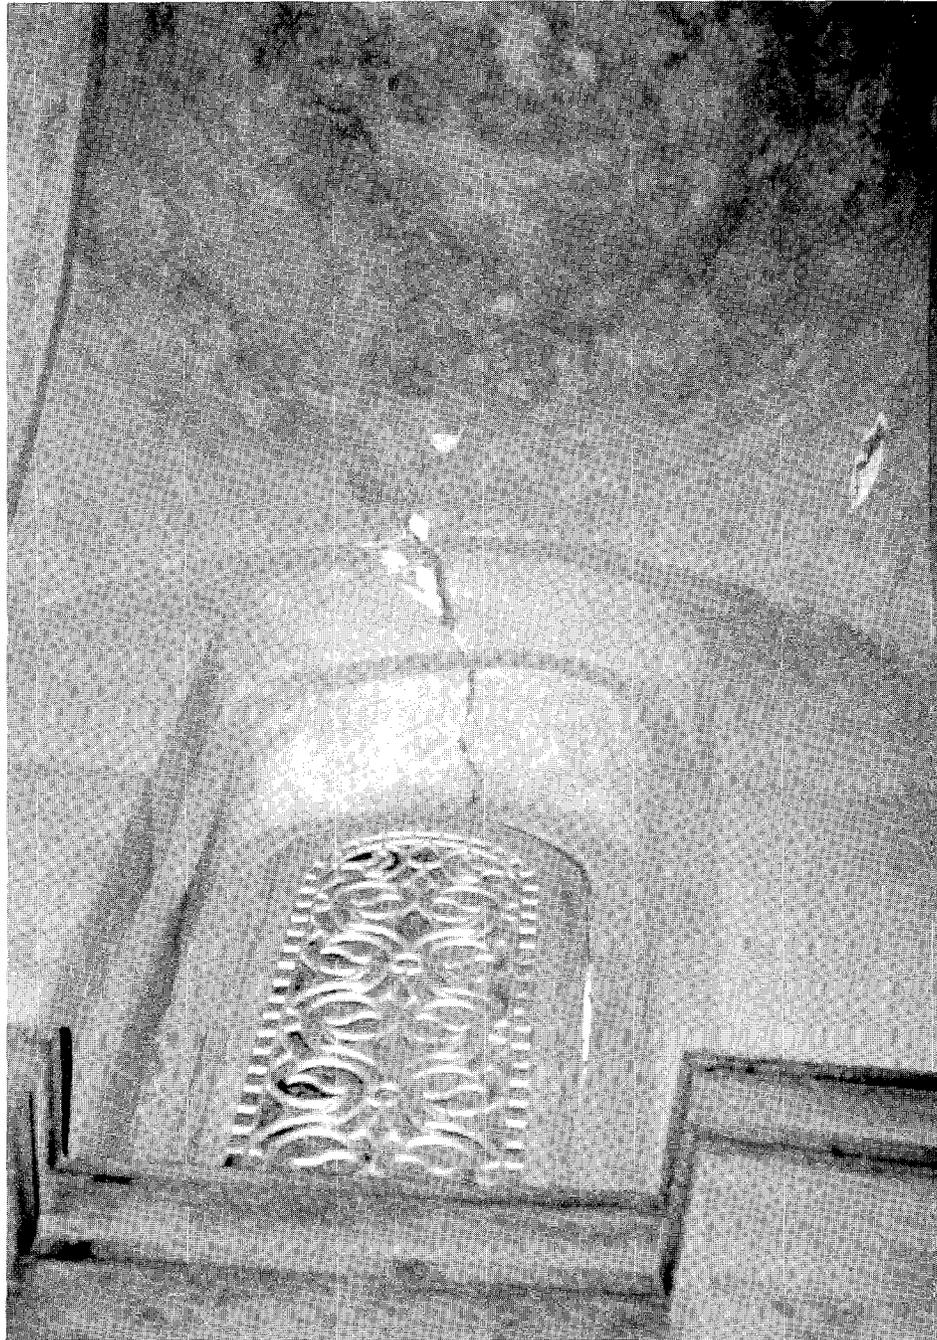
FIGURE 4-21 Top of arch and minor dome in Mausoleum of al-Mansur Qala'un showing significant cracks
