**Reconnaissance Report of Damage
to Historic Monuments in Cairo, Egypt
Following the October 12, 1992 Dahshur Earthquake**

Technical Report NCEER-93-0016

August 19, 1993

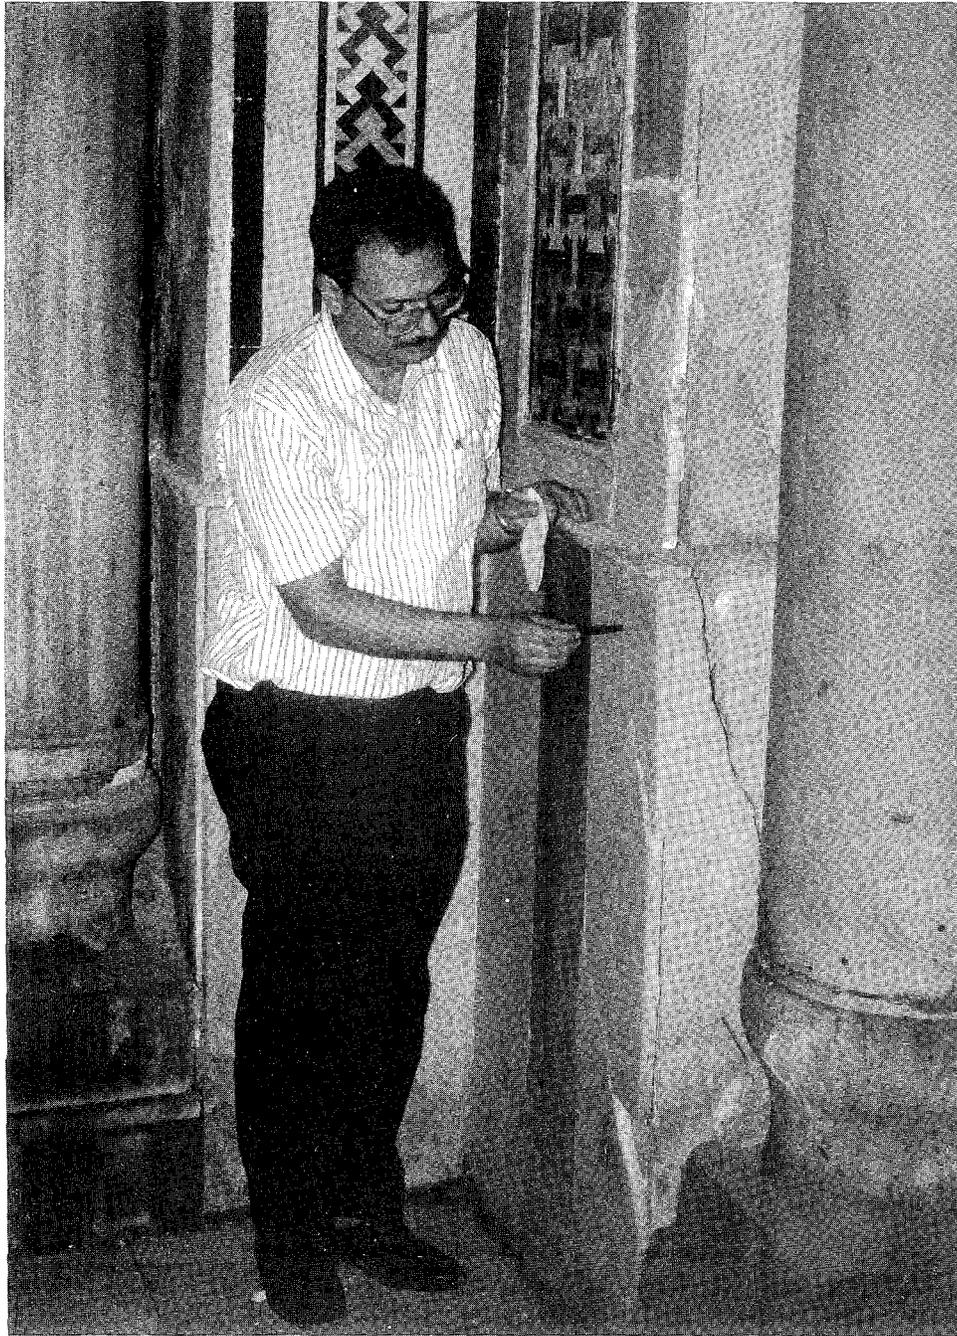
FIGURE 4-22 Base of pier in Mausoleum of al-Mansūr Qala'ūn showing large cracks

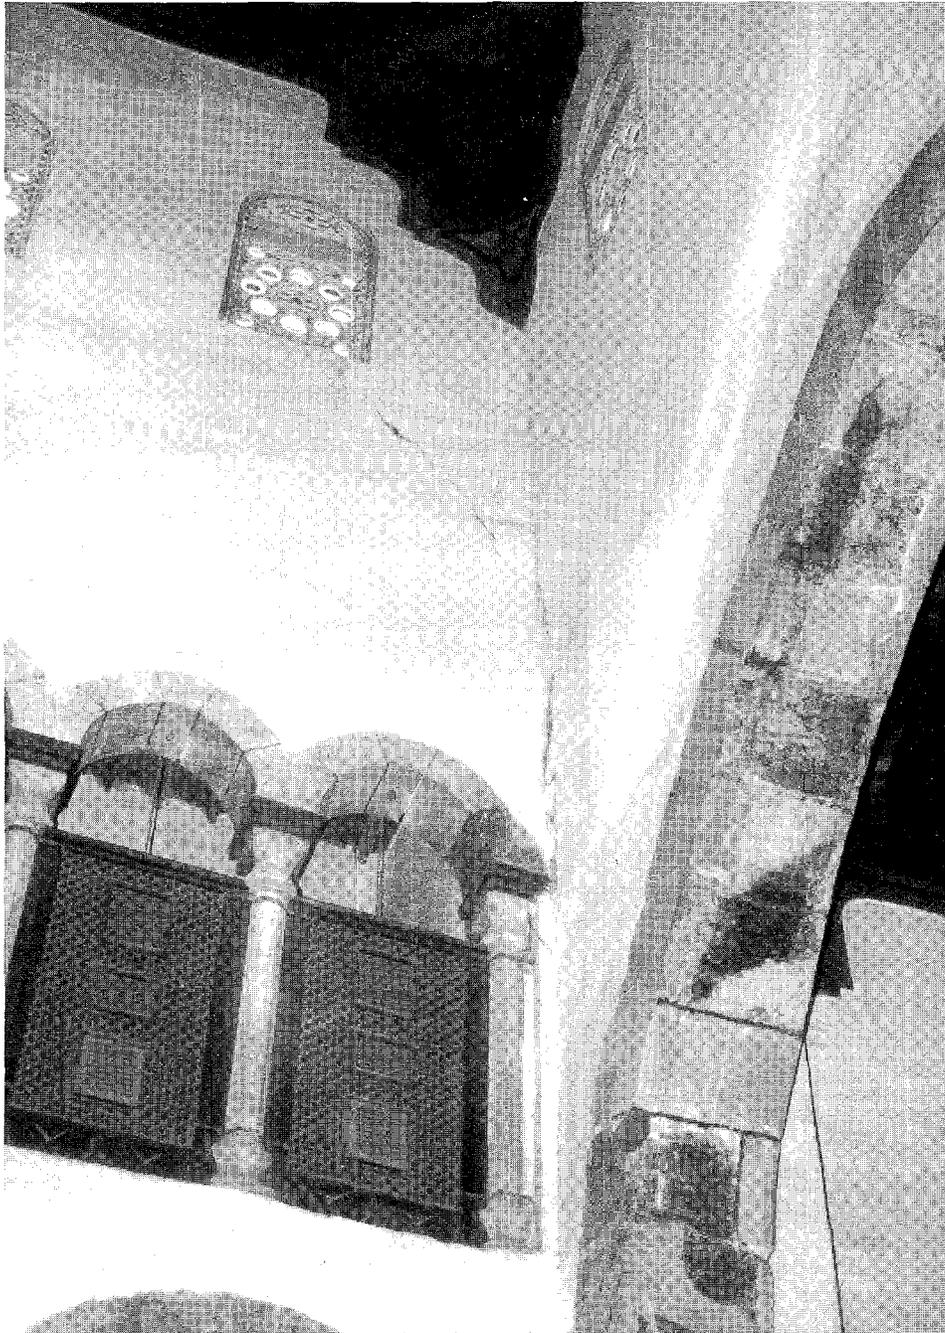
FIGURE 4-23 Western corner of qa'a at Palace of the Amir Beshtak showing large and continuous crack on southwest wall emanating from corner

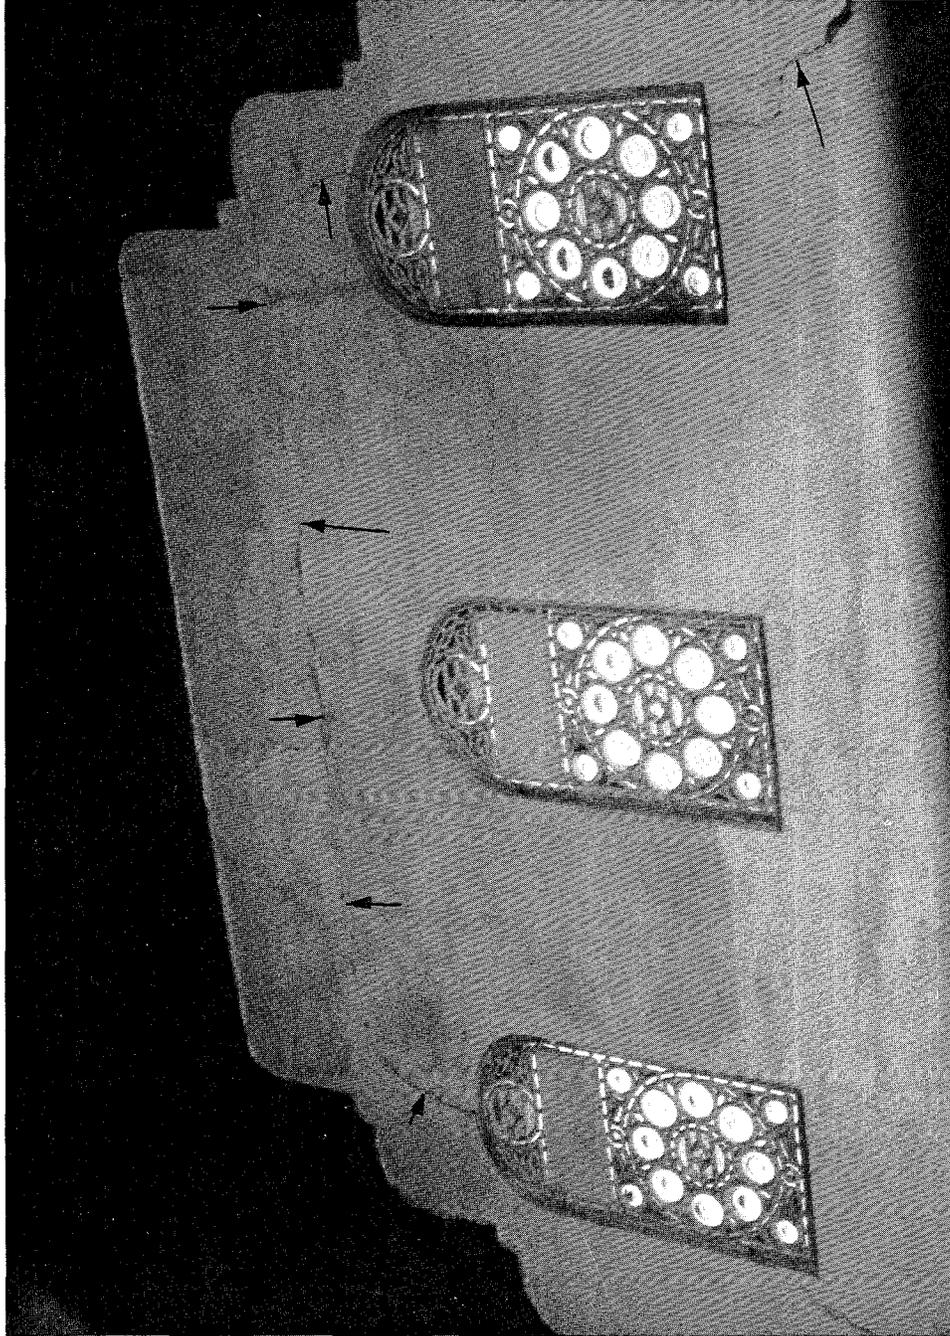
FIGURE 4-24 Southwest wall of qa'a at Palace of the Amir Beshtak showing extent of large and continuous crack

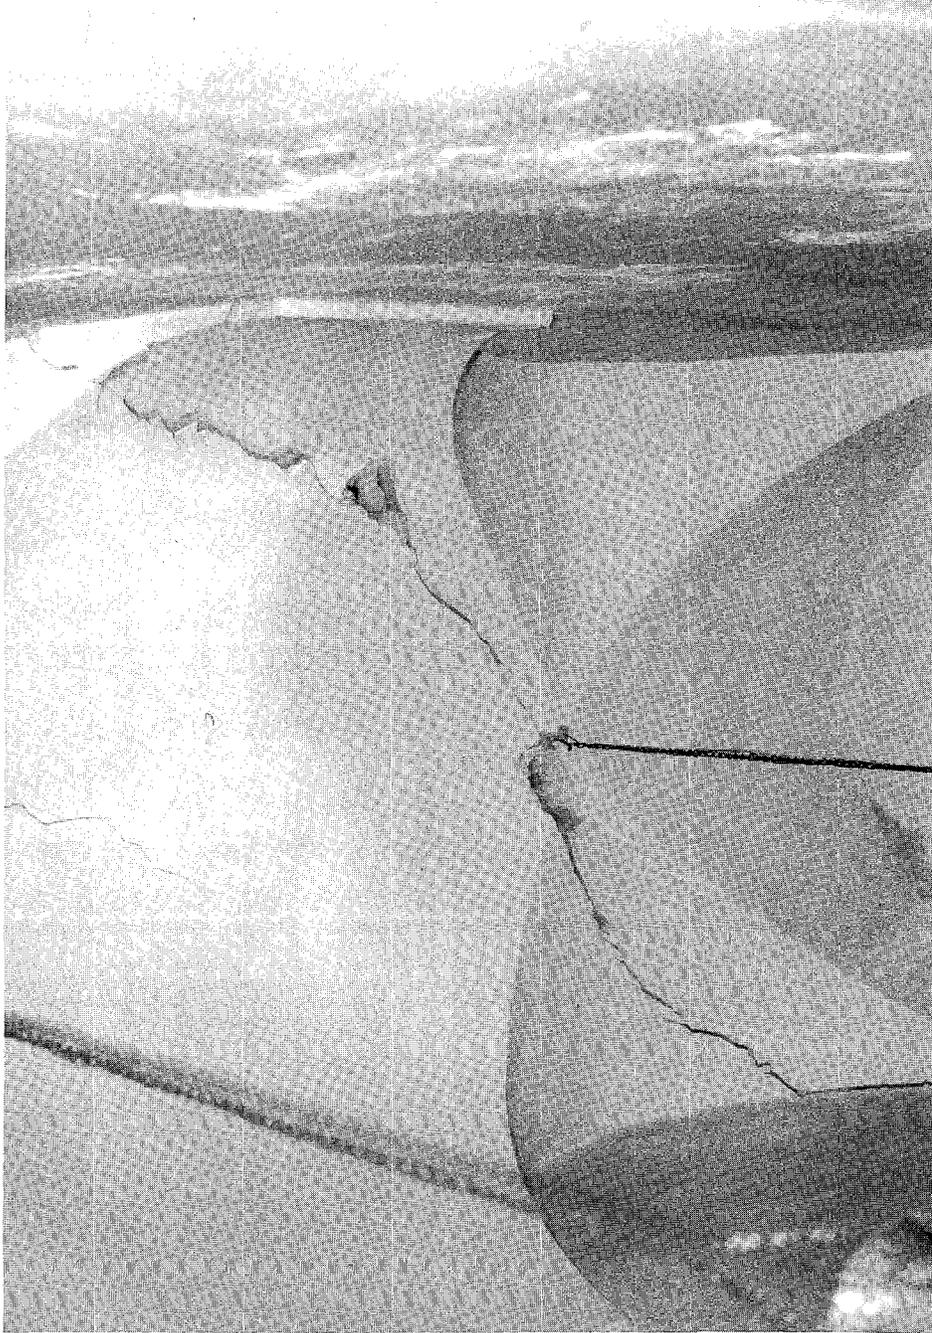
FIGURE 4-25 Ceiling of hallway on northwest side of Palace of the Amir Beshtak showing large and extensive cracks

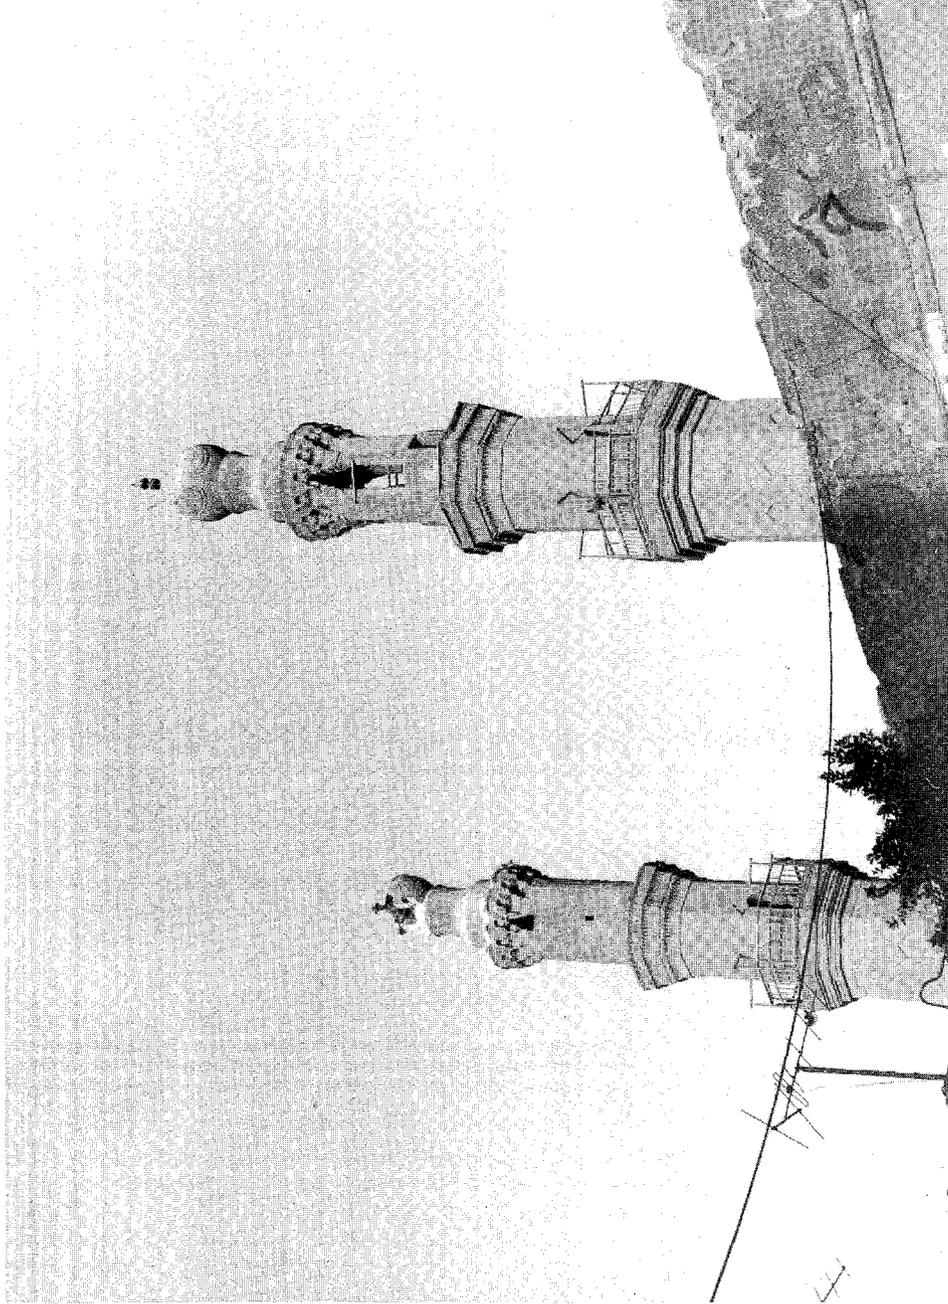
FIGURE 4-26 Minarets of the Mosque of Amir Shaykhū (left) and the Khanqāh of Amir Shaykhū (right) showing damage to the bulb at the mosque

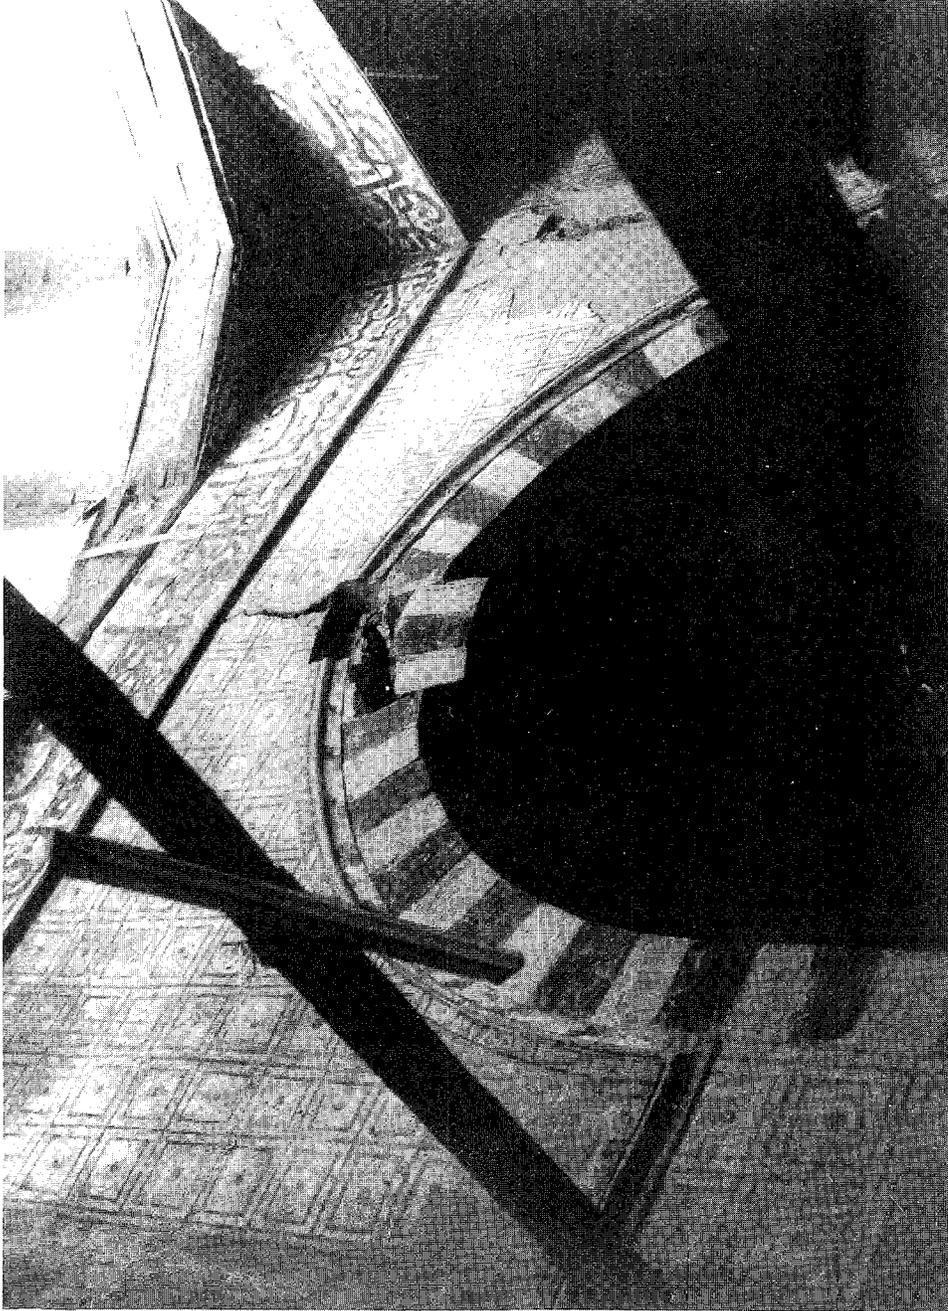
FIGURE 4-27 Arch on the west side of the northwest corner at the Khanqāh of Amir Shaykhū showing dropdown of keystone and two flanking voussoirs

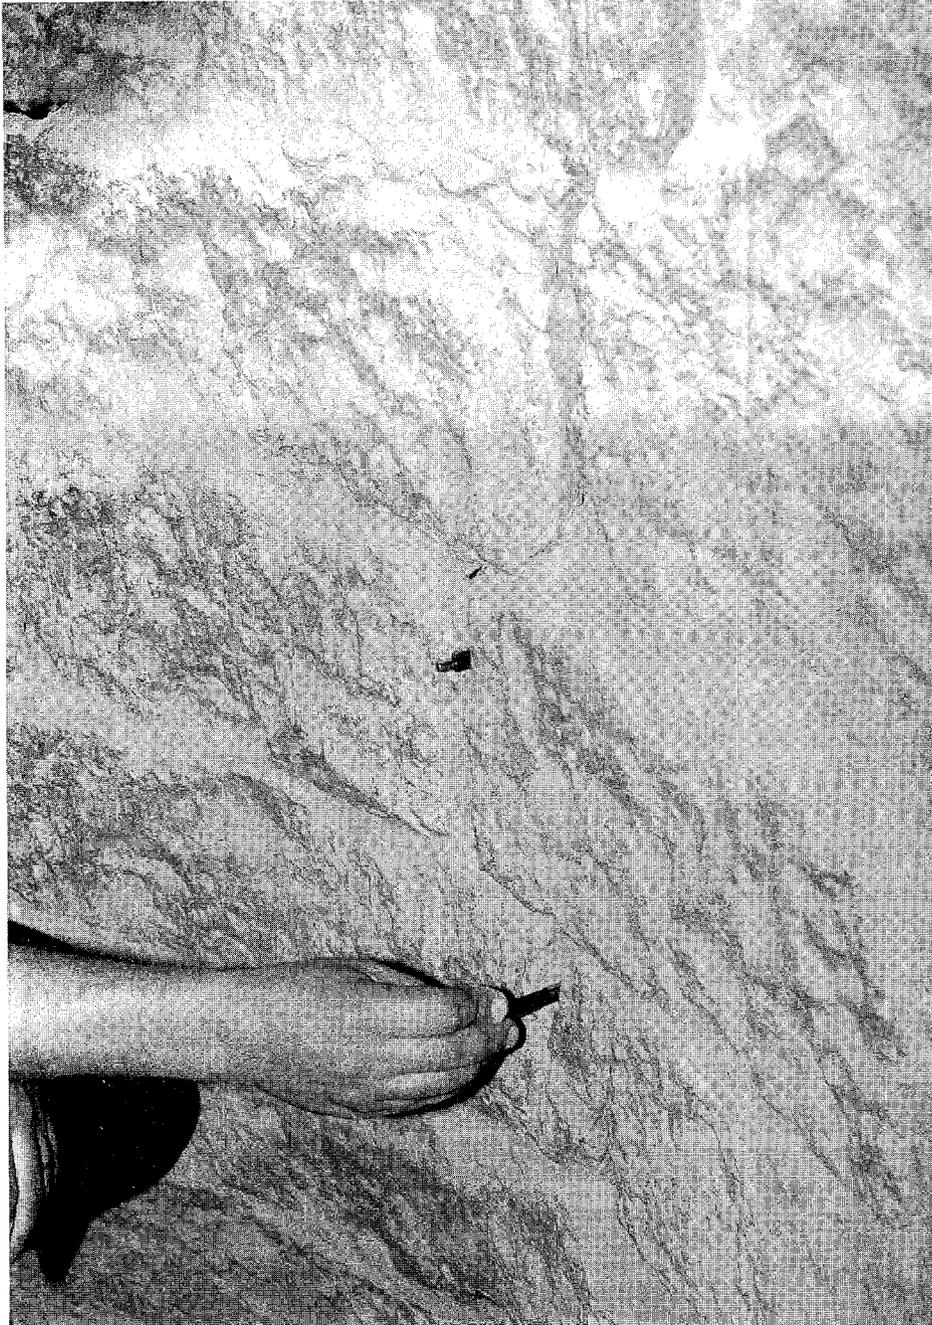
FIGURE 4-29 Interior of southern minaret wall at Mosque, Mausoleum, and Madrasa of Sultân Hasan showing large vertical crack

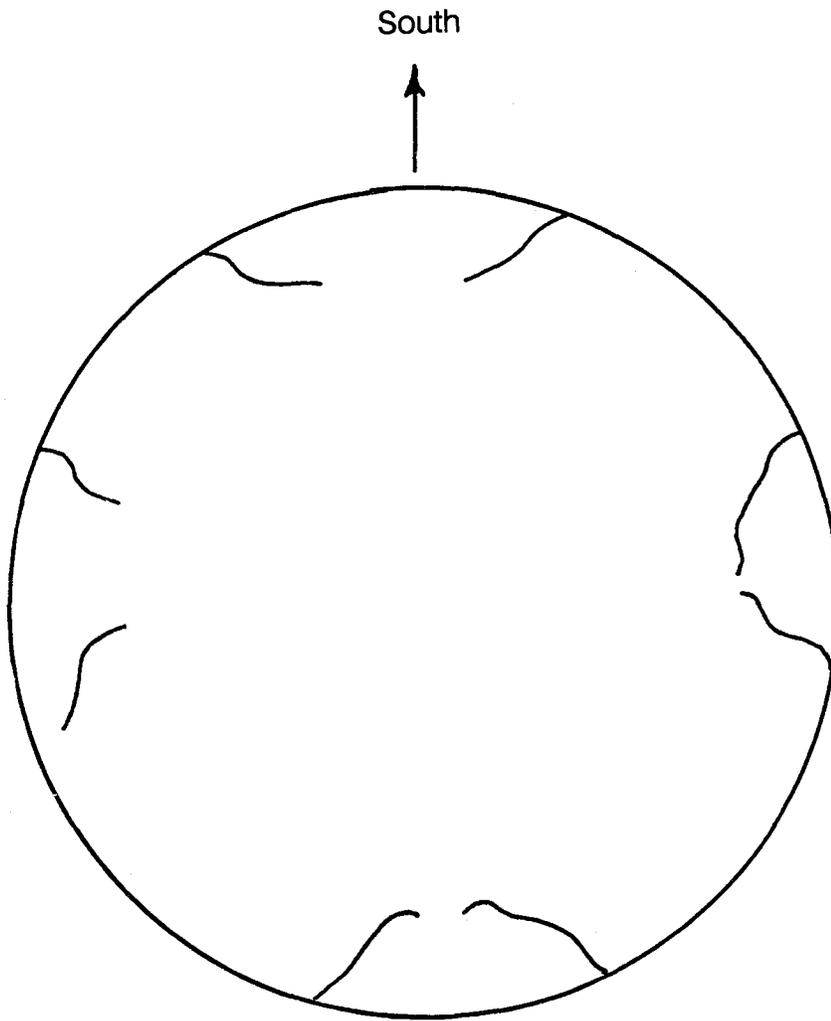
FIGURE 4-30 Sketch of interior crack pattern in dome of Mausoleum of Sultān Hasan looking up

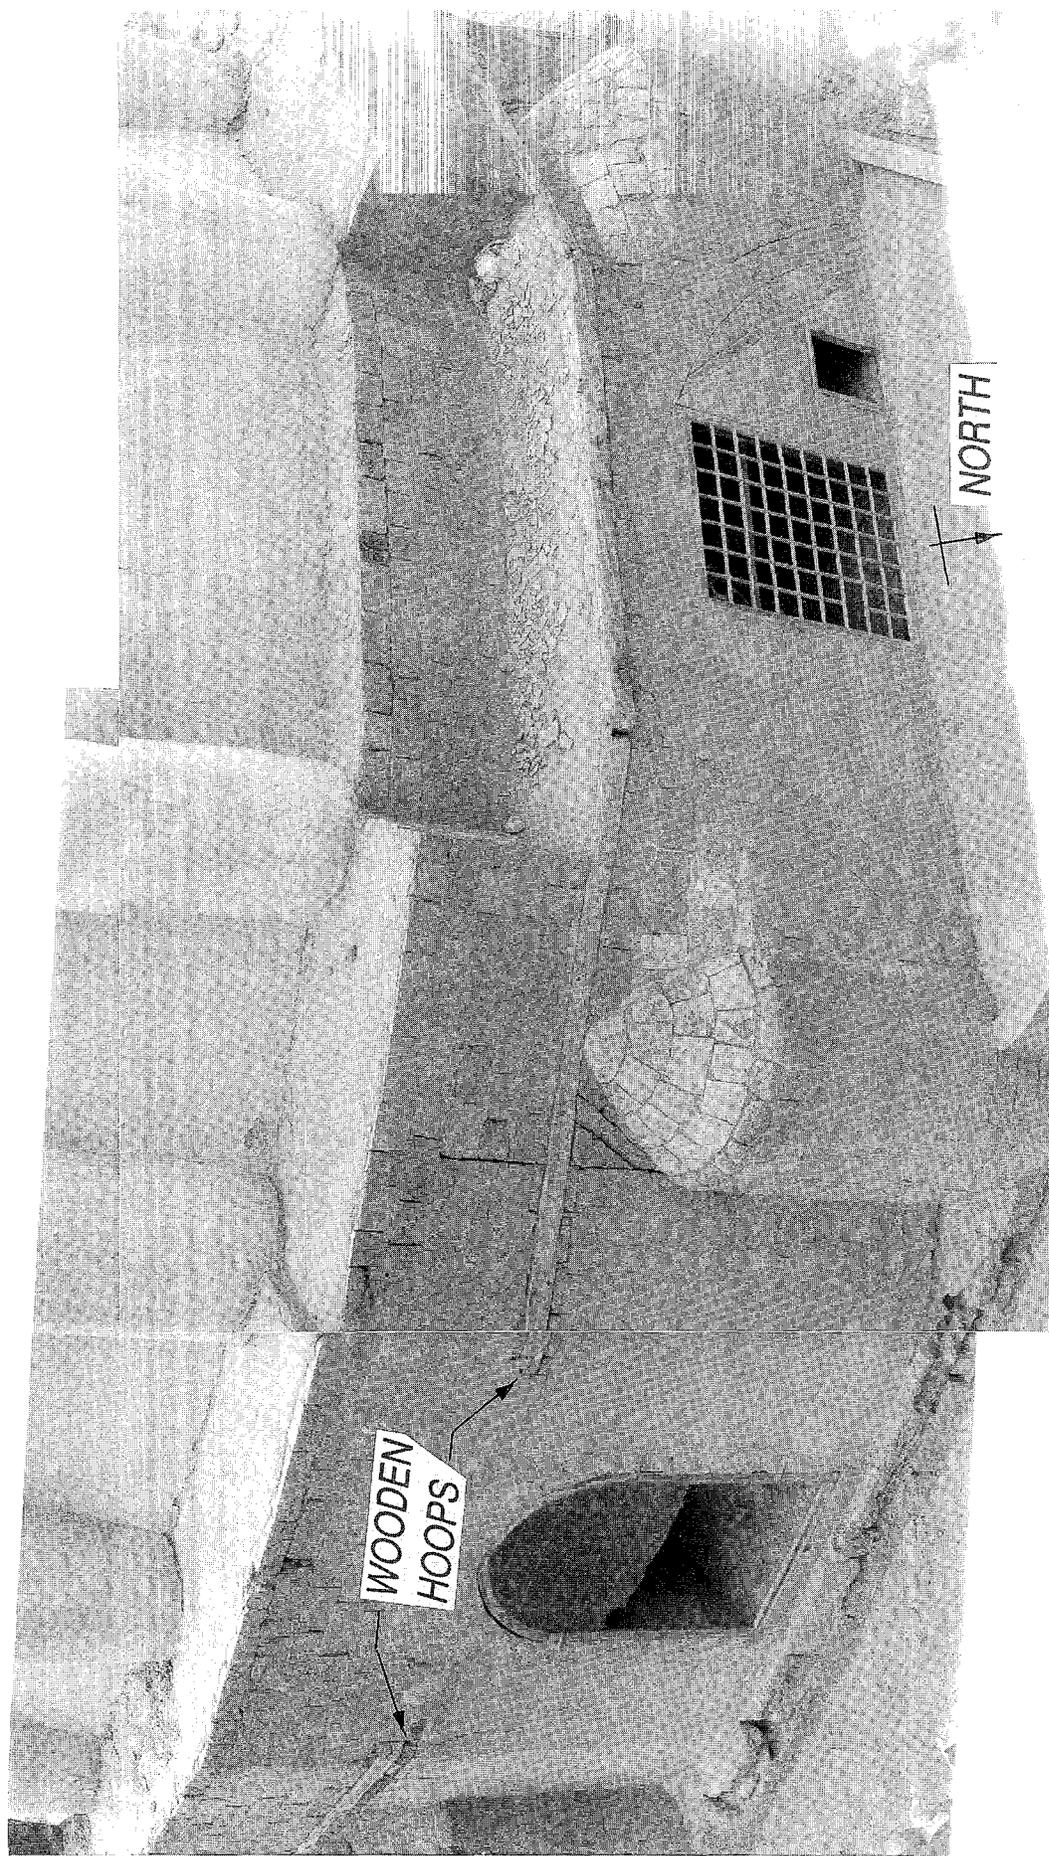
FIGURE 4-31 Exterior of major dome at Mausoleum of Sultan Hasan looking south showing wooden hoop structural support system

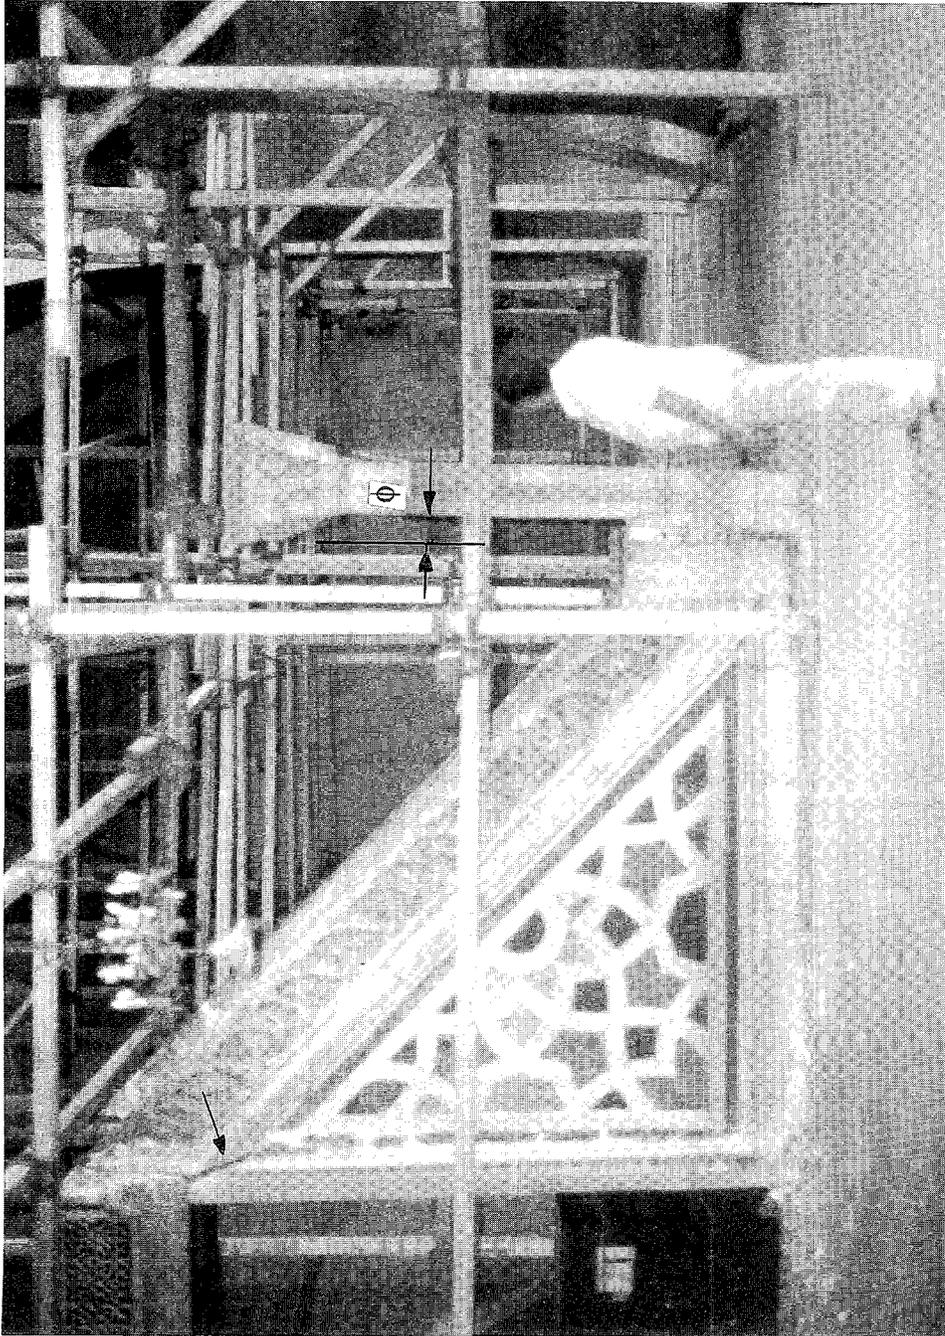
FIGURE 4-32 Minbar of Mosque of Ibrāhīm Āghā Mustahfīzān showing signs of relative displacement

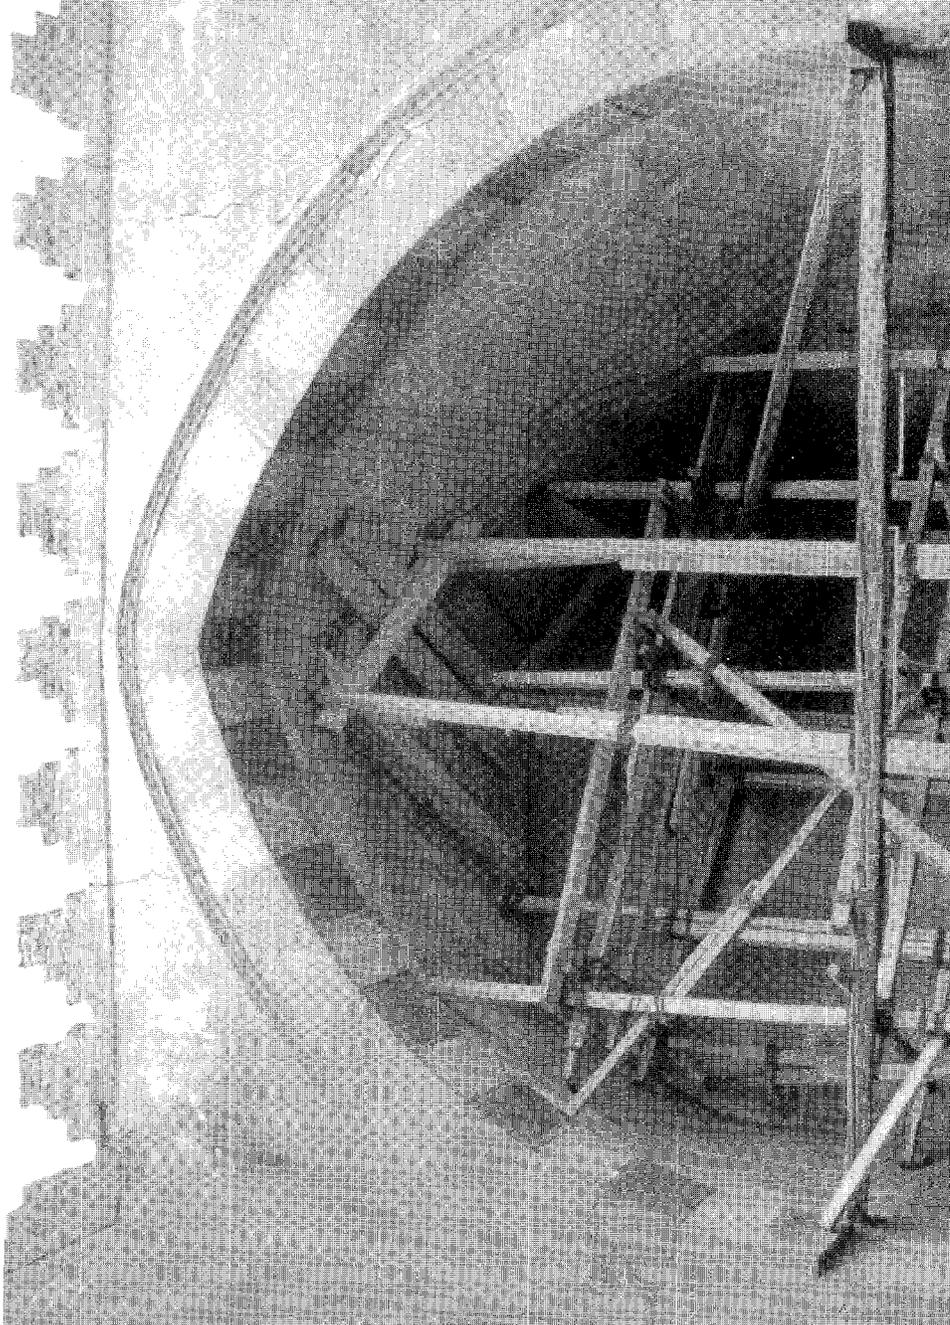
FIGURE 4-33 Arch at Mosque of Ibrāhīm Āghā Mustahfīzān showing cracks and bracing

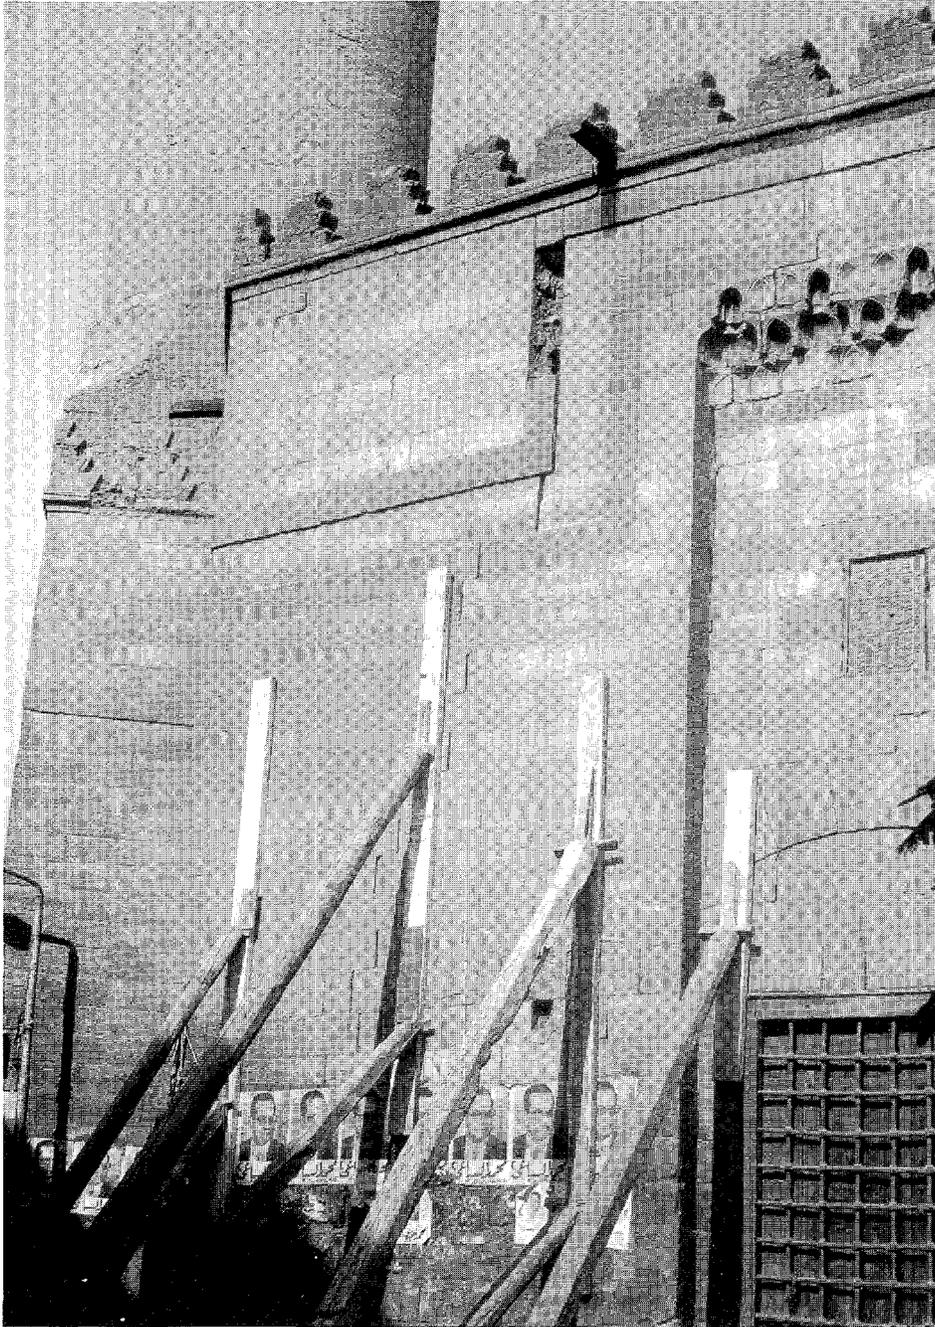
FIGURE 4-34. Exterior wall and base of minaret at Mosque of Ibrāhīm Aghā Mustahfizān looking northeast showing cracks, distortions, and bracing

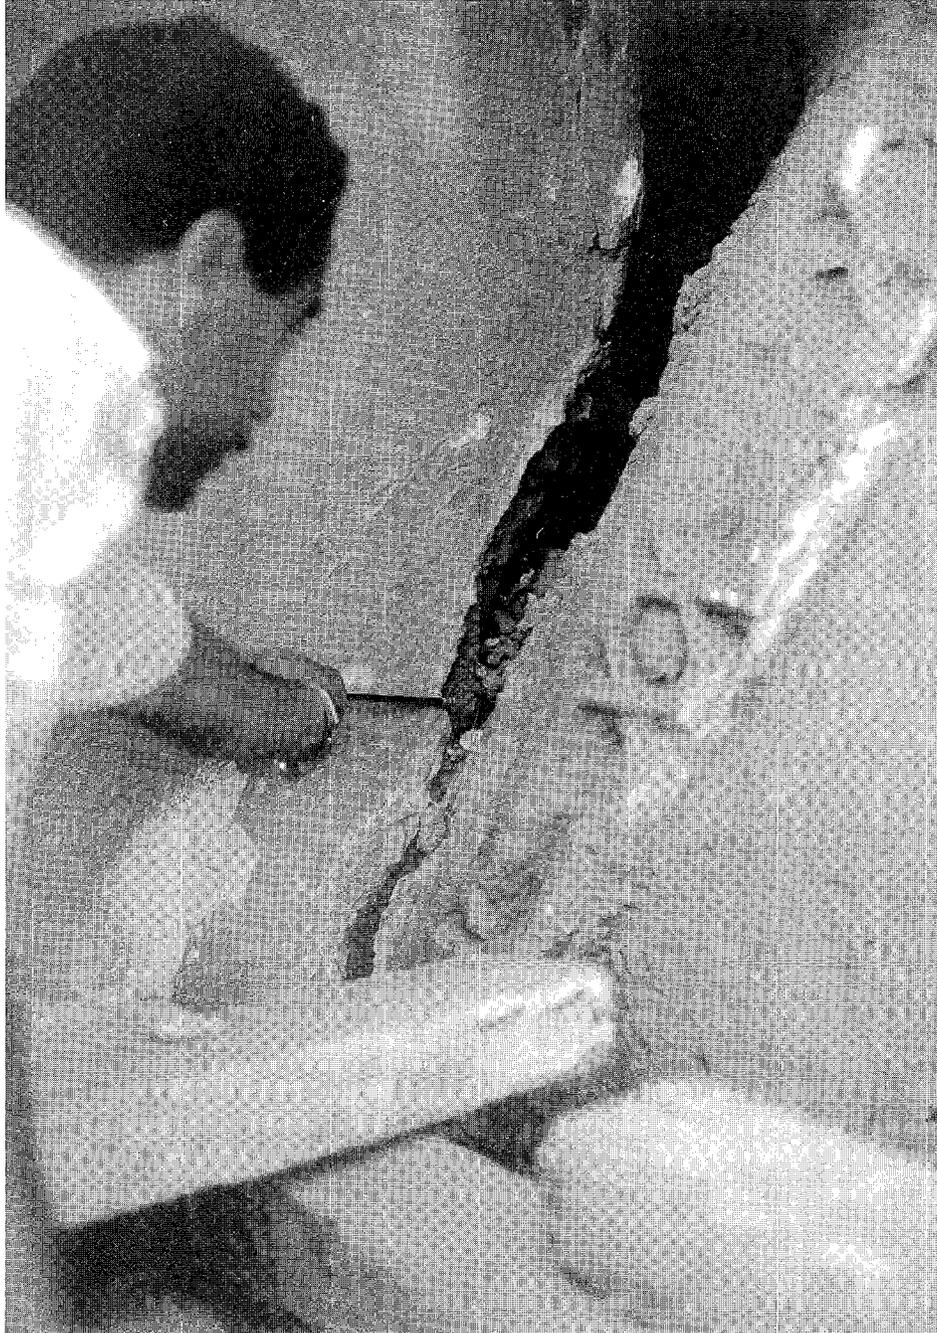
FIGURE 4-35 Base of minaret at Hasan Pasha Tâhir Mosque showing separation between mosque and minaret

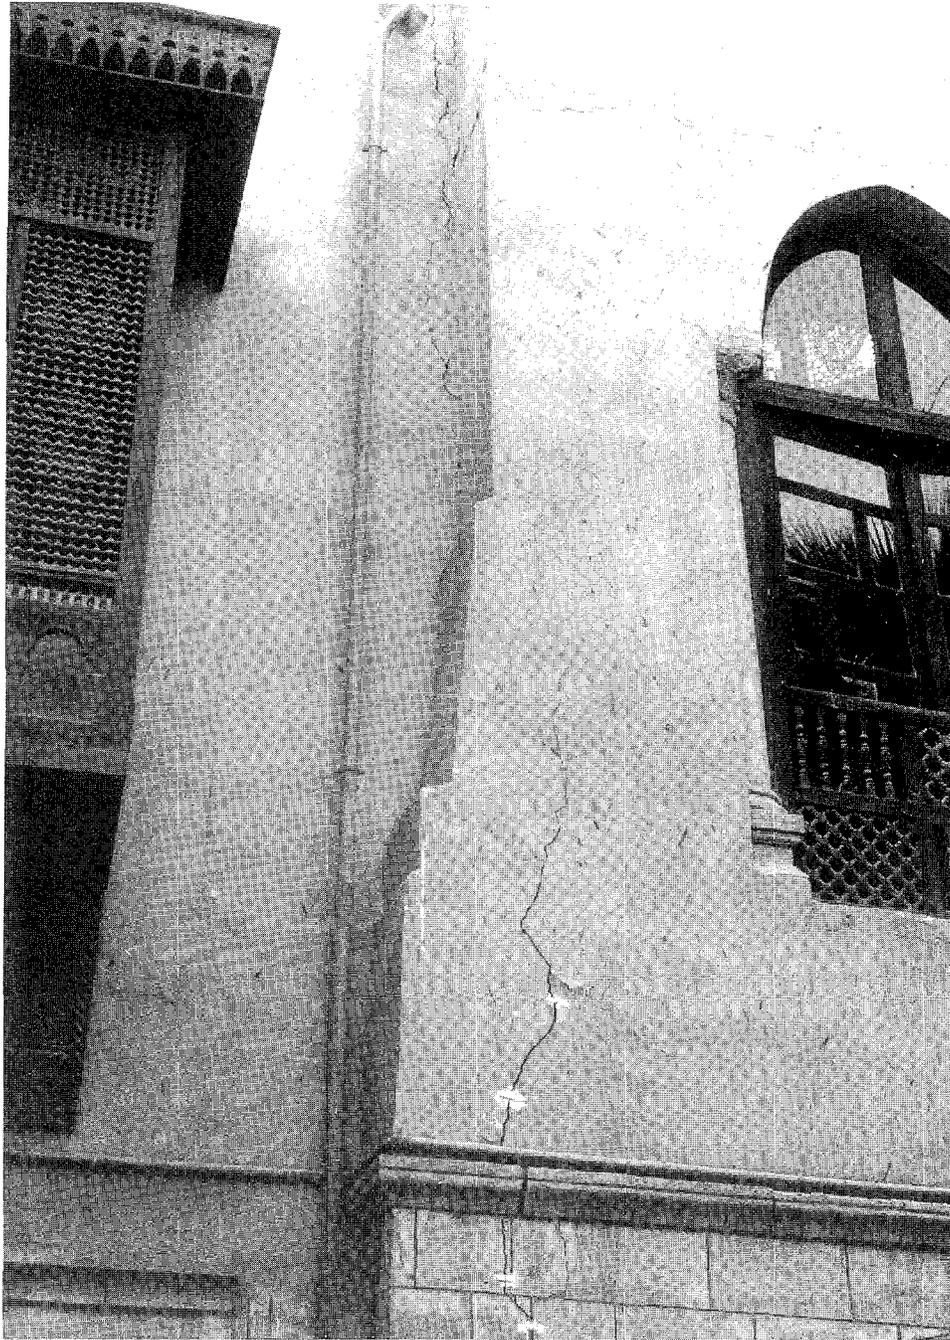
FIGURE 4-36 Exterior wall of Coptic Museum looking north showing large cracks

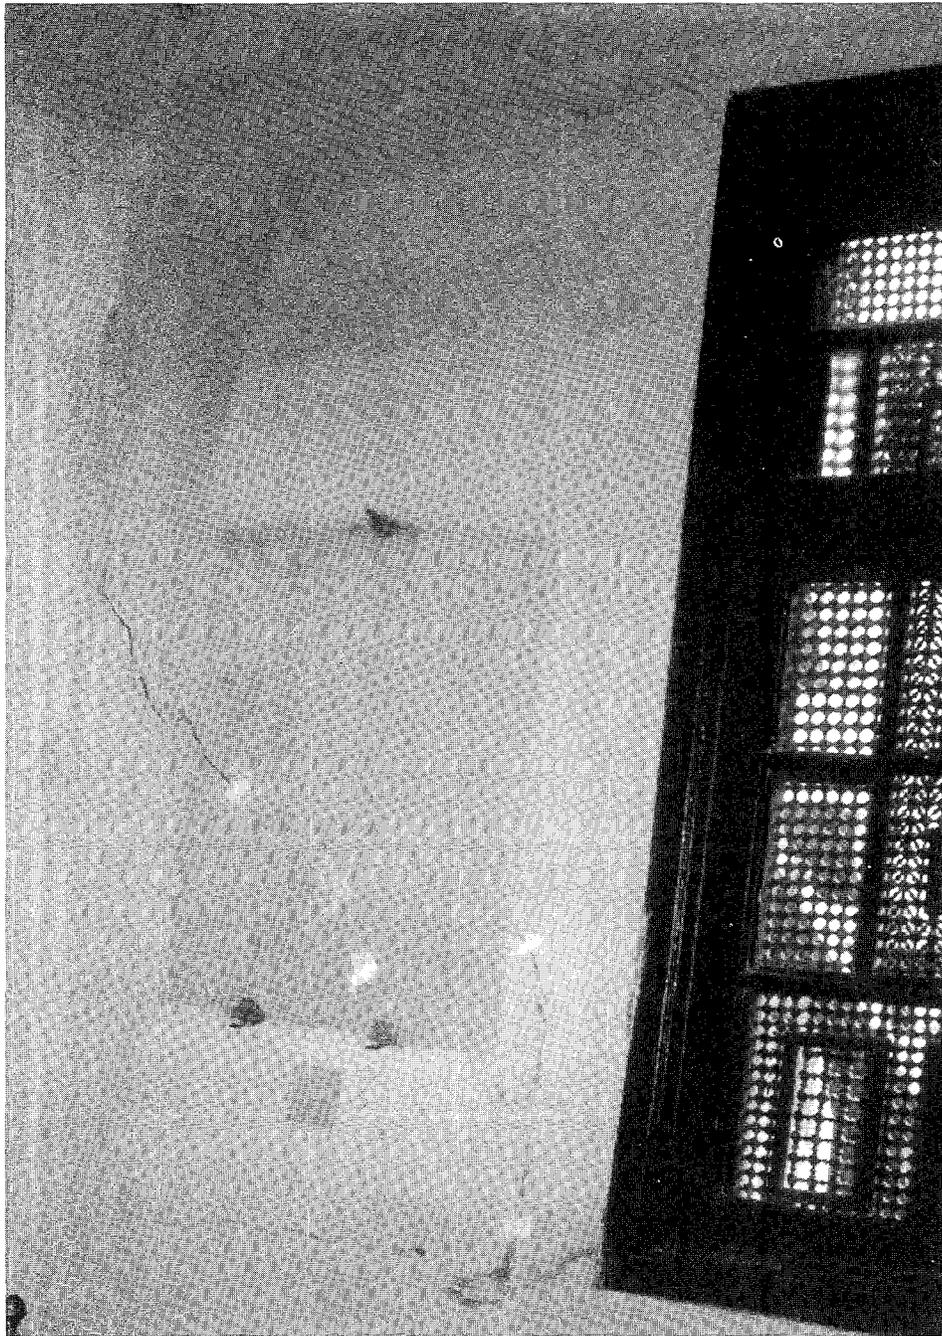
FIGURE 4-37 Interior wall of Coptic Museum showing large cracks

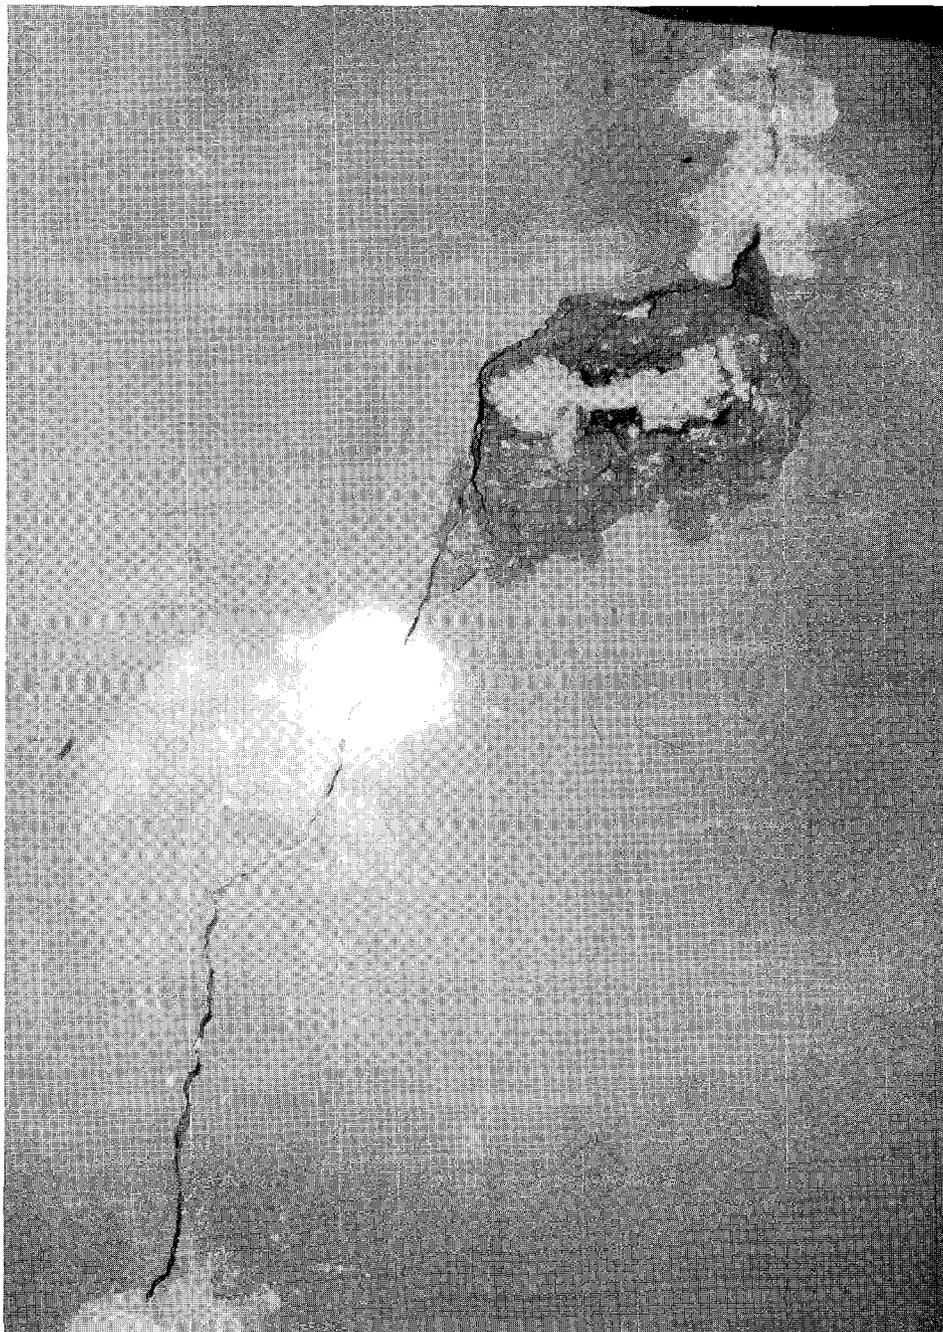
FIGURE 4-39 Interior wall of el-Moalloqa Church showing cracks and deformations

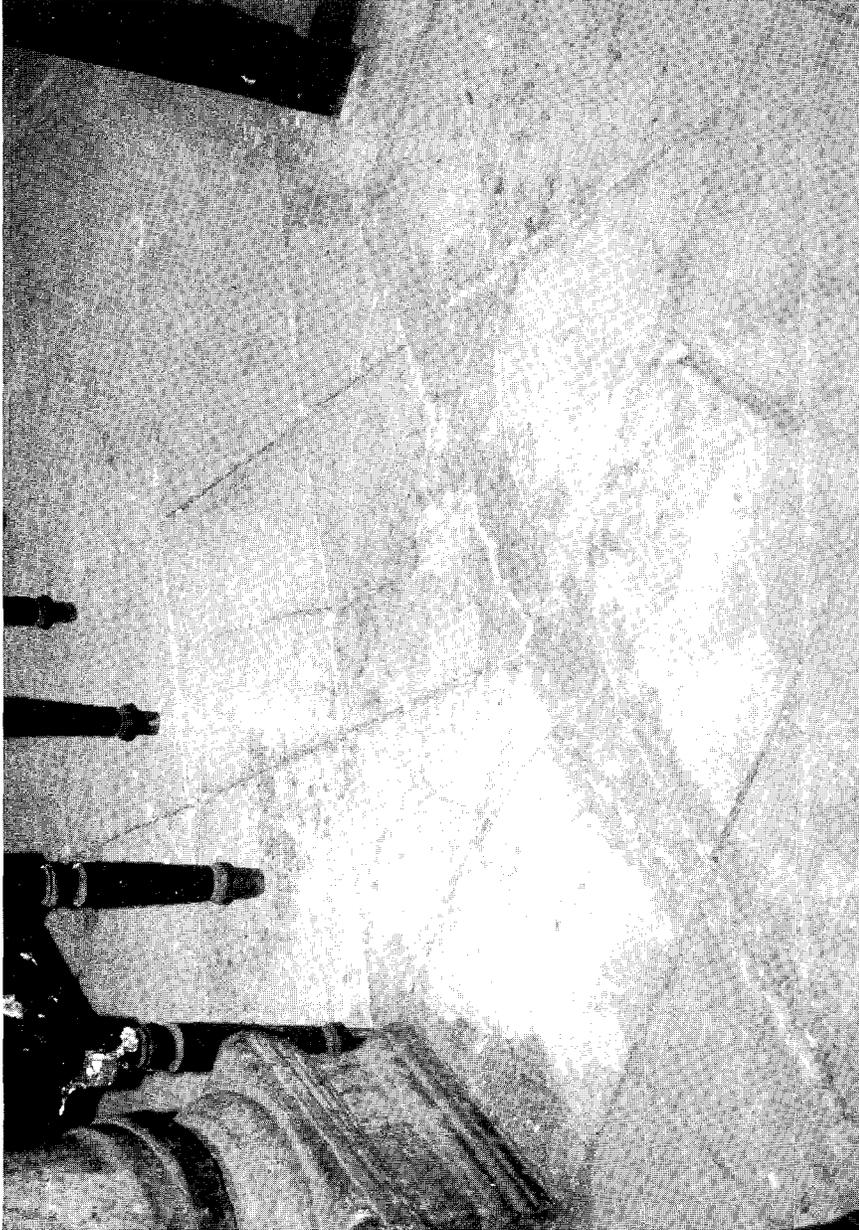
FIGURE 4-40 Floor of el-Moalloga Church in nave showing cracks
in area of large depression

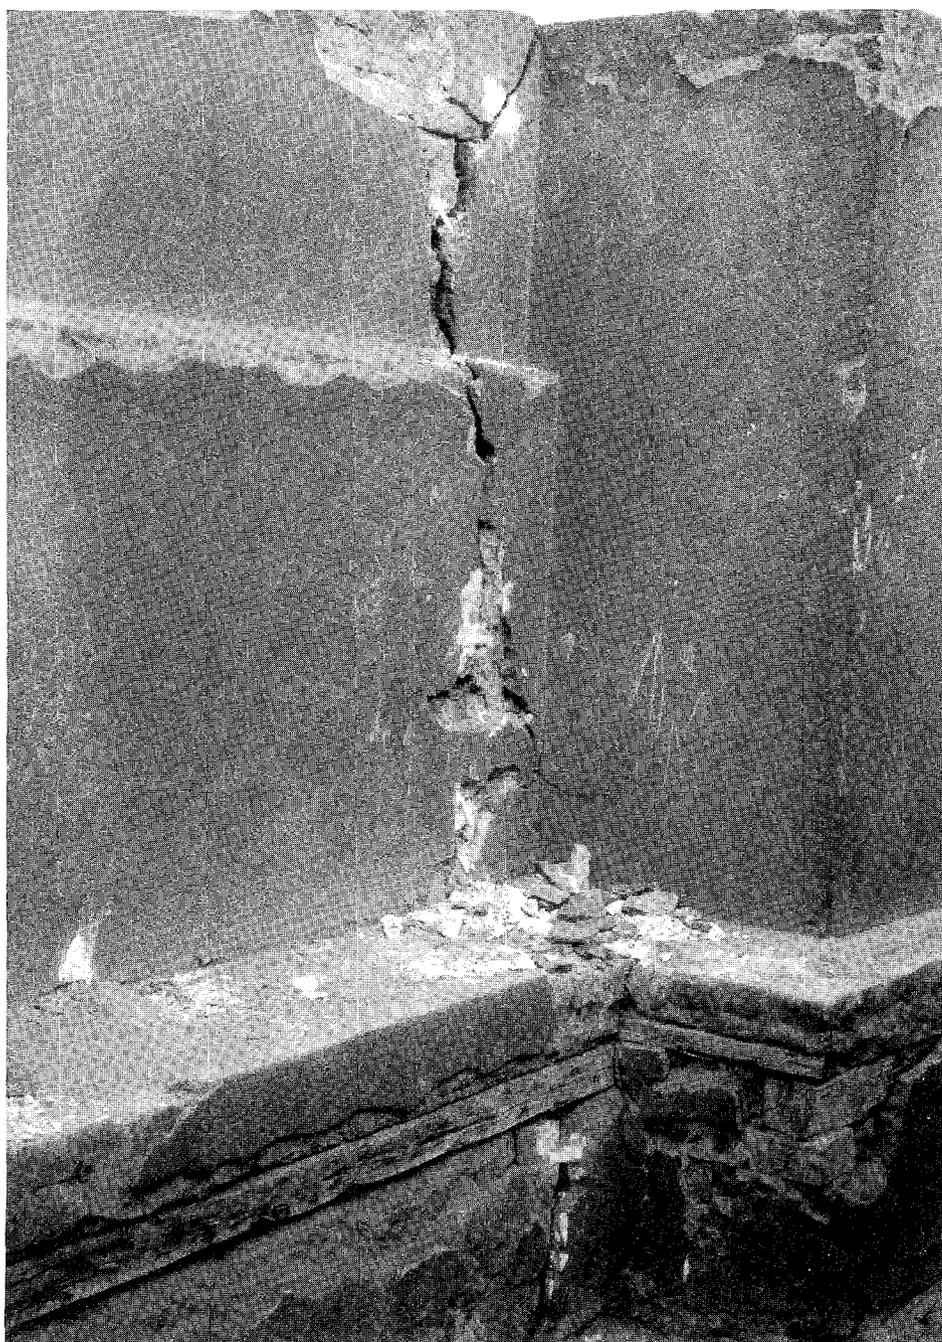
**FIGURE 4-41 Northern parapet wall of el-Moalloqa Church
looking east showing cracks and deformations**
