**Reconnaissance Report of Damage
to Historic Monuments in Cairo, Egypt
Following the October 12, 1992 Dahshur Earthquake**

Technical Report NCEER-93-0016

August 19, 1993

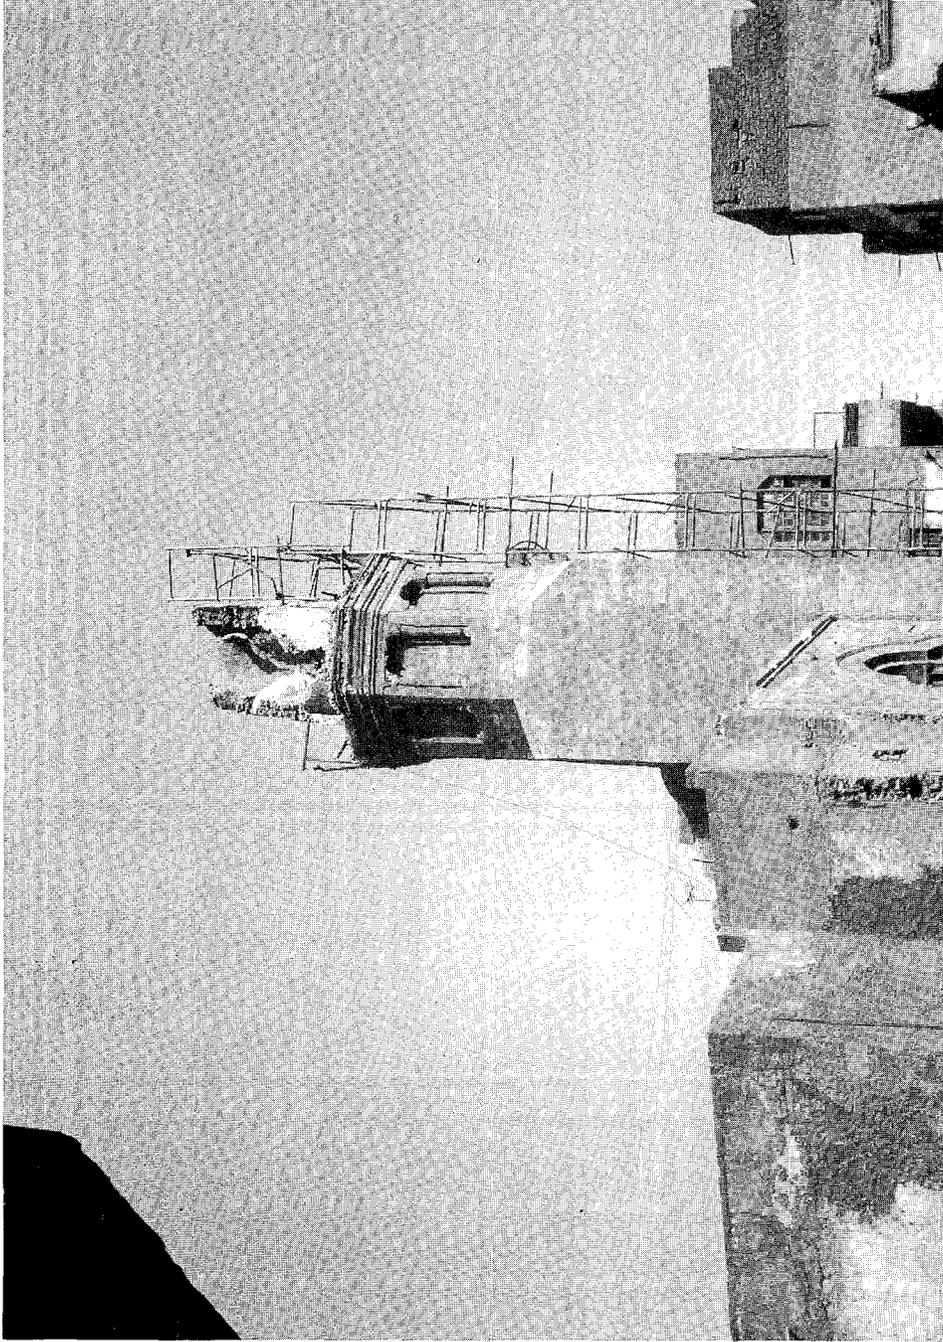
FIGURE 4-42 Broken minaret of as-Saghir Mosque looking east

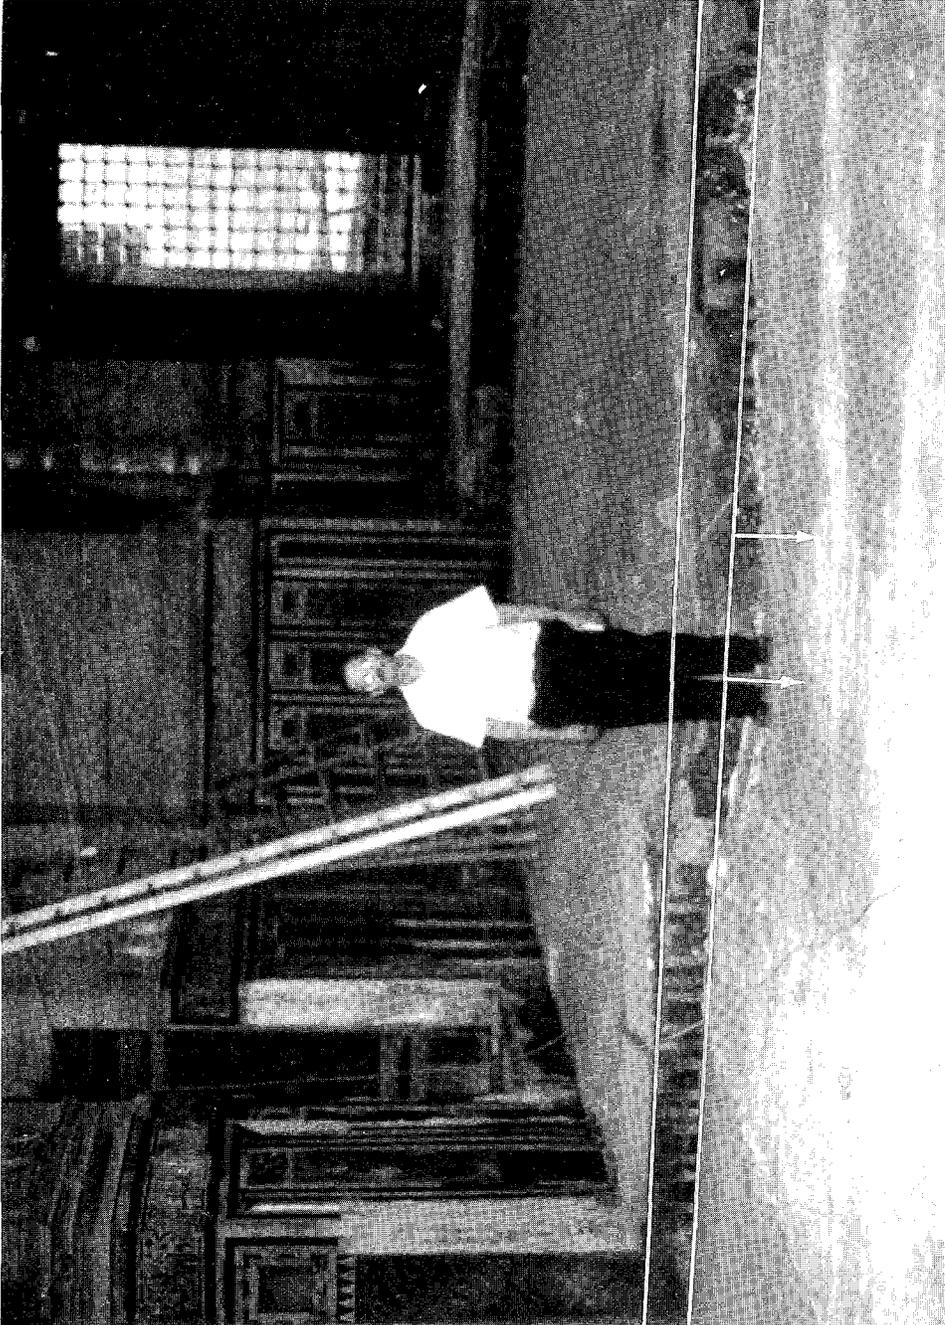
FIGURE 4-43 Floor of Mosque of al-Ghūri looking southwest showing depression

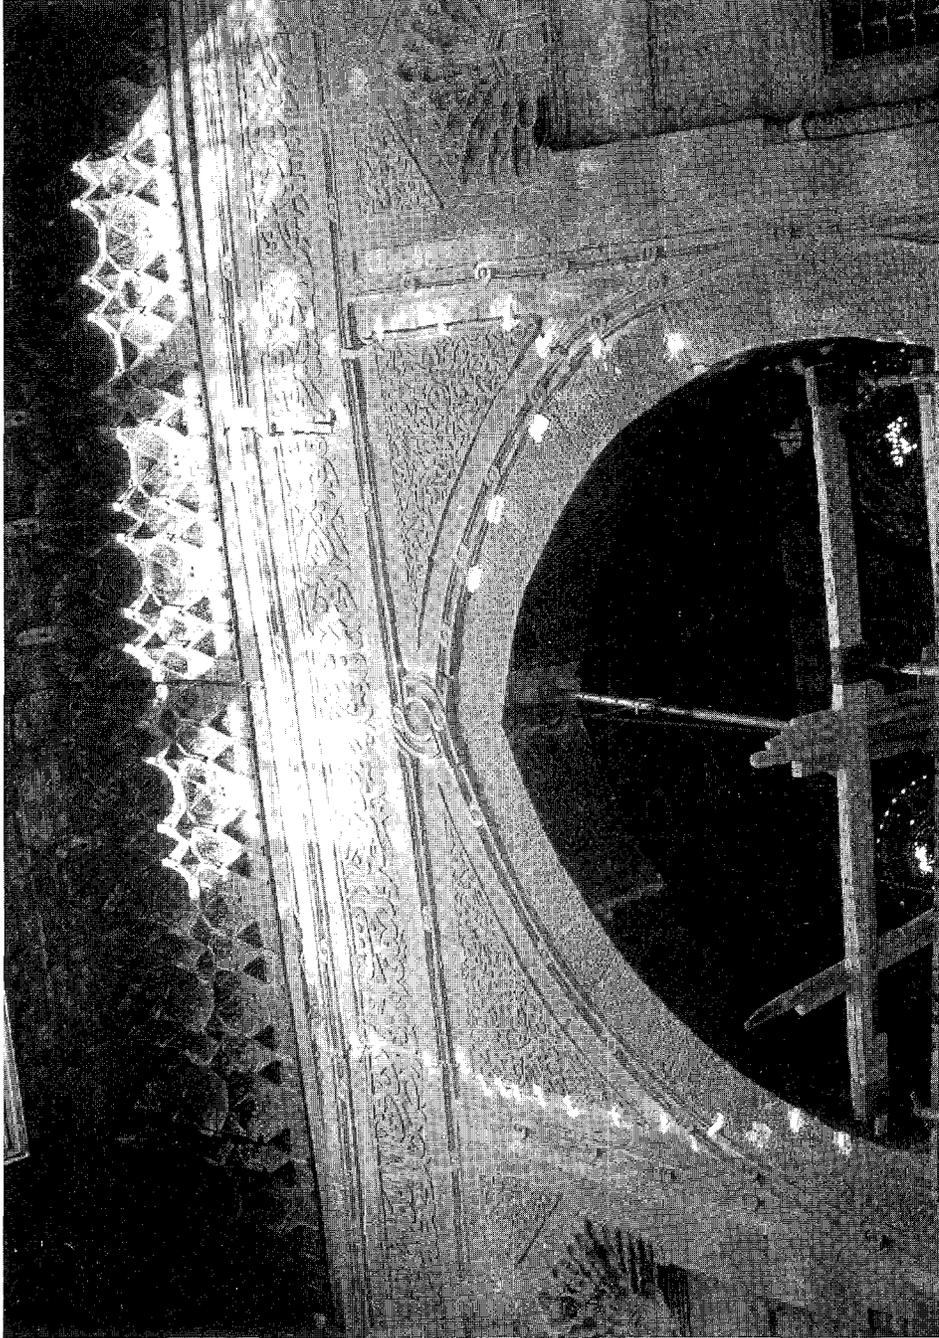
FIGURE 4-44 Main arch of Mosque of al-Ghūri looking northwest showing cracks and distortions

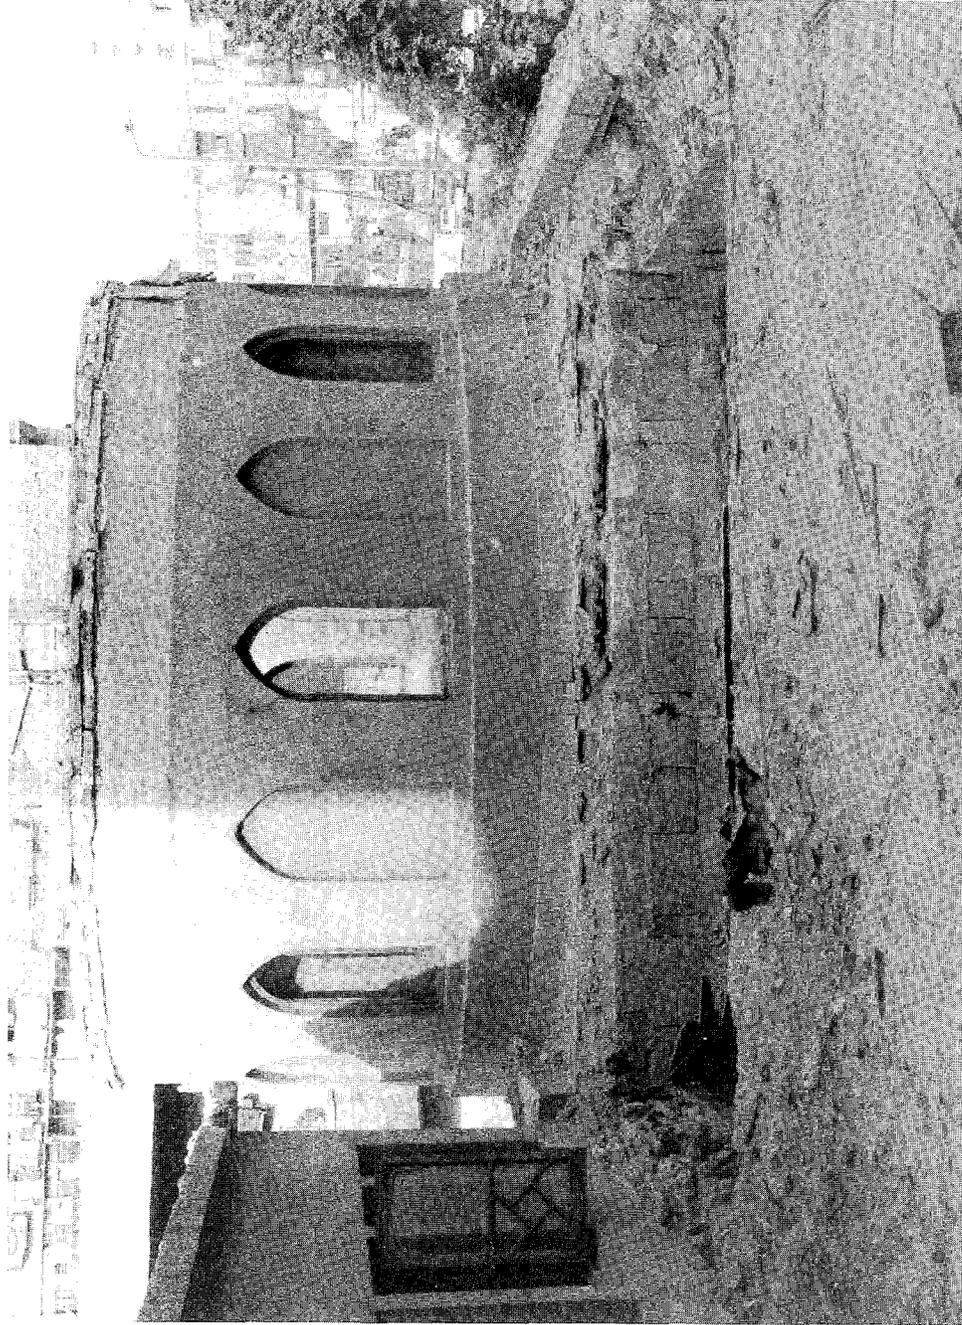
FIGURE 4-45 Collapsed dome of ad-Dashtūti Mosque looking southwest showing damage to roof

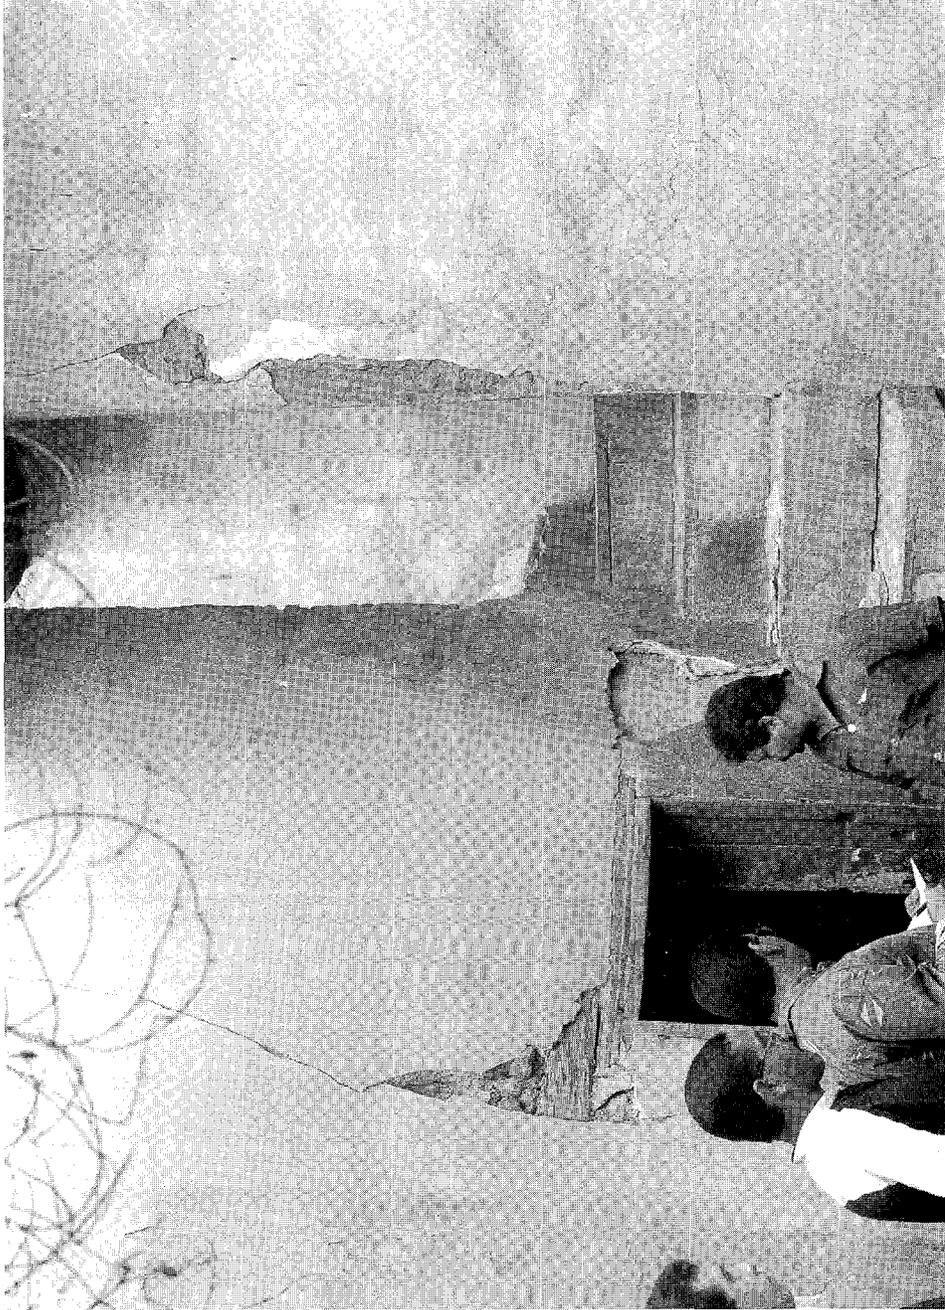
FIGURE 4-46 Exterior walls of court at Bayt as-Sihaymi showing cracks and missing stucco

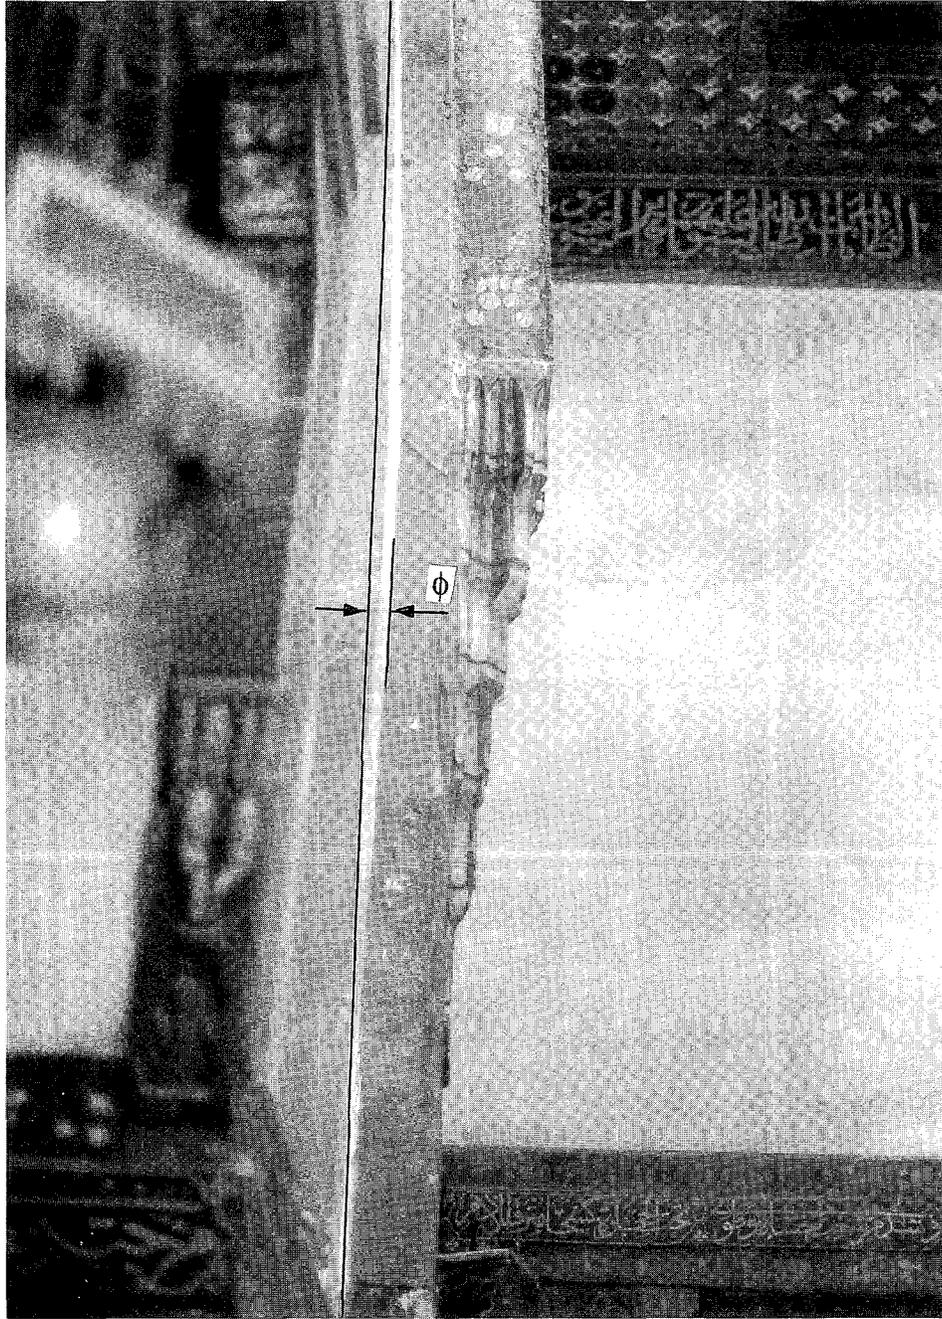
FIGURE 4-47 Interior wall and column at Bayt as-Sihaymi showing out-of-plumb column

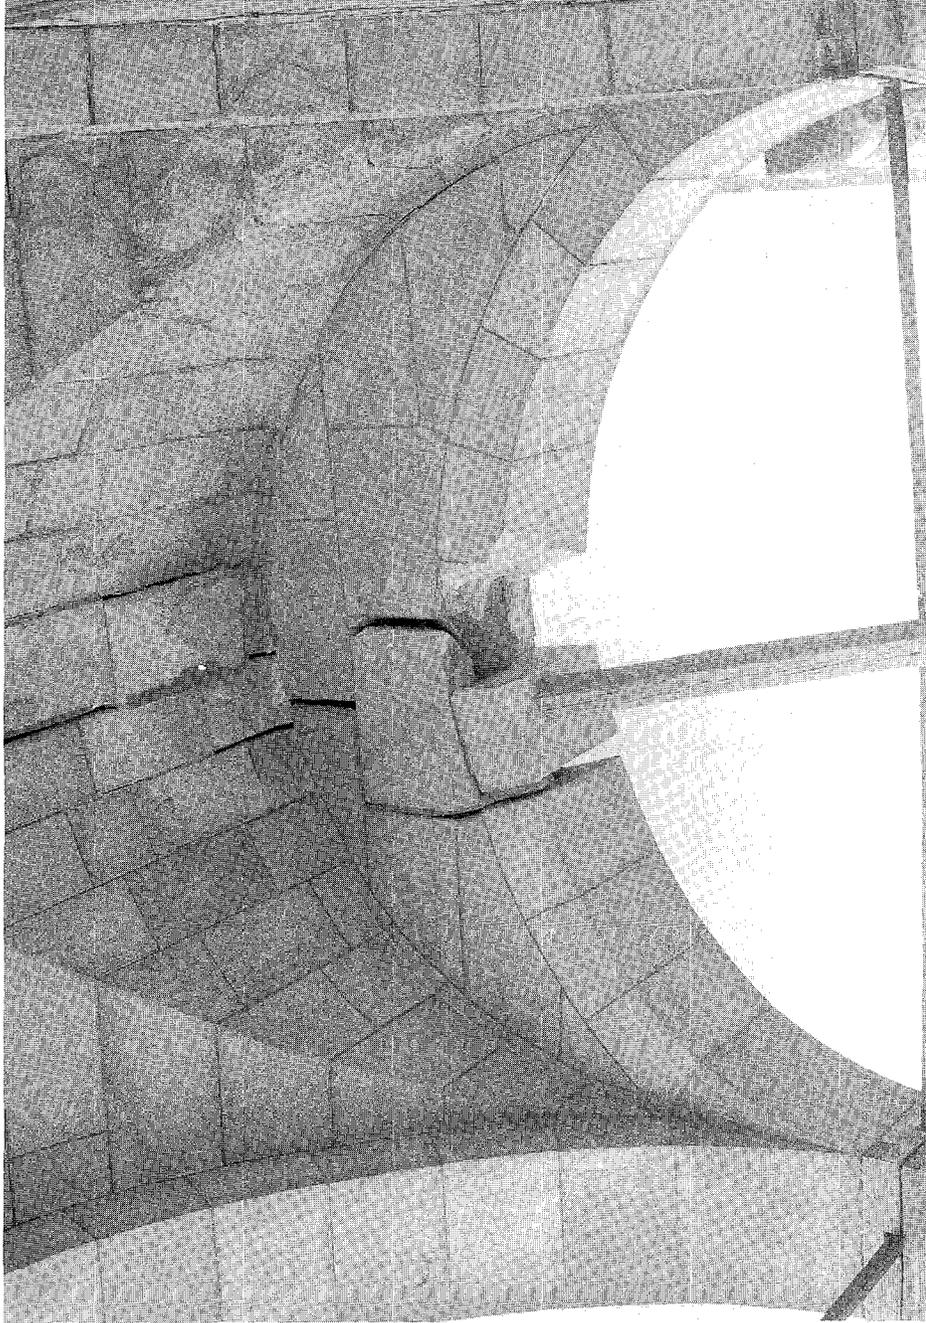
FIGURE 4-49 Arch of portico to Saraya el-Adl at Citadel showing missing stone, large cracks, separation, and distortion

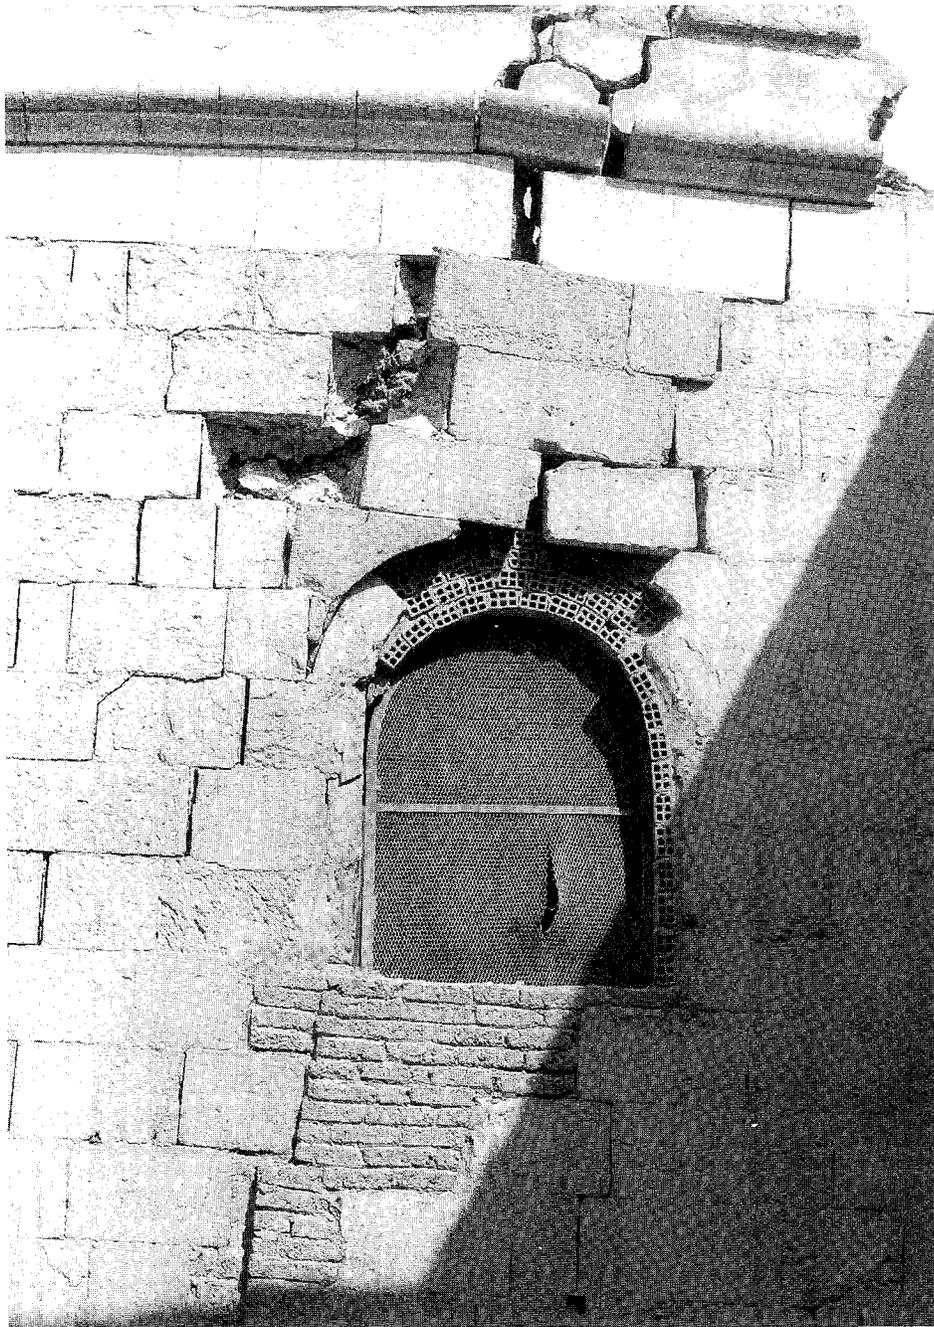
FIGURE 4-50 Back wall of Saraya el-Adl at Citadel showing missing stones, large cracks and separation

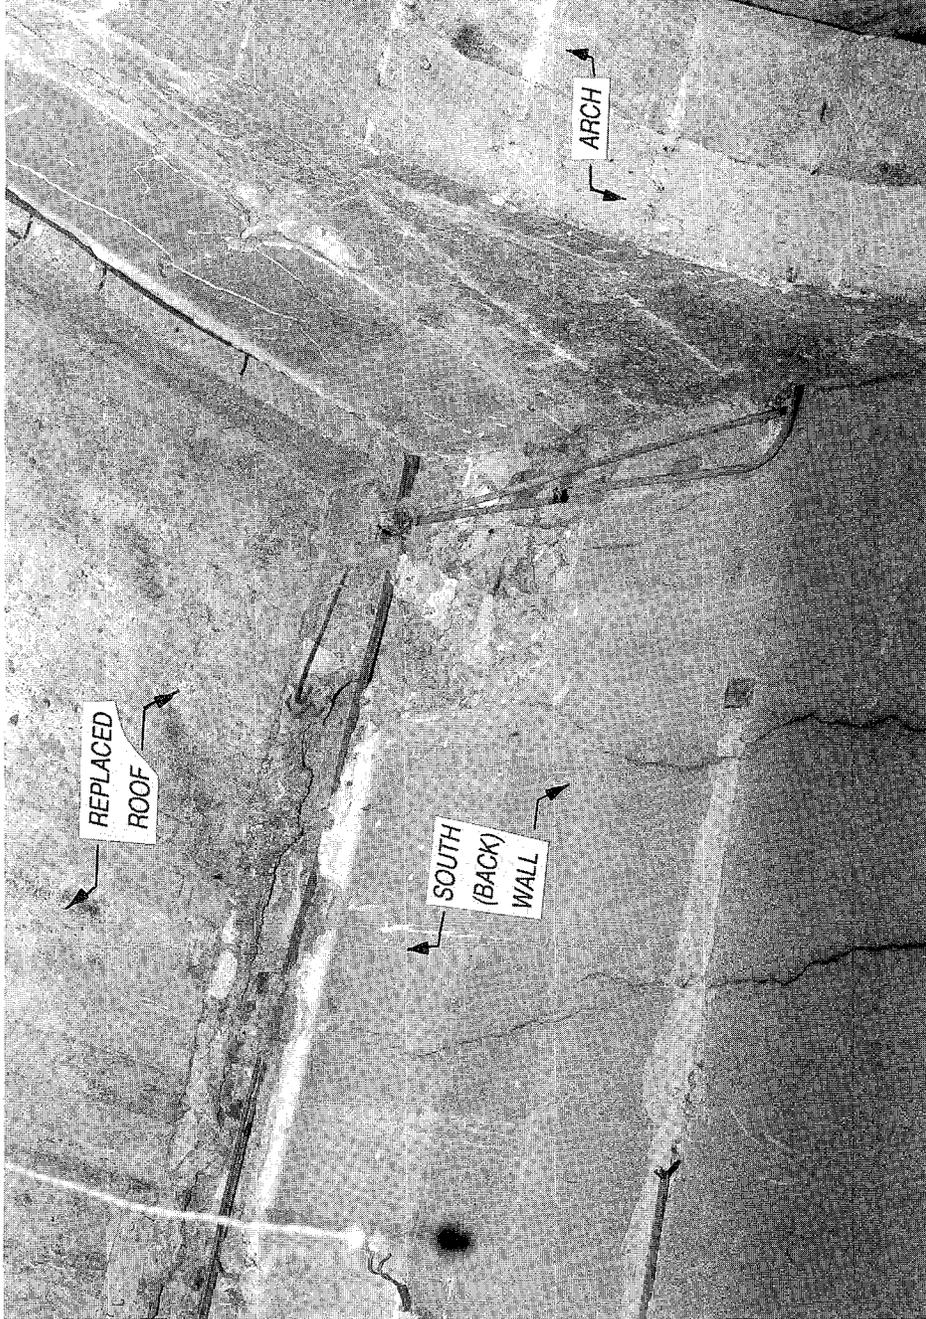
FIGURE 4-51 Interior south wall of Saraya el-Adl looking up at contact between wall, arch, and concrete ceiling showing cracks, separation, and distortions

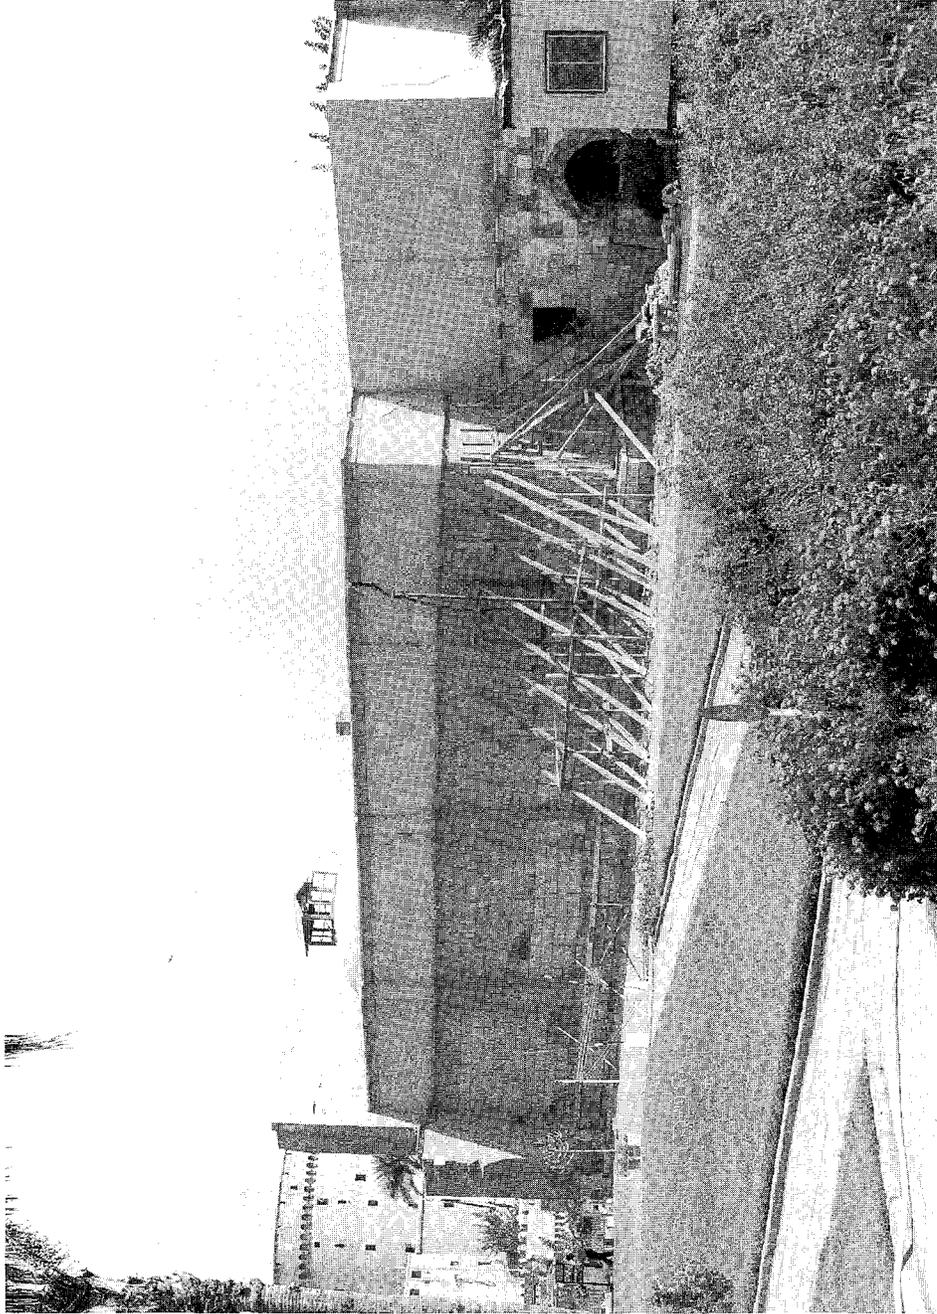
FIGURE 4-52 Collapsed southwest corner of Mint at Citadel showing large crack and separation and external bracing

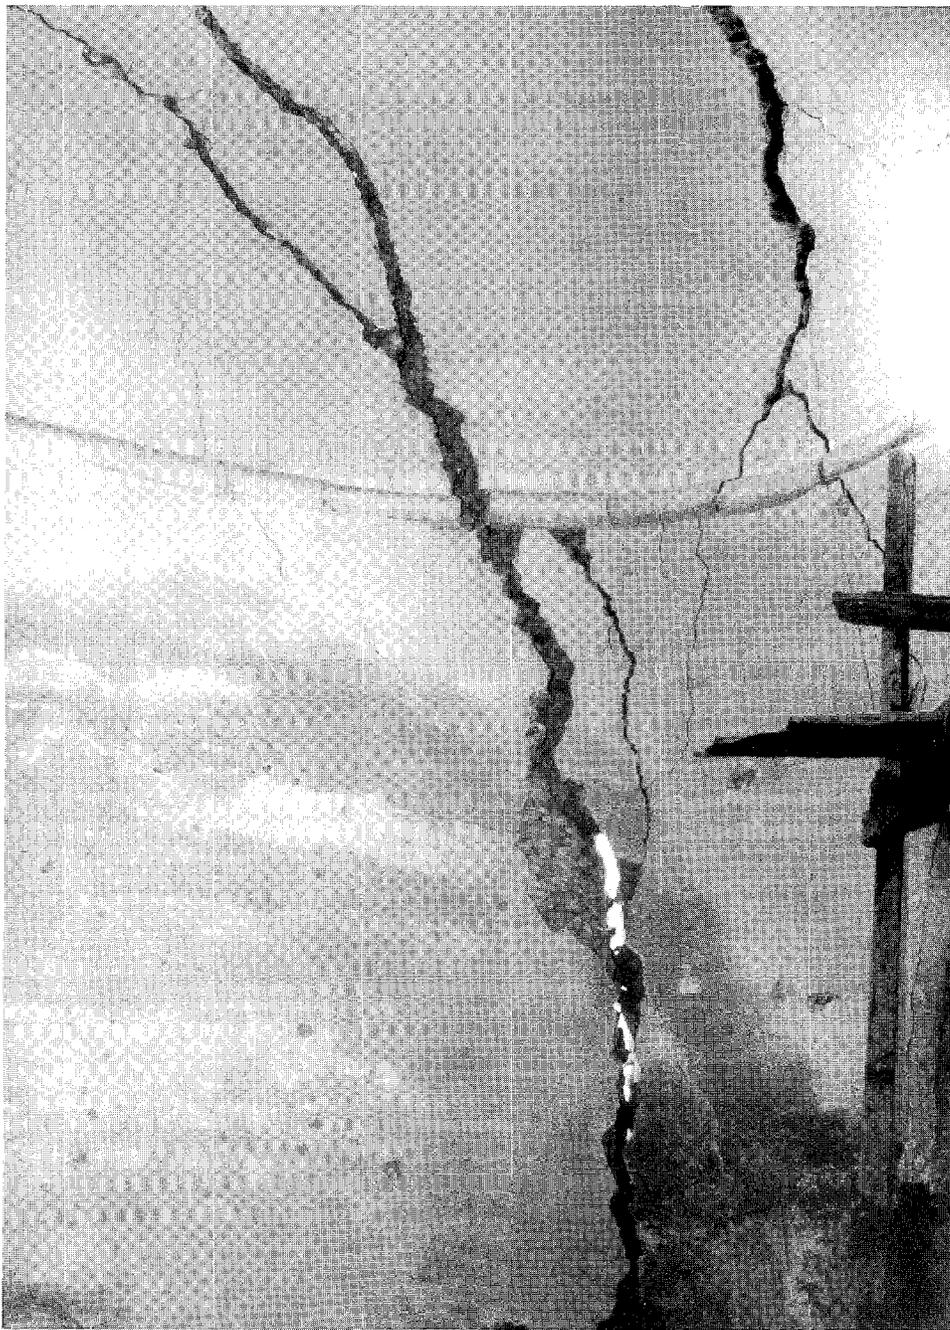
FIGURE 4-53 Interior minor dome near southwest corner of Mint at Citadel showing large cracks and separation
