REPORT NO.
UCB/EERC-94/01
JANUARY 1994

PRELIMINARY REPORT ON THE
SEISMOLOGICAL AND ENGINEERING ASPECTS
OF THE JANUARY 17, 1994
NORTHRIDGE EARTHQUAKE

Preliminary findings from field investigations by teams from the University of California at Berkeley immediately following the earthquake.

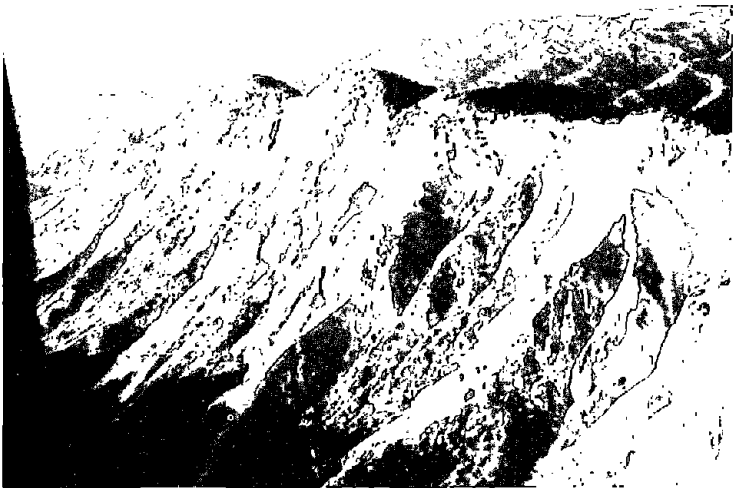
Figure 2.8: Displacements along steeply south-dipping bedding planes to the east of the Newhall-Potrero oilfield.

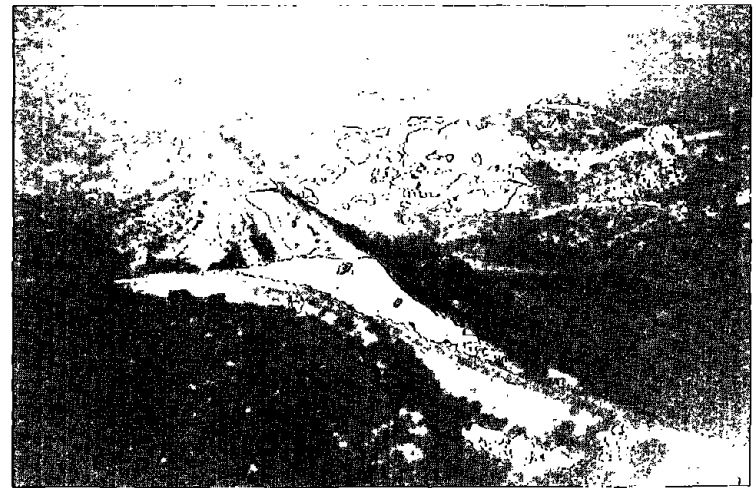
Figure 2.9: Typical rockfall, northwest of the Route 14/5 interchange, Santa Susana Mountains.

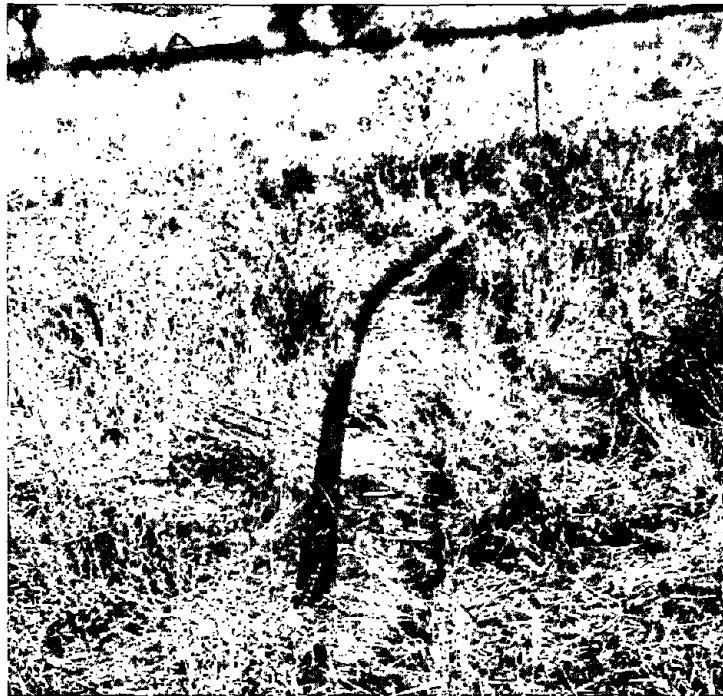
Fig. 4.3: Evidence of localized compression in Potrero Canyon. Note that originally straight pipe was pushed up and laterally; shortening across its length was 5 inches.

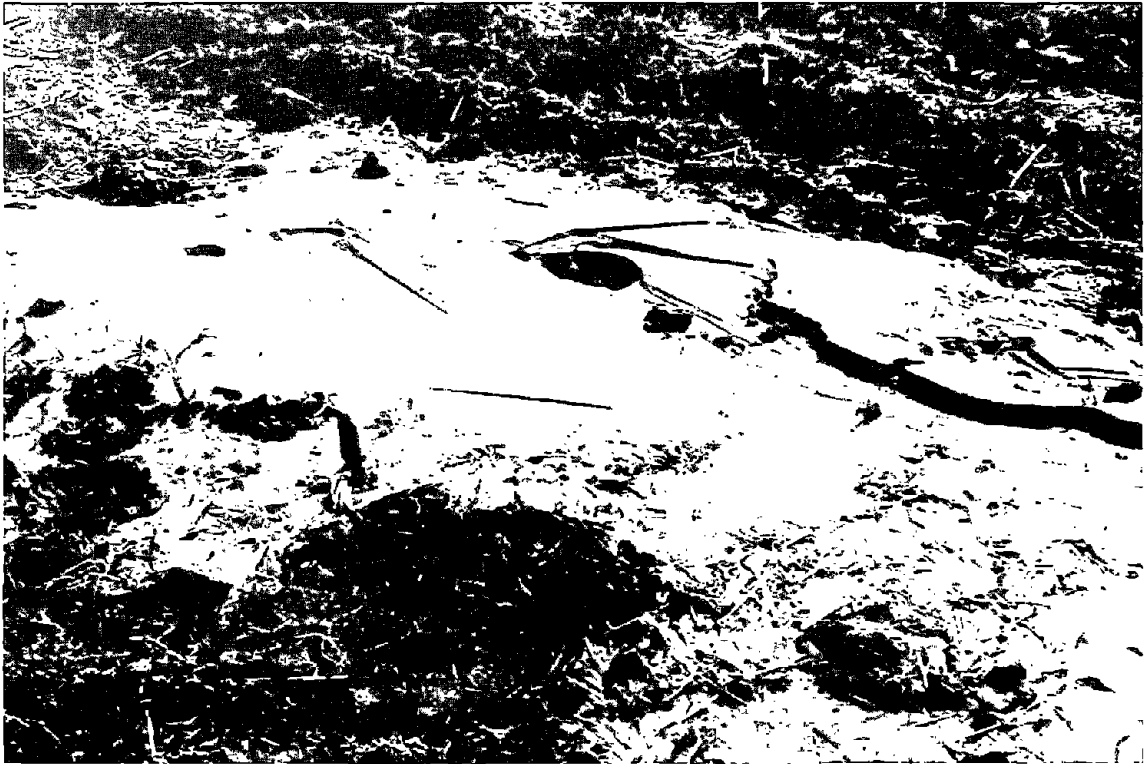
Fig. 4.4: Liquefaction of sand deposit with appreciable fines content in Potrero Canyon

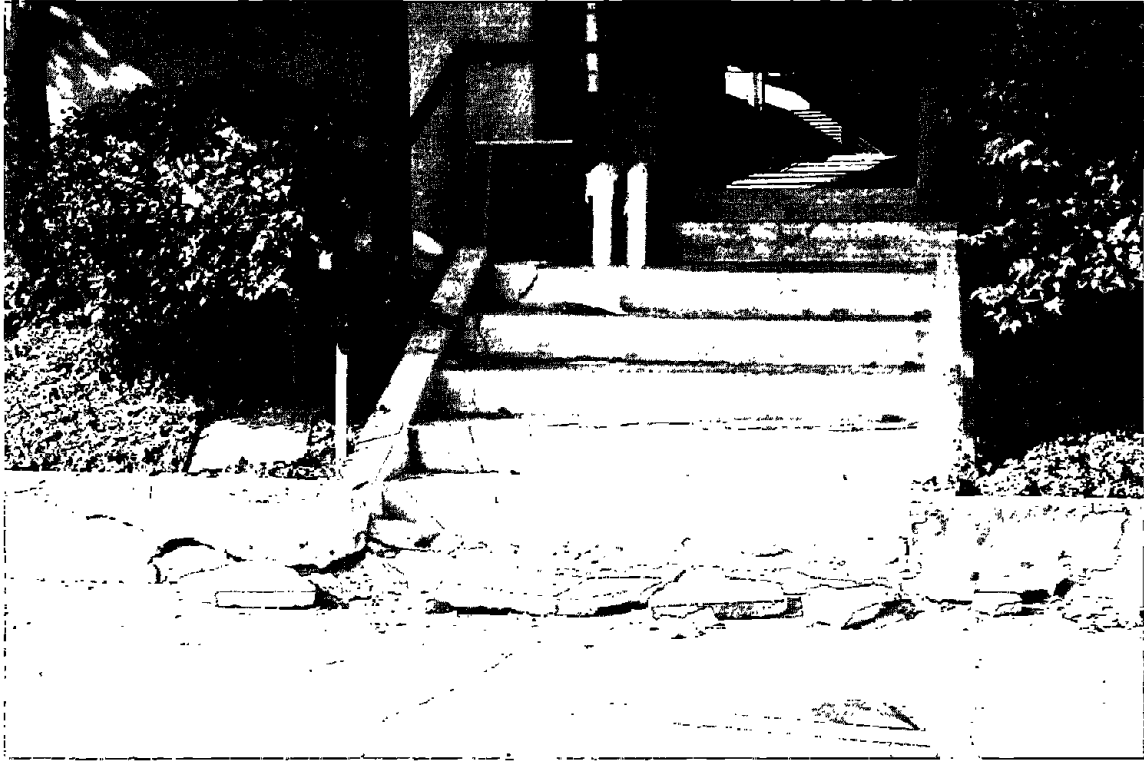
The city of Granada Hills, located north of Northridge, and northern and central Northridge experienced significant ground movement as evidenced by numerous cracks in streets and broken and buckled curbs (Figures 4.7 and 4.8). Significant ground fracturing was found west of Woodley Ave., south of Midwood Dr., east of Shoshone Avenue, and north of Highway 118. Figure 4.9 is an example of a compressional feature due to lateral spreading in this general area, whereas Figure 4.10 is an example of lateral spreading clearly

Fig. 4.7: Damage from lateral spreading, Northridge Hospital

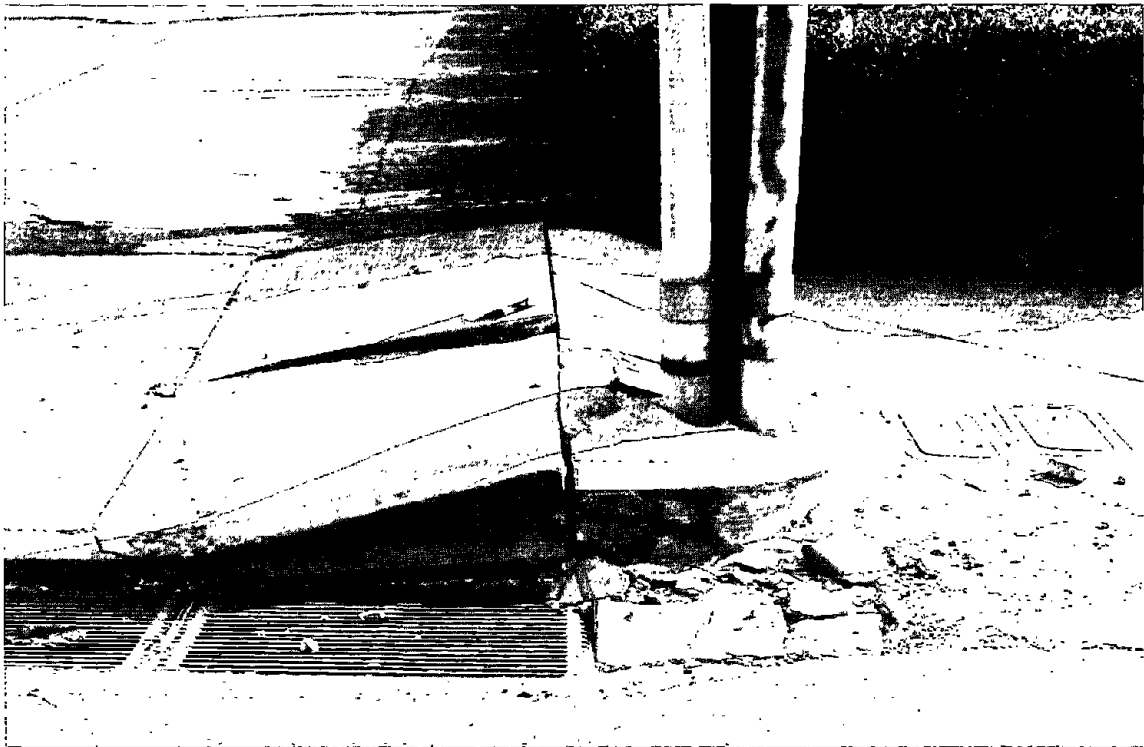
Fig. 4.8: Buckling of curb from lateral spreading, Northridge Hospital

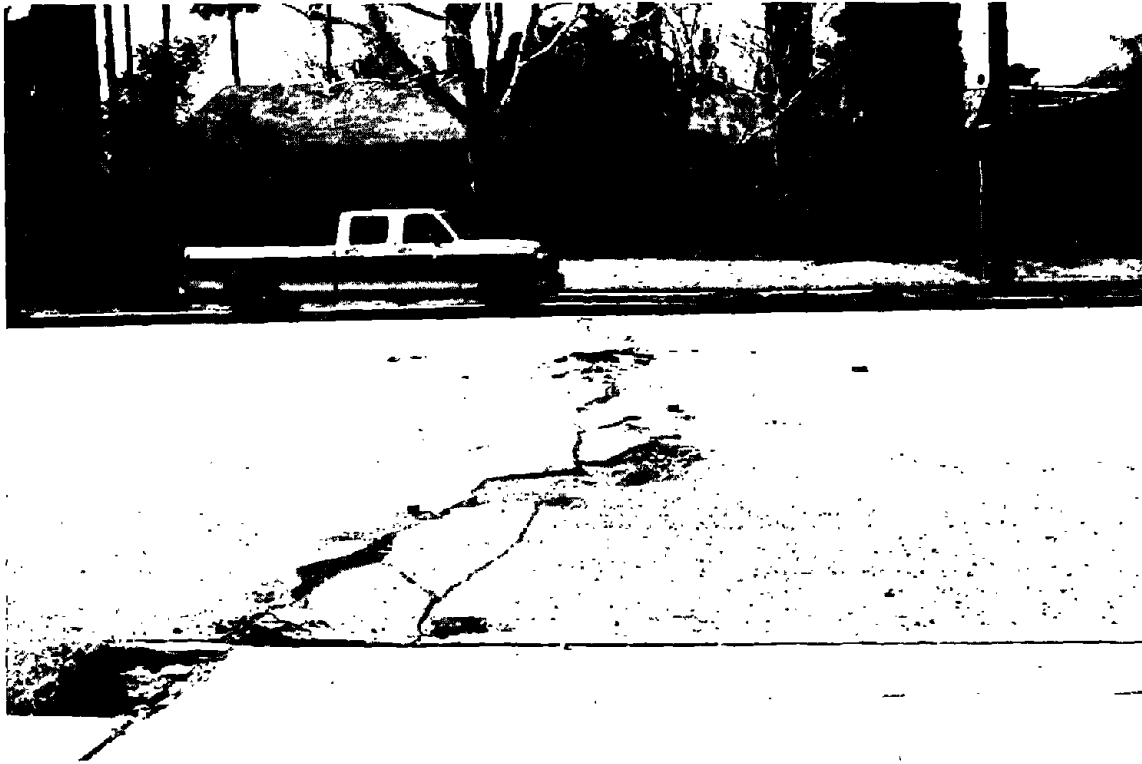
Fig. 4.9: Localized compression feature and pavement damage in Northridge near Highway 118

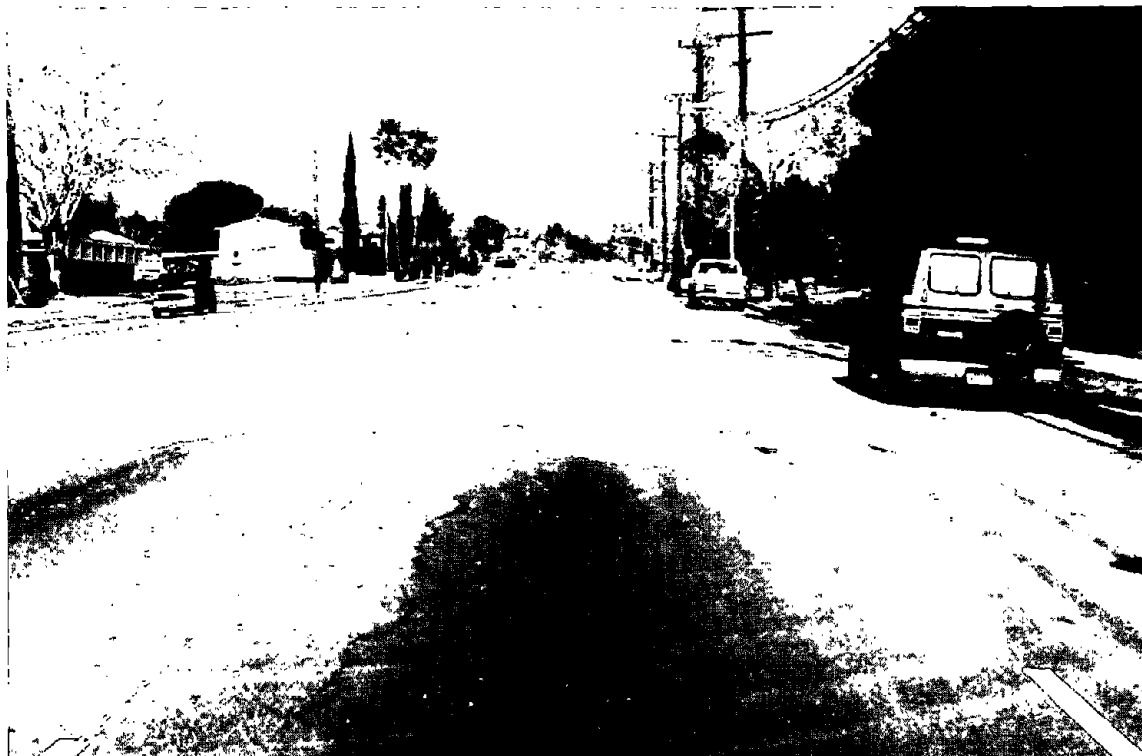
related to soil liquefaction. The cracks are typically up to 2 inches wide in the asphalt concrete pavement, although in one case a 6 inch separation between a house foundation and the adjacent ground was noted. The ground cracking generally trends east to west and continues for more than one mile. This area was also the site of numerous water and gas pipe breaks. The water pipes (68 and 48 inch diameter) and the gas pipe (12 inch diameter) on Balboa Boulevard just north of Rinaldi Street, were separated by 8 to 12 inches according to the repair crew at the site. At one location nearby, a maintenance crew reported that a 1-inch diameter pipe separated six inches and was displaced six inches laterally.

Fig. 4.10: Evidence of liquefaction and lateral spreading, northeast Northridge

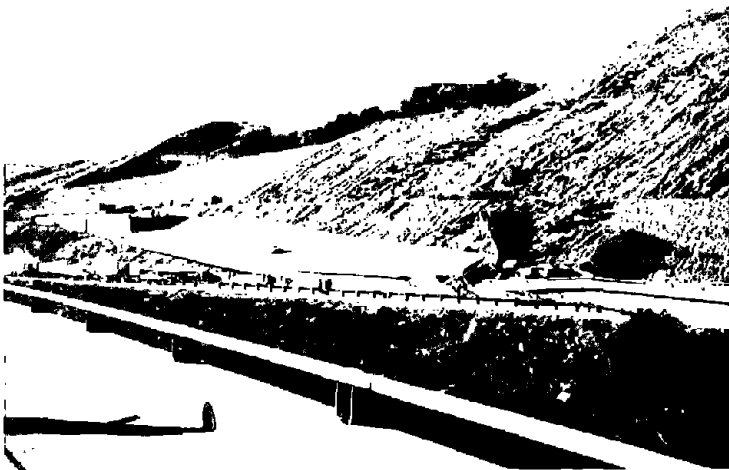
Fig. 5.4: Overview of Interstate 5/Route 14, South Overhead Failure

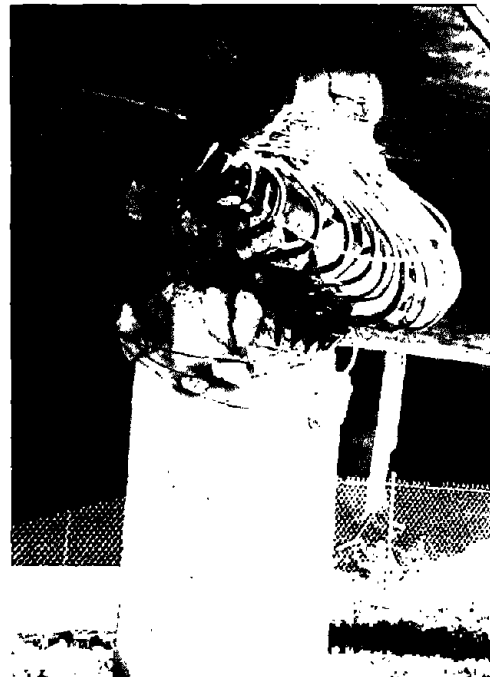
Fig. 5.9: Column Failure at Bent 2, Bull Creek Canyon Channel Bridge

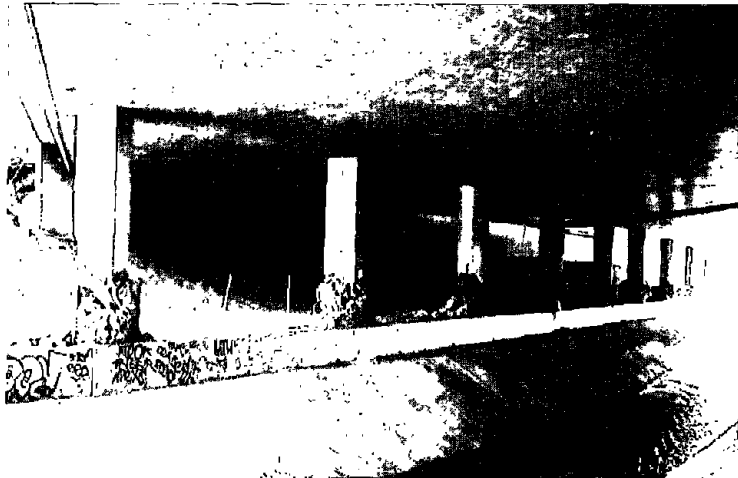
Fig. 5.10: Column Failure at Bent 3, Bull Creek Canyon Channel Bridge

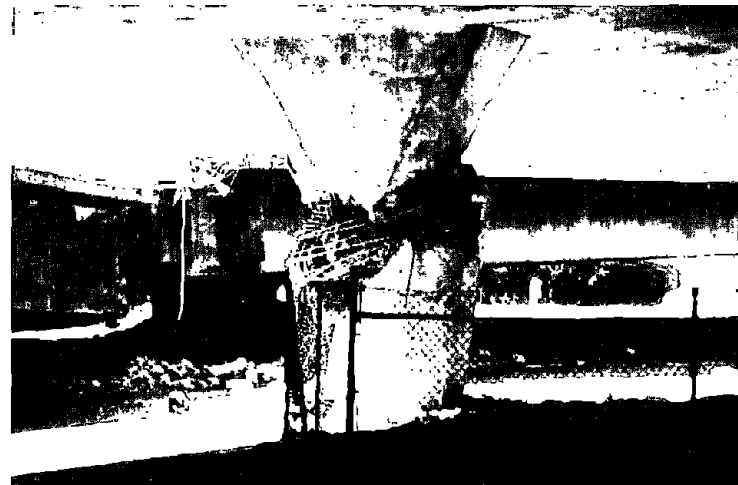
Fig. 5.13: South Column of Bent 3-Left, Mission-Gothic Undercrossing

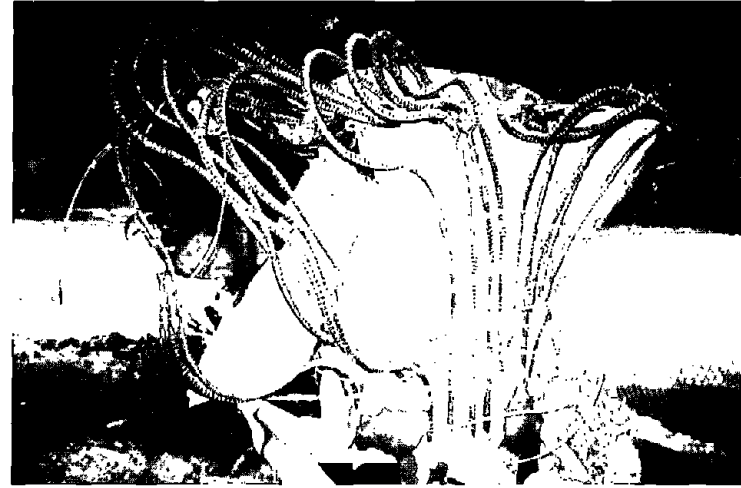
Fig. 5.15: Column Failure at Fairfax Overcrossing

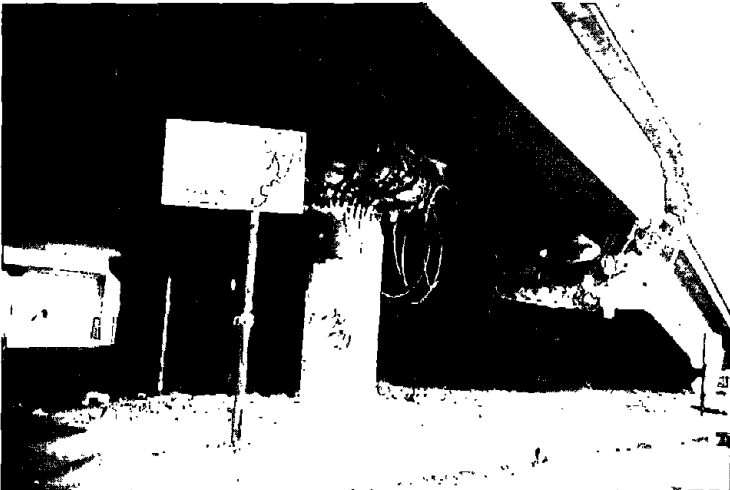
Fig. 5.16: Overview of La Cienega-Venice Undercrossing Collapse

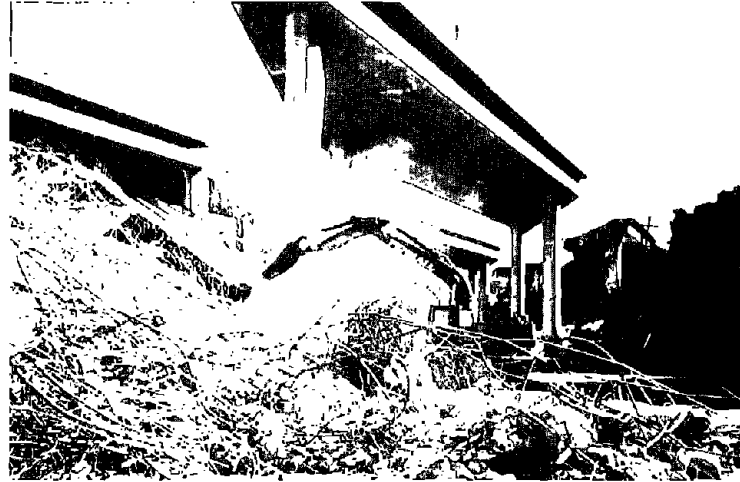
Fig. 5.19: Collapsed Spans at Gavin Canyon Undercrossing

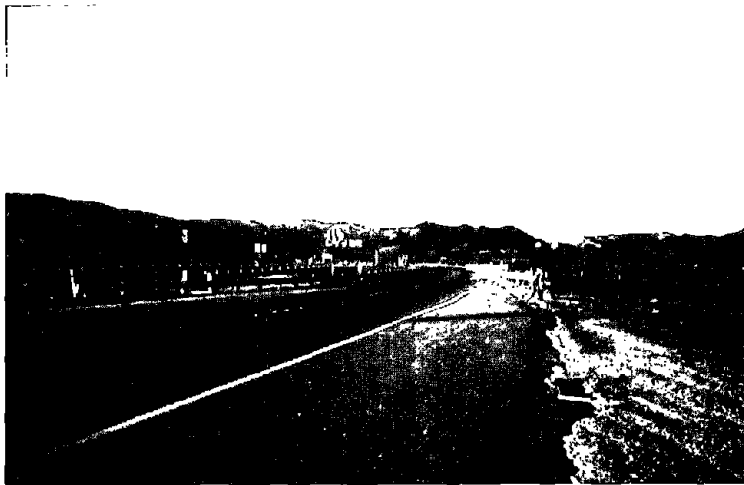
Fig. 5.24: Ground Cracks at East Approach of Interstate 5/Route 126 Separation

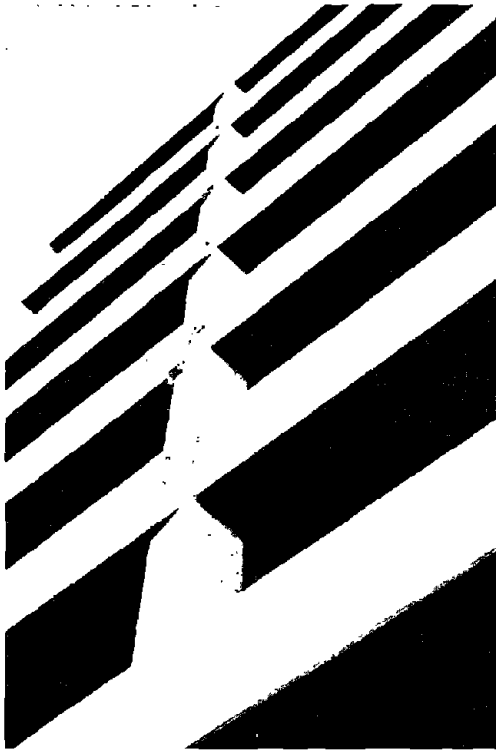
Fig. 6.1 Cast-In-Place Parking Garage With Joint Shear Failure

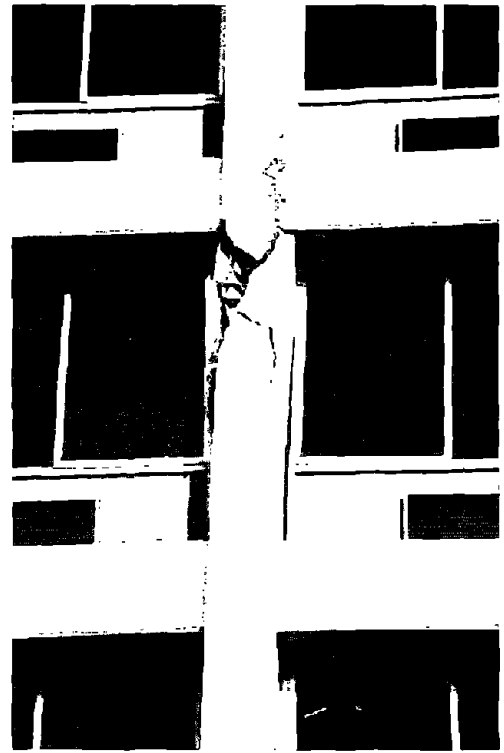
Fig. 6.2 Shear-Bond Failure in Columns of 7-Story Moment Resisting Frame

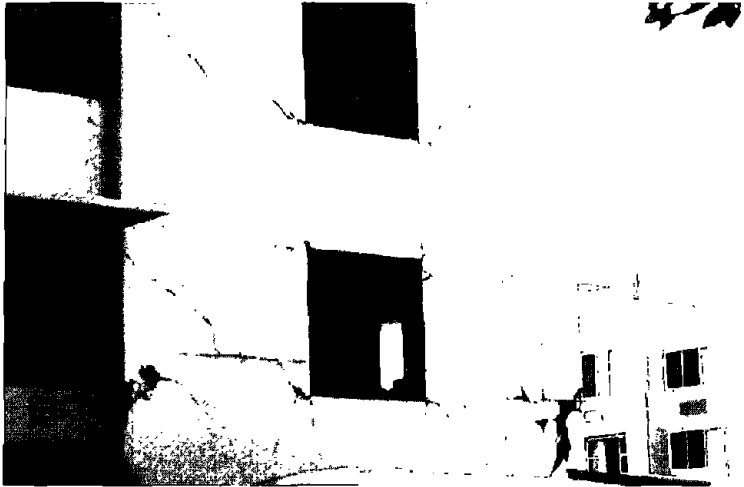
Fig. 6.5 Damage to Shear Wall of Dual Frame-Wall System

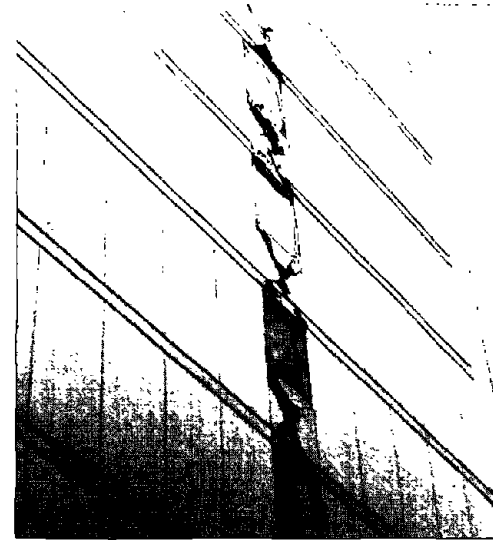
Fig. 6.6 Shear Failure of Coupling Beams in 15-story Coupled Shear Wall

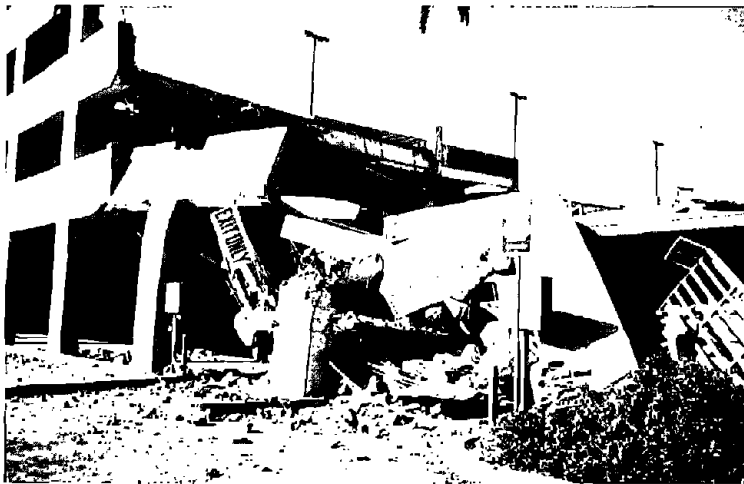
Fig. 6.7 Characteristic "Implosion" of Precast Parking Structure

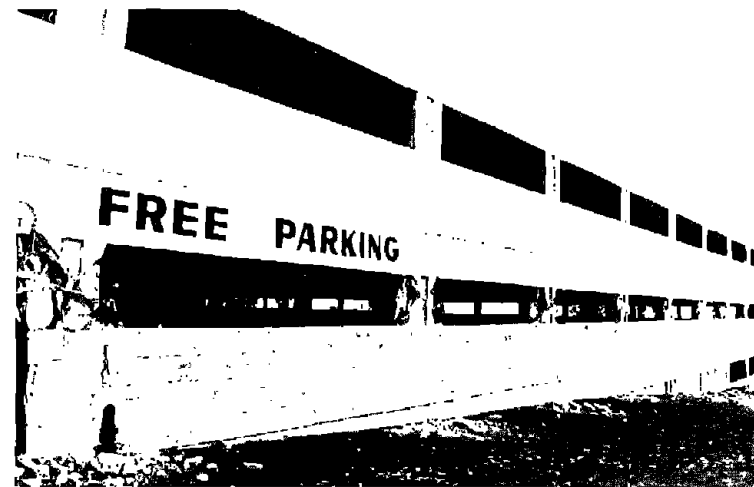
Fig. 6.8 Short Column Effect due to Partial Infill

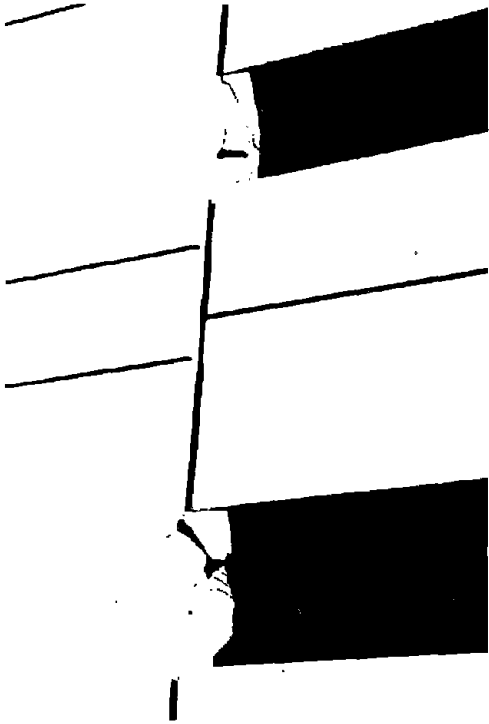
Fig. 6.9 Typical Corbel Damage in Precast Frame of Parking Garage

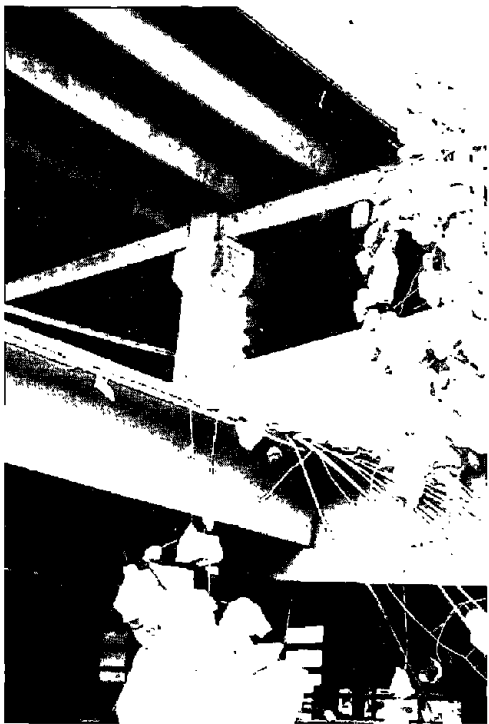
Fig. 6.11 Partial Roof Collapse with Subsequent Punching of Floors Below

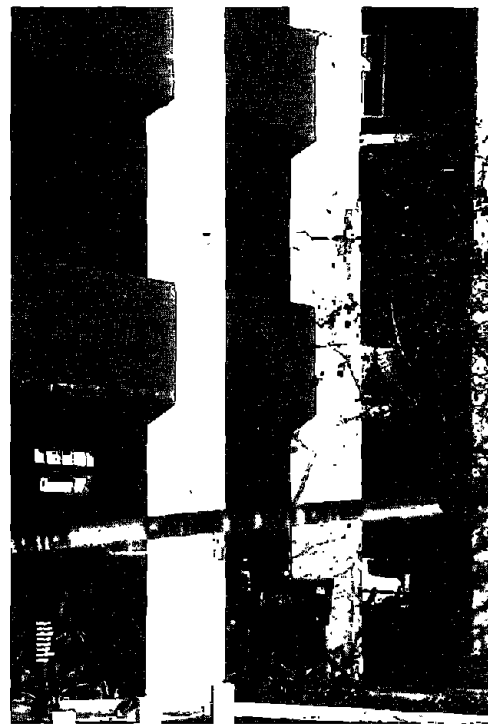
Fig. 6.12 Shear Cracking in Columns

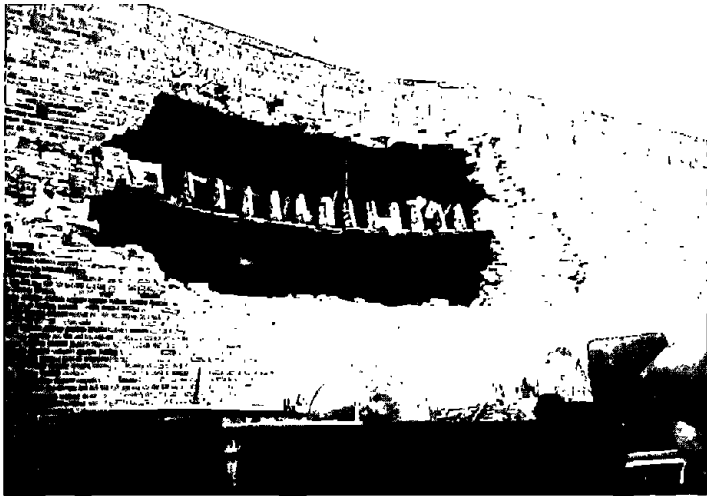
Fig. 6.13 Out of Plane Bending Failure of Retrofit URM Building

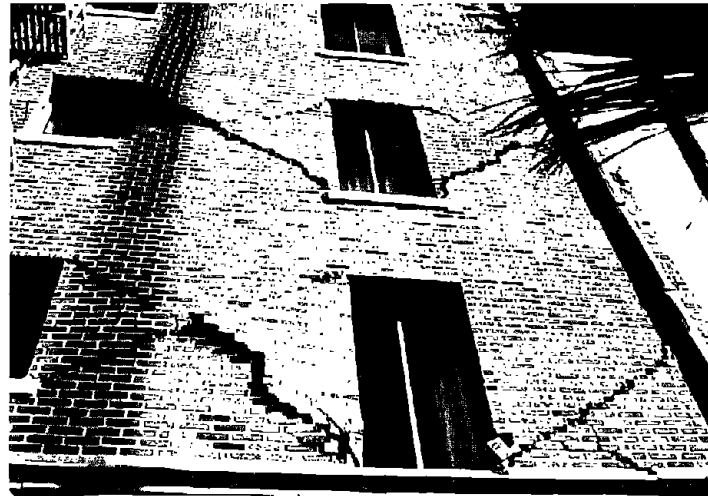
Fig. 6.14 Shear Cracking in Non-Bearing Masonry Wall

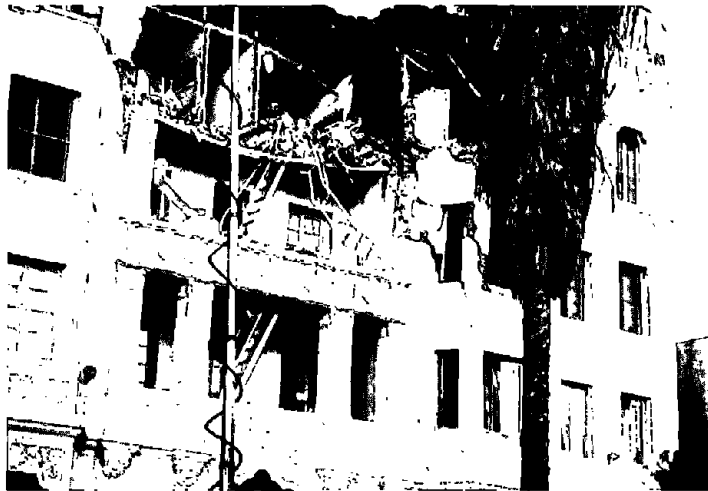
Fig. 6.15 Typical Shear and Out-of-Plane URM Failure

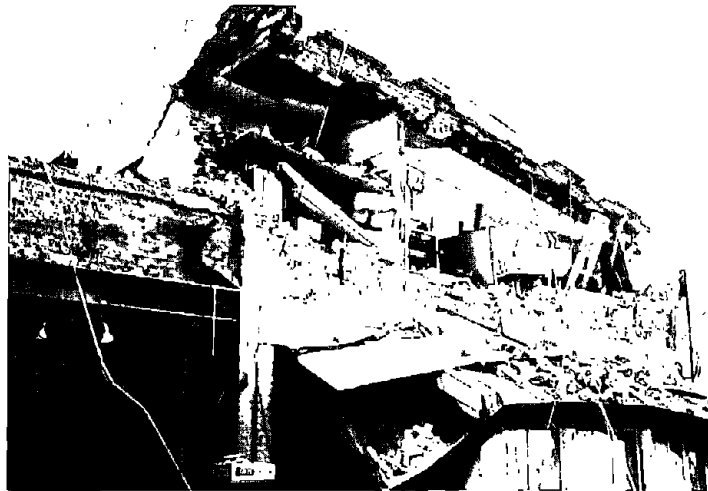
Fig. 6.16 Typical Shear and Out-of-Plane URM Failure

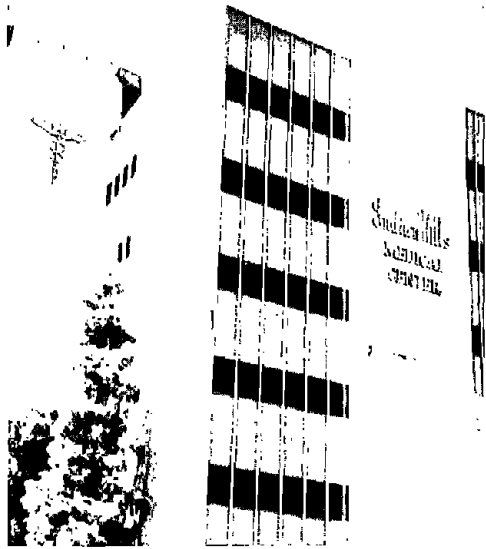
Fig. 6.17 Shear Wall Damage at Indian Hills Hospital
