PB94-181500
4. Title and Subtitle Hokkaido Nansei-oki Japan Earthquake of July 12, 1993		5. Report Date December 23, 1993

Hokkaido Nansei-oki, Japan Earthquake of July 12, 1993

Technical Report NCEER-93-0023

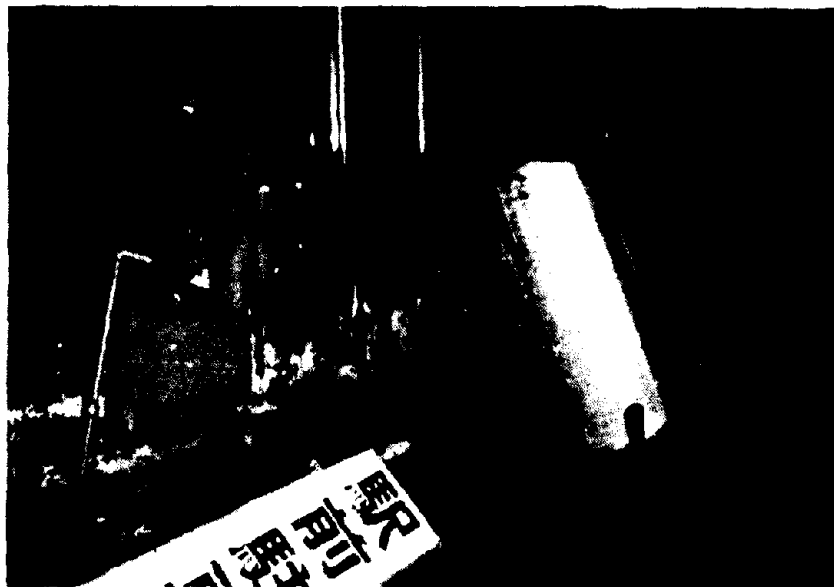
Figure 7-5: An overturned exterior kerosene tank in the town of Kuromatsunai. The highest horizontal acceleration recorded in the main earthquake (0.50g) occurred a few meters away from the tank.

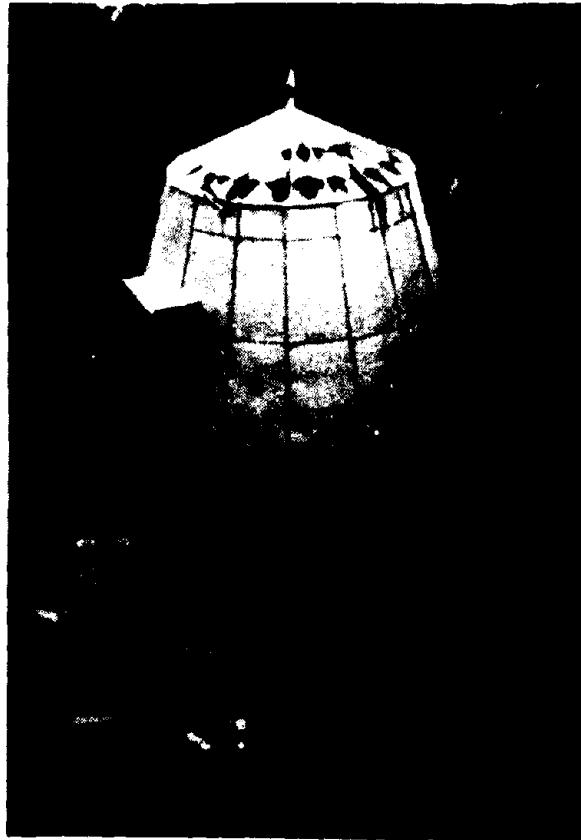
Figure 8-1: Typical collapsed unreinforced concrete-block silos a few kilometers north of Aonae.

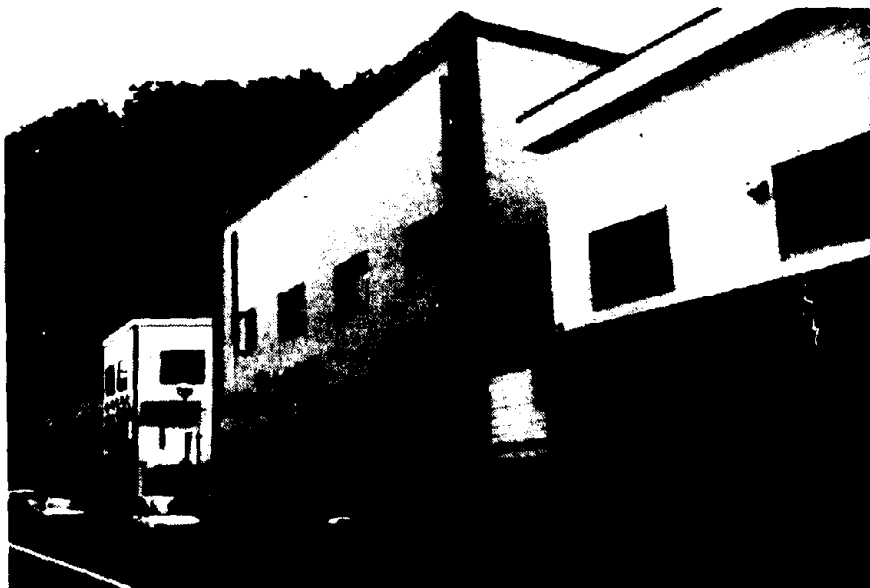
Figure 8-2: Lightly damaged commercial buildings in Okushiri-cho. Typically these buildings are wood-frame with stucco. Note the damaged stucco and brick veneer.

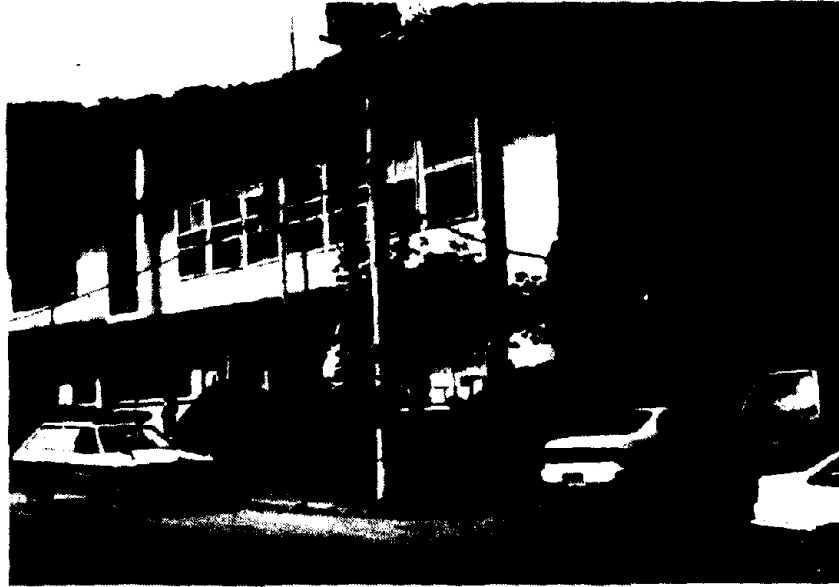
Figure 8-4: The light wood-frame and stucco City Offices Building in Okushiri-cho (upper photograph) and a smaller building (lower photograph) suffered extensive damage to their stucco facades but not major structural damage. These rather flimsily built structures suffered probably as much damage from shaking as any building observed in the town.

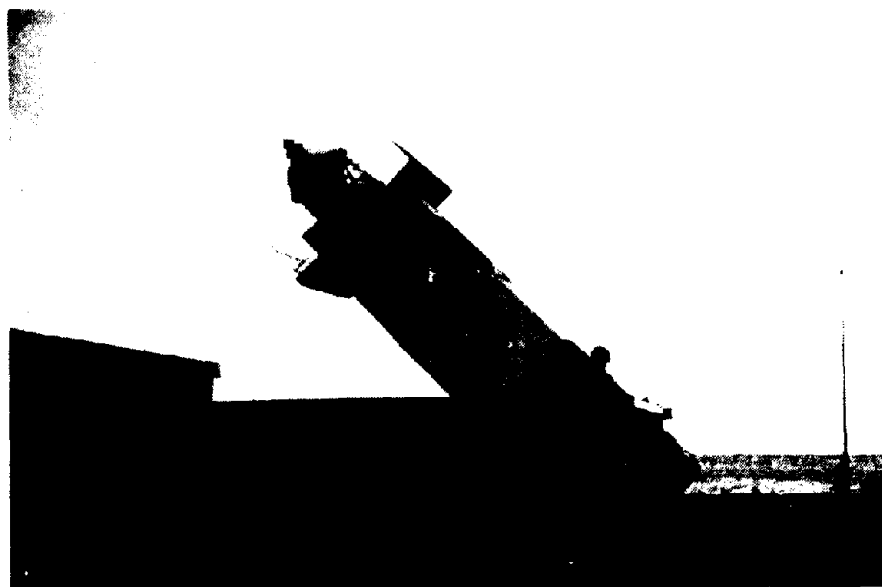
There appeared to be a concentration of damage around the lighthouse. Because of its location right on the edge of the bluff, it may have experienced local site amplification.

Figure 8-7: The Aonae lighthouse collapsed during the earthquake. The failure was caused by fracture of the tower structure at the base, along with pull-out of reinforcing steel dowels from the foundation. The inspection indicated an apparent bond failure of plain J anchorage bars (approximately 24 mm in diameter).

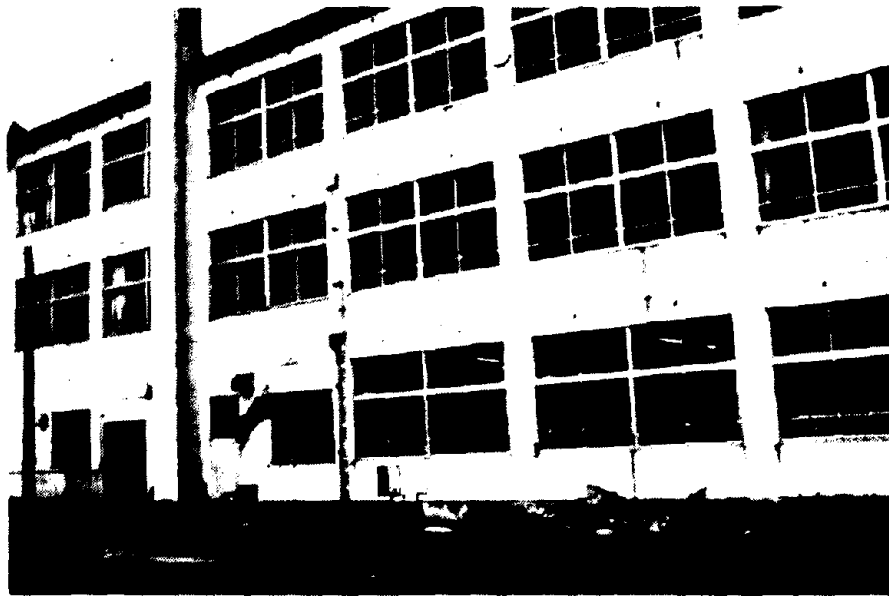
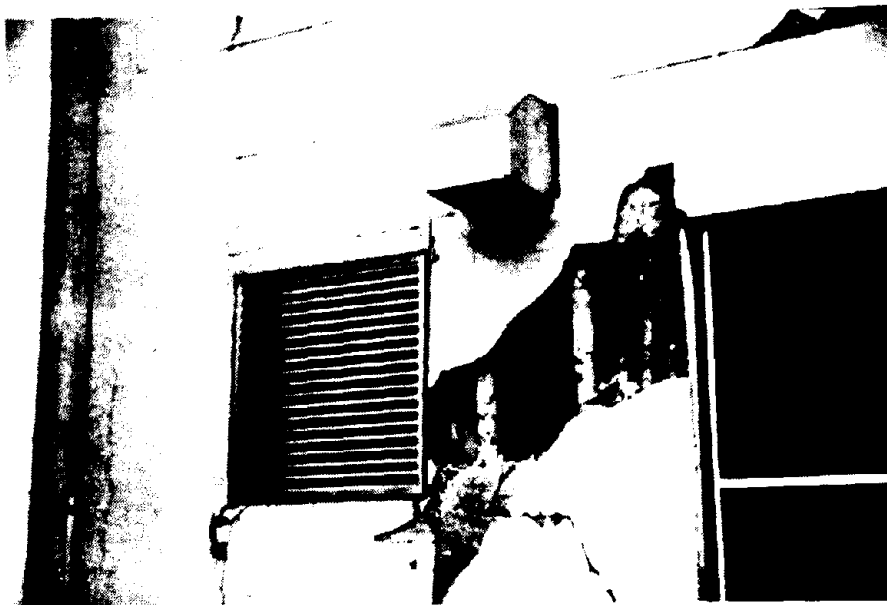
Figure 8-10: Aonae Elementary School damage.

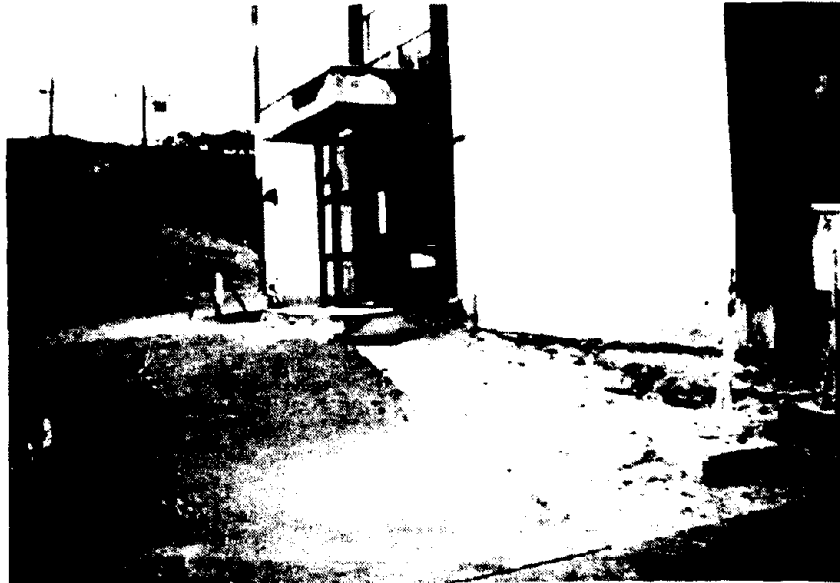
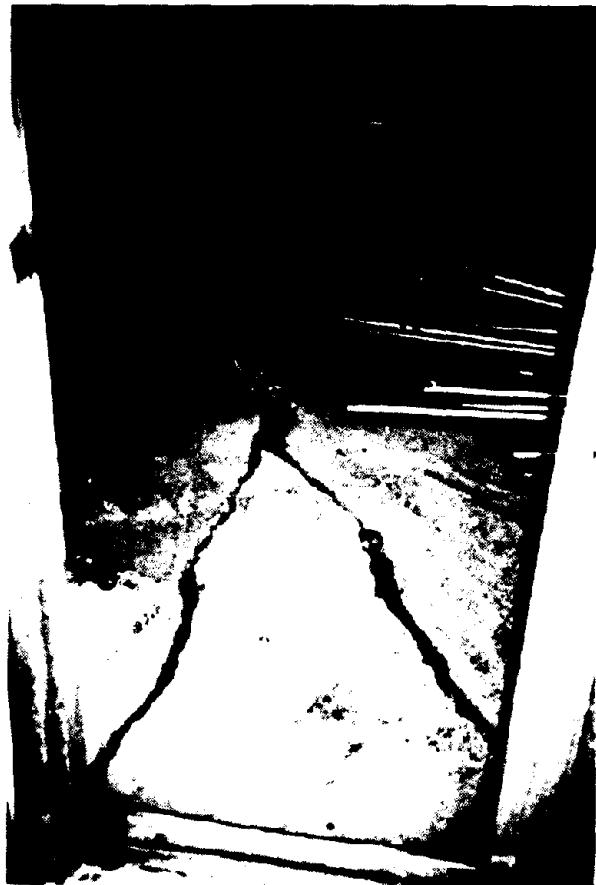
Figure 8-12: Aonae Elementary School. Settlement of fill in the southeast corner of the three-story building (upper photograph) and a cracked floor slab (lower photograph) indicate that the ground failure extended below the structure.

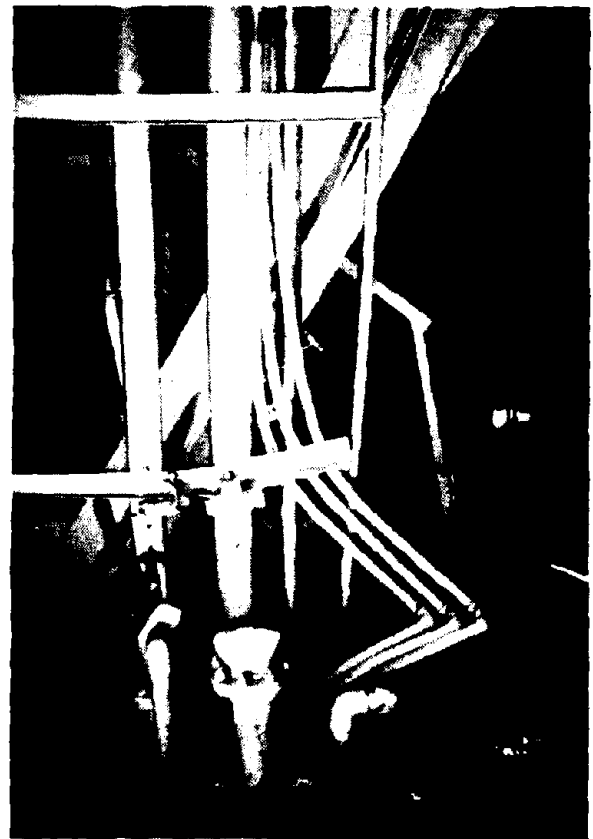
Figure 8-17: OCBP; buckled small-bore piping on the second floor of the partially collapsed hopper structure. The piping has been compressed on the order of 50 cm; some of this compression is taken through the piping floor penetration. Note the large ductility of threaded steel piping when the couplings do not pull apart.

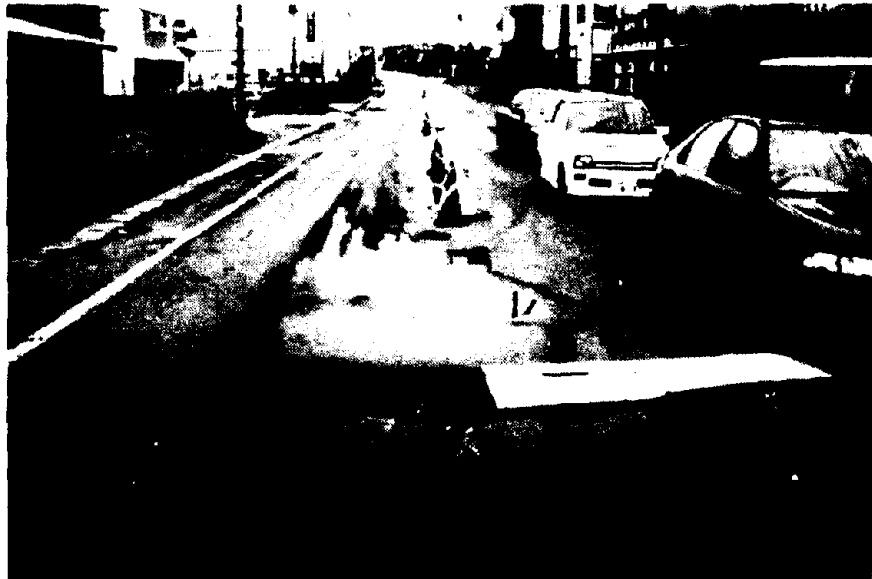
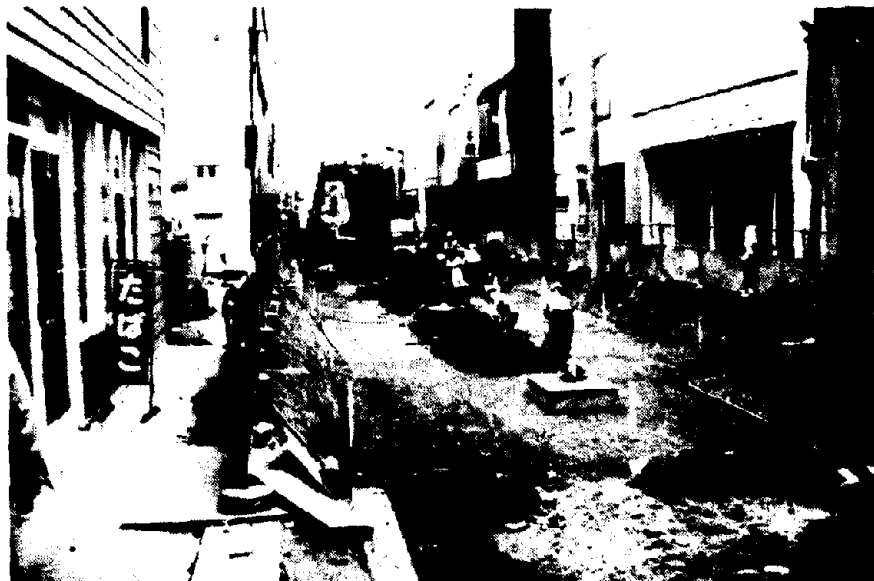
Figure 9-3: Many town streets suffered settlement damage, affecting both paving and various underground utilities. These are examples from Oshamanbe and Setana on Hokkaido.

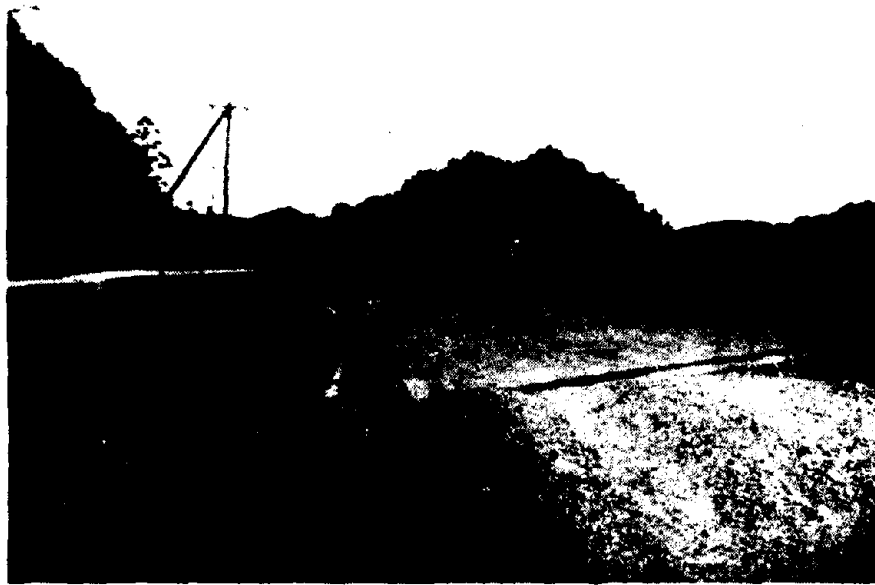
Figure 9-8: Typical road surface damage and abutment fill settlement at a bridge in Okushiri.

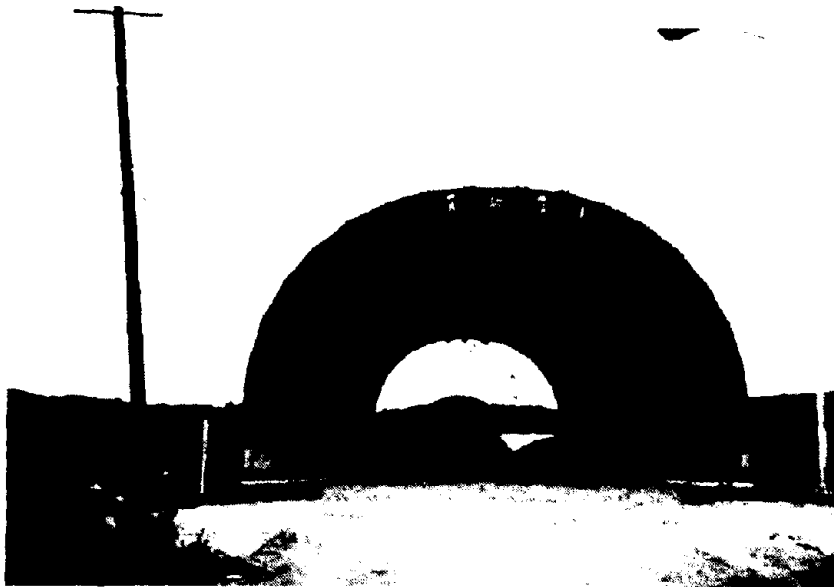
Figure 9-16: A collapsed snowshed (tunnel) north of Aonae. The just-completed structure is on fill in rice paddies. About one-third of the three-hinged arch structure collapsed. The rest is severely damaged. The approximately 2-m-wide quarter-circle panels are precast concrete and are bolted to the footings and to each other at the top.

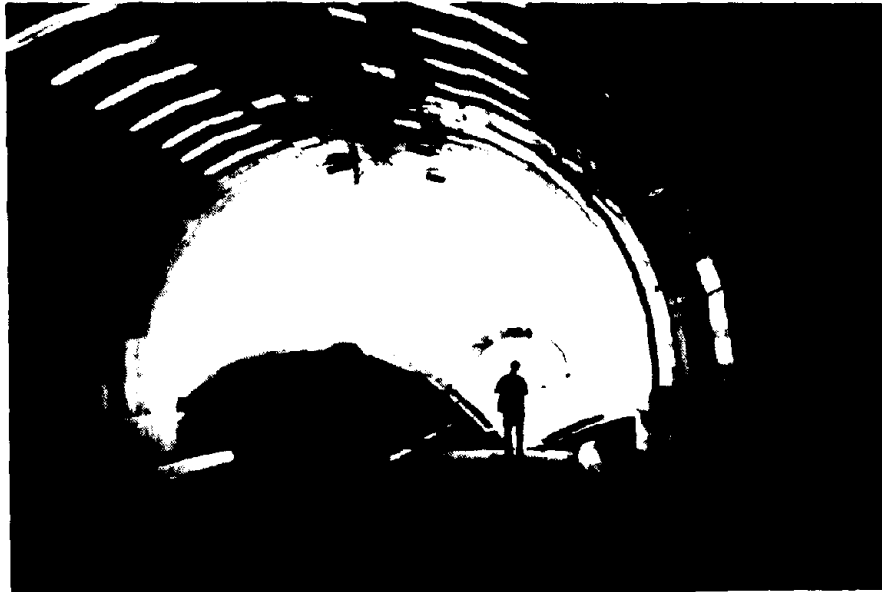
Figure 9-19: Although the arch has collapsed and dropped the precast planks onto the pavement, the planks are relatively undamaged, testifying to the general quality of construction of the superstructure.

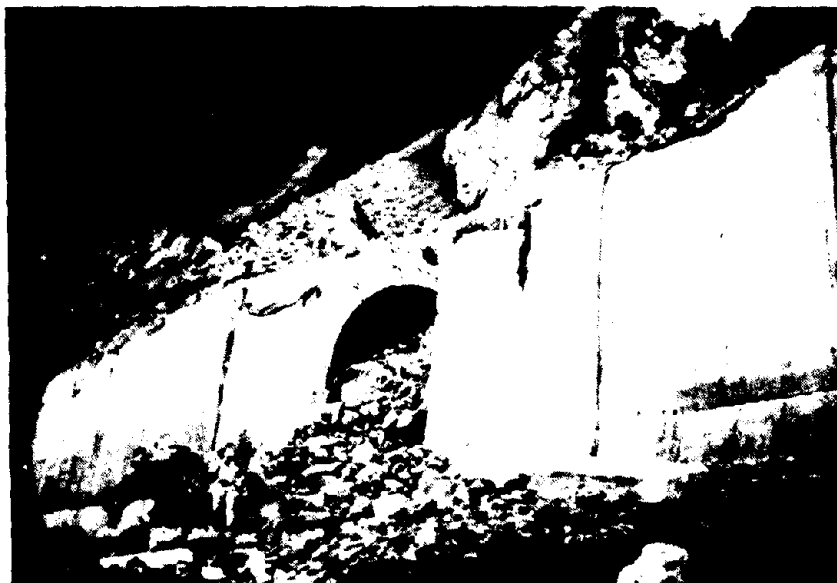
Figure 9-22: Close-up of the failed section of the Shiroito Tunnel.

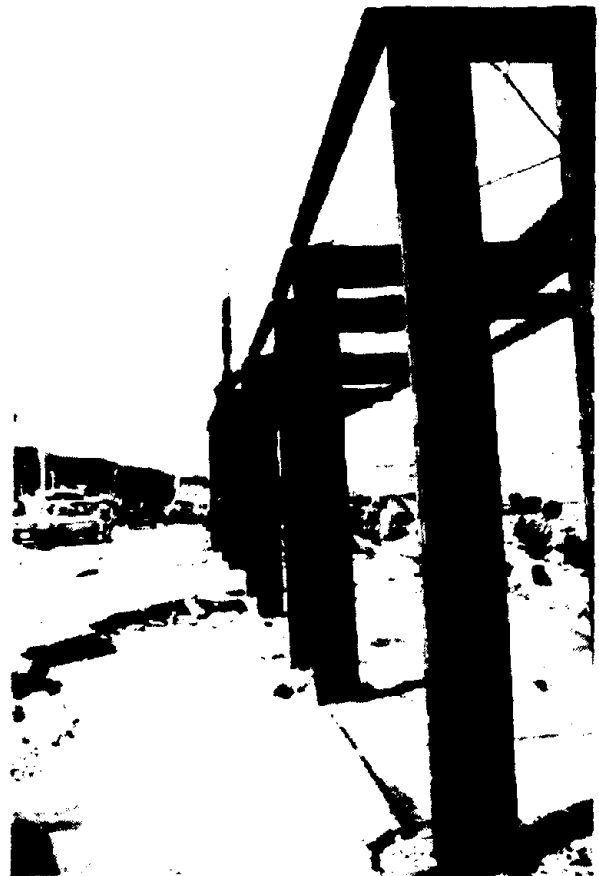
Figure 9-36: Damage to waterfront facilities at Okushiri-cho Port. The illustrated damage is due to soil failures from liquefaction, settlement, and lateral spreading of walls. Some of the damage is due to tsunami scour. Note that despite the severe damage to its foundations, the steel structure shown in both photographs has maintained its overall integrity, illustrating the large ductilities available in steel structures when properly designed and constructed.

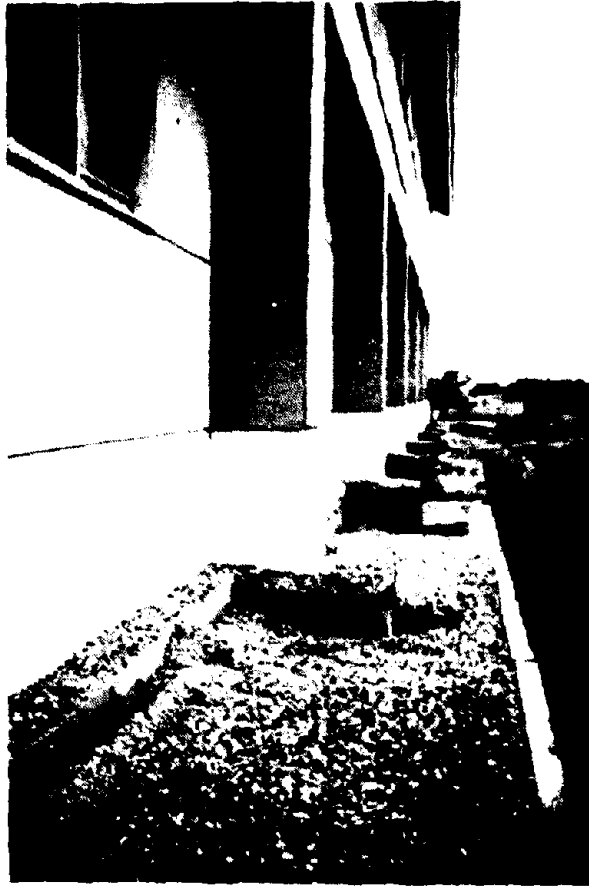
Figure 10-6: Oshamanbe Elementary School--note the minor cracking in spandrels near the column. Other minor cracking of shear walls was observed.

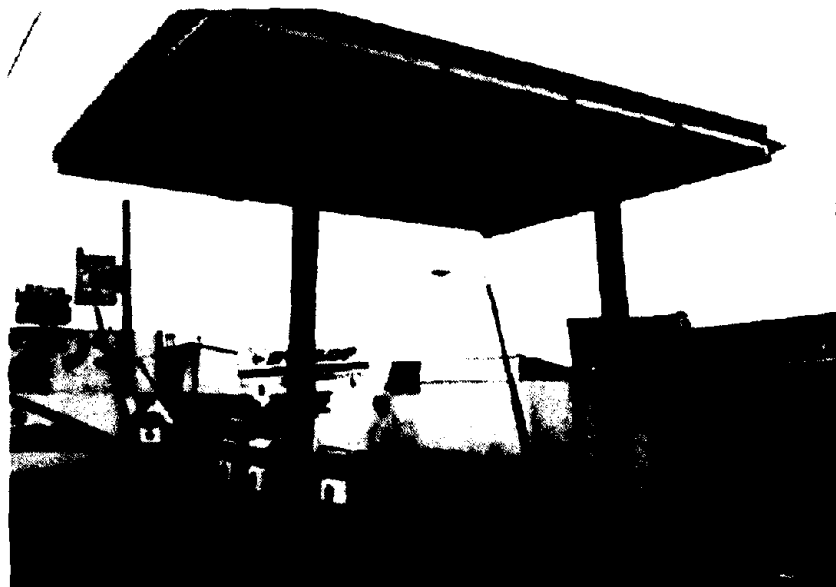
Figure 10-10: Substantial damage in Oshamanbe occurred to light buildings on shallow foundations due to liquefaction. This photo shows near-total damage to a gas station from liquefaction and settlement about 80 km from the edge of the aftershock area. Note how the tank(s) below are pushing up because of buoyancy. None of the glass is broken, indicating a low level of shaking. This is also a fill site on old farm land very near the shoreline. Much similar damage on poor soils was observed throughout the affected area.

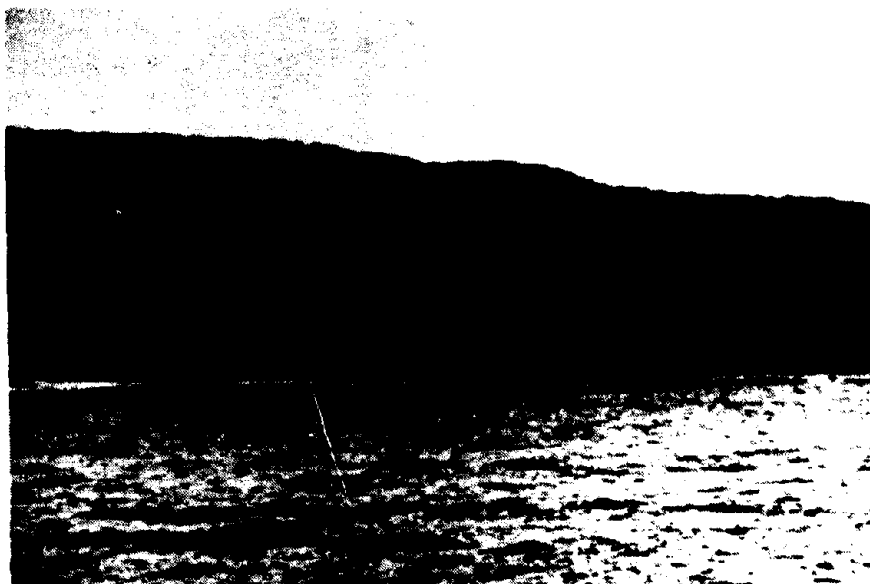
Figure 11-2: Landslides along the eastern coast of Okushiri Island. Similar and very large landslides were observed along the coastal bluffs of the Hokkaido coast south of Setana.
