REPORT DOCUMENTATION PAGE		1. REPORT NO. NCEER-94-0005	2.
4. Title and Subtitle The Northridge, California Earthquake of January 17, 1994: General Reconnaissance Report		5. Report Date March 11, 1994

**The Northridge, California Earthquake
of January 17, 1994:
General Reconnaissance Report**

Technical Report NCEER-94-0005

March 11, 1994

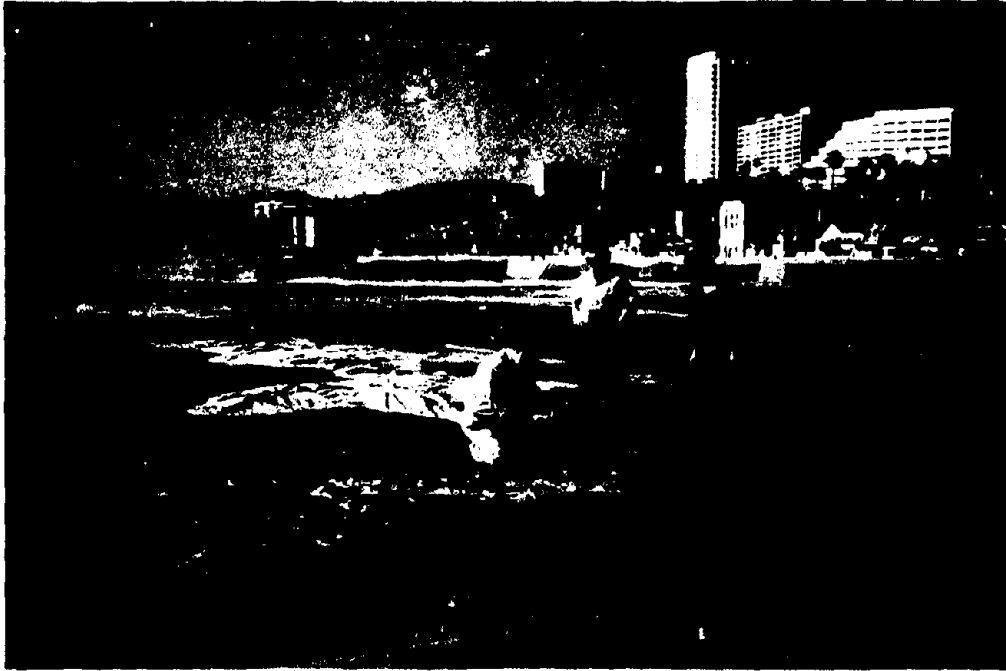
FIGURE 2-6 Liquefied Sand Ejected from Cracks in the Pavement of the Parking Lot in Santa Monica Beach

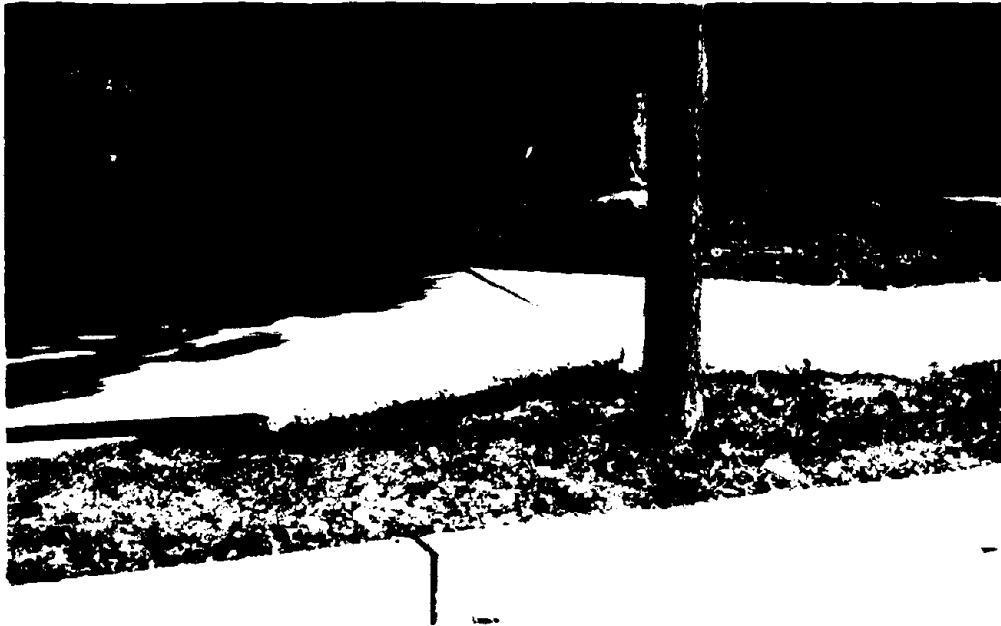
FIGURE 2-14 Compressive Ground Deformation Along Balboa Boulevard in Granada Hills

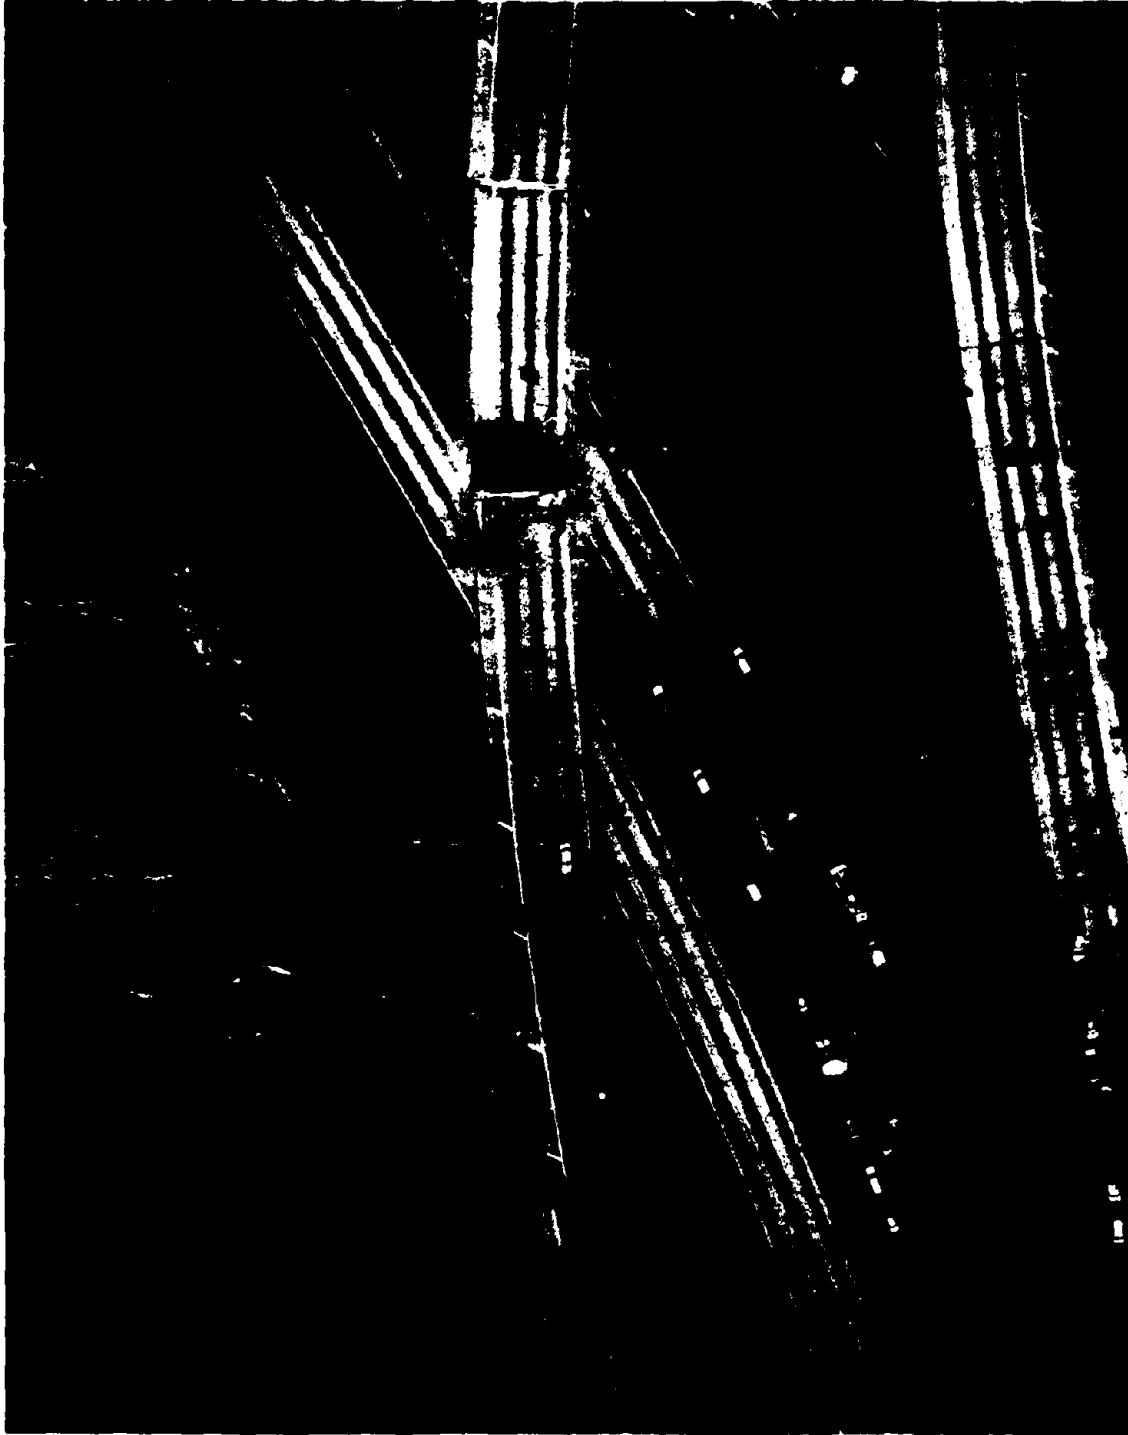
**FIGURE 3-5 SR14/I-5 Separation and Overhead (Southbound) -
Aerial View of Collapse**

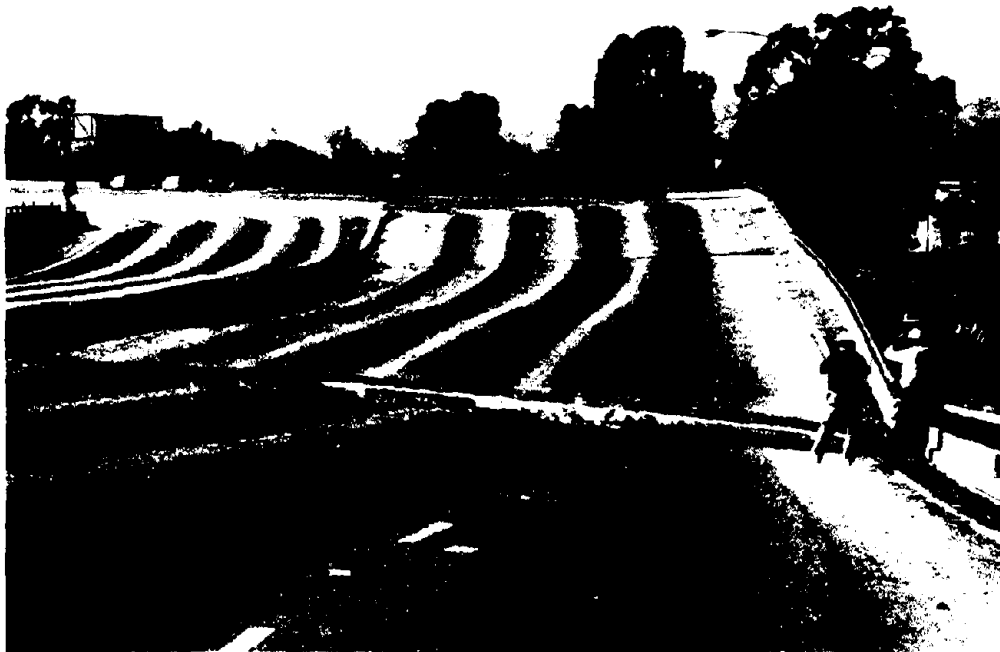
**FIGURE 3-13 La Cienega-Venice Undercrossing -
Superstructure Settlement Due to Column Failures**

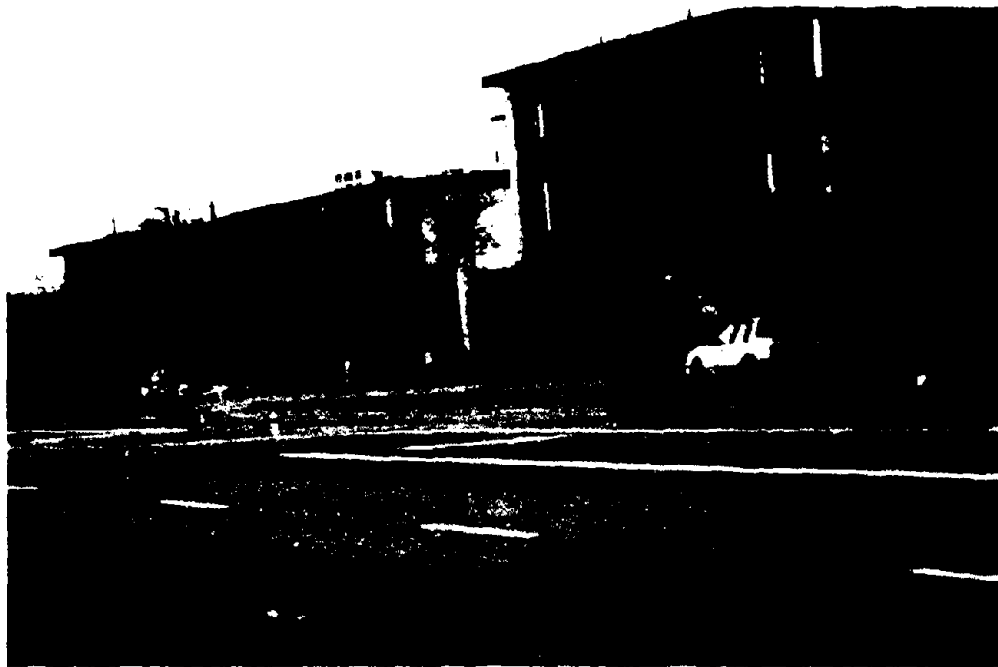
FIGURE 3-21 Apartment House Collapsed (Left) on Reseda Boulevard in Northridge

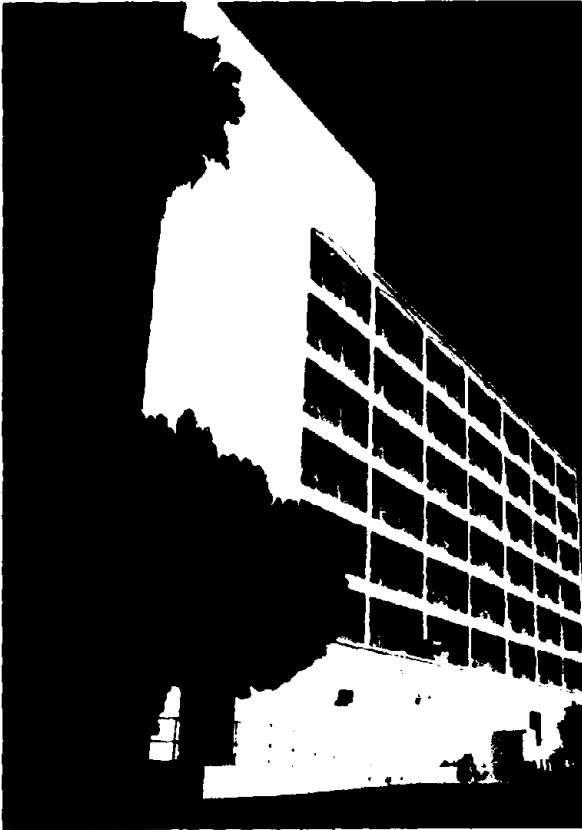
FIGURE 3-24 Damaged Seven-Story Hotel in Van Nuys

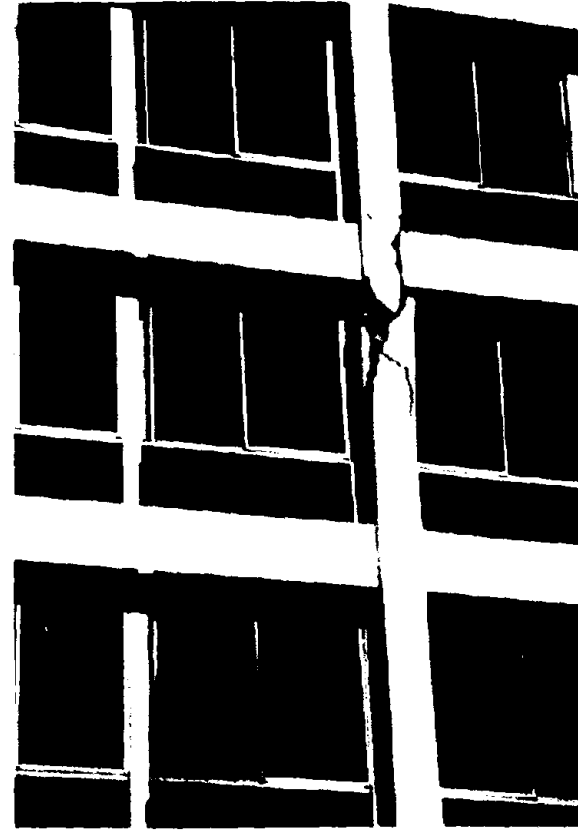
FIGURE 3-25 Damaged Columns in Seven-Story Hotel in Van Nuys

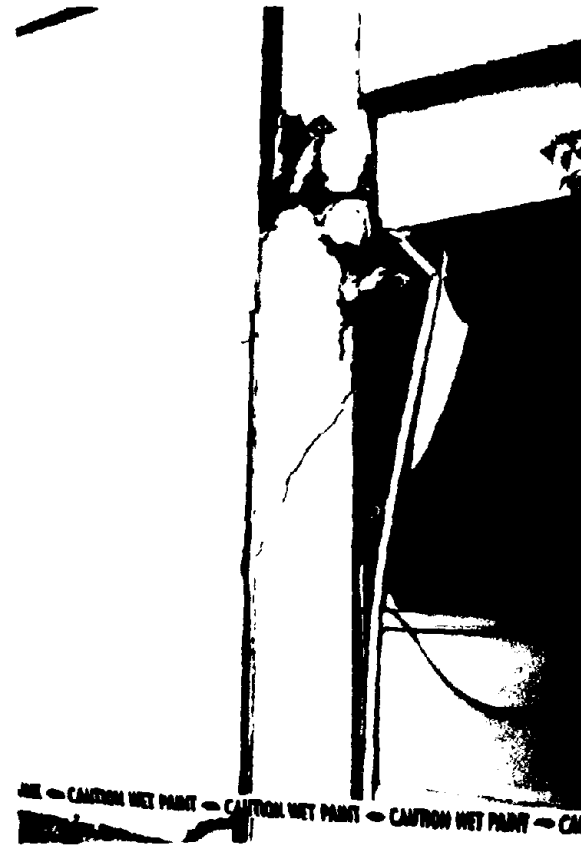
FIGURE 3-27 Column Shear Failure at First Floor of Hotel Building in Sherman Oaks

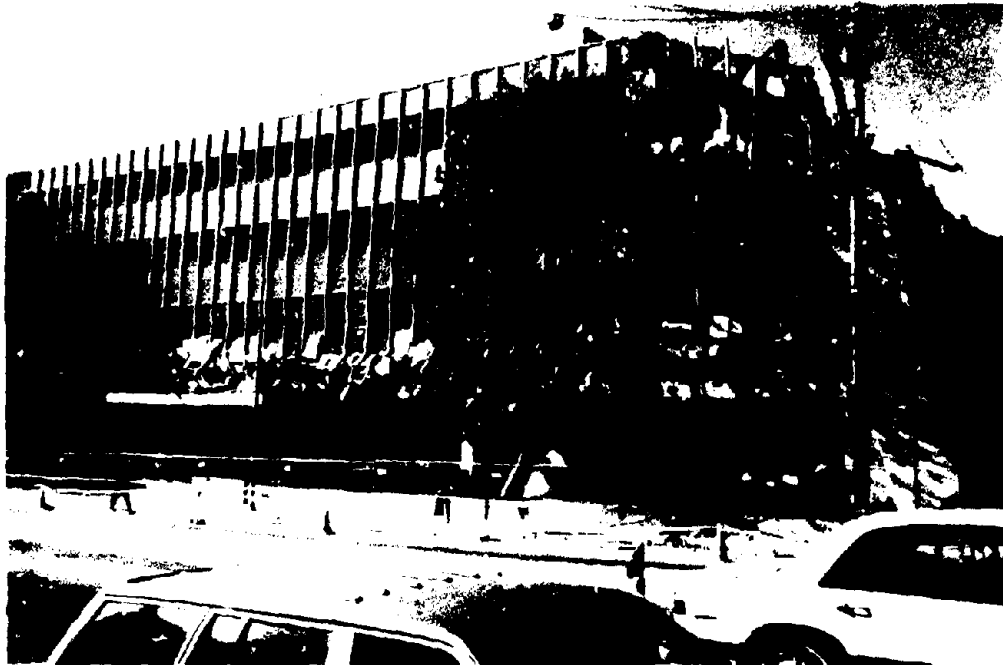
FIGURE 3-28 Collapse of Five-Story Reinforced Concrete Office Building on Balboa Boulevard, Northridge

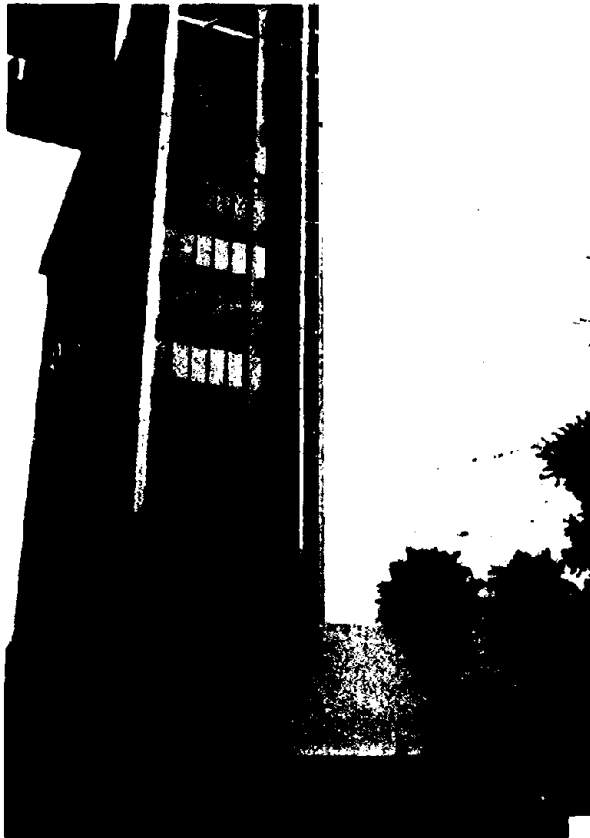
FIGURE 3-34 Office Building with Damaged Shear Walls in Sherman Oaks

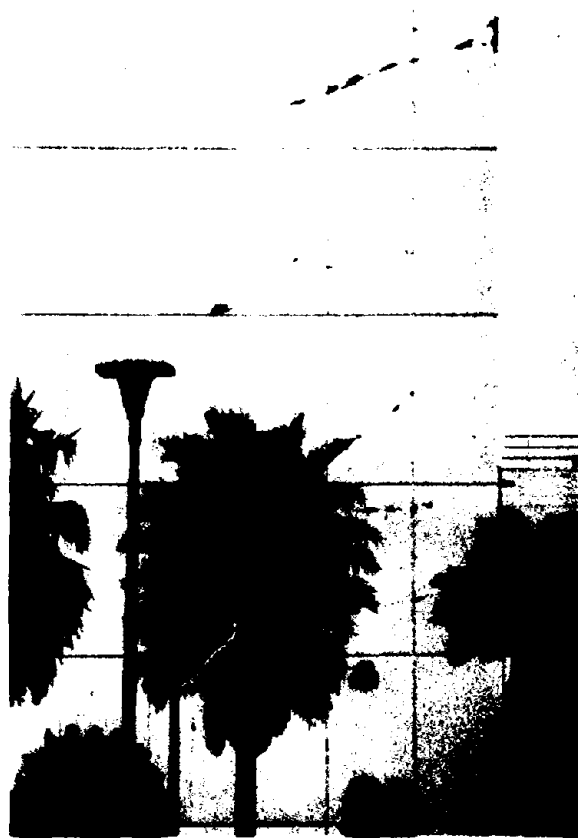
FIGURE 3-35 Damaged Shear Wall in Sherman Oaks

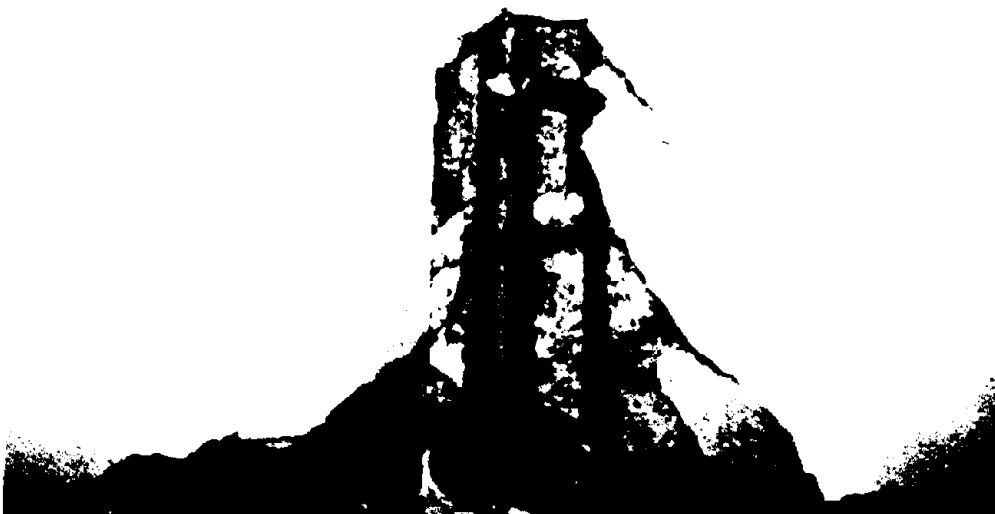
FIGURE 3-37 Shear Wall Failure at Floor Construction Joint in Office Building Near Epicenter

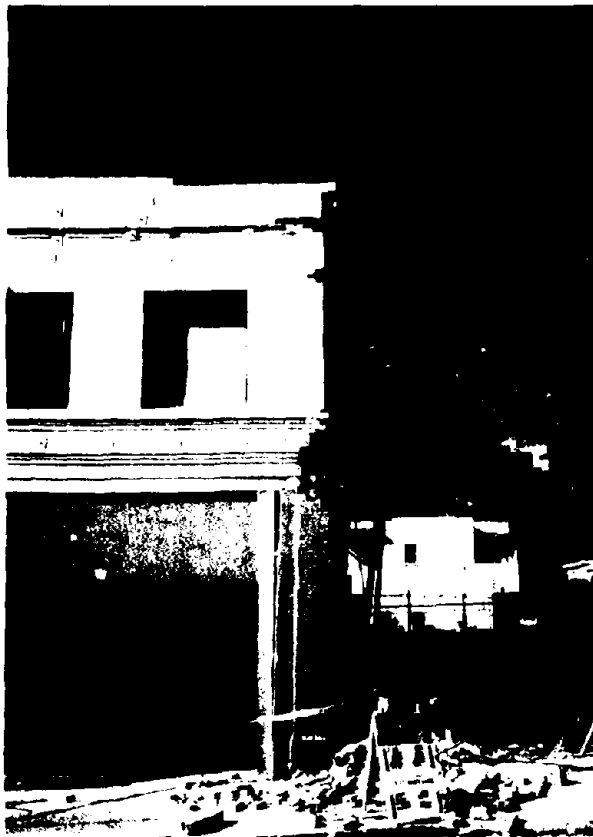
FIGURE 3-44 Damage of Retrofitted Masonry Structures

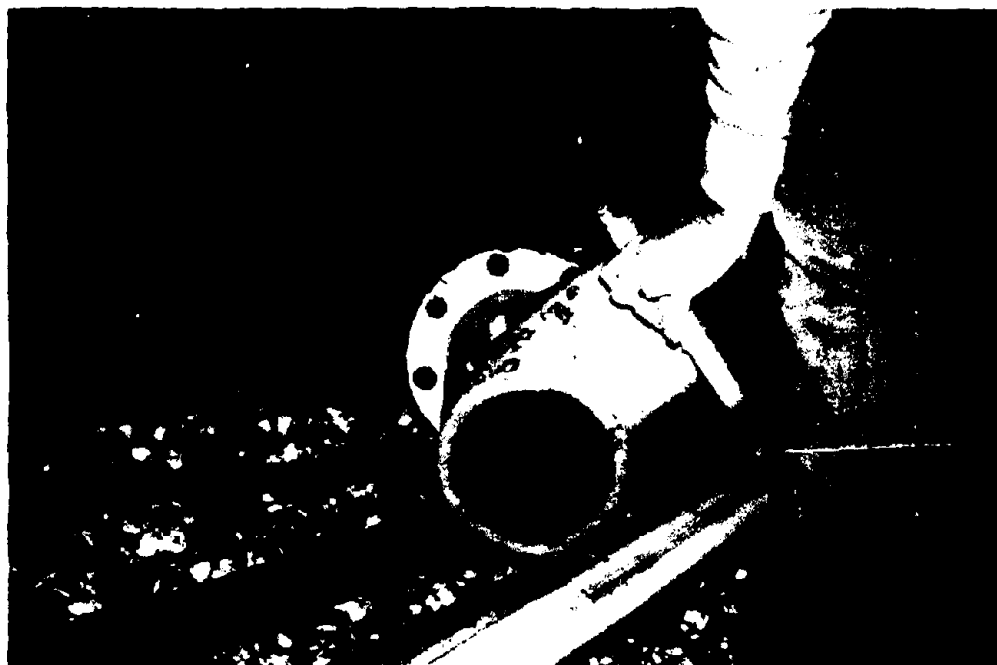
FIGURE 3-54 Process Tank Anchorage Failures Led to Excessive Piping Loads, Resulting in Failures in Flanged Piping

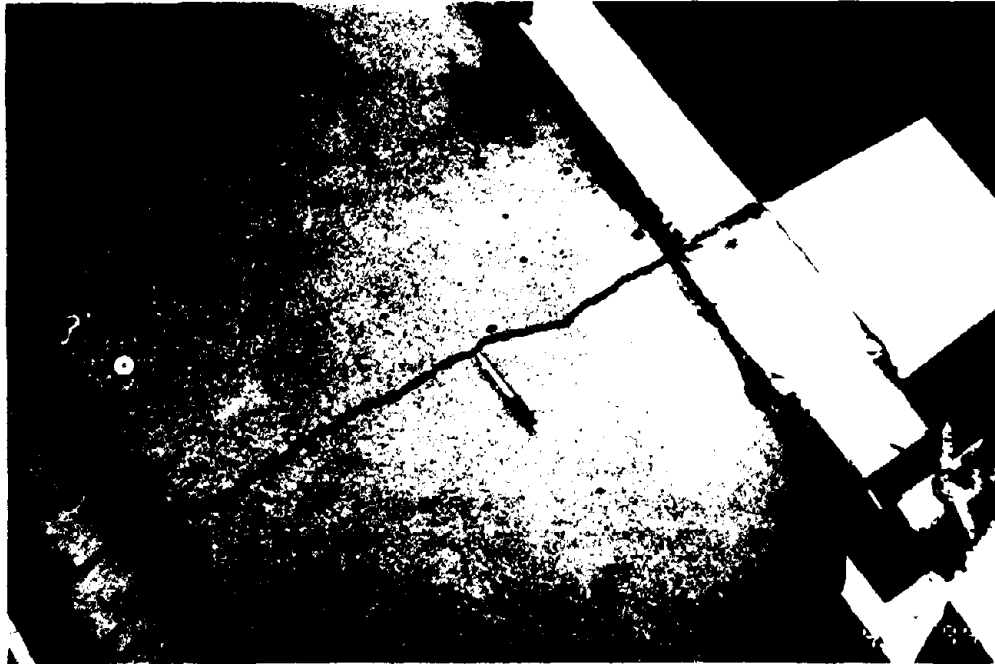
FIGURE 4-12 Typical Cracks (up to 1/2 Inch Wide) in Concrete Basins in the 15-mgd Wastewater Treatment Plant in the Santa Clarita Valley

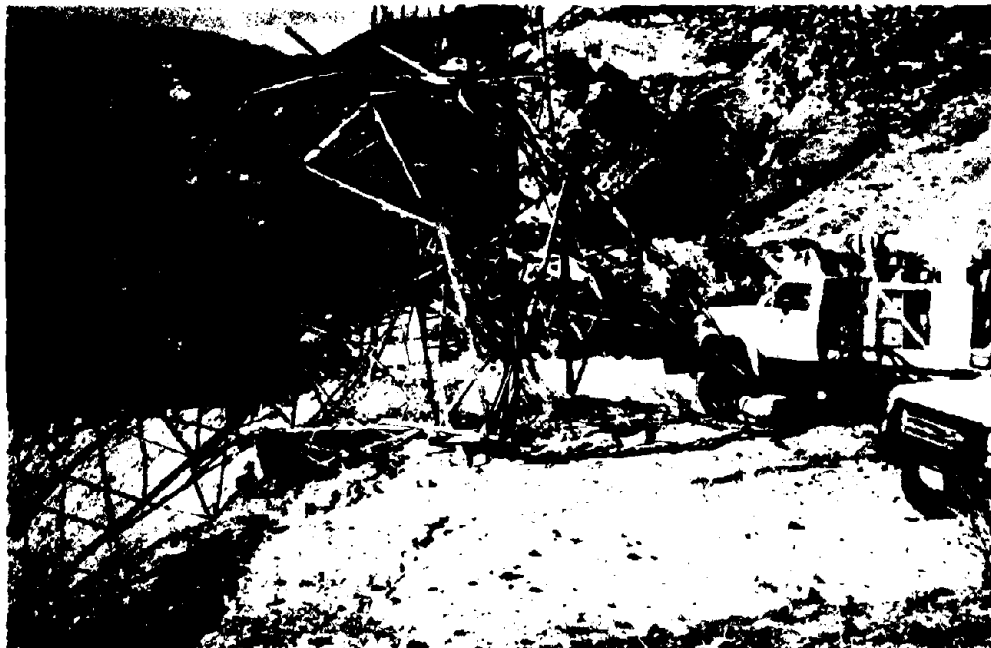
FIGURE 4-15 Several Electrical Transmission Towers Failed During the Earthquake - Foundation Distress was Observed at Most of the Failed Towers

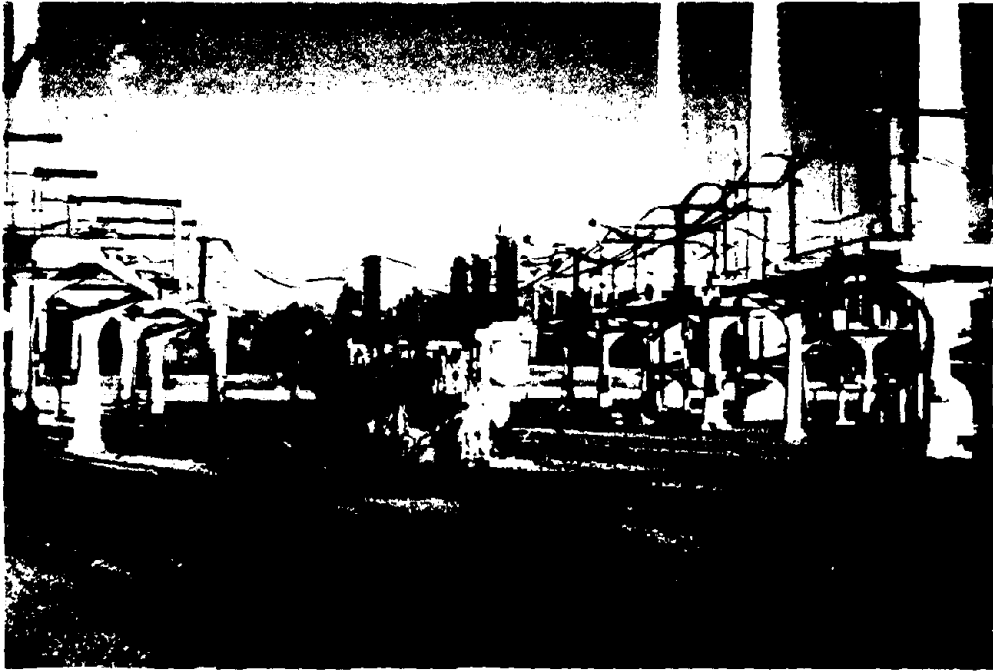
FIGURE 4-16 High Voltage Substation Apparatus Supported by Brittle Porcelain Insulators were Damaged at Several Substations
