REPORT NO.
UCB/EERC-94/08
JUNE 1994

EARTHQUAKE ENGINEERING RESEARCH CENTER

**PRELIMINARY REPORT ON THE
PRINCIPAL GEOTECHNICAL ASPECTS
OF THE JANUARY 17, 1994
NORTHRIDGE EARTHQUAKE**

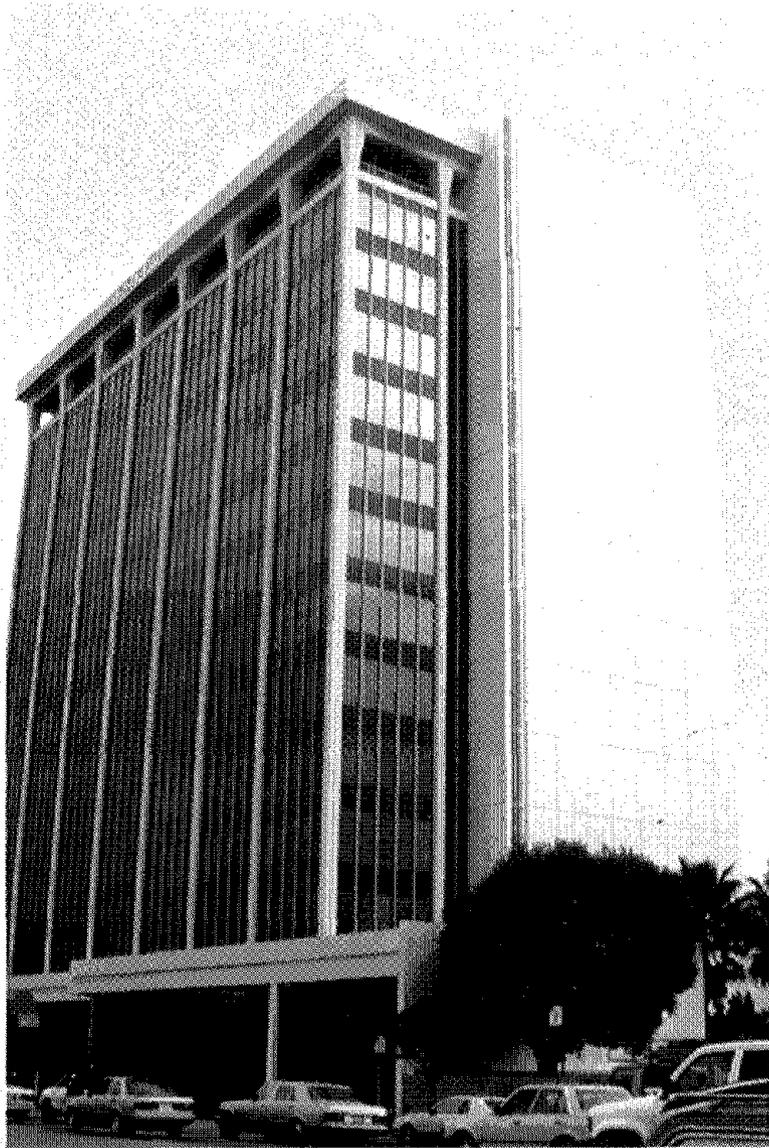
(c): Cracking in shear wall of a 13-story reinforced concrete structure on Ventura Boulevard

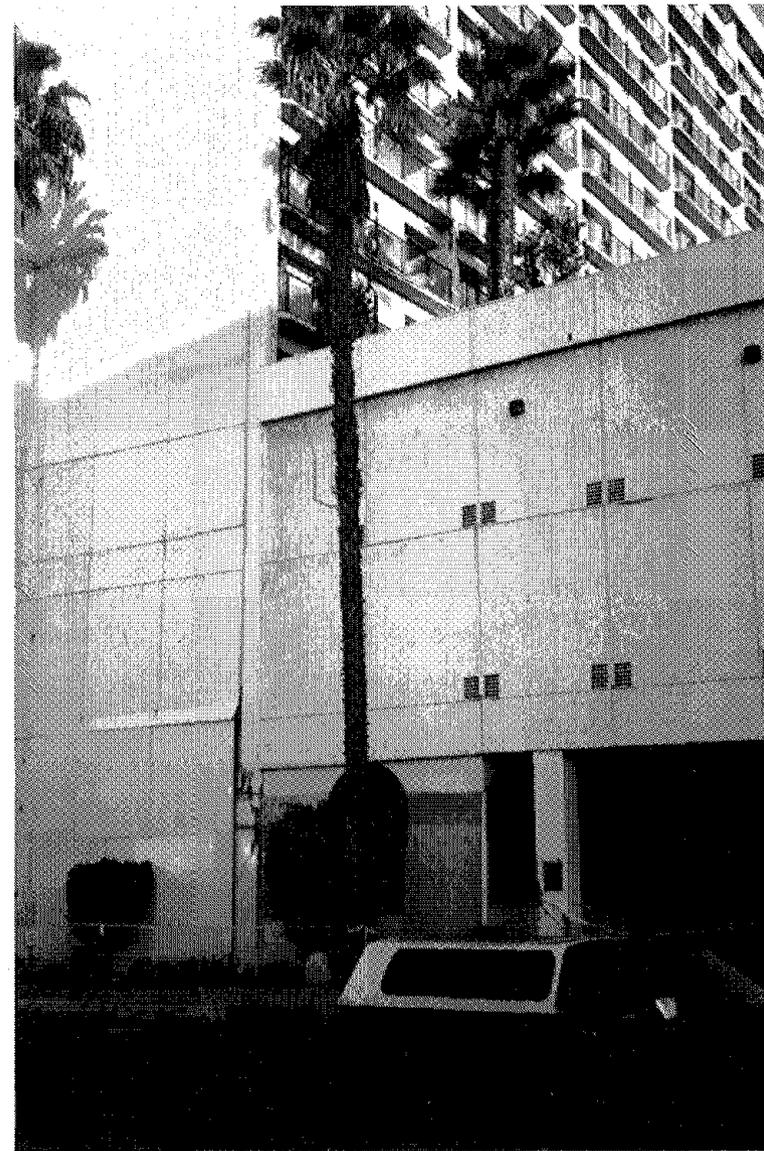
(d): Red-tagged 12-story hotel on Ventura Boulevard

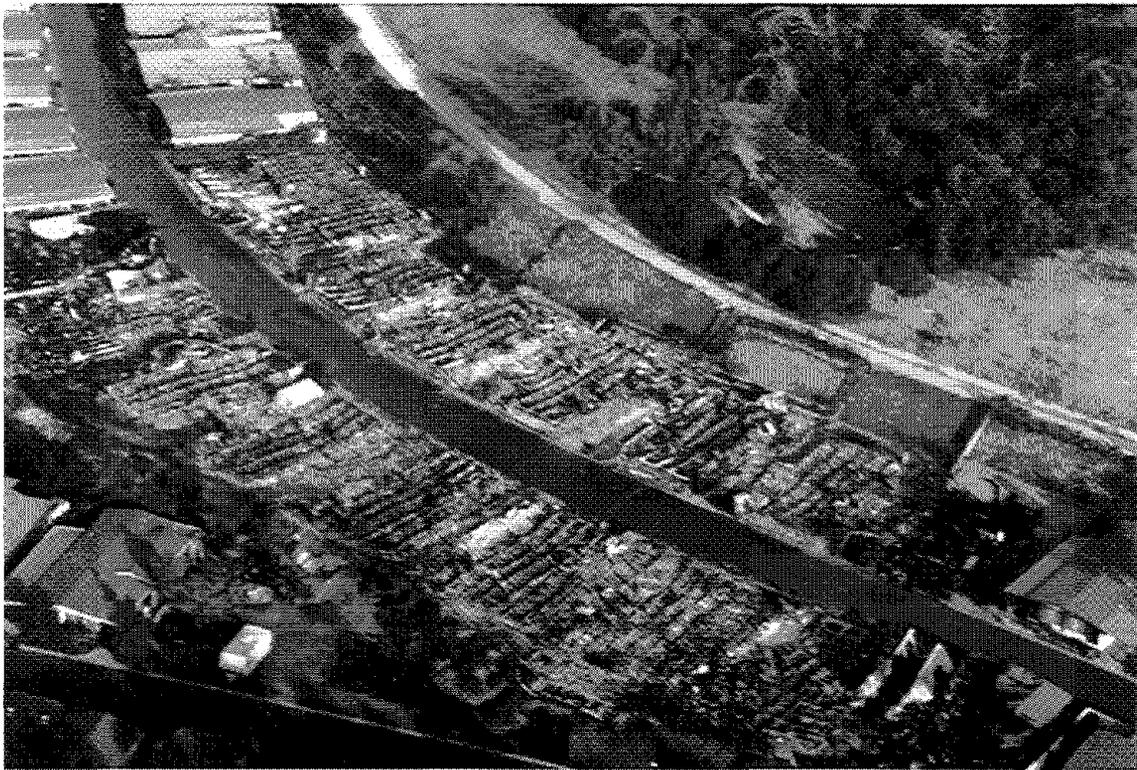
Fig. 4.4: Homes destroyed by fires in Pacoima

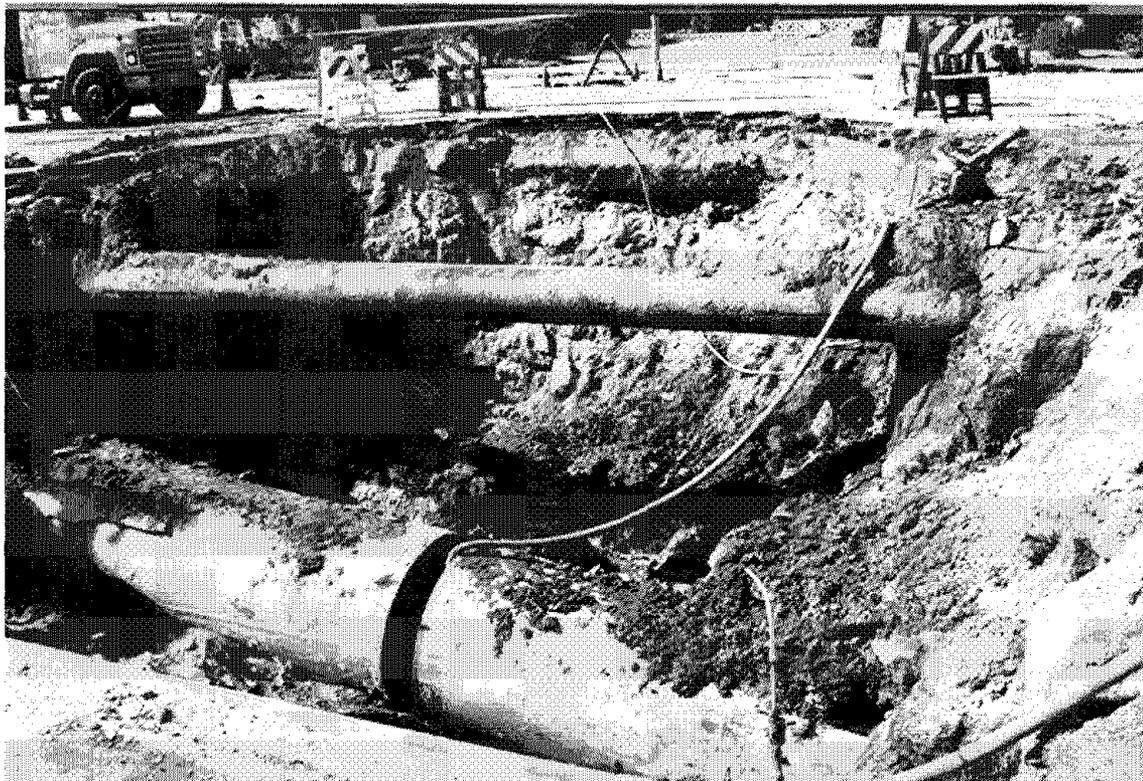
Fig. 4.8: Water pipe broken by extensional ground movement, Balboa Boulevard, Granada Hills

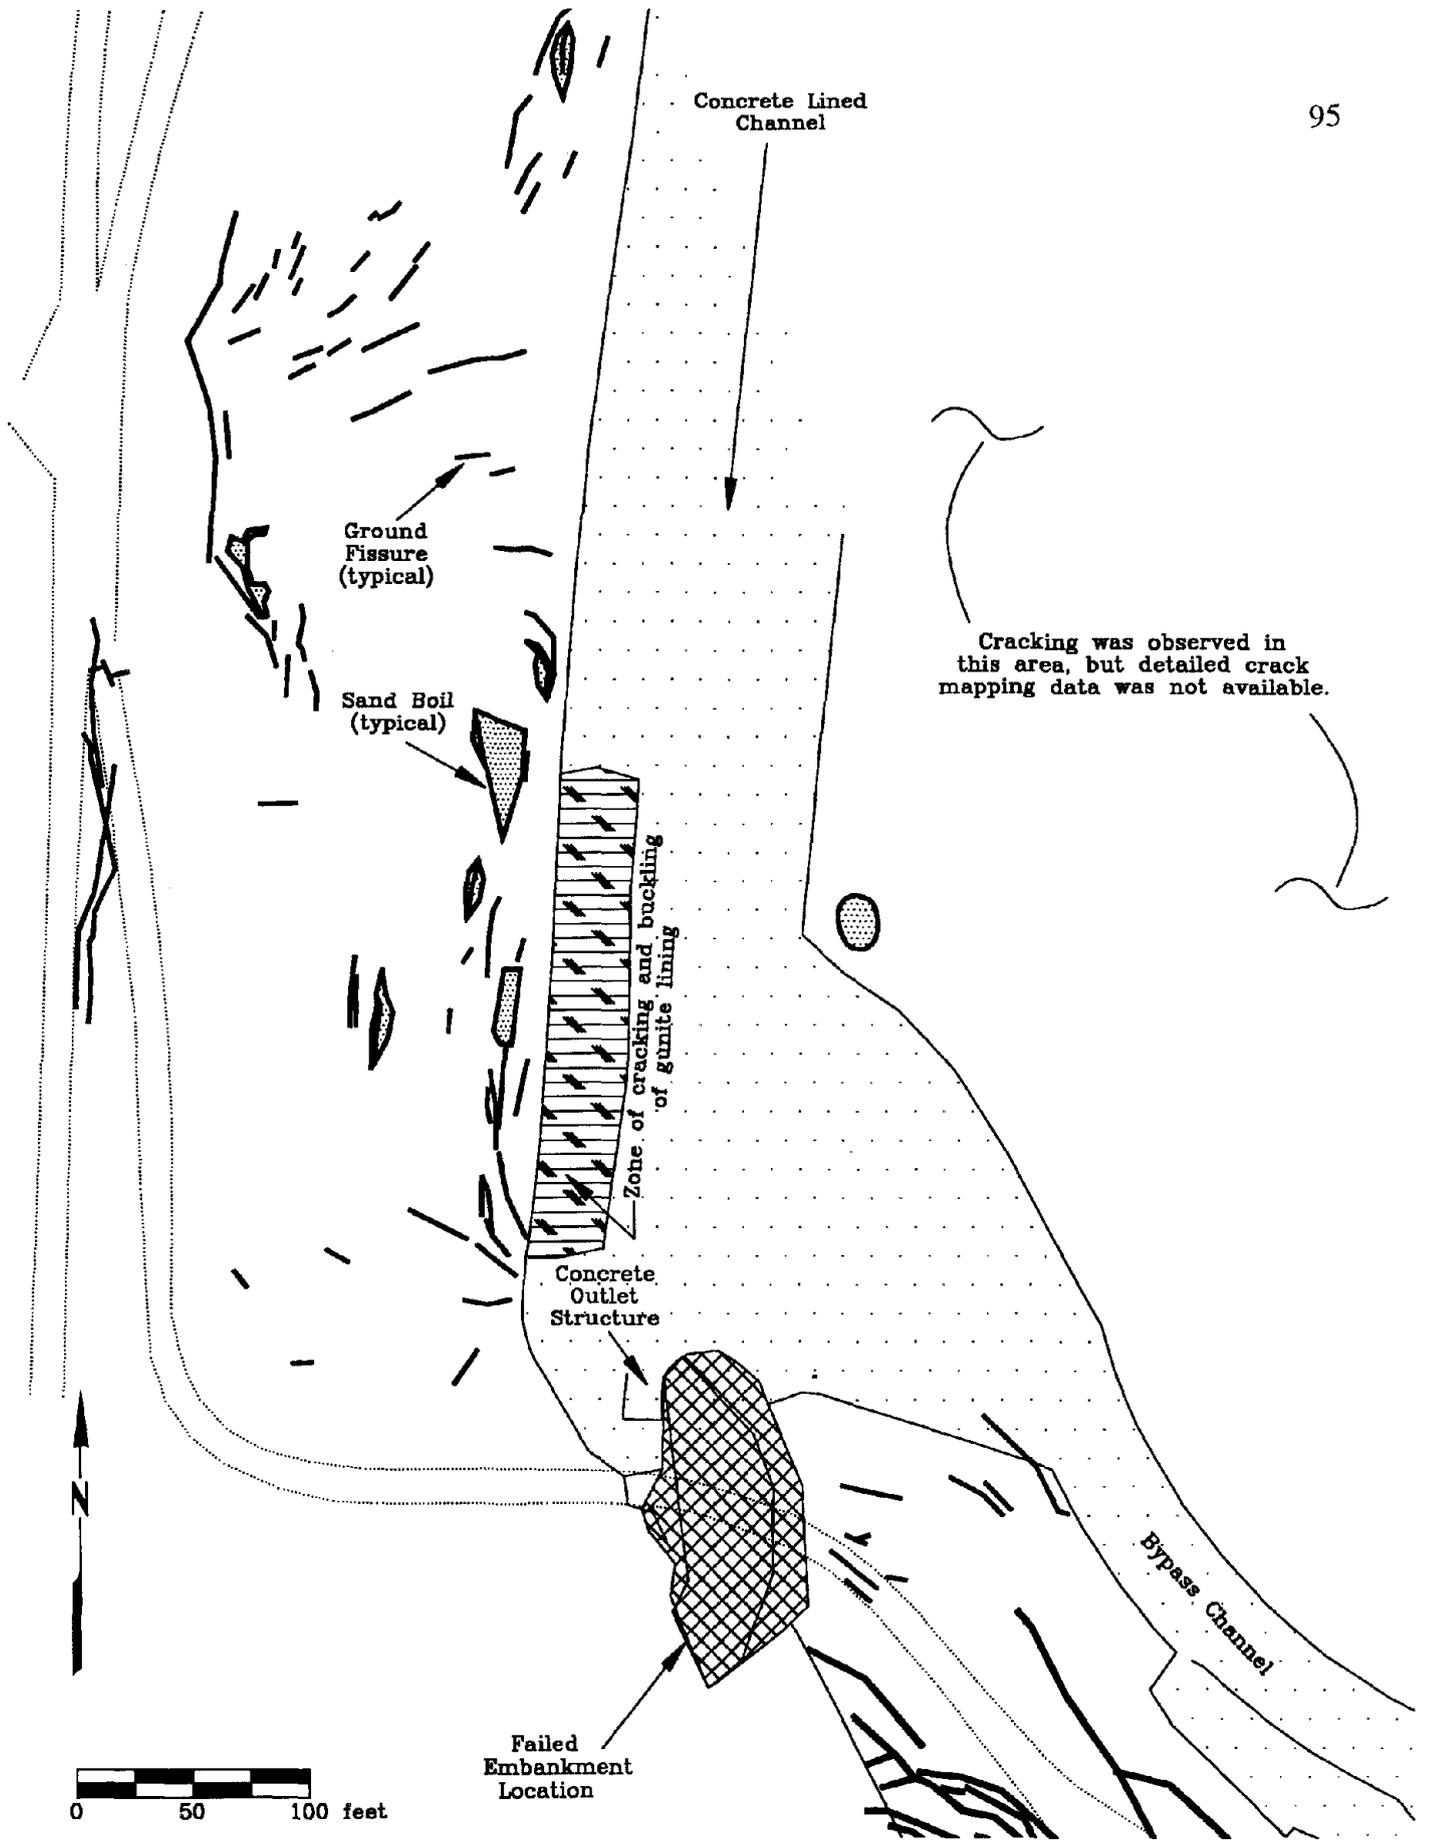
Fig. 4.30: Map of San Fernando Power Plant Tailrace facility showing locations of embankment breach and cracks induced by lateral spreading during the Northridge Earthquake. (data courtesy of Los Angeles Department of Water and Power)

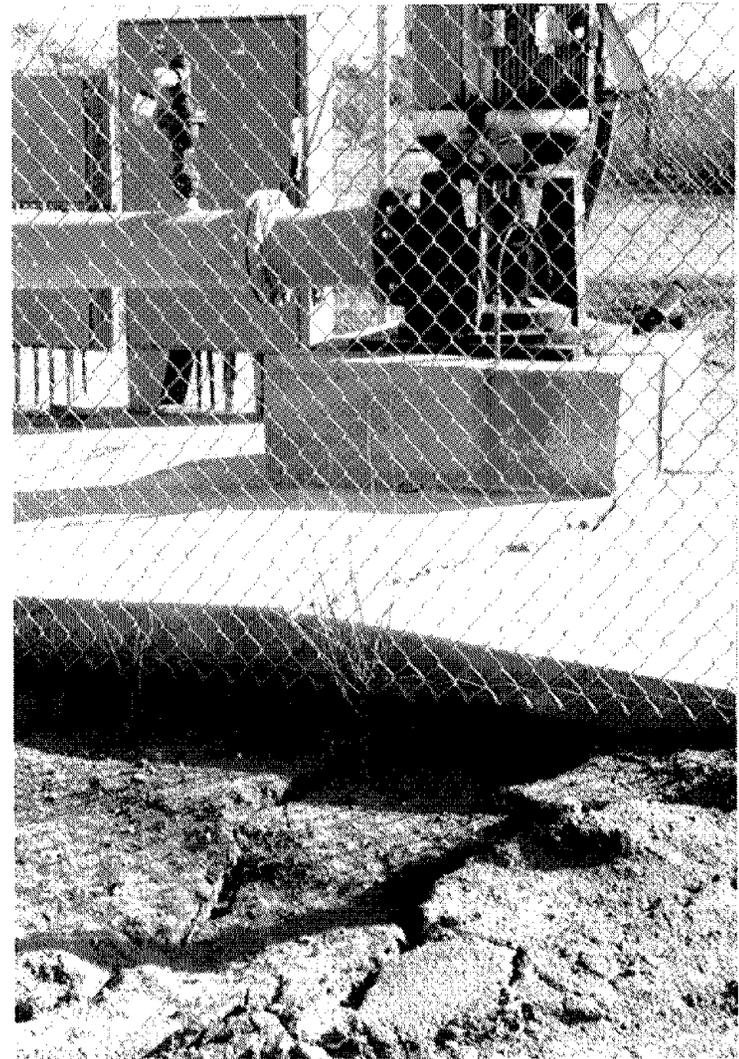
Fig. 4.70: Slab at water well buckled by lateral spreading near the Santa Clara River, Santa Clarita (photo courtesy of Valencia Water Company)

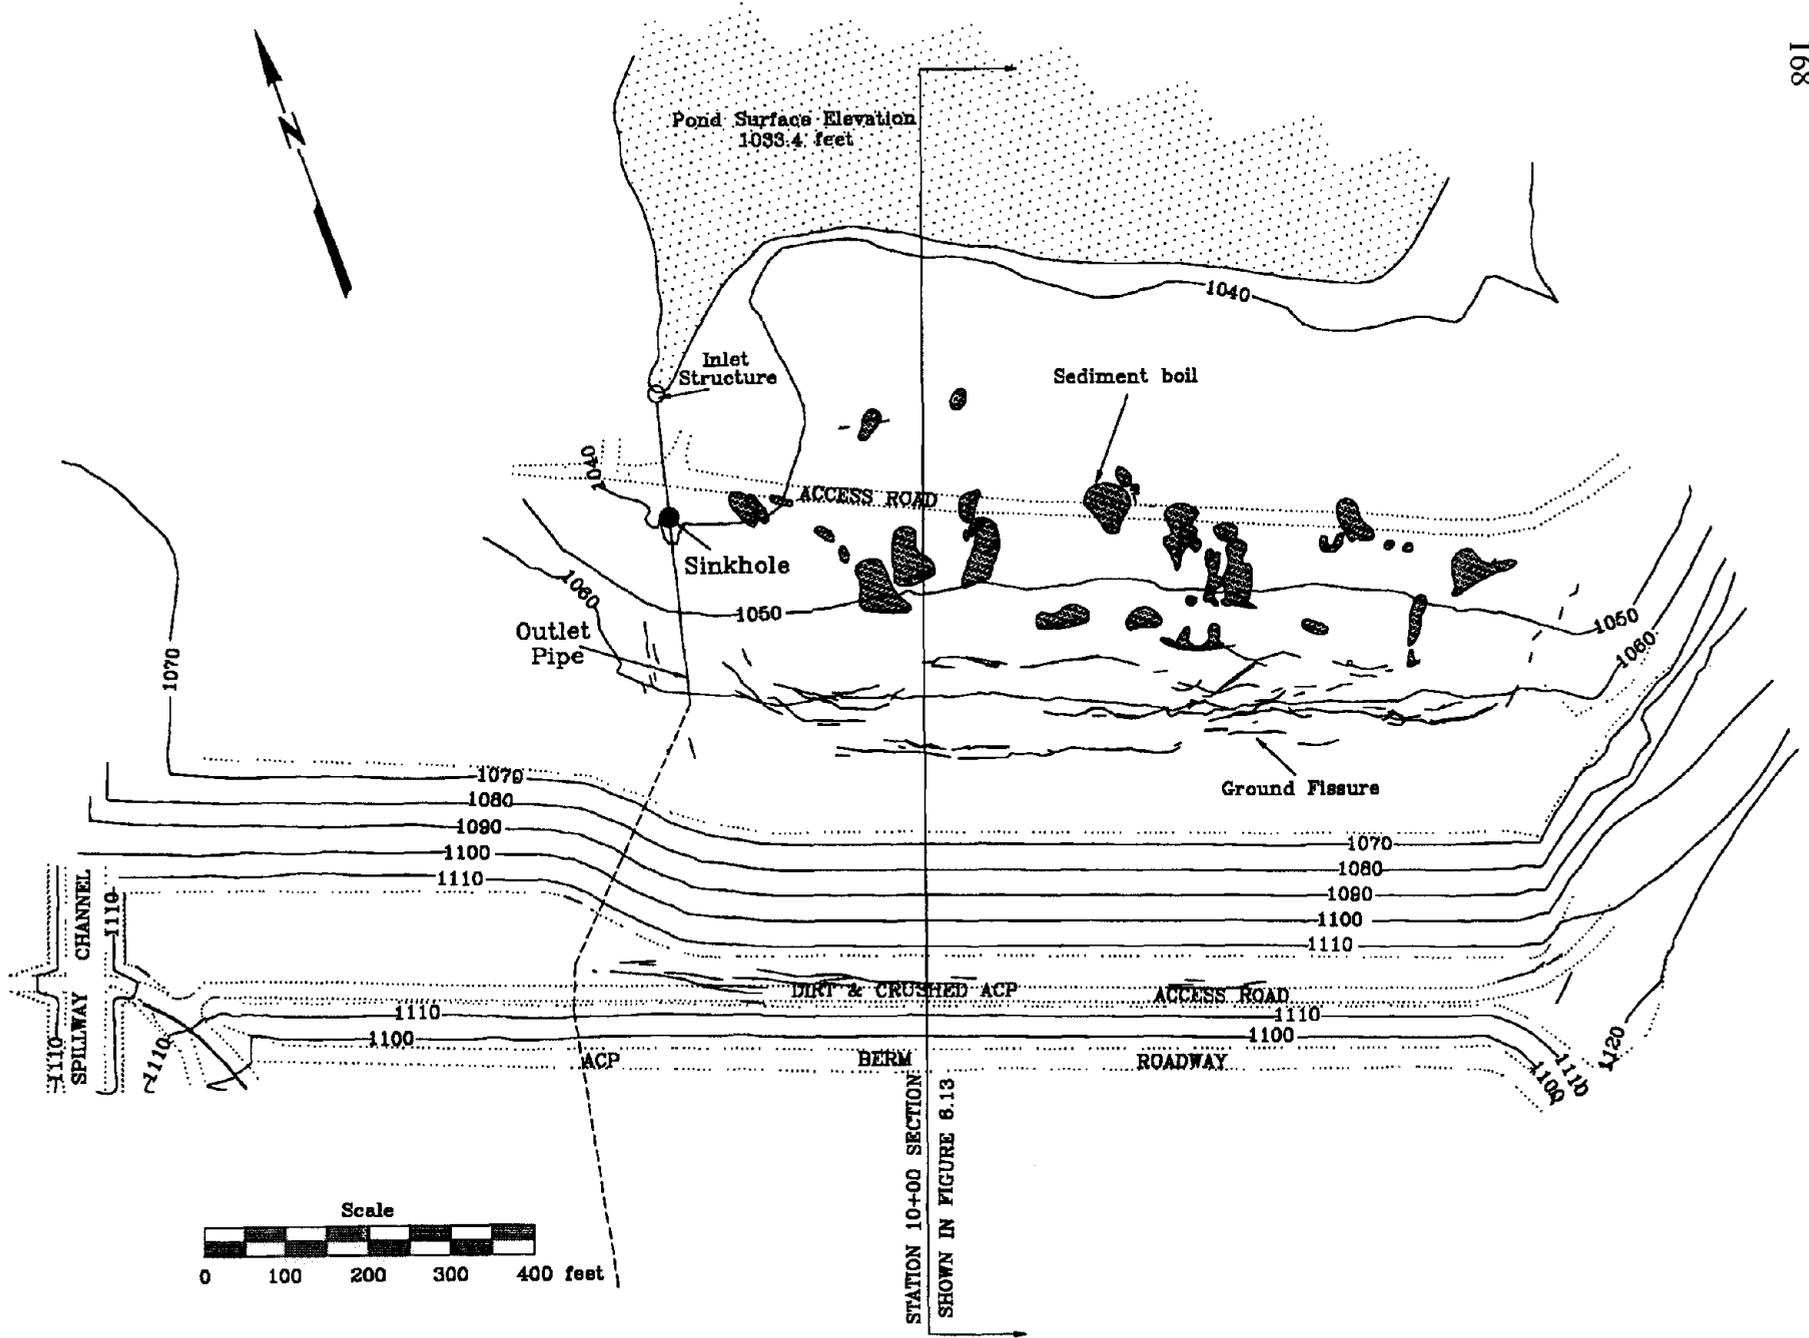
Fig. 6.18: Plan view of Lower San Fernando Dam showing locations of cracking and sediment boils (data courtesy Los Angeles Department of Water and Power)

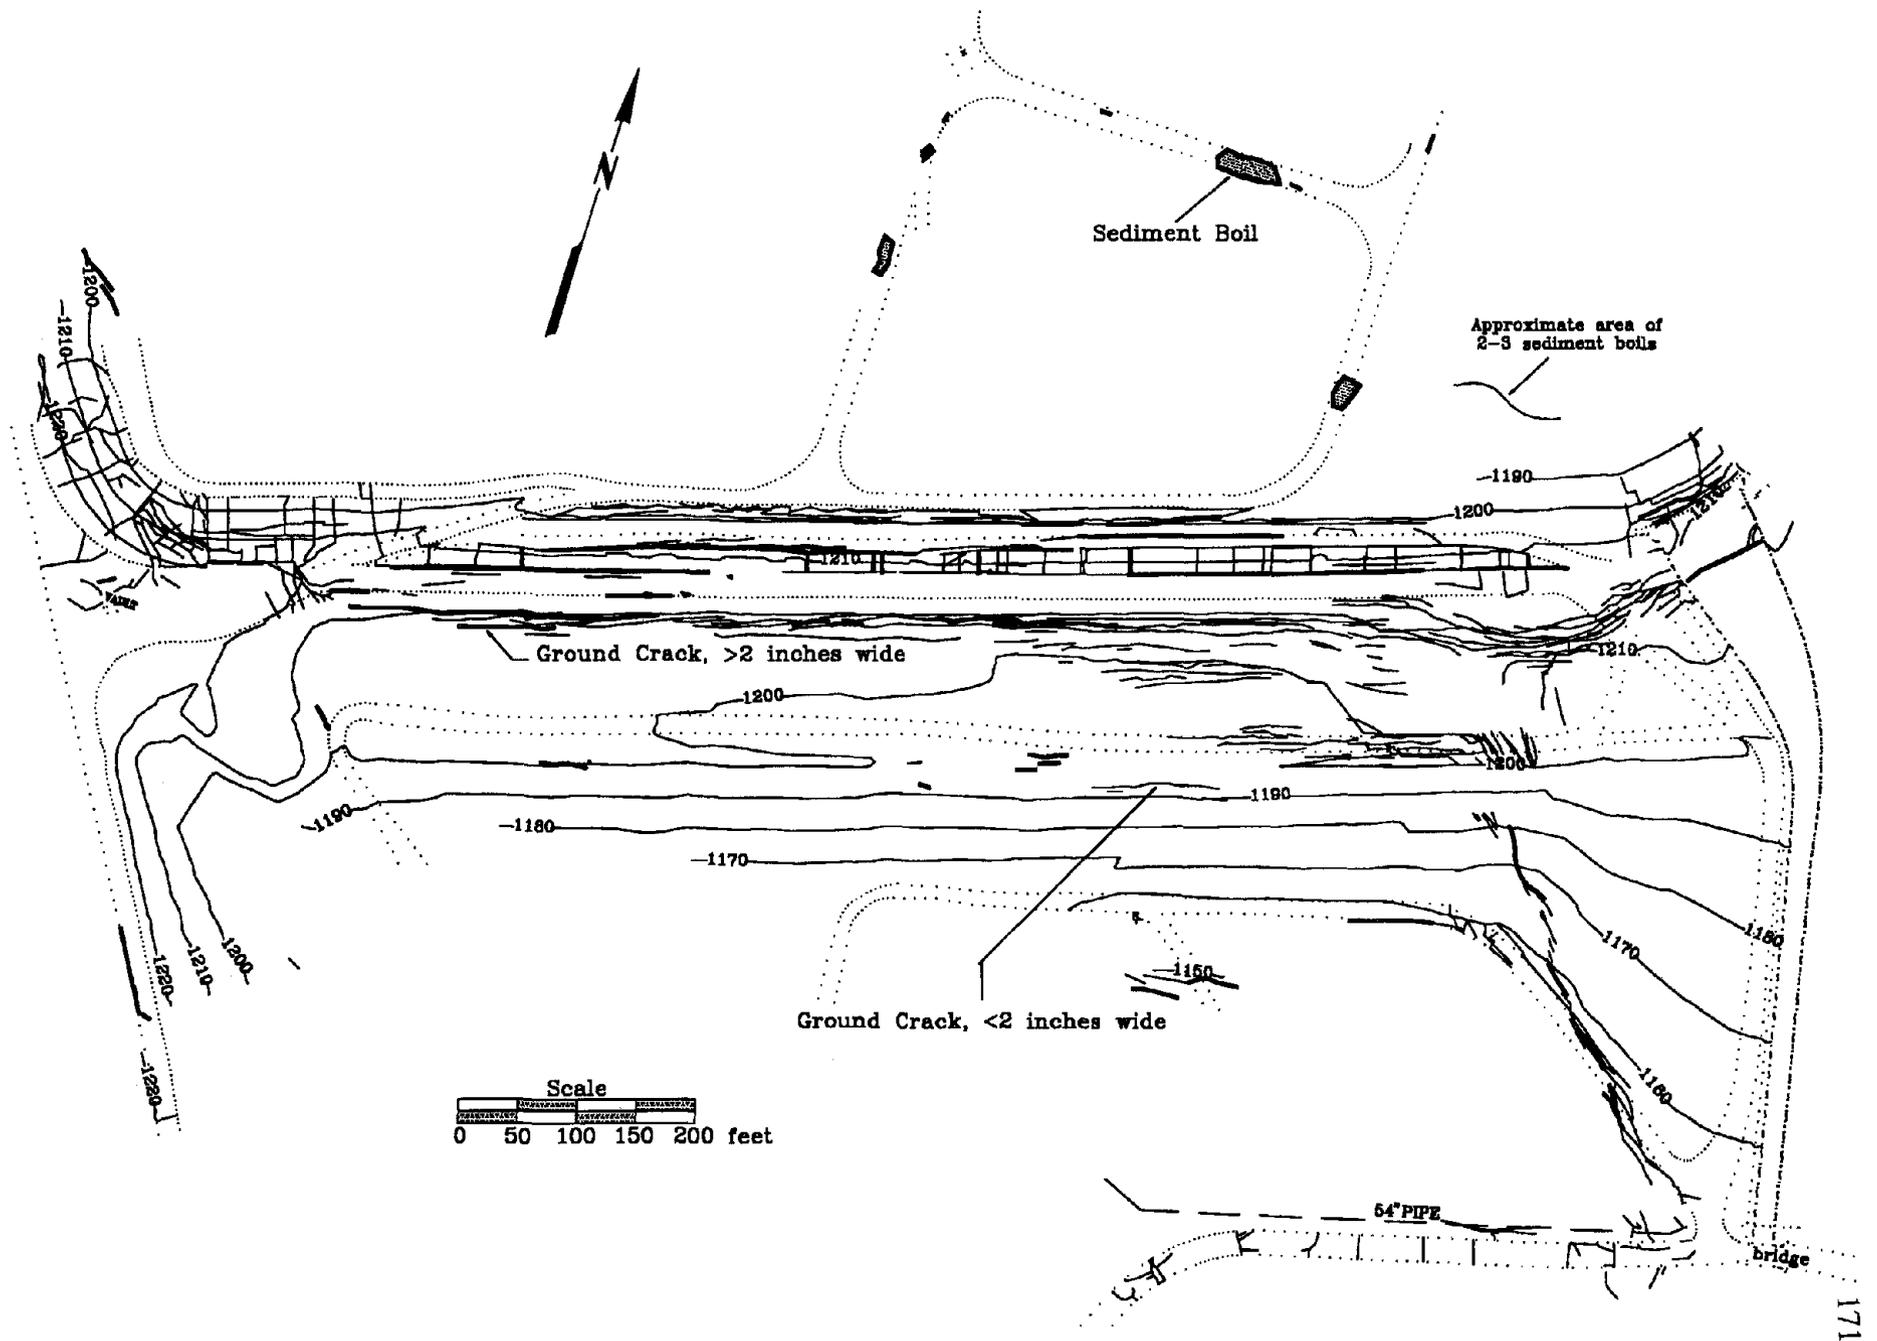
Fig. 6.23: Plan view of Upper San Fernando Dam showing locations of cracking and sediment boils (data courtesy Los Angeles Department of Water and Power)

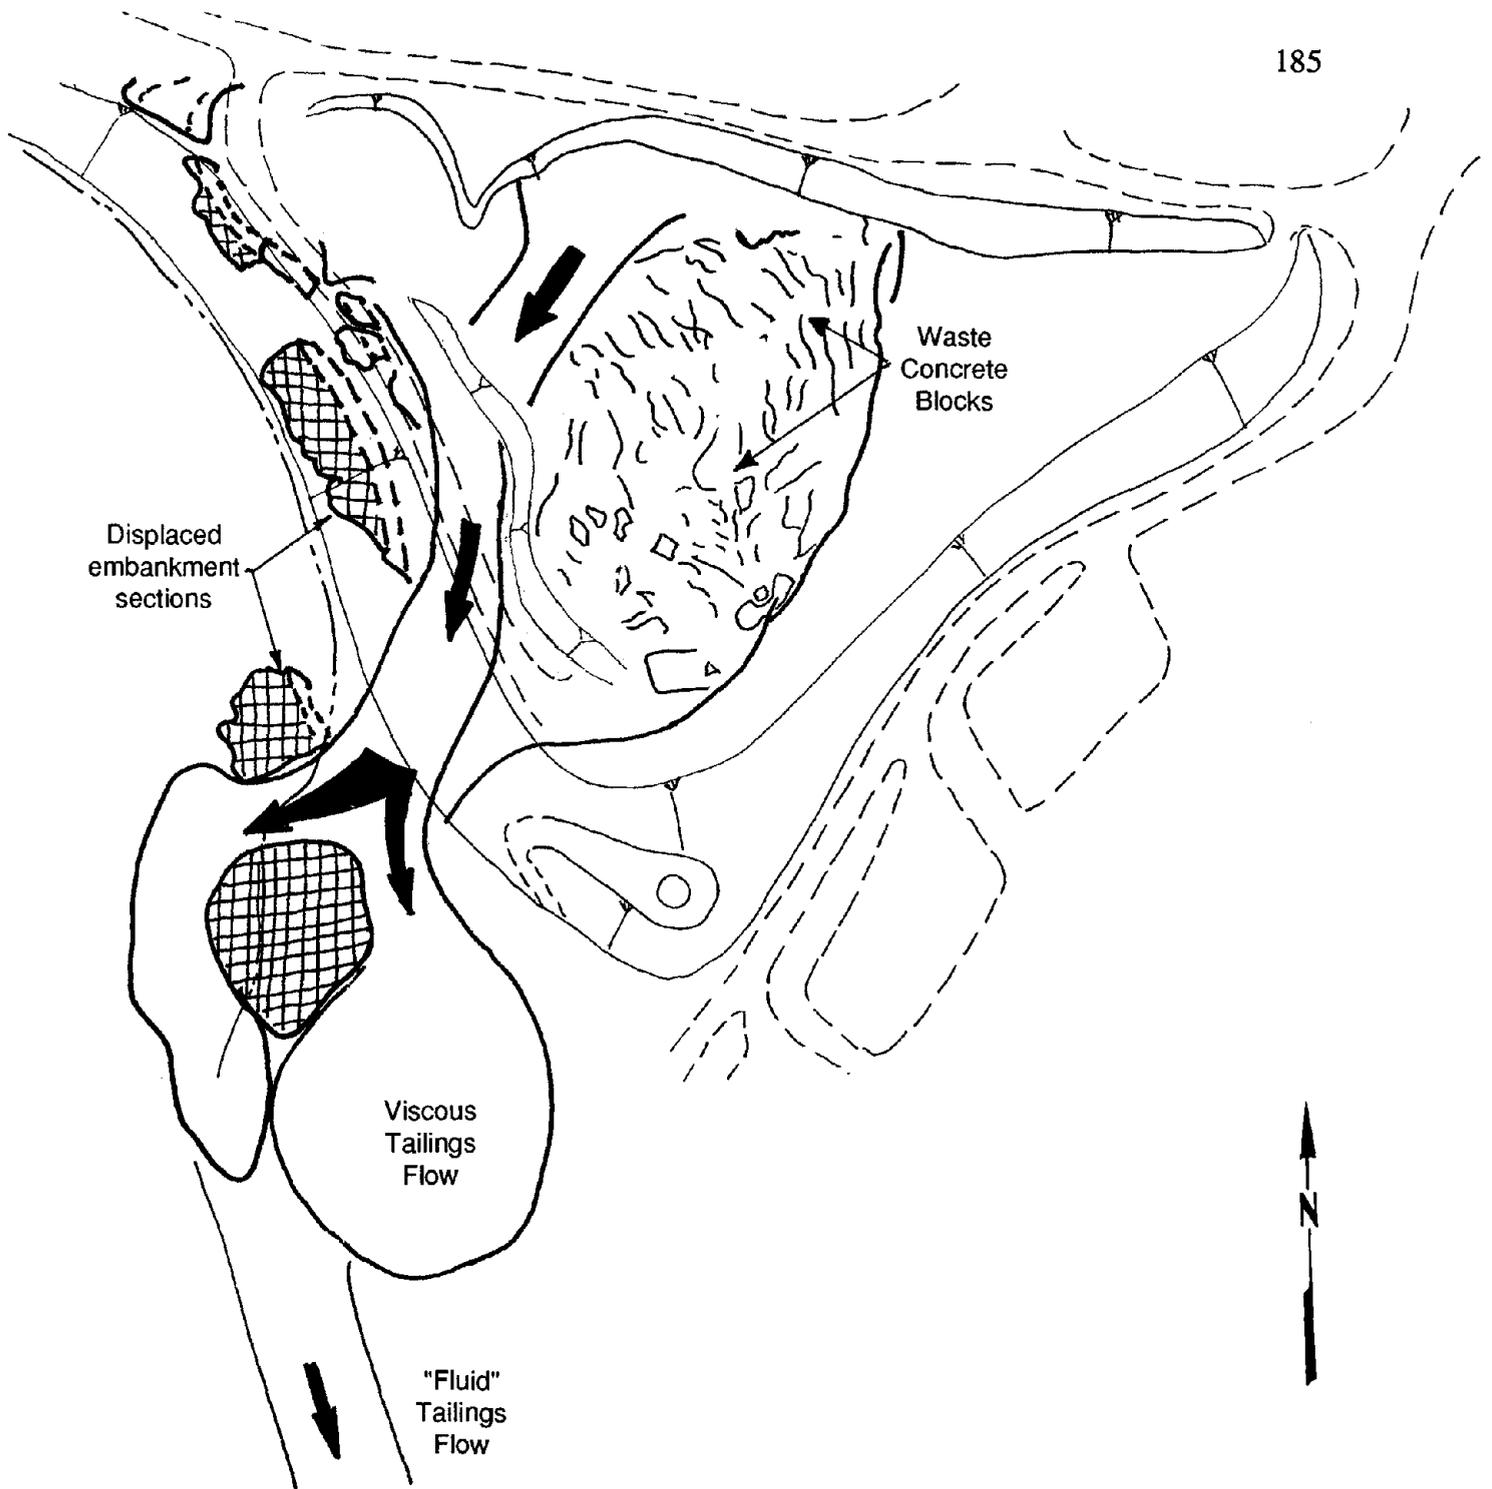
Fig. 6.40: Schematic of Tapo Canyon Tailings Dam failure and resulting flow slide

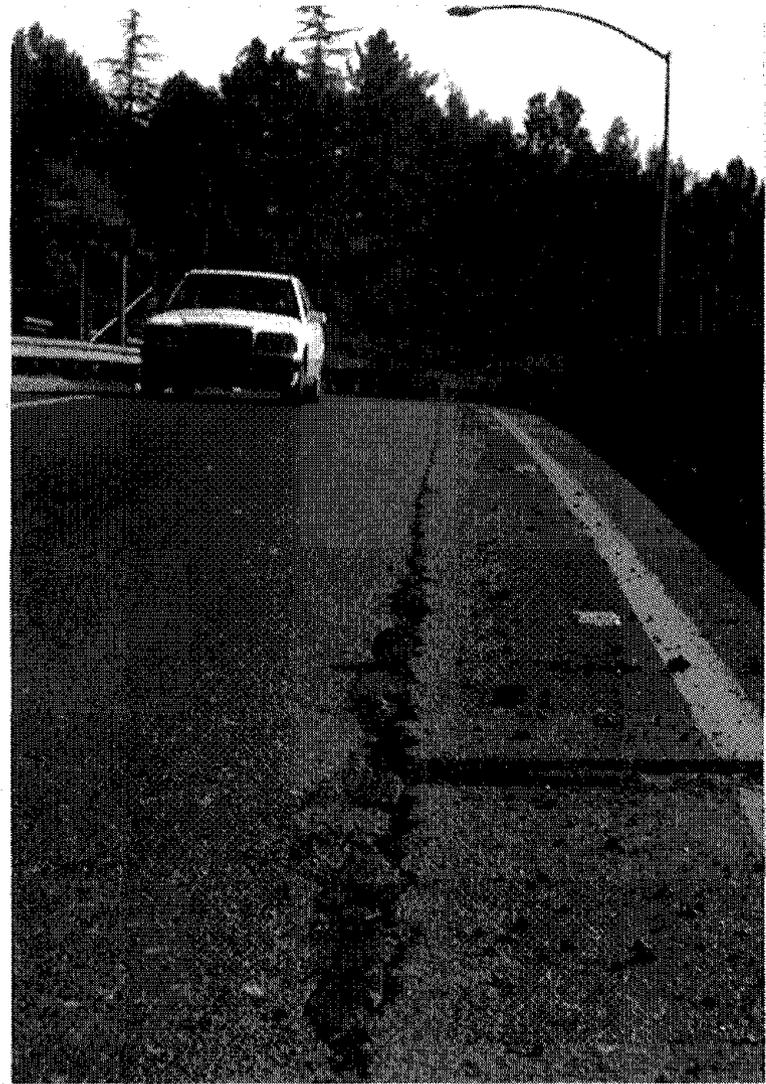
Fig. 6.63: Close-up of crack behind the southern-most crib wall at Universal Center Drive Overcrossing
