**The Northridge, California Earthquake
of January 17, 1994:
Performance of Gas Transmission Pipelines**

T.D. O'Rourke and M.C. Palmer
Cornell University
School of Civil and Environmental Engineering
Ithaca, New York 14853

Technical Report NCEER-94-0011

May 16, 1994

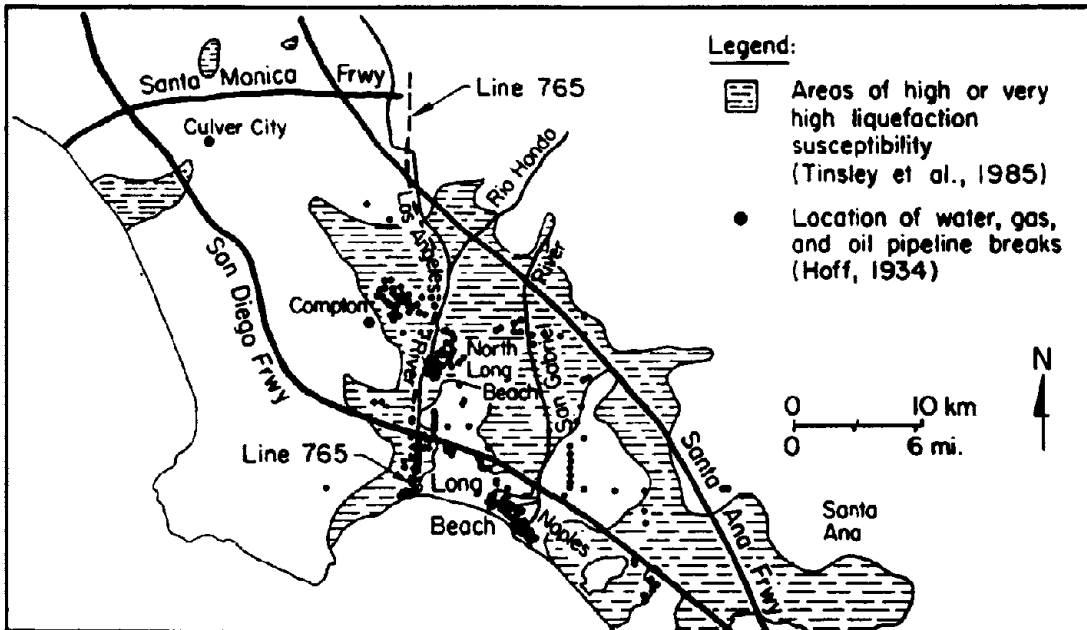
FIGURE 2-1. Pipeline Damage Caused by the 1933 Long Beach Earthquake [adapted from Hoff, 1934]

As shown in Figure 2-1, the areas with the greatest number of repairs were the mouth of the San Gabriel River (Naples and North Seal Beach) and the North Long Beach/Compton/Clearwater area. About 85% of all plotted repairs fall within these areas of high and very high liquefaction susceptibility.

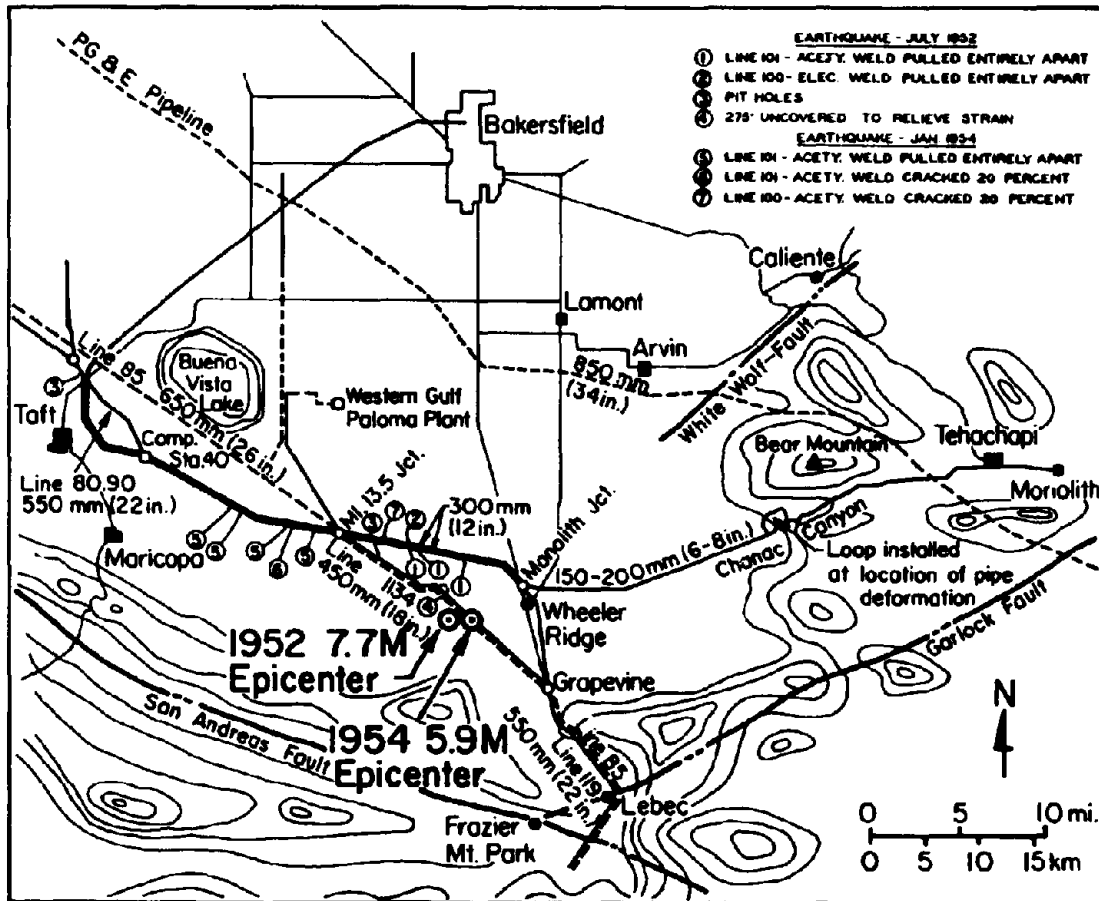
As shown on Figure 2-4, this quake parted the acetylene-welded line

FIGURE 2-4. Gas Pipeline Damage Caused by the 1952 and 1954 Kern County Earthquakes [adapted from Newby, 1954]

at four welds at locations marked 5, and cracked an acetylene weld 20% at location marked 6, and on the electric-welded line, a lone acetylene weld cracked 20% at location 7."

(referred to as a loop in Figure 2-4) was installed to provide a parallel emergency path. The original was kept in service without any repairs.

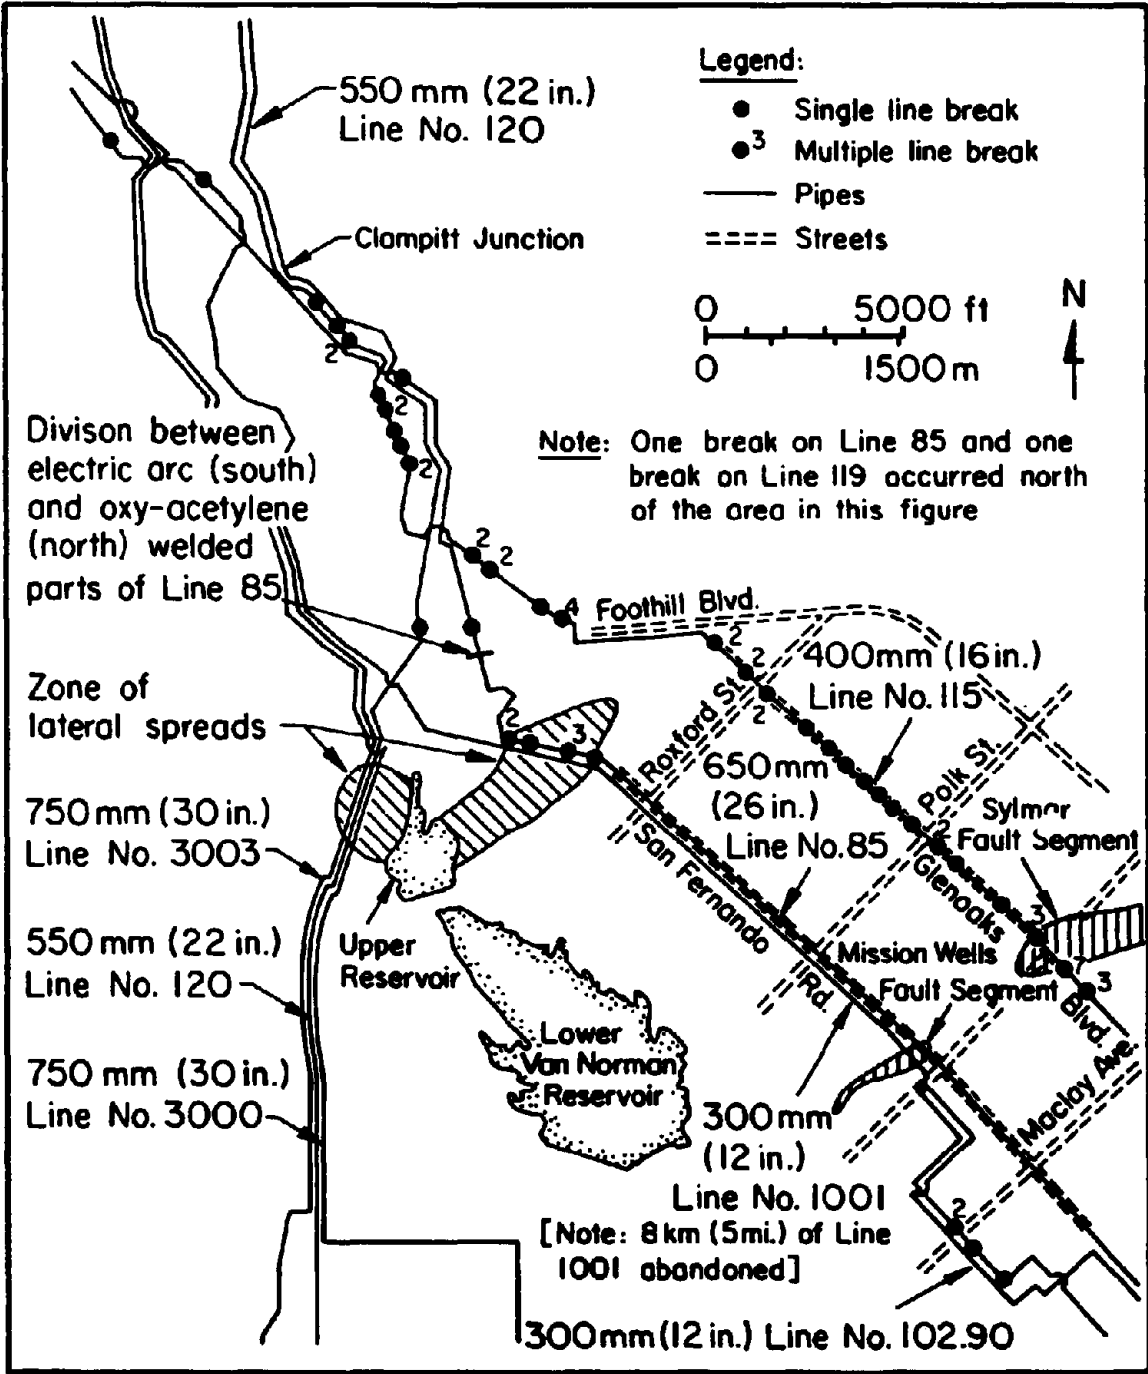
FIGURE 2-5. Locations of Gas Pipeline Damage, Lateral Spreads, and Fault Segments Associated with the 1971 San Fernando Earthquake [adapted from Southern California Gas Company, 1973]

in Subsection 2.3.3. The pipeline was damaged at three other locations north of the division, of which only two are shown in the figure. All damage north of the division was at original oxy-acetylene welds, and no repairs were made at joints in this area which were reinforced in 1932 with electric arc welding procedures. No difficulties were experienced where the line crossed the Mission Wells segment of the fault.

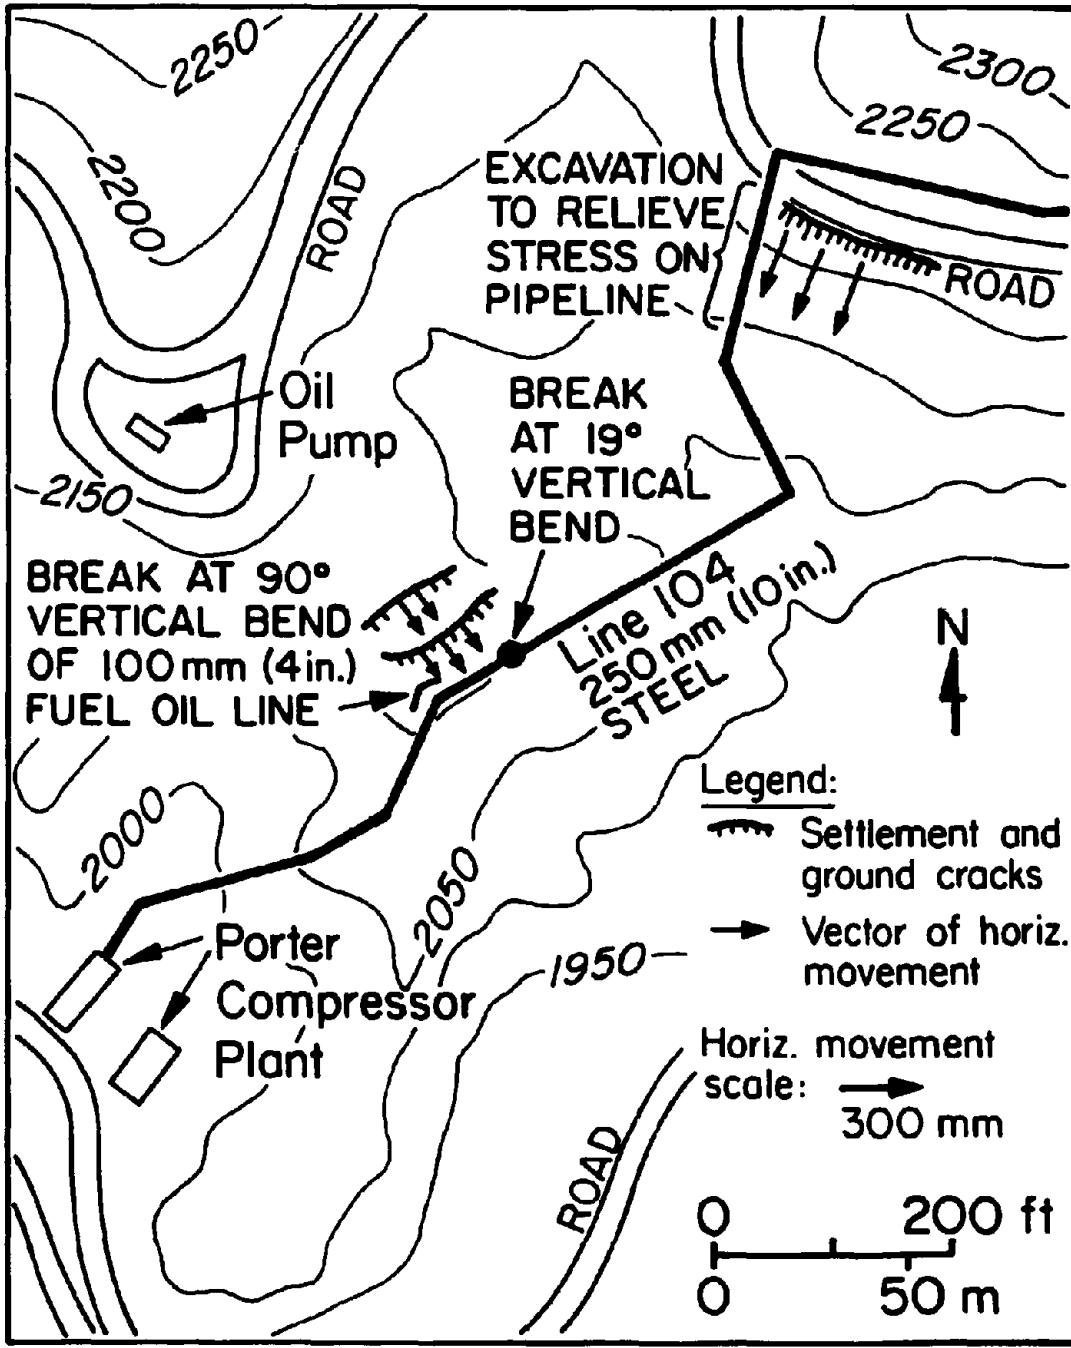
As shown in Figure 3-1, there was a break in Line 104 inside the Aliso Canyon Gas Storage Field. The pipeline is 250 mm (10 in.) in diameter and has an MAOP of 1.6 MPa (228 psi). It was constructed with electric arc girth welds in 1941. The pipe has a 5.2-mm- (0.203-in.)-thick wall of unknown grade steel.

FIGURE 3-5. Plan View of Line 104 in the Aliso Canyon Gas Storage Field

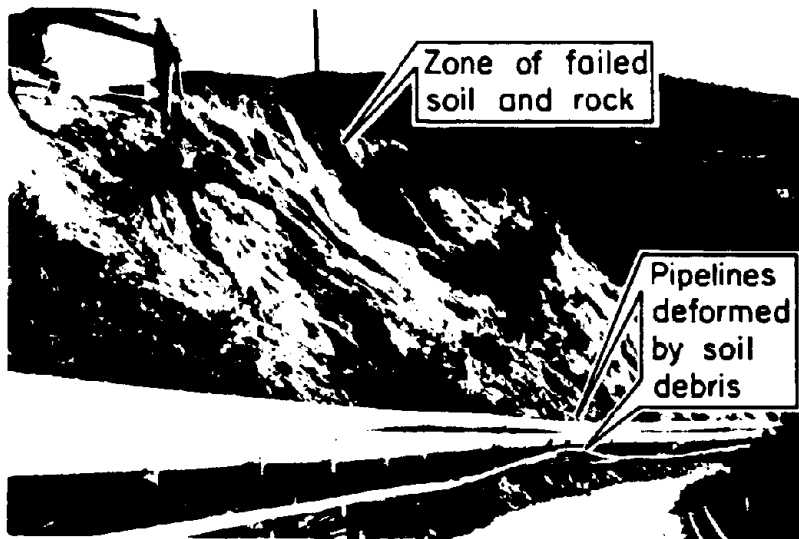
There were numerous landslides throughout the facility. Figure 3-7 shows a landslide of approximately 380 m³ (500 yd³) which undermined an injection line near the top of the slope. Debris from the slide caused deformation of two withdrawal lines and an injection line, which are located adjacent to the roadway shown in

FIGURE 3-7. Local Landslide in Sandstone and Overlying Soil at the Aliso Canyon Gas Storage Field

the photograph. The landslide illustrated in the photo was typical of ground displacements in several locations. The slide was activated along joints dipping at approximately 60° subparallel to the 45° slope. The rock is friable sandstone of the Topanga Formation.

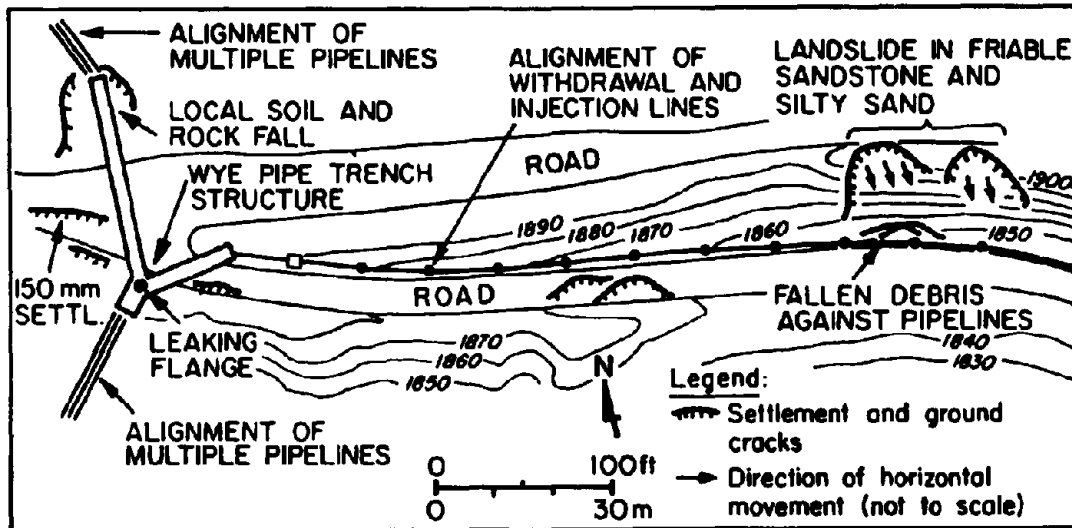
With the exception of a leaking flange in an area of slope movement, there were no leaks or ruptures of aboveground withdrawal and injection pipelines. Serious damage to aboveground pipes was scarce, even though there were many deformed pipe supports and sections of line undermined and distorted by local landslides. The presence of large ground cracks and the potential for further ground movement are likely to require continuing remedial action to stabilize slopes and protect vulnerable pipes.

FIGURE 3-8. Plan View of Wye Pipe Trench Structure and Aboveground Pipelines Influenced by Local Landslide Activity at Aliso Canyon

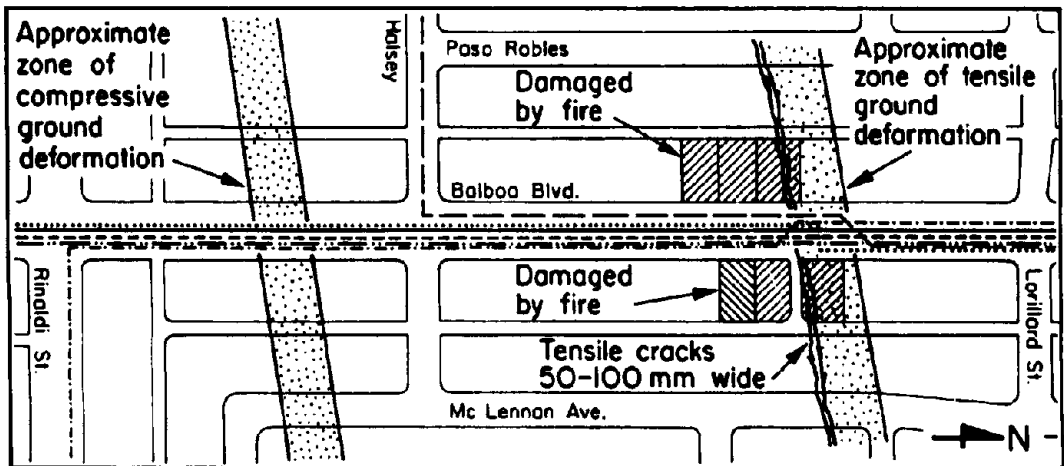
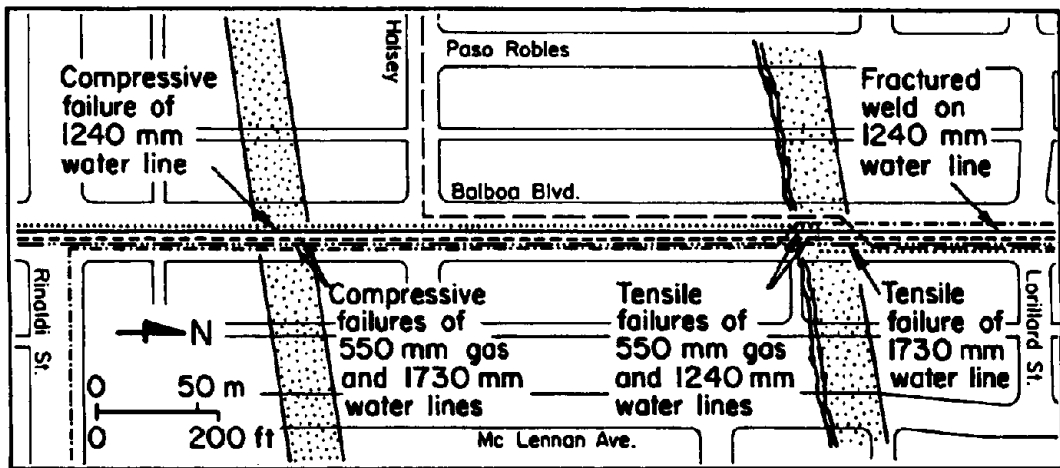
Figures 3-9 and 3-10 show maps of the pipelines in Balboa Blvd. near the zones of permanent ground deformation. In addition to numerous distribution mains, there were six transmission and water trunk lines at this site. There were two 750-mm- (30-in.)-diameter gas transmission lines constructed of X-52 steel in the 1950s which were not damaged. There was a 400-mm- (16-in.)-diameter petroleum pipeline, operated by the Mobil Oil Corporation, which was not damaged. The pipeline was composed of X-52 steel and installed in 1991. Two water trunk lines, the 1,240-mm- (49-in.)-diameter Granada and the 1,730-mm- (68-in.)-diameter Rinaldi Trunk Lines, failed in tension and compression in the tensile and compressive zones of ground deformation, respectively.

FIGURE 3-9. Map of Major Pipelines, Fire Damage, and Ground Deformation on Balboa Boulevard

FIGURE 3-10. Map of Major Pipelines, Ground Deformation Zones, and Locations of Pipeline Damage on Balboa Boulevard

A 150-mm- (6-in.)-diameter gas distribution pipeline along the eastern side of Balboa Blvd. was ruptured in tension and compression in the tensile and compressive ground deformation zones, respectively. This pipeline was operated at a pressure of approximately 0.3 MPa (45 psi). Gas escaping from the tensile rupture caught fire.
