REPORT NO.
UCB/EERC-95/11
OCTOBER 1995

STUDIES IN STEEL MOMENT RESISTING BEAM-TO-COLUMN CONNECTIONS FOR SEISMIC-RESISTANT DESIGN

BRENT BLACKMAN
EGOR P. POPOV

UCB/EERC-95/11
Earthquake Engineering Research Center
College of Engineering
University of California at Berkeley

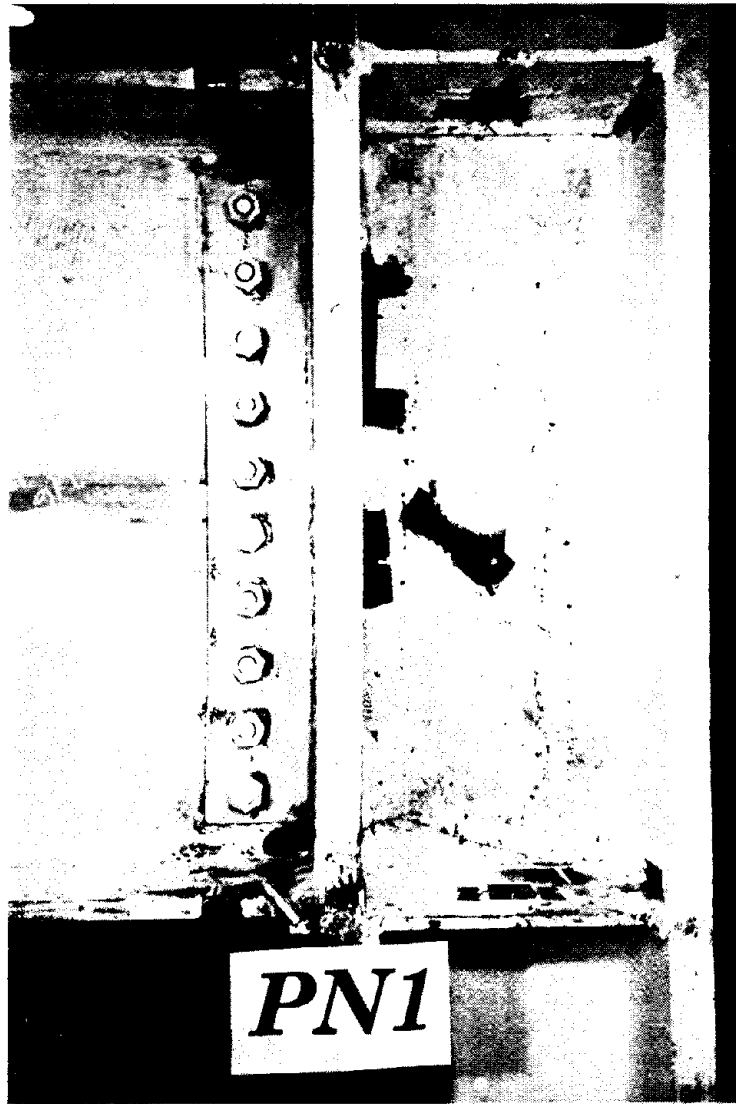
Figure 3-15. Specimen PN1 Joint after Test

is plotted in Figure 3-14. In general, the specimen failed in an abrupt manner near the end of the first 3-in. displacement cycle. The maximum plastic rotation and energy dissipated at failure were 0.94 percent and 1770 kip-in., respectively. Figure 3-15 shows the joint after the test.

The specimen failed near the end of the first 3-in. displacement cycle by brittle fractures in the column flange and panel zone neighboring the bottom beam flange. The failure was associated with a loud noise and sudden loss of approximately 150 kips of connection strength. The crack initiated at the backup bar that was left in place after the bottom beam flange was welded. The crack extended across the column flange width and crossed diagonally through its thickness into the panel zone. In the panel zone, the crack propagated approximately 10 in. vertically up the column k-region and 8 in. horizontally along the continuity plate. The test concluded subsequent to the column fracturing. Figures 3-16 through 3-19 show damaged locations following the test. Table 3 summarizes the performance of Specimen PN1. It should be noted that this is the first time a column flange failure was reproduced in a laboratory experiment.

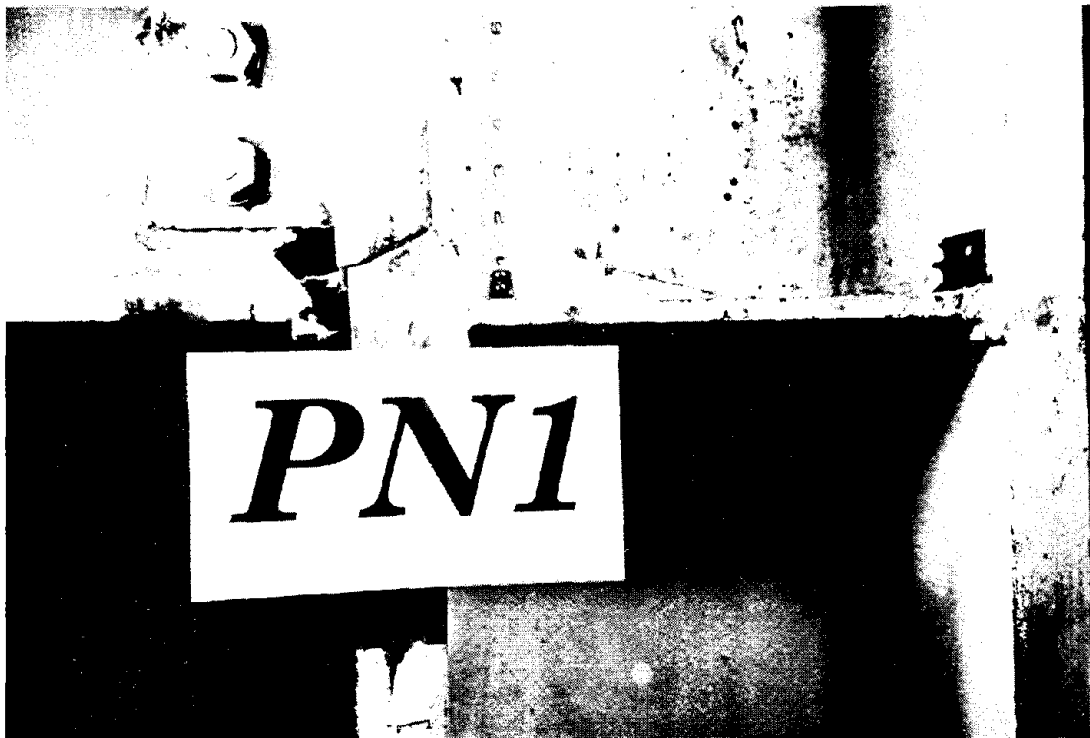
Figure 3-16. Failure of Column Flange at Bottom Groove Weld

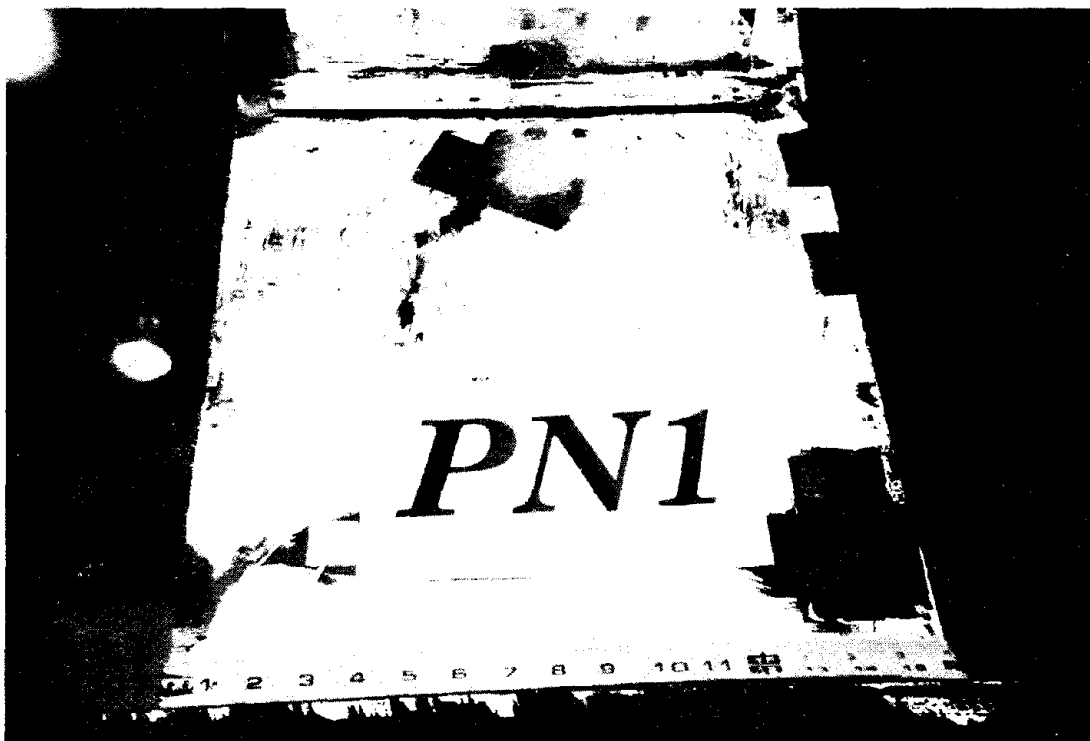
Figure 3-17. Separation Between Bottom Backup Bar and Column Flange

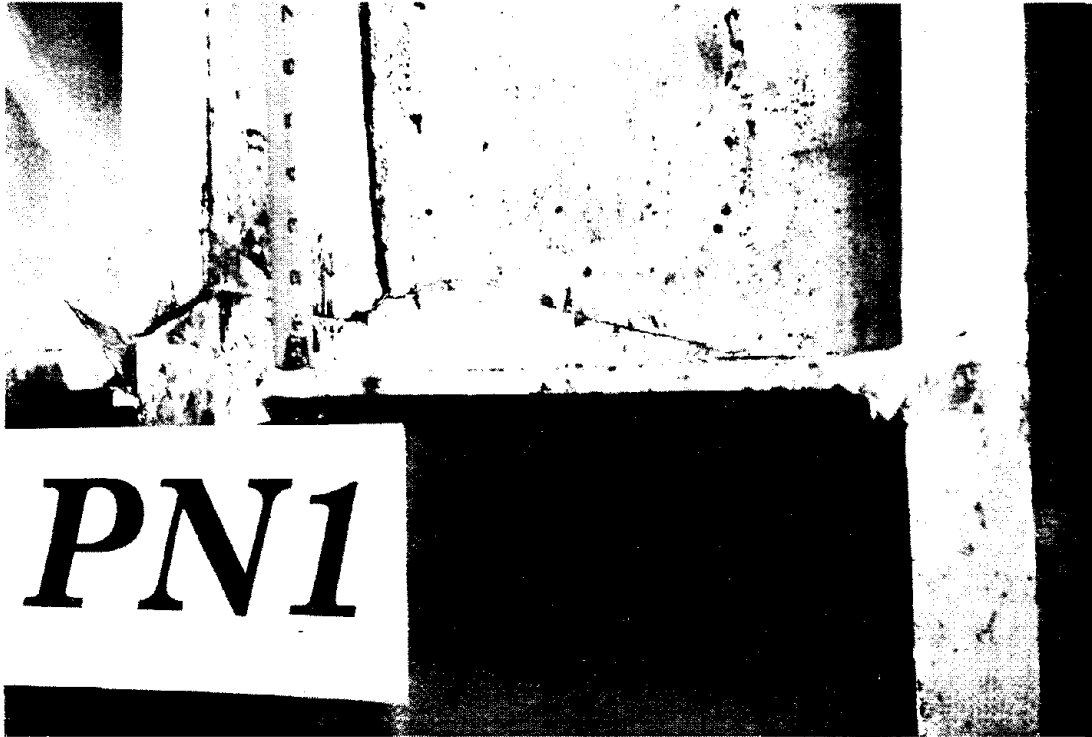
Figure 3-18. Cracks in Column Flange and Web

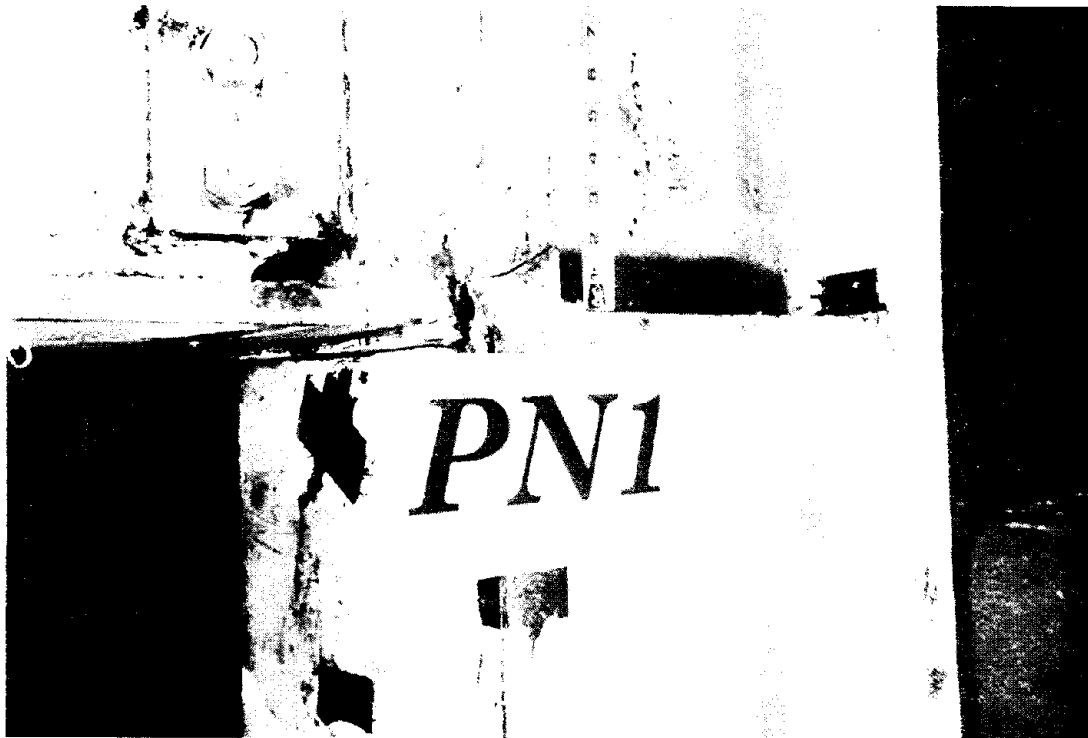
Figure 3-19. Crack in Column Flange

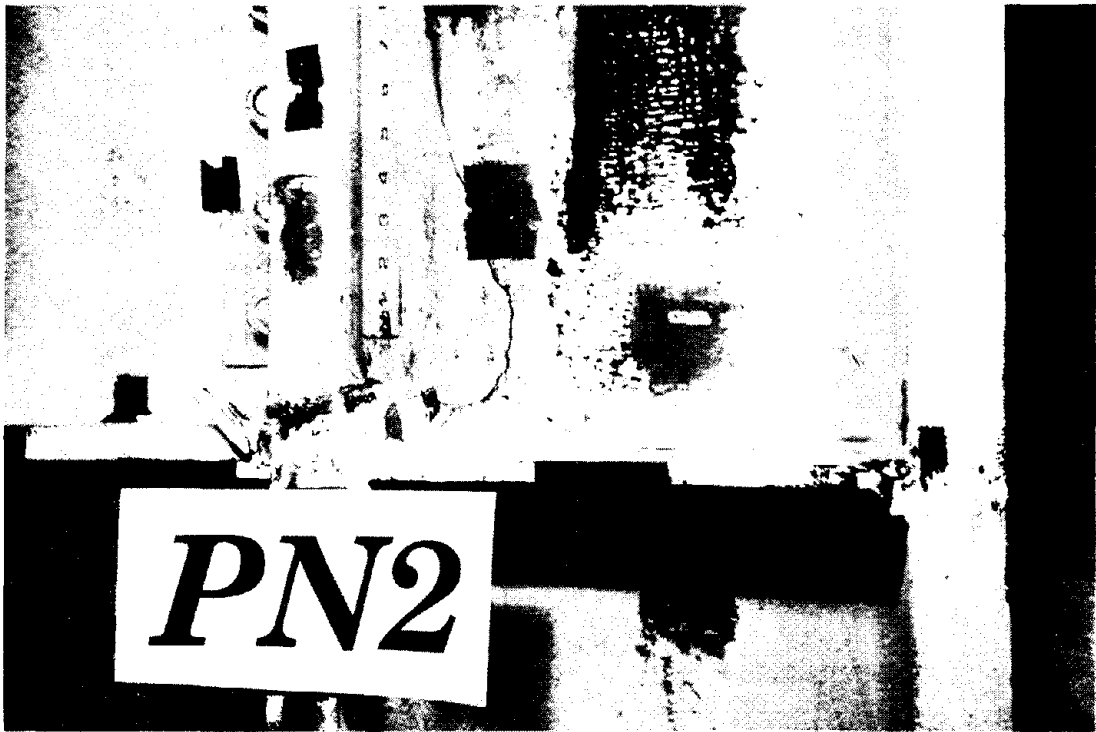
Figure 3-23. Cracks in Column Flange and Web Adjacent to Bottom Beam Flange

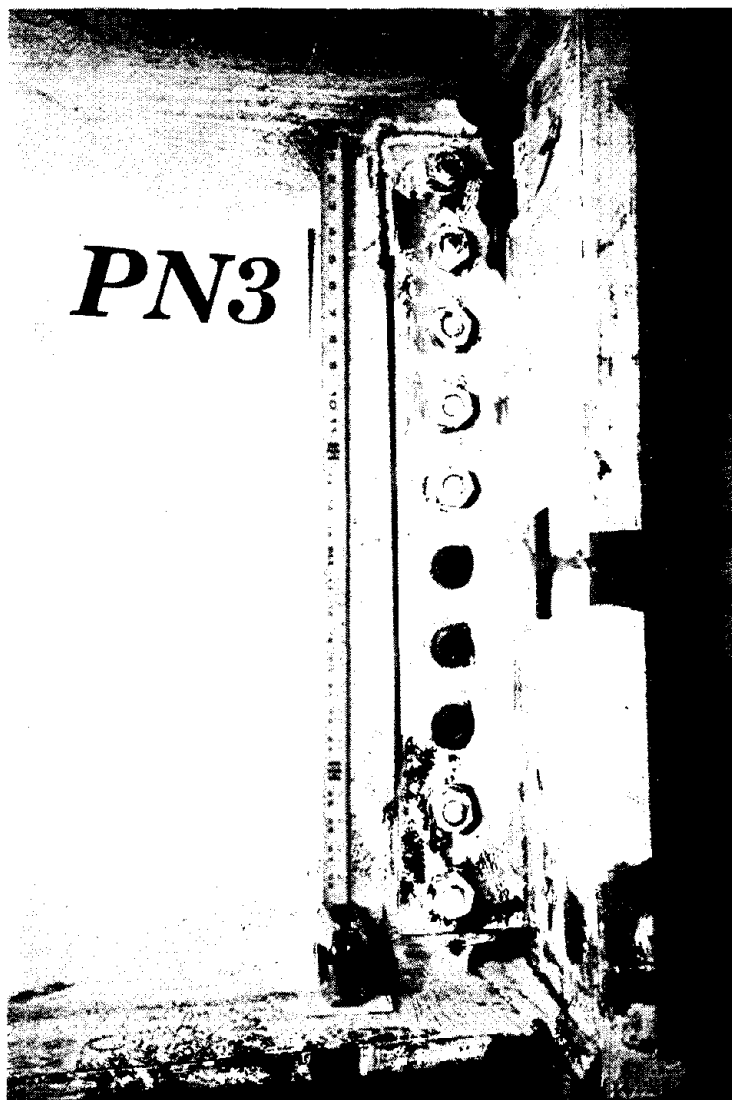
Figure 3-28. Damage to Shear Tab and Bottom Groove Weld

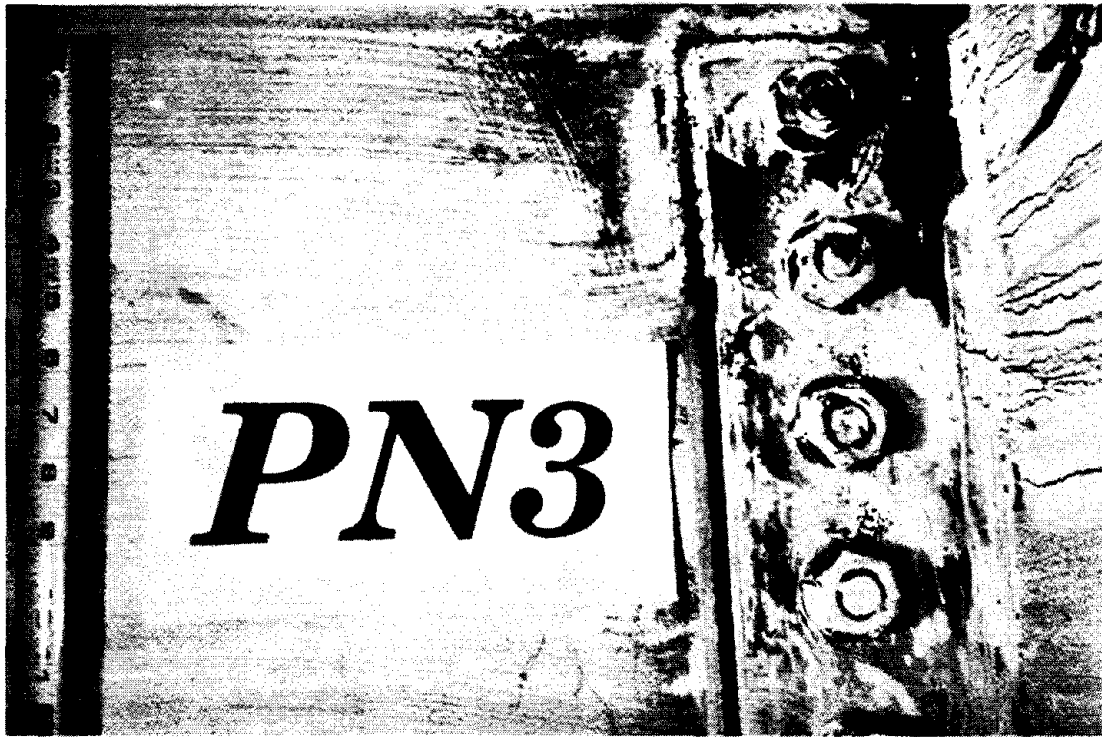
Figure 3-29. Tearing of Weld Return and Yielding at Top of Shear Tab

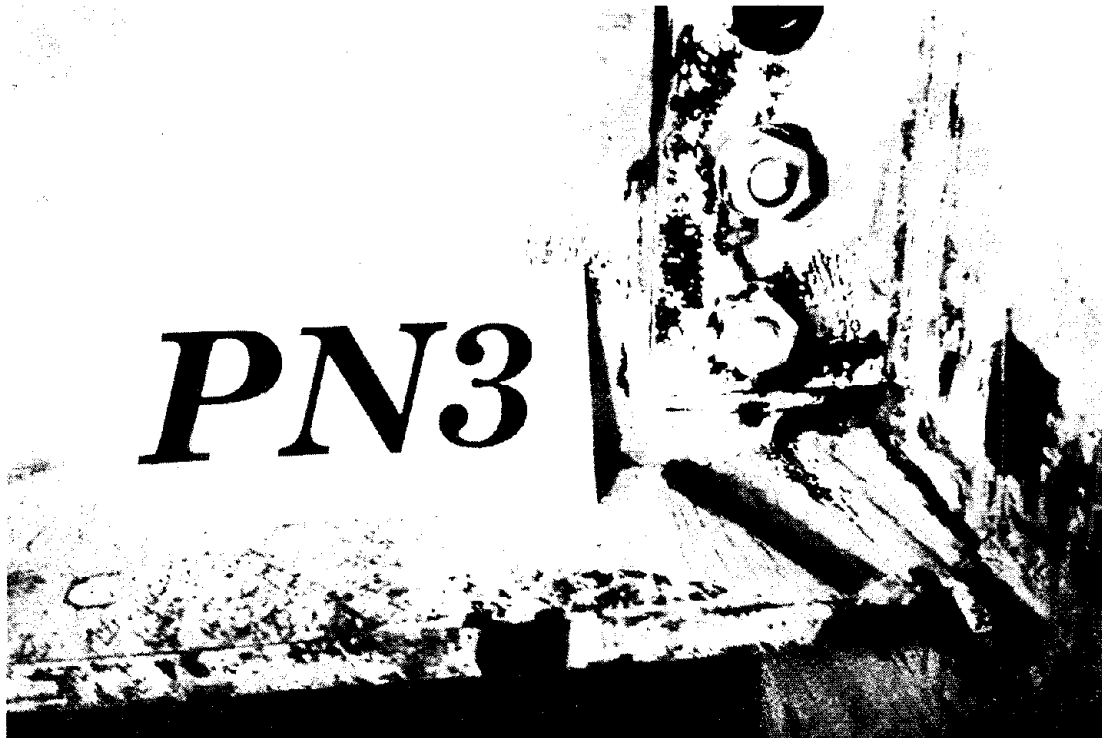
Figure 3-30. Brittle Failure of Shear Tab and Groove Weld at Bottom Flange

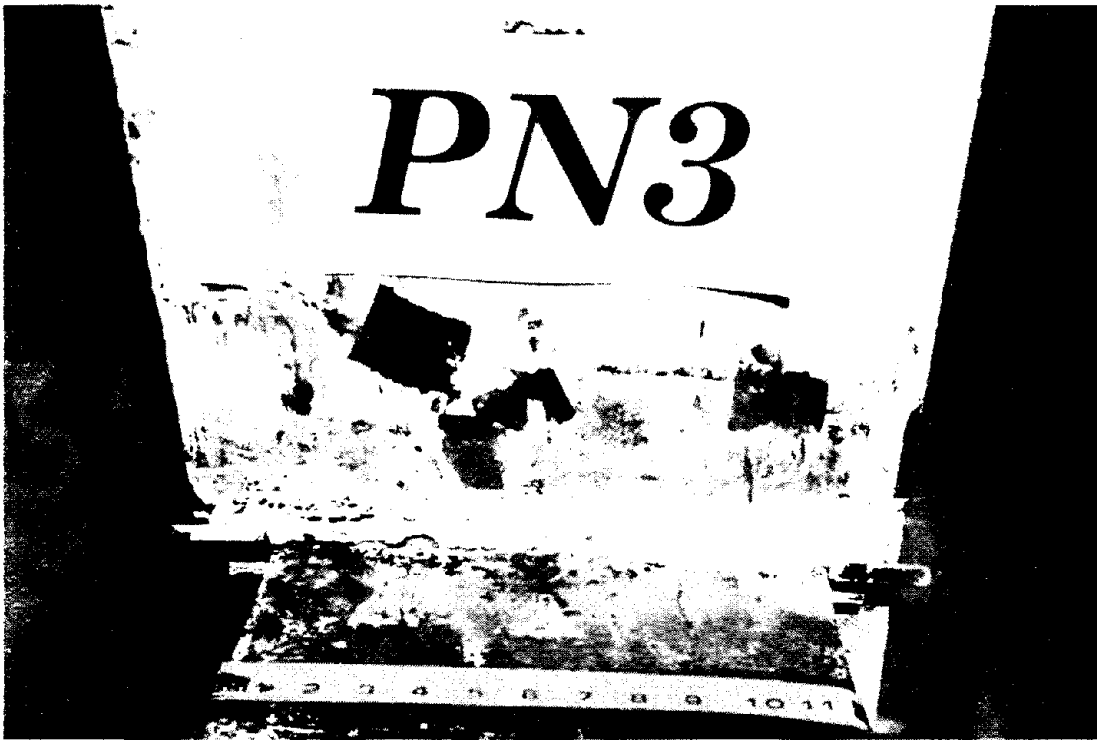
Figure 3-31. Gradual Tearing of Top Beam Flange Adjacent to Groove Weld

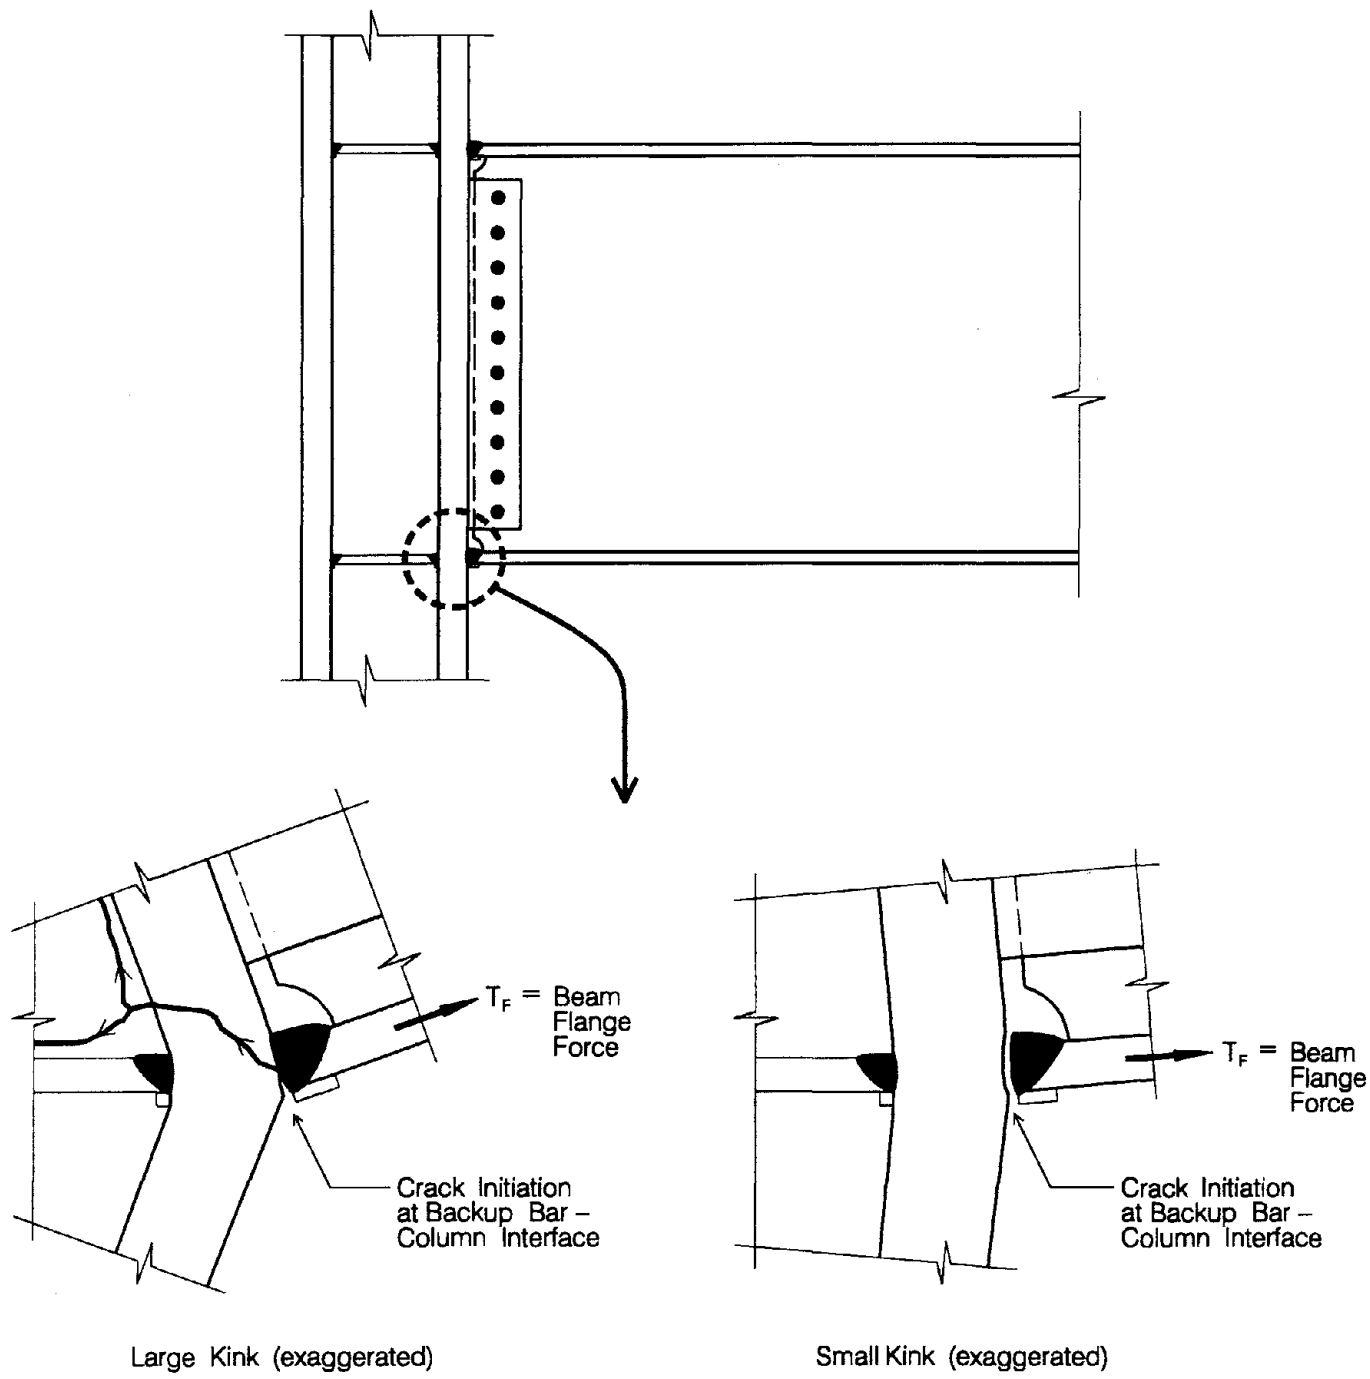
**Figure 3-33a. Specimens PN1 and PN2
Crack Propagation.**

**Figure 3-33b. Specimen PN3
Crack Propagation.**

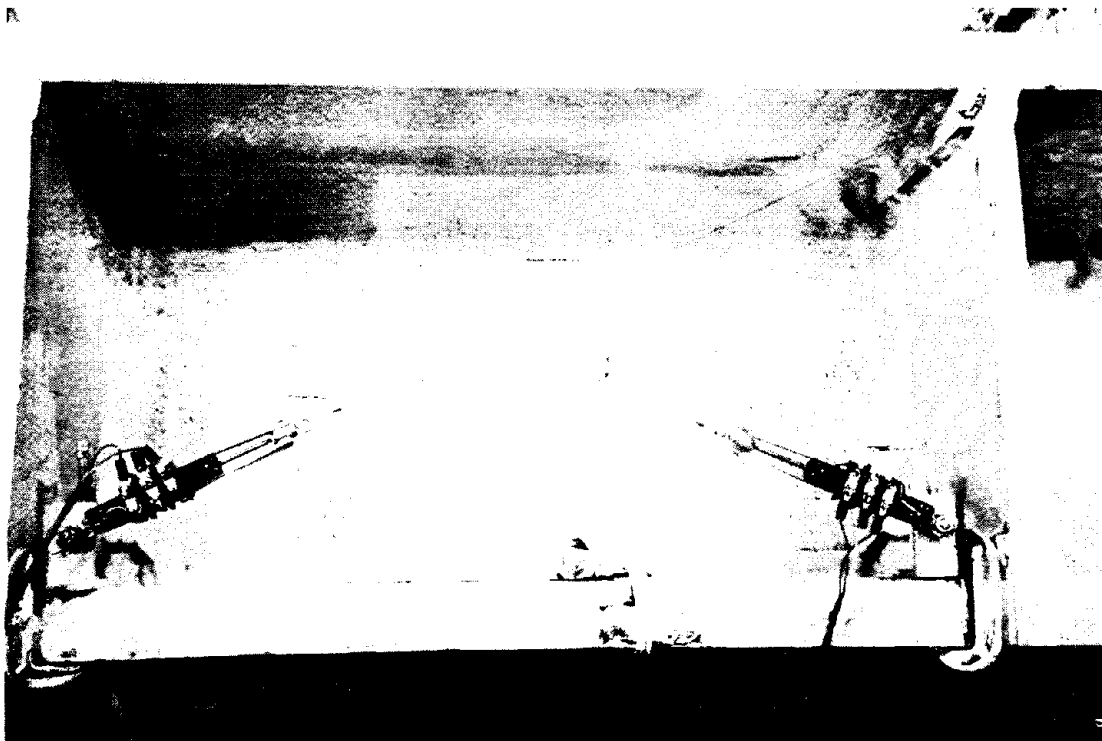
Figure 4-14. Whitewash Spalling of Doubler Plate During Third 2-in. Displacement Cycle

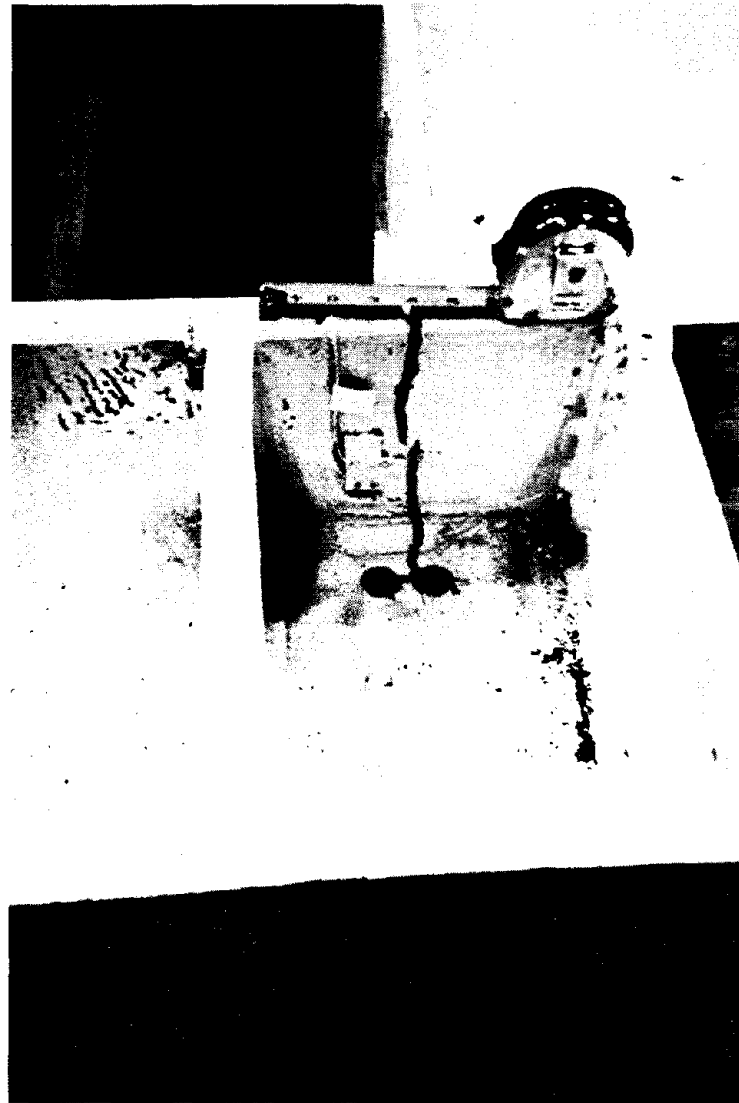
**Figure 4-16. Failure of Column Flange Adjacent to Bottom Beam Flange
@ Displ. = 3.08 in. and Force = 236.3 kips**

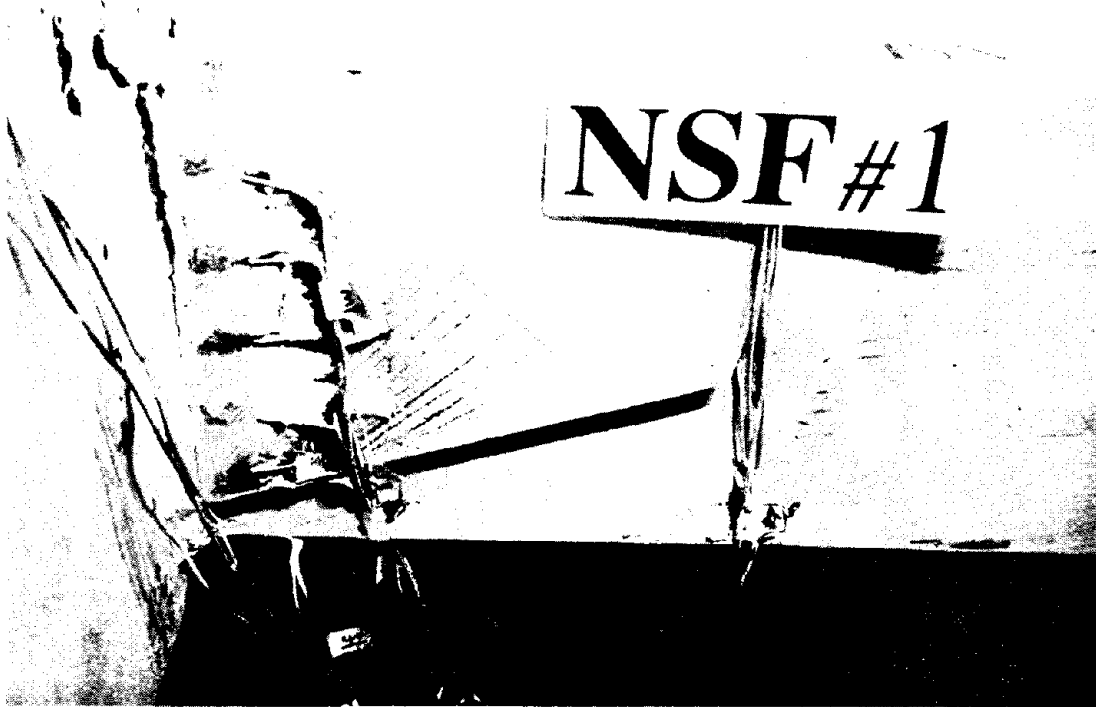
Figure 4-18. Propagation of Column Crack into the Top Beam Flange and Cover Plate-to-Column Weld Area During 4-in. Displacement, Cycle 1

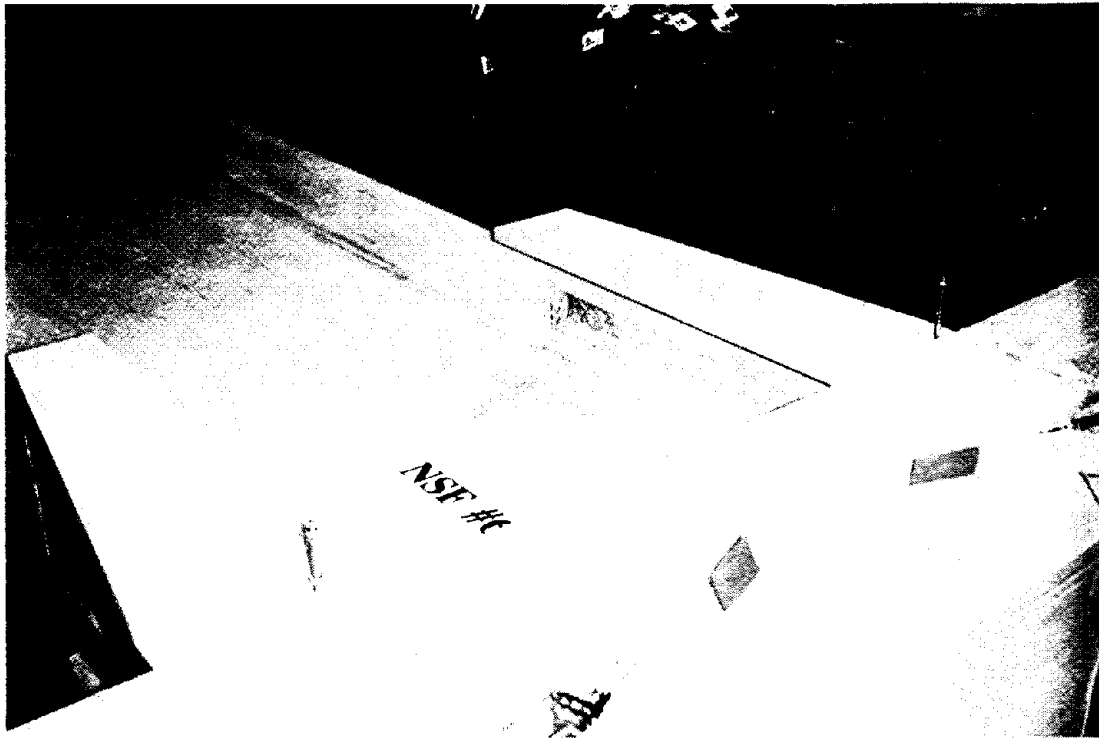
Figure 4-33. First Sign of Yielding in Beam Web Adjacent to Top Beam Flange at 2-in. Displacement, Cycle 1

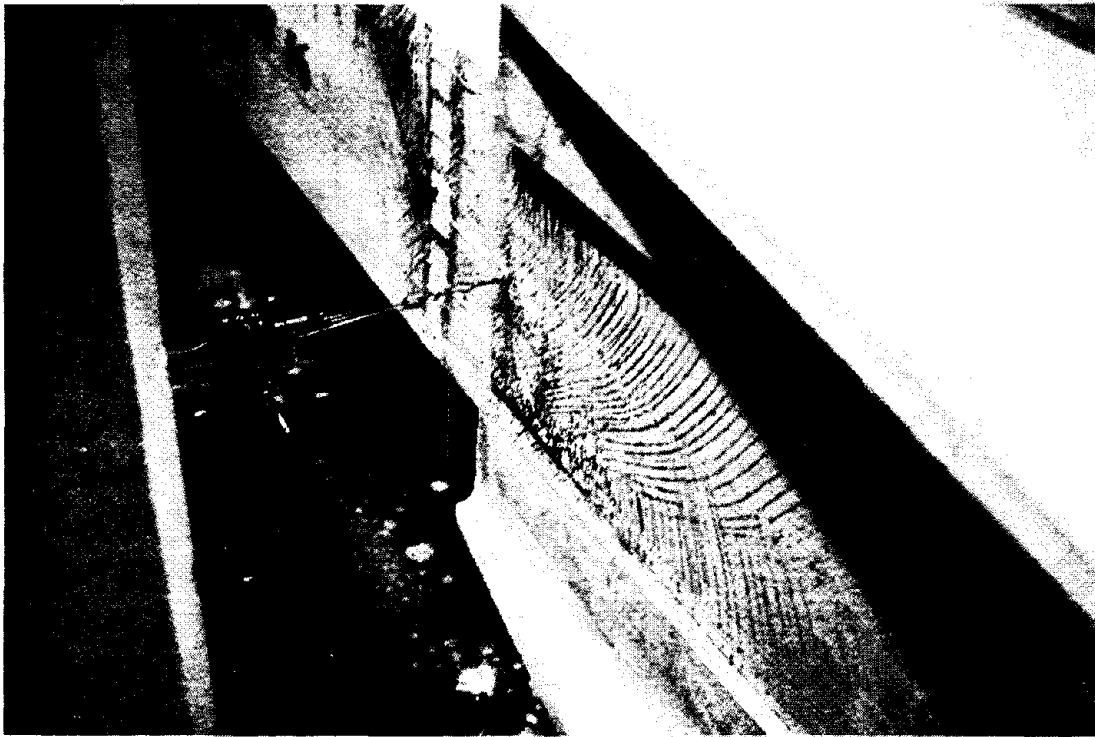
Figure 4-35. Yield Pattern of Bottom Beam Flange and Separation Between Beam Flange and Tee at 2-in. Displacement, Cycle 2 (caused by 3-in. long weld tear)

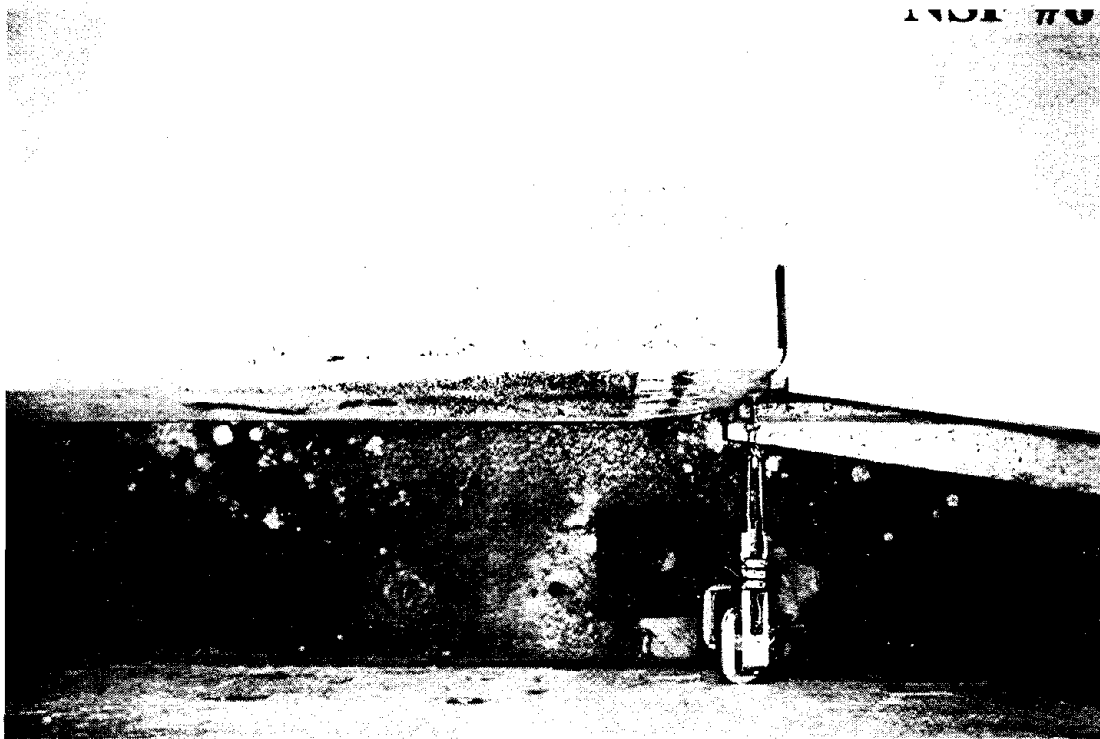
Figure 4-36. Buckling of Bottom Beam Flange and Web at 3-in. Displacement, Cycle 2

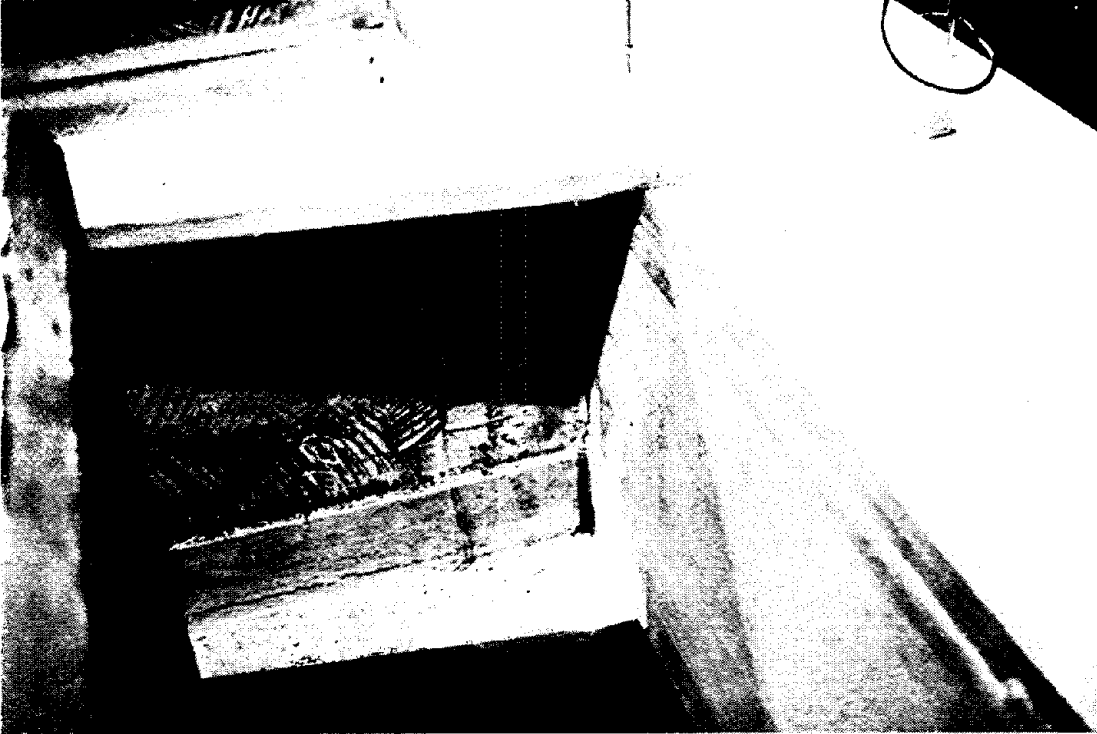
Figure 4-37. Propagation of Tee-to-Beam Flange Weld Tear (to length = 21 in.) and Subsequent Fracture Within the Column Flange Material (partial "divot") at 4-in. Displacement, Cycle 1

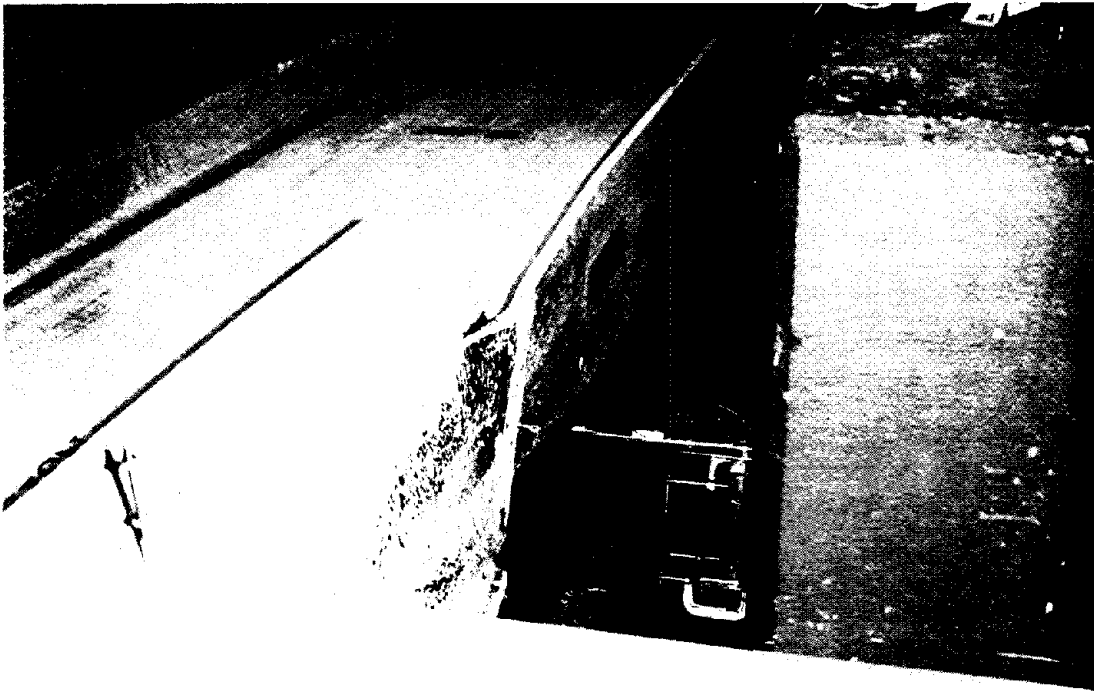
Figure 4-38. Yield Pattern and Buckling of Top Beam Flange and Subsequent Weld Tear at 4-in. Displacement, Cycle 1

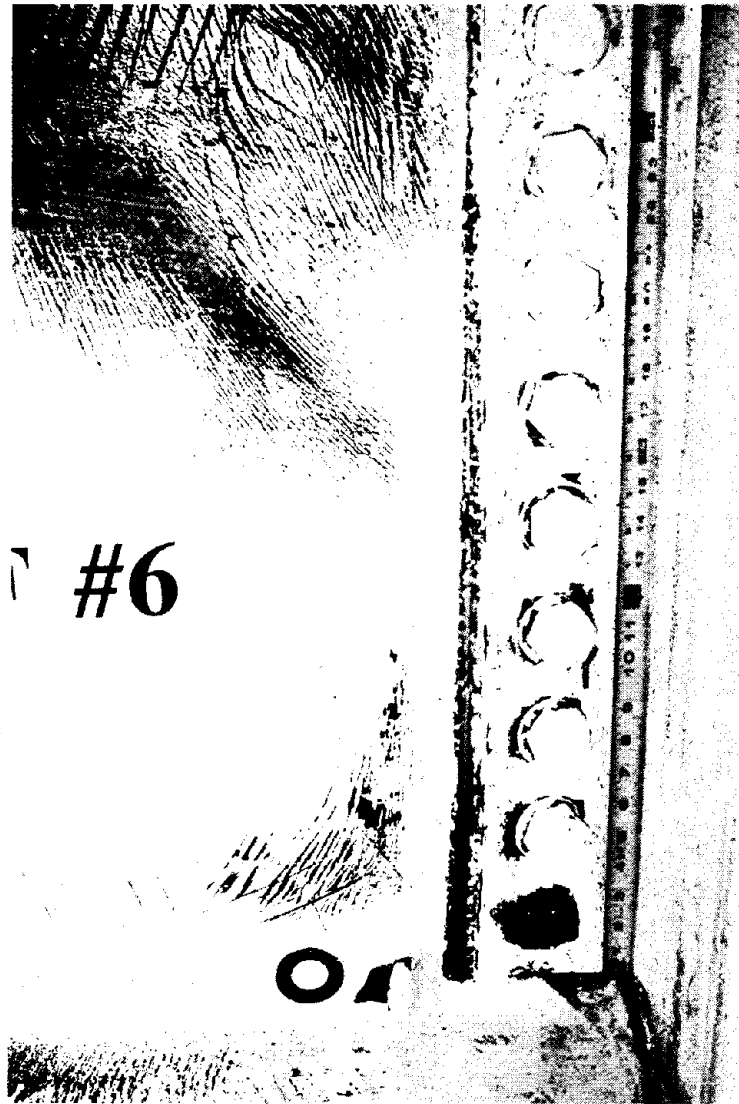
Figure 4-42. Damage and Yield Pattern of Shear Tab and Adjacent Areas after Test
