REPORT NO.
UCB/EERC-95/01
AUGUST 1995

EARTHQUAKE ENGINEERING RESEARCH CENTER

**GEOTECHNICAL RECONNAISSANCE
OF THE EFFECTS OF THE
JANUARY 17, 1995,
HYOGOKEN-NANBU EARTHQUAKE, JAPAN**

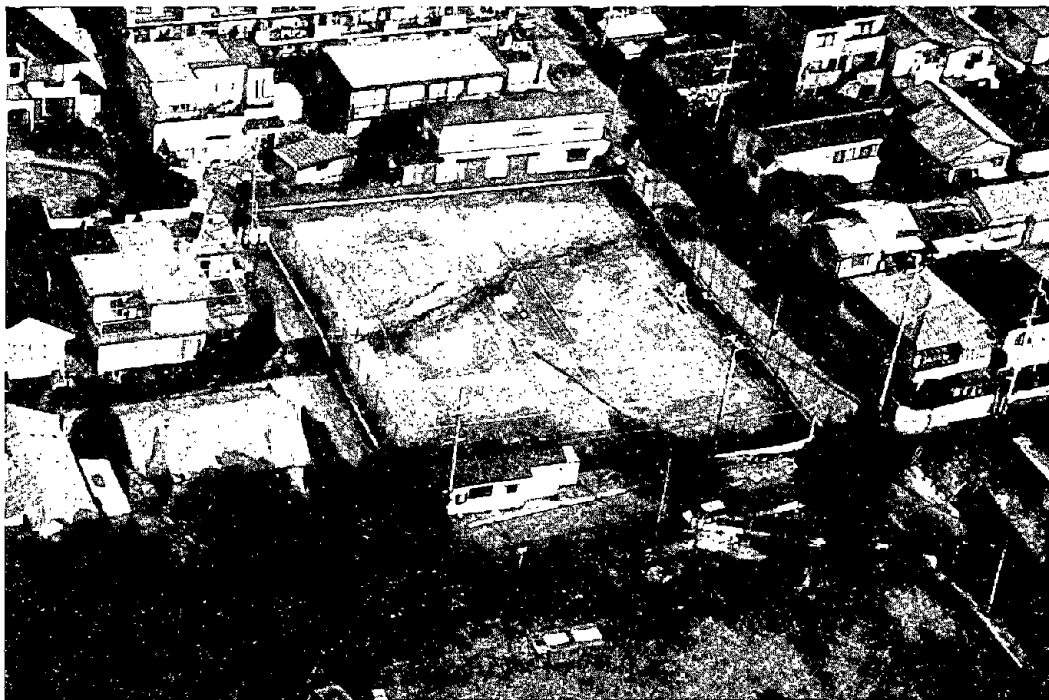
Figure 2.11: Aerial view of possible right lateral surface rupture in tennis court in area just southwest of Takarazuka.

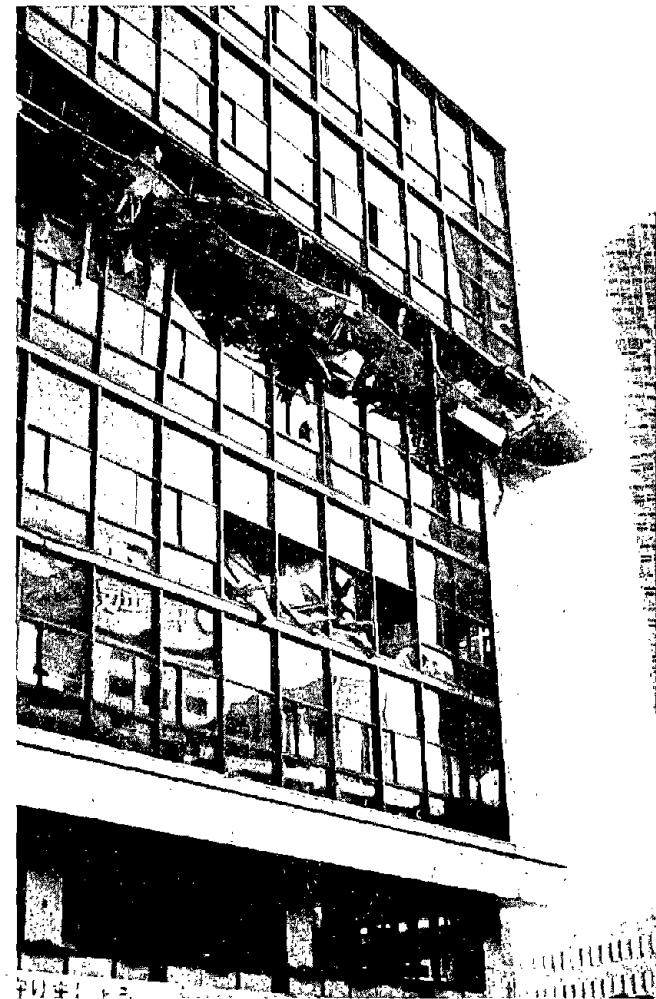
Figure 2.17: Building in central Kobe with mid-height story collapse in the fault-normal direction.

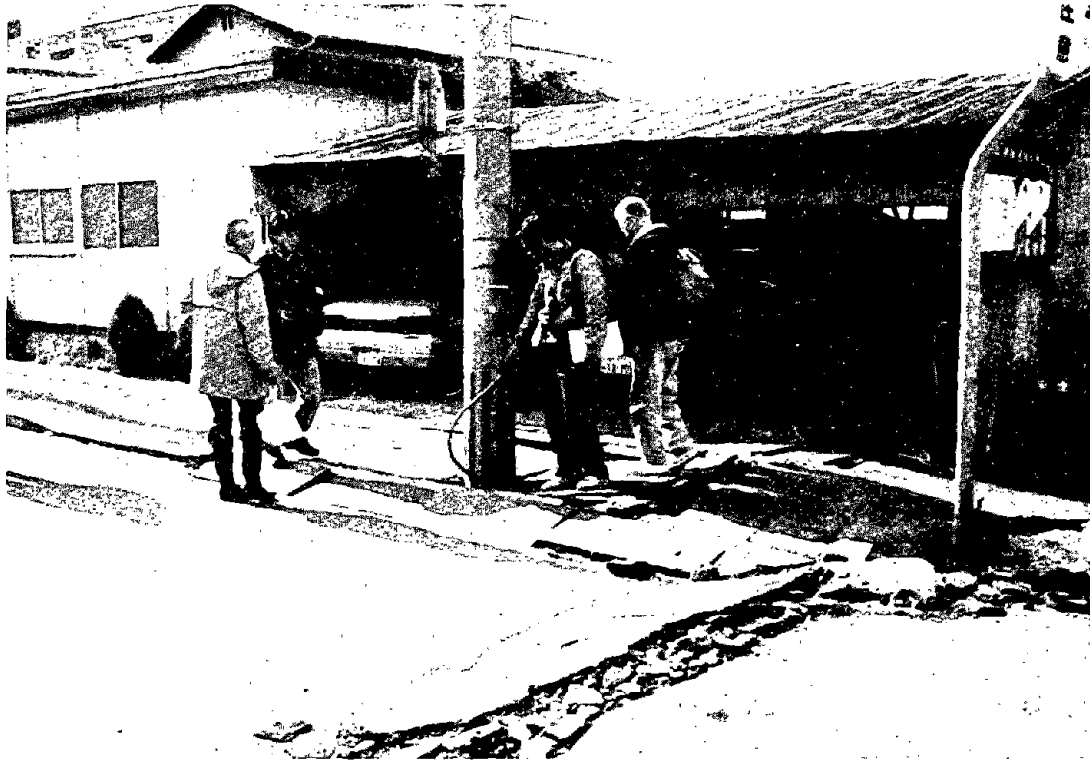
Figure 3.2: Evidence of liquefaction damage in a residential area of Nishinomiya; buckled pavement, cracked curbs, differential settlement.

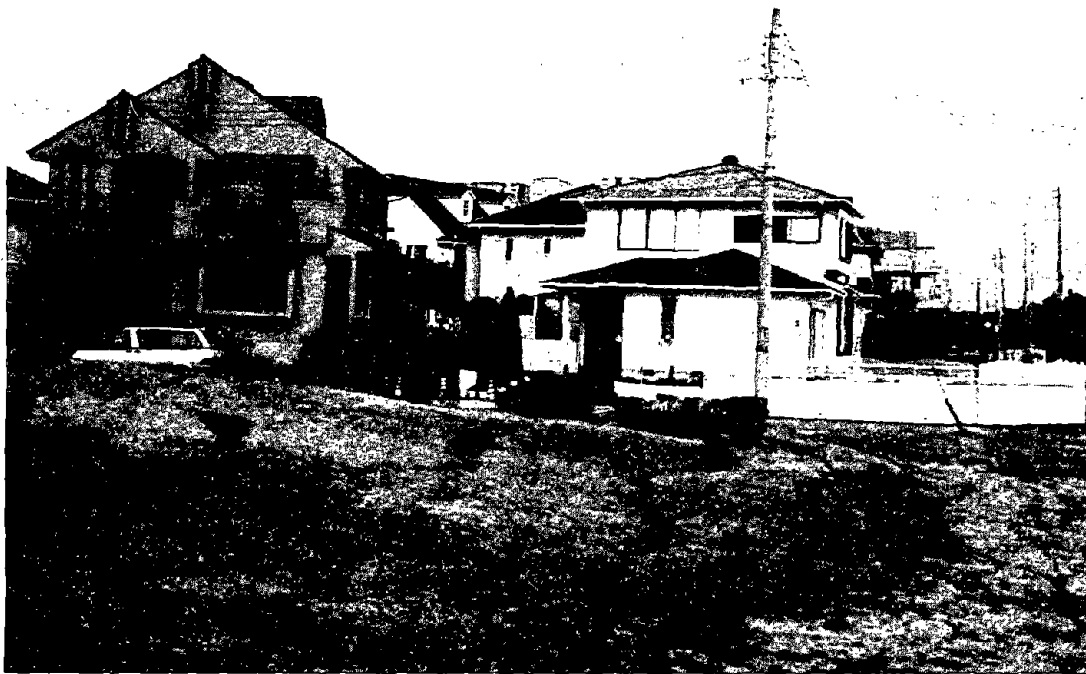
Figure 3.3: Relatively undamaged houses in a residential area in Ashiya. Note the evidence of lateral spreading caused by the liquefaction of the fill.

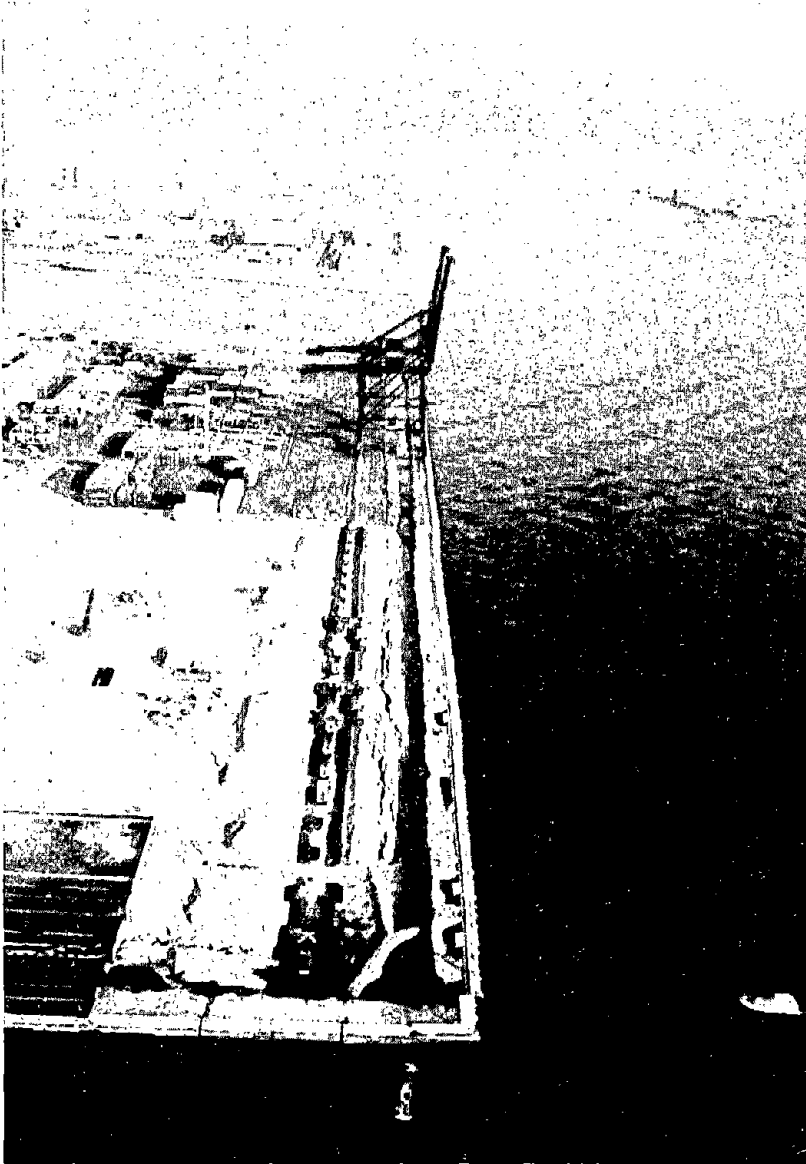
Figure 3.16: Air view of damaged quay walls and port facilities on Rokko Island. Quay walls have been pushed outward by 2 m to 3 m with depressed areas called grabens 3 m to 4 m deep forming behind the walls.

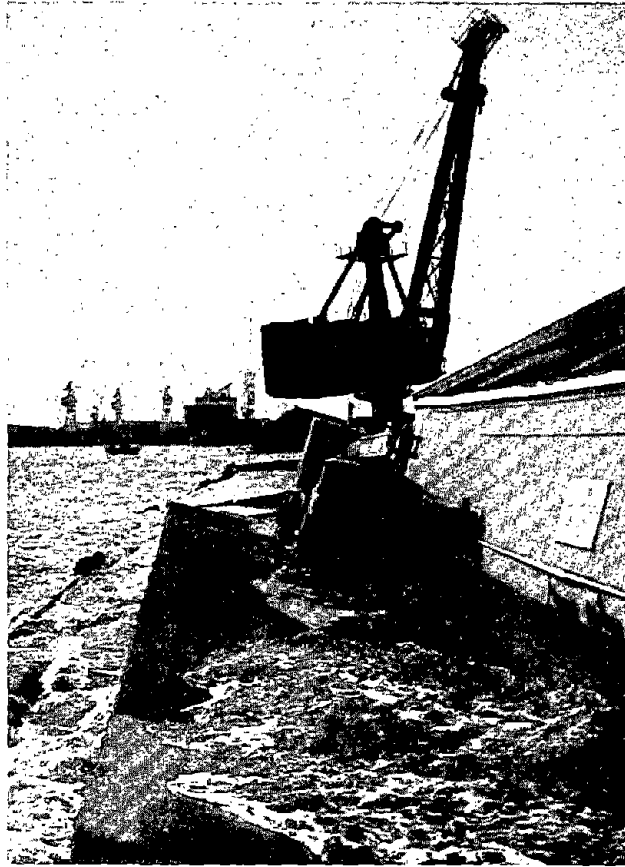
Figure 3.22: Damage to the end of Hyogo Pier No. 2.

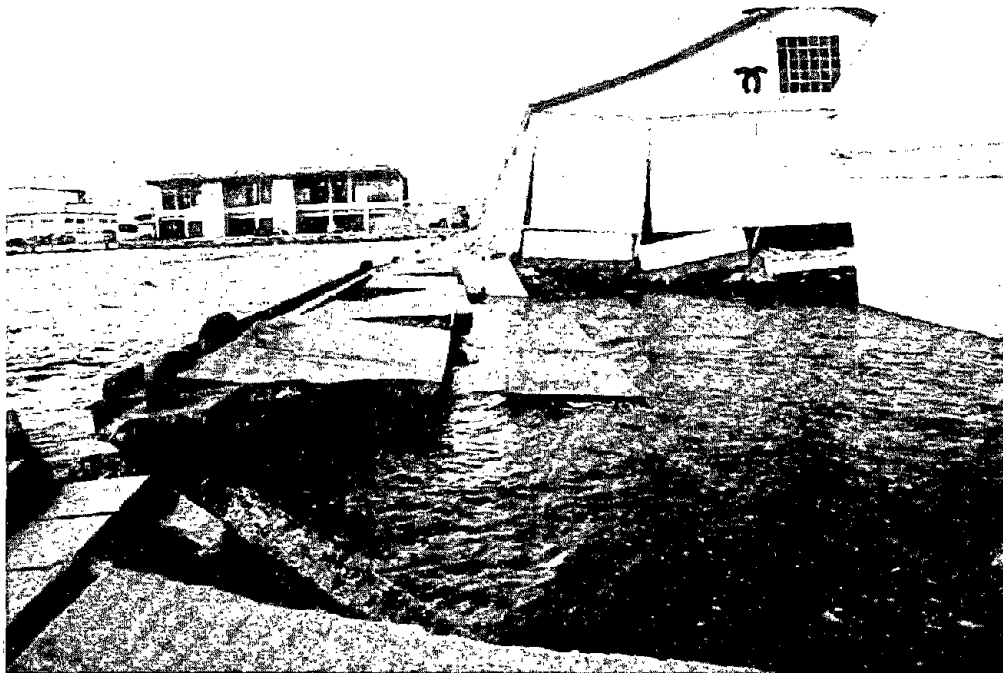
Figure 3.23: Damage to the end of Hyogo Pier No. 2.

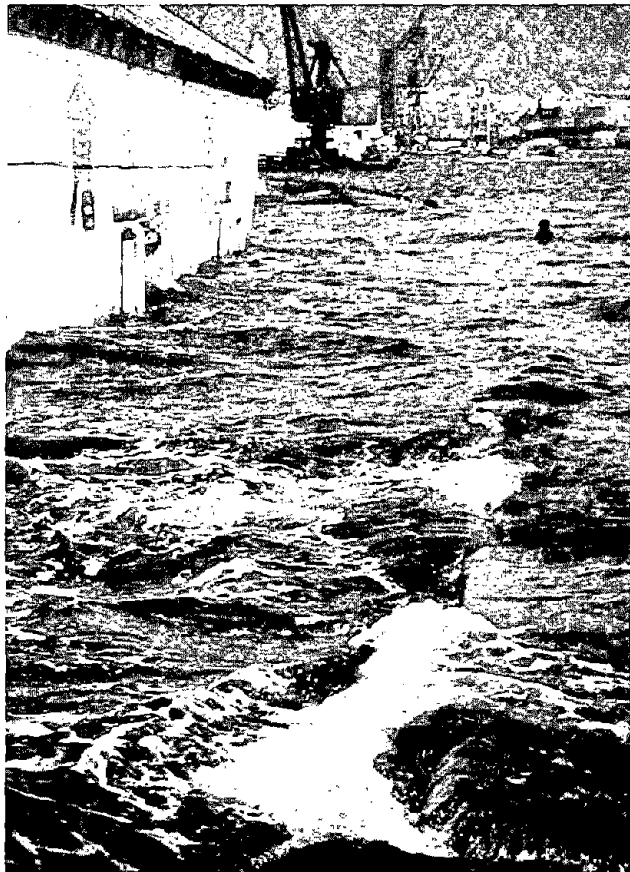
Figure 3.24: Damage to the end of Hyogo Pier No. 2.

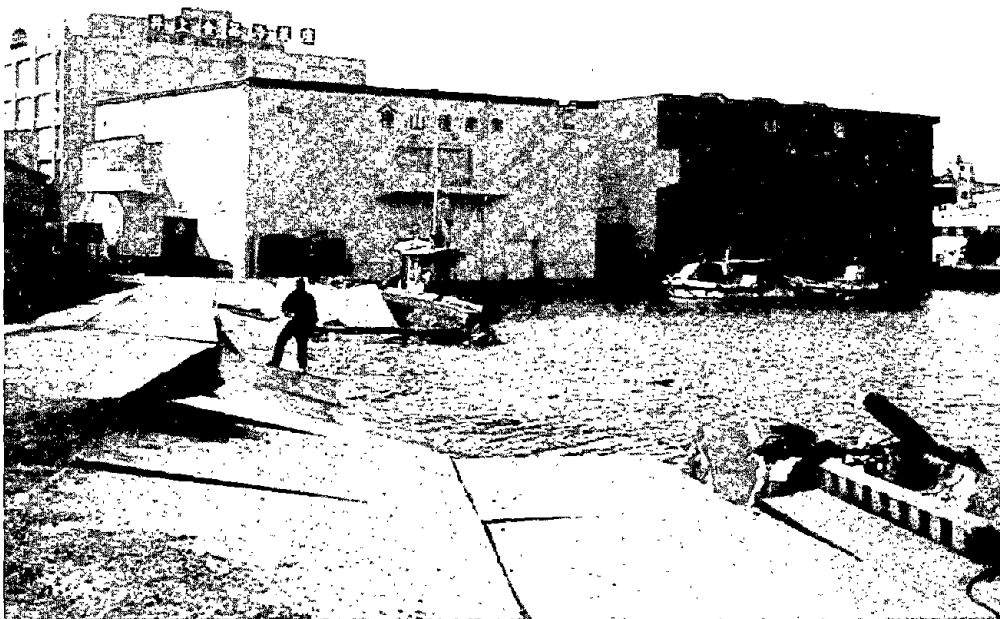
Figure 3.25: Damaged quay wall on west side of Tsukiji-cho.

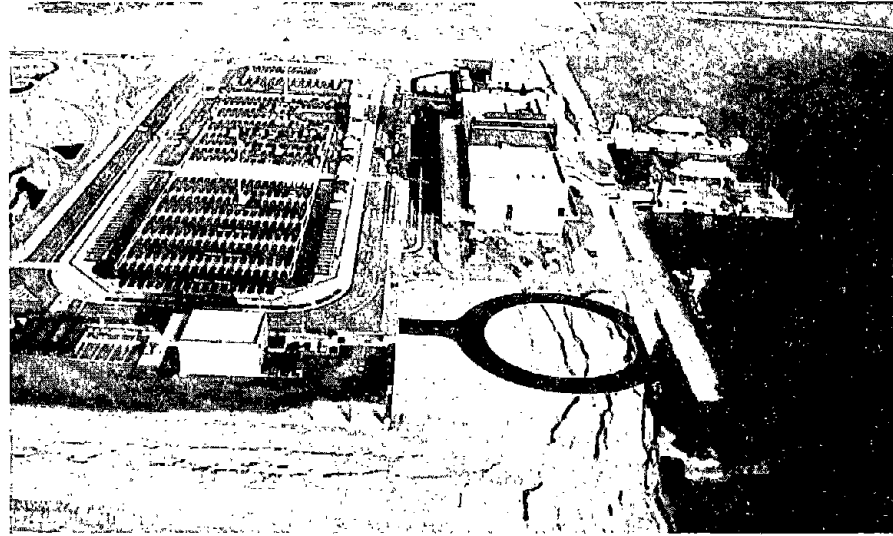
The second and smaller building at the ferry port was either constructed on shallow foundations or a deep foundation that did not fully penetrate the liquefiable fill. This building remained intact and generally undamaged, but tilted about 2.5 degrees downward toward the graben. The back part of the building subsided into the graben, but the structure rotated as a block, with little or no structural damage, at least as revealed by a brief inspection of the first floor. There were a few hairline fractures in the foundation a few meters inland from the edge of the graben, but these cracks did not continue upward into the superstructure. The building was also intersected by several open fissures, indicative of lateral spreading toward the graben, without fracture of the foundation.

Figure 3.48: Air view of ferry terminal buildings on Port Island. Backs of buildings are in graben area. Lateral spread fissures, dark lines on top of photo, pass beneath buildings. View looking southward.

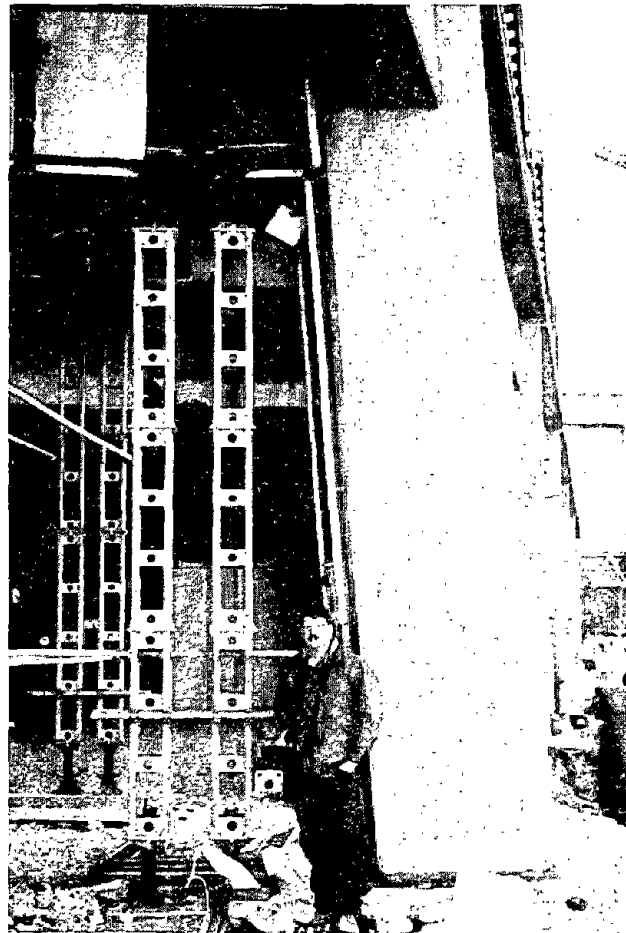
Figure 3.52: Damaged column-beam connection on north side of Harborland ferry terminal.

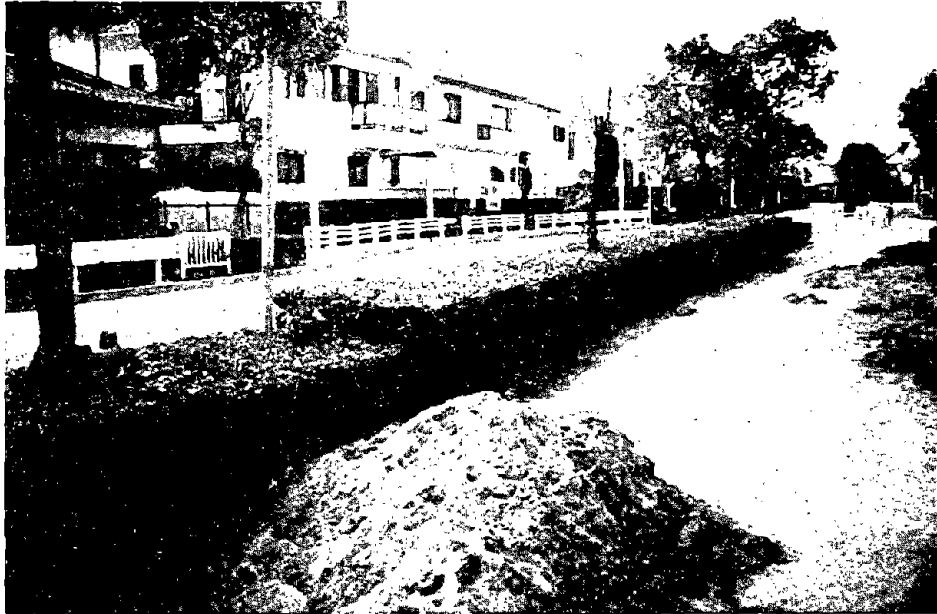
Figure 3.53: Modern Japanese houses in Ashiya constructed with wood studs and plywood sheathing similar to many U.S. single-unit houses. Liquefaction and ground oscillation occurred beneath area. Piles of sand in roadway are from residents clearing sand boil deposits from their gardens. The only damage noted in this area was slight tilting of a few houses.

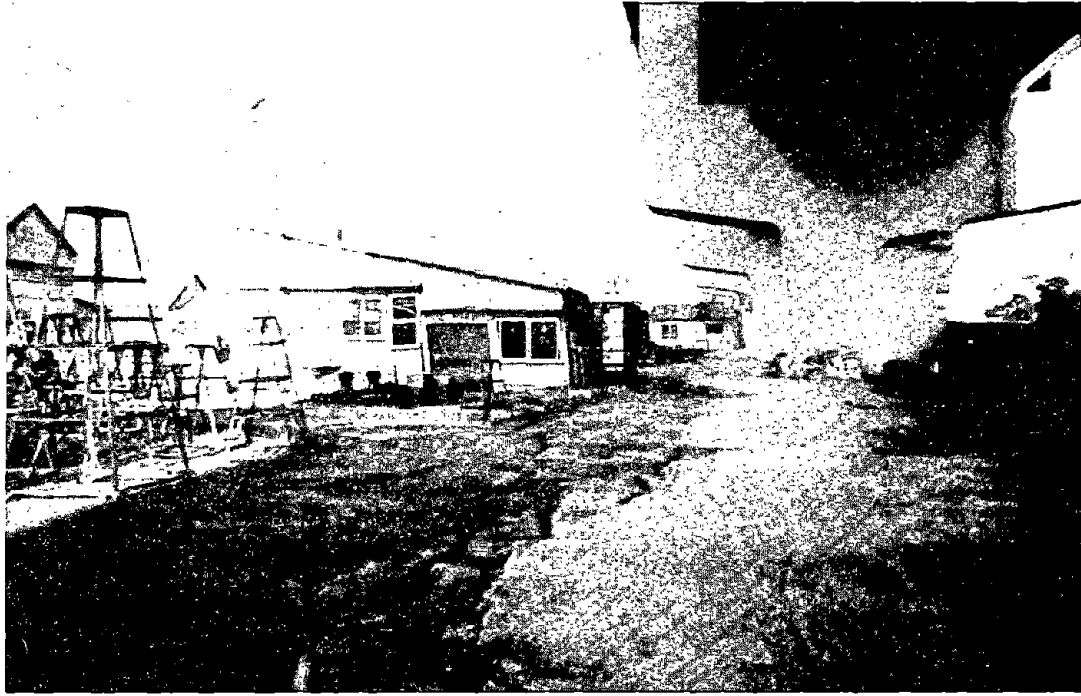
Figure 3.55: Major elevated highway structure in Kobe that suffered considerable spalling of concrete and distress of reinforcing steel in single column support. No evidence of foundation penetration or tilting was detected, even though fissures in foreground and nearby sand boils indicate liquefaction and ground oscillation were pervasive beneath bridge.

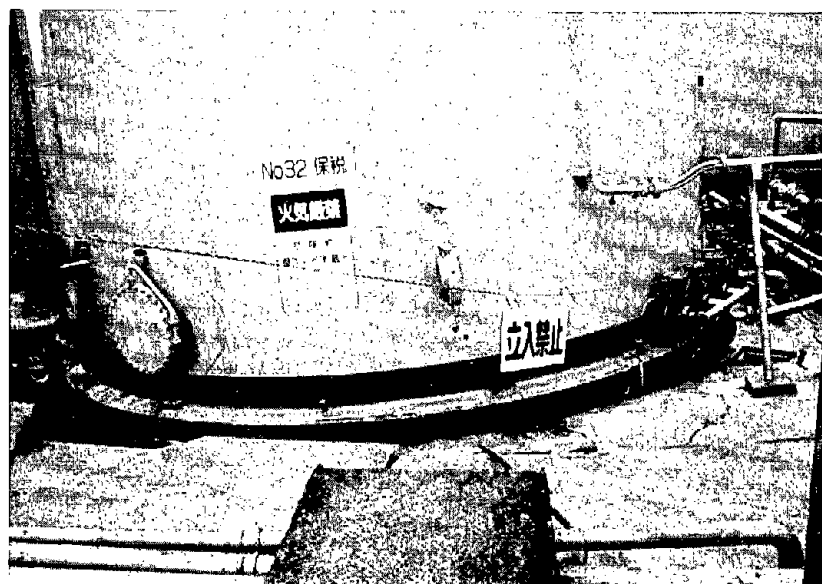
Figure 3.72: Differential settlement at the base of a chemical tank in the Nippon Gatx complex.

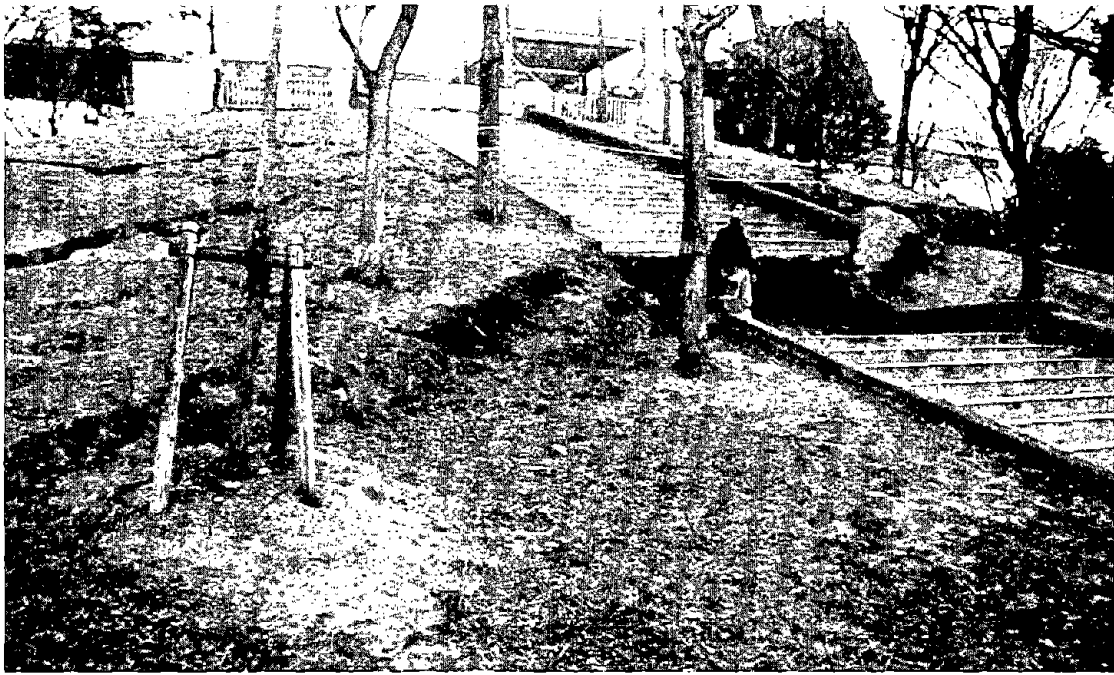
Figure 3.73: Fissure indicative of liquefaction and lateral spread in Osakako park which is located on a small artificial island near the ferry terminal at the port of Osaka.

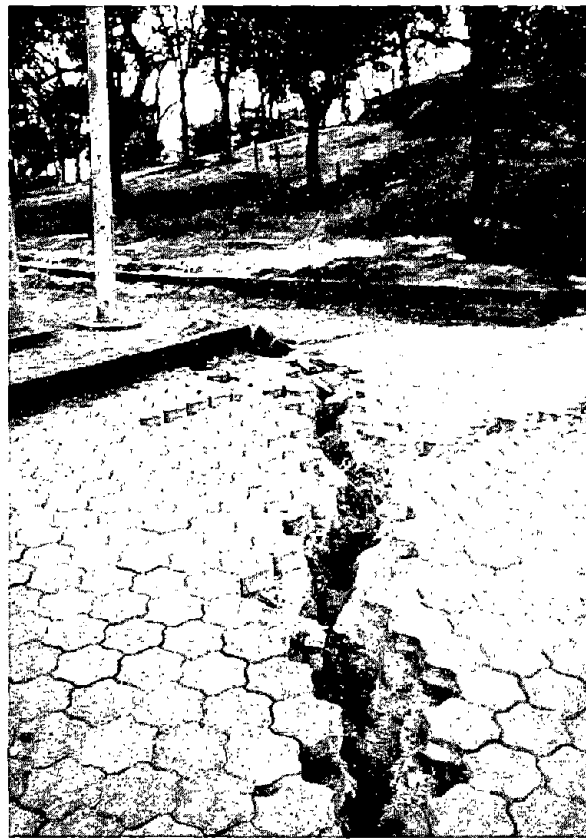
Figure 3.74: Fissures in Osakako park indicative of liquefaction, differential ground settlement, and lateral spread.

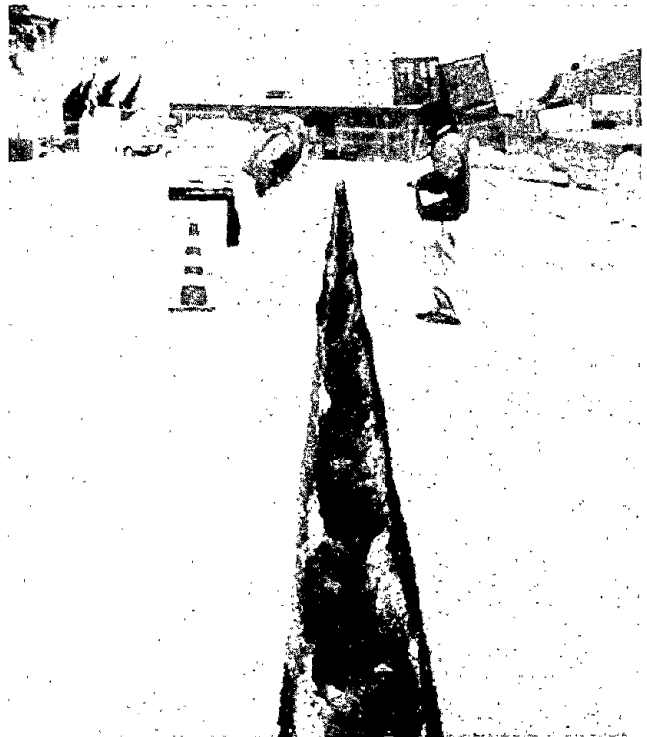
Figure 4.20: Displaced sea wall and cracked pavement at the southeast corner of Port Island Phase I.

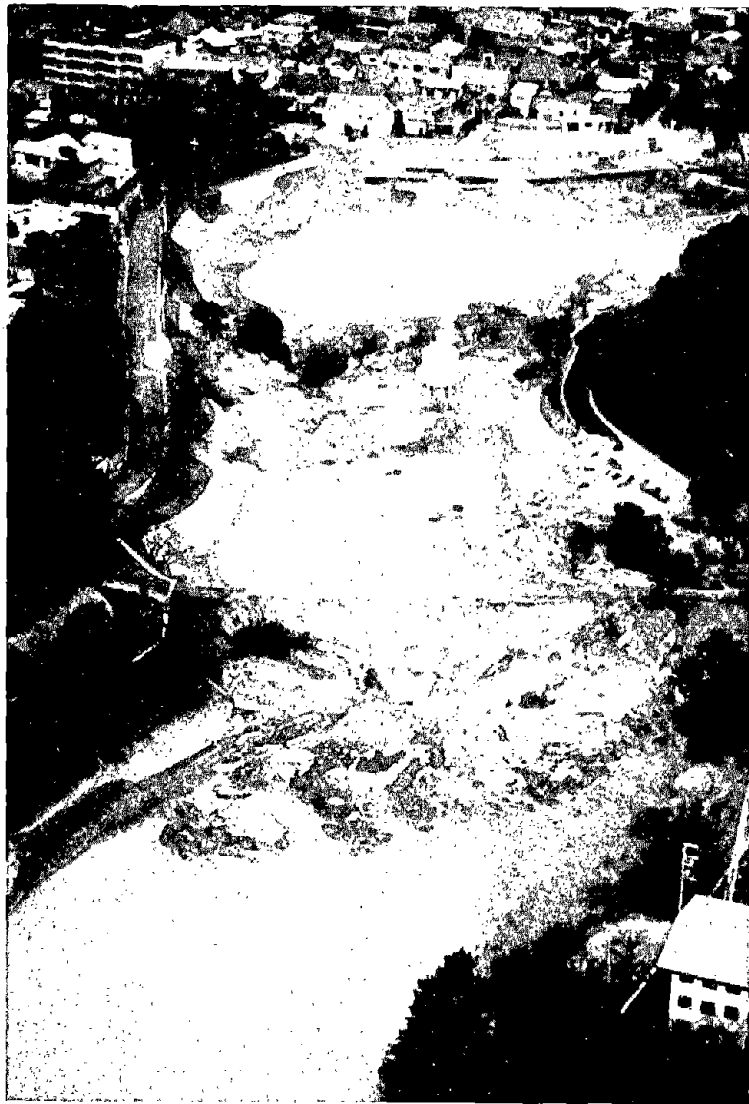
Figure 5.4: Aerial photograph of flow failures at Upper and Middle Niteko Dams.

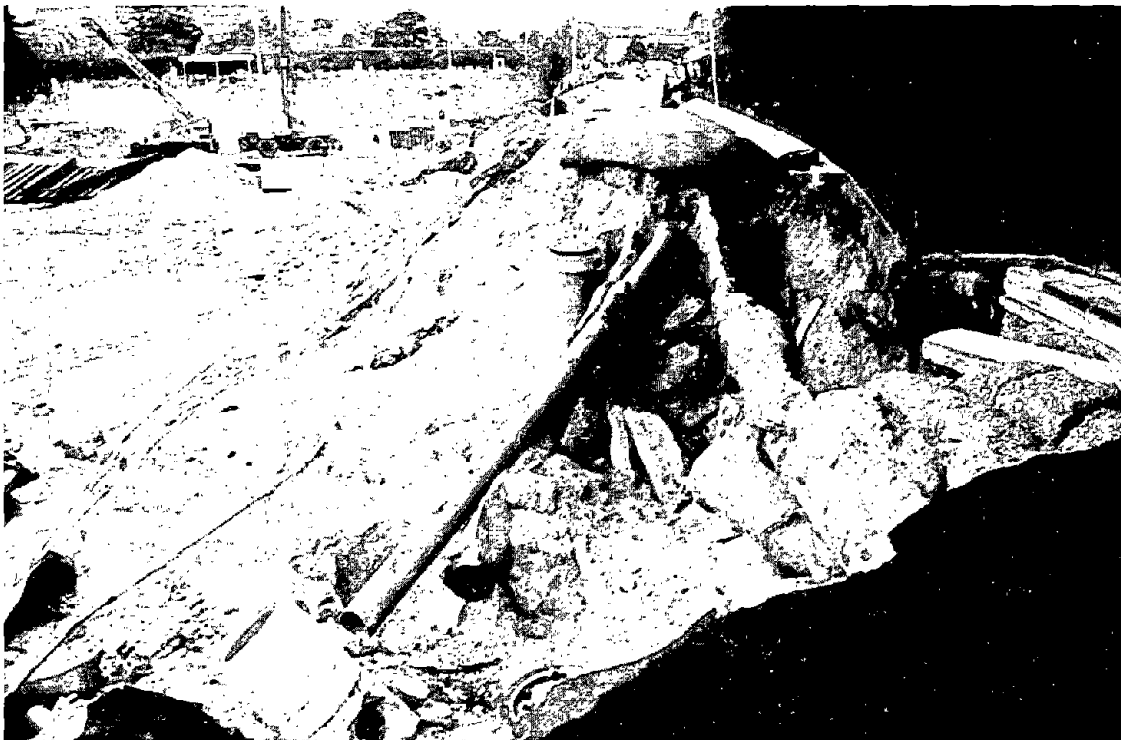
Figure 5.8: Failed perimeter roadway fill along Upper Niteko Reservoir.

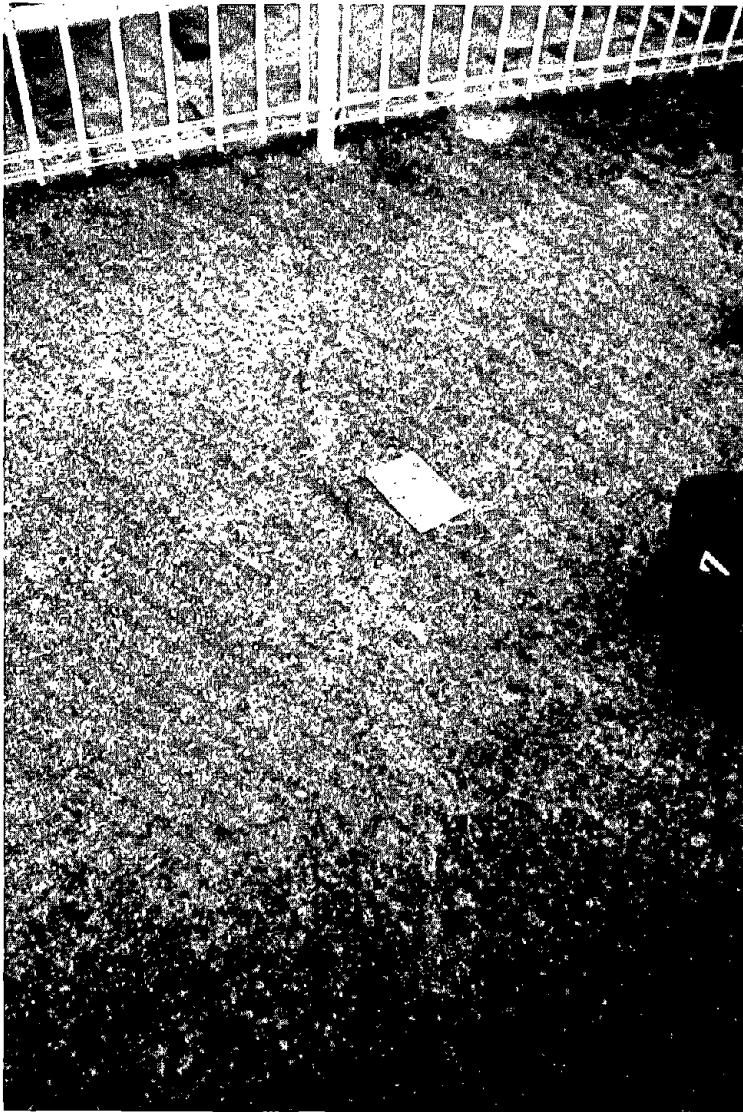
Figure 5.15: Old crack observed on crest of Karasuhara Dam.

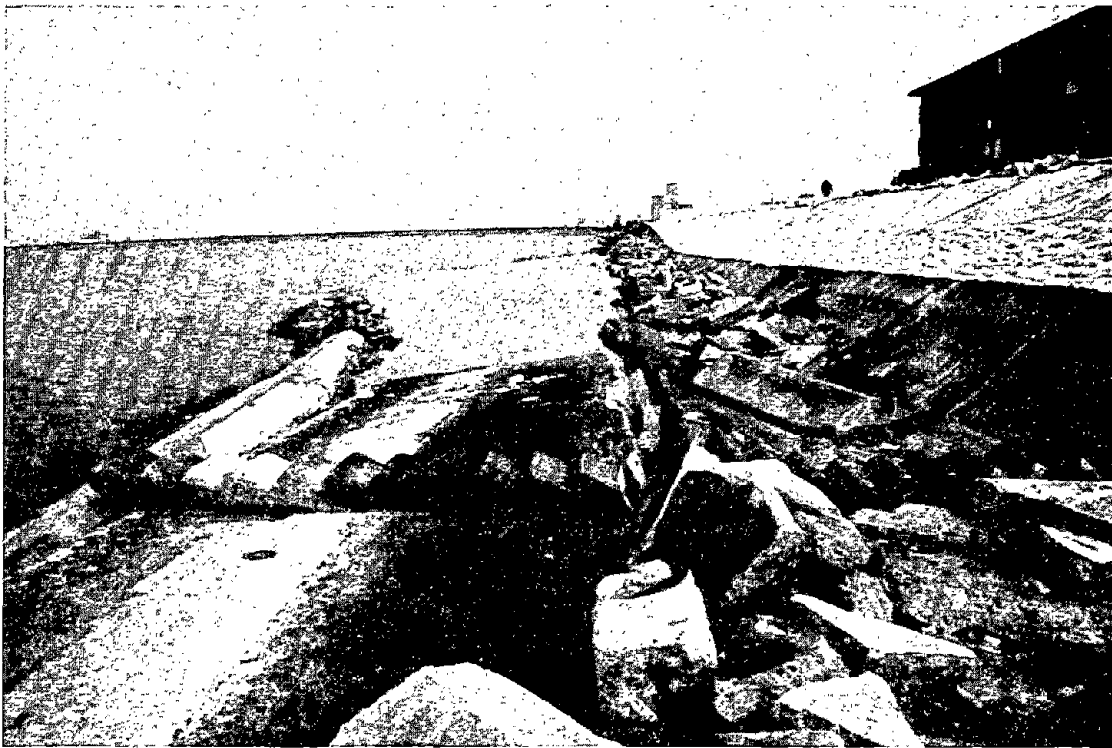
Figure 5.19: Upstream slope of failed Yodo River levee after initial repairs (note horizontal stairway).

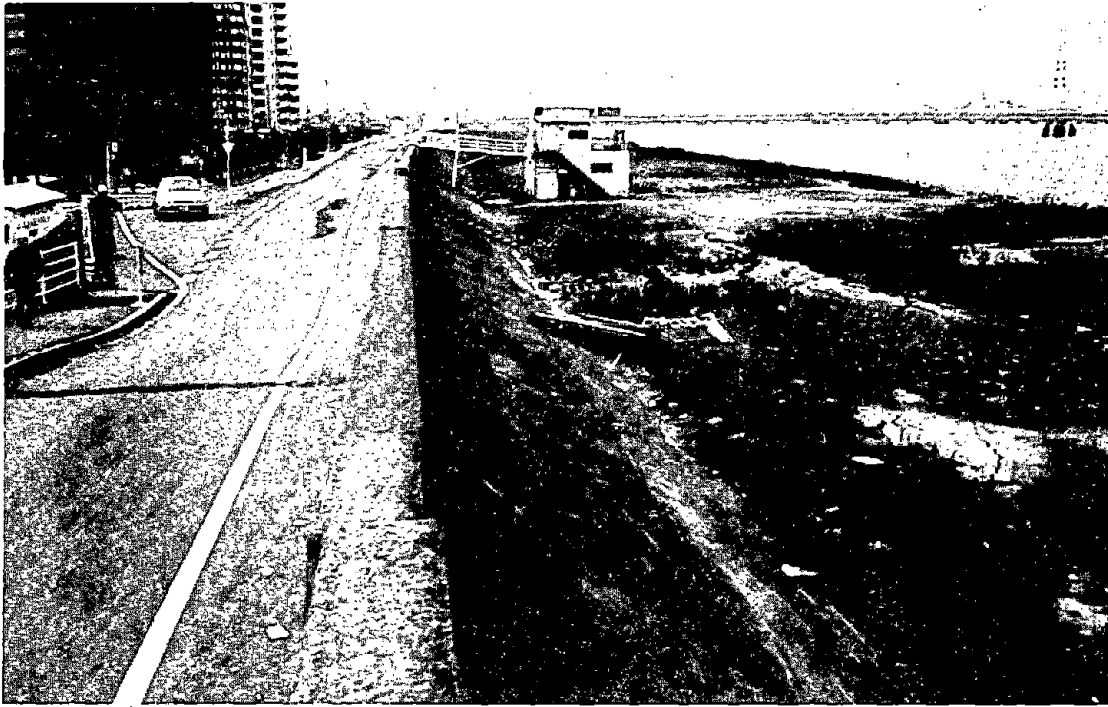
Figure 5.20: Moderately damaged Yodo River levee (note sand boils on exposed waterside foundation).

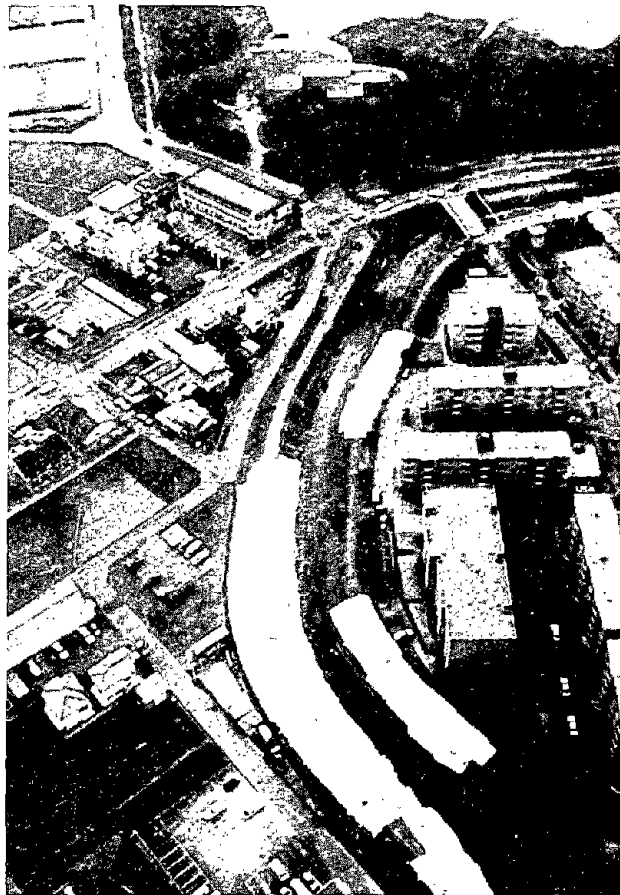
Figure 5.21: Aerial photograph of distressed levees on tributary to Mukogawa.

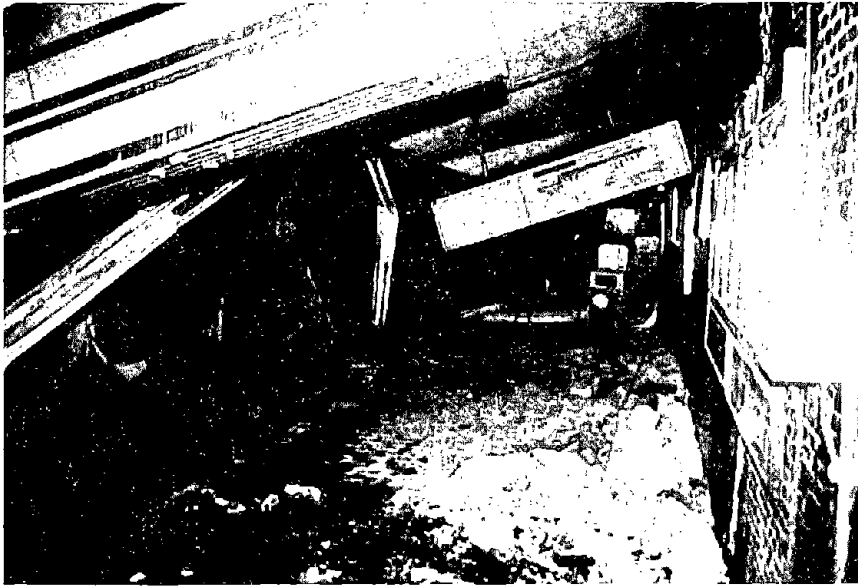
Figure 6.3: Collapsed subway roof at Daikai Station.

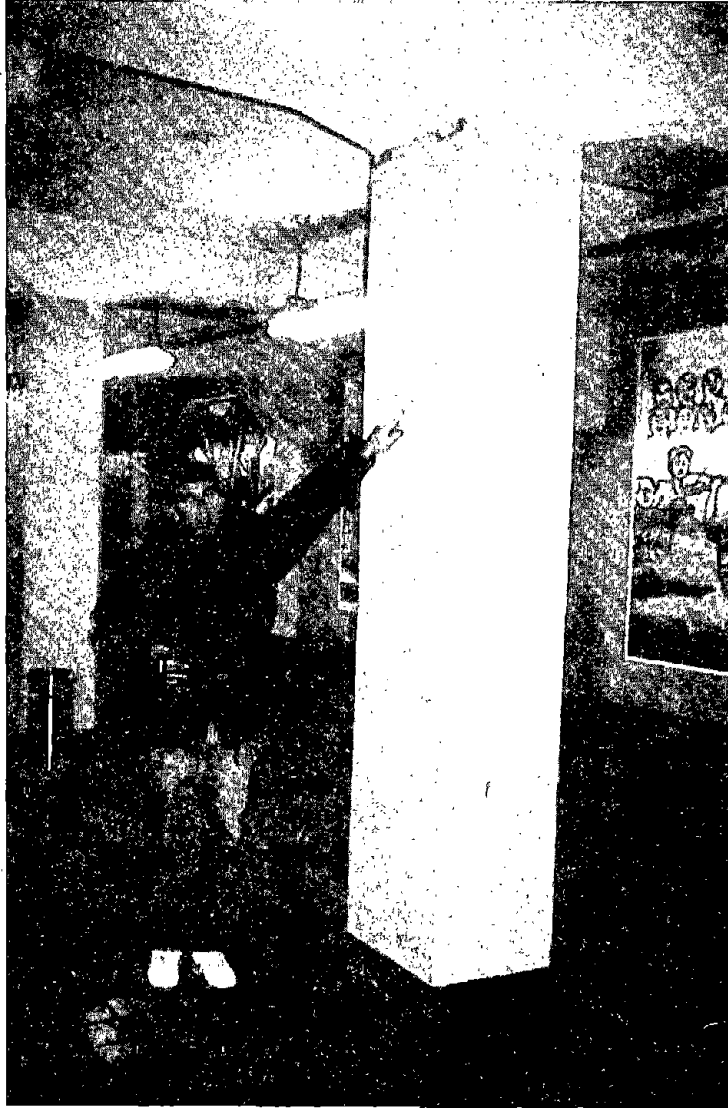
Figure 6.7: Cracked reinforced concrete column in shopping mall adjacent to Kobe Kosoku.

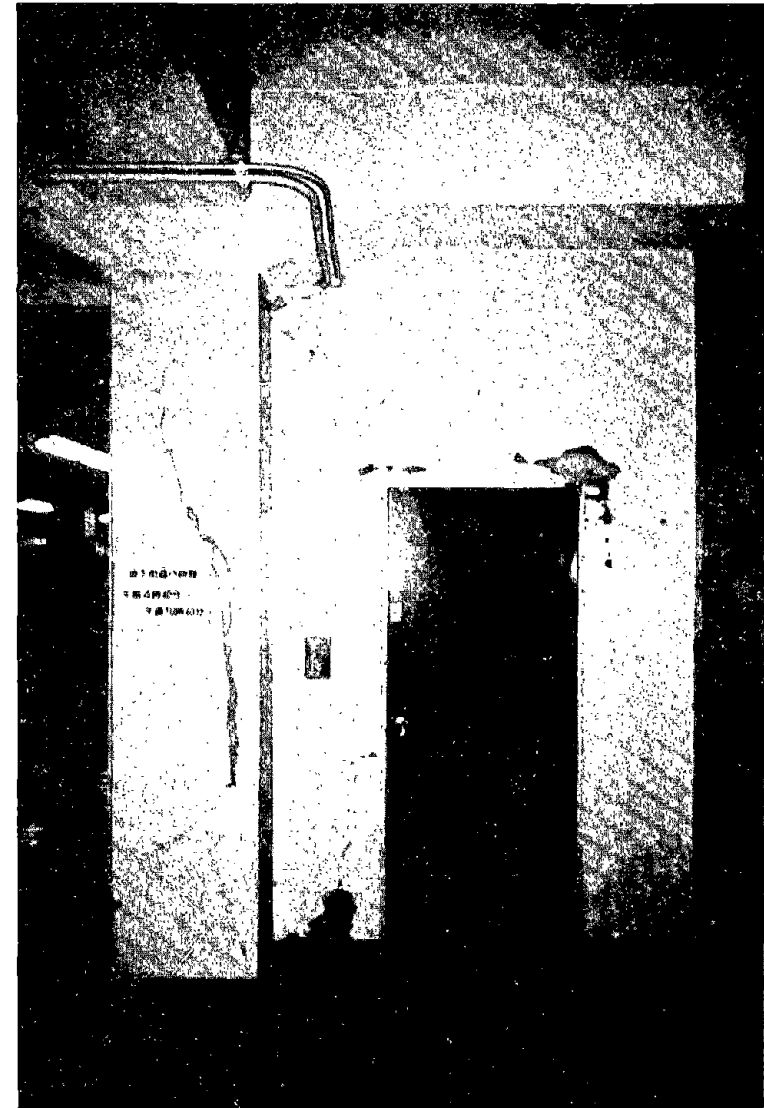
Figure 6.8: Shear cracks in column and partition wall at Kobe Kosoku shopping mall.

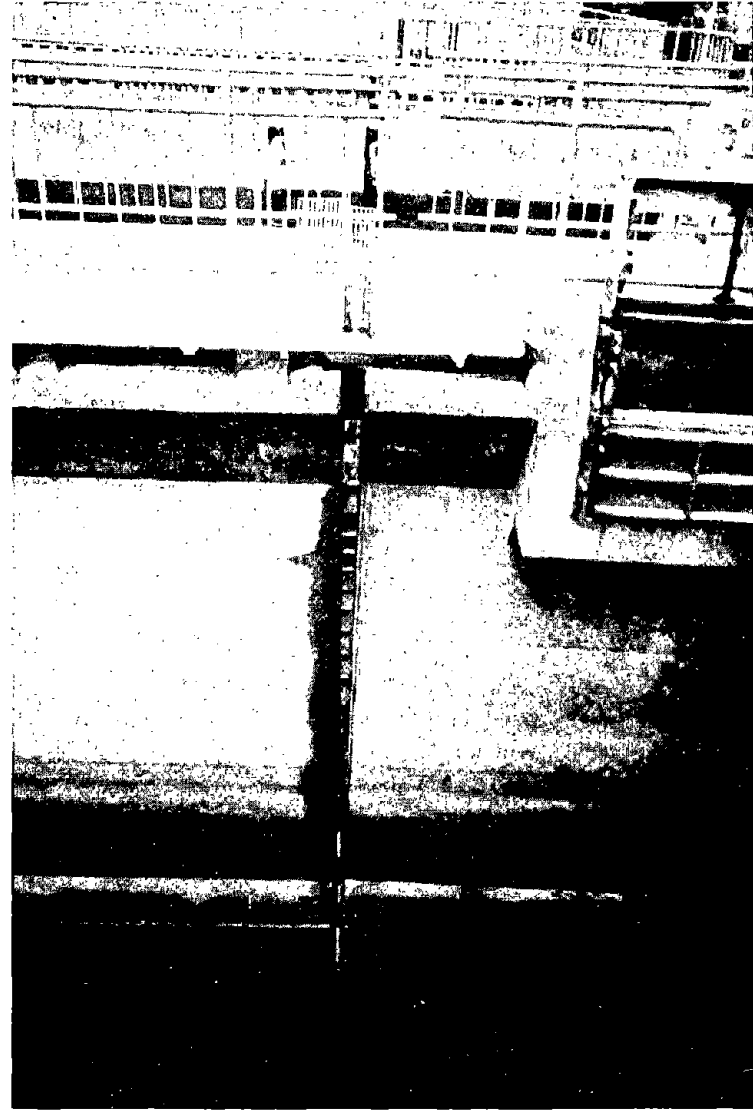
Figure 6.19: Separations in the reinforced concrete walls of the aeration tanks.

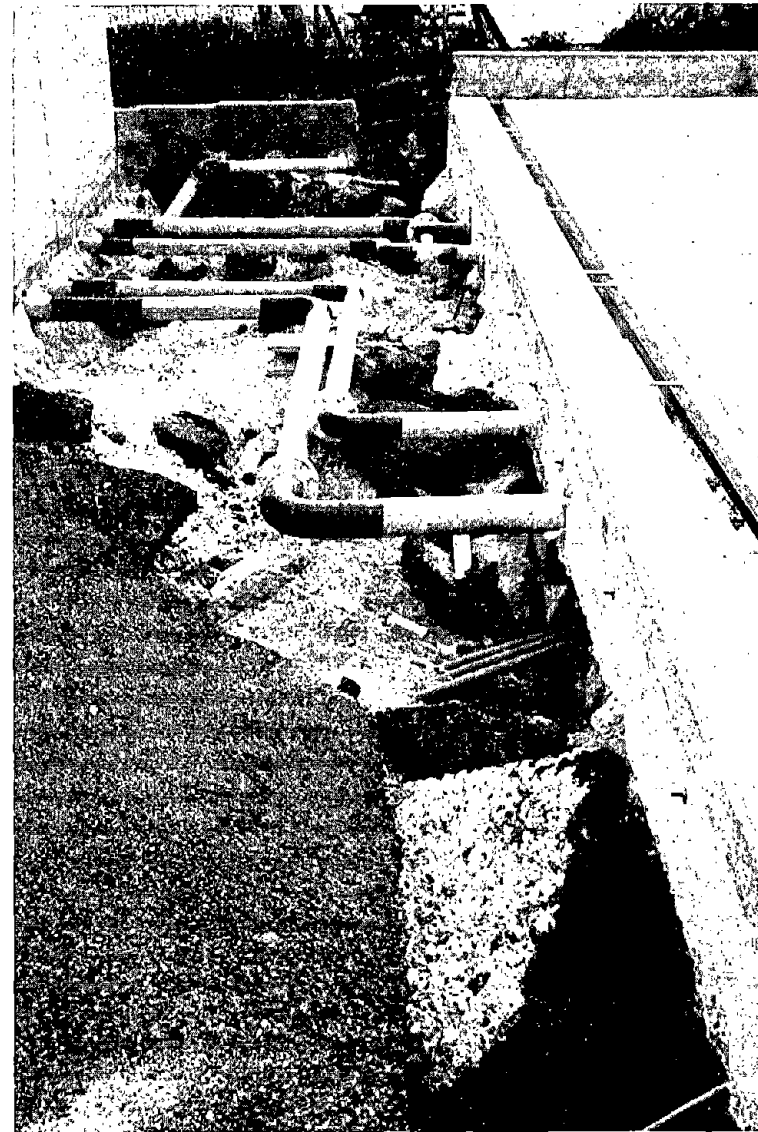
Figure 6.22: Repaired pipes near Nakahara Wharf, Port Island. Prior to earthquake pipes followed a straight path between slabs.

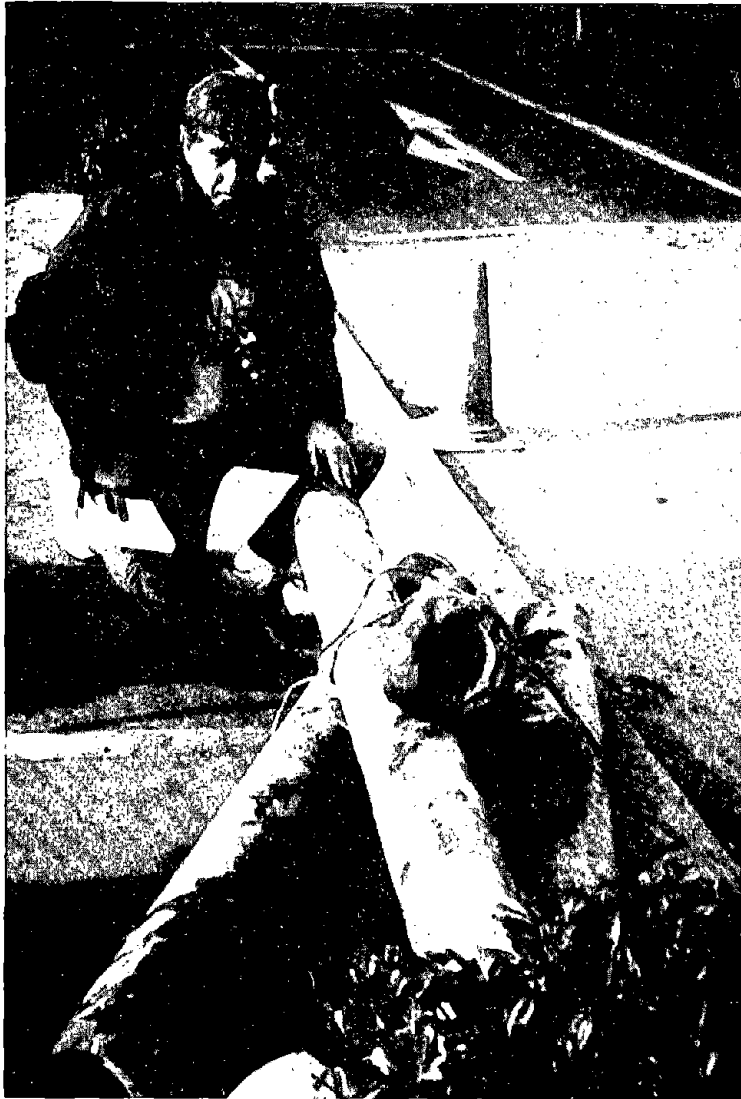
Figure 6.23: Rupture of 6 KV electric cable conduit in Kobe City. (Dr. T. Holzer in photo).

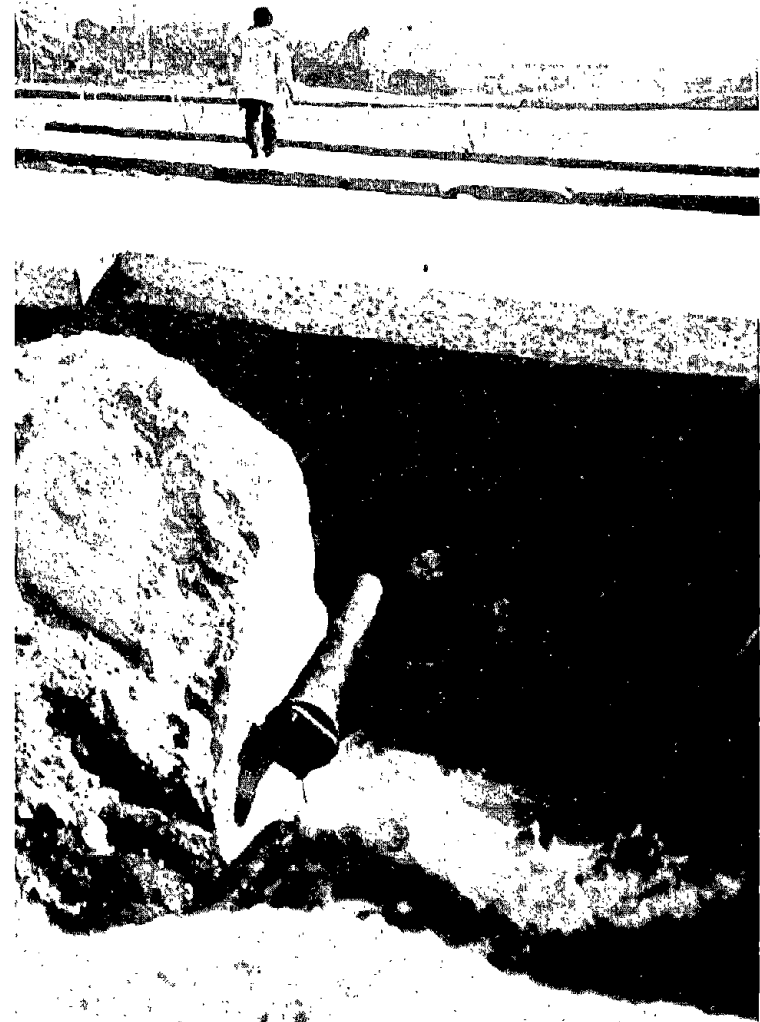
Figure 6.24: Rupture of electric conduit caused by seawall deformation adjacent to north side of Kobe Port Island Bridge.

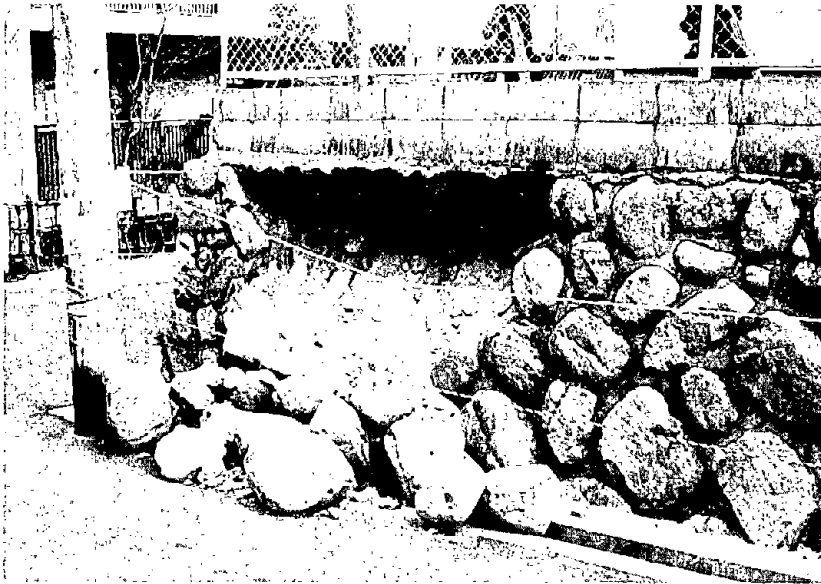
Figure 7.12: Typical failure of a stone retaining wall in a residential area.

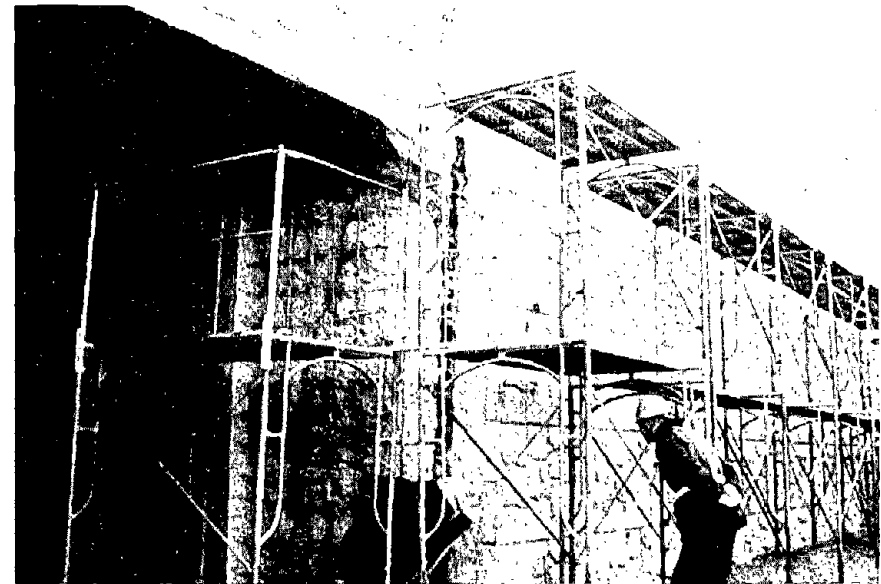
Figure 7.19: Evidence of outward rotation and displacement of the Tanata GRS-RW wall, about 20 cm at the toe and about 10 cm near the base.
