REPORT NO.
UCB/EERC-95/01
AUGUST 1995

EARTHQUAKE ENGINEERING RESEARCH CENTER

**GEOTECHNICAL RECONNAISSANCE
OF THE EFFECTS OF THE
JANUARY 17, 1995,
HYOGOKEN-NANBU EARTHQUAKE, JAPAN**

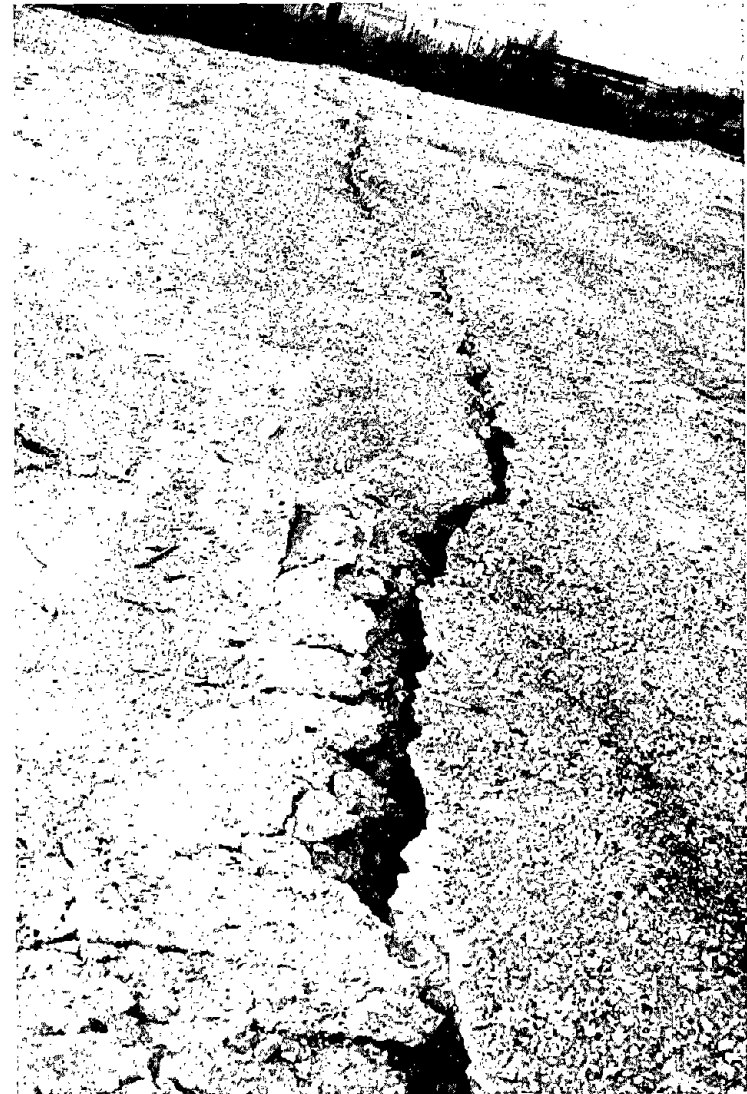
Figure 7.25: Close-up view of a ground crack in the southwest corner to the right of the site shown in Figure 7.22.
