SEISMOLOGICAL AND ENGINEERING ASPECTS OF THE 1995 HYOGOKEN-NANBU (KOBE) EARTHQUAKE

REPORT NO.
UCB/EERC-95/10
NOVEMBER 1995

EARTHQUAKE ENGINEERING RESEARCH CENTER

A reconnaissance report by
teams funded by

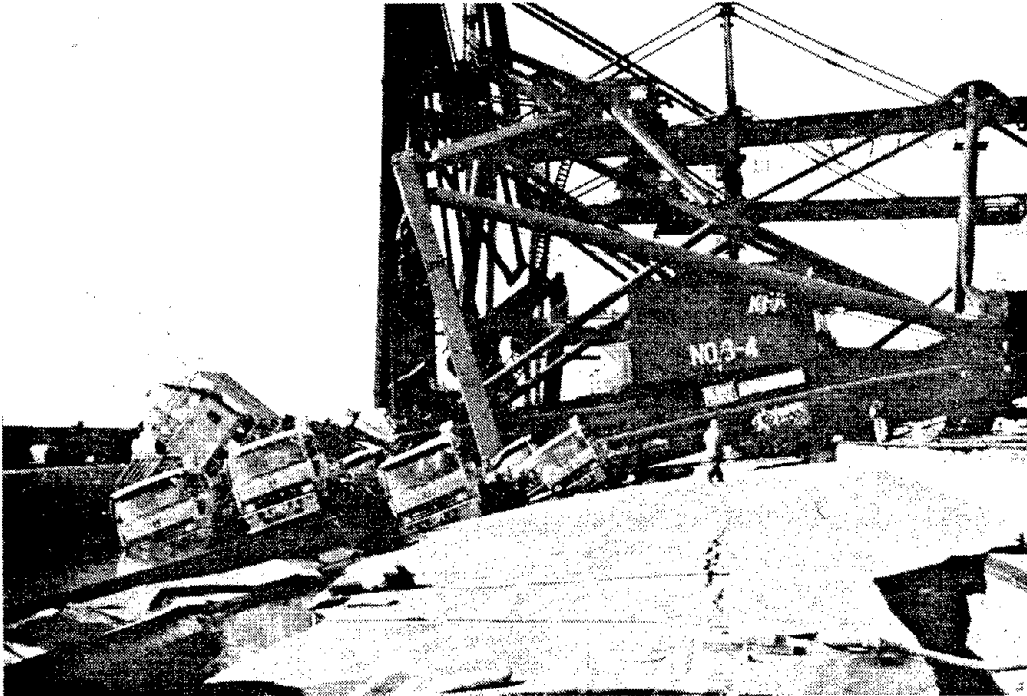
Fig. 4.2 Crane collapsed due to outward lateral movement of the quay wall on Rokko Island. The depth of the resulting graben is ≈ 2 m.

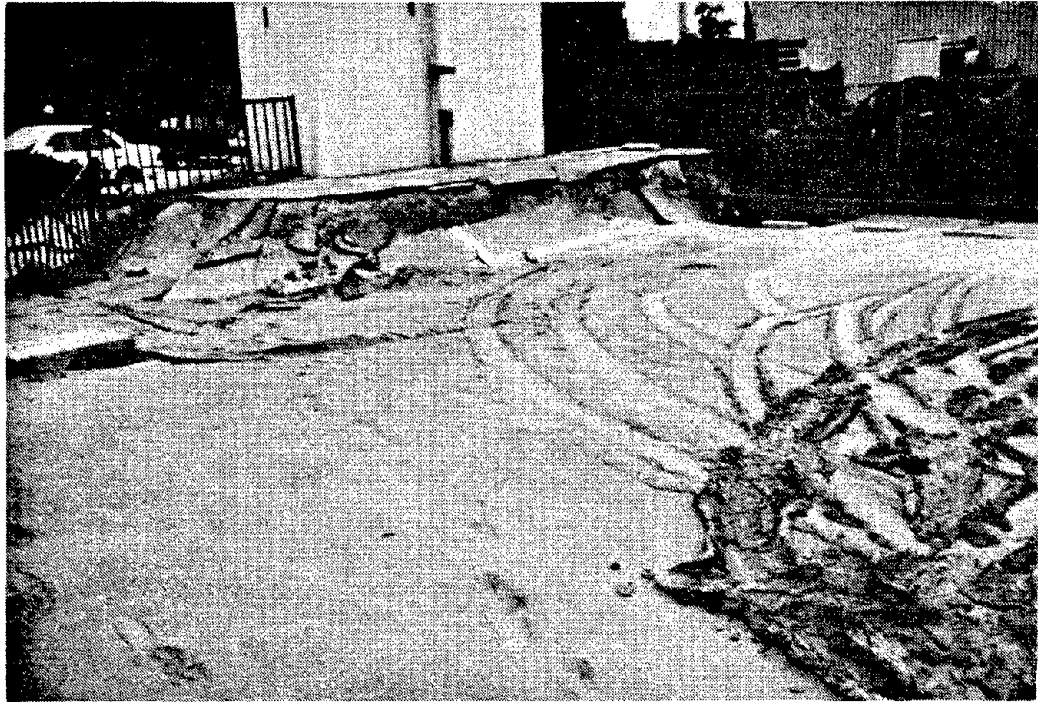
Fig. 4.4 Liquefaction-induced differential settlement (≈ 40 cm) next to a pile-supported pier of the elevated railway on Port Island.

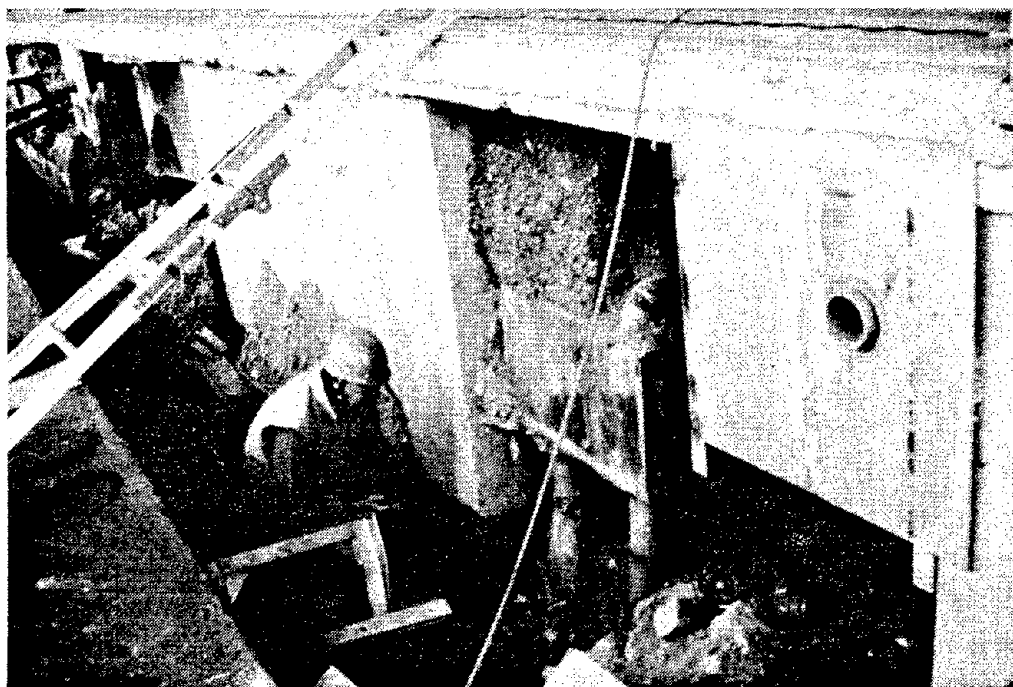
Fig. 4.15 Utility lines broken along a graben formed around the perimeter of a foundation.

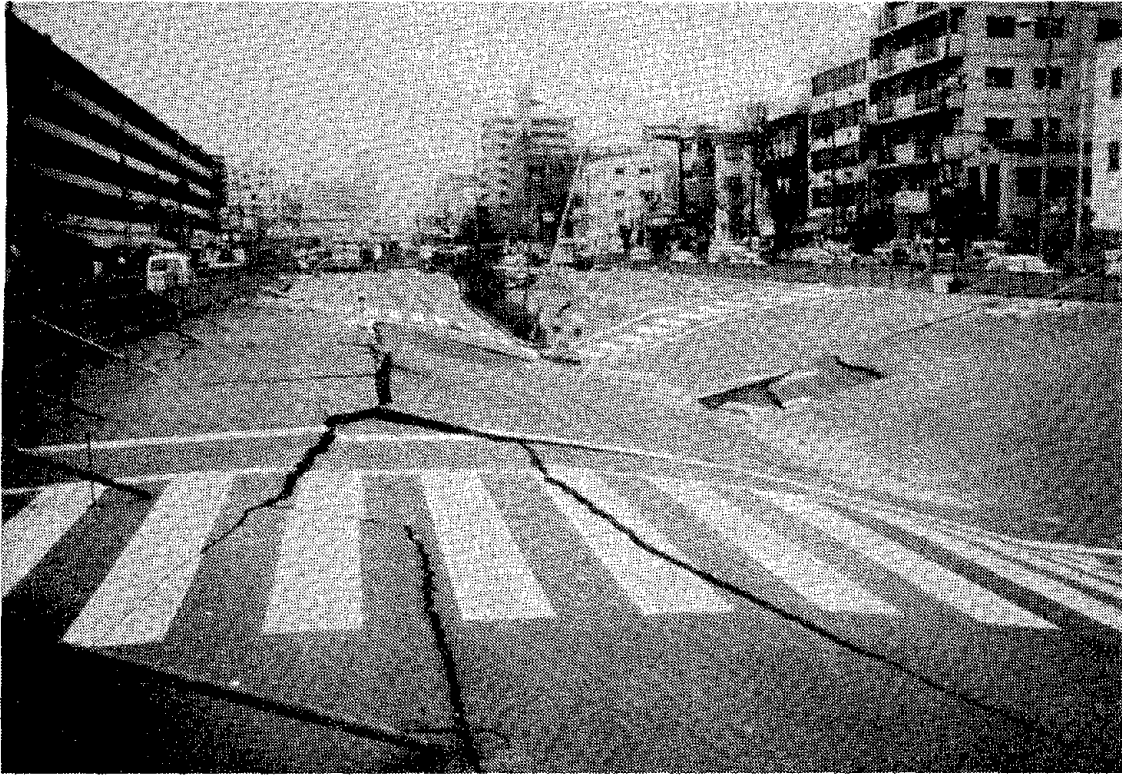
Fig. 4.16 Collapsed street surface over Dakai Station.

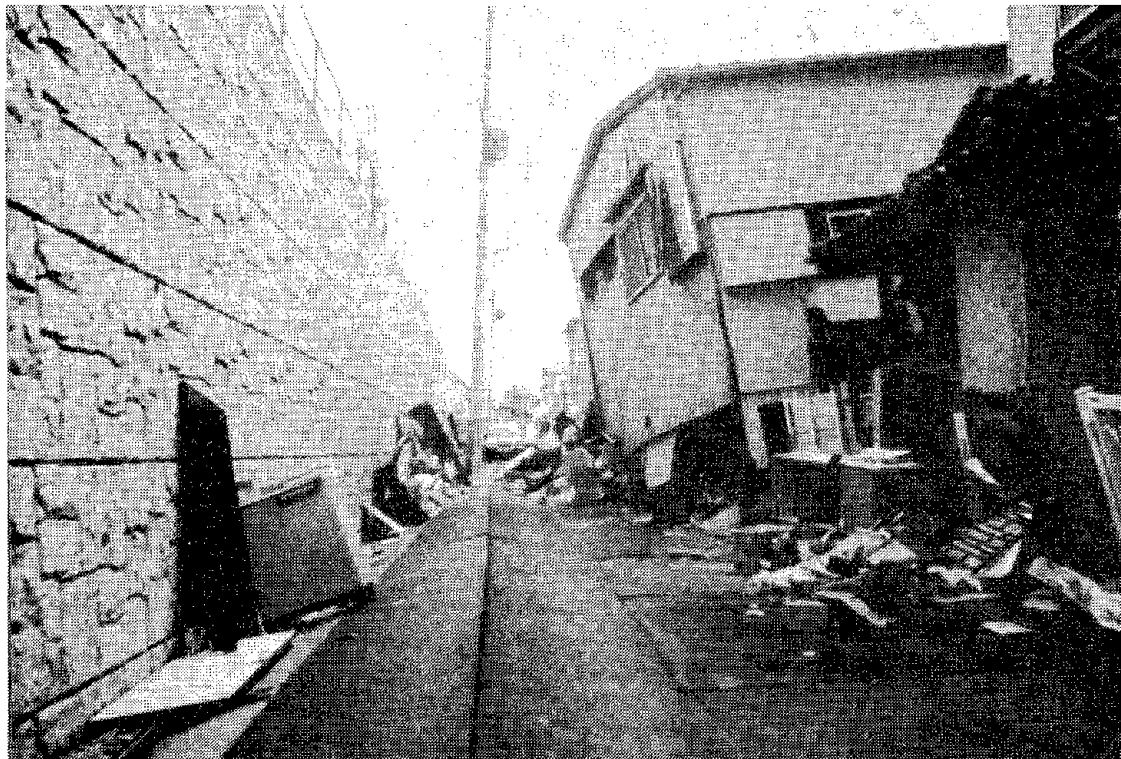
Fig. 4.19 This mechanically stabilized wall experienced only minor deformation in contrast to the extensive damage to the residential structures in the vicinity.

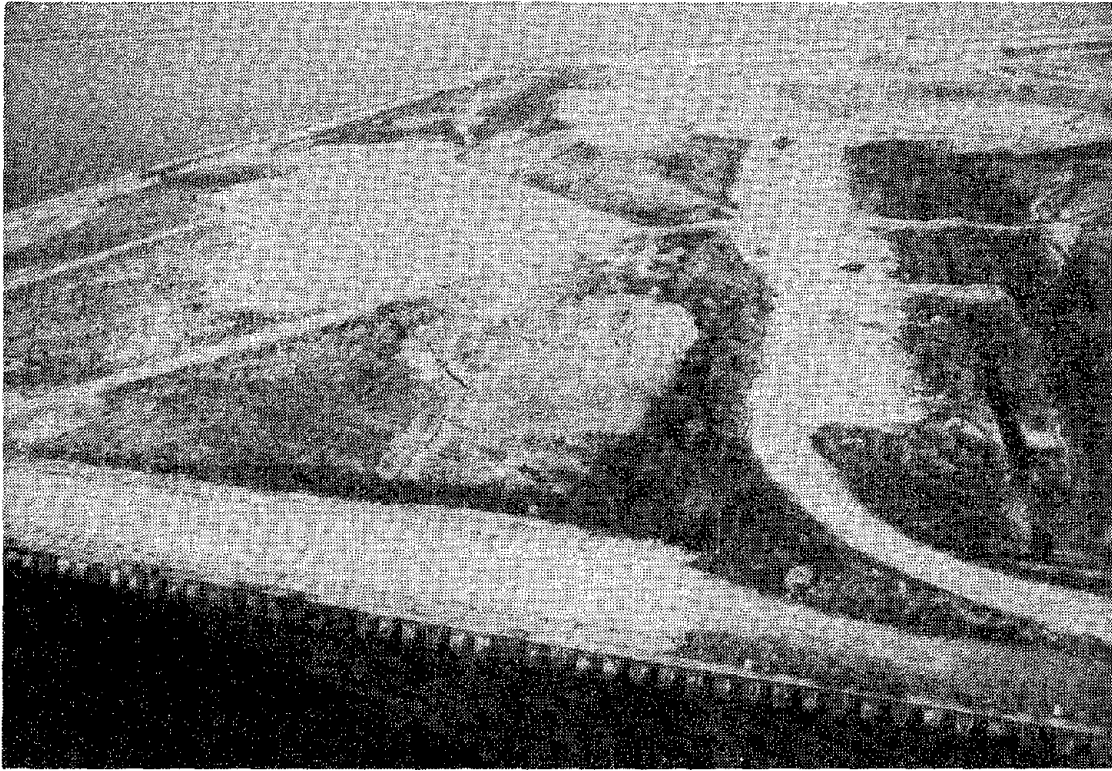
Fig. 4.20 Aerial view of ground cracking at a waste fill site west of Osaka.

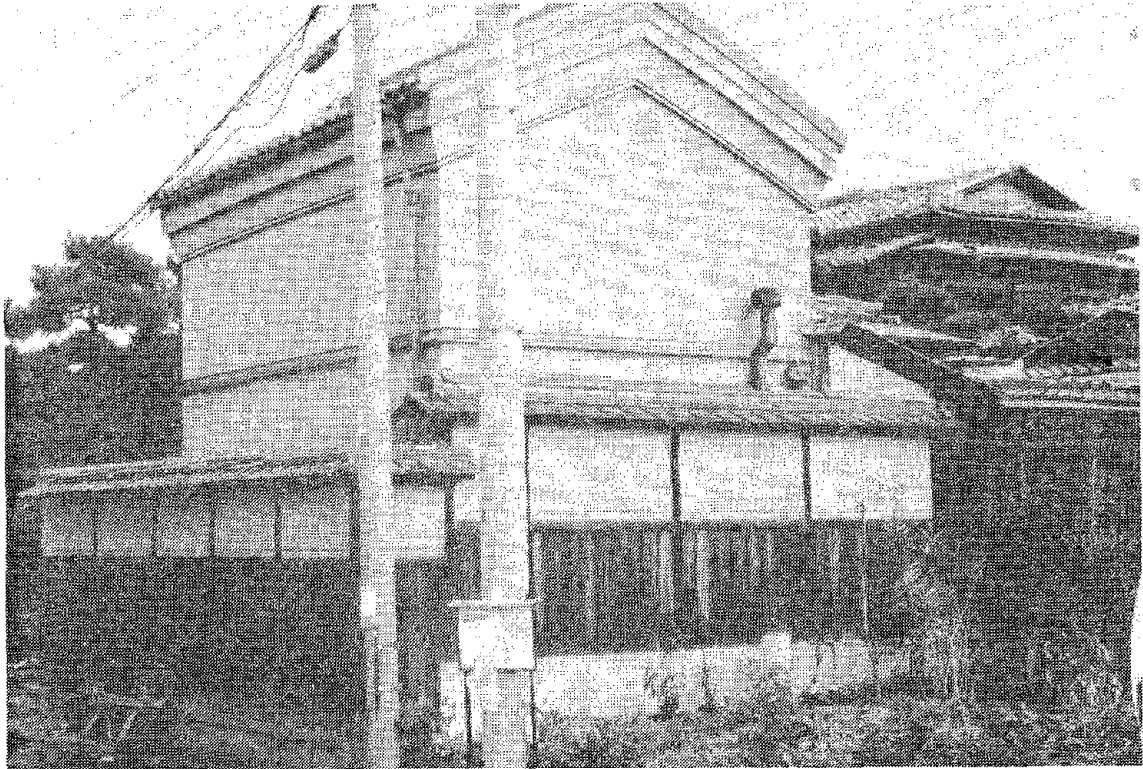
Fig. 5.1 Residence in Nishinomiya. The kura is in tact while the residence itself is damaged although remains standing. Note the disturbed roof tiles.

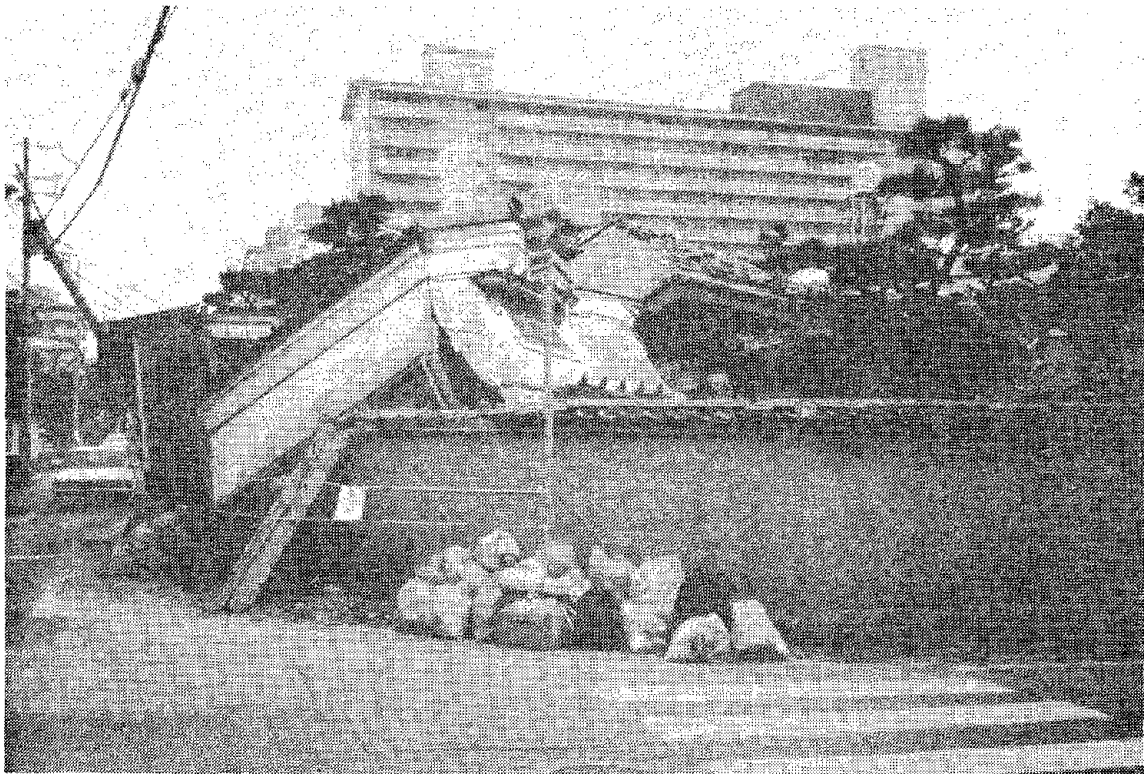
Fig. 5.2 Residence in Ashiya. The kura and residence have both collapsed in a northerly direction.

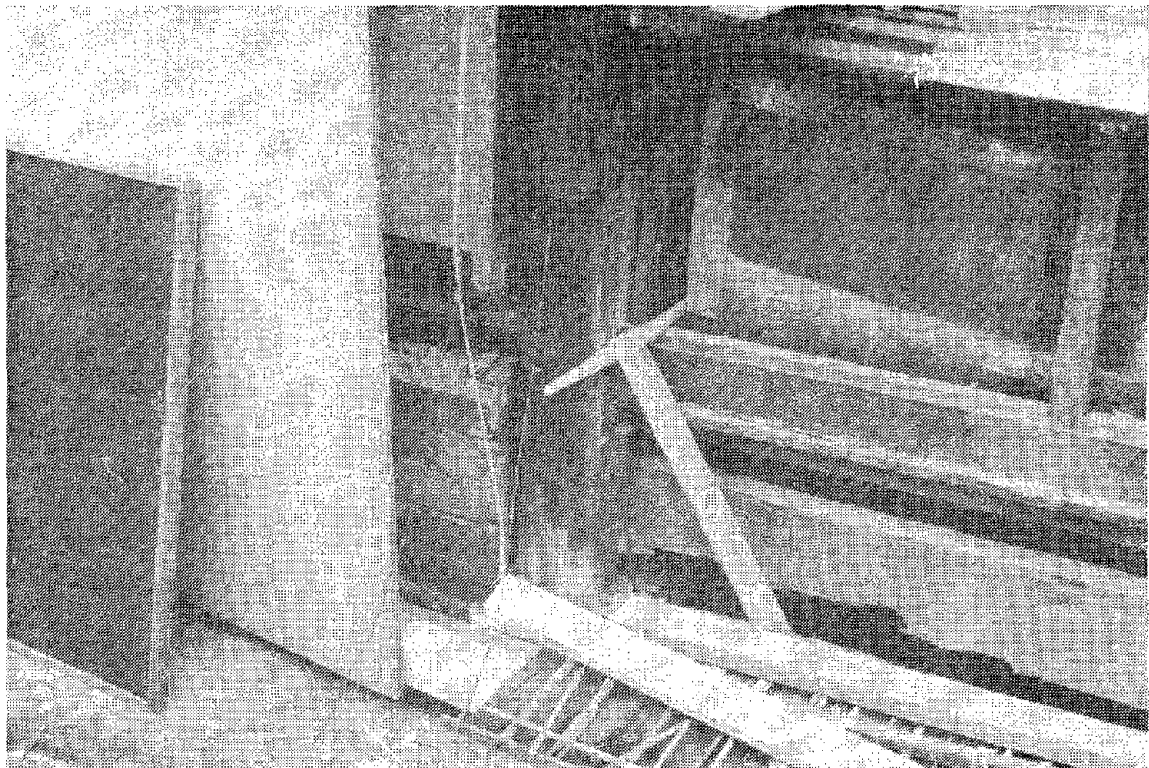
Fig. 5.6 Residence in Nishinomiya. Detail of post illustrating lack of ties between foundation and post.

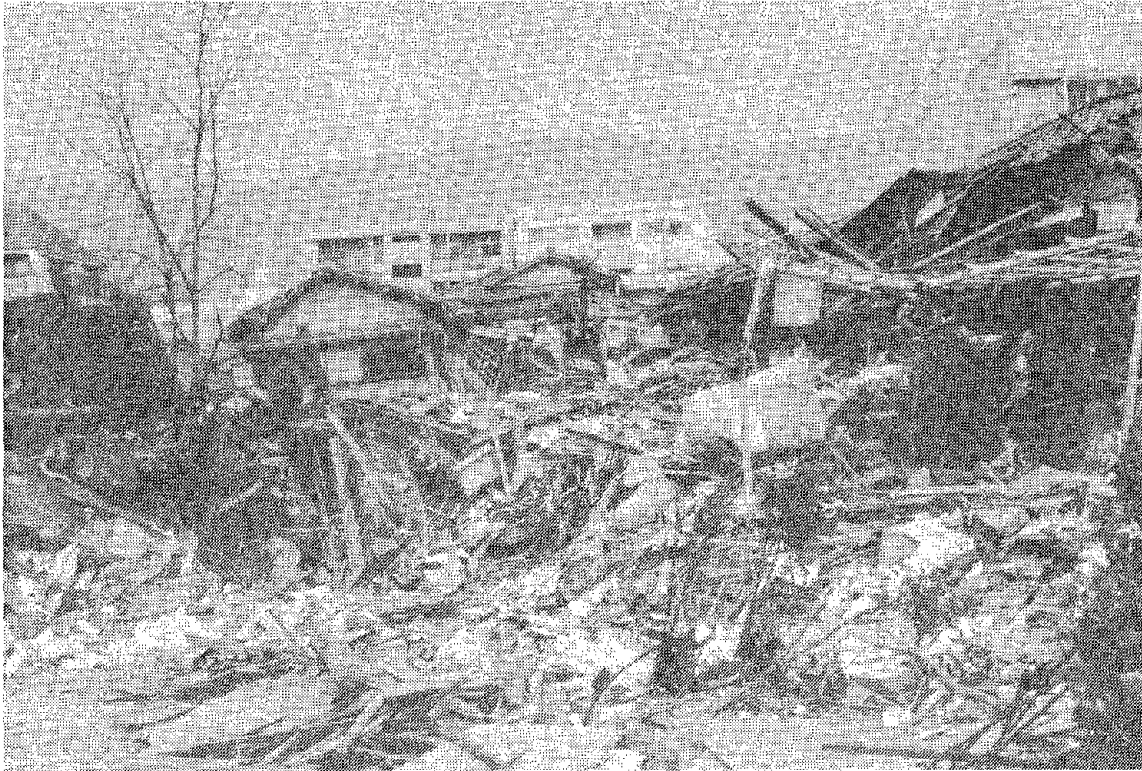
Fig. 5.7 Machiya ruins in Ashiya. The lack of metal fasteners, plywood and plastic and the abundance of small pieces of wood, sand, and terra-cotta make these structures completely recyclable.

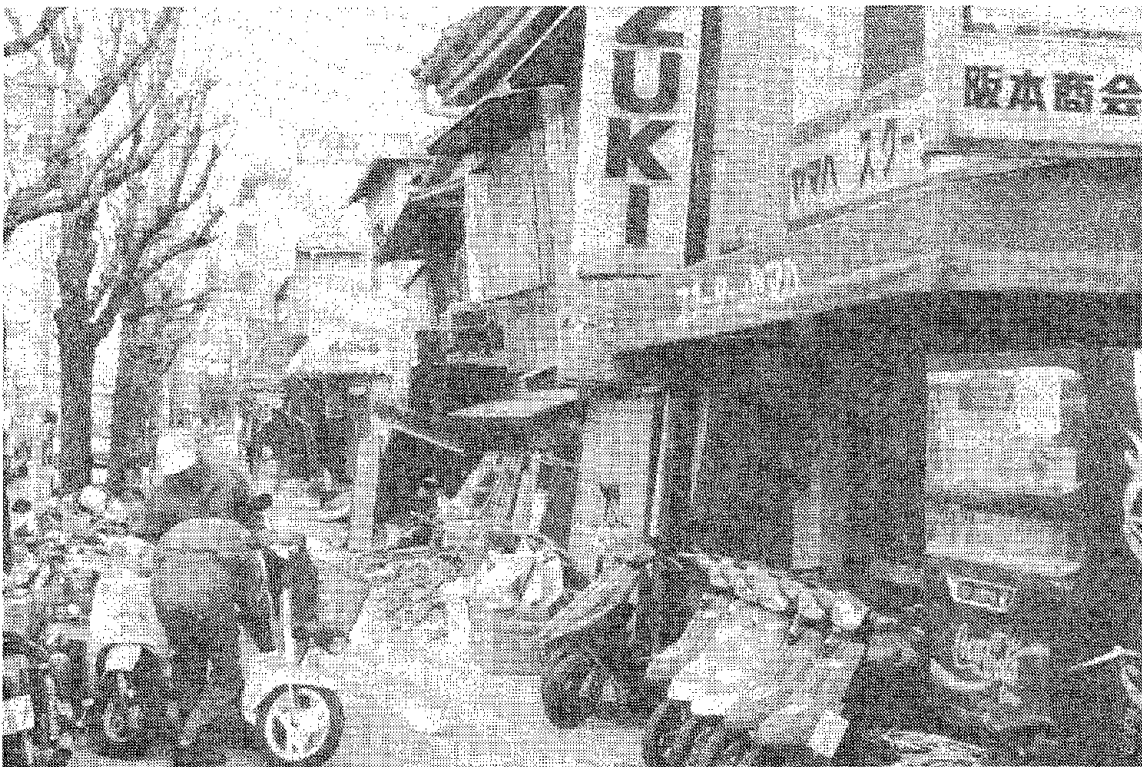
Fig. 5.8 Machiyas still standing but gravely damaged in Ashiya. Each demonstrates the effects of soft stories.

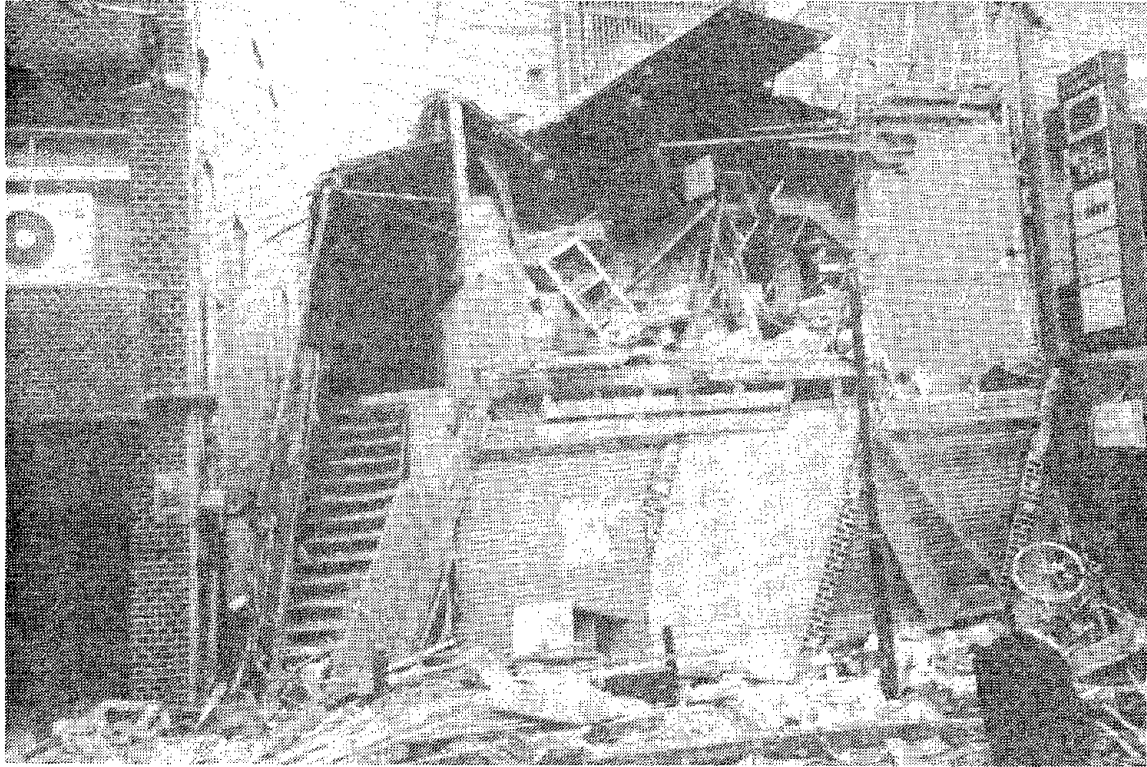
Fig. 5.9 Modernized machiya of traditional construction in downtown Kobe. Soft story collapse.

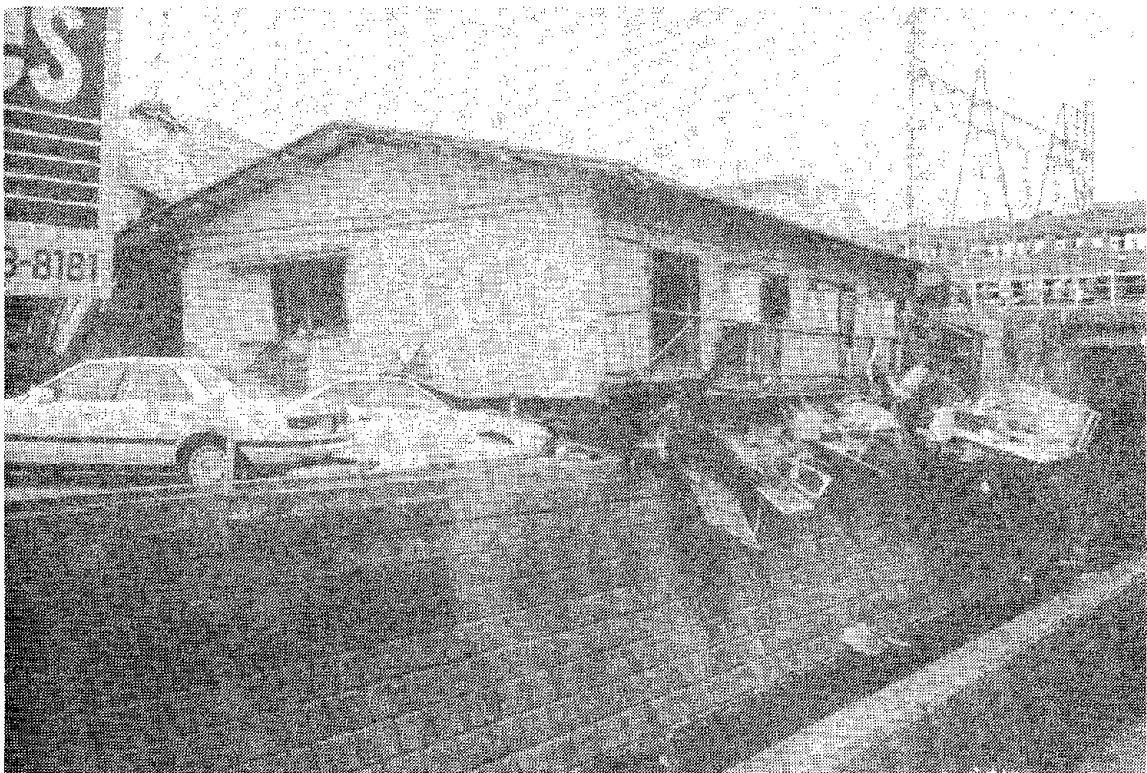
Fig. 5.10 Soft story failure in Ashiya.

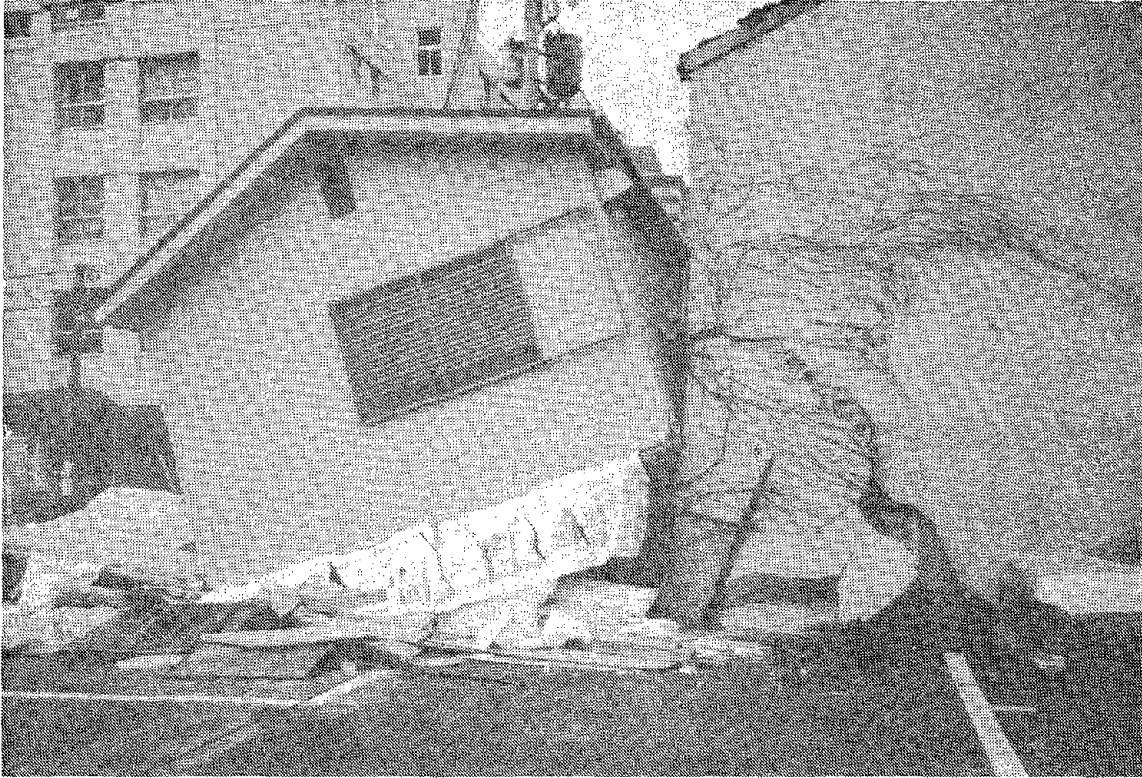
Fig. 5.11 Soft story collapse of newly constructed building in Ashiya which slammed into older structure next door.

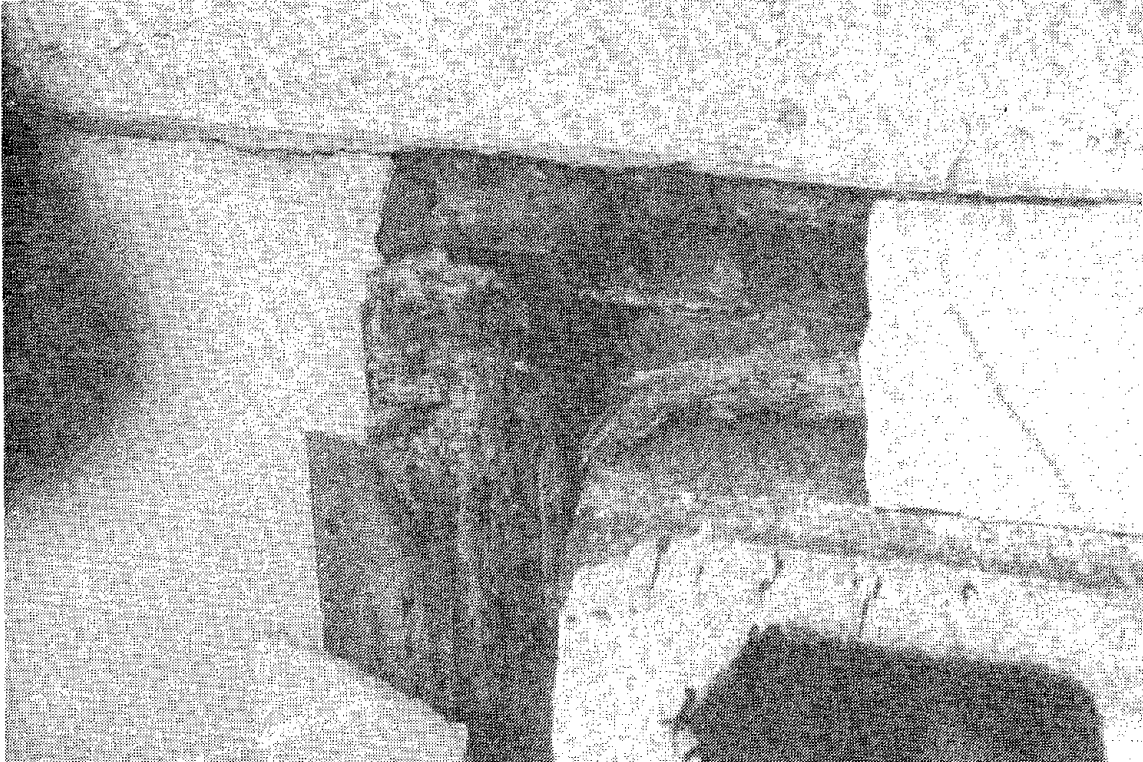
Fig. 5.13 Machiya in downtown Kobe. Detail of termite-damaged connection.

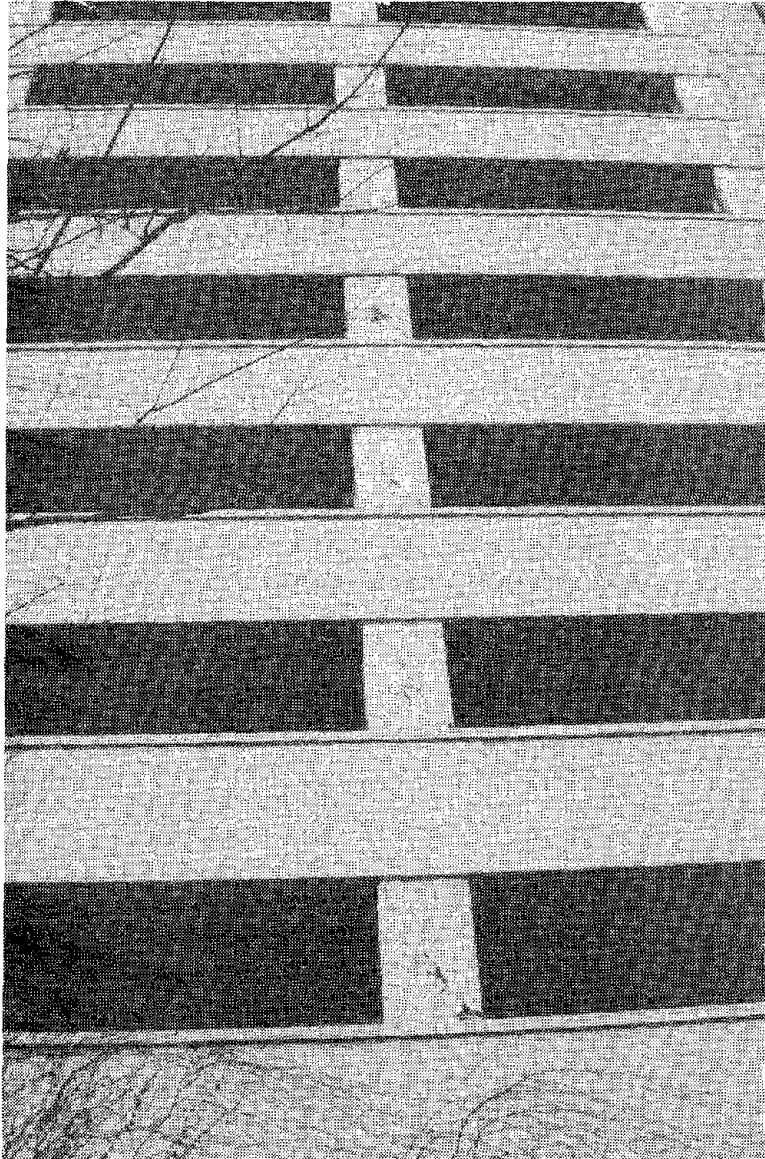
Fig. 6.42 Damage to shear-critical reinforced concrete columns

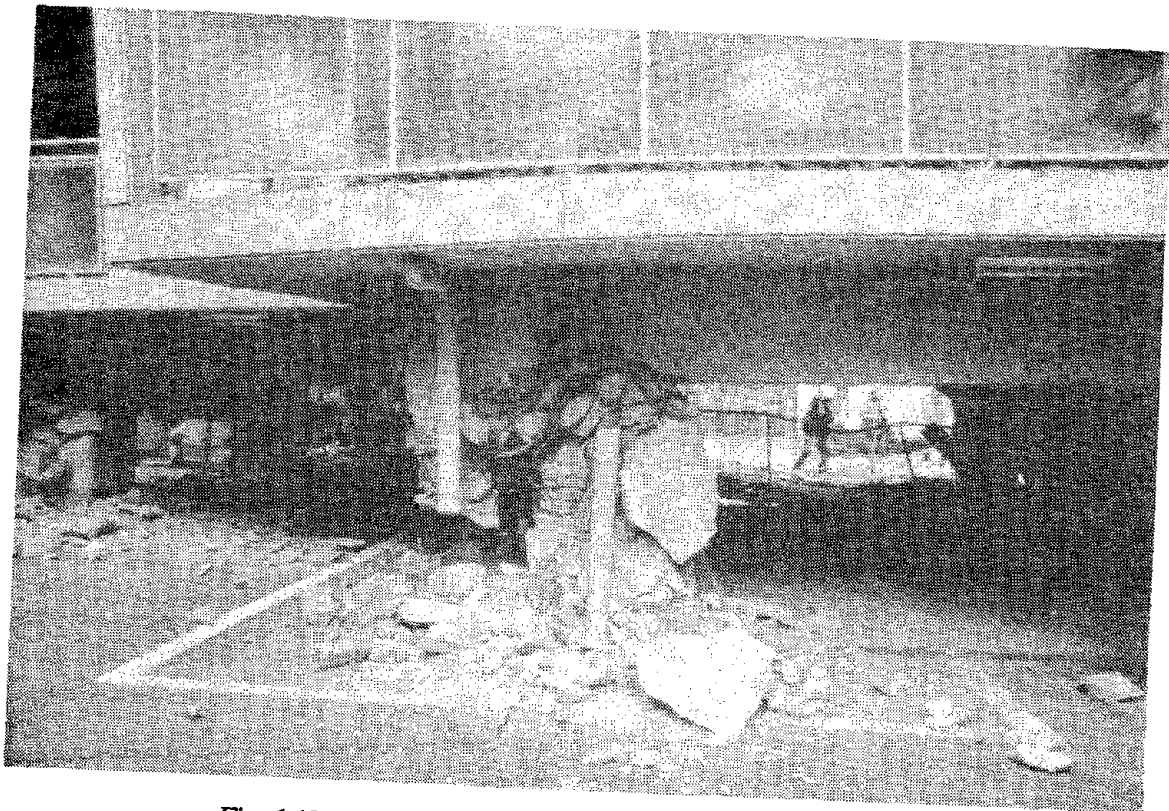
Fig. 6.43 Shear failure of first-story reinforced concrete columns

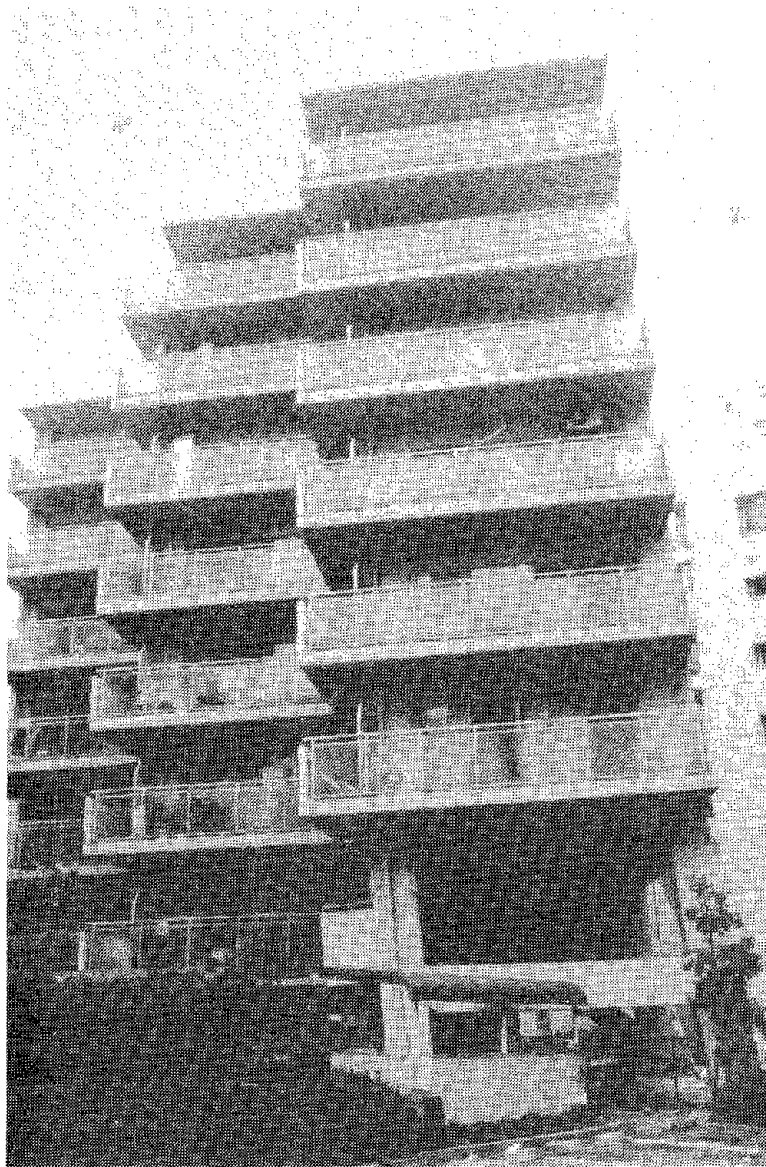
Fig. 6.44 Nine-story building with failed first-story columns

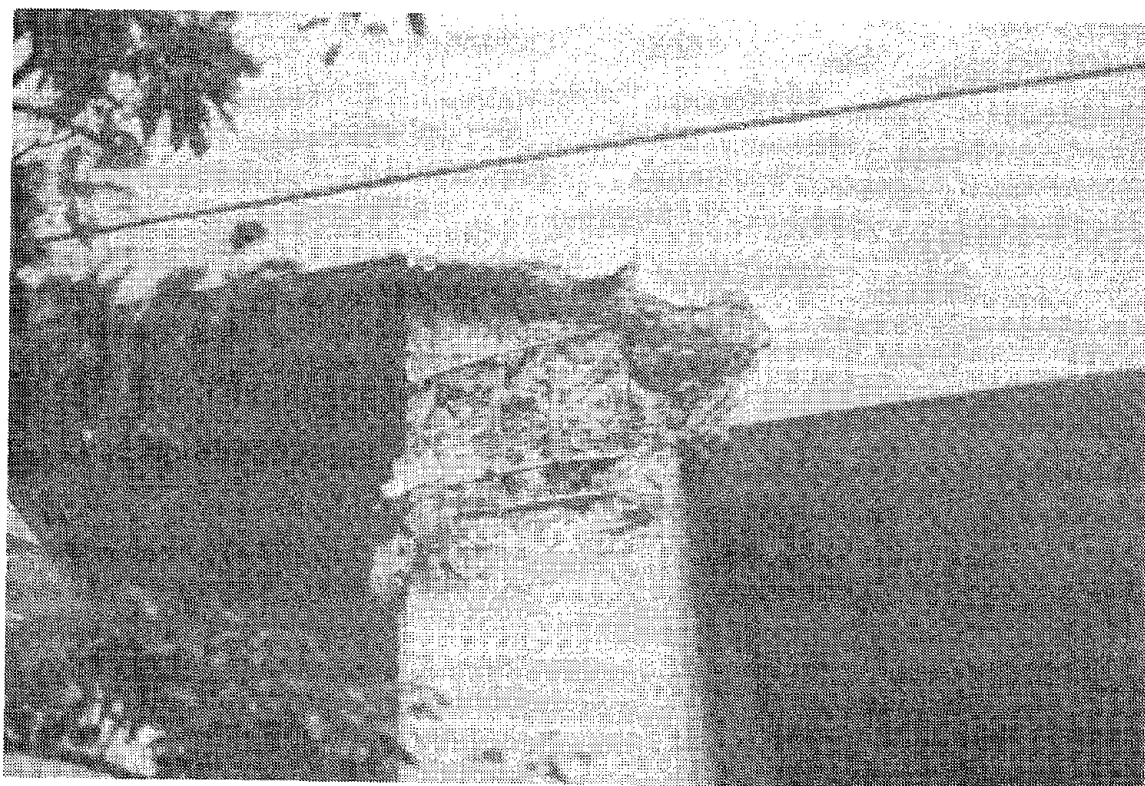
Fig. 6.50 Damage to a modern beam-column joint

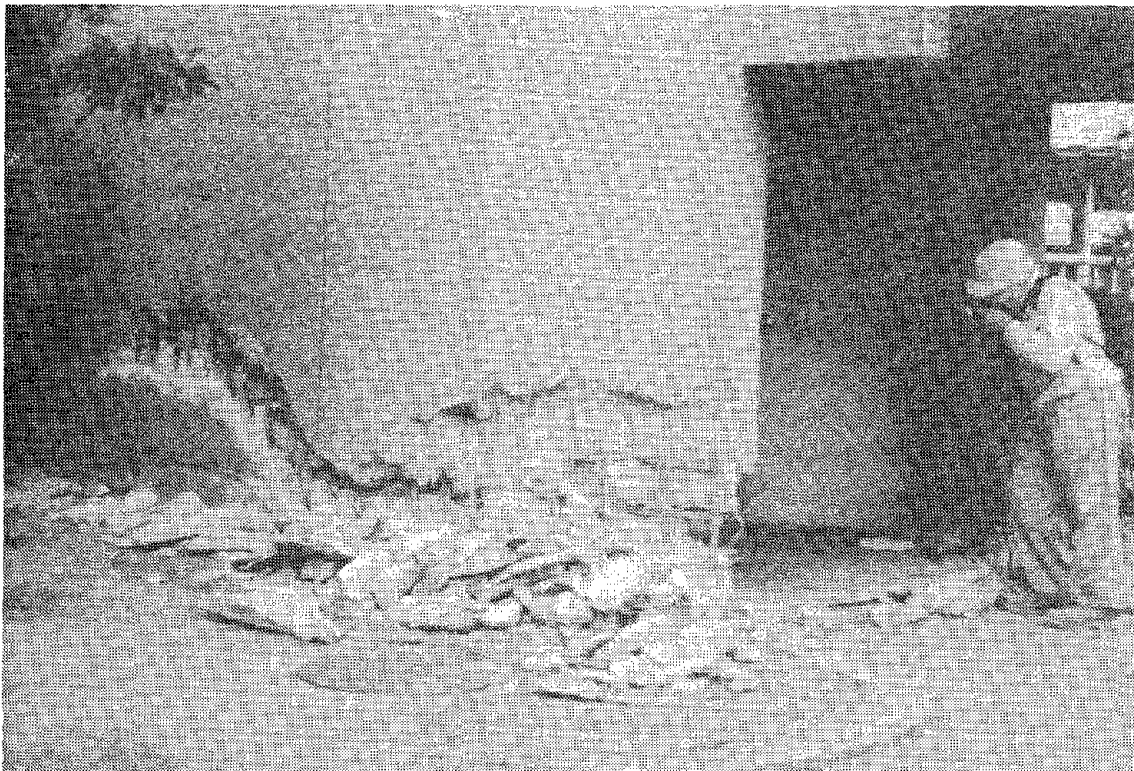
Fig. 6.56 Damage to a reinforced concrete structural wall

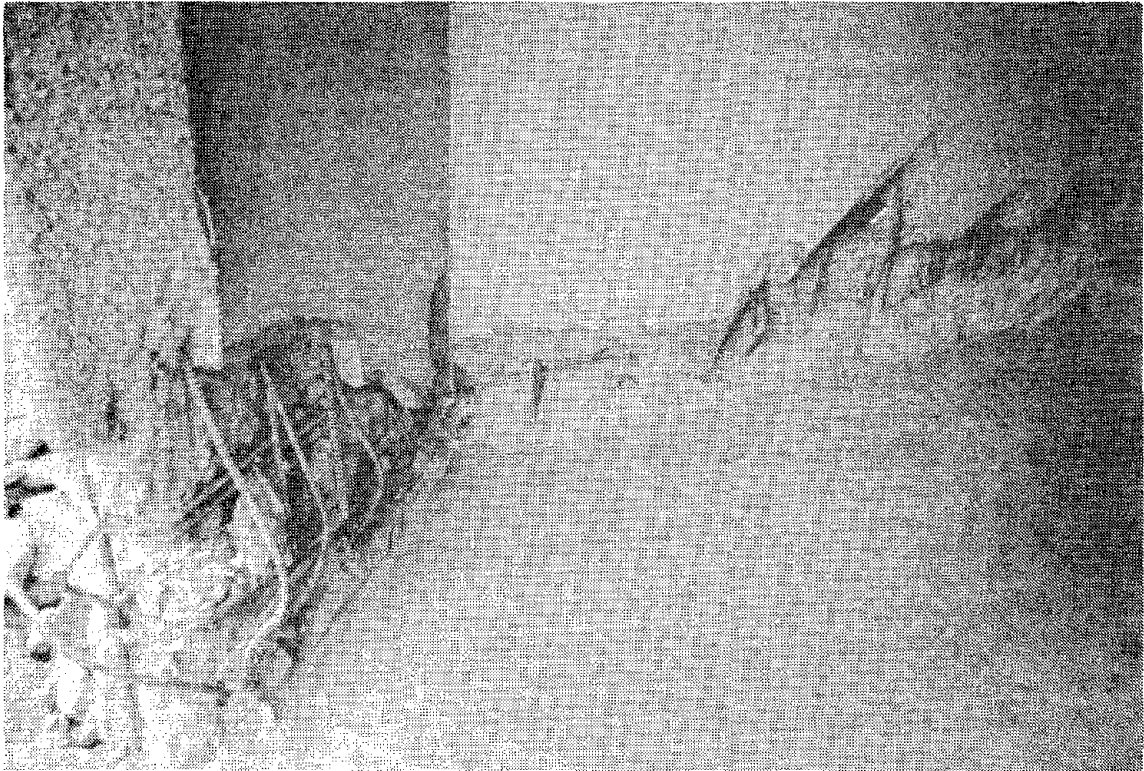
Fig. 6.57 Damage to a reinforced concrete structural wall

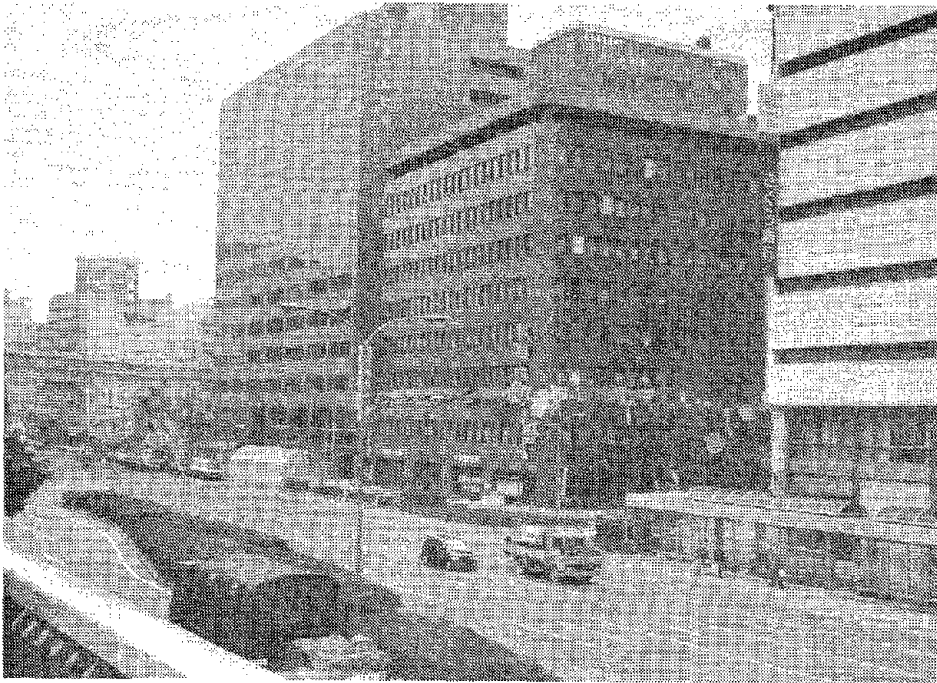
Fig. 6.86 View of two damaged SRC buildings

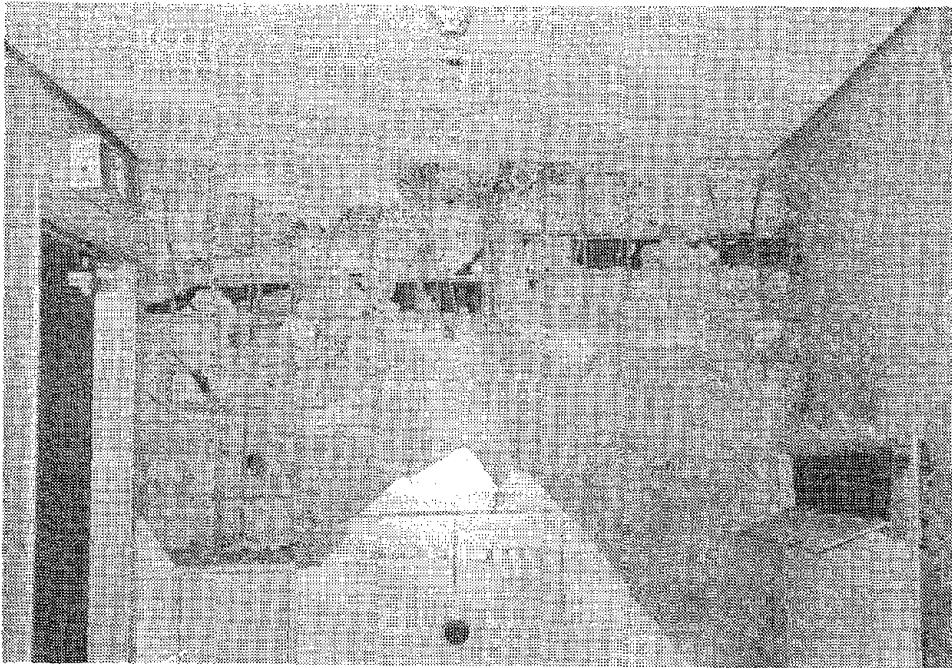
Fig. 6.87 Damage to a post-1981 SRC building incorporating structural walls

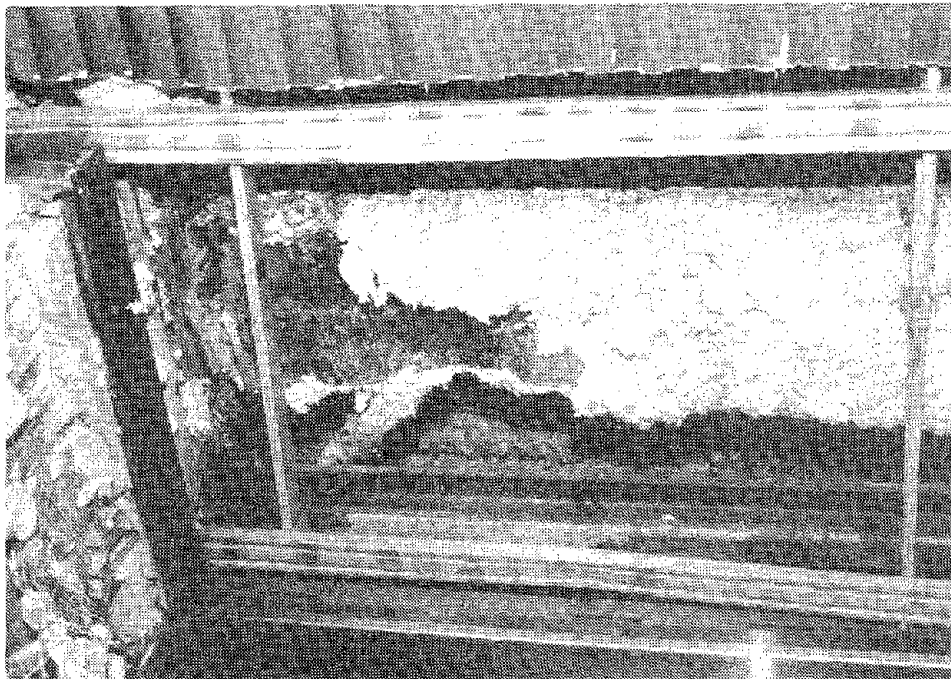
Fig. 6.99 Type 1 fracture of a moment-frame connection

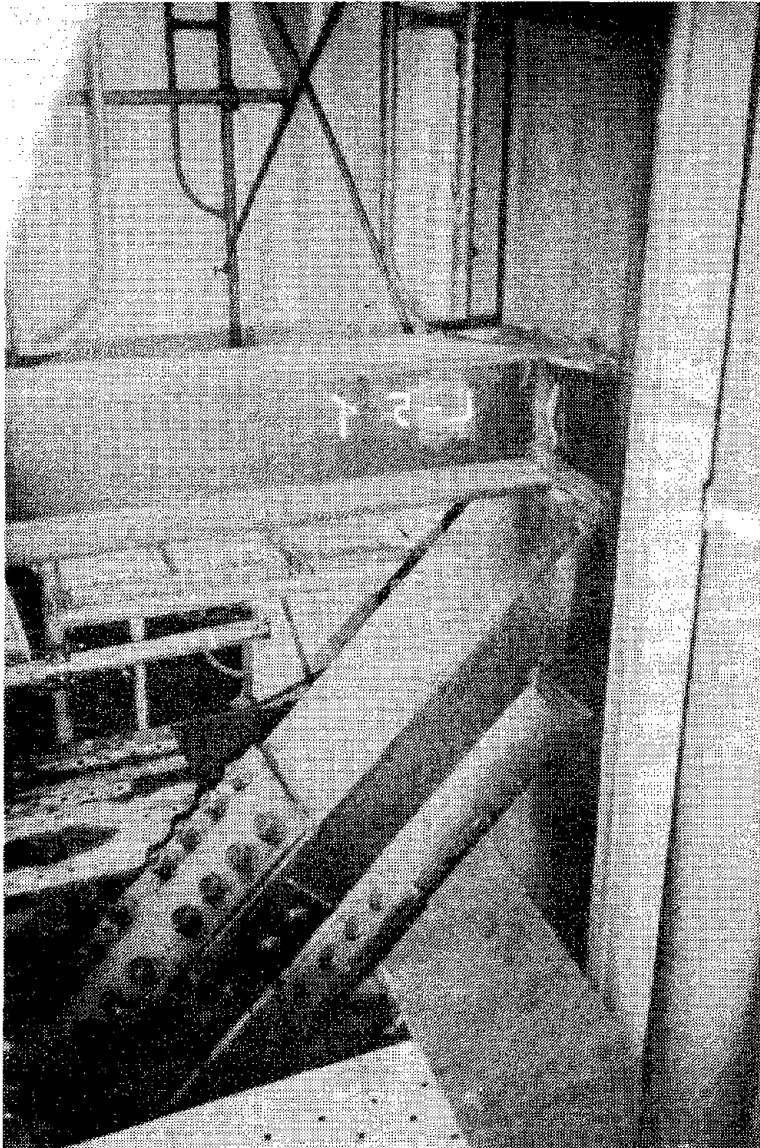
Fig. 6.135
Failed connection in braced tower

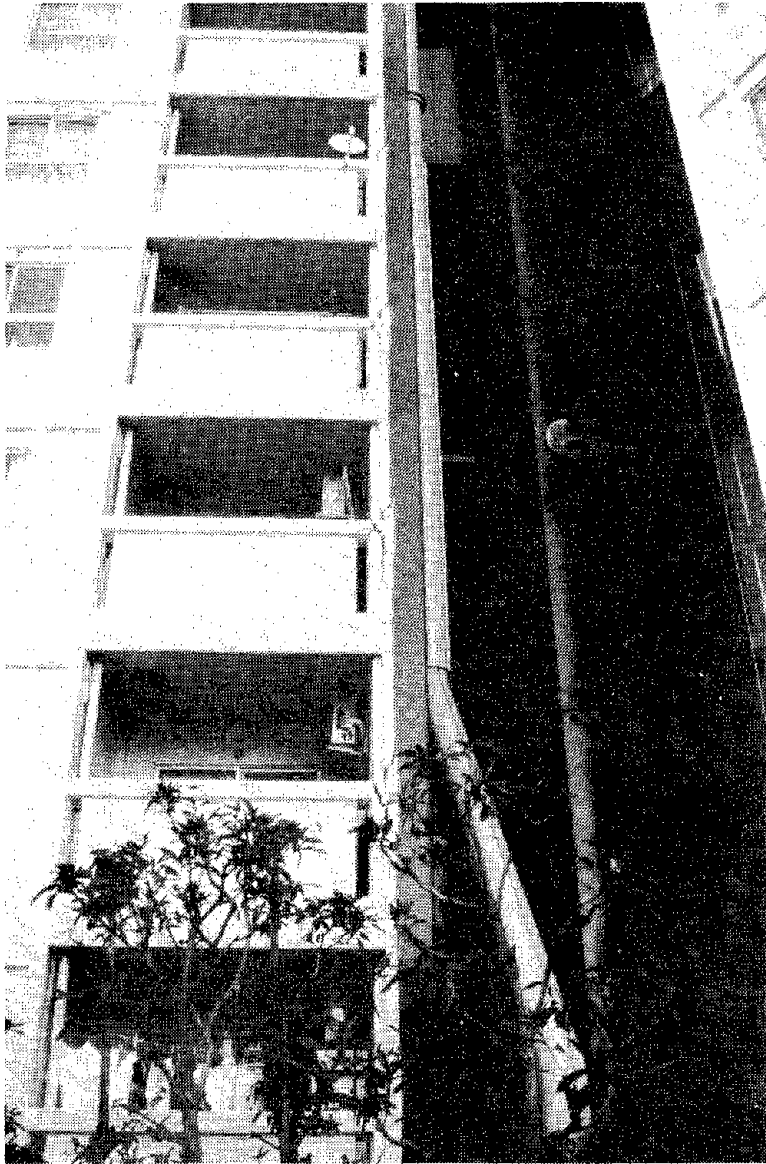
Fig. 6.137
Lightly-damaged precast cladding

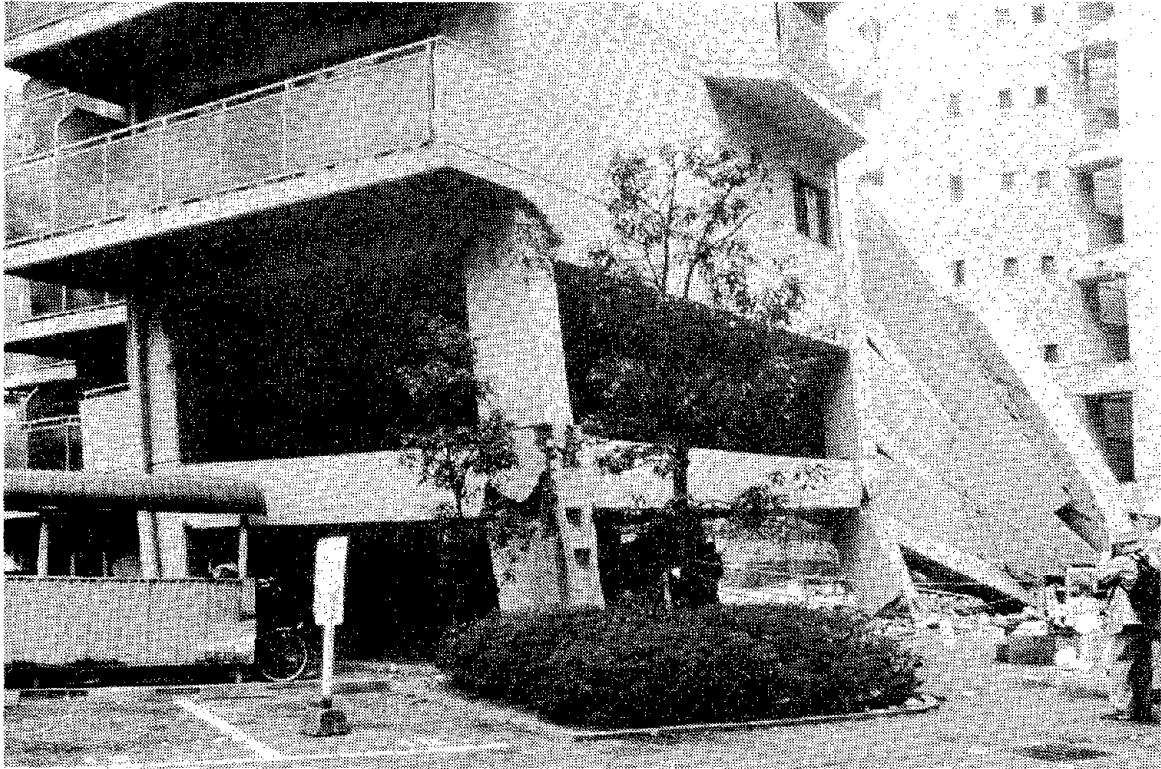
Fig. 6.143 Collapse of elevated walkways connecting apartment blocks
