SEISMOLOGICAL AND ENGINEERING ASPECTS OF THE 1995 HYOGOKEN-NANBU (KOBE) EARTHQUAKE

REPORT NO.
UCB/EERC-95/10
NOVEMBER 1995

EARTHQUAKE ENGINEERING RESEARCH CENTER

A reconnaissance report by
teams funded by

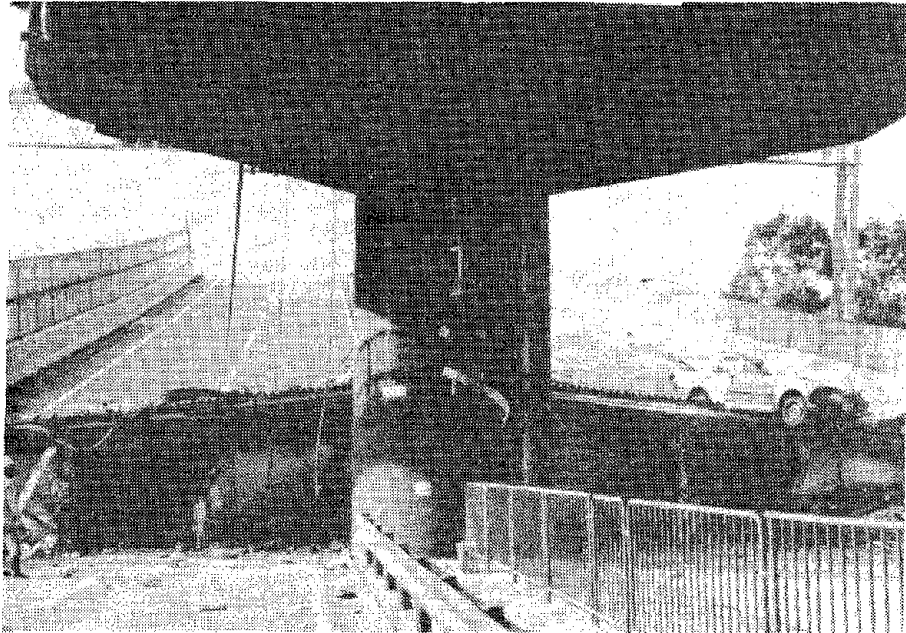
Fig. 7.7 Restrainer failure in Kobe Route

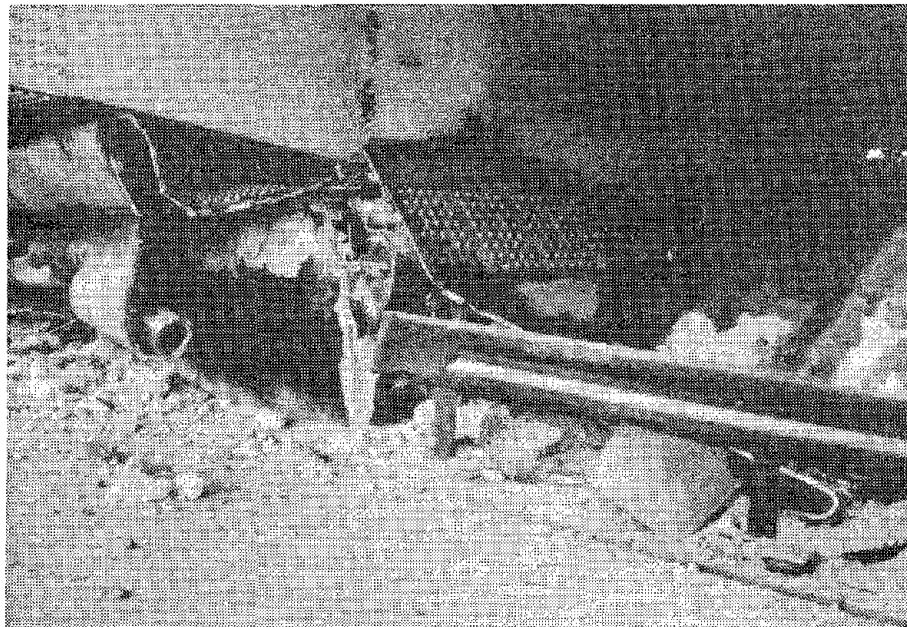
Fig. 7.8 Failure of steel piers

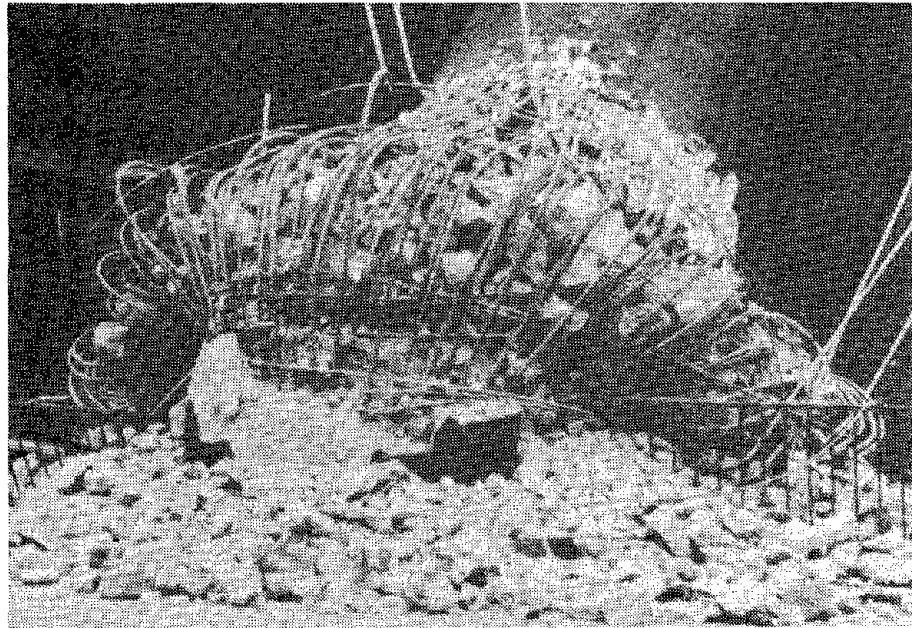
Fig. 7.9 Failure from insufficient confinement steel

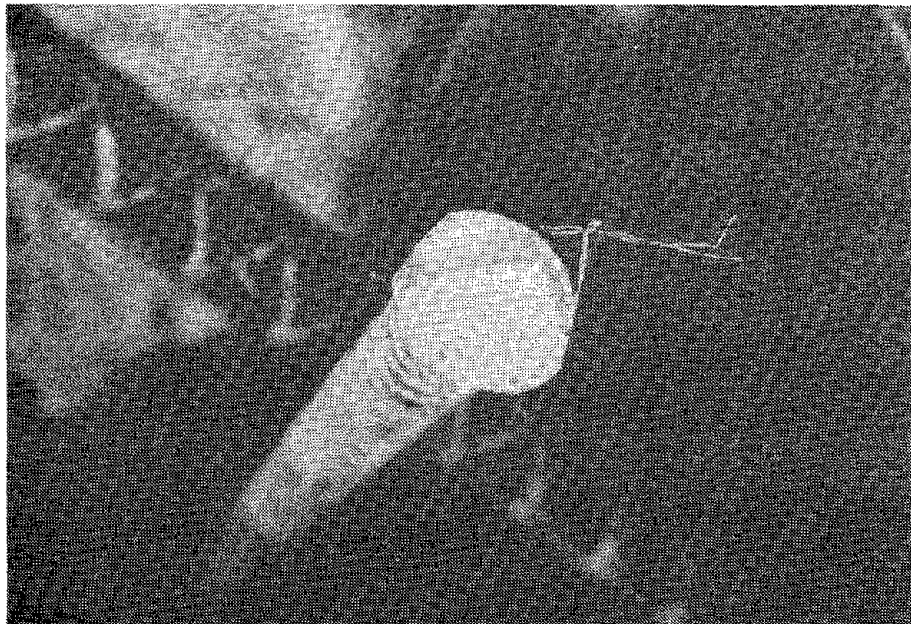
Fig. 7.10 Close-up of gas pressure weld splice failure

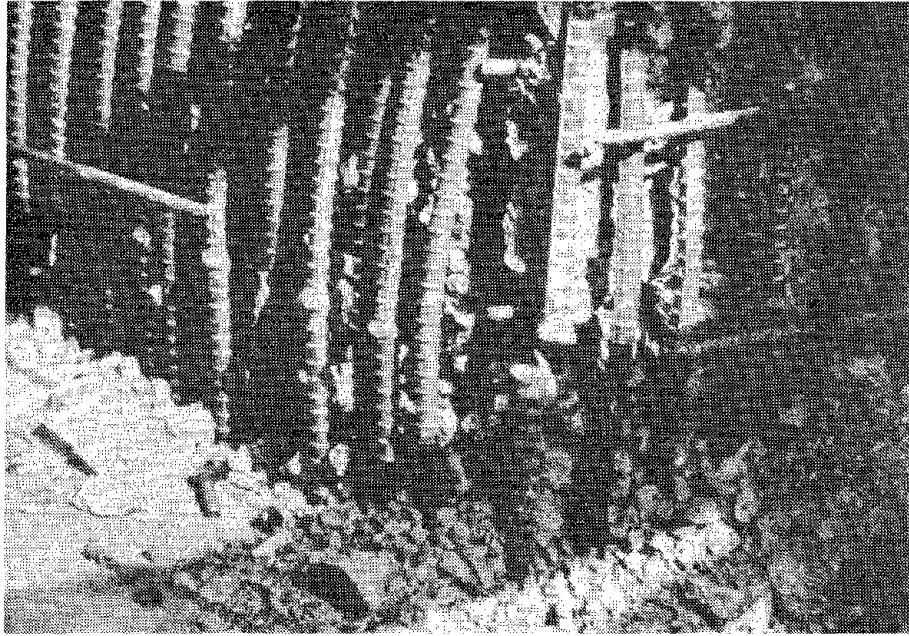
Fig. 7.11 Splice failure at the base of a pier

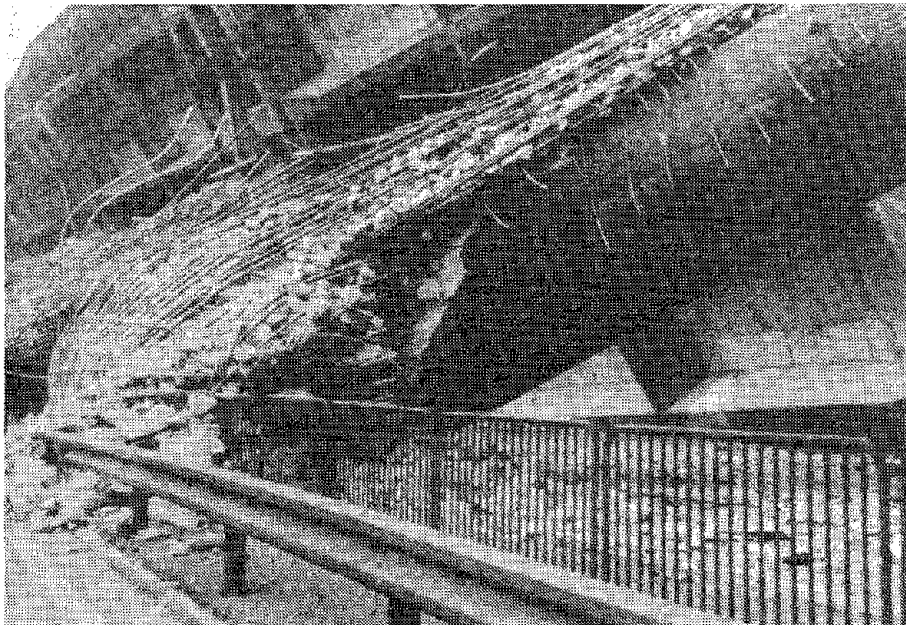
Fig. 7.12 Splice failure at mid-height of pier

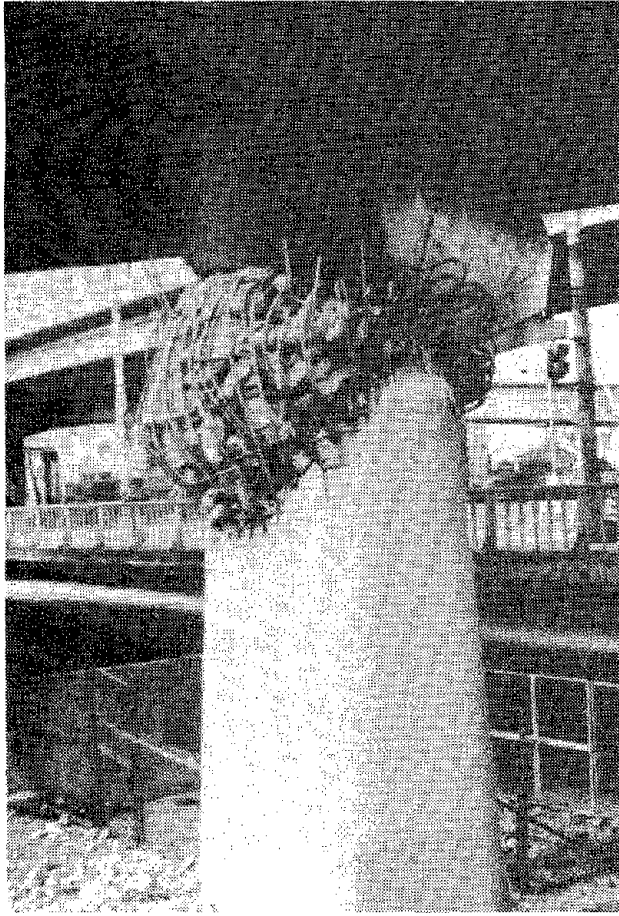
Fig. 7.13 Splice failure just under pier cap

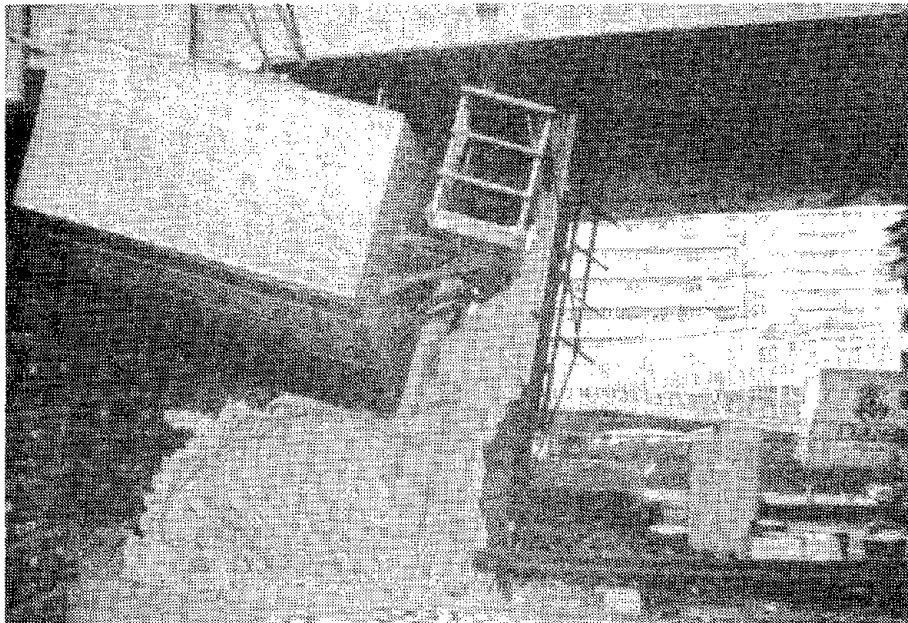
Fig. 7.14 Splice failure followed by shear failure of square pier

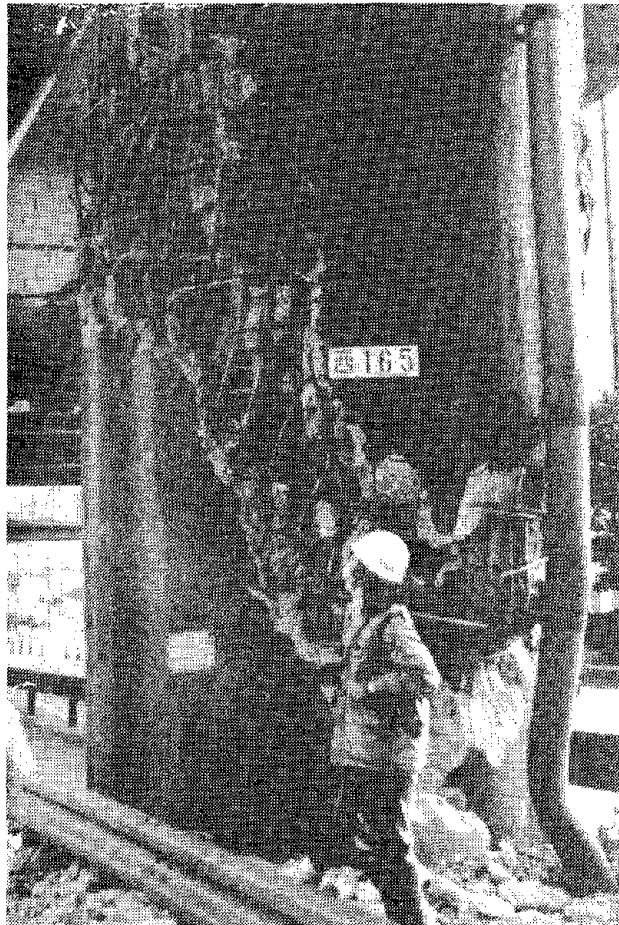
Fig. 7.15 Splice failure followed by shear failure of circular pier

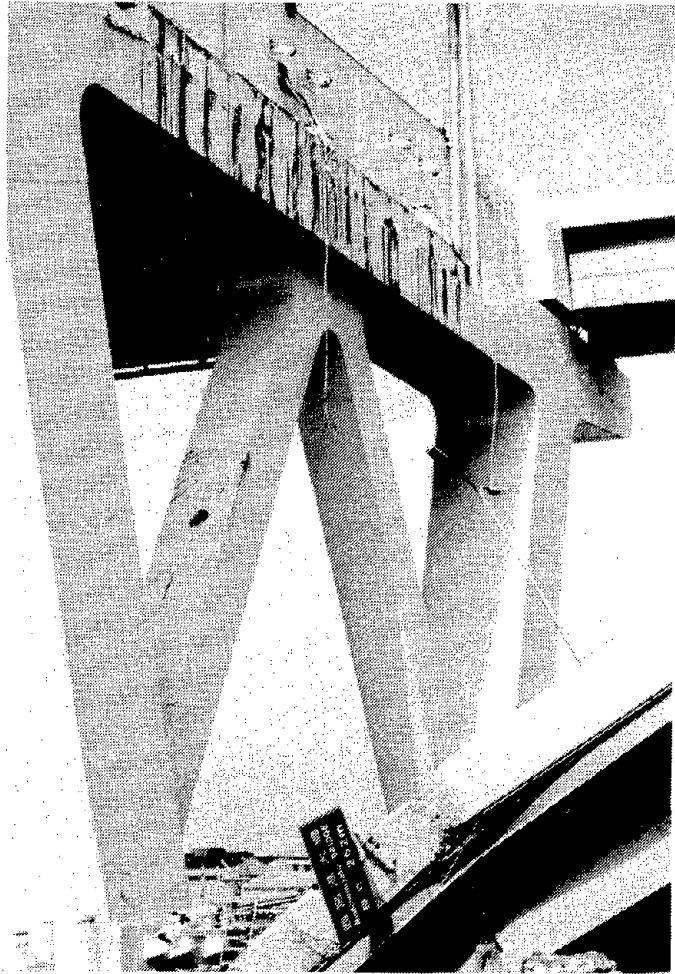
Fig. 7.17 Restrainer failure in approach span to Nishnomiya Ko tied arch bridge

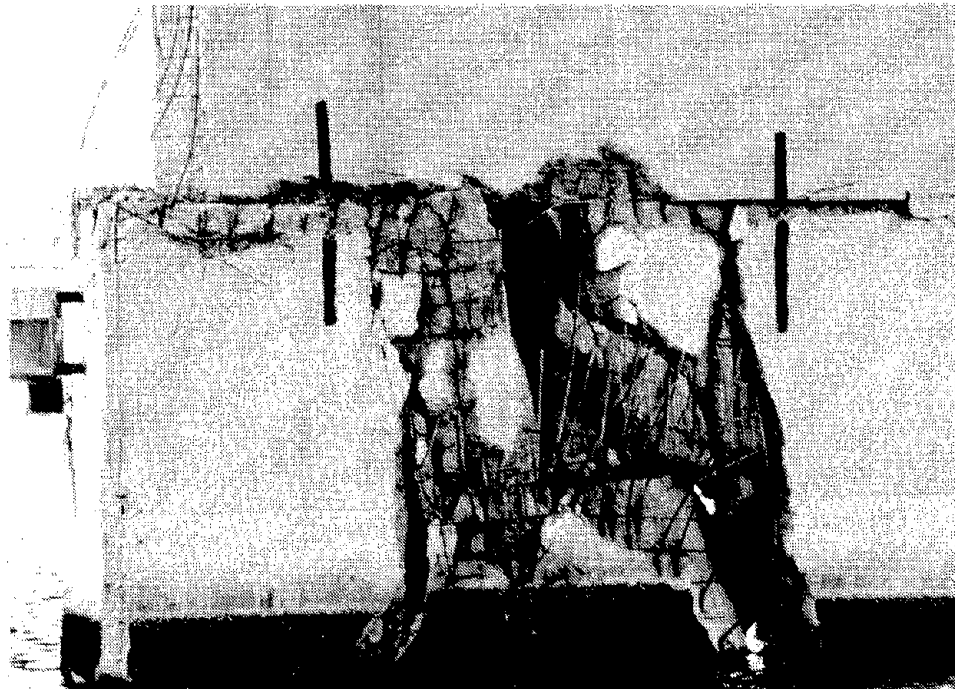
Fig. 7.21 Close-up of pier damage

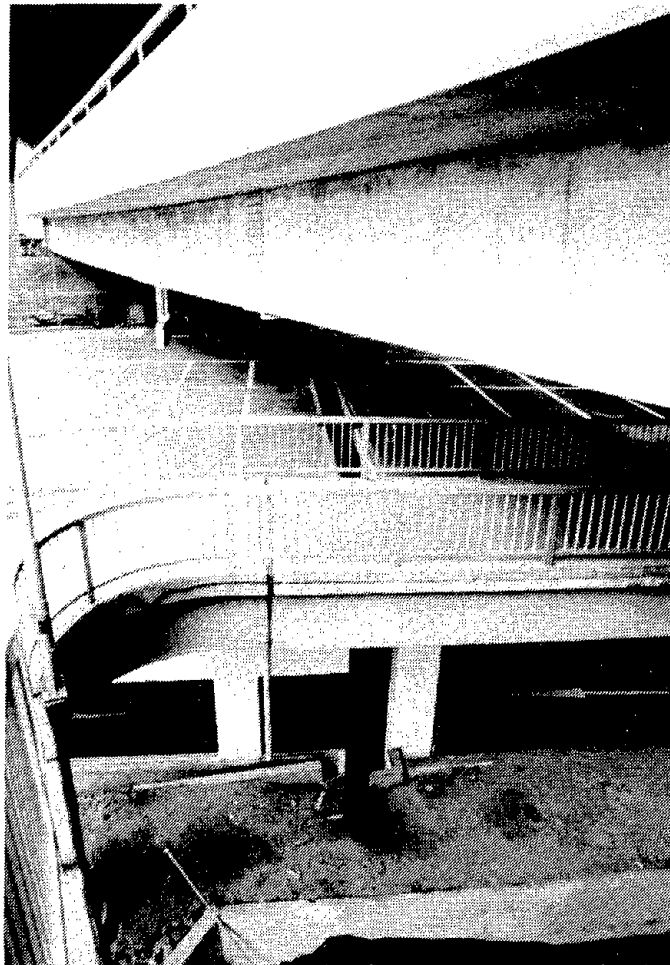
Fig. 7.39 Damaged parking facilities

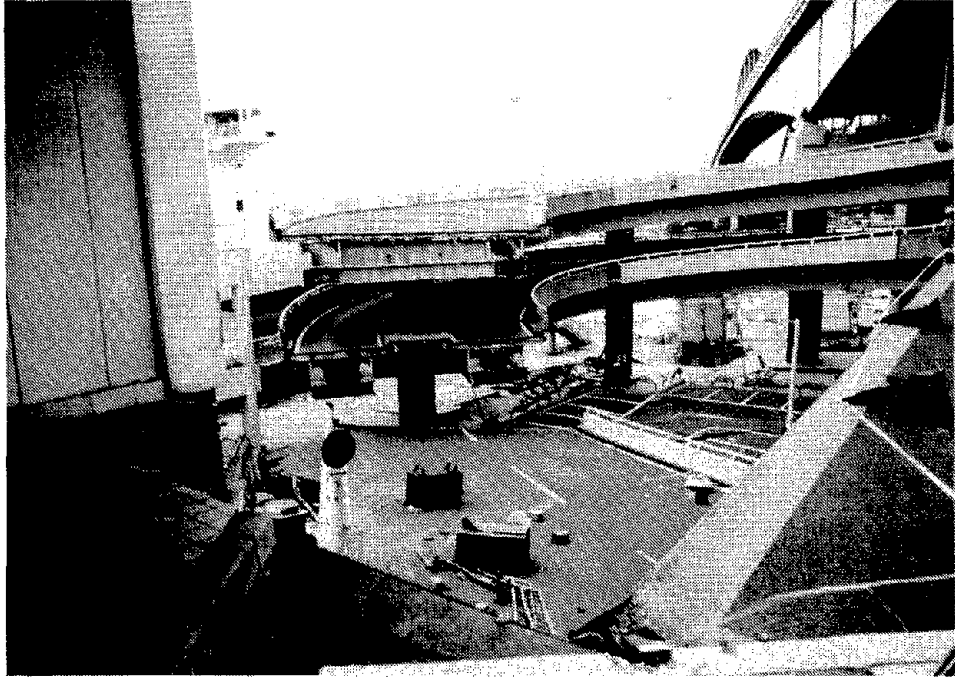
Fig. 7.40 Dropped span in parking structure at north end of Port Island bridge

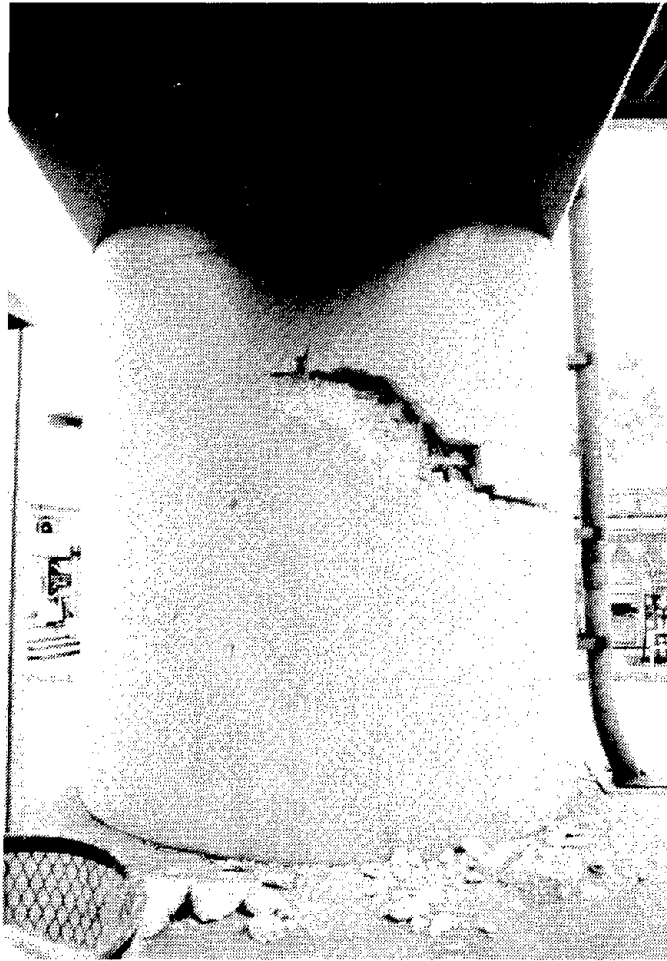
Fig. 7.43 Spalling in large modern column

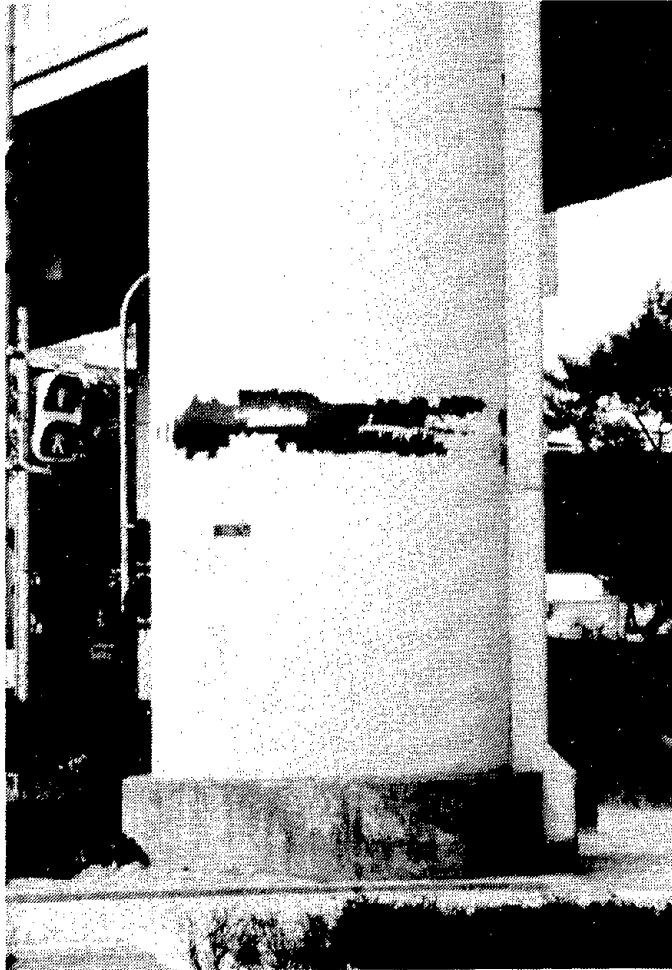
Fig. 7.44 Buckled steel column

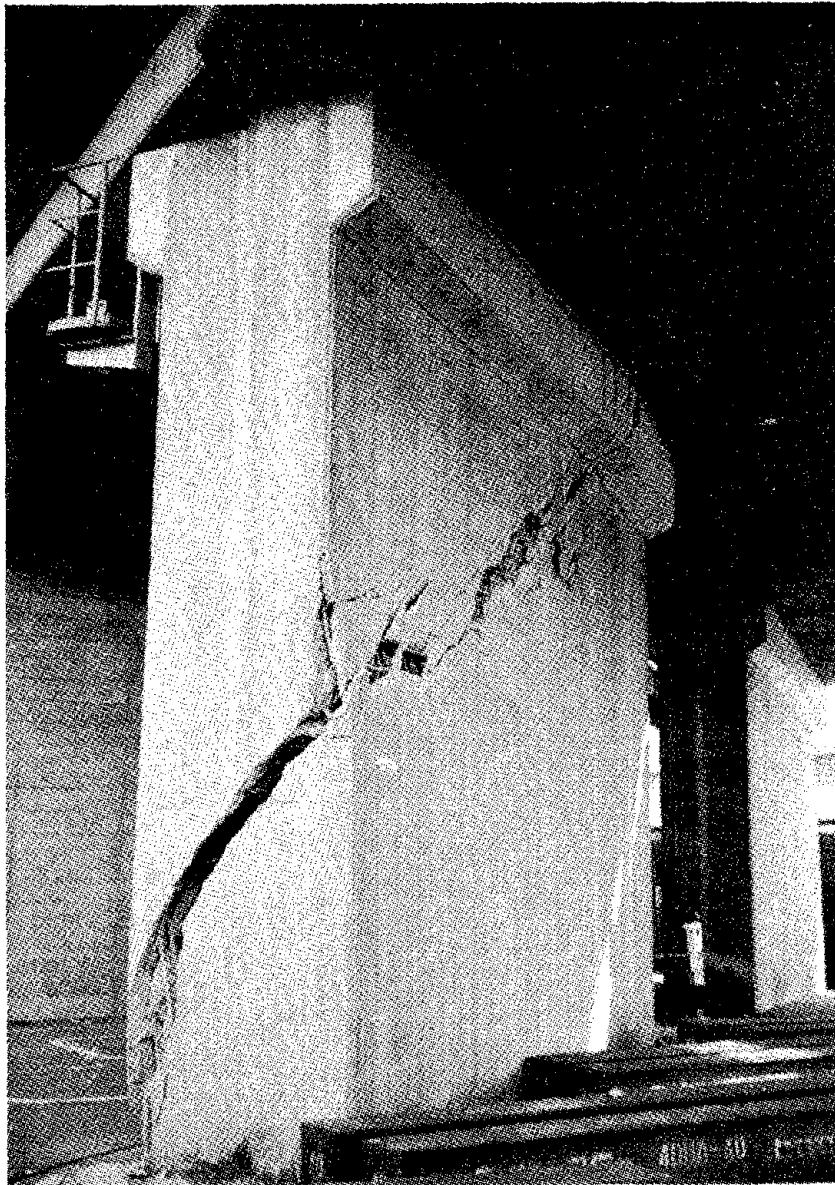
Fig. 7.46 Damage to the Kawaragi-nish Bridge [JHC, 1995]

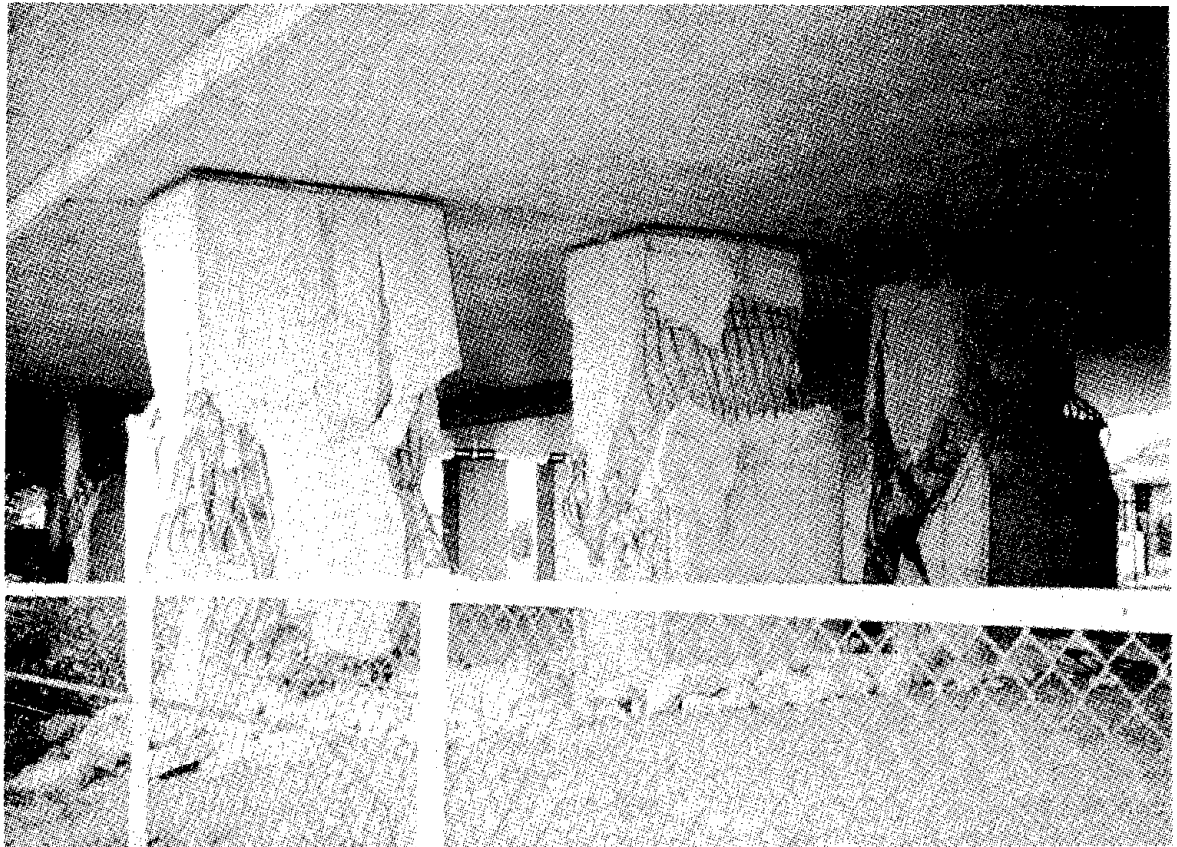
Fig. 7.47 Damage to the Takarazuka Bridge [JHC, 1995]
