# The Loma Prieta, California, Earthquake of October 17, 1989—Landslides

STRONG GROUND MOTION AND GROUND FAILURE

U.S. GEOLOGICAL SURVEY PROFESSIONAL PAPER 1551-C

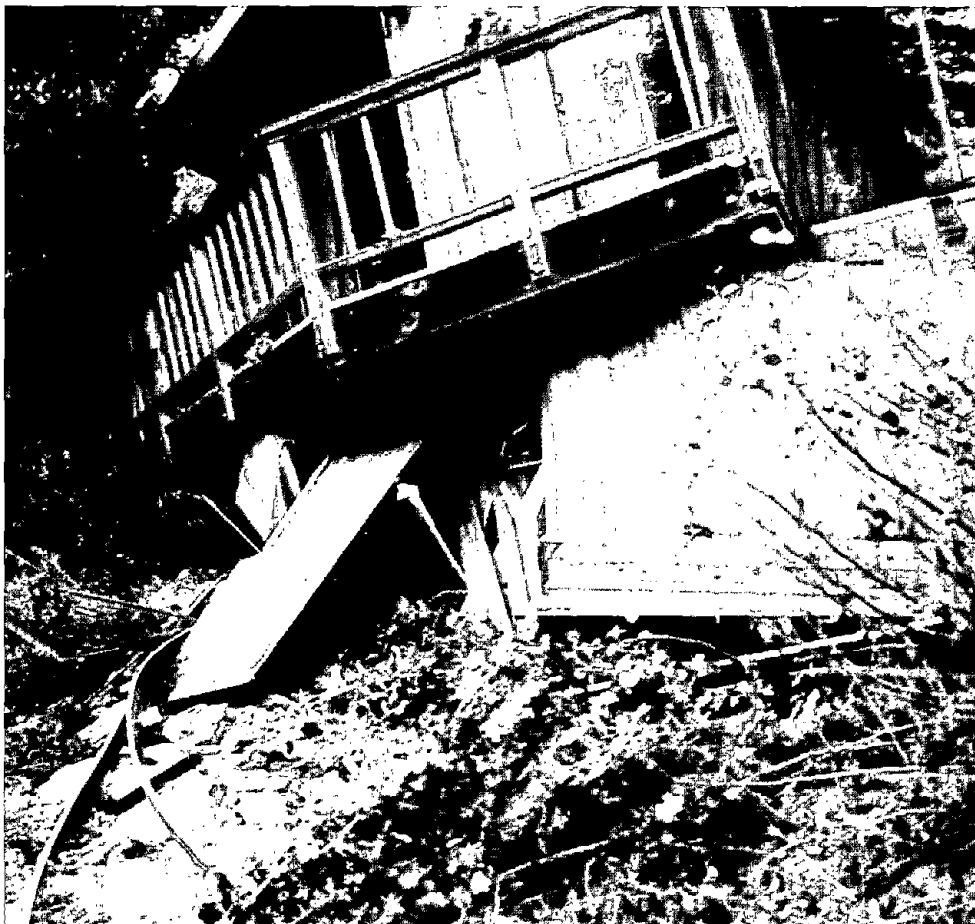
Figure 8.—Severely damaged house on Rebecca Drive landslide (see pl. 1 for location). Main scarp of landslide passes under house. Note ground cracks in foreground.

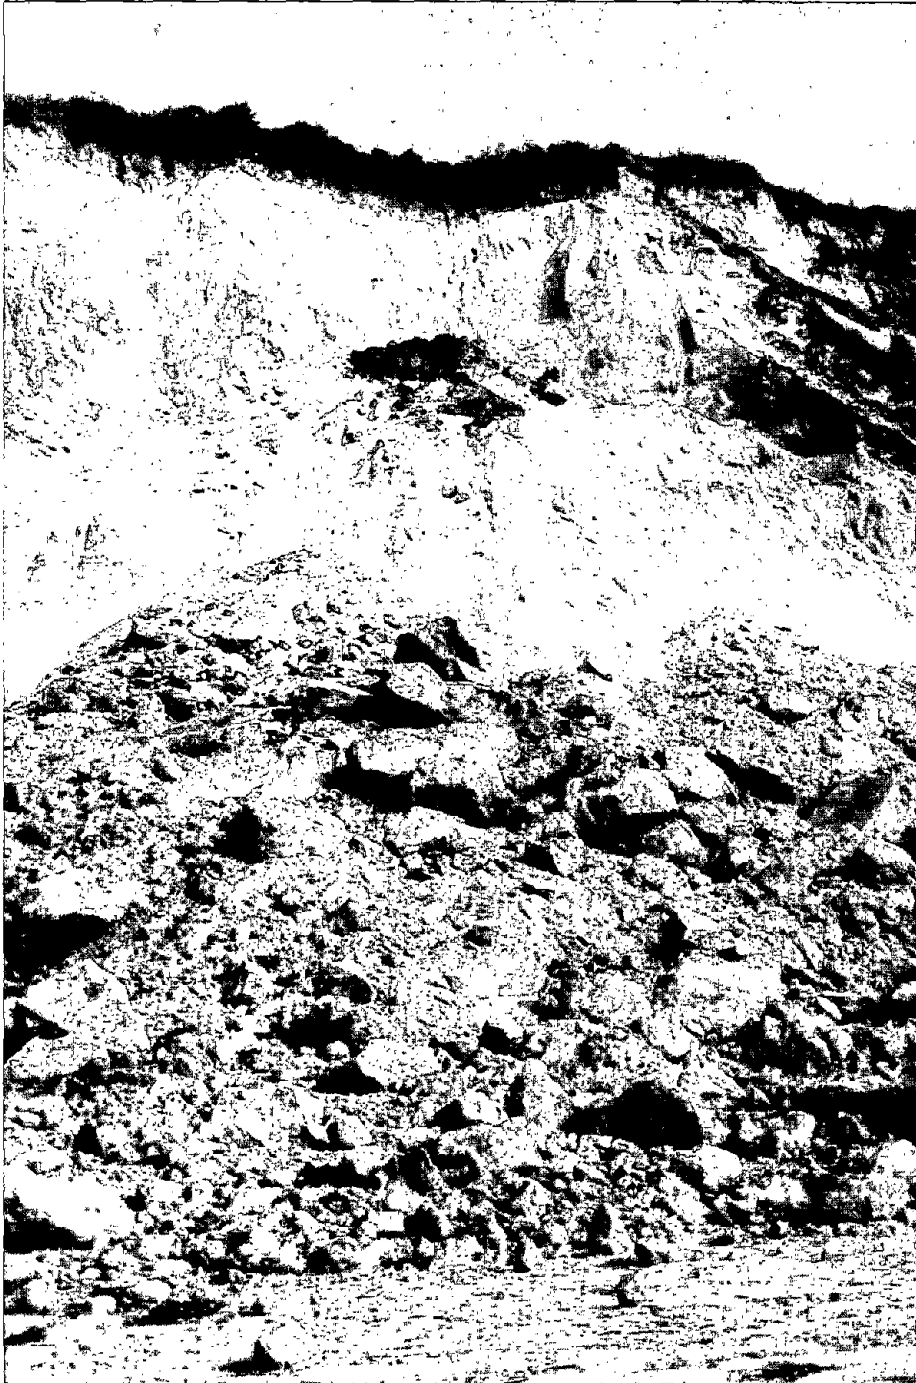
Figure 15.—Coastal landslide about 0.8 km south of mouth of San Gregorio Creek (see fig. 14 for location). Toe of deposit is approximately 60 m wide. Photograph by Mary M. Donato, U.S. Geological Survey.

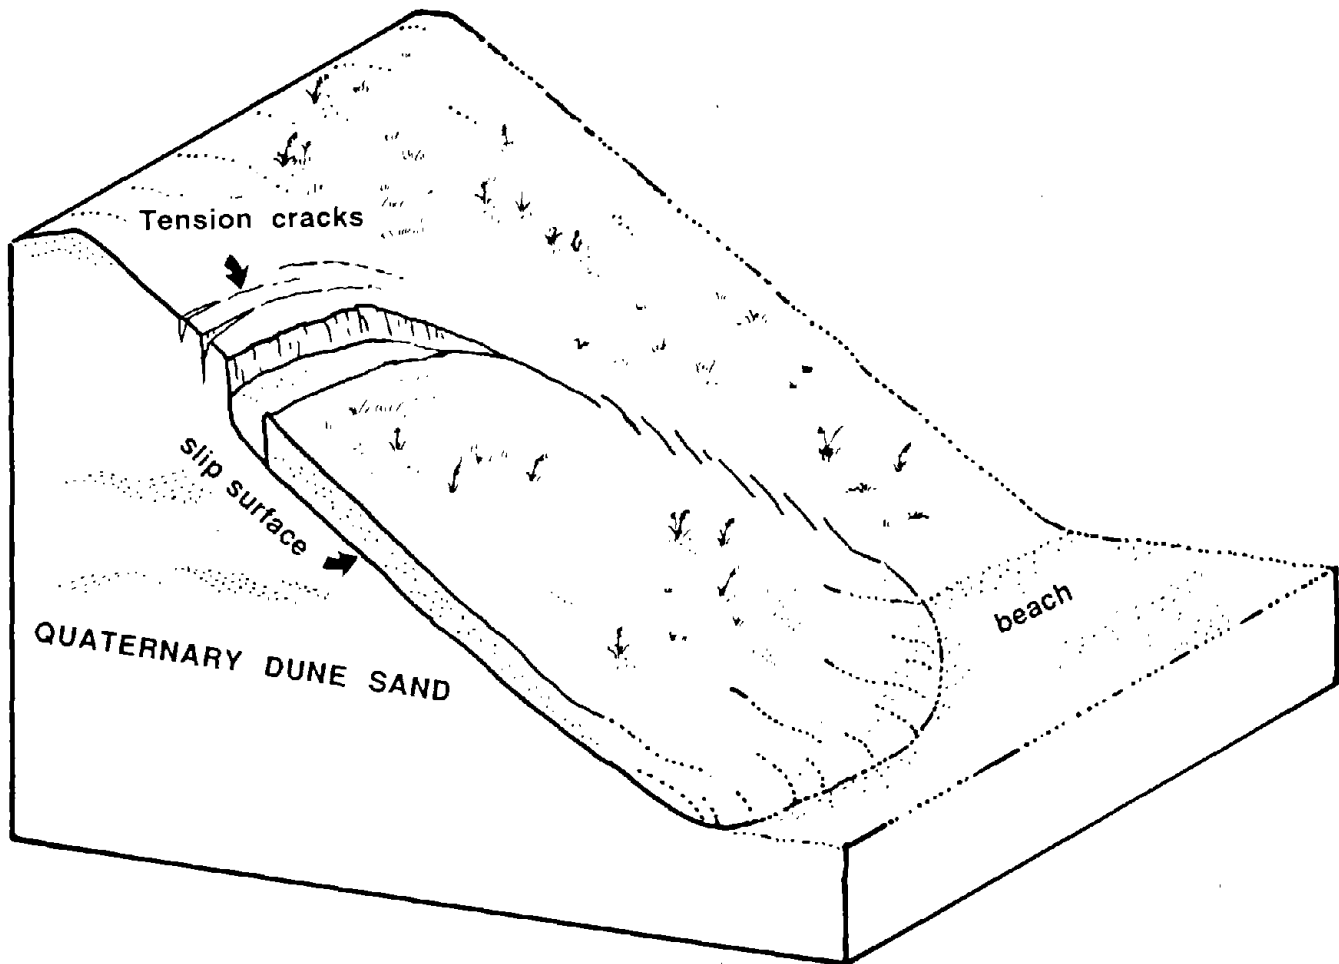
Figure 9.—Dry sandflow in uncemented eolian deposits. Note tension cracks in overlying, more cohesive surficial soils.

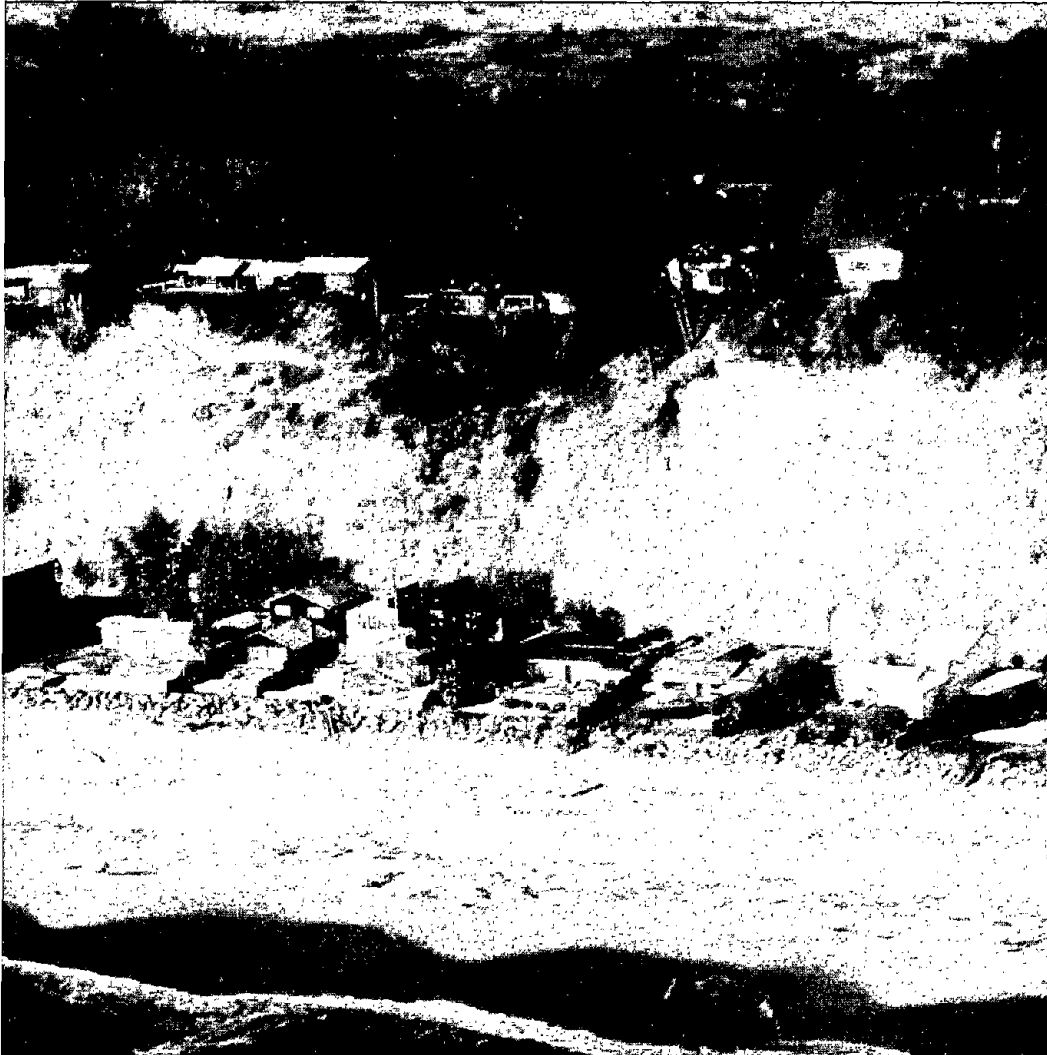
Figure 12 —Earthquake-induced failure of terrace deposits and sandstone of the Purisima Formation between Capitola and Rio Del Mar (see fig. 5 for location).

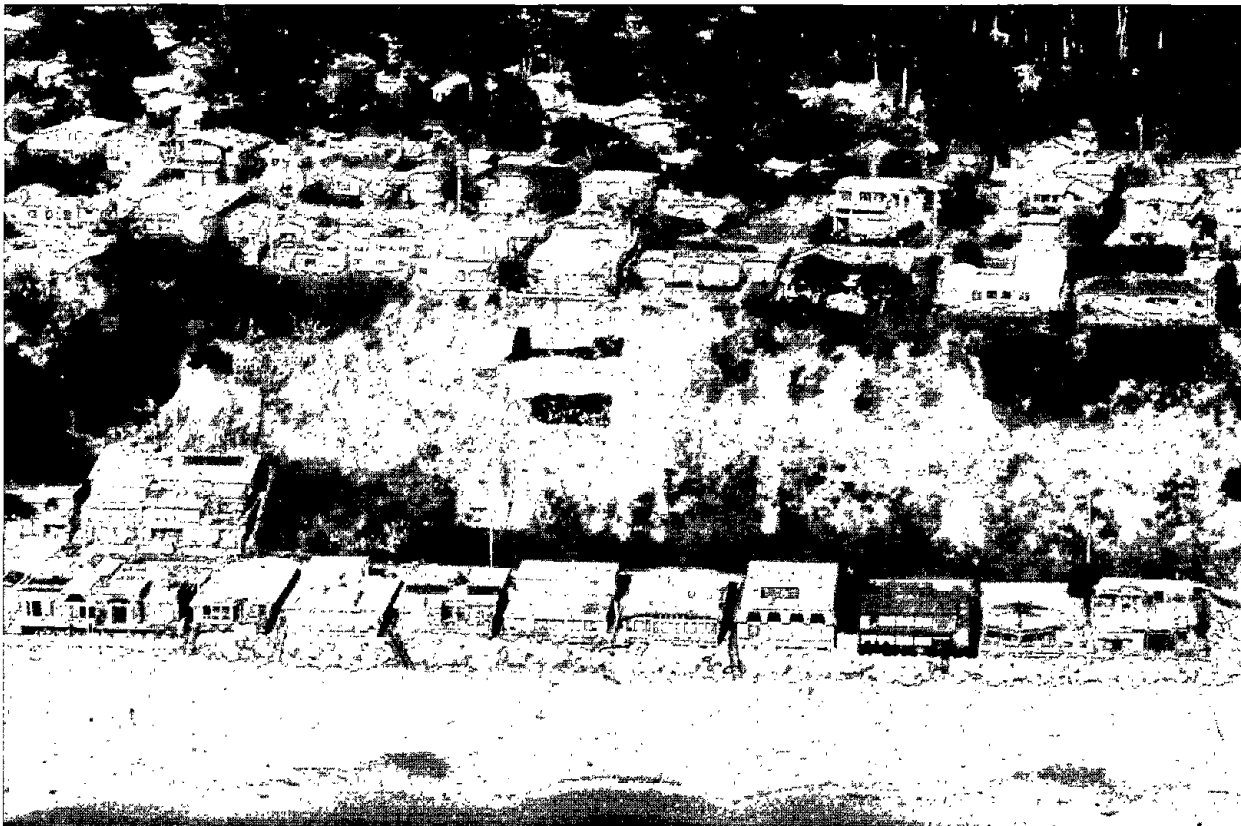
Figure 20.—Earthquake-induced bluff failures in Beach Drive area of Rio Del Mar (fig. 5). New homes are being proposed at base of this bluff behind existing beach-front homes.

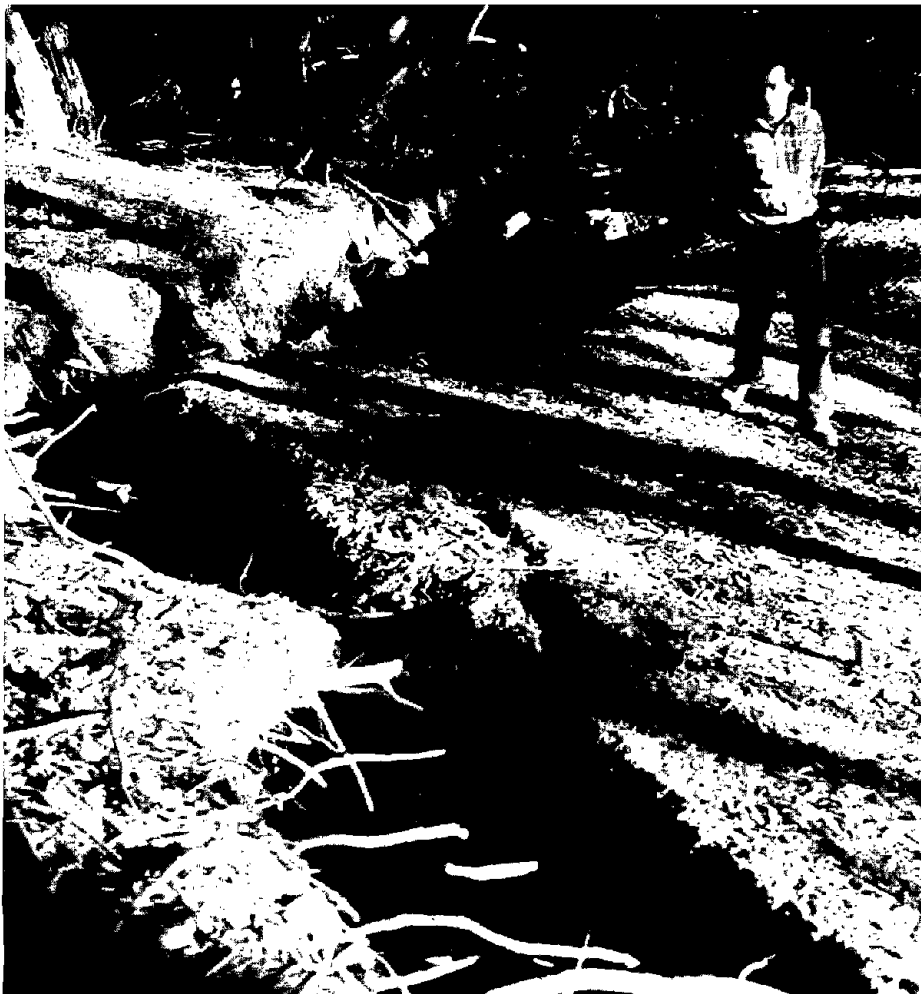
Figure 10.—Part of main scarp of Upper Schultheis Road landslide. Measurements near this locality showed 1.07 m of extensional displacement and 46 cm of vertical displacement across main scarp. View eastward from near landslide crown (loc. A, fig. 9A).

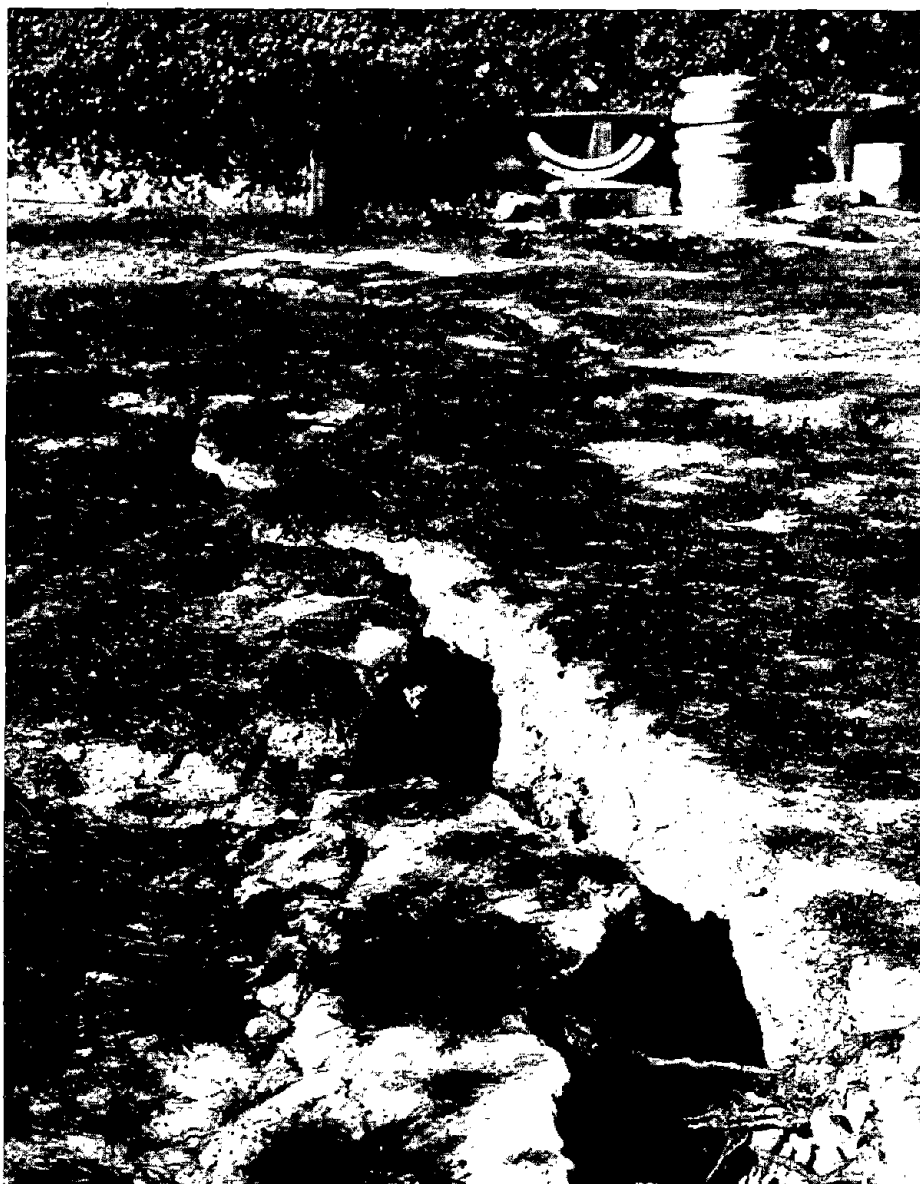
Figure 13.—Segment of main scarp of Villa Del Monte landslide in Sunset Drive area. View northwestward from near quadrilateral-array station 14 (fig. 12A). Photograph by Kevin M. Schmidt, U.S. Geological Survey.

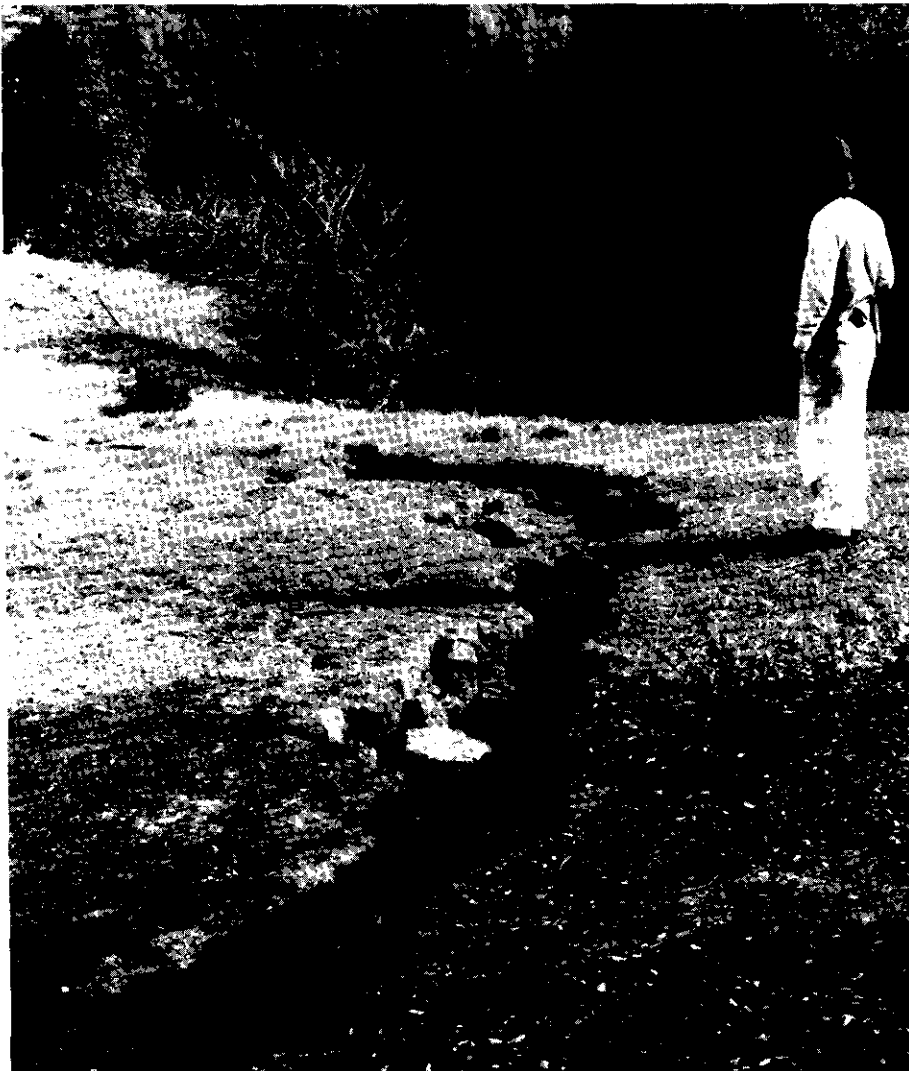
Figure 23.—Part of main scarp of Lower Schultheis Road West landslide. View eastward from just west of Schultheis Road (loc. A', fig. 22). Ridgecrest to left (north) is involved in landslide.
