## Repair/Upgrade Procedures for Welded Beam to Column Connections

PEER  
98/03  
MAY 1998

Report No. PEER-98/03  
Pacific Earthquake Engineering Research Center  
College of Engineering  
University of California, Berkeley  
May 1998

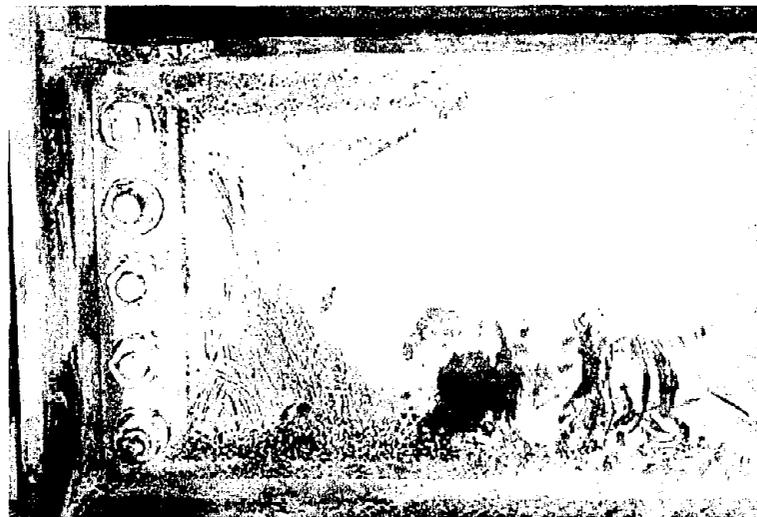
Figure 4.2.5 Plastic Hinge in Beam, 1R

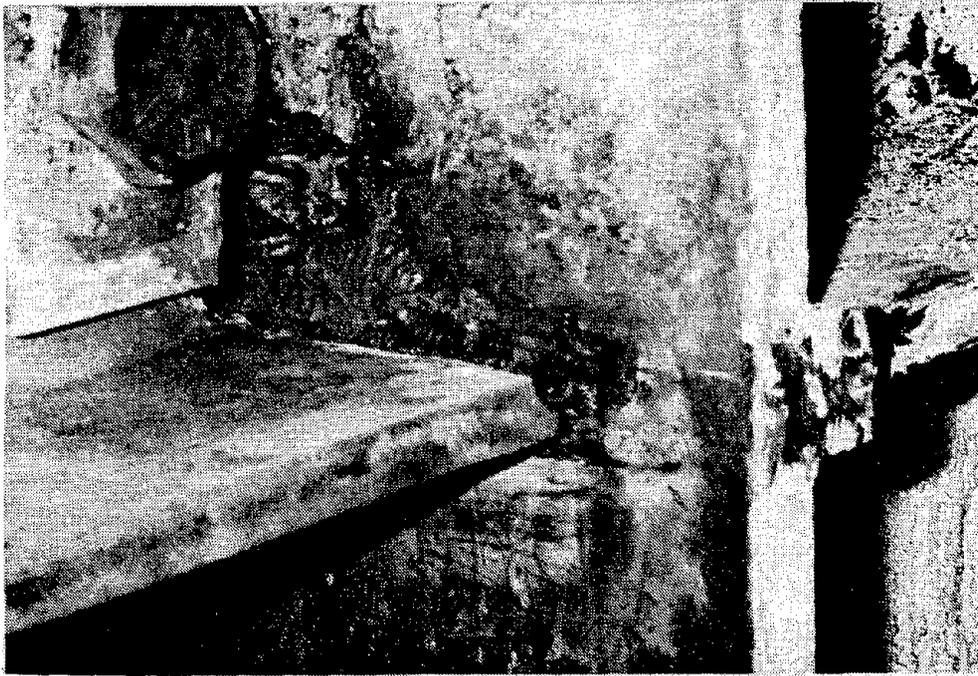
Figure 4.4.1 Gouged Out Crack, Spec. 2R

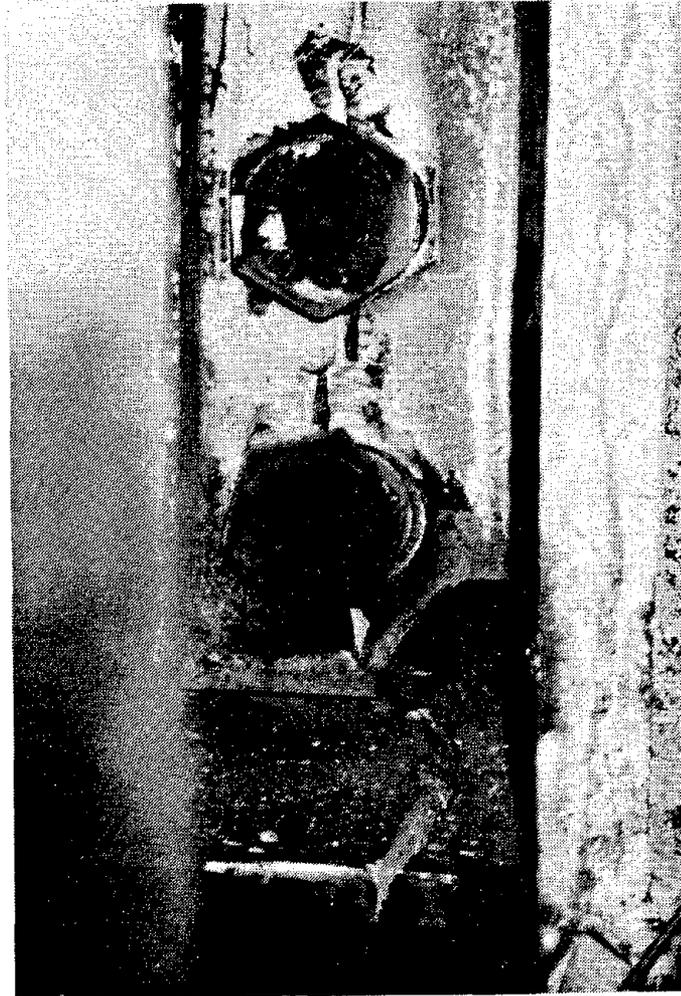
Figure 4.4.3 Beam Bottom Flange Fracture, Spec. 2R

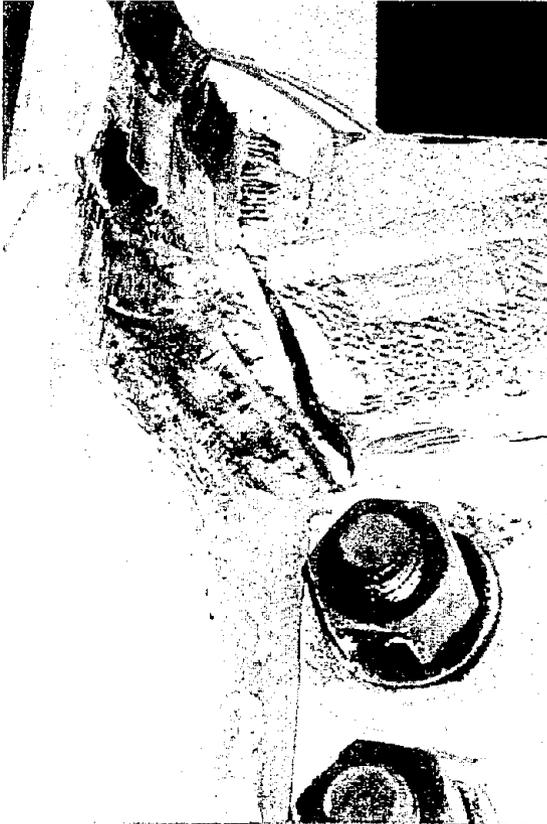
Figure 5.1.5 Fracture at Beam Top Flange, Spec. 3

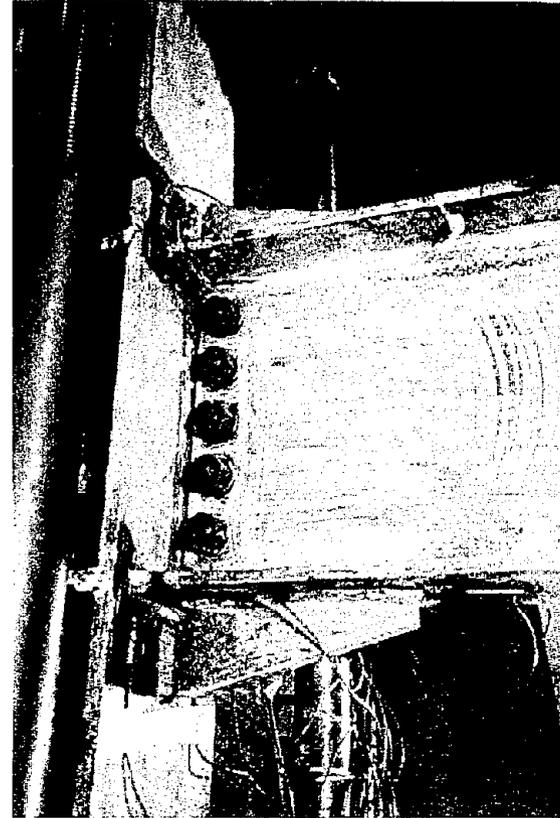
Figure 5.1.6 Formation of Plastic Hinge, Spec.3

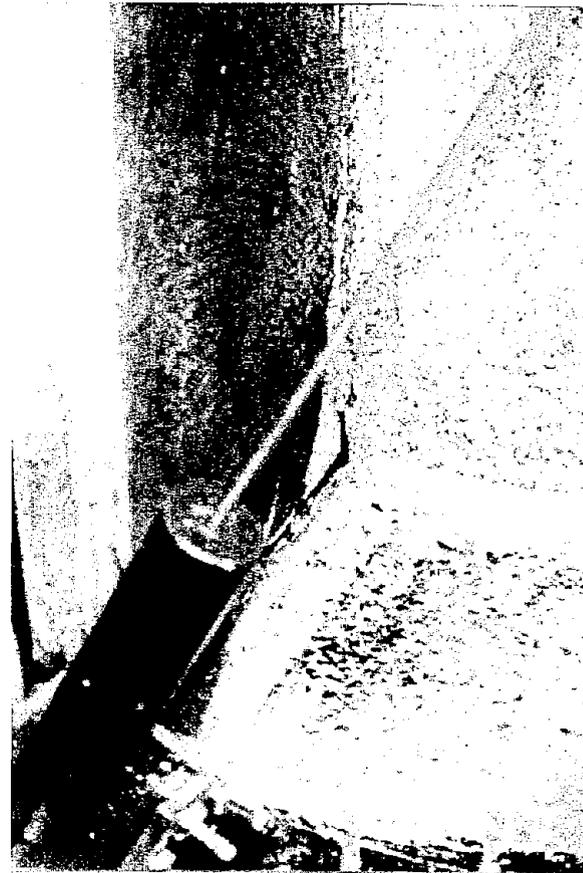
The cracking in the column flange looked very similar to that observed in a previous study [12]. This test appears to indicate that if the panel zone is too flexible, the deformation at high joint rotation may lead to the cracking of the column flange and that this crack may propagate into the panel zone.

Figure 5.3.5 Crack in Panel Zone, Spec. 6

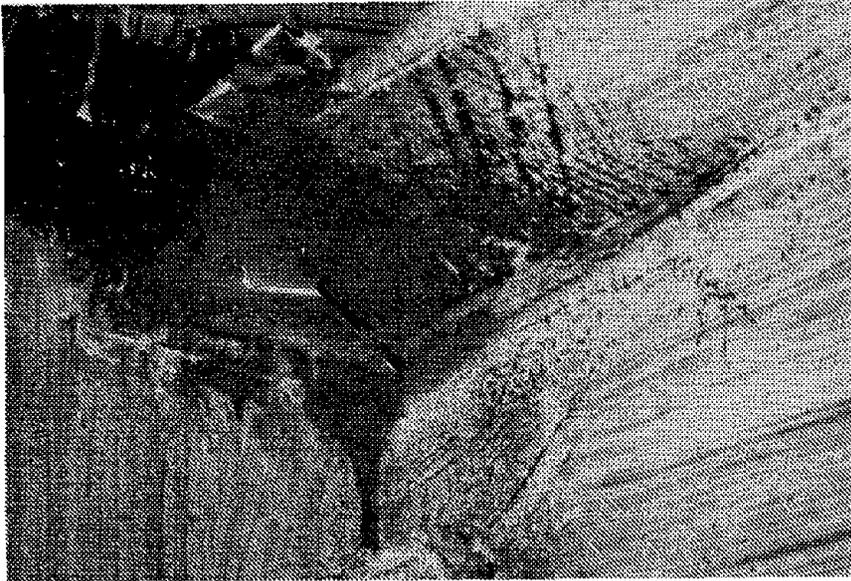
Figure 6.4.5 Crack in Top Flange of Beam

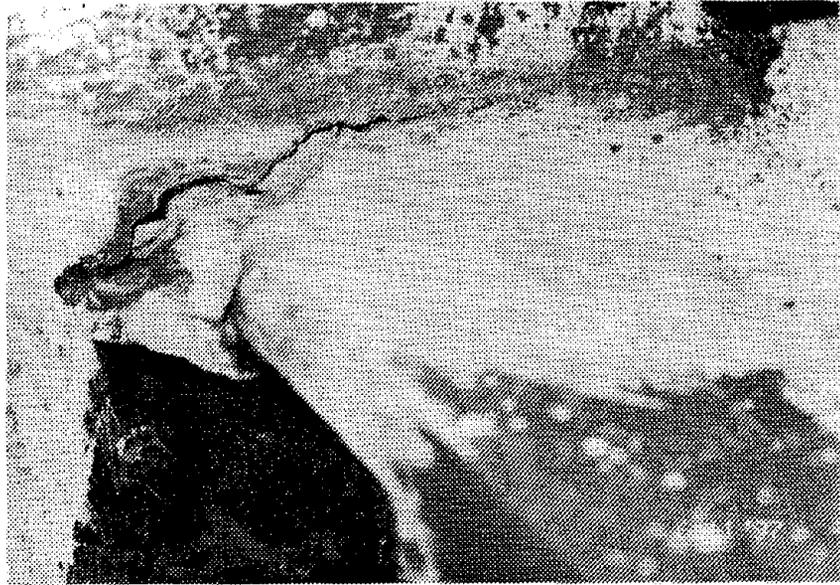
Figure 7.1.4 Crack at Beam Bottom Flange, Spec. 12

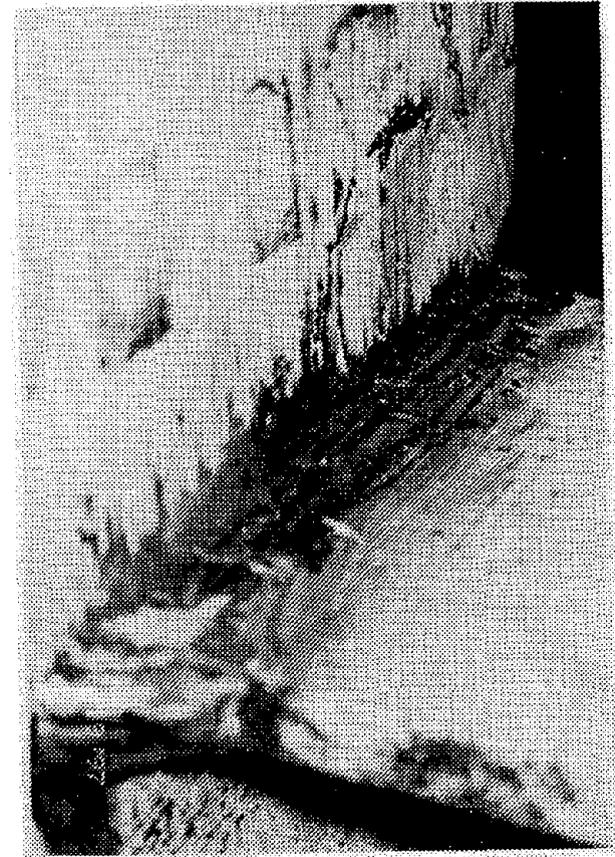
Figure 7.2.7 Initial Crack in Beam Top Flange, Spec. 10

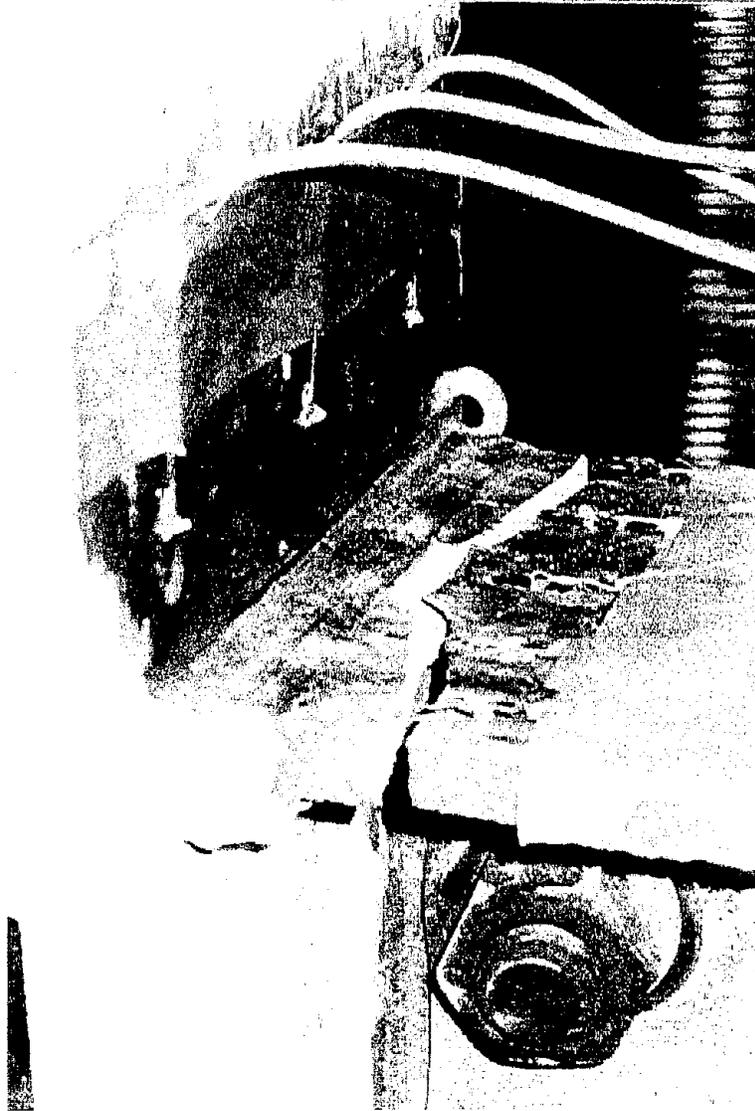
Figure 7.3.4 Crack in HAZ of Beam Top Flange, Spec. 11

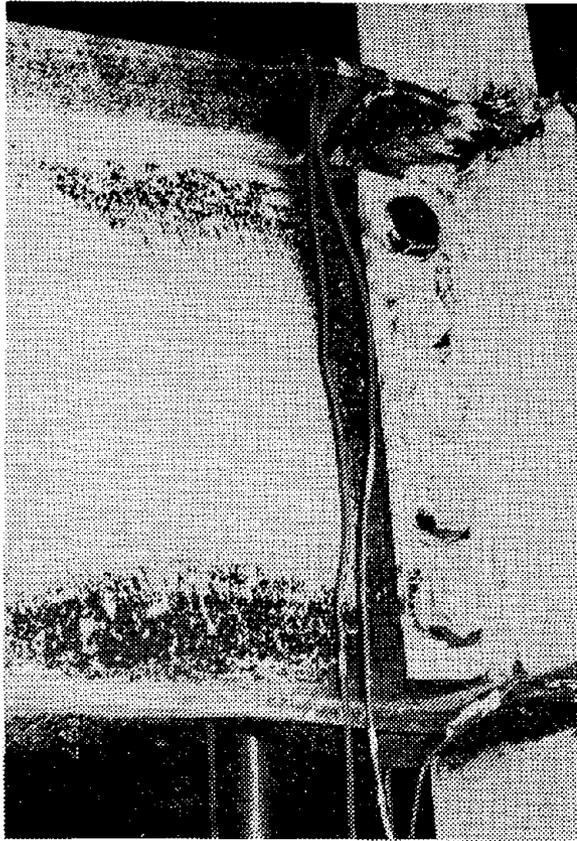
Figure 7.4.7 Buckled Flange Fracture, Spec. 14

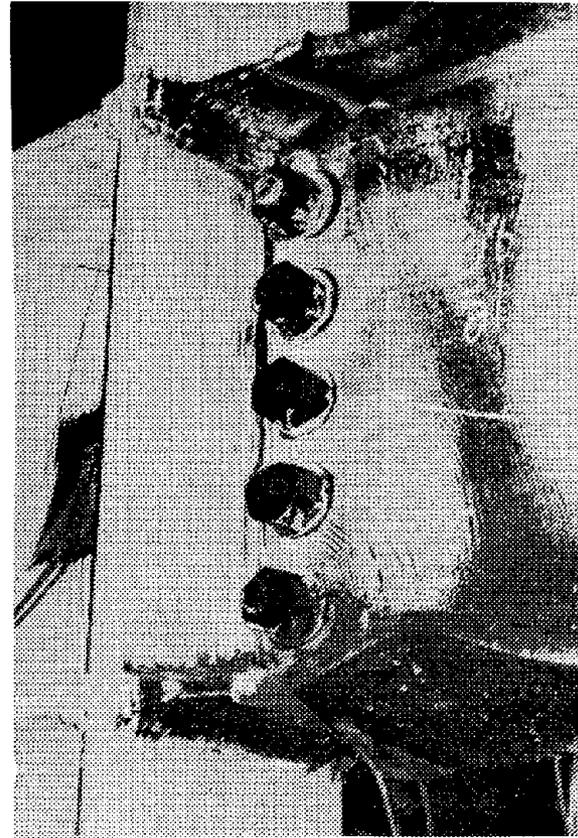
Figure 7.4.8 Bolt Slippage and Flange Buckle, Spec. 14

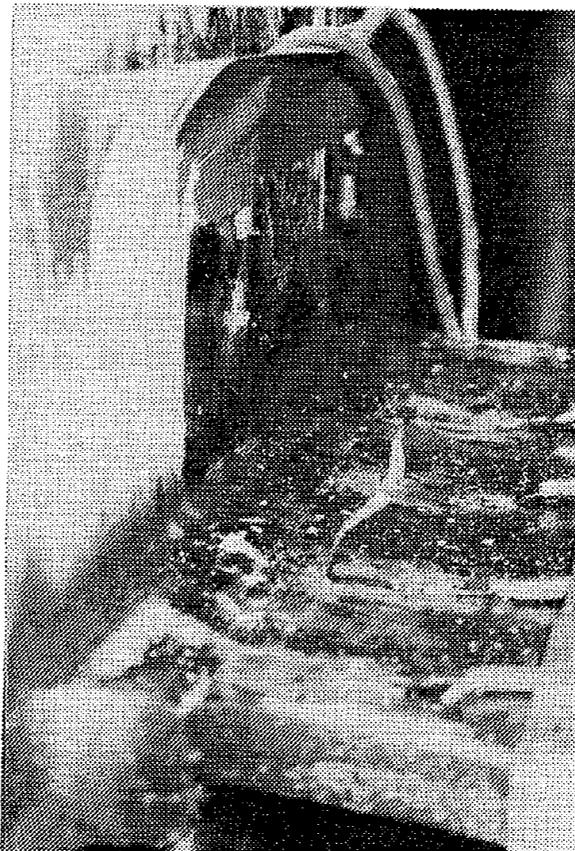
Figure 8.1.5 Crack in Beam Top Flange, Spec. 13

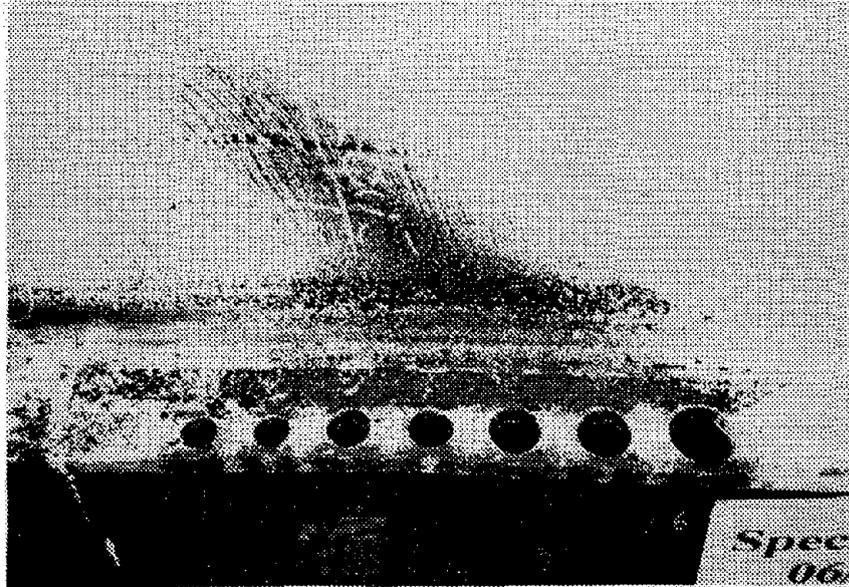
The plastic hinge has been shifted from the column face to the center of the hole group as shown in **Figure 8.1.6**. The holes in the bottom flange of the beam, some of which are out of round, are shown in **Figure 8.1.7**. This figure indicates that the holes

Figure 8.1.6 Yielding in Flange Perforations, Spec. 13
