Implications for Earthquake Risk Reduction in the United States from the Kocaeli, Turkey, Earthquake of August 17, 1999

U.S. Geological Survey Circular 1193

By U.S. Geological Survey

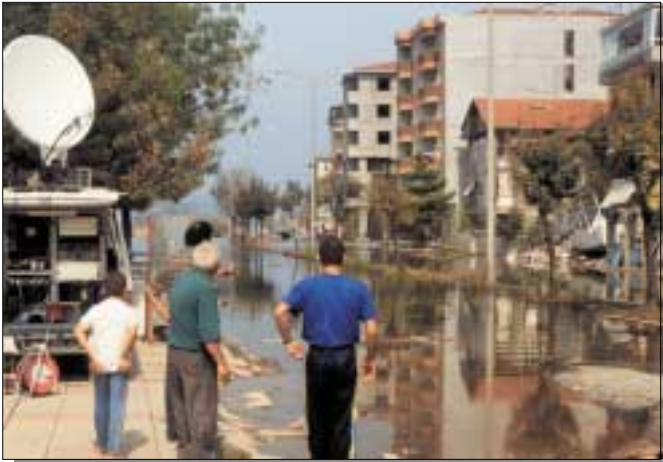
Figure 12. Submergence of shoreline in Gölcük caused by tectonic subsidence associated with normal faulting. *Upper photograph by Robert Langridge; lower photograph by Thomas L. Holzer.*

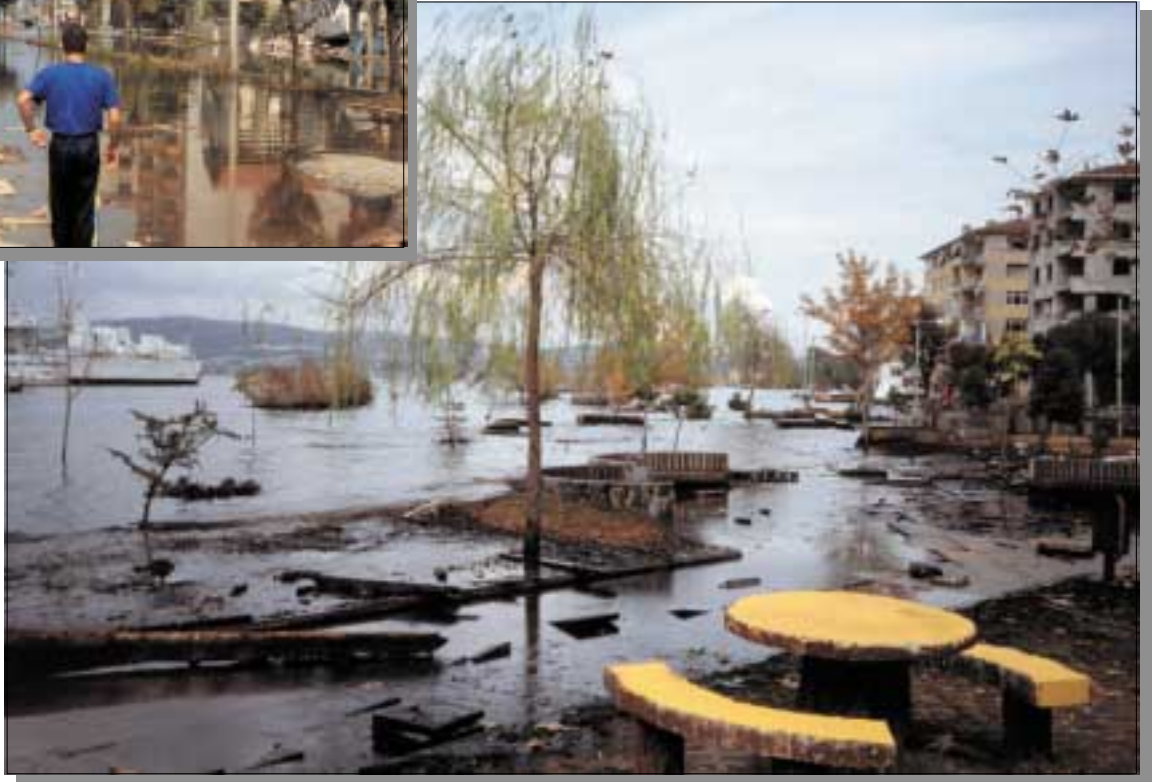
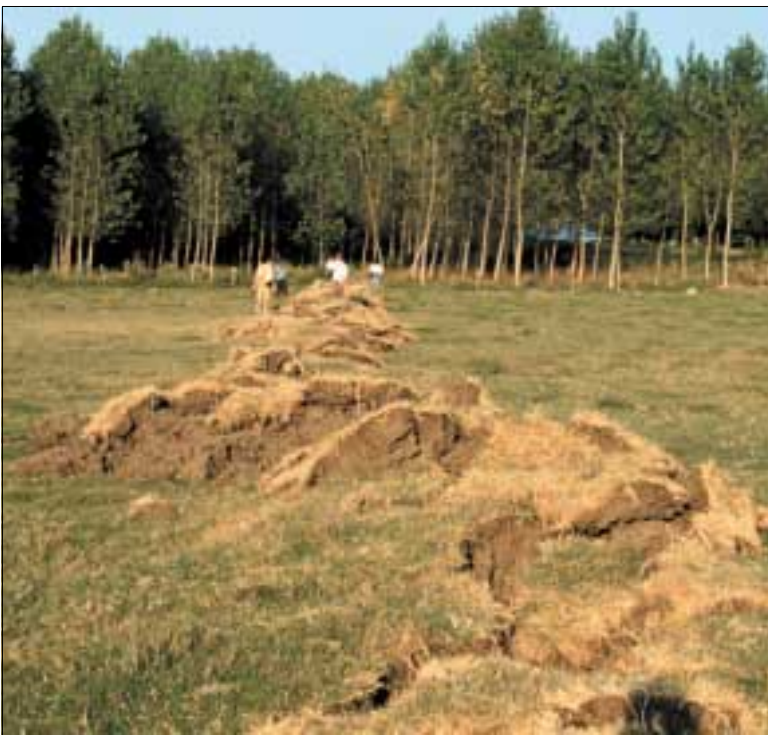
Figure 13. Mole track along ground rupture near Izmit. Right-lateral strike-slip displacement was about 3 m. Positive topographic relief of the mole track was localized and did not represent a component of the motion. *Photograph by Heidi Stenner.*

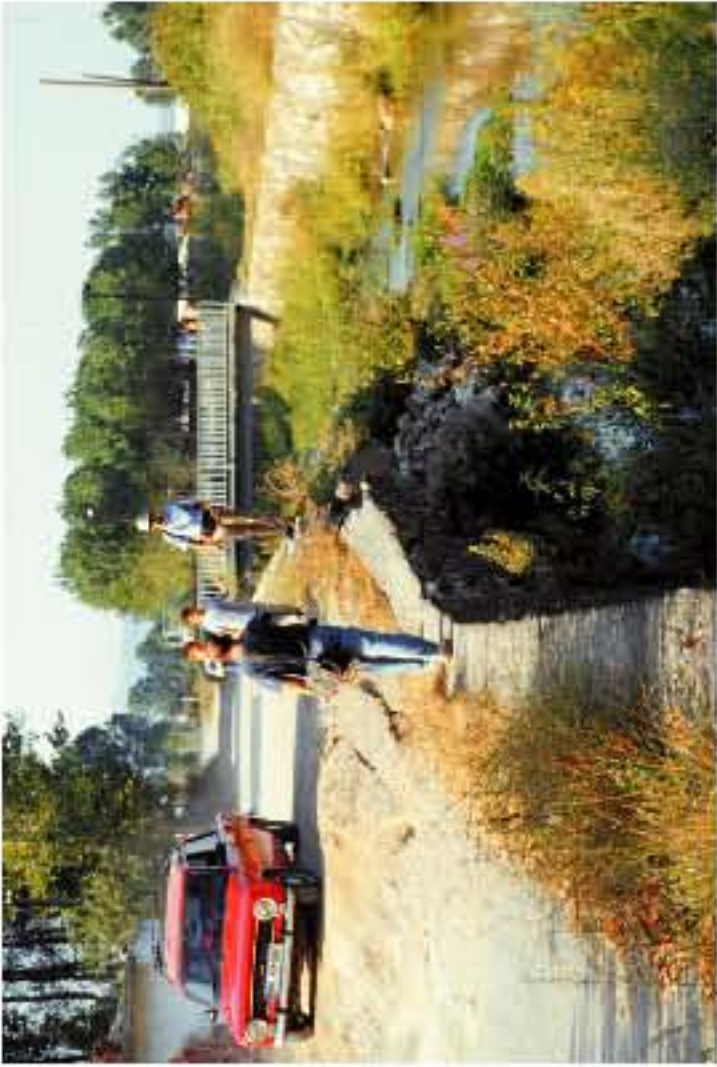
Figure 14. Offset canal near Izmit. Strike-slip displacement across the whole zone here was more than 2.5 m and included a vertical component (middle left). Photograph by Heidi Stenner.

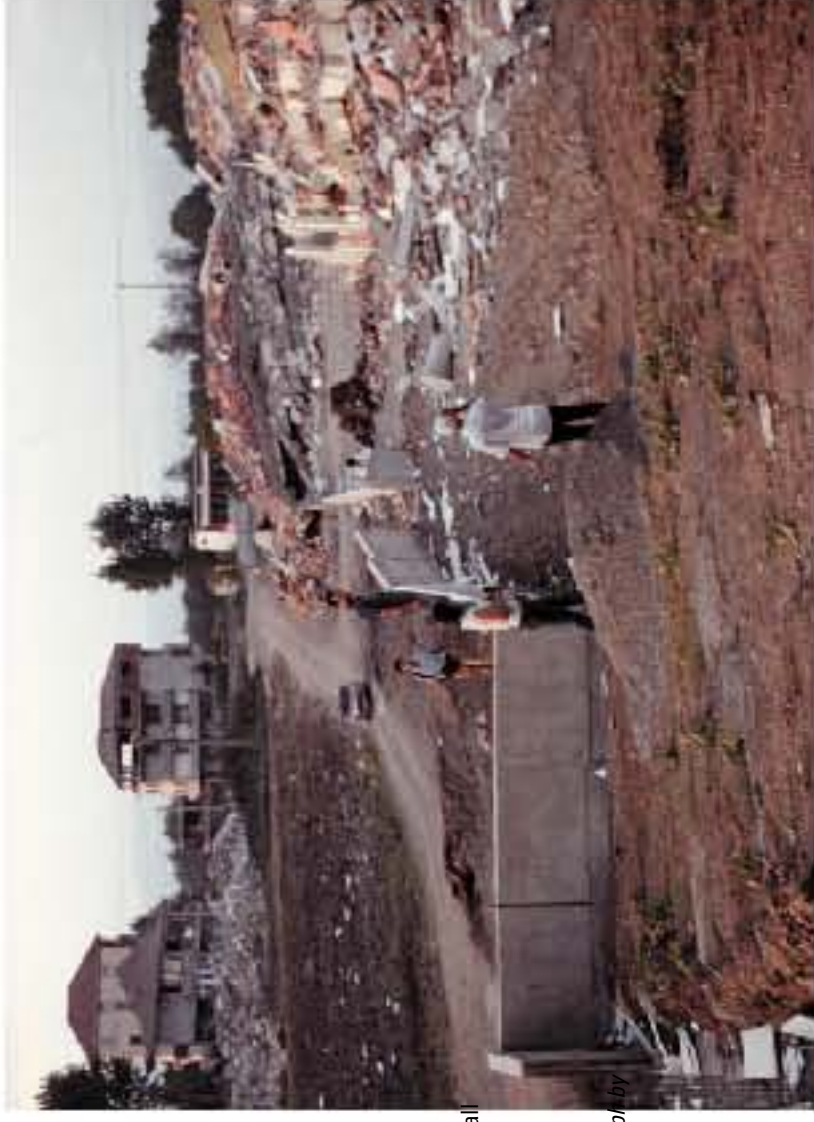
Figure 15. Surface rupture extending through boundary wall and collapsed apartments, to the east of Izmit. Strike-slip displacement here was about 3 m. Photograph by Heidi Stenner.

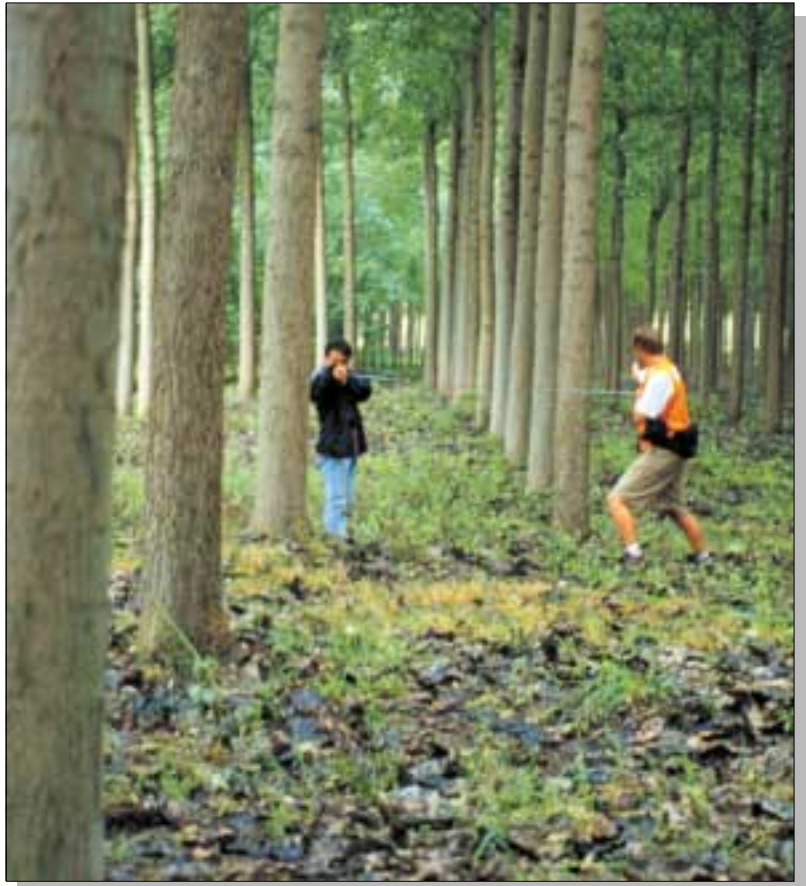
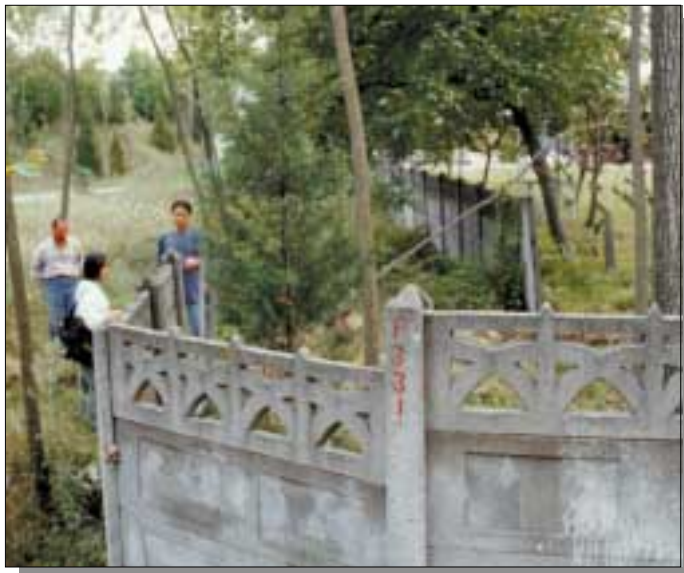
Figure 18. Offset wall near Arifiye. The right-lateral displacement is 4.58 m. *Photograph by Heidi Stenner.*

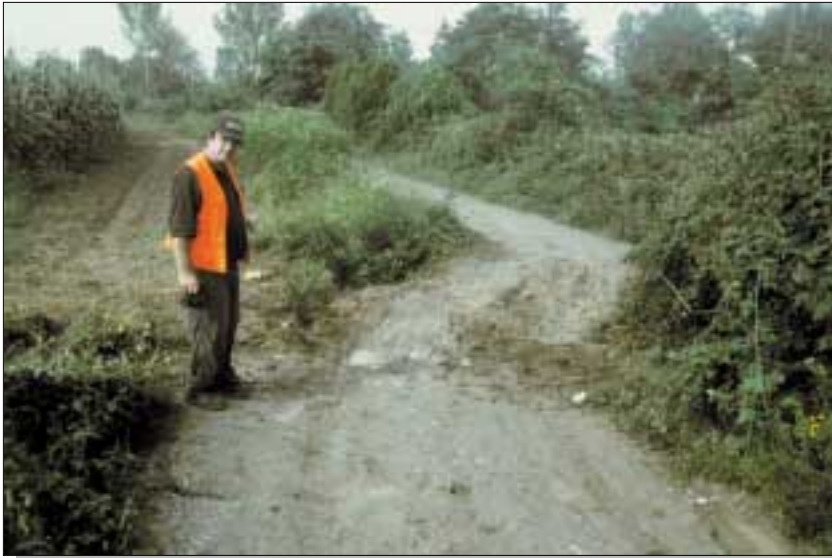
Figure 19. Road offset right laterally 4.66 m near Arifiye. *Photograph by Robert Langridge.*

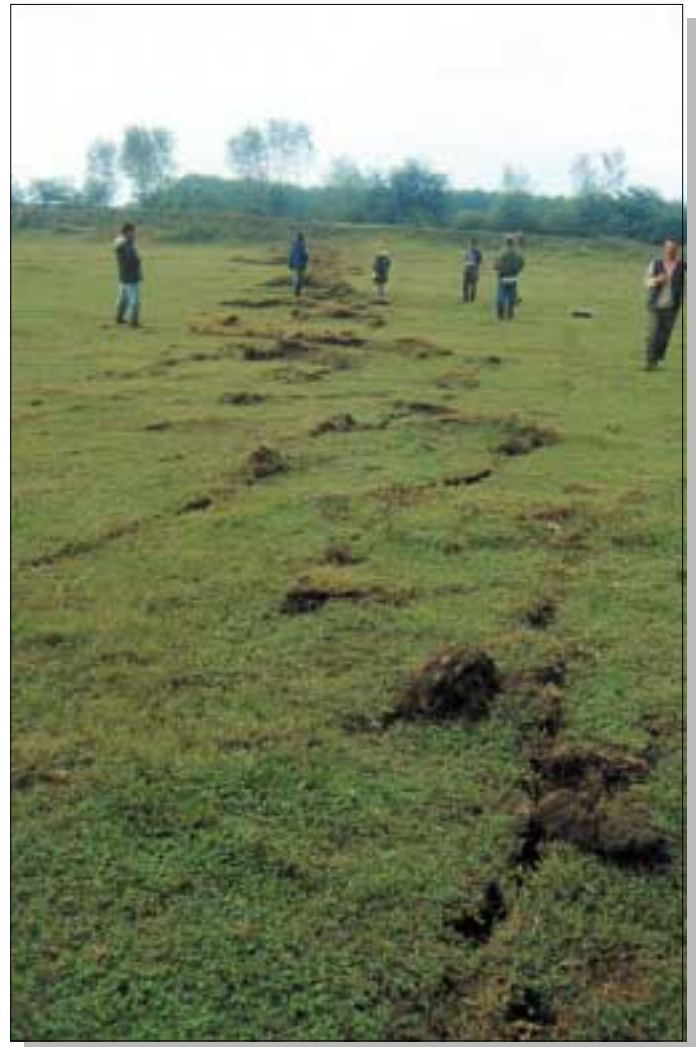
Figure 20. Complex surface rupture pattern with linking en echelon cracks seen near the Açalık canal site. Right-lateral strike-slip displacement here amounted to 2.26 m and was 2.40 m in the dike of the canal, seen in the distance. *Photograph by Robert Langridge.*

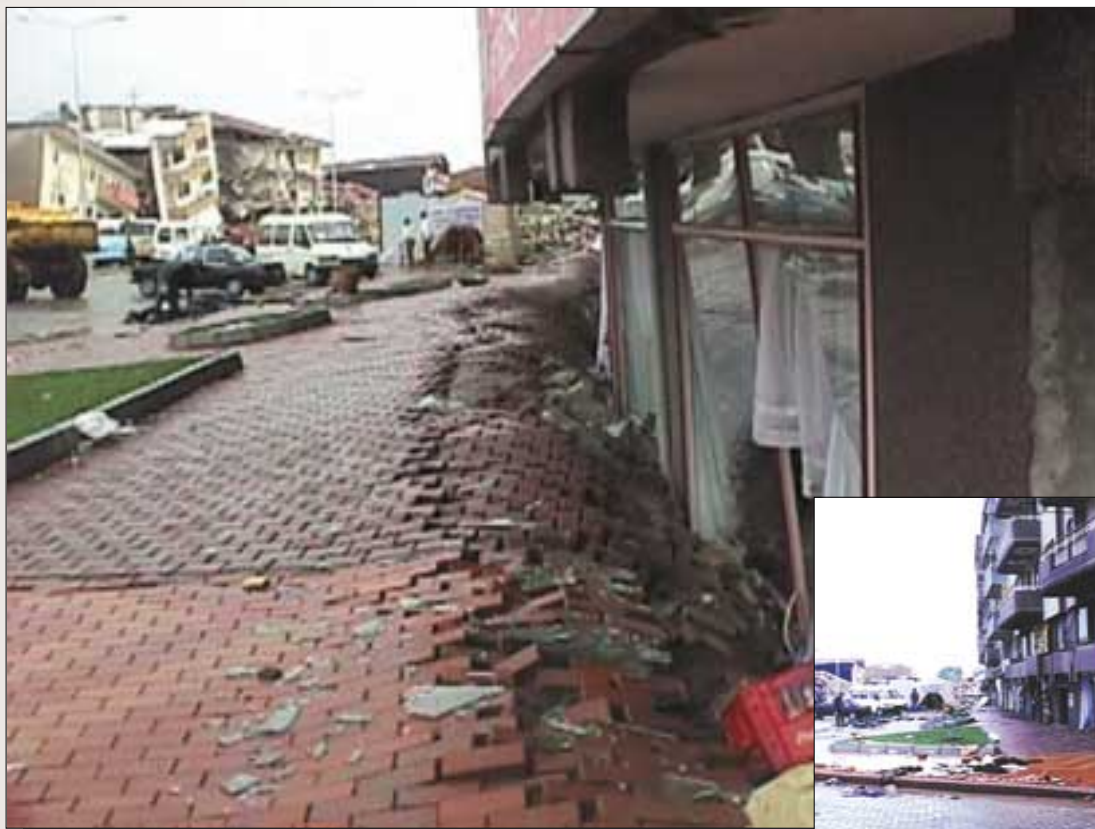
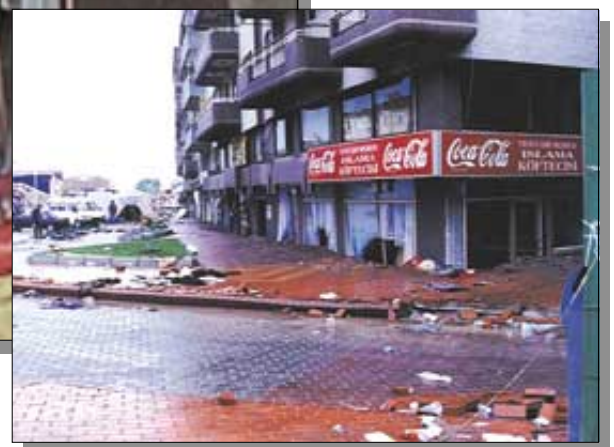
Figure 34. Building in Adapazari that sank 1.5 m uniformly into the ground when the soil beneath it liquefied and was pushed outward from beneath the building. Magnitudes of sinking were proportional to weight of building. *Upper photograph by Thomas L. Holzer; lower photograph by National Institute of Standards and Technology.*

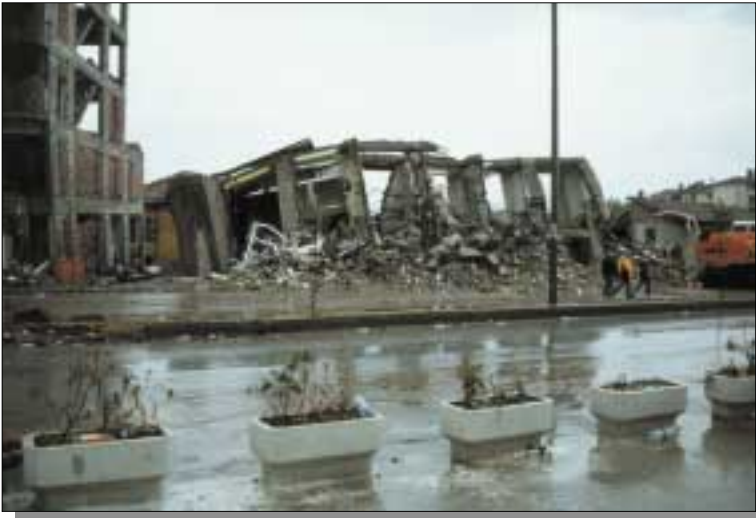
Figure 35. Buildings in Adapazari that either toppled or partially overturned because soil beneath them liquefied and weakened the foundation. *Upper photograph by Thomas L. Holzer; lower photograph by Richard S. Olsen.*

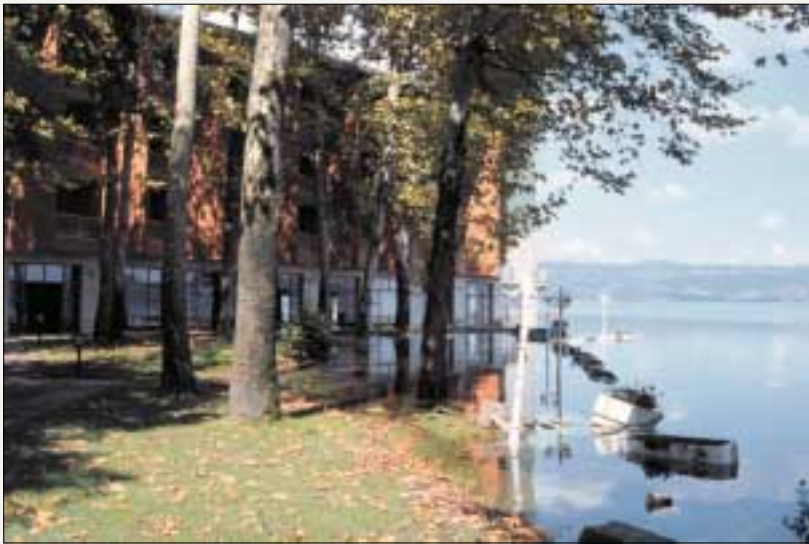
Figure 37. Submergence of shoreline at Lake Sapanca and settlement of Sapanca Hotel. "Moat" adjacent to wall indicates the hotel has sunk into the ground because of liquefaction of underlying sandy soil. *Photographs by Thomas L. Holzer.*

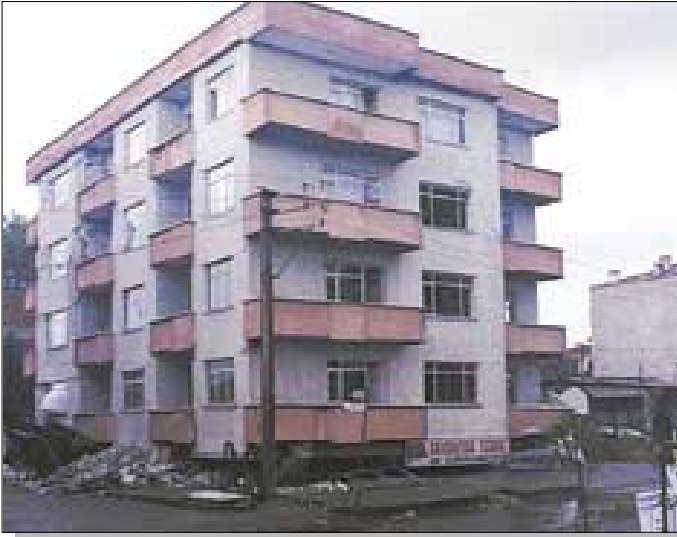
Figure 41. Partial building collapse in Yalova as the result of shear failure of first story columns. *Photograph by National Institute of Standards and Technology.*

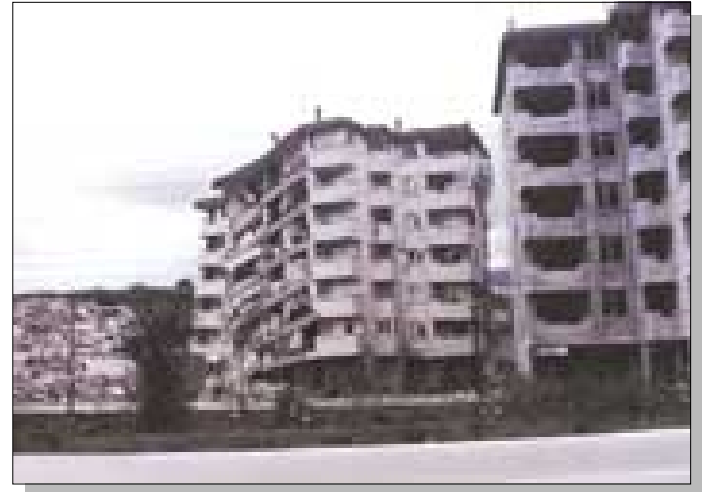
Figure 42. Partial collapse of building near Izmit as the result of shear failure of intermediate columns. Note various stages of damage despite apparently similar construction. *Photograph by National Institute of Standards and Technology.*

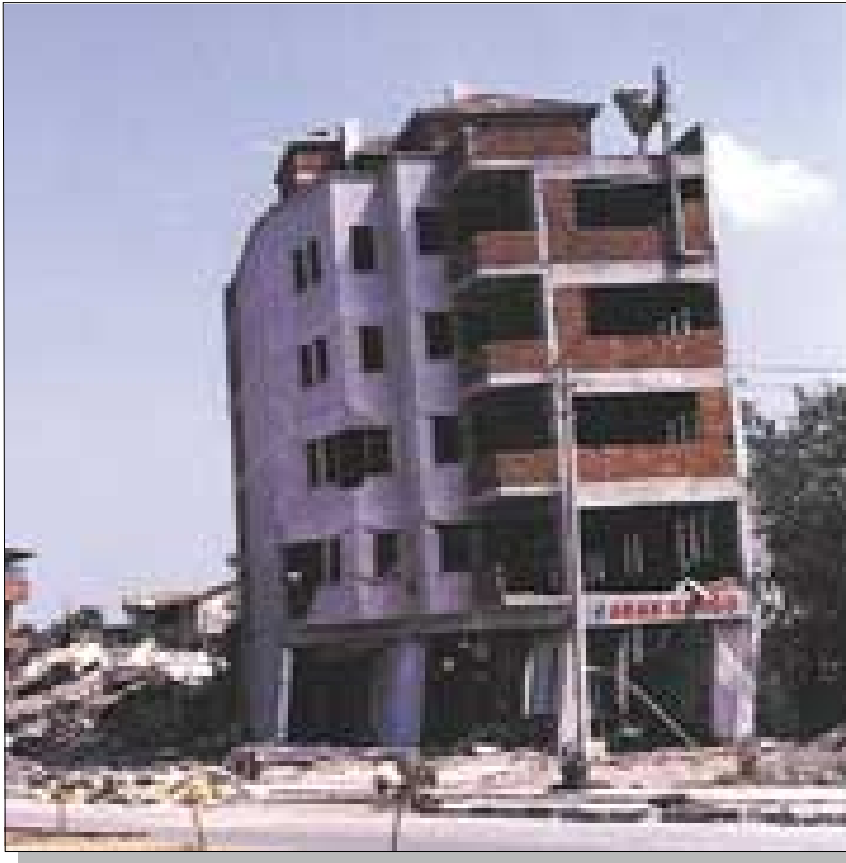
Figure 43. Near collapse of building in Adapazari as the result of formation of column hinges in the first story. *Photograph by National Institute of Standards and Technology.*

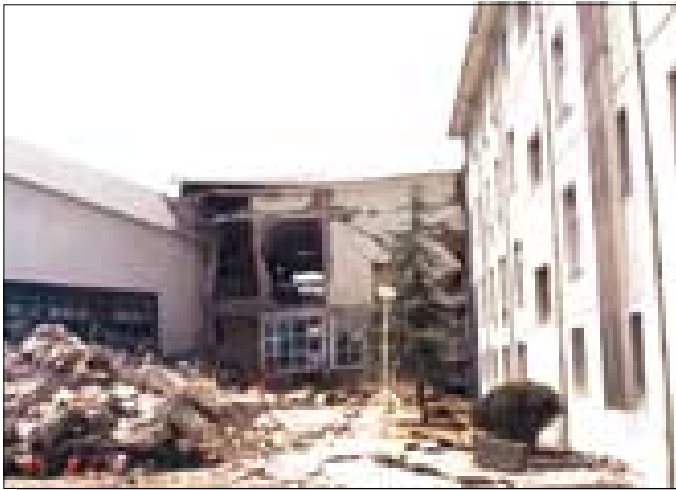
Figure 44. Damage to Officer's Club on Turkish Naval Base, Gölcük, which was located directly on the surface fault rupture. *Photograph by National Institute of Standards and Technology.*

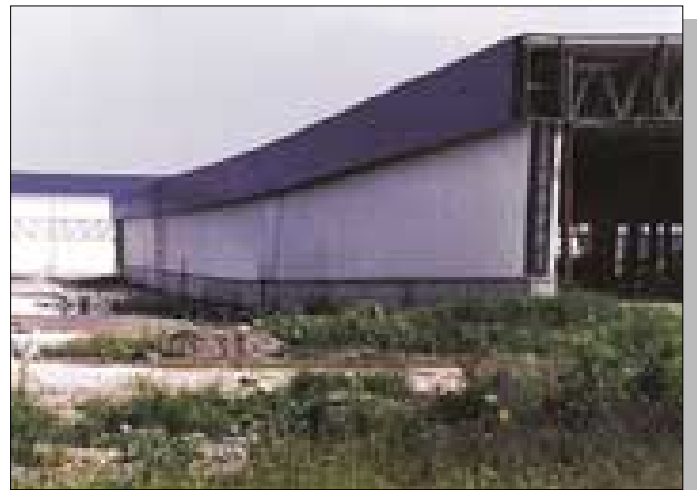
Figure 45. Industrial building damaged by near-fault ground movements east of Gölcük. Building is on downthrown block of normal fault and near a major change of strike in the surface fault scarp. *Photograph by National Institute of Standards and Technology.*

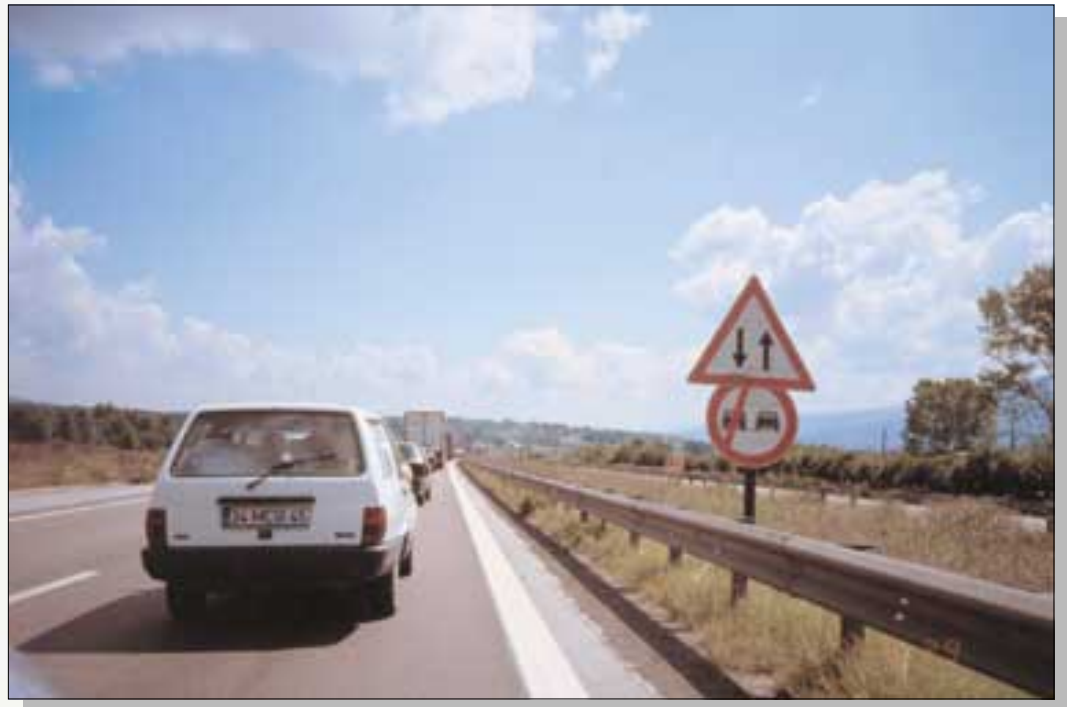
Figure 48. Following the earthquake, road surface repairs forced alternative use of the eastbound and westbound lanes of the Trans European Motorway as a two-way highway with greatly reduced speeds from Izmit to about 50 km east of Izmit. *Photograph by Thomas L. Holzer.*

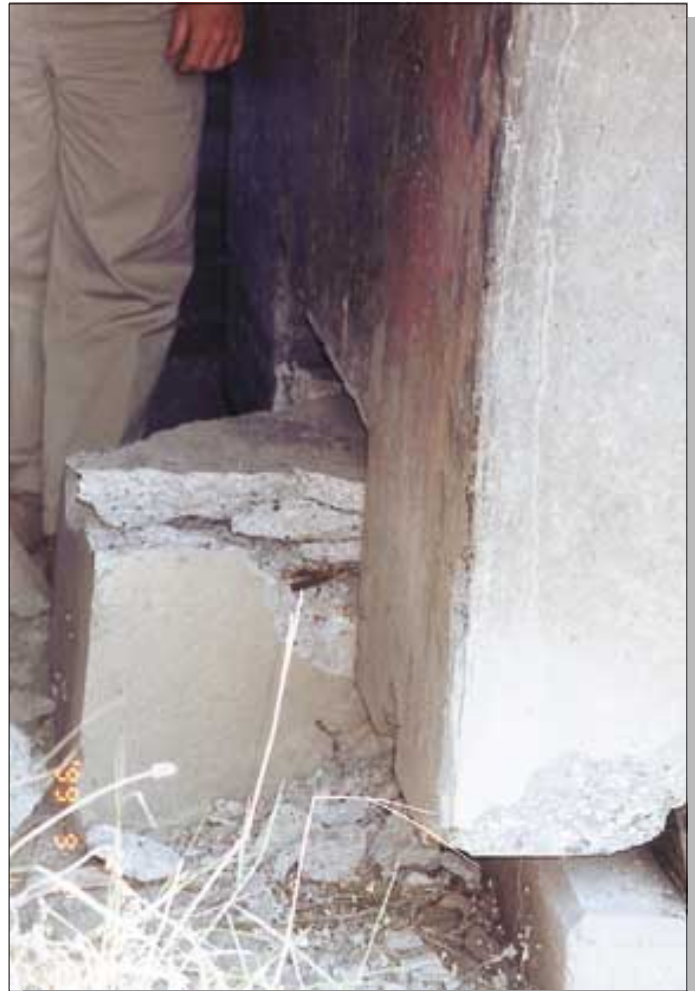
Figure 50. Failure of shear keys was common at bridges of the Trans European Motorway. Shear keys at the end of girders prevent transverse and longitudinal seismic movements. *Photograph by Selcuk Toprak.*

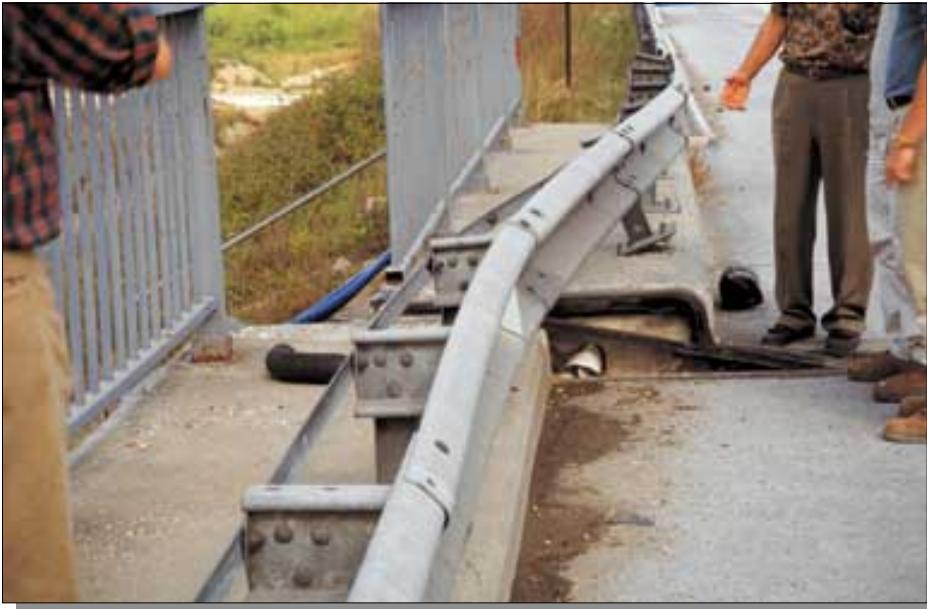
Figure 51. Ground shaking caused the westbound span of the Sakarya River bridge to displace 50 cm relative to the east abutment. This was the largest permanent displacement caused by shaking at any bridge. *Photograph by Selcuk Toprak.*

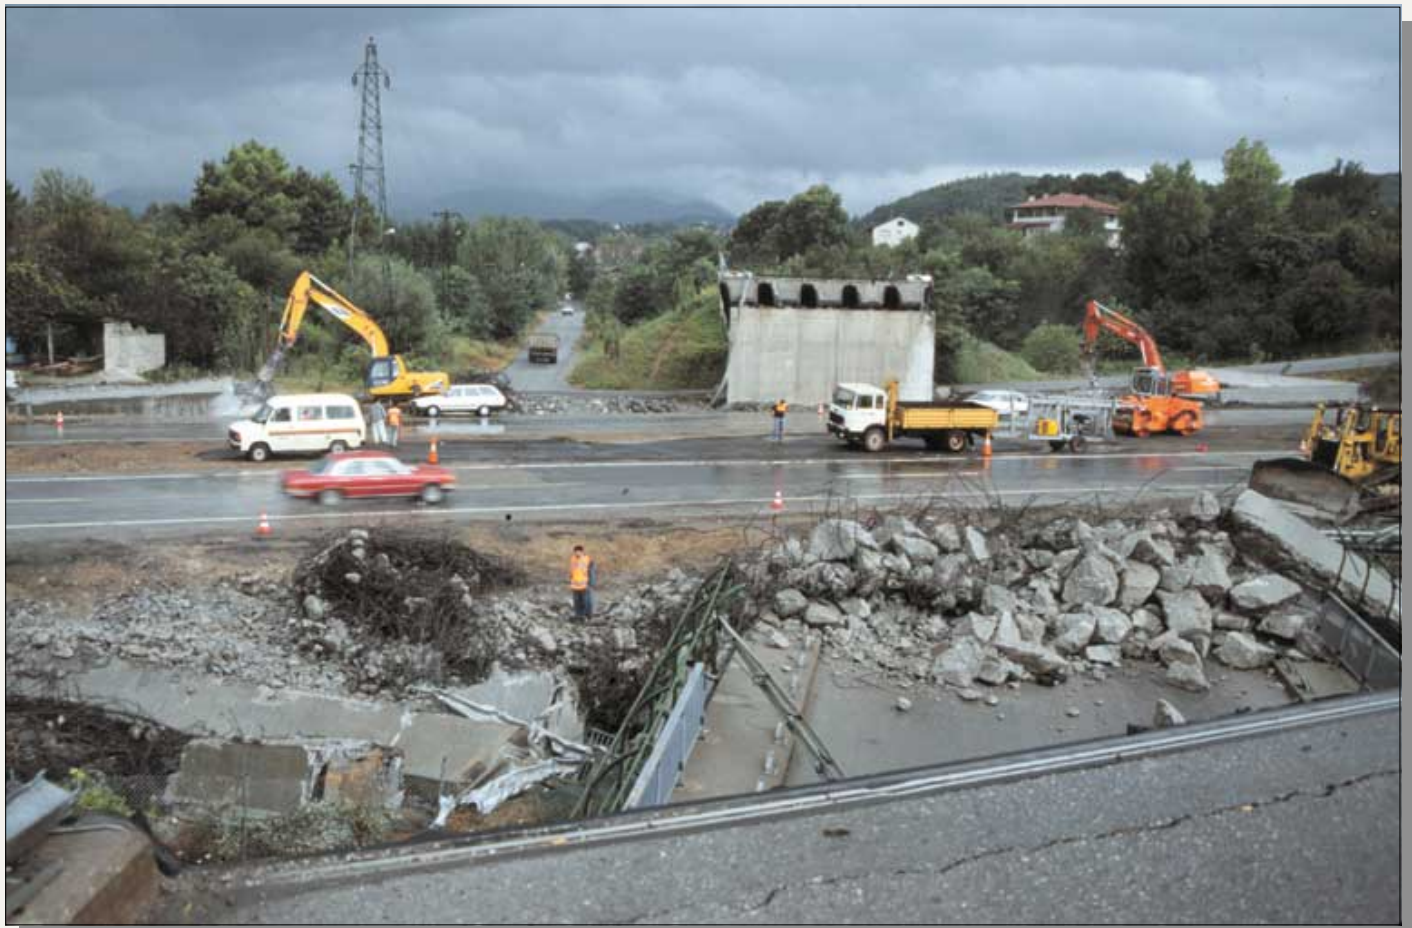
Figure 53. The Arifiye overpass collapsed because the surface fault rupture passed directly through its north abutment (foreground). Ten riders of a bus were killed when the bus collided with the collapsed overpass. *Photograph by Thomas L. Holzer.*

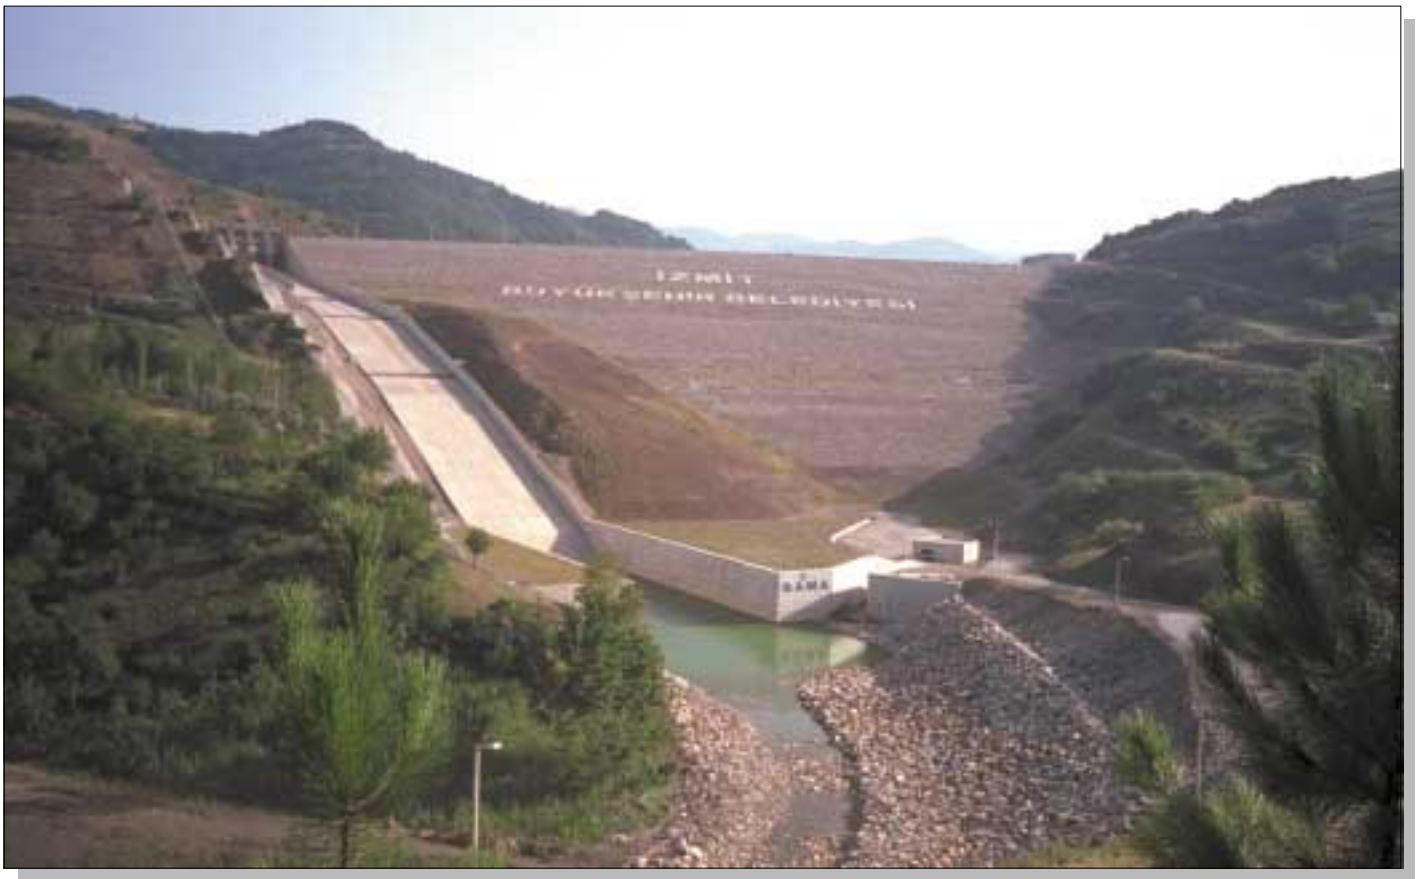
Figure 55. View of Kirazdere (Yuvacik) Dam after the Kocaeli earthquake. The dam was only about 4 km from the surface rupture and did not suffer damage. *Photograph by Richard S. Olsen.*

Kirazdere Dam, also known as Yuvacik Dam, is an earth-fill dam with a clay core, sand and gravel filters, and a rock shell (fig. 55). Kirazdere Dam is of particular interest because it is only 4 km from the surface rupture associated with the Kocaeli earthquake. The dam is inferred to have experienced 0.3 to 0.4 g of peak horizontal acceleration, a shaking duration of 30 s with accelerations greater than 0.05 g, and a spectral range of excitations from 0.2 to 6.0 Hz. However, the dam appears to have suffered no damage from the earthquake. The dam manager stated that a few short 2-mm-wide cracks resulted from the earthquake on the gravel road along the crest near the left abutment looking upstream, parallel to the axis of the dam. The lengths of these cracks were not measured. The road on the crest is heavily used and the cracks quickly disappeared. A few hairline cracks were seen in a one-story concrete structure at the dam. No cracks were seen in the concrete of the spillway.

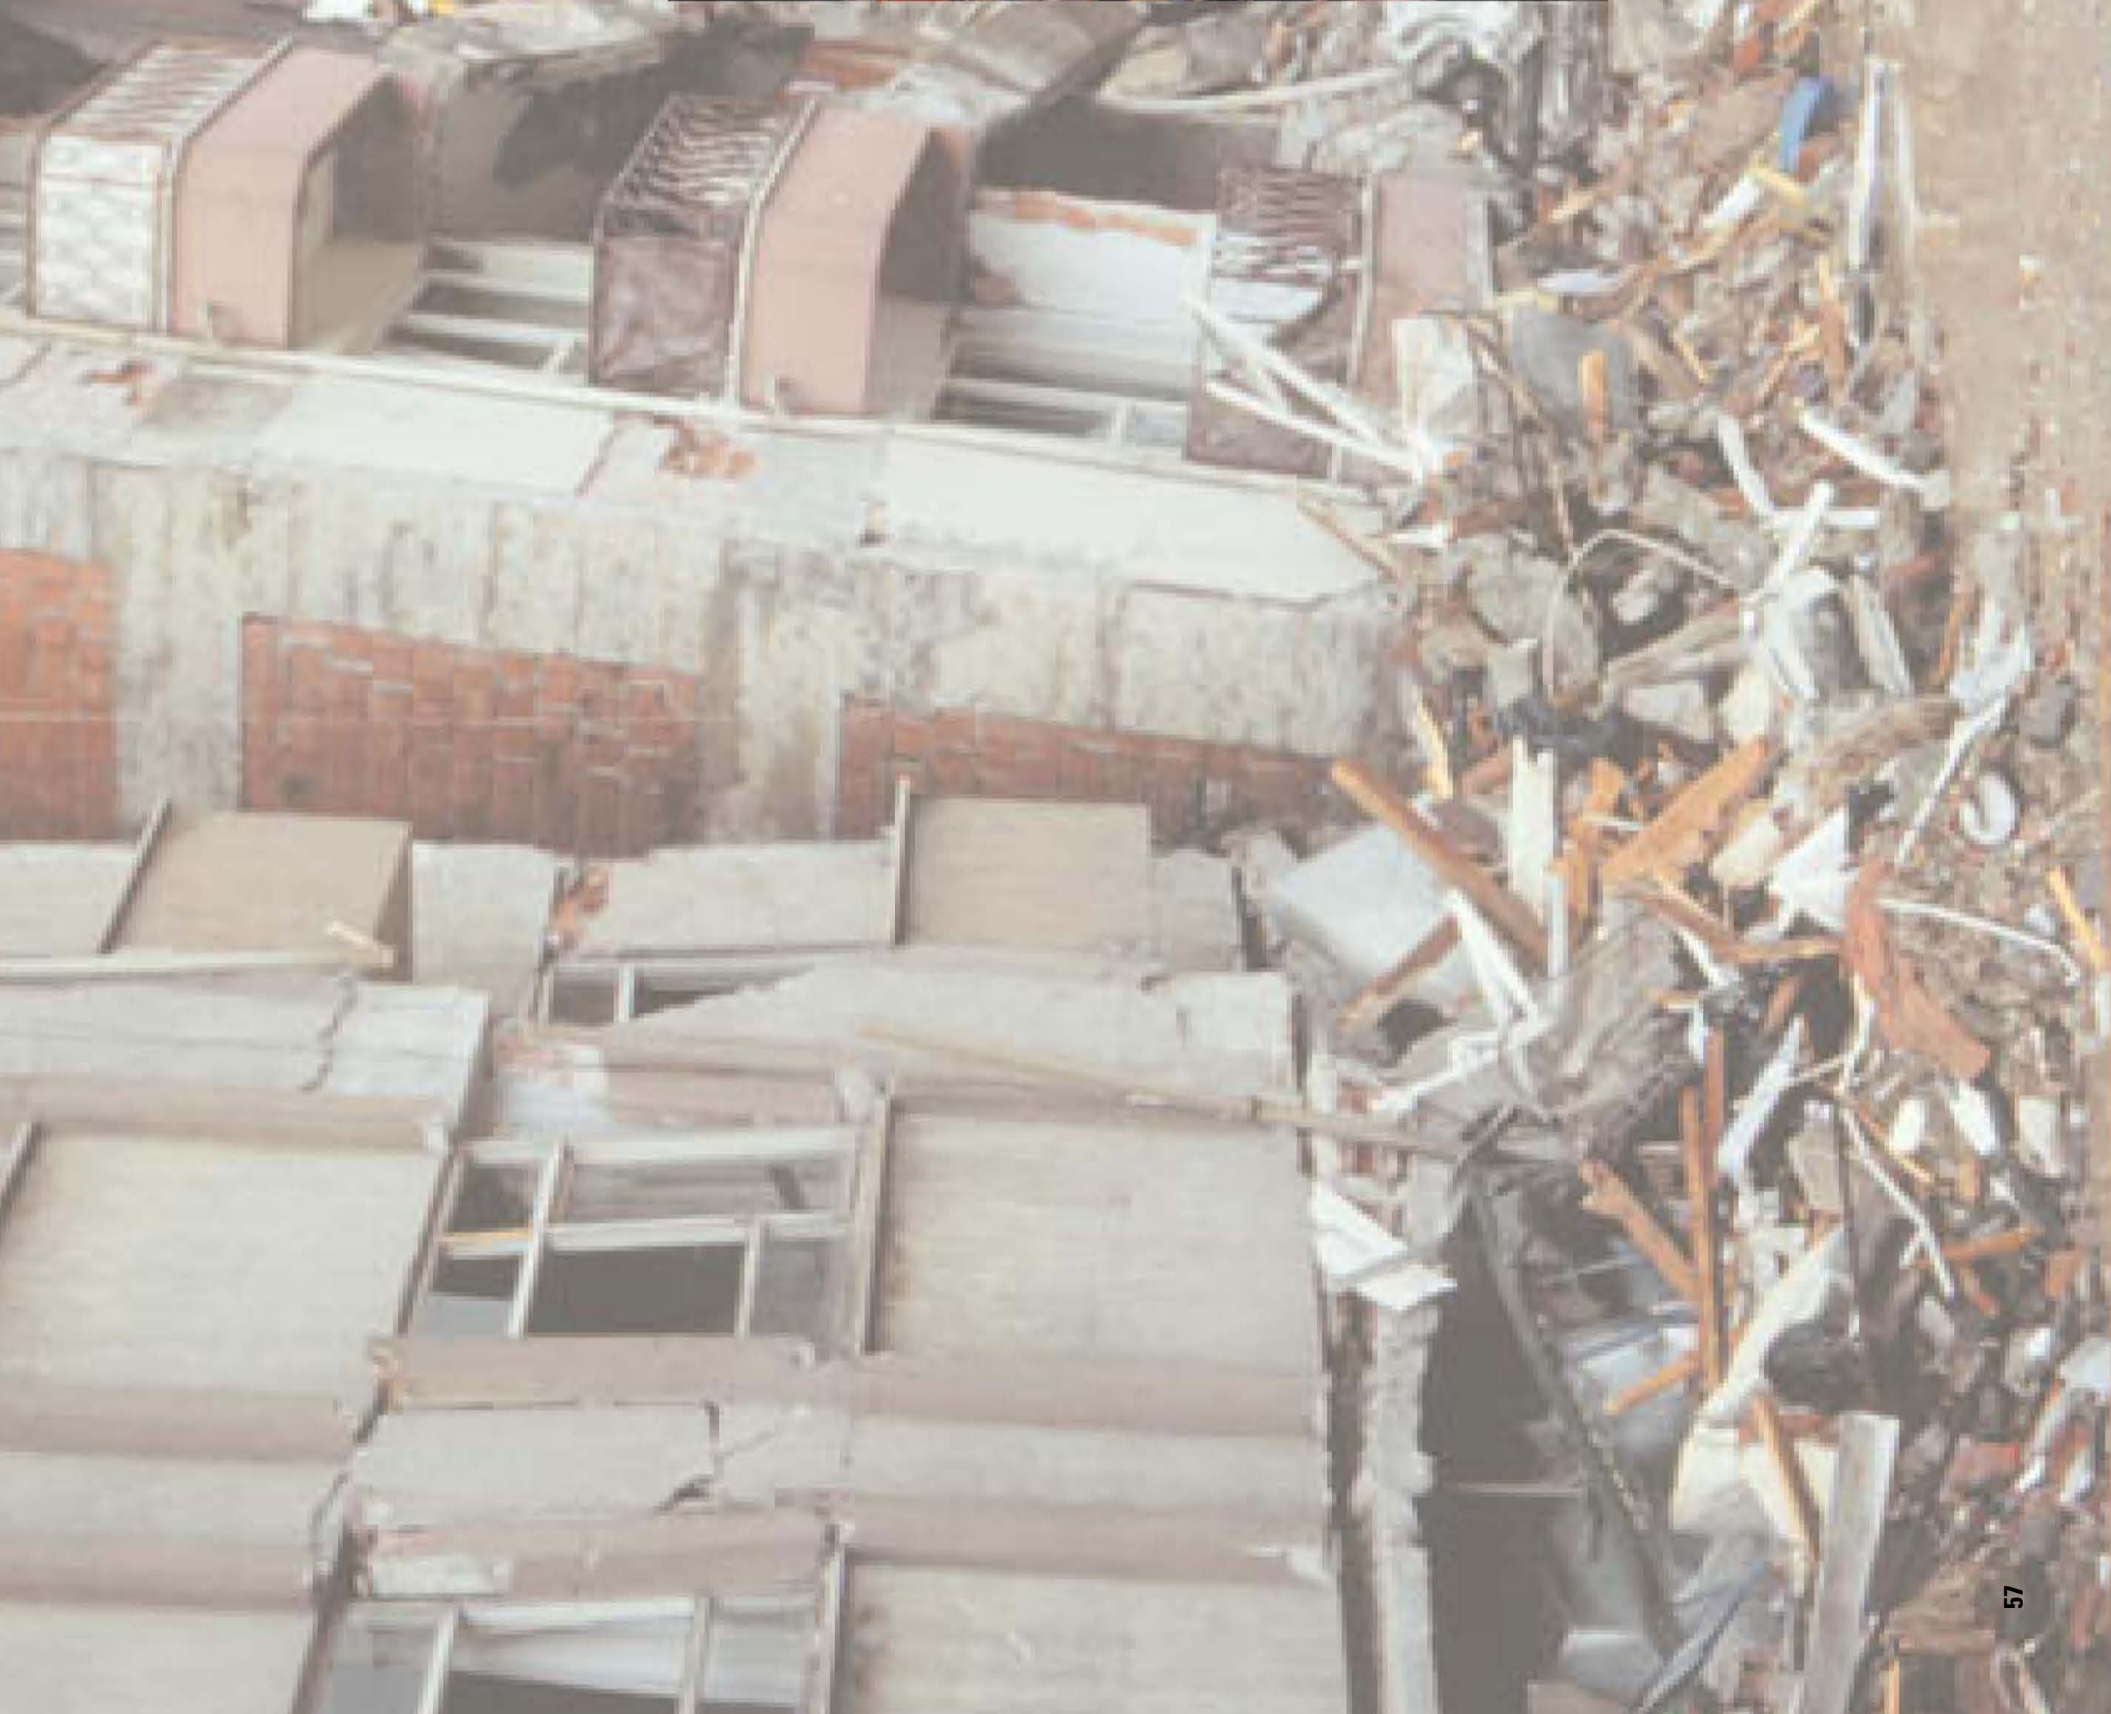
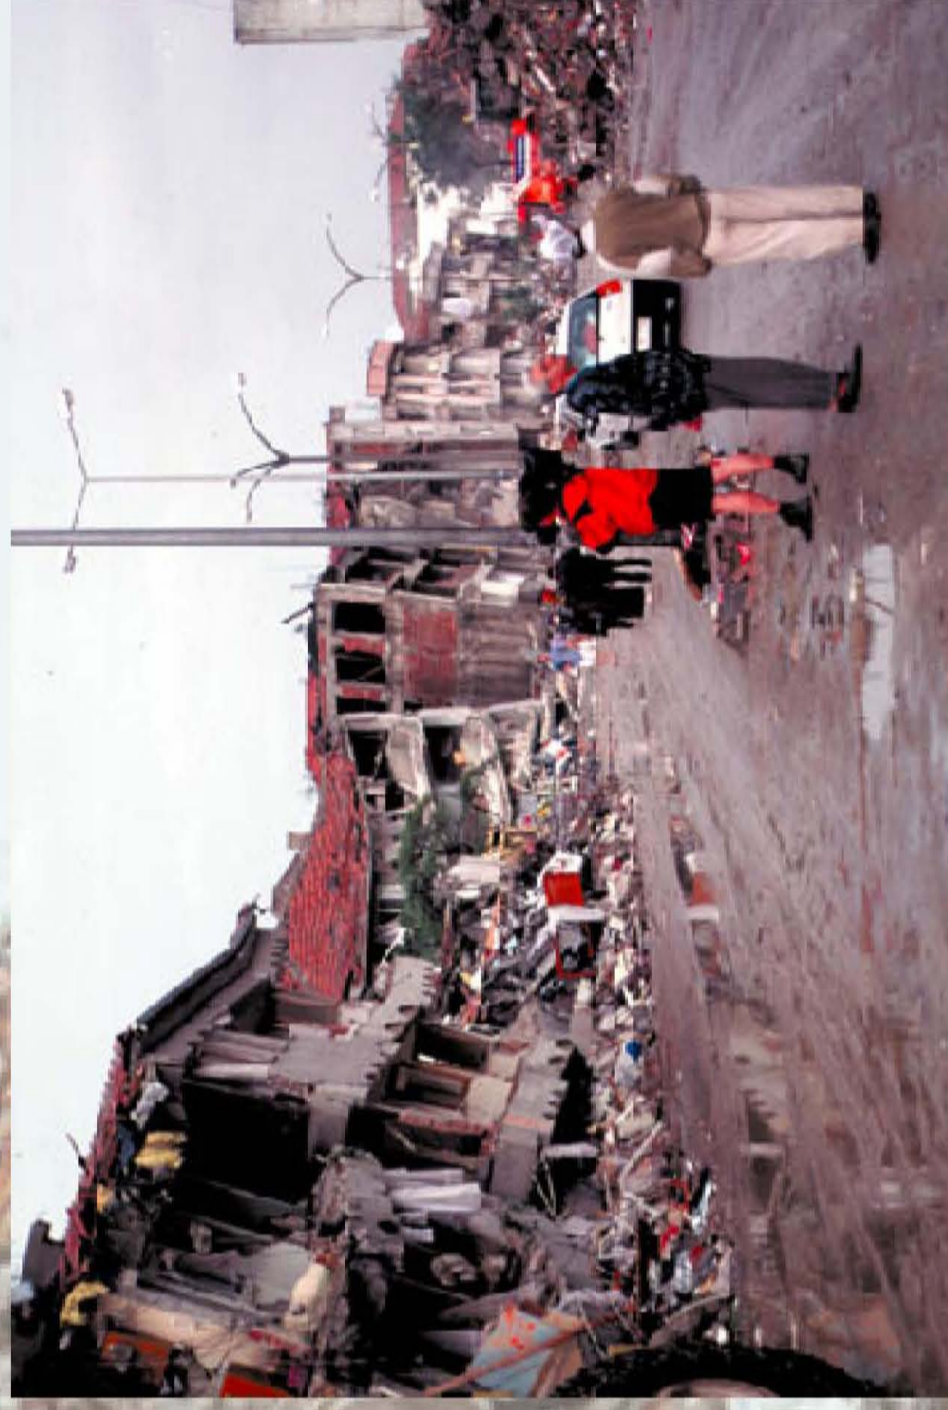
Figure 57. Street scene in Adapazarı following the Kocaeli, Turkey, earthquake. Extensive damage to concrete structures with little or no ductility displaced more than a quarter of a million people from their homes in the epicentral region. *Photograph by Thomas L. Holzer.*
