**NISTIR 5944**

Failure Analysis of Welded Steel Moment Frames Damaged in the Northridge Earthquake

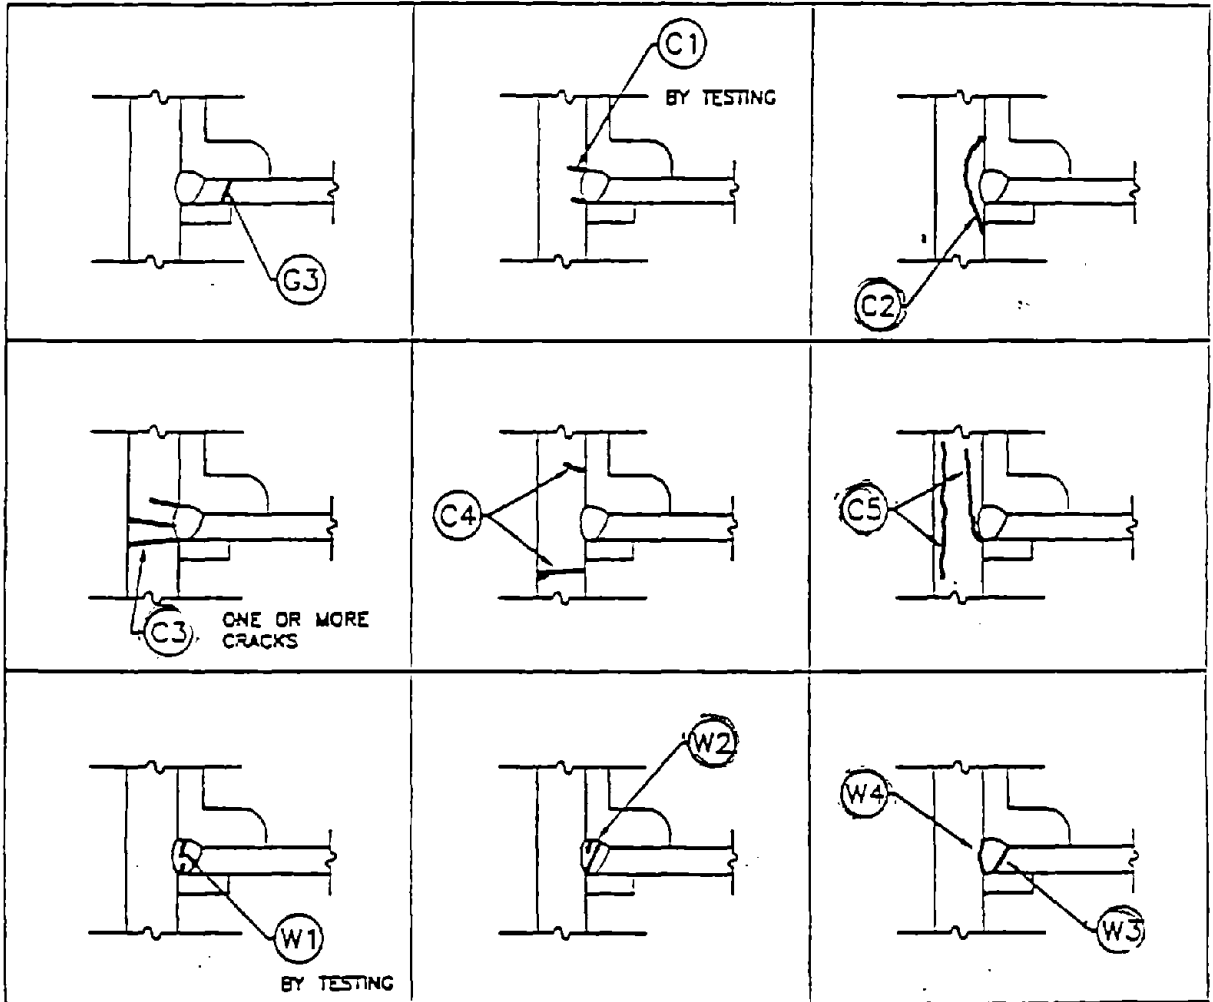
Figure 2 - WSMF Damage Types (Youssef et al.).

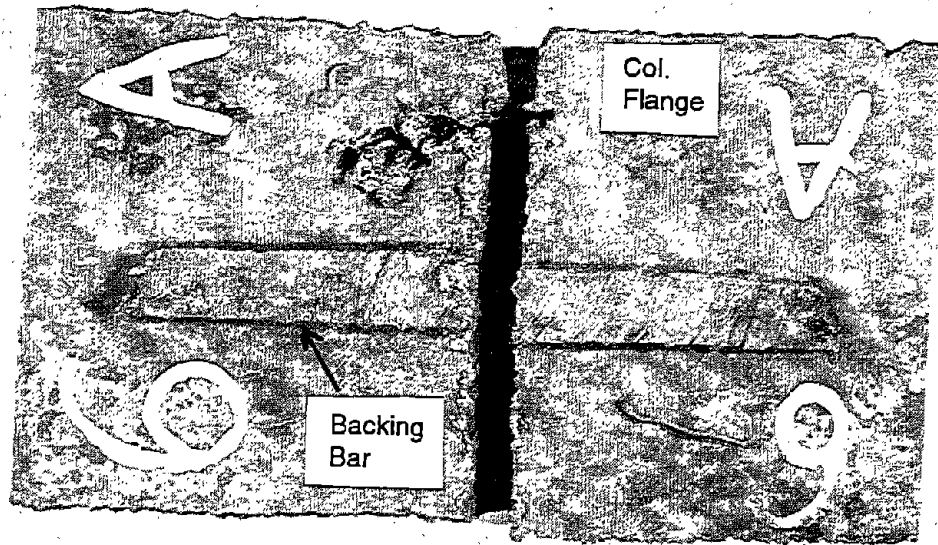
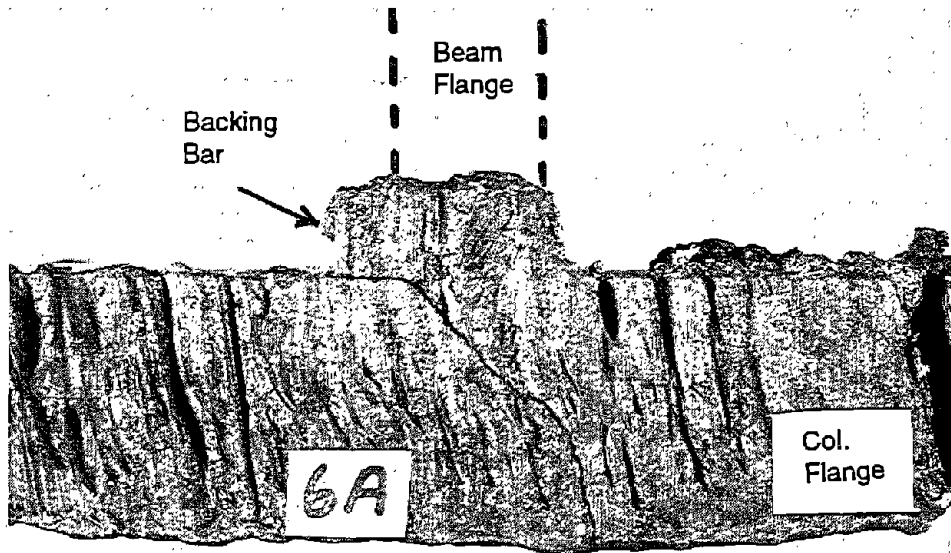
Figure 3 - Building Sample A6.
Top: Column flange face with cut beam flange weld.
Bottom: Edge view showing column flange fracture.

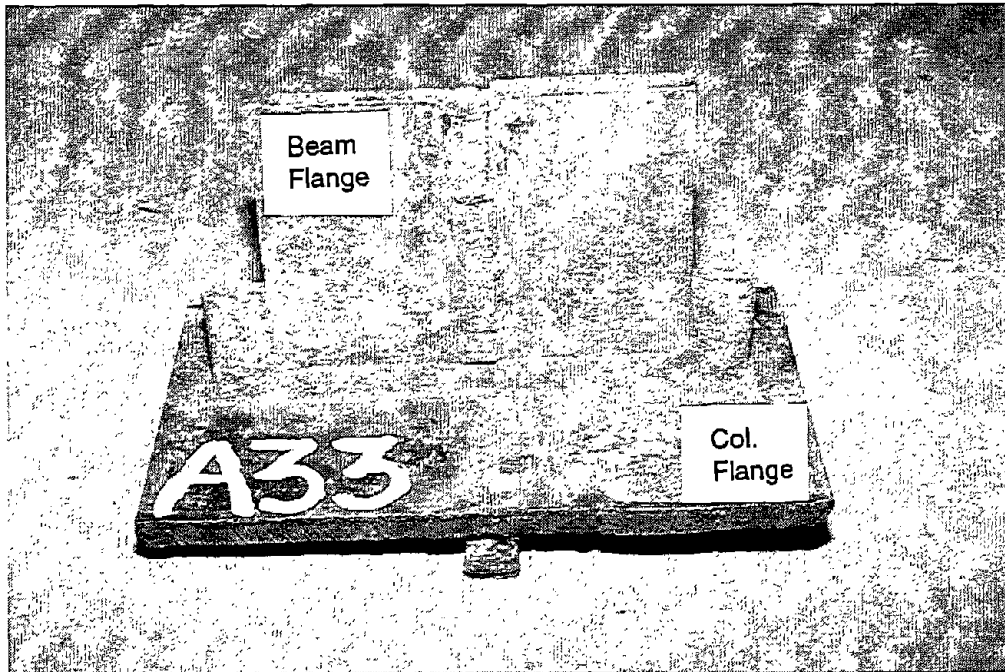
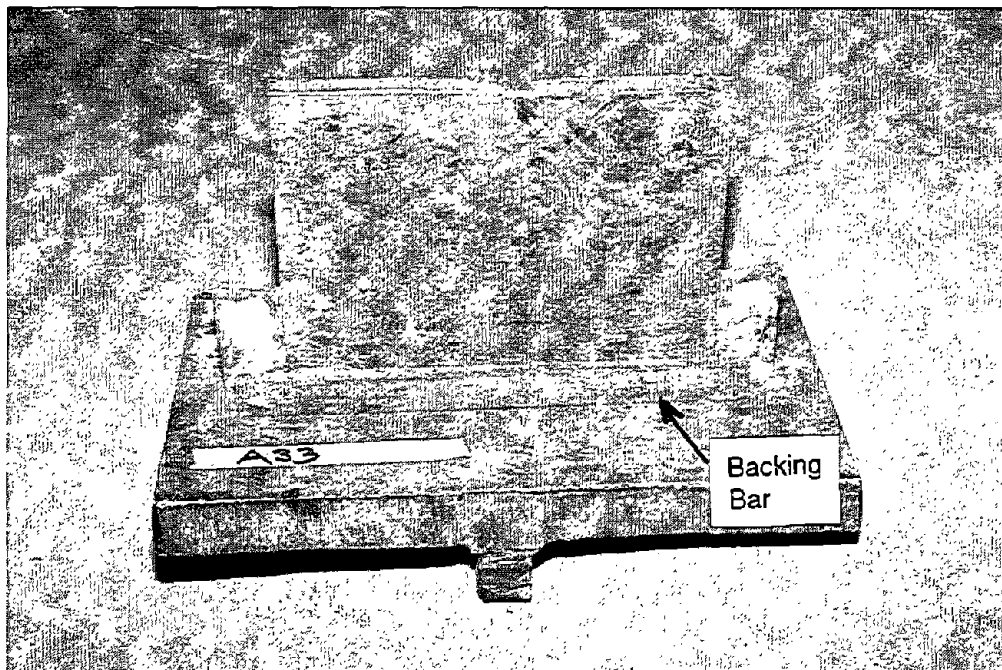
Figure 4 - Building Sample A33. No cracking is visible.

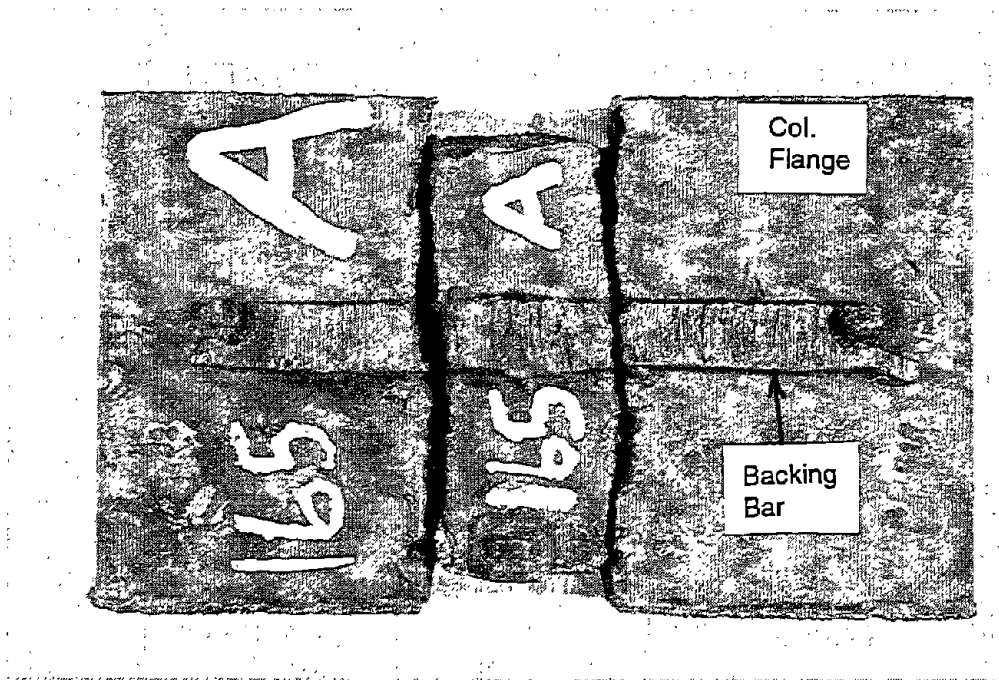
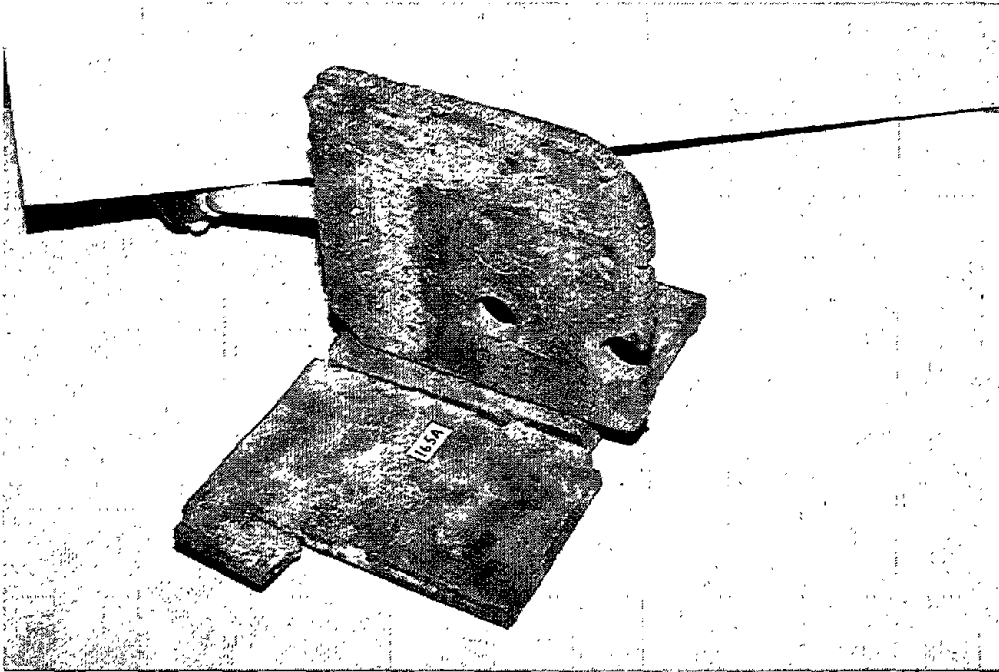
Figure 5 - Building Sample A165.
Top: Column flange face with cut beam flange weld.
Bottom: Beam bottom flange.

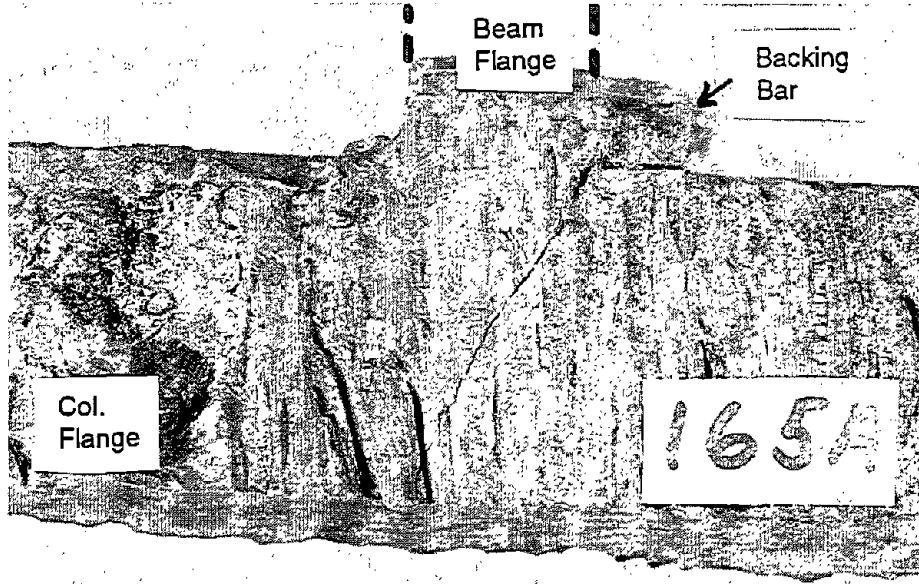
Figure 6 - Edge view of Sample A165 column flange showing fracture path.

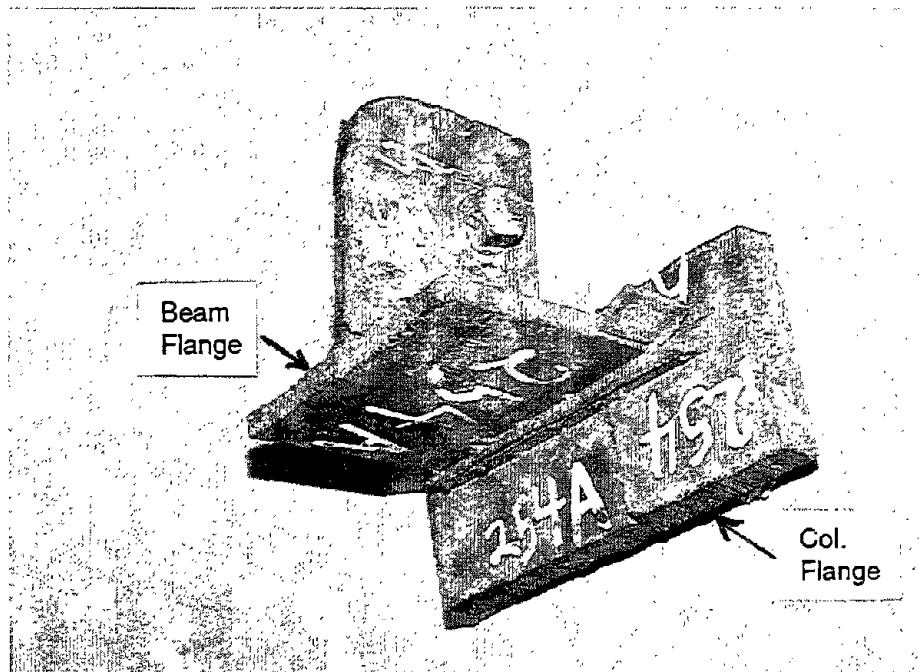
Figure 7 - Building Sample A254.

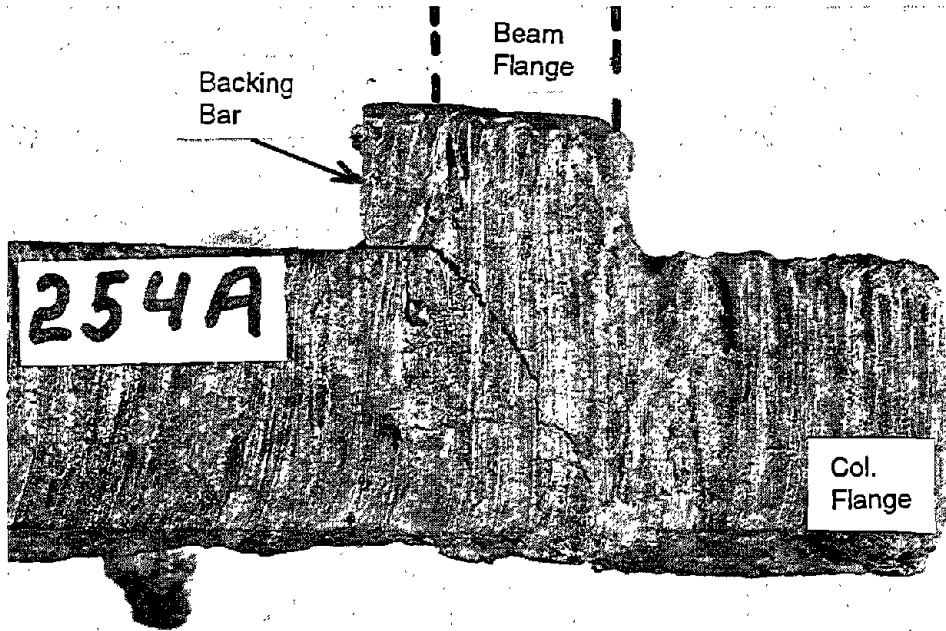
Figure 8 - Edge view of Sample A254 showing column flange fracture.

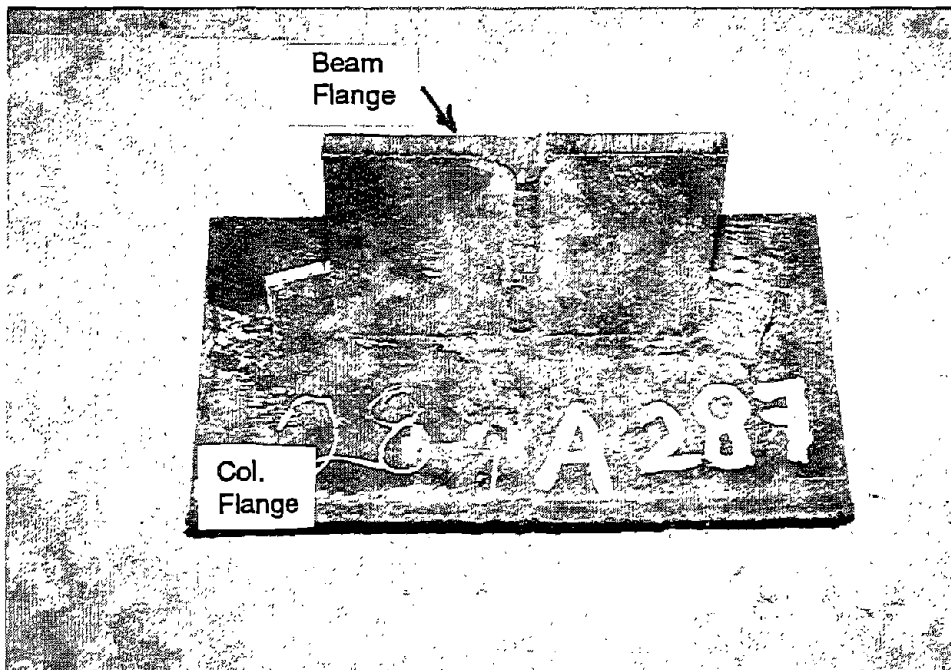
Figure 9 - Building Sample A287. No cracking is visible.

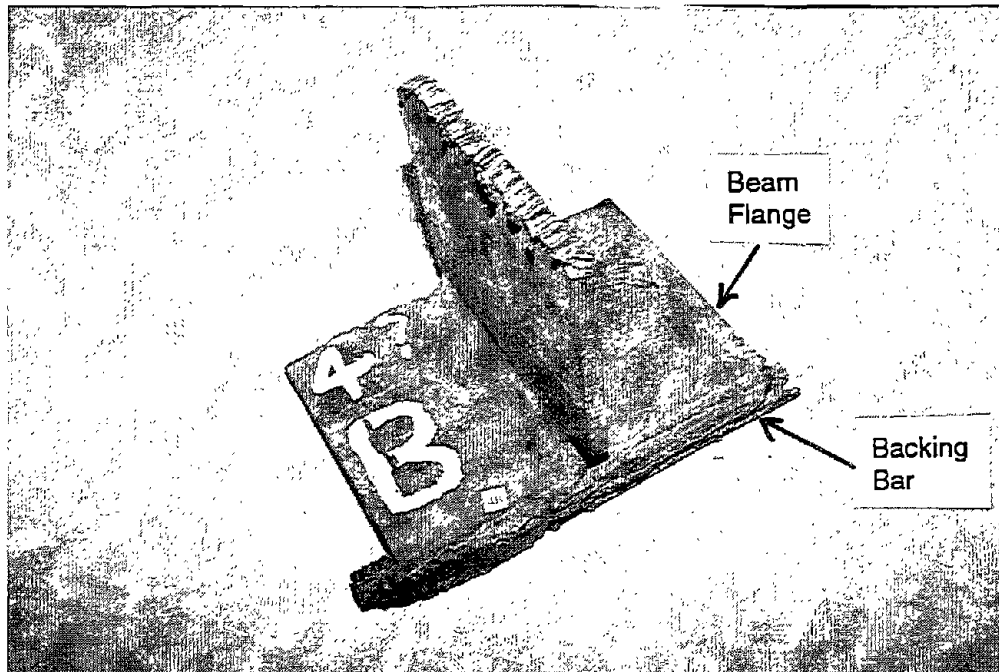
Figure 10 - Building Sample B4 showing beam bottom flange and fracture (Type W4).

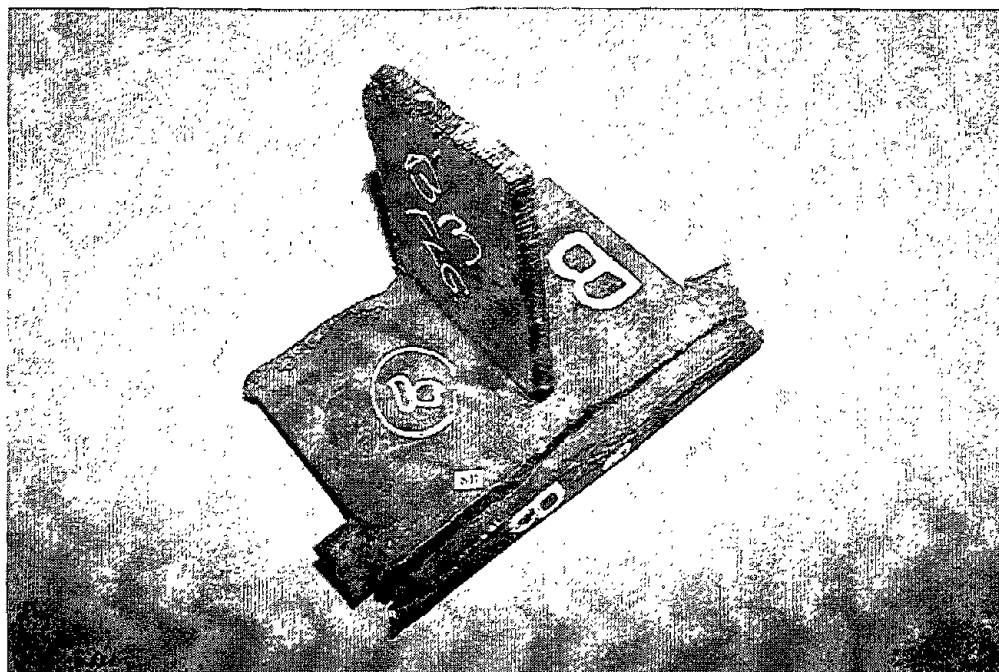
Figure 11 - Building Sample B8 showing beam bottom flange and fracture (Type W4).

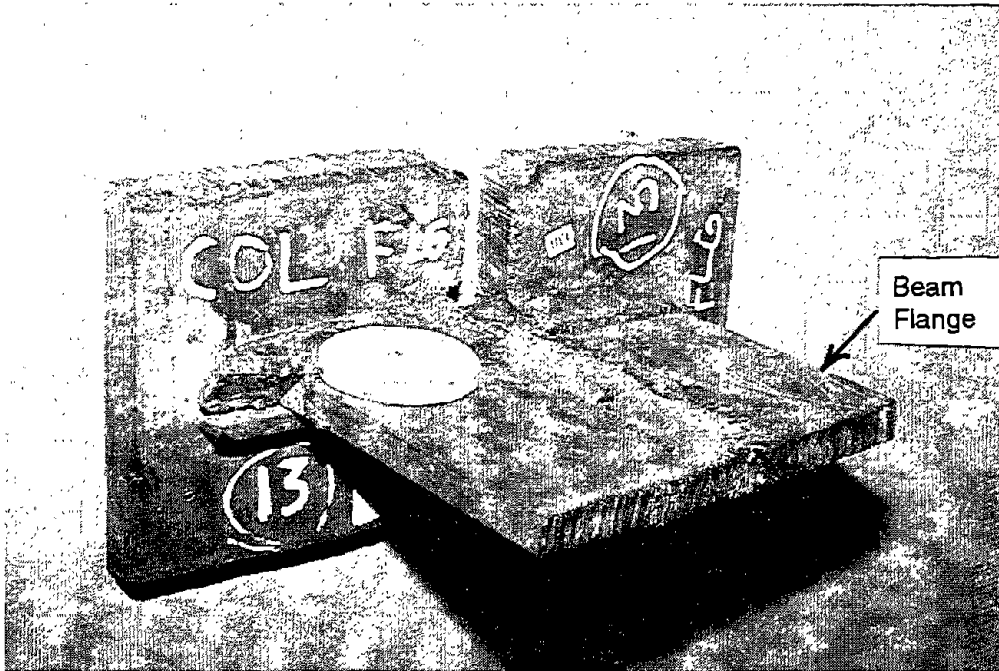
Figure 12 - Building Sample B13.

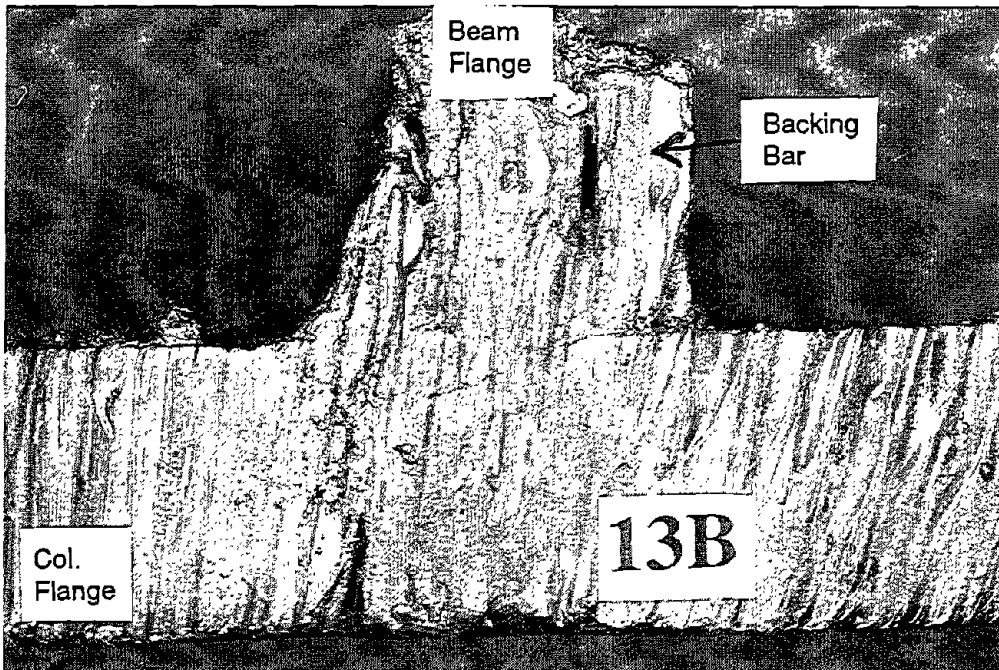
Figure 13 - Edge view of Sample B13 showing column flange fracture.

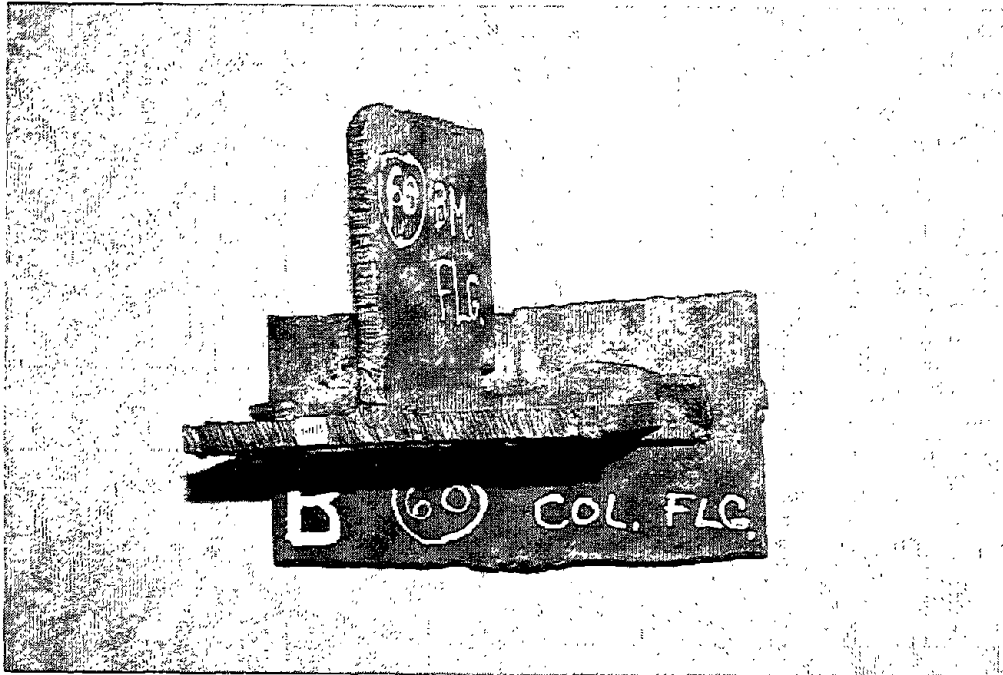
Figure 14 - Building Sample B60.

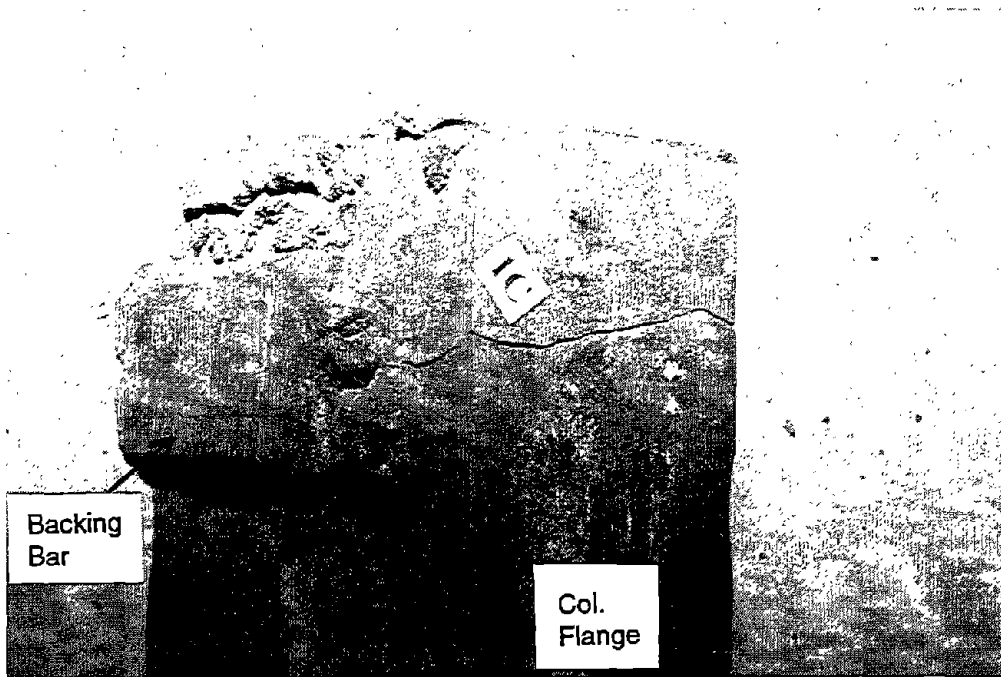
Figure 16 - Edge view of column flange fracture in Sample C1.

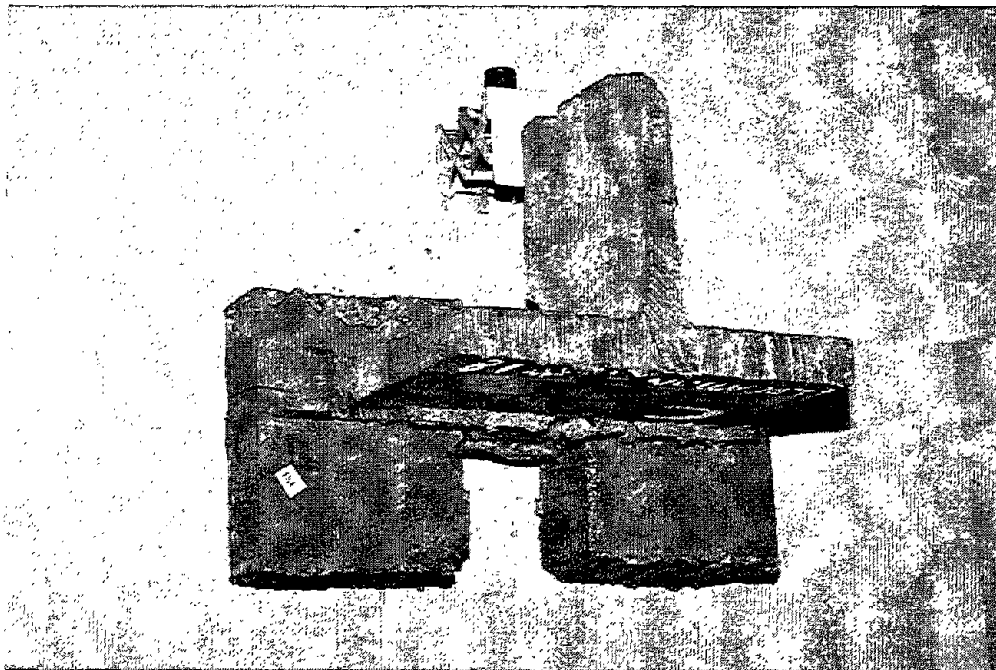
Figure 17 - Building Sample C18.

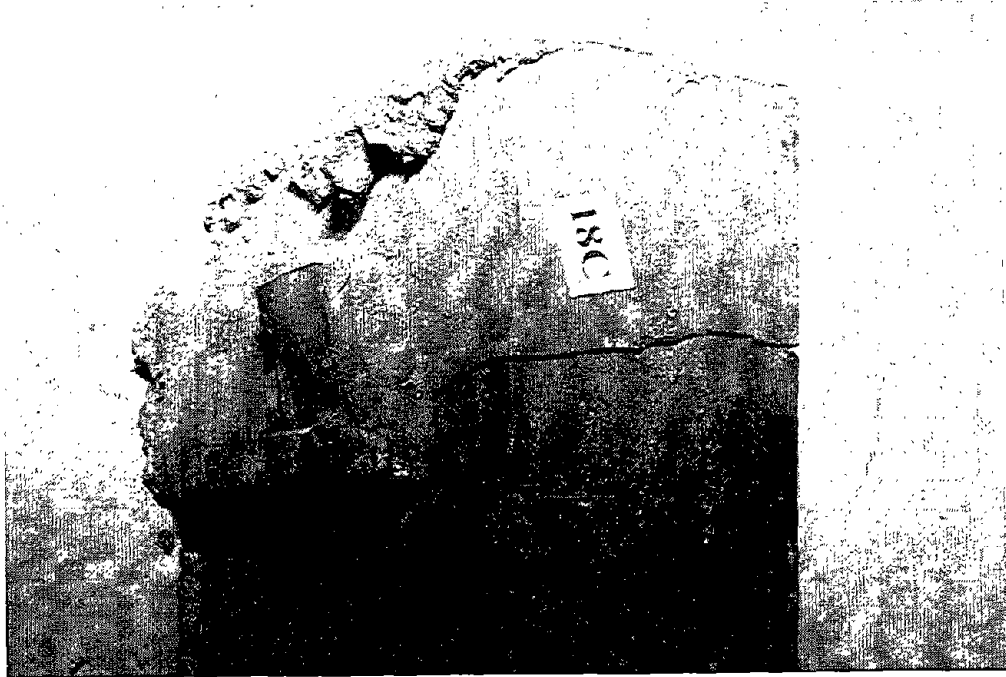
Figure 18 - Edge view of column flange fracture in Sample C18.

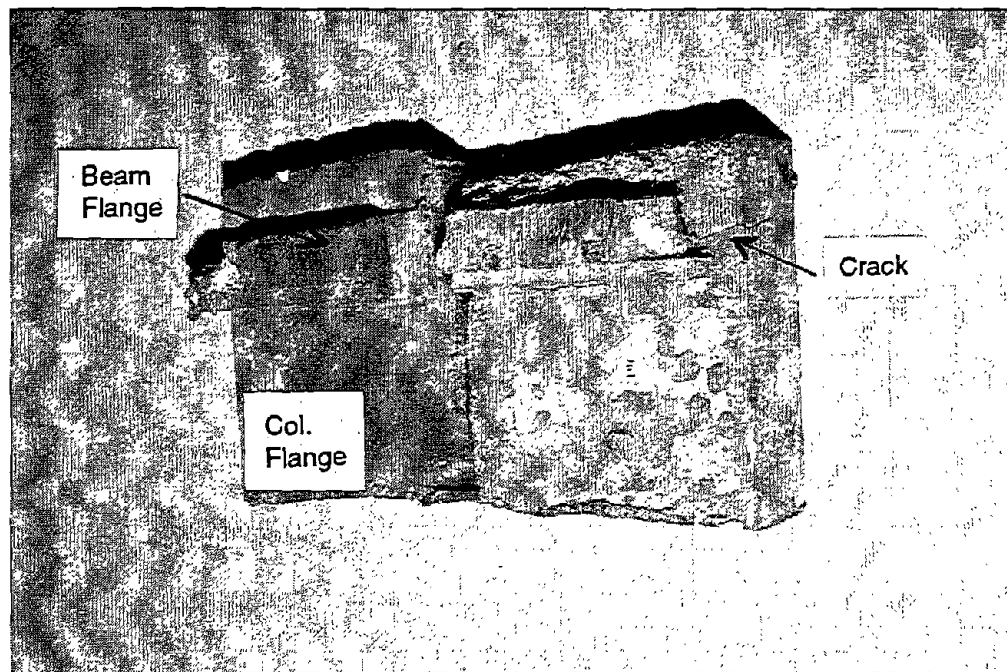
Figure 19 - Building Sample C19.

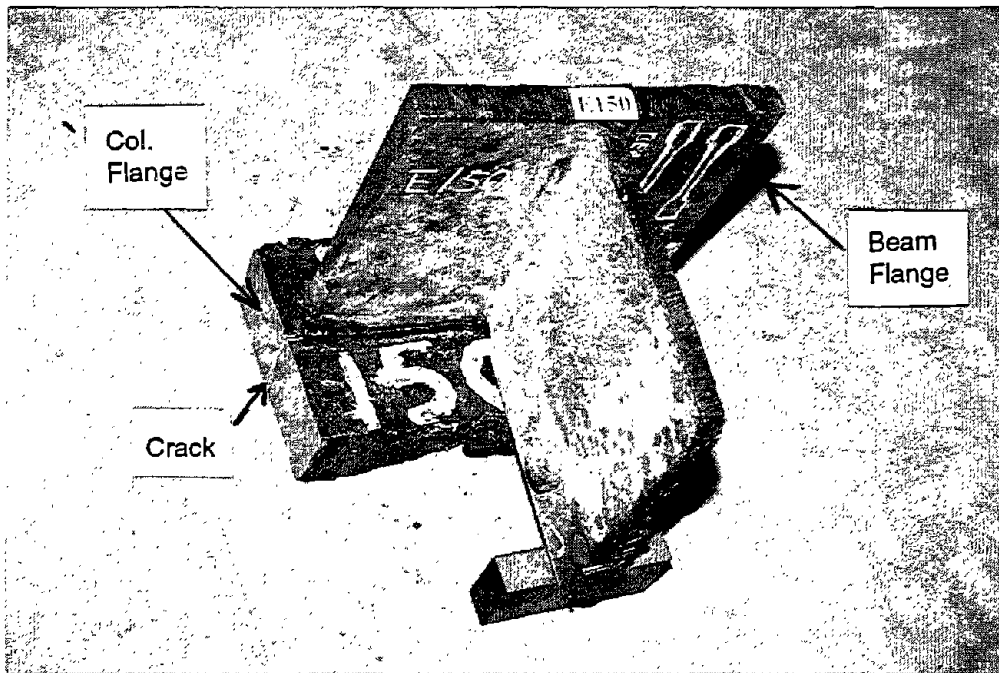
Figure 20 - Building Sample E150. Note column flange fracture.

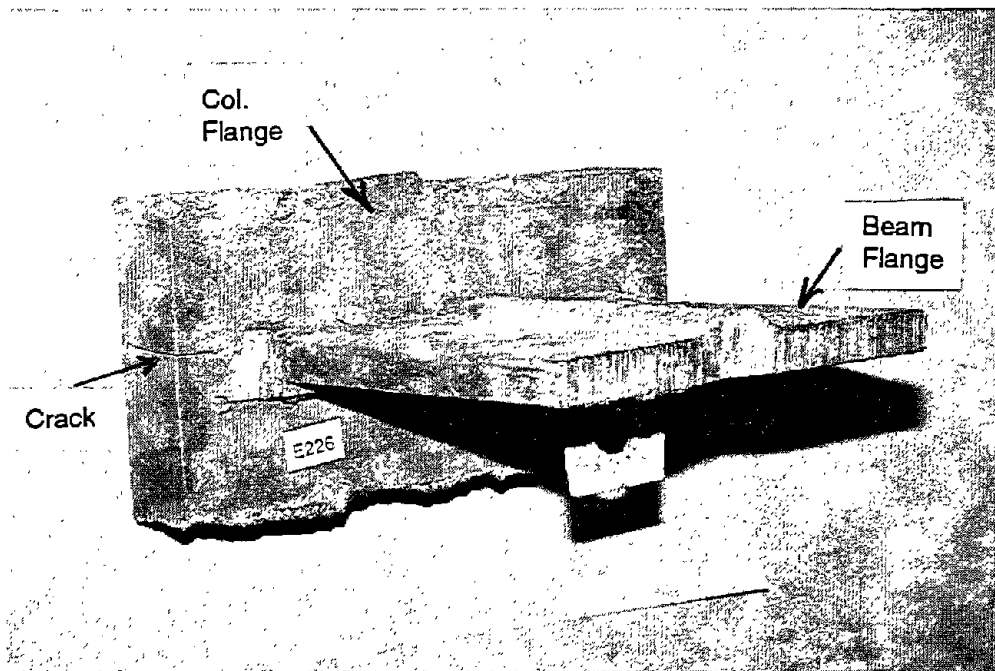
Figure 21 - Building Sample E226. Note column flange fracture.

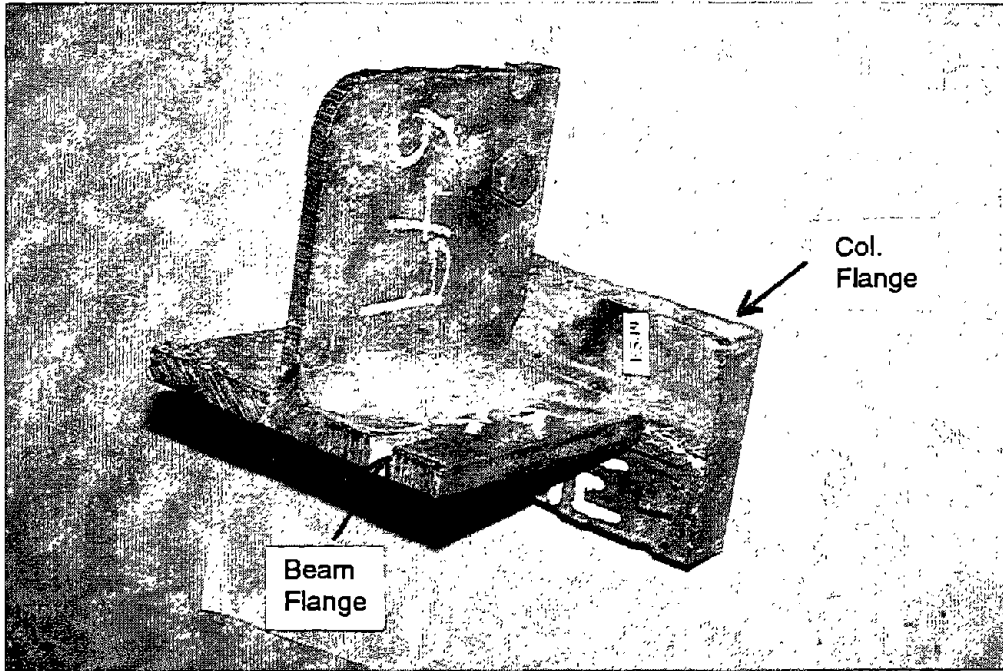
Figure 22 - Building Sample E549. No cracking is visible.

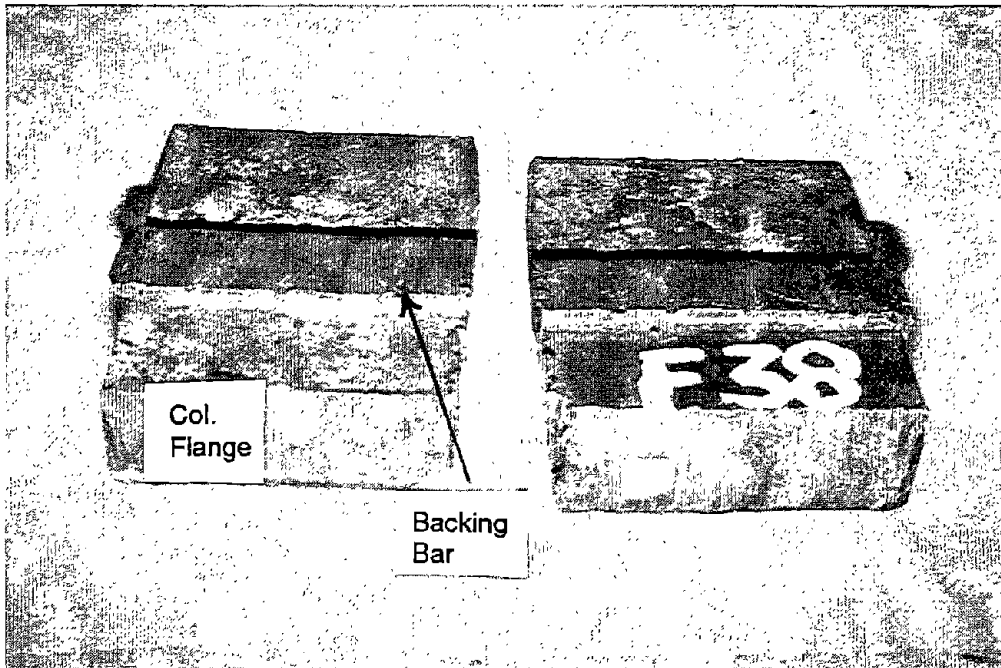
Figure 23 - Building Sample F38 showing column flange and cut beam flange weld.

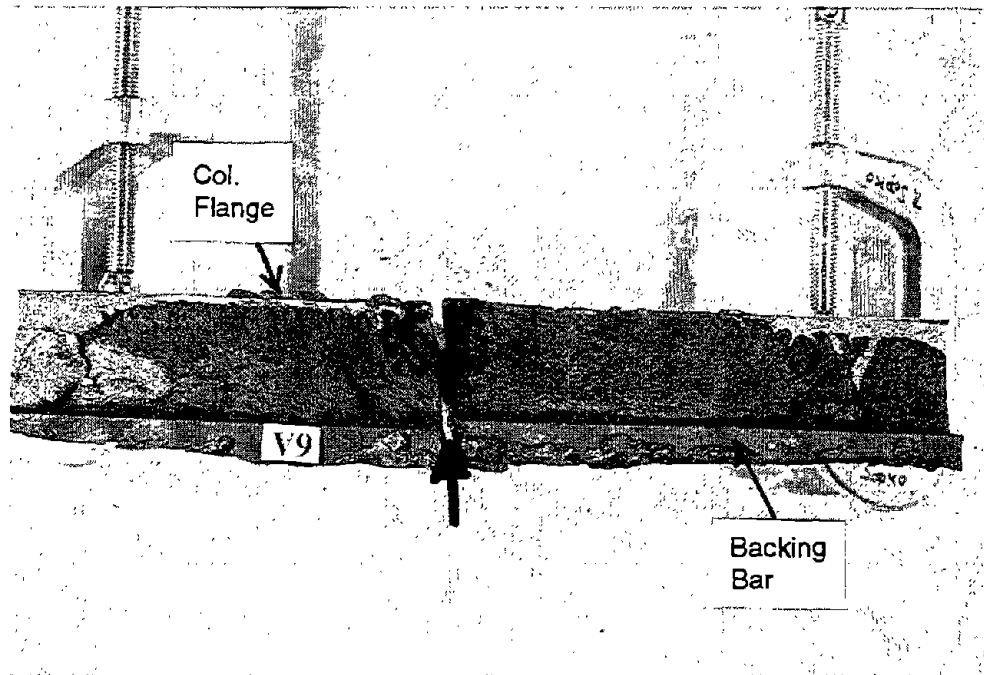
Figure 25 - Column flange fracture surface from Sample A6.
Arrow indicates location of fracture origin.

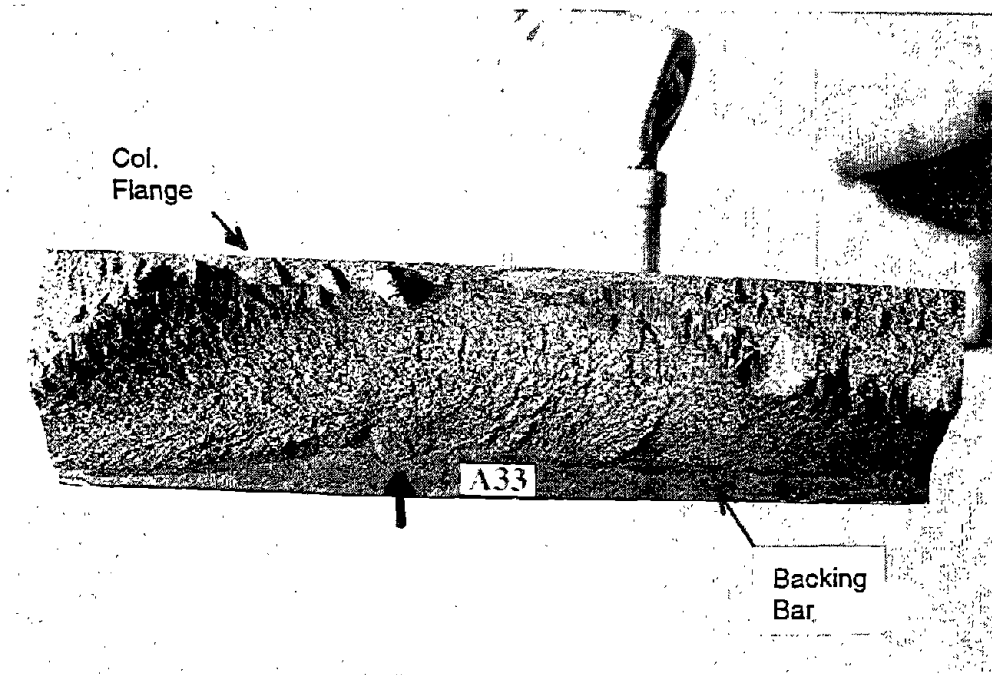
Figure 26 - Column flange fracture surface from Sample A33.
Arrow indicates location of fracture origin.

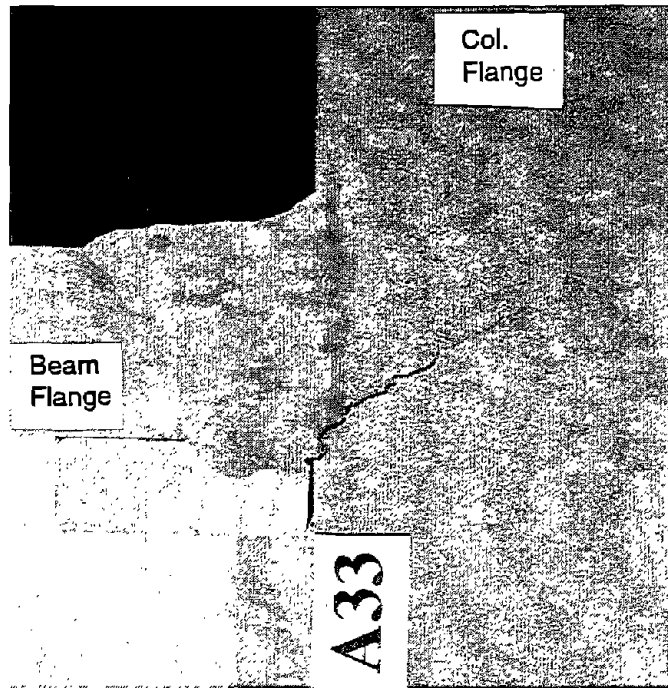
Figure 27 - Cross-section of fracture in Sample A33.

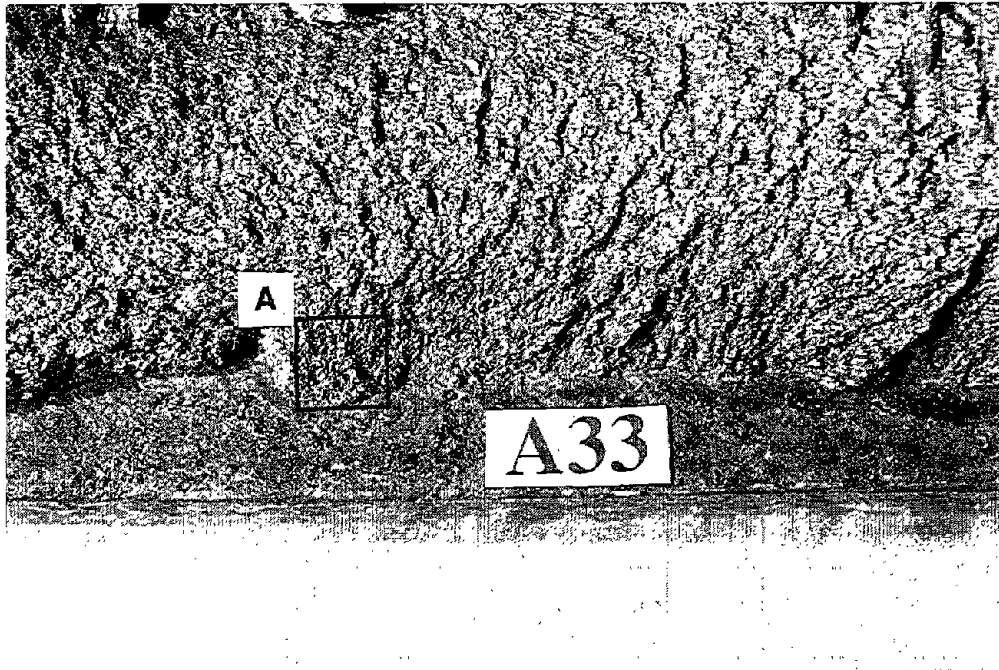
Figure 28 - Enlarged view of fracture origin area of Sample A33.
Note incomplete fusion along weld root.

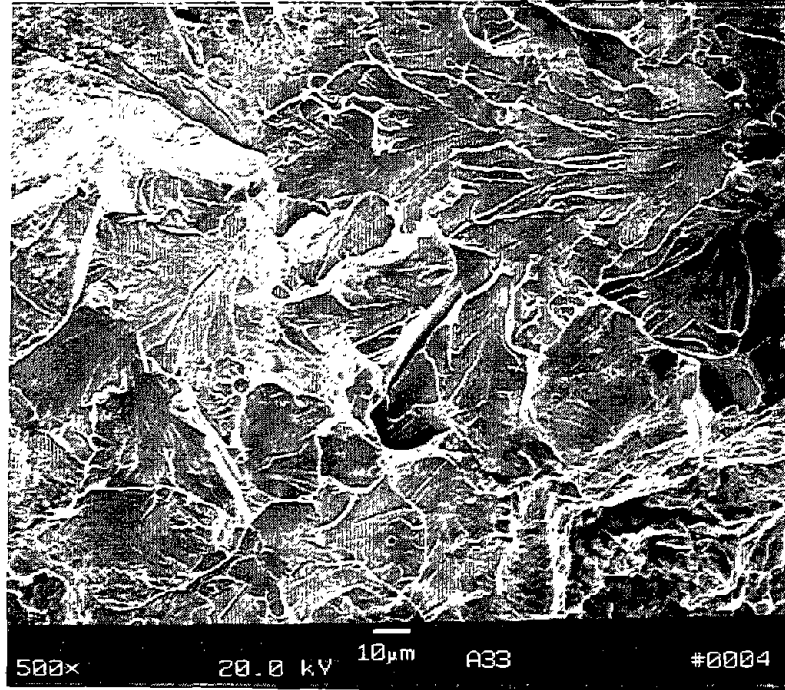
Figure 29 - SEM micrograph of the fracture origin (Area marked "A" in Figure 28) showing cleavage fracture. (Mag. 500X)

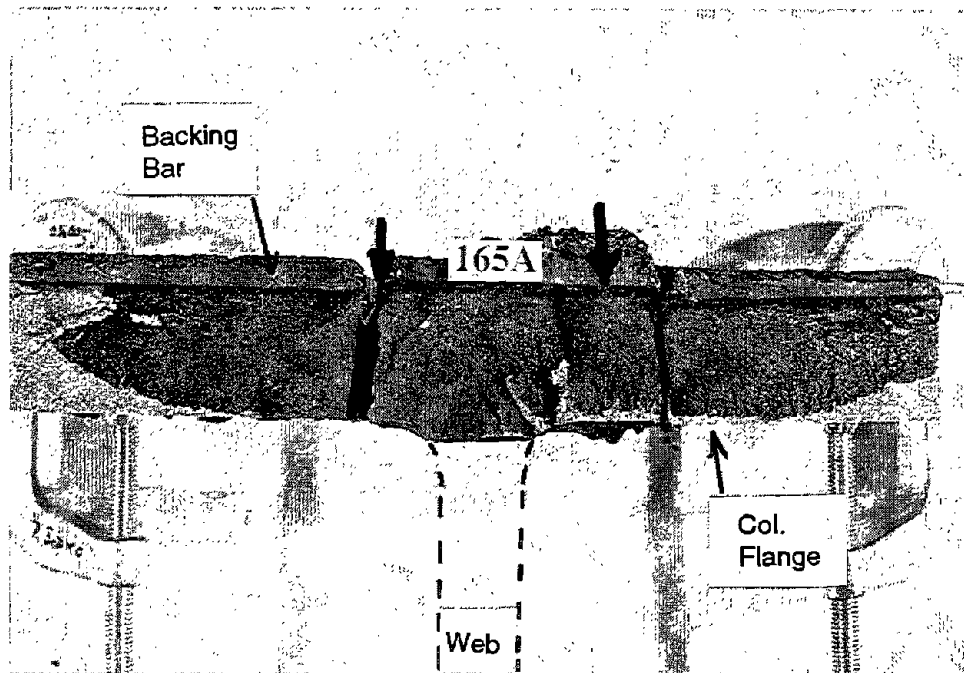
Figure 30 - Fracture surface of Sample A165. Arrow shows location of fracture origin.

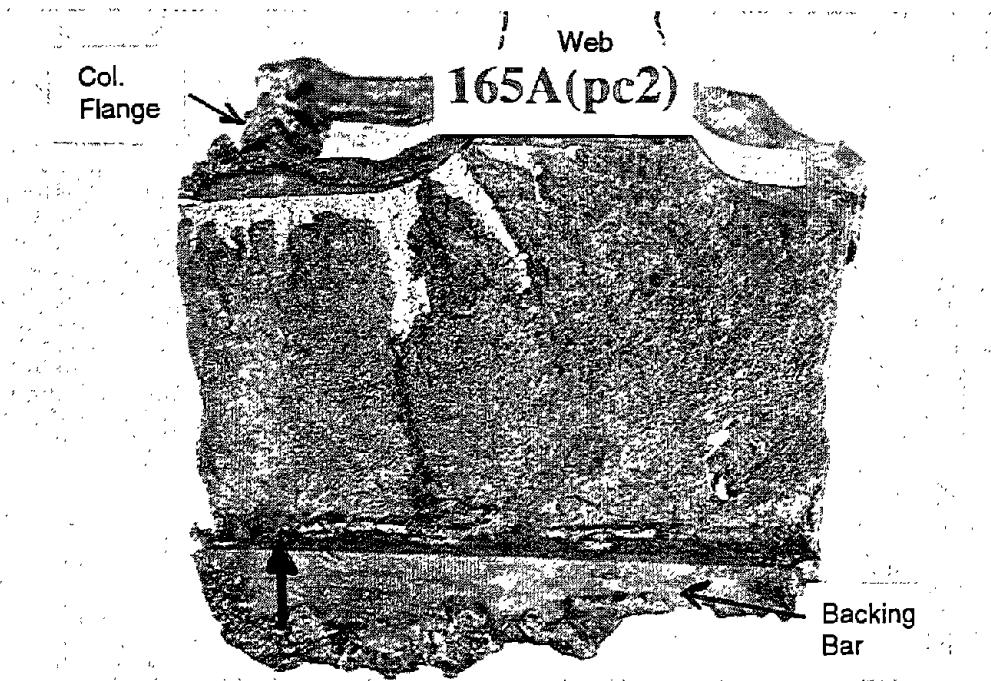
Figure 31 - Enlarged view of the fracture origin area at the weld root of Sample A165.

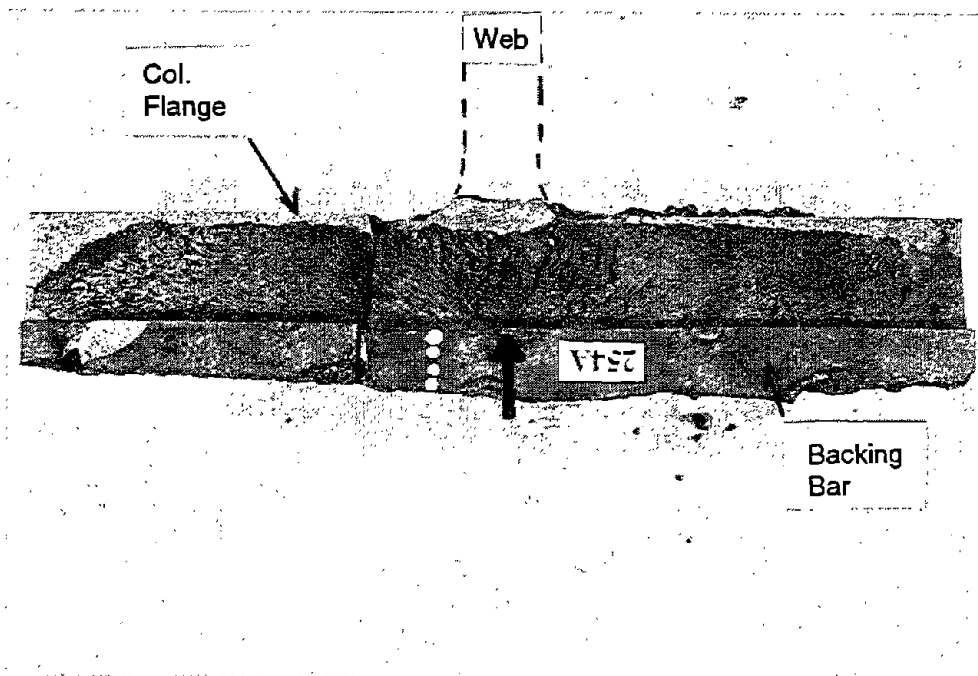
Figure 32 - Fracture surface from Sample A254. Arrow shows location of fracture origin.

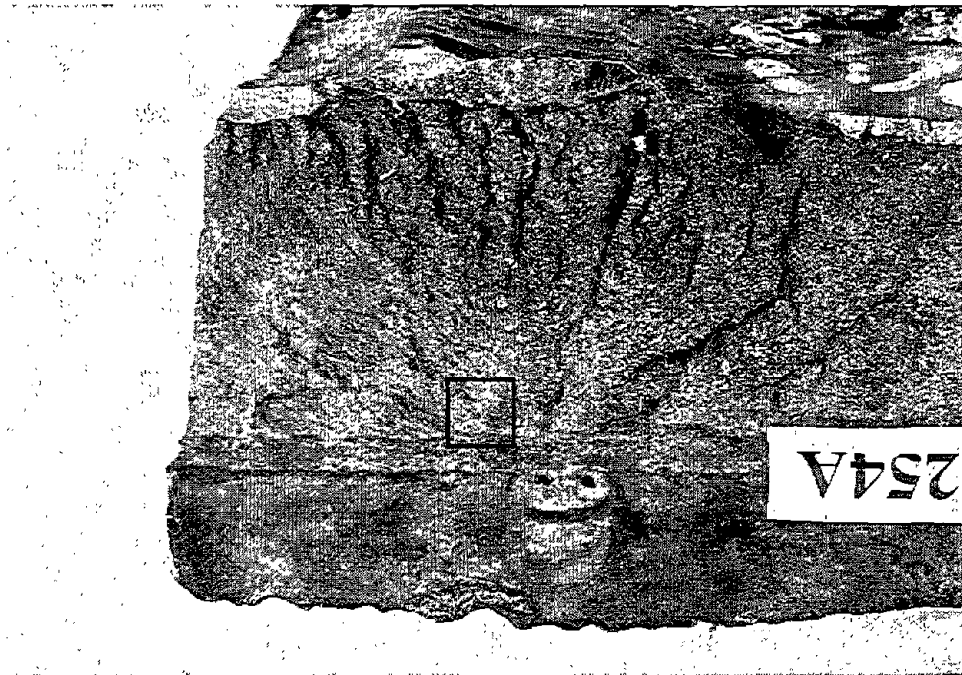
Figure 33 - Enlarged view of the fracture origin area at the weld root of Sample A254.

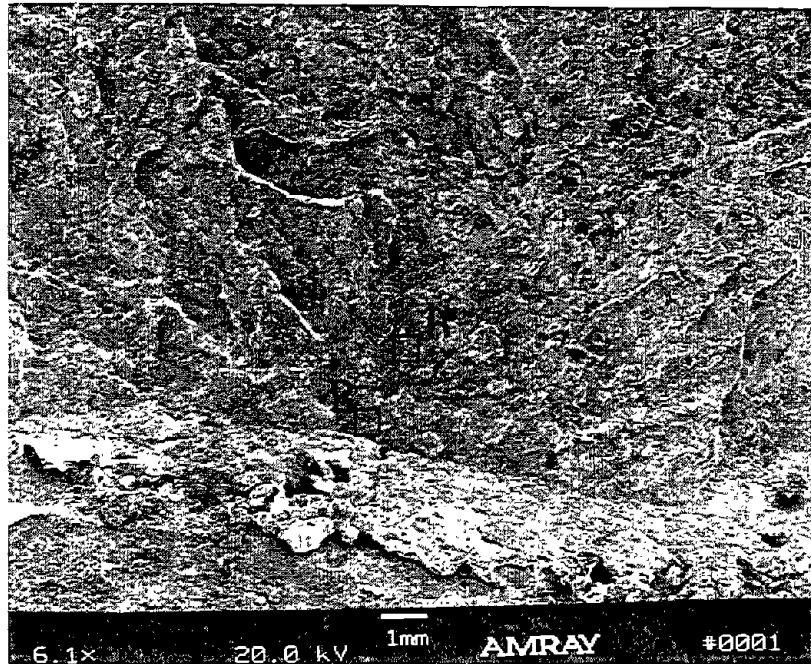
Figure 34 - Low magnification SEM micrograph of the fracture origin area of Sample A254. (Boxed area seen in Figure 33) (Mag. 6.1X).
