**NISTIR 5944**

Failure Analysis of Welded Steel Moment Frames Damaged in the Northridge Earthquake

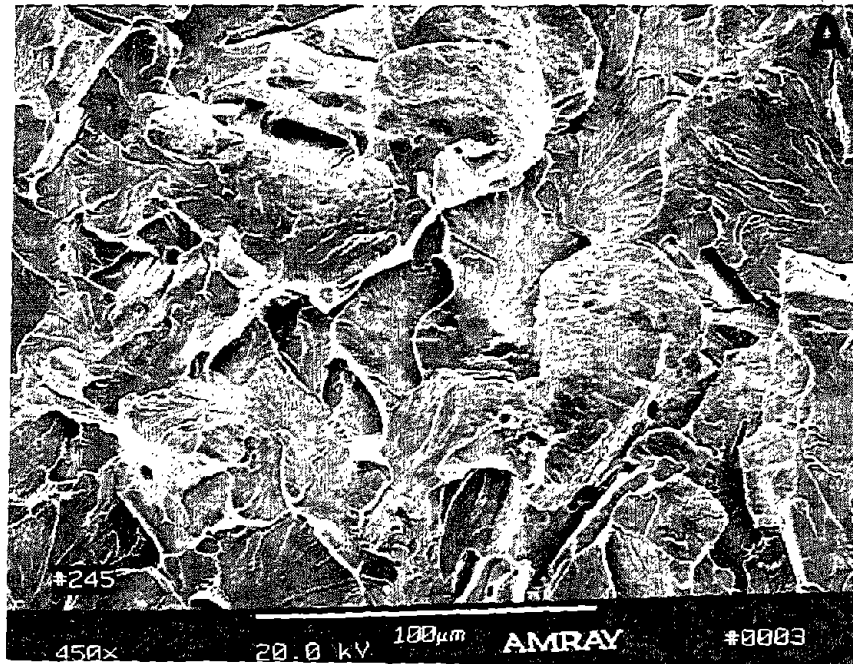
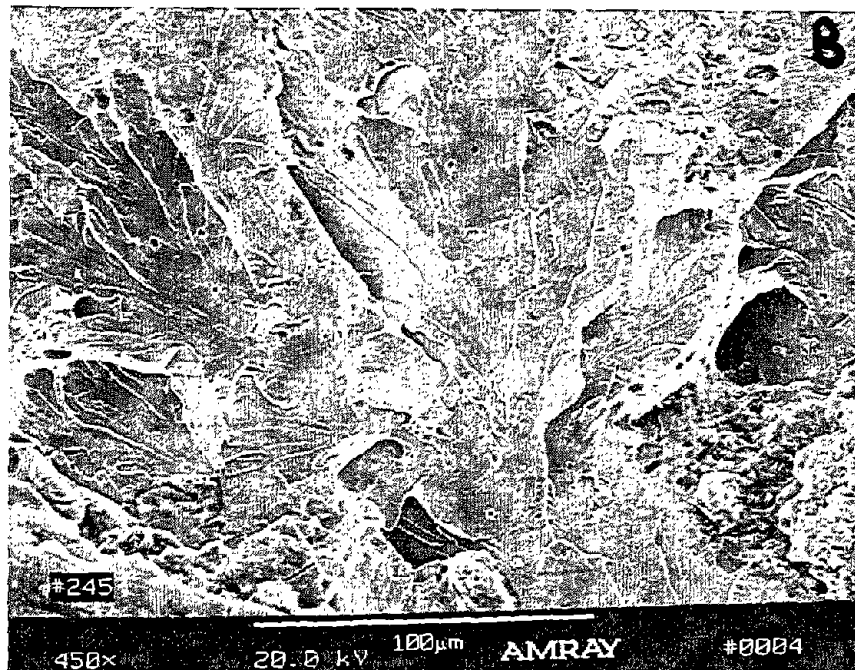
Figure 35 - Higher magnification micrographs of the fracture origin of Sample A254 showing cleavage fracture. (Mag. 450X)
Top: Boxed area "A" in Figure 34. Bottom: Boxed area "B" in Figure 34.

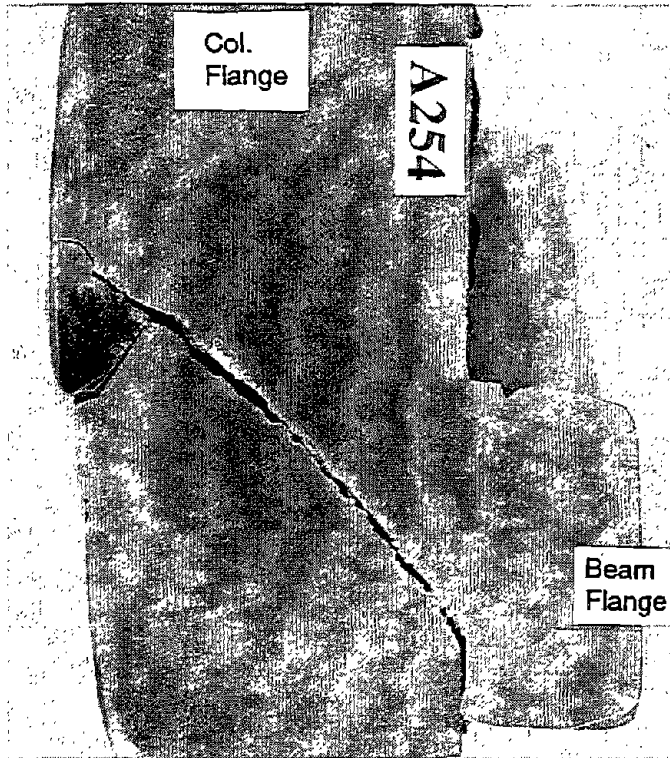
Figure 36 - Cross-section of fracture in Sample A254 adjacent to the fracture origin.

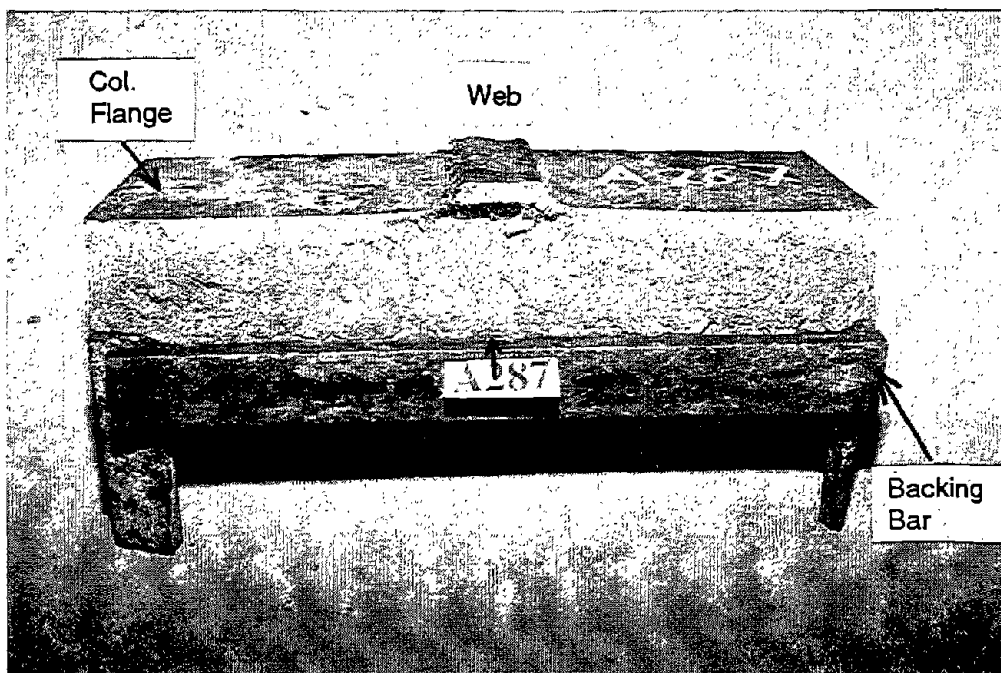
Figure 37 - Fracture surface of Sample A287. Arrow shows location of fracture origin.

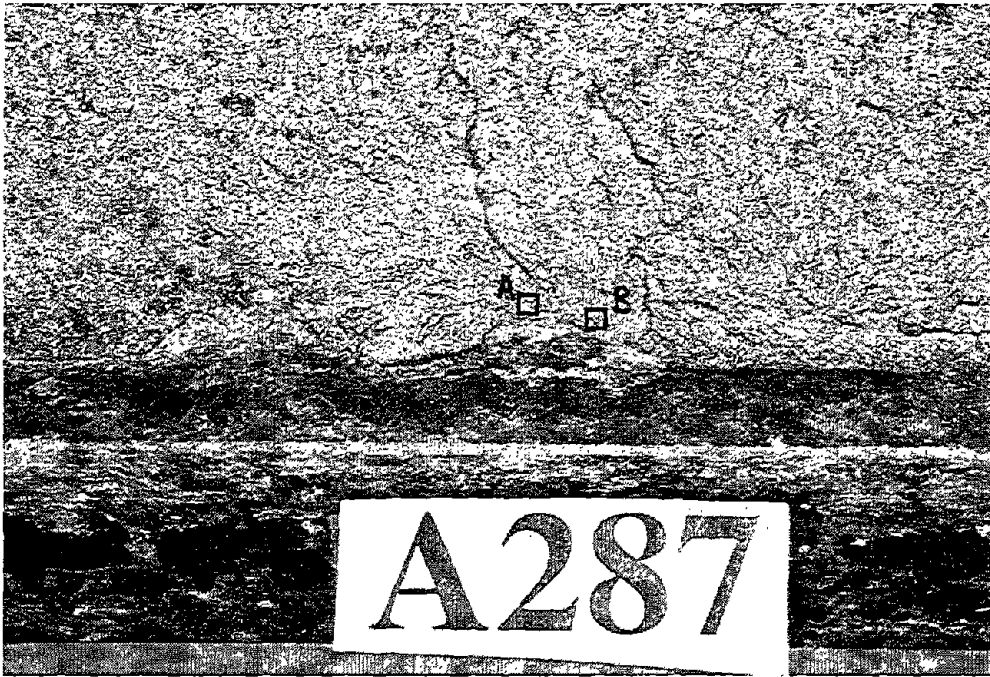
Figure 38 - Enlarged view of the weld root fracture origin in Sample A287.

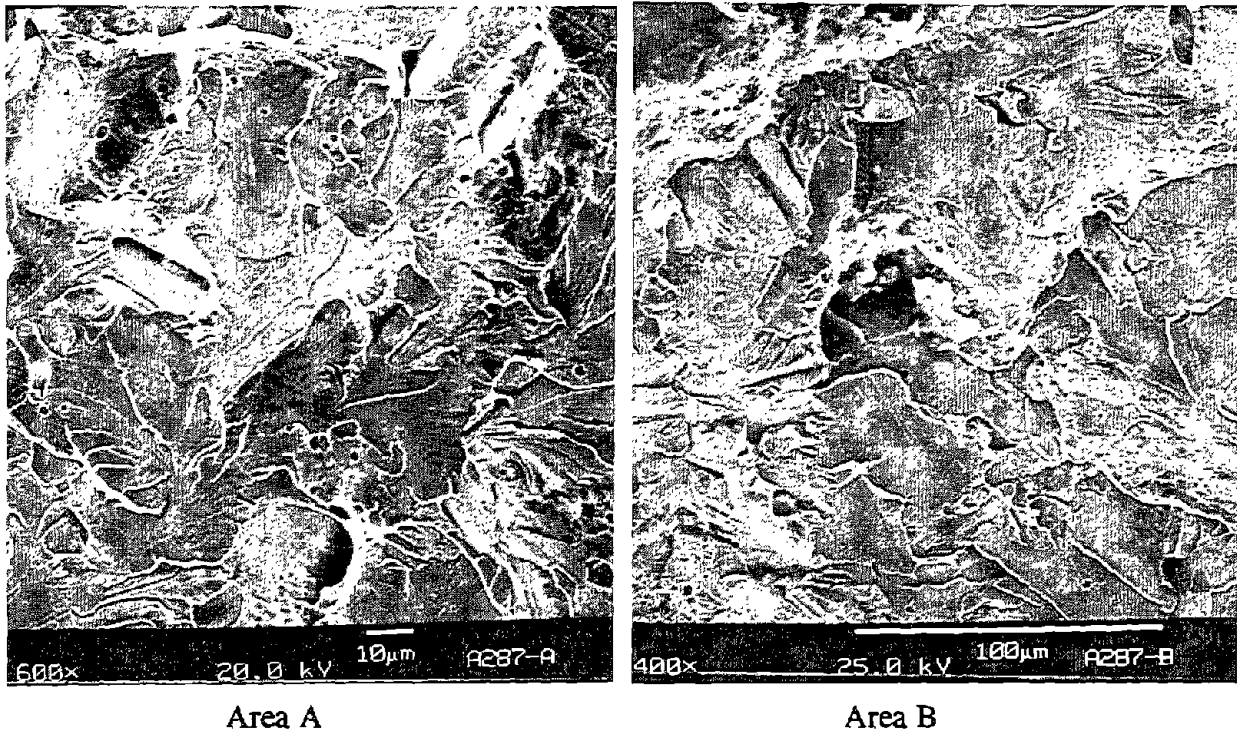
Figure 39 - SEM micrographs of the crack surface obtained adjacent to the weld root flaw in Sample A287. (Boxed areas "A" and "B" in Figure 38)

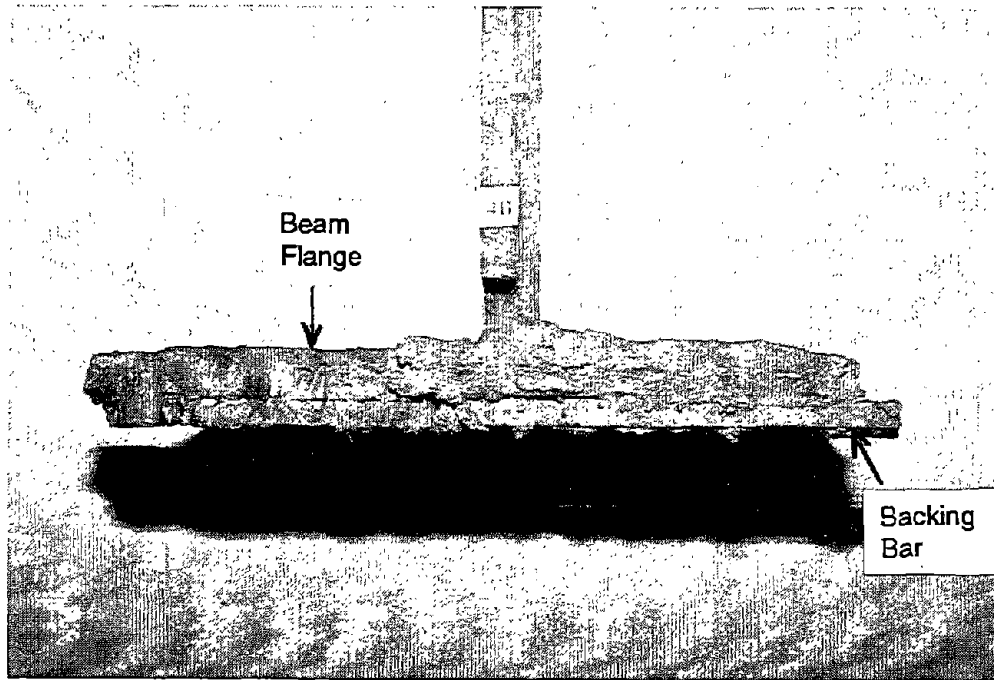
Figure 40 - Fracture surface from Sample B4 showing arc gouging damage. Fracture path is near the weld fusion line.

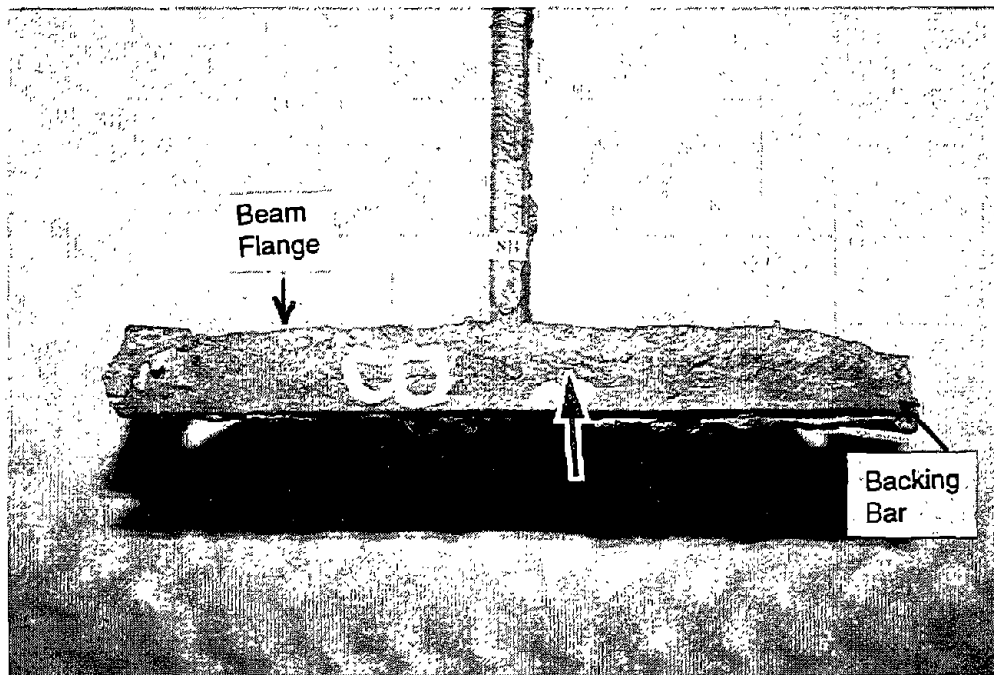
Figure 41 - Fracture surface from Sample B8. Fracture path is near the weld fusion line. Arrow shows location of fracture origin.

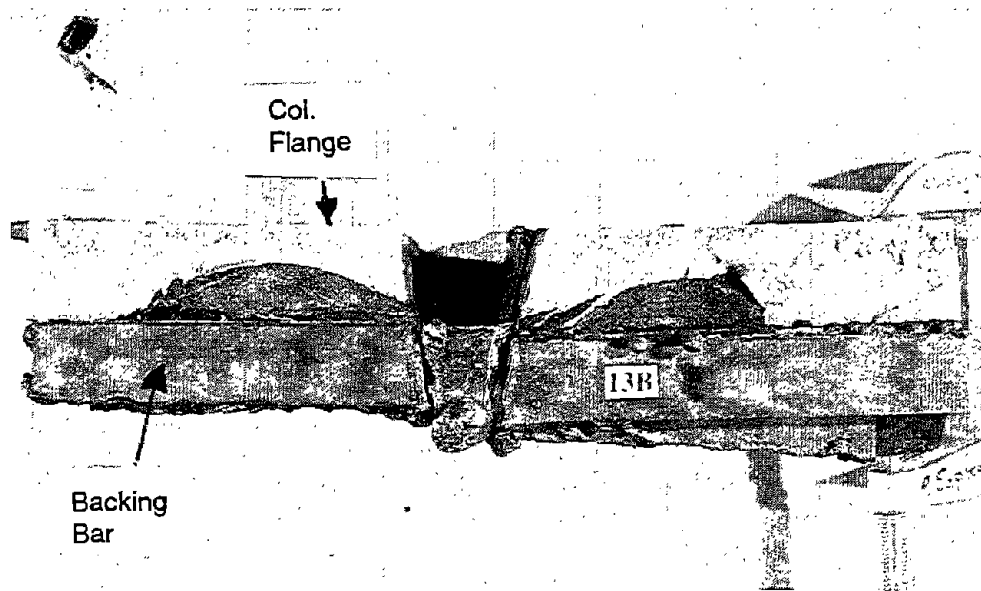
Figure 42 - Fracture surface from Sample B13 showing a portion of the divot fracture exposed. The fracture origin is located within the missing area of the surface at the web centerline.

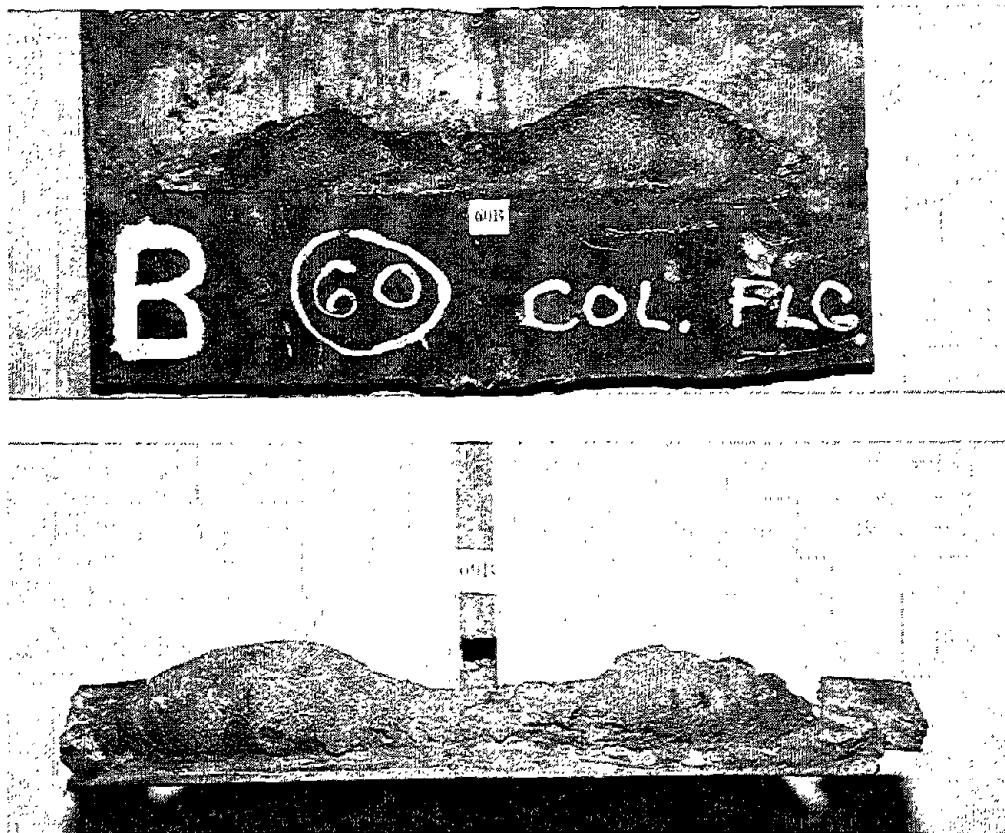
Figure 43 - Column divot fracture surface from Sample B60. Arrow shows the location of the fracture origin.

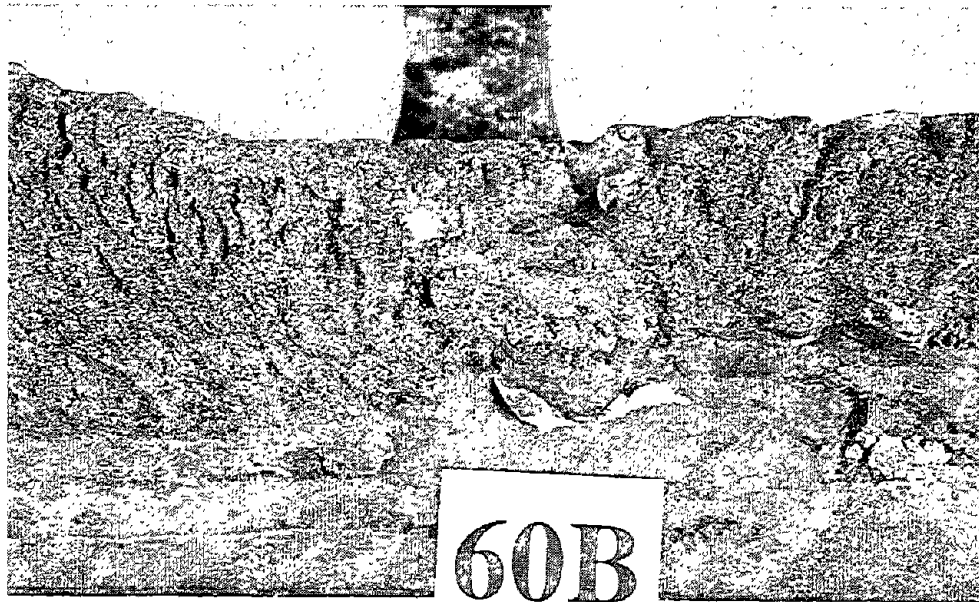
Figure 44 - Enlarged view of the fracture origin of Sample B60 showing a deep weld root incomplete fusion flaw.

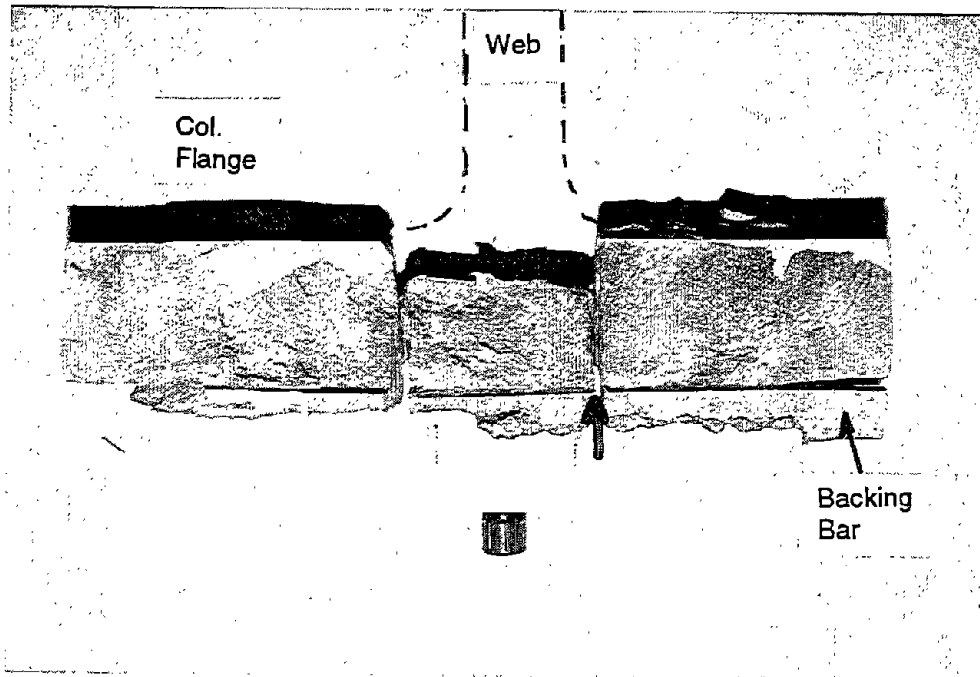
Figure 45 - Fracture surface of Sample C1. Arrow shows the location of the fracture origin eliminated during removal of the sample.

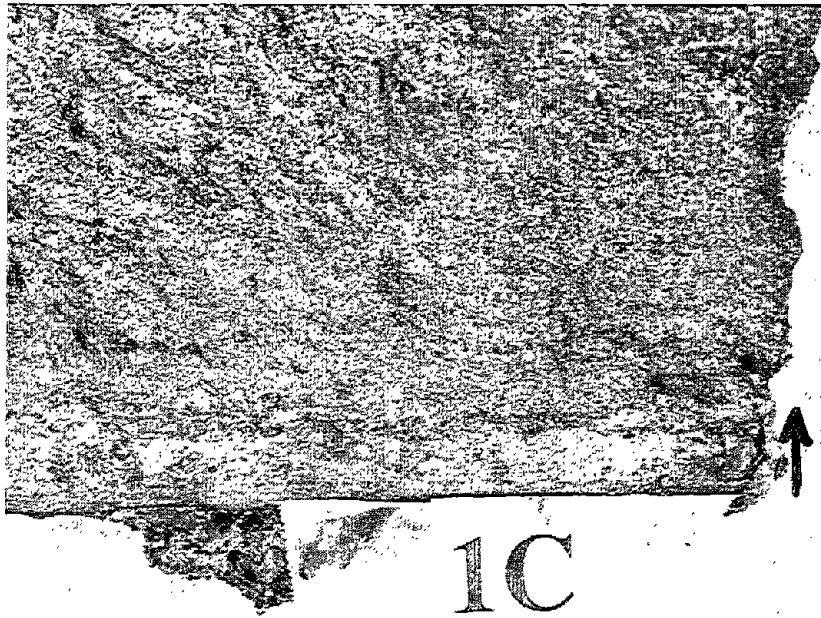
Figure 46 - Enlarged view of the crack surface from Sample C1 next to the fracture origin.

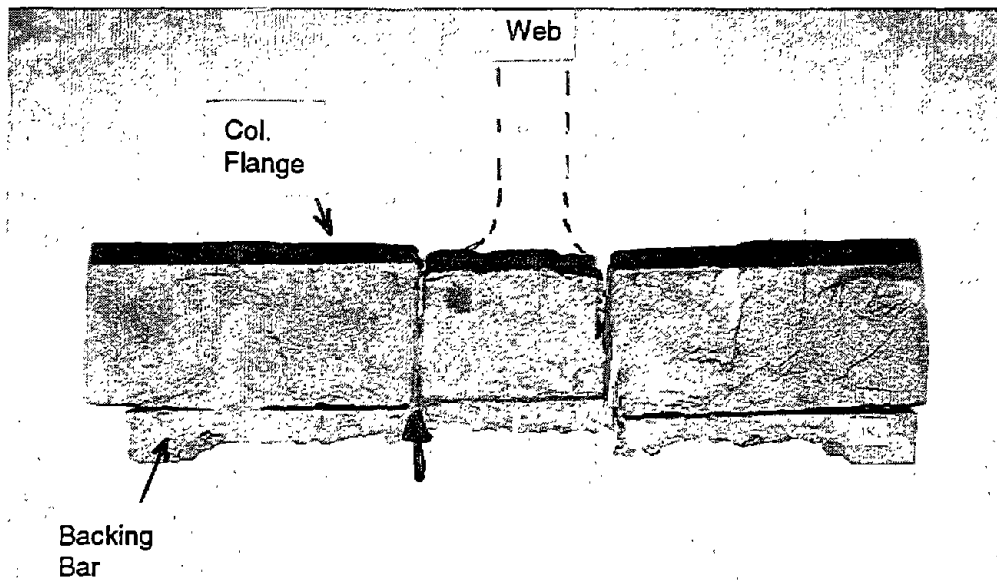
Figure 47 - Fracture surface from Sample C18. Arrow shows location of the fracture origin eliminated during sample removal.

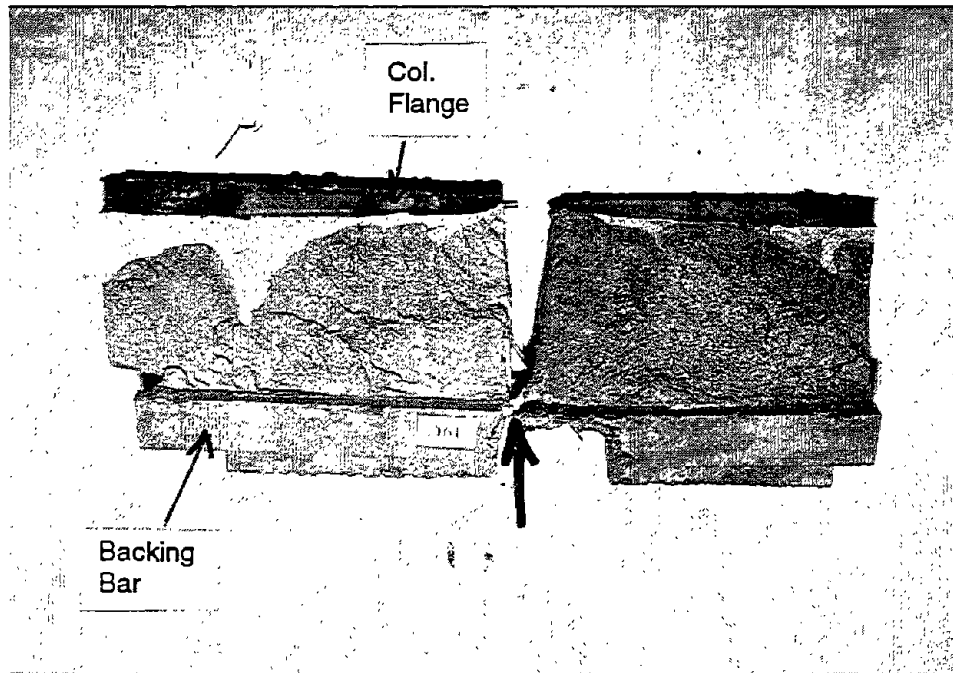
Figure 48 - Fracture surface from Sample C19. The fracture origin is located within the missing area of the fracture at the web centerline.

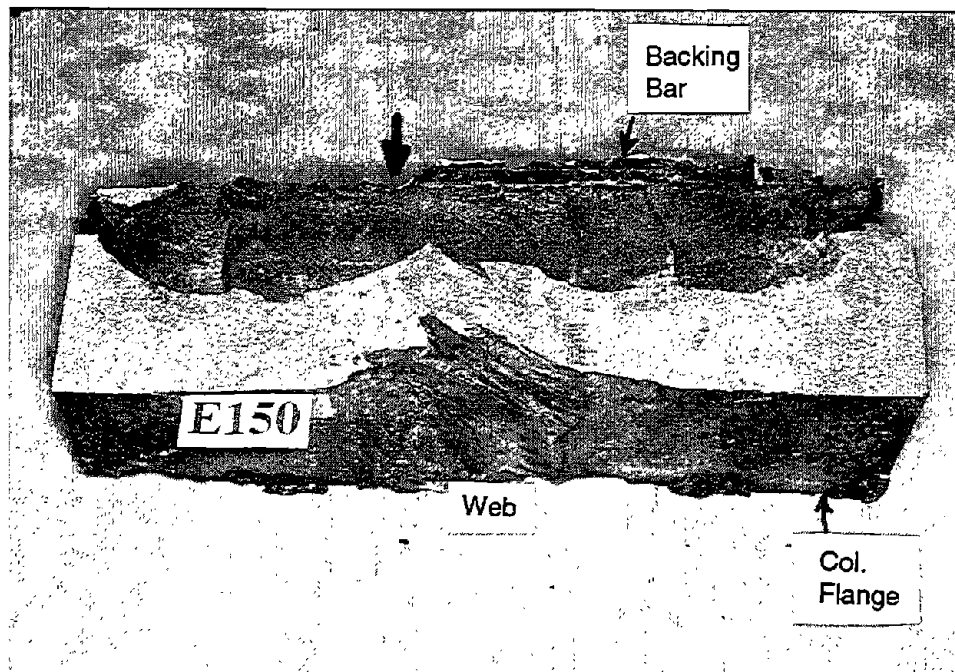
Figure 49 - Fracture surface from Sample E150 showing a portion of the divot fracture exposed. The fracture origin is located along the weld root at a location damaged by arc gouging (see arrow).

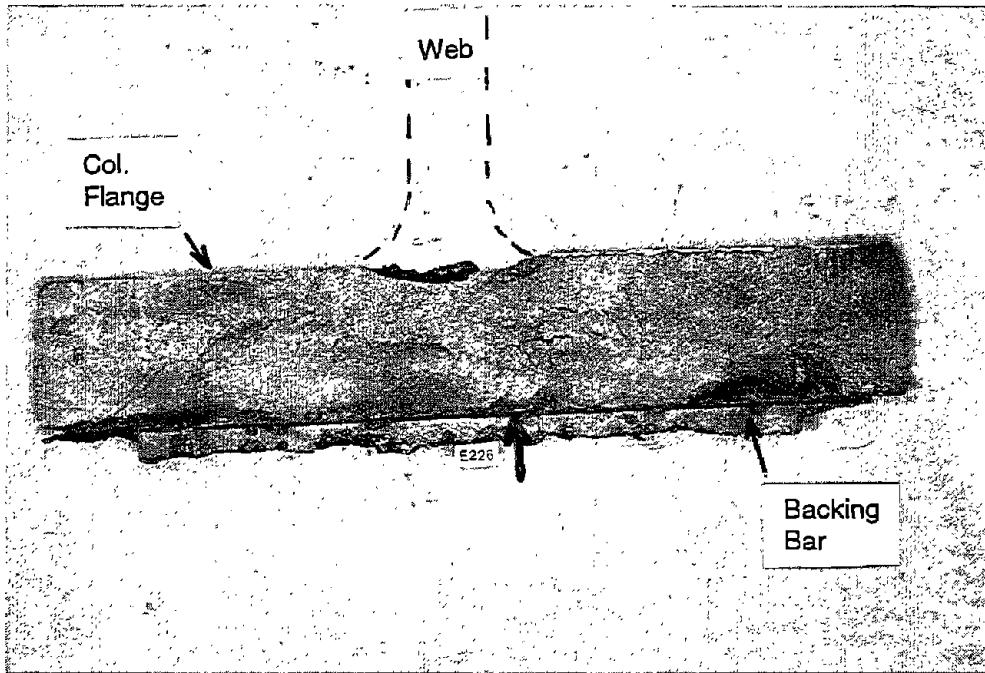
Figure 50 - Fracture surface from Sample E226. Arrow shows the location of the fracture origin.

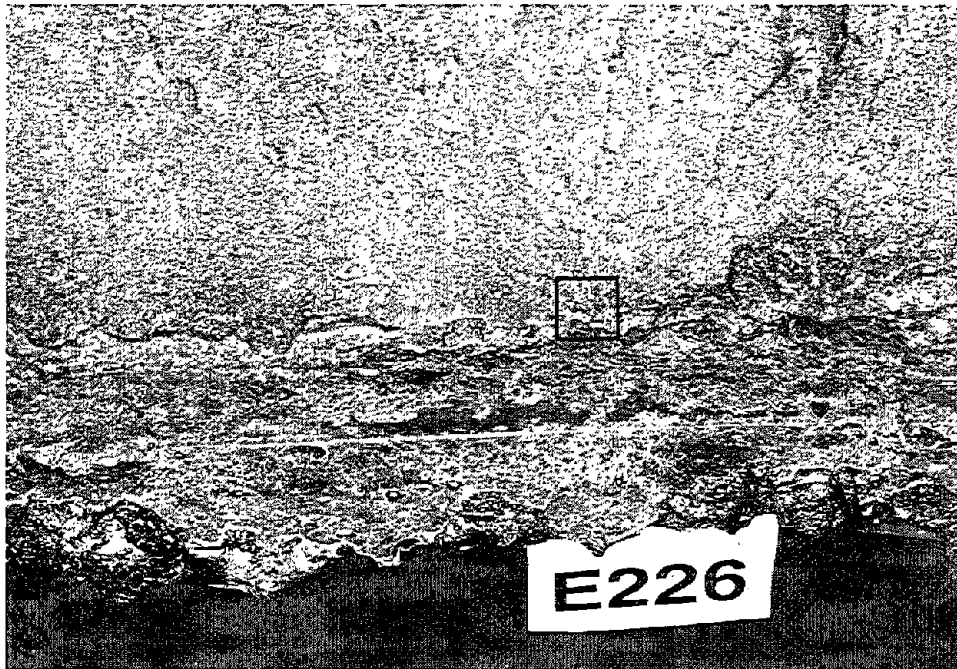
Figure 51 - Enlarged view of the fracture origin area of Sample E226. The fracture initiates from an incomplete fusion flaw at the weld root.

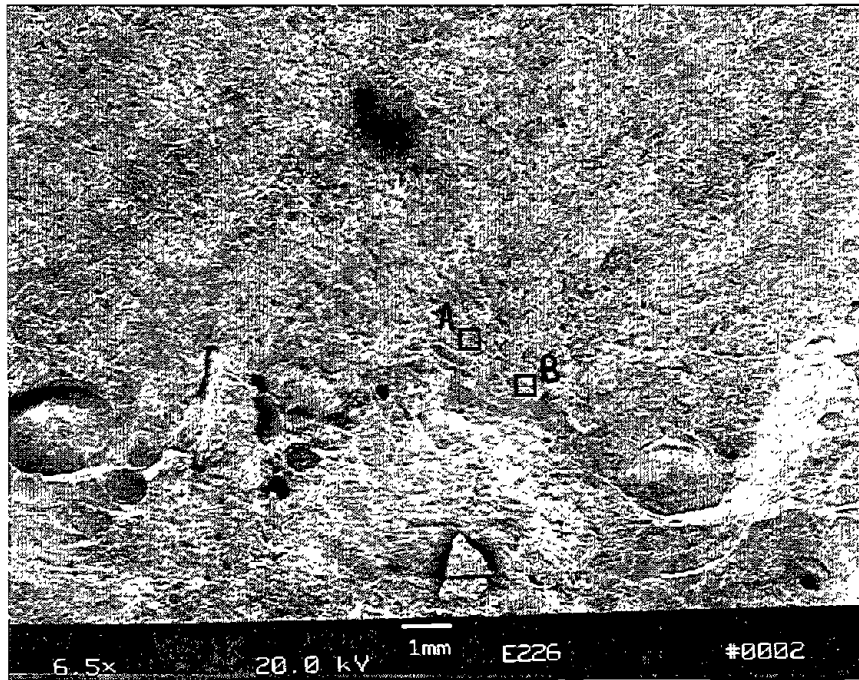
Figure 52 - Low magnification SEM micrograph of the fracture origin of Sample E226. (Boxed area in Figure 51) (Mag. 6.5X)

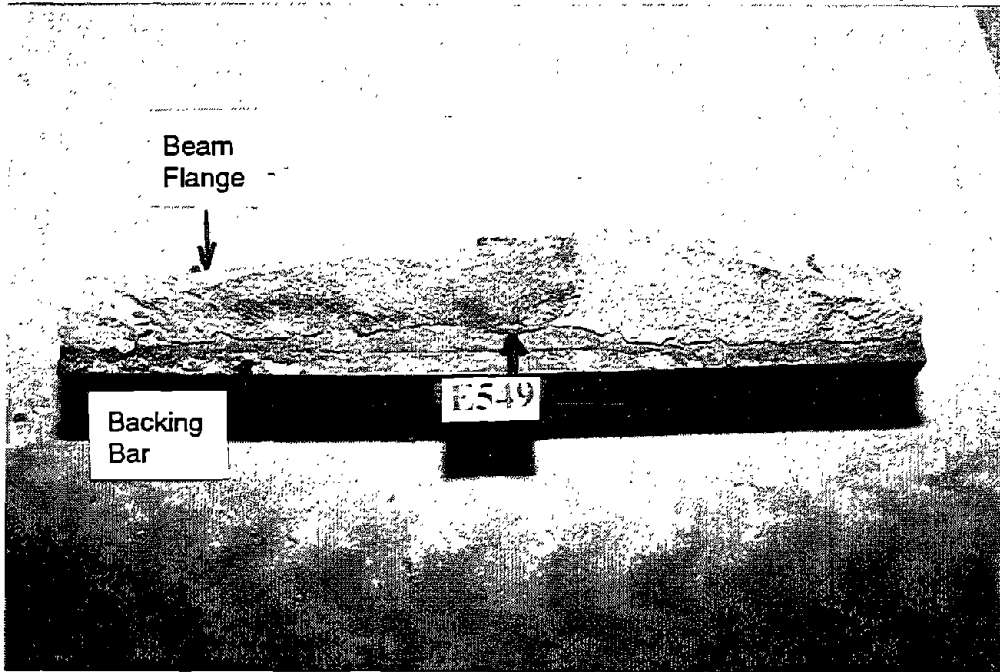
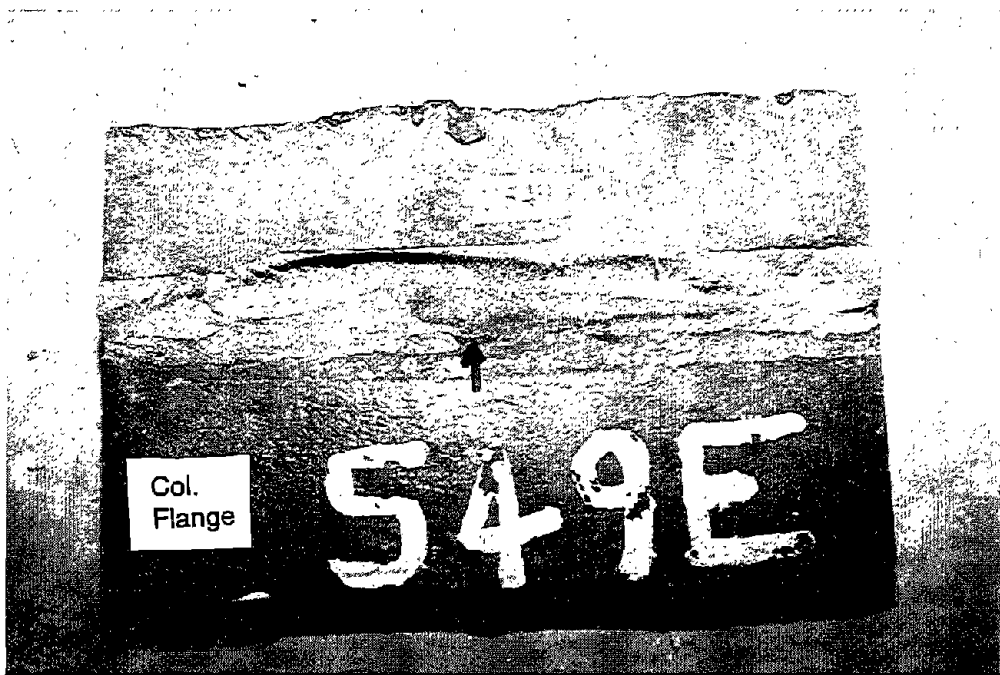
Figure 54 - Divot fracture surfaces from Sample E549. Arrow shows the location of the fracture origin. Note the deep incomplete fusion defect along the weld root.

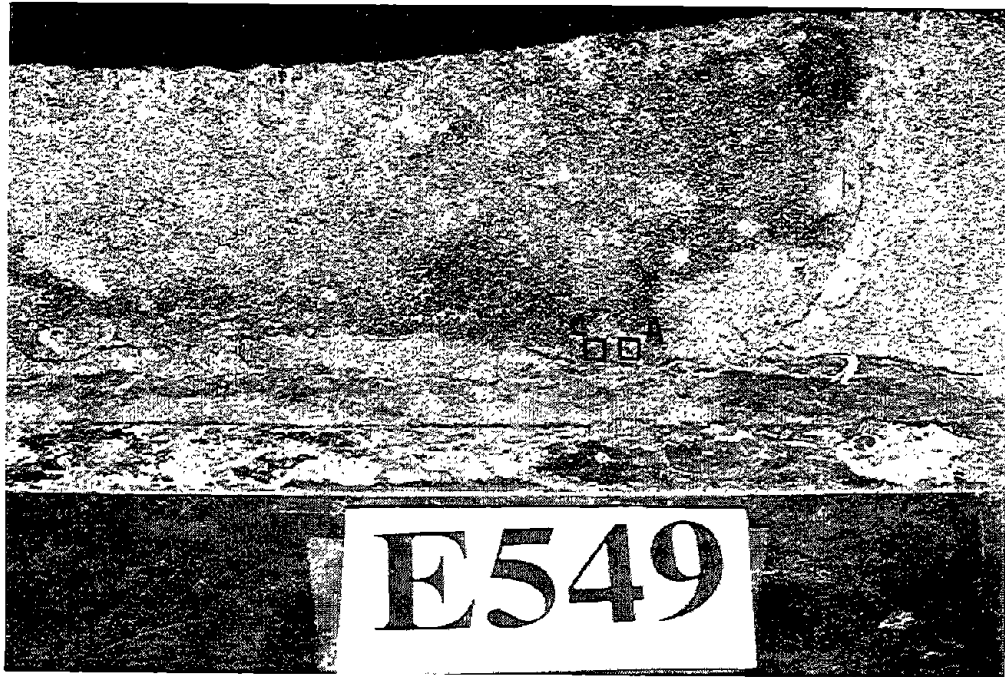
Figure 55 - Enlarged view of the fracture origin area from Sample E549.

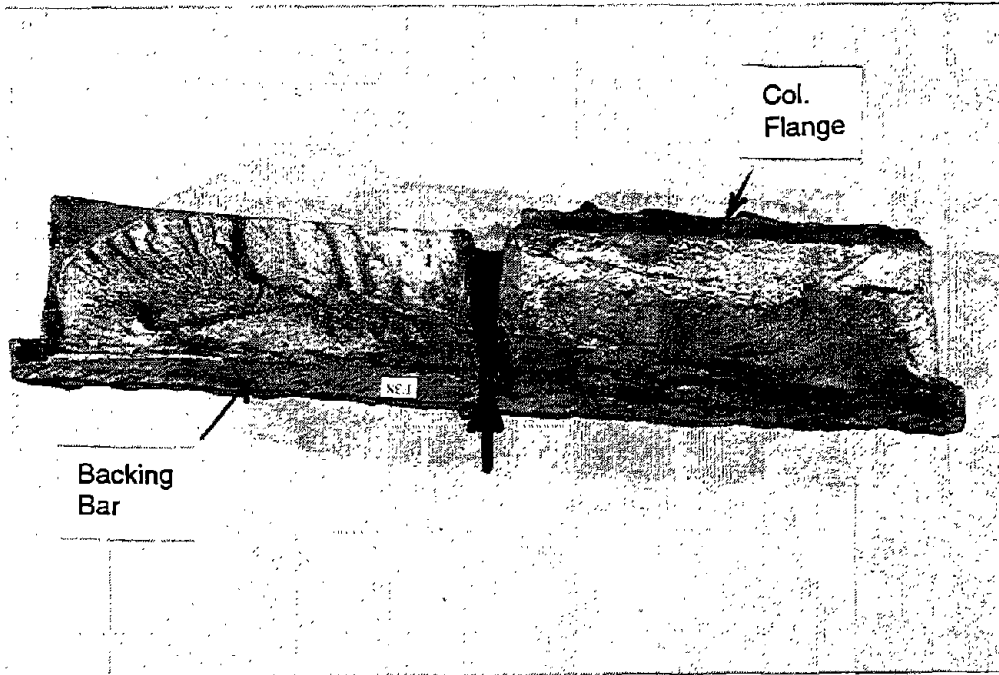
Figure 57 - Fracture surface from Sample F38. Arrow shows the location of the fracture origin eliminated during sample removal.

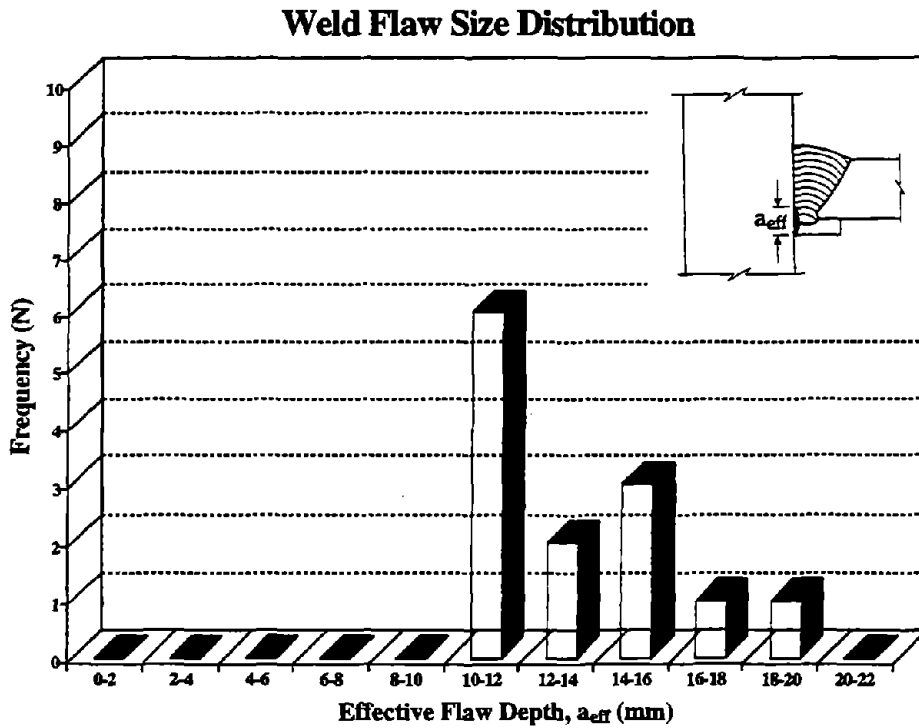
Figure 58 - Distribution of fracture initiating weld flaw sizes.

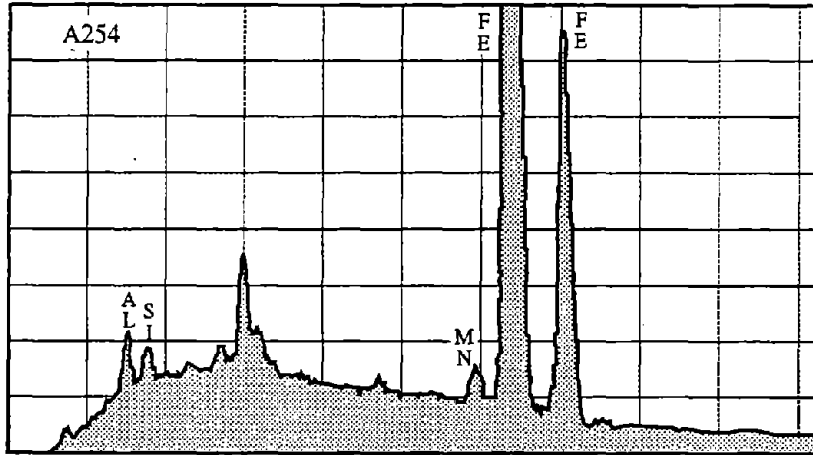
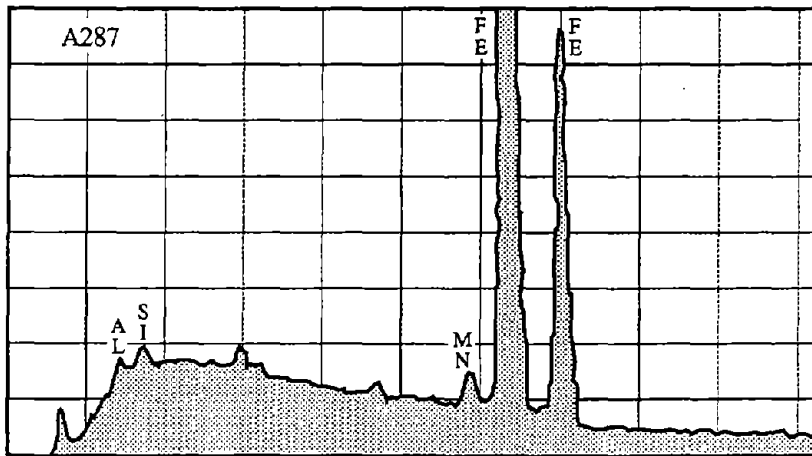
Figure 60 - EDS spectra obtained from the fracture surface of Samples A254 and A287 at the fracture origin.

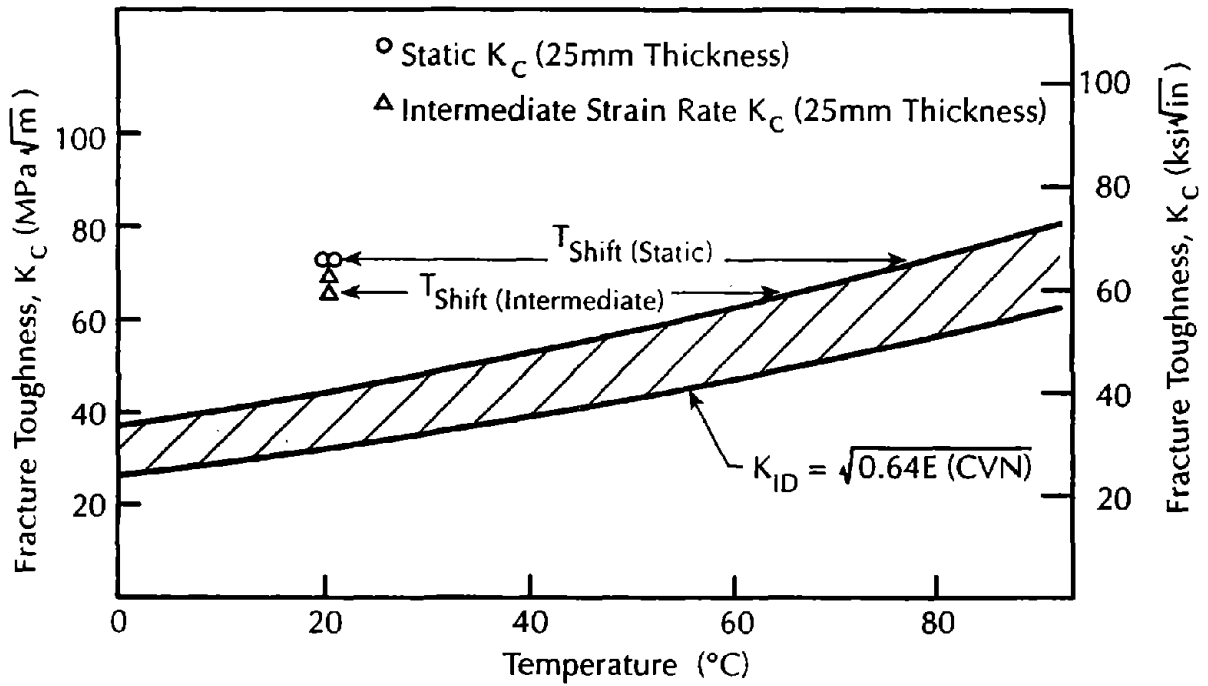
Figure 61 - Fracture toughness of E70T-4 weld metal.

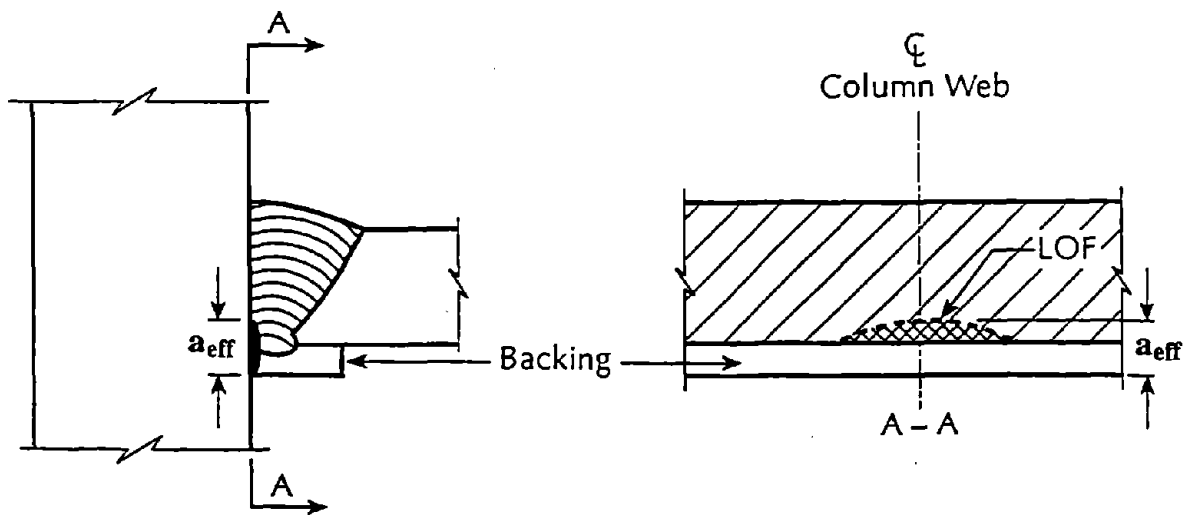
Figure 62 - Edge crack model used for fracture analysis.

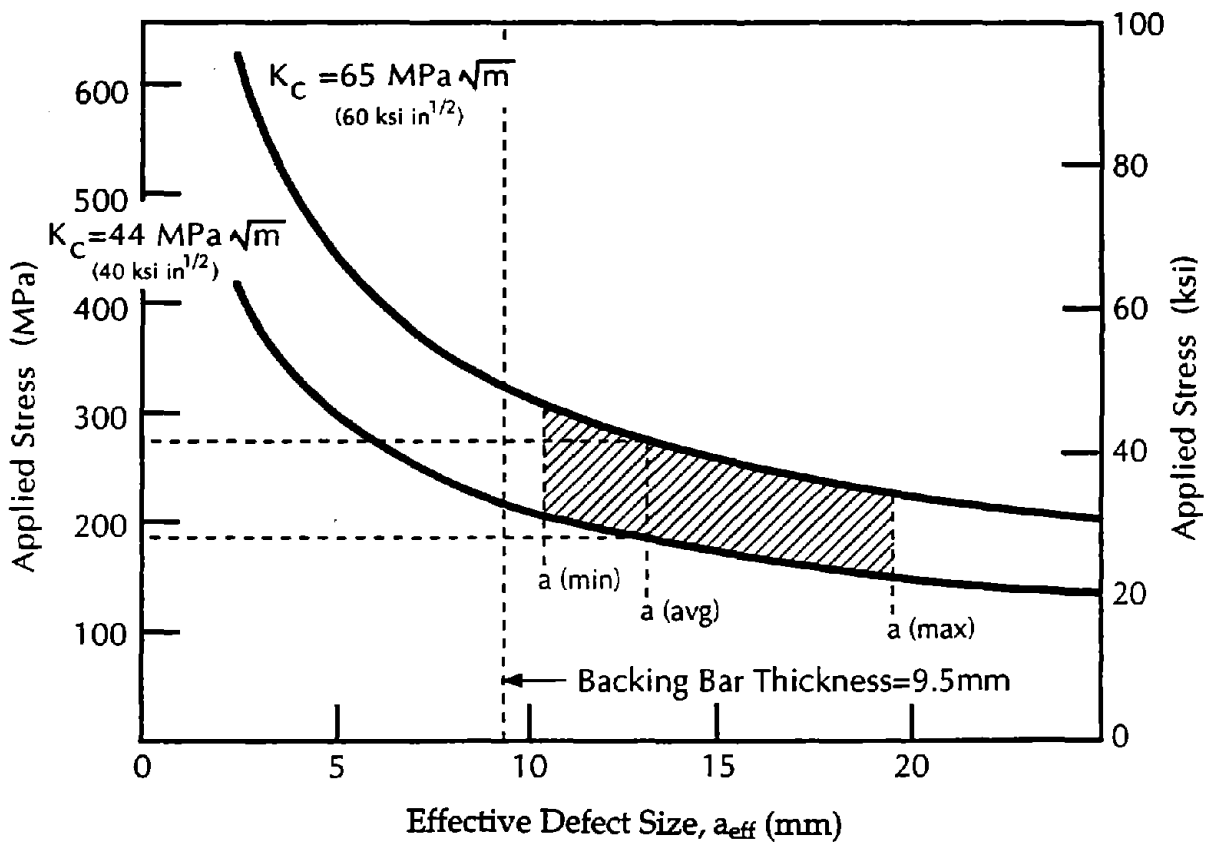
Figure 63 - Critical applied stress vs. defect size for weld root defects in WSMF connections.

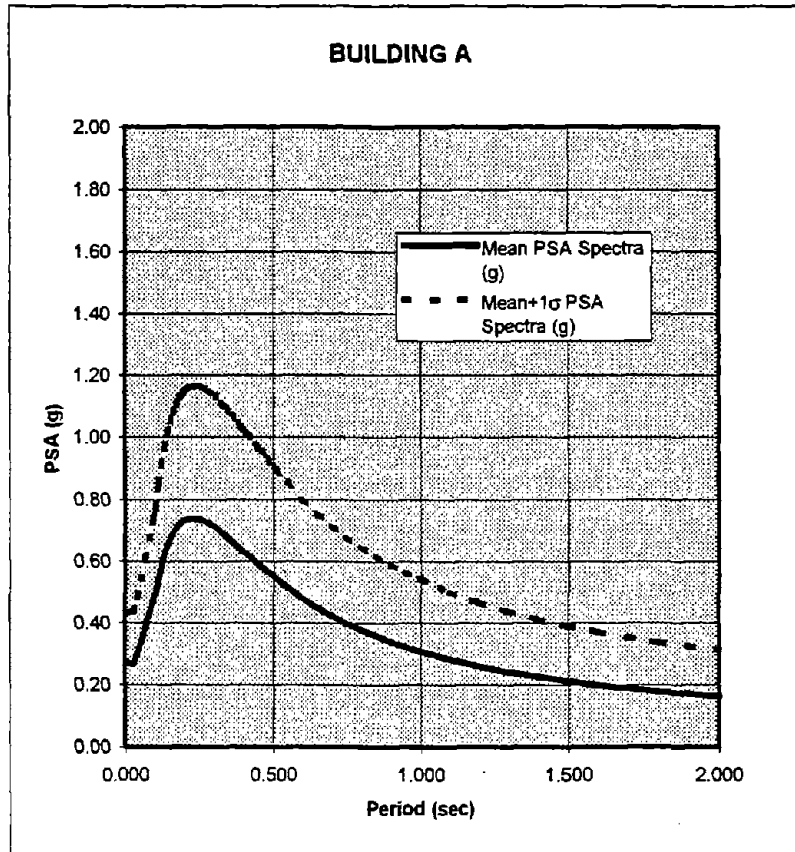
Figure 64 - Estimated ground motion spectra for Building A.

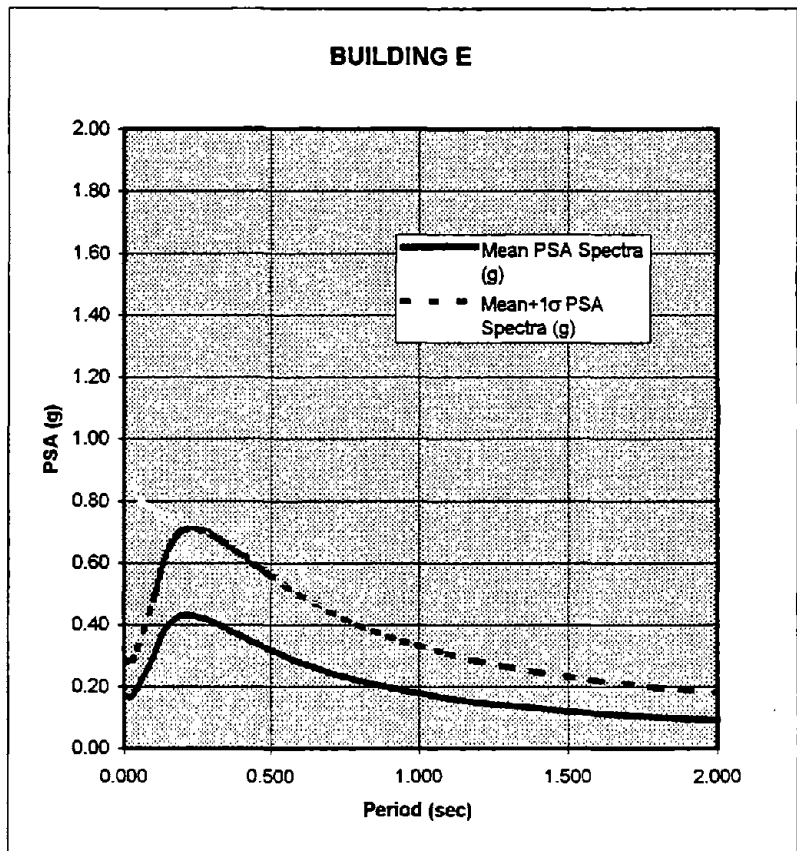
Figure 67 - Estimated ground motion spectra for Building E

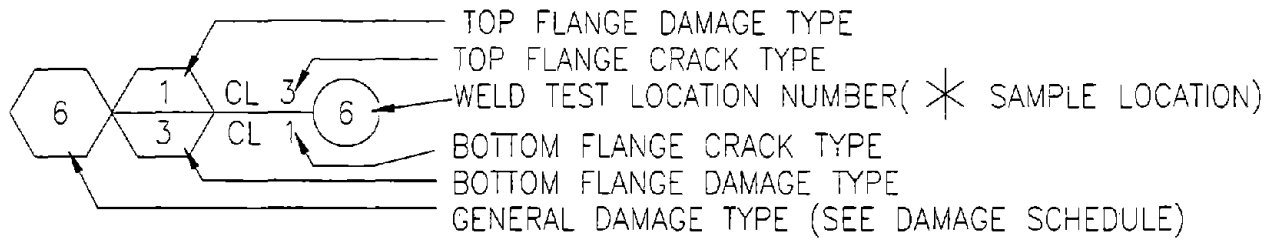
DAMAGE SCHEDULE (BLDG. A)			
DAMAGE TYPE	DESCRIPTION	-	-
①	PARTIAL CRACK IN WELD AT ROOT	-	-
②	PARTIAL CRACK IN WELD ABOVE ROOT		
③	THROUGH CRACK IN WELD		
④	SHEAR TAB WELD CRACK		
⑤	SHEAR TAB OR BEAM WEB CRACK		
⑥	BENT SHEAR TAB OR BEAM WEB		
⑦	LOOSE OR MISSING BOLTS		
⑧	PARTIAL OR THROUGH CRACK IN COLUMN FLANGE WITHIN 45° ANGLE ZONE		
⑨	PARTIAL OR THROUGH CRACK IN COLUMN FLANGE OUTSIDE 45° ANGLE ZONE		
⑩	COLUMN WEB CRACK		
⑪	LOOSE OR DAMAGED COL. OR BEAM FIREPROOFING		
⑫	BEAM SEAT WELD CRACK		
⑬	COLUMN FLANGE LAMINAR TEARING POTENTIAL

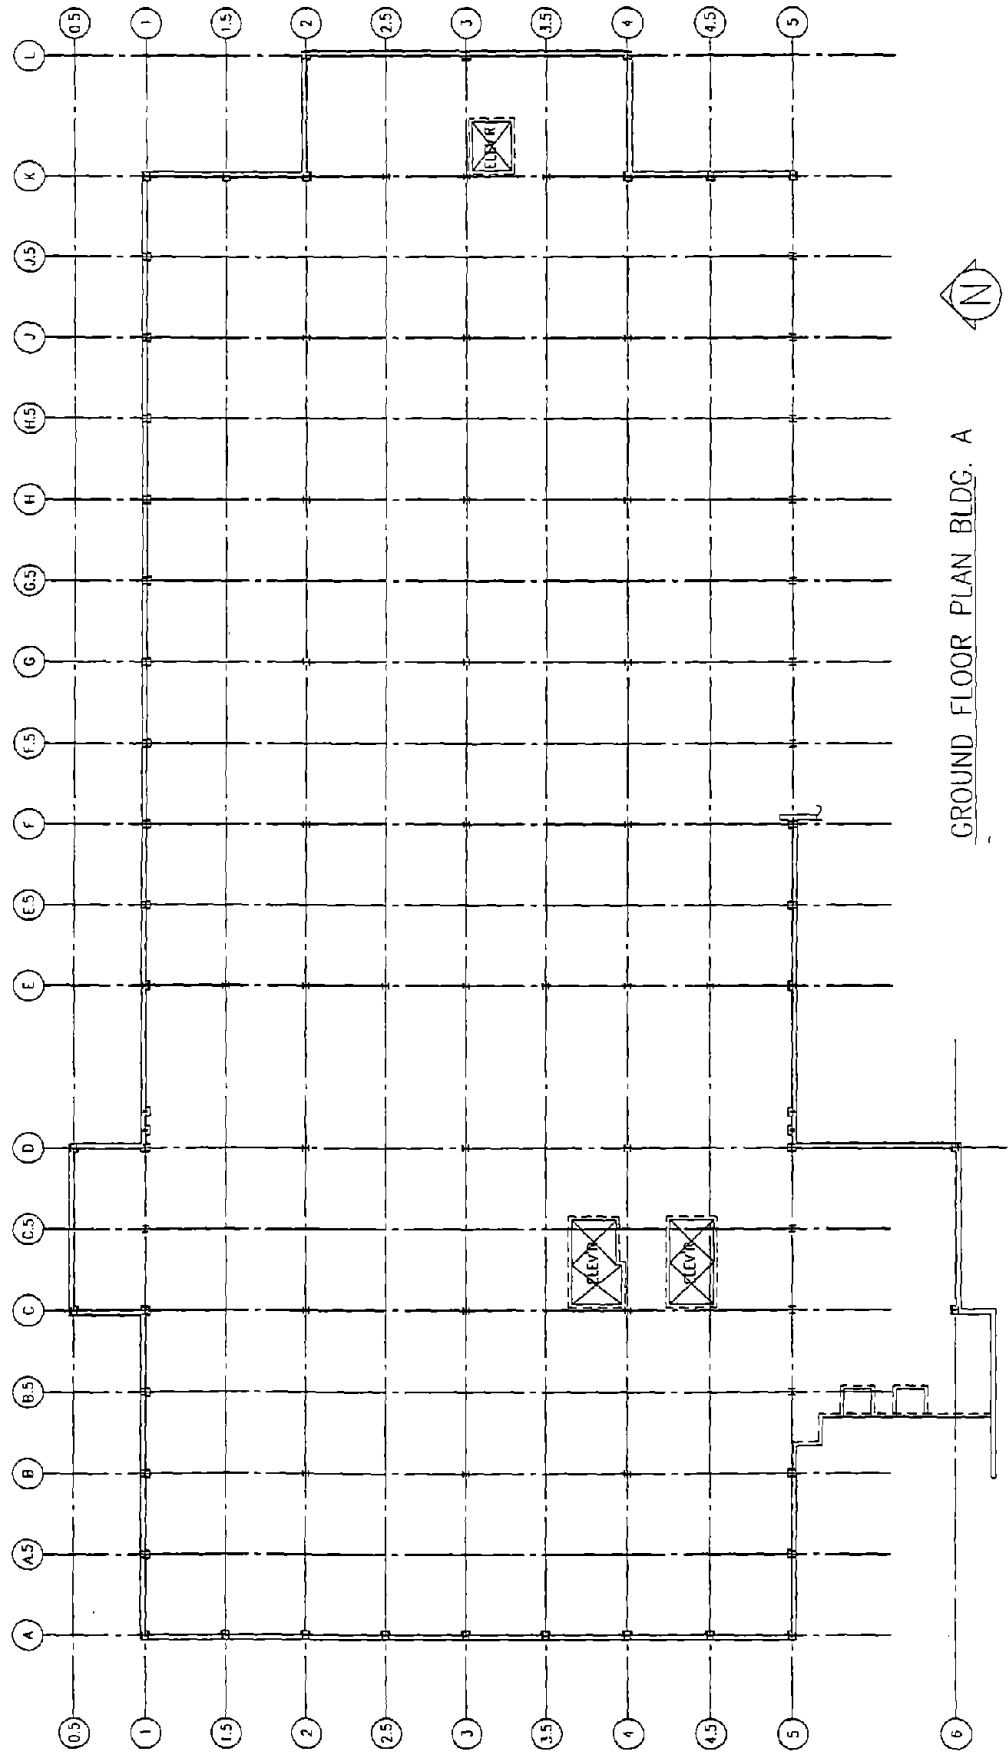
'CL X' INDICATES FLANGE OR PORTION OF FLANGE INACCESSIBLE DURING INITIAL TESTING.
