**NISTIR 5944**

Failure Analysis of Welded Steel Moment Frames Damaged in the Northridge Earthquake

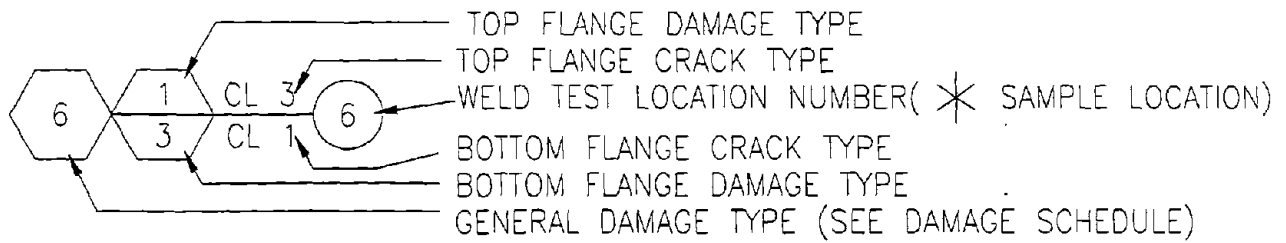
DAMAGE SCHEDULE (BLDG. B)				
DAMAGE TYPE	DESCRIPTION		-	-
①	PARTIAL CRACK IN WELD	TOP FLANGE	-	-
		BOTTOM FLANGE		
②	THROUGH CRACK IN WELD (NO GAP)	TOP FLANGE		
		BOTTOM FLANGE		
③	THROUGH CRACK IN WELD (WITH GAP)	TOP FLANGE		
		BOTTOM FLANGE		
④	SHEAR TAB WELD CRACK			
⑤	SHEAR TAB OR BEAM WEB CRACK			
⑥	BENT SHEAR TAB OR BEAM WEB			
⑦	LOOSE OR MISSING BOLTS			
⑧	PARTIAL OR THROUGH CRACK IN COLUMN FLANGE WITHIN 45° ANGLE ZONE			
⑨	PARTIAL OR THROUGH CRACK IN COLUMN FLANGE OUTSIDE 45° ANGLE ZONE			
⑩	COLUMN WEB CRACK			
⑪	LOOSE OR DAMAGED COL. OR BEAM FIREPROOFING

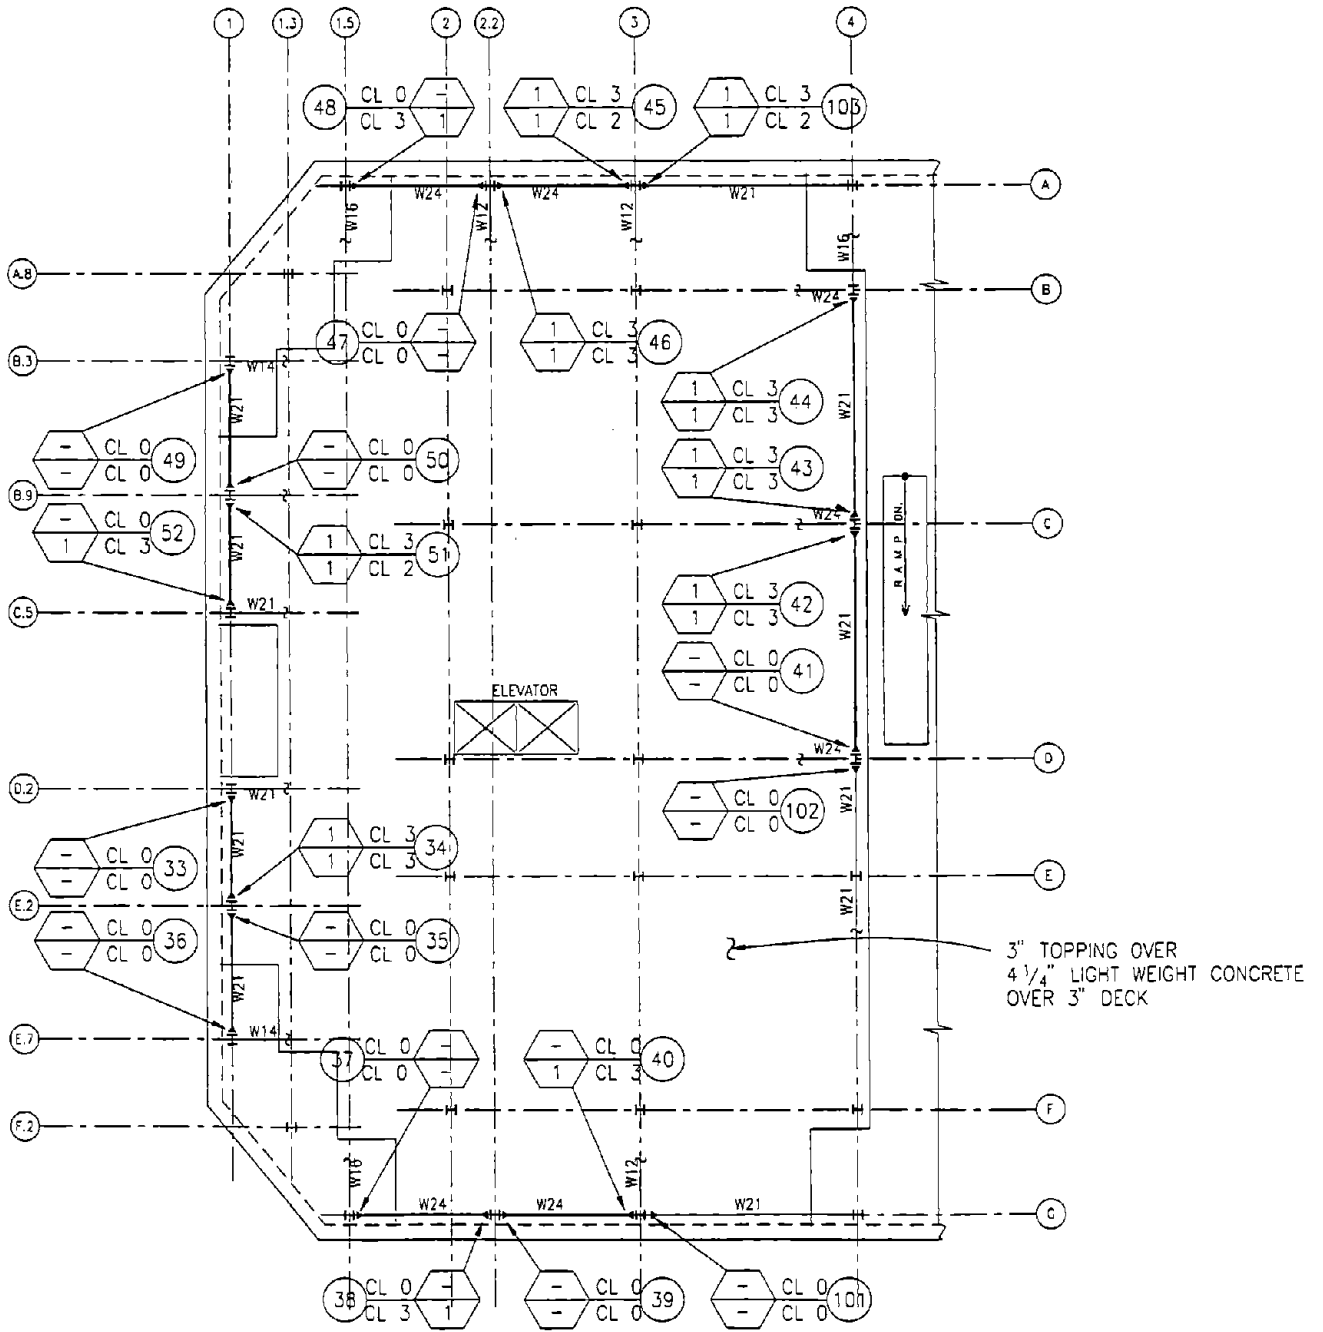
1ST FLOOR FRAMING PLAN, BLDG. "B"

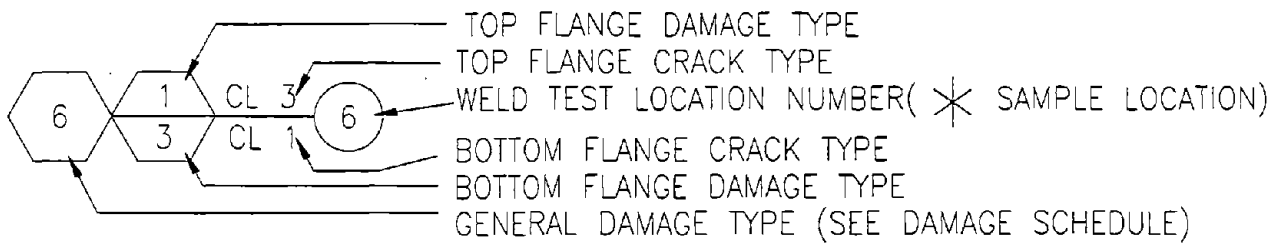
DAMAGE SCHEDULE (BLDG. C)			
DAMAGE TYPE	DESCRIPTION	-	-
①	PARTIAL CRACK IN WELD AT ROOT	-	-
②	PARTIAL CRACK IN WELD ABOVE ROOT		
③	THROUGH CRACK IN WELD		
④	SHEAR TAB WELD CRACK		
⑤	SHEAR TAB OR BEAM WEB CRACK		
⑥	BENT SHEAR TAB OR BEAM WEB		
⑦	LOOSE OR MISSING BOLTS		
⑧	PARTIAL OR THROUGH CRACK IN COLUMN FLANGE WITHIN 45° ANGLE ZONE		
⑨	PARTIAL OR THROUGH CRACK IN COLUMN FLANGE OUTSIDE 45° ANGLE ZONE		
⑩	COLUMN WEB CRACK		
⑪	LOOSE OR DAMAGED COL. OR BEAM FIREPROOFING		
⑫	DAMAGED CONCRETE AT BASE PLATE

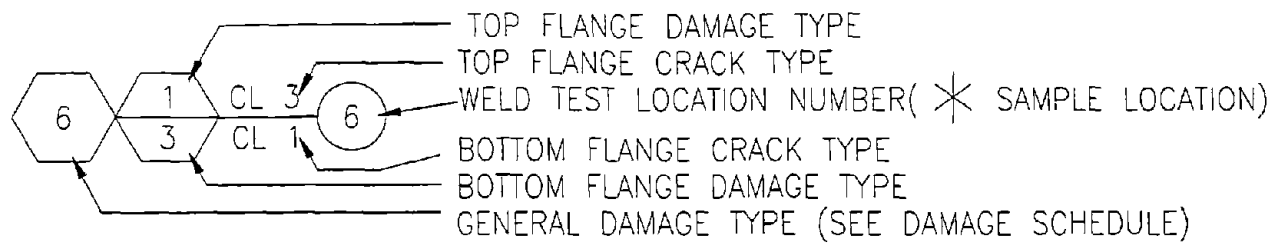
DAMAGE SCHEDULE (BLDG. E)			
DAMAGE TYPE	DESCRIPTION	-	-
1	PARTIAL CRACK IN WELD AT ROOT	-	-
2	PARTIAL CRACK IN WELD ABOVE ROOT		
3	THROUGH CRACK IN WELD		
3A	THROUGH CRACK IN WELD WITH GAP		
4	SHEAR TAB WELD CRACK		
5	SHEAR TAB OR BEAM WEB CRACK		
6	BENT SHEAR TAB OR BEAM WEB		
7	LOOSE OR MISSING BOLTS		
8	PARTIAL OR THROUGH CRACK IN COLUMN FLANGE WITHIN 45° ANGLE ZONE		
9	PARTIAL OR THROUGH CRACK IN COLUMN FLANGE OUTSIDE 45° ANGLE ZONE		
10	COLUMN WEB CRACK		
11	LOOSE OR DAMAGED COL. OR BEAM FIREPROOFING		
12	BEAM FLANGE CRACK		
13	DOUBLER PLATE WELD CRACK

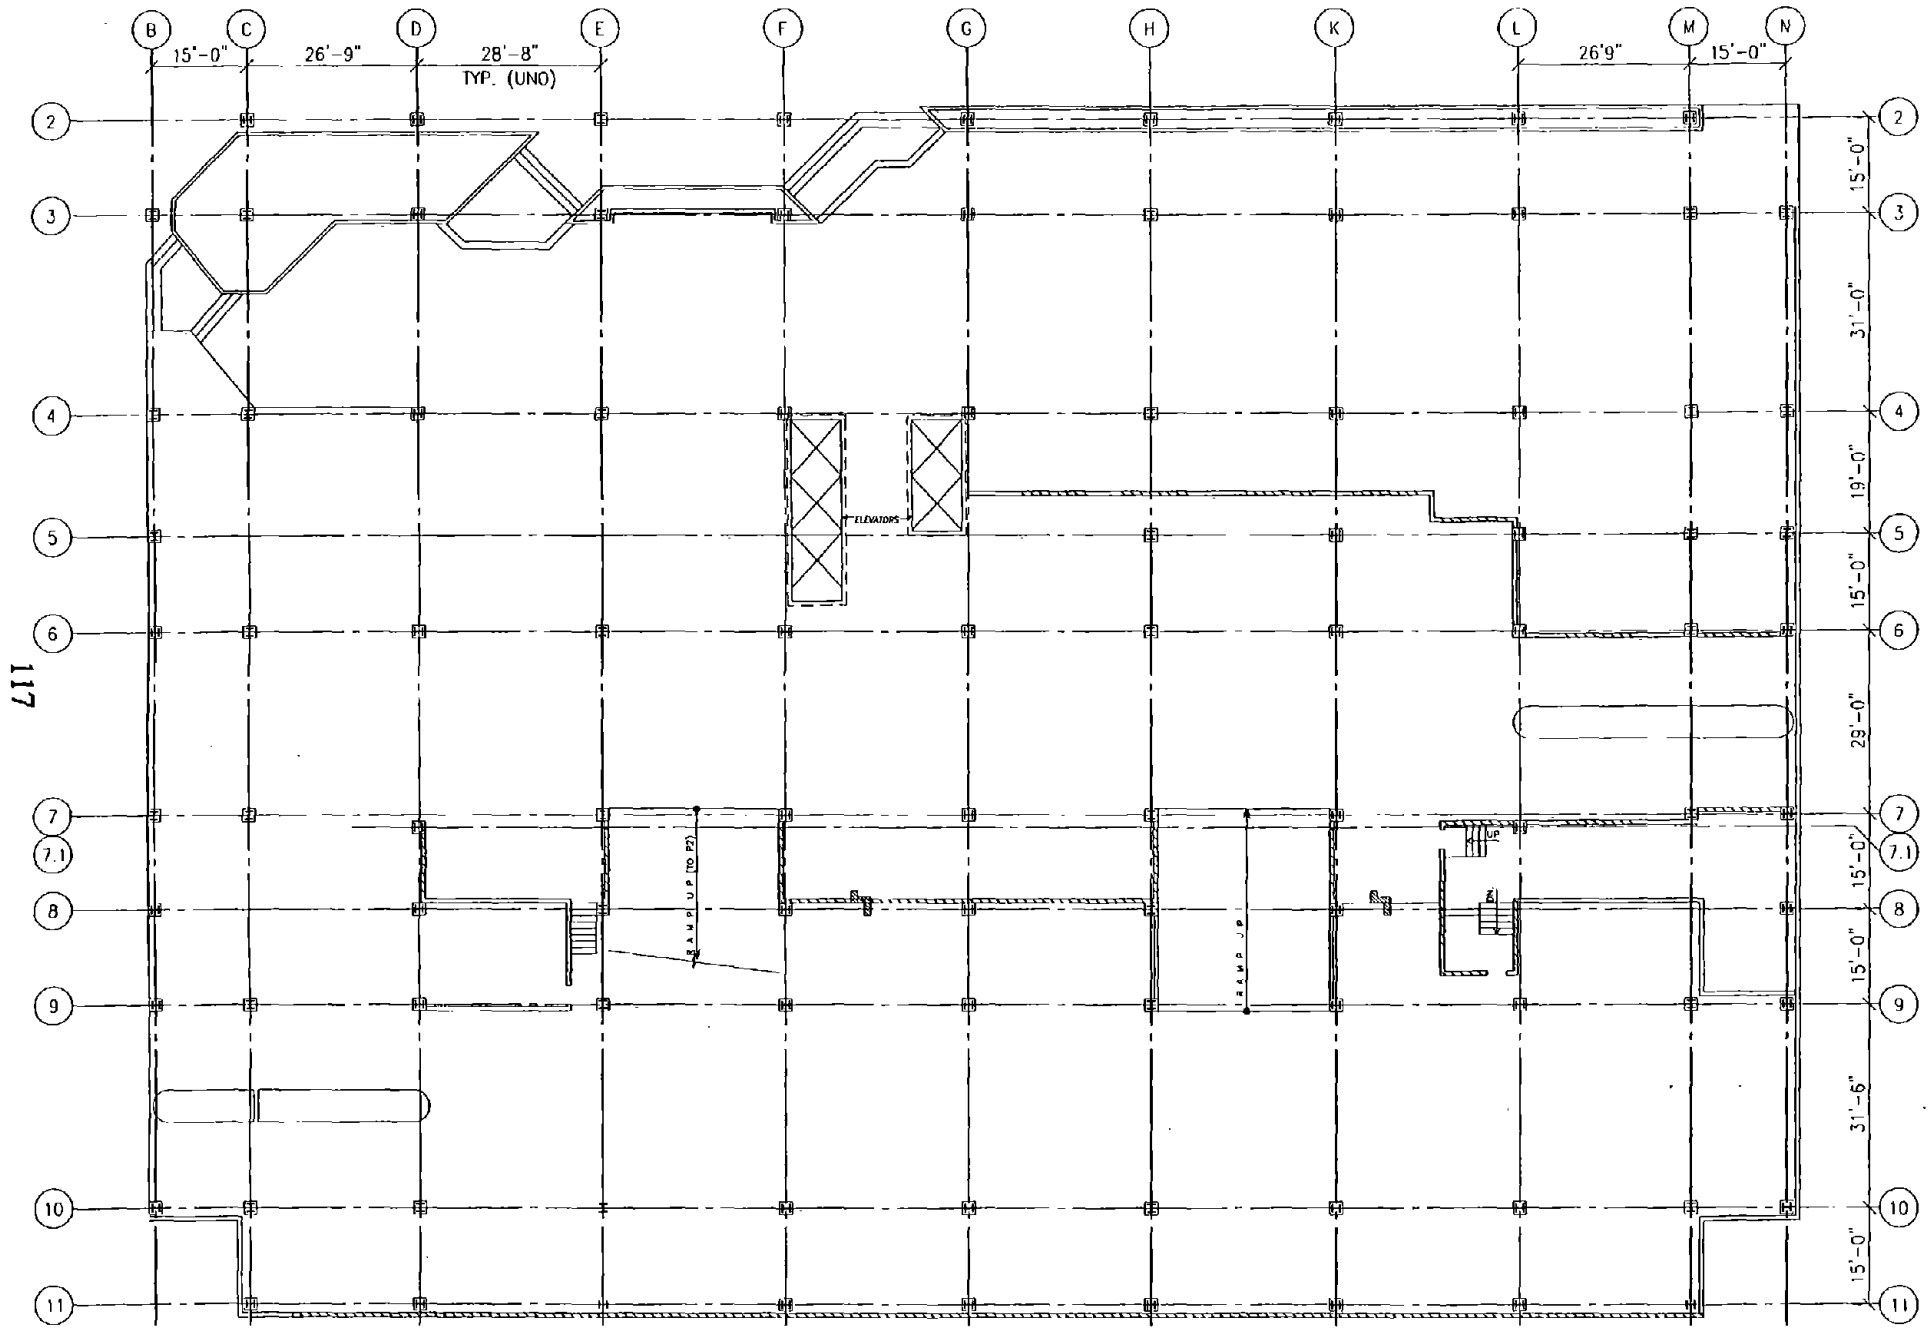
'CL X' INDICATES FLANGE OR PORTION OF FLANGE INACCESSIBLE DURING INITIAL TESTING.

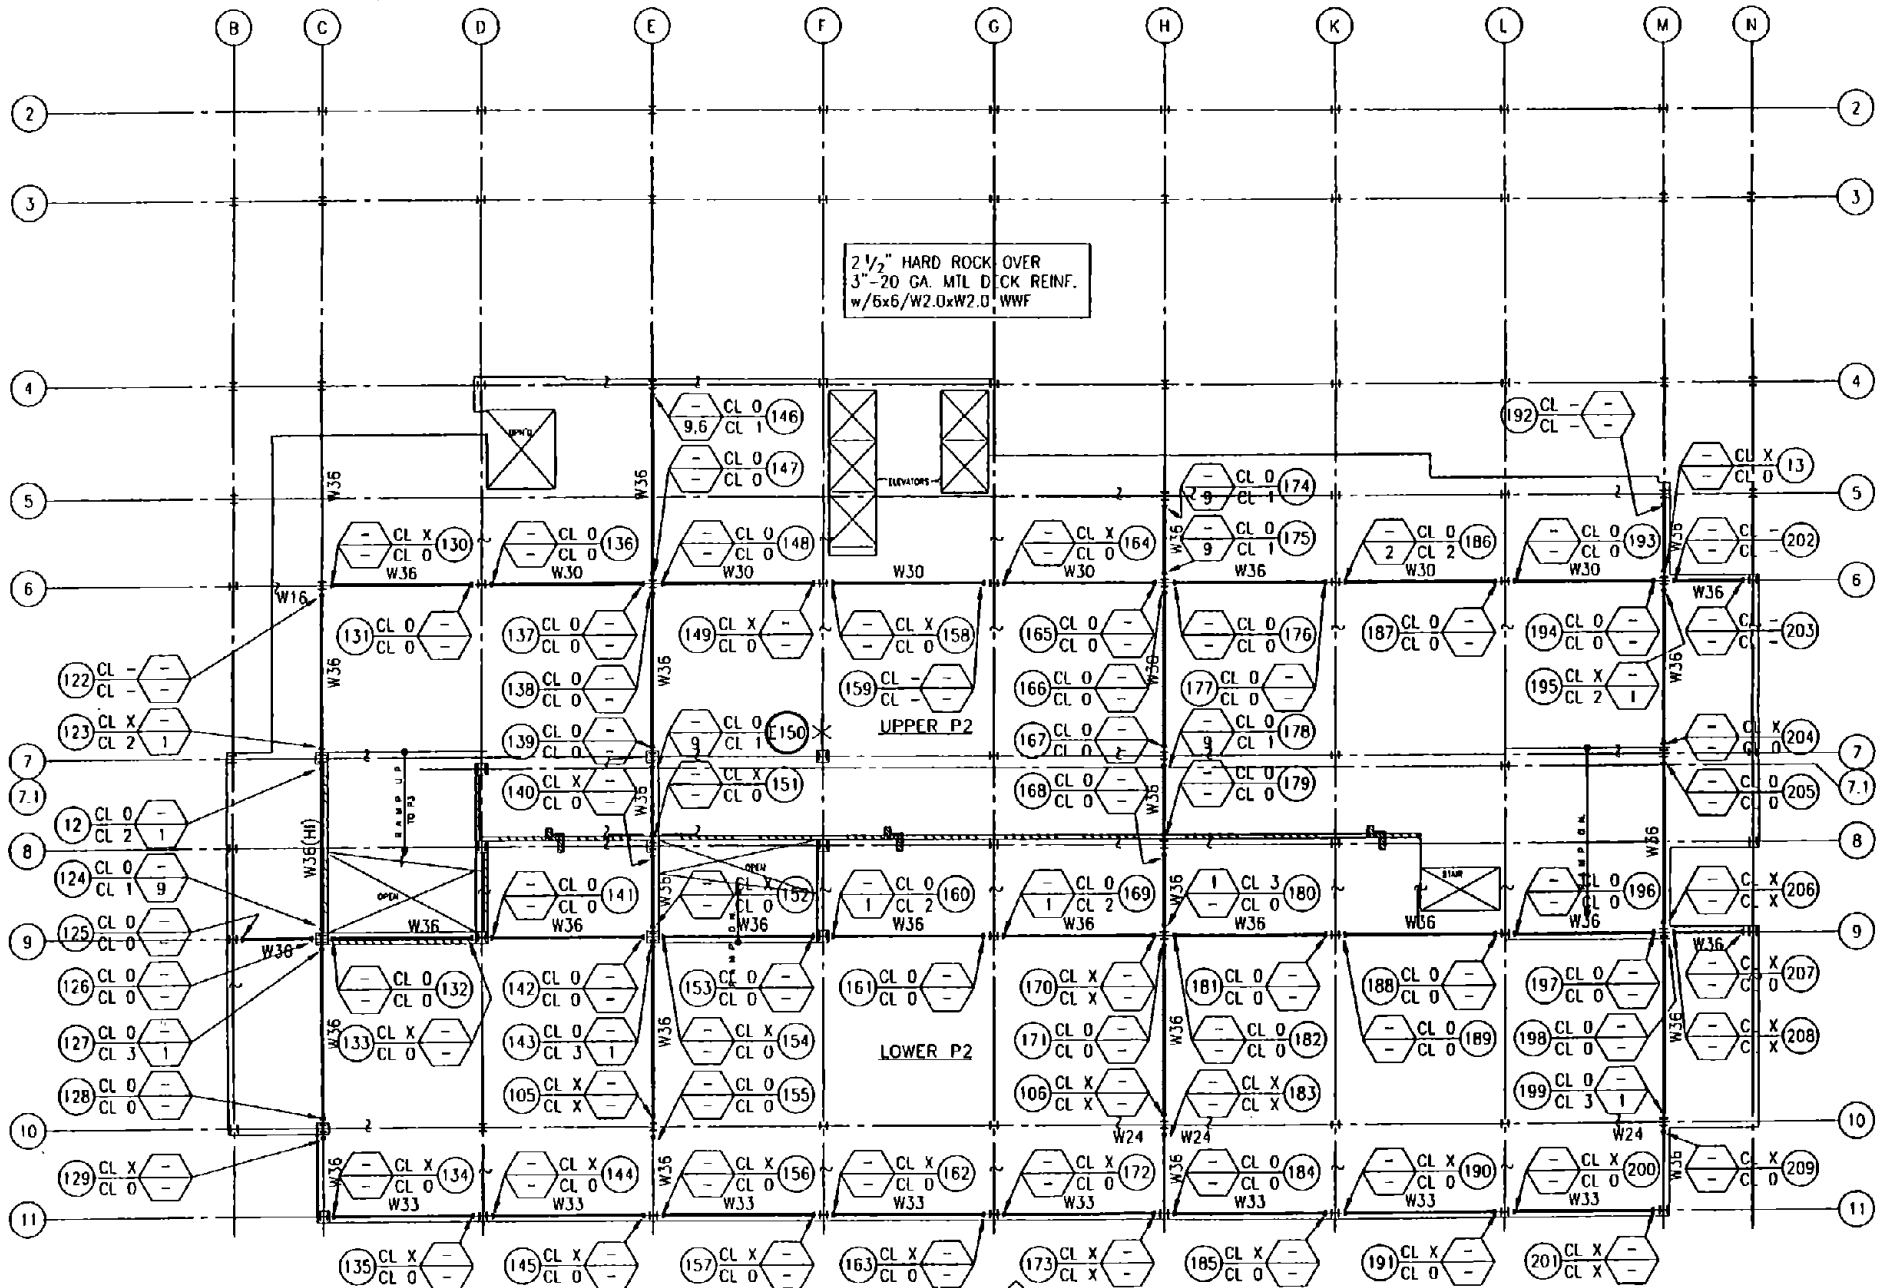
2 1/2" HARD ROCK OVER
 3"-20 GA. MTL DECK REINF.
 w/6x6/W2.0xW2.0 WWF

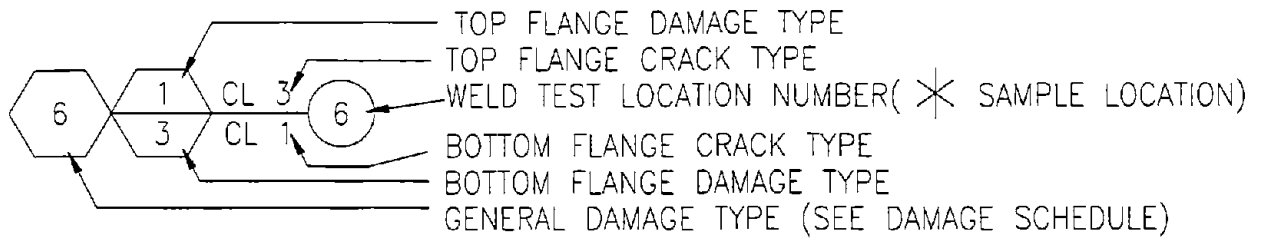
DAMAGE SCHEDULE (BLDG. F)			
DAMAGE TYPE	DESCRIPTION	-	-
①	PARTIAL CRACK IN WELD	-	-
②	THROUGH CRACK IN WELD (NO GAP)		
③	THROUGH CRACK IN WELD (WITH GAP)		
④	SHEAR TAB WELD CRACK		
⑤	SHEAR TAB OR BEAM WEB CRACK		
⑥	BENT SHEAR TAB AND/OR BEAM WEB		
⑦	LOOSE OR MISSING BOLTS		
⑧	PARTIAL OR THROUGH CRACK IN COLUMN FLANGE WITHIN 45° ANGLE ZONE		
⑨	PARTIAL OR THROUGH CRACK IN COLUMN FLANGE OUTSIDE 45° ANGLE ZONE		
⑩	COLUMN WEB CRACK		
⑪	LOOSE OR DAMAGED COL. OR BEAM FIREPROOFING		
⑫	STRESS RELIEF PROCEDURE (REPLACE WELD)		
⑬	GAP BETWEEN SHEAR TAB AND BEAM WEB

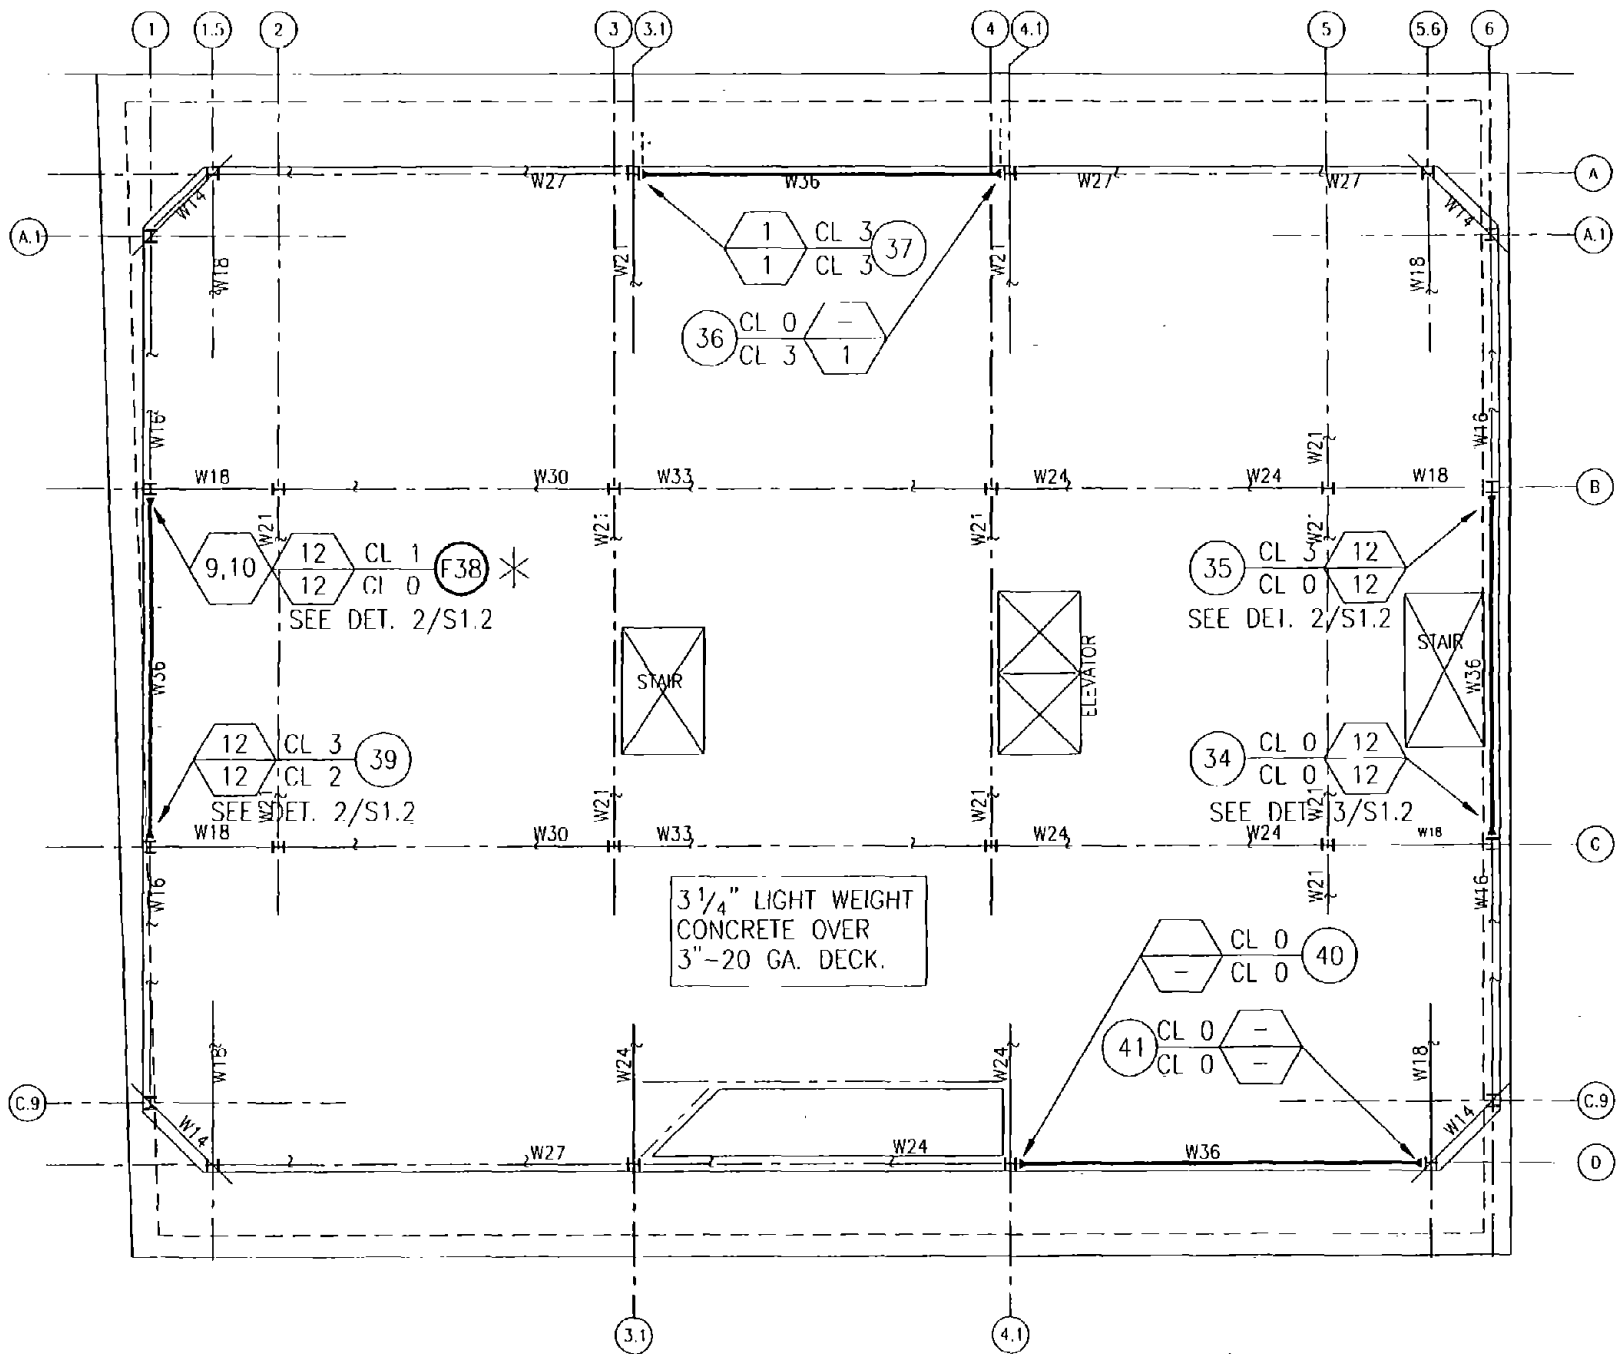
1ST FLOOR FRAMING PLAN
1/16" = 1'-0"

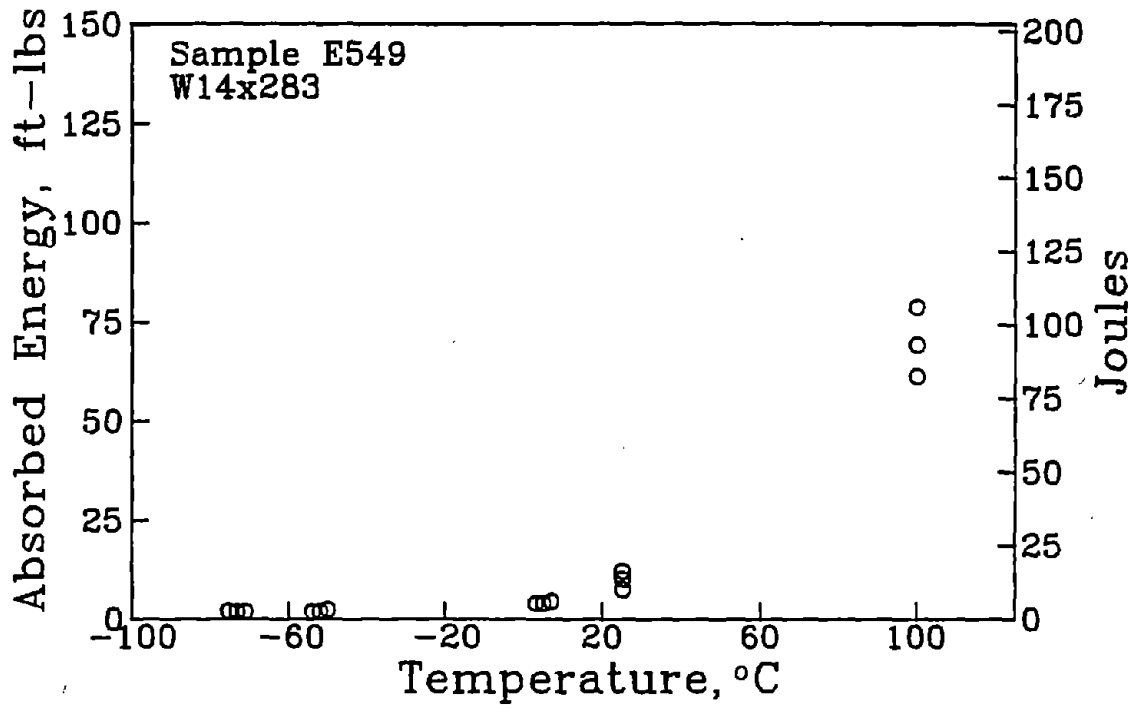
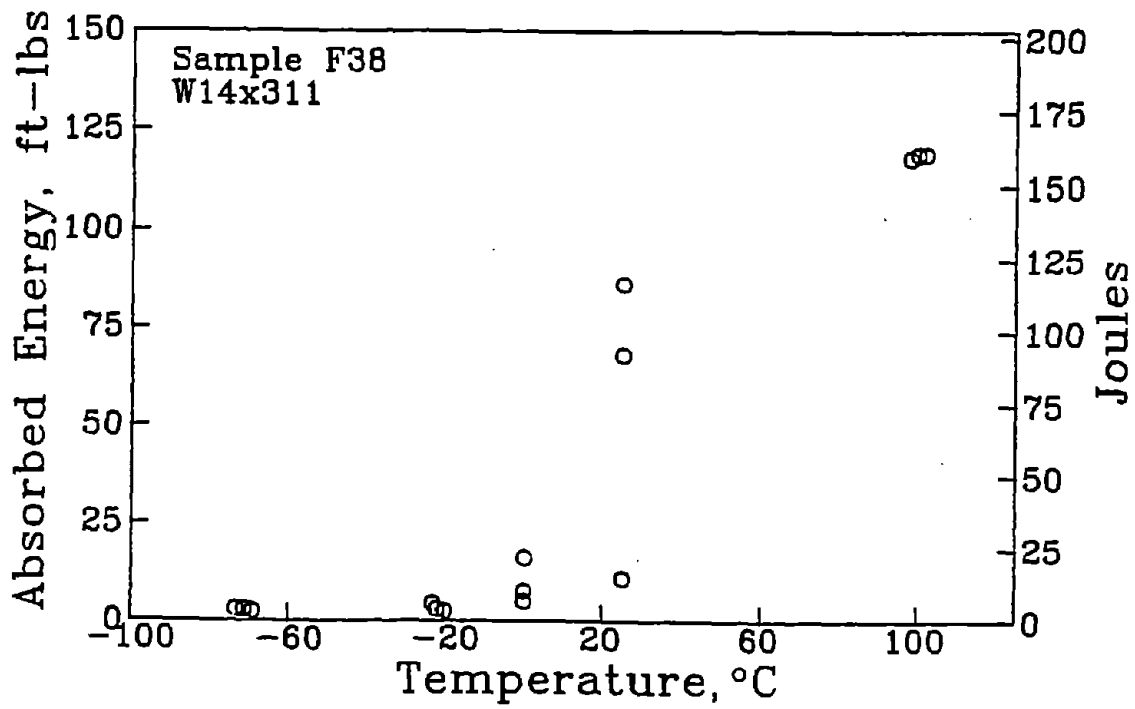
APPENDIX C
BEAM AND COLUMN FLANGE MICROSTRUCTURE

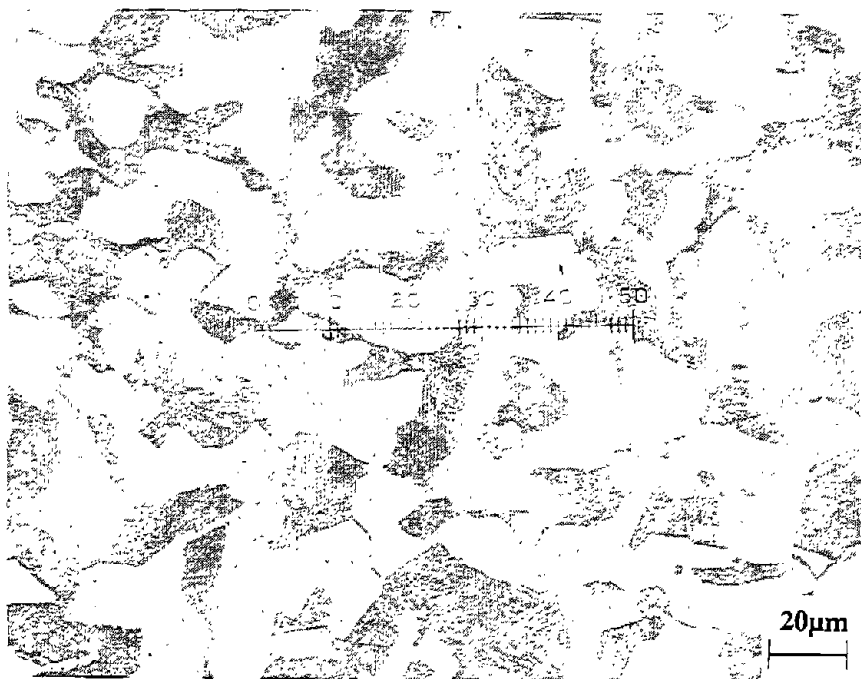
Sample A6 - Column Flange
Magnification: 500X Etchant: 2% Nital
