# Miyagi-Ken-Oki, Japan Earthquake, June 12, 1978 Reconnaissance Report

# EARTHQUAKE ENGINEERING RESEARCH INSTITUTE RECONNAISSANCE REPORT

PETER I. YANEY, EDITOR

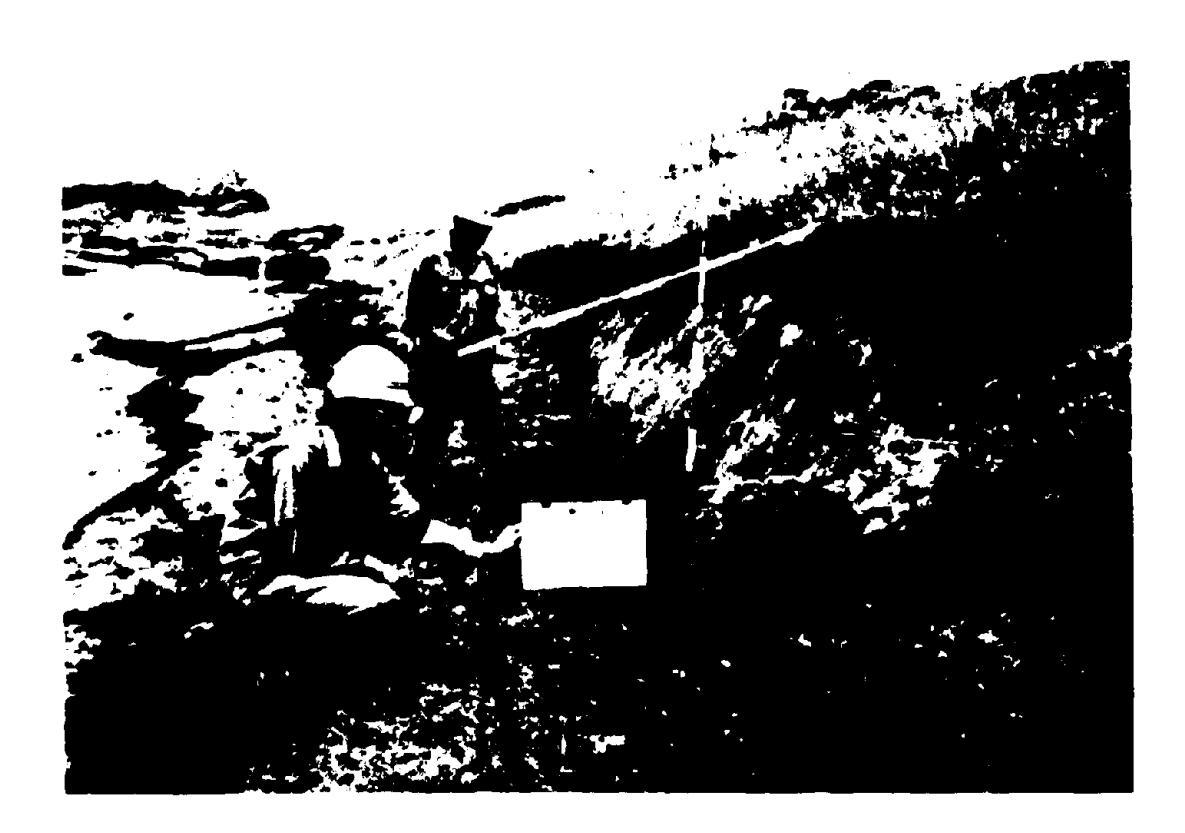
3c Liquefaction-induced slumping of dike on flank away from river. View north. (Photo courtesy Tohoku Regional Construction Bureau)

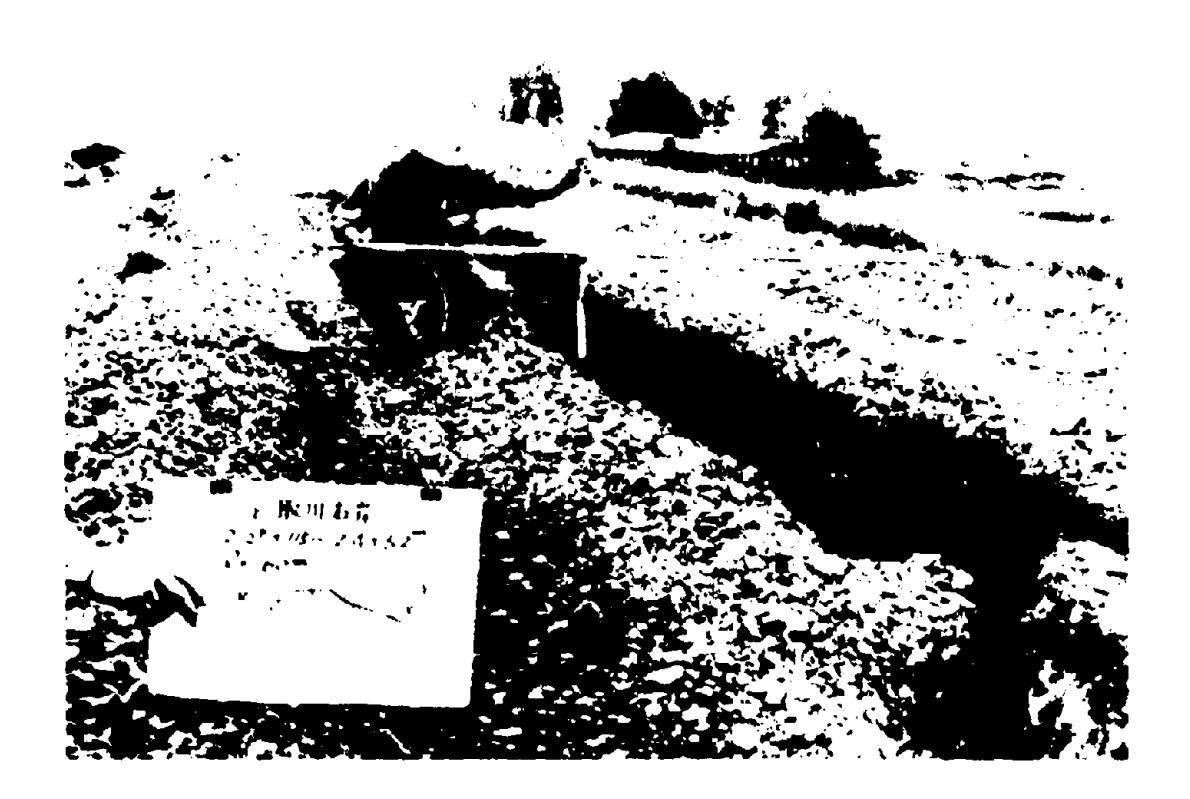
3d Cracking and settlement of dike crest caused by lateral spreading. View southeast. (Photo courtesy Tohoku Regional Construction Bureau)

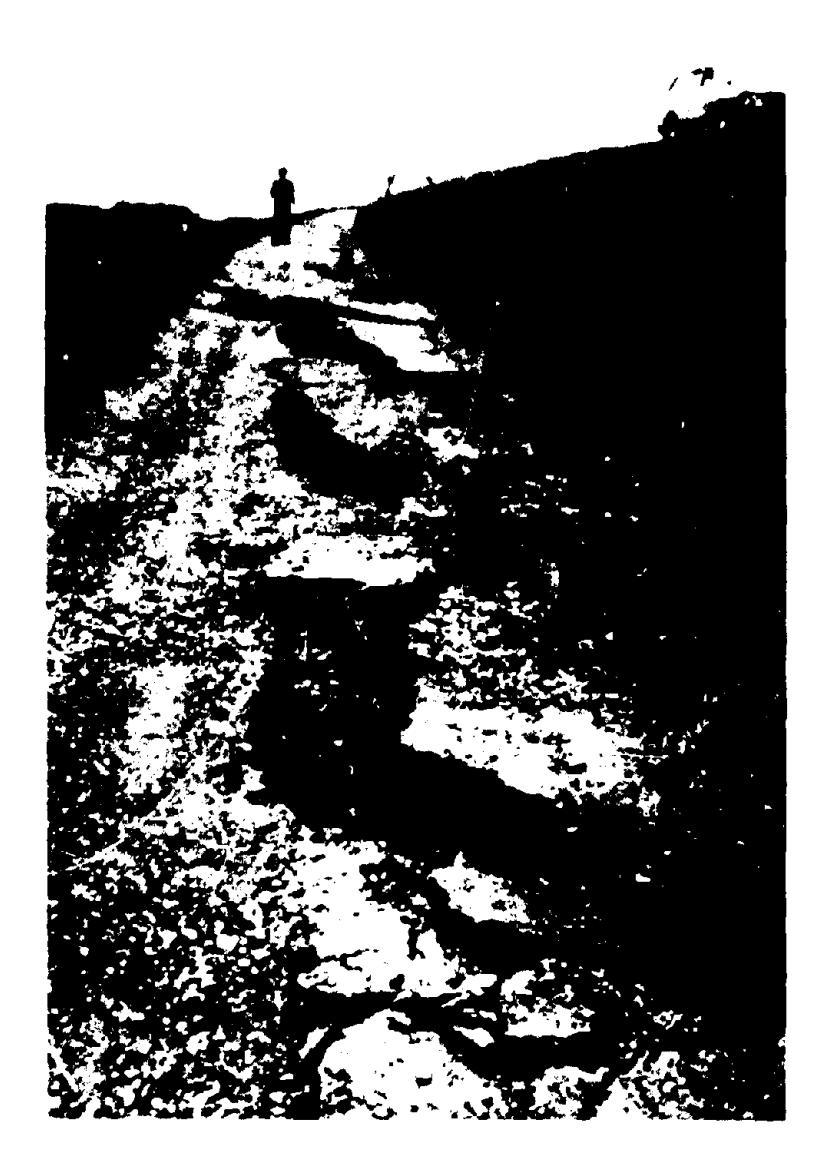
3e Cracking of roadway on dike caused by slumping or lateral spreading. View Southeast. (Photo courtesy Tohoku Regional Construction Bursau)

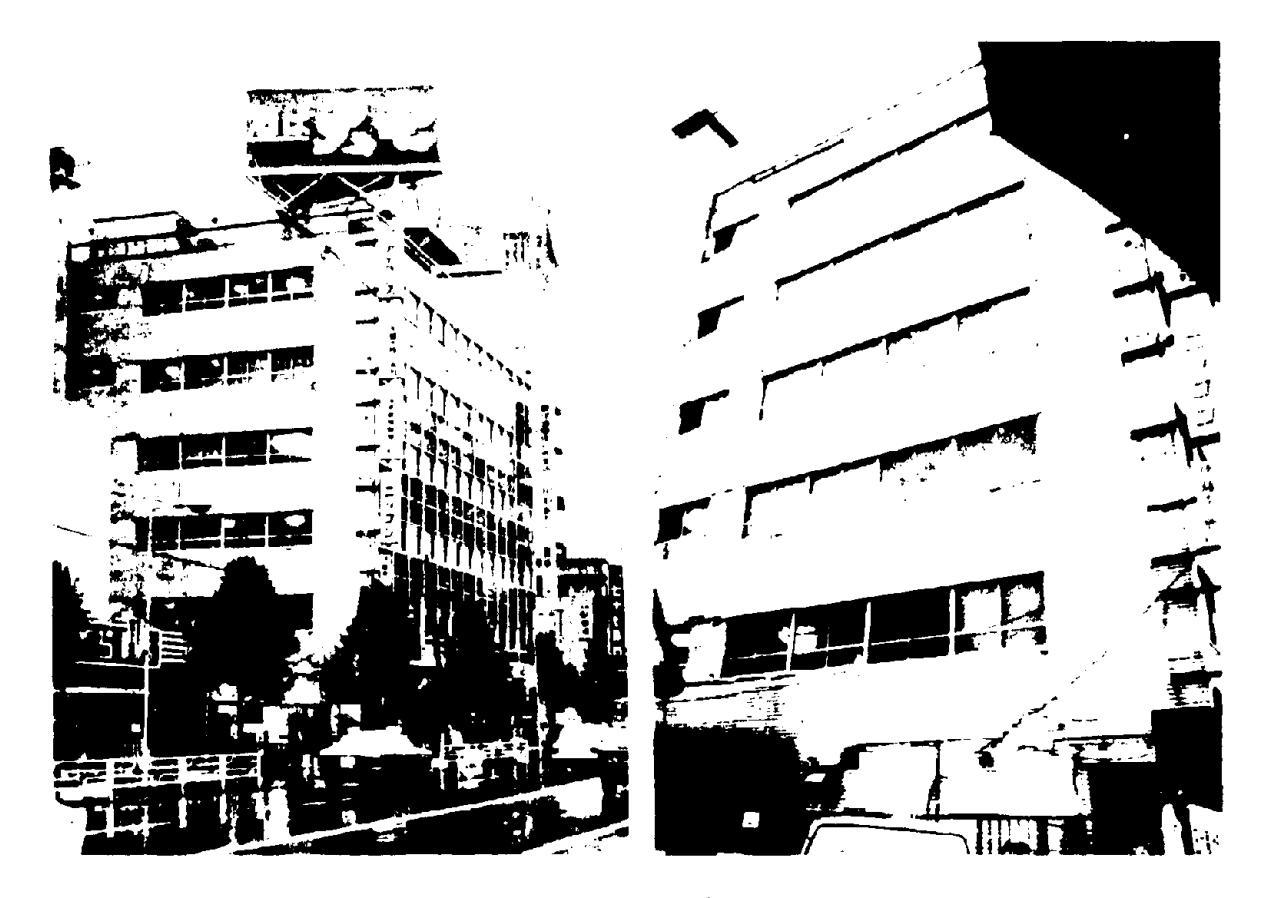
Figure 5 Minami Machidori building, Sendai. This 6-story reinforced concrete building in downtown Sendai suffered extensive cracking to its brick veneer facing and shows signs of possible structural damage as well. The damage is typical for many similar buildings in the city.

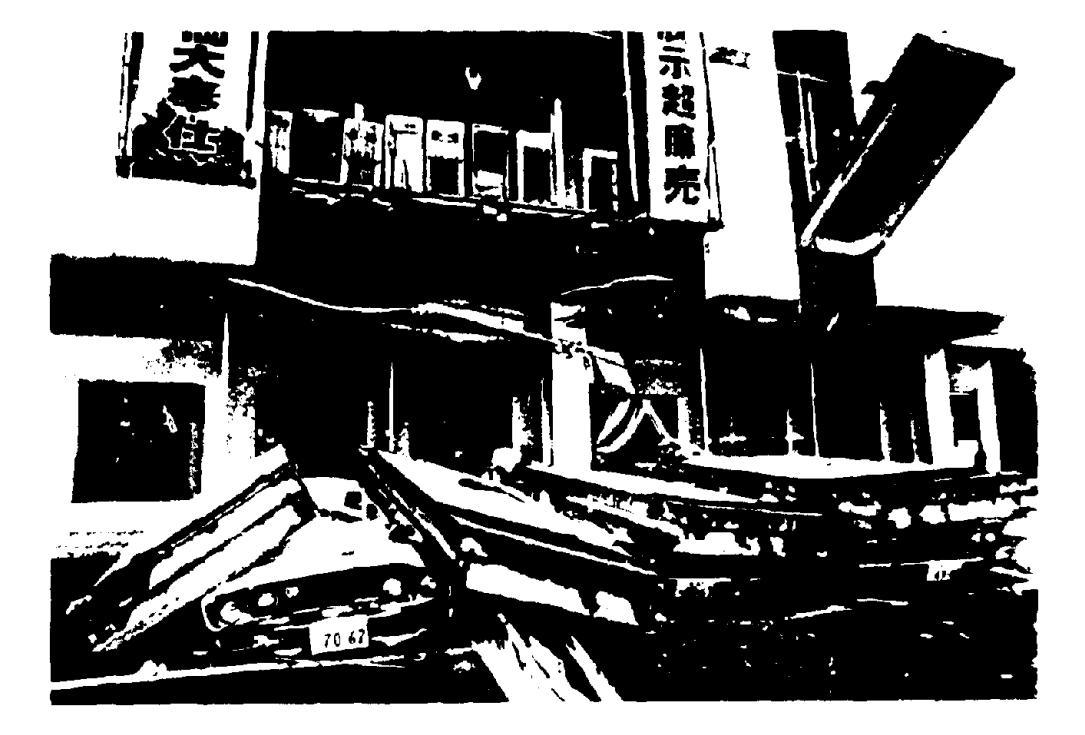
Figure 9 Sasaki building, outskirts of Sendai: a damaged 4-story steel-framed building. The exterior precast concrete panel anchorages falled. (Kawahoku Newspaper Co. photograph)

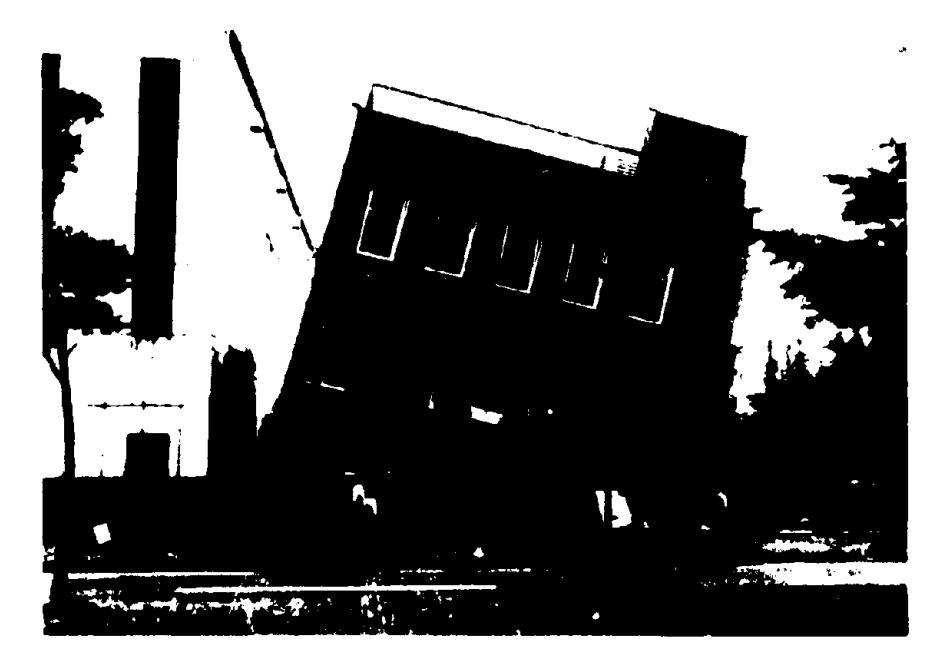
Figure 14 Obisan building, Oroshicho area, Sendai: view from the northwest. This is a 3story reinforced concrete frame building with a soft first story, one span in each direction. The columns were inadequate to resist the torsional force caused by a heavy eccentric stairwell that cantilevered over the column line at the right end of the building.

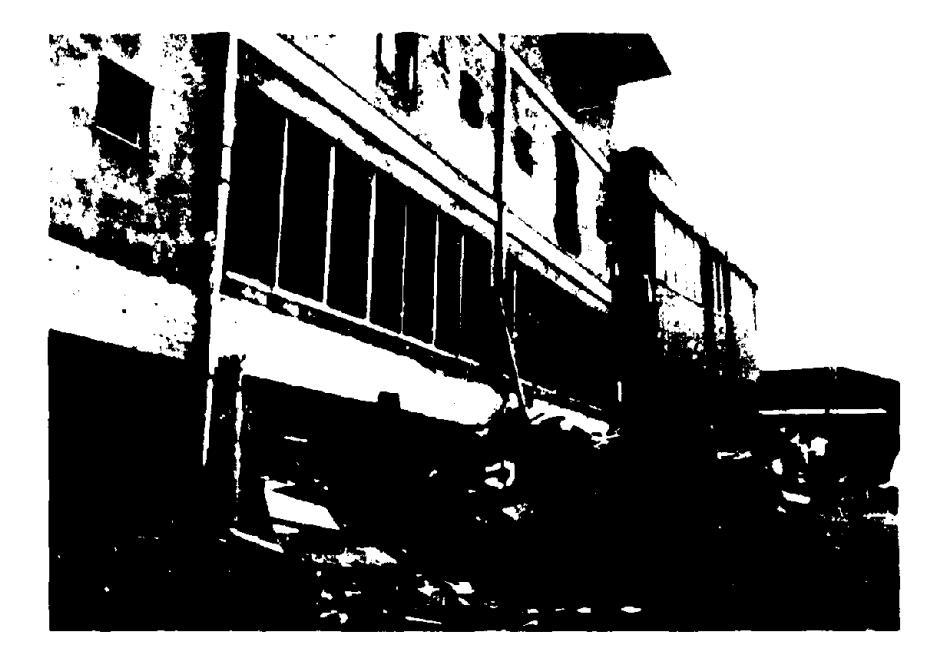
Figure 25 Yazaki Industries buildings, Oroshicho area, Sendai: view of the failed ground floor of the 4-story concrete building.

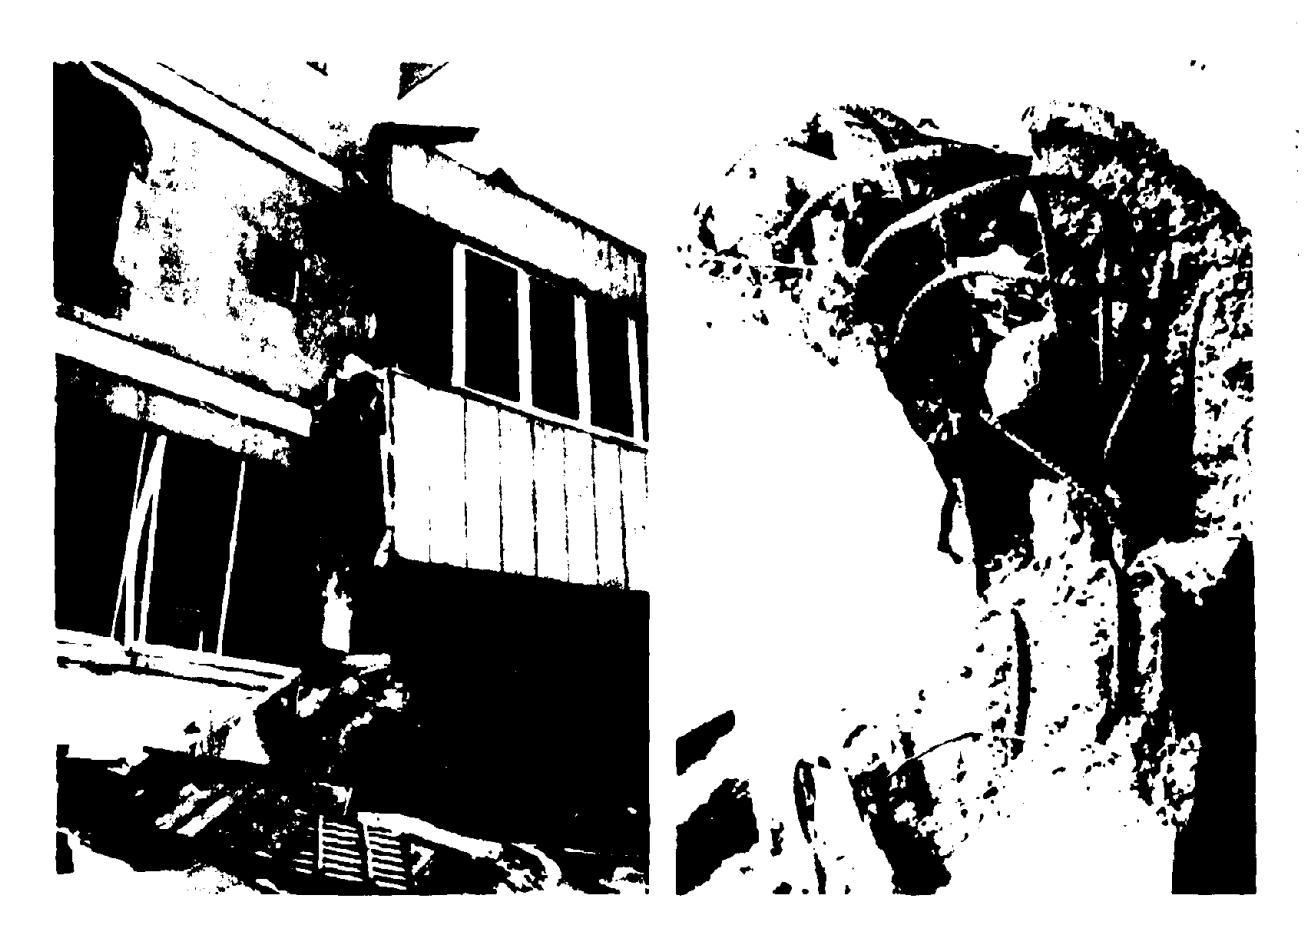
Figure 26 Yazaki industries buildings, Oroshicho area, Sendai: details of damage to the concrete structure. The photograph to the left shows the impact area between the concrete building and the steel frame building. Deformed bars were used in this building, as shown in detail photograph, right.

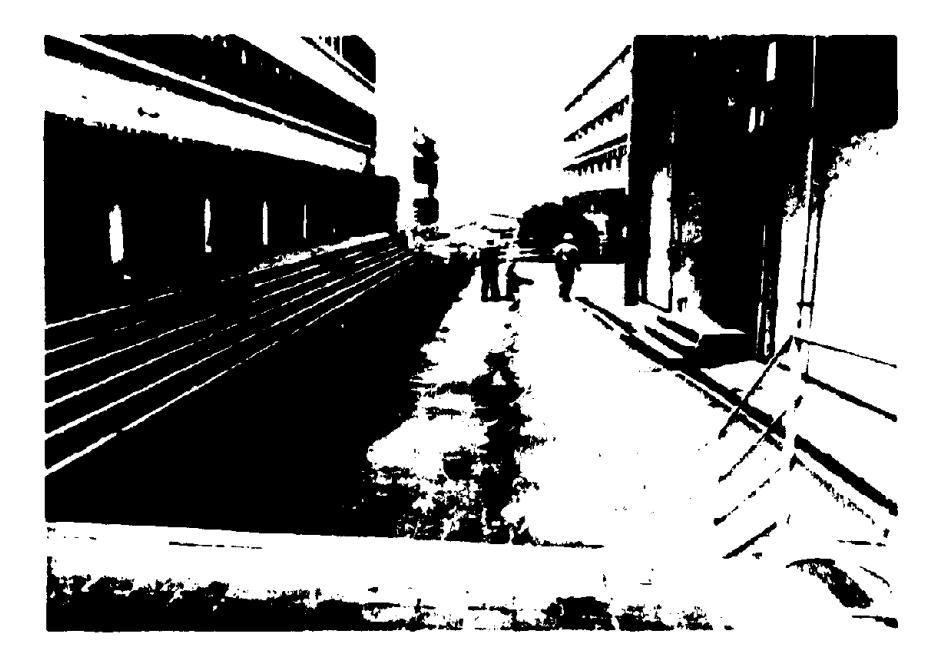
Figure 39 Tohoku Institute of Technology, Building 5: a view of the entrance area of the north entrance to Building 5 showing settlement of backfill along most of the length of the building. The settlement caused extensive damage to the stairs and to the adjacent retaining walls.

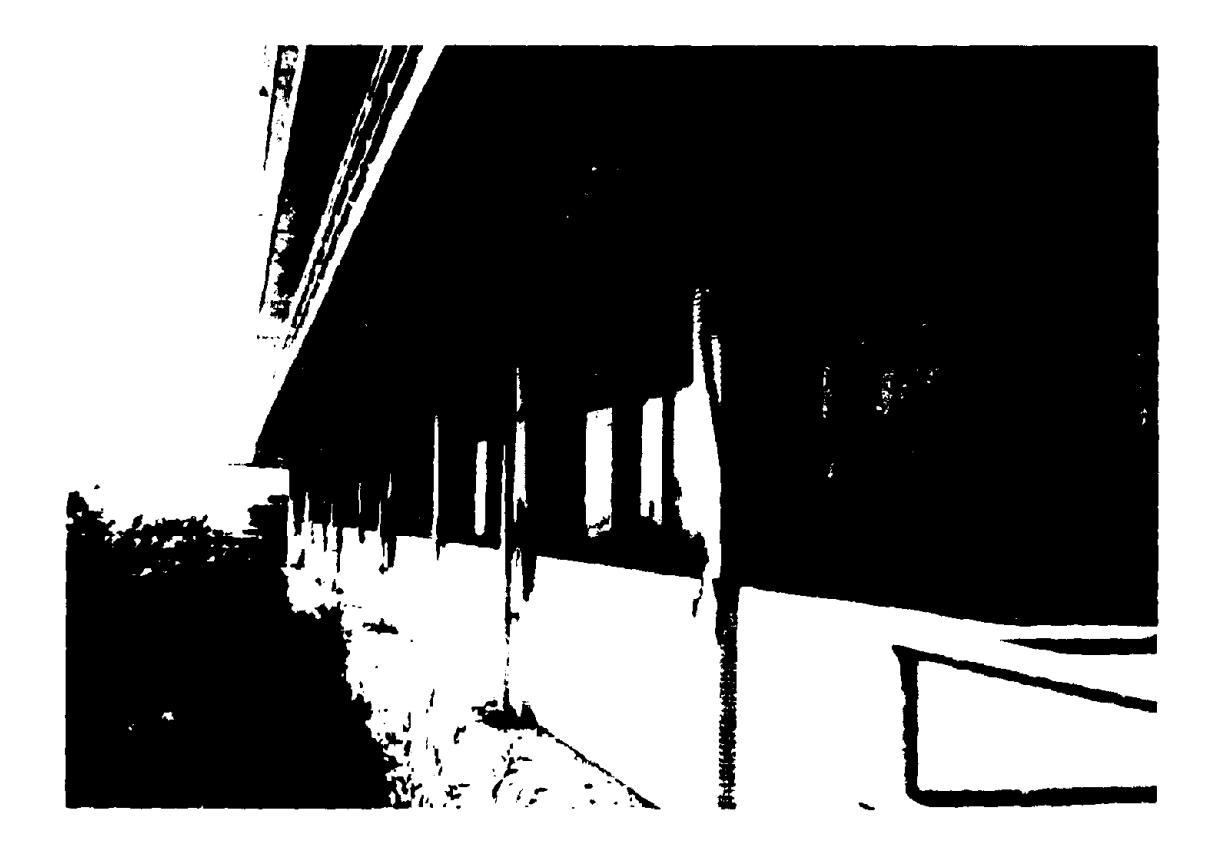
Figure 41 Tohoku Institute of Technology, Building 3: demage to the ground floor columns. Similar damage is present all along the opposite (north) side of the building.

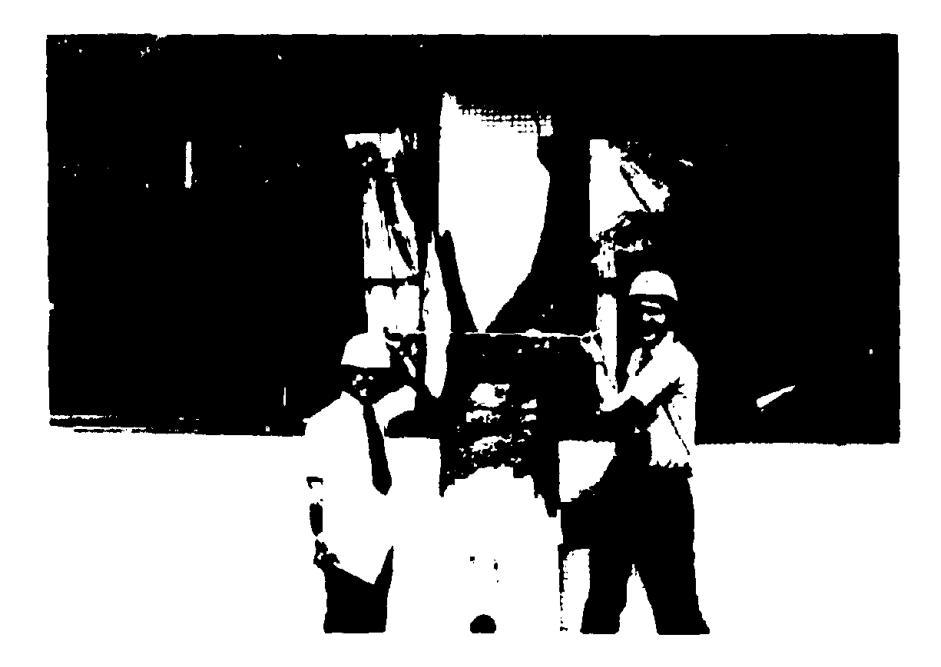
Figure 43 Tohoku institute of Technology, Building 3: typical damage to a column on the ground floor of the north-facing exterior frame. The interior shear walls in the transverse (north-south) direction also suffered extensive damage.

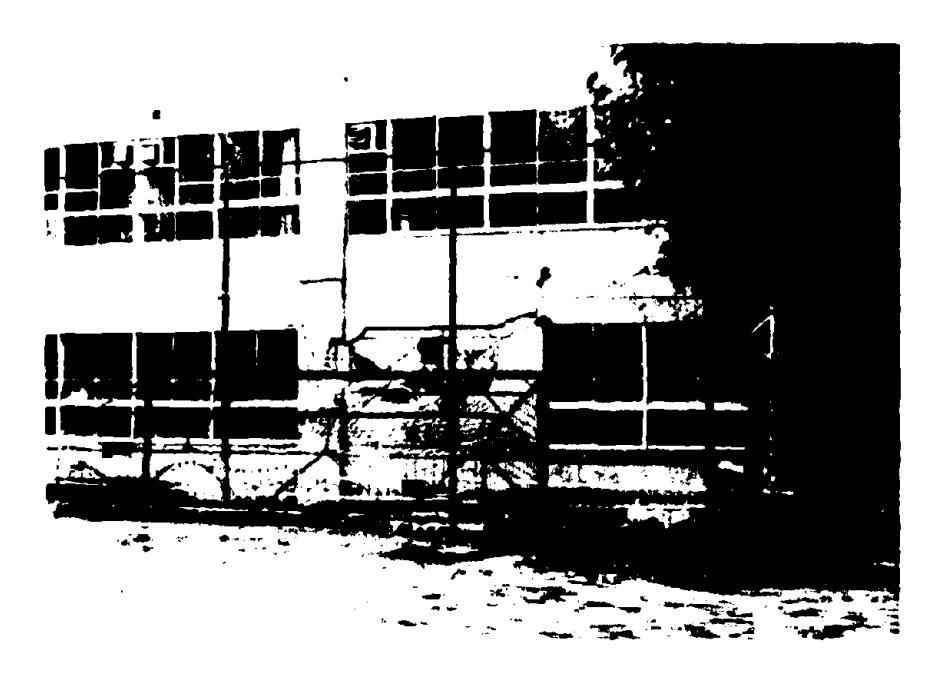
Figure 45 Tonan High School: detail of damage to the west face.

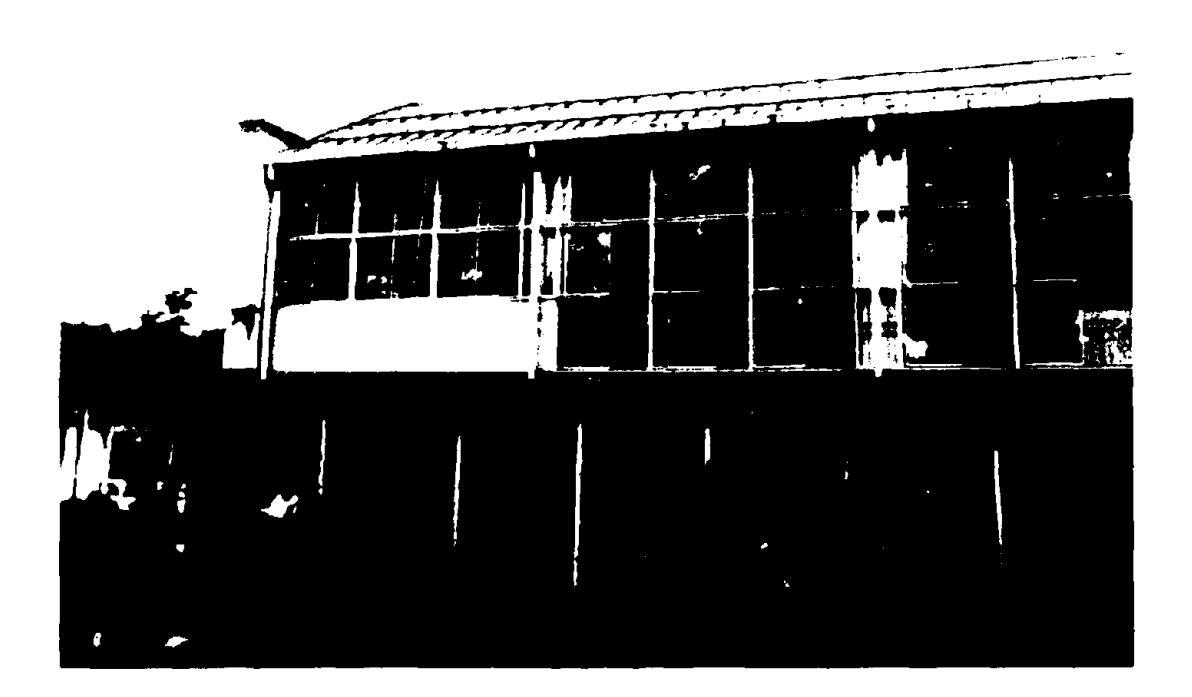
Figure 48 Izumi High School: partial view of the slightly damaged, steel-frame auditorium.

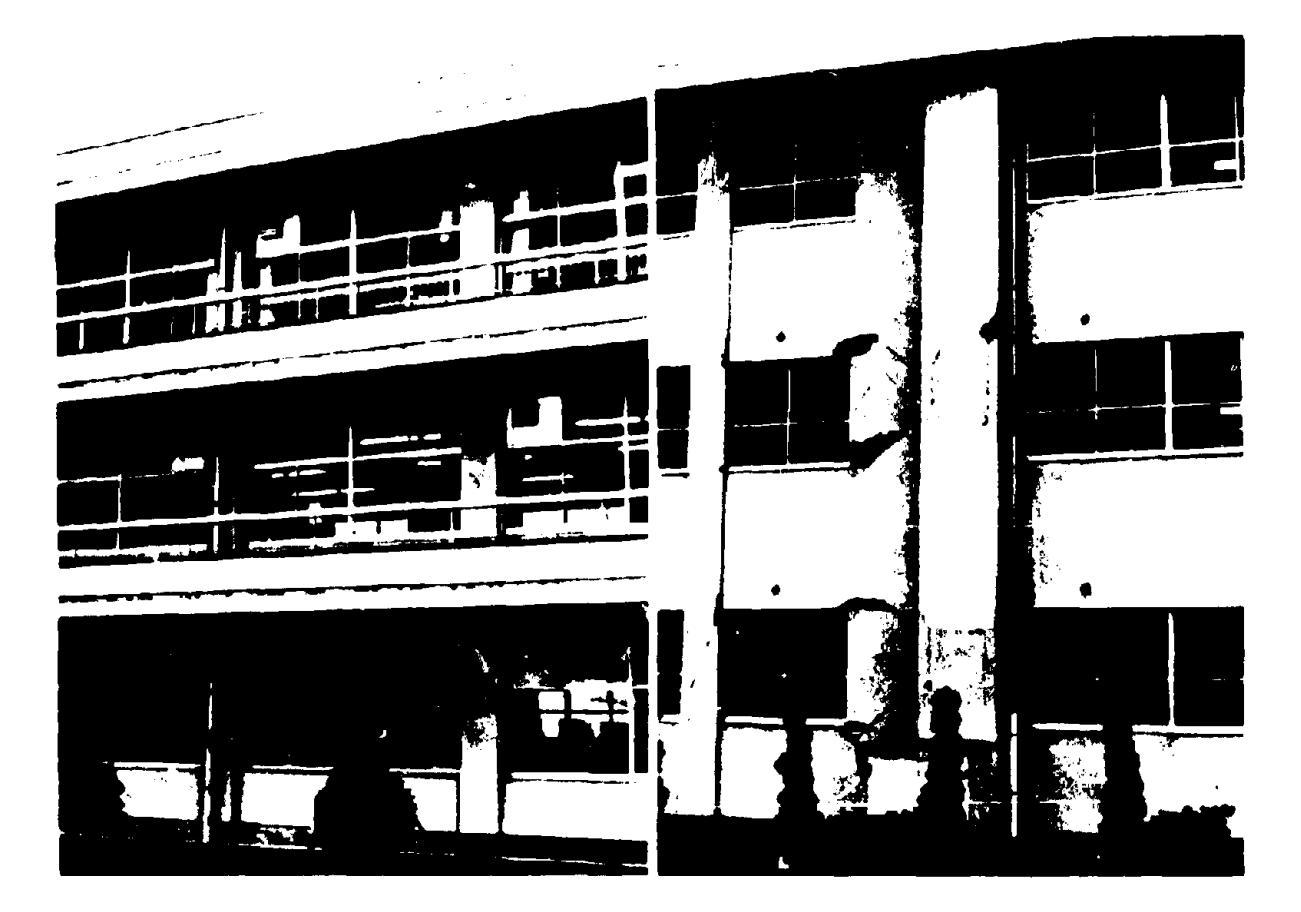
Figure 51 Izumi High School. The two illustrations show, respectively, two sides of a typical building. The rear of the building (left), which is relatively open, suffered little apparent damage; damage was heavier on the side with partial-infill wall panels (right). In addition, the interior transverse shear walls frame into the columns on the rear but do not frame into the columns on the front because of a longitudinal corridor. All of the buildings experienced this type of damage.

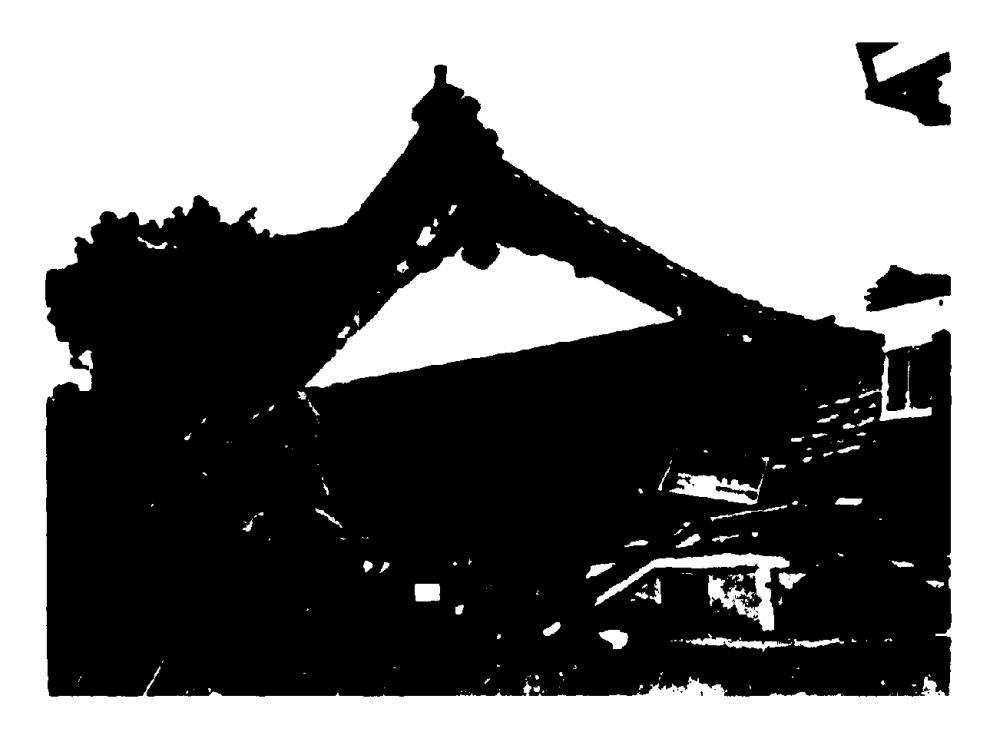
Figure 54 A collapsed older, wood-frame temple building with a tile roof. (Kawanoku Newspaper Co. photograph)

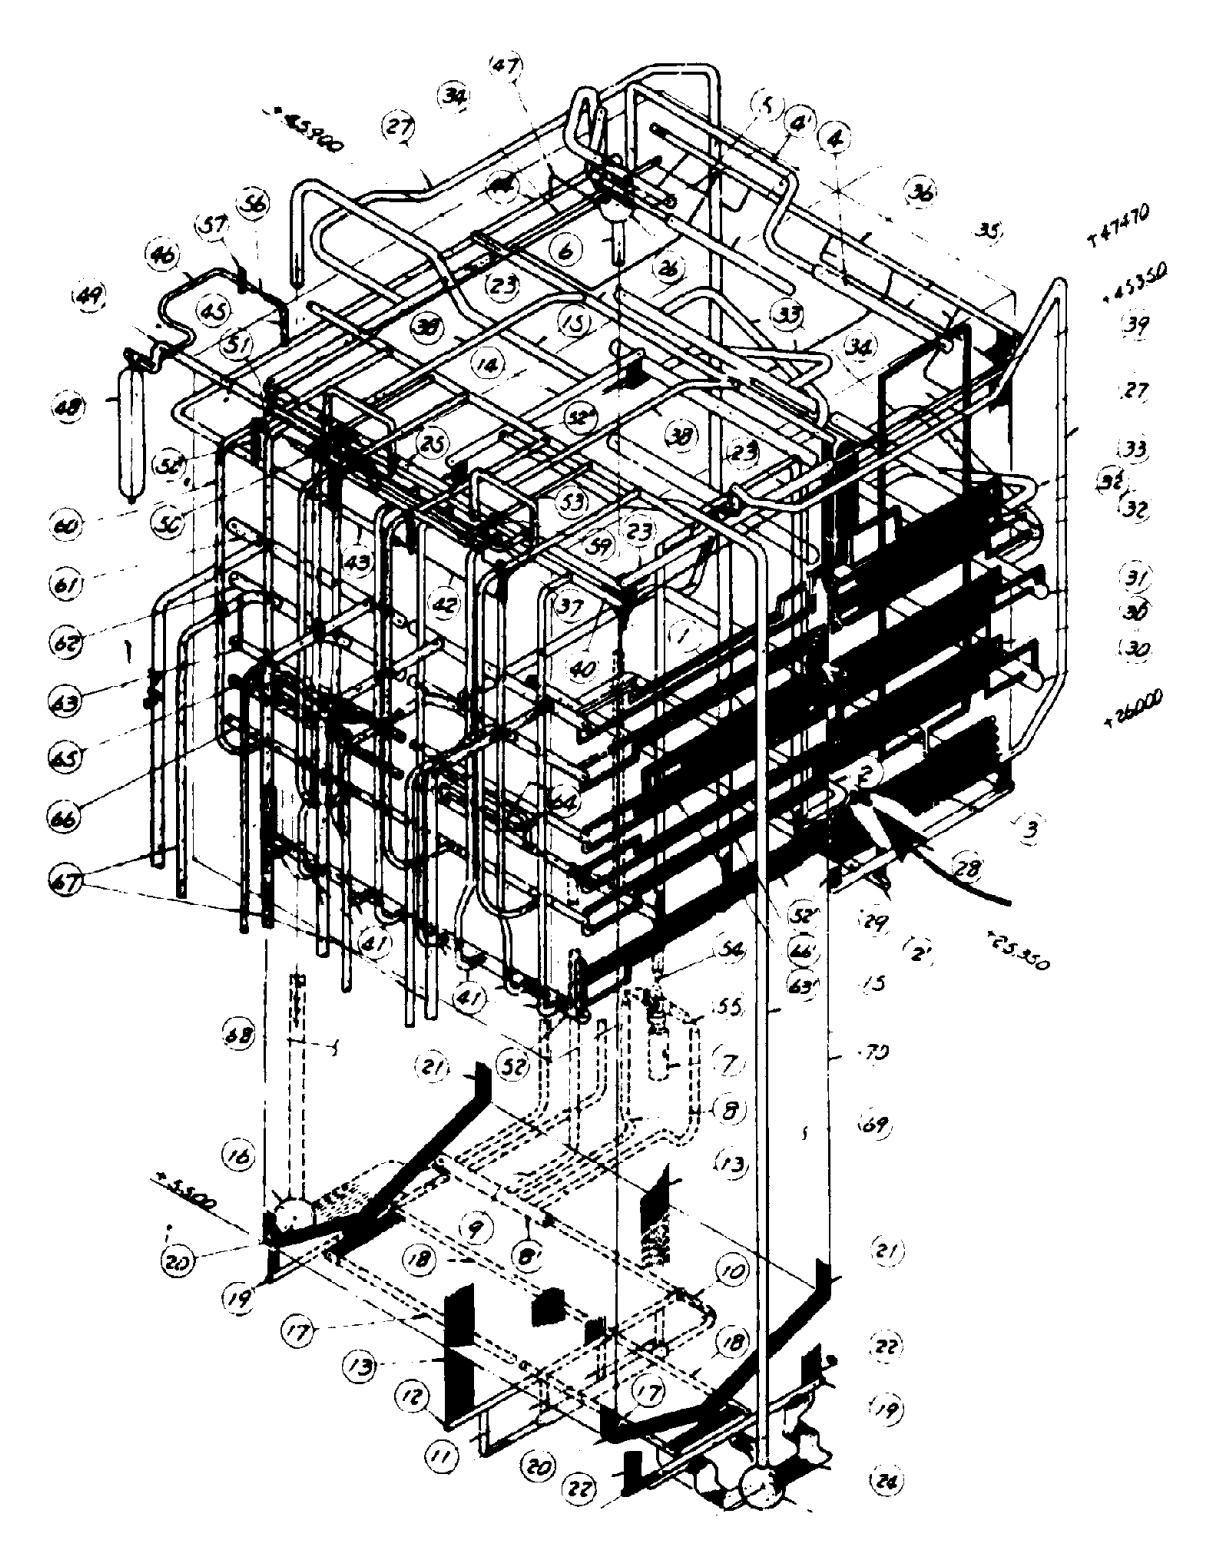
Figure 64 New Sendal Power Plant, Tohoku Electric Power Company. The arrow points to the location of the damaged horizontal spacer tubes in the 600-NW boiler of Unit No. 2. See Figure 63.

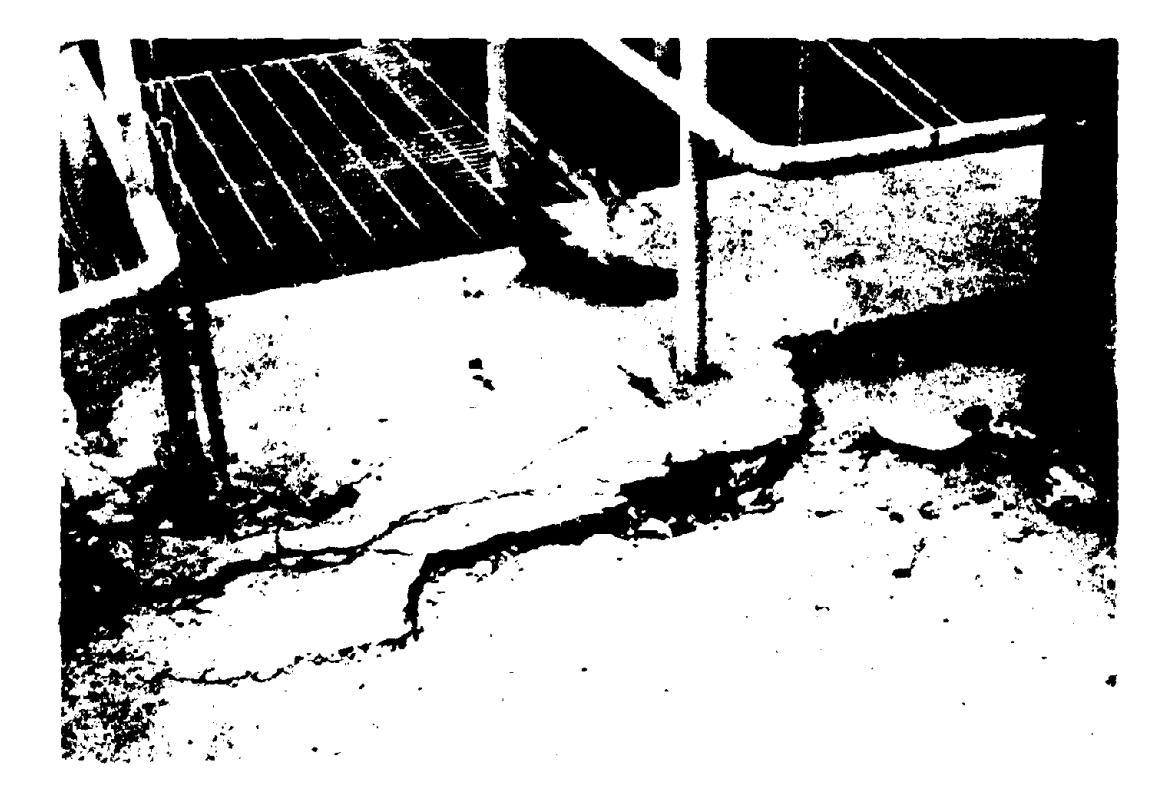
Figure 66 New Sendal Power Plant, lohoku Electric Power Company: damage around the water intake structure from minor settlement. Other examples of minor settlement were observed throughout the site.

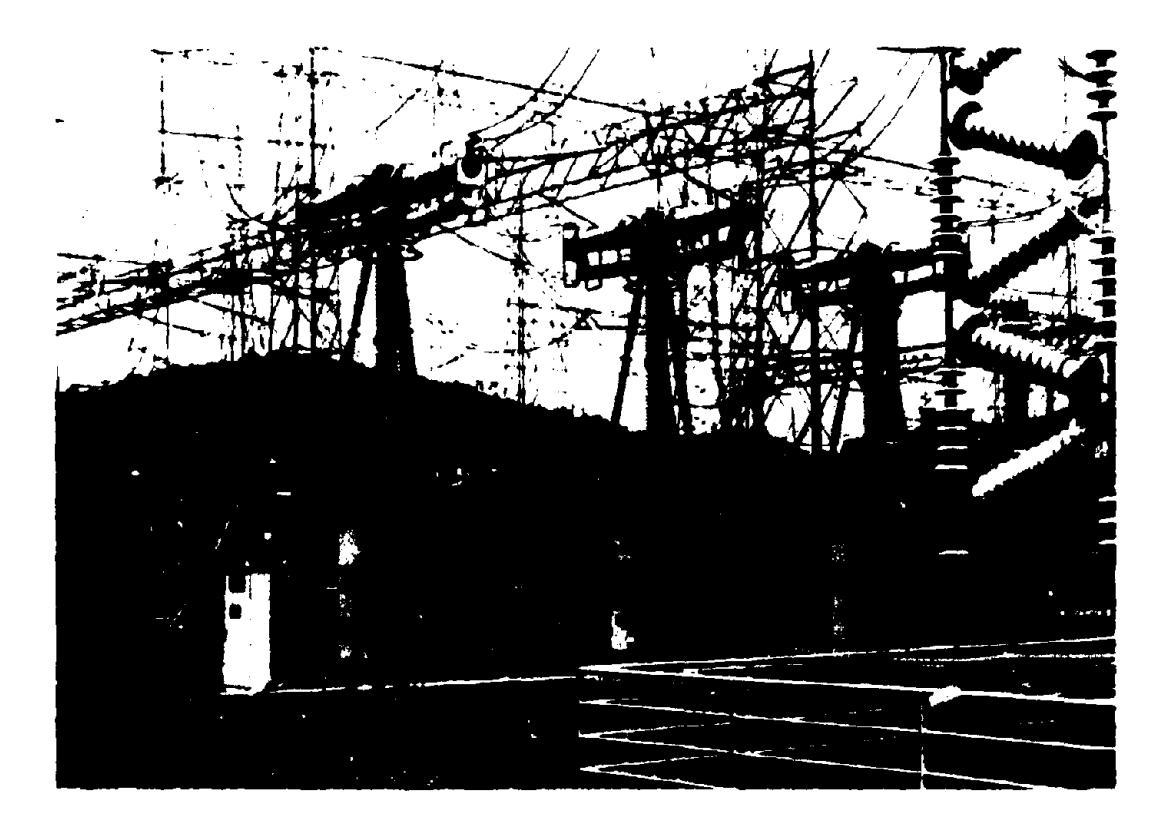
Figure 69 Sendai Substation, Tohoku Electric Power Company, Izumi: three circuit breakers, like the one illustrated in Figure 68, that have been repaired.

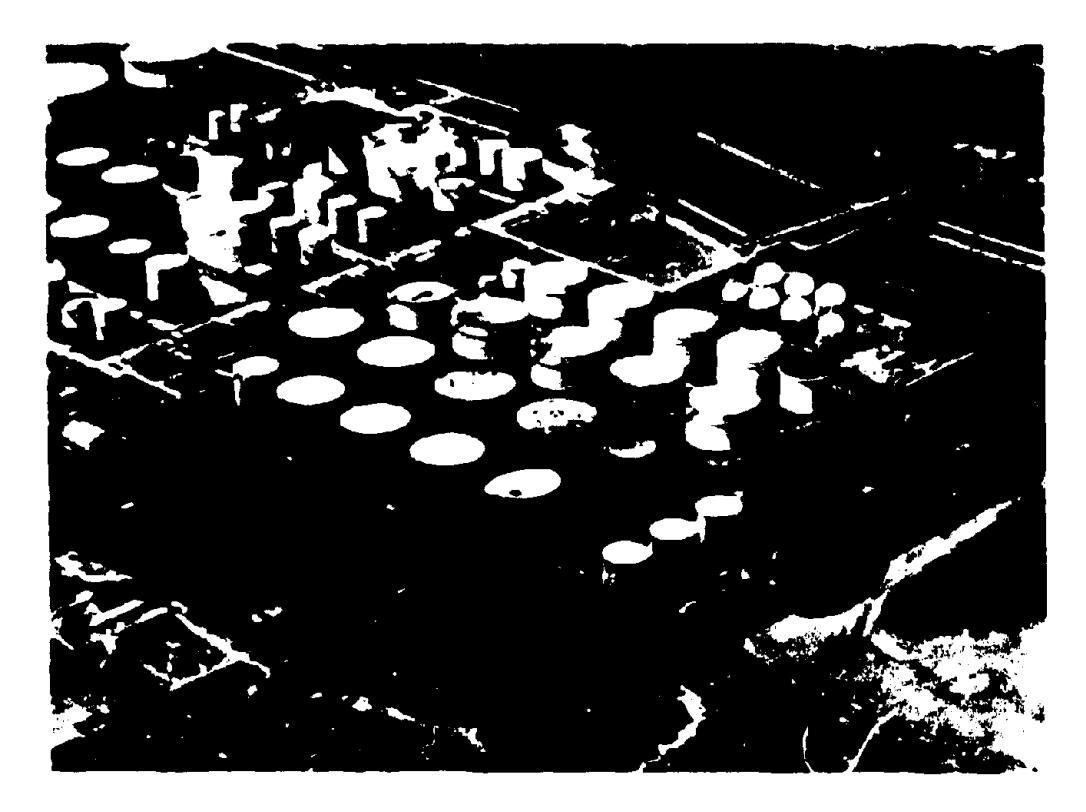
Figure 80 Sendai Refinery, Tohoku Oil Company, Ltd.: an overall view of the refinery's tank farm. The spilled oil appears as the dark area of the photograph.

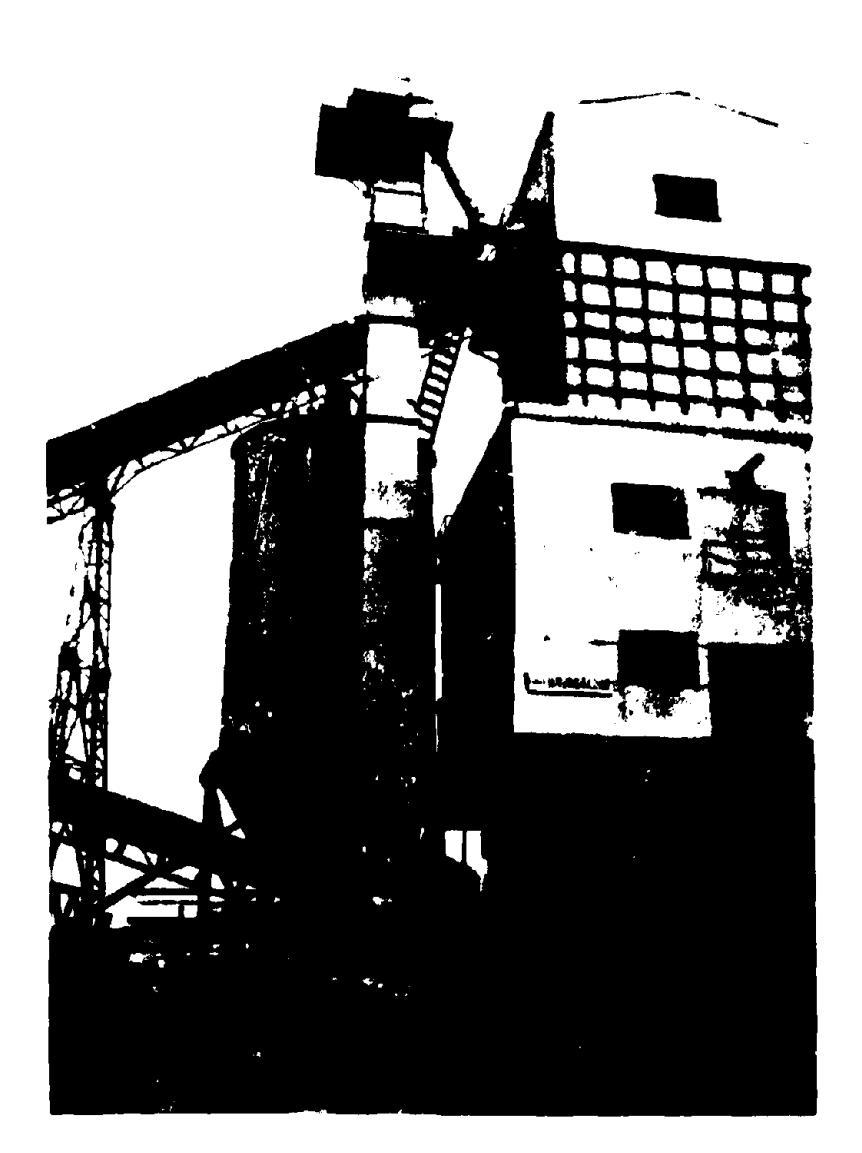
Figure B6 Concrete Batch Plant, Sendai. Differential motion of the upper (light steel) structure and the conveyor belt structure damaged the vertical stack and was responsible for extensive damage to the light steel structure. The stiffer reinforced concrete substructure was not damaged.

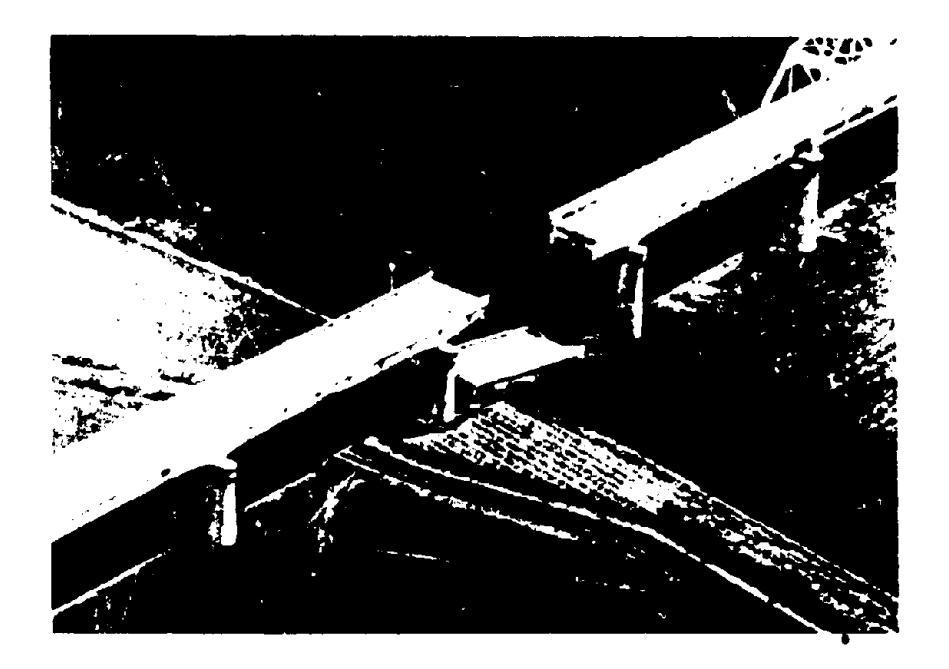
Figure 90 Kin-Noh Bridge: view of the collapsed suspended plate-girder span. (Kawahoku Newspaper Co. photograph)

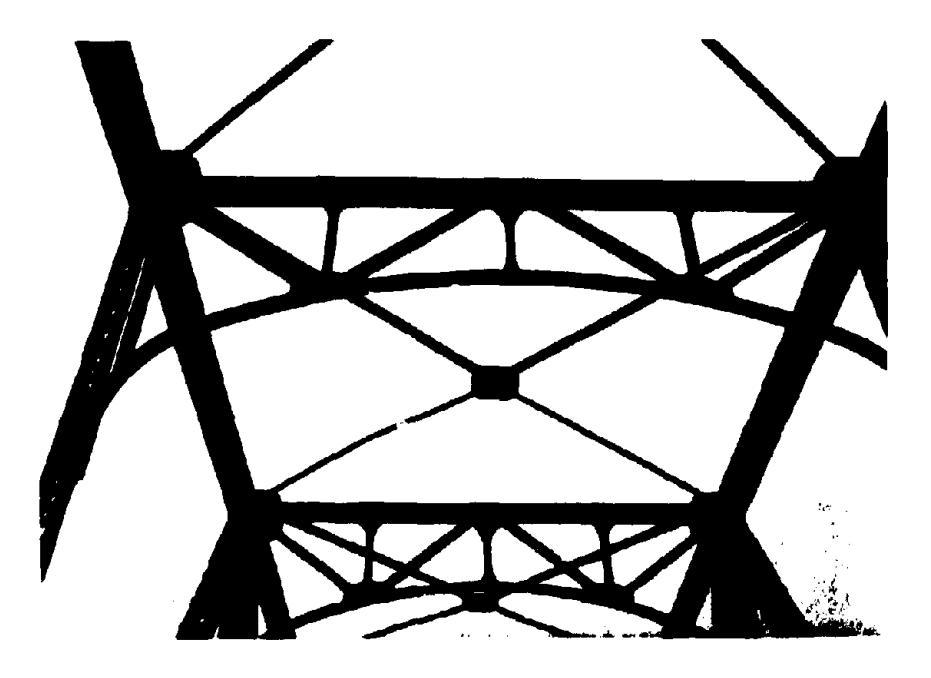
Figure 118 Maiya Ohashi Bridge: buckled diagonal braces of the overhead trusses.
