INFLUENCE OF SITE CHARACTERISTICS ON BUILDING DAMAGE DURING THE OCTOBER 3, 1974 LIMA EARTHQUAKE

Report No. UCB/EERC-80/41

September 1980

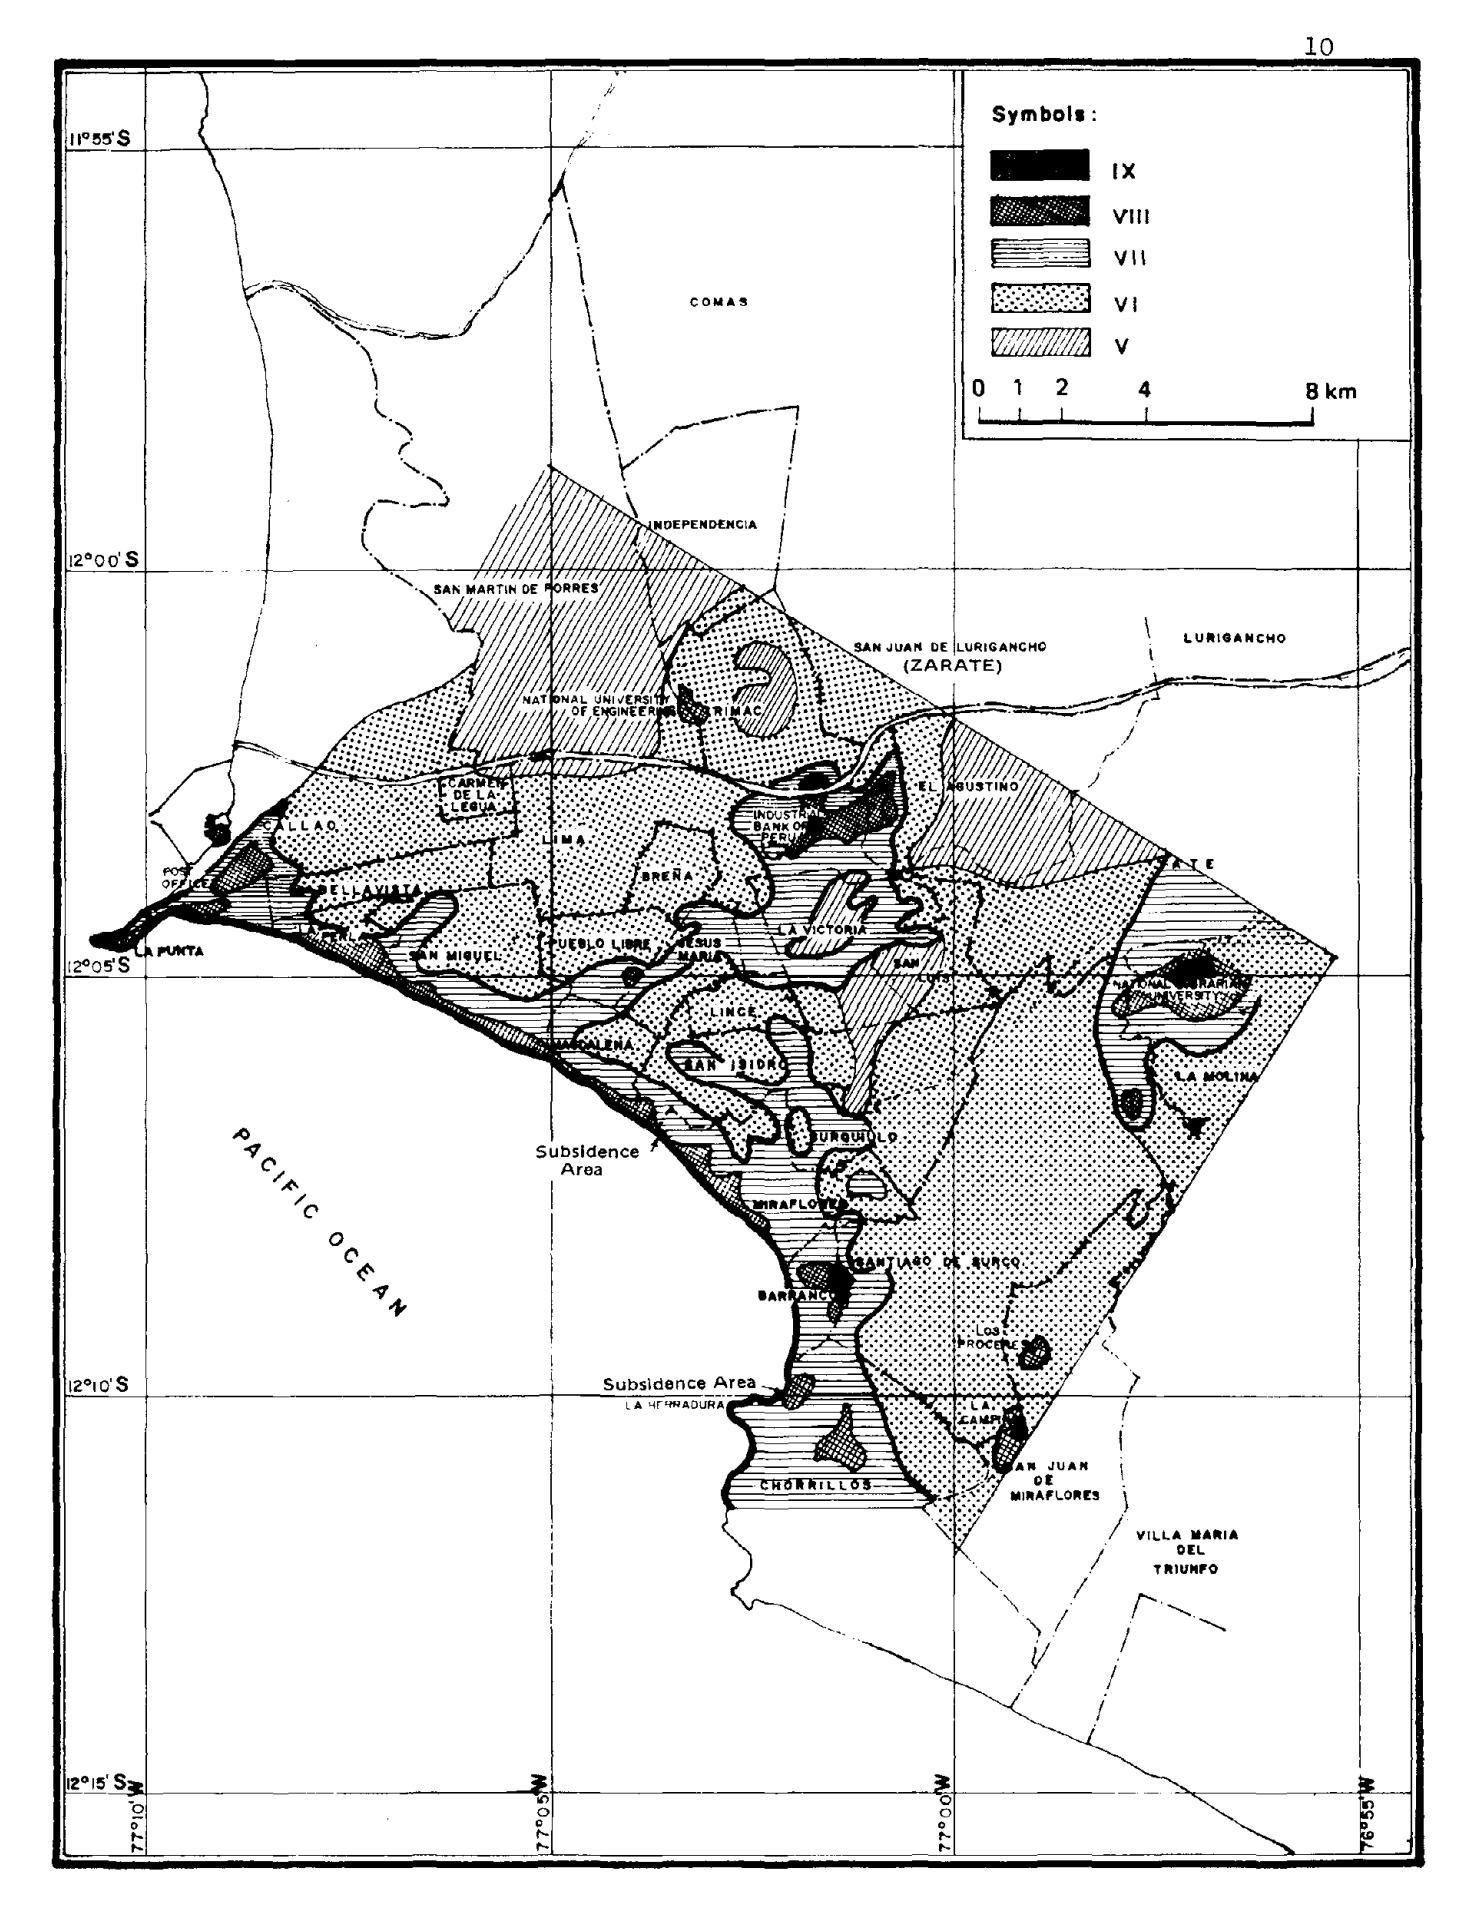
Fig. 4 – MODIFIED MERCALLI INTENSITY DISTRIBUTION (From Husid et al.)

A comparison of the areas of highest intensity (VII or greater) shown in Figure 4 (taken from Husid et al.) and reproduced in Fig. 5 with Figures 1 and 3 of this study shows that the zones with the highest MM Intensity rating coincide remarkably well with the area known to have the oldest and most abundant quincha and adobe construction (Figure 1) in existence prior to 1932. At the outset of this investigation therefore, it was considered necessary to isolate structural effects from other factors that may have been indicative of the influence of local subsurface conditions on the type and distribution of damage in the Lima area. For this purpose, a field damage study within the area of highest intensity identified in Figure 4 was carried out. The results of the study are presented in the following section.

Sample Area No. 7 was selected adjacent to the 8-story Banco Industrial, in the district of Lima. Damage to this building led Husid et al. to designate the area as MM Intensity IX (see Figure 4). However, this building was classified as damage intensity 2 by Repetto since damage was due to the collapse of a non-reinforced parapet along the facade of the building, which fell onto a cantilevered section of the second floor. A survey of 54 city blocks around the building (see Table 11) disclosed that there are 68 buildings 3 or more stories high in the area, all of which had damage intensity of 3 or lower during the earthquake.

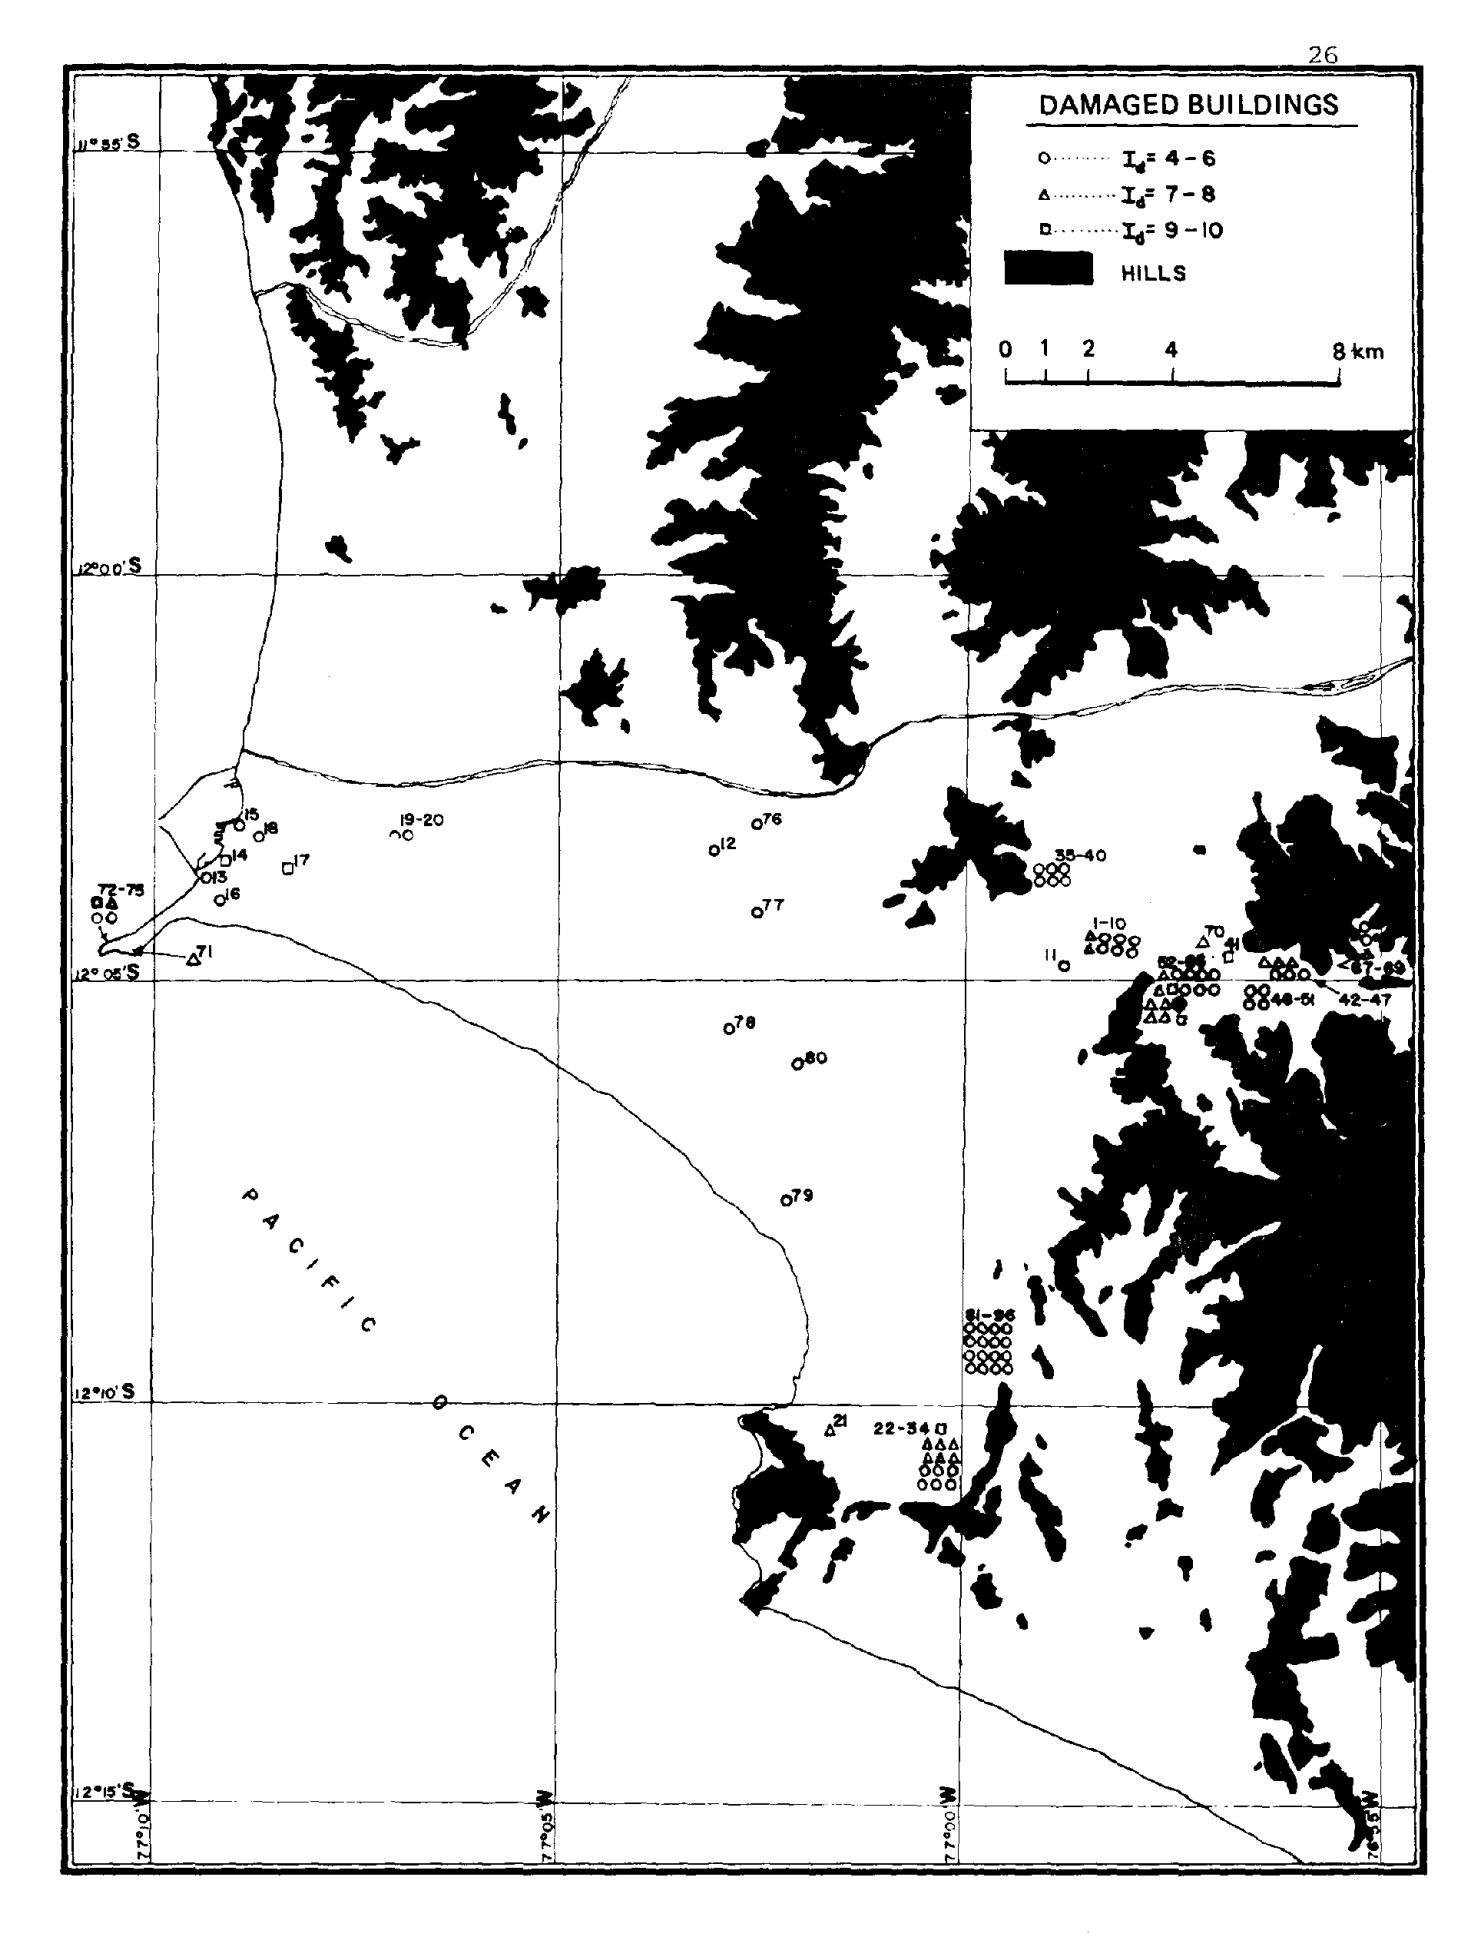
Fig. 6 - LOCATION OF DAMAGED BUILDINGS, GREATER LIMA

Figure 1, in combination with the damage distribution map presented in Figure 6, clearly shows that there are concentrations of damage in three zones within the greater Lima area, as follows:

In fact, it can be seen from Table 10 that 86 percent of the damaged structures studied are located in these three zones. Furthermore, the highest average damage intensities occur in the districts of Callao-La Punta, Chorillos, and La Molina.

Detailed studies of the damage data pertaining to the structures shown in Figure 6 indicated that for some structures the damage resulting from the earthquake could easily be related to structural and/or construction details, or to foundation-related effects rather than the influence of local subsurface conditions on ground shaking intensities. Thus, for example, the following factors could readily be discerned:

In addition to the structures discussed above, Figure 6 shows six structures (Nos. 12, and 76 through 80) located in the central area of greater Lima, which deserve special consideration. These six structures are all of the R.C. frame type, 3 to 12 stories high, with brick walls, and foundations supported on spread footings. Observed damage consisted

of cracked beams and columns ($I_d = 4$ to 6). The question arises as to whether the type of structure typified by these buildings is particularly vulnerable to earthquake ground motions in the central zone of Lima, as suggested by these data.

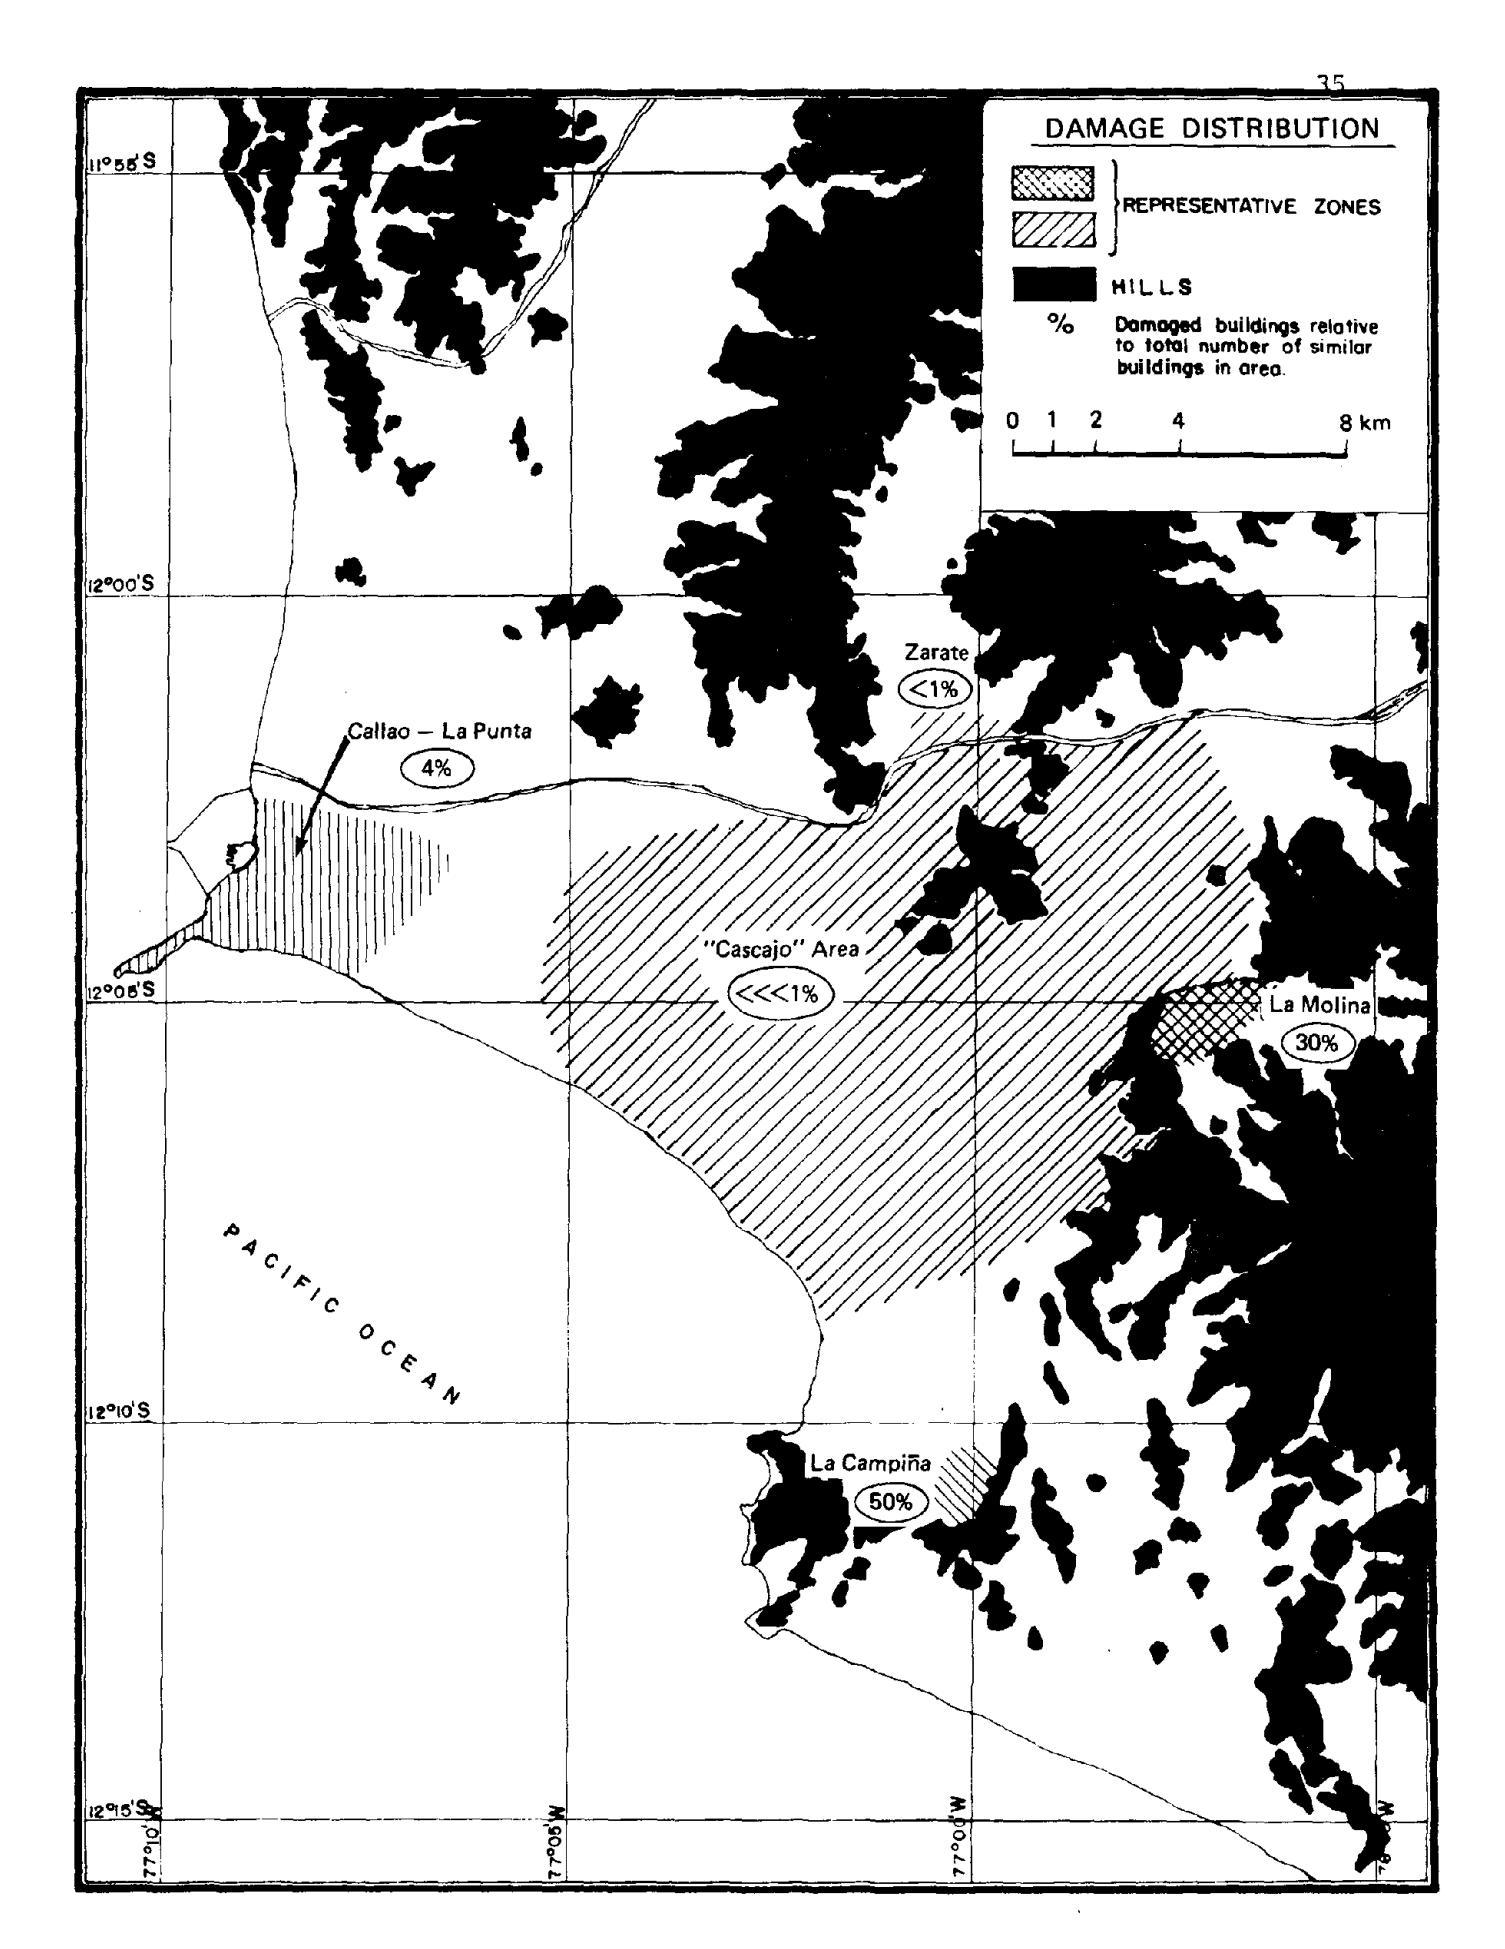
Fig. 7 - DAMAGE DISTRIBUTION, GREATER LIMA

It would appear that the damage induced by earthquake shaking in the 33 structures discussed in this section of the report does not follow any soil-related pattern, but rather can be related to structural or constructional details. Eliminating these 33 structures, from the 96 considered in Tables 9 and 10 leaves 63 damaged structures, 52 of which are located in the districts previously identified as having the highest damage concentration and the highest damage intensity rating. Table 12 groups these 63 structures, for which damage is not apparently related to structural details, by districts. Table 13 summarizes the same information with structures grouped in three zones (comprising 4 districts) and gives, in addition, the percentage of damaged structures relative to the estimated total number of similar buildings for the different zones. For comparison purposes, Table 12 also gives the same information for structures located in the areas of greater Lima that are underlain by a dense to very dense, gravelly fluvial material deposited by the Rimac River, locally named "cascajo." The characteristics of the "cascajo" will be described subsequently in greater detail in this report. The damage distribution in the three most affected areas, and in the "cascajo underlain zone," are shown in Figure 7.
