### **REPAIR AND STRENGTHENING OF BEAM-TO-COLUMN CONNECTIONS SUBJECTED TO EARTHQUAKE LOADING**

February 28, 1989

Technical Report NCEER-89-0013

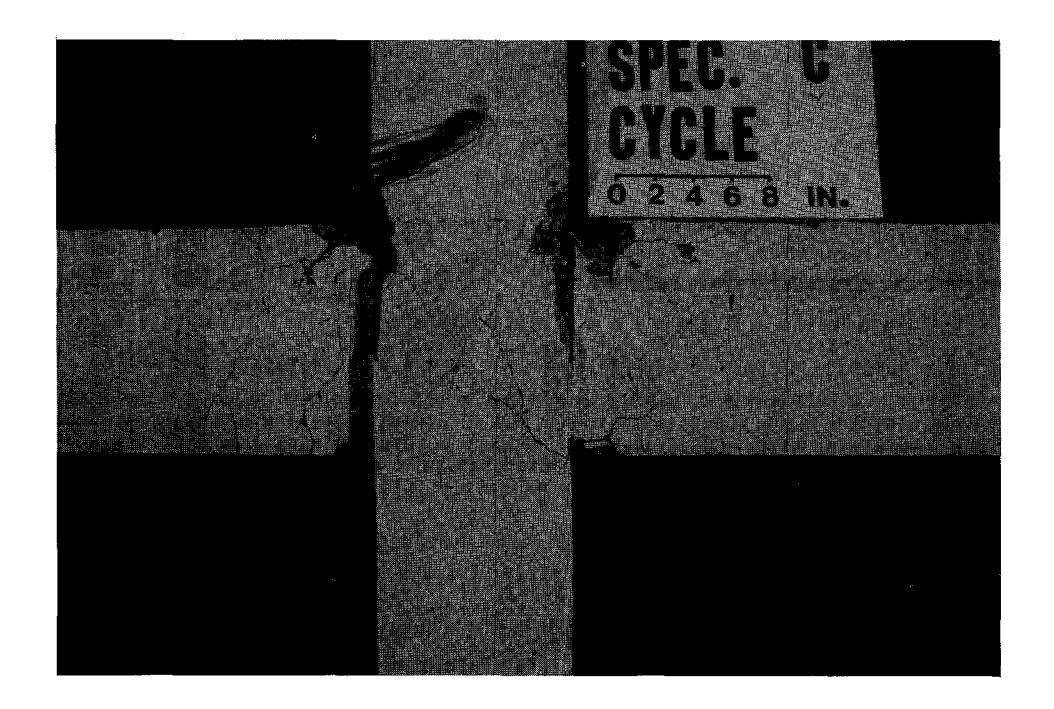
# FIGURE 3-2 Damage in Specimen CR Before Repairs

During the test before repairs, these two specimens suffered considerable damage in beam segments adjacent to the joints and, in the case of specimen CR, the joints and part of the columns were also damaged as shown in figure 3-2. The deterioration of bond between the longitudinal reinforcement and the concrete inside the joint can be seen in figure 3-3 where the loose concrete has been carefully removed. The damage inside the joint in specimen CTBR could not be observed due to the presence of transverse beams although flexural cracks were visible in the columns as shown in figure 3-4. The method chosen to repair such extensive damage was replacement of damaged concrete. In the case of specimen CR, the concrete within the joints and adjacent portions of beams and columns was removed as shown in figure 3-5a, while in the case of specimen CTBR only the damaged portions of beams were removed as shown in figure 3-5b. The purpose of removing concrete from the joint and its vicinities in specimen CR was to use this somewhat ideal type of repair as a basis for comparison with a

a) Exterior joint

b) Interior joint

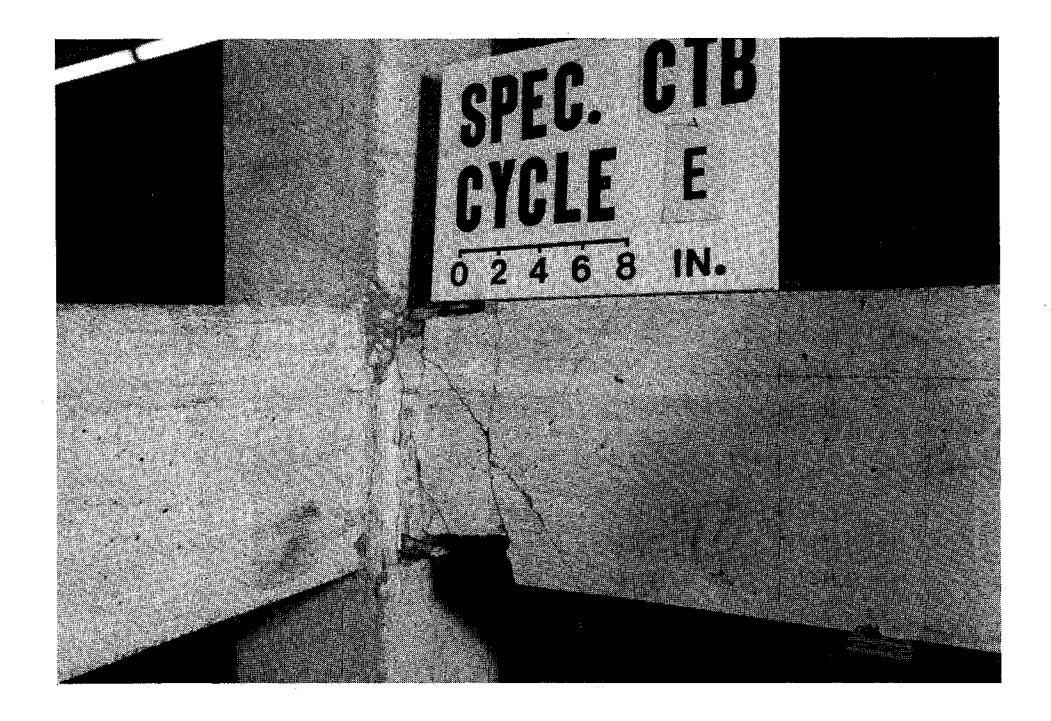
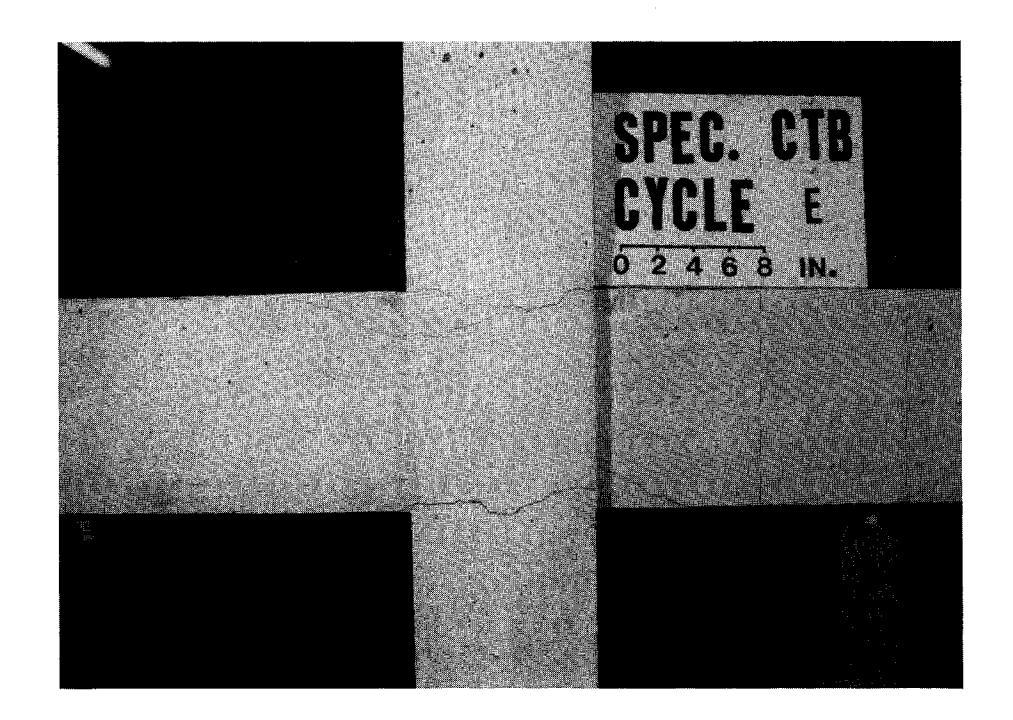
# FIGURE 3-4 Damage in Specimen CTBR Before Repairs

a) Beam damage in exterior joint

b) Column damage in exterior joint

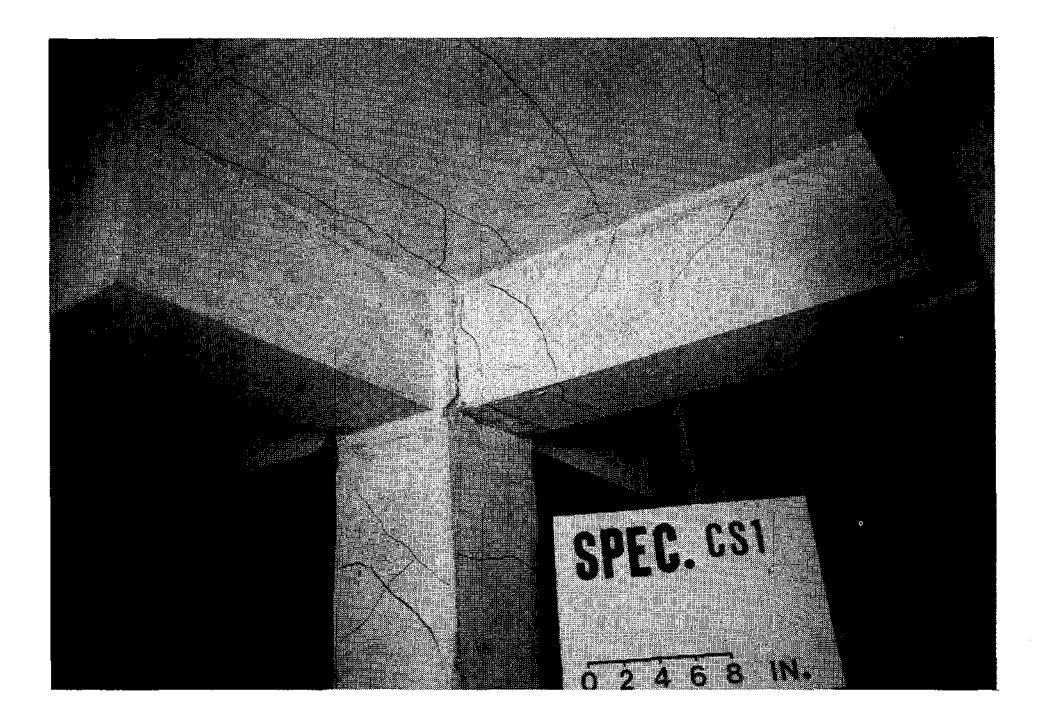
FIGURE 3-6 Specimen CS1R Before Repairs

Specimen CS1R exhibited a large number of cracks of width less than 1/8 in. wide in beams, columns, and the slab as seen in figure 3-6. In addition, some spalled concrete less than 1 in. deep was also removed at the intersections of beam and column surfaces. The epoxy injection method was chosen as the main repair procedure for this specimen and the spalled concrete was replaced with a mixture of high viscosity epoxy and sand. The aim here was to compare this often used technique with others from the point of view of the behavior of the repaired specimens.

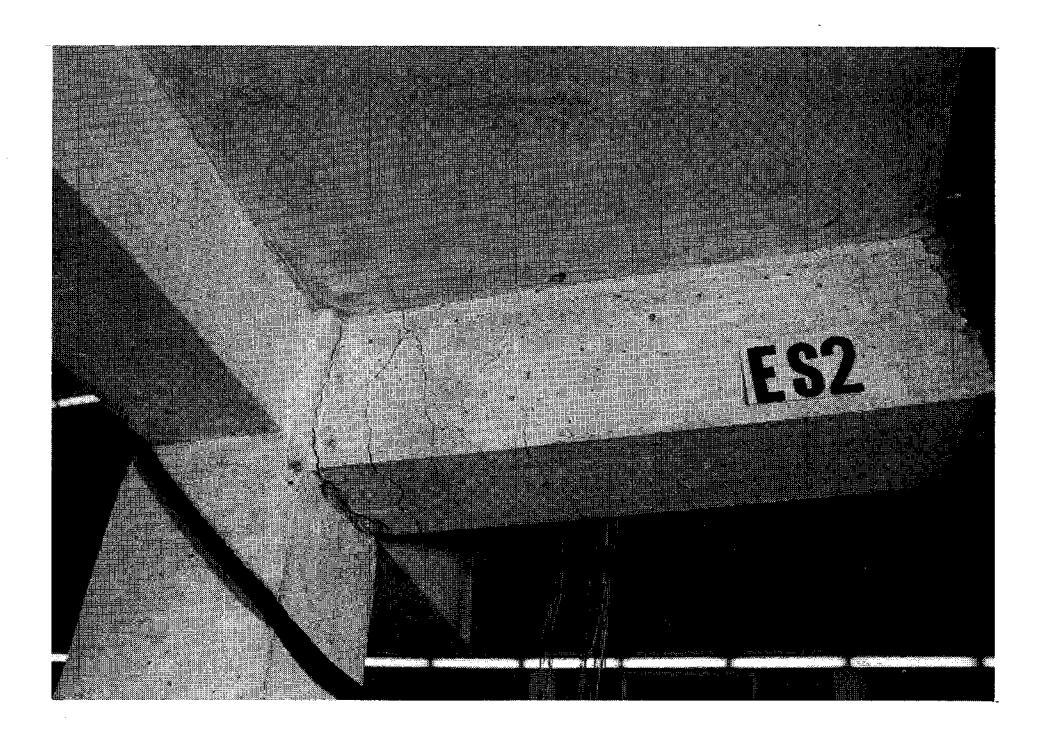
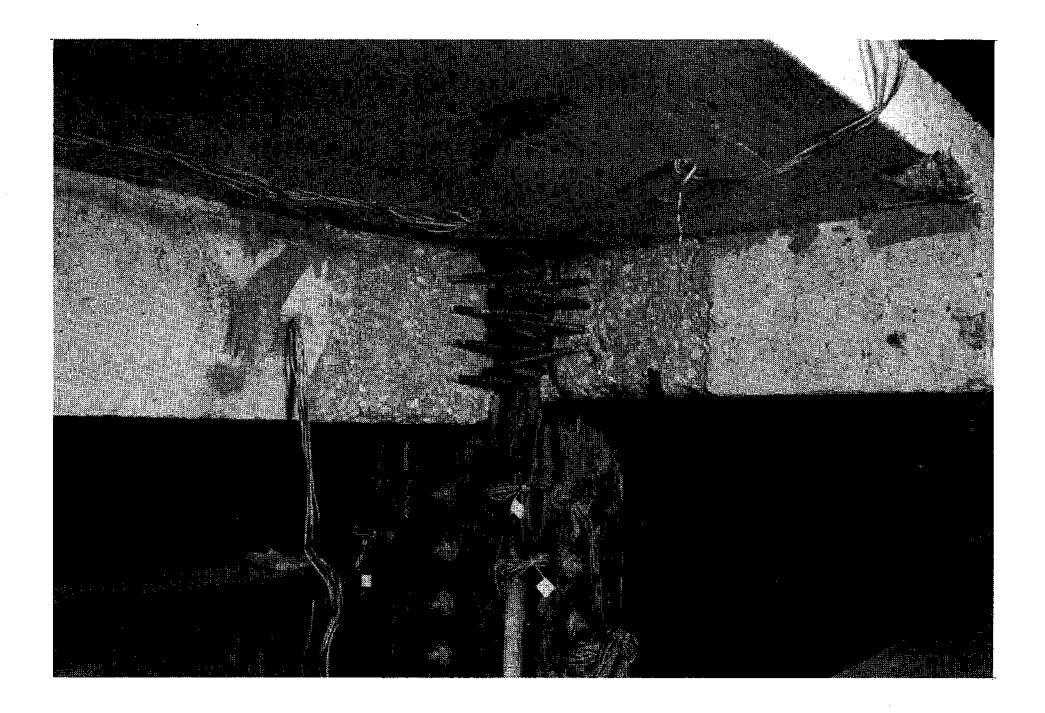
# FIGURE 3-15 Repair of Specimen ES2R

a) Damage before repairs

b) Column and joint reinforcement details

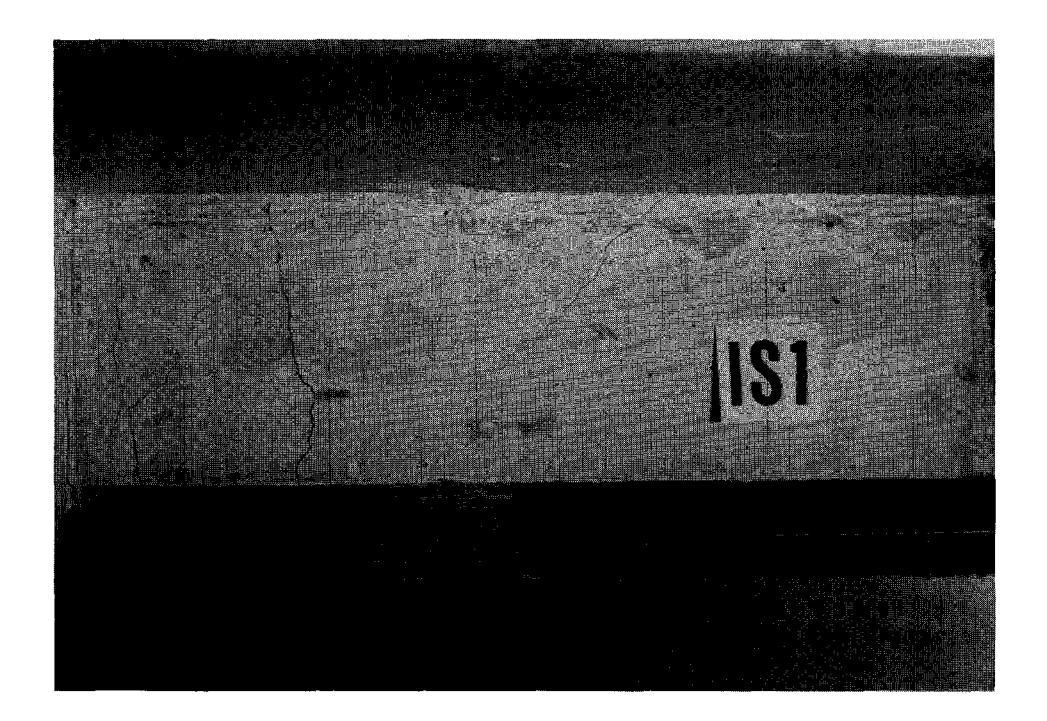
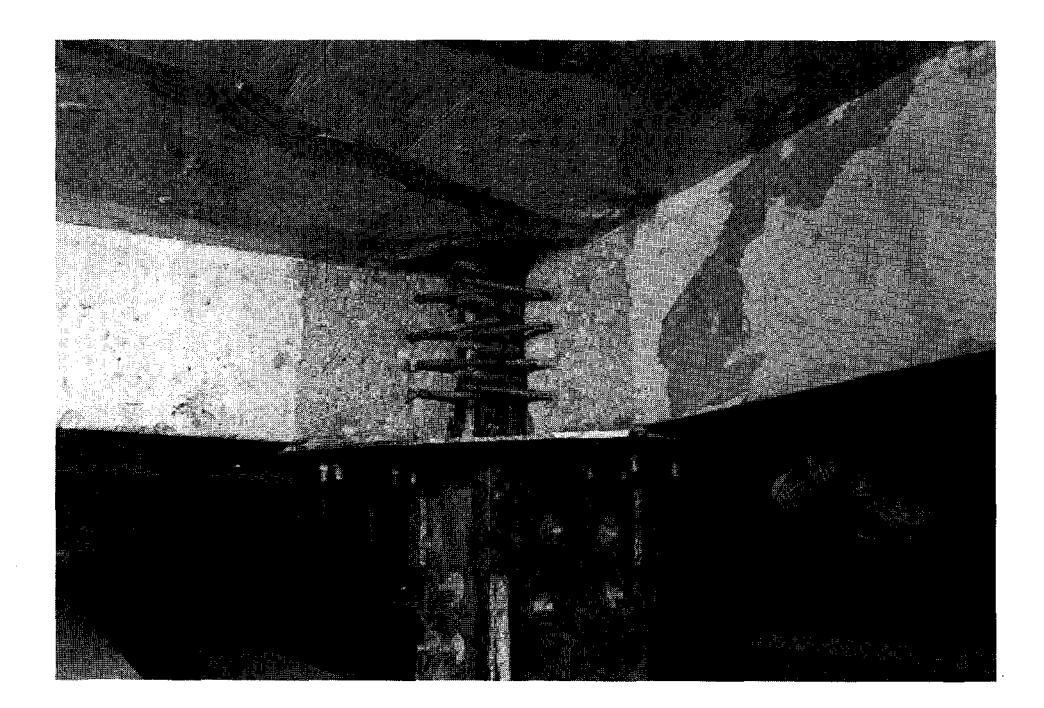
# FIGURE 3-16 Repair of Specimen IS1R

### a) Damage before repairs

b) Column and joint reinforcement details

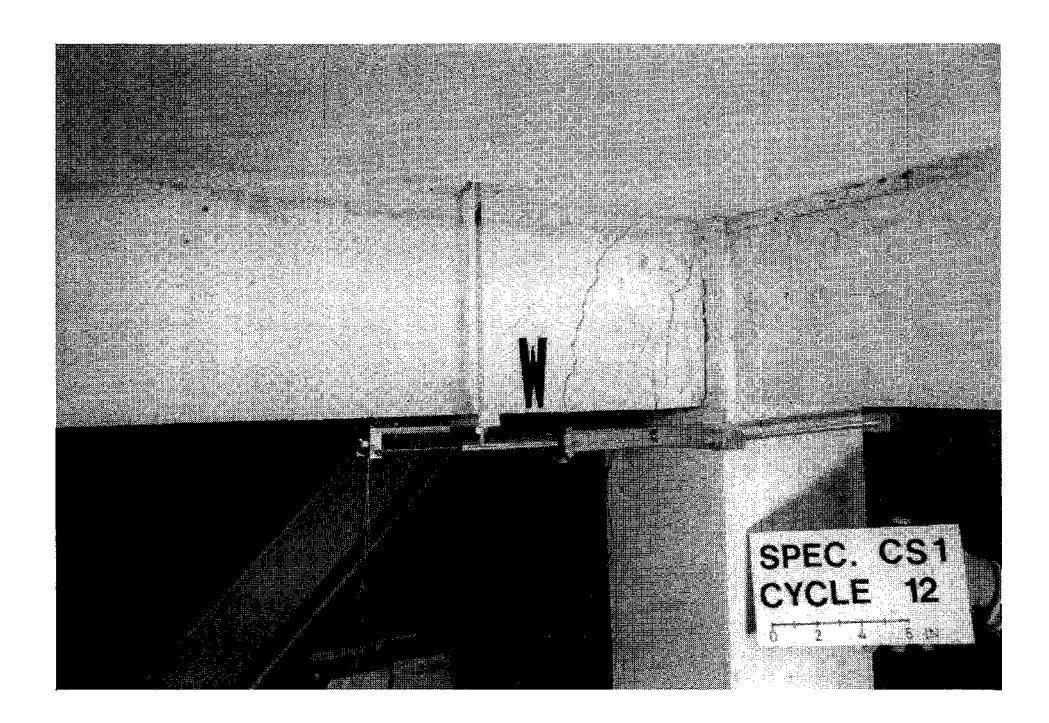
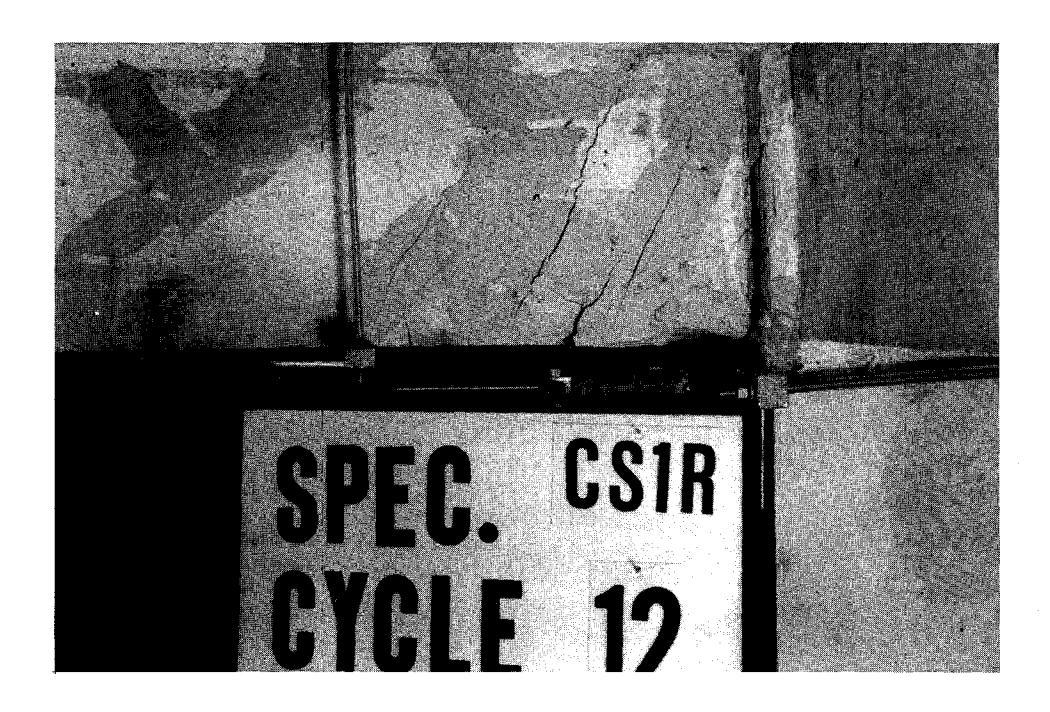
# FIGURE 4-2 Cracking Pattern of CS1R Before and After Repairs

a) Test before repairs

b) Test after repairs

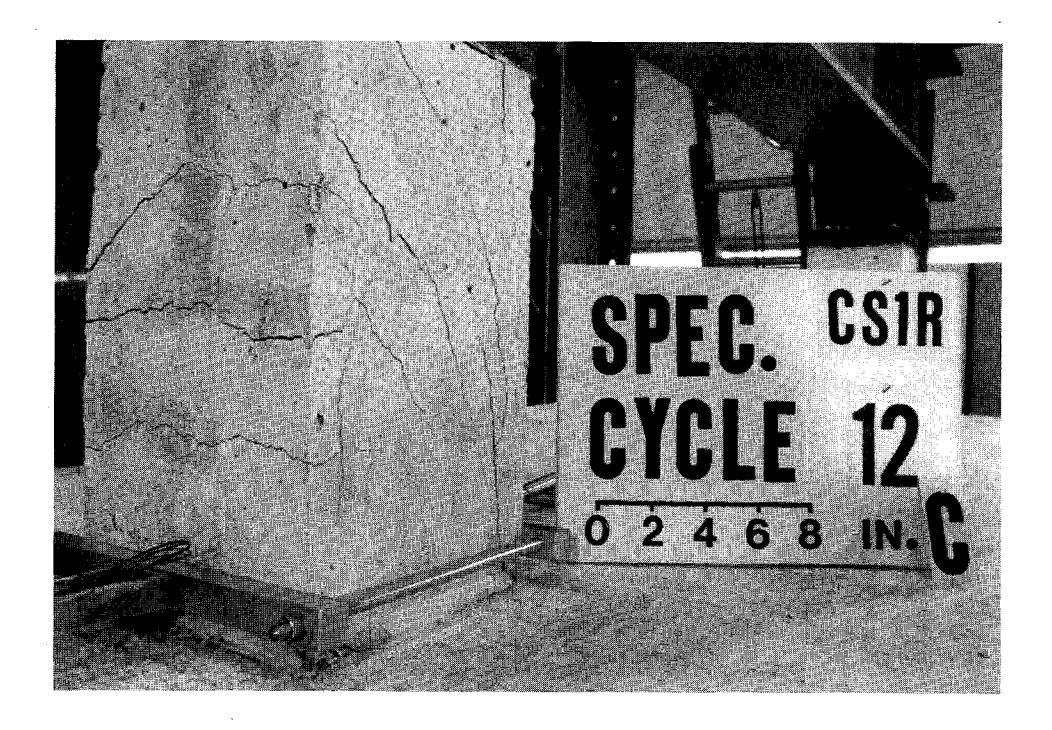
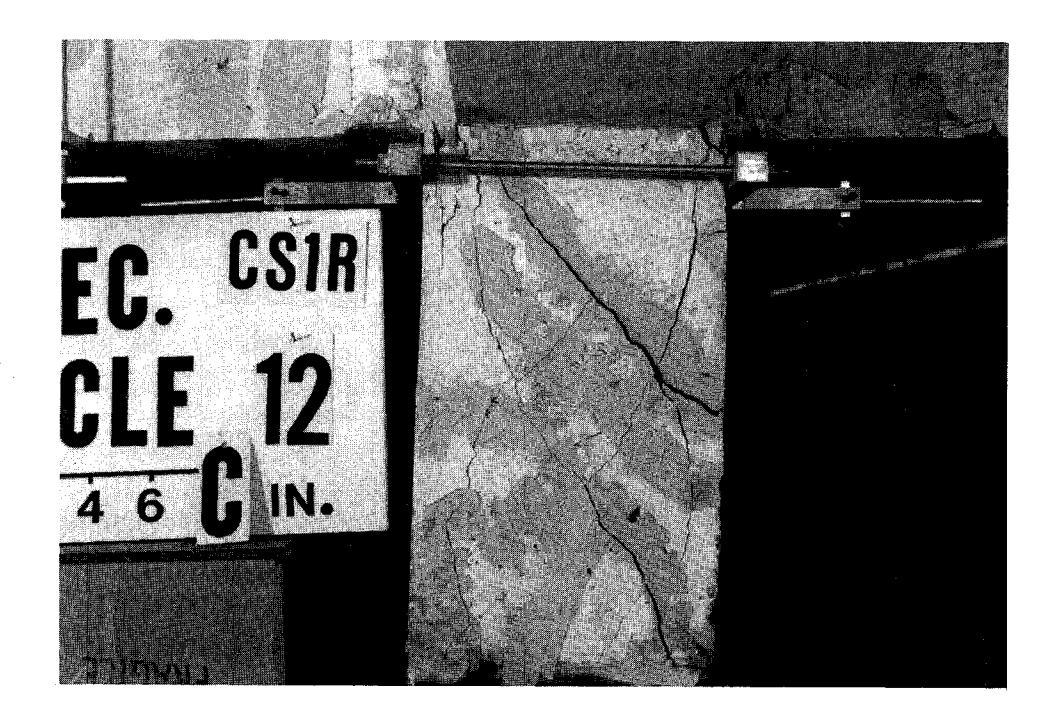
# FIGURE 4-3 Cracking in Center of Column of Specimen CS1R 4-10

a) Column cracking above the slab

b) Column cracking below the slab

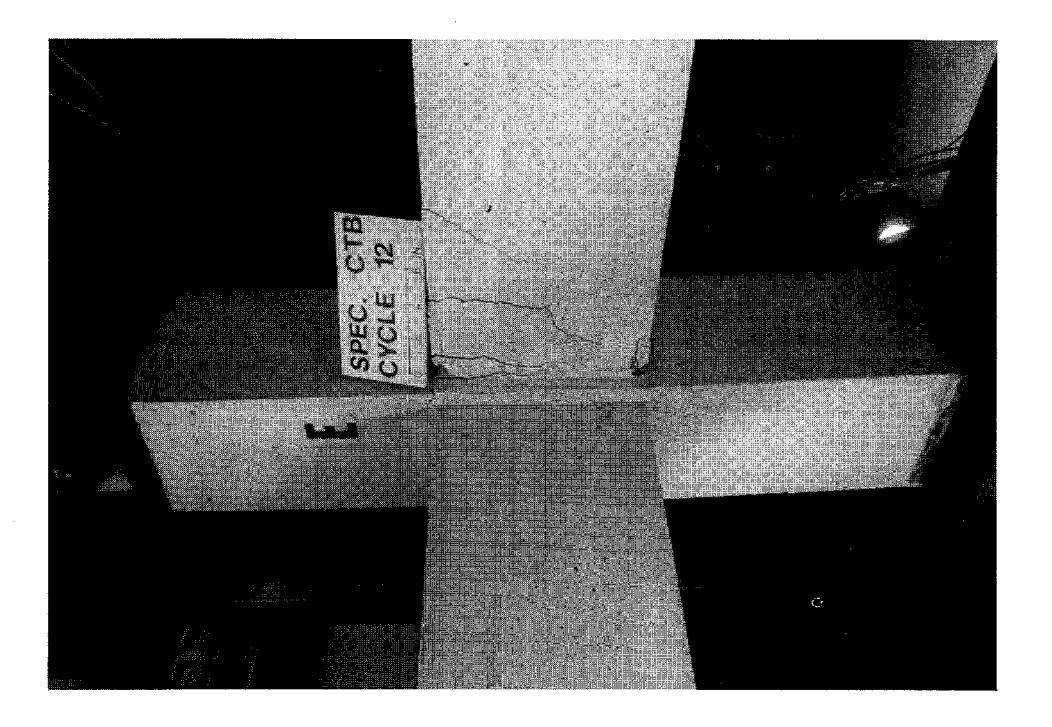
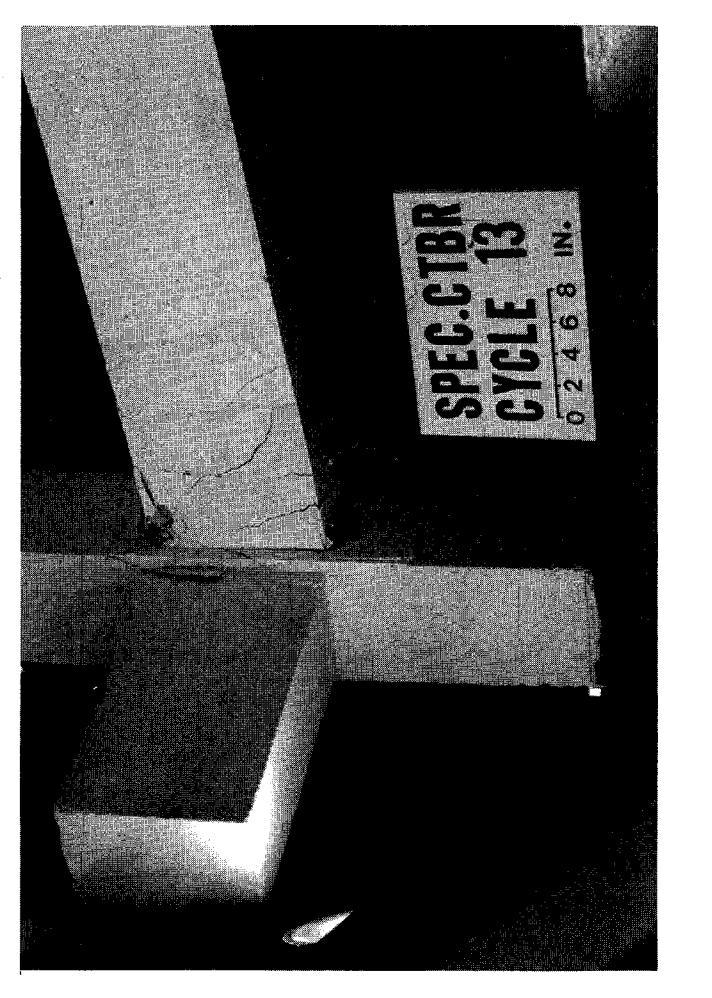
# FIGURE 4-15 Cracking Pattern of Specimen CTBR

b) Test after repairs

a) Test before repairs

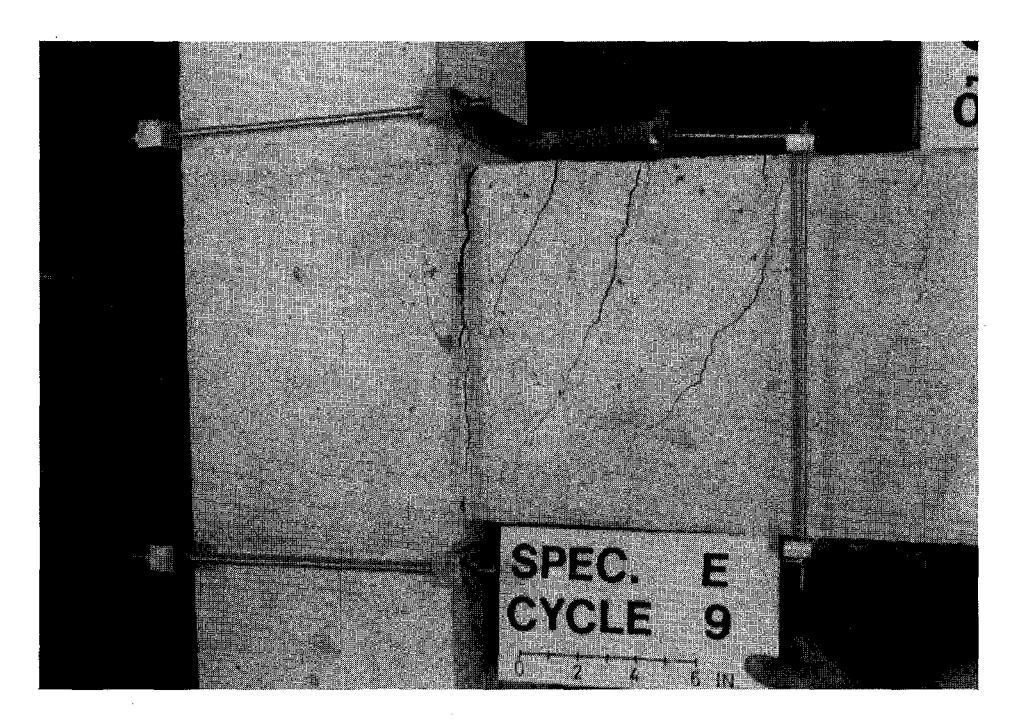
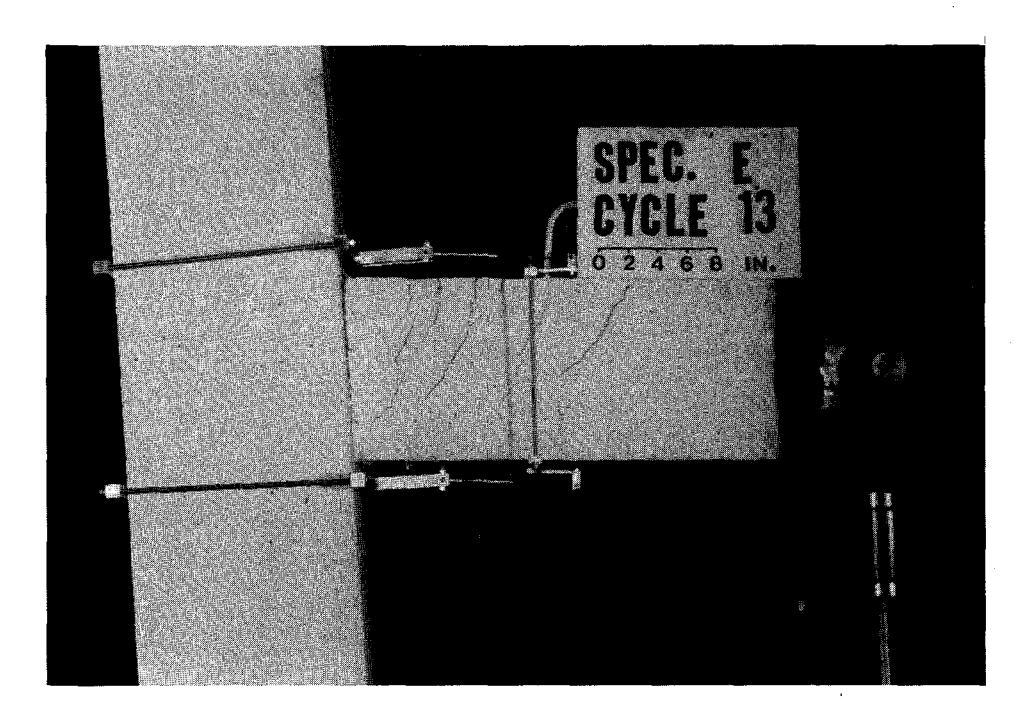
# FIGURE 4-19 Damage in Specimen ER Before and After Repairs

b) Test after repairs

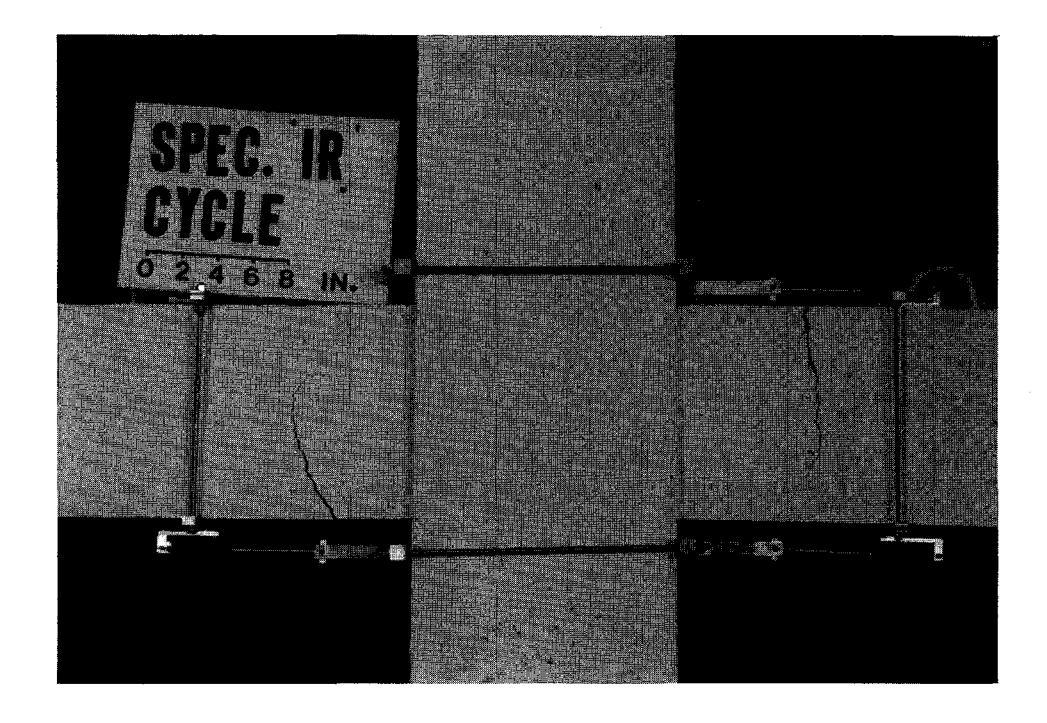
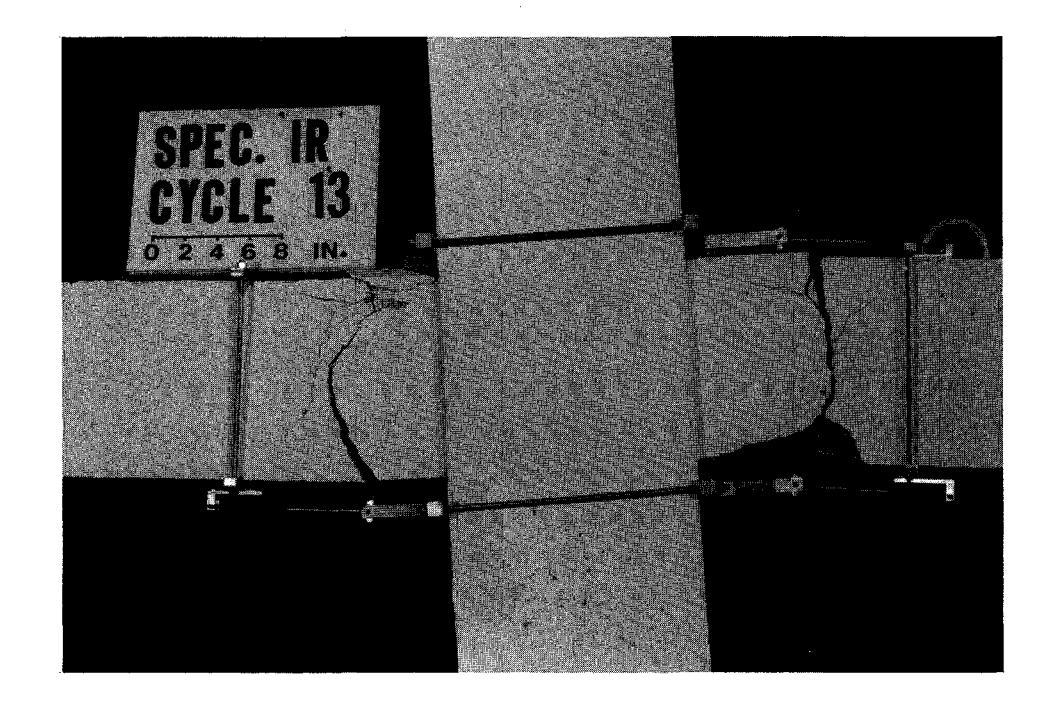
# FIGURE 4-23 Damage in Specimen IR Before and After Repairs

a) Damage at the beginning of the test

b) Damage during load cycle 13

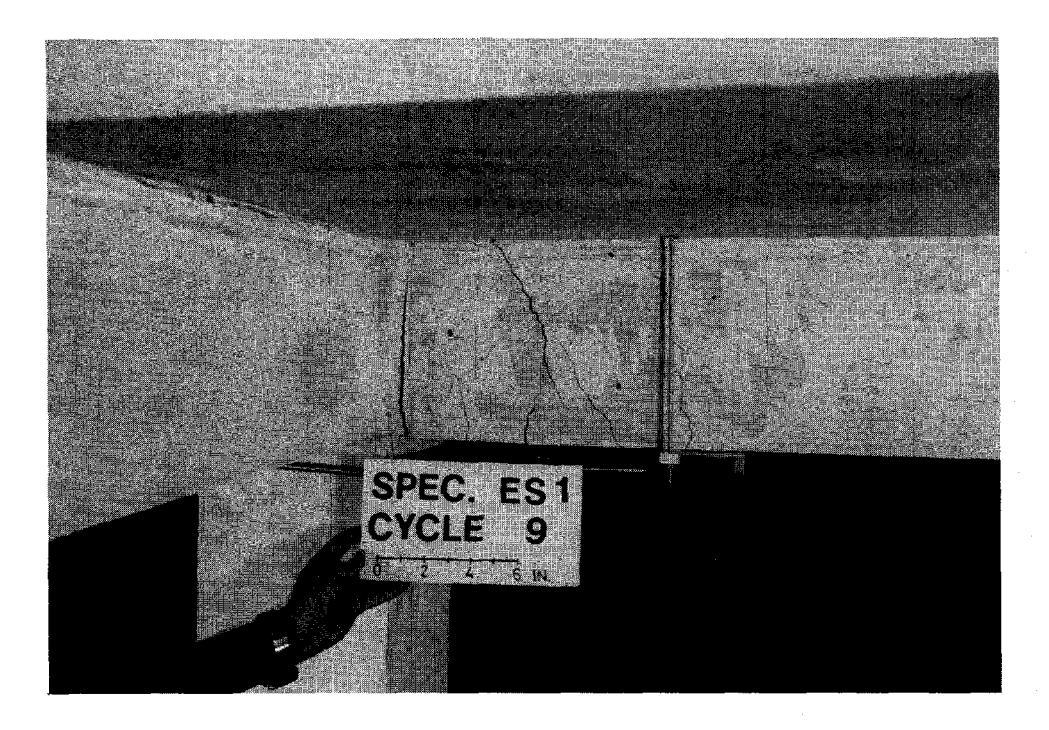
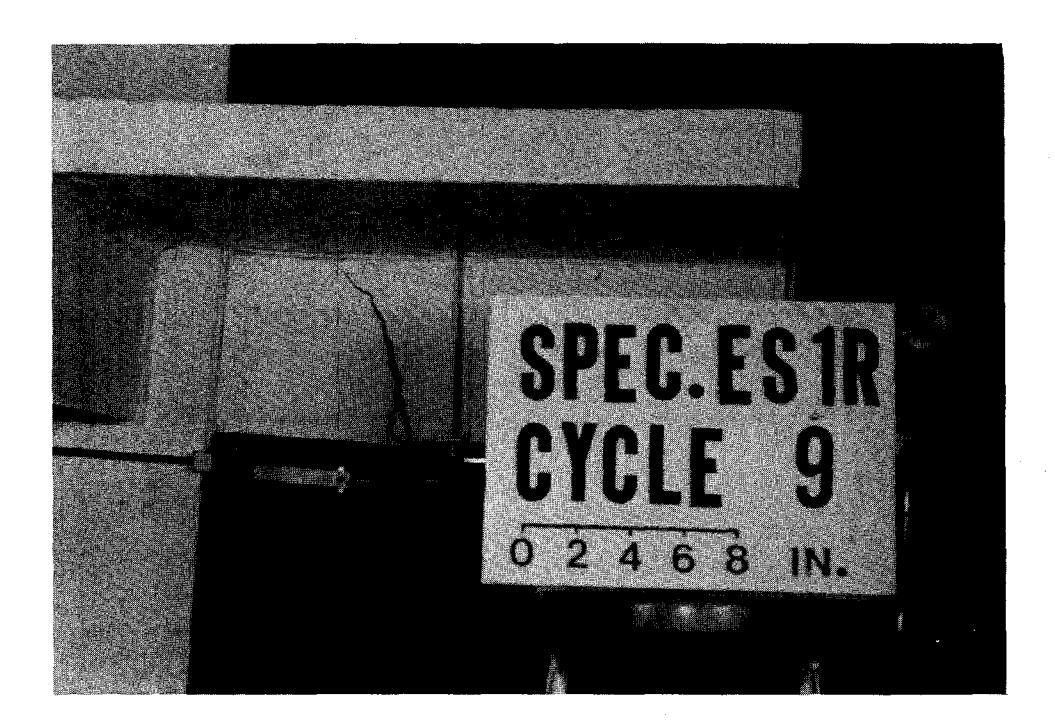
# FIGURE 4-26 Damage in Specimen ES1R Before and After Repairs

b) Test after repairs

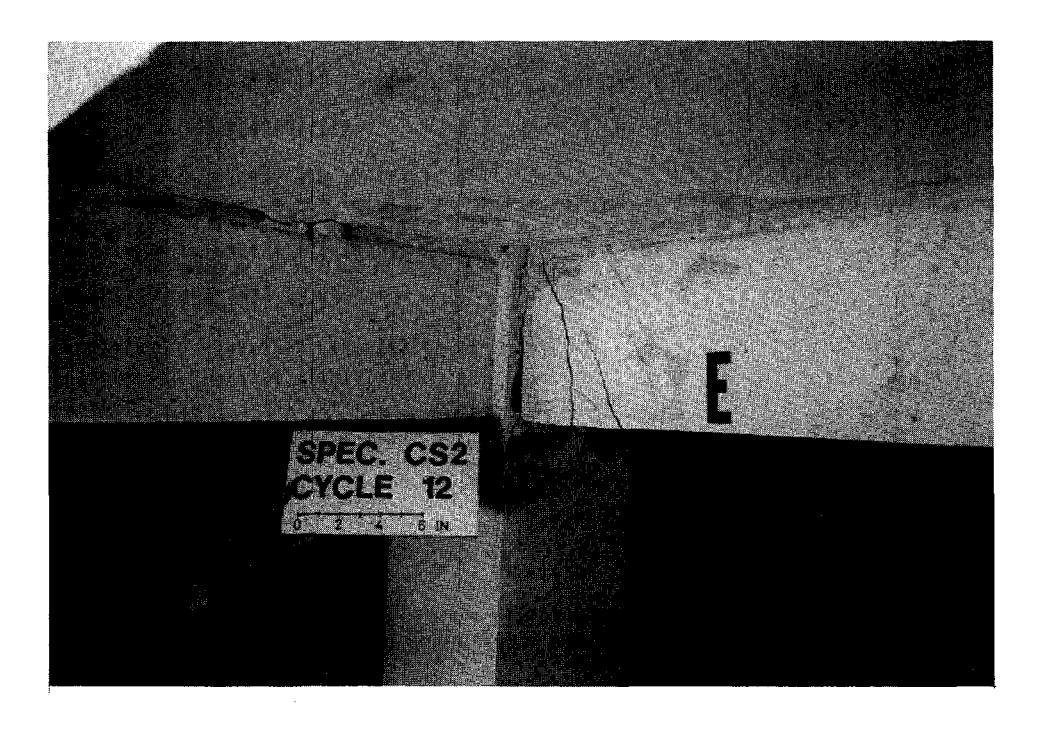
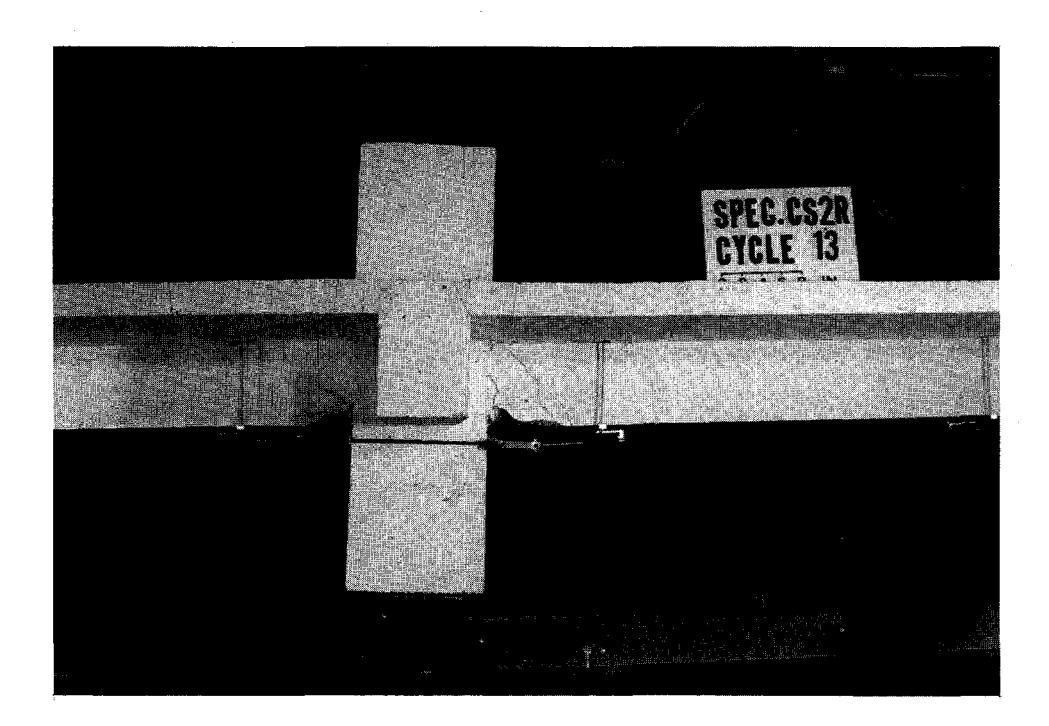
# FIGURE 4-30 Damage in Specimen CS2R Before and After Repairs

b) Test after repairs

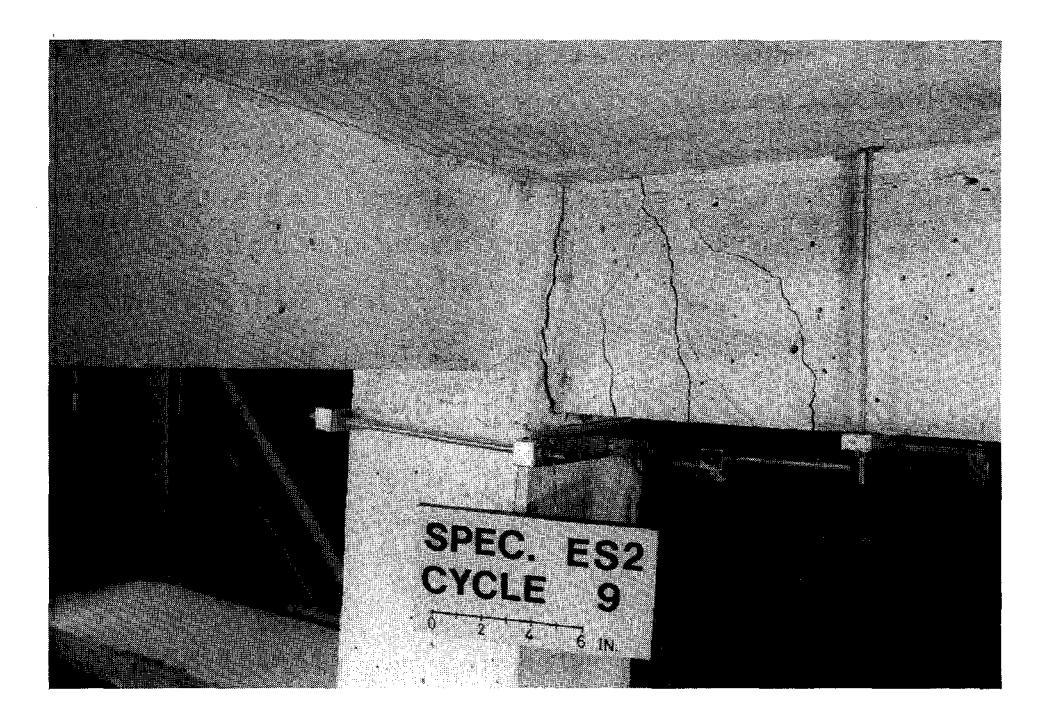
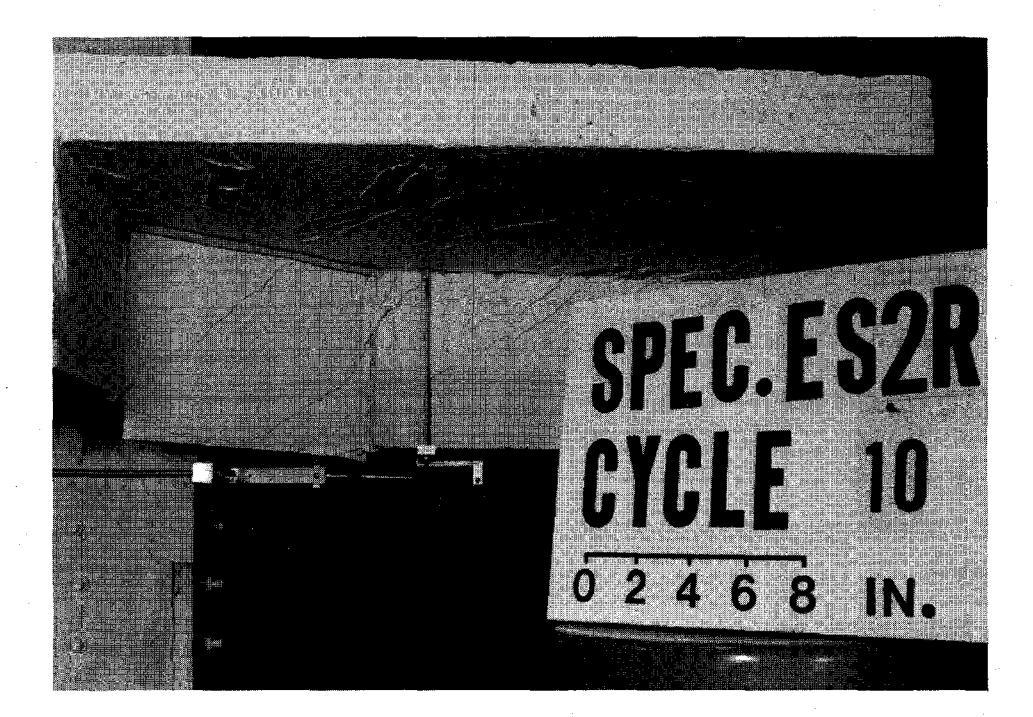
# FIGURE 4-38 Damage in Specimen ES2R Before and After Repairs

b) Test after repairs

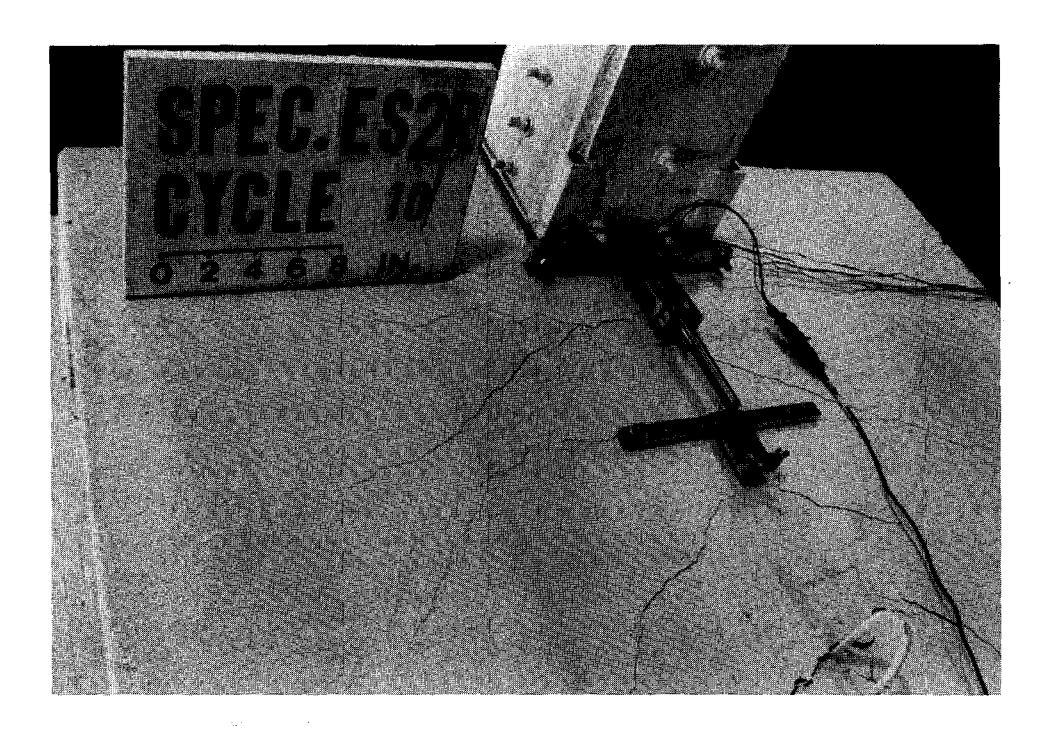
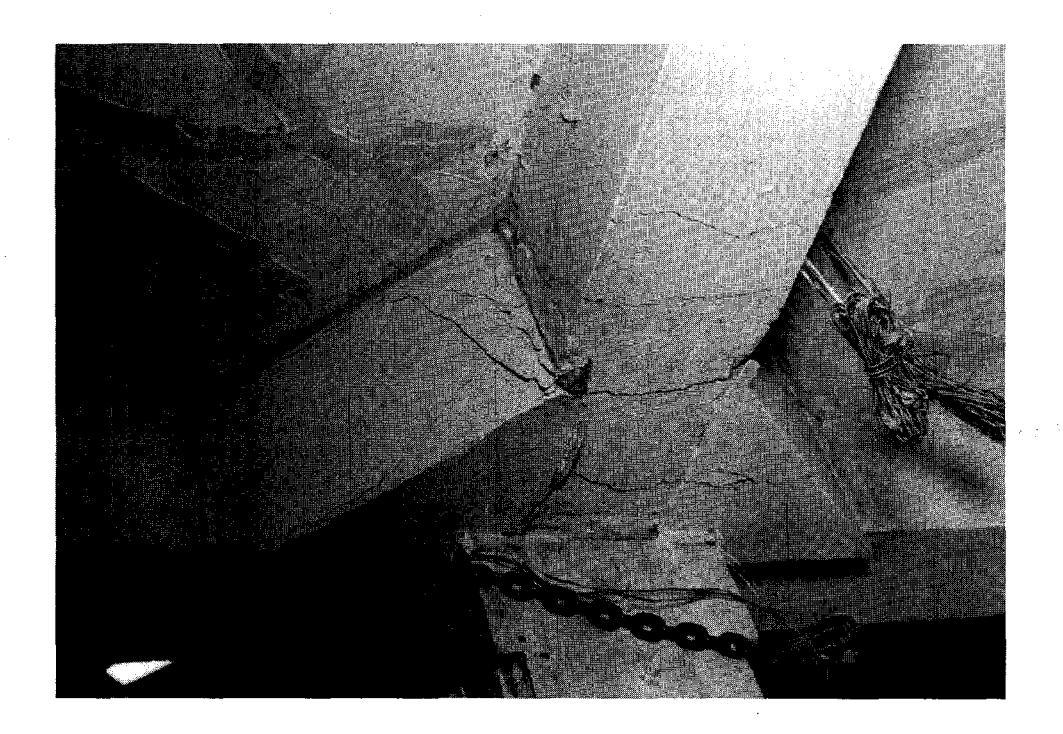
# FIGURE 4-39 Damage Detail in Repaired Specimen ES2R

a) Cracking in the slab

b) Damage at the end of the test

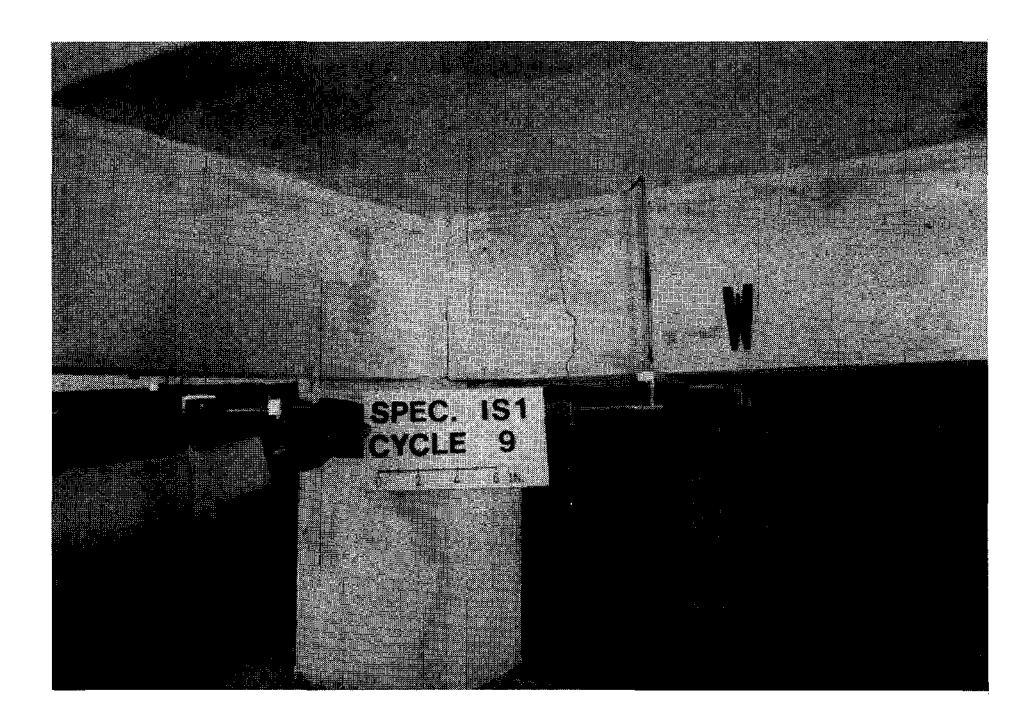
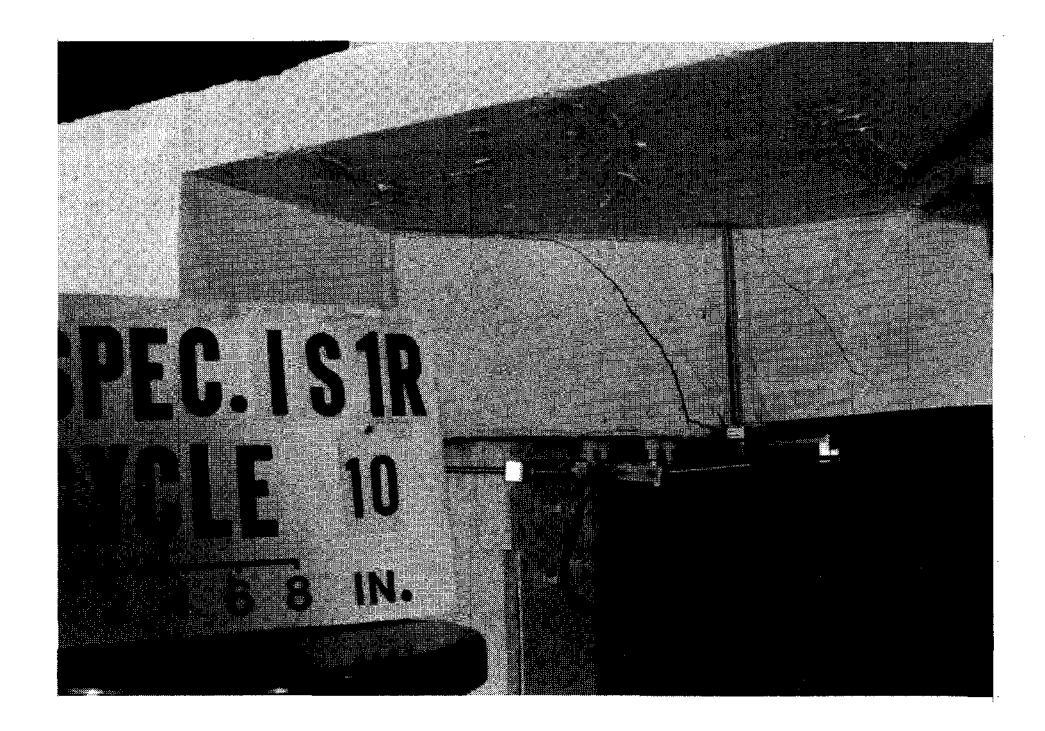
## FIGURE 4-43 Damage in Specimen IS1R Before and After Repairs

b) Test after repairs
